# White Oak Creek WMA- ADA EVAL (WEB) 2025

**WMA- White Oak Creek, Omaha TX, ADA Evaluation**

**Accessibility Evaluation**

**Inspection Date: 09/11/2025**

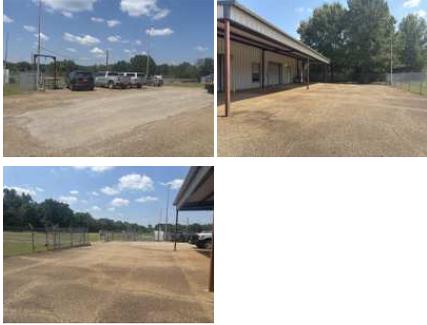
Finding Number	Area Description	Finding	As Built	Recommendation	Citation	Photos	Figure
1	Exterior of Property (Public): WMA HQ Parking Lot (0 Spaces)	There are no accessible parking spaces. Each lot where parking is provided for the public as clients, guests or employees, shall provide accessible parking and shall be located on the shortest accessible route of travel from adjacent parking to an accessible entrance. There are a total of 0 parking spaces in the parking lot that could be reasonably associated with this facility. There should be a minimum of 1 accessible spaces with a minimum of 1 being designed as van accessible.	There are no ADA accessible stalls provided. The lot is asphalt and in good condition for most part and meets most accessibility standards. designated ADA parking and access aisles not provided.	Review parking stall and access aisle requirements <a href="https://www.access-board.gov/ada/#ada-208_2">https://www.access-board.gov/ada/#ada-208_2</a> <a href="https://www.access-board.gov/ada/#ada-502">https://www.access-board.gov/ada/#ada-502</a>	2012 TAS Section: 208.2  2010 ADAS Section: 208.2  2015 ABAAS Section: F208.2

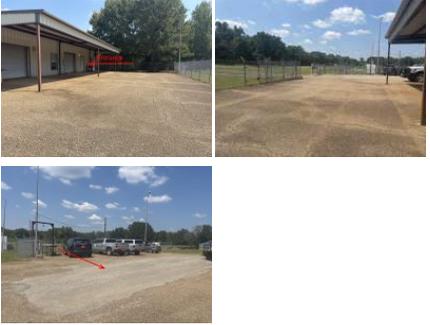
Finding Number	Area Description	Finding	As Built	Recommendation	Citation	Photos	Figure
4	Exterior of Property (Public): WMA HQ Parking Lot (0 Spaces) - Path of Travel to HQ (Main Route)	The path of travel has been found to be in substantial compliance with accessibility codes, standards, and regulations.	Path of travel meets accessibility standards and is considered compliant. Ground is slip resistant with cracking and sloping minimal. Parking area provided needs improvement to parking spaces and initial route but route is good once past parking area	N/A	2012 TAS Section: Advisory 2010 ADAS Section: Advisory 2015 ABAAS Section: Advisory

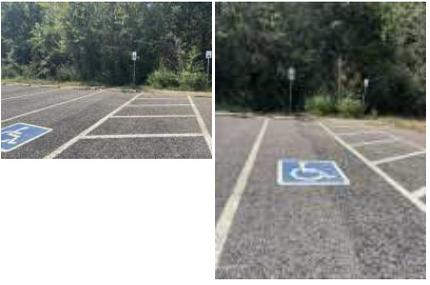
5	Exterior of Property (Public): Primitive Camping Parking Lot (2 Spaces) 1 Van 1 Car	The parking lot has been found to be in substantial compliance with accessibility codes, standards, and regulations.	Van and car accessible parking provided for primitive camping meet compliance. Correct markings, dimensions, and sloping. Sign heights and types meet compliance.	N/A	2012 TAS Section: Advisory 2010 ADAS Section: Advisory 2015 ABAAS Section: Advisory

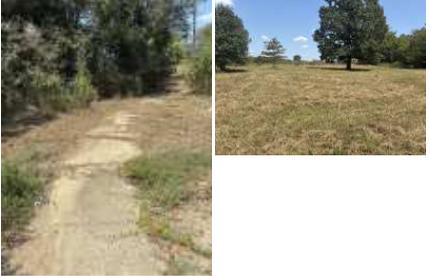
6	Exterior of Property (Public): Primitive Camping Parking Lot (2 Spaces) 1 Van 1 Car - Path of Travel to Primitive Camping (Main Route)	The accessible route contains loose gravel and/or surface materials that do not provide for a stable, firm slip resistant surface. Floor and ground surfaces shall be stable, firm, and slip resistant.	overgrowth and debris on accessible route leading to primitive camping do not meet compliance.	<a href="https://www.access-board.gov/ada/#ada-302_1">https://www.access-board.gov/ada/#ada-302_1</a>	2012 TAS Section: 302.1 2010 ADAS Section: 302.1 2015 ABAAS Section: 302.1

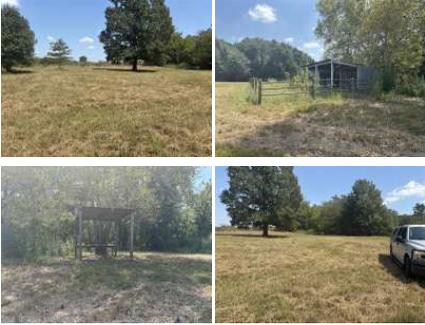
Finding Number	Area Description	Finding	As Built	Recommendation	Citation	Photos	Figure
7	Exterior of Property (Public): Primitive Camping Parking Lot (2 Spaces) 1 Van 1 Car - Primitive Camping	The campground has been found to be in substantial compliance with accessibility codes, standards, and regulations.	Primitive Camping space is considered compliant as there are not amenities of any kind offered. The structure on campgrounds was left there from previous owners and is not accessible, Efforts should be made to improve access to structure and sidewalk leading to campsite but is not required per primitive status.	Campgrounds meet primitive designation by offering no structures that would need to be made accessible. Suggestions were offered to improve access to structure on site and route to campgrounds but are not required. Suggestions to provide accessible porta-stall also relayed when campground is in use	2012 TAS Section: Advisory 2010 ADAS Section: Advisory 2015 ABAAS Section: Advisory

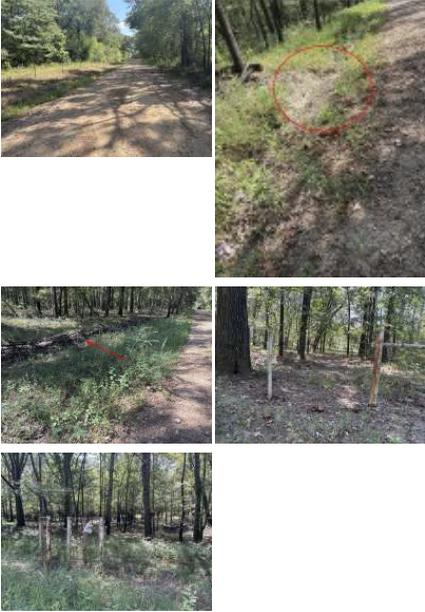
Finding Number	Area Description	Finding	As Built	Recommendation	Citation	Photos	Figure
9	Exterior of Property (Public): WMA Compartment (Hunting Access and Parking) - County RD 4507 Parking and Hunter Access	County Road 4507 is subject to frequent flooding, as evidenced by documented flood damage, debris accumulation along fence lines, and persistent ground ruts that remain wet even on dry days. Flooding can result in road closures lasting several weeks. When flooding occurs only the first entrance at compartment 14 is available to the public along County Road.	Existing unpaved parking areas and the county road are not ADA compliant. These parking areas were not originally designed to meet ADA standards. The use of ATVs on County Road 4507 depends on whether the vehicle is street-legal, which is subject to county regulations. The Texas Parks and Wildlife Department (TPWD) does not have jurisdiction over parking regulations or road closures related to this county road. Several hunter access points exist along the fence line, some of which do not have formal parking areas but allow parking along the adjacent county road. Access to these entry points from county road are no more than 15-30 yards away.	The White Oak Creeks Wildlife Management Area (WMA) is managed by two full-time staff which significantly affects availability and ability to repair areas where fence is missing. ADA upgrades would require input from various agencies and needed permission to break ground with accompanying justifications and jurisdiction compliance, beyond routine maintenance such as mowing or adding gravel.	2012 TAS Section: 502.1, 502.1 Exception  2010 ADAS Section: 502.1, 502.1 Exception  2015 ABAAS Section: 502.1, 502.1 Exception

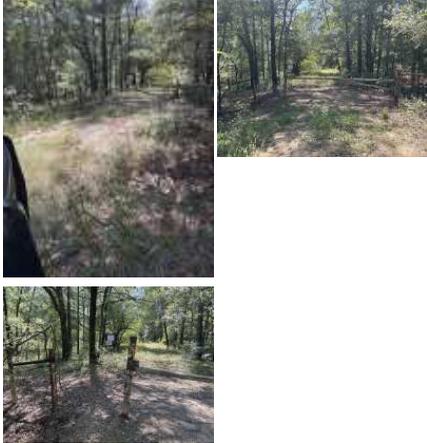
Finding Number	Area Description	Finding	As Built	Recommendation	Citation	Photos	Figure
10	Exterior of Property (Public): WMA Compartment (Hunting Access and Parking) - Compartment #14 (Entry Point-14)	Entry Point (#14) parking is small, fits 2-3 cars total. Compartments 12, 13, and 14 are accessible via County Road 4507. Parking is available either directly on County Road 4507 or within unpaved designated parking areas for the compartments. WMA staff maintain these areas, including mowing or adding gravel during the hunting season to facilitate access.	Existing unpaved parking areas and the county road are not ADA compliant. These parking areas were not originally designed to meet ADA standards. Parking provided differentiates in sizes and proximity to compartment entry points. These access points provide a designated six-foot-wide opening within the fence line, allowing controlled entry	ADA upgrades would require input from various agencies and needed permission to break ground with accompanying justifications and jurisdiction compliance.	2012 TAS Section: 502.1, 502.1 Exception  2010 ADAS Section: 502.1, 502.1 Exception  2015 ABAAS Section: 502.1, 502.1 Exception

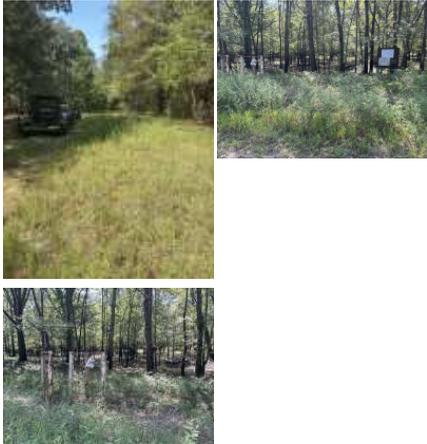
11	Exterior of Property (Public): WMA Compartment (Hunting Access and Parking) - Compartment #14 (Entry Point-Big Parking Lot)	Entry Point (Big Parking Lot) is large, space allows for 6-8 vehicles and or trailers. Entry point pictured originally established by the U.S. Army Corps of Engineers prior to TPWD management. restricts access to V-shaped passing space. Compartments 12, 13, and 14 are accessible via County Road 4507. Parking is available either directly on County Road 4507 or within unpaved designated parking areas for the compartments. WMA staff maintain these areas, including mowing or adding gravel during the hunting season to facilitate access.	Existing unpaved parking areas and the county road are not ADA compliant. These parking areas were not originally designed to meet ADA standards. Parking provided differentiates in sizes and proximity to compartment entry points. These access points provide a designated six-foot-wide opening within the fence line, allowing controlled entry	ADA upgrades would require input from various agencies and needed permission to break ground with accompanying justifications and jurisdiction compliance.	2012 TAS Section: 502.1, 502.1 Exception  2010 ADAS Section: 502.1, 502.1 Exception  2015 ABAAS Section: 502.1, 502.1 Exception

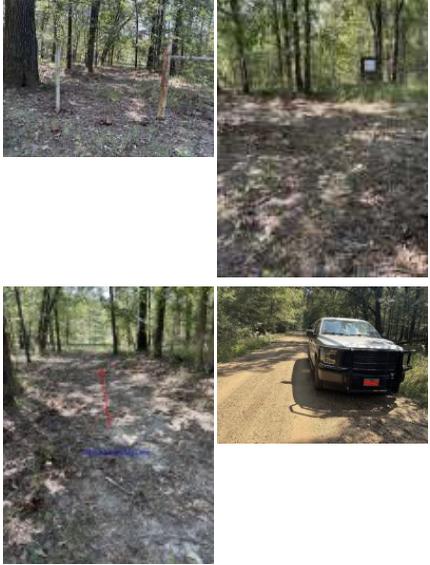
Finding Number	Area Description	Finding	As Built	Recommendation	Citation	Photos	Figure
12	Exterior of Property (Public): WMA Compartment (Hunting Access and Parking) - Compartment #14 (Entry Point-Beaver Pond*)	Entry Point (Beaver Pond) is moderate size, fitting 3-5 cars. Compartments 12, 13, and 14 are accessible via County Road 4507. Parking is available either directly on County Road 4507 or within unpaved designated parking areas for the compartments. WMA staff maintain these areas, including mowing or adding gravel during the hunting season to facilitate access.	High priority area* Beaver Pond area as it leads to Flag Lake. Existing unpaved parking areas and the county road are not ADA compliant. These parking areas were not originally designed to meet ADA standards. Parking provided differentiates in sizes and proximity to compartment entry points. These access points provide a designated six-foot-wide opening within the fence line, allowing controlled entry.	ADA upgrades would require input from various agencies and needed permission to break ground with accompanying justifications and jurisdiction compliance.	2012 TAS Section: 502.1, 502.1 Exception  2010 ADAS Section: 502.1, 502.1 Exception  2015 ABAAS Section: 502.1, 502.1 Exception

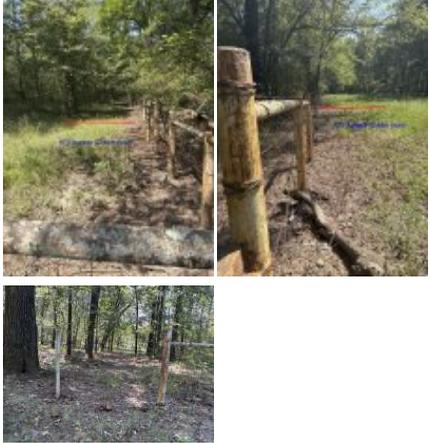
13	Exterior of Property (Public): WMA Compartment (Hunting Access and Parking) - Compartment #14 (Entry Point-Beaver Pond*)	ATVs and other motorized vehicles are permitted only on designated rights-of-way, which are boundary lines of fence, during drawn hunts. They are not allowed to drive through wooded areas, and can use County Road 4507. Those areas pictured in examples. The use of ATVs is subject to specific environmental conditions. If areas are flooded, or certain areas are closed, the use of motorized vehicles is prohibited. Drawn hunts are regulated and assigned areas require strict check-ins and check-outs.	No vehicles are permitted to drive anywhere on or through the fenced-in property beyond these designated entry points in the compartments in question, only allowed during drawn hunting times. The use of ATVs within property boundaries is restricted to specific designated areas, and time frames during the drawn hunts, meaning environmental impact is concentrated, time-limited, regulated, and tracked.	N/A	2010 ADAS Section: Advisory

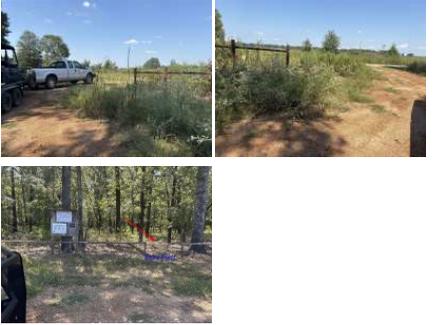
Finding Number	Area Description	Finding	As Built	Recommendation	Citation	Photos	Figure
14	Exterior of Property (Public): WMA Compartment (Hunting Access and Parking) - Compartment #13 (Entry Point-13)	Entry Point (Entry Point 13) is moderate size, space allows for 3-4 vehicles and or trailers. Compartments 12, 13, and 14 are accessible via County Road 4507. Parking is available either directly on County Road 4507 or within unpaved designated parking areas for the compartments. WMA staff maintain these areas, including mowing or adding gravel during the hunting season to facilitate access.	Existing unpaved parking areas and the county road are not ADA compliant. These parking areas were not originally designed to meet ADA standards. Parking provided differentiates in sizes and proximity to compartment entry points. These access points provide a designated six-foot-wide opening within the fence line, allowing controlled entry	ADA upgrades would require input from various agencies and needed permission to break ground with accompanying justifications and jurisdiction compliance.	2012 TAS Section: 502.1, 502.1 Exception  2010 ADAS Section: 502.1, 502.1 Exception  2015 ABAAS Section: 502.1, 502.1 Exception

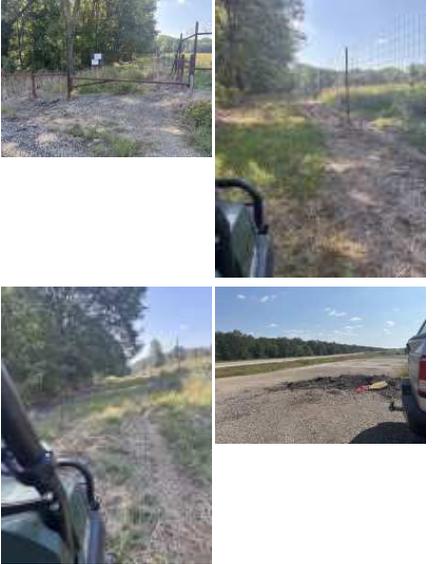
15	Exterior of Property (Public): ADA ATV Trails and Hunter Access - Compartment #5 - ATV (ADA) Trail/Hunting Access	ATV ADA trail is located on high ground providing around 5 miles of access for compartment 5 hunting access. Fence line routes pictured are mowed and maintained by WMA staff	There is no formal accessible parking available to use these trails, recommendations to improve these areas were relayed to WMA staff. The parking areas are asphalt but there is no striping or designation for accessible spaces provided.	N/A	2010 ADAS Section: Advisory

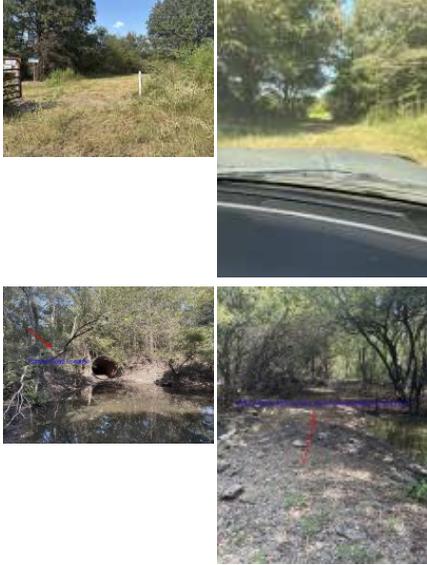
Finding Number	Area Description	Finding	As Built	Recommendation	Citation	Photos	Figure
19	Exterior of Property (Public): ADA ATV Trails and Hunter Access - Twin Lakes - ATV (ADA) Trail/Hunting Access	Trail ends at a washed-out culvert, with documented evidence of destruction; no ATV or OPDMD access is permitted beyond this point. The existing trail, nearly a mile long, follows an old pre-existing roadway that has been used for ADA ATV access. The trail area is prone to flooding and washed-out culvert marks end of trail.	There is no formal accessible parking available to use these trails, recommendations to improve these areas were relayed to WMA staff. The parking areas are asphalt but there is no striping or designation for accessible spaces provided.	Restoration of the trail or road to previous conditions would be a significant financial undertaking, with rough cost estimates near \$250,000 and requiring coordination with multiple agencies, including TXDOT, archeological clearance, and a 404 permit.	2010 ADAS Section: Advisory

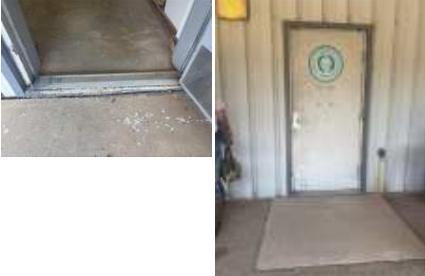
Finding Number	Area Description	Finding	As Built	Recommendation	Citation	Photos	Figure
23	Structures on Property (Public) : HQ Offices (Interior) - Entrance/Exit Doors	The threshold is greater than 1/2 inch high. The threshold at a doorway shall be no higher than 1/2 inch. Changes in level between 1/4 inch and 1/2 inch must be beveled at 1:2 or less. 1/4 inch is the maximum vertical rise.	Threshold for entrance doors do not meet compliance due to height and gap not meeting standards, Door is heavy but no enforceable code for exterior doors at this time, only recommendations of 8-10lbs of force recommended, Public only uses this door to pick up permits and are not permitted to use elements, including restroom, inside HQ, Interior of HQ considered STAFF are only.	<a href="https://www.access-board.gov/ada/#ada-404_2_5">https://www.access-board.gov/ada/#ada-404_2_5</a> Suggestions made to leave call for assistance number for people who need accommodation placed on door or outside gate entrance. Due to staff limitations and non accessible door, best solution at this time.	2012 TAS Section: 404.2.5  2010 ADAS Section: 404.2.5  2015 ABAAS Section: 404.2.5

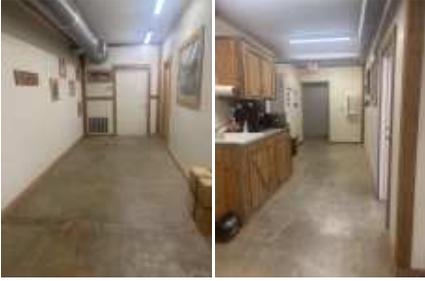
Finding Number	Area Description	Finding	As Built	Recommendation	Citation	Photos	Figure
24	Structures on Property (STAFF) : HQ Offices (Interior)	The interior walkways has been found to be in substantial compliance with accessibility codes, standards, and regulations.	Interior walkways meet compliance, clutter free and clear floor space provided.	N/A	2012 TAS Section: Advisory 2010 ADAS Section: Advisory 2015 ABAAS Section: Advisory

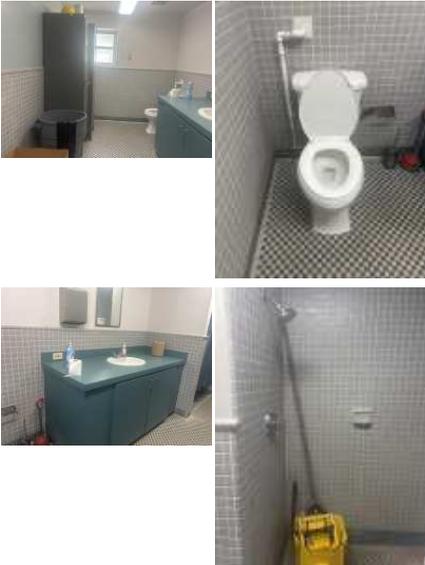
26	Structures on Property (STAFF) : HQ Offices (Interior) - Restroom/Showers	The restroom is not nearly compliant. The restroom does not have the required minimum clear floor space or maneuvering clearances for the toilet. The restroom does not have the required minimum clear floor space or maneuvering clearances for the lavatory. The entry door does not contain the required minimum maneuvering spaces on the pull/push sides. The entry door encroach into the required clear floor space for fixtures. Grab bars are missing and/or incorrectly installed. Accessories, such as toilet seat covers, paper towel holders, garbage cans, hand dryers, and mirrors are either too high or without clear floor space or both. The restroom contain floor level changes greater than a 1/2 inch of the floor drains and is slope (XX) - (XX), the shower is too small and missing numerous accessible elements.	This restroom requires a number of component to gain compliance.	<a href="https://www.access-board.gov/ada/#ada-213_2">https://www.access-board.gov/ada/#ada-213_2</a> Review restrooms components to make accessible. <a href="https://www.access-board.gov/ada/#ada-603">https://www.access-board.gov/ada/#ada-603</a>	2012 TAS Section: 213.2 2010 ADAS Section: 213.2 2015 ABAAS Section: F213.2
