Access Audit Site Report

Stephen F. Austin State Park

Accessibility Evaluation

Inspection Date: 08/18/2022

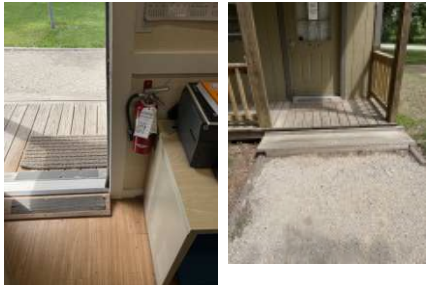
Finding Number	Area Description	Lat/Long	Finding	As Built	Recommendation	Citation	Photos	Figure
16	Headquarters Area: HQ - Restrooms	[29.8119865 , -96.108079 6]	50% of the single accommodation restrooms provided in this grouping are not nearly compliant. The restrooms do not have the required minimum clear floor space or maneuvering clearances for the toilet, The restrooms do not have the required minimum clear floor space or maneuvering clearances for the lavatory, The entry doors do not contain the required minimum maneuvering spaces on the pull/push sides, The entry doors encroach into the required clear floor space for fixtures, Grab bars are missing and/or incorrectly installed, Accessories, such as toilet seat covers, paper towel holders, garbage cans, hand dryers, and mirrors are either too high or without clear floor space or both, The restrooms contain floor level changes greater than a 1/2 inch, the showers are too small and missing numerous accessible elements.	Both public and employee restroom lacks accessible features	Create compliant wheelchair accessible restrooms and correct all features to be accessible if feasible to meet 50% compliant restrooms in this location.	2015 ABAAS Section: 603.1 2012 TAS Section: 603.1 2010 ADAS Section: 603.1

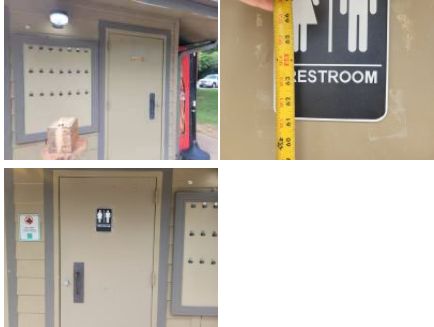
19	Headquarters Area: HQ - Restrooms	[29.8119841 , -96.108075 8]	Minimum maneuvering clearances at doors and gates shall comply with 404.2.4. Maneuvering clearances shall extend the full width of the doorway and the required latch side or hinge side clearance. The sweep period for doors with closers shall be adjusted so that from an open position of 70 degrees, the door will take at least 3 seconds to move to a point 3 inches from the latch, measured to the leading edge of the door. Exterior doors are recommended to be maintained at 8.5 lbf as a smart practice. Force is to be measured at the operating hardware or 30 inches from the hinges, whichever is greater.	Both restrooms - wall push side, 15 lbf, closes fast	For all doors along the public circulation route, provide required maneuvering clearance on push and pull side of doors. For all doors along the public circulation route, inspect, adjust, and maintain closing speed on door closers. For all doors along the public circulation route, inspect, adjust, and maintain 8.5 lbf to open exterior doors as a smart practice.	2010 ADAS Section: 404.2.3, 404.2.7, 404.2.4, 404.2.11, 404.2.11 Exception

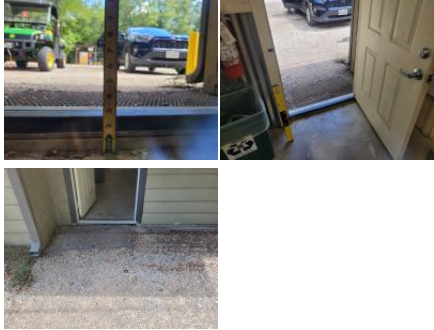
21	Employee Areas: Maintenance	[29.8125715 , -96.108689]	There is a change in level greater than 1/4 inch. 1/4 inch is the maximum vertical rise. Changes in level between 1/4 inch and 1/2 inch must be beveled at 1:2 or less. Changes in level greater than 1/2 inch must be by way of a ramp.	shop with laundry to break - 3" CIL	Repair, bevel or ramp CIL along accessible route (AR) to max .25".	2015 ABAAS Section: 303.3 2012 TAS Section: 303.3 2010 ADAS Section: 303.3

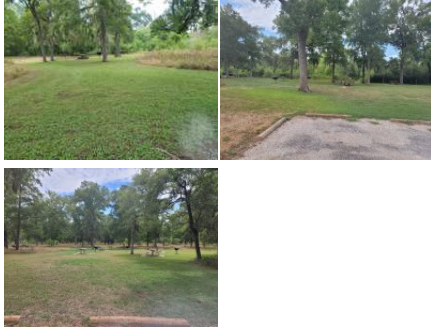
Finding Number	Area Description	Lat/Long	Finding	As Built	Recommendation	Citation	Photos	Figure
36	Day Use Area: Day Use - Picnic Area	[29.8139746 , -96.1110214]	At least one accessible route shall connect accessible buildings, accessible facilities, accessible elements, and accessible spaces that are on the same site. For areas of sport activity, an accessible route is required to connect to the boundary of each area of sport activity. The size of an area of sport activity includes only the space needed to play. Where multiple sports fields or courts are provided, an accessible route is required to each field or area of sport activity.	0 of 22 picnic area grills on AR, lacks AR to fire pits, water spouts, and hooks where provided	Provide an accessible route (AR) to each element within the site.	2010 ADAS Section: 206.2.2, 206.2

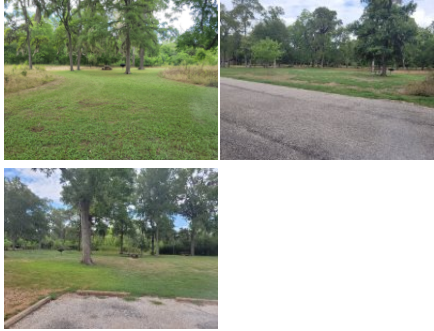
37	Day Use Area: Day Use - Picnic Area	[29.8138833 , -96.1105513]	The route of travel at this location does not provide the required minimum width. The minimum clear width for sidewalks and walks is 36 inches.	24" wide sidewalk to recycling	Widen EAR to min 36" clear width.	2015 ABAAS Section: 403.5.1 2012 TAS Section: 403.5.1 2010 ADAS Section: 403.5.1

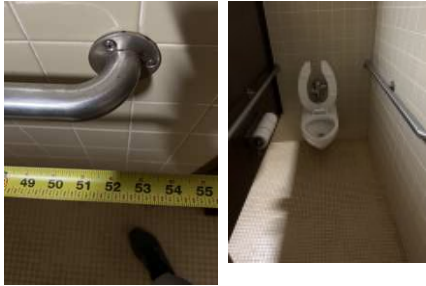
48	Day Use Area: Day Use - Men's Restroom	[29.8138127 , -96.112451 8]	The toilet paper is not installed within the compliant range in front of the toilet. Toilet paper dispensers shall be 7 inches minimum and 9 inches maximum in front of the water closet measured to the centerline of the dispenser. The outlet of the dispenser shall be 15 inches minimum and 48 inches maximum above the finish floor and shall not be located behind grab bars. Dispensers shall not be of a type that controls delivery or that does not allow continuous paper flow. There shall be a clearance of 1 1/2 inches minimum below the grab bar.	TP not within compliant range	Remount toilet paper dispenser max 7" to 9" from front of toilet, 15" to 48" AFF and min 12" above or 1.5" below grab bar.	2015 ABAAS Section: 604.7 2012 TAS Section: 604.7 2010 ADAS Section: 604.7

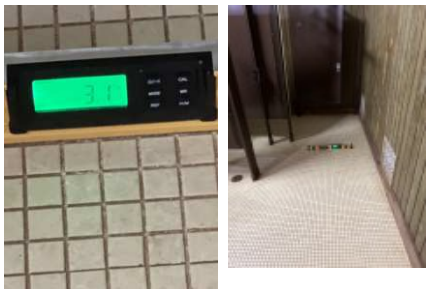
Finding Number	Area Description	Lat/Long	Finding	As Built	Recommendation	Citation	Photos	Figure
50	Day Use Area: Day Use - Men's Restroom	[29.8138149 , -96.1124507]	Minimum maneuvering clearances at doors and gates shall comply with 404.2.4. Maneuvering clearances shall extend the full width of the doorway and the required latch side or hinge side clearance. The sweep period for doors with closers shall be adjusted so that from an open position of 70 degrees, the door will take at least 3 seconds to move to a point 3 inches from the latch, measured to the leading edge of the door. Exterior doors are recommended to be maintained at 8.5 lbf as a smart practice. Force is to be measured at the operating hardware or 30 inches from the hinges, whichever is greater.	Men's door - lacks clearance on both sides, 15 lbf, fast closing	For all doors along the public circulation route, provide required maneuvering clearance on push and pull side of doors. For all doors along the public circulation route, inspect, adjust, and maintain closing speed on door closers. For all doors along the public circulation route, inspect, adjust, and maintain 8.5 lbf to open exterior doors as a smart practice.	2010 ADAS Section: 404.2.3, 404.2.7, 404.2.4, 404.2.11, 404.2.11 Exception

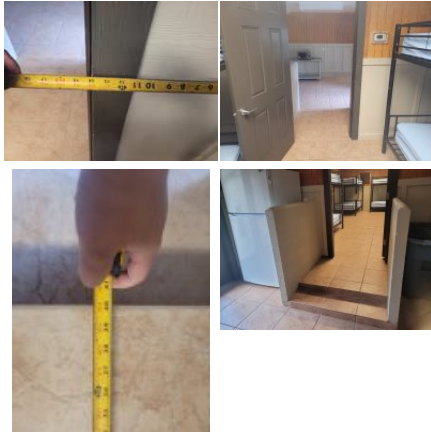
88	Bullinger Creek Group Lodge: Bullinger Creek - Lodge	[29.8149826 , -96.110502 4]	The threshold has a vertical change greater than 1/4 inch high. The threshold has a gap greater than 1/2 inch wide.	Bedroom off kitchen w/ steps exterior door - 7" step, 1" gap	For all doors along the public circulation route, repair, bevel, or ramp CILs at door entries to max .25". For all doors along the public circulation route, fill gaps at door entries to max .5".	2010 ADAS Section: 404.2.3, 404.2.7, 404.2.4, 404.2.11, 404.2.11 Exception

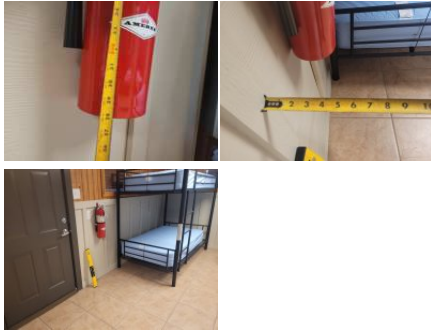
91	Bullinger Creek Group Lodge: Bullinger Creek - Lodge	[29.8149924 , -96.1105105]	An item or items project more than 4 inches into the circulation path. Wall-mounted objects that have leading edges between 27 inches and 80 inches from the floor must not project more than 4 inches into the circulation path. Protruding objects that extend to the floor or within 27 inches of the floor are cane detectable and are therefore not hazardous. Where it is necessary or desirable to have objects protrude from the wall, a manner of cane detection must be provided.	lodge kitchen- fire extinguisher protrudes 5"	Relocate protruding objects or place cane detectable warning or bollard at foot of item.	2015 ABAAS Section: 307.2 2012 TAS Section: 307.2 2010 ADAS Section: 307.2

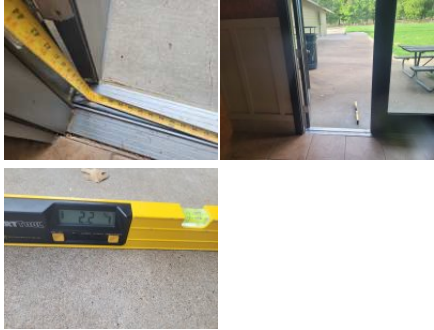
95	Bullinger Creek Group Lodge: Bullinger Creek - Lodge	[29.8148953 , -96.1104939]	Minimum maneuvering clearances at doors and gates shall comply with 404.2.4. Maneuvering clearances shall extend the full width of the doorway and the required latch side or hinge side clearance. Maneuvering clearances shall have a max slope of 2.08%. Door openings shall provide a clear width of 32 inches (815 mm) minimum. Clear openings of doorways with swinging doors shall be measured between the face of the door and the stop, with the door open 90 degrees. Openings more than 24 inches (610 mm) deep shall provide a clear opening of 36 inches (915 mm) minimum. There shall be no projections into the required clear opening width lower than 34 inches (865 mm) above the finish floor or ground. Projections into the clear opening width between 34 inches (865 mm) and 80 inches (2030 mm) above the finish floor or ground shall not exceed 4 inches (100 mm).	Toilet room off kitchen area - 29.5" wide, 3.7% slope	For all doors along the public circulation route, correct slope in door clearance to max 2.08%. For all doors along the public circulation route, replace doors with doors having 80" overhead clearance and 32" clear width.	2010 ADAS Section: 404.2.3, 404.2.7, 404.2.4, 404.2.11, 404.2.11 Exception

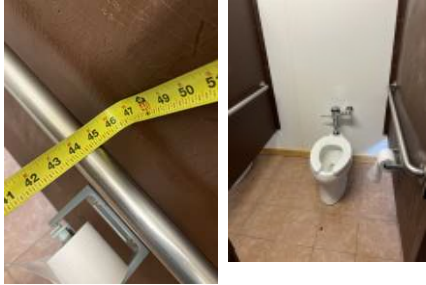
155	Bullinger Creek Group Lodge: Bullinger Creek - Interpretive Center	[29.8145115, -96.109402]	The toilet is not located within the range to the side wall or partition. The centerline of the toilet shall be 17 inches minimum and 19 inches maximum side wall or partition in the ambulatory accessible toilet compartment.	men's- centerline 27" from partition	Remount toilet to 17" to 19" from the side wall to center line in ambulatory stalls.	2015 ABAAS Section: 604.9.1 2012 TAS Section: 604.9.1 2010 ADAS Section: 604.9.1

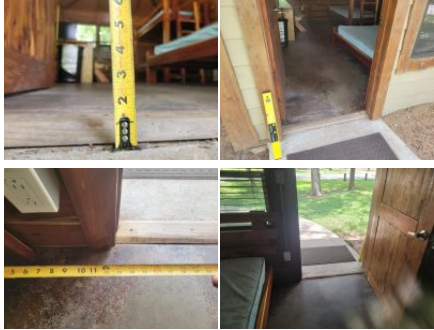
185	Shelter Campsites Area: Shelter Campsites - Sample Campsite	[29.8171519, -96.1110557]	There is insufficient turning space within this room or space. The space required for a wheelchair to make a 180-degree turn is a clear space of 60 inches in diameter or a T-shaped space.	Site 20 - Depth reduces with furniture placement	Relocate obstacles to create turning space.	2015 ABAAS Section: 304.3.1, 304.3.2 2012 TAS Section: 304.3.1, 304.3.2 2010 ADAS Section: 304.3.1, 304.3.2

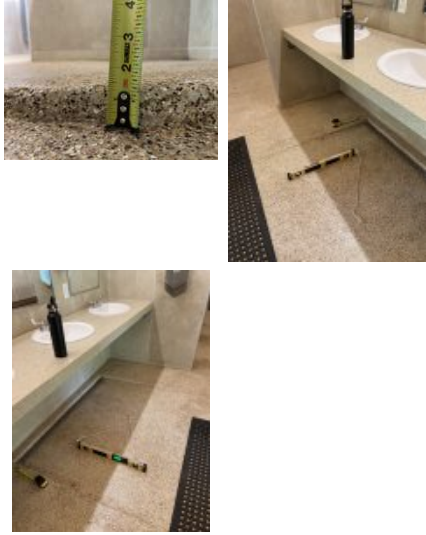
212	Campsites with Water (along Ironwood Trail): Campsites Water - Men's Restroom	[29.8184772 , -96.1091445]	The accessible route contains running slopes greater than 5 percent and cross slopes greater than 2 percent across the width of the walk and has not been constructed as a ramp (i.e. handrails, wheel guides, etc.). When the slope in the direction of travel of any walk exceeds 1 unit vertical in 20 units horizontal (5-percent slope), it must be constructed as ramp. Surface cross slopes must not exceed one unit vertical in 48 units. Horizontal (2-percent slope).	4.1% under sinks	Correct or repair slope to max 2.08% in restroom.	2015 ABAAS Section: 403.3 2012 TAS Section: 403.3 2010 ADAS Section: 403.3

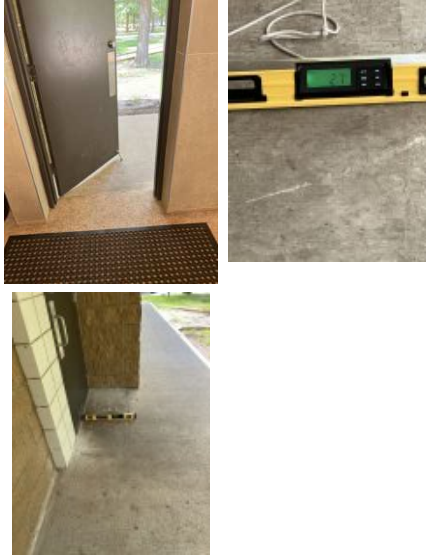
217	Campsites with Water (along Ironwood Trail): Campsites Water - Men's Restroom	[29.8184739 , -96.109150 3]	The doormat is greater than 1/2 tall and is not beveled around the perimeter. Changes in level of 1/4 inch maximum in height shall be permitted to be vertical. Changes in level greater than 1/4 inch in height and not more than 1/2 inch maximum in height shall be beveled with a slope not steeper than 1:2.	Men's door - Large gaps in mat at door	Replace mat with one having gaps max .5"	2015 ABAAS Section: 302.2 2012 TAS Section: 302.2 2010 ADAS Section: 302.2

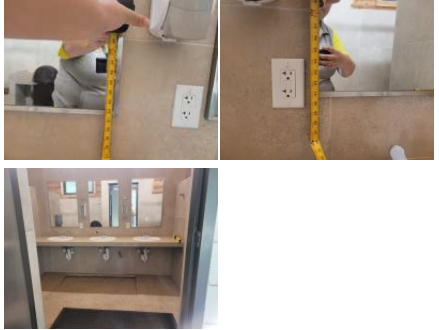
220	Campsites with Water (along Ironwood Trail): Campsites Water - Women's Restroom	[29.8184808 , -96.109133 3]	Knee clearance at 27 inches off the floor is not 8 inches minimum deep. The knee clearance, measured from the bottom of the apron or the outside bottom edge of the lavatory, must be 27 inches at a point located 8 inches back from the front edge and continuing to 11 inches minimum in depth at 9 inches above the floor. The top of the lavatory rim may be no higher than 34 inches.	Right side 29.5" wide before dip, slope in center	Correct floor surface to provide CFS at sink	2015 ABAAS Section: 306.3.1, 306.3.2, 306.3.3, 306.3.4 , 306.3.5 2012 TAS Section: 306.3.2, 306.3.3, 306.3.4, 306.3.5, 306.3.1 2010 ADAS Section: 306.3.3, 306.3.2, 306.3.4, 306.3.5, 306.3.1
