# Access Audit Site Report

**Abilene State Park**

**Accessibility Evaluation**

**Inspection Date: 12/14/2021**

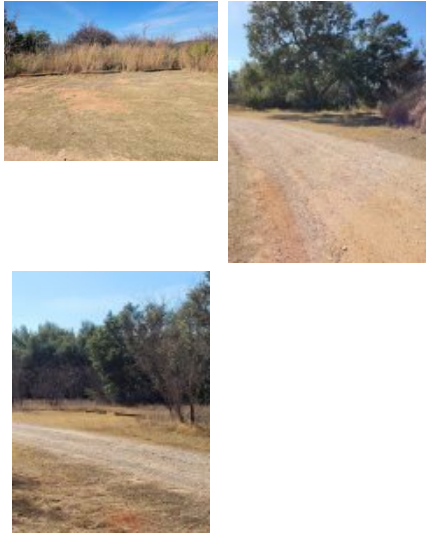
Finding Number	Area Description	Lat/Long	Finding	As Built	Recommendation	Citation	Photos	Figure
1	Exterior: Parking	[32.2334969 , -99.895507 7]	There are no accessible parking stalls. Each lot where parking is provided for the public as clients, guests or employees, shall provide accessible parking and shall be located on the shortest accessible route of travel from adjacent parking to an accessible entrance. There are a total of 9 parking stalls in the parking lot that could be reasonably associated with this facility. There should be a minimum of 1 accessible stalls with a minimum of 1 being designed as van accessible.	Parking at beach swimming area lacks required number of accessible spaces - 9 standard, 0 accessible	Create one or more 8' accessible parking stalls, with one 5' adjacent access aisle, with proper signage and striping based on the total number of stalls.	2015 ABAAS Section: F208.2  2012 TAS Section: 208.2  2010 ADAS Section: 208.2

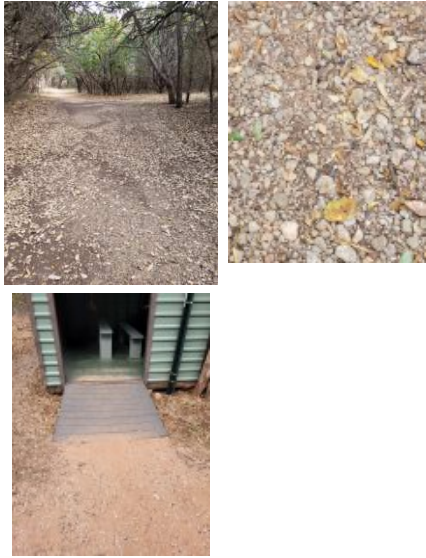
Finding Number	Area Description	Lat/Long	Finding	As Built	Recommendation	Citation	Photos	Figure
7	Exterior: Exterior Accessible Route	[32.2341854 , -99.879916 1]	The accessible route contains loose gravel and/or surface materials that do not provide for a stable, firm slip resistant surface. Floor and ground surfaces shall be stable, firm, and slip resistant.	Lacks route to bird blind - gravel road only	Create AR with crushed and compacted stone or similar outdoor material from parking or sidewalk to the building.	2015 ABAAS Section: 302.1  2012 TAS Section: 302.1  2010 ADAS Section: 302.1

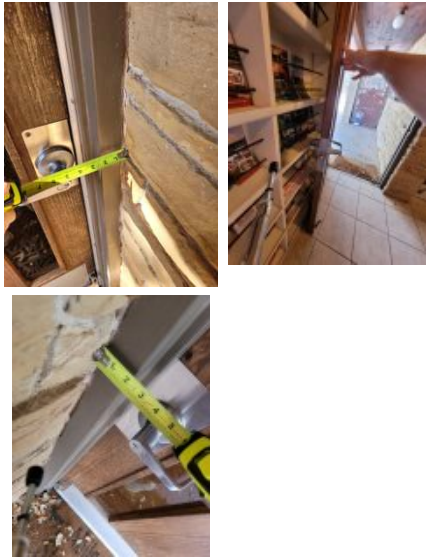
25	Headquarters : Public Spaces	[32.2405753 , -99.879073 8]	Minimum maneuvering clearances at doors and gates shall comply with 404.2.4. Maneuvering clearances shall extend the full width of the doorway and the required latch side or hinge side clearance. Exterior doors are recommended to be maintained at 8.5 lbf as a smart practice. Force is to be measured at the operating hardware or 30 inches from the hinges, whichever is greater.	Park facing entry door to HQ - 12# push, 4" maneuvering clearance on pull side Entry to park side - shelving in back door clearance, 3" clearance on push side, 10# push	For all doors along the public circulation route, provide required maneuvering clearance on push and pull side of doors. For all doors along the public circulation route, inspect, adjust, and maintain 8.5 lbf to open exterior doors as a smart practice.	2010 ADAS Section: 404.2.3, 404.2.7, 404.2.4, 404.2.11, 404.2.11 Exception

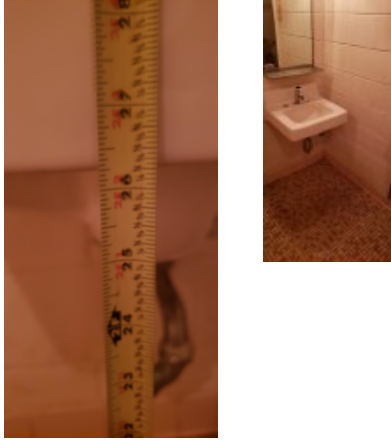
33	Headquarters : Headquarters Restroom	[32.2406298 , -99.879087 3]	Knee clearance at 27 inches off the floor is not 8 inches minimum deep. The knee clearance, measured from the bottom of the apron or the outside bottom edge of the lavatory, must be 27 inches at a point located 8 inches back from the front edge and continuing to 11 inches minimum in depth at 9 inches above the floor. The top of the lavatory rim may be no higher than 34 inches.	Sink lacks knee clearance - 26.25"	Replace sink with one providing 27" knee clearance that is a min 8" deep.	2015 ABAAS Section: 306.3.1, 306.3.2, 306.3.3, 306.3.4 , 306.3.5  2012 TAS Section: 306.3.2, 306.3.3, 306.3.4, 306.3.5, 306.3.1  2010 ADAS Section: 306.3.3, 306.3.2, 306.3.4, 306.3.5, 306.3.1

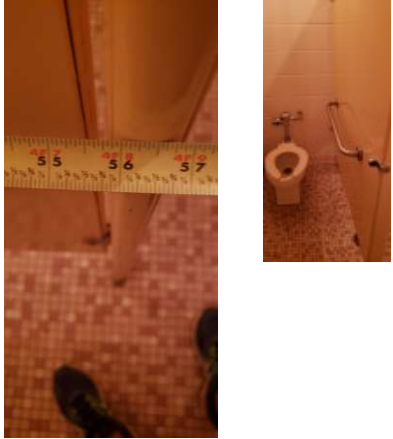
Finding Number	Area Description	Lat/Long	Finding	As Built	Recommendation	Citation	Photos	Figure
36	Headquarters : Headquarters Restroom	[32.2406332 , -99.879060 4]	The ambulatory stall is not between 35" to 37" wide and 60" deep.	Ambulatory stall is 56" deep	Correct ambulatory stall to be 35" to 37" wide and minimum 60" deep. In the alternative, use existing ambulatory stall to create required wheelchair accessible stall.	2015 ABAAS Section: 604.8.2.1  2012 TAS Section: 604.8.2.1  2010 ADAS Section: 604.8.2.1

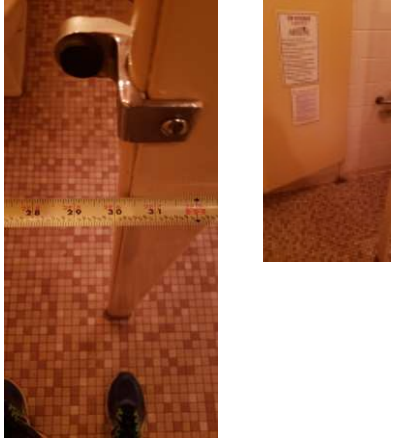
37	Headquarters : Headquarters Restroom	[32.240623, -99.879080 5]	The stall door fails to comply with all of the door requirements. The stall door must be a minimum of 32" wide and have compliant hardware on both sides. The stall door must be self-closing.	Ambulatory stall door is not self-closing and 30" wide	Widen stall doors to 32" when opened to 90 degrees. Adjust stall door to be self-closing.	2015 ABAAS Section: 404.2.3, 404.2.7, 604.8.2.2  2012 TAS Section: 404.2.3, 404.2.7, 604.8.2.2  2010 ADAS Section: 404.2.3, 404.2.7, 604.8.2.2

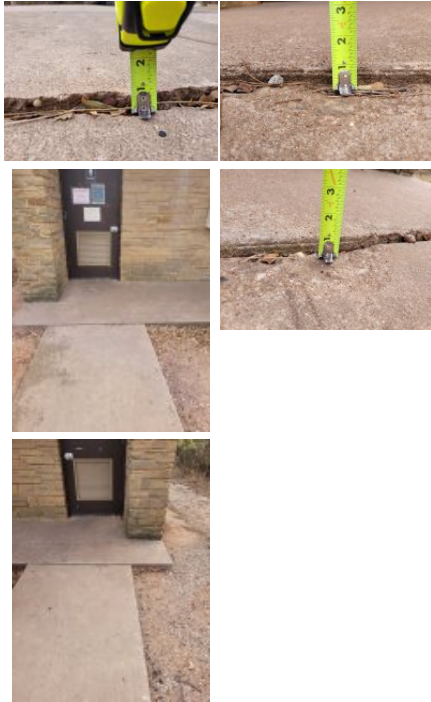
Finding Number	Area Description	Lat/Long	Finding	As Built	Recommendation	Citation	Photos	Figure
46	Pecan Grove: Parking and Exterior Accessible Route	[32.23311, -99.884859 4]	There is a gap spaced greater than a 1/2 inch. Openings in floor or ground surfaces shall not allow passage of a sphere more than 1/2 inch diameter. Elongated openings shall be placed so that the long dimension is perpendicular to the dominant direction of travel.	2" gap at entry to Pecan Grove restroom building, two 2" gaps outside of men's restroom	Correct or fill gaps to be max .5".	2015 ABAAS Section: 302.3 2012 TAS Section: 302.3 2010 ADAS Section: 302.3

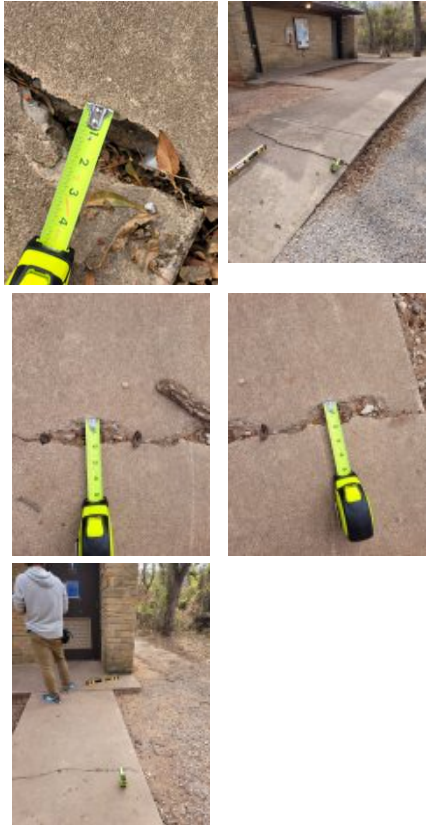
47	Pecan Grove: Parking and Exterior Accessible Route	[32.2331588, -99.884879 5]	The running slope of walking surfaces shall not be steeper than 1:20.	11.5% slope at entry to Pecan Grove restroom building	Correct running slope along the AR to max 5%.	2015 ABAAS Section: 403.3 2012 TAS Section: 403.3 2010 ADAS Section: 403.3

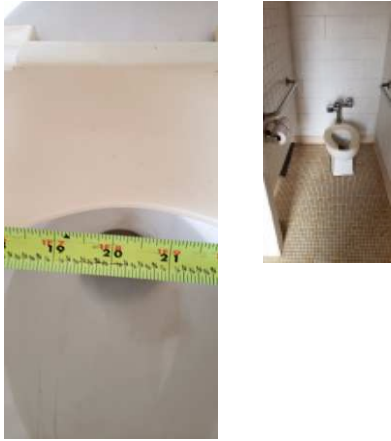
74	Pecan Grove: Pecan Grove - Men's Restroom	[32.2331191 , -99.884832 5]	The ambulatory stall is not between 35" to 37" wide and 60" deep.	Ambulatory stall - 38" wide by 57" deep	Correct ambulatory stall to be 35" to 37" wide and minimum 60" deep. In the alternative, use existing ambulatory stall to create required wheelchair stall.	2015 ABAAS Section: 604.8.2.1  2012 TAS Section: 604.8.2.1  2010 ADAS Section: 604.8.2.1

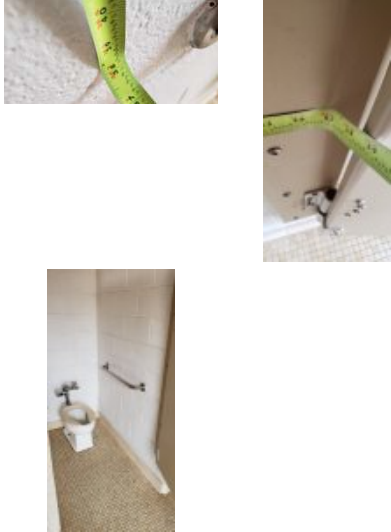
Finding Number	Area Description	Lat/Long	Finding	As Built	Recommendation	Citation	Photos	Figure
75	Pecan Grove: Pecan Grove - Men's Restroom	[32.2331077 , -99.884862]	There are not enough accessible toilet compartments. The room contains several toilet compartments. A minimum of 1 must be wheelchair accessible .	Ambulatory stall only	Create a wheelchair accessible stall with grab bars and fixtures mounted in correct locations and at correct heights.	2015 ABAAS Section: F213.3.1  2012 TAS Section: 213.3.1  2010 ADAS Section: 213.3.1

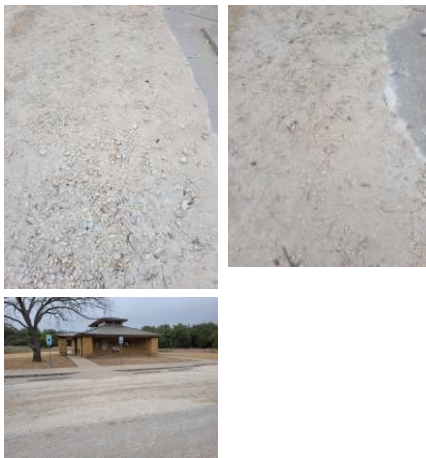
84	Oak Grove: Parking and Exterior Accessible Route	[32.235777, -99.8803439]	The accessible parking stall is not wide enough. Each parking space must be at least 8' feet wide and shall be marked to define the width. The measurements of parking spaces and access aisles shall be made from the centerline of the markings. Where the parking space is not adjacent to another parking space or access aisle, the measurement shall be permitted to include the full width of the line defining the parking space.	Shelter Restroom - lacks compliant parking surface, lacks striping - unable to test width	Create one or more 8' accessible parking stalls, with one 8' adjacent access aisle, with proper signage and striping on a firm and stable surface.	2015 ABAAS Section: 502.2 2012 TAS Section: 502.2 2010 ADAS Section: 502.2

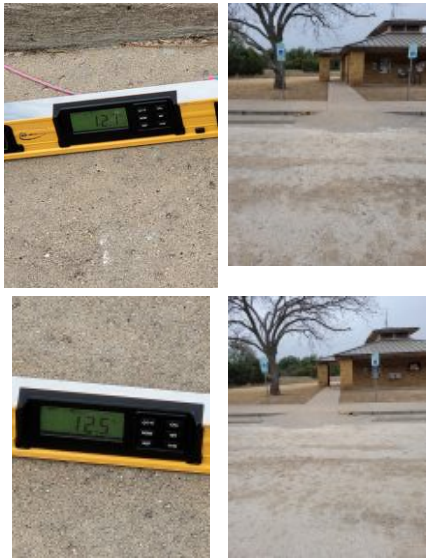
88	Oak Grove: Parking and Exterior Accessible Route	[32.2367809 , -99.881411 4]	The accessible route of travel on the accessible route contains cross slopes greater than 2%. Cross slopes shall not exceed one unit vertical in 48 units horizontal (2-percent slope).	4.9% slope on backside of group hall by yurts	Correct or repair cross slope along AR to max 2.08%.	2015 ABAAS Section: 403.3  2012 TAS Section: 403.3  2010 ADAS Section: 403.3

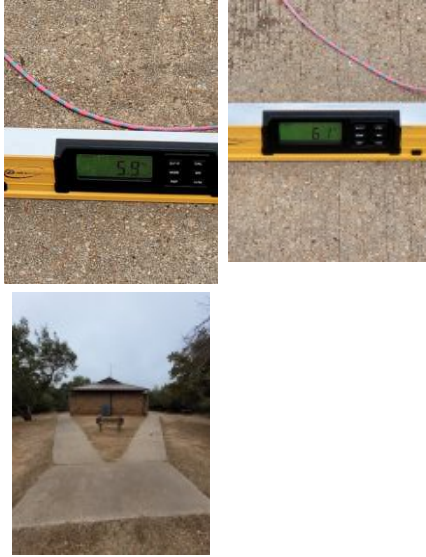
Finding Number	Area Description	Lat/Long	Finding	As Built	Recommendation	Citation	Photos	Figure
90	Oak Grove: Parking and Exterior Accessible Route	[32.2366153 , -99.881385 9]	The building entrance is not located on an accessible route. When a building, or portion of a building, is required to be accessible, an accessible route of travel shall be provided to all portions of the building, to accessible building entrances and between the building and the public way. All walks, halls, corridors, aisles, skywalks, tunnels, and other spaces that are part of an accessible route must comply. An accessible route of travel must not pass through kitchens, storage rooms, restrooms, closets or other spaces used for similar purposes. At least one accessible route within the boundary of the site must be provided from public transportation stops, accessible parking and accessible passenger loading zones and public streets or sidewalks to the accessible building entrance they serve. The accessible route shall, to the maximum extent feasible, coincide with the route for the general public. At least one accessible route shall connect accessible buildings, facilities, elements and spaces that are on the same site. At least one accessible route shall connect accessible building or facility entrances with all accessible spaces and elements.	Lacks accessible route to group shelter by yurts	Create AR with crushed and compacted stone or similar outdoor material from parking or sidewalk to building entrance.	2015 ABAAS Section: F206.2.1  2012 TAS Section: 206.2.1  2010 ADAS Section: 206.2.1

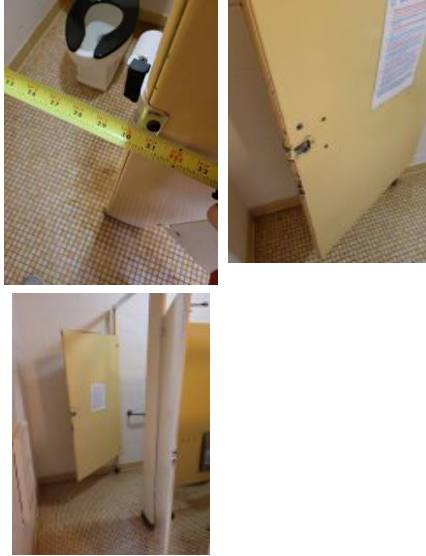
Finding Number	Area Description	Lat/Long	Finding	As Built	Recommendation	Citation	Photos	Figure
100	Oak Grove: Group Hall by Yurts - Women's Restroom	[32.2367174 , -99.881404 7]	Grab bars shall comply with 609. A side-wall grab bar complying with 604.5.1 shall be provided on both sides of the compartment. The space between the wall and the grab bar shall be 1½ inches (38 mm). The space between the grab bar and projecting objects below and at the ends shall be 1½ inches (38 mm) minimum. The space between the grab bar and projecting objects above shall be 12 inches (305 mm) minimum. Grab bars shall be installed in a horizontal position, 33 inches (840 mm) minimum and 36 inches (915 mm) maximum above the finish floor measured to the top of the gripping surface, except that at water closets for children's use complying with 604.9, grab bars shall be installed in a horizontal position 18 inches (455 mm) minimum and 27 inches (685 mm) max	Lacks grab bar on partition side, grab bar on brick side - 30" length	Replace or add side grab bars with a 42" long grab bar, mounted max 12" from the rear wall at the close end and min 54" on the far end and 33" to 36" AFF.	2015 ABAAS Section: 604.8.2.3, 609.3, 609.4  2012 TAS Section: 609.4, 609.3, 604.8.2.3  2010 ADAS Section: 609.3, 609.4, 604.8.2.3

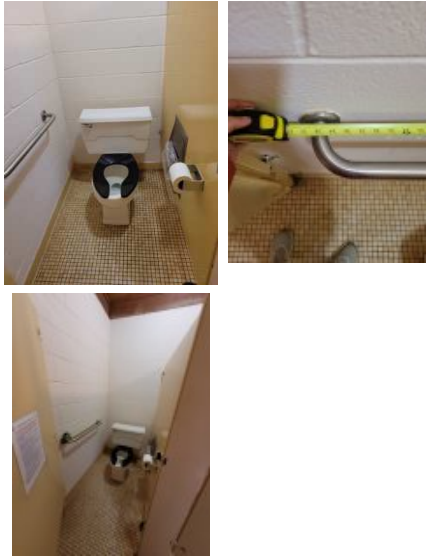
101	Oak Grove: Group Hall by Yurts - Women's Restroom	[32.2367446 , -99.877735 4]	The side grab bars are not in the correct location. Grab bars on the side wall must be installed so that the end closest to the rear wall is maximum 12" from the rear wall. The end furthest from the rear wall must be mounted minimum 54" from the rear wall.	Grab bar ends 48" from rear wall	Remount side grab bar to max 12" from the rear wall at the close end and min 54" on the far end, and 33" to 36" AFF. See previous finding.	2015 ABAAS Section: 604.5.1  2012 TAS Section: 604.5.1  2010 ADAS Section: 604.5.1

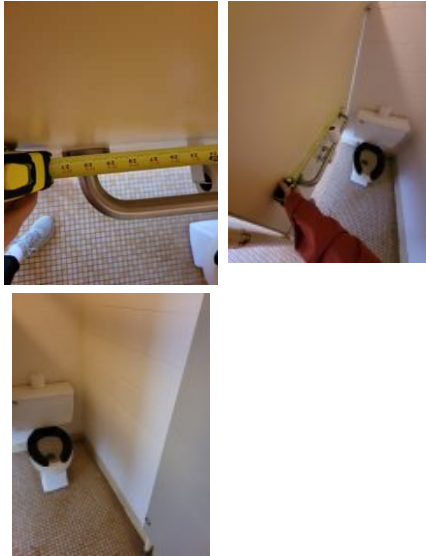
113	Oak Grove: Group Hall By Yurts - Men's Restroom	[32.236731, -99.881415 4]	The side grab bars are not in the correct location. Grab bars on the side wall must be installed so that the end closest to the rear wall is maximum 12" from the rear wall. The end furthest from the rear wall must be mounted minimum 54" from the rear wall.	Grab bar ends 48" from rear wall	Remount side grab bar to max 12" from the rear wall at the close end and min 54" on the far end, and 33" to 36" AFF. See previous finding for cost.	2015 ABAAS Section: 604.5.1  2012 TAS Section: 604.5.1  2010 ADAS Section: 604.5.1

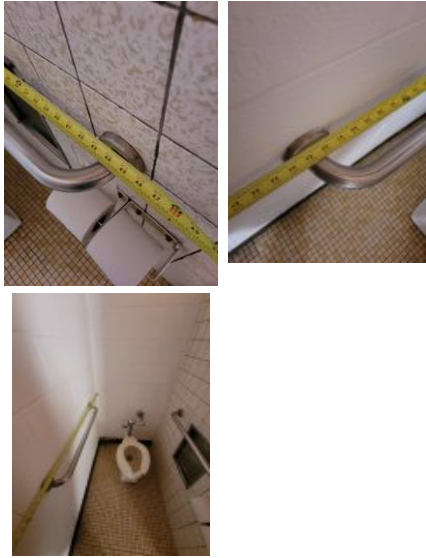
Finding Number	Area Description	Lat/Long	Finding	As Built	Recommendation	Citation	Photos	Figure
158	Cedar Grove: Cedar Grove - Women's Restroom	[32.2379108 , -99.878642]	The grab bar height and/or spacing fails. Grab bars must be mounted between 33" and 36" to the top of the gripping surface. There must be 1.5" of clearance between the grab bar and the wall. There must be a minimum of 1.5" of clearance below and minimum 12" above the grab bar to any dispenser or other obstruction.	Both bars have 3" clearance between them and wall	Replace grab bars per previous finding and assure gap between bar and wall in max 1.5".	2015 ABAAS Section: 609.3, 609.4  2012 TAS Section: 609.4, 609.3  2010 ADAS Section: 609.3, 609.4

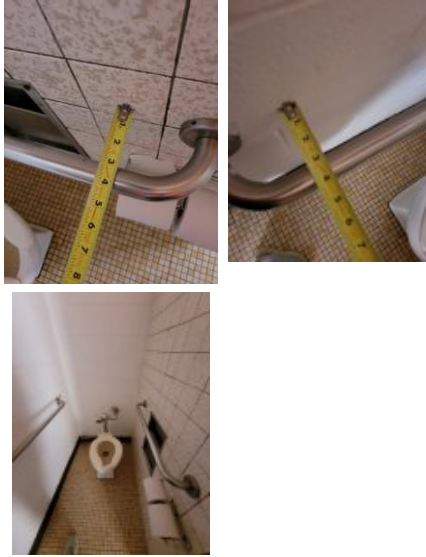
159	Cedar Grove: Cedar Grove - Women's Restroom	[32.2380197 , -99.878690 3]	The toilet paper is not installed within the compliant range in front of the toilet. Toilet paper dispensers shall be 7 inches minimum and 9 inches maximum in front of the water closet measured to the centerline of the dispenser. The outlet of the dispenser shall be 15 inches minimum and 48 inches maximum above the finish floor and shall not be located behind grab bars. Dispensers shall not be of a type that controls delivery or that does not allow continuous paper flow. There shall be a clearance of 1 1/2 inches minimum below the grab bar.	TP is 11" from front of toilet	Remount toilet paper dispenser max 7" to 9" from front of toilet, 15" to 48" AFF and min 12" above or 1.5" below grab bar.	2015 ABAAS Section: 604.7  2012 TAS Section: 604.7  2010 ADAS Section: 604.7

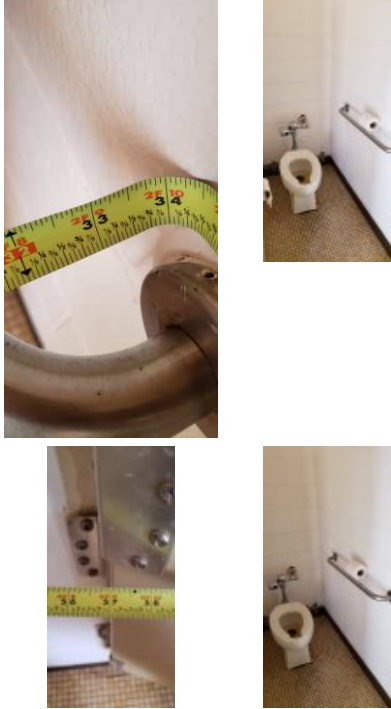
Finding Number	Area Description	Lat/Long	Finding	As Built	Recommendation	Citation	Photos	Figure
176	Cedar Grove: Cedar Grove - Men's Restroom	[32.2379652 , -99.878663 5]	There are not enough accessible toilet compartments. The room contains several toilet compartments. A minimum of 1 must be wheelchair accessible .	Ambulatory stall only	Create a wheelchair accessible stall with grab bars and fixtures mounted in correct locations and at correct heights.	2015 ABAAS Section: F213.3.1  2012 TAS Section: 213.3.1  2010 ADAS Section: 213.3.1

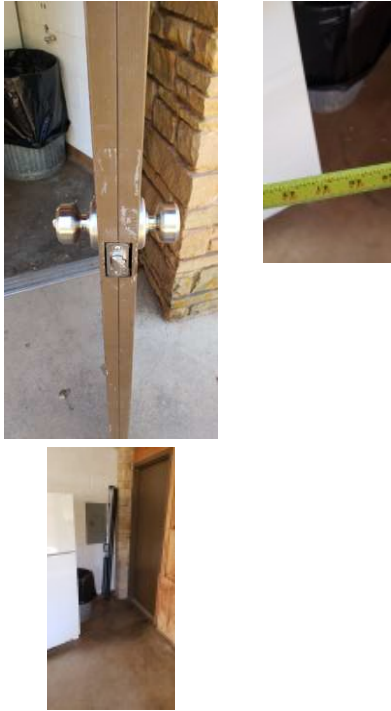
Finding Number	Area Description	Lat/Long	Finding	As Built	Recommendation	Citation	Photos	Figure
190	Wagon Circle: Dining Hall	[32.2375387 , -99.883461 9]	Minimum maneuvering clearances at doors and gates shall comply with 404.2.4. Maneuvering clearances shall extend the full width of the doorway and the required latch side or hinge side clearance. The sweep period for doors with closers shall be adjusted so that from an open position of 70 degrees, the door will take at least 3 seconds to move to a point 3 inches from the latch, measured to the leading edge of the door. Exterior doors are recommended to be maintained at 8.5 lbf as a smart practice. Force is to be measured at the operating hardware or 30 inches from the hinges, whichever is greater. Hand-activated door opening hardware, handles, pulls, latches, locks, and other operating devices on accessible doors shall have a shape that is easy to grasp with one hand and does not require tight grasping, tight pinching or twisting of the wrist to operate. Hardware shall be 34 inches minimum and 48 inches maximum above the finish floor or ground.	Oven side door - trash in push side clearance, knob, 22# push, fast close	For all doors along the public circulation route, provide required maneuvering clearance on push and pull side of doors. For all doors along the public circulation route, inspect, adjust, and maintain closing speed on door closers. For all doors along the public circulation route, inspect, adjust, and maintain 8.5 lbf to open exterior doors as a smart practice. For all doors along the public circulation route, replace hardware with lever hardware or hardware operable without a tight pinch or grasp.	2010 ADAS Section: 404.2.3, 404.2.7, 404.2.4, 404.2.11, 404.2.11 Exception

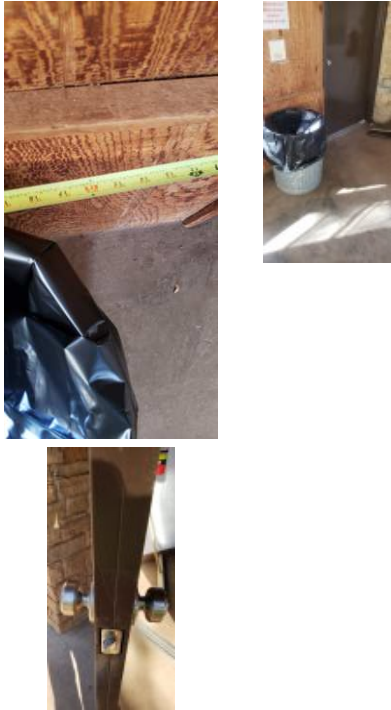
Finding Number	Area Description	Lat/Long	Finding	As Built	Recommendation	Citation	Photos	Figure
191	Wagon Circle: Dining Hall - Women's Restroom	[32.2375432, -99.8834861]	The restroom sign does not comply with one or more applicable requirements for the location, height, and properties of the sign.	Lacks compliant signage - mounted on door at 67" AFF, lacks ISA	Replace sign with one of contrasting colors that includes Braille, raised characters, and the symbol of accessibility and mount on the wall, latch side of the door, 48" to the baseline of the lowest character and 60" to the baseline of the highest character.	2015 ABAAS Section: F216.2, 703.1, 703.2, 703.5, 703.6  2012 TAS Section: 216.2, 703.1, 703.2, 703.5, 703.6  2010 ADAS Section: 216.2, 703.1, 703.2, 703.5, 703.6

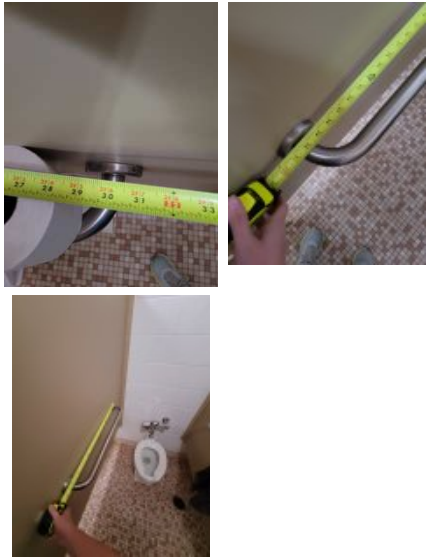
Finding Number	Area Description	Lat/Long	Finding	As Built	Recommendation	Citation	Photos	Figure
199	Wagon Circle: Dining Hall - Women's Restroom	[32.2375591 , -99.883464 6]	The side grab bars are not in the correct location. Grab bars on the side wall must be installed so that the end closest to the rear wall is maximum 12" from the rear wall. The end furthest from the rear wall must be mounted minimum 54" from the rear wall.	Left bar ends 43" from rear wall, right bar ends 44" from rear wall	Remount side grab bar to max 12" from the rear wall at the close end and min 54" on the far end, and 33" to 36" AFF. See previous finding for cost.	2015 ABAAS Section: 604.5.1  2012 TAS Section: 604.5.1  2010 ADAS Section: 604.5.1

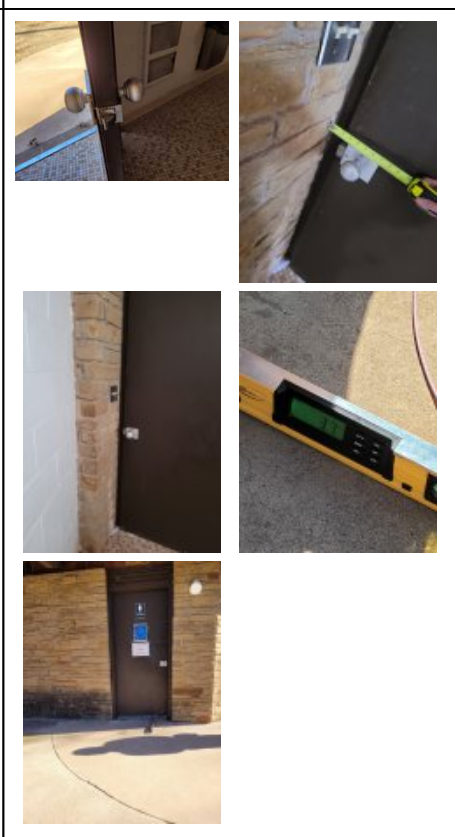
Finding Number	Area Description	Lat/Long	Finding	As Built	Recommendation	Citation	Photos	Figure
204	Wagon Circle: Dining Hall - Men's Restroom	[32.2375478 , -99.883437 8]	Minimum maneuvering clearances at doors and gates shall comply with 404.2.4. Maneuvering clearances shall extend the full width of the doorway and the required latch side or hinge side clearance. The sweep period for doors with closers shall be adjusted so that from an open position of 70 degrees, the door will take at least 3 seconds to move to a point 3 inches from the latch, measured to the leading edge of the door. Exterior doors are recommended to be maintained at 8.5 lbf as a smart practice. Force is to be measured at the operating hardware or 30 inches from the hinges, whichever is greater. Hand-activated door opening hardware, handles, pulls, latches, locks, and other operating devices on accessible doors shall have a shape that is easy to grasp with one hand and does not require tight grasping, tight pinching or twisting of the wrist to operate. Hardware shall be 34 inches minimum and 48 inches maximum above the finish floor or ground.	Restroom door - knob, wall in pull side clearance, 20lbf, fast close	For all doors along the public circulation route, provide required maneuvering clearance on push and pull side of doors. For all doors along the public circulation route, inspect, adjust, and maintain closing speed on door closers. For all doors along the public circulation route, inspect, adjust, and maintain 8.5 lbf to open exterior doors as a smart practice. For all doors along the public circulation route, replace hardware with lever hardware or hardware operable without a tight pinch or grasp.	2010 ADAS Section: 404.2.3, 404.2.7, 404.2.4, 404.2.11, 404.2.11 Exception

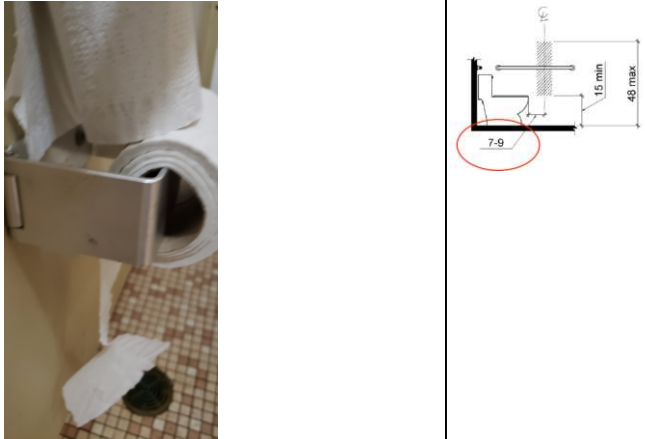
Finding Number	Area Description	Lat/Long	Finding	As Built	Recommendation	Citation	Photos	Figure
206	Wagon Circle: Dining Hall - Men's Restroom	[32.2375659 , -99.883448 5]	The grab bar height and/or spacing fails. Grab bars must be mounted between 33" and 36" to the top of the gripping surface. There must be 1.5" of clearance between the grab bar and the wall. There must be a minimum of 1.5" of clearance below and minimum 12" above the grab bar to any dispenser or other obstruction.	Both bars 3" from wall	Replace grab bars per previous finding and assure gap between bar and wall in max 1.5".	2015 ABAAS Section: 609.3, 609.4  2012 TAS Section: 609.4, 609.3  2010 ADAS Section: 609.3, 609.4

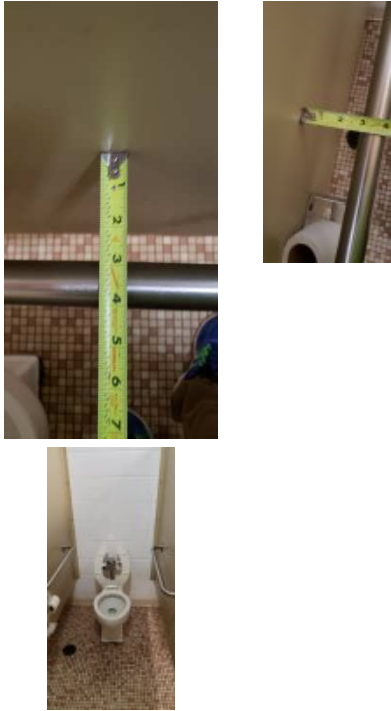
Finding Number	Area Description	Lat/Long	Finding	As Built	Recommendation	Citation	Photos	Figure
207	Wagon Circle: Dining Hall - Men's Restroom	[32.2375704 , -99.883510 2]	The side grab bars are not in the correct location. Grab bars on the side wall must be installed so that the end closest to the rear wall is maximum 12" from the rear wall. The end furthest from the rear wall must be mounted minimum 54" from the rear wall.	Grab bars start 13.5" and end 43.5" from rear wall	Remount side grab bar to max 12" from the rear wall at the close end and min 54" on the far end, and 33" to 36" AFF. See previous finding for cost.	2015 ABAAS Section: 604.5.1  2012 TAS Section: 604.5.1  2010 ADAS Section: 604.5.1

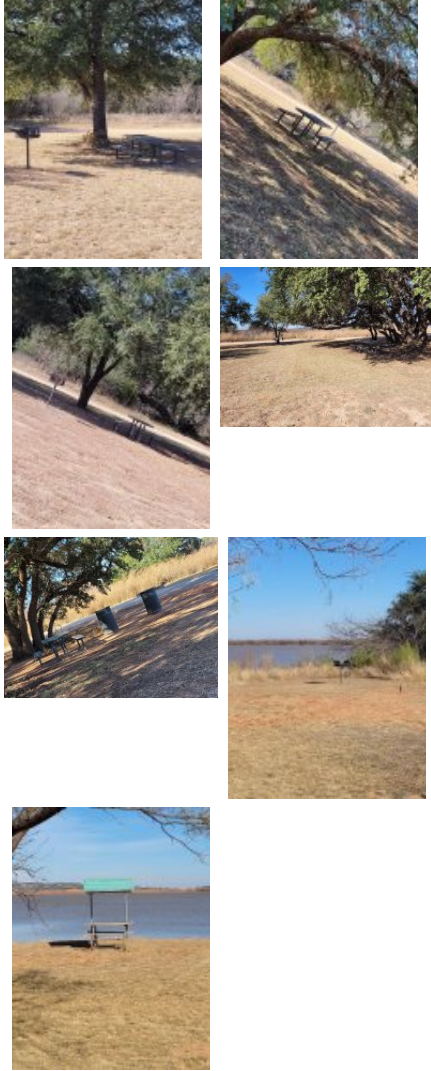
Finding Number	Area Description	Lat/Long	Finding	As Built	Recommendation	Citation	Photos	Figure
219	Park Site: Park Elements	[32.2320391 , -99.891033 8]	There is no accessible route to the PFD, beach, sign at swimming area, and 3 picnic tables at the kayak launch. At least one accessible route shall connect accessible buildings, accessible facilities, accessible elements, and accessible spaces that are on the same site.	Lacks AR to PFD, beach, sign at swimming area, and 3 picnic tables at kayak launch	Create an accessible route with crushed stone or other outdoor material from parking or walkway to the PFD, beach, sign at swimming area, and 3 picnic tables at the kayak launch.	2015 ABAAS Section: F206.2.2  2012 TAS Section: 206.2.2  2010 ADAS Section: 206.2.2

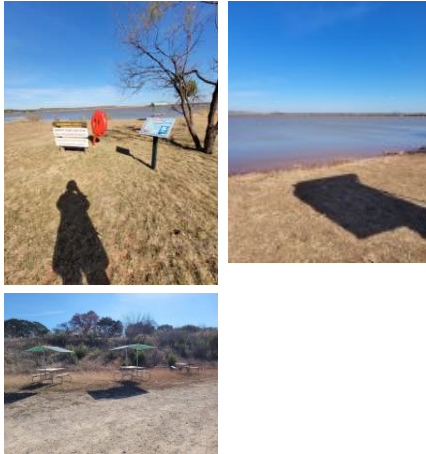
Finding Number	Area Description	Lat/Long	Finding	As Built	Recommendation	Citation	Photos	Figure
220	Park Site: Park Elements	[32.2377792 , -99.881356 4]	There is no accessible route to the picnic tables. At least one accessible route shall connect accessible buildings, accessible facilities, accessible elements, and accessible spaces that are on the same site.	Picnic area behind pool - Lacks AR to 26 of 26 picnic tables	Create an accessible route with crushed stone or other outdoor material from parking or walkway to 6 picnic tables.	2015 ABAAS Section: F206.2.2  2012 TAS Section: 206.2.2  2010 ADAS Section: 206.2.2

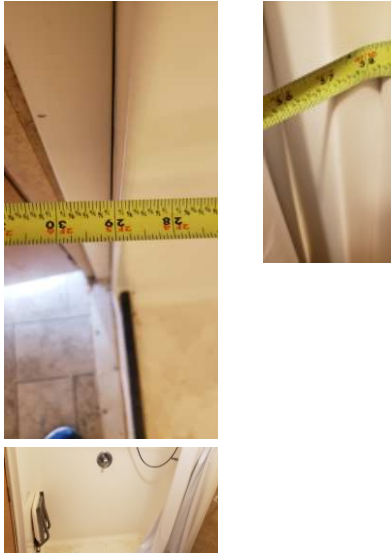
240	Park Site: Maintenance	[32.2405878 , -99.881152 6]	The required grab bars are not provided in the shower compartment. Where a seat is provided in standard roll-in type shower compartments, grab bars shall be provided on the back wall and the side wall opposite the seat. Grab bars shall not be provided above the seat. Where a seat is not provided in standard roll-in type shower compartments, grab bars shall be provided on three walls. Grab bars shall be installed 6 inches maximum from adjacent walls.	Office across residence - Lacks grab bars	Provide grab bars in the shower mounted in the correct locations for the shower type.	2015 ABAAS Section: 608.3.2  2012 TAS Section: 608.3.2  2010 ADAS Section: 608.3.2

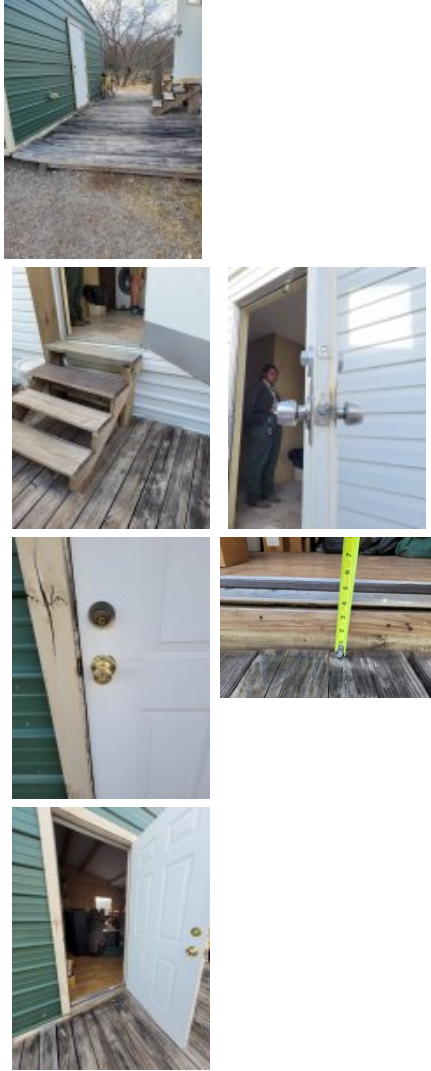
Finding Number	Area Description	Lat/Long	Finding	As Built	Recommendation	Citation	Photos	Figure
245	Park Site: Maintenance	[32.240615, -99.881109 6]	Employee Work Areas. Common use circulation paths within employee work areas shall comply with 402. EXCEPTIONS: 1. Common use circulation paths located within employee work areas that are less than 1000 square feet (93 m2) and defined by permanently installed partitions, counters, casework, or furnishings shall not be required to comply with 402. 2. Common use circulation paths located within employee work areas that are an integral component of work area equipment shall not be required to comply with 402. 3. Common use circulation paths located within exterior employee work areas that are fully exposed to the weather shall not be required to comply with 402.	Work space across from residence - storage within storage trailer reduces path throughout space	Make corrections for compliant circulation path.	2015 ABAAS Section: F206.2.8, F206.2.8.1, F206.2.8.2  2012 TAS Section: 206.2.8, 206.2.8 Exception 1, 206.2.8 Exception 2, 206.2.8 Exception 3, 206.2.8 Advisory 1, 206.2.8 Advisory 2  2010 ADAS Section: 206.2.8, 206.2.8 Exception 1, 206.2.8 Exception 2, 206.2.8 Exception 3
