Access Audit Site Report

Bentsen-Rio Grande Valley State Park

Accessibility Evaluation

Inspection Date: 07/13/2022

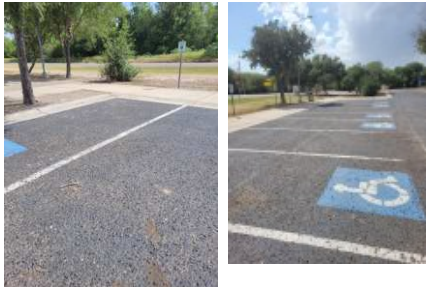
| Finding Number | Area Description | Lat/Long | Finding | As Built | Recommendation | Citation | Photos | Figure |
|---|---|---|---|--|--|--|--|---|
| 3 | Exterior: Parking | [26.1860349 , -98.378839 5] | The parking stall contains abrupt edges and surface irregularities over a 1/4 inch vertical. Parking spaces and access aisles serving them shall be stable, firm, and slip resistant. Access aisles shall be at the same level as the parking spaces they serve. Changes in level are not permitted and shall not be sloped steeper than 2% in any direction. | HQ - some loose gravel within all access aisles and stalls | Maintain accessible stalls and access aisles to reduce any loose gravel. | 2015 ABAAS Section: 502.4 2012 TAS Section: 502.4 2010 ADAS Section: 502.4 | | 1/4 max 1/4 2 1/4 1/2 |

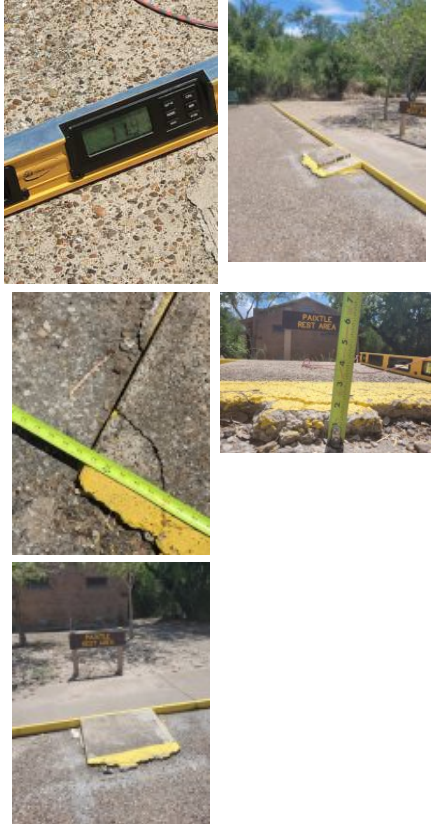
| Finding Number | Area Description | Lat/Long | Finding | As Built | Recommendation | Citation | Photos | Figure |
|---|---|---|---|--|---|--|--|---|
| 6 | Exterior: Exterior Accessible Route | [26.1767535 , -98.384639 8] | The change in level where the gutter meets the curb ramp is greater than 1/4 inch. 1/4 inch is the maximum vertical rise. Changes in level between 1/4 inch and 1/2 inch must be beveled at 1:2 or less. Changes in level greater than 1/2 inch must be by way of a ramp. | Paixtle restroom curb ramp - 11.9% slope, 37" width, 1.25" change in level | Replace curb ramp with one having max running slope 8.33%, max cross slope 2.08%, having a top landing as wide as the ramp and 36" deep and side flares with a max slope 10%. | 2015 ABAAS Section: 303.3 2012 TAS Section: 303.3 2010 ADAS Section: 303.3 | | |

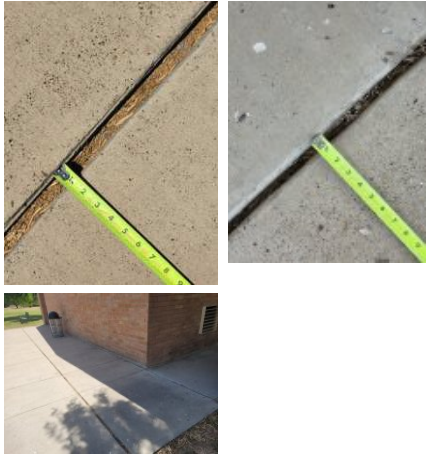
| Finding Number | Area Description | Lat/Long | Finding | As Built | Recommendation | Citation | Photos | Figure |
|---|---|---|--|---|---|--|---|---|
| 7 | Exterior: Exterior Accessible Route | [26.1772866 , -98.388525] | There is a gap spaced greater than a 1/2 inch. Openings in floor or ground surfaces shall not allow passage of a sphere more than 1/2 inch diameter. Elongated openings shall be placed so that the long dimension is perpendicular to the dominant direction of travel. | Hackberry restroom - two 1" gaps | Correct or fill gaps to be max .5". | 2015 ABAAS Section: 302.3 2012 TAS Section: 302.3 2010 ADAS Section: 302.3 | | |

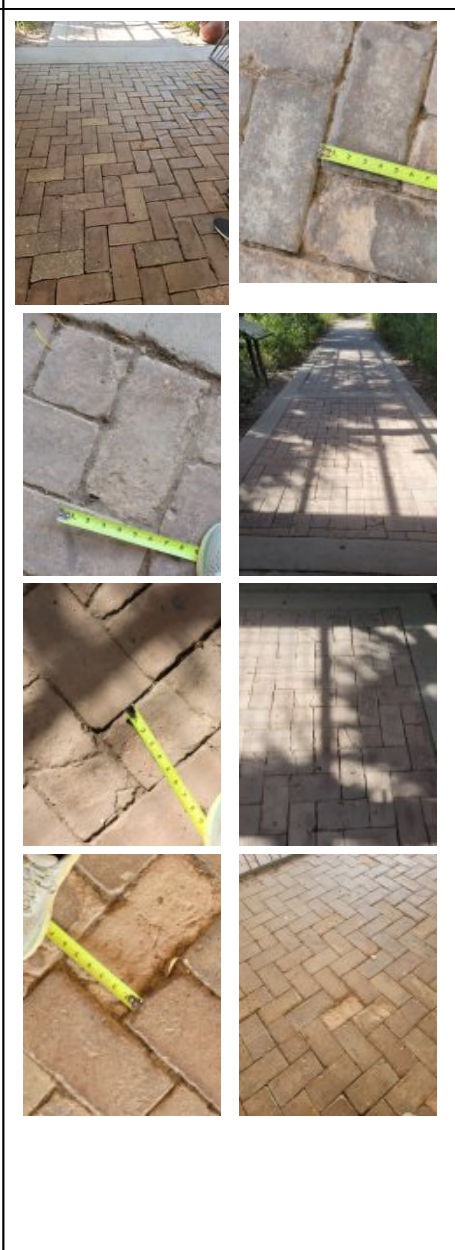
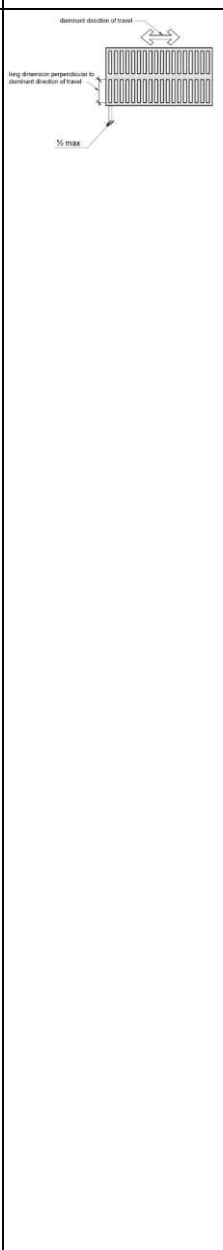
| Finding Number | Area Description | Lat/Long | Finding | As Built | Recommendation | Citation | Photos | Figure |
|---|---|---|--|---|---|--|--|--|
| 11 | Exterior: Exterior Accessible Route | [26.18571, -98.37984] | There is a gap spaced greater than a 1/2 inch. Openings in floor or ground surfaces shall not allow passage of a sphere more than 1/2 inch diameter. Elongated openings shall be placed so that the long dimension is perpendicular to the dominant direction of travel. | pavers at HQ have multiple gaps - 7 instances | Repair and reset pavers to eliminate changes in level and gaps. | 2015 ABAAS Section: 302.3 2012 TAS Section: 302.3 2010 ADAS Section: 302.3 | | |

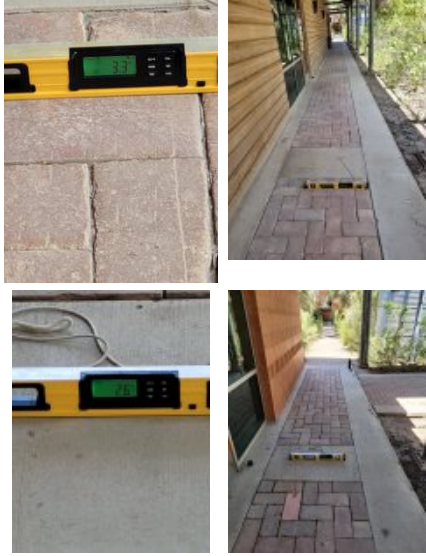
| Finding Number | Area Description | Lat/Long | Finding | As Built | Recommendation | Citation | Photos | Figure |
|---|---|---|---|---|--|--|--|---|
| 13 | Exterior: Exterior Accessible Route | [26.18568, -98.38081] | The accessible route of travel contains cross slopes greater than 2%. Cross slopes shall not exceed one unit vertical in 48 units horizontal (2-percent slope). | Administrative Office Area - 3.3%, 2.6% cross | Correct or repair cross slope along AR to max 2.08%. | 2015 ABAAS Section: 403.3 2012 TAS Section: 403.3 2010 ADAS Section: 403.3 | | |

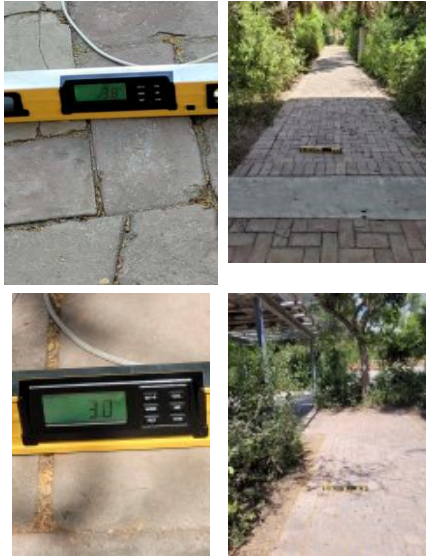
| Finding Number | Area Description | Lat/Long | Finding | As Built | Recommendation | Citation | Photos | Figure |
|---|---|---|---|--|--|--|--|---|
| 16 | Exterior: Exterior Accessible Route | [26.18546, -98.37991] | The accessible route of travel contains cross slopes greater than 2%. Cross slopes shall not exceed one unit vertical in 48 units horizontal (2-percent slope). | slopes from back of Exhibit Hall to Park Store - 3.8%, 3% | Correct or repair cross slope along AR to max 2.08%. | 2015 ABAAS Section: 403.3 2012 TAS Section: 403.3 2010 ADAS Section: 403.3 | | |

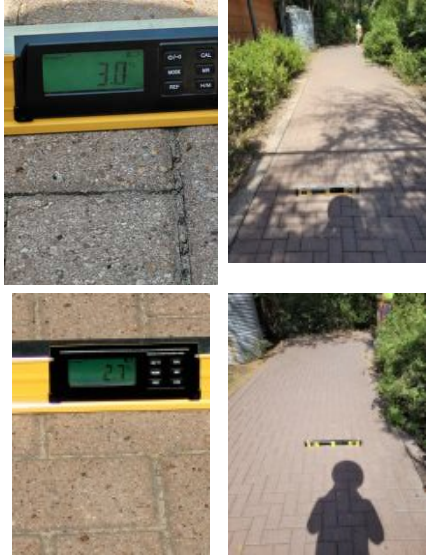
| Finding Number | Area Description | Lat/Long | Finding | As Built | Recommendation | Citation | Photos | Figure |
|---|---|---|---|--|--|--|--|---|
| 17 | Exterior: Exterior Accessible Route | [26.185485, -98.380779 2] | The accessible route of travel contains cross slopes greater than 2%. Cross slopes shall not exceed one unit vertical in 48 units horizontal (2-percent slope). | from park store to tram pick up - 3%, 2.7%, 3.9%, 3.5%, 3.7% | Correct or repair cross slope along AR to max 2.08%. | 2015 ABAAS Section: 403.3 2012 TAS Section: 403.3 2010 ADAS Section: 403.3 | | |

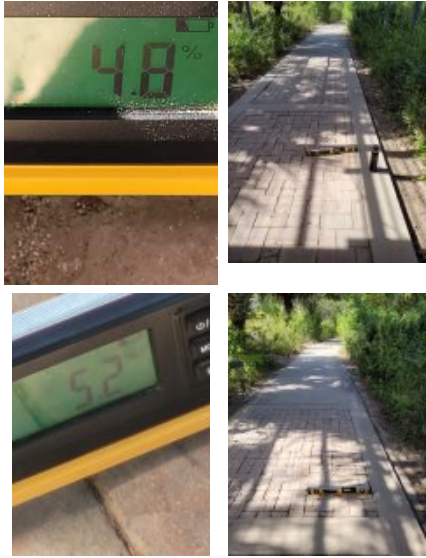
| Finding Number | Area Description | Lat/Long | Finding | As Built | Recommendation | Citation | Photos | Figure |
|---|---|---|---|---|--|--|---|---|
| 18 | Exterior: Exterior Accessible Route | [26.1859783 , -98.379760 7] | The accessible route of travel contains cross slopes greater than 2%. Cross slopes shall not exceed one unit vertical in 48 units horizontal (2-percent slope). | from park store to mailbox turn around - 4.8%, 5.2% | Correct or repair cross slope along AR to max 2.08%. | 2015 ABAAS Section: 403.3 2012 TAS Section: 403.3 2010 ADAS Section: 403.3 | | |

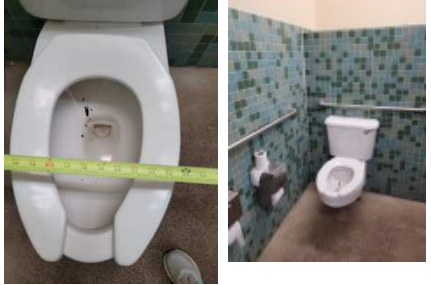
| Finding Number | Area Description | Lat/Long | Finding | As Built | Recommendation | Citation | Photos | Figure |
|---|---|---|---|--|---|--|---|---|
| 23 | Headquarters Area: HQ - Men's Restroom | [26.18571, -98.37984] | The toilet is not located within the range allowed from the side wall or partition. The centerline of the toilet must be 16 to 18 inches from the side wall. | 19" centerline | Remount toilets to 16" to 18" from the side wall to centerline. | 2015 ABAAS Section: 604.2 2012 TAS Section: 604.2 2010 ADAS Section: 604.2 | | |

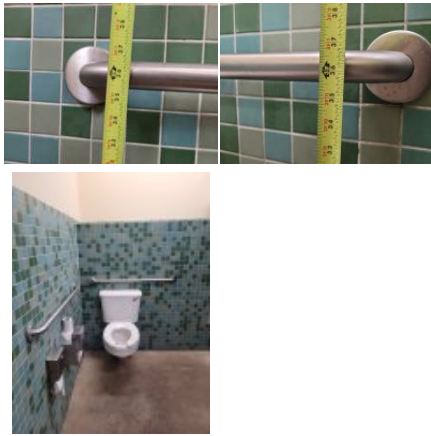
| Finding Number | Area Description | Lat/Long | Finding | As Built | Recommendation | Citation | Photos | Figure |
|---|---|---|---|--|---|--|---|---|
| 24 | Headquarters Area: HQ - Men's Restroom | [26.18571, -98.37984] | The grab bar height and/or spacing fails. Grab bars must be mounted between 33" and 36" to the top of the gripping surface. There must be 1.5" of clearance between the grab bar and the wall. There must be a minimum of 1.5" of clearance below and minimum 12" above the grab bar to any dispenser or other obstruction. | both mounted 36.75" above finished floor | Remount grab bars in accessible stall to 33" to 36" above the finished floor (AFF). | 2015 ABAAS Section: 609.3, 609.4 2012 TAS Section: 609.4, 609.3 2010 ADAS Section: 609.3, 609.4 | | |

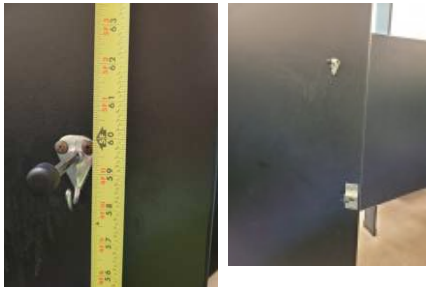
| Finding Number | Area Description | Lat/Long | Finding | As Built | Recommendation | Citation | Photos | Figure |
|---|--|---|---|---|---|---|--|--|
| 30 | Headquarters Area: HQ - Women's Restroom | [26.18571, -98.37984] | The operable part is positioned too high for either a side or front approach. Where a clear floor or ground space allows a parallel approach to an element and the side reach is unobstructed, the high side reach shall be 48 inches maximum and the low side reach shall be 15 inches minimum above the finish floor or ground. Where a forward reach is unobstructed, the high forward reach shall be 48 inches maximum and the low forward reach shall be 15 inches minimum above the finish floor or ground. | hook in stall 60" above finished floor | Remount operable parts to be in reach range of 15" min to 48" max | 2015 ABAAS Section: 308.1 2012 TAS Section: 308.1 2010 ADAS Section: 308.1 | | |

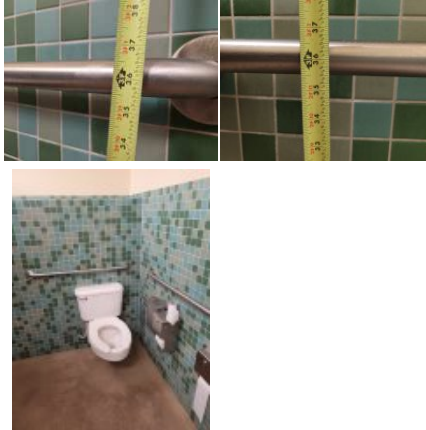
| Finding Number | Area Description | Lat/Long | Finding | As Built | Recommendation | Citation | Photos | Figure |
|---|--|---|--|---|---|--|---|---|
| 32 | Headquarters Area: HQ - Women's Restroom | [26.18571, -98.37984] | The grab bar height and/or spacing fails. Grab bars must be mounted between 33" and 36" to the top of the gripping surface. There must be 1.5" of clearance between the grab bar and the wall. There must be a minimum of 1.5" of clearance below and minimum 12" above the grab bar to any dispenser or other obstruction. | both 36.75" above finished floor | Remount grab bars in accessible stall to 33" to 36" above the finished floor (AFF). | 2015 ABAAS Section: 609.3, 609.4 2012 TAS Section: 609.4, 609.3 2010 ADAS Section: 609.3, 609.4 | | |

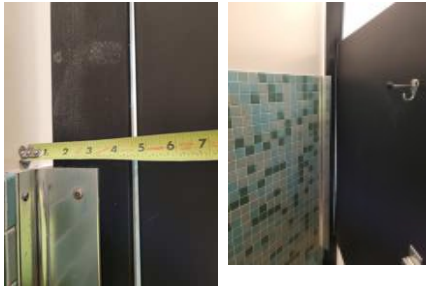
| Finding Number | Area Description | Lat/Long | Finding | As Built | Recommendation | Citation | Photos | Figure |
|---|--|---|--|--|---|--|---|---|
| 34 | Headquarters Area: HQ - Women's Restroom | [26.18571, -98.37984] | The compartment door is located too far from the partition or wall. The door shall be located in front of the clear space and diagonal to the water closet. Where located in the front partition, the door opening shall be 4 inches maximum from the side wall or partition farthest from the water closet. Where located in the side wall or partition, the door opening shall be 4 inches maximum from the front partition. Toilet compartment doors shall not swing into the minimum required compartment area. | partition 4.5" from adjacent wall | Rehang stall door to be max 4" from adjacent stall partition and on the stall wall farthest from the toilet. | 2015 ABAAS Section: 604.8.1.2 2012 TAS Section: 604.8.1.2 2010 ADAS Section: 604.8.1.2 | | |

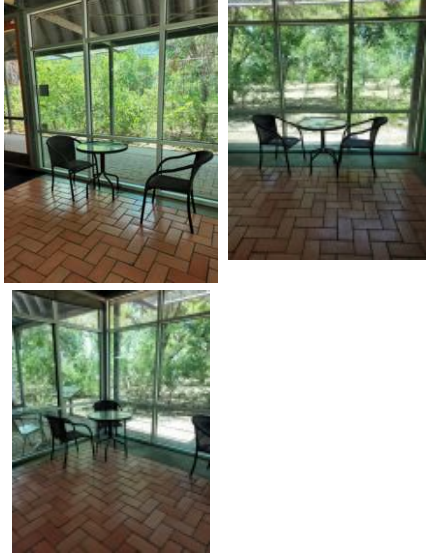
| Finding Number | Area Description | Lat/Long | Finding | As Built | Recommendation | Citation | Photos | Figure |
|---|--|---|--|--|--|---|---|---|
| 37 | Headquarters Area: HQ - Public Spaces | [26.18571, -98.37984] | There are no accessible tables/seated or standing. At least 5% of each type in each functional area of dining surfaces must be accessible and must be dispersed throughout the space or facility containing dining surfaces. An accessible table must be on an accessible route (36 inches minimum) and have knee and toe spaces at least 27 inches high, 30 inches wide and 19 inches deep. The tops of tables and counters shall be 28 inches to 34 inches from the floor or ground. | cafe - 0 of 3 bistro tables offer wheelchair toe clearance | Replace 5% of the tables with ones providing the required knee and toe clearances. | 2015 ABAAS Section: F226.1 2012 TAS Section: 226.1 2010 ADAS Section: 226.1 | | |

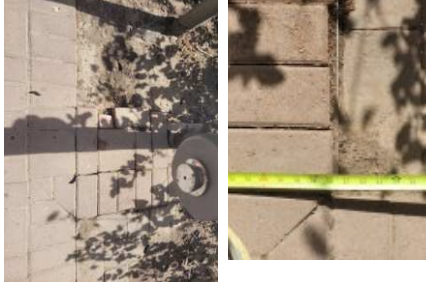
| Finding Number | Area Description | Lat/Long | Finding | As Built | Recommendation | Citation | Photos | Figure |
|---|--|---|--|--|--|---|---|---|
| 39 | Headquarters Area: HQ - Public Spaces | [26.18571, -98.37984] | The clear floor space required at accessible drinking fountains is not positioned for a forward approach. Units shall have a clear floor or ground space positioned for a forward approach and centered on the unit. | exterior fountain near restrooms - clear floor space 20" width due to missing pavers | Repair pavers in front of drinking fountain to provide a forward approach 30" X 48" CFS to the fountain. | 2015 ABAAS Section: 602.2 2012 TAS Section: 602.2 2010 ADAS Section: 602.2 | | |

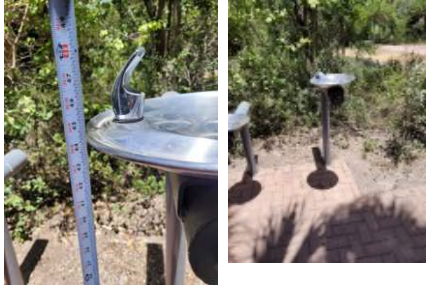
| Finding Number | Area Description | Lat/Long | Finding | As Built | Recommendation | Citation | Photos | Figure |
|---|--|---|--|---|--|--|---|--|
| 41 | Headquarters Area: HQ - Public Spaces | [26.18571, -98.37984] | The spout for the drinking fountain is too high. Spout outlets shall be 38 inches minimum and 43 inches maximum above the finish floor or ground for standing persons. | fountain at administrative restrooms - 46.5" above finished floor | Remount fountain for standing persons to 38" min and 43" max aff to the spout. | 2015 ABAAS Section: 602.7 2012 TAS Section: 602.7 2010 ADAS Section: 602.7 | | |

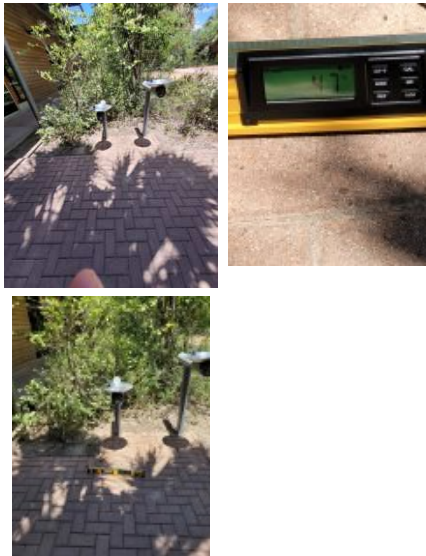
| Finding Number | Area Description | Lat/Long | Finding | As Built | Recommendation | Citation | Photos | Figure |
|---|--|---|--|--|--|--|--|---|
| 44 | Headquarters Area: HQ - Public Spaces | [26.18571, -98.37984] | The 30 inches minimum by 48 inches minimum clear floor space required at the operable part is not flat (2% or 1:48 maximum slope) in all directions. Changes in level are not permitted at required clear floor or ground space except that slopes not steeper than 1:48 shall be permitted. | administrative restrooms fountain - 4.7% slope in clear floor space | Correct or repair slope in CFS to max 2.08%. | 2015 ABAAS Section: 305.2 2012 TAS Section: 305.2 2010 ADAS Section: 305.2 | | |

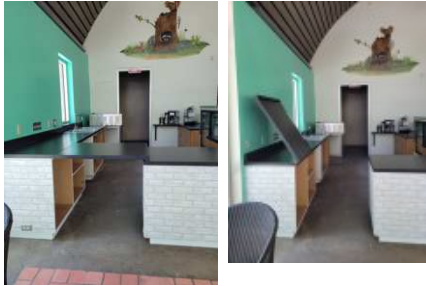
| Finding Number | Area Description | Lat/Long | Finding | As Built | Recommendation | Citation | Photos | Figure |
|---|---|---|---|---|--|---|--|---|
| 46 | Headquarters Area: HQ - Employee Spaces | [26.18571, -98.37984] | Spaces and elements within employee work areas shall only be required to comply with 206.2.8, 207.1, and 215.3 and shall be designed and constructed so that individuals with disabilities can approach, enter, and exit the employee work area. Employee work areas, or portions of employee work areas, other than raised courtroom stations, that are less than 300 square feet (28 m2) and elevated 7 inches (180 mm) or more above the finish floor or ground where the elevation is essential to the function of the space shall not be required to comply with these requirements or to be on an accessible route. | entering the food shop connected to the park store requires excessive force to lift counter | For employee spaces, relocate storage, furniture, and other obstacles at doorways to provide approach, enter and exit at the employee space. Replace lift counter with a lighter swing door if an employee with a disability works here. | 2015 ABAAS Section: F203.9 2012 TAS Section: 203.9 2010 ADAS Section: 203.9 | | |

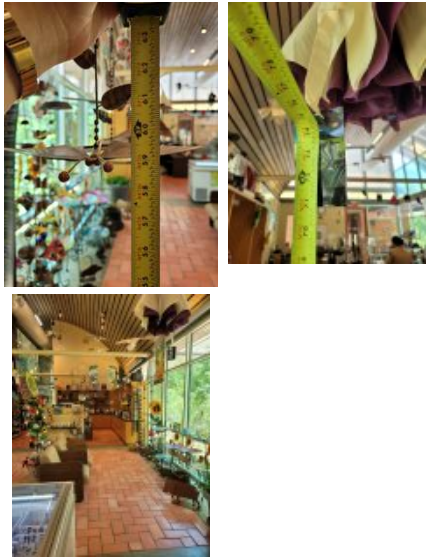
| Finding Number | Area Description | Lat/Long | Finding | As Built | Recommendation | Citation | Photos | Figure |
|---|---|---|--|---|---|---|--|---|
| 51 | Headquarters Area: HQ - Park Store | [26.18571, -98.37984] | The umbrellas and wind chimes extend down too close to the route of travel. Any obstruction that overhangs a route of travel must be a minimum of 80 inches above the walking surface as measured from the bottom of the obstruction. | umbrellas 71" above finished floor, wind chime 58" above finished floor | Raise merchandise to min 80" to prevent hazard in overhead clearance along AR. | 2015 ABAAS Section: 307.4 2012 TAS Section: 307.4 2010 ADAS Section: 307.4 | | |

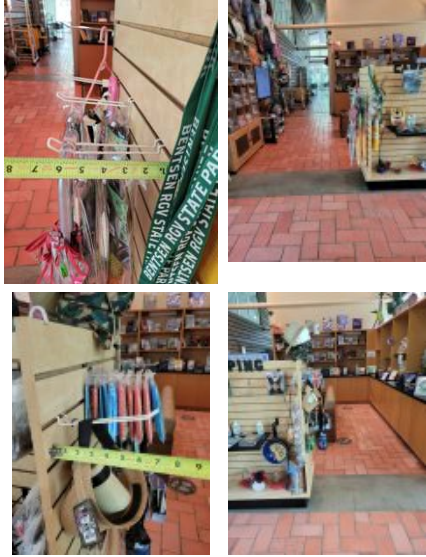
| Finding Number | Area Description | Lat/Long | Finding | As Built | Recommendation | Citation | Photos | Figure |
|---|---|---|---|---|--|--|--|--|
| 52 | Headquarters Area: HQ - Park Store | [26.18571, -98.37984] | An item or items project more than 4 inches into the circulation path. Wall-mounted objects that have leading edges between 27 inches and 80 inches from the floor must not project more than 4 inches into the circulation path. Protruding objects that extend to the floor or within 27 inches of the floor are cane detectable and are therefore not hazardous. Where it is necessary or desirable to have objects protrude from the wall, a manner of cane detection must be provided. | merchandise projects 6.5" | Relocate protruding objects or place cane detectable warning or bollard at foot of item. | 2015 ABAAS Section: 307.2 2012 TAS Section: 307.2 2010 ADAS Section: 307.2 | | |

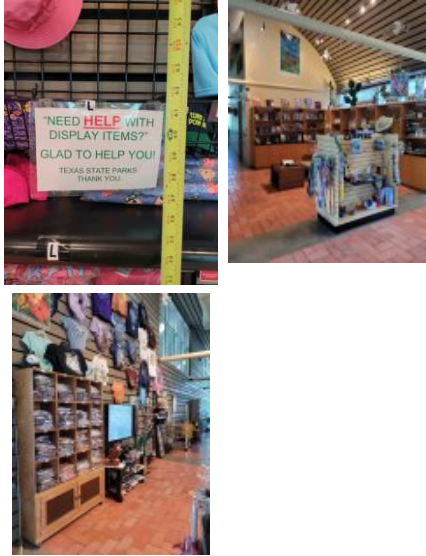
| Finding Number | Area Description | Lat/Long | Finding | As Built | Recommendation | Citation | Photos | Figure |
|---|---|---|---|---|--|--|--|--|
| 53 | Headquarters Area: HQ - Park Store | [26.18571, -98.37984] | The operable part is positioned too high for either a side or front approach. Where a clear floor or ground space allows a parallel approach to an element and the side reach is unobstructed, the high side reach shall be 48 inches maximum and the low side reach shall be 15 inches minimum above the finish floor or ground. Where a forward reach is unobstructed, the high forward reach shall be 48 inches maximum and the low forward reach shall be 15 inches minimum above the finish floor or ground. | merchandise exceeds 48" in many instances, sign mentions asking employee for help | Leave as is existing merchandise with a more permanent sign. | 2015 ABAAS Section: 308.1 2012 TAS Section: 308.1 2010 ADAS Section: 308.1 | | |

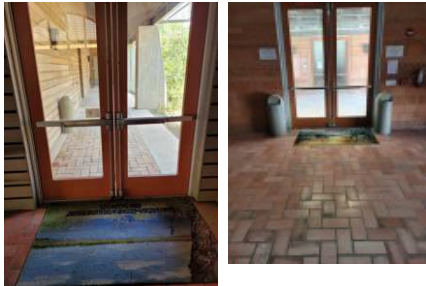
| Finding Number | Area Description | Lat/Long | Finding | As Built | Recommendation | Citation | Photos | Figure |
|---|---|---|---|--|--|---|--|---|
| 56 | Headquarters Area: HQ - Meeting Room | [26.18557, -98.38023] | Minimum maneuvering clearances at doors and gates shall comply with 404.2.4. Maneuvering clearances shall extend the full width of the doorway and the required latch side or hinge side clearance. Exterior doors are recommended to be maintained at 8.5 lbf as a smart practice. Force is to be measured at the operating hardware or 30 inches from the hinges, whichever is greater. | Meeting room - both sets of doors exceed 8.5 lbf, loose carpet on push | For all doors along the public circulation route, secure rug in door clearance to prevent trip hazard. For all doors along the public circulation route, inspect, adjust, and maintain 8.5 lbf to open exterior doors as a smart practice. | 2010 ADAS Section: 404.2.3, 404.2.7, 404.2.4, 404.2.11, 404.2.11 Exception | | |

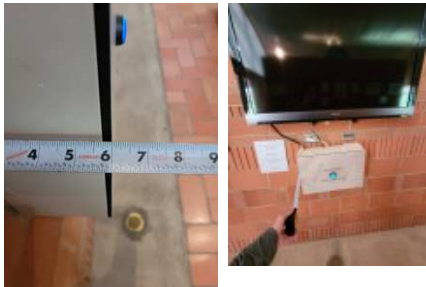
| Finding Number | Area Description | Lat/Long | Finding | As Built | Recommendation | Citation | Photos | Figure |
|---|---|---|---|---|---|--|--|--|
| 61 | Headquarters Area: HQ - Exhibit Hall | [26.18571, -98.37984] | An item or items project more than 4 inches into the circulation path. Wall-mounted objects that have leading edges between 27 inches and 80 inches from the floor must not project more than 4 inches into the circulation path. Protruding objects that extend to the floor or within 27 inches of the floor are cane detectable and are therefore not hazardous. Where it is necessary or desirable to have objects protrude from the wall, a manner of cane detection must be provided. | control for video display projects 6" | Relocate protruding objects or place cane detectable warning or bollard at foot of item. | 2015 ABAAS Section: 307.2 2012 TAS Section: 307.2 2010 ADAS Section: 307.2 | | |

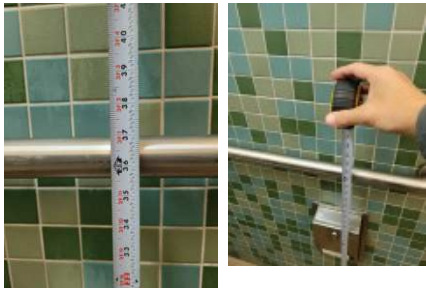
| Finding Number | Area Description | Lat/Long | Finding | As Built | Recommendation | Citation | Photos | Figure |
|---|---|---|--|---|--|--|---|---|
| 70 | Headquarters Area: Administrative Restrooms - Men's Restroom | [26.18571, -98.37984] | The grab bar height and/or spacing fails. Grab bars must be mounted between 33" and 36" to the top of the gripping surface. There must be 1.5" of clearance between the grab bar and the wall. There must be a minimum of 1.5" of clearance below and minimum 12" above the grab bar to any dispenser or other obstruction. | grab bars - both 37" AFF | Remount grab bars in accessible stall to 33" to 36" above the finished floor (AFF). | 2015 ABAAS Section: 609.3, 609.4 2012 TAS Section: 609.4, 609.3 2010 ADAS Section: 609.3, 609.4 | | |

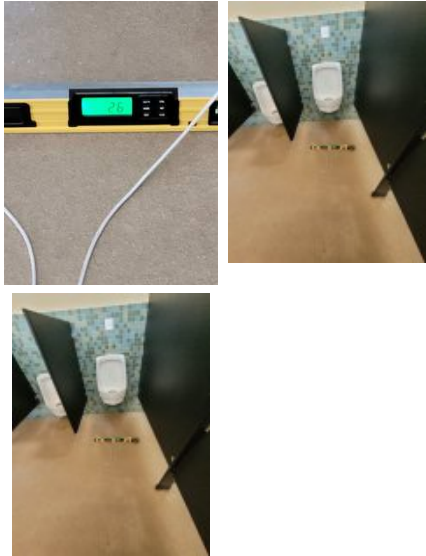
| Finding Number | Area Description | Lat/Long | Finding | As Built | Recommendation | Citation | Photos | Figure |
|---|---|---|---|---|---|--|---|---|
| 73 | Headquarters Area: Administrative Restrooms - Men's Restroom | [26.18571, -98.37984] | The accessible route contains running slopes greater than 5 percent and cross slopes greater than 2 percent across the width of the walk and has not been constructed as a ramp (i.e. handrails, wheel guides, etc.). When the slope in the direction of travel of any walk exceeds 1 unit vertical in 20 units horizontal (5-percent slope), it must be constructed as ramp. Surface cross slopes must not exceed one unit vertical in 48 units. Horizontal (2-percent slope). | 2.6% slope at urinal | Correct or repair slope to max 5% running and 2.08% cross. | 2015 ABAAS Section: 403.3 2012 TAA Section: 403.3 2010 ADAS Section: 403.3 | | |

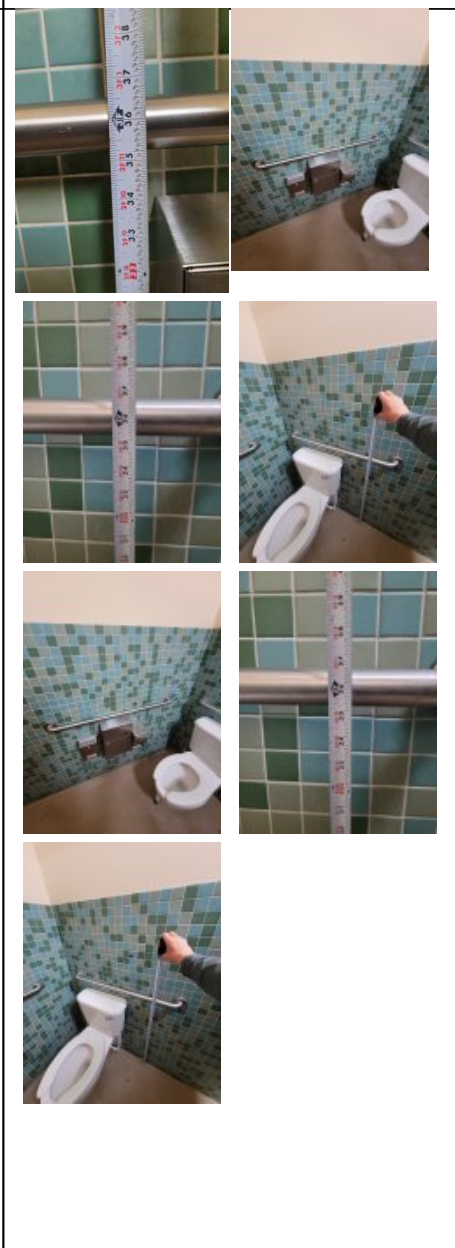
| Finding Number | Area Description | Lat/Long | Finding | As Built | Recommendation | Citation | Photos | Figure |
|---|---|---|---|---|---|---|--|---|
| | Women's Restroom | | the grab bar and the wall. There must be a minimum of 1.5" of clearance below and minimum 12" above the grab bar to any dispenser or other obstruction. | | | 2012 TAS Section: 609.4, 609.3 2010 ADAS Section: 609.3, 609.4 | | |

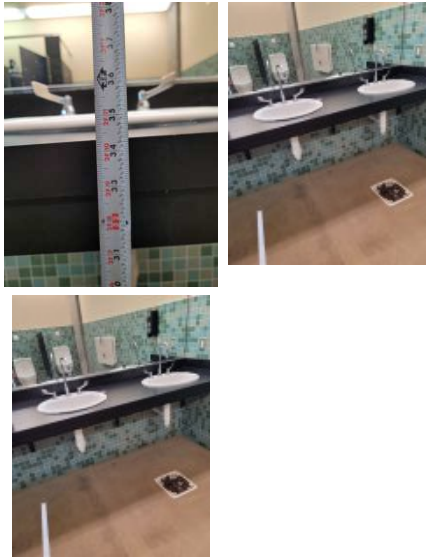
| Finding Number | Area Description | Lat/Long | Finding | As Built | Recommendation | Citation | Photos | Figure |
|---|--|---|---|---|--|---|--|---|
| 85 | Headquarters Area: Meeting Room - Men's Restroom | [26.18571, -98.37984] | The top rim of the sink is too high. All lavatories/sinks that are designated to be accessible shall be a minimum 17 inches in horizontal depth and mounted with the rim or counter edge no higher than 34 inches above the finished floor. | sink rim 35" AFF | Lower sinks to max 34" above the finished floor (AFF) to front of rim. | 2015 ABAAS Section: 606.3 2012 TAS Section: 606.3 2010 ADAS Section: 606.3 | | |

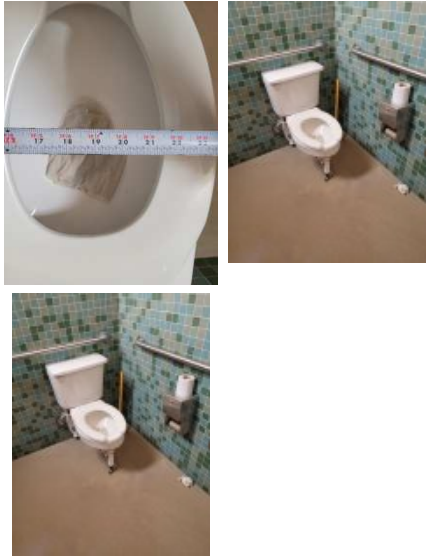
| Finding Number | Area Description | Lat/Long | Finding | As Built | Recommendation | Citation | Photos | Figure |
|---|--|---|---|---|---|---|--|---|
| 87 | Headquarters Area: Meeting Room - Men's Restroom | [26.18571, -98.37984] | The toilet is not located within the range allowed from the side wall or partition. The centerline of the toilet must be 16 to 18 inches from the side wall. | 18.75" centerline | Remount toilets to 16" to 18" from the side wall to centerline. | 2015 ABAAS Section: 604.2 2012 TAS Section: 604.2 2010 ADAS Section: 604.2 | | |

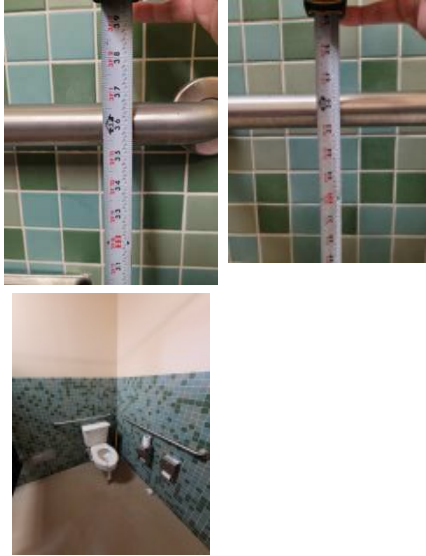
| Finding Number | Area Description | Lat/Long | Finding | As Built | Recommendation | Citation | Photos | Figure |
|---|--|---|---|---|---|---|--|---|
| 88 | Headquarters Area: Meeting Room - Men's Restroom | [26.18571, -98.37984] | The grab bar height and/or spacing fails. Grab bars must be mounted between 33" and 36" to the top of the gripping surface. There must be 1.5" of clearance between the grab bar and the wall. There must be a minimum of 1.5" of clearance below and minimum 12" above the grab bar to any dispenser or other obstruction. | Side grab bar 36.75" AFF; Rear grab bar 36.5" AFF | Remount grab bars in accessible stall to 33" to 36" above the finished floor (AFF). | 2015 ABAAS Section: 609.3, 609.4 2012 TAS Section: 609.4, 609.3 2010 ADAS Section: 609.3, 609.4 | | |

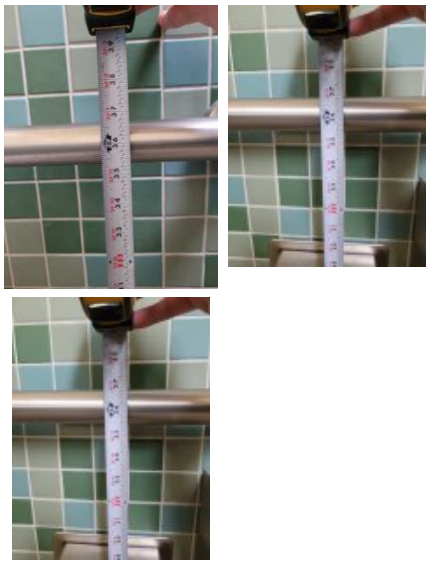
| Finding Number | Area Description | Lat/Long | Finding | As Built | Recommendation | Citation | Photos | Figure |
|---|--|---|---|--|---|--|--|---|
| 96 | Headquarters Area: Meeting Room - Women's Restroom | [26.18571, -98.37984] | The grab bar height and/or spacing fails. Grab bars must be mounted between 33" and 36" to the top of the gripping surface. There must be 1.5" of clearance between the grab bar and the wall. There must be a minimum of 1.5" of clearance below and minimum 12" above the grab bar to any dispenser or other obstruction. | both grab bars 36.75" above finished floor (AFF) | Remount grab bars in accessible stall to 33" to 36" above the finished floor (AFF). | 2015 ABAAS Section: 609.3, 609.4 2012 TAS Section: 609.4, 609.3 2010 ADAS Section: 609.3, 609.4 | | |

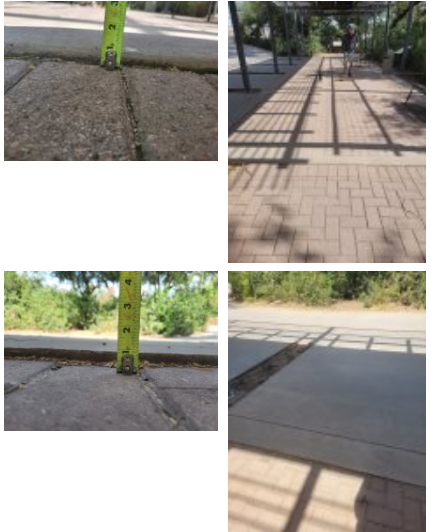
| Finding Number | Area Description | Lat/Long | Finding | As Built | Recommendation | Citation | Photos | Figure |
|---|---|---|--|--|--|---|--|---|
| 100 | Tram System: Tram Stops | [26.1855343 , -98.380349 6] | The walkway contains abrupt vertical edges and/or variations over a 1/4 inch. 1/4 inch is the maximum vertical rise. Changes in level between 1/4 inch and 1/2 inch must be beveled at 1:2 or less. Changes in level greater than 1/2 inch must be by way of a ramp. | .75" change in level (CIL) at tram stop | Repair, bevel or ramp CIL along route. | 2012 TAS Section: 303.2, 303.3 2010 ADAS Section: 303.2, 303.3 | | |

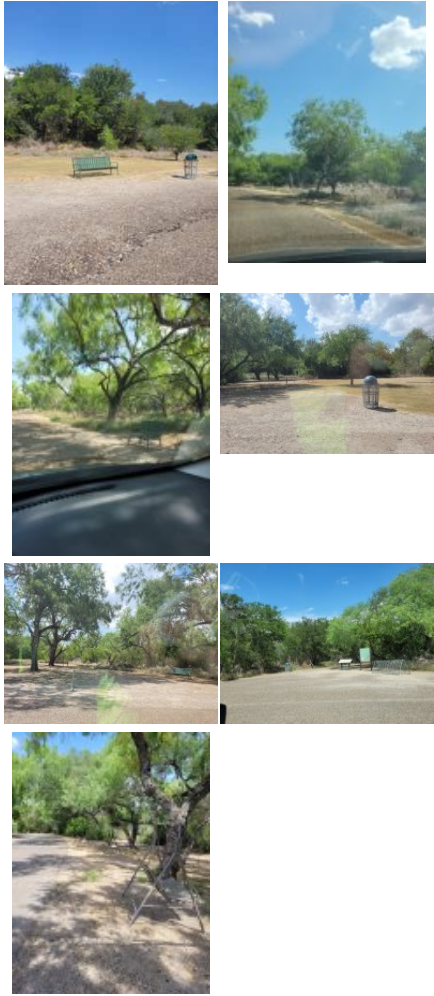
| Finding Number | Area Description | Lat/Long | Finding | As Built | Recommendation | Citation | Photos | Figure |
|---|---|---|--|--|--|---|--|---|
| 101 | Park Site: Park Elements | [26.1794398 , -98.3840967] | At least one accessible route shall connect accessible buildings, accessible facilities, accessible elements, and accessible spaces that are on the same site. For areas of sport activity, an accessible route is required to connect to the boundary of each area of sport activity. The size of an area of sport activity includes only the space needed to play. Where multiple sports fields or courts are provided, an accessible route is required to each field or area of sport activity. | no route to 3 of 3 benches, 4 of 4 swings, 2 of 2 bike racks, 1 of 1 trash | Provide an accessible route (AR) to one bench, and swings within the site. Relocate one bike rack and the garbage to be along an existing route. | 2010 ADAS Section: 206.2.2, 206.2 | | |

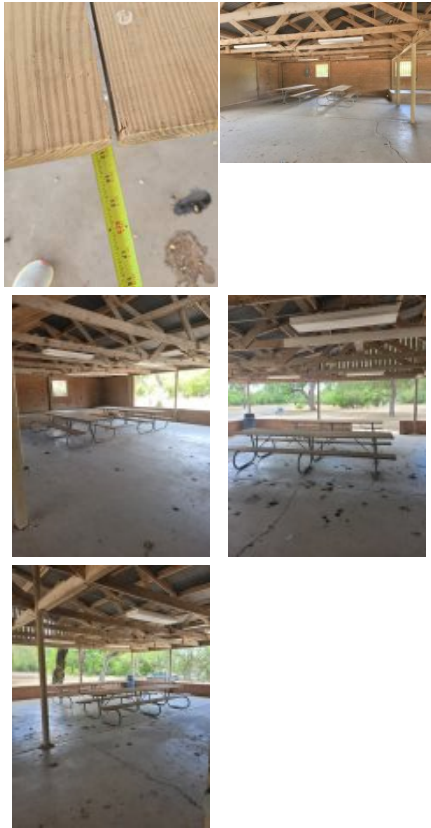
| Finding Number | Area Description | Lat/Long | Finding | As Built | Recommendation | Citation | Photos | Figure |
|---|---|---|--|---|--|---|--|---|
| 106 | Park Site: Pavilion | [26.1782194, -98.3872214] | Picnic tables shall provide at least one wheelchair space for each 24 linear feet (7320 mm) of usable table surface perimeter. Wheelchair spaces shall be 30 inches (760 mm) minimum by 48 inches (1220 mm) minimum. Wheelchair spaces shall be positioned for a forward approach to the table and provide knee and toe clearance complying with 306 under the table | by kings outlook - 0 of 6 picnic tables offer toe clearance | Replace two picnic tables with ones of an accessible design as a smart practice. | 2015 ABAAS Section: 1011.4.2 | | |

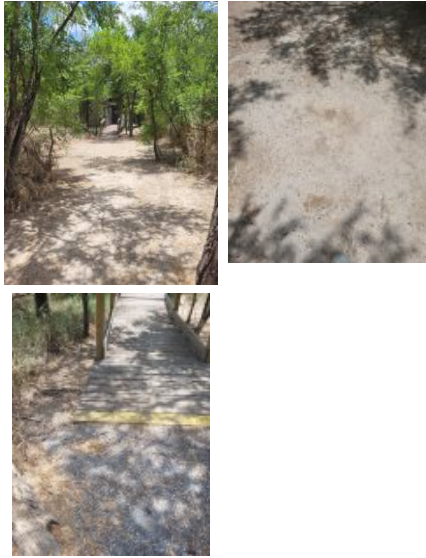
| Finding Number | Area Description | Lat/Long | Finding | As Built | Recommendation | Citation | Photos | Figure |
|---|---|---|--|--|--|---|---|---|
| 110 | Park Site: Bird Blind | [26.1674592, -98.3851079] | There is no accessible route to the Kisskadee Bird Blind. At least one accessible route shall connect accessible buildings, accessible facilities, accessible elements, and accessible spaces that are on the same site. | no route to Kisskadee Bird Blind due to surface | Create an accessible route with crushed stone or other outdoor material from parking or walkway to Kisskadee Bird Blind. | 2015 ABAAS Section: F206.2.2 2012 TAS Section: 206.2.2 2010 ADAS Section: 206.2.2 | | |

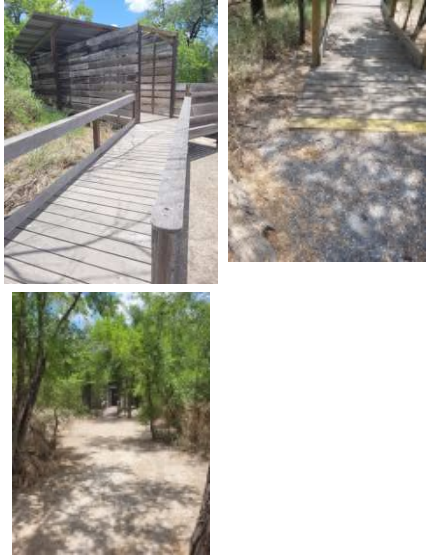
| Finding Number | Area Description | Lat/Long | Finding | As Built | Recommendation | Citation | Photos | Figure |
|---|---|---|---|---|---|---|--|---|
| 113 | Park Site: Bird Blind | [26.1767824 , -98.3900512] | The ramp does not have compliant handrails. Handrails are required on both sides of all surfaces that are sloped greater than 5 percent (1:20). Handrails must be between 34 inches and 38 inches above the ramp surface, must extend beyond the top and bottom of the ramp 12 inches and be parallel to the floor or ground surface. The diameter of the handrails must be between 1 inches and 2 inches in cross-sectional nominal dimension for circular handrails and handrail gripping surfaces with a non-circular cross section shall have a perimeter dimension of 4 inches minimum and 6 inches maximum, and a cross-section dimension of 2 inches maximum. The clear space between handrails and walls must 1-1/2 inches minimum. | both the Kisskadee Bird Blind and Green Jay Bird Blind - guard rails only | Install handrails that are rounded and/or extend to the ground, with handrail extensions and mounted 34" to 38" aff. | 2015 ABAAS Section: 505.1 2012 TAS Section: 505.1 2010 ADAS Section: 505.1 | | |

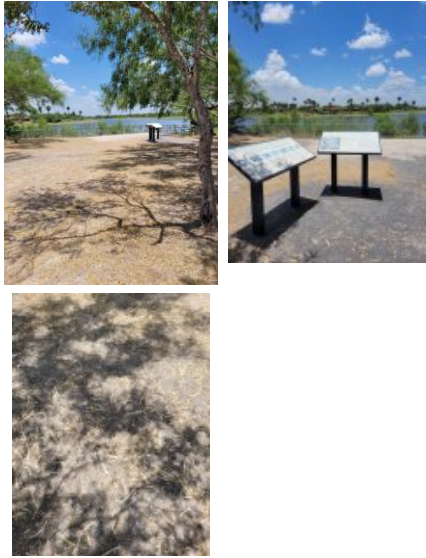
| Finding Number | Area Description | Lat/Long | Finding | As Built | Recommendation | Citation | Photos | Figure |
|---|---|---|--|--|--|---|--|---|
| 115 | Park Site: Kingfisher Overlook | [26.1787405, -98.3869277] | There is no accessible route to the overlook. At least one accessible route shall connect accessible buildings, accessible facilities, accessible elements, and accessible spaces that are on the same site. | no route to overlook due to surface | Create an accessible route with crushed stone or other outdoor material from parking or walkway to Kingfisher Landing. | 2015 ABAAS Section: F206.2.2 2012 TAS Section: 206.2.2 2010 ADAS Section: 206.2.2 | | |

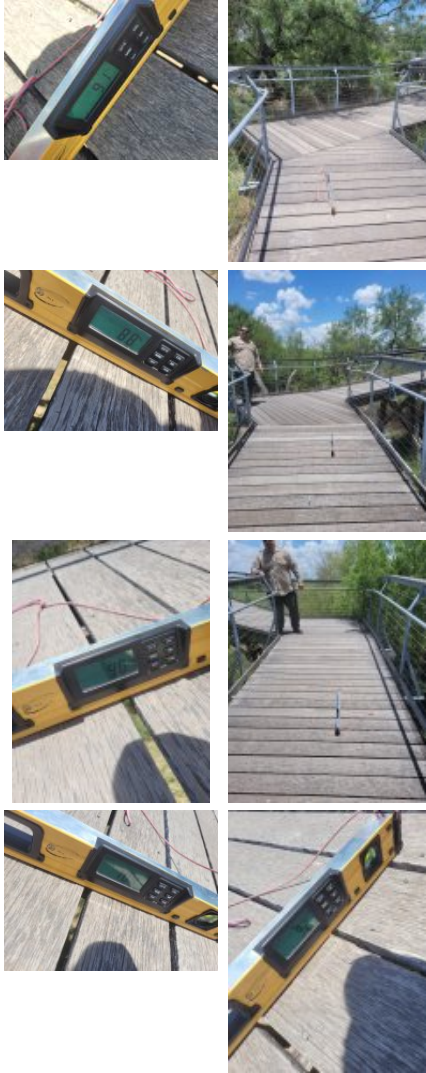
| Finding Number | Area Description | Lat/Long | Finding | As Built | Recommendation | Citation | Photos | Figure |
|---|---|--|---|---|---|--|--|---|
| 117 | Park Site: Hawk Tower | [26.1687688, -98.3811073], [26.169113, -98.3805253] | The ramp slope exceeds the maximum running slope (direction of travel) allowable of 8.33%. Ramps should have the least possible slope but in no case more than 8.3% (1:12). | Hawk Tower ramp - 9.1% at top of first run, 8.8% at second run, 9.6% slope at third turn, 10.4% slope at fourth turn, 9.2% slope approaching top, 9.3% slope at top | Correct slope of ramp to max 8.33%. | 2015 ABAAS Section: 405.2 2012 TAS Section: 405.2 2010 ADAS Section: 405.2 | | |

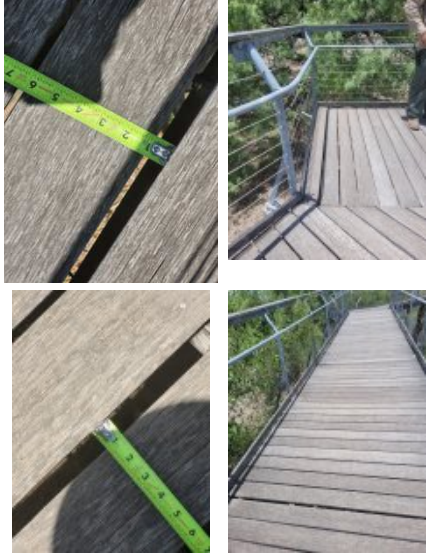
| Finding Number | Area Description | Lat/Long | Finding | As Built | Recommendation | Citation | Photos | Figure |
|---|---|--|--|---|---|--|--|---|
| 118 | Park Site: Hawk Tower | [26.1687279, -98.3811972], [26.1691082, -98.3805427] | Openings in floor or ground surfaces shall not allow passage of a sphere more than ½ inch (13 mm) diameter except as allowed in 407.4.3, 409.4.3, 410.4, 810.5.3 and 810.10. Elongated openings shall be placed so that the long dimension is perpendicular to the dominant direction of travel. | 17 instances of gaps along the ramp to Hawk Tower | Fill and maintain gaps to max .5". | 2015 ABAAS Section: 302.3 2012 TAS Section: 302.3 2010 ADAS Section: 302.3 | | |

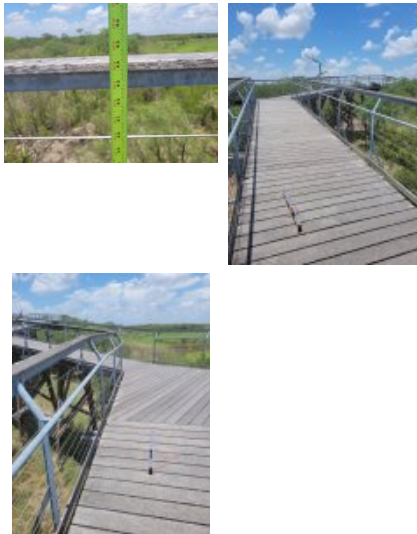
| Finding Number | Area Description | Lat/Long | Finding | As Built | Recommendation | Citation | Photos | Figure |
|---|---|---|--|---|--|---|--|---|
| 119 | Park Site: Hawk Tower | [26.168977, -98.3806688] | Each distinct viewing location shall provide a viewing space adjacent to the clear ground space required by 1015.2 through which the point of interest is viewable. The viewing space shall be 32 inches (815 mm) maximum and 51 inches (1295 mm) minimum high above the ground and shall extend the full width of the clear ground space. | Hawk Tower - guard railing 44" above finished floor | Lower a 36" wide portion of railing to provide an unobstructed view between 32" and 51" if doing so doesn't impact safety. | 2015 ABAAS Section: 1015.3 | | |

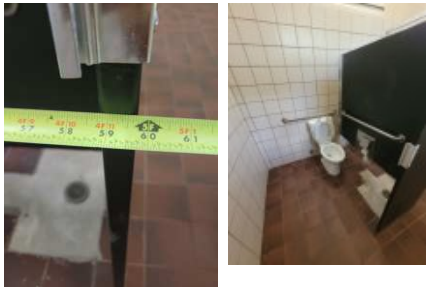
| Finding Number | Area Description | Lat/Long | Finding | As Built | Recommendation | Citation | Photos | Figure |
|---|--|---|--|--|---|--|--|--|
| 123 | Restrooms : Hackberry - Men's Restroom | [26.1773577 , -98.388506 2] | The dimensions of the toilet stall do not comply. Wheelchair accessible compartments shall be 60 inches wide and 59 inches deep minimum for floor mounted water closets measured perpendicular to the rear wall. Door shall not swing into the minimum clear floor space required for the toilet. | 58.75" depth | Widen accessible stalls to min. 60" clear width, 59" depth. In the alternative, leave as is citing construction tolerance. | 2015 ABAAS Section: 604.8.1.1 2012 TAS Section: 604.3.2 2010 ADAS Section: 604.3.2 | | |

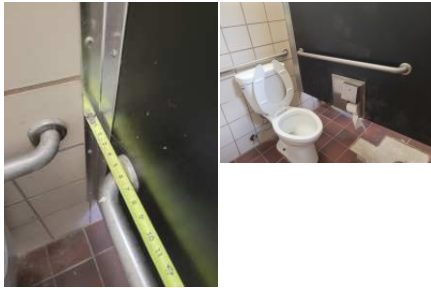
| Finding Number | Area Description | Lat/Long | Finding | As Built | Recommendation | Citation | Photos | Figure |
|---|--|---|--|---|--|--|--|---|
| 125 | Restrooms : Hackberry - Men's Restroom | [26.1773673 , -98.388498 2] | The side grab bars are not in the correct location. Grab bars on the side wall must be installed so that the end closest to the rear wall is maximum 12" from the rear wall. The end furthest from the rear wall must be mounted minimum 54" from the rear wall. | mounted 6" from wall, extends 48" to grab bar end | Remount side grab bar to max 12" from the rear wall at the close end and min 54" on the far end, and 33" to 36" aff. | 2015 ABAAS Section: 604.5.1 2012 TAS Section: 604.5.1 2010 ADAS Section: 604.5.1 | | |

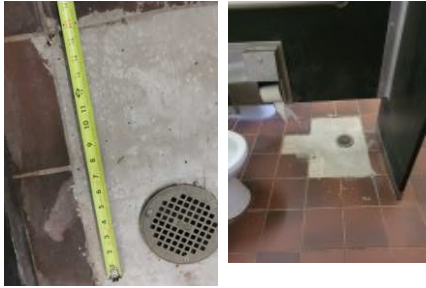
| Finding Number | Area Description | Lat/Long | Finding | As Built | Recommendation | Citation | Photos | Figure |
|---|--|---|--|--|--|--|---|---|
| 128 | Restrooms : Hackberry - Men's Restroom | [26.1773528 , -98.388525] | Openings in floor or ground surfaces shall not allow passage of a sphere more than 1/2 inch (13 mm) diameter except as allowed in 407.4.3, 409.4.3, 410.4, 810.5.3 and 810.10. Elongated openings shall be placed so that the long dimension is perpendicular to the dominant direction of travel. | large gap in stall due to missing tiles | Fill and maintain gaps to max .5". | 2015 ABAAS Section: 302.3 2012 TAS Section: 302.3 2010 ADAS Section: 302.3 | | |

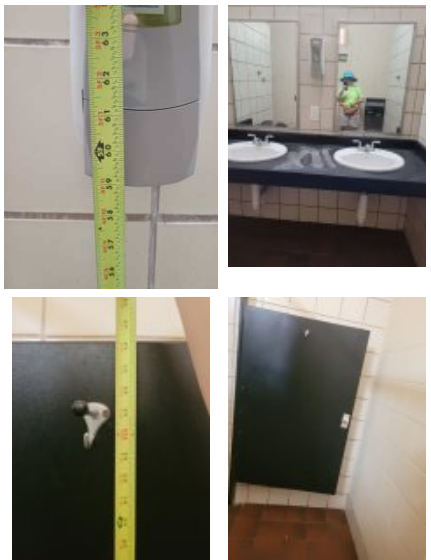
| Finding Number | Area Description | Lat/Long | Finding | As Built | Recommendation | Citation | Photos | Figure |
|---|---|---|--|---|---|--|--|--|
| 134 | Restrooms : Hackberry - Women's Restroom | [26.1773721 , -98.388519 6] | Where a high forward reach is over an obstruction, the clear floor space shall extend beneath the element for a distance not less than the required reach depth over the obstruction. The high forward reach shall be 48 inches (1220 mm) maximum where the reach depth is 20 inches (510 mm) maximum. Where the reach depth exceeds 20 inches (510 mm), the high forward reach shall be 44 inches (1120 mm) maximum and the reach depth shall be 25 inches (635 mm) maximum. Where a clear floor or ground space allows a parallel approach to an element and the high side reach is over an obstruction, the height of the obstruction shall be 34 inches (865 mm) maximum and the depth of the obstruction shall be 24 inches (610 mm) maximum. The high side reach shall be 48 inches (1220 mm) maximum for a reach depth of 10 inches (255 mm) maximum. Where the reach depth exceeds 10 inches (255 mm), the high side reach shall be 46 inches (1170 mm) maximum for a reach depth of 24 inches (610 mm) maximum. | soap 59" AFF, hook in stall 63" AFF | Lower hook to max 48" above the finished floor (AFF) to highest operable part. Lower soap to max 44" for a forward reach over the sink. | 2015 ABAAS Section: 308.2.1, 308.3.2 2012 TAS Section: 308.2.1, 308.3.2 2010 ADAS Section: 308.2.1, 308.3.2 | | |

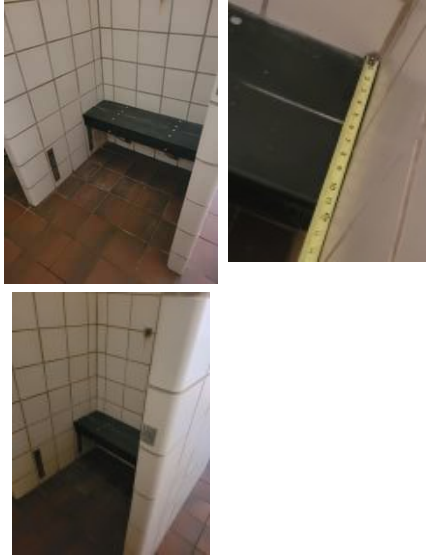
| Finding Number | Area Description | Lat/Long | Finding | As Built | Recommendation | Citation | Photos | Figure |
|---|---|---|--|--|--|---|---|---|
| 140 | Restrooms : Hackberry - Women's Restroom | [26.177348, -98.388530 4] | The bench is not deep enough or long enough or is missing. Benches shall be provided having seats that are 42 inches long minimum and 20 inches deep minimum and 24 inches deep maximum. The bench shall provide for back support or shall be affixed to a wall. Back support shall be 42 inches (1065 mm) long minimum and shall extend from a point 2 inches (51 mm) maximum above the seat surface to a point 18 inches (455 mm) minimum above the seat surface. Back support shall be 2½ inches (64 mm) maximum from the rear edge of the seat measured horizontally. The top of the bench seat surface shall be 17 inches (430 mm) minimum and 19 inches (485 mm) maximum above the finish floor or ground. Clear floor or ground space complying with 305 shall be provided and shall be positioned at the end of the bench seat and parallel to the short axis of the bench | 11.5" depth, lacks clear floor space on side | Replace bench in dressing area with one having a seat depth of 20" to 24" deep, 42" long, affixed to the wall or having a back and mounted 17" to 19" aff and provide required clear floor space on the short axis of the bench. | 2012 TAS Section: 903.4, 903.2, 903.3, 903.5 2010 ADAS Section: 903.4, 903.2, 903.3, 903.5 | | |

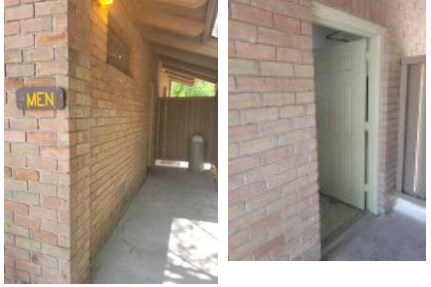
| Finding Number | Area Description | Lat/Long | Finding | As Built | Recommendation | Citation | Photos | Figure |
|---|---|---|--|--|--|---|--|---|
| 143 | Restrooms : Paixtle - Men's Restroom | [26.1766764 , -98.384748 4] | The restroom sign does not comply with one or more applicable requirements for the location, height, and properties of the sign. | sign lacks Braille, raised characters, and International Symbol of Accessibility (ISA) | Replace sign with one of contrasting colors that includes Braille, raised characters, and the symbol of accessibility and mount on the wall, latch side of the door, 48" to the baseline of the lowest character and 60" to the baseline of the highest character. | 2015 ABAAS Section: F216.2, 703.1, 703.2, 703.5, 703.6 2012 TAS Section: 216.2, 703.1, 703.2, 703.5, 703.6 2010 ADAS Section: 216.2, 703.1, 703.2, 703.5, 703.6 | | |

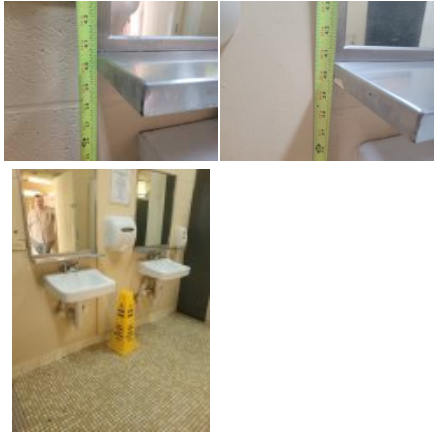
| Finding Number | Area Description | Lat/Long | Finding | As Built | Recommendation | Citation | Photos | Figure |
|---|---|---|--|--|--|--|---|---|
| 144 | Restrooms : Paixtle - Men's Restroom | [26.1766861 , -98.384751 1] | The mirror is mounted too high. Mirrors must have the bottom edge of the reflecting surface a maximum of 40 inches above the floor if above a sink or counter. Mirrors not located above lavatories or countertops shall be installed with the bottom edge of the reflecting surface 35 inches maximum above the finish floor or ground. | mirror 41.25" above finished floor | Lower mirror so bottom reflective surface is max 40" AFF and 74" at the top. | 2015 ABAAS Section: 603.3 2012 TAS Section: 603.3 2010 ADAS Section: 603.3 | | |

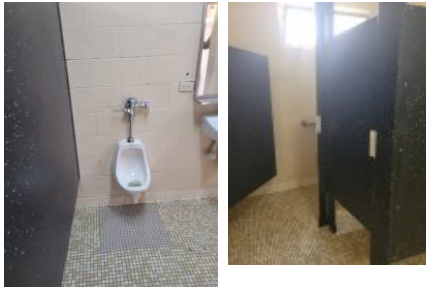
| Finding Number | Area Description | Lat/Long | Finding | As Built | Recommendation | Citation | Photos | Figure |
|---|---|---|--|--|--|--|---|---|
| 145 | Restrooms : Paixtle - Men's Restroom | [26.17665, -98.384743 1] | There are not enough accessible toilet compartments. The room contains toilet compartments. A minimum of 1 must be wheelchair accessible . | 1 urinal, 1 standard stall, 1 ambulatory stall, lacks wheelchair stall | Create a wheelchair accessible stall with grab bars and fixtures mounted in correct locations and at correct heights. | 2015 ABAAS Section: F213.3.1 2012 TAS Section: 213.3.1 2010 ADAS Section: 213.3.1 | | |

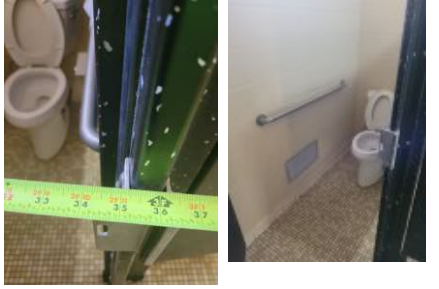
| Finding Number | Area Description | Lat/Long | Finding | As Built | Recommendation | Citation | Photos | Figure |
|---|---|---|--|--|--|--|---|---|
| 146 | Restrooms : Paixtle - Men's Restroom | [26.1766813 , -98.384759 2] | The ambulatory stall is not between 35" to 37" wide and 60" deep. | 34.5" width | Correct ambulatory stall to be 35" to 37" wide and minimum 60" deep. In the alternative, use existing stall to create required wheelchair stall. | 2015 ABAAS Section: 604.8.2.1 2012 TAS Section: 604.8.2.1 2010 ADAS Section: 604.8.2.1 | | |

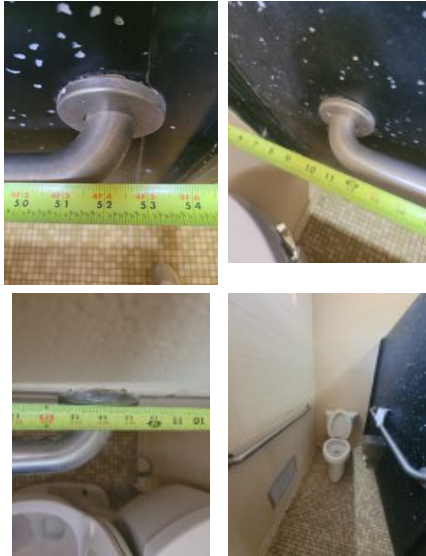
| Finding Number | Area Description | Lat/Long | Finding | As Built | Recommendation | Citation | Photos | Figure |
|---|---|---|---|--|---|---|--|---|
| 149 | Restrooms : Paixtle - Men's Restroom | [26.1767366 , -98.384603 6] | The side grab bars are not in the correct location. Grab bars on the side wall must be installed so that the end closest to the rear wall is maximum 12" from the rear wall. The end furthest from the rear wall must be mounted minimum 54" from the rear wall. | right mounted 10.5" from rear wall, extends 52.5" to grab bar end, left mounted 14" from rear wall | Remount side grab bar to max 12" from the rear wall at the close end and min 54" on the far end, and 33" to 36" aff. | 2015 ABAAS Section: 604.5.1 2012 TAS Section: 604.5.1 2010 ADAS Section: 604.5.1 | | |
