Access Audit Site Report

Bentsen-Rio Grande Valley State Park

Accessibility Evaluation

Inspection Date: 07/13/2022

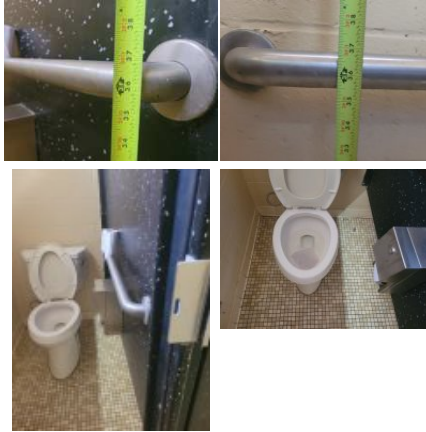
| Finding Number | Area Description | Lat/Long | Finding | As Built | Recommendation | Citation | Photos | Figure |
|---|---|---|---|--|---|---|--|---|
| 150 | Restrooms : Paixtle - Men's Restroom | [26.1766813 , -98.384756 5] | The grab bar height and/or spacing fails. Grab bars must be mounted between 33" and 36" to the top of the gripping surface. There must be 1.5" of clearance between the grab bar and the wall. There must be a minimum of 1.5" of clearance below and minimum 12" above the grab bar to any dispenser or other obstruction. | both 37" above finished floor, toilet paper on grab bar and too close to toilet | Remount grab bars in accessible stall to 33" to 36" above the finished floor (AFF). Remount toilet paper dispenser max 7" to 9" from front of toilet, 15" to 48" above the finished floor (AFF) and min 12" above or 1.5" below grab bar. | 2015 ABAAS Section: 609.3, 609.4 2012 TAS Section: 609.4, 609.3 2010 ADAS Section: 609.3, 609.4 | | |

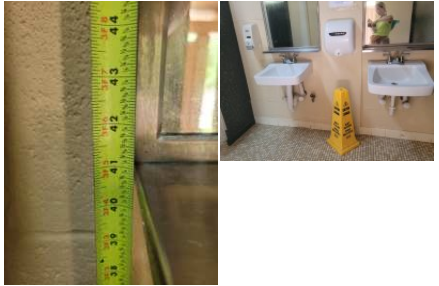
| Finding Number | Area Description | Lat/Long | Finding | As Built | Recommendation | Citation | Photos | Figure |
|---|---|---|--|---|---|--|--|---|
| 156 | Restrooms : Paixtle - Women's Restroom | [26.1766524 , -98.384751 1] | The mirror is mounted too high. Mirrors must have the bottom edge of the reflecting surface a maximum of 40 inches above the floor if above a sink or counter. Mirrors not located above lavatories or countertops shall be installed with the bottom edge of the reflecting surface 35 inches maximum above the finish floor or ground. | 41.5" above finished floor | Lower mirror so bottom reflective surface is max 40" AFF and 74" at the top. | 2015 ABAAS Section: 603.3 2012 TAS Section: 603.3 2010 ADAS Section: 603.3 | | |

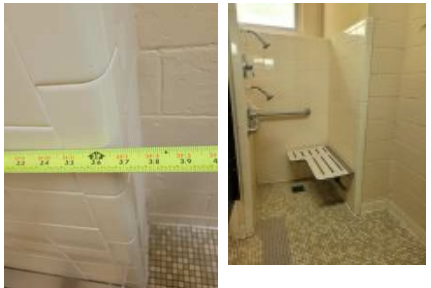
| Finding Number | Area Description | Lat/Long | Finding | As Built | Recommendation | Citation | Photos | Figure |
|---|---|---|--|---|---|---|--|--|
| 165 | Restrooms : Paixtle - Women's Restroom | [26.1766596 , -98.3847592] | Transfer type shower compartments shall be 36 inches (915 mm) by 36 inches (915 mm) clear inside dimensions measured at the center points of opposing sides and shall have a 36 inch (915 mm) wide minimum entry on the face of the shower compartment. Clearance of 36 inches (915 mm) wide minimum by 48 inches (1220 mm) long minimum measured from the control wall shall be provided. | 37" depth | Reconfigure transfer shower to compliant 36" by 36" clear inside dimension. In the alternative, leave as is citing construction tolerance. | 2015 ABAAS Section: 608.2.1 2012 TAS Section: 608.2.1 2010 ADAS Section: 608.2.1 | | |

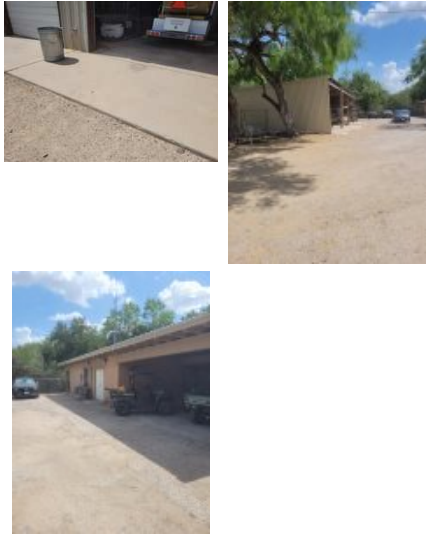
| Finding Number | Area Description | Lat/Long | Finding | As Built | Recommendation | Citation | Photos | Figure |
|---|---|---|---|---|--|---|--|---|
| 169 | Employee Areas: Maintenance | [26.1839926 , -98.382176 2] | Spaces and elements within employee work areas shall only be required to comply with 206.2.8, 207.1, and 215.3 and shall be designed and constructed so that individuals with disabilities can approach, enter, and exit the employee work area. Employee work areas, or portions of employee work areas, other than raised courtroom stations, that are less than 300 square feet (28 m2) and elevated 7 inches (180 mm) or more above the finish floor or ground where the elevation is essential to the function of the space shall not be required to comply with these requirements or to be on an accessible route. | no route to garages due to gravel surface | Create AR with crushed and compacted stone or similar outdoor material from parking to maintenance facilities. | 2015 ABAAS Section: F203.9 2012 TAS Section: 203.9 2010 ADAS Section: 203.9 | | |

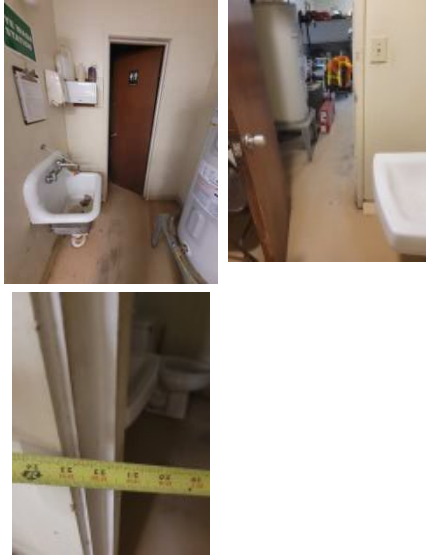
| Finding Number | Area Description | Lat/Long | Finding | As Built | Recommendation | Citation | Photos | Figure |
|---|---|---|--|--|--|---|---|---|
| 173 | Employee Areas: Maintenance | [26.1839577, -98.3822647] | Minimum maneuvering clearances at doors and gates shall comply with 404.2.4. Maneuvering clearances shall extend the full width of the doorway and the required latch side or hinge side clearance. Maneuvering clearances shall have a max slope of 2.08%. Door openings shall provide a clear width of 32 inches (815 mm) minimum. Clear openings of doorways with swinging doors shall be measured between the face of the door and the stop, with the door open 90 degrees. Openings more than 24 inches (610 mm) deep shall provide a clear opening of 36 inches (915 mm) minimum. There shall be no projections into the required clear opening width lower than 34 inches (865 mm) above the finish floor or ground. Projections into the clear opening width between 34 inches (865 mm) and 80 inches (2030 mm) above the finish floor or ground shall not exceed 4 inches (100 mm). Hand-activated door opening hardware, handles, pulls, latches, locks, and other operating devices on accessible doors shall have a shape that is easy to grasp with one hand and does not require tight grasping, tight pinching or twisting of the wrist to operate. Hardware shall be 34 inches minimum and 48 inches maximum above the finish floor or ground. | restroom door - clearance on push and pull reduced by sinks, knob, 21.5" width | For all doors along the public circulation route, provide required maneuvering clearance on push and pull side of doors. For all doors along the public circulation route, replace doors with doors having 80" overhead clearance and 32" clear width. For all doors along the public circulation route, replace hardware with lever hardware or hardware operable without a tight pinch or grasp. | 2010 ADAS Section: 404.2.3, 404.2.7, 404.2.4, 404.2.11, 404.2.11 Exception | | |

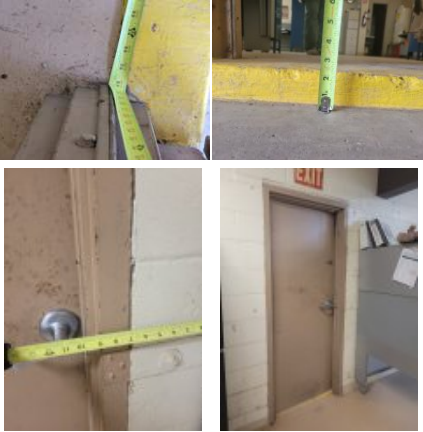
| Finding Number | Area Description | Lat/Long | Finding | As Built | Recommendation | Citation | Photos | Figure |
|---|---|---|---|---|--|---|---|---|
| 175 | Employee Areas: Maintenance | [26.183977, -98.382243 3] | Spaces and elements within employee work areas shall only be required to comply with 206.2.8, 207.1, and 215.3 and shall be designed and constructed so that individuals with disabilities can approach, enter, and exit the employee work area. Employee work areas, or portions of employee work areas, other than raised courtroom stations, that are less than 300 square feet (28 m2) and elevated 7 inches (180 mm) or more above the finish floor or ground where the elevation is essential to the function of the space shall not be required to comply with these requirements or to be on an accessible route. | side door - 2.5" change in level, 27" width, clearance on push reduced to 10" by movable office partition | For employee spaces, relocate storage, furniture, and other obstacles at doorways to provide approach, enter and exit at the employee space. Provide required maneuvering clearance on push and pull side of doors. Replace doors with doors having 80" overhead clearance and 32" clear width. Repair, bevel, or ramp CILs at door entries to max .25". | 2015 ABAAS Section: F203.9 2012 TAS Section: 203.9 2010 ADAS Section: 203.9 | | |

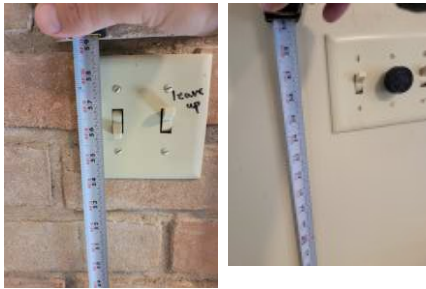
| Finding Number | Area Description | Lat/Long | Finding | As Built | Recommendation | Citation | Photos | Figure |
|---|--|---|---|---|--|--|---|---|
| 177 | La Familia Nature Center: La Familia - Public Spaces | [26.1836785 , -98.380558 8] | The operable part is positioned too high for either a side or front approach. Where a clear floor or ground space allows a parallel approach to an element and the side reach is unobstructed, the high side reach shall be 48 inches maximum and the low side reach shall be 15 inches minimum above the finish floor or ground. Where a forward reach is unobstructed, the high forward reach shall be 48 inches maximum and the low forward reach shall be 15 inches minimum above the finish floor or ground. | Light switch at 56" AFF | Remount operable parts to be in reach range of 15" min to 48" max. | 2015 ABAAS Section: 308.1 2012 TAS Section: 308.1 2010 ADAS Section: 308.1 | | |

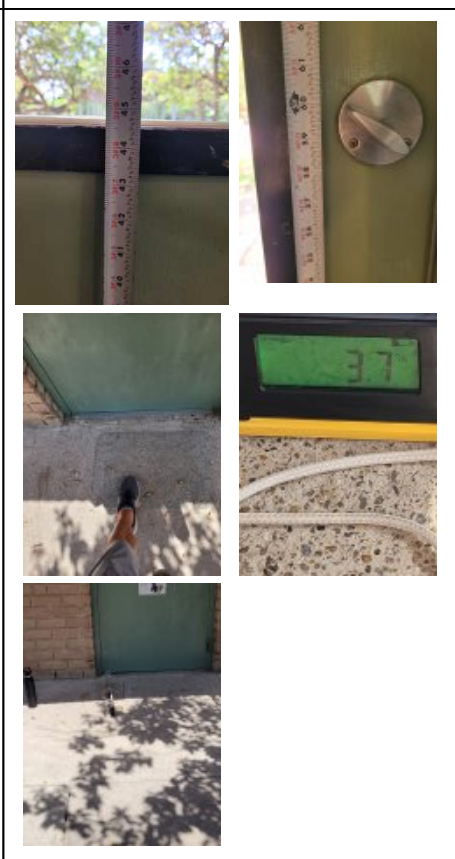
| Finding Number | Area Description | Lat/Long | Finding | As Built | Recommendation | Citation | Photos | Figure |
|---|--|---|---|---|--|--|--|---|
| 178 | La Familia Nature Center: La Familia - Public Spaces | [26.1837289 , -98.380555 9] | <p>Minimum maneuvering clearances at doors and gates shall comply with 404.2.4. Maneuvering clearances shall extend the full width of the doorway and the required latch side or hinge side clearance. Maneuvering clearances shall have a max slope of 2.08%. Hand-activated door opening hardware, handles, pulls, latches, locks, and other operating devices on accessible doors shall have a shape that is easy to grasp with one hand and does not require tight grasping, tight pinching or twisting of the wrist to operate. Hardware shall be 34 inches minimum and 48 inches maximum above the finish floor or ground. Doors, gates, and side lights adjacent to doors or gates, containing one or more glazing panels that permit viewing through the panels shall have the bottom of at least one glazed panel located 43 inches (1090 mm) maximum above the finish floor. EXCEPTION: Vision lights with the lowest part more than 66 inches (1675 mm) from the finish floor or ground shall not be required to comply with 404.2.11.</p> | exit door to pavilion - window 44.75" above finished floor (AFF), lock 66" AFF, loose rug, 3.7% slope | For all doors along the public circulation route, secure rug in door clearance to prevent trip hazard. For all doors along the public circulation route, correct slope in door clearance to max 2.08%. For all doors along the public circulation route, leave as is lock on door - employee operated. For all doors along the public circulation route, replace doors with ones having sidelight viewing windows max 43" AFF. | 2010 ADAS Section: 404.2.3, 404.2.7, 404.2.4, 404.2.11, 404.2.11 Exception | | |

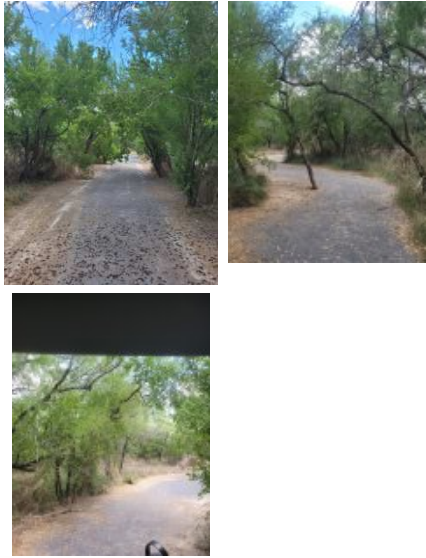
| Finding Number | Area Description | Lat/Long | Finding | As Built | Recommendation | Citation | Photos | Figure |
|---|---|---|---|---|--|---|--|---|
| 192 | Trails: Trail Surface | [26.1778872, -98.387124 9] | Constructed elements on trails, passing spaces, and resting intervals shall comply with 307. Any constructed object cannot protrude into the pathway more than 4" between 27" and 80" above the trail surface | overhead reduced at Kissadee Trail due to trees in 5 instances; employee stated it is park policy that they cannot trim overgrowth until August due to nesting season for the birds | Until trees can be trimmed, mount signage warning patrons of reduced overhead clearance. | 2015 ABAAS Section: 1017.9 | | |

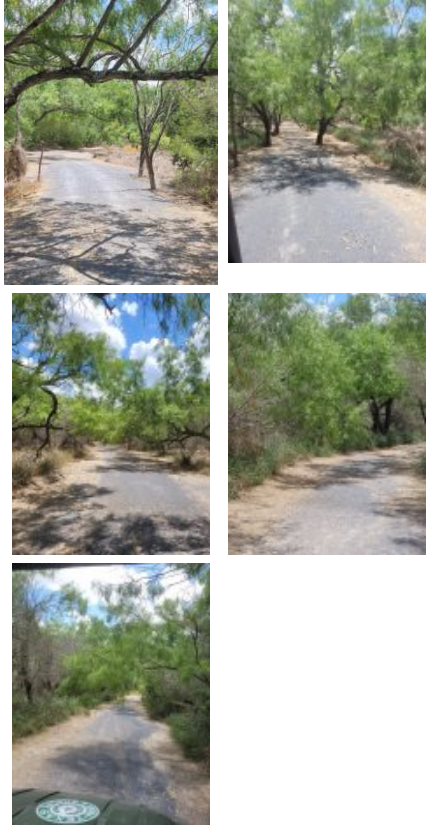
| Finding Number | Area Description | Lat/Long | Finding | As Built | Recommendation | Citation | Photos | Figure |
|---|---|---|---|--|--|---|--|---|
| 194 | Trails: Trail Surface | [26.1695343 , -98.381921 4] | Constructed elements on trails, passing spaces, and resting intervals shall comply with 307. Any constructed object cannot protrude into the pathway more than 4" between 27" and 80" above the trail surface | Rio Grande trail - 20 plus instances of overhang, unable to cut until August due to park policy | Until trees can be trimmed, mount signage warning patrons of reduced overhead clearance. | 2015 ABAAS Section: 1017.9 | | |
