Access Audit Site Report

Prepared By
WT Group

Blanco State Park
101 Park Rd 23
Blanco, TX 78606
Accessibility Evaluation
Inspection Date: 02/09/2022
Inspectors: Tanya Scheibe

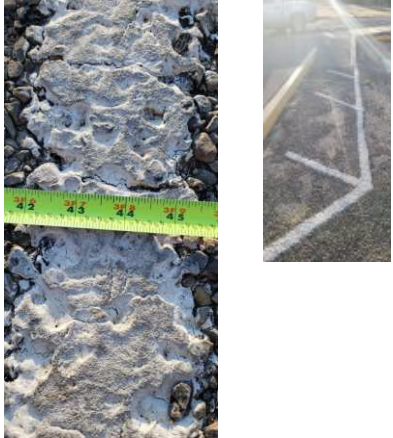
Finding Number	Area Description	Lat/Long	Finding	As Built	Recommendation	Citation	Photos	Figure
7	Headquarters (HQ) : HQ - Parking	[30.0929558, -98.4238711]	There are no van accessible parking stalls. 1 in every 6, minimum of one, required accessible stalls must be a van accessible stall. There are a total of 4 parking stalls in the parking lot that could be reasonably associated with this facility. There should be a minimum of 1 accessible stalls with a minimum of 1 being designed as van accessible.	HQ parking - Accessible stall is not a van accessible	Add van parking sign to 1 accessible stall and repaint stall and access aisle to 11' and 5' or 8' and 8'.	2015 ABAAS Section: F208.2, F208.2.4 2012 TAS Section: 208.2, 208.2.4 2010 ADAS Section: 208.2, 208.2.4

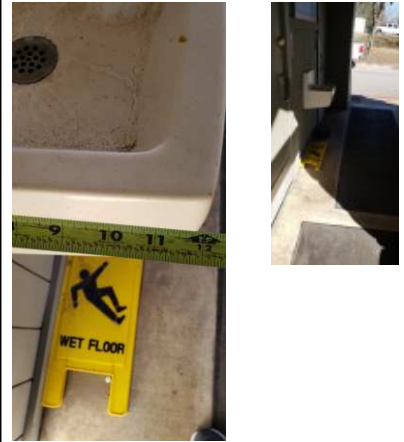
18	Headquarters (HQ) : HQ - Public Spaces	[30.0930567 , -98.423855]	An item or items project more than 4 inches into the circulation path. Wall-mounted objects that have leading edges between 27 inches and 80 inches from the floor must not project more than 4 inches into the circulation path. Protruding objects that extend to the floor or within 27 inches of the floor are cane detectable and are therefore not hazardous. Where it is necessary or desirable to have objects protrude from the wall, a manner of cane detection must be provided.	Drinking fountain protrudes 12"	Relocate protruding objects or place cane detectable warning or bollard at foot of item.	2015 ABAAS Section: 307.2 2012 TAS Section: 307.2 2010 ADAS Section: 307.2

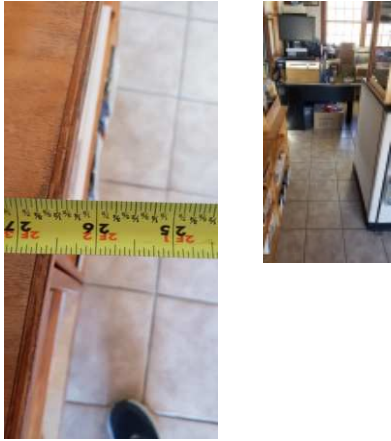
Finding Number	Area Description	Lat/Long	Finding	As Built	Recommendation	Citation	Photos	Figure
19	Headquarters (HQ) : HQ - Employee Spaces	[30.0930811 , -98.423873 8]	Spaces and elements within employee work areas shall only be required to comply with 206.2.8, 207.1, and 215.3 and shall be designed and constructed so that individuals with disabilities can approach, enter, and exit the employee work area. Employee work areas, or portions of employee work areas, other than raised courtroom stations, that are less than 300 square feet (28 m2) and elevated 7 inches (180 mm) or more above the finish floor or ground where the elevation is essential to the function of the space shall not be required to comply with these requirements or to be on an accessible route.	Entry to employee area 27" wide	For employee spaces, relocate storage, furniture, and other obstacles at doorways to provide approach, enter and exit at the employee space. Correct entry to provide 32" clear width.	2015 ABAAS Section: F203.9 2012 TAS Section: 203.9 2010 ADAS Section: 203.9

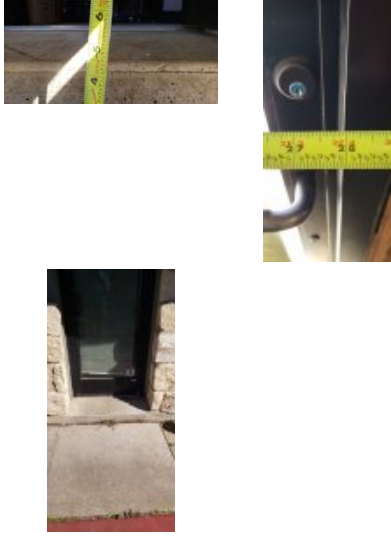
20	Headquarters (HQ) : HQ - Employee Spaces	[30.0930718 , -98.423864 4]	Door openings shall provide a clear width of 32 inches (815 mm) minimum. Clear openings of doorways with swinging doors shall be measured between the face of the door and the stop, with the door open 90 degrees. Openings more than 24 inches (610 mm) deep shall provide a clear opening of 36 inches (915 mm) minimum. There shall be no projections into the required clear opening width lower than 34 inches (865 mm) above the finish floor or ground. Projections into the clear opening width between 34 inches (865 mm) and 80 inches (2030 mm) above the finish floor or ground shall not exceed 4 inches (100 mm). The threshold has a vertical change greater than 1/4 inch high. Exterior doors are recommended to be maintained at 8.5 lbf as a smart practice. Force is to be measured at the operating hardware or 30 inches from the hinges, whichever is greater.	HQ side door - 4.5" change in level (CIL), 27.5" wide, 10# push	For all doors along the public circulation route, replace doors with doors having 80" overhead clearance and 32" clear width. For all doors along the public circulation route, repair, bevel, or ramp CILs at door entries to max .25". For all doors along the public circulation route, inspect, adjust, and maintain 8.5 lbf to open exterior doors as a smart practice.	2010 ADAS Section: 404.2.3, 404.2.7, 404.2.4, 404.2.11, 404.2.11 Exception

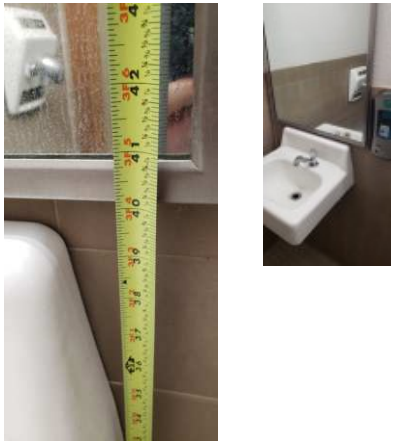
Finding Number	Area Description	Lat/Long	Finding	As Built	Recommendation	Citation	Photos	Figure
21	Headquarters (HQ) : HQ - Men's Restroom	[30.0930846 , -98.423869 8]	The tactile restroom wall sign is missing the International Symbol of Accessibility (ISA). Accessible toilet rooms or bathing rooms shall be identified by the International Symbol of Accessibility (ISA). Wall signs identifying permanent rooms and spaces of a building shall have be horizontal format and the characters raised 1/32 inch minimum and shall be sans serif uppercase characters a minimum of 5/8 inch and a maximum of 2 inches high. Contracted Grade 2 Braille shall be in a horizontal format and shall be placed a minimum of 3/8 inch and a maximum of 1/2 inch directly below the tactile characters; flush left or centered. Signs with raised characters or Braille shall be located 48 inches minimum above the finish floor or ground surface, measured from the baseline of the lowest tactile character and 60 inches maximum above the finish floor or ground surface, measured from the baseline of the highest tactile character.	Signage lacks ISA	Acquire and mount signage, including access symbol.	2015 ABAAS Section: F216.8 2012 TAS Section: 216.8 2010 ADAS Section: 216.8

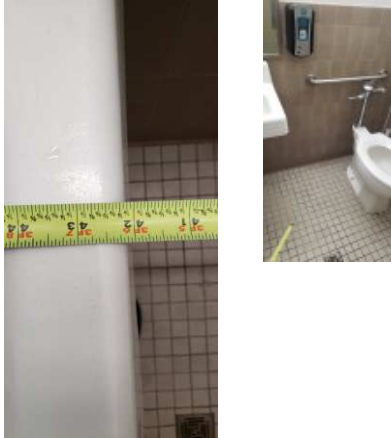
Finding Number	Area Description	Lat/Long	Finding	As Built	Recommendation	Citation	Photos	Figure
23	Headquarters (HQ) : HQ - Men's Restroom	[30.0930765 , -98.423877 8]	The water and drain pipes under the lavatory are not adequately insulated. Water supply and drain pipes under lavatories and sinks shall be insulated or otherwise configured to protect against contact. There shall be no sharp or abrasive surfaces under lavatories and sinks.	Sink lacks insulated pipes	Insulate exposed pipes under one sink.	2015 ABAAS Section: 606.5 2012 TAS Section: 606.5 2010 ADAS Section: 606.5

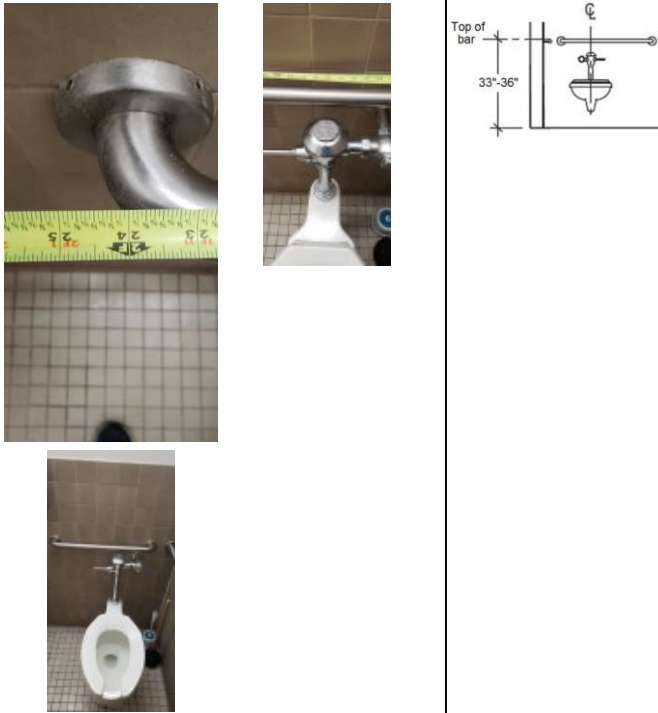
Finding Number	Area Description	Lat/Long	Finding	As Built	Recommendation	Citation	Photos	Figure
25	Headquarters (HQ) : HQ - Men's Restroom	[30.0930683 , -98.423876 5]	The side grab bars are not in the correct location. Grab bars on the side wall must be installed so that the end closest to the rear wall is maximum 12" from the rear wall. The end furthest from the rear wall must be mounted minimum 54" from the rear wall.	Side grab bar ends 52" from rear wall	Remount side grab bar to max 12" from the rear wall at the close end and min 54" on the far end, and 33" to 36" AFF.	2015 ABAAS Section: 604.5.1 2012 TAS Section: 604.5.1 2010 ADAS Section: 604.5.1

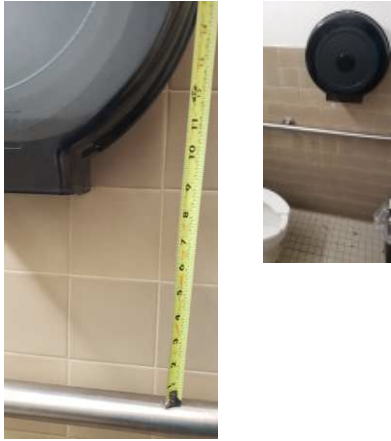
Finding Number	Area Description	Lat/Long	Finding	As Built	Recommendation	Citation	Photos	Figure
27	Headquarters (HQ) : HQ - Men's Restroom	[30.0930869 , -98.423879 2]	The grab bar height and/or spacing fails. Grab bars must be mounted between 33" and 36" to the top of the gripping surface. There must be 1.5" of clearance between the grab bar and the wall. There must be a minimum of 1.5" of clearance below and minimum 12" above the grab bar to any dispenser or other obstruction.	Toilet paper mounted 9" above bar	Remount toilet paper dispenser max 7" to 9" from front of toilet, 15" to 48" above the finished floor (AFF) and min 12" above or 1.5" below grab bar.	2015 ABAAS Section: 609.3, 609.4 2012 TAS Section: 609.4, 609.3 2010 ADAS Section: 609.3, 609.4

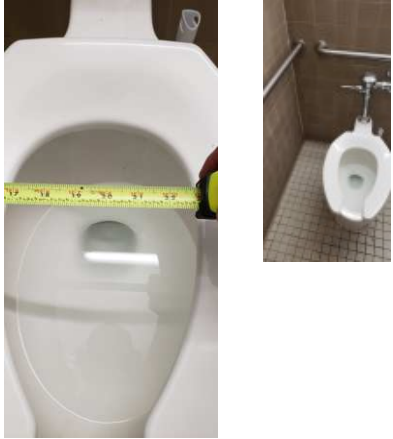
Finding Number	Area Description	Lat/Long	Finding	As Built	Recommendation	Citation	Photos	Figure
33	Headquarters (HQ) : HQ - Women's Restroom	[30.0930788 , -98.423867 1]	The toilet is not located within the range allowed from the side wall or partition. The centerline of the toilet must be 16 to 18 inches from the side wall.	toilet centerline 20" to wall	Remount toilets to 16" to 18" from the side wall to centerline.	2015 ABAAS Section: 604.2 2012 TAS Section: 604.2 2010 ADAS Section: 604.2

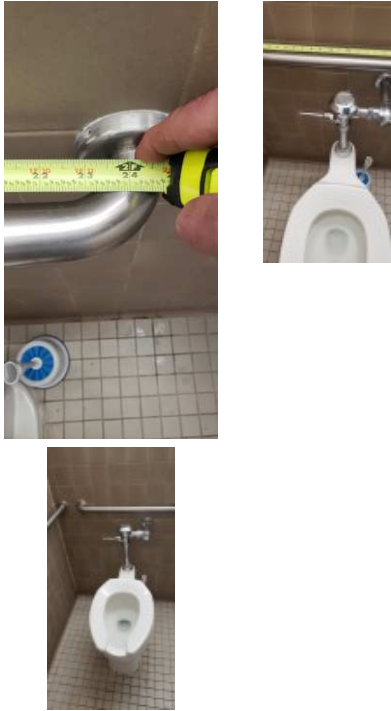
Finding Number	Area Description	Lat/Long	Finding	As Built	Recommendation	Citation	Photos	Figure
35	Headquarters (HQ) : HQ - Women's Restroom	[30.0930823 , -98.4238657]	The rear grab bar is not 36" long or is not mounted in the correct location. The rear grab bar must be a minimum of 36" long and extend from the toilet centerline a minimum 12" towards the wall side and a minimum 24" towards the open side of the toilet. Grab bars shall be installed in a horizontal position, 33 inches minimum and 36 inches maximum above the finish floor measured to the top of the gripping surface and the space between the grab bar and the top of the tank shall be 1-1/2 inches minimum.	Rear grab bar is 24", and is almost centered on the toilet	Replace rear grab bar with one 36" long, mounted behind the toilet, 12" to one side of center and 24" to the other and 33" to 36" AFF.	2015 ABAAS Section: 604.5.2 2012 TAS Section: 604.5.2 2010 ADAS Section: 604.5.2

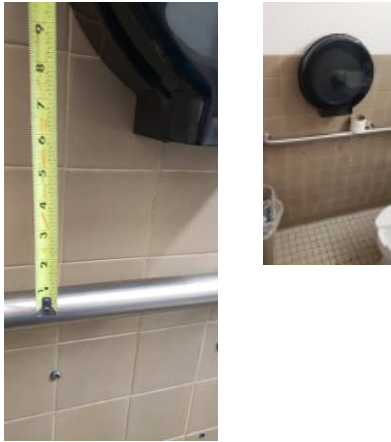
36	Headquarters (HQ) : HQ - Women's Restroom	[30.0930753 , -98.4238657]	The grab bar height and/or spacing fails. Grab bars must be mounted between 33" and 36" to the top of the gripping surface. There must be 1.5" of clearance between the grab bar and the wall. There must be a minimum of 1.5" of clearance below and minimum 12" above the grab bar to any dispenser or other obstruction.	Toilet paper mounted 6" above grab bar	Remount toilet paper dispenser max 7" to 9" from front of toilet, 15" to 48" above the finished floor (AFF) and min 12" above or 1.5" below grab bar.	2015 ABAAS Section: 609.3, 609.4 2012 TAS Section: 609.4, 609.3 2010 ADAS Section: 609.3, 609.4

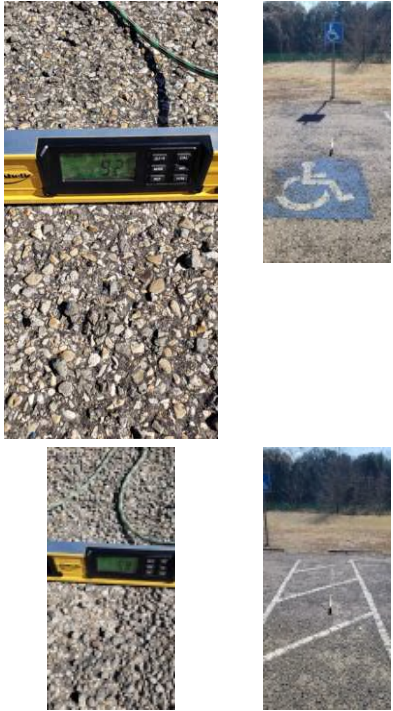
Finding Number	Area Description	Lat/Long	Finding	As Built	Recommendation	Citation	Photos	Figure
41	Day Use : Day Use - Parking	[30.0943389 , -98.421361 9]	The cross slopes (narrow dimension) and/or running slopes (long dimension) of the access aisle exceeds 2%. The running slope and the cross slope in an accessible parking stall and the access aisle must not exceed 2%.	Day use area restroom parking (HQ side of river) - Slopes of 9.2% in stall, 6.8% in access aisle	Repair or correct slope of parking space and access aisle to max 2.08% in any direction.	2015 ABAAS Section: 502.4 2012 TAS Section: 502.4 2010 ADAS Section: 502.4

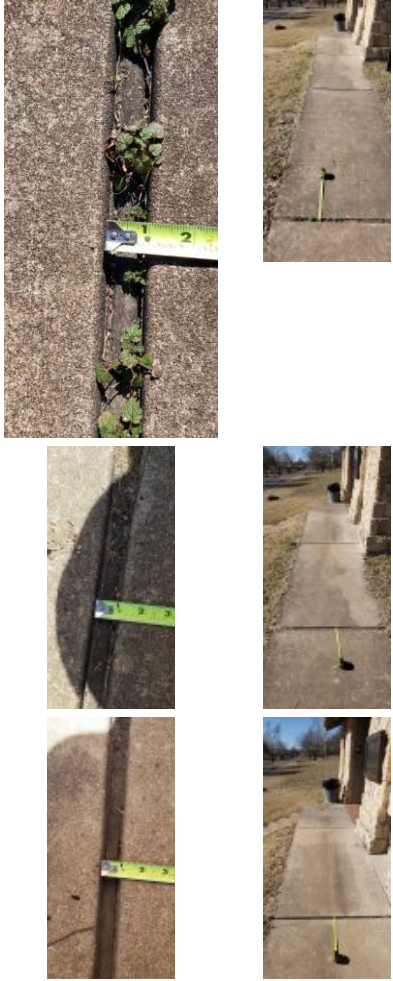
Finding Number	Area Description	Lat/Long	Finding	As Built	Recommendation	Citation	Photos	Figure
46	Day Use : Day Use - East Side Restroom Exterior Accessible Route	[30.0943737 , -98.4215067]	There is a gap spaced greater than a 1/2 inch. Openings in floor or ground surfaces shall not allow passage of a sphere more than 1/2 inch diameter. Elongated openings shall be placed so that the long dimension is perpendicular to the dominant direction of travel.	Day use HQ side restroom EAR - Multiple (4) 1" expansion gaps	Correct or fill gaps to be max .5".	2015 ABAAS Section: 302.3 2012 TAS Section: 302.3 2010 ADAS Section: 302.3

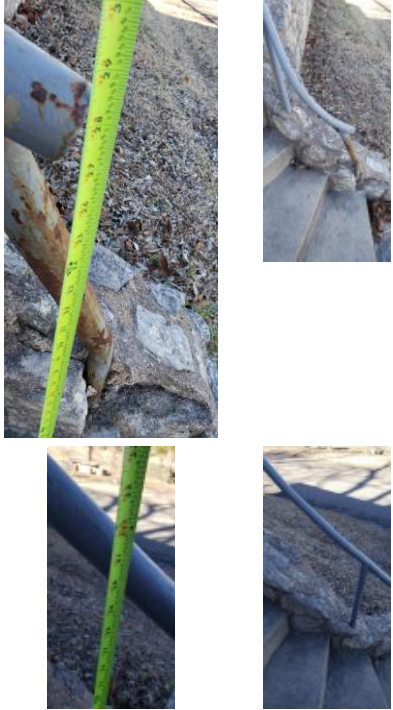
Finding Number	Area Description	Lat/Long	Finding	As Built	Recommendation	Citation	Photos	Figure
68	Day Use : Day Use - West Side Restroom Exterior Accessible Route	[30.0913, -98.429522 5]	The handrails as well as the handrail extensions are not at the correct height. The tops of handrails and their extensions must be between 34 inches and 38 inches above the stair nosing or ground.	Campground side, day use restroom building stairs - Gripping surface between 29" and 32" AGL	Remount handrails to 34" to 38" AGL.	2015 ABAAS Section: 505.4 2012 TAS Section: 505.4 2010 ADAS Section: 505.4

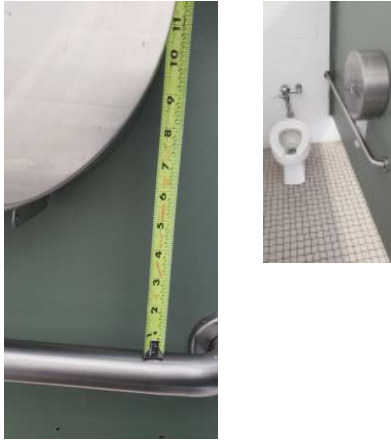
80	Day Use : Day Use - West Side Men's Restroom	[30.0912559, -98.429576 2]	The toilet paper is not installed within the compliant range in front of the toilet. Toilet paper dispensers shall be 7 inches minimum and 9 inches maximum in front of the water closet measured to the centerline of the dispenser. The outlet of the dispenser shall be 15 inches minimum and 48 inches maximum above the finish floor and shall not be located behind grab bars. Dispensers shall not be of a type that controls delivery or that does not allow continuous paper flow. There shall be a clearance of 1 1/2 inches minimum below the grab bar.	TP dispenser 13" from front of toilet	Remount toilet paper dispenser max 7" to 9" from front of toilet, 15" to 48" AFF and min 12" above or 1.5" below grab bar.	2015 ABAAS Section: 604.7 2012 TAS Section: 604.7 2010 ADAS Section: 604.7

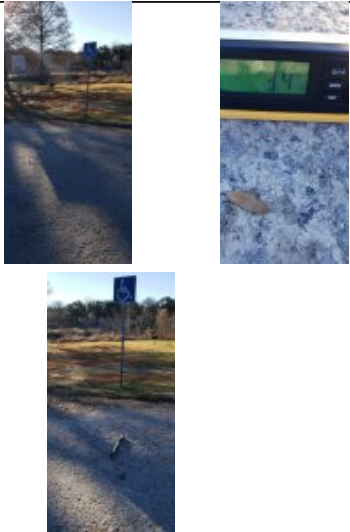
93	Day Use : Day Use - Picnic Area (HQ Side Of The River)	[30.0910424 , -98.424901 1]	Beach access routes shall connect an entry point to the beach to the: 1. High tide level at tidal beaches; 2. Mean high water level at river beaches; or 3. Normal recreation water level at lake, pond, and reservoir beaches	Lacks accessible route or entry to swimming area	Create a beach access route to normal recreational water level of a firm and stable material as a smart practice.	2015 ABAAS Section: 1018.2

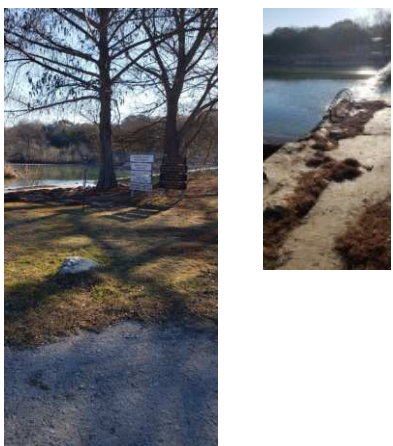
Finding Number	Area Description	Lat/Long	Finding	As Built	Recommendation	Citation	Photos	Figure
94	Day Use : Day Use - Picnic Area (HQ Side Of The River)	[30.0943517 , -98.421178 2]	An accessible access route is not provided between elements, spaces and the facilities provided within the accessible camping unit. At least one outdoor recreation access route shall connect accessible elements, spaces and facilities provided within camping units with mobility features.	Lacks AR to 29 of 29 picnic tables and grills	Create AR with crushed and compacted stone or similar outdoor material to 20% of the picnic tables as a smart practice. Replace six tables with ones of an accessible design as a smart practice.	2015 ABAAS Section: F244.5.1

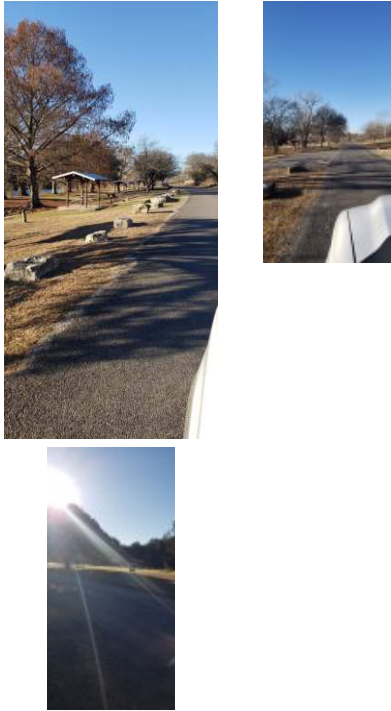
95	Day Use : Day Use - Picnic Area (HQ Side Of The River)	[30.0911155 , -98.426502 4]	There is no accessible route to the info sign. At least one accessible route shall connect accessible buildings, accessible facilities, accessible elements, and accessible spaces that are on the same site.	Lacks route to info sign	Create an accessible route with crushed stone or other outdoor material from parking or walkway to the info sign.	2015 ABAAS Section: F206.2.2 2012 TAS Section: 206.2.2 2010 ADAS Section: 206.2.2

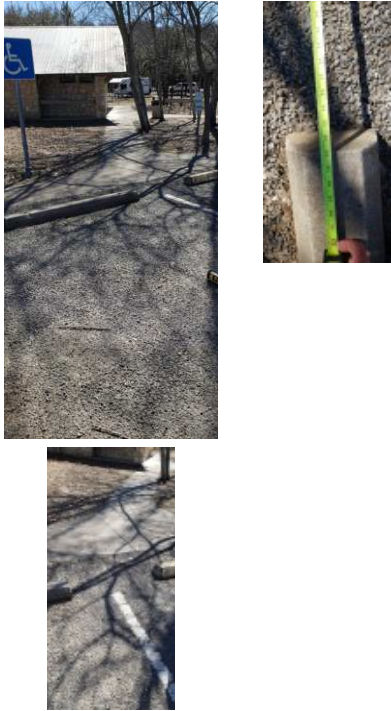
103	Campground Loop: Main Restroom Parking	[30.0896789 , -98.424402 2]	The accessible parking stall signage is incorrect and/or missing from each accessible parking space. Parking space identification signs shall include the International Symbol of Accessibility. Signs identifying van parking spaces shall contain the designation "van accessible." Signs shall be 60 inches minimum above the finish floor or ground surface measured to the bottom of the sign.	Campground loop restroom parking - lacks R7-8 sign	Acquire R7-8 sign and mount at appropriate heights and locations accessible parking signs where missing as a smart practice.	2015 ABAAS Section: 502.6 2012 TAS Section: 502.6

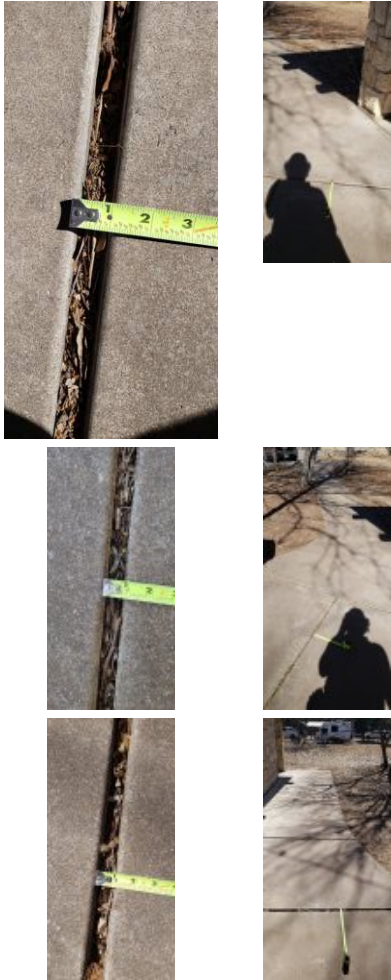
Finding Number	Area Description	Lat/Long	Finding	As Built	Recommendation	Citation	Photos	Figure
118	Campground Loop: Main Restroom Exterior Accessible Route	[30.0895594 , -98.4244827]	There is a gap spaced greater than a 1/2 inch. Openings in floor or ground surfaces shall not allow passage of a sphere more than 1/2 inch diameter. Elongated openings shall be placed so that the long dimension is perpendicular to the dominant direction of travel.	Camping loop restroom - Multiple (17) 1" expansion gaps counted - photos representative	Correct or fill gaps to be max .5".	2015 ABAAS Section: 302.3 2012 TAS Section: 302.3 2010 ADAS Section: 302.3

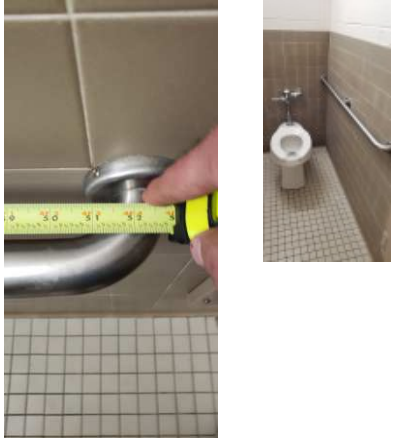
150	Campground Loop: Main Restroom - Men's Restroom	[30.0895014, -98.4243874]	The grab bar height and/or spacing fails. Grab bars must be mounted between 33" and 36" to the top of the gripping surface. There must be 1.5" of clearance between the grab bar and the wall. There must be a minimum of 1.5" of clearance below and minimum 12" above the grab bar to any dispenser or other obstruction.	Toilet paper dispenser mounted 8" above bar	Remount toilet paper dispenser max 7" to 9" from front of toilet, 15" to 48" above the finished floor (AFF) and min 12" above or 1.5" below grab bar.	2015 ABAAS Section: 609.3, 609.4 2012 TAS Section: 609.4, 609.3 2010 ADAS Section: 609.3, 609.4
