Access Audit Site Report

Bonham State Park
1363 State Park 24
Bonham, TX 75418
Accessibility Evaluation
Inspection Date: 10/15/2021
Inspectors: Tanya Scheibe

**TEXAS PARKS AND WILDLIFE DEPARTMENT
BONHAM STATE PARK**

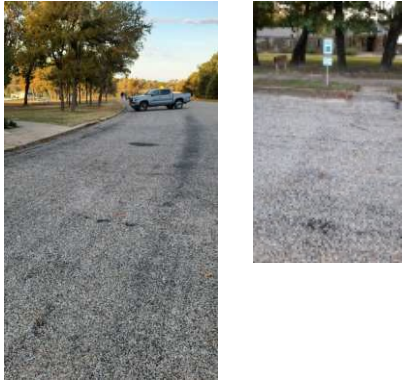
Finding Number	Area Description	Lat/Long	Finding	As Built	Recommendation	Citation	Photos	Figure
3	Headquarters Area: HQ Parking	[33.5471074 , -96.144658 4]	There are no accessible parking stalls. Each lot where parking is provided for the public as clients, guests or employees, shall provide accessible parking and shall be located on the shortest accessible route of travel from adjacent parking to an accessible entrance. There are a total of approximately 35 parking stalls in the parking lot that could be reasonably associated with this facility. There should be a minimum of 2 accessible stalls with a minimum of 1 being designed as van accessible.	Unlined area, unsure of total, only 1 sign	Create one or more 8' accessible parking stalls, with one 5' adjacent access aisle, with proper signage and striping based on the total number of stalls	2015 ABAAS Section: F208.2 2012 TAS Section: 208.2 2010 ADAS Section: 208.2

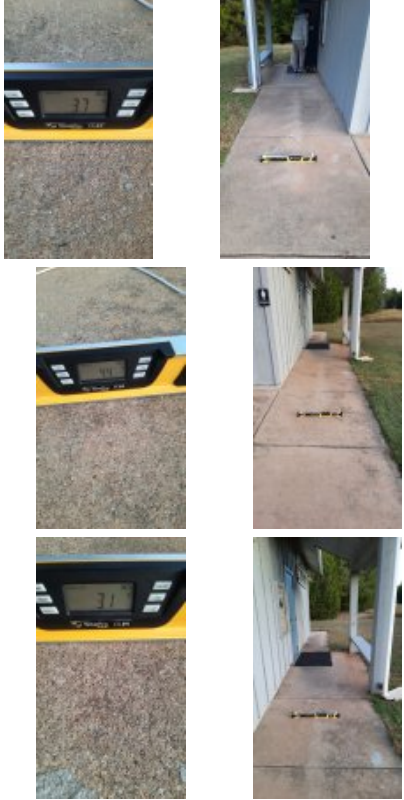
12	Headquarters Area: HQ Exterior Accessible Route	[33.5470895 , -96.144666 5]	The walkway contains abrupt vertical edges and/or variations over a 1/4 inch. Changes in level greater than 1/2 inch must be by way of a ramp.	HQ side has 2" bump at curb	Repair, bevel or ramp CIL along route.	2012 TAS Section: 303.2, 303.3 2010 ADAS Section: 303.2, 303.3

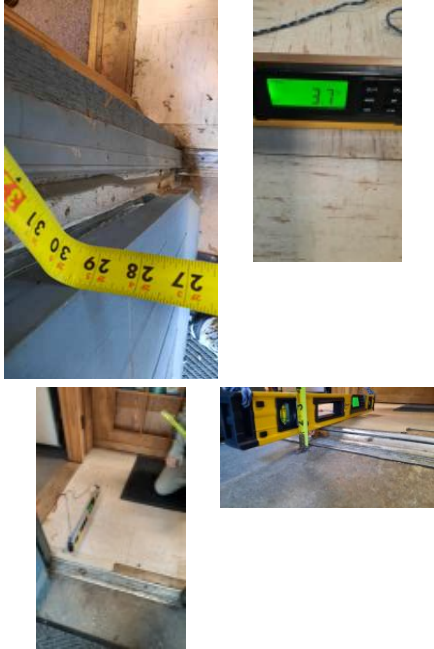
Finding Number	Area Description	Lat/Long	Finding	As Built	Recommendation	Citation	Photos	Figure
14	Headquarters Area: HQ Building	[33.5467531 , -96.144681 2]	Spaces and elements within employee work areas shall only be required to comply with 206.2.8, 207.1, and 215.3 and shall be designed and constructed so that individuals with disabilities can approach, enter, and exit the employee work area. Employee work areas, or portions of employee work areas, other than raised courtroom stations, that are less than 300 square feet (28 m2) and elevated 7 inches (180 mm) or more above the finish floor or ground where the elevation is essential to the function of the space shall not be required to comply with these requirements or to be on an accessible route.	Entry - 29" wide, 3.7% slope on push, 1" at threshold	For employee spaces, relocate storage, furniture, and other obstacles at doorways to provide approach, enter and exit at the employee space. Correct slope in door clearance to max 2.08%. Replace doors with doors having 80" overhead clearance and 32" clear width. Repair, bevel, or ramp CILs at door entries to max .25".	2015 ABAAS Section: F203.9 2012 TAS Section: 203.9 2010 ADAS Section: 203.9

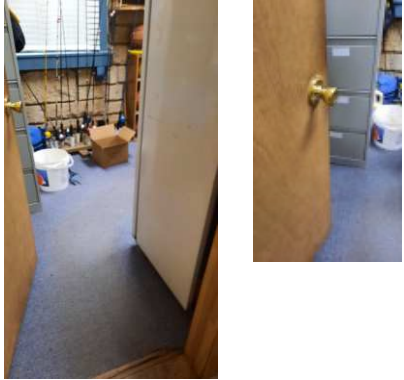
Finding Number	Area Description	Lat/Long	Finding	As Built	Recommendation	Citation	Photos	Figure
15	Headquarters Area: HQ Building	[33.5467419 , -96.1446597]	Employee Work Areas. Common use circulation paths within employee work areas shall comply with 402. EXCEPTIONS: 1. Common use circulation paths located within employee work areas that are less than 1000 square feet (93 m2) and defined by permanently installed partitions, counters, casework, or furnishings shall not be required to comply with 402. 2. Common use circulation paths located within employee work areas that are an integral component of work area equipment shall not be required to comply with 402. 3. Common use circulation paths located within exterior employee work areas that are fully exposed to the weather shall not be required to comply with 402.	Fridge on pull side of storage room, knob hardware	Make corrections for compliant circulation path. Relocate fridge and replace door knob with lever.	2015 ABAAS Section: F206.2.8, F206.2.8.1, F206.2.8.2 2012 TAS Section: 206.2.8, 206.2.8 Exception 1, 206.2.8 Exception 2, 206.2.8 Exception 3, 206.2.8 Advisory 1, 206.2.8 Advisory 2 2010 ADAS Section: 206.2.8, 206.2.8 Exception 1, 206.2.8 Exception 2, 206.2.8 Exception 3

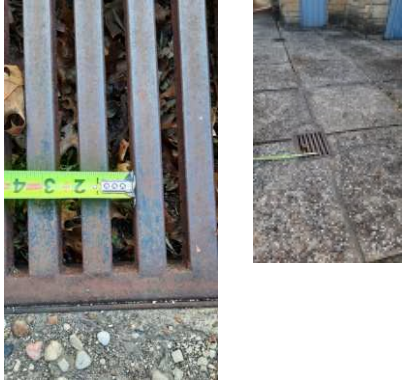
16	Headquarters Area: HQ Building	[33.54623, -96.14919]	Spaces and elements within employee work areas shall only be required to comply with 206.2.8, 207.1, and 215.3 and shall be designed and constructed so that individuals with disabilities can approach, enter, and exit the employee work area. Employee work areas, or portions of employee work areas, other than raised courtroom stations, that are less than 300 square feet (28 m2) and elevated 7 inches (180 mm) or more above the finish floor or ground where the elevation is essential to the function of the space shall not be required to comply with these requirements or to be on an accessible route.	Back storage rooms -route has .75" gaps at grate, 1.5" at pavers, door width 31.5" and 30.5", storm shelter slope 5.1%	For employee spaces, relocate storage, furniture, and other obstacles at doorways to provide approach, enter and exit at the employee space. Correct slope in door clearance to max 2.08%. Replace grate with one having max gaps of .5" if existing size isn't essential to the location. Replace doors with doors having 80" overhead clearance and 32" clear width. Fill gaps at door entries and along route to max .5".	2015 ABAAS Section: F203.9 2012 TAS Section: 203.9 2010 ADAS Section: 203.9

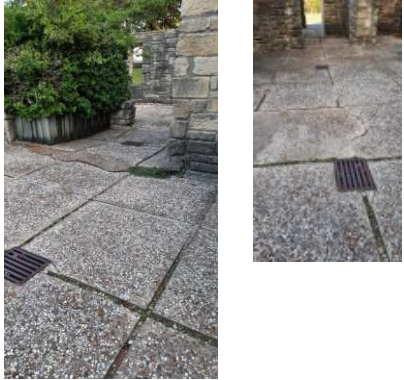
Finding Number	Area Description	Lat/Long	Finding	As Built	Recommendation	Citation	Photos	Figure
17	Headquarters Area: HQ Building	[33.5467497, -96.1446557]	Employee Work Areas. Common use circulation paths within employee work areas shall comply with 402.	Route is deteriorated	Make corrections for compliant circulation path.	2015 ABAAS Section: F206.2.8, F206.2.8.1, F206.2.8.2 2012 TAS Section: 206.2.8, 206.2.8 Exception 1, 206.2.8 Exception 2, 206.2.8 Exception 3, 206.2.8 Advisory 1, 206.2.8 Advisory 2 2010 ADAS Section: 206.2.8, 206.2.8 Exception 1, 206.2.8 Exception 2, 206.2.8 Exception 3

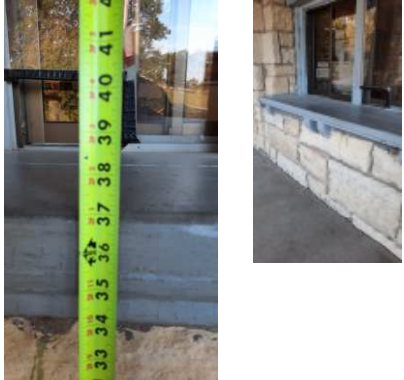
18	Headquarters Area: HQ Building	[33.546752, -96.1446437]	The transaction counter is too high. A portion of the counter surface that is 36 inches long minimum and 36 inches high maximum above the finish floor shall be provided. Knee and toe space must be provided for a forward approach. A 30 inch by 48 inch clear floor space on an accessible route must be provided for either a forward or parallel approach.	37" high counter	Lower 36" wide segment of service counter to max 36" aff	2015 ABAAS Section: 904.4.2, 904.4.1 2012 TAS Section: 904.4.1, 904.4.2 2010 ADAS Section: 904.4.2, 904.4.1

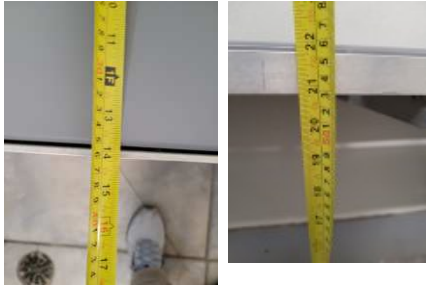
Finding Number	Area Description	Lat/Long	Finding	As Built	Recommendation	Citation	Photos	Figure
19	Headquarters Area: HQ Men's Restroom	[33.547483, -96.144873 1]	The bench is not deep enough or long enough or is missing. Benches shall be provided having seats that are 42 inches long minimum and 20 inches deep minimum and 24 inches deep maximum. The bench shall provide for back support or shall be affixed to a wall. Back support shall be 42 inches (1065 mm) long minimum and shall extend from a point 2 inches (51 mm) maximum above the seat surface to a point 18 inches (455 mm) minimum above the seat surface. Back support shall be 2½ inches (64 mm) maximum from the rear edge of the seat measured horizontally. The top of the bench seat surface shall be 17 inches (430 mm) minimum and 19 inches (485 mm) maximum above the finish floor or ground. Clear floor or ground space complying with 305 shall be provided and shall be positioned at the end of the bench seat and parallel to the short axis of the bench	14" deep bench, 22" high bench	Replace bench in dressing area with one having a seat depth of 20" to 24" deep, 42" long, affixed to the wall or having a back and mounted 17" to 19" AFF and provide required clear floor space on the short axis of the bench.	2012 TAS Section: 903.4, 903.2, 903.3, 903.5 2010 ADAS Section: 903.4, 903.2, 903.3, 903.5

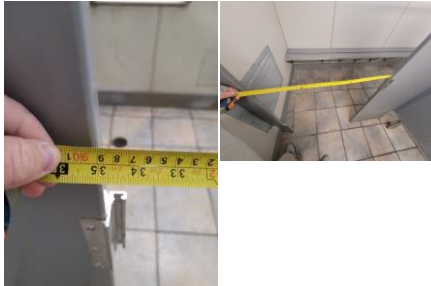
20	Headquarters Area: HQ Men's Restroom	[33.5474517, -96.144889 2]	Alternate roll-in type shower compartments shall be 36 inches (915 mm) wide and 60 inches (1525 mm) deep minimum clear inside dimensions measured at center points of opposing sides. A 36 inch (915 mm) wide minimum entry shall be provided at one end of the long side of the compartment.	Lacks 36" wide opening, 35" wide	Enlarge shower stall entry, if feasible, to compliant dimensions of 36" opening on the long dimension	2015 ABAAS Section: 608.2.3 2012 TAS Section: 608.2.3 2010 ADAS Section: 608.2.3

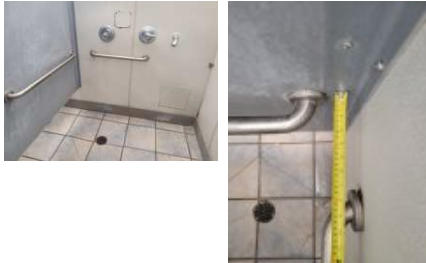
Finding Number	Area Description	Lat/Long	Finding	As Built	Recommendation	Citation	Photos	Figure
21	Headquarters Area: HQ Men's Restroom	[33.5474517 , -96.144873 1]	Standard Roll-In Type Shower Compartments. Where a seat is provided in standard roll-in type shower compartments, grab bars shall be provided on the back wall and the side wall opposite the seat. Grab bars shall not be provided above the seat. Where a seat is not provided in standard roll-in type shower compartments, grab bars shall be provided on three walls. Grab bars shall be installed 6 inches (150 mm) maximum from adjacent walls. Grab bars shall be installed in a horizontal position, 33 inches (840 mm) minimum and 36 inches (915 mm) maximum above the finish floor measured to the top of the gripping surface, except that at water closets for children's use complying with 604.9, grab bars shall be installed in a horizontal position 18 inches (455 mm) minimum and 27 inches (685 mm) maximum above the finish floor measured to the top of the gripping surface.	Lacks 3rd grab bar, only 2 grab bars, 9" from grab bar to wall	Remount grab bars to the correct location in the shower, mounted 33" to 36" above finish floor (AFF) and maximum 6" from adjacent walls. Provide and install 3rd grab bar.	2015 ABAAS Section: 608.3.2, 608.3.3, 609.4 2012 TAS Section: 609.4, 608.3.2, 608.3.3 2010 ADAS Section: 609.4, 608.3.2, 608.3.3

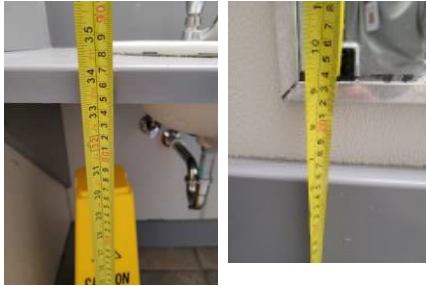
Finding Number	Area Description	Lat/Long	Finding	As Built	Recommendation	Citation	Photos	Figure
23	Headquarters Area: HQ Men's Restroom	[33.547474, -96.144886 5]	The mirror is mounted too high. Mirrors must have the bottom edge of the reflecting surface a maximum of 40 inches above the floor if above a sink or counter. Mirrors not located above lavatories or countertops shall be installed with the bottom edge of the reflecting surface 35 inches maximum above the finish floor or ground.	43" above finish floor to bottom of mirror	Lower mirror so reflective surface is max 40" above finish floor (AFF)	2015 ABAAS Section: 603.3 2012 TAS Section: 603.3 2010 ADAS Section: 603.3

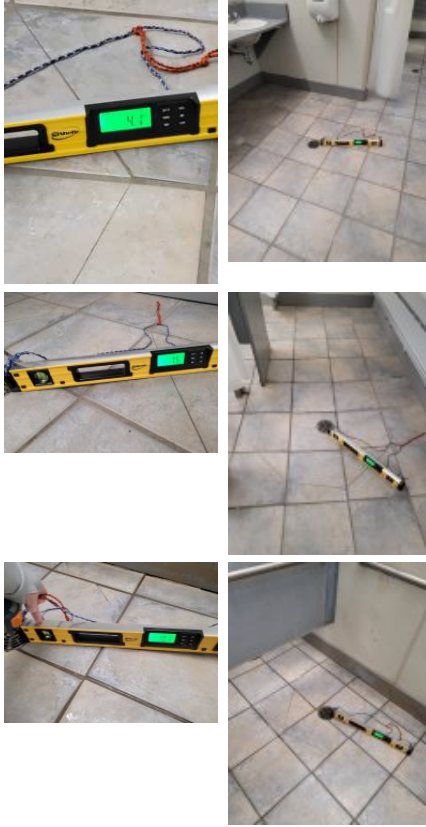
Finding Number	Area Description	Lat/Long	Finding	As Built	Recommendation	Citation	Photos	Figure
35	Headquarters Area: HQ Men's Restroom	[33.5474606 , -96.144894 5]	The accessible route contains running slopes greater than 5 percent and cross slopes greater than 2 percent across the width of the walk and has not been constructed as a ramp (i.e. handrails, wheel guides, etc.). When the slope in the direction of travel of any walk exceeds 1 unit vertical in 20 units horizontal (5-percent slope), it must be constructed as ramp. Surface cross slopes must not exceed one unit vertical in 48 units. Horizontal (2-percent slope).	4.1% slope at drain, 7.5% slope at path to shower drain, 10.1% slope at shower drain	Correct or repair slope to max 2.08% cross	2015 ABAAS Section: 403.3 2012 TAS Section: 403.3 2010 ADAS Section: 403.3

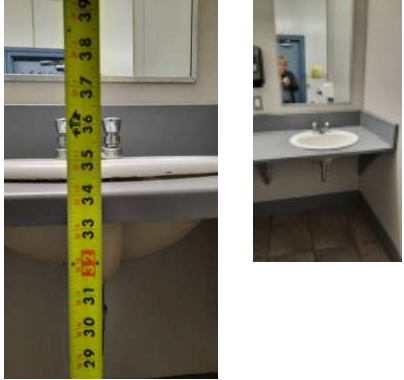
Finding Number	Area Description	Lat/Long	Finding	As Built	Recommendation	Citation	Photos	Figure
43	Headquarters Area: HQ Women's Restroom	[33.5474774 , -96.144903 8]	The top rim of the sink is too high. All lavatories/sinks that are designated to be accessible shall be a minimum 17 inches in horizontal depth and mounted with the rim or counter edge no higher than 34 inches above the finished floor.	Sink rim at 35"	Lower one sink to max 34" above finish floor (AFF) to front of rim.	2015 ABAAS Section: 606.3 2012 TAS Section: 606.3 2010 ADAS Section: 606.3

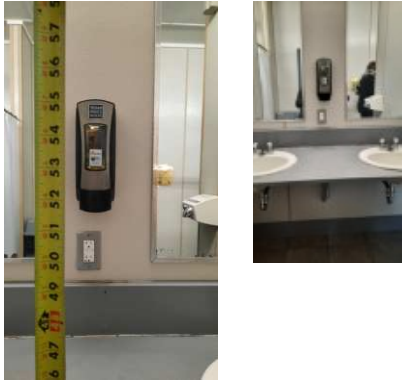
Finding Number	Area Description	Lat/Long	Finding	As Built	Recommendation	Citation	Photos	Figure
46	Headquarters Area: HQ Women's Restroom	[33.5474662, -96.1448931]	Where a high forward reach is over an obstruction, the clear floor space shall extend beneath the element for a distance not less than the required reach depth over the obstruction. The high forward reach shall be 48 inches (1220 mm) maximum where the reach depth is 20 inches (510 mm) maximum. Where the reach depth exceeds 20 inches (510 mm), the high forward reach shall be 44 inches (1120 mm) maximum and the reach depth shall be 25 inches (635 mm) maximum. Where a clear floor or ground space allows a parallel approach to an element and the high side reach is over an obstruction, the height of the obstruction shall be 34 inches (865 mm) maximum and the depth of the obstruction shall be 24 inches (610 mm) maximum. The high side reach shall be 48 inches (1220 mm) maximum for a reach depth of 10 inches (255 mm) maximum. Where the reach depth exceeds 10 inches (255 mm), the high side reach shall be 46 inches (1170 mm) maximum for a reach depth of 24 inches (610 mm) maximum.	Soap at 52" over sink	Lower soap dispenser to max 44" above finish floor (AFF) for a forward reach over counter	2015 ABAAS Section: 308.2.1, 308.3.2 2012 TAS Section: 308.2.1, 308.3.2 2010 ADAS Section: 308.2.1, 308.3.2

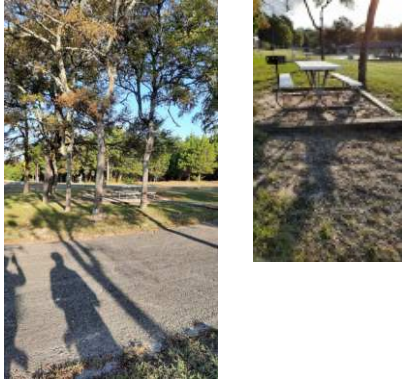
56	Headquarters Area: HQ Picnic Area	[33.5463462 , -96.1450943]	Picnic tables shall provide at least one wheelchair space for each 24 linear feet (7320 mm) of usable table surface perimeter. Wheelchair spaces shall be 30 inches (760 mm) minimum by 48 inches (1220 mm) minimum. Wheelchair spaces shall be positioned for a forward approach to the table and provide knee and toe clearance complying with 306 under the table	Shelter - 0 of 14 picnic tables accessible	Replace three picnic tables with ones of an accessible design as a smart practice	2015 ABAAS Section: 1011.4.2

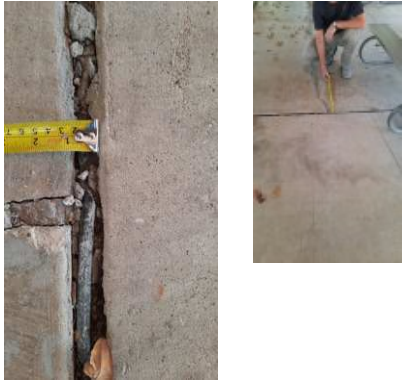
91	Group Picnic Area: Group Picnic	[33.5487225 , -96.145660 2]	The walkway contains abrupt vertical edges and/or variations over a 1/4 inch. 1/4 inch is the maximum vertical rise. Changes in level between 1/4 inch and 1/2 inch must be beveled at 1:2 or less.	.5" change in level at entry	Repair, bevel or ramp change in level at shelter entry.	2012 TAS Section: 303.2, 303.3 2010 ADAS Section: 303.2, 303.3

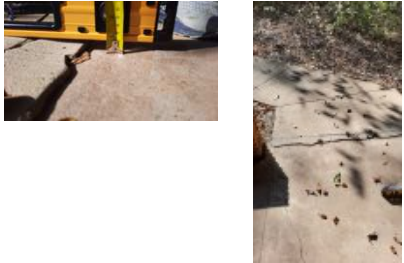
92	Group Picnic Area: Group Picnic	[33.5486621 , -96.145638 8]	Where picnic facilities contain two or fewer picnic units, each picnic unit shall provide mobility features complying with F245.2.	Lacks accessible route to grill	Create an ORAR from shelter to grill as a smart practice.	2015 ABAAS Section: F245.2.1

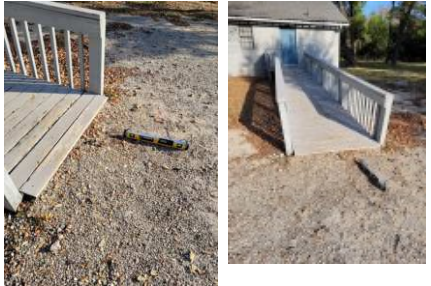
Finding Number	Area Description	Lat/Long	Finding	As Built	Recommendation	Citation	Photos	Figure
101	Group Barracks: Group Barracks	[33.5465363 , -96.140431 3]	The accessible route contains loose gravel and/or surfaces that do not provide for a stable, firm slip resistant surface.	Dining Hall Ramp - Clear floor space met but not firm & stable, ramp not connected to accessible route	Resurface AR where deterioration occurs. Provide an accessible route from parking to the ramp.	2015 ABAAS Section: 302.1 2012 TAS Section: 302.1 2010 ADAS Section: 302.1

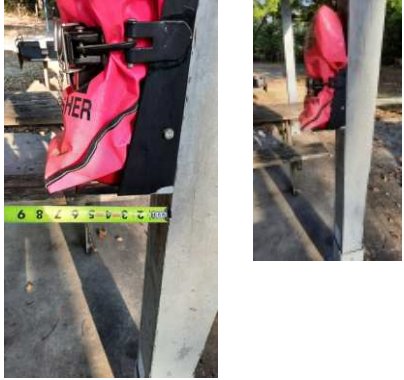
Finding Number	Area Description	Lat/Long	Finding	As Built	Recommendation	Citation	Photos	Figure
110	Group Barracks: Group Barracks	[33.5466212 , -96.140522 4]	The fire extinguisher projects more than 4 inches into the circulation path. Wall-mounted objects that have leading edges between 27 inches and 80 inches from the floor must not project more than 4 inches into the circulation path. Protruding objects that extend to the floor or within 27 inches of the floor are cane detectable and are therefore not hazardous. Where it is necessary or desirable to have objects protrude from the wall, a manner of cane detection must be provided.	Mess hall - fire extinguisher protrudes	Relocate protruding objects or place cane detectable warning or bollard at foot of item.	2015 ABAAS Section: 307.2 2012 TAS Section: 307.2 2010 ADAS Section: 307.2

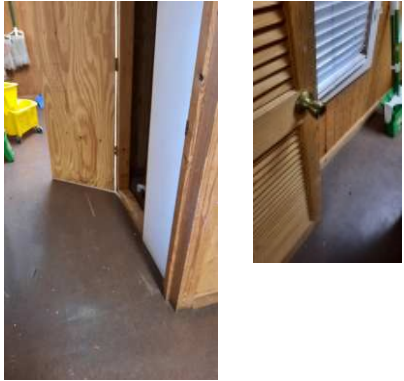
113	Group Barracks: Group Barracks	[33.5465955 , -96.140635 1]	The door opening does not provide at least 32 inches between the face of the door and the opposite stop. Door openings shall provide a clear width of 32 inches minimum. Clear openings of doorways with swinging doors shall be measured between the face of the door and the stop, with the door open 90 degrees.	Staff bunk room - door width 28.5"	Replace door with a door that provides 32" wide opening when door is open to 90 degrees	2015 ABAAS Section: 404.2.3 2012 TAS Section: 404.2.3 2010 ADAS Section: 404.2.3

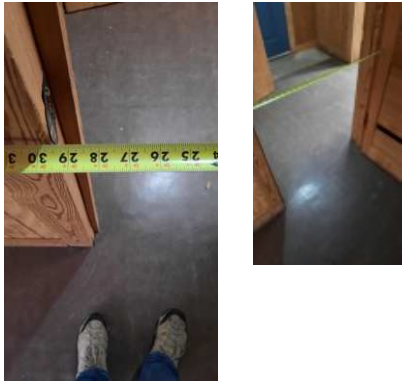
Hinged Door
114	Group Barracks: Group Barracks	[33.5466067 , -96.140631 1]	The door opening does not provide at least 32 inches between the face of the door and the opposite stop. Door openings shall provide a clear width of 32 inches minimum. Clear openings of doorways with swinging doors shall be measured between the face of the door and the stop, with the door open 90 degrees.	Staff Restroom - door width 29.75"	Replace door with a door that provides 32" wide opening when door is open to 90 degrees	2015 ABAAS Section: 404.2.3 2012 TAS Section: 404.2.3 2010 ADAS Section: 404.2.3

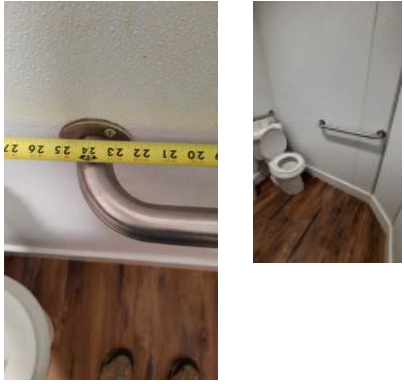
121	Group Barracks: Group Barracks	[33.5465843 , -96.140629 7]	The rear grab bar is not 36" long or is not mounted in the correct location. The rear grab bar must be a minimum of 36" long and extend from the toilet centerline a minimum 12" towards the wall side and a minimum 24" towards the open side of the toilet. Grab bars shall be installed in a horizontal position, 33 inches minimum and 36 inches maximum above the finish floor measured to the top of the gripping surface and the space between the grab bar and the top of the tank shall be 1-1/2 inches minimum.	Staff restroom - 24" bar, not centered	Replace rear grab bar with one 36" long, mounted behind the toilet, 12" to one side of center and 24" to the other and 33" to 36" above finish floor (AFF)	2015 ABAAS Section: 604.5.2 2012 TAS Section: 604.5.2 2010 ADAS Section: 604.5.2

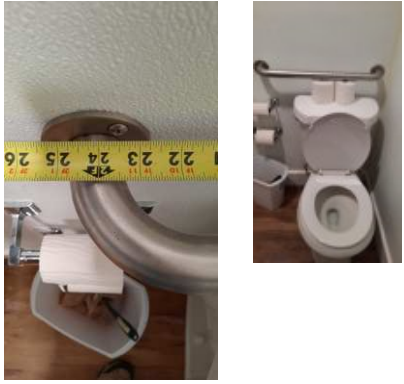
Finding Number	Area Description	Lat/Long	Finding	As Built	Recommendation	Citation	Photos	Figure
122	Group Barracks: Group Barracks	[33.5465944 , -96.140637 8]	The grab bar height and/or spacing fails. Grab bars must be mounted between 33" and 36" to the top of the gripping surface. There must be 1.5" of clearance between the grab bar and the wall. There must be a minimum of 1.5" of clearance below and minimum 12" above the grab bar to any dispenser or other obstruction.	Staff restroom - side 36.5", rear 37.5", 2.5" gap	Replace grab bars with ones providing a 1.5" gap and remount in accessible stall to 33" to 36" above finish floor (AFF)	2015 ABAAS Section: 609.3, 609.4 2012 TAS Section: 609.4, 609.3 2010 ADAS Section: 609.3, 609.4

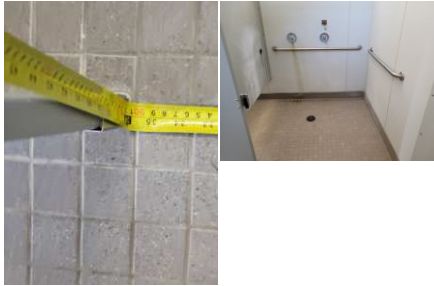
136	Group Barracks: Group Barracks Men's Restroom	[33.5463507 , -96.140462 2]	Standard Roll-In Type Shower Compartments. Where a seat is provided in standard roll-in type shower compartments, grab bars shall be provided on the back wall and the side wall opposite the seat. Grab bars shall not be provided above the seat. Where a seat is not provided in standard roll-in type shower compartments, grab bars shall be provided on three walls. Grab bars shall be installed 6 inches (150 mm) maximum from adjacent walls. Alternate Roll-In Type Shower Compartments. In alternate roll-in type shower compartments, grab bars shall be provided on the back wall and the side wall farthest from the compartment entry. Grab bars shall not be provided above the seat. Grab bars shall be installed 6 inches (150 mm) maximum from adjacent walls. Grab bars shall be installed in a horizontal position, 33 inches (840 mm) minimum and 36 inches (915 mm) maximum above the finish floor measured to the top of the gripping surface, except that at water closets for children's use complying with 604.9, grab bars shall be installed in a horizontal position 18 inches (455 mm) minimum and 27 inches (685 mm) maximum above the finish floor measured to the top of the gripping surface.	Lacks 1 grab bar, 2 provided	Remount grab bars to the correct location in the shower, mounted 33" to 36" aff and max 6" from adjacent walls. Add required 3rd garb bar.	2015 ABAAS Section: 608.3.2, 608.3.3, 609.4 2012 TAS Section: 609.4, 608.3.2, 608.3.3 2010 ADAS Section: 609.4, 608.3.2, 608.3.3

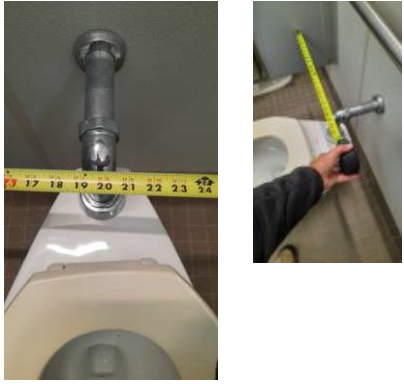
140	Group Barracks: Group Barracks Women's Restroom	[33.5463217 , -96.140464 8]	The rear grab bar is not 36" long or is not mounted in the correct location. The rear grab bar must be a minimum of 36" long and extend from the toilet centerline a minimum 12" towards the wall side and a minimum 24" towards the open side of the toilet. Grab bars shall be installed in a horizontal position, 33 inches minimum and 36 inches maximum above the finish floor measured to the top of the gripping surface and the space between the grab bar and the top of the tank shall be 1-1/2 inches minimum.	rear grab bar mounted 13.25" to center line	Remount rear grab bar to behind the toilet, 12" to one side of center and 24" to the other and 33" to 36" above finish floor (AFF)	2015 ABAAS Section: 604.5.2 2012 TAS Section: 604.5.2 2010 ADAS Section: 604.5.2
