Access Audit Site Report

Brazos Bend State Park
21901 Farm to Market Rd 762
Needville, TX 77461
Accessibility Evaluation
Inspection Date: 06/14/2021
Inspectors: Tanya Scheibe

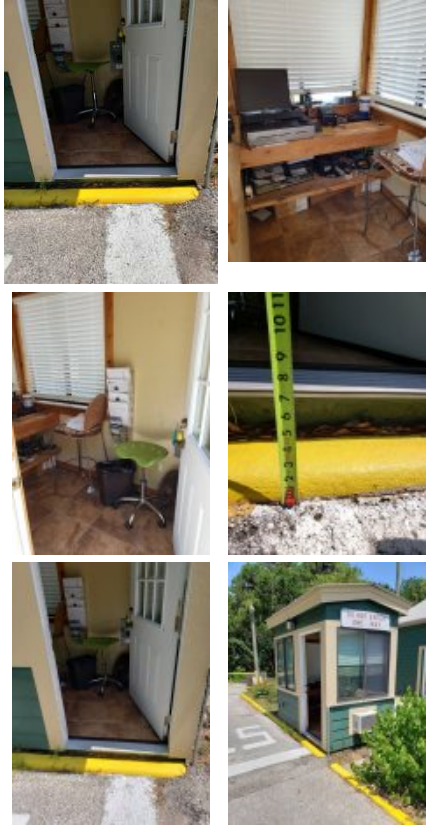
Finding Number	Area Description	Lat/Long	Finding	As Built	Recommendation	Citation	Photos	Figure
6	Headquarters Area: Headquarters	[29.3709082 , -95.631963 5]	The threshold has a vertical change greater than 1/4 inch high. Hand-activated door opening hardware, handles, pulls, latches, locks, and other operating devices on accessible doors shall have a shape that is easy to grasp with one hand and does not require tight grasping, tight pinching or twisting of the wrist to operate. Hardware shall be 34 inches minimum and 48 inches maximum above the finish floor or ground.	Gatehouse entry door - CIL of 7", knobs	For all doors along the public circulation route, repair, bevel, or ramp CILs at door entries to max .25" For all doors along the public circulation route, replace hardware with lever hardware or hardware operable without a tight pinch or grasp	2010 ADAS Section: 404.2.3, 404.2.7, 404.2.4, 404.2.11, 404.2.11 Exception

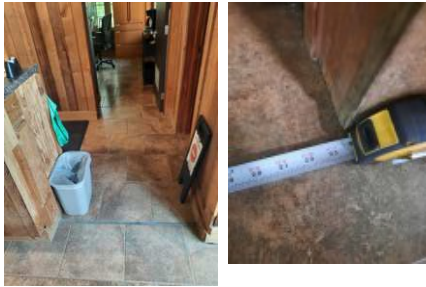
7	Headquarters Area: Headquarters	[29.371004, -95.631887]	Minimum maneuvering clearances at doors and gates shall comply with 404.2.4. Maneuvering clearances shall extend the full width of the doorway and the required latch side or hinge side clearance. Door openings shall provide a clear width of 32 inches (815 mm) minimum. Clear openings of doorways with swinging doors shall be measured between the face of the door and the stop, with the door open 90 degrees. Openings more than 24 inches (610 mm) deep shall provide a clear opening of 36 inches (915 mm) minimum. There shall be no projections into the required clear	Entry to offices - Lacks clear entry due to storage (garbage can and sign) Small office door - Lacks maneuvering clearance on pull side (garbage can), and lacks 32" clear width (24") Superintendent office door - Lacks maneuvering clearance on pull side (coffee stand), and	For employee spaces, relocate storage, furniture, and other obstacles at doorways to provide approach, enter and exit at the employee space. For all doors along the public circulation route, provide required maneuvering clearance on push and pull side of doors For all doors along the public circulation route, replace doors with doors having 80" overhead clearance and 32" clear width For all doors along the public circulation route, replace hardware with lever hardware or hardware operable without a tight pinch or grasp	2010 ADAS Section: 404.2.3, 404.2.7, 404.2.4, 404.2.11, 404.2.11 Exception

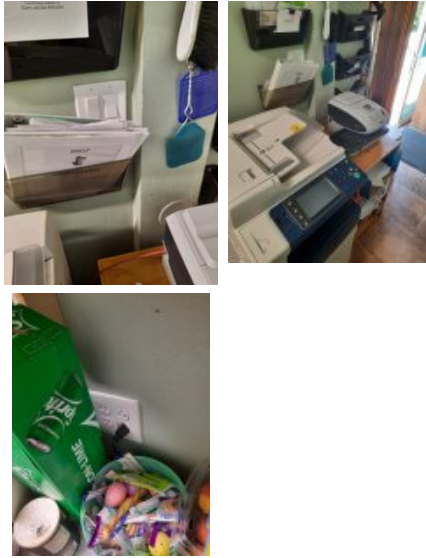
Finding Number	Area Description	Lat/Long	Finding	As Built	Recommendation	Citation	Photos	Figure
10	Headquarters Area: Headquarters	[29.3709993 , -95.631908 5]	The operable part is not accessible because there is not adequate clear floor space for either a forward or side approach. The clear floor or ground space shall be 30 inches minimum by 48 inches minimum.	Break room - Light switches and outlets lack clear floor space and are obstructed by a printer, furnishings, and other storage	Remove, or relocate storage in CFS at fixtures and operable parts along the AR Provide required 30" by 48" CFS at operable parts For deficit, leave as is, employee work area pursuant to 2010 Standards 106.5 Defined Terms, until an employee with a disability works here	2015 ABAAS Section: 305.3 2012 TAS Section: 305.3 2010 ADAS Section: 305.3

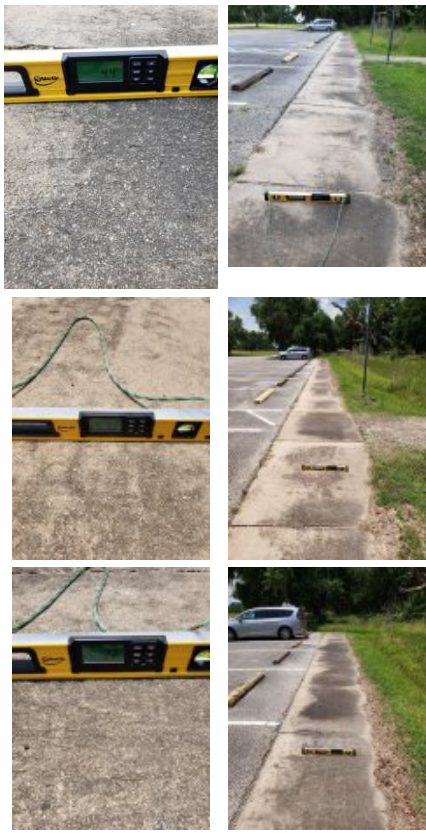
Finding Number	Area Description	Lat/Long	Finding	As Built	Recommendation	Citation	Photos	Figure
32	40 Acre Lake: Parking - 40 Acre Lake	[29.3705303, -95.6279639], [29.3704496, -95.6280122]	The accessible route of travel on the accessible route contains cross slopes greater than 2%. Cross slopes shall not exceed one unit vertical in 48 units horizontal (2-percent slope).	Cross slopes of 4.4%, 3.1%, and 2.3%	Correct or repair cross slope along AR to max 2.08%	2015 ABAAS Section: 403.3 2012 TAS Section: 403.3 2010 ADAS Section: 403.3

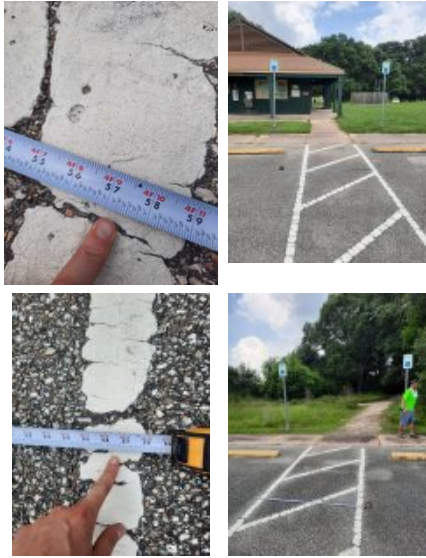
Finding Number	Area Description	Lat/Long	Finding	As Built	Recommendation	Citation	Photos	Figure
34	40 Acre Lake: Parking - 40 Acre Lake	[29.3706277, -95.6271811], [29.37045, -95.6279911]	The access aisle is not a minimum 5 feet wide. A car accessible parking stall's access aisle must be a minimum of 5 feet wide measured from centerline to centerline. Where the access aisle is not adjacent to another parking space or access aisle, measurements shall be permitted to include the full width of the line defining the access aisle.	Access aisle near bathroom - Lacks width requirement for access aisles (57") Access aisle near trail - Lacks width requirement for access aisles (56.5")	Repaint access aisles to be 5' each	2015 ABAAS Section: 502.3.1 2012 TAS Section: 502.3.1 2010 ADAS Section: 502.3.1

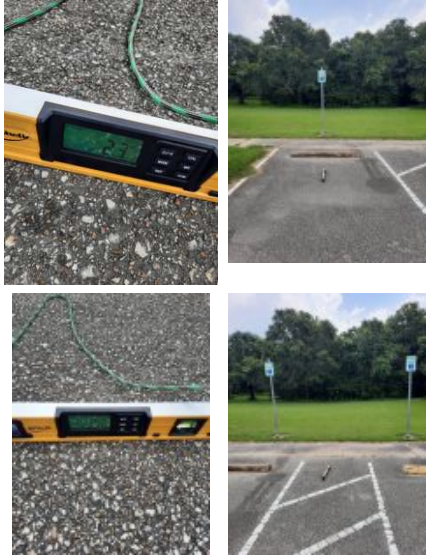
35	40 Acre Lake: Parking - 40 Acre Lake	[29.3704021, -95.6272482], [29.3702525, -95.6274064]	The cross slopes (narrow dimension) and/or running slopes (long dimension) of the access aisle exceeds 2%. The running slope and the cross slope in an accessible parking stall and the access aisle must not exceed 2%.	Slopes of 2.3% (access aisle near playground), 3.1% (access aisle 1), 3% (access aisle 2), 2.8% (access aisle 3), 3% (access aisle 4)	Resurface stalls and access aisles to eliminate slopes	2015 ABAAS Section: 502.4 2012 TAS Section: 502.4 2010 ADAS Section: 502.4

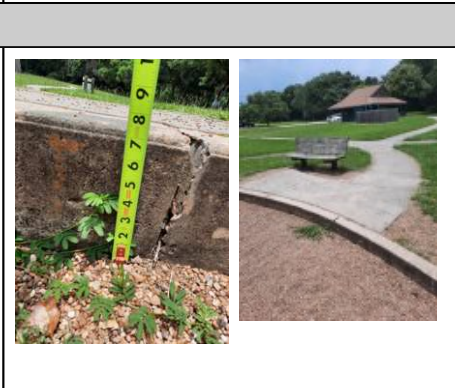
62	40 Acre Lake: 40 Acre Lake Playground	[29.3704921 , -95.6267265]	As a smart practice, play area should have a minimum 60" wide entry, free of changes in level, gaps, and slope.	Lacks designated entry (CIL of 7" to access playground)	Repair, bevel or ramp CIL at playground entry/border	2015 ABAAS Section: F206.1 2012 TAS Section: 206.1 2010 ADAS Section: 206.1

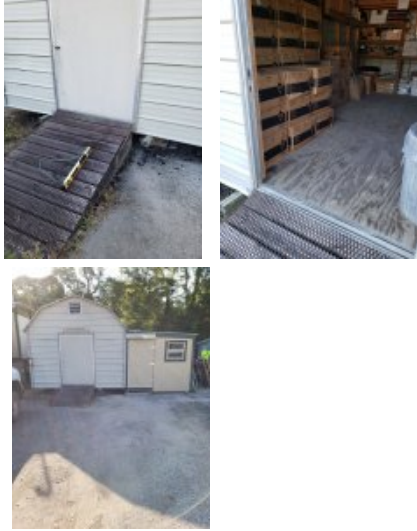
77	Employee Spaces: Maintenance	[29.3691609 , -95.596998 2]	The accessible route contains loose gravel and/or surface materials that do not provide for a stable, firm slip resistant surface. Floor and ground surfaces shall be stable, firm, and slip resistant.	Consumables Building - Lacks maneuvering clearance and firm and stable landing due to loose gravel	Resurface AR where deterioration occurs	2015 ABAAS Section: 302.1 2012 TAS Section: 302.1 2010 ADAS Section: 302.1

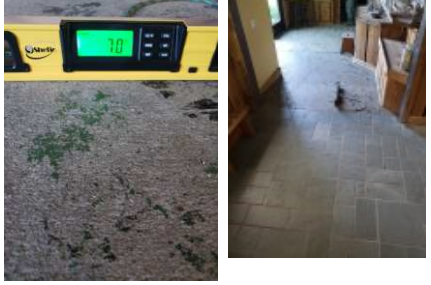
118	Creekfield Lake Area: Nature Center	[29.3763613 , -95.596835 9]	Openings in floor or ground surfaces shall not allow passage of a sphere more than 1/2 inch (13 mm) diameter except as allowed in 407.4.3, 409.4.3, 410.4, 810.5.3 and 810.10. Elongated openings shall be placed so that the long dimension is perpendicular to the dominant direction of travel.	Gap of 1" (crack in floor)	Fill and maintain gaps to max .5"	2015 ABAAS Section: 302.3 2012 TAS Section: 302.3 2010 ADAS Section: 302.3

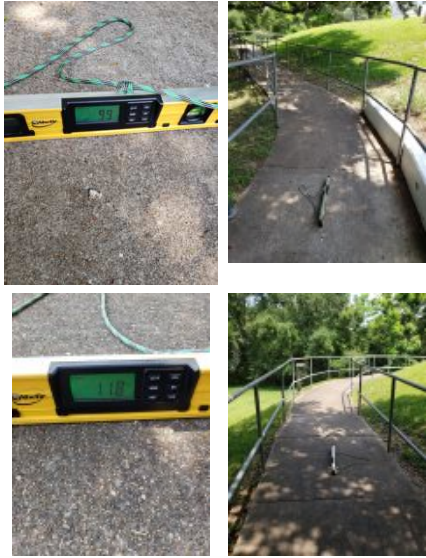
175	Creekfield Lake Area: George Observatory	[29.3751459 , -95.593424 2]	The ramp on the accessible route contains cross slopes greater than 2%. Surface cross slopes shall not exceed one unit vertical in 48 units horizontal (2-percent slope).	250' continuous ramp - Cross slope of 3.6%	Correct ramp cross slope to max 2.08%	2015 ABAAS Section: 405.3 2012 TAS Section: 405.3 2010 ADAS Section: 405.3

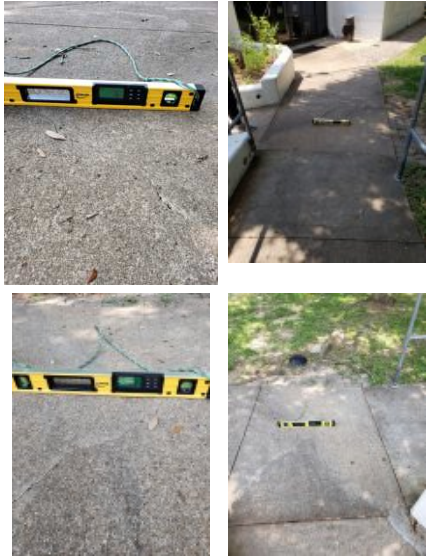
177	Creekfield Lake Area: George Observatory	[29.3749051 , -95.593410 8]	The handrail is mounted incorrectly. Handrails are measured at the top and must be between 34 inches and 38 inches above the ramp surface. Handrails must extend horizontally beyond the top and bottom of the ramp 12 inches minimum.	250' continuous ramp - Handrails at 44" agl	Remount handrails to 34" to 38" aff	2015 ABAAS Section: 505.4 2012 TAS Section: 505.4 2010 ADAS Section: 505.4

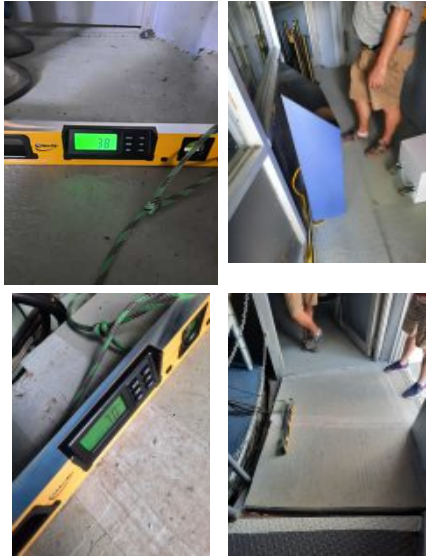
209	Creekfield Lake Area: George Observatory	[29.3751826 , -95.593634 1]	The threshold has a vertical change greater than 1/4 inch high. All interior doors must be maintained so that the operating pressure does not exceed 5 lb. force to open. The sweep period for doors with closers shall be adjusted so that from an open position of 70 degrees, the door will take at least 3 seconds to move to a point 3 inches from the latch, measured to the leading edge of the door.	Door to telescope - CIL of 4" at threshold, 13# push, fast close	For all doors along the public circulation route, repair, bevel, or ramp CILs at door entries to max .25" For all doors along the public circulation route, inspect, adjust, and maintain 5 lbf to open interior doors For all doors along the public circulation route, inspect, adjust, and maintain closing speed on door closers	2010 ADAS Section: 404.2.3, 404.2.7, 404.2.4, 404.2.11, 404.2.11 Exception

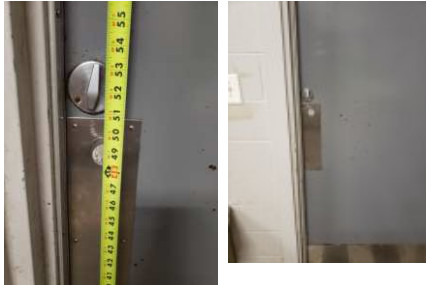
297	Camping Area: Camping Restrooms 2	[29.3820221 , -95.598228]	It is recommended that exterior doors be maintained so that the operating pressure does not exceed 8.5 lb. force to open. The sweep period for doors with closers shall be adjusted so that from an open position of 70 degrees, the door will take at least 3 seconds to move to a point 7 inches from the latch, measured to the leading edge of the door.	Men's restroom door - 15# push	For all doors along the public circulation route, inspect, adjust, and maintain 8.5 lbf to open exterior doors as a smart practice For all doors along the public circulation route, inspect, adjust, and maintain closing speed on door closers	2012 TAS Section: 404.2.9, 404.2.9 Advisory, 404.2.8.1 2010 ADAS Section: 404.2.9, 404.2.8.1

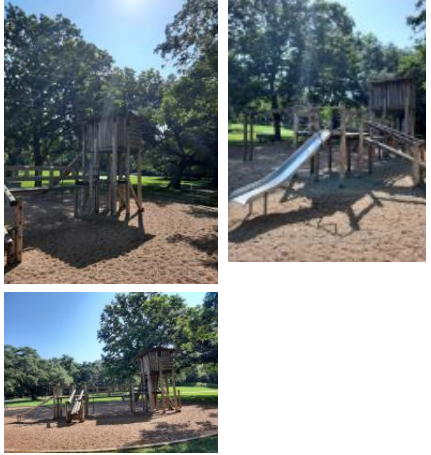
324	Camping Area: Camping Playground	[29.3814182 , -95.598195 6]	The walkway contains abrupt vertical edges and/or variations over a 1/4 inch. 1/4 inch is the maximum vertical rise. Changes in level between 1/4 inch and 1/2 inch must be beveled at 1:2 or less. Changes in level greater than 1/2 inch must be by way of a ramp.	CILs of 2.5" (towards dining hall), 1" (towards picnic table), and 2" (towards camping restrooms)	Repair, bevel or ramp CIL along AR	2012 TAS Section: 303.2, 303.3 2010 ADAS Section: 303.2, 303.3

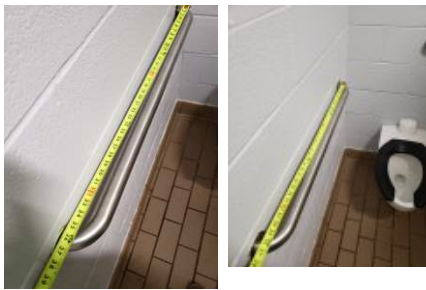
360	Hale Lake Area: Hale Lake Restrooms	[29.3757138 , -95.583186 2]	The side grab bars are not in the correct location. Grab bars on the side wall must be installed so that the end closest to the rear wall is maximum 12" from the rear wall. The end furthest from the rear wall must be mounted minimum 54" from the rear wall.	Men's restroom - Side grab bars end less than 54" from rear wall	Remount side grab bar to max 12" from the rear wall at the close end and min 54" on the far end, and 33" to 36" aff	2015 ABAAS Section: 604.5.1 2012 TAS Section: 604.5.1 2010 ADAS Section: 604.5.1
