Access Audit Site Report

Caprock Canyons State Park and Trailway

Accessibility Evaluation

Inspection Date: 05/19/2022

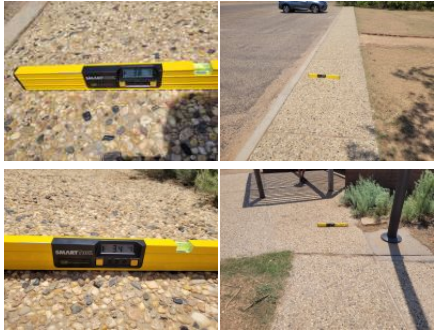
6	Headquarters Area: Discovery Center - Exterior Accessible Route	[34.4133801, -101.0597241], [34.4133458, -101.0596812]	The accessible route of travel contains cross slopes greater than 2%. Cross slopes shall not exceed one unit vertical in 48 units horizontal (2-percent slope).	Old HQ- 3.8% to sign, 3.4%	Correct or repair cross slope along AR to max 2.08%.	2015 ABAAS Section: 403.3 2012 TAS Section: 403.3 2010 ADAS Section: 403.3

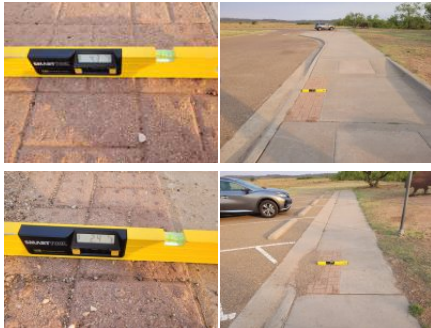
11	Headquarters Area: Discovery Center - Exterior Accessible Route	[34.4105141, -101.0539924]	There is a gap spaced greater than a 1/2 inch. Openings in floor or ground surfaces shall not allow passage of a sphere more than 1/2 inch diameter. Elongated openings shall be placed so that the long dimension is perpendicular to the dominant direction of travel.	1.25" gap near parking, a few 1" gaps between at joints where wood filler sinking/missing	Correct or fill gaps to be max .5"	2015 ABAAS Section: 302.3 2012 TAS Section: 302.3 2010 ADAS Section: 302.3

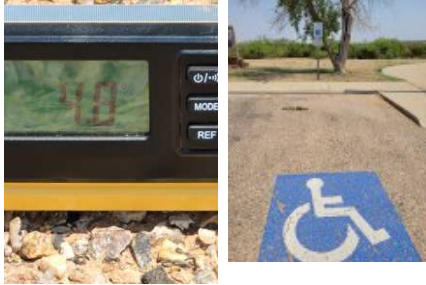
67	Headquarters Area: Discovery Center - Parking	[34.4133344, -101.0597337]	The parking stall contains abrupt edges and surface irregularities over a 1/4 inch vertical. Parking spaces and access aisles serving them shall be stable, firm, and slip resistant. Access aisles shall be at the same level as the parking spaces they serve. Changes in level are not permitted and shall not be sloped steeper than 2% in any direction.	Old HQ- Loose gravel and debris	Resurface accessible stalls and access aisles with a firm, stable, and slip resistant material.	2015 ABAAS Section: 502.4 2012 TAS Section: 502.4 2010 ADAS Section: 502.4

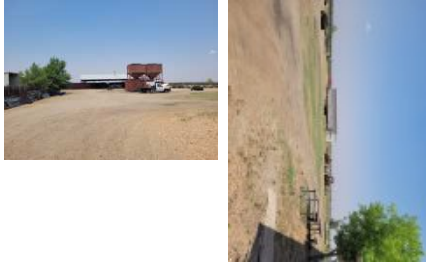
95	Employee Areas: Maintenance	[34.4110375, -101.0482431]	The restroom is not compliant. The restroom does not have the required minimum clear floor space or maneuvering clearances for the toilet. The restroom does not have the required minimum clear floor space or maneuvering clearances for the lavatory. The entry door does not contain the required minimum maneuvering spaces on the pull/push sides. The entry door encroach into the required clear floor space for fixtures. Grab bars are missing and/or incorrectly installed. Accessories, such as toilet seat covers, paper towel holders, garbage cans, hand dryers, and mirrors are either too high or without clear floor space or both.	restroom lacks accessible features	Create a compliant wheelchair accessible restroom and correct all features to be accessible if feasible.	2015 ABAAS Section: 603.1 2012 TAS Section: 603.1 2010 ADAS Section: 603.1

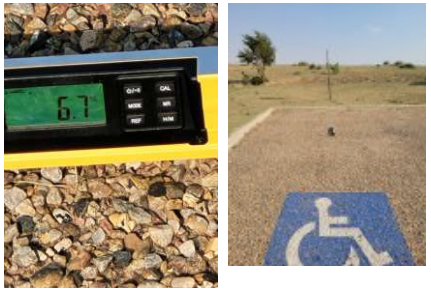
113	Lake Theo Day Use Area: Lake Theo - Parking	[34.4140159, -101.0645805]	The parking stall contains abrupt edges and surface irregularities over a 1/4 inch vertical. Parking spaces and access aisles serving them shall be stable, firm, and slip resistant. Access aisles shall be at the same level as the parking spaces they serve. Changes in level are not permitted and shall not be sloped steeper than 2% in any direction.	near boat ramp- loose stones, unstable surface	Resurface accessible stalls and access aisles with a firm, stable, and slip resistant material.	2015 ABAAS Section: 502.4 2012 TAS Section: 502.4 2010 ADAS Section: 502.4

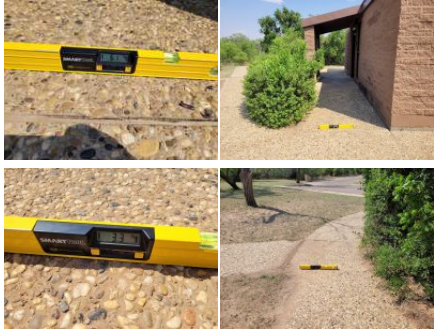
161	Lake Theo Day Use Area: Lake Theo - Men's Restroom	[34.4169114, -101.0667893]	The curb ramp slope exceeds the maximum running slope (Parallel to the direction of travel) allowable of 8.33%. Curb ramps should have the least possible slope but in no case more than 8.3% (1:12).	9.2% running slope at parking	Correct curb ramp running slope to max 8.33%	2015 ABAAS Section: 406.1 2012 TAS Section: 406.1 2010 ADAS Section: 406.1

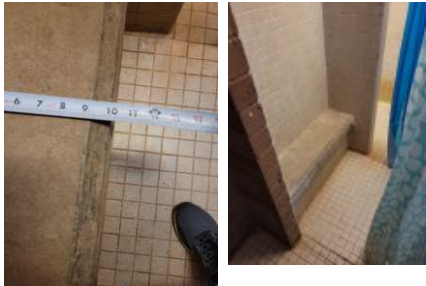
Finding Number	Area Description	Lat/Long	Finding	As Built	Recommendation	Citation	Photos	Figure
238	Honey Flat Camping Area: Honey Flat - Men's Restroom	[34.4210876, -101.0543653]	There are no accessible bathing or shower facilities. Where facilities for bathing are provided for the public, clients or employees, including showers or bathtubs, at least one shower or bathtub and support facilities such as lockers, and not less than 1 percent of all facilities, shall be accessible.	shower has narrow entry, change in level at entry, lacks accessible features	Create an accessible shower in locker/bathing room.	2015 ABAAS Section: F213.3.6 2012 TAS Section: 213.3.6 2010 ADAS Section: 213.3.6

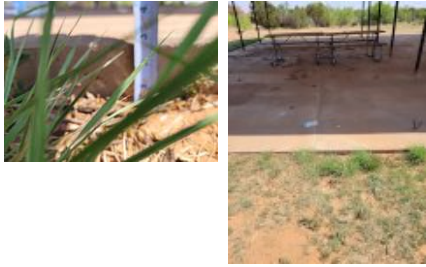
268	Wild Horse Camping Area: Wild Horse - Picnic Area	[34.4423244, -101.0545919]	Where picnic facilities contain two or fewer picnic units, each picnic unit shall provide mobility features complying with F245.2.	Lacks AR to grill and water spigot	Create an ORAR to shelter or picnic area and provide accessible features as a smart practice.	2015 ABAAS Section: F245.2.1

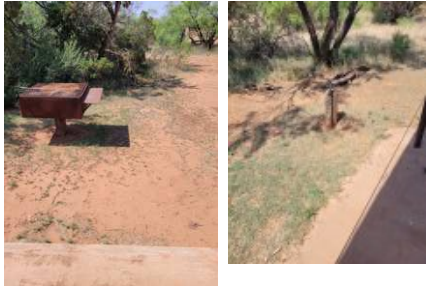
269	Wild Horse Camping Area: Wild Horse - Picnic Area	[34.44231, -101.0545892]	Objects project more than 4 inches into the circulation path. Wall-mounted objects that have leading edges between 27 inches and 80 inches from the floor must not project more than 4 inches into the circulation path. Protruding objects that extend to the floor or within 27 inches of the floor are cane detectable and are therefore not hazardous. Where it is necessary or desirable to have objects protrude from the wall, a manner of cane detection must be provided.	Some brackets protrude 5" above 27" AFF	Relocate object to not protrude into the circulation path.	2015 ABAAS Section: 307.2 2012 TAS Section: 307.2 2010 ADAS Section: 307.2

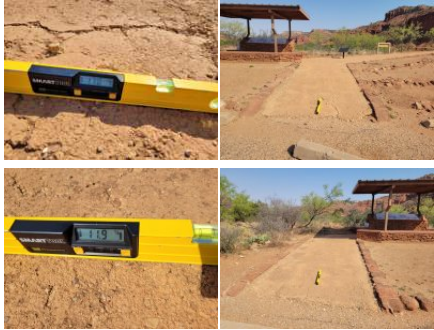
301	South Prong: Trailhead	[34.4410598, -101.0929577], [34.4410233, -101.0930247]	Obstacles on outdoor recreation access routes, passing spaces, and resting intervals shall not exceed 1/2 inch (13 mm) in height measured vertically to the highest point. EXCEPTION: Where the surface is other than asphalt, concrete, or boards, obstacles shall be permitted to not exceed 1 inch (25 mm) in height measured vertically to the highest point.	.75" and higher CIL at both entries from parking	Repair, bevel or ramp CIL along the ORAR to max .5" or 1" for surfaces other than concrete, asphalt or boards as a smart practice.	2015 ABAAS Section: 1016.5, 1016.5 EXCEPTION

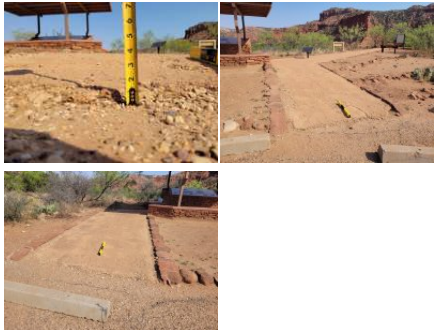
302	South Prong: Trailhead	[34.4410811, -101.0929805]	Openings in the surface of outdoor recreation access routes shall not allow the passage of a sphere more than 1/2 inch (13 mm) in diameter. Advisory: Spaces between the boards in a boardwalk and drainage grates are examples of openings. Where possible, drainage grates should be located outside the minimum clear width of the outdoor recreation access route. Elongated openings should be placed so that the long dimension is perpendicular, or as close to perpendicular as possible, to the dominant direction of travel	surface deteriorated creating multiple gaps	Correct or fill gaps along the ORAR to max .5" as a smart practice.	2015 ABAAS Section: 1016.6, Advisory 1016.6
