# Access Audit Site Report

**Colorado Bend State Park**  
**1201 Colorado Park Road**  
**Bend, TX 76824**  
**Accessibility Evaluation**  
**Inspection Date: 03/02/2022**  
**Inspectors: Tanya Scheibe**

Prepared By  
**WT Group**

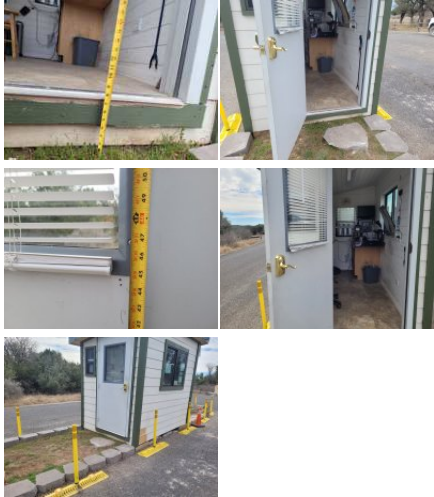
Finding Number	Area Description	Lat/Long	Finding	As Built	Recommendation	Citation	Photos	Figure
1	Entry Gate : Fee Booth/ Entry Gate	[31.0639159 , -98.504739 3]	Spaces and elements within employee work areas shall only be required to comply with 206.2.8, 207.1, and 215.3 and shall be designed and constructed so that individuals with disabilities can approach, enter, and exit the employee work area. Employee work areas, or portions of employee work areas, other than raised courtroom stations, that are less than 300 square feet (28 m2) and elevated 7 inches (180 mm) or more above the finish floor or ground where the elevation is essential to the function of the space shall not be required to comply with these requirements or to be on an accessible route.	fee booth door - lacks route, window high, 8" step	For employee spaces, relocate storage, furniture, and other obstacles at doorways to provide approach, enter and exit at the employee space. Provide required maneuvering clearance on push and pull side of doors and connect to a route. Ramp step at door entries to max .25". Replace doors with ones having sidelight viewing windows max 43" AFF.	2015 ABAAS Section: F203.9 2012 TAS Section: 203.9 2010 ADAS Section: 203.9

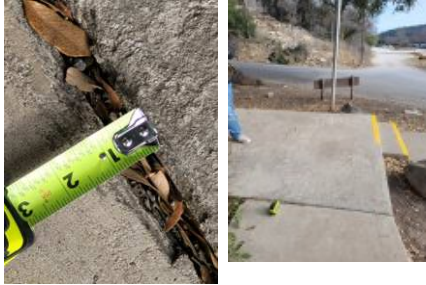
Finding Number	Area Description	Lat/Long	Finding	As Built	Recommendation	Citation	Photos	Figure
11	Headquarters (HQ) : HQ - Parking and Exterior Accessible Route	[31.0227975 , -98.442459 8]	There is a gap spaced greater than a 1/2 inch. Openings in floor or ground surfaces shall not allow passage of a sphere more than 1/2 inch diameter. Elongated openings shall be placed so that the long dimension is perpendicular to the dominant direction of travel.	1" gap at top of walkway from accessible parking stall at HQ	Correct or fill gaps to be max .5"	2015 ABAAS Section: 302.3 2012 TAS Section: 302.3 2010 ADAS Section: 302.3

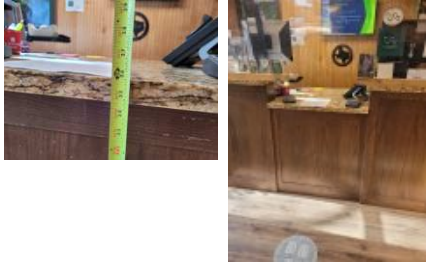
Finding Number	Area Description	Lat/Long	Finding	As Built	Recommendation	Citation	Photos	Figure
15	Headquarters (HQ) : HQ - Public Spaces	[31.0228584 , -98.442465 2]	Element meets all standards and requirements	Service counter complies	None	2010 ADAS Section: N/A

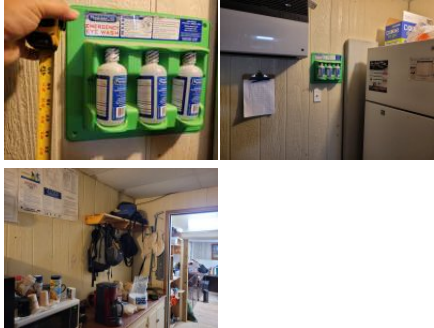
Finding Number	Area Description	Lat/Long	Finding	As Built	Recommendation	Citation	Photos	Figure
22	Headquarters (HQ) : HQ - Employee Spaces	[31.0228733 , -98.4424786]	Spaces and elements within employee work areas shall only be required to comply with 206.2.8, 207.1, and 215.3 and shall be designed and constructed so that individuals with disabilities can approach, enter, and exit the employee work area. Employee work areas, or portions of employee work areas, other than raised courtroom stations, that are less than 300 square feet (28 m2) and elevated 7 inches (180 mm) or more above the finish floor or ground where the elevation is essential to the function of the space shall not be required to comply with these requirements or to be on an accessible route.	reduced entry from lobby - 24" width, fan in pull side clearance, 24" width door; entry door - 10# push, wall in pull side clearance, shoe cleaner grate in pull side clearance, closes fast, 4" change in level (CIL)	For employee spaces, relocate storage, furniture, and other obstacles at doorways to provide approach, enter and exit at the employee space. Provide required maneuvering clearance on push and pull side of doors. Remove shoe grate from door clearance. Widen doors with doors having 80" overhead clearance and 32" clear width. Repair, bevel, or ramp CILs at door entries to max .25". Inspect, adjust, and maintain 5 lbf to open interior doors. Inspect, adjust, and maintain closing speed on door closers. Replace hardware with lever hardware or hardware operable without a tight pinch or grasp.	2015 ABAAS Section: F203.9 2012 TAS Section: 203.9 2010 ADAS Section: 203.9

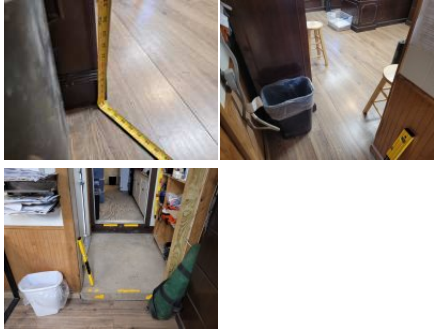
Finding Number	Area Description	Lat/Long	Finding	As Built	Recommendation	Citation	Photos	Figure
24	Headquarters (HQ) : HQ - Employee Spaces	[31.0228205 , -98.442577 8]	Spaces and elements within employee work areas shall only be required to comply with 206.2.8, 207.1, and 215.3 and shall be designed and constructed so that individuals with disabilities can approach, enter, and exit the employee work area. Employee work areas, or portions of employee work areas, other than raised courtroom stations, that are less than 300 square feet (28 m2) and elevated 7 inches (180 mm) or more above the finish floor or ground where the elevation is essential to the function of the space shall not be required to comply with these requirements or to be on an accessible route.	Debbie - steps, 1" threshold, 8.7% slope, 29.5" wide; Aaron - steps, knob	For employee spaces, relocate storage, furniture, and other obstacles at doorways to provide approach, enter and exit at the employee space. Provide required maneuvering clearance on push and pull side of doors. Correct slope in door clearance to max 2.08%. Replace doors with doors having 80" overhead clearance and 32" clear width. Repair, provide beveled threshold. Replace hardware with lever hardware or hardware operable without a tight pinch or grasp. See previous finding for ramp recommendation.	2015 ABAAS Section: F203.9 2012 TAS Section: 203.9 2010 ADAS Section: 203.9

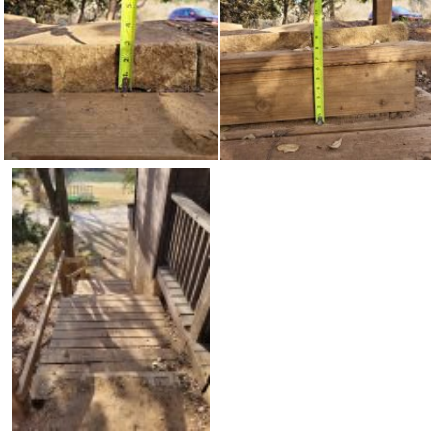
29	1-17 campsites side (Right from HQ) : Exterior Accessible Route in 1-17 Area	[31.0186968 , -98.447305 2]	There is no accessible route to restroom 1, 3, and 4 At least one accessible route shall connect accessible buildings, accessible facilities, accessible elements, and accessible spaces that are on the same site.	no route to restroom 4, no route to restroom 3, no route to restroom 1	Create an accessible route with crushed stone or other outdoor material from parking or walkway to restroom 1, 3, and 4	2015 ABAAS Section: F206.2.2  2012 TAS Section: 206.2.2  2010 ADAS Section: 206.2.2

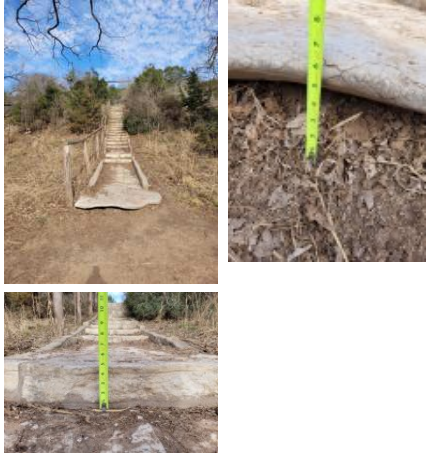
33	1-17 campsites side (Right from HQ) : Exterior Accessible Route in 1-17 Area	[31.0195864, -98.4454478]	Treads shall be 11 inches (280 mm) deep minimum and uniform	stairway to sites 1-10 - tread depth is not uniform	Correct tread depth on stairs to 11" minimum and consistent, leave as is if technically infeasible	2015 ABAAS Section: 504.2 2012 TAS Section: 504.2 2010 ADAS Section: 504.2

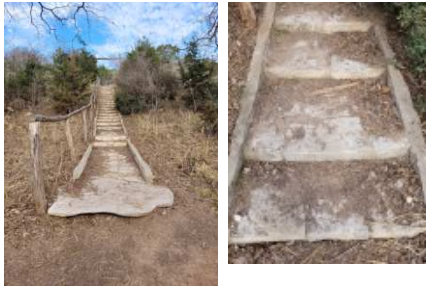
34	1-17 campsites side (Right from HQ) : Exterior Accessible Route in 1-17 Area	[31.0195841, -98.44548]	Surface of stairs shall be firm, stable and slip resistant. Changes of elevation are not permitted on stair treads.	stairway to sites 1-10 - debris and build up on steps	Correct or repair CIL along stair tread where noted and assure surface is firm stable and slip resistant	2015 ABAAS Section: 504.4, 302.1 2012 TAS Section: 504.4 2010 ADAS Section: 504.4

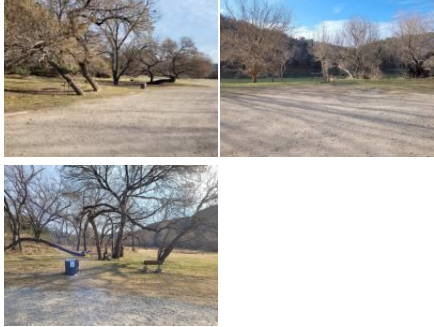
43	1-17 campsites side (Right from HQ) : Spicewood Springs Day Use Area	[31.0182991, -98.4472878]	Benches shall have a 36" by 48" clear ground space (CGS) positioned near the bench with one side of the space adjoining an outdoor recreation access route (ORAR) or trail, as applicable The CGS shall not overlap with the ORAR or trail or another CGS	bench in Spicewood Springs day use area lacks CFS	Construct firm, stable, and slip resistant pads at least 36" by 48" adjacent to 20% of benches, and locate along an AR as a smart practice.	2015 ABAAS Section: 1011.2.1

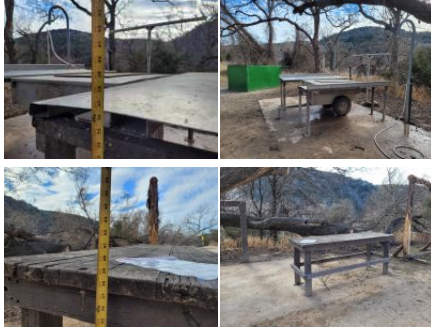
46	1-17 campsites side (Right from HQ) : Fish Cleaning	[31.0221493 , -98.442599 3]	The operable part is positioned too high for either a side or front approach. Where a clear floor or ground space allows a parallel approach to an element and the side reach is unobstructed, the high side reach shall be 48 inches maximum and the low side reach shall be 15 inches minimum above the finish floor or ground. Where a forward reach is unobstructed, the high forward reach shall be 48 inches maximum and the low forward reach shall be 15 inches minimum above the finish floor or ground.	lowest hook at fish cleaning is 56" AFF	Lower at least one hook to 15" min to 48" max	2015 ABAAS Section: 308.1 2012 TAS Section: 308.1 2010 ADAS Section: 308.1

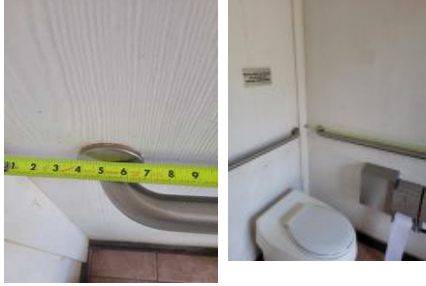
52	1-17 campsites side (Right from HQ) : Women's Restroom 3	[31.0218999 , -98.442824 6]	The grab bar height and/or spacing fails. Grab bars must be mounted between 33" and 36" to the top of the gripping surface. There must be 1.5" of clearance between the grab bar and the wall. There must be a minimum of 1.5" of clearance below and minimum 12" above the grab bar to any dispenser or other obstruction.	both mounted 36.5" aff	Remount grab bars in accessible stall to 33" to 36" above the finished floor (AFF).	2015 ABAAS Section: 609.3, 609.4  2012 TAS Section: 609.4, 609.3  2010 ADAS Section: 609.3, 609.4

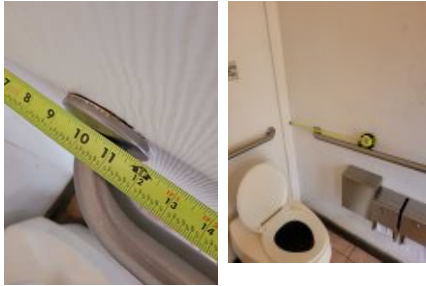
58	1-17 campsites side (Right from HQ) : Women's Restroom 4	[31.0186278 , -98.4473253]	The rear grab bar is not 36" long or is not mounted in the correct location. The rear grab bar must be a minimum of 36" long and extend from the toilet centerline a minimum 12" towards the wall side and a minimum 24" towards the open side of the toilet. Grab bars shall be installed in a horizontal position, 33 inches minimum and 36 inches maximum above the finish floor measured to the top of the gripping surface and the space between the grab bar and the top of the tank shall be 1-1/2 inches minimum.	10" centerline	Remount rear grab bar to behind the toilet, 12" to one side of center and 24" to the other and 33" to 36" aff	2015 ABAAS Section: 604.5.2 2012 TAS Section: 604.5.2 2010 ADAS Section: 604.5.2

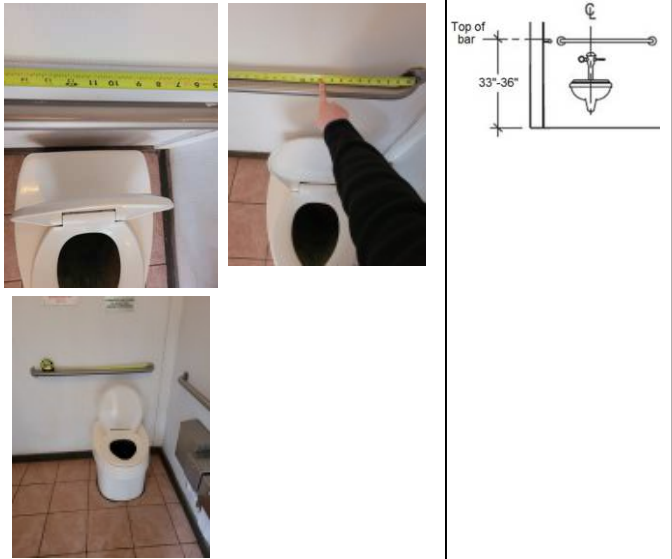
59	1-17 campsites side (Right from HQ) : Women's Restroom 4	[31.0186623 , -98.4473106]	The grab bar height and/or spacing fails. Grab bars must be mounted between 33" and 36" to the top of the gripping surface. There must be 1.5" of clearance between the grab bar and the wall. There must be a minimum of 1.5" of clearance below and minimum 12" above the grab bar to any dispenser or other obstruction.	side grab bar is 36.5" aff, rear is 37" aff	Remount grab bars in accessible stall to 33" to 36" above the finished floor (AFF). See previous findings for cost.	2015 ABAAS Section: 609.3, 609.4 2012 TAS Section: 609.4, 609.3 2010 ADAS Section: 609.3, 609.4

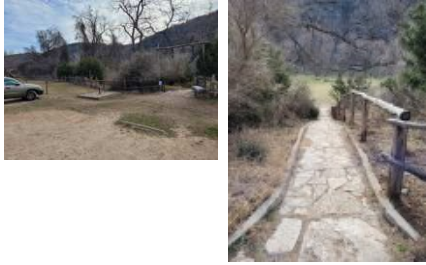
63	1-17 campsites side (Right from HQ) : Campsite 8	[31.0191565 , -98.445176 9]	The surface of outdoor recreation access routes, passing spaces, and resting intervals shall be firm and stable	site 8 - non compliant surface, sample site lacks any accessible features	Repair surface or ORAR to be firm and stable as a smart practice. Create required number of accessible campsites per previous finding.	2015 ABAAS Section: 1016.2

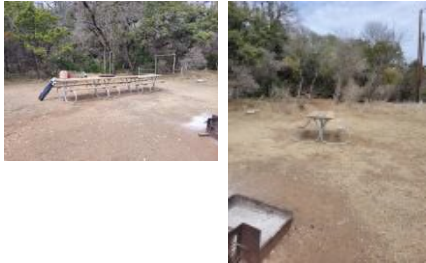
76	18-39 campsites side (Left from HQ): Grey Fox Group Site	[31.0268015, -98.440973 9]	Picnic tables are required to have clear ground space 36 inches (915 mm) on all usable sides of the table measured from the back edge of the benches.	Grey Fox - non accessible surface reduces clear ground space (CGS)	Provide required 36" clear ground space around all usable portions of the table as a smart practice.	2015 ABAAS Section: 1011.2.1

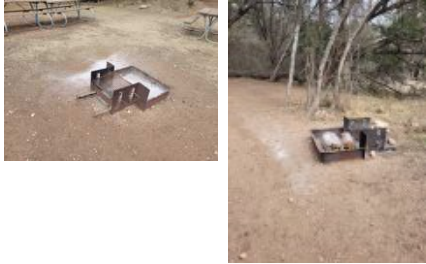
78	18-39 campsites side (Left from HQ): Grey Fox Group Site	[31.0270325, -98.441000 7]	Fire building surfaces shall be 9 inches (230 mm) minimum above the ground.	Grey Fox - fire building surface is ground level, 2 of 2	Correct fire building surface to be 9" min above the ground as a smart practice. In the alternative, replace fire ring with a compliant accessible fire ring.	2015 ABAAS Section: 1011.5.1

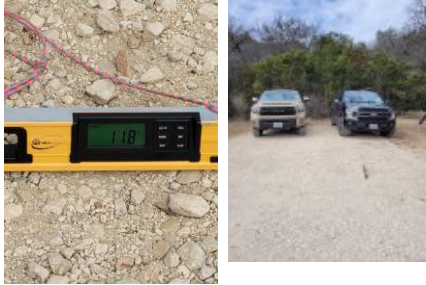
80	18-39 campsites side (Left from HQ): Canyon Group Site	[31.0263567 , -98.441259 5]	An accessible access route is not provided between elements, spaces and the facilities provided within the accessible camping unit. At least one outdoor recreation access route shall connect accessible elements, spaces and facilities provided within camping units with mobility features.	Canyon - non accessible site due to surface, no amenities connect	Create AR with crushed and compacted stone or similar outdoor material to camp sites and one of each type of amenity. In the alternative, leave as is and make other group sites accessible.	2015 ABAAS Section: F244.5.1

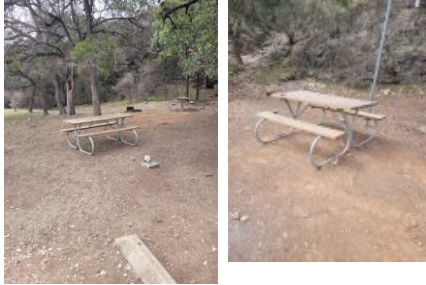
83	18-39 campsites side (Left from HQ): Canyon Group Site	[31.026305, -98.441279 6]	Picnic tables are required to have clear ground space 36 inches (915 mm) on all usable sides of the table measured from the back edge of the benches.	Canyon - non accessible surface reduces CFS	Provide required 36" clear ground space around all usable portions of the table as a smart practice.	2015 ABAAS Section: 1011.2.1

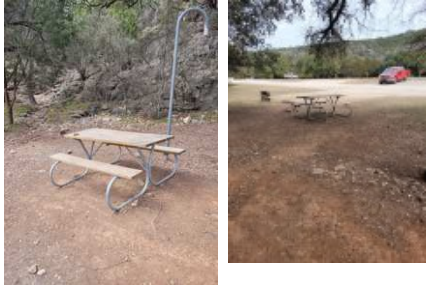
84	18-39 campsites side (Left from HQ): Canyon Group Site	[31.0263406 , -98.441258 2]	Clear ground space 48 inches (1220 mm) by 48 inches (1220 mm) should be provided on all usable sides of the fire ring, grill, fireplace, and woodstove. Center the space on each usable side of the grill, fireplace, and woodstove.	Canyon - lacks accessible surface	Provide required 48" clear ground space centered along usable side of fire ring, grill, fireplace, or woodstove as a smart practice.	2015 ABAAS Section: 1011.2

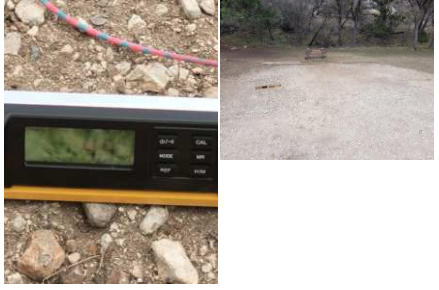
87	18-39 campsites side (Left from HQ): Primitive/ Shelter Campsites	[31.0237805 , -98.441447]	Camping facilities shall provide camping units with mobility features complying with F244.2 in accordance with Table F244.2. Where a camping facility provides different types of camping units, Table F244.2 shall apply to each type of camping unit provided. Total Number of Camping Units Provided in Camping Facility Minimum Number of Camping Units with Mobility Features Required 1 1 2 to 25 2 26 to 50 3 51 to 75 4 76 to 100 5 101 to 150 7 151 to 200 8 201 and over 8, plus 2 percent of the number over 200	0 of 6 campsites with shelter accessible, fire pit, shelter, table	Create the required number of accessible camp sites per table F244.2 as a smart practice	2015 ABAAS Section: F244.2

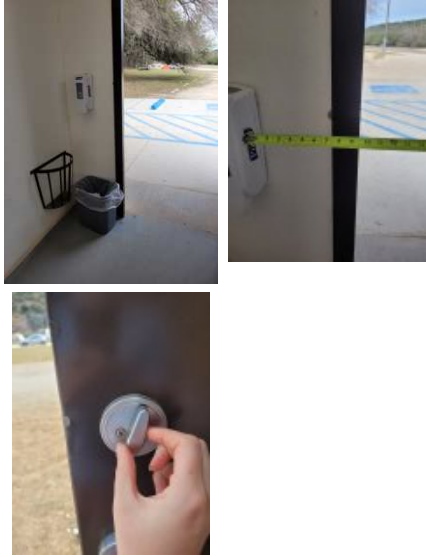
95	18-39 campsites side (Left from HQ): Women's Restroom 1	[31.0263648 , -98.440524 6]	The operable part is positioned too high for either a side or front approach. Where a clear floor or ground space allows a parallel approach to an element and the side reach is unobstructed, the high side reach shall be 48 inches maximum and the low side reach shall be 15 inches minimum above the finish floor or ground. Where a forward reach is unobstructed, the high forward reach shall be 48 inches maximum and the low forward reach shall be 15 inches minimum above the finish floor or ground.	hook 66" AFF	Remount operable parts to be in reach range of 15" min to 48" max	2015 ABAAS Section: 308.1  2012 TAS Section: 308.1  2010 ADAS Section: 308.1

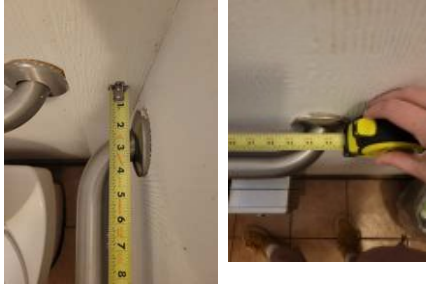
97	18-39 campsites side (Left from HQ): Women's Restroom 1	[31.0264073 , -98.440564 8]	The grab bar height and/or spacing fails. Grab bars must be mounted between 33" and 36" to the top of the gripping surface. There must be 1.5" of clearance between the grab bar and the wall. There must be a minimum of 1.5" of clearance below and minimum 12" above the grab bar to any dispenser or other obstruction.	both 37" AFF	Remount grab bars in accessible stall to 33" to 36" above the finished floor (AFF).	2015 ABAAS Section: 609.3, 609.4  2012 TAS Section: 609.4, 609.3  2010 ADAS Section: 609.3, 609.4

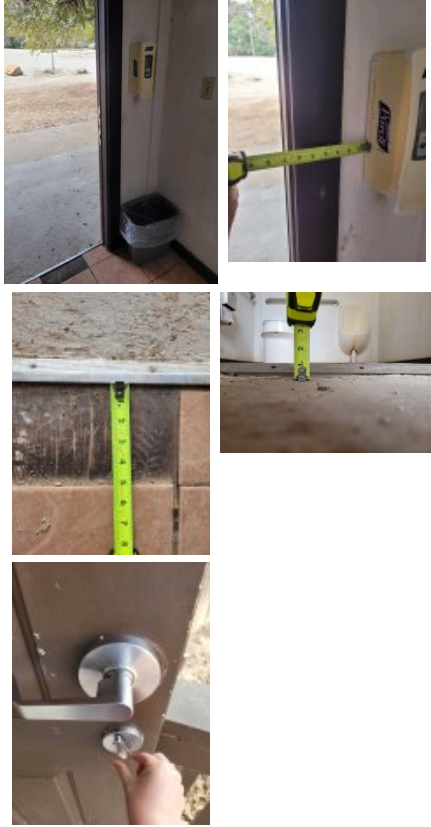
100	18-39 campsites side (Left from HQ): Men's Restroom 1	[31.0264337 , -98.440591 6]	The side grab bars are not in the correct location. Grab bars on the side wall must be installed so that the end closest to the rear wall is maximum 12" from the rear wall. The end furthest from the rear wall must be mounted minimum 54" from the rear wall.	42" grab bar mounted 3" from wall, extends 45" from rear wall to grab bar end	Remount side grab bar to max 12" from the rear wall at the close end and min 54" on the far end, and 33" to 36" aff.	2015 ABAAS Section: 604.5.1  2012 TAS Section: 604.5.1  2010 ADAS Section: 604.5.1

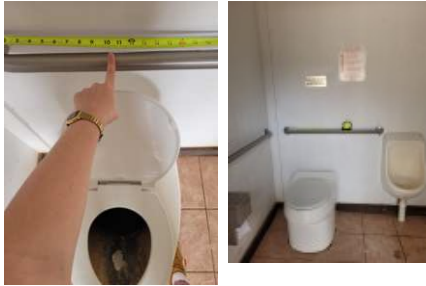
102	18-39 campsites side (Left from HQ): Men's Restroom 1	[31.0264291 , -98.440558 1]	The grab bar height and/or spacing fails. Grab bars must be mounted between 33" and 36" to the top of the gripping surface. There must be 1.5" of clearance between the grab bar and the wall. There must be a minimum of 1.5" of clearance below and minimum 12" above the grab bar to any dispenser or other obstruction.	side grab bar 36.5" AFF	Remount grab bars in accessible stall to 33" to 36" above the finished floor (AFF).	2015 ABAAS Section: 609.3, 609.4  2012 TAS Section: 609.4, 609.3  2010 ADAS Section: 609.3, 609.4

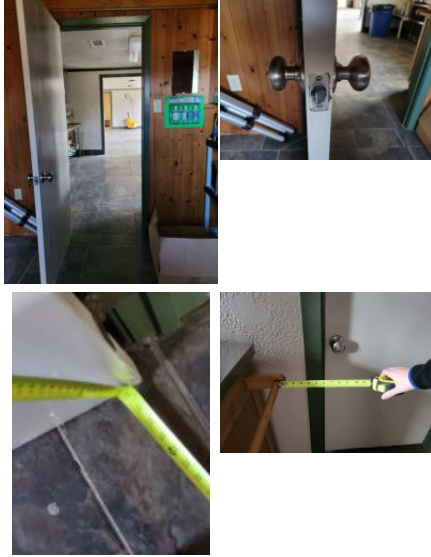
107	Gorman Falls/ Conference Center : Conference Center	[31.0569731 , -98.481860 1]	Spaces and elements within employee work areas shall only be required to comply with 206.2.8, 207.1, and 215.3 and shall be designed and constructed so that individuals with disabilities can approach, enter, and exit the employee work area. Employee work areas, or portions of employee work areas, other than raised courtroom stations, that are less than 300 square feet (28 m2) and elevated 7 inches (180 mm) or more above the finish floor or ground where the elevation is essential to the function of the space shall not be required to comply with these requirements or to be on an accessible route.	no route to center due to surface	For employee spaces, provide an accessible route to entry.	2015 ABAAS Section: F203.9 2012 TAS Section: 203.9 2010 ADAS Section: 203.9

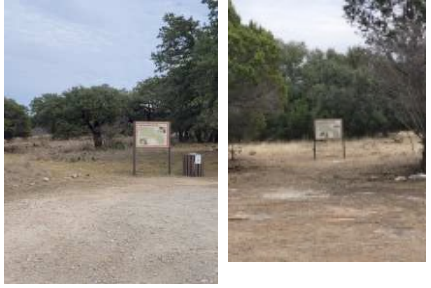
139	Trails: Trail Surface	[31.0392422, -98.4717951]	The surface of trails, passing spaces, and resting intervals shall be firm and stable	Lemons Ridge both trailheads - non accessible surface	Replace surface of trail with one that is firm and stable as a smart practice.	2015 ABAAS Section: 1017.2
