Access Audit Site Report

Cooper Lake State Park - South Sulphur Unit

Accessibility Evaluation

Inspection Date: 10/19/2021

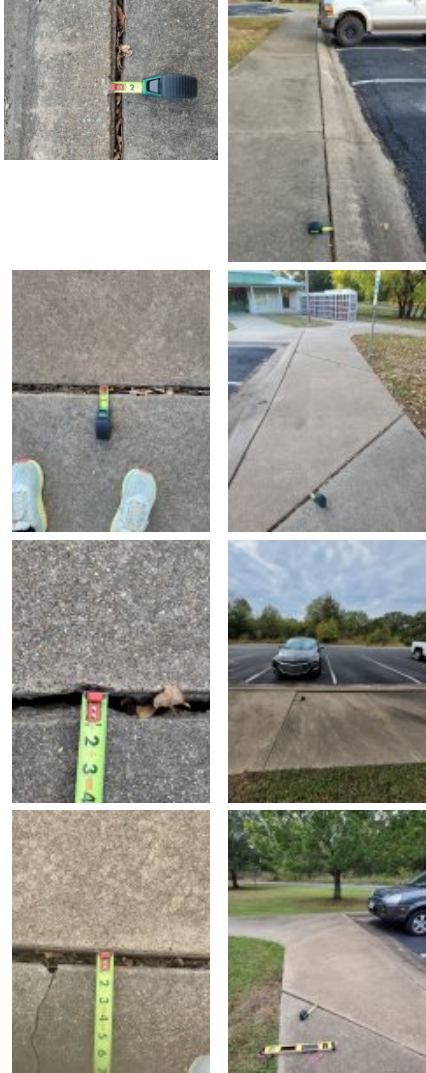
Finding Number	Area Description	Lat/Long	Finding	As Built	Recommendation	Citation	Photos	Figure
6	Headquarters Area: HQ Exterior Accessible Route	[33.2879605, -95.658248]	There is a gap spaced greater than a 1/2 inch. Openings in floor or ground surfaces shall not allow passage of a sphere more than 1/2 inch diameter. Elongated openings shall be placed so that the long dimension is perpendicular to the dominant direction of travel.	1" gap along side lot, 1" gap by accessible parking on side, on residence end in center of path - 1" gap, .75" gap at left corner of path, 3" gap going towards firewood lockers at corner, .75" gap at corner by firewood	Correct or fill gaps to be max .5"	2015 ABAAS Section: 302.3 2012 TAS Section: 302.3 2010 ADAS Section: 302.3

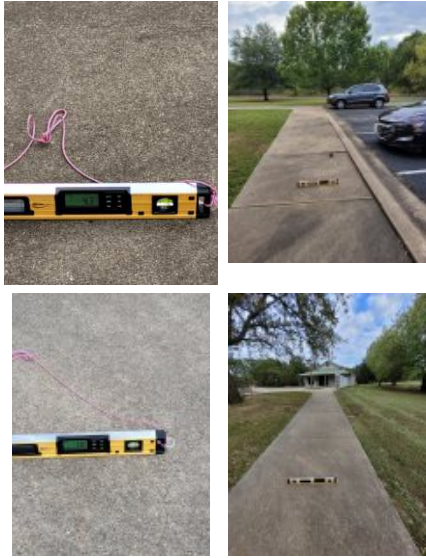
Finding Number	Area Description	Lat/Long	Finding	As Built	Recommendation	Citation	Photos	Figure
7	Headquarters Area: HQ Exterior Accessible Route	[33.2879975, -95.6583257], [33.2878888, -95.6583097]	The accessible route of travel on the accessible route contains cross slopes greater than 2%. Cross slopes shall not exceed one unit vertical in 48 units horizontal (2-percent slope).	4.3% slope on path along far end of parking. 3% slope going towards firewood	Correct or repair cross slope along AR to max 2.08%	2015 ABAAS Section: 403.3 2012 TAS Section: 403.3 2010 ADAS Section: 403.3

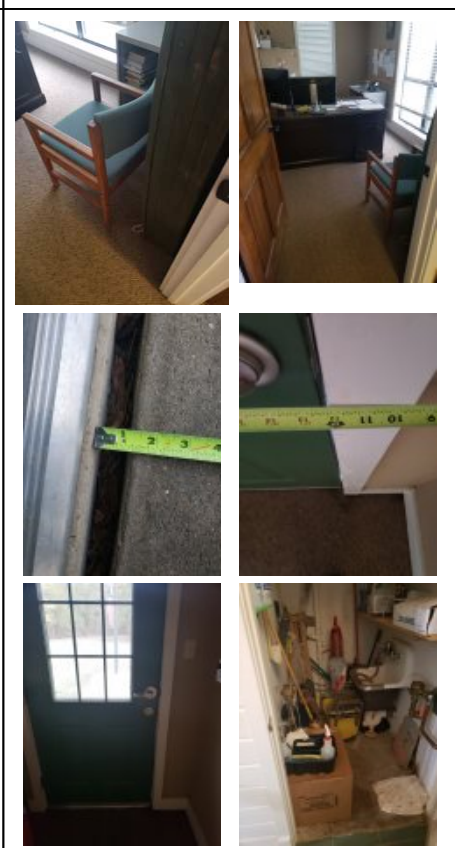
Finding Number	Area Description	Lat/Long	Finding	As Built	Recommendation	Citation	Photos	Figure
13	Headquarters Area: HQ Building	[33.2877318 , -95.657914]	Spaces and elements within employee work areas shall only be required to comply with 206.2.8, 207.1, and 215.3 and shall be designed and constructed so that individuals with disabilities can approach, enter, and exit the employee work area. Employee work areas, or portions of employee work areas, other than raised courtroom stations, that are less than 300 square feet (28 m2) and elevated 7 inches (180 mm) or more above the finish floor or ground where the elevation is essential to the function of the space shall not be required to comply with these requirements or to be on an accessible route.	chair and bookshelf in pull side maneuvering clearance (MC), rear door - 1" gap, 12" pull side MC, items stored in push side MC	For employee spaces, relocate storage, furniture, and other obstacles at doorways to provide approach, enter and exit at the employee space.	2015 ABAAS Section: F203.9 2012 TAS Section: 203.9 2010 ADAS Section: 203.9

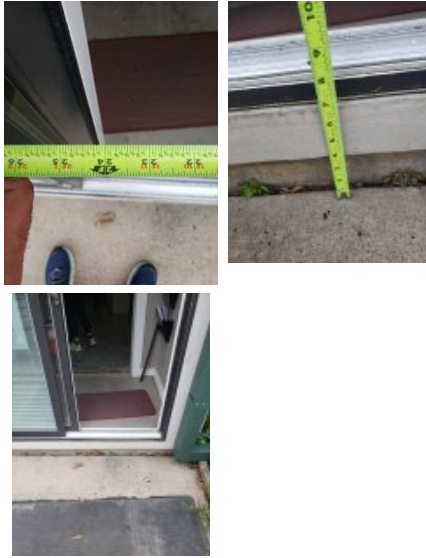
Finding Number	Area Description	Lat/Long	Finding	As Built	Recommendation	Citation	Photos	Figure
15	Headquarters Area: HQ Building	[33.2877543 , -95.657903 3]	Door openings shall provide a clear width of 32 inches (815 mm) minimum. Clear openings of doorways with swinging doors shall be measured between the face of the door and the stop, with the door open 90 degrees. Openings more than 24 inches (610 mm) deep shall provide a clear opening of 36 inches (915 mm) minimum. There shall be no projections into the required clear opening width lower than 34 inches (865 mm) above the finish floor or ground. Projections into the clear opening width between 34 inches (865 mm) and 80 inches (2030 mm) above the finish floor or ground shall not exceed 4 inches (100 mm). The threshold has a vertical change greater than 1/4 inch high.	sliding door- 24" wide, 8.5" CIL	For all doors along the public circulation route, replace doors with doors having 80" overhead clearance and 32" clear width. For all doors along the public circulation route, repair, bevel, or ramp CILs at door entries to max .25".	2010 ADAS Section: 404.2.3, 404.2.7, 404.2.4, 404.2.11, 404.2.11 Exception

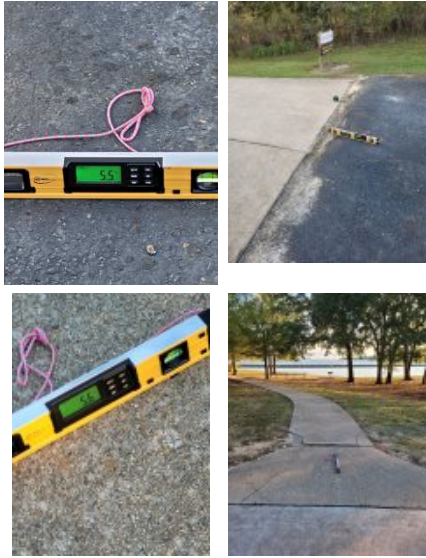
56	Heron Harbor Day Use Area: HH - Exterior Accessible Route	[33.2923606, -95.652732], [33.2922451, -95.652394]	The accessible route of travel on the accessible route contains cross slopes greater than 2%. Cross slopes shall not exceed one unit vertical in 48 units horizontal (2-percent slope).	6% slope on sidewalk along accessible parking. turn between picnic from lot closer to playground - 11.2% slope	Correct or repair cross slope along AR to max 2.08%	2015 ABAAS Section: 403.3 2012 TAS Section: 403.3 2010 ADAS Section: 403.3

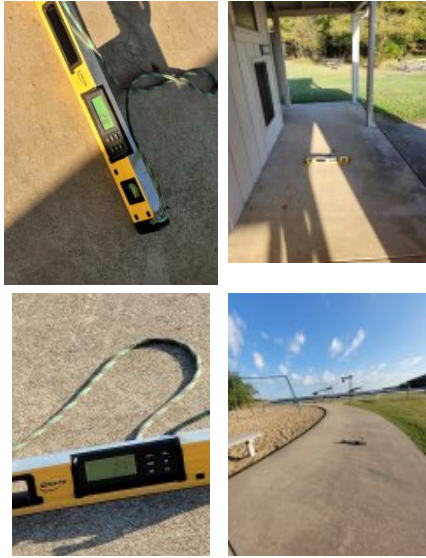
Finding Number	Area Description	Lat/Long	Finding	As Built	Recommendation	Citation	Photos	Figure
62	Heron Harbor Day Use Area: HH - Exterior Accessible Route	[33.2916196, -95.6521339], [33.2918696, -95.6518026]	There is a gap spaced greater than a 1/2 inch. Openings in floor or ground surfaces shall not allow passage of a sphere more than 1/2 inch diameter. Elongated openings shall be placed so that the long dimension is perpendicular to the dominant direction of travel.	1.5" gap on women's side of restroom building, 1" on men side entry. 2" gap at entry to swimming	Correct or fill gaps to be max .5"	2015 ABAAS Section: 302.3 2012 TAS Section: 302.3 2010 ADAS Section: 302.3

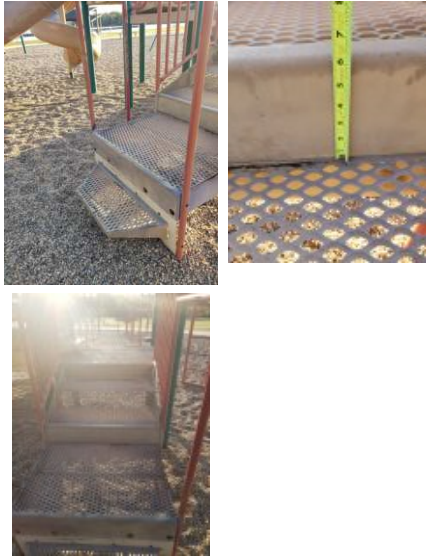
73	Heron Harbor Day Use Area: HH - Playground	[33.2918797 , -95.651954 2]	The steps on the transfer platform are greater than 8"	N/A	Correct transfer step riser height to 8" max and uniform	2015 ABAAS Section: 1008.3.2.2 2012 TAS Section: 1008.3.2.2 2010 ADAS Section: 1008.3.2.2

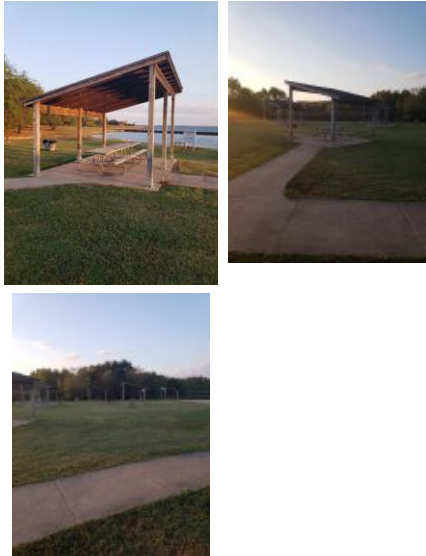
105	Heron Harbor Day Use Area: HH - Picnic Areas	[33.2920265 , -95.6514714]	There is no accessible route to the water spigots, trash bins, and benches. At least one accessible route shall connect accessible buildings, accessible facilities, accessible elements, and accessible spaces that are on the same site.	0 of 10 water spigots on AR, 0 of 3 trash can sets on AR, 0 of 4 beach benches on AR	Create an accessible route with crushed stone or other outdoor material from parking or walkway to beach side amenities.	2015 ABAAS Section: F206.2.2 2012 TAS Section: 206.2.2 2010 ADAS Section: 206.2.2

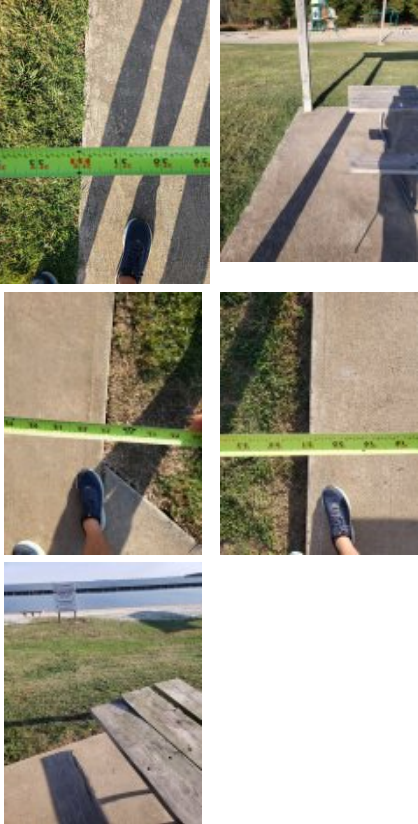
Finding Number	Area Description	Lat/Long	Finding	As Built	Recommendation	Citation	Photos	Figure
109	Heron Harbor Day Use Area: HH - Picnic Areas	[33.2925377 , -95.652261 3]	There is a gap spaced greater than a 1/2 inch. Openings in floor or ground surfaces shall not allow passage of a sphere more than 1/2 inch diameter. Elongated openings shall be placed so that the long dimension is perpendicular to the dominant direction of travel.	water side picnic - 1" gap at entry to picnic area; land side of sidewalk - 1" gap at entry, 1" gap at platform entry	Correct or fill gaps to be max .5".	2015 ABAAS Section: 302.3 2012 TAS Section: 302.3 2010 ADAS Section: 302.3

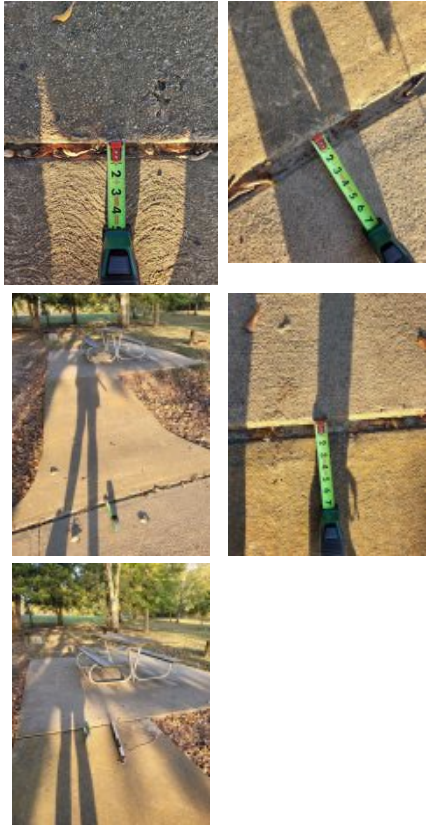
Finding Number	Area Description	Lat/Long	Finding	As Built	Recommendation	Citation	Photos	Figure
110	Heron Harbor Day Use Area: HH - Picnic Areas	[33.2925377, -95.6522613]	The running slope of walking surfaces shall not be steeper than 1:20.	water side picnic - 6.6% running slope; land side of sidewalk - 9.7% running slope	Correct running slope along the AR to max 5%	2015 ABAAS Section: 403.3 2012 TAS Section: 403.3 2010 ADAS Section: 403.3

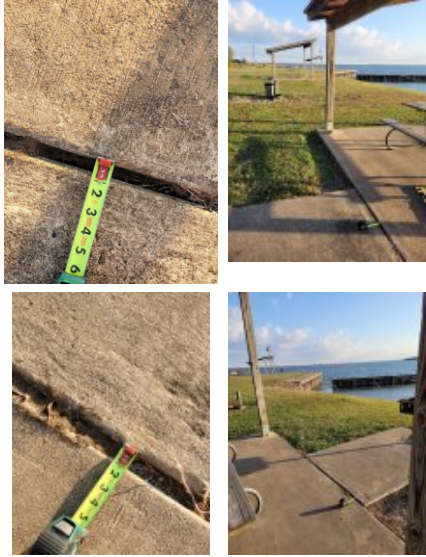
113	Heron Harbor Day Use Area: HH - Swimming	[33.2920691 , -95.651479 4]	The ramp slope exceeds the maximum running slope (direction of travel) allowable of 8.33%. Ramps should have the least possible slope but in no case more than 8.3% (1:12).	Running slopes between 8.4% and 9.5% running for 25'	Correct slope of ramp to max 8.33%	2015 ABAAS Section: 405.2 2012 TAS Section: 405.2 2010 ADAS Section: 405.2

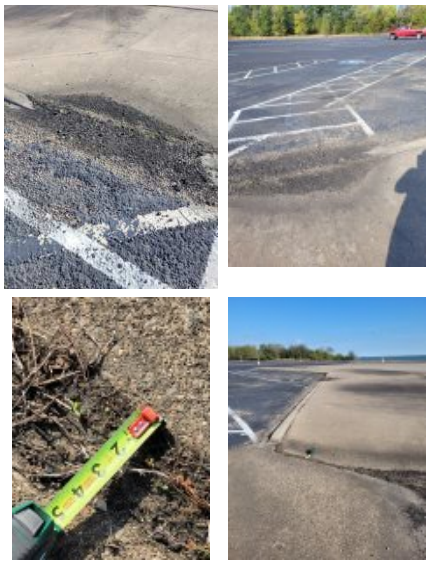
128	Gulls Bluff Day Use Area: GB - Parking	[33.2940936 , -95.652475 8]	The running slope of walking surfaces shall not be steeper than 1:20.	boat ramp lot - 8.7% slope at the pathway connected to accessible right stall	Correct running slope along the AR to max 5%	2015 ABAAS Section: 403.3 2012 TAS Section: 403.3 2010 ADAS Section: 403.3

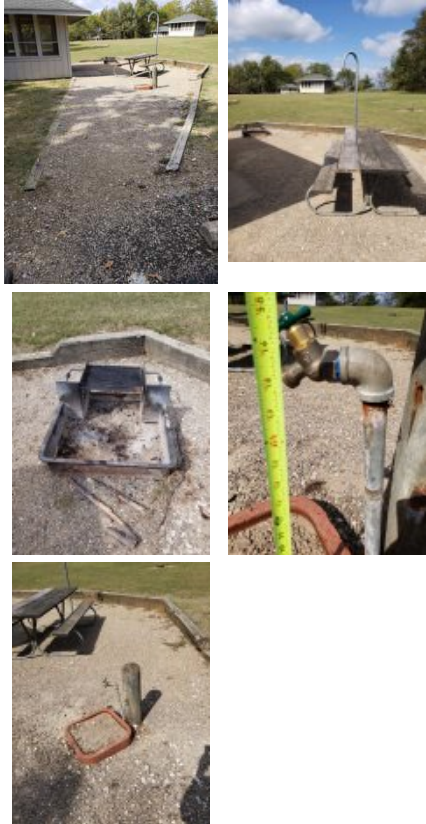
174	Eagle Point Shelters Area: EP - Campsites	[33.2946396 , -95.665561]	Picnic tables shall provide at least one wheelchair space for each 24 linear feet (7320 mm) of usable table surface perimeter. Wheelchair spaces shall be 30 inches (760 mm) minimum by 48 inches (1220 mm) minimum. Wheelchair spaces shall be positioned for a forward approach to the table and provide knee and toe clearance complying with 306 under the table	Shelter 11 - 1 picnic table, not accessible and no accessible route	Replace picnic table with one with knee and toe clearance, 19" deep at 27" high and 24" deep at 9" high, with a 36" AR around the table at shelter.	2015 ABAAS Section: 1011.4.2

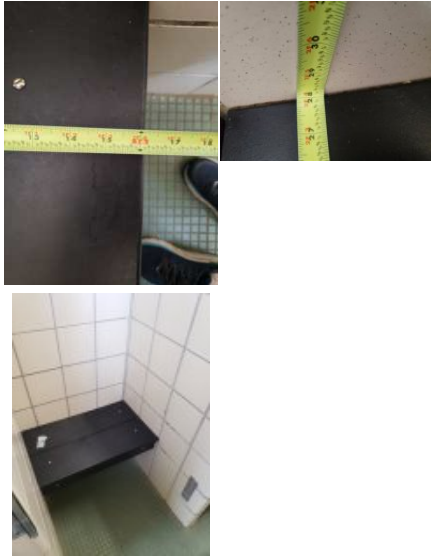
201	Eagle Point Shelters Area: EP - Men's Restroom	[33.2939715 , -95.6653974]	Transfer type shower compartments shall be 36 inches (915 mm) by 36 inches (915 mm) clear inside dimensions measured at the center points of opposing sides and shall have a 36 inch (915 mm) wide minimum entry on the face of the shower compartment. Clearance of 36 inches (915 mm) wide minimum by 48 inches (1220 mm) long minimum measured from the control wall shall be provided.	shower 32" wide	Enlarge transfer shower to compliant 36" by 36" clear inside dimension	2015 ABAAS Section: 608.2.1 2012 TAS Section: 608.2.1 2010 ADAS Section: 608.2.1

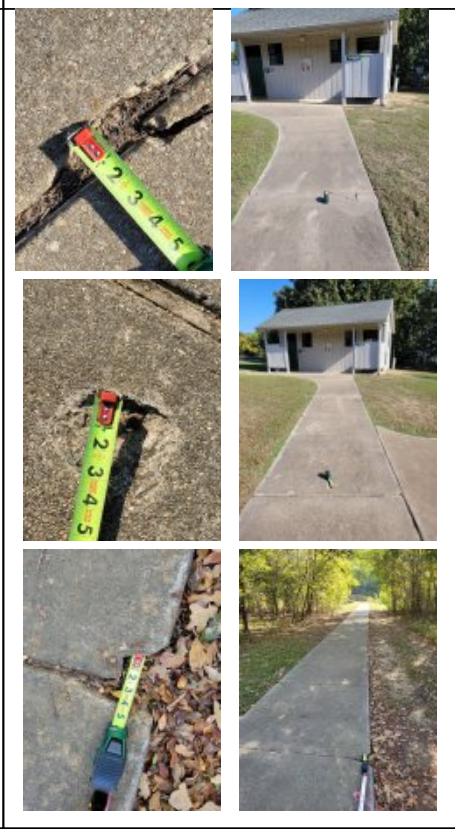
299	Honey Creek Day Use Area: HC - Exterior Accessible Route	[33.2890255, -95.676373]	The accessible route of travel on the accessible route contains cross slopes greater than 2%. Cross slopes shall not exceed one unit vertical in 48 units horizontal (2-percent slope).	4.7% slope on right path to fish clean	Correct or repair cross slope along AR to max 2.08%	2015 ABAAS Section: 403.3 2012 TAS Section: 403.3 2010 ADAS Section: 403.3

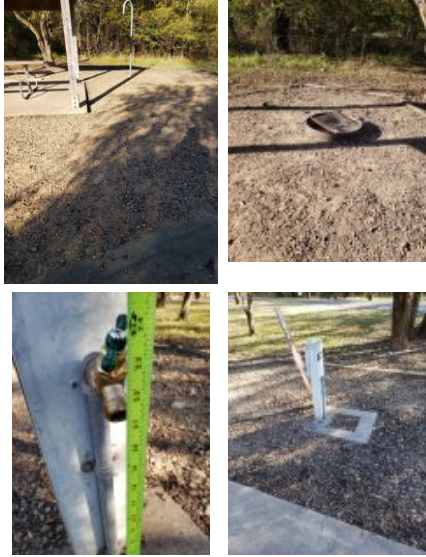
340	Deer Haven Camping Area: DH - Campsites	[33.2888294 , -95.679106 2]	Camping facilities shall provide camping units with mobility features complying with F244.2 in accordance with Table F244.2. Where a camping facility provides different types of camping units, Table F244.2 shall apply to each type of camping unit provided. Total Number of Camping Units Provided in Camping Facility Minimum Number of Camping Units with Mobility Features Required 1 1 2 to 25 2 26 to 50 3 51 to 75 4 76 to 100 5 101 to 150 7 151 to 200 8 201 and over 8, plus 2 percent of the number over 200	Site 51 - non accessible surface (sand/rock), CIL at table area, hook is well out of reach range, fire pit is below grade, water faucet and hookup too low and not accessible (the front desk thought this site was accessible but there are no accessible features)	Create the required number of accessible camp sites per table F244.2 as a smart practice	2015 ABAAS Section: F244.2

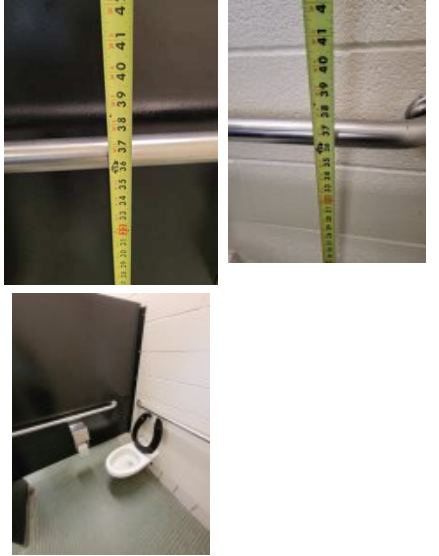
398	Buggy Whip Equestrian Camping Area: BW - Women's Restroom	[33.2874449, -95.6809891]	The flush handle is located on the wrong side of the toilet. Controls shall be operable with one hand and shall not require tight grasping, pinching or twisting. Controls for the flush valves shall be mounted on the wide side of toilet areas, no more than 44 inches above the floor.	flush on wall side	Remount flush mechanism on the open side, in the alternative, install an auto flush unit.	2015 ABAAS Section: 604.6 2012 TAS Section: 604.6 2010 ADAS Section: 604.6

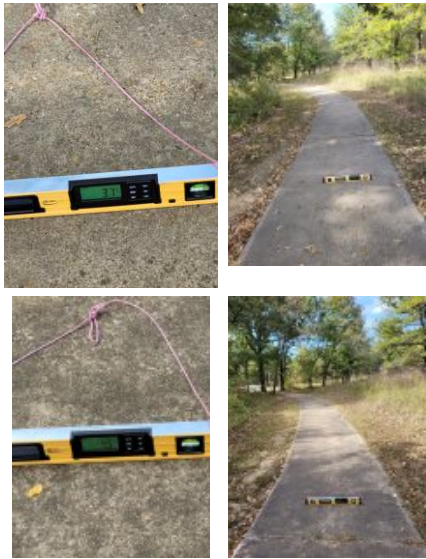
414	Trails: Trail Surface	[33.2889381 , -95.6774459]	Tread obstacles on trails, passing spaces, and resting intervals shall not exceed 1/2 inch (13 mm) in height measured vertically to the highest point. EXCEPTION: Where the surface is other than asphalt, concrete, or boards, tread obstacles shall be permitted to not exceed 2 inches (50 mm) in height measured vertically to the highest point.	.75 CIL at amphitheater entry on Honey Creek Trail	Repair, bevel or ramp tread obstacle along pathway to max .5" or 2" depending on surface type.	2015 ABAAS Section: 1017.5
