# Access Audit Site Report

**Davis Mountains State Park/Complex**

**Accessibility Evaluation**

**Inspection Date: 09/23/2021**

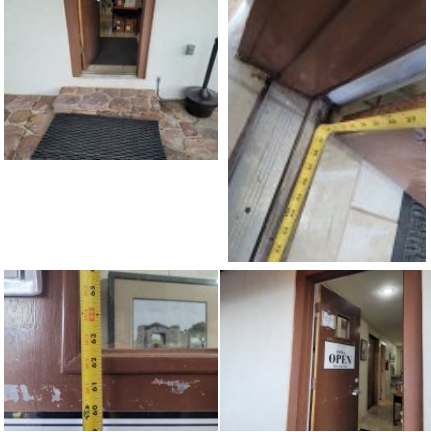
Finding Number	Area Description	Lat/Long	Finding	As Built	Recommendation	Citation	Photos	Figure
11	Davis Mountains Headquarters: DM Headquarters	[30.5991035, -103.9293629]	Minimum maneuvering clearances at doors and gates shall comply with 404.2.4. Maneuvering clearances shall extend the full width of the doorway and the required latch side or hinge side clearance. Floor or ground surface within required maneuvering clearances shall comply with 302. Changes in level are not permitted. EXCEPTIONS: 2. Changes in level at thresholds complying with 404.2.5 shall be permitted. Door openings shall provide a clear width of 32 inches (815 mm) minimum. Clear openings of doorways with swinging doors shall be measured between the face of the door and the stop, with the door open 90 degrees. Openings more than 24 inches (610 mm) deep shall provide a clear opening of 36 inches (915 mm) minimum. There shall be no projections into the required clear opening width lower than 34 inches (865 mm) above the finish floor or ground. Projections into the clear opening width between 34 inches (865 mm) and 80 inches (2030 mm) above the finish floor or ground shall not exceed 4 inches (100 mm). Doors, gates, and side lights adjacent to doors or gates, containing one or more glazing panels that permit viewing through the panels shall have the bottom of at least one glazed panel located 43 inches (1090 mm) maximum above the finish floor. EXCEPTION: Vision lights with the lowest part more than 66 inches (1675 mm) from the finish floor or ground shall not be required to comply with 404.2.11.	Exit side door - steps in push side clearance on push side, 29.5" wide, and vision panel at 62.5" AFF	For all doors along the public circulation route, provide required maneuvering clearance on push and pull side of doors. For all doors along the public circulation route, ramp steps in doorway clearance. For all doors along the public circulation route, replace doors with doors having 80" overhead clearance and 32" clear width. For all doors along the public circulation route, replace doors with ones having sidelight viewing windows max 43" AFF.	2010 ADAS Section: 404.2.3, 404.2.7, 404.2.4, 404.2.11, 404.2.11 Exception

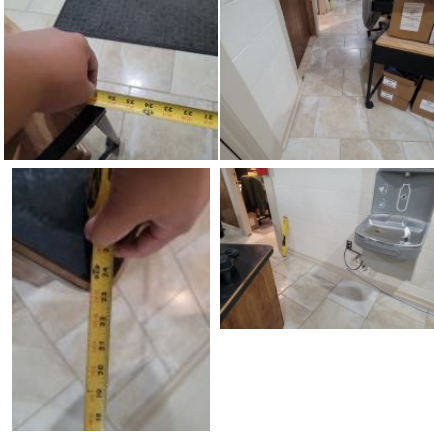
Finding Number	Area Description	Lat/Long	Finding	As Built	Recommendation	Citation	Photos	Figure
12	Davis Mountains Headquarters: DM Headquarters	[30.599101, -103.929418]	Employee Work Areas. Common use circulation paths within employee work areas shall comply with 402. EXCEPTIONS: 1. Common use circulation paths located within employee work areas that are less than 1000 square feet (93 m2) and defined by permanently installed partitions, counters, casework, or furnishings shall not be required to comply with 402. 2. Common use circulation paths located within employee work areas that are an integral component of work area equipment shall not be required to comply with 402. 3. Common use circulation paths located within exterior employee work areas that are fully exposed to the weather shall not be required to comply with 402.	Employee area - route narrows at both ends of desk	Make corrections for compliant circulation path.	2015 ABAAS Section: F206.2.8, F206.2.8.1, F206.2.8.2  2012 TAS Section: 206.2.8, 206.2.8 Exception 1, 206.2.8 Exception 2, 206.2.8 Exception 3, 206.2.8 Advisory 1, 206.2.8 Advisory 2  2010 ADAS Section: 206.2.8, 206.2.8 Exception 1, 206.2.8 Exception 2, 206.2.8 Exception 3

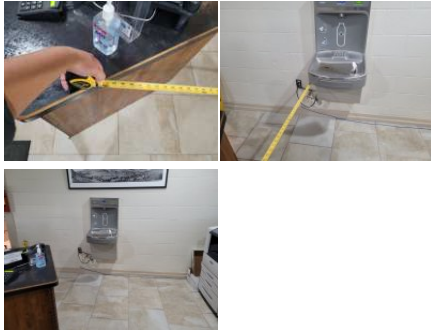
Finding Number	Area Description	Lat/Long	Finding	As Built	Recommendation	Citation	Photos	Figure
14	Davis Mountains Headquarters: DM Headquarters	[30.5990756 , -103.9294 373]	The clear floor space required at accessible drinking fountains is not centered on the low fountain. At "hi-low" type drinking fountains, the 30 inch by 48 inch clear floor space must be centered on the "low" fountain.	desk overlaps clear floor space at drinking fountain	Provide 30" by 48" deep CFS for a forward approach to fountain; centered on unit.	2015 ABAAS Section: 602.2  2012 TAS Section: 602.2  2010 ADAS Section: 602.2

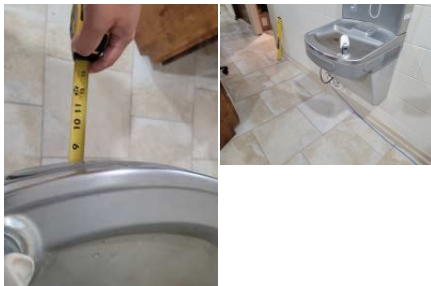
15	Davis Mountains Headquarters: DM Headquarters	[30.5990513 , -103.9294 253]	The drinking fountain projects more than 4 inches into the circulation path. Wall-mounted objects that have leading edges between 27 inches and 80 inches from the floor must not project more than 4 inches into the circulation path. Protruding objects that extend to the floor or within 27 inches of the floor are cane detectable and are therefore not hazardous. Where it is necessary or desirable to have objects protrude from the wall, a manner of cane detection must be provided.	Drinking fountain protrudes 8"	Relocate protruding objects or place cane detectable warning or bollard at foot of fountain.	2015 ABAAS Section: 307.2  2012 TAS Section: 307.2  2010 ADAS Section: 307.2

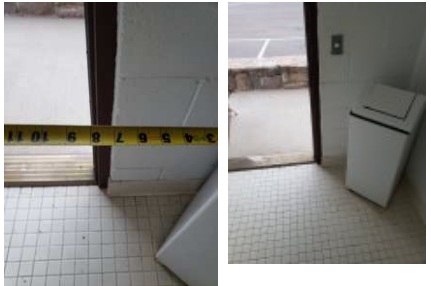
16	Davis Mountains Headquarters: DM HQ Men's Restroom	[30.5990652 , -103.9294 789]	Minimum maneuvering clearances at doors and gates shall comply with 404.2.4. Maneuvering clearances shall extend the full width of the doorway and the required latch side or hinge side clearance. The sweep period for doors with closers shall be adjusted so that from an open position of 70 degrees, the door will take at least 3 seconds to move to a point 3 inches from the latch, measured to the leading edge of the door. Exterior doors are recommended to be maintained at 8.5 lbf as a smart practice. Force is to be measured at the operating hardware or 30 inches from the hinges, whichever is greater.	Men's restroom door - garbage can in clearance on push side , 24# push, fast close	For all doors along the public circulation route, provide required maneuvering clearance on push and pull side of doors For all doors along the public circulation route, inspect, adjust, and maintain closing speed on door closers For all doors along the public circulation route, inspect, adjust, and maintain 8.5 lbf to open exterior doors as a smart practice	2010 ADAS Section: 404.2.3, 404.2.7, 404.2.4, 404.2.11, 404.2.11 Exception

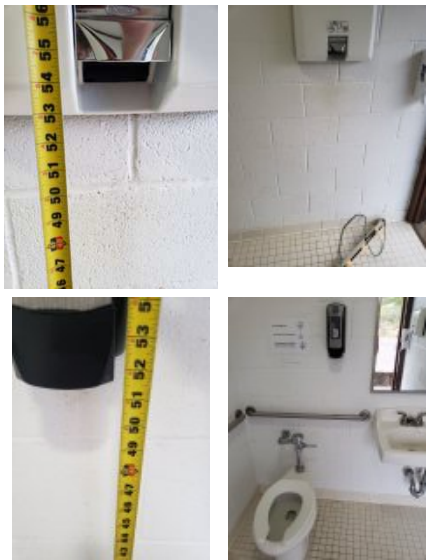
Finding Number	Area Description	Lat/Long	Finding	As Built	Recommendation	Citation	Photos	Figure
19	Davis Mountains Headquarters: DM HQ Men's Restroom	[30.5990709, -103.9294722]	Where a high forward reach is over an obstruction, the clear floor space shall extend beneath the element for a distance not less than the required reach depth over the obstruction. The high forward reach shall be 48 inches (1220 mm) maximum where the reach depth is 20 inches (510 mm) maximum. Where the reach depth exceeds 20 inches (510 mm), the high forward reach shall be 44 inches (1120 mm) maximum and the reach depth shall be 25 inches (635 mm) maximum. Where a clear floor or ground space allows a parallel approach to an element and the high side reach is over an obstruction, the height of the obstruction shall be 34 inches (865 mm) maximum and the depth of the obstruction shall be 24 inches (610 mm) maximum. The high side reach shall be 48 inches (1220 mm) maximum for a reach depth of 10 inches (255 mm) maximum. Where the reach depth exceeds 10 inches (255 mm), the high side reach shall be 46 inches (1170 mm) maximum for a reach depth of 24 inches (610 mm) maximum.	Hand dryer 54.5" AFF and soap dispenser 51.5" AFF over toilet	Lower operating mechanisms to max 48" above the finished floor (AFF) to highest operable part. Lower soap dispenser to max 44" above the finished floor (AFF) for a forward reach over counter.	2015 ABAAS Section: 308.2.1, 308.3.2  2012 TAS Section: 308.2.1, 308.3.2  2010 ADAS Section: 308.2.1, 308.3.2

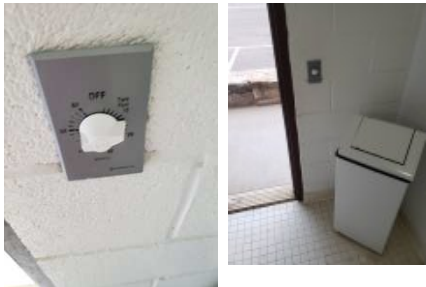
20	Davis Mountains Headquarters: DM HQ Men's Restroom	[30.5990686, -103.9294776]	The operable part is not accessible because it requires tight grasping, pinching or twisting of the wrist.	Light switch knob requires tight grasping, pinching, or twisting of the wrist	Replace operable part with one usable without a tight pinch or grasp	2015 ABAAS Section: 309.4  2012 TAS Section: 309.4  2010 ADAS Section: 309.4

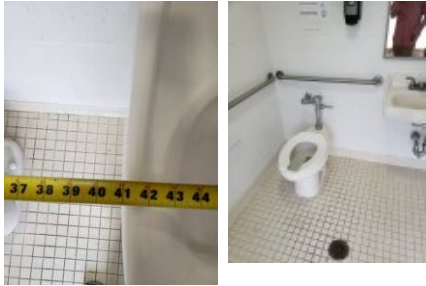
Finding Number	Area Description	Lat/Long	Finding	As Built	Recommendation	Citation	Photos	Figure
21	Davis Mountains Headquarters: DM HQ Men's Restroom	[30.5990629, -103.9294789]	The required 56 inches by 60 inches clear floor space for the water closet has been obstructed. The clear floor space around the water closet shall be 60 inches minimum measured perpendicular from the side wall and 56 inches minimum measured perpendicular from the rear wall.	Lacks 60" clear floor space around toilet - 41" to sink	Relocate sink to provide required 60" clearance around toilet. In the alternative, leave as is citing safe harbor.	2015 ABAAS Section: 604.3. 2012 TAS Section: 604.3.1 2010 ADAS Section: 604.3.1

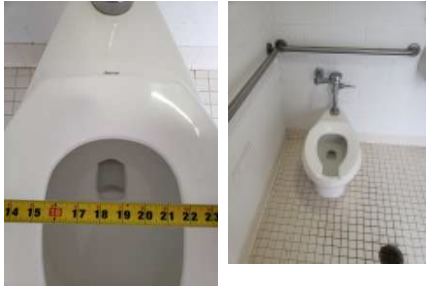
22	Davis Mountains Headquarters: DM HQ Men's Restroom	[30.5990663, -103.9294802]	The toilet is not located within the range allowed from the side wall or partition. The centerline of the toilet must be 16 to 18 inches from the side wall.	Centerline of the toilet is 18.5" from the side wall	Remount toilets to 16" to 18" from the side wall to centerline	2015 ABAAS Section: 604.2 2012 TAS Section: 604.2 2010 ADAS Section: 604.2

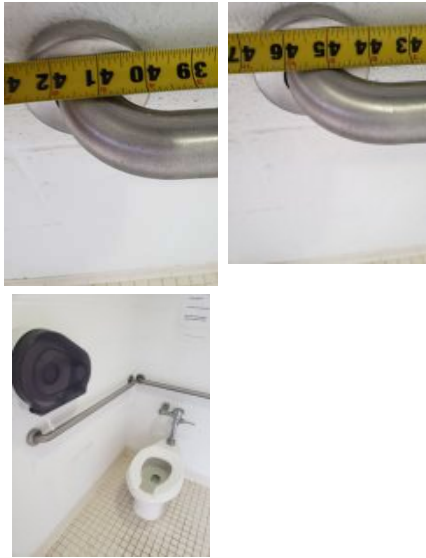
23	Davis Mountains Headquarters: DM HQ Men's Restroom	[30.5990686, -103.9294856]	The side grab bars are not in the correct location. Grab bars on the side wall must be installed so that the end closest to the rear wall is maximum 12" from the rear wall. The end furthest from the rear wall must be mounted minimum 54" from the rear wall.	Side grab bar 41" long and ends 45.25" from rear wall	Replace side grab bar with a 42" long bar mounted to max 12" from the rear wall at the close end and min 54" on the far end, and 33" to 36" aff.	2015 ABAAS Section: 604.5.1 2012 TAS Section: 604.5.1 2010 ADAS Section: 604.5.1

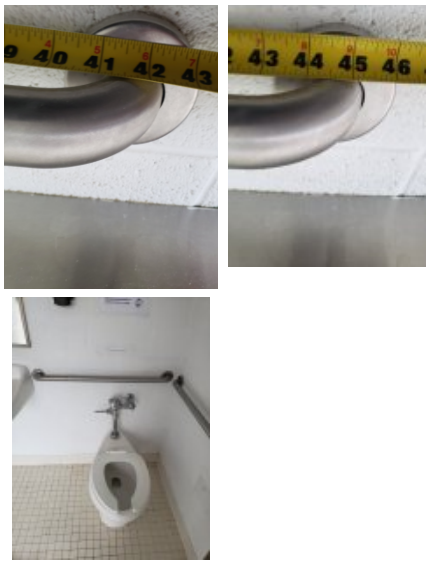
32	Davis Mountains Headquarters: DM HQ Women's Restroom	[30.5990617, -103.929489]	The side grab bars are not in the correct location. Grab bars on the side wall must be installed so that the end closest to the rear wall is maximum 12" from the rear wall. The end furthest from the rear wall must be mounted minimum 54" from the rear wall.	Side grab bar 41.5" long and ends 44.5" from rear wall	Replace side grab bar with one that is 42" long and mount to max 12" from the rear wall at the close end and min 54" on the far end, and 33" to 36" AFF.	2015 ABAAS Section: 604.5.1 2012 TAS Section: 604.5.1 2010 ADAS Section: 604.5.1

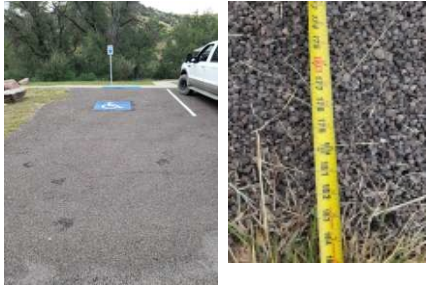
58	Davis Mountains Wildlife Viewing: DM Wildlife Viewing Picnic Area	[30.5951876 , -103.93606 1]	There are no van accessible parking stalls. 1 in every 6, minimum of one, required accessible stalls must be a van accessible stall. There are a total of 6 parking stalls in the parking lot that could be reasonably associated with this facility. There should be a minimum of 1 accessible stalls with a minimum of 1 being designed as van accessible.	Lacks access aisle and width requirements (stall is 15' wide) for a van accessible parking space	Add van parking sign to 1 accessible stall and repaint stall and access aisle to 11' and 5' or 8' and 8' per the table. See previous finding for cost.	2015 ABAAS Section: F208.2, F208.2.4  2012 TAS Section: 208.2, 208.2.4  2010 ADAS Section: 208.2, 208.2.4

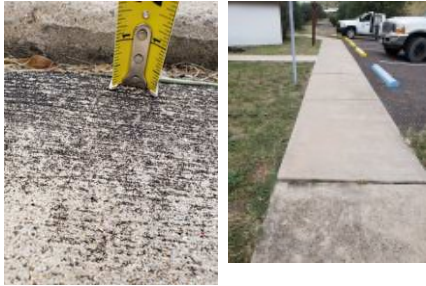
61	Davis Mountains Wildlife Viewing: DM Wildlife Viewing Picnic Area	[30.5951657, -103.9359806]	The accessible route has running slopes greater than 5% and has not been constructed as a ramp (i.e. handrails, edge protection, etc.). Cross slopes are greater than 2% across the width of the walk. When the slope in the direction of travel of any walk exceeds 1 unit vertical in 20 units horizontal (5-percent slope), it must be constructed as a ramp. Surface cross slopes must not exceed 1 unit vertical in 48 units horizontal (2-percent slope).	Cross slope of 2.2% and running slope 5.9%	Correct or repair sidewalk cross slope along AR to max 2.08%. Correct or repair sidewalk running slope along AR to max 5%.	2015 ABAAS Section: 403.3  2012 TAS Section: 403.3  2010 ADAS Section: 403.3

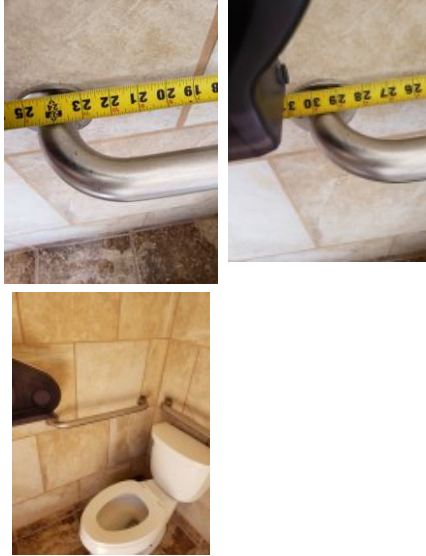
Finding Number	Area Description	Lat/Long	Finding	As Built	Recommendation	Citation	Photos	Figure
128	Davis Mountains Campsites 46-61: DM Campsites 46-61 Women's Restroom	[30.5977274, -103.9282527]	The rear grab bar is not 36" long or is not mounted in the correct location. The rear grab bar must be a minimum of 36" long and extend from the toilet centerline a minimum 12" towards the wall side and a minimum 24" towards the open side of the toilet. Grab bars shall be installed in a horizontal position, 33 inches minimum and 36 inches maximum above the finish floor measured to the top of the gripping surface and the space between the grab bar and the top of the tank shall be 1-1/2 inches minimum.	24" bar, lacks 24" to open side	Replace rear grab bar with one 36" long, mounted behind the toilet, 12" to the wall side of center and 24" to the open side and 33" to 36" AFF.	2015 ABAAS Section: 604.5.2 2012 TAS Section: 604.5.2 2010 ADAS Section: 604.5.2

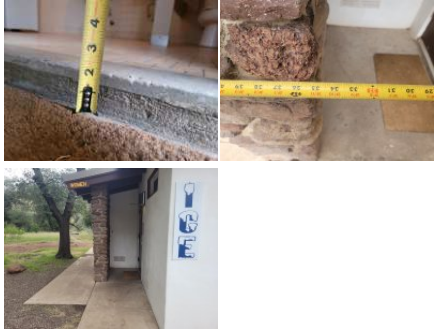
Finding Number	Area Description	Lat/Long	Finding	As Built	Recommendation	Citation	Photos	Figure
197	Davis Mountains Campsites 62-94: DM Campsites 62-94 Women's Restroom	[30.5937919, -103.9390866]	The restroom sign does not comply with one or more applicable requirements for the location, height, and properties of the sign.	Lacks Braille lettering and raised characters on restroom signage	Acquire and mount signage, including Braille and access symbol mounted on wall, latch side of door, 48" to baseline of lowest character and 60" to baseline of highest character	2015 ABAAS Section: F216.2, 703.1, 703.2, 703.5, 703.6  2012 TAS Section: 216.2, 703.1, 703.2, 703.5, 703.6  2010 ADAS Section: 216.2, 703.1, 703.2, 703.5, 703.6

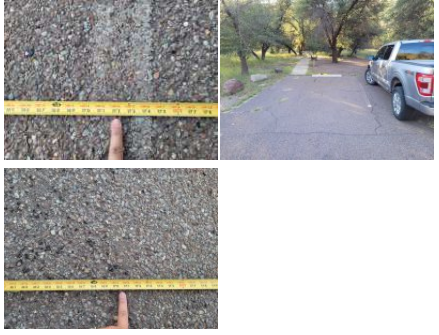
204	Davis Mountains Campsites 62-94: DM Campsite 63	[30.5935657, -103.9395788]	The surface of parking spaces and pull-up spaces shall be firm and stable. The slope of the surface of parking spaces and pull-up spaces shall not be steeper than 1:48 in any direction. EXCEPTION: Where the surface is other than asphalt, concrete, or boards, slopes not steeper than 1:20 shall be permitted when necessary for drainage.	Slopes of 3.7% in left stall and 2.5% in right stall	Correct surface of parking spaces to be firm and stable with slopes max of 2.08% as a smart practice.	2015 ABAAS Section: 1012.4, 1012.5, 1012.5 EXCEPTION

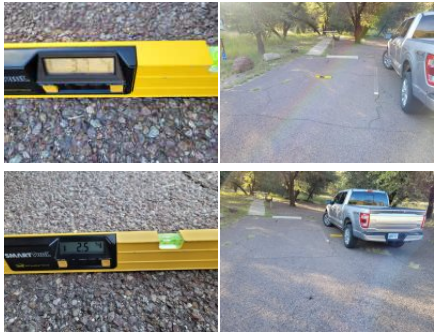
205	Davis Mountains Campsites 62-94: DM Campsite 64	[30.5933659, -103.9397169]	The cross slope shall not be steeper than 1:48. EXCEPTION: Where the surface is other than concrete, asphalt, or boards, cross slopes not steeper than 1:20 shall be permitted when necessary for drainage.	Cross slope of 3.2%	Correct or repair ORAR cross slope to max 2.08% or 5% for surfaces other than concrete, asphalt or board as a smart practice.	2015 ABAAS Section: 1016.7.2, 1016.7.2 EXCEPTION

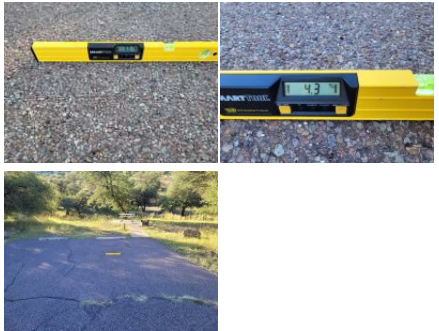
Finding Number	Area Description	Lat/Long	Finding	As Built	Recommendation	Citation	Photos	Figure
211	Davis Mountains Skyline Drive: DM Skyline Overlook 1	[30.5956482, -103.9230564]	There is no accessible route to the informational sign and bench. At least one accessible route shall connect accessible buildings, accessible facilities, accessible elements, and accessible spaces that are on the same site.	Lacks accessible route (gravel and rock path) to informational sign and bench	Create an accessible route with crushed stone or other outdoor material from parking or walkway to the informational sign and bench.	2015 ABAAS Section: F206.2.2 2012 TAS Section: 206.2.2 2010 ADAS Section: 206.2.2

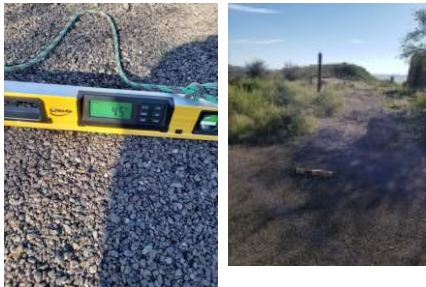
218	Davis Mountains Skyline Drive: DM Skyline Overlook 3	[30.5993688, -103.9063556]	Picnic tables shall provide at least one wheelchair space for each 24 linear feet (7320 mm) of usable table surface perimeter. Wheelchair spaces shall be 30 inches (760 mm) minimum by 48 inches (1220 mm) minimum. Wheelchair spaces shall be positioned for a forward approach to the table and provide knee and toe clearance complying with 306 under the table	0 out of 3 picnic areas accessible	Replace picnic table with one of an accessible design as a smart practice and connect an accessible route to the picnic area	2015 ABAAS Section: 1011.4.2
