# Access Audit Site Report

**Eisenhower State Park**  
**50 Park Rd 20**  
**Denison, TX 75020**  
**Accessibility Evaluation**  
**Inspection Date: 10/13/2021**  
**Inspectors: Tanya Scheibe**

**TEXAS PARKS AND WILDLIFE DEPARTMENT  
EISENHOWER STATE PARK**

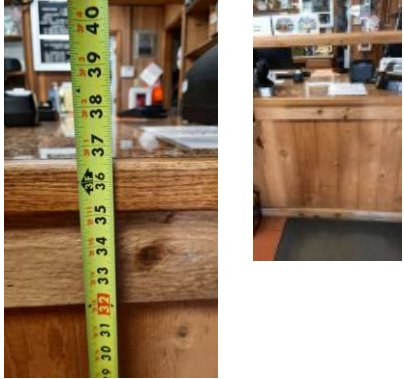
Finding Number	Area Description	Lat/Long	Finding	As Built	Recommendation	Citation	Photos	Figure
8	Headquarters: HQ Building	[33.8103569 , -96.599973 5]	Spaces and elements within employee work areas shall only be required to comply with 206.2.8, 207.1, and 215.3 and shall be designed and constructed so that individuals with disabilities can approach, enter, and exit the employee work area. Employee work areas, or portions of employee work areas, other than raised courtroom stations, that are less than 300 square feet (28 m2) and elevated 7 inches (180 mm) or more above the finish floor or ground where the elevation is essential to the function of the space shall not be required to comply with these requirements or to be on an accessible route.	Employee area entry - knob, 29" wide, wall on pull, offices have knobs (3), 1 has furniture in door clearance	For employee spaces, relocate storage, furniture, and other obstacles at doorways to provide approach, enter and exit at the employee space. Provide required maneuvering clearance on push and pull side of doors. Replace doors with doors having 80" overhead clearance and 32" clear width. Replace hardware with lever hardware or hardware operable without a tight pinch or grasp.	2015 ABAAS Section: F203.9  2012 TAS Section: 203.9  2010 ADAS Section: 203.9

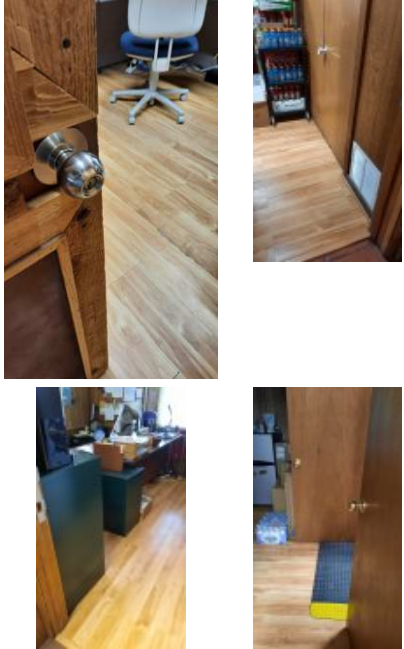
Finding Number	Area Description	Lat/Long	Finding	As Built	Recommendation	Citation	Photos	Figure
9	Headquarters: HQ Building	[33.810335, -96.600000 3]	Employee Work Areas. Common use circulation paths within employee work areas shall comply with 402. EXCEPTIONS: 1. Common use circulation paths located within employee work areas that are less than 1000 square feet (93 m2) and defined by permanently installed partitions, counters, casework, or furnishings shall not be required to comply with 402. 2. Common use circulation paths located within employee work areas that are an integral component of work area equipment shall not be required to comply with 402. 3. Common use circulation paths located within exterior employee work areas that are fully exposed to the weather shall not be required to comply with 402.	Main blg - route reduces to 35", door to behind counter has knob, cabinet on pull	Make corrections for compliant circulation path.	2015 ABAAS Section: F206.2.8, F206.2.8.1, F206.2.8.2  2012 TAS Section: 206.2.8, 206.2.8 Exception 1, 206.2.8 Exception 2, 206.2.8 Exception 3, 206.2.8 Advisory 1, 206.2.8 Advisory 2  2010 ADAS Section: 206.2.8, 206.2.8 Exception 1, 206.2.8 Exception 2, 206.2.8 Exception 3

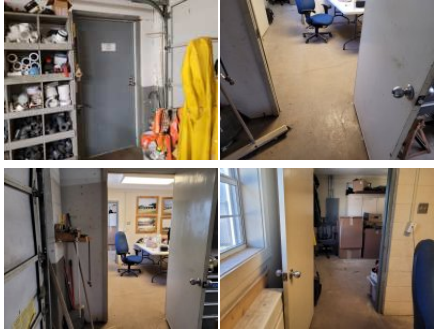
29	Employee Spaces: Maintenance	[33.8113815 , -96.602005 6]	Minimum maneuvering clearances at doors and gates shall comply with 404.2.4. Maneuvering clearances shall extend the full width of the doorway and the required latch side or hinge side clearance. The threshold has a vertical change greater than 1/4 inch high. The threshold at a doorway shall be no higher than 1/2 inch. Changes in level between 1/4 inch and 1/2 inch must be beveled at 1:2 or less. 1/4 inch is the maximum vertical rise. Hand-activated door opening hardware, handles, pulls, latches, locks, and other operating devices on accessible doors shall have a shape that is easy to grasp with one hand and does not require tight grasping, tight pinching or twisting of the wrist to operate. Hardware shall be 34 inches minimum and 48 inches maximum above the finish floor or ground.	Break room entry - 6.1% slope, 1.5" threshold, knob	For employee entry door, provide 2.08% max. slope in maneuvering clearance on push and pull side of doors For all doors along the public circulation route, repair, bevel, or ramp CILs at door entries to max .25" For all doors along the public circulation route, repair, provide beveled threshold For all doors along the public circulation route, replace hardware with lever hardware or hardware operable without a tight pinch or grasp.	2010 ADAS Section: 404.2.3, 404.2.7, 404.2.4, 404.2.11, 404.2.11 Exception

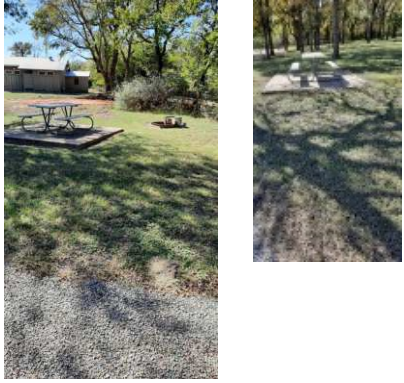
48	Bois D'Arc Ridge Camping Area: BDR - Campsites	[33.8170501 , -96.606229 7]	Picnic tables shall provide at least one wheelchair space for each 24 linear feet (7320 mm) of usable table surface perimeter. Wheelchair spaces shall be 30 inches (760 mm) minimum by 48 inches (1220 mm) minimum. Wheelchair spaces shall be positioned for a forward approach to the table and provide knee and toe clearance complying with 306 under the table	Sites 83, 107, 106, 103, 99 - lacks accessible table	Replace picnic table with one of an accessible design as a smart practice	2015 ABAAS Section: 1011.4.2

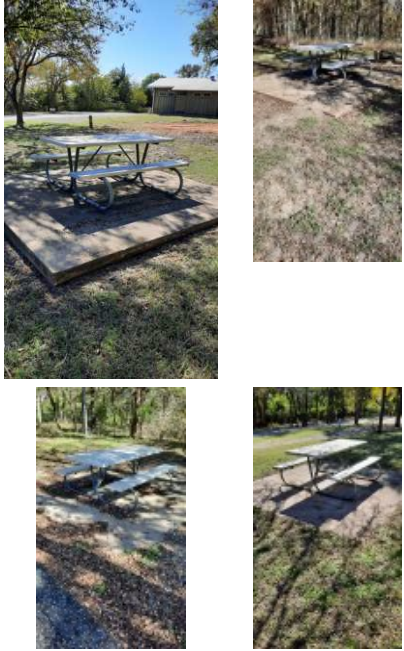
Finding Number	Area Description	Lat/Long	Finding	As Built	Recommendation	Citation	Photos	Figure
49	Bois D'Arc Ridge Camping Area: BDR - Campsites	[33.817017, -96.6062337]	Clear ground space 48 inches (1220 mm) by 48 inches (1220 mm) should be provided on all usable sides of the fire ring, grill, fireplace, and woodstove. Center the space on each usable side of the grill, fireplace, and woodstove.	Lacks accessible clear ground space at sites 107, 106, 103, 99 - grass, dirt surface	Provide required 48" clear ground space centered along usable side of fire ring, grill, fireplace, or woodstove as a smart practice.	2015 ABAAS Section: 1011.2

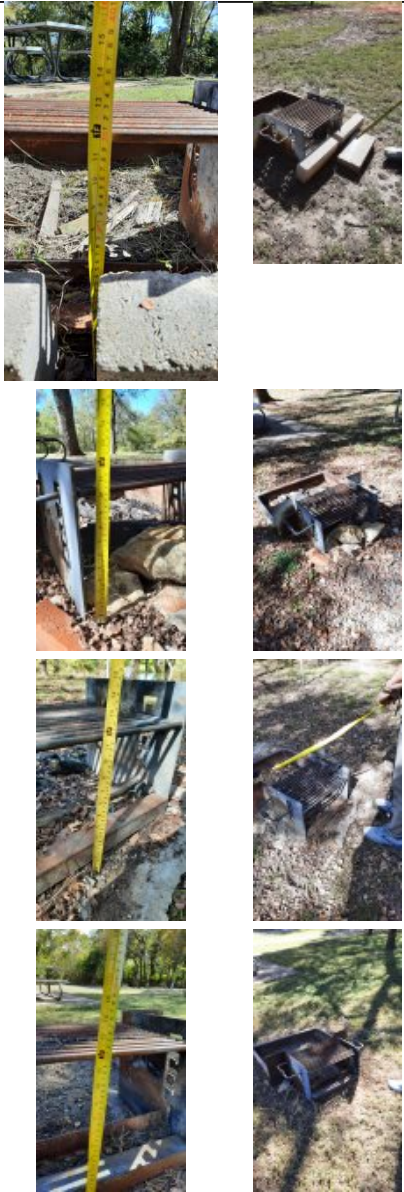
<p>52</p>	<p>Bois D'Arc Ridge Camping Area: BDR - Campsites</p>	<p>[33.817011, -96.606228 4]</p>	<p>A minimum of one of each type of outdoor constructed feature does not have mobility features. Where provided, at least one of each type of outdoor constructed features with mobility features must be provided.</p>	<p>Sites: 107 - hook at 89", 103 - hook at 85", 99 - hook at 80", 83 hook at 87"</p>	<p>Lower lantern hook at each accessible site to max 48" above the ground.</p>	<p>2015 ABAAS Section: F244.2.3.1, F245.2.5.1</p>

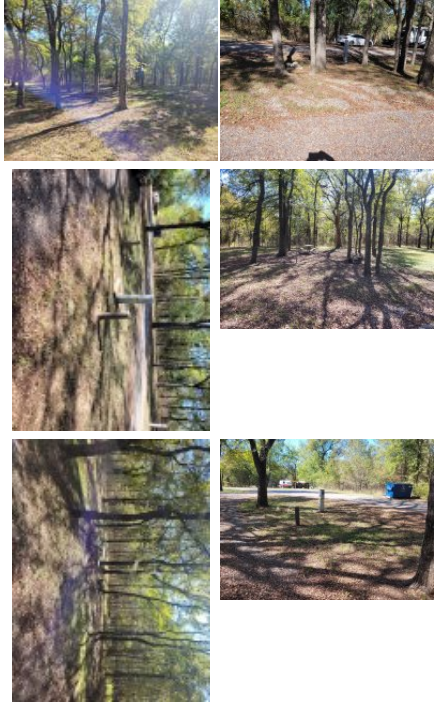
76	Bois D'Arc Ridge Camping Area: BDR - Campsites	[33.8165466 , -96.608751]	Picnic tables shall provide at least one wheelchair space for each 24 linear feet (7320 mm) of usable table surface perimeter. Wheelchair spaces shall be 30 inches (760 mm) minimum by 48 inches (1220 mm) minimum. Wheelchair spaces shall be positioned for a forward approach to the table and provide knee and toe clearance complying with 306 under the table	Sites 58, 60, 62, 64, 66 - All 5 sites tables lack wheelchair space	Replace picnic table with one of an accessible design as a smart practice	2015 ABAAS Section: 1011.4.2

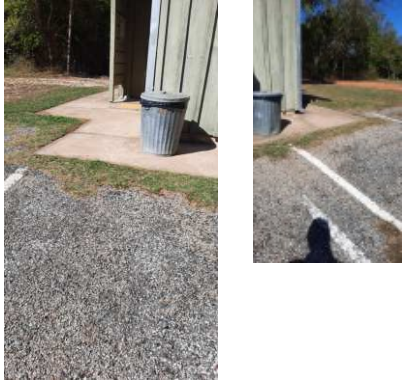
90	Bois D'Arc Ridge Camping Area: BDR - Restroom Parking and Exterior Accessible Route	[33.8167262 , -96.606577 1]	There is no accessible route to the vending machine. At least one accessible route shall connect accessible buildings, accessible facilities, accessible elements, and accessible spaces that are on the same site.	Route to vending blocked, machine lacks clear floor space	Create an clear floor space with crushed stone or other outdoor material from AR to vending machine	2015 ABAAS Section: F206.2.2  2012 TAS Section: 206.2.2  2010 ADAS Section: 206.2.2

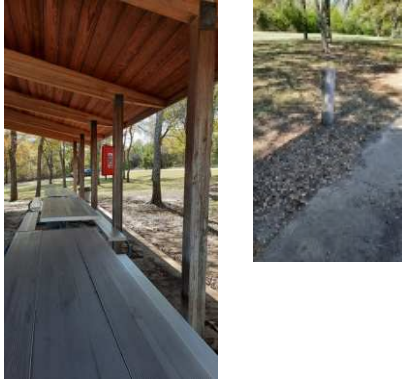
112	Cedar Hollow Group Trailer Area: CH - Group Picnic	[33.8195345 , -96.613832 4]	Objects project more than 4 inches into the circulation path. Wall-mounted objects that have leading edges between 27 inches and 80 inches from the floor must not project more than 4 inches into the circulation path. Protruding objects that extend to the floor or within 27 inches of the floor are cane detectable and are therefore not hazardous. Where it is necessary or desirable to have objects protrude from the wall, a manner of cane detection must be provided.	Fire extinguisher would protrude when tables moved	Relocate object to not protrude into the circulation path.	2015 ABAAS Section: 307.2  2012 TAS Section: 307.2  2010 ADAS Section: 307.2

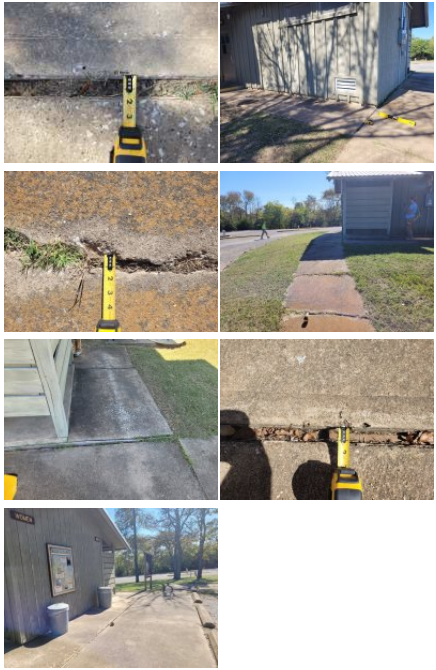
Finding Number	Area Description	Lat/Long	Finding	As Built	Recommendation	Citation	Photos	Figure
123	Cedar Hollow Group Trailer Area: CH - Restroom Parking and Exterior Accessible Route	[33.8197179 , -96.6135256], [33.8196218 , -96.6136048]	The walkway contains abrupt vertical edges and/or variations over a 1/4 inch. 1/4 inch is the maximum vertical rise. Changes in level between 1/4 inch and 1/2 inch must be beveled at 1:2 or less. Changes in level greater than 1/2 inch must be by way of a ramp.	Two .75" Change's in Level (CIL) and one 1" CIL	Repair, bevel or ramp CIL along AR	2012 TAS Section: 303.2, 303.3  2010 ADAS Section: 303.2, 303.3		
124	Cedar Hollow Group Trailer Area: CH - Men's Restroom	[33.8196393 , -96.6135508]	This restroom is not accessible. Where existing toilet rooms or bathing rooms do not comply, directional signs indicating the location of the nearest accessible toilet room or bathing room within the facility shall be provided. Signs shall include the International Symbol of Accessibility. Where existing toilet rooms or bathing rooms do comply), the accessible toilet rooms or bathing rooms shall be identified by the International Symbol of Where clustered single user toilet rooms or bathing facilities are permitted, accessible toilet rooms or bathing facilities shall be identified by the International Symbol of Accessibility unless all toilet rooms and bathing facilities are accessible.	Restroom not accessible - lacks directional signage	Restroom not accessible, acquire and mount signage directing patrons to accessible restroom	2015 ABAAS Section: F216.8  2012 TAS Section: 216.8  2010 ADAS Section: 216.8

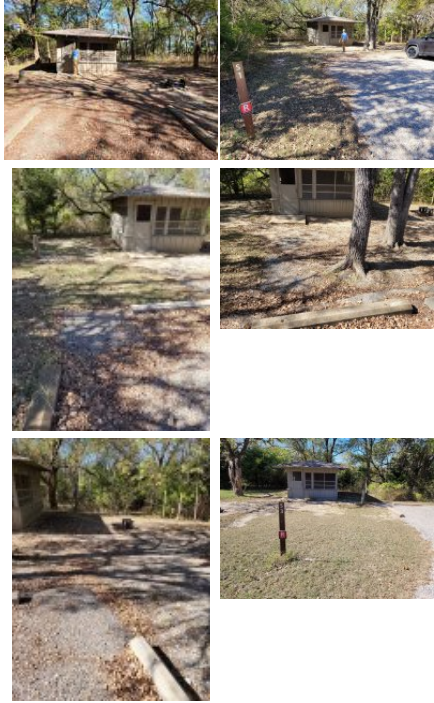
139	Deer Haven Camping Area: DH - Shelter Campsites - 1, 3 & 19	[33.8229698 , -96.612291 5]	The surface of outdoor recreation access routes, passing spaces, and resting intervals shall be firm and stable	Surface has loose gravel & dirt	Repair surface or ORAR to be firm and stable as a smart practice.	2015 ABAAS Section: 1016.2

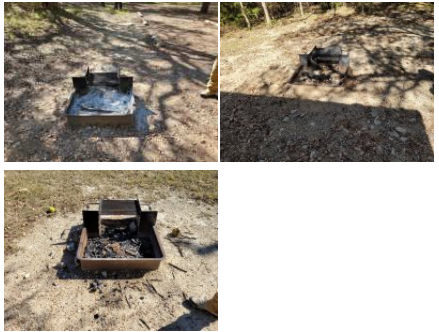
142	Deer Haven Camping Area: DH - Shelter Campsites - 1, 3 & 19	[33.8229765, -96.6122929]	Fire building surfaces shall be 9 inches (230 mm) minimum above the ground.	Fire building surface too low	Correct fire building surface to be 9" min above the ground as a smart practice. In the alternative, replace fire ring with a compliant accessible fire ring.	2015 ABAAS Section: 1011.5.1

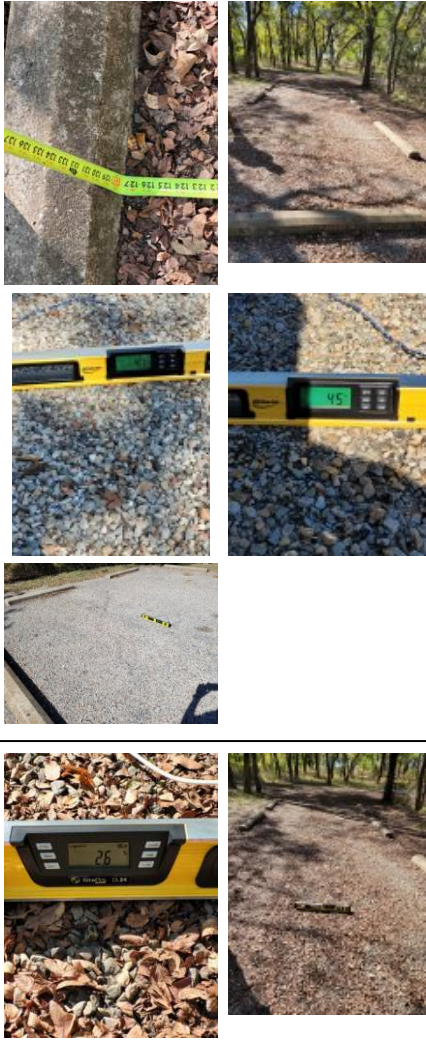
146	Deer Haven Camping Area: DH - Shelter Campsites - 1, 3 & 19	[33.822991, -96.6122003]	The surface of parking spaces and pull-up spaces shall be firm and stable. The slope of the surface of parking spaces and pull-up spaces shall not be steeper than 1:48 in any direction. EXCEPTION: Where the surface is other than asphalt, concrete, or boards, slopes not steeper than 1:20 shall be permitted when necessary for drainage.	Loose gravel surface	Maintain surface at parking to be firm and stable.	2015 ABAAS Section: 1012.4, 1012.5, 1012.5 EXCEPTION

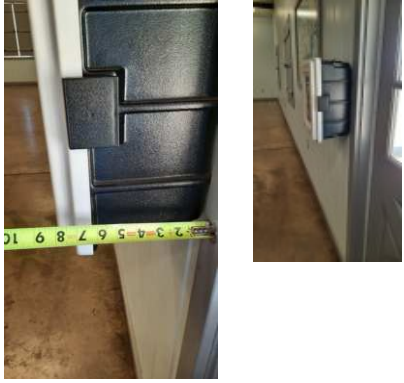
Finding Number	Area Description	Lat/Long	Finding	As Built	Recommendation	Citation	Photos	Figure
178	Deer Haven Camping Area: DH - Group Building	[33.8223508, -96.6106862]	The latch and switch are positioned too high for either a side or front approach. Where a clear floor or ground space allows a parallel approach to an element and the side reach is unobstructed, the high side reach shall be 48 inches maximum and the low side reach shall be 15 inches minimum above the finish floor or ground. Where a forward reach is unobstructed, the high forward reach shall be 48 inches maximum and the low forward reach shall be 15 inches minimum above the finish floor or ground.	Main room - Shutter latches at 57.5", switches at 54.75" in on position	Remount operable parts to be in reach range of 15" min to 48" max.	2015 ABAAS Section: 308.1 2012 TAS Section: 308.1 2010 ADAS Section: 308.1

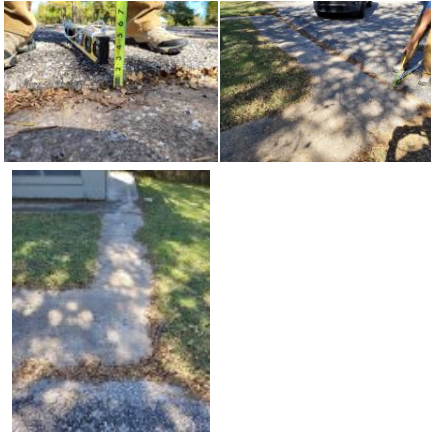
202	Deer Haven Camping Area: DH - Trailhead	[33.821928, -96.6129259]	The surface of trails, passing spaces, and resting intervals shall be firm and stable	Ike's Bike and Hike trail - not accessible surfacing	Leave as is and make other trails in the system accessible.	2015 ABAAS Section: 1017.2

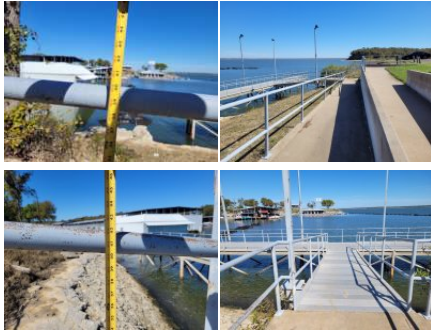
211	Deer Haven Camping Area: DH - Mid-Cove Road or Lighted Fishing Pier Day Use Area	[33.8192185 , -96.6046821]	The handrail is not continuous the entire length of the ramp. The handrail must be continuous. Handrails shall be placed on each side of each ramp, shall be continuous the full length of the ramp. The inside handrail on switch back or dogleg ramps shall always be continuous.	Lighted fishing pier - Handrails break frequently	Replace handrail with one that is continuous along the full length of the ramp.	2015 ABAAS Section: 505.3, 505.10.1 2012 TAS Section: 505.3, 505.10.1 2010 ADAS Section: 505.3, 505.10.1

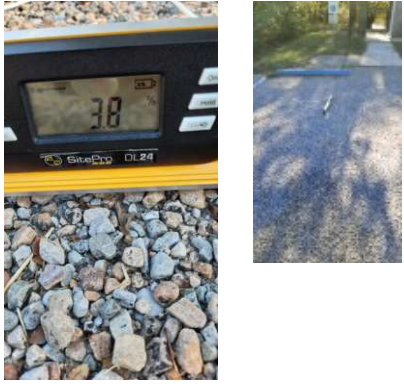
222	Fossil Ridge Camping Area: FR - Parking and Exterior Accessible Route	[33.8248934 , -96.616730 6]	The parking stall contains abrupt edges and surface irregularities over a 1/4 inch vertical. Parking spaces and access aisles serving them shall be stable, firm, and slip resistant. Access aisles shall be at the same level as the parking spaces they serve. Changes in level are not permitted and shall not be sloped steeper than 2% in any direction.	Loose gravel on surface	Resurface accessible stalls and access aisles with a firm, stable, and slip resistant material. Cost included in previous finding.	2015 ABAAS Section: 502.4 2012 TAS Section: 502.4 2010 ADAS Section: 502.4

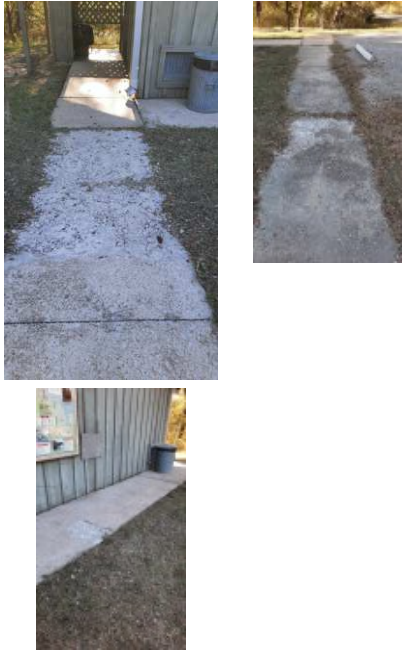
Finding Number	Area Description	Lat/Long	Finding	As Built	Recommendation	Citation	Photos	Figure
225	Fossil Ridge Camping Area: FR - Parking and Exterior Accessible Route	[33.8248032, -96.6167319]	There is a gap spaced greater than a 1/2 inch. Openings in floor or ground surfaces shall not allow passage of a sphere more than 1/2 inch diameter. Elongated openings shall be placed so that the long dimension is perpendicular to the dominant direction of travel.	1.5" gap to women's, 1" near door	Correct or fill gaps to be max .5"	2015 ABAAS Section: 302.3 2012 TAS Section: 302.3 2010 ADAS Section: 302.3		
226	Fossil Ridge Camping Area: FR - Campsites	[33.825127, -96.6168365]	An accessible access route is not provided between elements, spaces and the facilities provided within the accessible camping unit. At least one outdoor recreation access route shall connect accessible elements, spaces and facilities provided within camping units with mobility features.	Site 144 - no route to elements	Create AR with crushed and compacted stone or similar outdoor material to camp sites and one of each type of amenity.	2015 ABAAS Section: F244.5.1

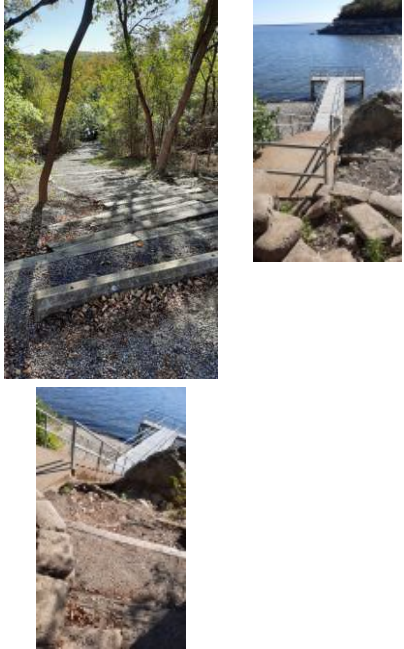
239	Fossil Ridge Camping Area: FR - Fishing	[33.8254516 , -96.614989 8]	The required handrails are not dispersed. Railings, guards, or handrails required to comply shall be dispersed throughout the fishing pier or platform.	Pier lacks lowered railing	Disperse lowered portions of railing throughout pier. In the alternative, leave as is and designate other fishing piers as accessible.	2015 ABAAS Section: 1005.2.1.1  2010 ADAS Section: 1005.2.1.1

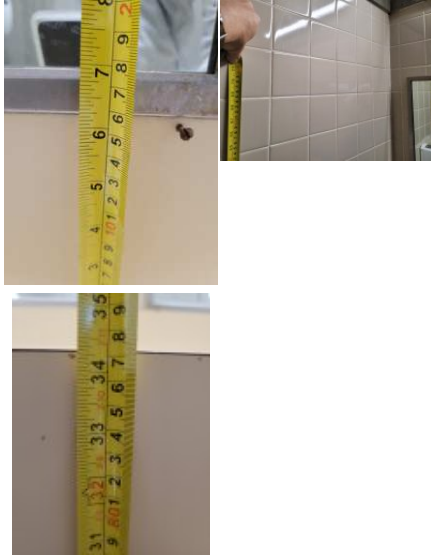
Finding Number	Area Description	Lat/Long	Finding	As Built	Recommendation	Citation	Photos	Figure
242	Fossil Ridge Camping Area: FR - Men's Restroom	[33.8248651, -96.616689]	The top rim of the sink is too high. All lavatories/sinks that are designated to be accessible shall be a minimum 17 inches in horizontal depth and mounted with the rim or counter edge no higher than 34 inches above the finished floor.	34.25"AFF	Lower sinks to max 34" aff to front of rim. In the alternative, leave as is citing construction tolerance.	2015 ABAAS Section: 606.3 2012 TAS Section: 606.3 2010 ADAS Section: 606.3
