Access Audit Site Report

Estero Llano Grande State Park
3301 S International Blvd
Weslaco, TX 78596
Accessibility Evaluation
Inspection Date: 07/13/2022
Inspectors: Tanya Scheibe

Prepared By
WT Group

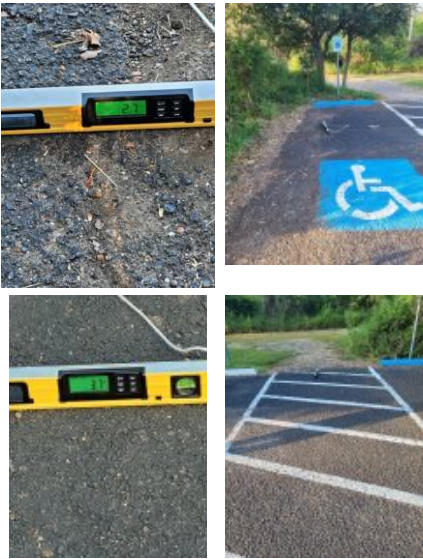
Finding Number	Area Description	Lat/Long	Finding	As Built	Recommendation	Citation	Photos	Figure
1	Exterior: Parking - Main lot to Visitor Center	[26.1270791, -97.9581839]	Element meets all standards and requirements	4 accessible; 40 standard	None	2010 ADAS Section: N/A		
2	Exterior: Parking - Main lot to Visitor Center	[26.1269924, -97.9581678]	The cross slopes (narrow dimension) and/or running slopes (long dimension) of the access aisle exceeds 2%. The running slope and the cross slope in an accessible parking stall and the access aisle must not exceed 2%.	left - 2.7% slope; right access aisle - 3.7%	Repair or correct slope of parking space and access aisle to max 2.08% in any direction.	2015 ABAAS Section: 502.4 2012 TAS Section: 502.4 2010 ADAS Section: 502.4

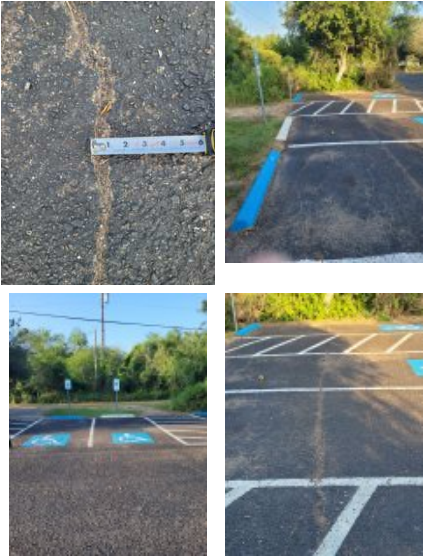
Finding Number	Area Description	Lat/Long	Finding	As Built	Recommendation	Citation	Photos	Figure
3	Exterior: Parking - Main lot to Visitor Center	[26.1269828 , -97.958114 2]	The parking stall contains abrupt edges and surface irregularities over a 1/4 inch vertical. Parking spaces and access aisles serving them shall be stable, firm, and slip resistant. Access aisles shall be at the same level as the parking spaces they serve. Changes in level are not permitted and shall not be sloped steeper than 2% in any direction.	1" gap at head of right center stall, other areas failing	Repair, bevel and ramp CIL in stalls and access aisles	2015 ABAAS Section: 502.4 2012 TAS Section: 502.4 2010 ADAS Section: 502.4

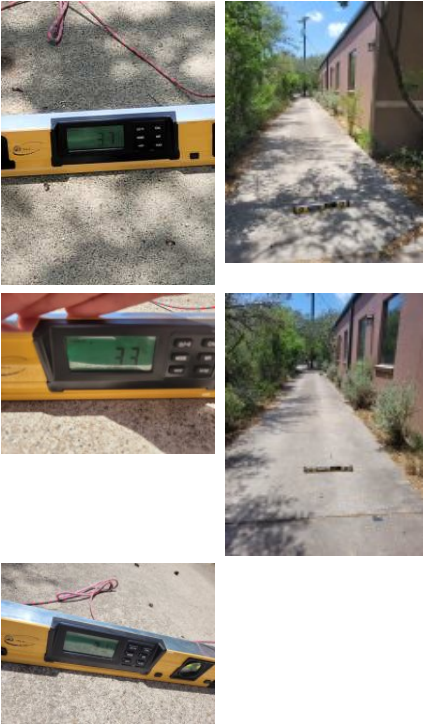
Finding Number	Area Description	Lat/Long	Finding	As Built	Recommendation	Citation	Photos	Figure
5	Exterior: Exterior Accessible Route	[26.1243049 , -97.960198 2]	The accessible route of travel contains cross slopes greater than 2%. Cross slopes shall not exceed one unit vertical in 48 units horizontal (2-percent slope).	Camp Thicket: Warbler Hall side path from front to back - Cross slopes of 3.7%, 3.3%, 3%	Correct or repair cross slope along AR to max 2.08%.	2015 ABAAS Section: 403.3 2012 TAS Section: 403.3 2010 ADAS Section: 403.3

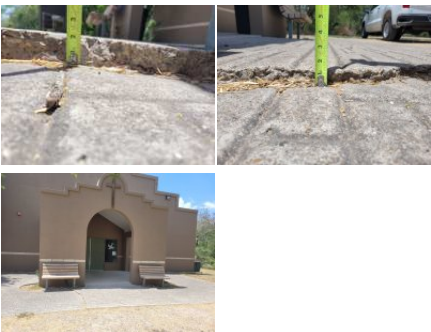
Finding Number	Area Description	Lat/Long	Finding	As Built	Recommendation	Citation	Photos	Figure
7	Exterior: Exterior Accessible Route	[26.1242567 , -97.960163 4]	The walkway contains abrupt vertical edges and/or variations over a 1/4 inch. 1/4 inch is the maximum vertical rise. Changes in level between 1/4 inch and 1/2 inch must be beveled at 1:2 or less. Changes in level greater than 1/2 inch must be by way of a ramp.	two 2" changes in level at entry to Camp Thicket: Warbler Hall	Repair, bevel or ramp CIL along AR.	2012 TAS Section: 303.2, 303.3 2010 ADAS Section: 303.2, 303.3

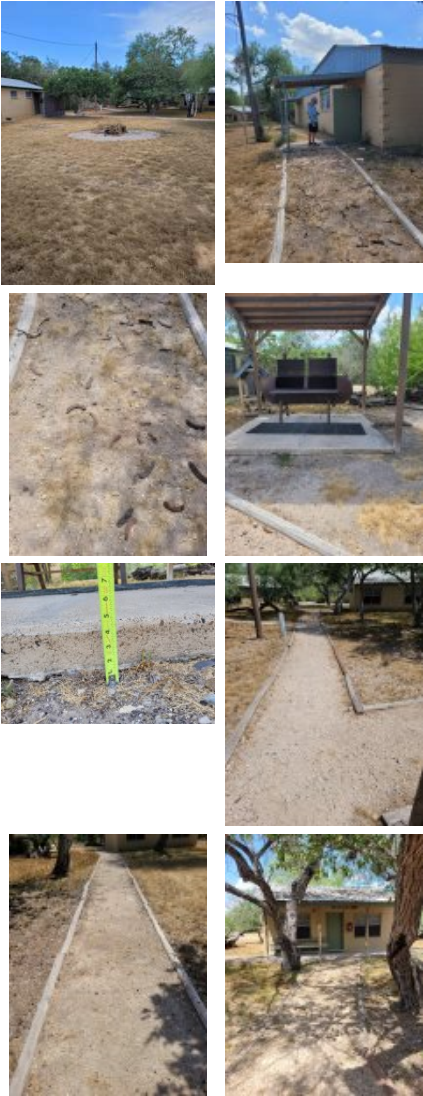
Finding Number	Area Description	Lat/Long	Finding	As Built	Recommendation	Citation	Photos	Figure
8	Exterior: Exterior Accessible Route	[26.124117, -97.960914 4]	There is no accessible route to the North Complex amenities. At least one accessible route shall connect accessible buildings, accessible facilities, accessible elements, and accessible spaces that are on the same site.	no route to firepit outside of Camp Thicket: Chachalaca Hall and Cabins, no route to any of the pathways within the North Complex due to surface, no route to grill due to surface and 4.5" change in level	Create an accessible route with crushed stone or other outdoor material from parking or walkway to walkway within the North Complex.	2015 ABAAS Section: F206.2.2 2012 TAS Section: 206.2.2 2010 ADAS Section: 206.2.2

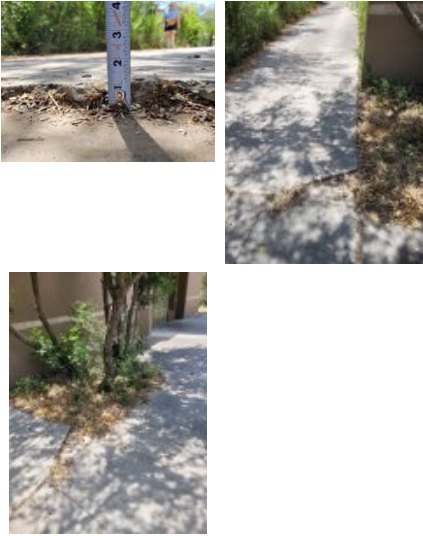
11	Exterior: Exterior Accessible Route	[26.1242711 , -97.960185 8]	The walkway contains abrupt vertical edges and/or variations over a 1/4 inch. 1/4 inch is the maximum vertical rise. Changes in level between 1/4 inch and 1/2 inch must be beveled at 1:2 or less. Changes in level greater than 1/2 inch must be by way of a ramp.	Camp Thicket Warbler Hall: 1" change in level near front door	Repair, bevel or ramp CIL along the route.	2012 TAS Section: 303.2, 303.3 2010 ADAS Section: 303.2, 303.3

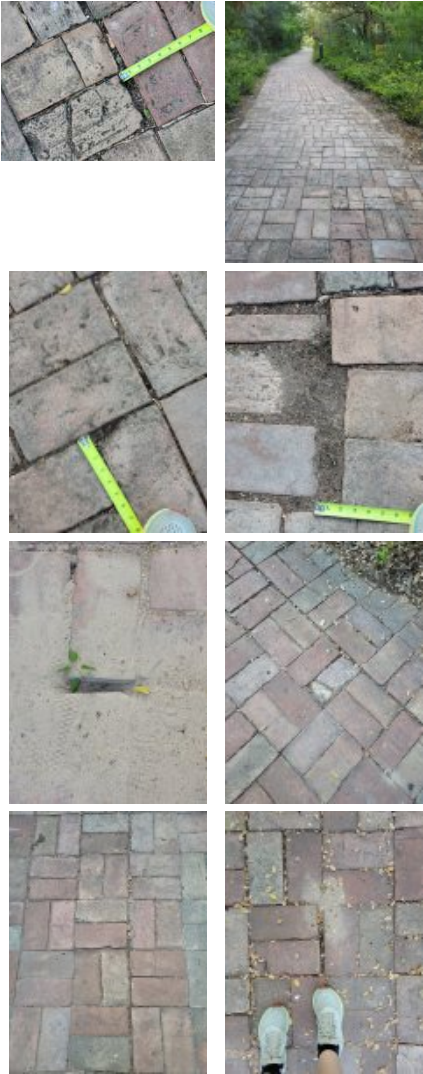
Finding Number	Area Description	Lat/Long	Finding	As Built	Recommendation	Citation	Photos	Figure
13	Exterior: Exterior Accessible Route	[26.126636, -97.956778 4], [26.1265457, -97.957799]	The accessible route contains loose gravel and/or surfaces that do not provide for a stable, firm slip resistant surface.	Entrance brick walkway - pavers cause gapping in over twenty instances, ranging from .75"-1.25"	Resurface AR where deterioration occurs.	2015 ABAAS Section: 302.1 2012 TAS Section: 302.1 2010 ADAS Section: 302.1

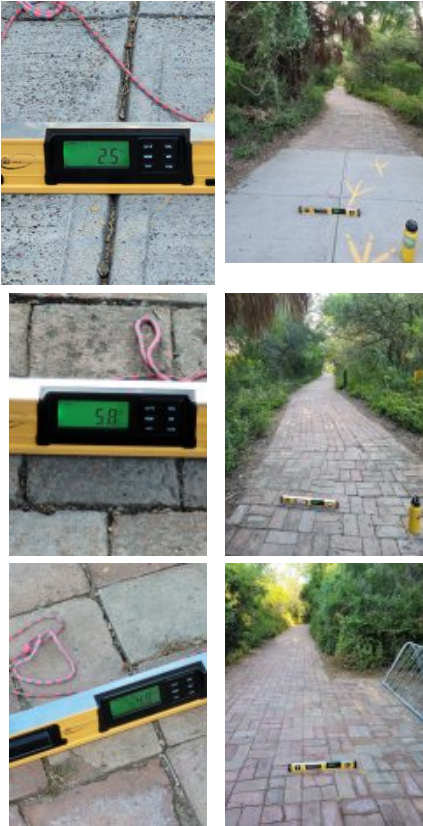
Finding Number	Area Description	Lat/Long	Finding	As Built	Recommendation	Citation	Photos	Figure
14	Exterior: Exterior Accessible Route	[26.1264241, -97.956714]	The accessible route of travel contains cross slopes greater than 2%. Cross slopes shall not exceed one unit vertical in 48 units horizontal (2-percent slope).	Entrance brick walkway - entry point 2.5% slope, 20' beyond - 5.8%, 4.9%	Correct or repair cross slope along AR to max 2.08%. Correction would be included in previous finding.	2015 ABAAS Section: 403.3 2012 TAS Section: 403.3 2010 ADAS Section: 403.3

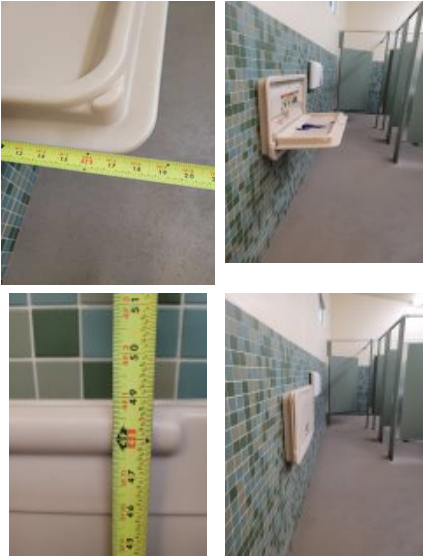
Finding Number	Area Description	Lat/Long	Finding	As Built	Recommendation	Citation	Photos	Figure
28	Headquarters Area: HQ - Women's Restroom	[26.1264433 , -97.956588]	The baby changing table is not compliant. Baby changing tables are work surfaces. If fixed or built-in baby changing tables are provided, at least 5%, but not less than one, must comply with TAS 902 based TAS 226.1. Baby changing tables cannot violate the protruding object requirements in either an open or closed position since either position is a potential hazard for persons with visual impairments. Baby changing tables are not prohibited from being located in wheelchair accessible toilet compartments; however, the minimum space required for the compartment cannot be obstructed by the baby changing table in either an open or closed position. The clear floor space required for a baby changing table may overlap the water closet clearance since baby changing tables are considered convenience "fixtures" based on Advisory 604.8.1.1. The overlap is applicable only to the clear floor space and not to actual table itself. Baby changing tables must be dispersed throughout a space, however, an additional baby changing table is not required in a common use area of a toilet or bathing room when the only baby changing table is located in a toilet compartment.	changer projects 19.5", mounted to 49" to top handle	Relocate baby changing table to eliminate protrusion when in the open position. Mount so the handle is max 48" AFF and the changing surface at 34".	2012 TAS Section: 226.1, 902.3, 604.3.2, 204.1, 226.1 Advisory, 226.2, 307.1, 604.8.1.1 Advisory, 902.1, 902.1 Advisory, 902.2

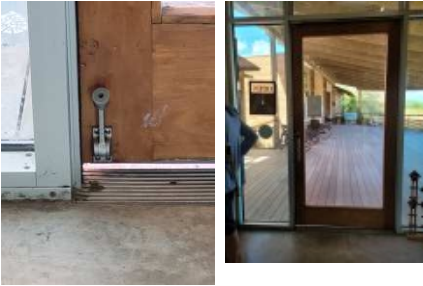
Finding Number	Area Description	Lat/Long	Finding	As Built	Recommendation	Citation	Photos	Figure
32	Headquarters Area: HQ - Public Spaces	[26.1263856 , -97.956614 8]	Exterior doors are recommended to be maintained at 8.5 lbf as a smart practice. Force is to be measured at the operating hardware or 30 inches from the hinges, whichever is greater. The bottom 10 inches on the push side must be smooth and free of obstructions (hold open devices). Opening hardware must be mounted between 30 and 44 inches above the floor or ground.	HQ entry - holder in bottom 10", 10lbf	For all doors along the public circulation route, inspect, adjust, and maintain 8.5 lbf to open exterior doors as a smart practice. For all doors along the public circulation route, remove door holder to provide a smooth surface on the push side of door from floor to 10" AFF.	2010 ADAS Section: 404.2.3, 404.2.7, 404.2.4, 404.2.11, 404.2.11 Exception

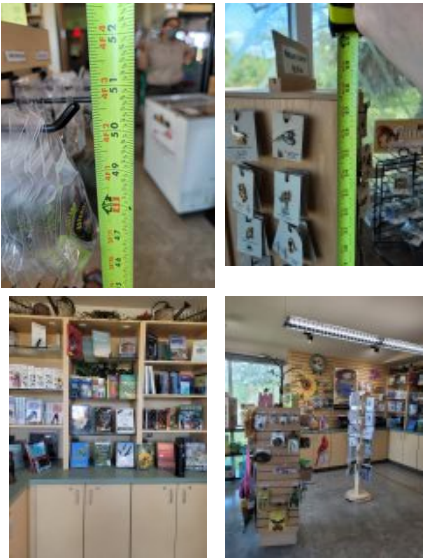
33	Headquarters Area: HQ - Public Spaces	[26.1263887 , -97.956649 7]	The operable part is positioned too high for either a side or front approach. Where a clear floor or ground space allows a parallel approach to an element and the side reach is unobstructed, the high side reach shall be 48 inches maximum and the low side reach shall be 15 inches minimum above the finish floor or ground. Where a forward reach is unobstructed, the high forward reach shall be 48 inches maximum and the low forward reach shall be 15 inches minimum above the finish floor or ground.	merchandise is 51" AFF over counter	Lower merchandise to max 44" AFF for a reach over the counter. In the alternative, train staff to be alert to patrons needing assistance.	2015 ABAAS Section: 308.1 2012 TAS Section: 308.1 2010 ADAS Section: 308.1

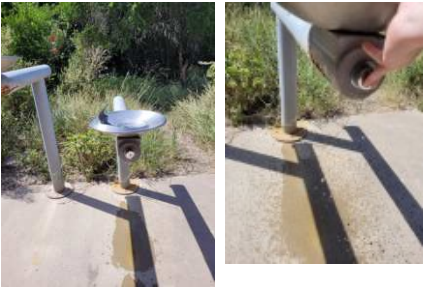
34	Headquarters Area: HQ - Public Spaces	[26.1263807 , -97.956601 4]	There is not enough knee clearance under the drinking fountain. The drinking fountain must have a clear knee space between the bottom of the drinking fountain and the floor not less than 27 inches in height, 30 inches in width, and 8 inches in depth.	fountains at HQ restrooms would comply, but the accessible fountain leaks in knee and toe clearance when pressed	Correct leak at fountain to prevent water overflow	2015 ABAAS Section: 602.2 2012 TAS Section: 602.2 2010 ADAS Section: 602.2

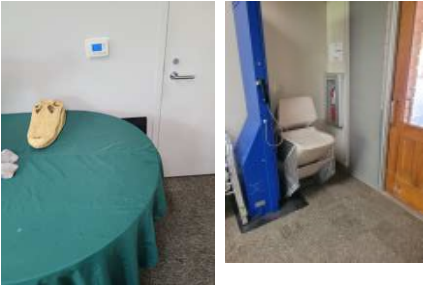
Finding Number	Area Description	Lat/Long	Finding	As Built	Recommendation	Citation	Photos	Figure
35	Headquarters Area: HQ - Public Spaces	[26.1265156 , -97.956499 5]	The operable part is not accessible because there is not adequate clear floor space for either a forward or side approach. The clear floor or ground space shall be 30 inches minimum by 48 inches minimum.	Ibis Room - table at thermostat; storage at fire extinguisher	Remove, or relocate storage in CFS at fixtures and operable parts.	2015 ABAAS Section: 305.3 2012 TAS Section: 305.3 2010 ADAS Section: 305.3

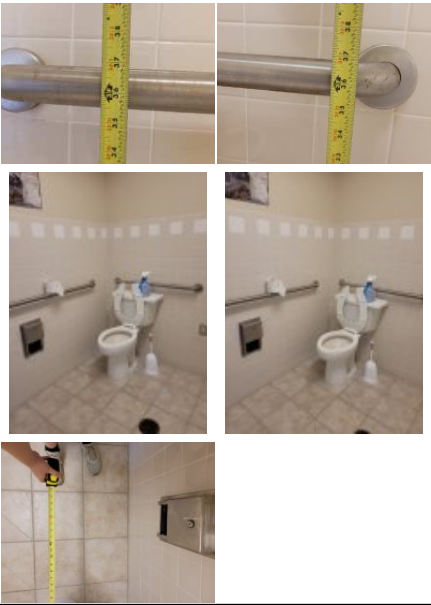
47	Employee Areas: Maintenance	[26.1275415 , -97.955592 9]	The grab bar height and/or spacing fails. Grab bars must be mounted between 33" and 36" to the top of the gripping surface. There must be 1.5" of clearance between the grab bar and the wall. There must be a minimum of 1.5" of clearance below and minimum 12" above the grab bar to any dispenser or other obstruction.	Staff Restroom - grab bars at 37" AFF, toilet paper on side grab bar; TP dispenser 13" from toilet	Remount grab bars in accessible stall to 33" to 36" above the finished floor (AFF). Remount toilet paper dispenser max 7" to 9" from front of toilet, 15" to 48" above the finished floor (AFF) and min 12" above or 1.5" below grab bar.	2015 ABAAS Section: 609.3, 609.4 2012 TAS Section: 609.4, 609.3 2010 ADAS Section: 609.3, 609.4

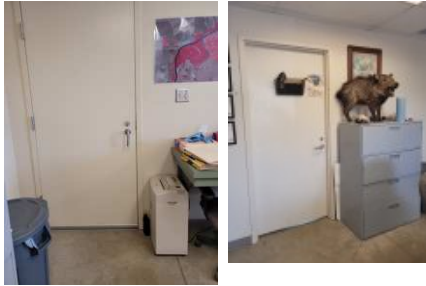
Finding Number	Area Description	Lat/Long	Finding	As Built	Recommendation	Citation	Photos	Figure
48	Employee Areas: Maintenance	[26.1275752 , -97.9555661]	Spaces and elements within employee work areas shall only be required to comply with 206.2.8, 207.1, and 215.3 and shall be designed and constructed so that individuals with disabilities can approach, enter, and exit the employee work area. Employee work areas, or portions of employee work areas, other than raised courtroom stations, that are less than 300 square feet (28 m2) and elevated 7 inches (180 mm) or more above the finish floor or ground where the elevation is essential to the function of the space shall not be required to comply with these requirements or to be on an accessible route.	offices off of back garage - 2 doors lack clearance due to storage on pull side	For employee spaces, relocate storage, furniture, and other obstacles at doorways to provide approach, enter and exit at the employee space.	2015 ABAAS Section: F203.9 2012 TAS Section: 203.9 2010 ADAS Section: 203.9

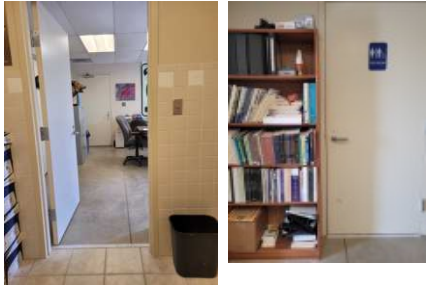
Finding Number	Area Description	Lat/Long	Finding	As Built	Recommendation	Citation	Photos	Figure
51	Employee Areas: Maintenance	[26.1275415 , -97.9555607]	Minimum maneuvering clearances at doors and gates shall comply with 404.2.4. Maneuvering clearances shall extend the full width of the doorway and the required latch side or hinge side clearance. Maneuvering clearances shall have a max slope of 2.08%.	restroom off break room - clearance of push and pull reduced by storage	For all doors along the public circulation route, provide required maneuvering clearance on push and pull side of doors.	2010 ADAS Section: 404.2.3, 404.2.7, 404.2.4, 404.2.11, 404.2.11 Exception

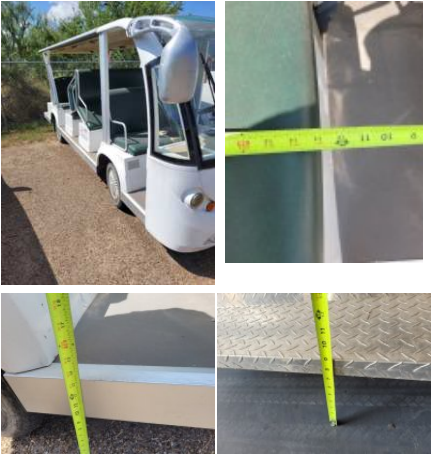
Finding Number	Area Description	Lat/Long	Finding	As Built	Recommendation	Citation	Photos	Figure
61	Park Site: Park Elements	[26.1273584, -97.9555392]	Services and programs must be accessible.	9" step up at tram, 19" width CFS for seat	Provide a tram car that has improved accessibility or other methods for guests with disabilities to access each part of the park.	Capture Section: 1

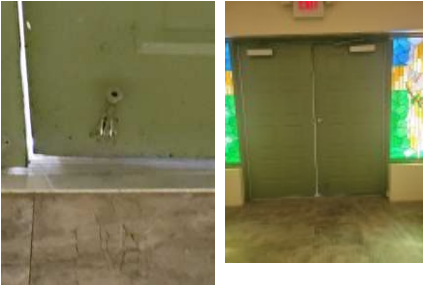
Finding Number	Area Description	Lat/Long	Finding	As Built	Recommendation	Citation	Photos	Figure
83	Camp Thicket Group Area: North Complex - Public Spaces	[26.124276, -97.960206 3]	Exterior doors are recommended to be maintained at 8.5 lbf as a smart practice. Force is to be measured at the operating hardware or 30 inches from the hinges, whichever is greater. Hand-activated door opening hardware, handles, pulls, latches, locks, and other operating devices on accessible doors shall have a shape that is easy to grasp with one hand and does not require tight grasping, tight pinching or twisting of the wrist to operate. Hardware shall be 34 inches minimum and 48 inches maximum above the finish floor or ground. The bottom 10 inches on the push side must be smooth and free of obstructions (hold open devices). Opening hardware must be mounted between 30 and 44 inches above the floor or ground.	Main door at warbler hall - 10lbf push, knob, opener in bottom 10"	For all doors along the public circulation route, inspect, adjust, and maintain 8.5 lbf to open exterior doors as a smart practice. For all doors along the public circulation route, replace hardware with lever hardware or hardware operable without a tight pinch or grasp. For all doors along the public circulation route, remove door holder to provide a smooth surface on the push side of door from floor to 10" AFF.	2010 ADAS Section: 404.2.3, 404.2.7, 404.2.4, 404.2.11, 404.2.11 Exception

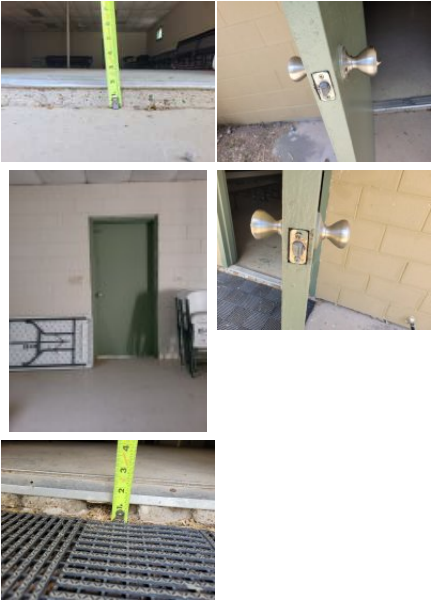
84	Camp Thicket Group Area: North Complex - Public Spaces	[26.1241604, -97.960978 8]	Minimum maneuvering clearances at doors and gates shall comply with 404.2.4. Maneuvering clearances shall extend the full width of the doorway and the required latch side or hinge side clearance. Maneuvering clearances shall have a max slope of 2.08%. The threshold has a vertical change greater than 1/4 inch high. Hand-activated door opening hardware, handles, pulls, latches, locks, and other operating devices on accessible doors shall have a shape that is easy to grasp with one hand and does not require tight grasping, tight pinching or twisting of the wrist to operate. Hardware shall be 34 inches minimum and 48 inches maximum above the finish floor or ground.	Cha Cha hall - rear door - 2" change in level, clearance on push reduced by table, door to cabin 4 - 1.5" change in level, knob	For all doors along the public circulation route, provide required maneuvering clearance on push and pull side of doors. For all doors along the public circulation route, repair, bevel, or ramp CILs at door entries to max .25". For all doors along the public circulation route, replace hardware with lever hardware or hardware operable without a tight pinch or grasp.	2010 ADAS Section: 404.2.3, 404.2.7, 404.2.4, 404.2.11, 404.2.11 Exception

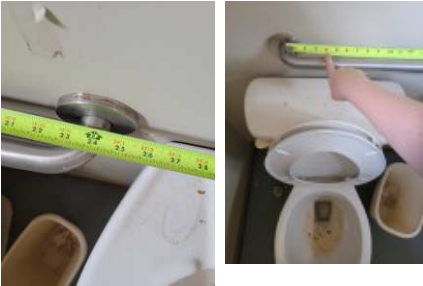
90	Camp Thicket Group Area: North Complex - Public Spaces	[26.1241893 , -97.961021 7]	The rear grab bar is not 36" long or is not mounted in the correct location. The rear grab bar must be a minimum of 36" long and extend from the toilet centerline a minimum 12" towards the wall side and a minimum 24" towards the open side of the toilet. Grab bars shall be installed in a horizontal position, 33 inches minimum and 36 inches maximum above the finish floor measured to the top of the gripping surface and the space between the grab bar and the top of the tank shall be 1-1/2 inches minimum.	Cha Cha Restroom - 24" grab bar, 4" centerline from closed side	Replace rear grab bar with one 36" long, mounted behind the toilet, 12" to the wall side of center and 24" to the open side and 33" to 36" AFF.	2015 ABAAS Section: 604.5.2 2012 TAS Section: 604.5.2 2010 ADAS Section: 604.5.2

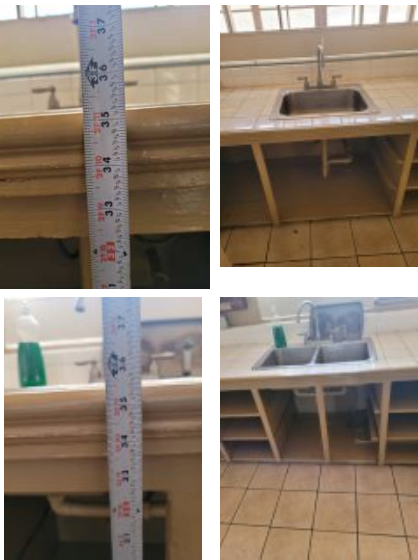
Finding Number	Area Description	Lat/Long	Finding	As Built	Recommendation	Citation	Photos	Figure
96	Camp Thicket Group Area: North Complex - Public Spaces	[26.124223, -97.961064 6]	The top rim of the sink is too high. All lavatories/sinks that are designated to be accessible shall be a minimum 17 inches in horizontal depth and mounted with the rim or counter edge no higher than 34 inches above the finished floor.	Cha Cha Kitchen - sinks: left 35.25" above finished floor (AFF), right 35.5" AFF	Lower one sink to max 34" above the finished floor (AFF) to front of rim.	2015 ABAAS Section: 606.3 2012 TAS Section: 606.3 2010 ADAS Section: 606.3

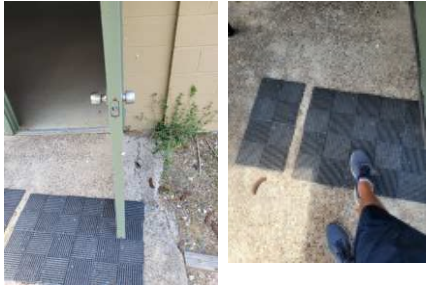
Finding Number	Area Description	Lat/Long	Finding	As Built	Recommendation	Citation	Photos	Figure
101	Camp Thicket Group Area: North Complex - Public Spaces	[26.12425, -97.96102]	Minimum maneuvering clearances at doors and gates shall comply with 404.2.4. Maneuvering clearances shall extend the full width of the doorway and the required latch side or hinge side clearance. Maneuvering clearances shall have a max slope of 2.08%. Hand-activated door opening hardware, handles, pulls, latches, locks, and other operating devices on accessible doors shall have a shape that is easy to grasp with one hand and does not require tight grasping, tight pinching or twisting of the wrist to operate. Hardware shall be 34 inches minimum and 48 inches maximum above the finish floor or ground.	Cha cha group hall, front door - knobs, mat not secure	For all doors along the public circulation route, secure rug in door clearance to prevent trip hazard. For all doors along the public circulation route, replace hardware with lever hardware or hardware operable without a tight pinch or grasp.	2010 ADAS Section: 404.2.3, 404.2.7, 404.2.4, 404.2.11, 404.2.11 Exception

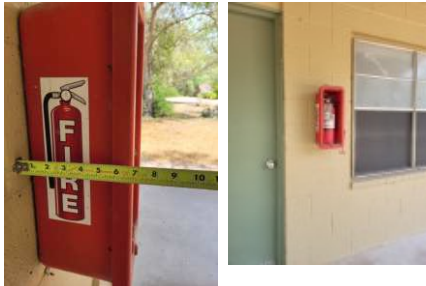
102	Camp Thicket Group Area: North Complex - Public Spaces	[26.1241965, -97.9607186]	An item or items project more than 4 inches into the circulation path. Wall-mounted objects that have leading edges between 27 inches and 80 inches from the floor must not project more than 4 inches into the circulation path. Protruding objects that extend to the floor or within 27 inches of the floor are cane detectable and are therefore not hazardous. Where it is necessary or desirable to have objects protrude from the wall, a manner of cane detection must be provided.	King Fisher Cabin - fire extinguisher projects on exterior 7"	Relocate protruding objects or place cane detectable warning or bollard at foot of item.	2015 ABAAS Section: 307.2 2012 TAS Section: 307.2 2010 ADAS Section: 307.2

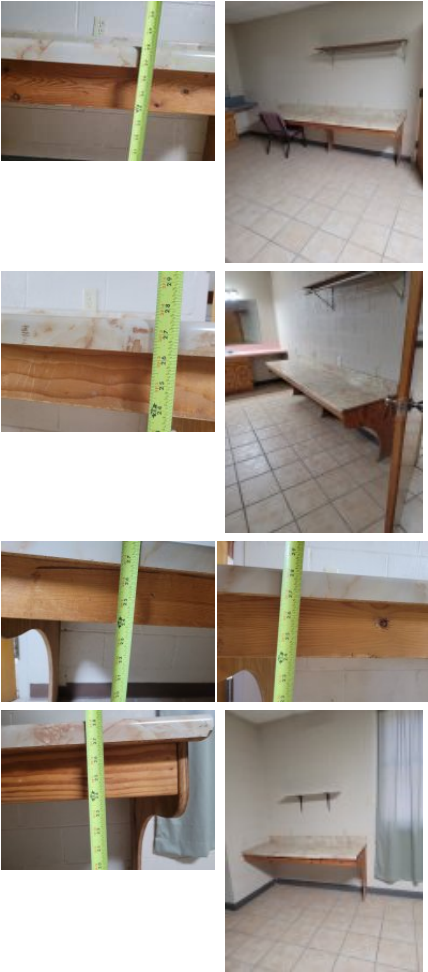
Finding Number	Area Description	Lat/Long	Finding	As Built	Recommendation	Citation	Photos	Figure
127	Camp Thicket Group Area: South Complex - Public Spaces	[26.1229852 , -97.9603136]	The top of the work surface is not within a compliant height range. The tops of tables and counters shall be 28 inches to 34 inches from the floor or ground.	The nest, in rooms 1-5 (5 total) vanity has 24" knee	Provide tables and work surfaces at 28" to 34" aff with required knee and toe clearances in at least one room.	2015 ABAAS Section: 902.3 2012 TAS Section: 902.3 2010 ADAS Section: 902.3

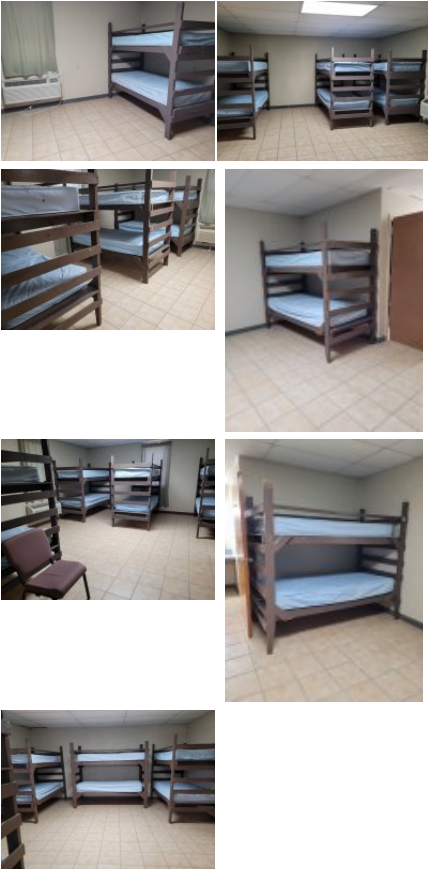
Finding Number	Area Description	Lat/Long	Finding	As Built	Recommendation	Citation	Photos	Figure
128	Camp Thicket Group Area: South Complex - Public Spaces	[26.1229563 , -97.960324 3]	The required clear space between the beds has not been provided. Accessible sleeping rooms shall have a 30 inch minimum by 48 inch minimum clear space located between the beds to provide a parallel approach.	The nest, rooms 1-5 - room 3 - bunk beds only; room 2 - bunk beds only; room 1 - 4 sets of bunk beds; room 4 - bunk beds only; room 5 - 4 sets of bunks	Arrange at least one room to provide 30" by 48" clear floor space on both sides of one bed and lower bed height to 17" to 23" AFF.	2015 ABAAS Section: 806.2.3, 806.2.3 EXCEPTION 2012 TAS Section: 806.2.3, 806.2.3 Exception 2010 ADAS Section: 806.2.3 Exception

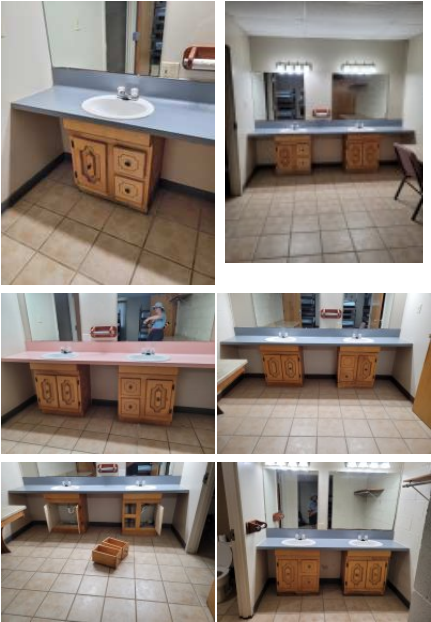
Finding Number	Area Description	Lat/Long	Finding	As Built	Recommendation	Citation	Photos	Figure
131	Camp Thicket Group Area: South Complex - Public Spaces	[26.1229659 , -97.9603028]	Knee and toe clearance has not been provided at the sink. The knee clearance shall be 11 inches deep minimum at 9 inches above the finish floor or ground, and 8 inches deep minimum at 27 inches above the finish floor or ground. The toe clearance is the space under the sink between the finish floor or ground and 9 inches above the finish floor 30 inches wide minimum.	The nest, restrooms 1-5 - sinks lack knee in all 5 rooms	Remove under sink cabinets to provide knee and toe clearances under sinks and insulate exposed pipes in at least one restroom.	2012 TAS Section: 606.2 2010 ADAS Section: 606.2

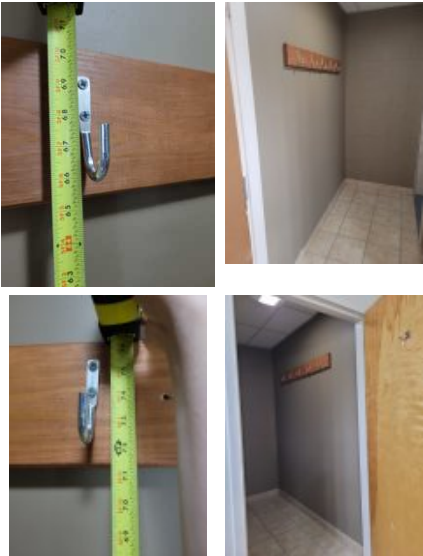
132	Camp Thicket Group Area: South Complex - Public Spaces	[26.1229659 , -97.9603163]	Coat hooks provided within the room shall be located within one of the reach ranges specified in 308. Shelves shall be 40 inches (1015 mm) minimum and 48 inches (1220 mm) maximum above the finish floor or ground. Where coat hooks or shelves are provided in dressing, fitting or locker rooms without individual compartments, at least one of each type shall comply with 803.5. Where coat hooks or shelves are provided in individual compartments at least one of each type complying with 803.5 shall be provided in individual compartments in dressing, fitting, or locker rooms required to comply with 222.1.	The nest, restrooms 1-5 - 1-4 rooms all have hooks too high, room 1 - 76" AFF, room 4 - 67" AFF, room 3 - 63" AFF, room 5 - 67" AFF	Remount at least one hook to max 48" aff and shelves to 40" - 48" aff in one restroom.	2015 ABAAS Section: 308.2.1, 308.1, F222.2, 803.5 2012 TAS Section: 308.2.1, 308.1, 222.2, 803.5 2010 ADAS Section: 308.2.1, 308.1, 222.2, 803.5
