Access Audit Site Report

Fort Boggy State Park
4994 Highway 75 South
Centerville, TX 75833
Accessibility Evaluation
Inspection Date: 09/15/2022
Inspectors: Tanya Scheibe

Prepared By
WT Group

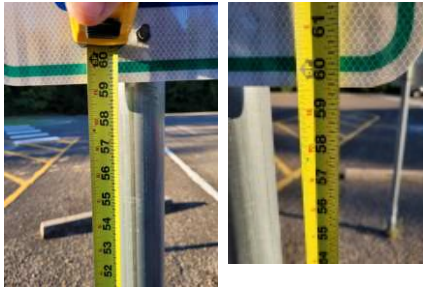
4	Headquarters Area: HQ - Parking	[31.1872815, -95.9768366]	The parking sign is mounted too low. Parking space identification signs shall include the International Symbol of Accessibility complying with. Signs identifying van parking spaces shall contain the designation "van accessible." Signs shall be 60 inches minimum above the finish floor or ground surface measured to the bottom of the sign.	entry side 59.25"; exit side 59.5"	Raise existing accessible parking signs so lowest end of bottom sign is min 60" above ground level (AGL) measured from the surface of the stall.	2015 ABAAS Section: 502.6 2012 TAS Section: 502.6 2010 ADAS Section: 502.6

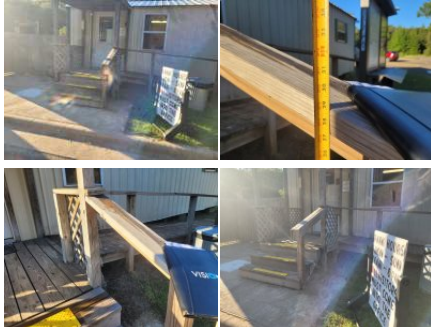
Finding Number	Area Description	Lat/Long	Finding	As Built	Recommendation	Citation	Photos	Figure
12	Headquarters Area: HQ - Exterior Accessible Route	[31.1874166 , -95.976629 8]	Stairways must have handrails on both sides. Handrails and their extensions must be between 34 inches and 38 inches above the stair nosing or ground. The top handrails shall extend a minimum of 12 inches beyond the top nosing and shall be parallel with the floor or ground surface. At the bottom of a stair flight, handrails shall extend at the slope of the stair flight for a horizontal distance at least equal to one tread depth beyond the last riser nosing. Extension shall return to a wall, guard, or the landing surface, or shall be continuous to the handrail of an adjacent stair flight. The orientation of at least one handrail, including the extension, shall be in the direction of the run of the stair and perpendicular to the direction of the stair nosing. Handrail gripping surfaces with a circular cross section shall have an outside diameter of 1-1/4 inches minimum and 2 inches maximum. Handrail gripping surfaces with a non-circular cross section shall have a perimeter dimension of 4 inches minimum and 6 1/4 inches maximum, and a cross-section dimension of 2-1/4 inches maximum. The hand grip portion of handrails shall have a smooth surface with no sharp corners. Gripping surfaces (top or sides) shall be uninterrupted by newel posts, other construction elements or obstructions. Any wall or other surface adjacent to the handrail shall be free of sharp or abrasive elements. Handrails projecting from a wall shall have a space of 1-1/2 inches minimum between the wall and the handrail.	Entry stairs - Handrail on one side only, other side fails - lacks extensions, grip too large, height fails	Install handrails on both sides of stairway, mounted 34" to 38" AFF with top and bottom extensions and having a 1.25" – 2" in diameter, or a non-circular grip that has a perimeter dimension of 4"- 6.25" max with a min gap of 1.5" between handrail and wall.	2015 ABAAS Section: 505.2 2012 TAS Section: 505.2 2010 ADAS Section: 505.2

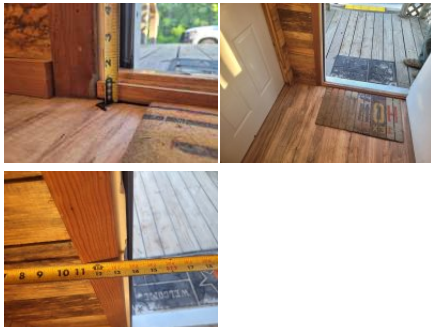
15	Headquarters Area: HQ - Public Spaces	[31.1873978, -95.976622 3]	Minimum maneuvering clearances at doors and gates shall comply with 404.2.4. Maneuvering clearances shall extend the full width of the doorway and the required latch side or hinge side clearance. Maneuvering clearances shall have a max slope of 2.08%. The threshold has a vertical change greater than 1/4 inch high. The threshold at a doorway shall be no higher than 1/2 inch. Changes in level between 1/4 inch and 1/2 inch must be beveled at 1:2 or less. 1/4 inch is the maximum vertical rise.	Entry - 1.5" threshold, 14" to wall pull	For all doors along the public circulation route, provide required maneuvering clearance on push and pull side of doors. For all doors along the public circulation route, repair, bevel, or ramp CILs at door entries to max .25". For all doors along the public circulation route, provide beveled threshold.	2010 ADAS Section: 404.2.3, 404.2.7, 404.2.4, 404.2.11, 404.2.11 Exception

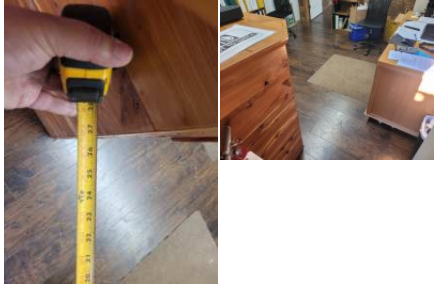
Finding Number	Area Description	Lat/Long	Finding	As Built	Recommendation	Citation	Photos	Figure
21	Headquarters Area: HQ - Employee Spaces	[31.1873732 , -95.976656 5]	Employee Work Areas. Common use circulation paths within employee work areas shall comply with 402. EXCEPTIONS: 1. Common use circulation paths located within employee work areas that are less than 1000 square feet (93 m2) and defined by permanently installed partitions, counters, casework, or furnishings shall not be required to comply with 402. 2. Common use circulation paths located within employee work areas that are an integral component of work area equipment shall not be required to comply with 402. 3. Common use circulation paths located within exterior employee work areas that are fully exposed to the weather shall not be required to comply with 402.	Offices - 26.75" clearance at desk	Make corrections for compliant circulation path.	2015 ABAAS Section: F206.2.8, F206.2.8.1, F206.2.8.2 2012 TAS Section: 206.2.8, 206.2.8 Exception 1, 206.2.8 Exception 2, 206.2.8 Exception 3, 206.2.8 Advisory 1, 206.2.8 Advisory 2 2010 ADAS Section: 206.2.8, 206.2.8 Exception 1, 206.2.8 Exception 2, 206.2.8 Exception 3

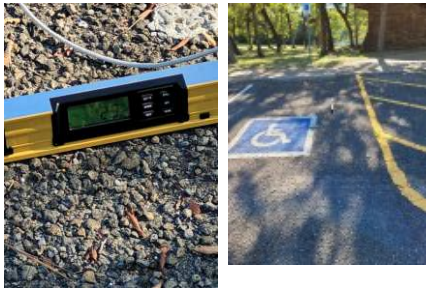
Finding Number	Area Description	Lat/Long	Finding	As Built	Recommendation	Citation	Photos	Figure
25	Day Use Area: Day Use - Parking	[31.1833587 , -95.977713 9]	Element meets all standards and requirements	Restroom Parking - 2 accessible, 16 standard, meets scoping	None	2010 ADAS Section: N/A		
26	Day Use Area: Day Use - Parking	[31.18333, -95.97773]	The cross slopes (narrow dimension) and/or running slopes (long dimension) of the access aisle exceeds 2%. The running slope and the cross slope in an accessible parking stall and the access aisle must not exceed 2%.	Restroom Parking - Left stall 2.9%	Repair or correct slope of parking space and access aisle to max 2.08% in any direction.	2015 ABAAS Section: 502.4 2012 TAS Section: 502.4 2010 ADAS Section: 502.4

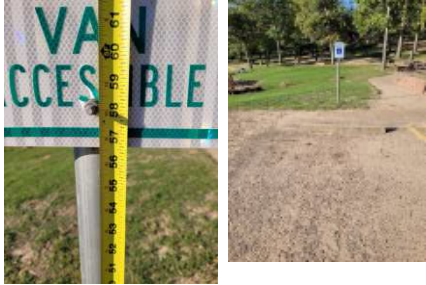
Finding Number	Area Description	Lat/Long	Finding	As Built	Recommendation	Citation	Photos	Figure
36	Day Use Area: Day Use - Parking	[31.1830366 , -95.977014 5]	The parking sign is mounted too low. Parking space identification signs shall include the International Symbol of Accessibility complying with. Signs identifying van parking spaces shall contain the designation "van accessible." Signs shall be 60 inches minimum above the finish floor or ground surface measured to the bottom of the sign.	Overflow lot - Left 56.5" AGL	Raise existing accessible parking signs so lowest end of bottom sign is min 60" above ground level (AGL) measured from the surface of the stall.	2015 ABAAS Section: 502.6 2012 TAS Section: 502.6 2010 ADAS Section: 502.6

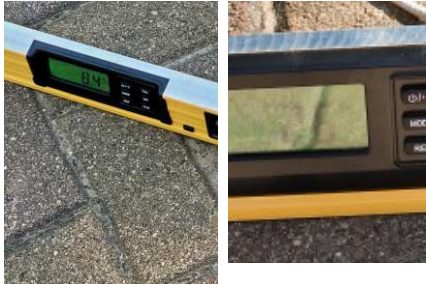
37	Day Use Area: Day Use - Exterior Accessible Route	[31.1834977 , -95.977499 3]	The running slope of walking surfaces shall not be steeper than 1:20. The cross slope of walking surfaces shall not be steeper than 1:48.	Route from parking to shower/foot bath - 8.4%, 2.6%	Correct running slopes to max 5% and cross to max 2.08%.	2012 TAS Section: 403.3 2010 ADAS Section: 403.3

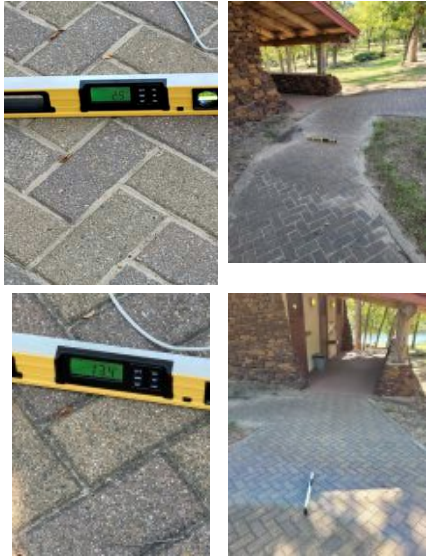
Finding Number	Area Description	Lat/Long	Finding	As Built	Recommendation	Citation	Photos	Figure
38	Day Use Area: Day Use - Exterior Accessible Route	[31.1833026 , -95.977617 8]	The running slope of walking surfaces shall not be steeper than 1:20. The cross slope of walking surfaces shall not be steeper than 1:48.	Route from parking to restrooms - 2.9%, 13.4%	Correct running slopes to max 5% and cross to max 2.08%.	2012 TAS Section: 403.3 2010 ADAS Section: 403.3

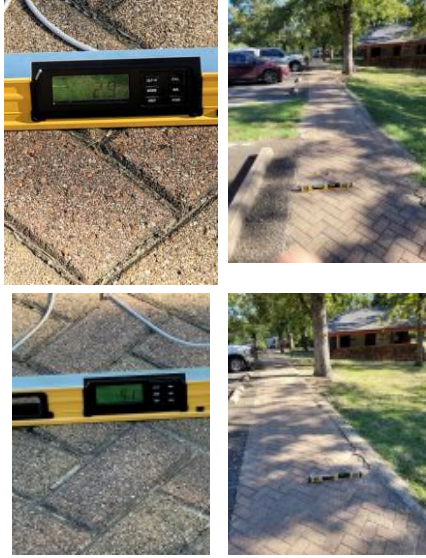
39	Day Use Area: Day Use - Exterior Accessible Route	[31.183002, -95.977703 6]	The running slope of walking surfaces shall not be steeper than 1:20. The cross slope of walking surfaces shall not be steeper than 1:48.	Route from pavilion to restrooms - 2.9%, 9.1%	Correct running slopes to max 5% and cross to max 2.08%.	2012 TAS Section: 403.3 2010 ADAS Section: 403.3

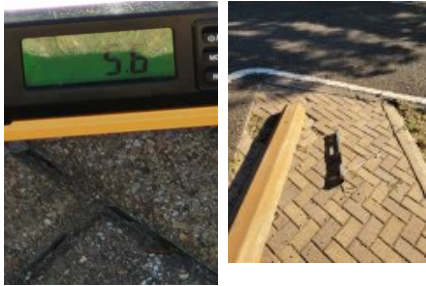
Finding Number	Area Description	Lat/Long	Finding	As Built	Recommendation	Citation	Photos	Figure
40	Day Use Area: Day Use - Exterior Accessible Route	[31.1831957 , -95.976839 7]	The running slope of walking surfaces shall not be steeper than 1:20.	Route from parking to boat ramp - 5.6%	Correct running slopes to max 5%.	2012 TAS Section: 403.3 2010 ADAS Section: 403.3

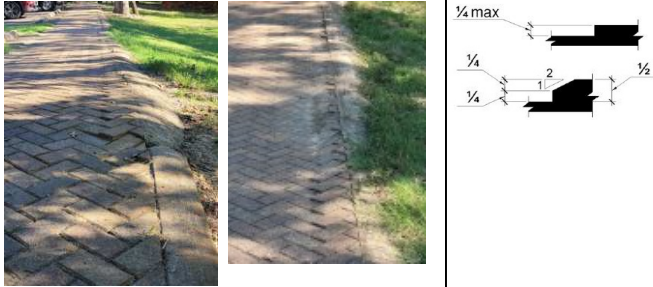
41	Day Use Area: Day Use - Exterior Accessible Route	[31.1830002 , -95.977708 4]	The walkway contains abrupt vertical edges and/or variations over a 1/4 inch. 1/4 inch is the maximum vertical rise. Changes in level between 1/4 inch and 1/2 inch must be beveled at 1:2 or less. Changes in level greater than 1/2 inch must be by way of a ramp.	Route from pavilion to restrooms - changes in level along right edge of pathway, bricks need to be reset	Repair or reset pavers to eliminate CIL.	2012 TAS Section: 303.2, 303.3 2010 ADAS Section: 303.2, 303.3

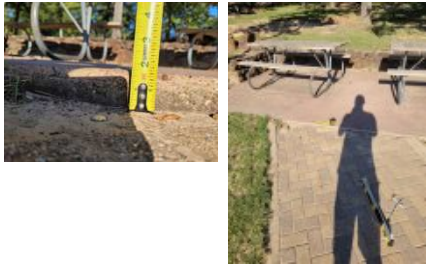
42	Day Use Area: Day Use - Exterior Accessible Route	[31.1829795 , -95.977083 4]	The walkway contains abrupt vertical edges and/or variations over a 1/4 inch. 1/4 inch is the maximum vertical rise. Changes in level between 1/4 inch and 1/2 inch must be beveled at 1:2 or less. Changes in level greater than 1/2 inch must be by way of a ramp.	Route from parking to picnic area - 1.75" change in level (CIL) at entry	Repair, bevel or ramp CIL along AR.	2012 TAS Section: 303.2, 303.3 2010 ADAS Section: 303.2, 303.3

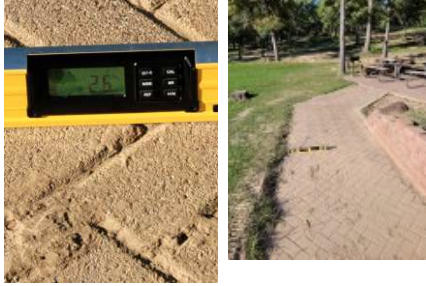
43	Day Use Area: Day Use - Exterior Accessible Route	[31.18296, -95.97707]	The cross slope shall not be steeper than 1:48. EXCEPTION: Where the surface is other than concrete, asphalt, or boards, cross slopes not steeper than 1:20 shall be permitted when necessary for drainage.	Route from parking to picnic area near boat ramp - 2.6% cross slope	Correct or repair ORAR cross slope to max 2.08% as a smart practice.	2015 ABAAS Section: 1016.7.2, 1016.7.2 EXCEPTION

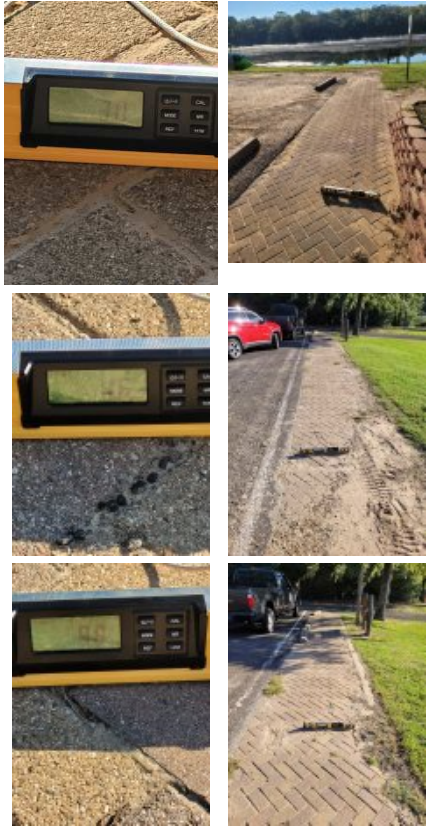
Finding Number	Area Description	Lat/Long	Finding	As Built	Recommendation	Citation	Photos	Figure
44	Day Use Area: Day Use - Exterior Accessible Route	[31.183159, -95.976867 8]	The running slope of walking surfaces shall not be steeper than 1:20. The cross slope of walking surfaces shall not be steeper than 1:48.	Route from parking to boat ramp - 3%, 4.6%, 9.8% cross slopes	Correct running slopes to max 5% and cross to max 2.08%.	2012 TAS Section: 403.3 2010 ADAS Section: 403.3

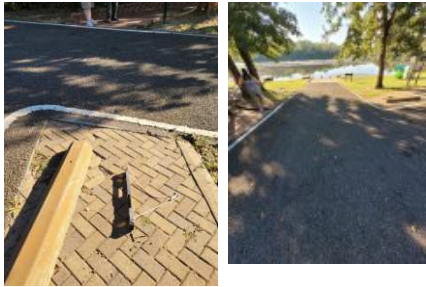
45	Day Use Area: Day Use - Exterior Accessible Route	[31.1832098, -95.97683 41], [31.1832511, -95.976805 9]	The accessible route of travel that crosses or adjoins the vehicular way and the walking surface is not separated by curbs, railings, or other elements between the pedestrian areas and vehicular areas. If a walk crosses or adjoins a vehicular way, and the walking surfaces are not separated by curbs, railings or other elements between the pedestrian areas and vehicular areas, the boundary between the areas shall be defined by a continuous detectable warning which is 36 inches wide.	Lacks detectable warning at boat ramp crossing	Install detectable warning where accessible route crosses the vehicular way as a smart practice.	2012 TAS Section: 705.1 2010 ADAS Section: 705

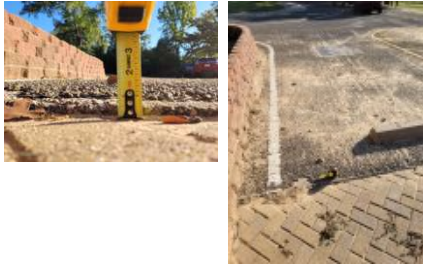
47	Day Use Area: Day Use - Exterior Accessible Route	[31.1830662 , -95.977061]	The walkway contains abrupt vertical edges and/or variations over a 1/4 inch. 1/4 inch is the maximum vertical rise. Changes in level between 1/4 inch and 1/2 inch must be beveled at 1:2 or less. Changes in level greater than 1/2 inch must be by way of a ramp.	.75" change in level (CIL) at parking	Repair, bevel or ramp CIL along AR.	2012 TAS Section: 303.2, 303.3 2010 ADAS Section: 303.2, 303.3

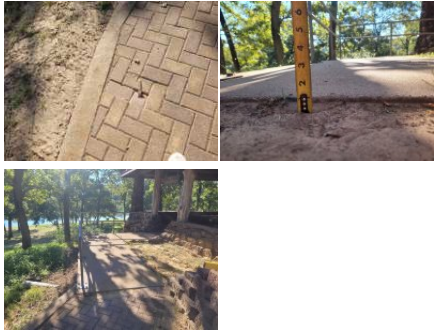
Finding Number	Area Description	Lat/Long	Finding	As Built	Recommendation	Citation	Photos	Figure
50	Day Use Area: Group Pavilion	[31.1825946, -95.9775806]	The walkway contains abrupt vertical edges and/or variations over a 1/4 inch. 1/4 inch is the maximum vertical rise. Changes in level between 1/4 inch and 1/2 inch must be beveled at 1:2 or less. Changes in level greater than 1/2 inch must be by way of a ramp.	Pavers shifting causing gaps and CILs, 1" CIL at shelter	Repair or reset pavers to eliminate CIL.	2012 TAS Section: 303.2, 303.3 2010 ADAS Section: 303.2, 303.3

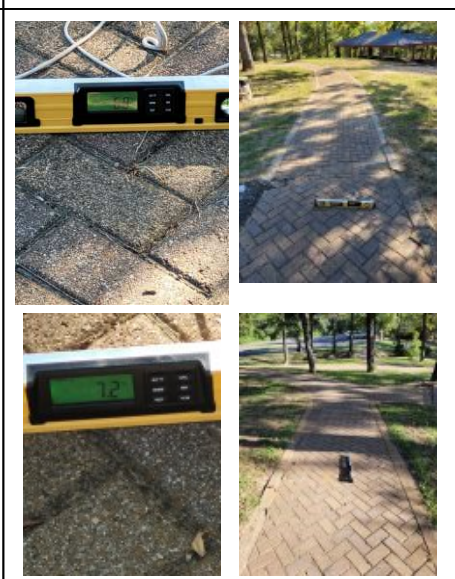
Finding Number	Area Description	Lat/Long	Finding	As Built	Recommendation	Citation	Photos	Figure
53	Day Use Area: Group Pavilion	[31.1825258 , -95.977819 7]	The running slope of walking surfaces shall not be steeper than 1:20. The cross slope of walking surfaces shall not be steeper than 1:48.	From parking at pavilion towards restrooms - 6.8%, 7.2%	Correct running slopes to max 5% and cross to max 2.08%.	2012 TAS Section: 403.3 2010 ADAS Section: 403.3

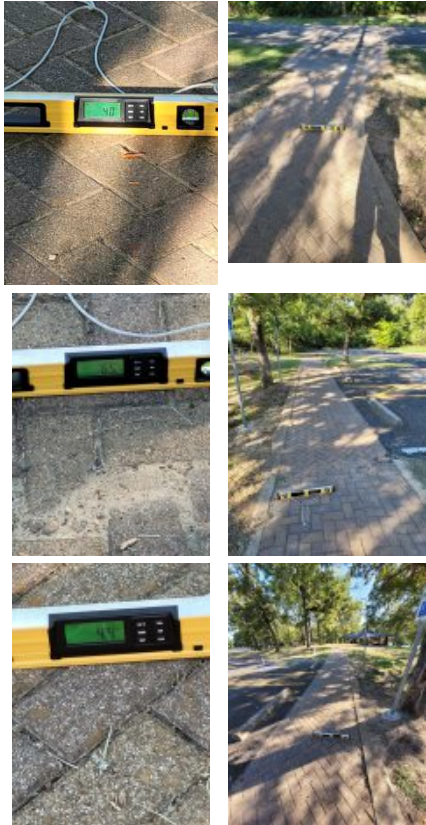
Finding Number	Area Description	Lat/Long	Finding	As Built	Recommendation	Citation	Photos	Figure
54	Day Use Area: Group Pavilion	[31.18266, -95.97775]	The running slope of walking surfaces shall not be steeper than 1:20. The cross slope of walking surfaces shall not be steeper than 1:48.	Parking at pavilion to roadway - 4%, near parking 6.5%, 4.4%	Correct running slopes to max 5% and cross to max 2.08%.	2012 TAS Section: 403.3 2010 ADAS Section: 403.3

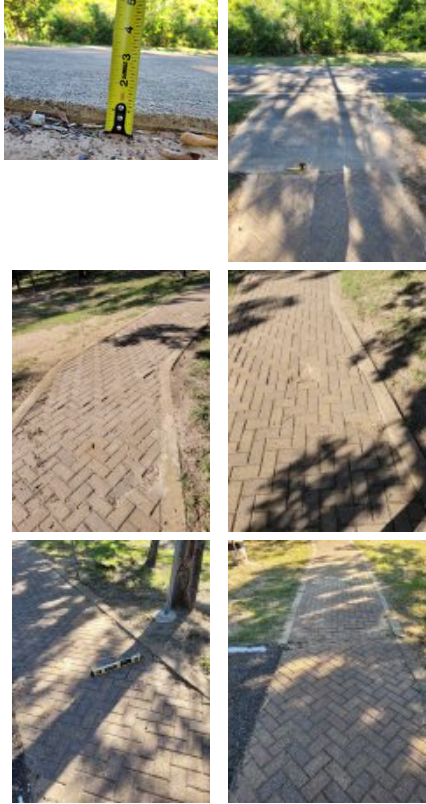
Finding Number	Area Description	Lat/Long	Finding	As Built	Recommendation	Citation	Photos	Figure
55	Day Use Area: Group Pavilion	[31.1823342 , -95.977862 7]	The walkway contains abrupt vertical edges and/or variations over a 1/4 inch. 1/4 inch is the maximum vertical rise. Changes in level between 1/4 inch and 1/2 inch must be beveled at 1:2 or less. Changes in level greater than 1/2 inch must be by way of a ramp.	Parking at pavilion to roadway - 1" CIL approaching roadway multiple areas where bricks are failing	Repair, bevel or ramp CIL along AR.	2012 TAS Section: 303.2, 303.3 2010 ADAS Section: 303.2, 303.3

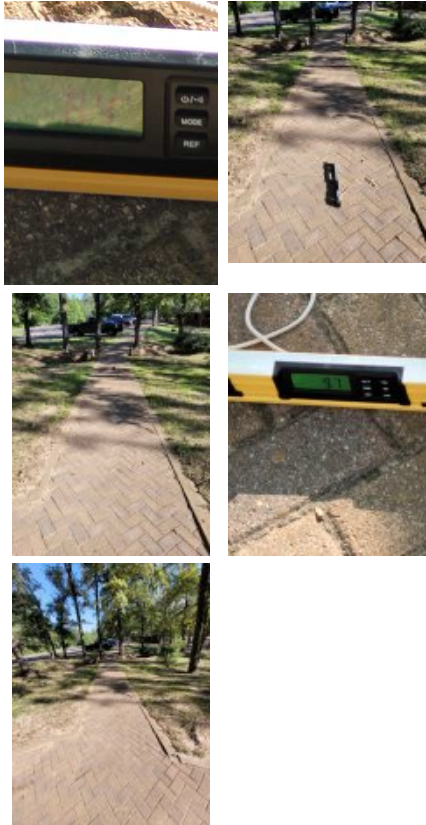
Finding Number	Area Description	Lat/Long	Finding	As Built	Recommendation	Citation	Photos	Figure
56	Day Use Area: Group Pavilion	[31.182808, -95.977745 9]	The running slope of any segment of an outdoor recreation access route shall not be steeper than 1:10 (10%). Where the running slope of a segment of an outdoor recreation access route is steeper than 1:20 (5%), the maximum length of the segment shall be in accordance with Table 1016.7.1, and a resting interval complying with 1016.8 shall be provided at the top and bottom of each segment. 5% to 8.33% - max length 50' 8.33% to 10% - max length 30'	route from pavilion to restrooms - 8.4%, 8%, 9.7% this is 30' or more of slope from Y to bridge	Correct or repair pathway running slope along AR to max 5% for any distance, 8.33% for 50' or 10% for 30' with level resting areas as a smart practice	2015 ABAAS Section: 1016.7, 1016.7.1

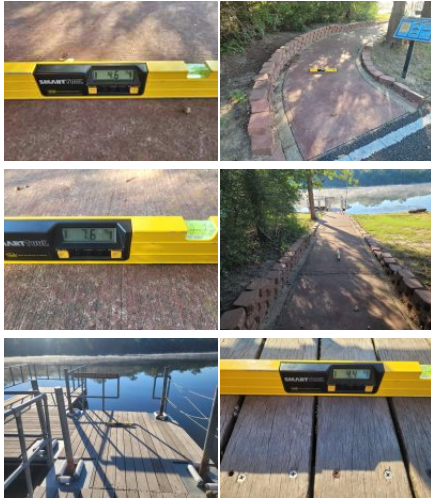
Finding Number	Area Description	Lat/Long	Finding	As Built	Recommendation	Citation	Photos	Figure
57	Day Use Area: Fishing Pier	[31.1832601, -95.9767757], [31.1832108, -95.9766778]	Accessible routes serving fishing piers and platforms, including gangways and floating piers, shall comply with Chapter 4. EXCEPTIONS: 1. Accessible routes serving floating fishing piers and platforms shall be permitted to use Exceptions 1, 2, 5, 6, 7 and 8 in 1003.2.1. 2. Where the total length of the gangway or series of gangways serving as part of a required accessible route is 30 feet (9145 mm) minimum, gangways shall not be required to comply with 405.2.	4.6% cross at curve, 7.6% running without landings, 4.4% on portion of pier that is sinking	Create an outdoor accessible route to the fishing pier or make corrections for a compliant route.	2015 ABAAS Section: 1005.1, 1005.1 EXCEPTIONS: 1, 1005.1 EXCEPTIONS: 2 2010 ADAS Section: 1005.1, 1005.1 Exception 1, 1005.1 Exception 2

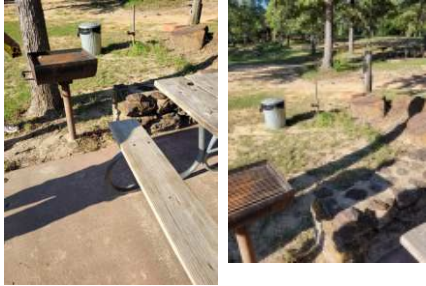
64	Day Use Area: Boat Ramp	[31.1829862 , -95.977124 8]	Where picnic facilities contain two or fewer picnic units, each picnic unit shall provide mobility features complying with F245.2.	Lacks route to grill, garbage, water	Extend an ORAR from picnic area to accessible features as a smart practice.	2015 ABAAS Section: F245.2.1

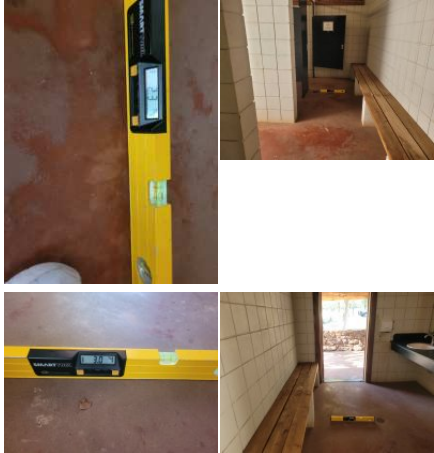
Finding Number	Area Description	Lat/Long	Finding	As Built	Recommendation	Citation	Photos	Figure
74	Day Use Area: Day Use - Men's Restroom	[31.18325, -95.97752]	The accessible route contains running slopes greater than 5 percent and cross slopes greater than 2 percent across the width of the walk and has not been constructed as a ramp (i.e. handrails, wheel guides, etc.). When the slope in the direction of travel of any walk exceeds 1 unit vertical in 20 units horizontal (5-percent slope), it must be constructed as ramp. Surface cross slopes must not exceed one unit vertical in 48 units. Horizontal (2-percent slope).	2.3% at drain by stalls, 3% at drain by sinks	Correct or repair slope to max 2.08% in restroom.	2015 ABAAS Section: 403.3 2012 TAS Section: 403.3 2010 ADAS Section: 403.3

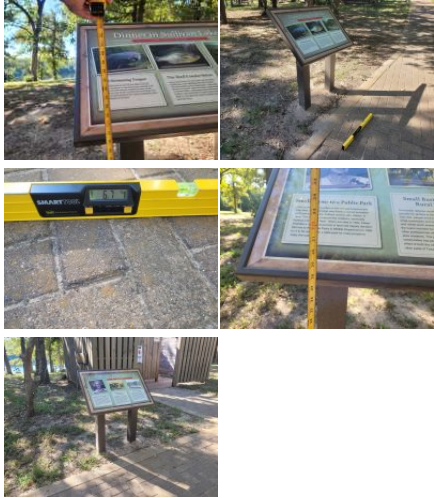
Finding Number	Area Description	Lat/Long	Finding	As Built	Recommendation	Citation	Photos	Figure
91	Day Use Area: Day Use - Showers	[31.1831714 , -95.976578 7]	Visual characters shall be 40 inches (1015 mm) minimum above the finish floor or ground. EXCEPTION: Visual characters indicating elevator car controls shall not be required to comply with 703.5.6.	Fish sign low; history sign low	Remount signage to min 40" AFF as a smart practice.	2015 ABAAS Section: 703.5.6, 703.5.6 EXCEPTION 2012 TAS Section: 703.5.6, 703.5.6 Exception 2010 ADAS Section: 703.5.6, 703.5.6 Exception

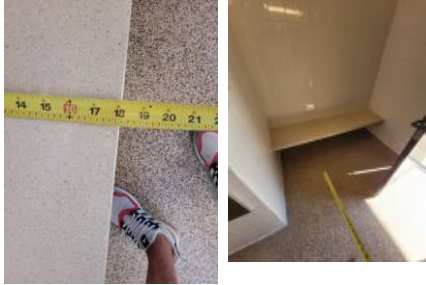
124	Cabins (1-5): New Restrooms	[31.18282, -95.97913]	Alternate roll-in type shower compartments shall be 36 inches (915 mm) wide and 60 inches (1525 mm) deep minimum clear inside dimensions measured at center points of opposing sides. A 36 inch (915 mm) wide minimum entry shall be provided at one end of the long side of the compartment.	Right Restroom - 37" width	Reconfigure shower stall, if feasible, to compliant dimensions for an alternate roll in shower of 36" deep by 60" wide with a 36" opening on the long dimension	2015 ABAAS Section: 608.2.3 2012 TAS Section: 608.2.3 2010 ADAS Section: 608.2.3

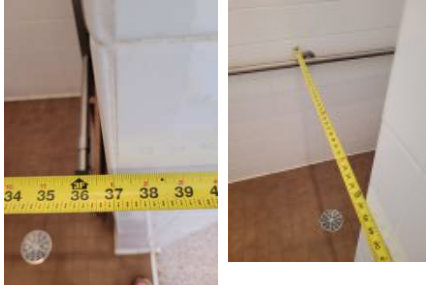
Finding Number	Area Description	Lat/Long	Finding	As Built	Recommendation	Citation	Photos	Figure
125	Cabins (1-5): New Restrooms	[31.18282, -95.97913]	The shower seat does not have a compliant space between it and the wall. The folding seat must be mounted 17-19 inches above the floor, and have a maximum space of 1-1/2 inches between the edge of the seat and the side wall and 2-1/2 inches maximum to the seat wall.	Right Restroom - seat mounted 6" from side wall, 21.5" from back wall	Remount shower seat to the correct location and height in the shower.	2015 ABAAS Section: 610.3.2 2012 TAS Section: 610.3.2 2010 ADAS Section: 610.3.2		
126	Cabins (1-5): New Restrooms	[31.1829469 , -95.979156 4]	It is recommended that exterior doors be maintained so that the operating pressure does not exceed 8.5 lb. force to open. The sweep period for doors with closers shall be adjusted so that from an open position of 70 degrees, the door will take at least 3 seconds to move to a point 7 inches from the latch, measured to the leading edge of the door.	Left restroom door - 15 lbf, fast closing	For all doors along the public circulation route, inspect, adjust, and maintain 8.5 lbf to open exterior doors as a smart practice For all doors along the public circulation route, inspect, adjust, and maintain closing speed on door closers	2012 TAS Section: 404.2.9, 404.2.9 Advisory, 404.2.8.1 2010 ADAS Section: 404.2.9, 404.2.8.1

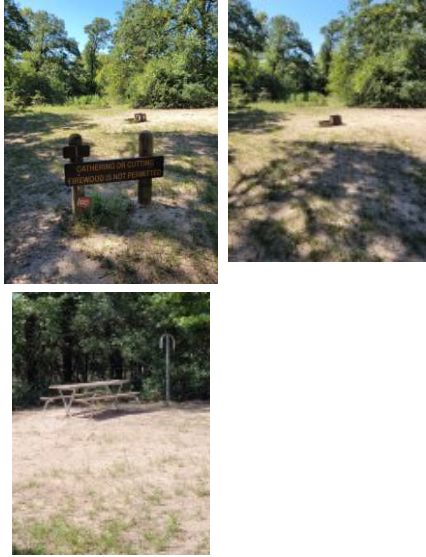
Finding Number	Area Description	Lat/Long	Finding	As Built	Recommendation	Citation	Photos	Figure
137	Primitive Camping Area (1-5): Sample Campsite	[31.17982, -95.98012]	Camping facilities shall provide camping units with mobility features complying with F244.2 in accordance with Table F244.2. Where a camping facility provides different types of camping units, Table F244.2 shall apply to each type of camping unit provided. Total Number of Camping Units Provided in Camping Facility Minimum Number of Camping Units with Mobility Features Required 1 1 2 to 25 2 26 to 50 3 51 to 75 4 76 to 100 5 101 to 150 7 151 to 200 8 201 and over 8, plus 2 percent of the number over 200	Primitive site 1 - lacks route to site; no route at site to elements; lacks accessible site elements	Create the required number of accessible camp sites per table F244.2 as a smart practice.	2015 ABAAS Section: F244.2
