Access Audit Site Report

Ft. Leaton State Historic Site

Accessibility Evaluation

Inspection Date: 09/22/2021

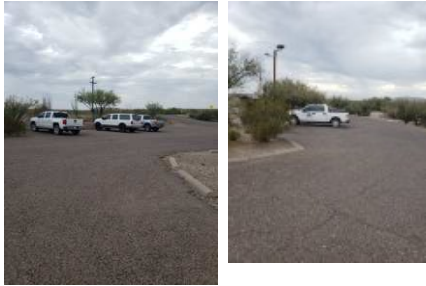
Finding Number	Area Description	Lat/Long	Finding	As Built	Recommendation	Citation	Photos	Figure
1	Exterior: Parking	[29.5427457, -104.3254141]	There are no accessible parking stalls. Each lot where parking is provided for the public as clients, guests or employees, shall provide accessible parking and shall be located on the shortest accessible route of travel from adjacent parking to an accessible entrance. There are a total of 25 parking stalls in the parking lot that could be reasonably associated with this facility. There should be a minimum of 1 accessible stalls with a minimum of 1 being designed as van accessible.	Lacks accessible parking spaces - approximately 25 standard, 0 accessible	Create one or more 8' accessible parking stalls, with one 5' adjacent access aisle, with proper signage and striping based on the total number of stalls.	2015 ABAAS Section: F208.2 2012 TAS Section: 208.2 2010 ADAS Section: 208.2

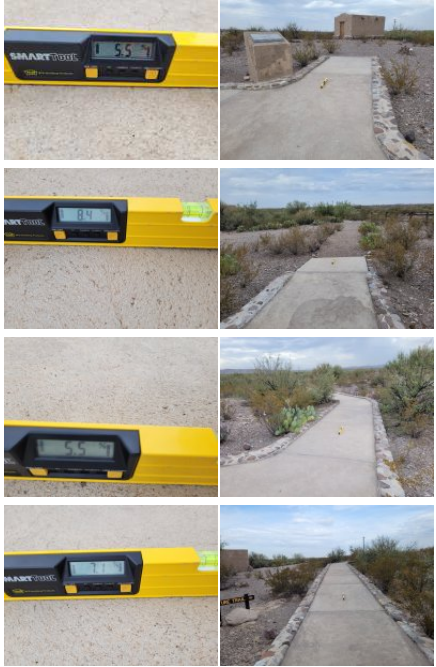
Finding Number	Area Description	Lat/Long	Finding	As Built	Recommendation	Citation	Photos	Figure
4	Exterior: Exterior Accessible Route	[29.5429744 , -104.3260 068]	The running slope of walking surfaces shall not be steeper than 1:20.	5.5% running slope to cemetery and overlapping sign CFS, 8.4% to nature trail, 5.5% near cemetery sign, 7.1% heading uphill towards cemetery	Correct running slope along the AR to max 5%.	2015 ABAAS Section: 403.3 2012 TAS Section: 403.3 2010 ADAS Section: 403.3

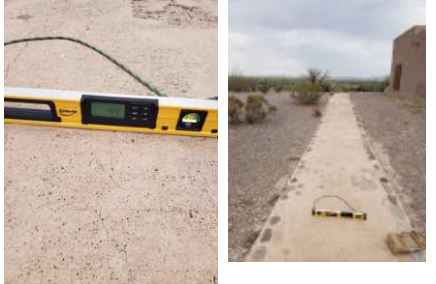
6	Exterior: Exterior Accessible Route	[29.5425147 , -104.3261 999]	The accessible route of travel on the accessible route contains cross slopes greater than 2%. Cross slopes shall not exceed one unit vertical in 48 units horizontal (2-percent slope).	Cross slope of 4.4% at section where the new and old entrance path intersect	Correct or repair cross slope along AR to max 2.08%.	2015 ABAAS Section: 403.3 2012 TAS Section: 403.3 2010 ADAS Section: 403.3

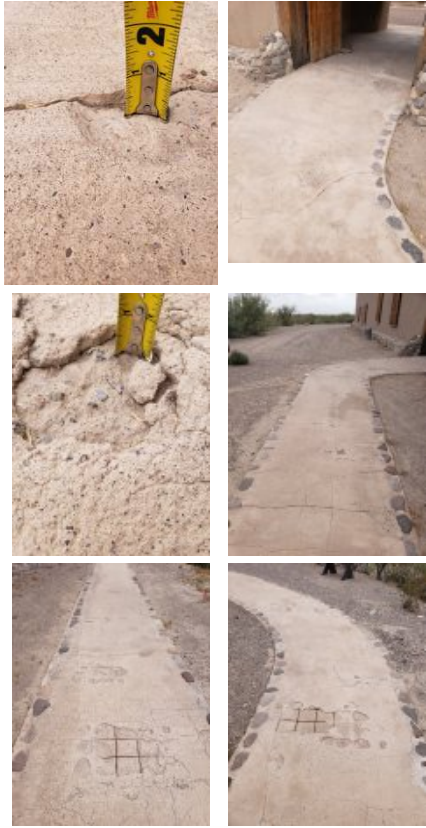
Finding Number	Area Description	Lat/Long	Finding	As Built	Recommendation	Citation	Photos	Figure
7	Exterior: Exterior Accessible Route	[29.5423412, -104.3264619]	The accessible route contains loose gravel and/or surfaces that do not provide for a stable, firm slip resistant surface.	Most of the older section of the entrance path has cracks exceeding .5", with deterioration causing CILs exceeding .25"	Resurface AR where deterioration occurs.	2015 ABAAS Section: 302.1 2012 TAS Section: 302.1 2010 ADAS Section: 302.1

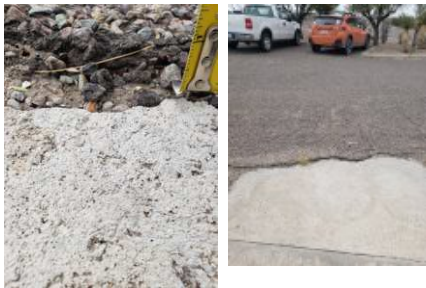
8	Exterior: Exterior Accessible Route	[29.5426212, -104.3252938]	The walkway contains abrupt vertical edges and/or variations over a 1/4 inch. 1/4 inch is the maximum vertical rise. Changes in level between 1/4 inch and 1/2 inch must be beveled at 1:2 or less. Changes in level greater than 1/2 inch must be by way of a ramp.	CIL exceeding .25" at transition from parking to picnic area	Repair, bevel or ramp CIL along AR.	2012 TAS Section: 303.2, 303.3 2010 ADAS Section: 303.2, 303.3

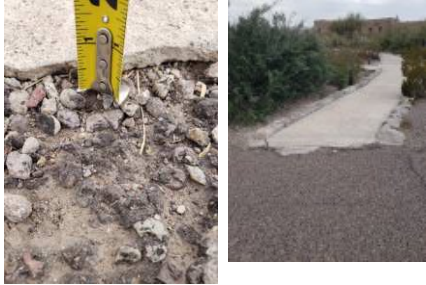
Finding Number	Area Description	Lat/Long	Finding	As Built	Recommendation	Citation	Photos	Figure
9	Exterior: Exterior Accessible Route	[29.542795, -104.32559 15]	The walkway contains abrupt vertical edges and/or variations over a 1/4 inch. 1/4 inch is the maximum vertical rise. Changes in level between 1/4 inch and 1/2 inch must be beveled at 1:2 or less. Changes in level greater than 1/2 inch must be by way of a ramp.	CIL exceeding .25" at transition from parking to entrance walkway	Repair, bevel or ramp CIL along AR.	2012 TAS Section: 303.2, 303.3 2010 ADAS Section: 303.2, 303.3

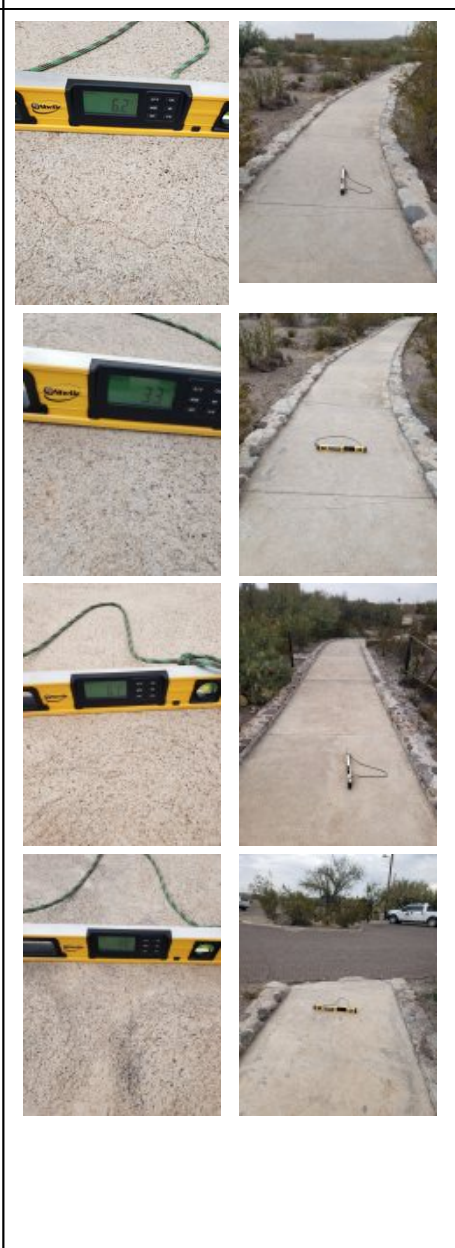
Finding Number	Area Description	Lat/Long	Finding	As Built	Recommendation	Citation	Photos	Figure
10	Exterior: Exterior Accessible Route	[29.5427924, -104.3256005]	The accessible route has running slopes greater than 5% and has not been constructed as a ramp (i.e. handrails, edge protection, etc.). Cross slopes are greater than 2% across the width of the walk. When the slope in the direction of travel of any walk exceeds 1 unit vertical in 20 units horizontal (5-percent slope), it must be constructed as a ramp. Surface cross slopes must not exceed 1 unit vertical in 48 units horizontal (2-percent slope).	Newer section of entrance walkway - running slopes of 6.2% and 6.1%, cross slopes of 3.3% and 3%	Correct or repair sidewalk cross slope along AR to max 2.08%. Correct or repair sidewalk running slope along AR to max 5%.	2015 ABAAS Section: 403.3 2012 TAS Section: 403.3 2010 ADAS Section: 403.3

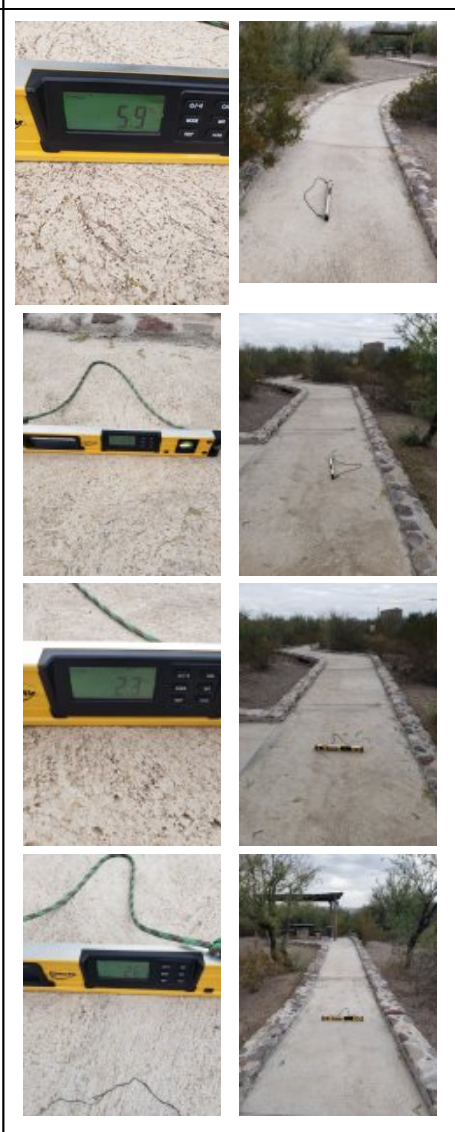
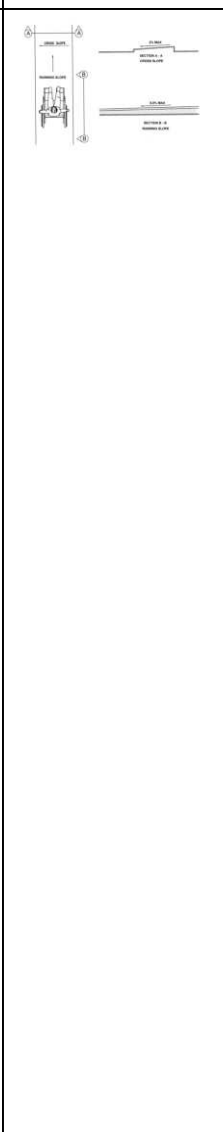
Finding Number	Area Description	Lat/Long	Finding	As Built	Recommendation	Citation	Photos	Figure
11	Exterior: Exterior Accessible Route	[29.5425917, -104.3255213]	The accessible route has running slopes greater than 5% and has not been constructed as a ramp (i.e. handrails, edge protection, etc.). Cross slopes are greater than 2% across the width of the walk. When the slope in the direction of travel of any walk exceeds 1 unit vertical in 20 units horizontal (5-percent slope), it must be constructed as a ramp. Surface cross slopes must not exceed 1 unit vertical in 48 units horizontal (2-percent slope).	Picnic area path - running slopes of 5.9% and 5.9%, cross slopes of 2.3% and 2.6%	Correct or repair sidewalk cross slope along AR to max 2.08%. Correct or repair sidewalk running slope along AR to max 5%.	2015 ABAAS Section: 403.3 2012 TAS Section: 403.3 2010 ADAS Section: 403.3

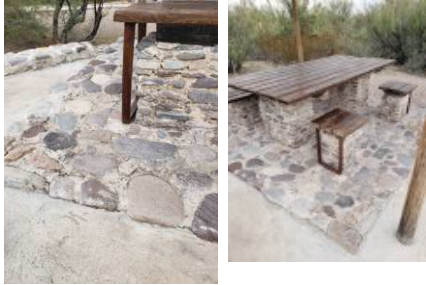
Finding Number	Area Description	Lat/Long	Finding	As Built	Recommendation	Citation	Photos	Figure
12	Picnic Areas: Picnic Areas	[29.5424972 , -104.3255 804]	The surface of the route to and into the picnic area or shelter must be firm and stable.	Lacks firm and stable surface at picnic area - surface is uneven cobble stone	Replace floor surface at one shelter/picnic area with one that is firm, stable, and slip resistant.	2015 ABAAS Section: 1016.1, 1016.1 EXCEPTION S 1, 1016.1 EXCEPTION S 2, 1016.1 EXCEPTION S 3

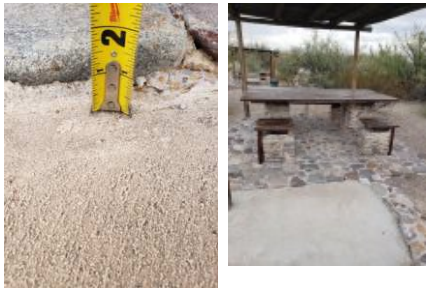
13	Picnic Areas: Picnic Areas	[29.54251, - 104.325564 3]	The walkway contains abrupt vertical edges and/or variations over a 1/4 inch. 1/4 inch is the maximum vertical rise. Changes in level between 1/4 inch and 1/2 inch must be beveled at 1:2 or less. Changes in level greater than 1/2 inch must be by way of a ramp.	1" CIL in CGS of wheelchair space at picnic table	Repair, bevel or ramp CIL along AR.	2012 TAS Section: 303.2, 303.3 2010 ADAS Section: 303.2, 303.3

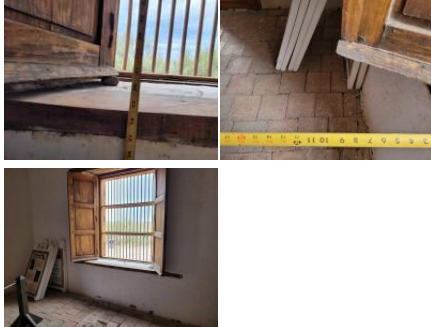
Finding Number	Area Description	Lat/Long	Finding	As Built	Recommendation	Citation	Photos	Figure
22	Fort Leaton: Public Spaces	[29.5424167, -104.3266023]	The window shutters project more than 4 inches into the circulation path. Wall-mounted objects that have leading edges between 27 inches and 80 inches from the floor must not project more than 4 inches into the circulation path. Protruding objects that extend to the floor or within 27 inches of the floor are cane detectable and are therefore not hazardous. Where it is necessary or desirable to have objects protrude from the wall, a manner of cane detection must be provided.	Formal parlor (3) - Internal window shutters protrude 10" when in open position.	Relocate protruding objects or place cane detectable warning or bollard at foot of item.	2015 ABAAS Section: 307.2 2012 TAS Section: 307.2 2010 ADAS Section: 307.2

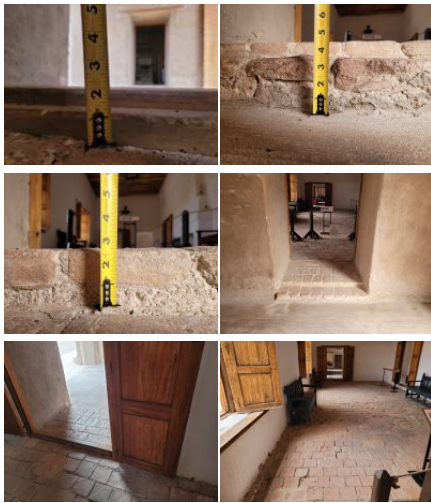
23	Fort Leaton: Public Spaces	[29.5424225, -104.3266251]	There is a change in level greater than 1/4 inch. 1/4 inch is the maximum vertical rise. Changes in level between 1/4 inch and 1/2 inch must be beveled at 1:2 or less. Changes in level greater than 1/2 inch must be by way of a ramp.	Formal parlor (3) - CILs to enter, multiple CILs in original flooring	Repair, bevel or ramp CIL along AR to max .25".	2015 ABAAS Section: 303.3 2012 TAS Section: 303.3 2010 ADAS Section: 303.3

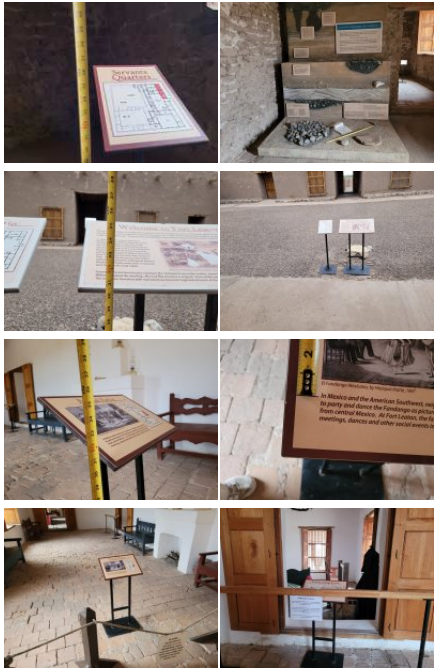
26	Fort Leaton: Public Spaces	[29.542453, -104.3267703]	The sign providing directional and information is noncompliant. Signs that identify, direct to or give information about accessible elements and features of a building or site, shall have a non-glare finish, contrast with their background, be selected from fonts where the width of the uppercase letter "O" is 55 percent minimum and 110 percent maximum of the height of the uppercase letter "I". Characters shall be uppercase or lowercase or a combination of both, conventional in form and shall not be italic, oblique, script, highly decorative, or of other unusual forms and be sized according to the viewing distance. Visual characters shall be 40 inches (1015 mm) minimum above the finish floor or ground.	Maps and exhibit signs less than 40" AGL, text less than 5/8" high where details provided; bar located in front of sign for family sitting room makes it difficult to read sign at lower heights	Create template for signs that addresses height of sign, size of characters, location of Braille, and other requirements (checklist). Remount signage to be a min of 40" AGL (above ground level).	2015 ABAAS Section: F216.3 2012 TAS Section: 216.3 2010 ADAS Section: 216.3, 703.5.6 Exception

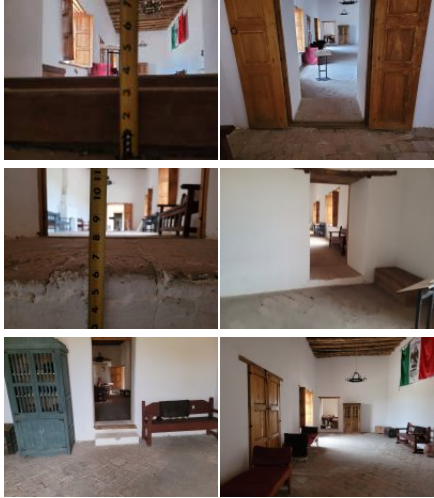
29	Fort Leaton: Public Spaces	[29.5424727, -104.3268142]	There is a change in level greater than 1/4 inch. 1/4 inch is the maximum vertical rise. Changes in level between 1/4 inch and 1/2 inch must be beveled at 1:2 or less. Changes in level greater than 1/2 inch must be by way of a ramp.	Family parlor (2) - CILs to enter the space and adjoining spaces	Repair, bevel or ramp CIL along AR to max .25".	2015 ABAAS Section: 303.3 2012 TAS Section: 303.3 2010 ADAS Section: 303.3

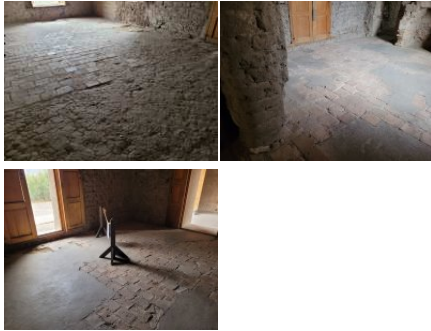
35	Fort Leaton: Public Spaces	[29.5423735, -104.3263287]	Openings in floor or ground surfaces shall not allow passage of a sphere more than 1/2 inch (13 mm) diameter except as allowed in 407.4.3, 409.4.3, 410.4, 810.5.3 and 810.10. Elongated openings shall be placed so that the long dimension is perpendicular to the dominant direction of travel.	Servant's quarters (4, 5, 6) - Original flooring has multiple gaps	Fill and maintain gaps to max .5".	2015 ABAAS Section: 302.3 2012 TAS Section: 302.3 2010 ADAS Section: 302.3

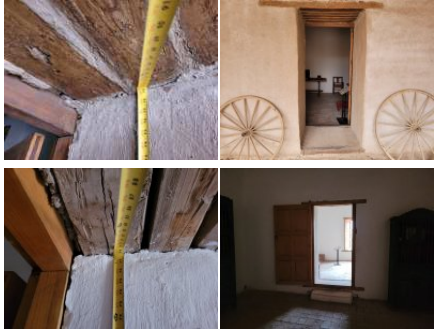
Finding Number	Area Description	Lat/Long	Finding	As Built	Recommendation	Citation	Photos	Figure
36	Fort Leaton: Public Spaces	[29.5425193, -104.3267257]	The entryways extends down too close to the route of travel. Any obstruction that overhangs a route of travel must be a minimum of 80 inches above the walking surface as measured from the bottom of the obstruction.	Dining room (11) - Entryways at 78" and 79" AGL	Raise entryways to min 80", or pad object to prevent hazard in overhead clearance along AR.	2015 ABAAS Section: 307.4 2012 TAS Section: 307.4 2010 ADAS Section: 307.4

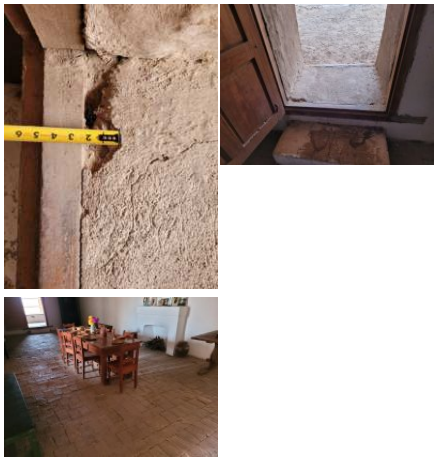
38	Fort Leaton: Public Spaces	[29.5425123, -104.3267176]	Openings in floor or ground surfaces shall not allow passage of a sphere more than 1/2 inch (13 mm) diameter except as allowed in 407.4.3, 409.4.3, 410.4, 810.5.3 and 810.10. Elongated openings shall be placed so that the long dimension is perpendicular to the dominant direction of travel.	Dining room (11) - 2" gap in doorway, gaps in original flooring	Fill and maintain gaps to max .5".	2015 ABAAS Section: 302.3 2012 TAS Section: 302.3 2010 ADAS Section: 302.3

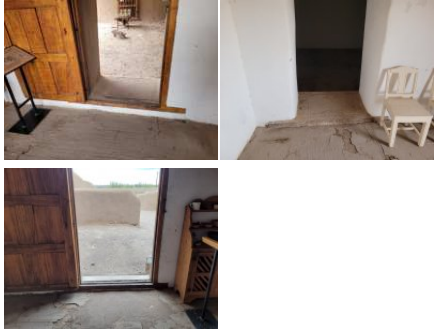
Finding Number	Area Description	Lat/Long	Finding	As Built	Recommendation	Citation	Photos	Figure
42	Fort Leaton: Public Spaces	[29.542594, -104.3266693]	There is a change in level greater than 1/4 inch. 1/4 inch is the maximum vertical rise. Changes in level between 1/4 inch and 1/2 inch must be beveled at 1:2 or less. Changes in level greater than 1/2 inch must be by way of a ramp.	Kitchen (14) and pantry (13) - CILs at each entryway	Repair, bevel or ramp CIL along AR to max .25".	2015 ABAAS Section: 303.3 2012 TAS Section: 303.3 2010 ADAS Section: 303.3

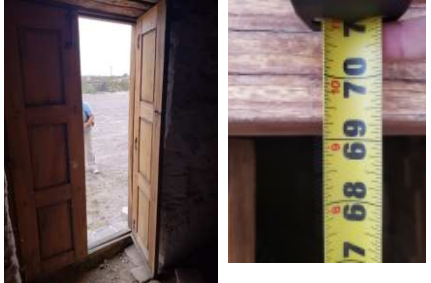
56	Fort Leaton: Employee Spaces	[29.5424486, -104.3264134]	Minimum maneuvering clearances at doors and gates shall comply with 404.2.4. Maneuvering clearances shall extend the full width of the doorway and the required latch side or hinge side clearance. Door openings shall provide a clear width of 32 inches (815 mm) minimum. Clear openings of doorways with swinging doors shall be measured between the face of the door and the stop, with the door open 90 degrees. Openings more than 24 inches (610 mm) deep shall provide a clear opening of 36 inches (915 mm) minimum. There shall be no projections into the required clear opening width lower than 34 inches (865 mm) above the finish floor or ground.	Warehouse door - lacks accessible route, steps at different heights, CIL at threshold, to pull side maneuvering clearance, 69" high door	For all doors along the public circulation route, provide required maneuvering clearance on push and pull side of doors. For all doors along the public circulation route, replace doors with doors having 80" overhead clearance and 32" clear width. For all doors along the public circulation route, repair, bevel, or ramp CILs at door entries to max .25". Create AR with crushed and compacted stone or similar outdoor material from parking or sidewalk to building entrance. Correct riser heights on stairs to consistent height between 4" to 7", leave as is if technically infeasible.	2010 ADAS Section: 404.2.3, 404.2.7, 404.2.4, 404.2.11, 404.2.11 Exception

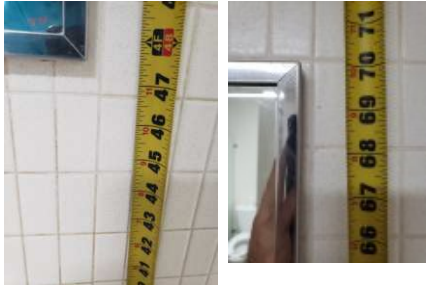
Finding Number	Area Description	Lat/Long	Finding	As Built	Recommendation	Citation	Photos	Figure
59	Fort Leaton: Men's Restroom	[29.5425707, -104.3265299]	The mirror is mounted too high. Mirrors must have the bottom edge of the reflecting surface a maximum of 40 inches above the floor if above a sink or counter. Mirrors not located above lavatories or countertops shall be installed with the bottom edge of the reflecting surface 35 inches maximum above the finish floor or ground.	Bottom edge at 48" AFF, top edge at 69.5" AFF	Lower mirror so bottom reflective surface is max 40" AFF and 74" at the top.	2015 ABAAS Section: 603.3 2012 TAS Section: 603.3 2010 ADAS Section: 603.3

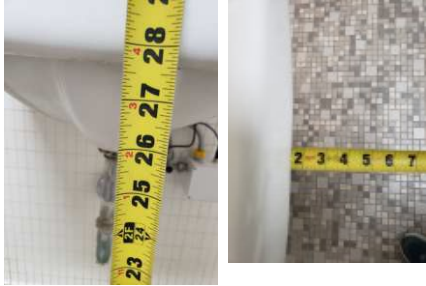
60	Fort Leaton: Men's Restroom	[29.5425695, -104.3265299]	Knee clearance at 27 inches off the floor is not 8 inches minimum deep. The knee clearance, measured from the bottom of the apron or the outside bottom edge of the lavatory, must be 27 inches at a point located 8 inches back from the front edge and continuing to 11 inches minimum in depth at 9 inches above the floor. The top of the lavatory rim may be no higher than 34 inches.	Sink lacks knee clearance	Raise sink to provide 27" knee clearance that is a min 8" deep.	2015 ABAAS Section: 306.3.1, 306.3.2, 306.3.3, 306.3.4, 306.3.5 2012 TAS Section: 306.3.2, 306.3.3, 306.3.4, 306.3.5, 306.3.1 2010 ADAS Section: 306.3.3, 306.3.2, 306.3.4, 306.3.5, 306.3.1

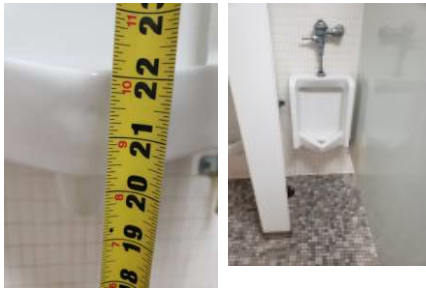
62	Fort Leaton: Men's Restroom	[29.5425637, -104.3264869]	The rim of the urinal is too high. Wall-hung urinals must be provided with an elongated rim projecting a minimum of 13 1/2 inches from the wall and a maximum of 17 inches above the floor.	Lowest urinal rim at 22" AFF	Lower urinal so that rim height is max 17" AFF.	2015 ABAAS Section: 605.2 2012 TAS Section: 605.2 2010 ADAS Section: 605.2

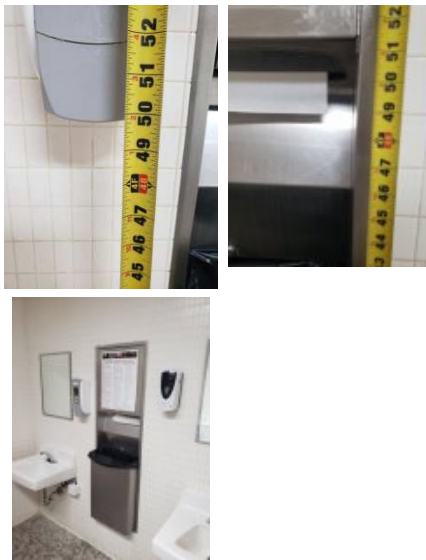
Finding Number	Area Description	Lat/Long	Finding	As Built	Recommendation	Citation	Photos	Figure
65	Fort Leaton: Men's Restroom	[29.5425637 , -104.3264 708]	Where a high forward reach is over an obstruction, the clear floor space shall extend beneath the element for a distance not less than the required reach depth over the obstruction. The high forward reach shall be 48 inches (1220 mm) maximum where the reach depth is 20 inches (510 mm) maximum. Where the reach depth exceeds 20 inches (510 mm), the high forward reach shall be 44 inches (1120 mm) maximum and the reach depth shall be 25 inches (635 mm) maximum. Where a clear floor or ground space allows a parallel approach to an element and the high side reach is over an obstruction, the height of the obstruction shall be 34 inches (865 mm) maximum and the depth of the obstruction shall be 24 inches (610 mm) maximum. The high side reach shall be 48 inches (1220 mm) maximum for a reach depth of 10 inches (255 mm) maximum. Where the reach depth exceeds 10 inches (255 mm), the high side reach shall be 46 inches (1170 mm) maximum for a reach depth of 24 inches (610 mm) maximum.	Soap and paper towel dispensers at 50" AFF	Lower soap dispenser to max 44" above the finished floor (AFF) for a forward reach over counter.	2015 ABAAS Section: 308.2.1, 308.3.2 2012 TAS Section: 308.2.1, 308.3.2 2010 ADAS Section: 308.2.1, 308.3.2

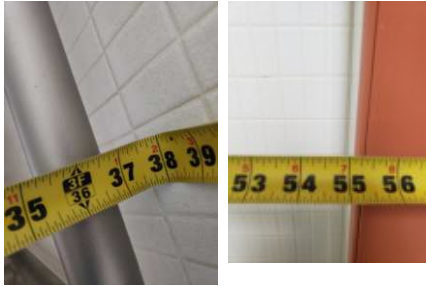
Finding Number	Area Description	Lat/Long	Finding	As Built	Recommendation	Citation	Photos	Figure
67	Fort Leaton: Men's Restroom	[29.542559, -104.32646 01]	The ambulatory stall is not between 35" to 37" wide and 60" deep.	Ambulatory stall lacks required dimensions - 38" wide x 55" deep	Correct ambulatory stall to be 35" to 37" wide and minimum 60" deep.	2015 ABAAS Section: 604.8.2.1 2012 TAS Section: 604.8.2.1 2010 ADAS Section: 604.8.2.1

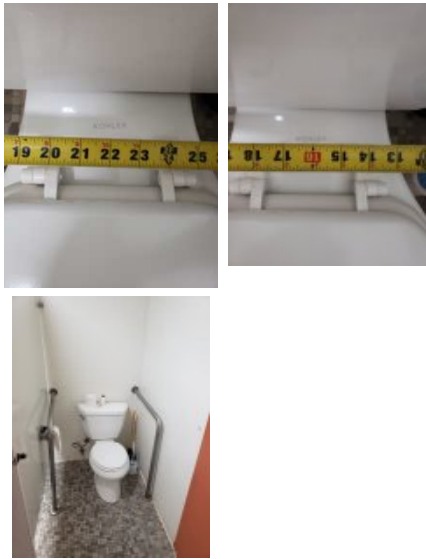
68	Fort Leaton: Men's Restroom	[29.5425567, -104.3264 574]	The toilet is not located within the range to the side wall or partition. The centerline of the toilet shall be 17 inches minimum and 19 inches maximum side wall or partition in the ambulatory accessible toilet compartment.	22" left, 16" right	Remount toilet to 17" to 19" from the side wall to center line in ambulatory stalls.	2015 ABAAS Section: 604.9.1 2012 TAS Section: 604.9.1 2010 ADAS Section: 604.9.1

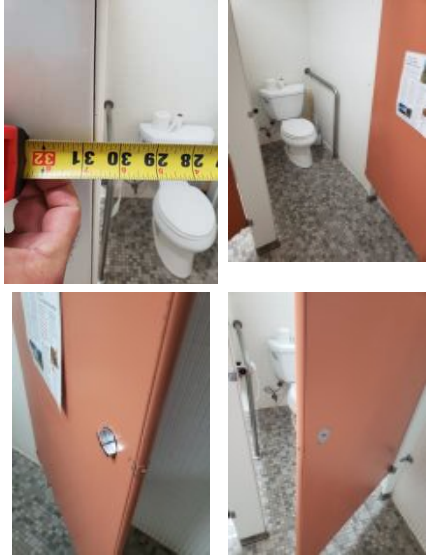
Finding Number	Area Description	Lat/Long	Finding	As Built	Recommendation	Citation	Photos	Figure
69	Fort Leaton: Men's Restroom	[29.5425567 , -104.3264 494]	The stall door fails to comply with all of the door requirements. The stall door must be a minimum of 32" wide and have compliant hardware on both sides. The stall door must be self-closing.	door 30.5", not self-closing, and hardware is not compliant	Widen stall doors to 32" when opened to 90 degrees. Adjust stall door to be self-closing. Replace stall hardware with hardware operable without a tight pinch or grasp on both sides of the stall door.	2015 ABAAS Section: 404.2.3, 404.2.7, 604.8.2.2 2012 TAS Section: 404.2.3, 404.2.7, 604.8.2.2 2010 ADAS Section: 404.2.3, 404.2.7, 604.8.2.2

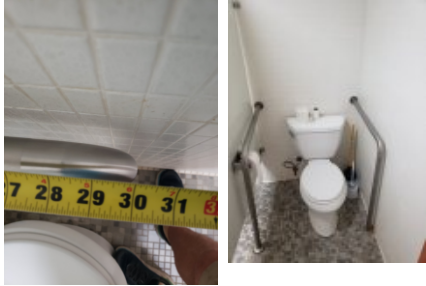
70	Fort Leaton: Men's Restroom	[29.542559, -104.32644 94]	Grab bars shall comply with 609. A side-wall grab bar complying with 604.5.1 shall be provided on both sides of the compartment. The space between the wall and the grab bar shall be 1½ inches (38 mm). The space between the grab bar and projecting objects below and at the ends shall be 1½ inches (38 mm) minimum. The space between the grab bar and projecting objects above shall be 12 inches (305 mm) minimum. Grab bars shall be installed in a horizontal position, 33 inches (840 mm) minimum and 36 inches (915 mm) maximum above the finish floor measured to the top of the gripping surface, except that at water closets for children's use complying with 604.9, grab bars shall be installed in a horizontal position 18 inches (455 mm) minimum and 27 inches (685 mm) max	Grab bars are 30" long	Replace or add side grab bars with a 42" long grab bar, mounted max 12" from the rear wall at the close end and min 54" on the far end and 33" to 36" AFF.	2015 ABAAS Section: 604.8.2.3, 609.3, 609.4 2012 TAS Section: 609.4, 609.3, 604.8.2.3 2010 ADAS Section: 609.3, 609.4, 604.8.2.3

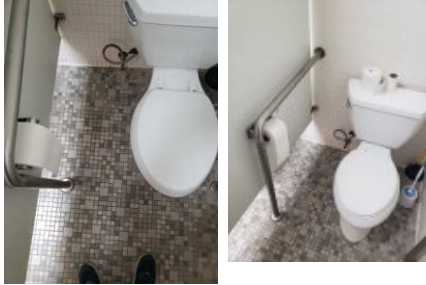
Finding Number	Area Description	Lat/Long	Finding	As Built	Recommendation	Citation	Photos	Figure
73	Fort Leaton: Men's Restroom	[29.5425544 , -104.3264 507]	The toilet paper is not installed within the compliant range in front of the toilet. Toilet paper dispensers shall be 7 inches minimum and 9 inches maximum in front of the water closet measured to the centerline of the dispenser. The outlet of the dispenser shall be 15 inches minimum and 48 inches maximum above the finish floor and shall not be located behind grab bars. Dispensers shall not be of a type that controls delivery or that does not allow continuous paper flow. There shall be a clearance of 1 1/2 inches minimum below the grab bar.	Toilet paper mounted behind front of toilet	Remount toilet paper dispenser max 7" to 9" from front of toilet, 15" to 48" AFF and min 12" above or 1.5" below grab bar.	2015 ABAAS Section: 604.7 2012 TAS Section: 604.7 2010 ADAS Section: 604.7

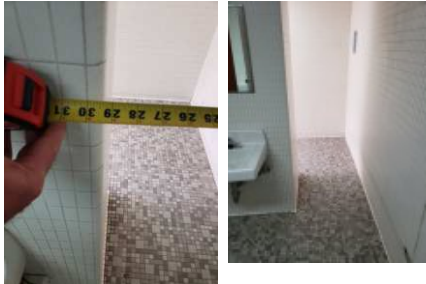
74	Fort Leaton: Men's Restroom	[29.5425544 , -104.3264 601]	The route of travel at this location does not provide a minimum width of 36 inches. The clear width shall be permitted to be reduced to 32 inches minimum for a length of 24 inches maximum provided that reduced width segments are separated by segments that are 48 inches long minimum and 36 inches wide minimum.	Entrance to restroom is 29" wide	Widen AR to compliant 36" clear width	2015 ABAAS Section: 403.5.1 2012 TAS Section: 403.5.1 2010 ADAS Section: 403.5.1

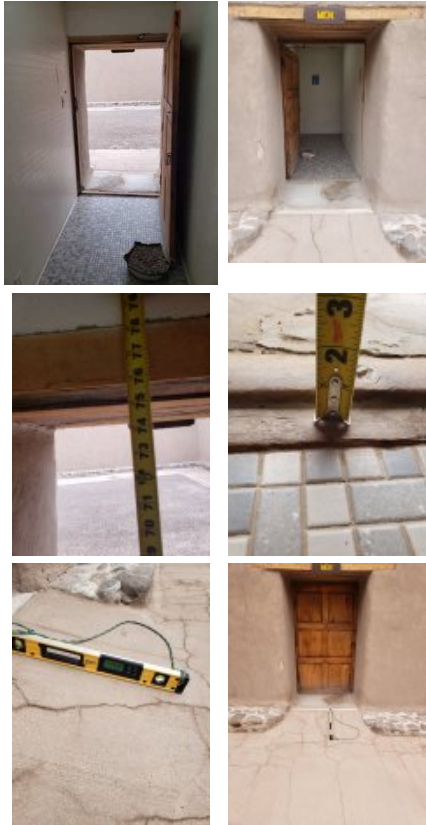
Finding Number	Area Description	Lat/Long	Finding	As Built	Recommendation	Citation	Photos	Figure
75	Fort Leaton: Men's Restroom	[29.5425579 , -104.3264 615]	Minimum maneuvering clearances at doors and gates shall comply with 404.2.4. Maneuvering clearances shall extend the full width of the doorway and the required latch side or hinge side clearance. Maneuvering clearances shall have a max slope of 2.08%. The threshold has a vertical change greater than 1/4 inch high. The sweep period for doors with closers shall be adjusted so that from an open position of 70 degrees, the door will take at least 3 seconds to move to a point 3 inches from the latch, measured to the leading edge of the door. Exterior doors are recommended to be maintained at 8.5 lbf as a smart practice. Force is to be measured at the operating hardware or 30 inches from the hinges, whichever is greater.	Men's restroom door - 26# push, fast close, lacks push and pull maneuvering clearance (structural), .5" CIL in threshold, slope to door 25.7%	For all doors along the public circulation route, provide required maneuvering clearance on push and pull side of doors. For all doors along the public circulation route, correct slope in door clearance to max 2.08%. For all doors along the public circulation route, repair, bevel, or ramp CILs at door entries to max .25". For all doors along the public circulation route, inspect, adjust, and maintain closing speed on door closers. For all doors along the public circulation route, inspect, adjust, and maintain 8.5 lbf to open exterior doors as a smart practice.	2010 ADAS Section: 404.2.3, 404.2.7, 404.2.4, 404.2.11, 404.2.11 Exception
