Access Audit Site Report

Fort Parker State Park

Accessibility Evaluation

Inspection Date: 03/03/2022

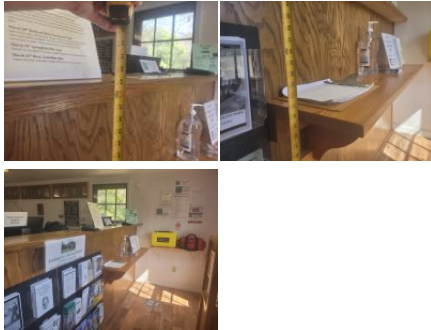
Finding Number	Area Description	Lat/Long	Finding	As Built	Recommendation	Citation	Photos	Figure
10	Headquarters (HQ) : HQ - Public Spaces	[31.5923243 , -96.526669 7]	The transaction counter is too high. A portion of the counter surface that is 36 inches long minimum and 36 inches high maximum above the finish floor shall be provided. Knee and toe space must be provided for a forward approach. A 30 inch by 48 inch clear floor space on an accessible route must be provided for either a forward or parallel approach.	Service counter at 50" AFF - lowered counter that is in front of the high counter is compliant height	Lower 36" wide segment of service counter to max 36" AFF.	2015 ABAAS Section: 904.4.2, 904.4.1 2012 TAS Section: 904.4.1, 904.4.2 2010 ADAS Section: 904.4.2, 904.4.1

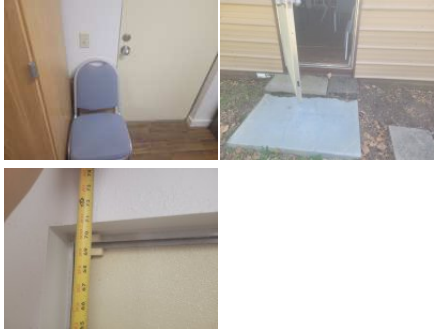
Finding Number	Area Description	Lat/Long	Finding	As Built	Recommendation	Citation	Photos	Figure
15	Headquarters (HQ) : HQ - Employee Spaces	[31.592353, -96.526668 6]	Minimum maneuvering clearances at doors and gates shall comply with 404.2.4. Maneuvering clearances shall extend the full width of the doorway and the required latch side or hinge side clearance. Maneuvering clearances shall have a max slope of 2.08%. Door openings shall provide a clear width of 32 inches (815 mm) minimum. Clear openings of doorways with swinging doors shall be measured between the face of the door and the stop, with the door open 90 degrees. Openings more than 24 inches (610 mm) deep shall provide a clear opening of 36 inches (915 mm) minimum. There shall be no projections into the required clear opening width lower than 34 inches (865 mm) above the finish floor or ground. Projections into the clear opening width between 34 inches (865 mm) and 80 inches (2030 mm) above the finish floor or ground shall not exceed 4 inches (100 mm). The threshold has a vertical change greater than 1/4 inch high. Hand-activated door opening hardware, handles, pulls, latches, locks, and other operating devices on accessible doors shall have a shape that is easy to grasp with one hand and does not require tight grasping, tight pinching or twisting of the wrist to operate. Hardware shall be 34 inches minimum and 48 inches maximum above the finish floor or ground.	Back door - steps, knob, 69.75" clearance, chair pull side	For all doors along the public circulation route, provide required maneuvering clearance on push and pull side of doors. For all doors along the public circulation route, replace doors with doors having 80" overhead clearance and 32" clear width. For all doors along the public circulation route, repair, bevel, or ramp CILs at door entries to max .25". For all doors along the public circulation route, replace hardware with lever hardware or hardware operable without a tight pinch or grasp.	2010 ADAS Section: 404.2.3, 404.2.7, 404.2.4, 404.2.11, 404.2.11 Exception

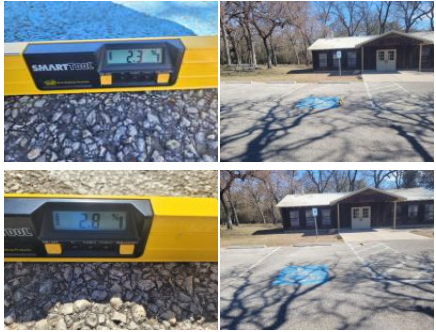
Finding Number	Area Description	Lat/Long	Finding	As Built	Recommendation	Citation	Photos	Figure
23	Group Barracks : Group Barracks - Parking	[31.59189, -96.53038]	Element meets all standards and requirements	Parking at group barracks meets scoping requirements - 11 standard, 1 accessible	None	2010 ADAS Section: N/A		
24	Group Barracks : Group Barracks - Parking	[31.592259, -96.530321]	The cross slopes (narrow dimension) and/or running slopes (long dimension) of the access aisle exceeds 2%. The running slope and the cross slope in an accessible parking stall and the access aisle must not exceed 2%.	group barracks- slopes of 2.3% in stall, 2.8% in AA	Repair or correct slope of parking space and access aisle to max 2.08% in any direction.	2015 ABAAS Section: 502.4 2012 TAS Section: 502.4 2010 ADAS Section: 502.4

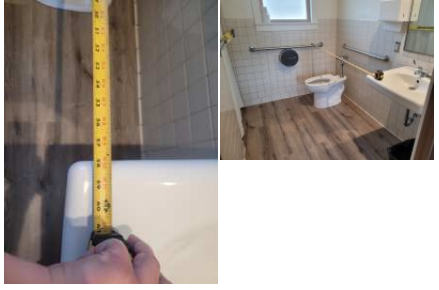
67	Group Barracks : Group Barracks - "Staff" Buildings	[31.5920819 , -96.530068 9]	The toilet is not located within the range allowed from the side wall or partition. The centerline of the toilet must be 16 to 18 inches from the side wall.	restroom in barracks without kitchen- centerline 19.5" to wall	Remount toilets to 16" to 18" from the side wall to centerline.	2015 ABAAS Section: 604.2 2012 TAS Section: 604.2 2010 ADAS Section: 604.2

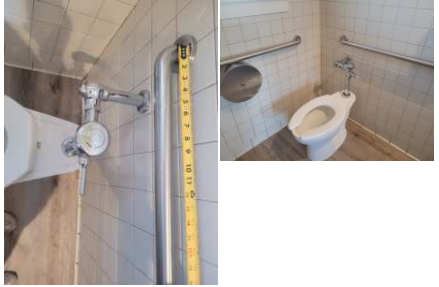
Finding Number	Area Description	Lat/Long	Finding	As Built	Recommendation	Citation	Photos	Figure
69	Group Barracks : Group Barracks - "Staff" Buildings	[31.5920751 , -96.530044 7]	The grab bar height and/or spacing fails. Grab bars must be mounted between 33" and 36" to the top of the gripping surface. There must be 1.5" of clearance between the grab bar and the wall. There must be a minimum of 1.5" of clearance below and minimum 12" above the grab bar to any dispenser or other obstruction.	restroom in barracks without kitchen- TP dispenser mounted against bottom of side bar	Remount toilet paper dispenser max 7" to 9" from front of toilet, 15" to 48" above the finished floor (AFF) and min 12" above or 1.5" below grab bar.	2015 ABAAS Section: 609.3, 609.4 2012 TAS Section: 609.4, 609.3 2010 ADAS Section: 609.3, 609.4

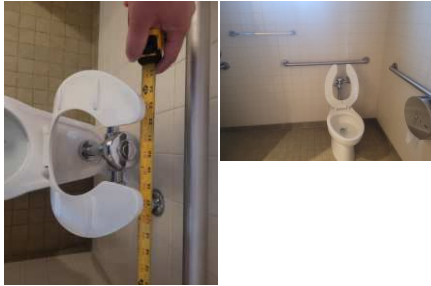
84	Group Barracks : Group Barracks - "Staff" Buildings	[31.5920728 , -96.530052 8]	The grab bar height and/or spacing fails. Grab bars must be mounted between 33" and 36" to the top of the gripping surface. There must be 1.5" of clearance between the grab bar and the wall. There must be a minimum of 1.5" of clearance below and minimum 12" above the grab bar to any dispenser or other obstruction.	barracks with kitchen dorm restroom- TP dispenser .5" below side bar	Remount toilet paper dispenser max 7" to 9" from front of toilet, 15" to 48" above the finished floor (AFF) and min 12" above or 1.5" below grab bar.	2015 ABAAS Section: 609.3, 609.4 2012 TAS Section: 609.4, 609.3 2010 ADAS Section: 609.3, 609.4

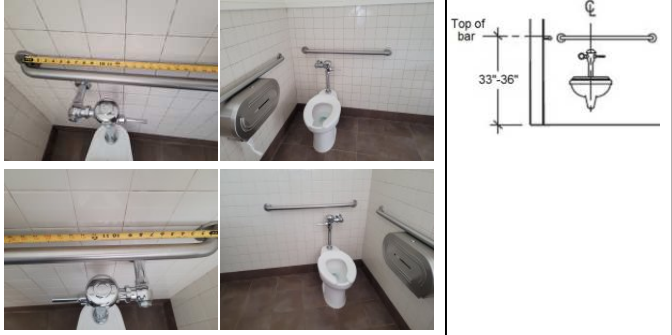
Finding Number	Area Description	Lat/Long	Finding	As Built	Recommendation	Citation	Photos	Figure
119	Group Barracks : Group Barracks- Dining Hall	[31.592219, -96.530648 2]	The grab bar height and/or spacing fails. Grab bars must be mounted between 33" and 36" to the top of the gripping surface. There must be 1.5" of clearance between the grab bar and the wall. There must be a minimum of 1.5" of clearance below and minimum 12" above the grab bar to any dispenser or other obstruction.	Both - TP dispenser against bottom of side bar	Remount toilet paper dispenser max 7" to 9" from front of toilet, 15" to 48" above the finished floor (AFF) and min 12" above or 1.5" below grab bar.	2015 ABAAS Section: 609.3, 609.4 2012 TAS Section: 609.4, 609.3 2010 ADAS Section: 609.3, 609.4

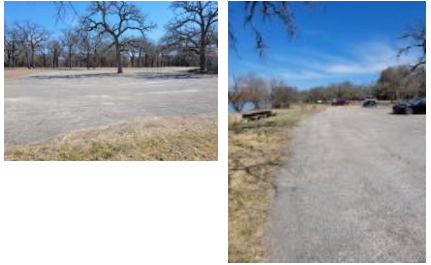
122	Rec Hall/ Nature Center: Rec Hall/Nature Center - Exterior Accessible Route	[31.5965214 , -96.536177 6]	The walkway contains abrupt vertical edges and/or variations over a 1/4 inch. 1/4 inch is the maximum vertical rise. Changes in level between 1/4 inch and 1/2 inch must be beveled at 1:2 or less. Changes in level greater than 1/2 inch must be by way of a ramp.	1" CIL between rec hall and green restrooms	Repair, bevel or ramp CIL along AR.	2012 TAS Section: 303.2, 303.3 2010 ADAS Section: 303.2, 303.3

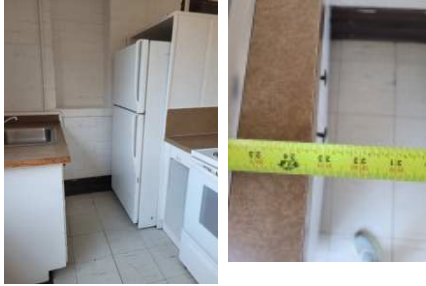
Finding Number	Area Description	Lat/Long	Finding	As Built	Recommendation	Citation	Photos	Figure
136	Rec Hall/ Nature Center: Rec Hall/ Nature Center - Public Spaces	[31.5967015 , -96.536321 1]	The route of travel at this location does not provide a minimum width of 36 inches. The clear width shall be permitted to be reduced to 32 inches minimum for a length of 24 inches maximum provided that reduced width segments are separated by segments that are 48 inches long minimum and 36 inches wide minimum.	kitchen- 34" between microwave and counter	Relocate microwave cart to widen AR to compliant 36" clear width.	2015 ABAAS Section: 403.5.1 2012 TAS Section: 403.5.1 2010 ADAS Section: 403.5.1

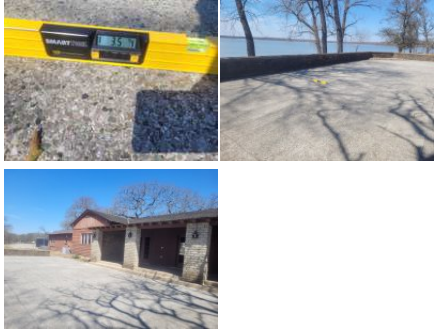
141	Rec Hall/ Nature Center: Rec Hall/ Nature Center - Public Spaces	[31.59677, -96.53643]	The walkway contains abrupt vertical edges and/or variations over a 1/4 inch. 1/4 inch is the maximum vertical rise. Changes in level between 1/4 inch and 1/2 inch must be beveled at 1:2 or less. Changes in level greater than 1/2 inch must be by way of a ramp.	1" CIL to patio	Repair, bevel or ramp CIL along AR.	2012 TAS Section: 303.2, 303.3 2010 ADAS Section: 303.2, 303.3

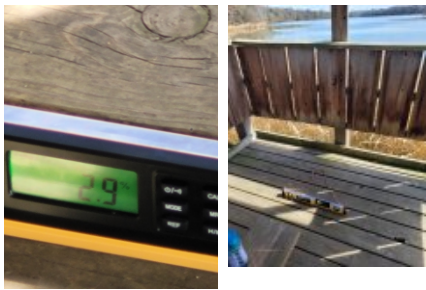
150	Park Site: Park Elements	[31.5936081 , -96.533429 7]	There is no accessible route to the bird blind. At least one accessible route shall connect accessible buildings, accessible facilities, accessible elements, and accessible spaces that are on the same site.	Lacks AR to bird blind	Create an accessible route with crushed stone or other outdoor material from parking or walkway to bird blind.	2015 ABAAS Section: F206.2.2 2012 TAS Section: 206.2.2 2010 ADAS Section: 206.2.2

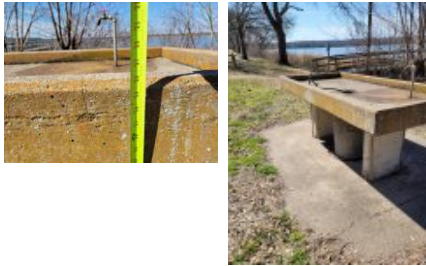
173	Park Site: Fishing	[31.6002437 , -96.536974 2]	There is no accessible route to the fish cleaning station and pier at RV camping. At least one accessible route shall connect accessible buildings, accessible facilities, accessible elements, and accessible spaces that are on the same site.	Lacks route to fish cleaning station and pier at RV camping	Create an accessible route with crushed stone or other outdoor material from parking or walkway to the fish cleaning station and pier at RV camping.	2015 ABAAS Section: F206.2.2 2012 TAS Section: 206.2.2 2010 ADAS Section: 206.2.2

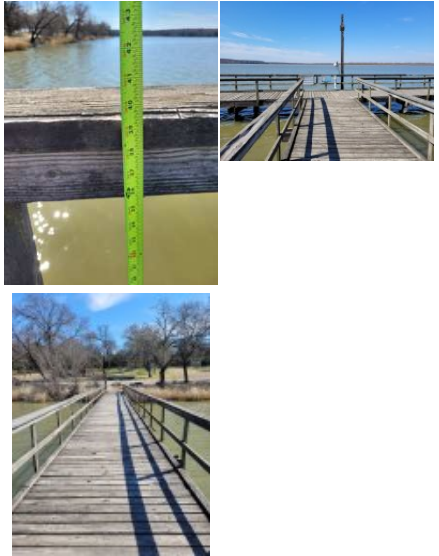
175	Park Site: Fishing	[31.5922464 , -96.531125 7]	Accessible routes serving fishing piers and platforms, including gangways and floating piers, shall comply with Chapter 4. EXCEPTIONS: 1. Accessible routes serving floating fishing piers and platforms shall be permitted to use Exceptions 1, 2, 5, 6, 7 and 8 in 1003.2.1. 2. Where the total length of the gangway or series of gangways serving as part of a required accessible route is 30 feet (9145 mm) minimum, gangways shall not be required to comply with 405.2.	Fishing pier at group barracks - Stairs only to access pier and fish cleaning station, gaps between boards frequently, gaps at knots and damaged boards	Create an outdoor accessible route to the fishing pier or make corrections for a compliant route.	2015 ABAAS Section: 1005.1, 1005.1 EXCEPTIONS: 1, 1005.1 EXCEPTIONS: 2 2010 ADAS Section: 1005.1, 1005.1 Exception 1, 1005.1 Exception 2

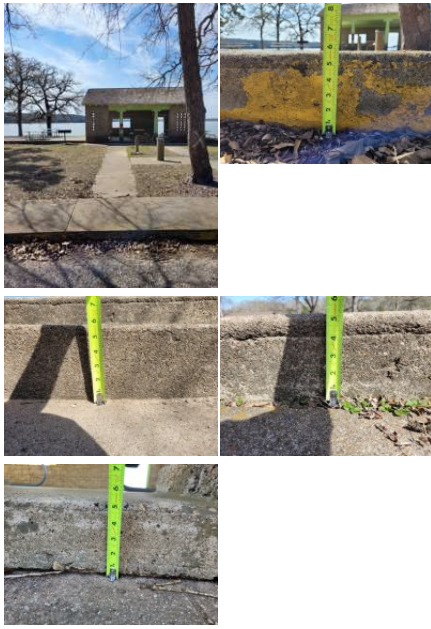
Finding Number	Area Description	Lat/Long	Finding	As Built	Recommendation	Citation	Photos	Figure
187	Park Site: Green Picnic Shelter	[31.5956814, -96.536081]	The stair risers are not uniform in height. Stair riser heights shall be 7 inches maximum and 4 inches minimum. On any given flight of stairs, all steps shall have uniform riser height and uniform tread widths.	Stairs to beach behind green picnic shelter - Top step riser is 11"	Correct riser heights on stairs to consistent height between 4" to 7".	2015 ABAAS Section: 504.2 2012 TAS Section: 504.2 2010 ADAS Section: 504.2		
188	Park Site: Green Picnic Shelter	[31.59571, -96.536077]	The stripe on the stair tread does not contrast adequately with the stair tread. Exterior and interior stairs are recommended to have the upper approach and lower treads marked by a stripe providing clear visual contrast.	Stairs to beach behind green picnic shelter - Lacks visual contrast (10 steps)	Install contrasting stripe along front 2" of each tread. The stripe shall be a minimum of 2 inches wide to a maximum of 4 inches wide placed parallel to, and not more than 1 inch from, the nose of the step or upper approach. The stripe shall extend the full width of the step or upper approach and shall be of material that is at least as slip resistant as the other treads of the stair. A painted stripe shall be acceptable. Grooves shall not be used to satisfy this requirement.	2015 ABAAS Section: Advisory 504.4 2012 TAS Section: 504.4 Advisory 2010 ADAS Section: 504.4

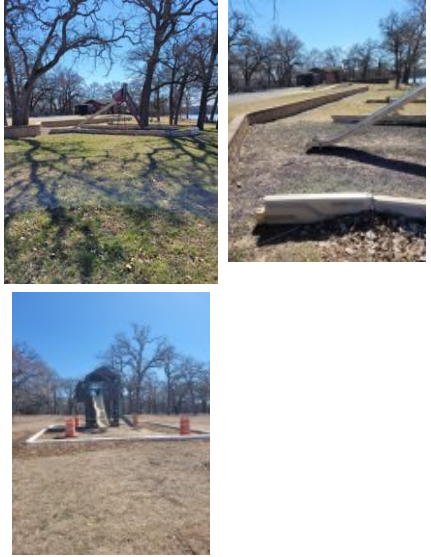
192	Playground: Play Area	[31.5970202, -96.5366376], [31.5976644, -96.536643]	Play area lacks designated entry. As a smart practice, play area should have a minimum 60" wide entry, free of changes in level, gaps, and slope.	Lacks designated entries at both GLPC and EPC areas	Create designated entry by removing 60" portion of play area boundary as a smart practice.	2015 ABAAS Section: F206.1 2012 TAS Section: 206.1 2010 ADAS Section: 206.1

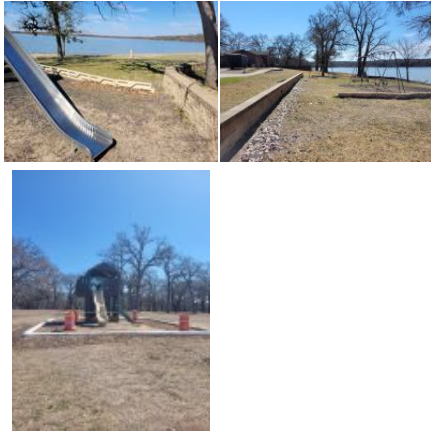
Finding Number	Area Description	Lat/Long	Finding	As Built	Recommendation	Citation	Photos	Figure
193	Playground: Play Area	[31.597019, -96.536628 2], [31.5976359, -96.536649 7]	Play area shall have signage listing designated ages of intended users.	Lacks signage with designated ages of intended users at both GLPC and EPC areas	Acquire and install intended user signage and mount at designated entry as a smart practice.	2015 ABAAS Section: F240.1 2012 TAS Section: 240.1 2010 ADAS Section: 240.1

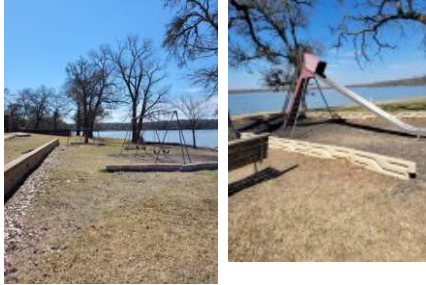
194	Playground: Play Area	[31.597019, -96.536618 8], [31.597645, -96.536629 5]	Compliance with ASTM F 1951 for accessibility for ground surfaces on accessible routes, clear floor or ground spaces, and turning spaces has not been determined. Ground surfaces shall comply with ASTM F 1951. Ground surfaces shall be inspected and maintained regularly and frequently to ensure continued compliance with ASTM F 1951.	Grass surface at GLPC area, sand surface at EPC area	Replace existing surface with an accessible surface such as EWF, PIP or tiles, with compliant slopes and CILs.	2012 TAS Section: 1008.2.6.1 2010 ADAS Section: 1008.2.6.1

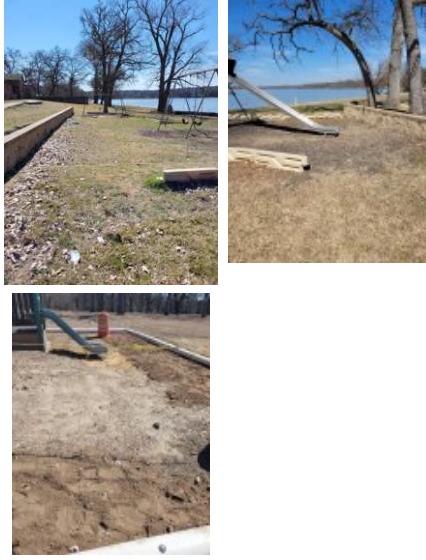
195	Playground: Play Area	[31.5970133, -96.536633 6]	The accessible route to the ground level play component(s) is not wide enough. At ground level play components, the clear width of accessible routes shall be 60 inches minimum.	37" between slide and barrier at GLPC	Enlarge border or relocate play elements to provide 60" clear width AR.	2012 TAS Section: 1008.2.4.1 2010 ADAS Section: 1008.2.4.1

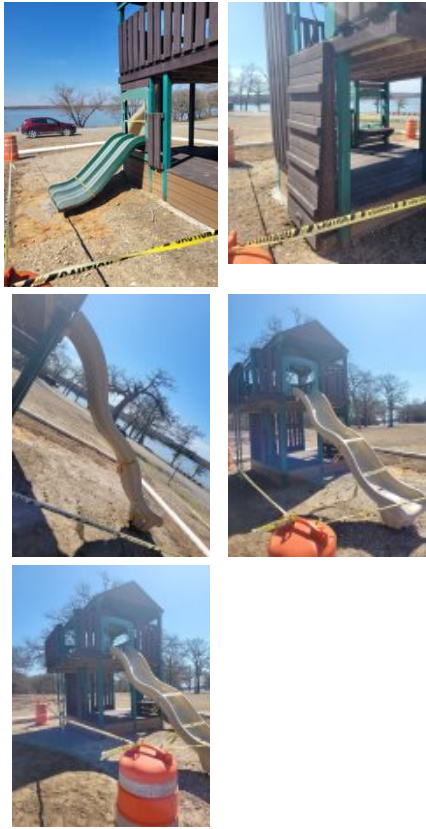
Finding Number	Area Description	Lat/Long	Finding	As Built	Recommendation	Citation	Photos	Figure
198	Playground: Play Area	[31.5970167, -96.5366242], [31.5976473, -96.5366349]	Element meets all standards and requirements	GLPCs have AR to one of each type if corrections made to AR and surface: 1 slide, 4 belt swings, 2 basket swings	None	2010 ADAS Section: N/A

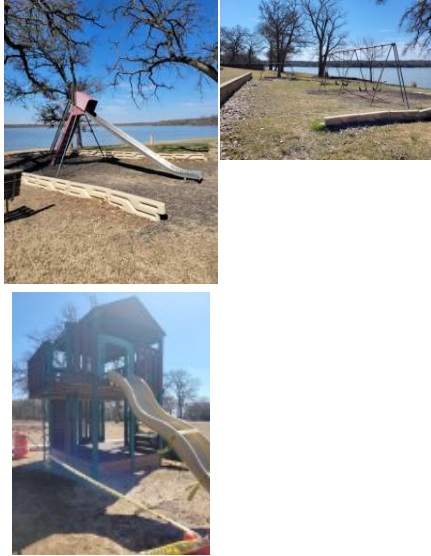
199	Playground: Play Area	[31.5970247, -96.5366295], [31.5976553, -96.536651]	The ground level play components are not dispersed throughout the play area. Where two or more required ground level play components are provided, they shall be dispersed throughout the play area and integrated with other play components.	N/A	Relocate accessible GLPCs to be dispersed through play area.	2012 TAS Section: 240.2.1 2010 ADAS Section: 240.2.1

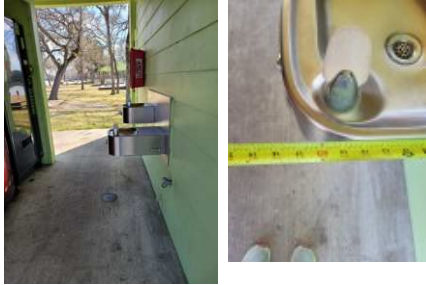
205	Green Restroom Building in Day Use Area: Green Restroom - Exterior Accessible Route	[31.5961463 , -96.536122 6]	There is not enough knee clearance under the drinking fountain. The drinking fountain must have a clear knee space between the bottom of the apron and the floor not less than 27 inches in height, 30 inches in width, and 8 inches in depth.	Drinking fountain at green restroom - 24.25" knee clearance	Raise drinking fountain to provide required 27" knee clearance.	2015 ABAAS Section: 602.2 2012 TAS Section: 602.2 2010 ADAS Section: 602.2

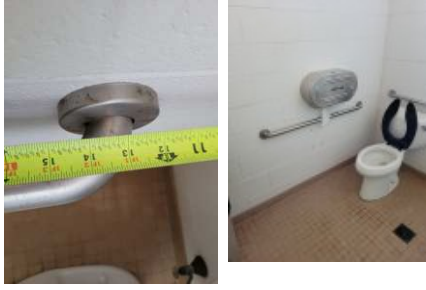
211	Green Restroom Building in Day Use Area: Mens - Green Restroom By Rec	[31.5961395, -96.536119 9]	The rear grab bar is not 36" long or is not mounted in the correct location. The rear grab bar must be a minimum of 36" long and extend from the toilet centerline a minimum 12" towards the wall side and a minimum 24" towards the open side of the toilet. Grab bars shall be installed in a horizontal position, 33 inches minimum and 36 inches maximum above the finish floor measured to the top of the gripping surface and the space between the grab bar and the top of the tank shall be 1-1/2 inches minimum.	rear bar 11" towards wall	Remount rear grab bar to behind the toilet, 12" to one side of center and 24" to the other and 33" to 36" AFF.	2015 ABAAS Section: 604.5.2 2012 TAS Section: 604.5.2 2010 ADAS Section: 604.5.2

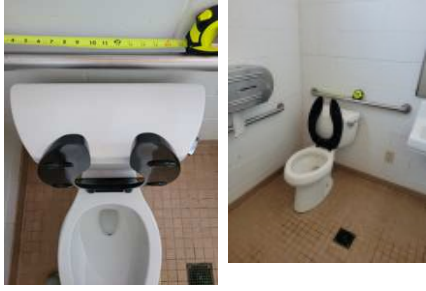
212	Green Restroom Building in Day Use Area: Mens - Green Restroom By Rec	[31.5961372, -96.536114 6]	The grab bar height and/or spacing fails. Grab bars must be mounted between 33" and 36" to the top of the gripping surface. There must be 1.5" of clearance between the grab bar and the wall. There must be a minimum of 1.5" of clearance below and minimum 12" above the grab bar to any dispenser or other obstruction.	Side grab bar - 31" AFF, toilet paper 5.25" above grab bar	Remount grab bars in accessible stall to 33" to 36" above the finished floor (AFF). Remount toilet paper dispenser max 7" to 9" from front of toilet, 15" to 48" above the finished floor (AFF) and min 12" above or 1.5" below grab bar.	2015 ABAAS Section: 609.3, 609.4 2012 TAS Section: 609.4, 609.3 2010 ADAS Section: 609.3, 609.4

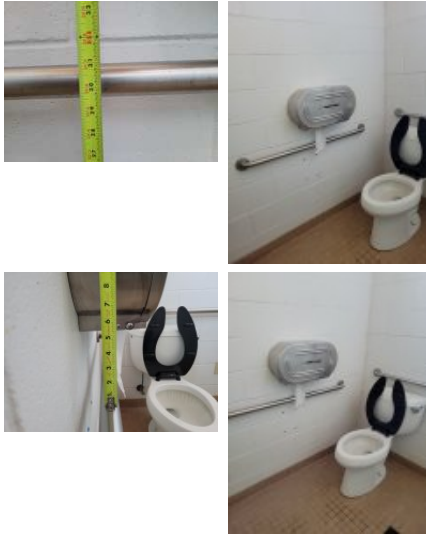
Finding Number	Area Description	Lat/Long	Finding	As Built	Recommendation	Citation	Photos	Figure
213	Green Restroom Building in Day Use Area: Mens - Green Restroom By Rec	[31.5961452 , -96.5361159]	The toilet paper is not installed within the compliant range in front of the toilet. Toilet paper dispensers shall be 7 inches minimum and 9 inches maximum in front of the water closet measured to the centerline of the dispenser. The outlet of the dispenser shall be 15 inches minimum and 48 inches maximum above the finish floor and shall not be located behind grab bars. Dispensers shall not be of a type that controls delivery or that does not allow continuous paper flow. There shall be a clearance of 1 1/2 inches minimum below the grab bar.	TP too close to front of toilet	Remount toilet paper dispenser max 7" to 9" from front of toilet, 15" to 48" AFF and min 12" above or 1.5" below grab bar.	2015 ABAAS Section: 604.7 2012 TAS Section: 604.7 2010 ADAS Section: 604.7

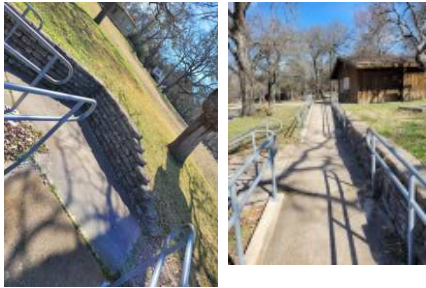
229	Campground Restroom Buildings: RV Campground Restrooms - Exterior Accessible Route	[31.6003008 , -96.536742 2]	Openings in floor or ground surfaces shall not allow passage of a sphere more than 1/2 inch (13 mm) diameter except as allowed in 407.4.3, 409.4.3, 410.4, 810.5.3 and 810.10. Elongated openings shall be placed so that the long dimension is perpendicular to the dominant direction of travel.	Ramp to RV restroom, men's side - 1" gap at top of 3rd run, 1" gap at top of 2nd run, 1" gap at bottom of 2nd run, 1.25" gap at top of 1st run, 1" at bottom of first run	Fill and maintain gaps to max .5".	2015 ABAAS Section: 302.3 2012 TAS Section: 302.3 2010 ADAS Section: 302.3

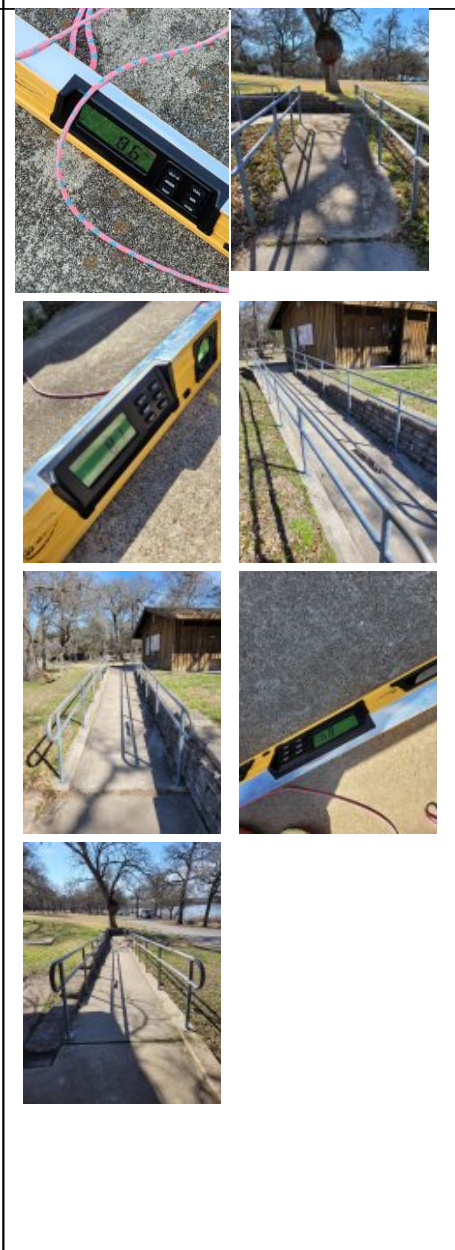
Finding Number	Area Description	Lat/Long	Finding	As Built	Recommendation	Citation	Photos	Figure
231	Campground Restroom Buildings: RV Campground Restrooms - Exterior Accessible Route	[31.6004161 , -96.536734 2]	The ramp does not have compliant handrails. Handrails are required on both sides of all surfaces that are sloped greater than 5 percent (1:20). Handrails must be between 34 inches and 38 inches above the ramp surface, must extend beyond the top and bottom of the ramp 12 inches and be parallel to the floor or ground surface. The diameter of the handrails must be between 1 inches and 2 inches in cross-sectional nominal dimension for circular handrails and handrail gripping surfaces with a non-circular cross section shall have a perimeter dimension of 4 inches minimum and 6 inches maximum, and a cross-section dimension of 2 inches maximum. The clear space between handrails and walls must 1-1/2 inches minimum.	Ramp to RV restroom, women's side - Guard rail on 1 side only	Install handrails that are rounded and/or extend to the ground, with handrail extensions and mounted 34" to 38" AFF.	2015 ABAAS Section: 505.1 2012 TAS Section: 505.1 2010 ADAS Section: 505.1

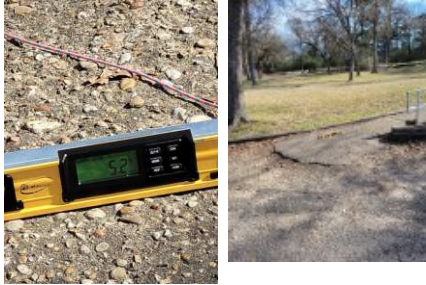
Finding Number	Area Description	Lat/Long	Finding	As Built	Recommendation	Citation	Photos	Figure
234	Campground Restroom Buildings: RV Campground Restrooms - Exterior Accessible Route	[31.600423, -96.536723 4]	The ramps slope exceeds the maximum running slope (direction of travel) allowable of 8.33%. Ramps should have the least possible slope but in no case more than 8.3% (1:12).	Ramp to RV restroom, women's side - 11.6% at bottom, 13.9% at middle, 13.9% at top	Correct slope of ramp to max 8.33%.	2015 ABAAS Section: 405.2 2012 TAS Section: 405.2 2010 ADAS Section: 405.2

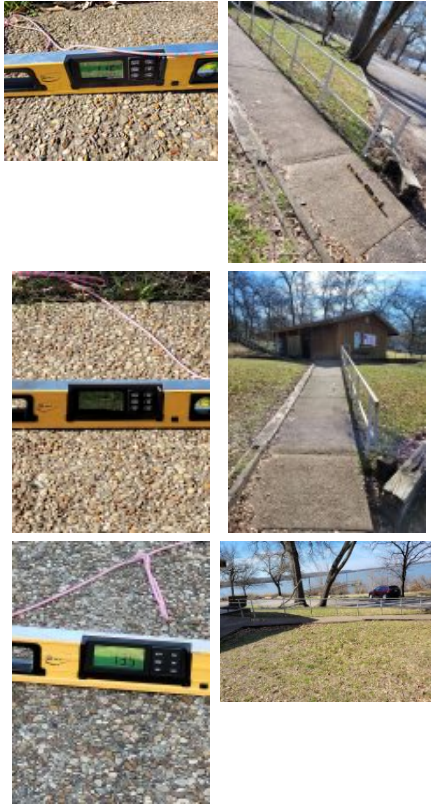
235	Campground Restroom Buildings: RV Campground Restrooms - Exterior Accessible Route	[31.6004139, -96.536747 6]	There is no accessible route to the ramp at restroom building. At least one accessible route shall connect accessible buildings, accessible facilities, accessible elements, and accessible spaces that are on the same site.	Lacks AR to ramp on women's side to restroom building in RV area due to surface	Create an accessible route with crushed stone or other outdoor material from parking or walkway to the ramp at the restroom building.	2015 ABAAS Section: F206.2.2 2012 TAS Section: 206.2.2 2010 ADAS Section: 206.2.2

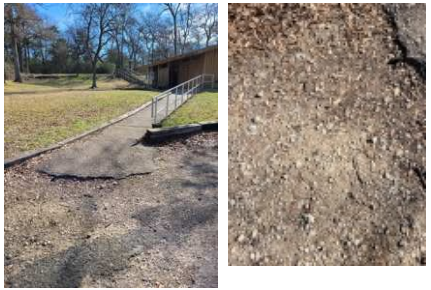
Finding Number	Area Description	Lat/Long	Finding	As Built	Recommendation	Citation	Photos	Figure
236	Campground Restroom Buildings: RV Campground Restrooms - Exterior Accessible Route	[31.600383, -96.536661 7]	There is no accessible route to the restroom. At least one accessible route shall connect accessible buildings, accessible facilities, accessible elements, and accessible spaces that are on the same site.	Lacks AR to restroom from shelter area due to stairs	Create an accessible route with crushed stone or other outdoor material from parking or walkway to restroom.	2015 ABAAS Section: F206.2.2 2012 TAS Section: 206.2.2 2010 ADAS Section: 206.2.2

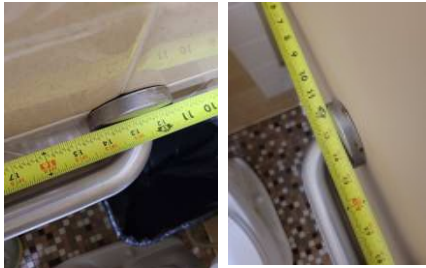
Finding Number	Area Description	Lat/Long	Finding	As Built	Recommendation	Citation	Photos	Figure
241	Campground Restroom Buildings: RV Campground - Men's Restroom	[31.6003784 , -96.536669 8]	The grab bar height and/or spacing fails. Grab bars must be mounted between 33" and 36" to the top of the gripping surface. There must be 1.5" of clearance between the grab bar and the wall. There must be a minimum of 1.5" of clearance below and minimum 12" above the grab bar to any dispenser or other obstruction.	Partition side is 31" AFF, tile side is 30.5" AFF, toilet paper 4.25" above bar	Remount grab bars in accessible stall to 33" to 36" above the finished floor (AFF). Remount toilet paper dispenser max 7" to 9" from front of toilet, 15" to 48" above the finished floor (AFF) and min 12" above or 1.5" below grab bar.	2015 ABAAS Section: 609.3, 609.4 2012 TAS Section: 609.4, 609.3 2010 ADAS Section: 609.3, 609.4

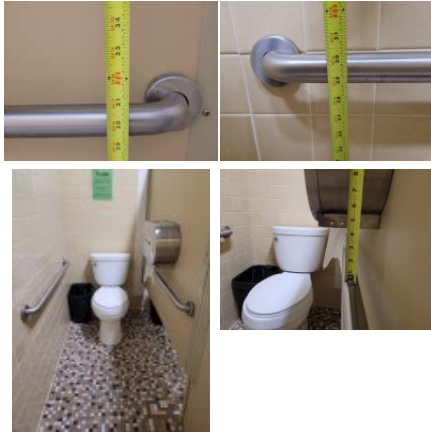
242	Campground Restroom Buildings: RV Campground - Men's Restroom	[31.6003842 , -96.536661 7]	The toilet paper is not installed within the compliant range in front of the toilet. Toilet paper dispensers shall be 7 inches minimum and 9 inches maximum in front of the water closet measured to the centerline of the dispenser. The outlet of the dispenser shall be 15 inches minimum and 48 inches maximum above the finish floor and shall not be located behind grab bars. Dispensers shall not be of a type that controls delivery or that does not allow continuous paper flow. There shall be a clearance of 1 1/2 inches minimum below the grab bar.	TP dispenser too close to the front of toilet	Remount toilet paper dispenser max 7" to 9" from front of toilet, 15" to 48" AFF and min 12" above or 1.5" below grab bar.	2015 ABAAS Section: 604.7 2012 TAS Section: 604.7 2010 ADAS Section: 604.7

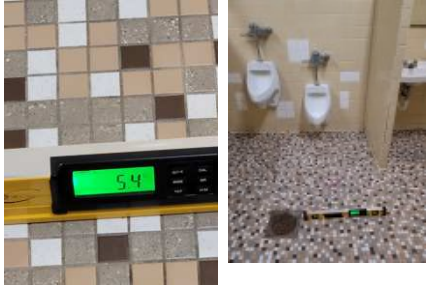
Finding Number	Area Description	Lat/Long	Finding	As Built	Recommendation	Citation	Photos	Figure
244	Campground Restroom Buildings: RV Campground - Men's Restroom	[31.6003807 , -96.5366604]	The bench is not deep enough or long enough or is missing. Benches shall be provided having seats that are 42 inches long minimum and 20 inches deep minimum and 24 inches deep maximum. The bench shall provide for back support or shall be affixed to a wall. Back support shall be 42 inches (1065 mm) long minimum and shall extend from a point 2 inches (51 mm) maximum above the seat surface to a point 18 inches (455 mm) minimum above the seat surface. Back support shall be 2½ inches (64 mm) maximum from the rear edge of the seat measured horizontally. The top of the bench seat surface shall be 17 inches (430 mm) minimum and 19 inches (485 mm) maximum above the finish floor or ground. Clear floor or ground space complying with 305 shall be provided and shall be positioned at the end of the bench seat and parallel to the short axis of the bench	bench has 11.75" depth, bolted to ground and has 3.5" gap	Replace bench in dressing area with one having a seat depth of 20" to 24" deep, 42" long, affixed to the wall or having a back and mounted 17" to 19" AFF and provide required clear floor space on the short axis of the bench.	2012 TAS Section: 903.4, 903.2, 903.3, 903.5 2010 ADAS Section: 903.4, 903.2, 903.3, 903.5

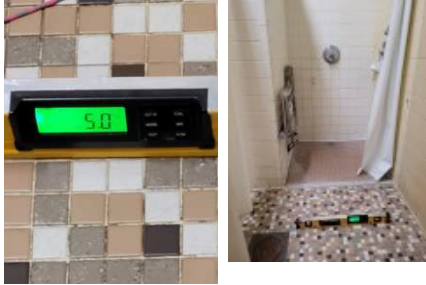
247	Campground Restroom Buildings: RV Campground - Men's Restroom	[31.6003796 , -96.5366564]	In transfer type compartments, grab bars shall be provided across the control wall and back wall to a point 18 inches (455 mm) from the control wall.	shower lacks grab bars	Remount grab bars to the correct location in the transfer shower.	2015 ABAAS Section: 608.3.1 2012 TAS Section: 608.3.1 2010 ADAS Section: 608.3.1
