# Access Audit Site Report

**Franklin Mountains State Park  
Tom Mays Unit  
El Paso, TX 79911  
Accessibility Evaluation  
Inspection Date: 10/19/2022  
Inspectors: Tanya Scheibe**

Prepared By  
**WT Group**

**TEXAS PARKS AND WILDLIFE DEPARTMENT  
FRANKLIN MOUNTAINS STATE PARK**

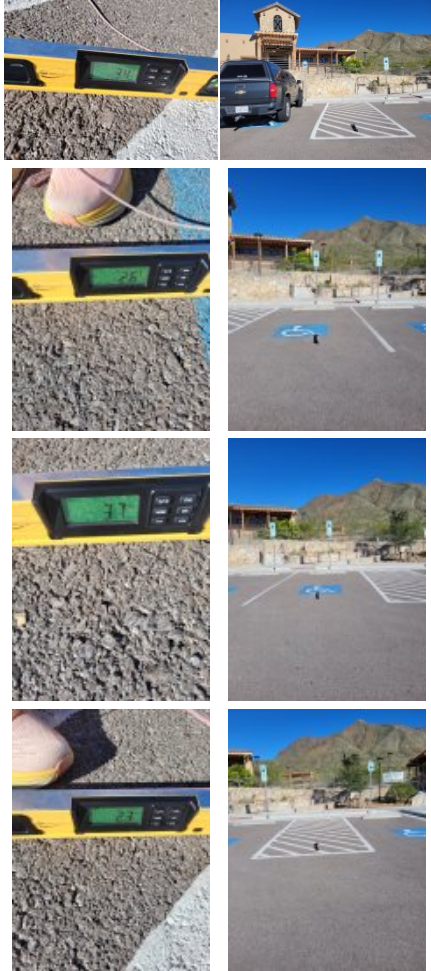
Finding Number	Area Description	Lat/Long	Finding	As Built	Recommendation	Citation	Photos	Figure
1	Headquarters/Visitor's Center: HQ - Parking	[31.9103993, -106.5183779]	The cross slopes (narrow dimension) and/or running slopes (long dimension) of the access aisle exceeds 2%. The running slope and the cross slope in an accessible parking stall and the access aisle must not exceed 2%.	Left to right: access aisle - 3.4%, stall - 2.6%, stall - 3.7%, access aisle - 2.3%	Repair or correct slope of parking space and access aisle to max 2.08% in any direction.	2015 ABAAS Section: 502.4 2012 TAS Section: 502.4 2010 ADAS Section: 502.4

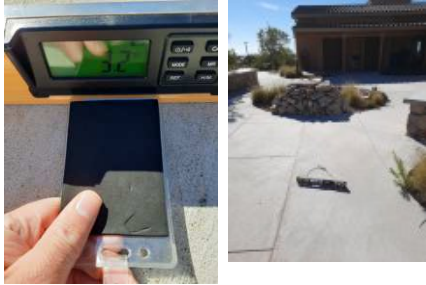
Finding Number	Area Description	Lat/Long	Finding	As Built	Recommendation	Citation	Photos	Figure
3	Headquarters/Visitor's Center: HQ - Exterior Accessible Route	[31.910492, -106.51795 03]	The running slope of walking surfaces shall not be steeper than 1:20. The cross slope of walking surfaces shall not be steeper than 1:48.	Cross slope of 3.2% near water feature at Visitor Center	Correct cross slopes to max 2.08%.	2012 TAS Section: 403.3  2010 ADAS Section: 403.3

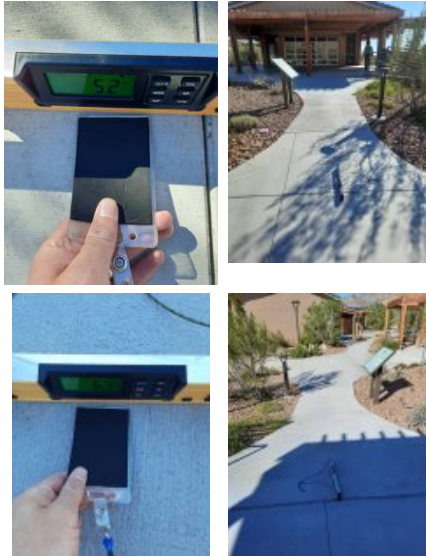
Finding Number	Area Description	Lat/Long	Finding	As Built	Recommendation	Citation	Photos	Figure
6	Headquarters/Visitor's Center: HQ - Exterior Accessible Route	[31.9103137 , -106.518147]	The running slope of walking surfaces shall not be steeper than 1:20. The cross slope of walking surfaces shall not be steeper than 1:48.	Running slopes of 5.2% to 6.7% for 12' on route between restrooms and interpretive center	Correct running slopes to max 5%.	2012 TAS Section: 403.3  2010 ADAS Section: 403.3

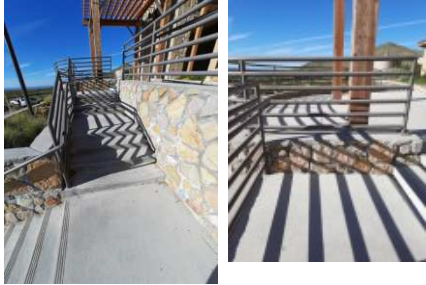
Finding Number	Area Description	Lat/Long	Finding	As Built	Recommendation	Citation	Photos	Figure
7	Headquarters/Visitor's Center: HQ - Exterior Accessible Route	[31.9104623, -106.5182759]	Stairways must have handrails on both sides. Handrails and their extensions must be between 34 inches and 38 inches above the stair nosing or ground. The top handrails shall extend a minimum of 12 inches beyond the top nosing and shall be parallel with the floor or ground surface. At the bottom of a stair flight, handrails shall extend at the slope of the stair flight for a horizontal distance at least equal to one tread depth beyond the last riser nosing. Extension shall return to a wall, guard, or the landing surface, or shall be continuous to the handrail of an adjacent stair flight. The orientation of at least one handrail, including the extension, shall be in the direction of the run of the stair and perpendicular to the direction of the stair nosing. Handrail gripping surfaces with a circular cross section shall have an outside diameter of 1-1/4 inches minimum and 2 inches maximum. Handrail gripping surfaces with a non-circular cross section shall have a perimeter dimension of 4 inches minimum and 6 1/4 inches maximum, and a cross-section dimension of 2-1/4 inches maximum. The hand grip portion of handrails shall have a smooth surface with no sharp corners. Gripping surfaces (top or sides) shall be uninterrupted by newel posts, other construction elements or obstructions. Any wall or other surface adjacent to the handrail shall be free of sharp or abrasive elements. Handrails projecting from a wall shall have a space of 1-1/2 inches minimum between the wall and the handrail.	Stairs to main entry at Visitor Center - Lacks handrails on one side	Install handrails on both sides of stairway, mounted 34" to 38" AFF with top and bottom extensions and having a 1.25" – 2" in diameter, or a non-circular grip that has a perimeter dimension of 4"- 6.25" max with a min gap of 1.5" between handrail and wall.	2015 ABAAS Section: 505.2  2012 TAS Section: 505.2  2010 ADAS Section: 505.2

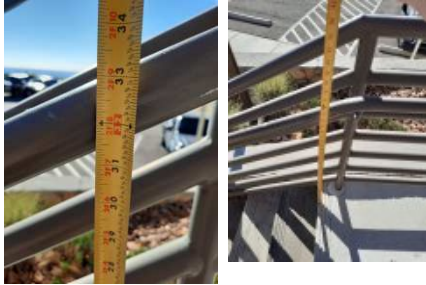
Finding Number	Area Description	Lat/Long	Finding	As Built	Recommendation	Citation	Photos	Figure
8	Headquarters/Visitor's Center: HQ - Exterior Accessible Route	[31.9104509, -106.5182685]	The handrails as well as the handrail extensions are not at the correct height. The tops of handrails and their extensions must be between 34 inches and 38 inches above the stair nosing or ground.	Stairs to main entry at Visitor Center -existing handrail on sloped sections at 33" above the stair surface	Replace or remount handrails to 34" to 38" AFF. In the alternative, leave as is citing construction tolerance.	2015 ABAAS Section: 505.4 2012 TAS Section: 505.4 2010 ADAS Section: 505.4

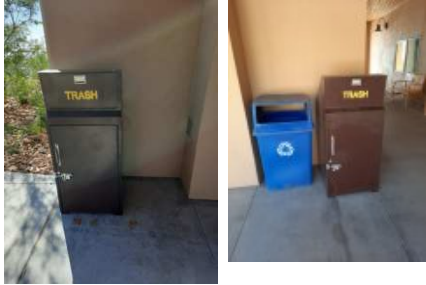
Finding Number	Area Description	Lat/Long	Finding	As Built	Recommendation	Citation	Photos	Figure
17	Headquarters/Visitor's Center: HQ - Public Spaces	[31.9105179, -106.5180713]	Element meets all standards and requirements	3 of 3 garbage cans at Visitor Center restrooms comply	None	2010 ADAS Section: N/A

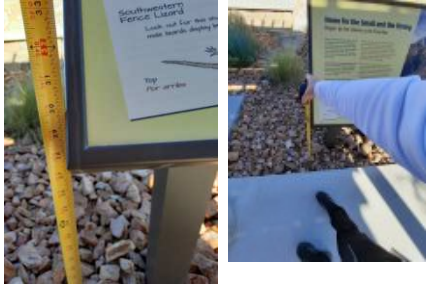
Finding Number	Area Description	Lat/Long	Finding	As Built	Recommendation	Citation	Photos	Figure
20	Headquarters/Visitor's Center: HQ - Public Spaces	[31.91059, -106.518]	Visual characters shall be 40 inches (1015 mm) minimum above the finish floor or ground. EXCEPTION: Visual characters indicating elevator car controls shall not be required to comply with 703.5.6.	"Home for the small and the strong" info sign at Visitors Center is low	Remount signage to min 40" AFF as a smart practice.	2015 ABAAS Section: 703.5.6, 703.5.6 EXCEPTION  2012 TAS Section: 703.5.6, 703.5.6 Exception  2010 ADAS Section: 703.5.6, 703.5.6 Exception

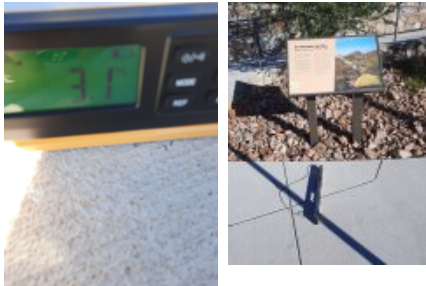
21	Headquarters/Visitor's Center: HQ - Public Spaces	[31.91034, -106.5183]	The 30 inches minimum by 48 inches minimum clear floor space required at the operable part is not flat (2% or 1:48 maximum slope) in all directions. Changes in level are not permitted at required clear floor or ground space except that slopes not steeper than 1:48 shall be permitted.	Slope of 3.1% in CFS of "Our Mountains, our place" info sign	Correct or repair slope in CFS to max 2.08%.	2015 ABAAS Section: 305.2  2012 TAS Section: 305.2  2010 ADAS Section: 305.2

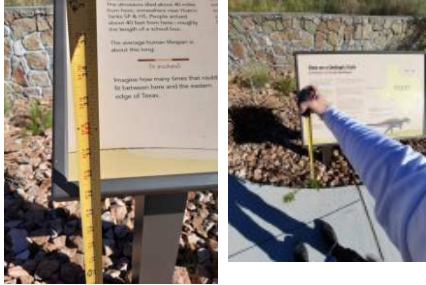
Finding Number	Area Description	Lat/Long	Finding	As Built	Recommendation	Citation	Photos	Figure
22	Headquarters/Visitor's Center: HQ - Public Spaces	[31.91059, -106.518]	Visual characters shall be 40 inches (1015 mm) minimum above the finish floor or ground. EXCEPTION: Visual characters indicating elevator car controls shall not be required to comply with 703.5.6.	"Time on geologic scale" info sign at Visitor Center is low	Remount signage to min 40" AFF as a smart practice.	2015 ABAAS Section: 703.5.6, 703.5.6 EXCEPTION  2012 TAS Section: 703.5.6, 703.5.6 Exception  2010 ADAS Section: 703.5.6, 703.5.6 Exception

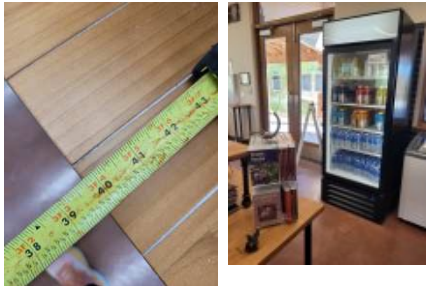
23	Headquarters/Visitor's Center: HQ - Public Spaces	[31.9106192, -106.5180543]	The operable part is not accessible because there is not adequate clear floor space for either a forward or side approach. The clear floor or ground space shall be 30 inches minimum by 48 inches minimum.	Clear floor space in front of drink cooler reduced to 39.75"	Remove, or relocate storage in CFS at fixtures and operable parts along the AR.	2015 ABAAS Section: 305.3  2012 TAS Section: 305.3  2010 ADAS Section: 305.3

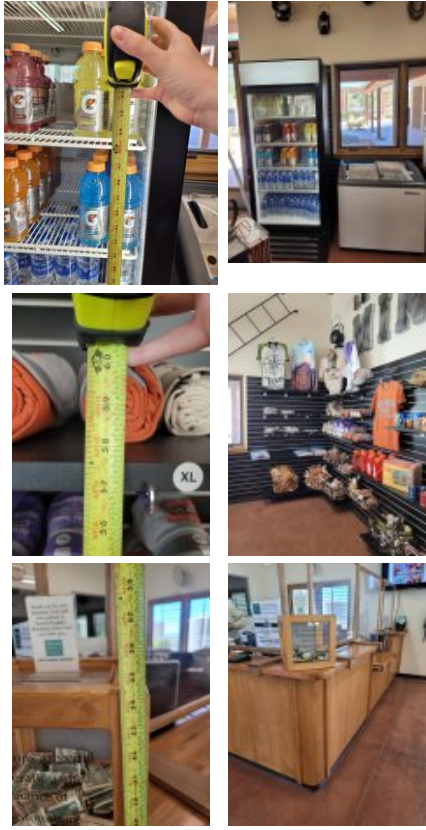
Finding Number	Area Description	Lat/Long	Finding	As Built	Recommendation	Citation	Photos	Figure
24	Headquarters/Visitor's Center: HQ - Public Spaces	[31.9106089, -106.5180858]	The operable part is positioned too high for either a side or front approach. Where a clear floor or ground space allows a parallel approach to an element and the side reach is unobstructed, the high side reach shall be 48 inches maximum and the low side reach shall be 15 inches minimum above the finish floor or ground. Where a forward reach is unobstructed, the high forward reach shall be 48 inches maximum and the low forward reach shall be 15 inches minimum above the finish floor or ground.	Top 2 shelves in cooler over 48" above the finished floor (AFF), 57.5" AFF to t-shirts, donation box 54.5" AFF	Relocate merchandise or remount operable parts to be in reach range of 15" min to 48" max.	2015 ABAAS Section: 308.1 2012 TAS Section: 308.1 2010 ADAS Section: 308.1

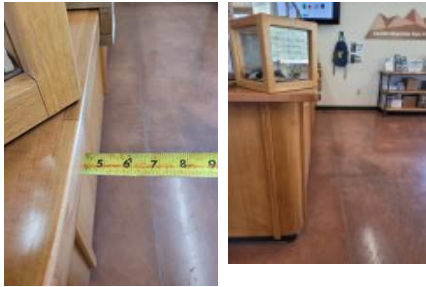
25	Headquarters/Visitor's Center: HQ - Public Spaces	[31.910601, -106.5180805]	An item or items project more than 4 inches into the circulation path. Wall-mounted objects that have leading edges between 27 inches and 80 inches from the floor must not project more than 4 inches into the circulation path. Protruding objects that extend to the floor or within 27 inches of the floor are cane detectable and are therefore not hazardous. Where it is necessary or desirable to have objects protrude from the wall, a manner of cane detection must be provided.	Counter projects 4.5"	Relocate protruding objects or place cane detectable warning or bollard at foot of item. In the alternative, leave as is citing construction tolerance.	2015 ABAAS Section: 307.2 2012 TAS Section: 307.2 2010 ADAS Section: 307.2

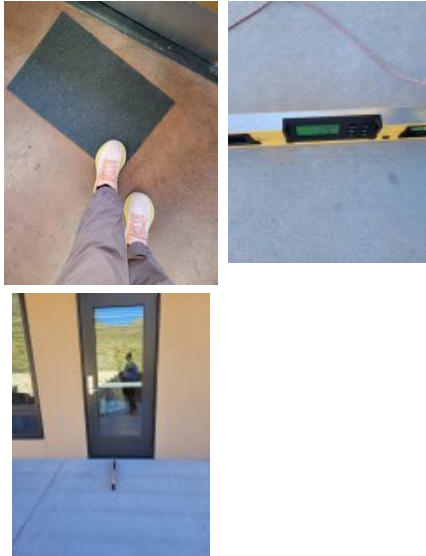
Finding Number	Area Description	Lat/Long	Finding	As Built	Recommendation	Citation	Photos	Figure
26	Headquarters/Visitor's Center: HQ - Public Spaces	[31.910572, -106.5181022]	Minimum maneuvering clearances at doors and gates shall comply with 404.2.4. Maneuvering clearances shall extend the full width of the doorway and the required latch side or hinge side clearance. Maneuvering clearances shall have a max slope of 2.08%. The sweep period for doors with closers shall be adjusted so that from an open position of 70 degrees, the door will take at least 3 seconds to move to a point 3 inches from the latch, measured to the leading edge of the door. Exterior doors are recommended to be maintained at 8.5 lbf as a smart practice. Force is to be measured at the operating hardware or 30 inches from the hinges, whichever is greater.	Main entry door to HQ - loose rug, fast close, 16# push; Door in back parallel to viewing equipment - 15# push; Door in corner - 15# push, 2.5% slope in exterior side clearance	For all doors along the public circulation route, provide required maneuvering clearance on push and pull side of doors. For all doors along the public circulation route, secure rug in door clearance to prevent trip hazard. For all doors along the public circulation route, correct slope in door clearance to max 2.08%. For all doors along the public circulation route, inspect, adjust, and maintain closing speed on door closers. For all doors along the public circulation route, inspect, adjust, and maintain 8.5 lbf to open exterior doors as a smart practice.	2010 ADAS Section: 404.2.3, 404.2.7, 404.2.4, 404.2.11, 404.2.11 Exception

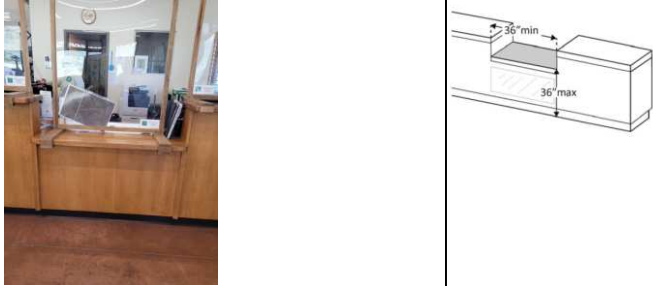
27	Headquarters/Visitor's Center: HQ - Public Spaces	[31.9105868, -106.5180968]	The transaction counter is too high. A portion of the counter surface that is 36 inches long minimum and 36 inches high maximum above the finish floor shall be provided. Knee and toe space must be provided for a forward approach. A 30 inch by 48 inch clear floor space on an accessible route must be provided for either a forward or parallel approach.	lowered portion of front desk exists but there's a map posted on it	Train staff to keep lowered counter free of materials and available for use.	2015 ABAAS Section: 904.4.2, 904.4.1  2012 TAS Section: 904.4.1, 904.4.2  2010 ADAS Section: 904.4.2, 904.4.1

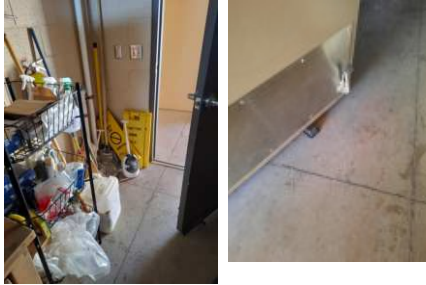
Finding Number	Area Description	Lat/Long	Finding	As Built	Recommendation	Citation	Photos	Figure
28	Headquarters/Visitor's Center: HQ - Employee Spaces	[31.9105001, -106.5180893]	Spaces and elements within employee work areas shall only be required to comply with 206.2.8, 207.1, and 215.3 and shall be designed and constructed so that individuals with disabilities can approach, enter, and exit the employee work area. Employee work areas, or portions of employee work areas, other than raised courtroom stations, that are less than 300 square feet (28 m2) and elevated 7 inches (180 mm) or more above the finish floor or ground where the elevation is essential to the function of the space shall not be required to comply with these requirements or to be on an accessible route.	Storage room/pipe chase between restrooms at Visitor Center - Storage in pull side clearance, hold open device on push side, fast close, 12# push	For employee spaces, relocate storage, furniture, and other obstacles at doorways to provide approach, enter and exit at the employee space. Provide required maneuvering clearance on push and pull side of doors. Inspect, adjust, and maintain closing speed on door closers. Inspect, adjust, and maintain 8.5 lbf to open exterior doors as a smart practice. Remove door holder to provide a smooth surface on the push side of door from floor to 10" AFF.	2015 ABAAS Section: F203.9 2012 TAS Section: 203.9 2010 ADA Section: 203.9

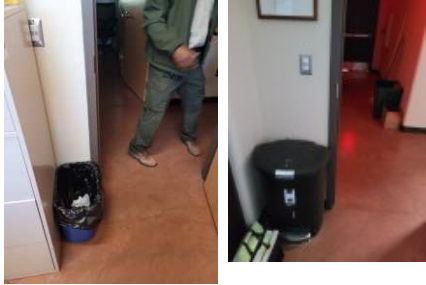
Finding Number	Area Description	Lat/Long	Finding	As Built	Recommendation	Citation	Photos	Figure
30	Headquarters/Visitor's Center: HQ - Employee Spaces	[31.9106323, -106.5180834]	Spaces and elements within employee work areas shall only be required to comply with 206.2.8, 207.1, and 215.3 and shall be designed and constructed so that individuals with disabilities can approach, enter, and exit the employee work area. Employee work areas, or portions of employee work areas, other than raised courtroom stations, that are less than 300 square feet (28 m2) and elevated 7 inches (180 mm) or more above the finish floor or ground where the elevation is essential to the function of the space shall not be required to comply with these requirements or to be on an accessible route.	Park superintendent office - clearance on pull side reduced by garbage	For employee spaces, relocate storage, furniture, and other obstacles at doorways to provide approach, enter and exit at the employee space. Provide required maneuvering clearance on push and pull side of doors.	2015 ABAAS Section: F203.9 2012 TAS Section: 203.9 2010 ADAS Section: 203.9

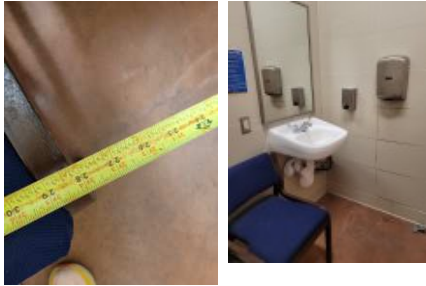
Finding Number	Area Description	Lat/Long	Finding	As Built	Recommendation	Citation	Photos	Figure
36	Headquarters/Visitor's Center: HQ - Employee Spaces	[31.9105983, -106.5181195]	The operable part is not accessible because there is not adequate clear floor space for either a forward or side approach. The clear floor or ground space shall be 30 inches minimum by 48 inches minimum.	Chair reduces clear floor space (CFS) of sink to 28"	Remove, or relocate storage in CFS at fixtures and operable parts.	2015 ABAAS Section: 305.3 2012 TAS Section: 305.3 2010 ADAS Section: 305.3

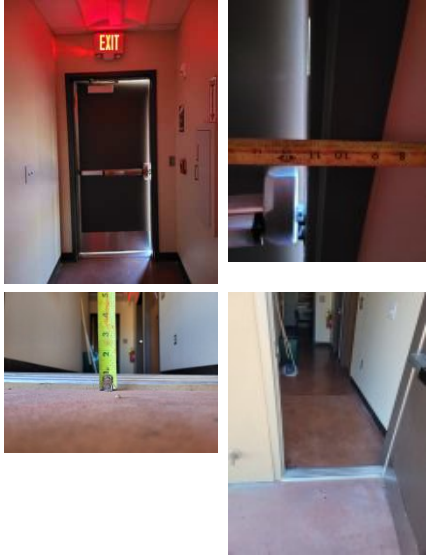
Finding Number	Area Description	Lat/Long	Finding	As Built	Recommendation	Citation	Photos	Figure
39	Headquarters/Visitor's Center: HQ - Employee Spaces	[31.910605, -106.5181049]	Minimum maneuvering clearances at doors and gates shall comply with 404.2.4. Maneuvering clearances shall extend the full width of the doorway and the required latch side or hinge side clearance. Maneuvering clearances shall have a max slope of 2.08%. The threshold has a vertical change greater than 1/4 inch high. Egress doors shall provide a sign having Braille and tactile characters.	Exit door at rear of employee spaces - lacks tactile exit sign, 11.25" clearance on push side, 1" change in elevation (CIL)	For all doors along the public circulation route, provide required maneuvering clearance on push and pull side of doors. For all doors along the public circulation route, repair, bevel, or ramp CILs at door entries to max .25". For all doors along the public circulation route, provide egress signage.	2010 ADAS Section: 404.2.3, 404.2.7, 404.2.4, 404.2.11, 404.2.11 Exception

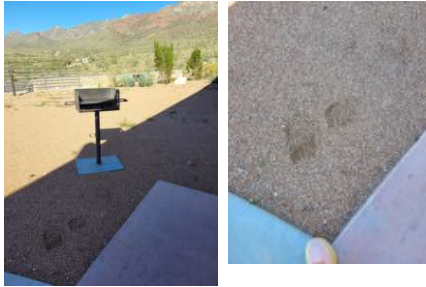
40	Headquarters/Visitor's Center: HQ - Employee Spaces	[31.9106808, -106.5181437]	There is no accessible route to the employee grill. At least one accessible route shall connect accessible buildings, accessible facilities, accessible elements, and accessible spaces that are on the same site.	Lacks route to employee grill in rear of HQ due to surface	Create an accessible route with crushed stone or other outdoor material from parking or walkway to the employee grill.	2015 ABAAS Section: F206.2.2 2012 TAS Section: 206.2.2 2010 ADAS Section: 206.2.2

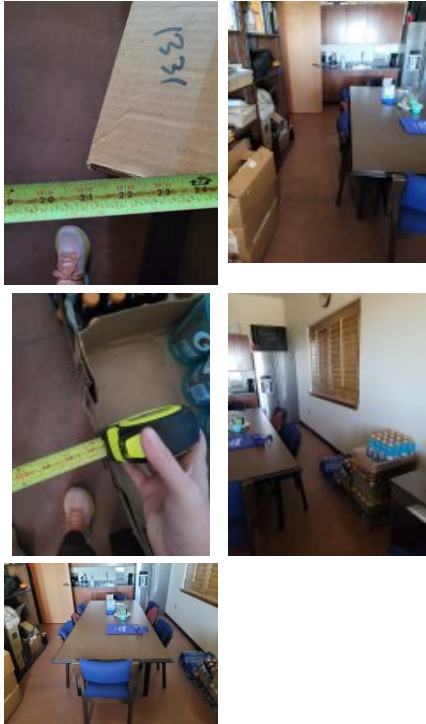
Finding Number	Area Description	Lat/Long	Finding	As Built	Recommendation	Citation	Photos	Figure
42	Headquarters/Visitor's Center: HQ - Employee Spaces	[31.9105993, -106.5181153]	The route of travel at this location does not provide a minimum width of 36 inches. The clear width shall be permitted to be reduced to 32 inches minimum for a length of 24 inches maximum provided that reduced width segments are separated by segments that are 48 inches long minimum and 36 inches wide minimum.	Route in breakroom reduces to 21" and 19" around table due to storage	Relocate storage to widen AR to compliant 36" clear width.	2015 ABAAS Section: 403.5.1 2012 TAS Section: 403.5.1 2010 ADAS Section: 403.5.1

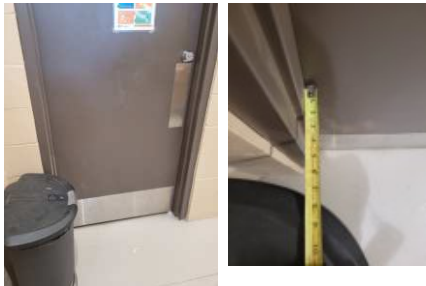
52	Headquarters/Visitor's Center: HQ - Women's Restroom	[31.9105003, -106.5180968]	Minimum maneuvering clearances at doors and gates shall comply with 404.2.4. Maneuvering clearances shall extend the full width of the doorway and the required latch side or hinge side clearance. Exterior doors are recommended to be maintained at 8.5 lbf as a smart practice. Force is to be measured at the operating hardware or 30 inches from the hinges, whichever is greater.	HQ women's restroom door - garbage 7.5" in back clearance on push side, 15# push	For all doors along the public circulation route, provide required maneuvering clearance on push and pull side of doors. For all doors along the public circulation route, inspect, adjust, and maintain 8.5 lbf to open exterior doors as a smart practice.	2010 ADAS Section: 404.2.3, 404.2.7, 404.2.4, 404.2.11, 404.2.11 Exception

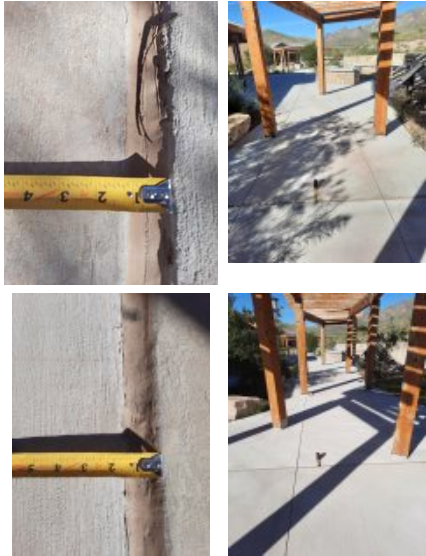
Finding Number	Area Description	Lat/Long	Finding	As Built	Recommendation	Citation	Photos	Figure
54	Interpretive Building: Interpretive - Exterior Accessible Route	[31.910103, -106.518074]	There is a gap spaced greater than a 1/2 inch. Openings in floor or ground surfaces shall not allow passage of a sphere more than 1/2 inch diameter. Elongated openings shall be placed so that the long dimension is perpendicular to the dominant direction of travel.	Two 1.25" gaps on mountain side of interpretive center	Correct or fill gaps to be max .5".	2015 ABAAS Section: 302.3 2012 TAS Section: 302.3 2010 ADAS Section: 302.3

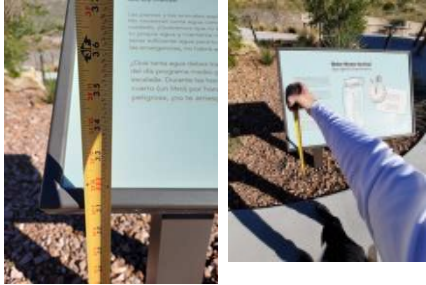
Finding Number	Area Description	Lat/Long	Finding	As Built	Recommendation	Citation	Photos	Figure
60	Interpretive Building: Interpretive - Public Spaces	[31.9101527 , -106.518139]	Visual characters shall be 40 inches (1015 mm) minimum above the finish floor or ground. EXCEPTION: Visual characters indicating elevator car controls shall not be required to comply with 703.5.6.	"Water means survival" info sign at Interpretive Center is low	Remount signage to min 40" AFF as a smart practice.	2015 ABAAS Section: 703.5.6, 703.5.6 EXCEPTION  2012 TAS Section: 703.5.6, 703.5.6 Exception  2010 ADAS Section: 703.5.6, 703.5.6 Exception

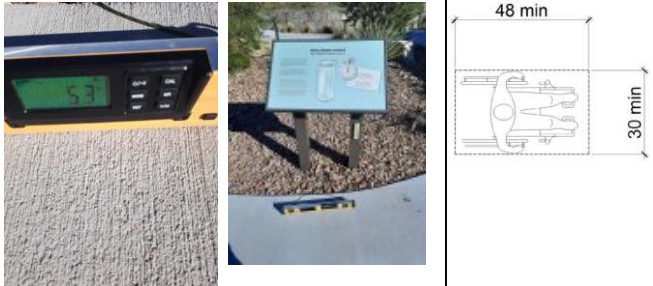
61	Interpretive Building: Interpretive - Public Spaces	[31.9101755 , -106.5180645]	The 30 inches minimum by 48 inches minimum clear floor space required at the operable part is not flat (2% or 1:48 maximum slope) in all directions. Changes in level are not permitted at required clear floor or ground space except that slopes not steeper than 1:48 shall be permitted.	"Water means survival" info sign at Interpretive Center has slope of 5.3% in CFS	Correct or repair slope in CFS to max 2.08%.	2015 ABAAS Section: 305.2  2012 TAS Section: 305.2  2010 ADAS Section: 305.2

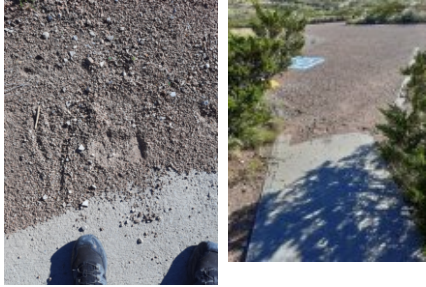
87	Restroom 1 Area: RR 1 - Picnic Areas	[31.9140264, -106.5167799]	The surface of the route to and into the picnic area or shelter must be firm and stable.	Loose gravel at transition from shelter walkway to accessible parking	Replace or correct surface to be firm and stable as a smart practice.	2015 ABAAS Section: 1016.1, 1016.1 EXCEPTION S 1, 1016.1 EXCEPTION S 2, 1016.1 EXCEPTION S 3

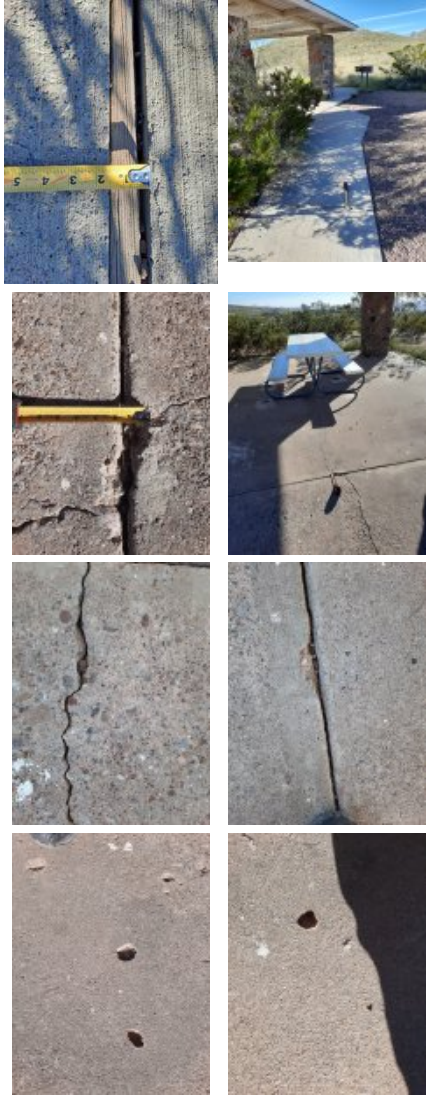
Finding Number	Area Description	Lat/Long	Finding	As Built	Recommendation	Citation	Photos	Figure
88	Restroom 1 Area: RR 1 - Picnic Areas	[31.9141357 , -106.5167 826]	Openings in the surface of outdoor recreation access routes shall not allow the passage of a sphere more than 1/2 inch (13 mm) in diameter. Advisory: Spaces between the boards in a boardwalk and drainage grates are examples of openings. Where possible, drainage grates should be located outside the minimum clear width of the outdoor recreation access route. Elongated openings should be placed so that the long dimension is perpendicular, or as close to perpendicular as possible, to the dominant direction of travel	Gap of 1.5" on walkway to shelter; multiple gaps (7) in shelter surface	Correct or fill gaps along the ORAR to max .5" as a smart practice.	2015 ABAAS Section: 1016.6, Advisory 1016.6

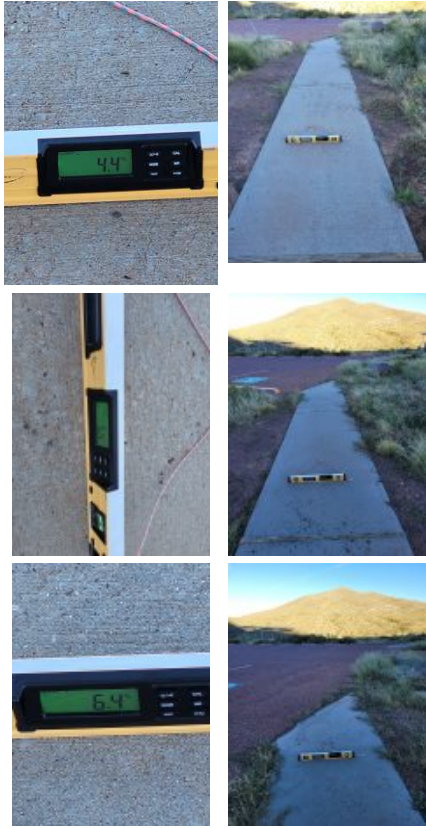
Finding Number	Area Description	Lat/Long	Finding	As Built	Recommendation	Citation	Photos	Figure
119	Restroom 2 Area: RR 2 - Picnic Areas	[31.9160972, -106.5137208]	The cross slope shall not be steeper than 1:48. EXCEPTION: Where the surface is other than concrete, asphalt, or boards, cross slopes not steeper than 1:20 shall be permitted when necessary for drainage.	Walkway to site 10 - consistent cross slopes for whole path - 4.4%, 5.4%, 6.4%	Correct or repair ORAR cross slope to max 2.08% as a smart practice.	2015 ABAAS Section: 1016.7.2, 1016.7.2 EXCEPTION

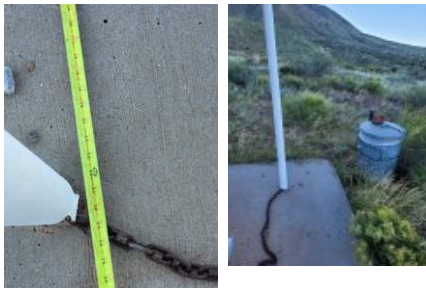
120	Restroom 2 Area: RR 2 - Picnic Areas	[31.9160228, -106.5136638]	The required clear floor space is not deep enough. The clear floor or ground space shall be 30 inches minimum by 48 inches minimum.	Site 10 - Clear floor space of garbage can reduced to 26" due to pole	Relocate garbage can along an AR with compliant clear floor space.	2015 ABAAS Section: 305.3 2012 TAS Section: 305.3 2010 ADAS Section: 305.3

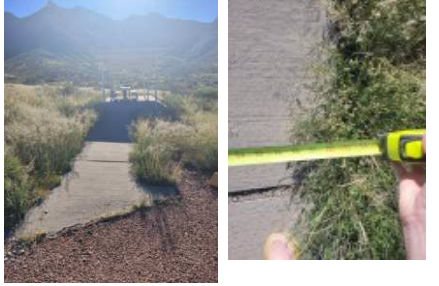
154	Camping Area (Restroom 3 Area): Camping/RR 3 - Picnic Areas	[31.9284029, -106.5105961]	The clear width of outdoor recreation access routes shall be 36 inches (915 mm) minimum.	Site 23 - width reduced by plant overgrowth	Widen ORAR to min 36" clear width as a smart practice.	2015 ABAAS Section: 1016.3

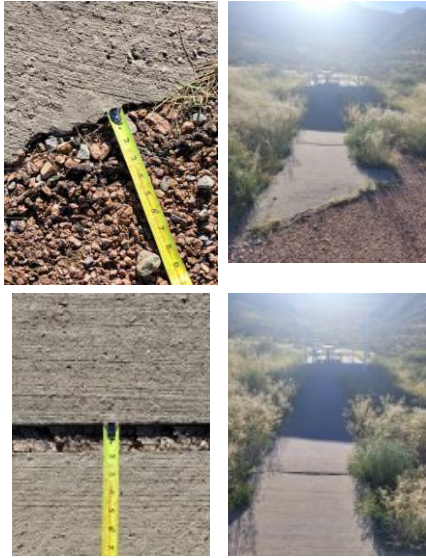
Finding Number	Area Description	Lat/Long	Finding	As Built	Recommendation	Citation	Photos	Figure
155	Camping Area (Restroom 3 Area): Camping/RR 3 - Picnic Areas	[31.928375, -106.51054 23]	Openings in the surface of outdoor recreation access routes shall not allow the passage of a sphere more than 1/2 inch (13 mm) in diameter. Advisory: Spaces between the boards in a boardwalk and drainage grates are examples of openings. Where possible, drainage grates should be located outside the minimum clear width of the outdoor recreation access route. Elongated openings should be placed so that the long dimension is perpendicular, or as close to perpendicular as possible, to the dominant direction of travel	Site 23 - 2.5" at entry, 1.5" at path	Correct or fill gaps along the ORAR to max .5" as a smart practice.	2015 ABAAS Section: 1016.6, Advisory 1016.6
