Access Audit Site Report

Galveston Island State Park

Accessibility Evaluation

Inspection Date: 08/17/2022

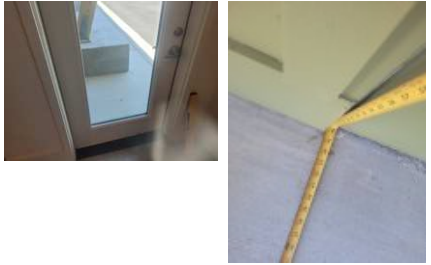
11	Headquarters Area: HQ - Employee Spaces	[29.1936838 , -94.957313 4]	Minimum maneuvering clearances at doors and gates shall comply with 404.2.4. Maneuvering clearances shall extend the full width of the doorway and the required latch side or hinge side clearance. The sweep period for doors with closers shall be adjusted so that from an open position of 70 degrees, the door will take at least 3 seconds to move to a point 3 inches from the latch, measured to the leading edge of the door. Exterior doors are recommended to be maintained at 8.5 lbf as a smart practice. Force is to be measured at the operating hardware or 30 inches from the hinges, whichever is greater. Egress doors shall provide a continuous and unobstructed way of egress travel from any point in a building or facility that provides an accessible route to an area of refuge, a horizontal exit, or a public way.	Entry booth - wall push side, 12#, closes fast, lacks egress	For all doors along the public circulation route, provide required maneuvering clearance on push and pull side of doors. For all doors along the public circulation route, inspect, adjust, and maintain closing speed on door closers. For all doors along the public circulation route, inspect, adjust, and maintain 8.5 lbf to open exterior doors as a smart practice. For all doors along the public circulation route, enlarge cement pad at exit to allow 18" clearance on the latch side, and extend a pathway away from the building for emergency egress.	2010 ADAS Section: 404.2.3, 404.2.7, 404.2.4, 404.2.11, 404.2.11 Exception

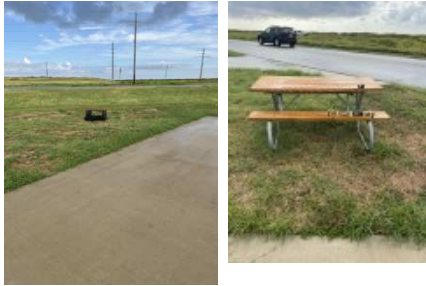
87	Beachside - Dry Camping Loop: Dry Camping - Campsites (86-95)	[29.1866168 , -94.9660968]	Clear ground space 48 inches (1220 mm) by 48 inches (1220 mm) should be provided on all usable sides of the fire ring, grill, fireplace, and woodstove. Center the space on each usable side of the grill, fireplace, and woodstove.	Fire pit lacks clear ground space	Provide required 48" clear ground space centered along usable side of fire ring, grill, fireplace, or woodstove as a smart practice.	2015 ABAAS Section: 1011.2

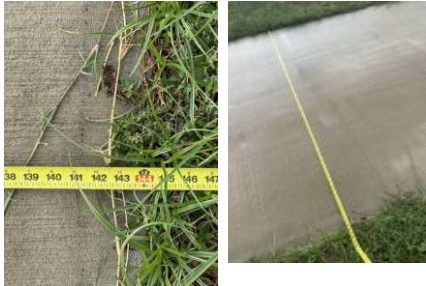
91	Beachside - Dry Camping Loop: Dry Camping - Equestrian Day Use	[29.185319, -94.967690 8]	At least one accessible route shall connect accessible buildings, accessible facilities, accessible elements, and accessible spaces that are on the same site. For areas of sport activity, an accessible route is required to connect to the boundary of each area of sport activity. The size of an area of sport activity includes only the space needed to play. Where multiple sports fields or courts are provided, an accessible route is required to each field or area of sport activity.	No features provided at equestrian day use, if features are installed add accessible route to features	Provide an accessible route (AR) to each element within the site.	2010 ADAS Section: 206.2.2, 206.2

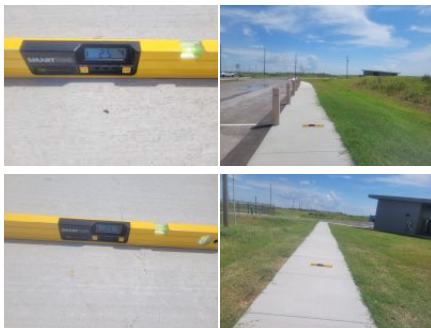
122	Beachside - Day Use Area: Day Use - Shelter/Picnic Area	[29.1914337, -94.9572621]	Where picnic facilities contain two or fewer picnic units, each picnic unit shall provide mobility features complying with F245.2.	Lacks AR to grill at SE and SW corner shelters	Create an ORAR to shelter or picnic area and provide accessible features as a smart practice.	2015 ABAAS Section: F245.2.1

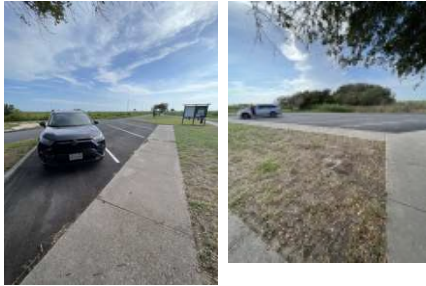
156	Bayside - Entrance: Entrance - Parking	[29.1988599, -94.9564167]	There is a gap spaced greater than a 1/2 inch. Openings in floor or ground surfaces shall not allow passage of a sphere more than 1/2 inch diameter. Elongated openings shall be placed so that the long dimension is perpendicular to the dominant direction of travel.	Large gap leading to entrance	Correct or fill gaps to be max .5".	2015 ABAAS Section: 302.3 2012 TAS Section: 302.3 2010 ADAS Section: 302.3

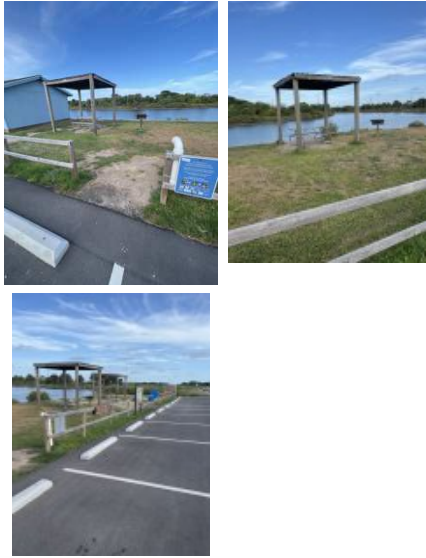
183	Bayside - Oak Bayou Area: Oak - Shelter/Picnic Area	[29.2043679 , -94.956651 4]	The operable part is not accessible because there is not adequate clear floor space for either a forward or side approach. The clear floor or ground space shall be 30 inches minimum by 48 inches minimum.	0 of 2 garbage lacks route/CGS	Relocate 20% of garbage cans to be along the AR	2015 ABAAS Section: 305.3 2012 TAS Section: 305.3 2010 ADAS Section: 305.3

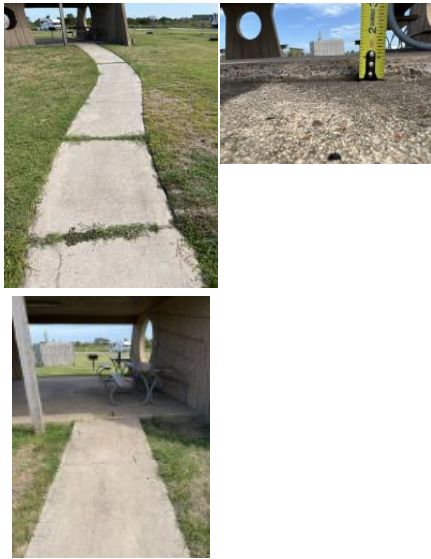
200	Bayside Area: Bayside - Water & Electric Camping Loop (106-125)	[29.2120774 , -94.954701 5]	There is a gap spaced greater than a 1/2 inch. Openings in floor or ground surfaces shall not allow passage of a sphere more than 1/2 inch diameter. Elongated openings shall be placed so that the long dimension is perpendicular to the dominant direction of travel.	9" gap approaching shelter	Correct or fill gaps to be max .5".	2015 ABAAS Section: 302.3 2012 TAS Section: 302.3 2010 ADAS Section: 302.3

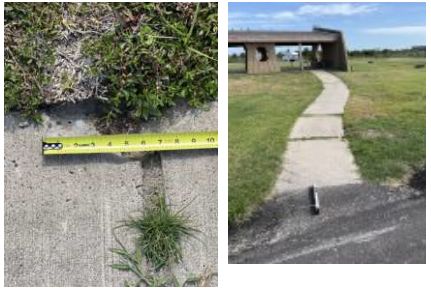
Finding Number	Area Description	Lat/Long	Finding	As Built	Recommendation	Citation	Photos	Figure
201	Bayside Area: Bayside - Water & Electric Camping Loop (106-125)	[29.2120182 , -94.954670 5]	The running slope of walking surfaces shall not be steeper than 1:20.	15.4% approaching campsite 119 from shelter, 5.2% at shelter entry	Correct running slope along the AR to max 5%.	2015 ABAAS Section: 403.3 2012 TAS Section: 403.3 2010 ADAS Section: 403.3

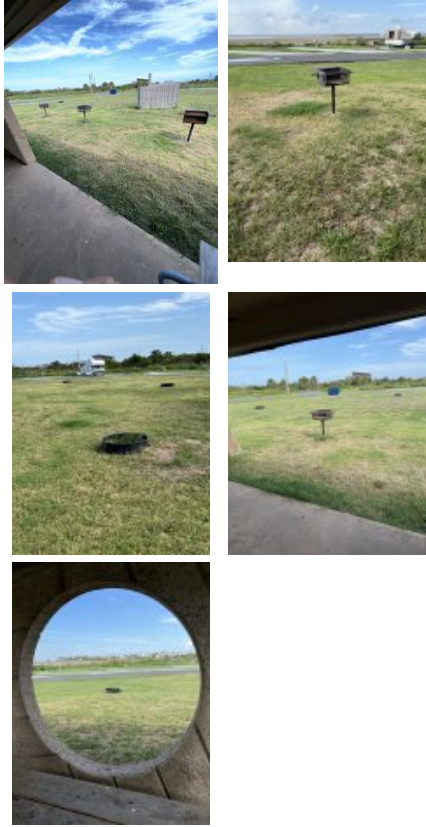
203	Bayside Area: Bayside - Water Only Camping Loop (96-105)	[29.2101211 , -94.9546982]	An accessible access route is not provided between elements, spaces and the facilities provided within the accessible camping unit. At least one outdoor recreation access route shall connect accessible elements, spaces and facilities provided within camping units with mobility features.	Site 96 lacks route to table, fire pit and water	Create AR with crushed and compacted stone or similar outdoor material to camp sites and one of each type of amenity.	2015 ABAAS Section: F244.5.1

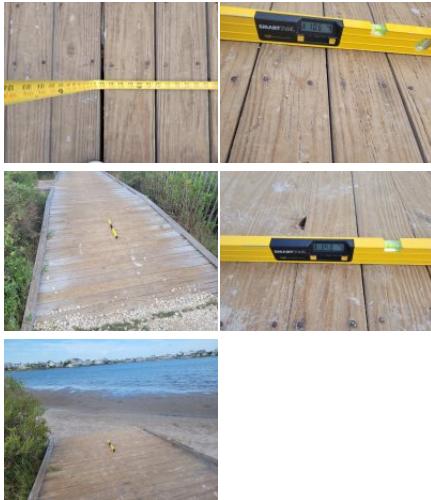
215	Bayside Area: Lake Como - Canoe/Kayak Launch	[29.21304, -94.95336]	There is a gap spaced greater than a 1/2 inch. Openings in floor or ground surfaces shall not allow passage of a sphere more than 1/2 inch diameter. Elongated openings shall be placed so that the long dimension is perpendicular to the dominant direction of travel.	Gaps in boardwalk at kayak launch	Correct or fill gaps to be max .5".	2015 ABAAS Section: 302.3 2012 TAS Section: 302.3 2010 ADAS Section: 302.3

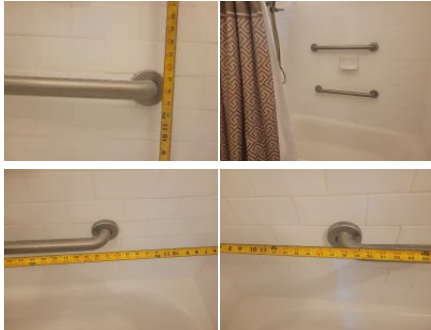
241	Bayside Area: Stewart House	[29.2090831, -94.9528869]	The top grab bar is not located correctly. Two grab bars shall be installed on the back wall, one installed in a horizontal position, 33 inches minimum and 36 inches maximum above the finish floor measured to the top of the gripping surface and the other located 8 inches minimum and 10 inches maximum above the rim of the bathtub. Each grab bar shall be installed 15 inches maximum from the head end wall and 12 inches maximum from the control end wall.	Top bar too high, too far from ends	Remount tub grab bar to proper location	2015 ABAAS Section: 607.4.1.1, 607.4.2.1 2012 TAS Section: 607.4.1.1, 607.4.2.1 2010 ADAS Section: 607.4.2.1, 607.4.1.1

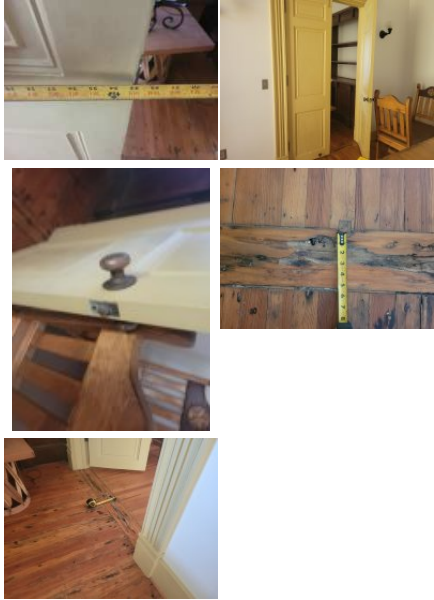
Finding Number	Area Description	Lat/Long	Finding	As Built	Recommendation	Citation	Photos	Figure
244	Bayside Area: Stewart House	[29.20914, -94.95293]	Door openings shall provide a clear width of 32 inches (815 mm) minimum. Clear openings of doorways with swinging doors shall be measured between the face of the door and the stop, with the door open 90 degrees. Openings more than 24 inches (610 mm) deep shall provide a clear opening of 36 inches (915 mm) minimum. There shall be no projections into the required clear opening width lower than 34 inches (865 mm) above the finish floor or ground. Projections into the clear opening width between 34 inches (865 mm) and 80 inches (2030 mm) above the finish floor or ground shall not exceed 4 inches (100 mm). The threshold has a gap greater than 1/2 inch wide. Hand-activated door opening hardware, handles, pulls, latches, locks, and other operating devices on accessible doors shall have a shape that is easy to grasp with one hand and does not require tight grasping, tight pinching or twisting of the wrist to operate. Hardware shall be 34 inches minimum and 48 inches maximum above the finish floor or ground.	Double door between entry and dining room- 24" wide, gaps in doorway where remodel occurring, knobs	For all doors along the public circulation route, replace doors with doors having 80" overhead clearance and 32" clear width. For all doors along the public circulation route, fill gaps at door entries to max .5". For all doors along the public circulation route, replace hardware with lever hardware or hardware operable without a tight pinch or grasp.	2010 ADAS Section: 404.2.3, 404.2.7, 404.2.4, 404.2.11, 404.2.11 Exception

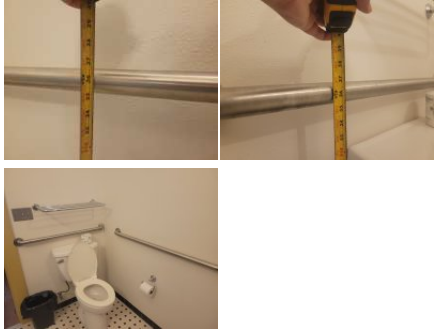
250	Bayside Area: Stewart House	[29.20912, -94.95286]	The toilet paper is not installed within the compliant range in front of the toilet. Toilet paper dispensers shall be 7 inches minimum and 9 inches maximum in front of the water closet measured to the centerline of the dispenser. The outlet of the dispenser shall be 15 inches minimum and 48 inches maximum above the finish floor and shall not be located behind grab bars. Dispensers shall not be of a type that controls delivery or that does not allow continuous paper flow. There shall be a clearance of 1 1/2 inches minimum below the grab bar.	Toilet paper not within compliant range	Remount toilet paper dispenser max 7" to 9" from front of toilet, 15" to 48" AFF and min 12" above or 1.5" below grab bar.	2015 ABAAS Section: 604.7 2012 TAS Section: 604.7 2010 ADAS Section: 604.7

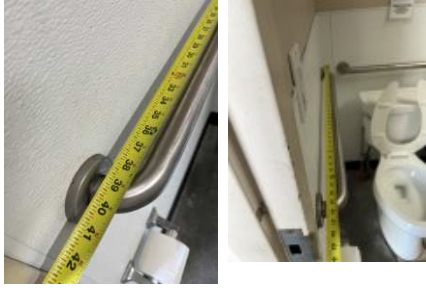
287	Employee Areas: Maintenance	[29.2064771 , -94.954918 9]	The grab bar height and/or spacing fails. Grab bars must be mounted between 33" and 36" to the top of the gripping surface. There must be 1.5" of clearance between the grab bar and the wall. There must be a minimum of 1.5" of clearance below and minimum 12" above the grab bar to any dispenser or other obstruction.	restroom- both grab bars 37" AFF	Remount grab bars in accessible stall to 33" to 36" above the finished floor (AFF).	2015 ABAAS Section: 609.3, 609.4 2012 TAS Section: 609.4, 609.3 2010 ADAS Section: 609.3, 609.4

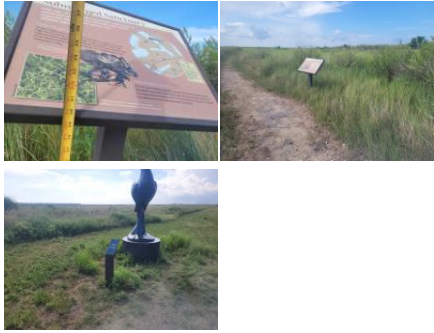
Finding Number	Area Description	Lat/Long	Finding	As Built	Recommendation	Citation	Photos	Figure
299	Trails: Trail Surface	[29.2041288 , -94.960980 1]	The surface of trails, passing spaces, and resting intervals shall be firm and stable	natural surface trails throughout, large gravel, dirt, some boardwalk	Replace surface of trail with one that is firm and stable as a smart practice.	2015 ABAAS Section: 1017.2

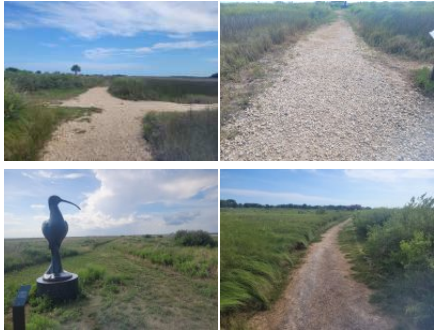
300	Trails: Trail Surface	[29.2013781 , -94.962863 6]	The surface of trails, passing spaces, and resting intervals shall be firm and stable	surface to accessible viewing area mostly large rocks	Replace surface of trail with one that is firm and stable as a smart practice.	2015 ABAAS Section: 1017.2
