Access Audit Site Report

Goose Island State Park

Accessibility Evaluation

Inspection Date: 10/07/2021

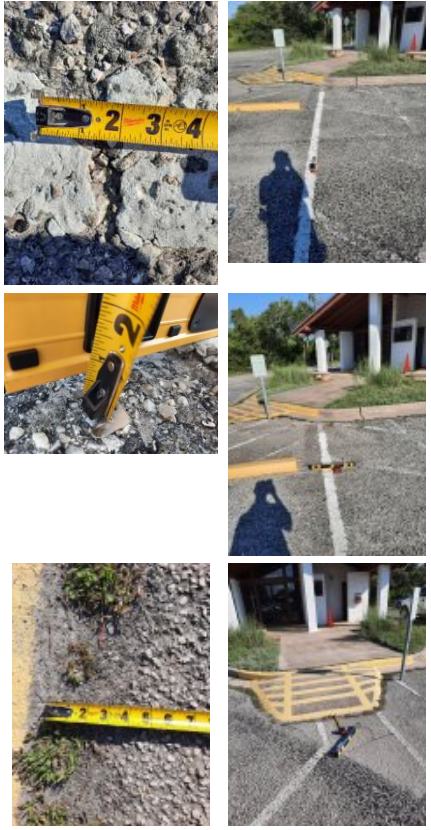
Finding Number	Area Description	Lat/Long	Finding	As Built	Recommendation	Citation	Photos	Figure
4	Headquarters Area: Headquarters Building Parking	[28.1333994 , -96.984316 2]	The parking stall contains abrupt edges and surface irregularities over a 1/4 inch vertical. Parking spaces and access aisles serving them shall be stable, firm, and slip resistant. Access aisles shall be at the same level as the parking spaces they serve. Changes in level are not permitted and shall not be sloped steeper than 2% in any direction.	Multiple gaps and changes in level (CIL) due to deterioration of paint and/or the parking surface being rough concrete with loose rock, weeds, grass, dirt/sand on top	Resurface stalls and access aisles to eliminate gaps and cracks Resurface accessible stalls and access aisles with a firm, stable, and slip resistant material	2015 ABAAS Section: 502.4 2012 TAS Section: 502.4 2010 ADAS Section: 502.4

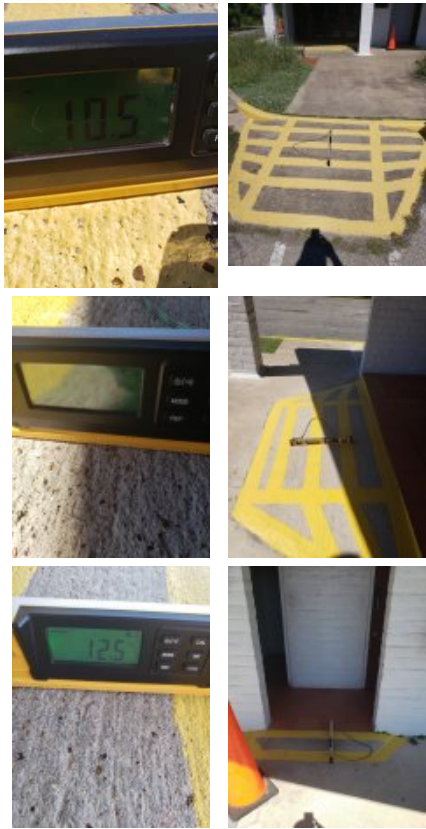
Finding Number	Area Description	Lat/Long	Finding	As Built	Recommendation	Citation	Photos	Figure
8	Headquarters Area: Headquarters Building	[28.1335342 , -96.984316 2]	Exterior doors are recommended to be maintained at 8.5 lbf as a smart practice. Force is to be measured at the operating hardware or 30 inches from the hinges, whichever is greater. The bottom 10 inches on the push side must be smooth and free of obstructions (hold open devices).	Double leaf, entry doors require 28 lbf, glass begins 4" from bottom on push side	For all doors along the public circulation route, inspect, adjust, and maintain 8.5 lbf to open exterior doors as a smart practice For all doors along the public circulation route, provide kick plate on push side of door from floor to 10" aff	2010 ADAS Section: 404.2.3, 404.2.7, 404.2.4, 404.2.11, 404.2.11 Exception

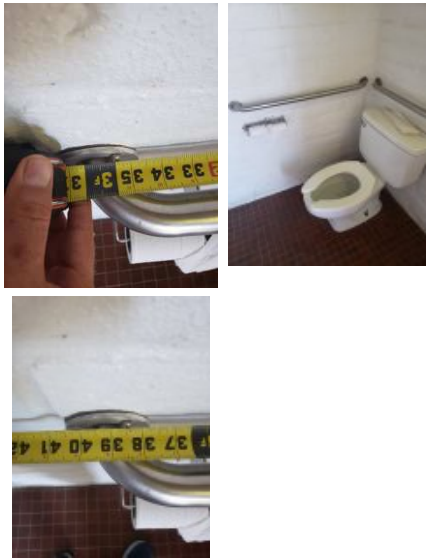
Finding Number	Area Description	Lat/Long	Finding	As Built	Recommendation	Citation	Photos	Figure
18	Headquarters Area: Headquarters Bathroom Left	[28.1335413 , -96.984308 1]	The rear grab bar is not 36" long or is not mounted in the correct location. The rear grab bar must be a minimum of 36" long and extend from the toilet centerline a minimum 12" towards the wall side and a minimum 24" towards the open side of the toilet. Grab bars shall be installed in a horizontal position, 33 inches minimum and 36 inches maximum above the finish floor measured to the top of the gripping surface and the space between the grab bar and the top of the tank shall be 1-1/2 inches minimum.	Rear grab bar is 24" long and extends 11" from centerline of toilet to open side of toilet	Replace rear grab bar with one 36" long, mounted behind the toilet, 12" to one side of center and 24" to the other and 33" to 36" aff	2015 ABAAS Section: 604.5.2 2012 TAS Section: 604.5.2 2010 ADAS Section: 604.5.2

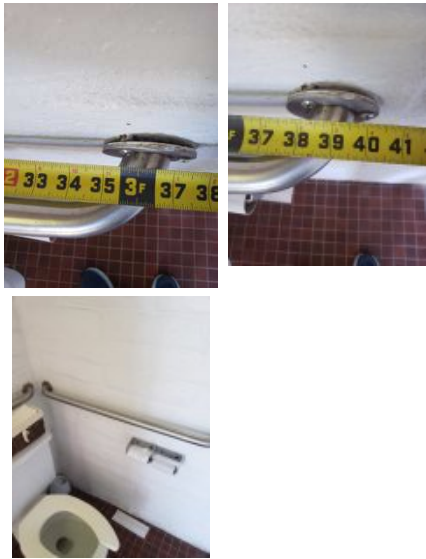
Finding Number	Area Description	Lat/Long	Finding	As Built	Recommendation	Citation	Photos	Figure
30	Headquarters Area: Headquarters Bathroom Right	[28.1335603 , -96.984324 2]	The rear grab bar is not 36" long or is not mounted in the correct location. The rear grab bar must be a minimum of 36" long and extend from the toilet centerline a minimum 12" towards the wall side and a minimum 24" towards the open side of the toilet. Grab bars shall be installed in a horizontal position, 33 inches minimum and 36 inches maximum above the finish floor measured to the top of the gripping surface and the space between the grab bar and the top of the tank shall be 1-1/2 inches minimum.	Rear grab bar is 24" long and extends 12" from centerline of toilet to open side of the toilet	Replace rear grab bar with one 36" long, mounted behind the toilet, 12" to one side of center and 24" to the other and 33" to 36" aff	2015 ABAAS Section: 604.5.2 2012 TAS Section: 604.5.2 2010 ADAS Section: 604.5.2

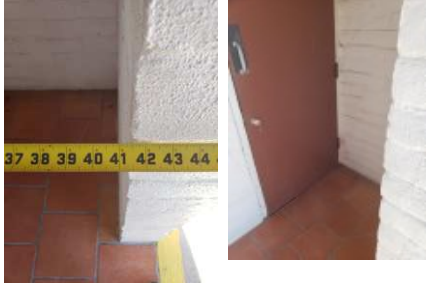
Finding Number	Area Description	Lat/Long	Finding	As Built	Recommendation	Citation	Photos	Figure
34	Employee Spaces: Maintenance	[28.1335839 , -96.986105 2]	<p>Minimum maneuvering clearances at doors and gates shall comply with 404.2.4. Maneuvering clearances shall extend the full width of the doorway and the required latch side or hinge side clearance. Maneuvering clearances shall have a max slope of 2.08%. Door openings shall provide a clear width of 32 inches (815 mm) minimum. Clear openings of doorways with swinging doors shall be measured between the face of the door and the stop, with the door open 90 degrees. Openings more than 24 inches (610 mm) deep shall provide a clear opening of 36 inches (915 mm) minimum. There shall be no projections into the required clear opening width lower than 34 inches (865 mm) above the finish floor or ground. Projections into the clear opening width between 34 inches (865 mm) and 80 inches (2030 mm) above the finish floor or ground shall not exceed 4 inches (100 mm). The threshold has a vertical change greater than 1/4 inch high. All interior doors must be maintained so that the operating pressure does not exceed 5 lbf to open. The sweep period for doors with closers shall be adjusted so that from an open position of 70 degrees, the door will take at least 3 seconds to move to a point 3 inches from the latch, measured to the leading edge of the door. Hand-activated door opening hardware, handles, pulls, latches, locks, and other operating devices on accessible doors shall have a shape that is easy to grasp with one hand and does not require tight grasping, tight pinching or twisting of the wrist to operate. Hardware shall be 34 inches minimum and 48 inches maximum above the finish floor or ground.</p>	<p>Maintenance door - Lacks pull side clearance, CILs of 3" and 3", knobs, lacks secure floor mat Office door - refrigerator in pull side clearance, 15 lbf, fast close, knobs, and lacks secure floor mat Storage door - storage in push and pull side clearances, 27.5" clear width Restroom door - storage in push and pull side clearances, 21" clear width Hall to bathroom and storage closet lacks 36" wide route of travel (35.5") and is obstructed with hanging storage</p>	<p>For all doors along the public circulation route, provide required maneuvering clearance on push and pull side of doors. For all doors along the public circulation route, secure rug in door clearance to prevent trip hazard. For all doors along the public circulation route, replace doors with doors having 80" overhead clearance and 32" clear width. For all doors along the public circulation route, repair, bevel, or ramp CILs at door entries to max .25". For all doors along the public circulation route, inspect, adjust, and maintain 5 lbf to open interior doors. For all doors along the public circulation route, inspect, adjust, and maintain closing speed on door closers. For all doors along the public circulation route, replace hardware with lever hardware or hardware operable without a tight pinch or grasp.</p>	2010 ADAS Section: 404.2.3, 404.2.7, 404.2.4, 404.2.11, 404.2.11 Exception

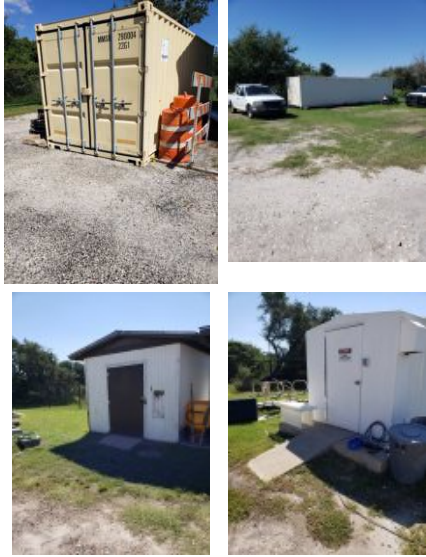
38	Employee Spaces: Maintenance	[28.1335839 , -96.986089 1]	This restroom is not accessible. Where existing toilet rooms or bathing rooms do not comply, directional signs indicating the location of the nearest accessible toilet room or bathing room within the facility shall be provided. Signs shall include the International Symbol of Accessibility. Where existing toilet rooms or bathing rooms do comply), the accessible toilet rooms or bathing rooms shall be identified by the International Symbol of Where clustered single user toilet rooms or bathing facilities are permitted, accessible toilet rooms or bathing facilities shall be identified by the International Symbol of Accessibility unless all toilet rooms and bathing facilities are accessible.	This restroom is not accessible, 37" wide and lacks directional sign to an accessible restroom	Restroom not accessible, acquire and mount signage directing patrons to accessible restroom	2015 ABAAS Section: F216.8 2012 TAS Section: 216.8 2010 ADAS Section: 216.8

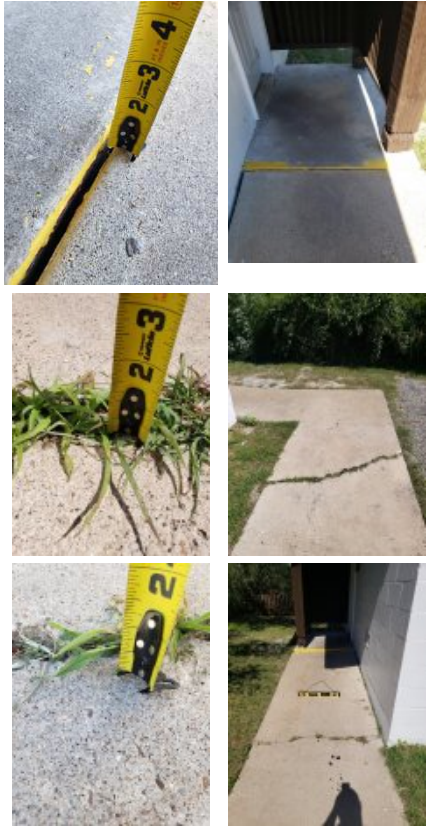
96	Bayberry: Bayberry EAR	[28.135119, -96.986551 8]	There is no accessible route to the informational sign, pet station, trash cans, and dumpster. At least one accessible route shall connect accessible buildings, accessible facilities, accessible elements, and accessible spaces that are on the same site.	Lacks accessible route to informational sign, pet station, trash cans, and dumpster	Create an accessible route with crushed stone or other outdoor material from parking or walkway to informational sign, pet station, trash cans, and dumpster.	2015 ABAAS Section: F206.2.2 2012 TAS Section: 206.2.2 2010 ADAS Section: 206.2.2

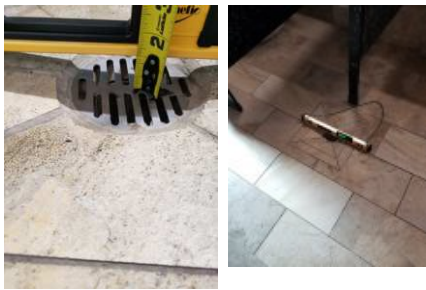
112	Bayberry: Bayberry Men's Restroom	[28.1352633 , -96.986558 5]	The accessible route contains running slopes greater than 5 percent and cross slopes greater than 2 percent across the width of the walk and has not been constructed as a ramp (i.e. handrails, wheel guides, etc.). When the slope in the direction of travel of any walk exceeds 1 unit vertical in 20 units horizontal (5-percent slope), it must be constructed as ramp. Surface cross slopes must not exceed one unit vertical in 48 units. Horizontal (2-percent slope).	Slope of 17.6% near floor drain	Correct or repair slope to max 5% running and 2.08% cross	2015 ABAAS Section: 403.3 2012 TAS Section: 403.3 2010 ADAS Section: 403.3

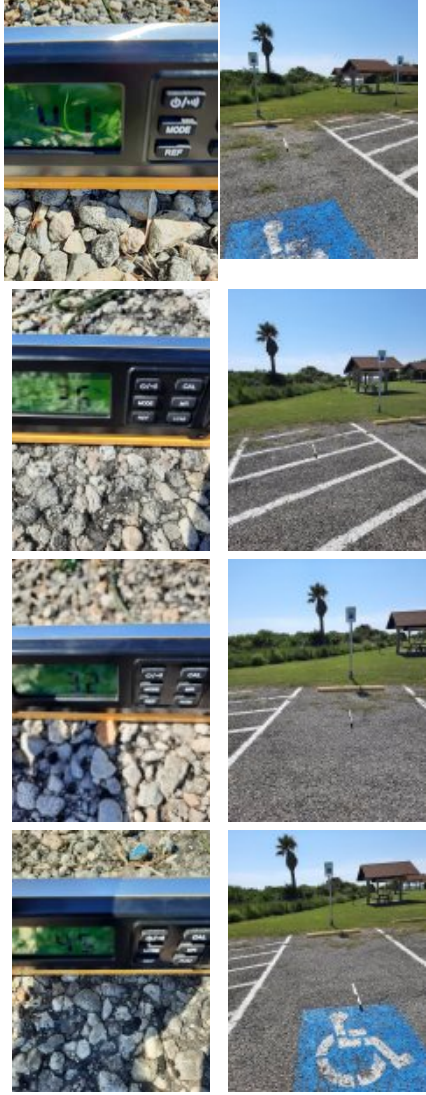
Finding Number	Area Description	Lat/Long	Finding	As Built	Recommendation	Citation	Photos	Figure
			<p>Access aisles shall be at the same level as the parking spaces they serve. Changes in level are not permitted and shall not be sloped steeper than 2% in any direction.</p>	<p>parking surface being rough concrete with loose rock, weeds, grass, dirt/sand on top</p>		<p>2012 TAS Section: 502.4 2010 ADAS Section: 502.4</p>

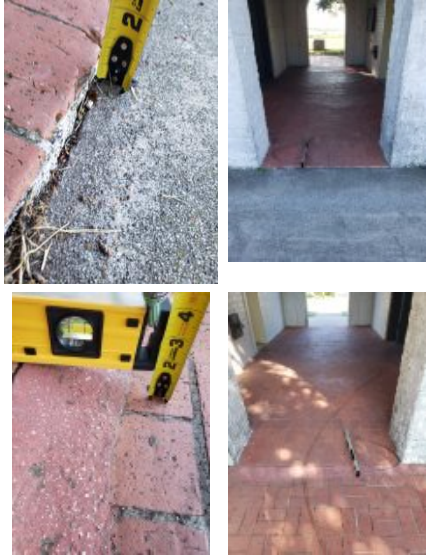
Finding Number	Area Description	Lat/Long	Finding	As Built	Recommendation	Citation	Photos	Figure
152	Day Use Area: Day Use Recreation Hall EAR	[28.1303363 , -96.985523 2]	The running slope of walking surfaces shall not be steeper than 1:20. The cross slope of walking surfaces shall not be steeper than 1:48.	Slopes of 27.8% (entry/opening to restrooms), 5%, and 38%	Correct running slopes to max 5% and cross to max 2.08%.	2012 TAS Section: 403.3 2010 ADAS Section: 403.3

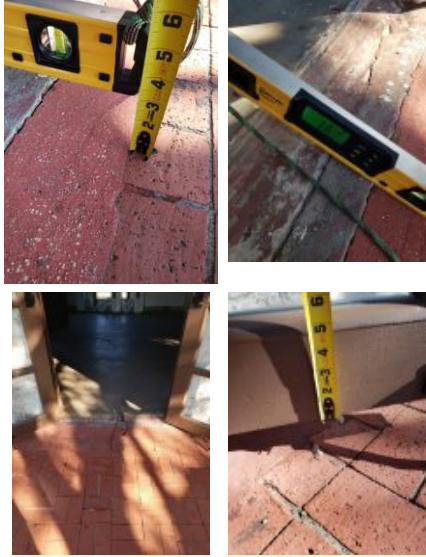
Finding Number	Area Description	Lat/Long	Finding	As Built	Recommendation	Citation	Photos	Figure
158	Day Use Area: Day Use Recreation Hall	[28.1303292 , -96.985437 3]	Minimum maneuvering clearances at doors and gates shall comply with 404.2.4. Maneuvering clearances shall extend the full width of the doorway and the required latch side or hinge side clearance. Floor or ground surface within required maneuvering clearances shall comply with 302. Changes in level are not permitted. EXCEPTIONS: 1. Slopes not steeper than 1:48 shall be permitted. The threshold has a vertical change greater than 1/4 inch high. The bottom 10 inches on the push side must be smooth and free of obstructions (hold open devices). Opening hardware must be mounted between 30 and 44 inches above the floor or ground.	For 3 sets of exterior, glass double doors on back of building - slopes of 38.9% and 40.7% in pull side clearances, CIL of 3", lacks kick plate - glass	Correct or repair slope at doorway landing to max 2.08% in any direction for level For all doors along the public circulation route, repair, bevel, or ramp CILs at door entries to max .25" For all doors along the public circulation route, provide kick plate on push side of door from floor to 10" aff	2010 ADAS Section: 404.2.3, 404.2.7, 404.2.4, 404.2.11, 404.2.11 Exception

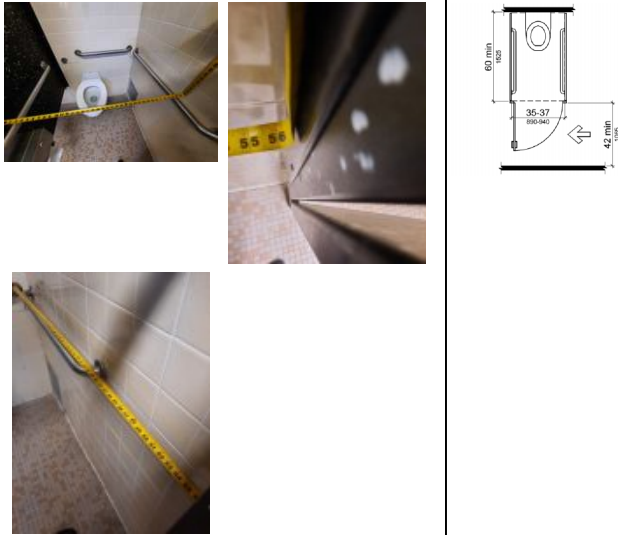
Finding Number	Area Description	Lat/Long	Finding	As Built	Recommendation	Citation	Photos	Figure
167	Day Use Area: Day Use Recreational Hall Women's Restroom	[28.1303126 , -96.985423 9]	The toilet is not located within the range to the side wall or partition. The centerline of the toilet shall be 17 inches minimum and 19 inches maximum side wall or partition in the ambulatory accessible toilet compartment.	Centerline of toilet is 15" from one wall	Remount toilet to 17" to 19" from the side wall to center line in ambulatory stalls	2015 ABAAS Section: 604.9.1 2012 TAS Section: 604.9.1 2010 ADAS Section: 604.9.1
