Access Audit Site Report

Government Canyon State Natural Area

Accessibility Evaluation

Inspection Date: 03/22/2022

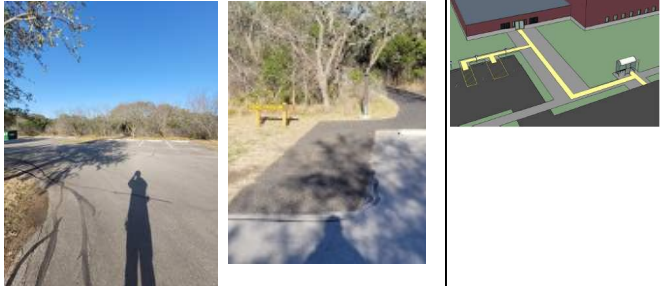
Finding Number	Area Description	Lat/Long	Finding	As Built	Recommendation	Citation	Photos	Figure
1	Headquarters Area: HQ - Parking Lot A and Exterior Accessible Route	[29.5484797 , -98.764635 2]	Element meets all standards and requirements	Parking lot meets scoping - 6 accessible, 64 standard	None	2010 ADAS Section: N/A		
2	Headquarters Area: HQ - Parking Lot A and Exterior Accessible Route	[29.5485363 , -98.765276 6]	The access aisle is not located on an accessible route of travel to the accessible building entrance. Accessible parking spaces serving a particular building shall be located on the shortest accessible route of travel from adjacent parking to an accessible entrance. In buildings with multiple accessible entrances with adjacent parking, accessible parking spaces shall be dispersed and located closest to the accessible entrances.	Lacks accessible parking at accessible route to picnic pavilion	Consider relocating one stall to be adjacent to the picnic area route for dispersion.	2015 ABAAS Section: F208.3.1 2012 TAS Section: 208.3.1 2010 ADAS Section: 208.3.1

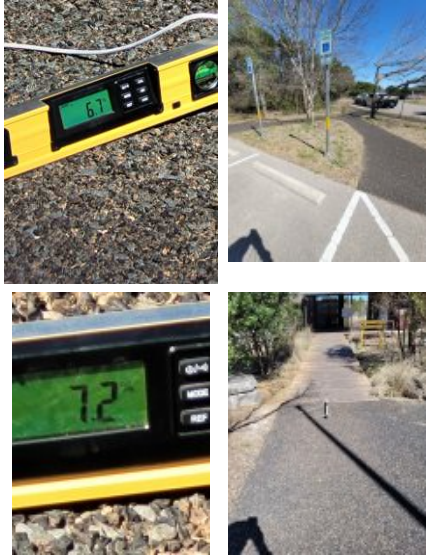
Finding Number	Area Description	Lat/Long	Finding	As Built	Recommendation	Citation	Photos	Figure
4	Headquarters Area: HQ - Parking Lot A and Exterior Accessible Route	[29.5490838, -98.7647127], [29.5485773, -98.7646188]	The running slope of walking surfaces shall not be steeper than 1:20.	From lot A right path to visitor center - 6.7%, 7.2% running slopes	Correct running slope along the AR to max 5%	2015 ABAAS Section: 403.3 2012 TAS Section: 403.3 2010 ADAS Section: 403.3

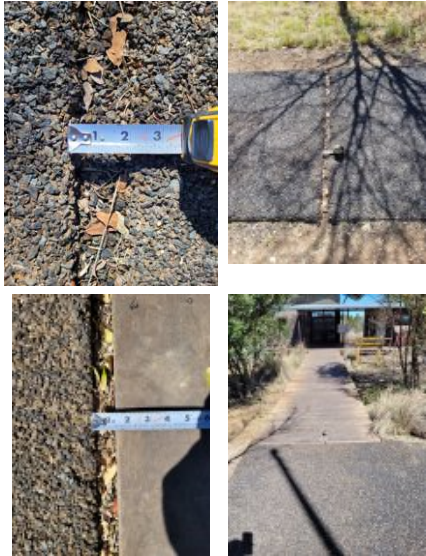
5	Headquarters Area: HQ - Parking Lot A and Exterior Accessible Route	[29.5488555, -98.7648138], [29.5491062, -98.7647119]	There is a gap spaced greater than a 1/2 inch. Openings in floor or ground surfaces shall not allow passage of a sphere more than 1/2 inch diameter. Elongated openings shall be placed so that the long dimension is perpendicular to the dominant direction of travel.	From lot A, left path - 2", 1.25" gaps	Correct or fill gaps to be max .5".	2015 ABAAS Section: 302.3 2012 TAS Section: 302.3 2010 ADAS Section: 302.3

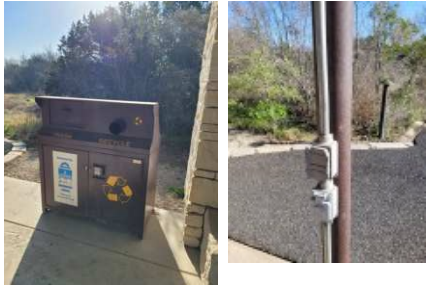
Finding Number	Area Description	Lat/Long	Finding	As Built	Recommendation	Citation	Photos	Figure
9	Headquarters Area: HQ - Group Picnic Pavilion	[29.5488253 , -98.7657417]	Element meets all standards and requirements	Picnic pavilion - garbage and outlets comply	None	2010 ADAS Section: N/A

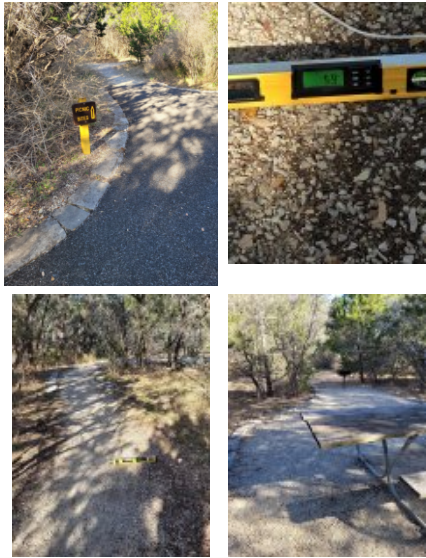
11	Headquarters Area: HQ - Group Picnic Pavilion	[29.5486751 , -98.7657621]	The cross slope shall not be steeper than 1:48. EXCEPTION: Where the surface is other than concrete, asphalt, or boards, cross slopes not steeper than 1:20 shall be permitted when necessary for drainage.	Picnic sites to the left approaching pavilion - 5.9% right side, loose gravel, but mostly level; BBQ surface is compliant; 2 of 2 sites with picnic tables with wheelchair space	Correct or repair ORAR cross slope to max 5% for surfaces other than concrete, asphalt or board as a smart practice.	2015 ABAAS Section: 1016.7.2, 1016.7.2 EXCEPTION

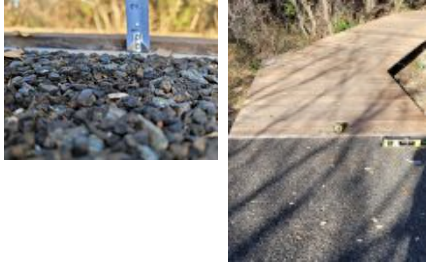
Finding Number	Area Description	Lat/Long	Finding	As Built	Recommendation	Citation	Photos	Figure
12	Headquarters Area: HQ - Picnic Area	[29.5486076 , -98.765593 3]	Obstacles on outdoor recreation access routes, passing spaces, and resting intervals shall not exceed 1/2 inch (13 mm) in height measured vertically to the highest point. EXCEPTION: Where the surface is other than asphalt, concrete, or boards, obstacles shall be permitted to not exceed 1 inch (25 mm) in height measured vertically to the highest point.	From parking A to picnic pavilion - .75" at boardwalk	Repair, bevel or ramp CIL along the ORAR to max .5" as a smart practice.	2015 ABAAS Section: 1016.5, 1016.5 EXCEPTION

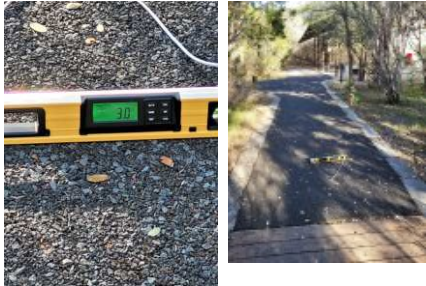
13	Headquarters Area: HQ - Picnic Area	[29.5486578 , -98.765673 5]	The cross slope shall not be steeper than 1:48. EXCEPTION: Where the surface is other than concrete, asphalt, or boards, cross slopes not steeper than 1:20 shall be permitted when necessary for drainage.	Approaching picnic pavilion from lot A - 3%	Correct or repair ORAR cross slope to max 2.08% as a smart practice.	2015 ABAAS Section: 1016.7.2, 1016.7.2 EXCEPTION

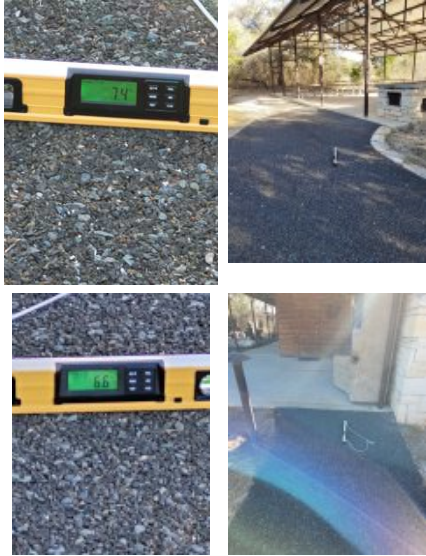
14	Headquarters Area: HQ - Picnic Area	[29.5488873 , -98.76557 26], [29.5487739 , -98.765658 5]	The running slope of walking surfaces shall not be steeper than 1:20.	Approaching pavilion from lot A - 7.4%, approaching visitor center from picnic pavilion - 6.6%	Correct running slope along the AR to max 5%.	2015 ABAAS Section: 403.3 2012 TAS Section: 403.3 2010 ADAS Section: 403.3

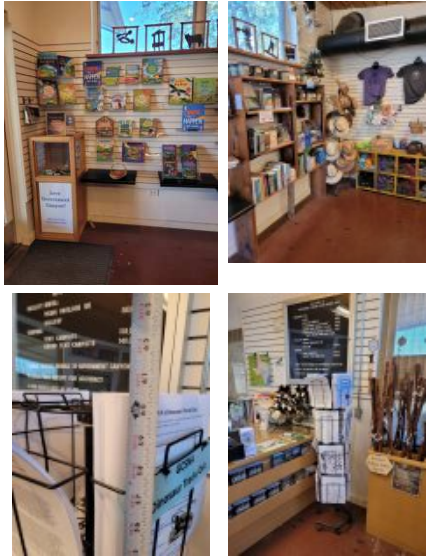
Finding Number	Area Description	Lat/Long	Finding	As Built	Recommendation	Citation	Photos	Figure
17	Headquarters Area: HQ - Public Spaces	[29.549261, -98.764755]	The operable part is positioned too high for either a side or front approach. Where a clear floor or ground space allows a parallel approach to an element and the side reach is unobstructed, the high side reach shall be 48 inches maximum and the low side reach shall be 15 inches minimum above the finish floor or ground. Where a forward reach is unobstructed, the high forward reach shall be 48 inches maximum and the low forward reach shall be 15 inches minimum above the finish floor or ground.	Souvenirs high, top rack of dinosaur tracks quiz at 60"	Remount operable parts to be in reach range of 15" min to 48" max.	2015 ABAAS Section: 308.1 2012 TAS Section: 308.1 2010 ADAS Section: 308.1

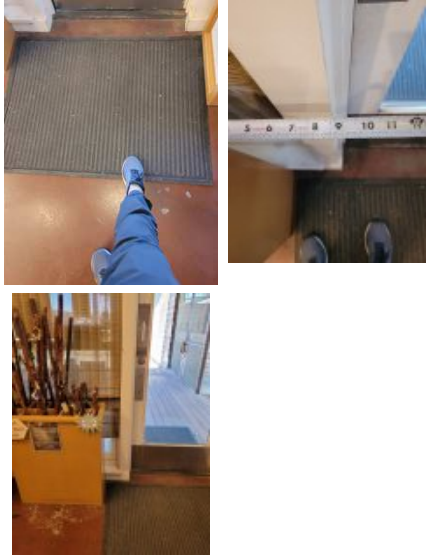
18	Headquarters Area: HQ - Public Spaces	[29.5493365, -98.7647878]	Minimum maneuvering clearances at doors and gates shall comply with 404.2.4. Maneuvering clearances shall extend the full width of the doorway and the required latch side or hinge side clearance. Exterior doors are recommended to be maintained at 8.5 lbf as a smart practice. Force is to be measured at the operating hardware or 30 inches from the hinges, whichever is greater.	Main entry to visitor center - carpet not secure, maneuvering clearance reduced to 9.25" by walking sticks, 14# push	For all doors along the public circulation route, provide required maneuvering clearance on push and pull side of doors. For all doors along the public circulation route, inspect, adjust, and maintain 8.5 lbf to open exterior doors as a smart practice. Secure carpet to floor.	2010 ADAS Section: 404.2.3, 404.2.7, 404.2.4, 404.2.11, 404.2.11 Exception

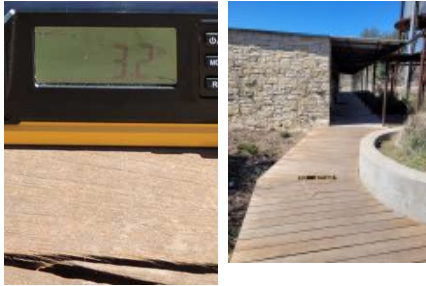
Finding Number	Area Description	Lat/Long	Finding	As Built	Recommendation	Citation	Photos	Figure
19	Headquarters Area: HQ - Public Spaces	[29.54928, -98.76486]	The accessible route of travel contains cross slopes greater than 2%. Cross slopes shall not exceed one unit vertical in 48 units horizontal (2-percent slope).	Approaching restrooms - 3.2% cross	Correct or repair cross slope along AR to max 2.08%.	2015 ABAAS Section: 403.3 2012 TAS Section: 403.3 2010 ADAS Section: 403.3

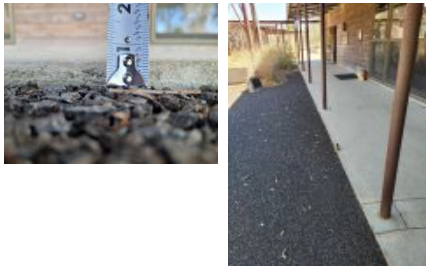
20	Headquarters Area: HQ - Public Spaces	[29.5491543, -98.7650089]	The walkway contains abrupt vertical edges and/or variations over a 1/4 inch. 1/4 inch is the maximum vertical rise. Changes in level between 1/4 inch and 1/2 inch must be beveled at 1:2 or less. Changes in level greater than 1/2 inch must be by way of a ramp.	.75" change in level along route at seating area (rock garden)	Repair, bevel or ramp CIL along AR.	2012 TAS Section: 303.2, 303.3 2010 ADAS Section: 303.2, 303.3

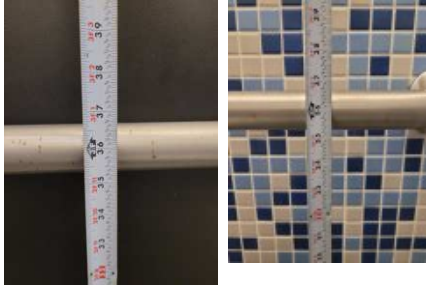
26	Headquarters Area: HQ - Men's Restroom	[29.5493209 , -98.7648485]	The grab bar height and/or spacing fails. Grab bars must be mounted between 33" and 36" to the top of the gripping surface. There must be 1.5" of clearance between the grab bar and the wall. There must be a minimum of 1.5" of clearance below and minimum 12" above the grab bar to any dispenser or other obstruction.	Both grab bars 36.75" above finished floor	Remount grab bars in accessible stall to 33" to 36" above the finished floor (AFF).	2015 ABAAS Section: 609.3, 609.4 2012 TAS Section: 609.4, 609.3 2010 ADAS Section: 609.3, 609.4

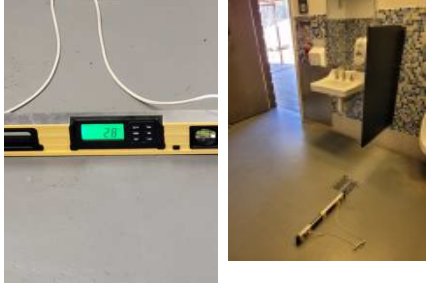
29	Headquarters Area: HQ - Men's Restroom	[29.5493092 , -98.764859 2]	The accessible route contains running slopes greater than 5 percent and cross slopes greater than 2 percent across the width of the walk and has not been constructed as a ramp (i.e. handrails, wheel guides, etc.). When the slope in the direction of travel of any walk exceeds 1 unit vertical in 20 units horizontal (5-percent slope), it must be constructed as ramp. Surface cross slopes must not exceed one unit vertical in 48 units. Horizontal (2-percent slope).	2.8% near drain at sink	Correct or repair slope to max 2.08% in restroom.	2015 ABAAS Section: 403.3 2012 TAS Section: 403.3 2010 ADAS Section: 403.3

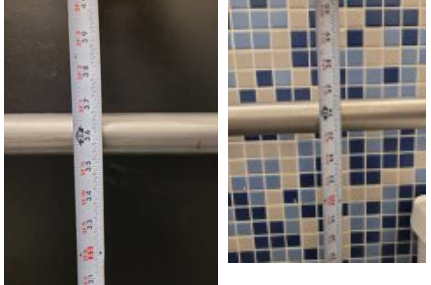
31	Headquarters Area: HQ - Women's Restroom	[29.54932, -98.7648485]	The grab bar height and/or spacing fails. Grab bars must be mounted between 33" and 36" to the top of the gripping surface. There must be 1.5" of clearance between the grab bar and the wall. There must be a minimum of 1.5" of clearance below and minimum 12" above the grab bar to any dispenser or other obstruction.	Side grab bar 36.75", rear grab bar 36.5" above finished floor	Remount grab bars in accessible stall to 33" to 36" above the finished floor (AFF).	2015 ABAAS Section: 609.3, 609.4 2012 TAS Section: 609.4, 609.3 2010 ADAS Section: 609.3, 609.4

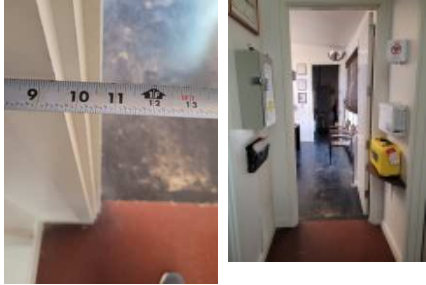
Finding Number	Area Description	Lat/Long	Finding	As Built	Recommendation	Citation	Photos	Figure
34	Headquarters Area: HQ - Employee Spaces	[29.5493347, -98.7648411]	Spaces and elements within employee work areas shall only be required to comply with 206.2.8, 207.1, and 215.3 and shall be designed and constructed so that individuals with disabilities can approach, enter, and exit the employee work area. Employee work areas, or portions of employee work areas, other than raised courtroom stations, that are less than 300 square feet (28 m2) and elevated 7 inches (180 mm) or more above the finish floor or ground where the elevation is essential to the function of the space shall not be required to comply with these requirements or to be on an accessible route.	office door - lacks maneuvering clearance (MC) on push 10.75", storage also protrudes in push MC	For employee spaces, relocate storage, furniture, and other obstacles at doorways to provide approach, enter and exit at the employee space. Provide required maneuvering clearance on push and pull side of doors.	2015 ABAAS Section: F203.9 2012 TAS Section: 203.9 2010 ADAS Section: 203.9

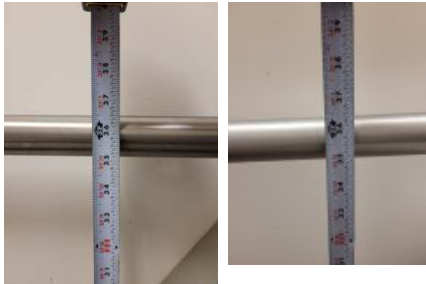
35	Headquarters Area: HQ - Employee Spaces	[29.5493311, -98.7648512]	The grab bar height and/or spacing fails. Grab bars must be mounted between 33" and 36" to the top of the gripping surface. There must be 1.5" of clearance between the grab bar and the wall. There must be a minimum of 1.5" of clearance below and minimum 12" above the grab bar to any dispenser or other obstruction.	Employee Restroom - Both grab bars 36.5" above finished floor	Remount grab bars in accessible stall to 33" to 36" above the finished floor (AFF).	2015 ABAAS Section: 609.3, 609.4 2012 TAS Section: 609.4, 609.3 2010 ADAS Section: 609.3, 609.4

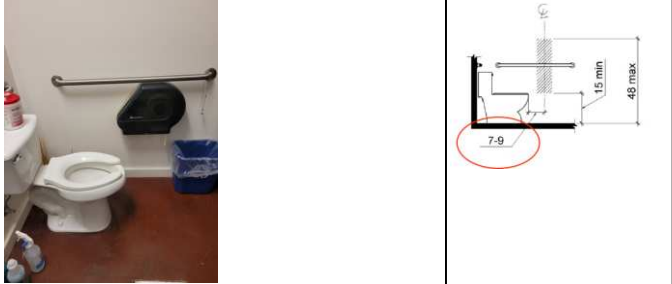
36	Headquarters Area: HQ - Employee Spaces	[29.5493455, -98.7648498]	The toilet paper is not installed within the compliant range in front of the toilet. Toilet paper dispensers shall be 7 inches minimum and 9 inches maximum in front of the water closet measured to the centerline of the dispenser. The outlet of the dispenser shall be 15 inches minimum and 48 inches maximum above the finish floor and shall not be located behind grab bars. Dispensers shall not be of a type that controls delivery or that does not allow continuous paper flow. There shall be a clearance of 1 1/2 inches minimum below the grab bar.	Employee Restroom - TP too close to toilet	Remount toilet paper dispenser max 7" to 9" from front of toilet, 15" to 48" aff and min 12" above or 1.5" below grab bar	2015 ABAAS Section: 604.7 2012 TAS Section: 604.7 2010 ADAS Section: 604.7

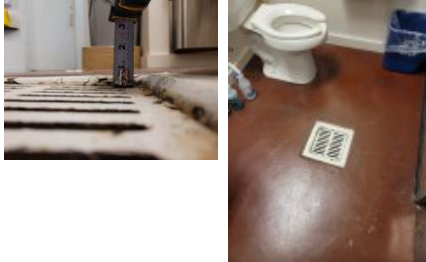
Finding Number	Area Description	Lat/Long	Finding	As Built	Recommendation	Citation	Photos	Figure
37	Headquarters Area: HQ - Employee Spaces	[29.549337, -98.764852 5]	There is a change in level greater than 1/4 inch. 1/4 inch is the maximum vertical rise. Changes in level between 1/4 inch and 1/2 inch must be beveled at 1:2 or less. Changes in level greater than 1/2 inch must be by way of a ramp.	Employee Restroom - .5" change in level (CIL) at grate	Repair, bevel or ramp CIL along accessible route (AR) to max .25".	2015 ABAAS Section: 303.3 2012 TAS Section: 303.3 2010 ADAS Section: 303.3

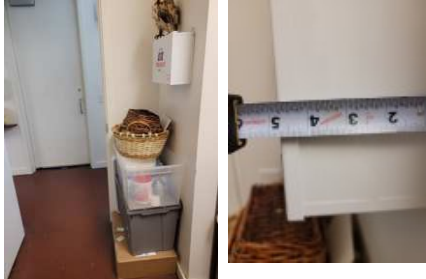
38	Headquarters Area: HQ - Employee Spaces	[29.5493318, -98.764815]	Minimum maneuvering clearances at doors and gates shall comply with 404.2.4. Maneuvering clearances shall extend the full width of the doorway and the required latch side or hinge side clearance.	Restroom door - storage and first aid kit protrudes 4.75"	Provide required maneuvering clearance around pull side of door Relocate storage, furniture and other obstacles to create 60" maneuvering clearance around door	2015 ABAAS Section: 404.2.4.1, 404.2.4.4 2012 TAS Section: 404.2.4.4, 404.2.4.1 2010 ADAS Section: 404.2.4.4, 404.2.4.1

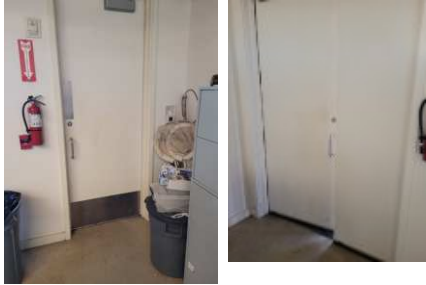
Finding Number	Area Description	Lat/Long	Finding	As Built	Recommendation	Citation	Photos	Figure
40	Headquarters Area: HQ - Employee Spaces	[29.5491189 , -98.765096 1]	Spaces and elements within employee work areas shall only be required to comply with 206.2.8, 207.1, and 215.3 and shall be designed and constructed so that individuals with disabilities can approach, enter, and exit the employee work area. Employee work areas, or portions of employee work areas, other than raised courtroom stations, that are less than 300 square feet (28 m2) and elevated 7 inches (180 mm) or more above the finish floor or ground where the elevation is essential to the function of the space shall not be required to comply with these requirements or to be on an accessible route.	Offices near rock garden - first door fire extinguisher and storage in push clearance, all doors 10#+ push	For employee spaces, relocate storage, furniture, and other obstacles at doorways to provide approach, enter and exit at the employee space. Provide required maneuvering clearance on push and pull side of doors. Inspect, adjust, and maintain 5 lbf to open interior doors.	2015 ABAAS Section: F203.9 2012 TAS Section: 203.9 2010 ADAS Section: 203.9

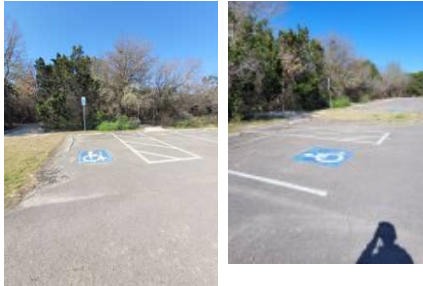
Finding Number	Area Description	Lat/Long	Finding	As Built	Recommendation	Citation	Photos	Figure
42	Day Use Area: Day Use - Parking Lot C and Exterior Accessible Route	[29.5485991 , -98.759529 6]	Element meets all standards and requirements	Parking lot complies with scoping - 4 accessible, 79 standard	None	2010 ADAS Section: N/A		
43	Day Use Area: Day Use - Parking Lot C and Exterior Accessible Route	[29.5486493 , -98.75965 17], [29.5485866 , -98.759528 3]	The accessible parking is not located on the shortest accessible route to the building. Accessible parking spaces serving a particular building or facility entrance shall be located on the shortest accessible route of travel from the parking to an accessible entrance.	First 2 stalls near playground lack route to picnic areas	Relocate stalls to be on the shortest AR to the building entry or park features or provide a connect route to site amenities.	2015 ABAAS Section: F208.3.1 2012 TAS Section: 208.3.1 2010 ADAS Section: 208.3.1

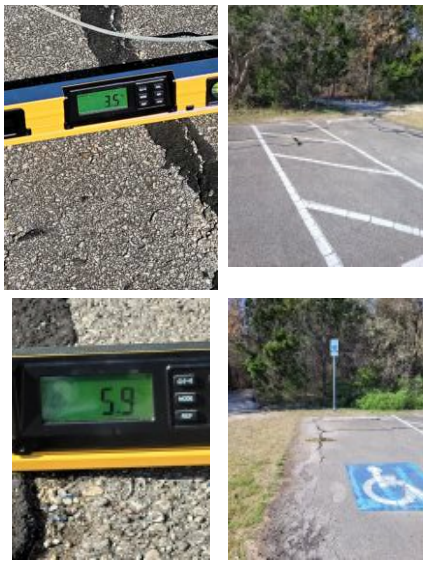
44	Day Use Area: Day Use - Parking Lot C and Exterior Accessible Route	[29.5486517 , -98.75966 64], [29.5486434 , -98.758979 8]	The cross slopes (narrow dimension) and/or running slopes (long dimension) of the access aisle exceeds 2%. The running slope and the cross slope in an accessible parking stall and the access aisle must not exceed 2%.	Stalls near picnic area and playground - left access aisle - 3.5%; middle stall 5.9%, access aisle 3.1%; CXT restroom - stall 3.5%, access aisle 3.4%	Repair or correct slope of parking space and access aisle to max 2.08% in any direction.	2015 ABAAS Section: 502.4 2012 TAS Section: 502.4 2010 ADAS Section: 502.4

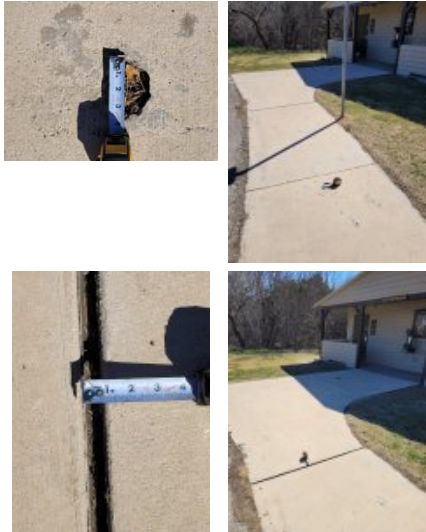
Finding Number	Area Description	Lat/Long	Finding	As Built	Recommendation	Citation	Photos	Figure
47	Day Use Area: Day Use - Parking Lot C and Exterior Accessible Route	[29.5486854 , -98.759031 2]	There is a gap spaced greater than a 1/2 inch. Openings in floor or ground surfaces shall not allow passage of a sphere more than 1/2 inch diameter. Elongated openings shall be placed so that the long dimension is perpendicular to the dominant direction of travel.	From parking to restroom - 3.5" and .75"	Correct or fill gaps to be max .5".	2015 ABAAS Section: 302.3 2012 TAS Section: 302.3 2010 ADAS Section: 302.3

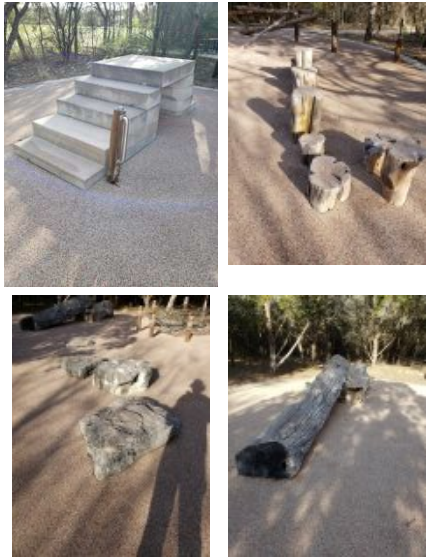
48	Day Use Area: Day Use - Playground	[29.5487444 , -98.759930 6]	Element meets all standards and requirements	Compliant elements: 9 of two types of ground level play components are on the route - 6 climbers and 3 manipulable	None	2010 ADAS Section: N/A

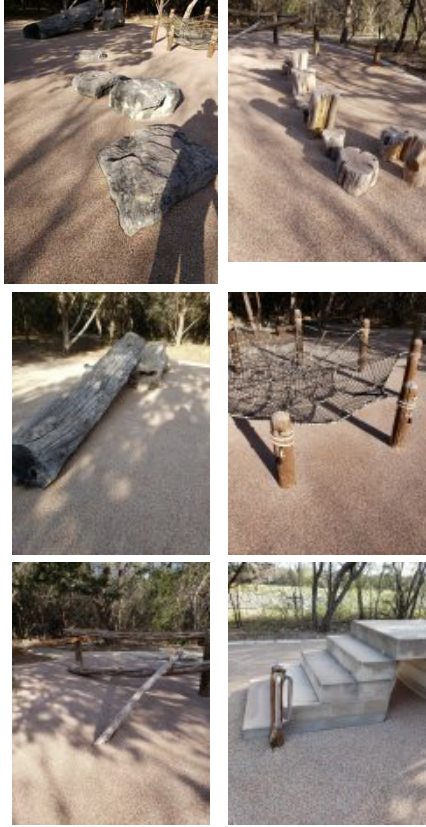
Finding Number	Area Description	Lat/Long	Finding	As Built	Recommendation	Citation	Photos	Figure
49	Day Use Area: Day Use - Playground	[29.5487241 , -98.759976 2]	Where play components require transfer to entry points or seats, at least one means of support for transferring shall be provided.	5 of 6 ground level play components lack transfer supports; concrete block does have support	Provide transfer supports for transfer onto play component.	2012 TAS Section: 1008.4.5 2010 ADAS Section: 1008.4.5

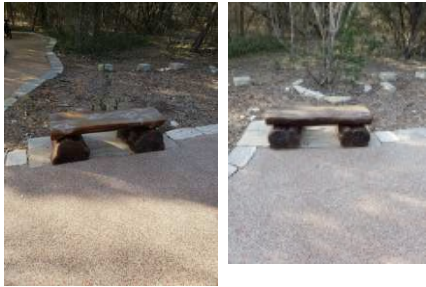
50	Day Use Area: Day Use - Playground	[29.5487015 , -98.759954 8]	Element meets all standards and requirements	2 of 2 benches at playground have clear floor space adjacent to seating	None	2010 ADAS Section: N/A

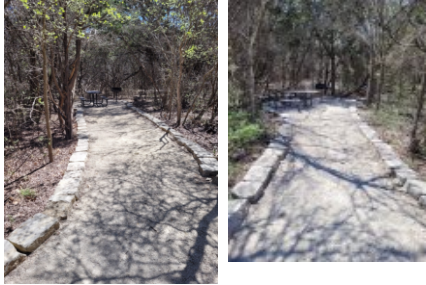
Finding Number	Area Description	Lat/Long	Finding	As Built	Recommendation	Citation	Photos	Figure
51	Day Use Area: Day Use - Picnic Area	[29.5486, -98.75971]	There is no outdoor recreation access route that connects accessible elements, spaces, and facilities within the picnic unit. At least one outdoor recreation access route shall connect accessible elements, spaces, and facilities provided within picnic units with mobility features.	2 of 13 picnic areas with route	Provide an outdoor recreation access route to one more picnic unit.	2015 ABAAS Section: F245.4.1

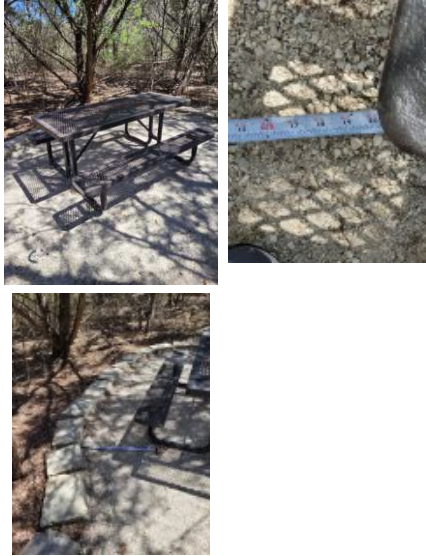
52	Day Use Area: Day Use - Picnic Area	[29.54852, -98.75959]	Picnic tables shall provide at least one wheelchair space for each 24 linear feet (7320 mm) of usable table surface perimeter. Wheelchair spaces shall be 30 inches (760 mm) minimum by 48 inches (1220 mm) minimum. Wheelchair spaces shall be positioned for a forward approach to the table and provide knee and toe clearance complying with 306 under the table	2 of 2 picnic areas from accessible parking lacks accessible tables; both lack clear width	Replace picnic table with one of an accessible design as a smart practice	2015 ABAAS Section: 1011.4.2

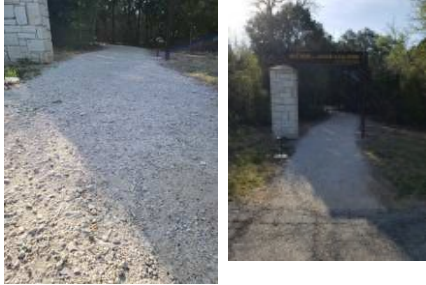
53	Day Use Area: Day Use - Amphitheater	[29.5482227, -98.759012]	There is no accessible route to the amphitheater. At least one accessible route shall connect accessible buildings, accessible facilities, accessible elements, and accessible spaces that are on the same site.	Lacks accessible route to amphitheater. larger rock path	Create an accessible route with crushed stone or other outdoor material from parking or walkway to amphitheater.	2015 ABAAS Section: F206.2.2 2012 TAS Section: 206.2.2 2010 ADAS Section: 206.2.2

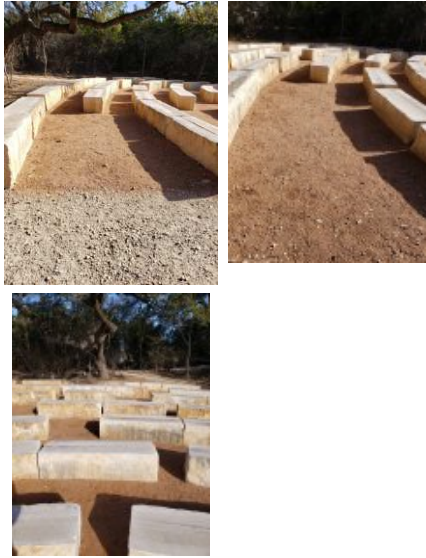
Finding Number	Area Description	Lat/Long	Finding	As Built	Recommendation	Citation	Photos	Figure
54	Day Use Area: Day Use - Amphitheater	[29.5481854, -98.759012]	Element meets all standards and requirements	there are several spaces left open throughout the seating area that could be used as wheelchair spaces; assure route to these areas, and seating area itself is maintained to be level; approximately 125 seats with 10 potential spaces	None	2010 ADAS Section: N/A

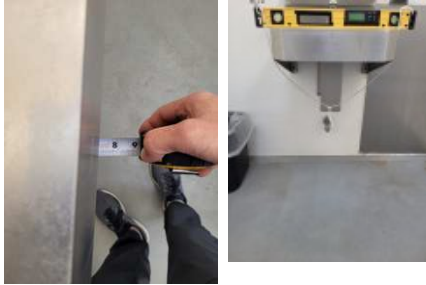
Finding Number	Area Description	Lat/Long	Finding	As Built	Recommendation	Citation	Photos	Figure
61	Day Use Area: Day Use - Women's Restroom	[29.5486146 , -98.758902]	Knee clearance at 27 inches off the floor is not 8 inches minimum deep. The knee clearance, measured from the bottom of the apron or the outside bottom edge of the lavatory, must be 27 inches at a point located 8 inches back from the front edge and continuing to 11 inches minimum in depth at 9 inches above the floor. The top of the lavatory rim may be no higher than 34 inches.	7.25" at knee clearance	Remove pipe cover to provide 8" deep knee clearance	2015 ABAAS Section: 306.3.1, 306.3.2, 306.3.3, 306.3.4 , 306.3.5 2012 TAS Section: 306.3.2, 306.3.3, 306.3.4, 306.3.5, 306.3.1 2010 ADAS Section: 306.3.3, 306.3.2, 306.3.4, 306.3.5, 306.3.1

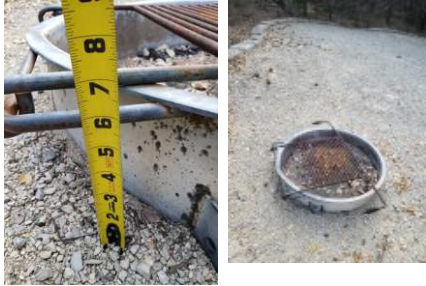
88	Camping Area: Camping - Campsite 1	[29.5496961 , -98.757377 2]	The operable part is not accessible because it requires tight grasping, pinching or twisting of the wrist.	Latch not operable without pinch	Replace operable part with one usable without a tight pinch or grasp	2015 ABAAS Section: 309.4 2012 TAS Section: 309.4 2010 ADAS Section: 309.4

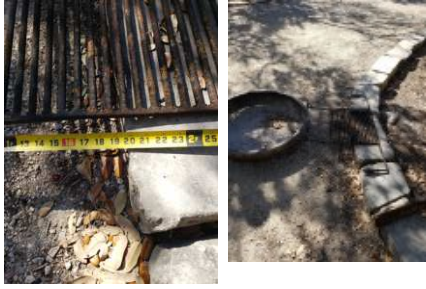
92	Camping Area: Camping - Campsite 14	[29.5504395 , -98.754304 7]	Fire building surfaces shall be 9 inches (230 mm) minimum above the ground.	Fire building surface is at grade	Correct fire building surface to be 9" min above the ground as a smart practice. In the alternative, replace fire ring with a compliant accessible fire ring.	2015 ABAAS Section: 1011.5.1

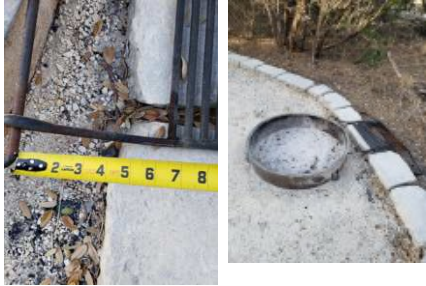
101	Camping Area: Camping - Campsite 18	[29.5506863 , -98.755624 4]	Fire building surfaces shall be 9 inches (230 mm) minimum above the ground.	Fire building surface is at grade	Correct fire building surface to be 9" min above the ground as a smart practice. In the alternative, replace fire ring with a compliant accessible fire ring.	2015 ABAAS Section: 1011.5.1

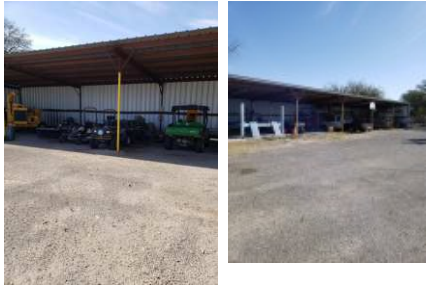
132	Employee Spaces: Maintenance	[29.5376978 , -98.751002 9]	Spaces and elements within employee work areas shall only be required to comply with 206.2.8, 207.1, and 215.3 and shall be designed and constructed so that individuals with disabilities can approach, enter, and exit the employee work area. Employee work areas, or portions of employee work areas, other than raised courtroom stations, that are less than 300 square feet (28 m2) and elevated 7 inches (180 mm) or more above the finish floor or ground where the elevation is essential to the function of the space shall not be required to comply with these requirements or to be on an accessible route.	Main entry - deteriorated asphalt to the entrance; 5.5" change in level	For employee spaces, relocate storage, furniture, and other obstacles at doorways to provide approach, enter and exit at the employee space.	2015 ABAAS Section: F203.9 2012 TAS Section: 203.9 2010 ADAS Section: 203.9
