Access Audit Site Report

Guadalupe River State Park
3350 Park Rd 31
Spring Branch, TX 78070
Accessibility Evaluation
Inspection Date: 03/21/2022
Inspectors: Tanya Scheibe

Prepared By
WT Group

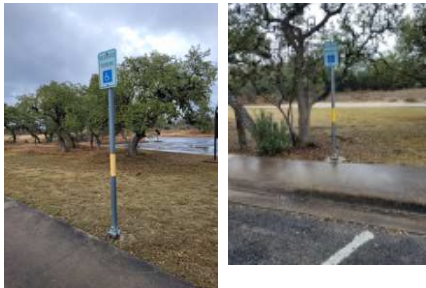
Finding Number	Area Description	Lat/Long	Finding	As Built	Recommendation	Citation	Photos	Figure
1	Headquarters Area: HQ Parking	[29.85591, -98.50416]	Element meets all standards and requirements	parking scoping complies- 2 accessible, 13 standards	None	2010 ADAS Section: N/A		
2	Headquarters Area: HQ Parking	[29.8533044, -98.5043196]	There are no van accessible parking stalls. 1 in every 6, minimum of one, required accessible stalls must be a van accessible stall. There are a total of (13) parking stalls in the parking lot that could be reasonably associated with this facility. There should be a minimum of (1) accessible stalls with a minimum of (1) being designed as van accessible.	Lacks van signage	Add van parking sign to 1 accessible stall and repaint stall and access aisle to 11' and 5' or 8' and 8'.	2015 ABAAS Section: F208.2, F208.2.4 2012 TAS Section: 208.2, 208.2.4 2010 ADAS Section: 208.2, 208.2.4

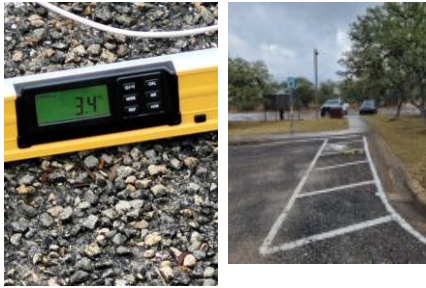
3	Headquarters Area: HQ Parking	[29.8535209, -98.5043987]	The cross slopes (narrow dimension) and/or running slopes (long dimension) of the access aisle exceeds 2%. The running slope and the cross slope in an accessible parking stall and the access aisle must not exceed 2%.	West access aisle, right 3.4%,	Repair or correct slope of parking space and access aisle to max 2.08% in any direction.	2015 ABAAS Section: 502.4 2012 TAS Section: 502.4 2010 ADAS Section: 502.4

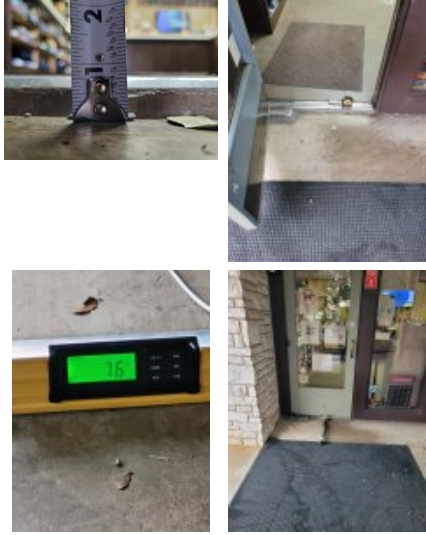
Finding Number	Area Description	Lat/Long	Finding	As Built	Recommendation	Citation	Photos	Figure
4	Headquarters Area: HQ Exterior Accessible Route	[29.8530726, -98.5044546]	Minimum maneuvering clearances at doors and gates shall comply with 404.2.4. Maneuvering clearances shall extend the full width of the doorway and the required latch side or hinge side clearance. Maneuvering clearances shall have a max slope of 2.08%. The threshold has a vertical change greater than 1/4 inch high. Exterior doors are recommended to be maintained at 8.5 lbf as a smart practice. Force is to be measured at the operating hardware or 30 inches from the hinges, whichever is greater.	Main entry door - 15# push, .75" change in level (CIL), 7.6% slope on pull	For all doors along the public circulation route, correct slope in door clearance to max 2.08%. For all doors along the public circulation route, repair, bevel, or ramp CILs at door entries to max .25". For all doors along the public circulation route, inspect, adjust, and maintain 8.5 lbf to open exterior doors as a smart practice.	2010 ADAS Section: 404.2.3, 404.2.7, 404.2.4, 404.2.11, 404.2.11 Exception

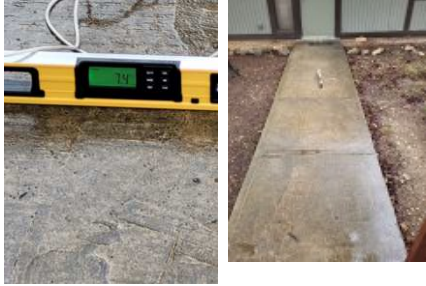
5	Headquarters Area: HQ Exterior Accessible Route	[29.8531786, -98.5043941]	The running slope of walking surfaces shall not be steeper than 1:20.	Route to seating area - 7.4%; entire exterior accessible route exceeds slope limit	Correct running slope along the AR to max 5%.	2015 ABAAS Section: 403.3 2012 TAS Section: 403.3 2010 ADAS Section: 403.3

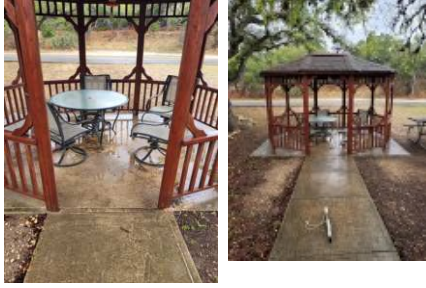
6	Headquarters Area: HQ Exterior Accessible Route	[29.85315, -98.50451]	Picnic tables shall provide at least one wheelchair space for each 24 linear feet (7320 mm) of usable table surface perimeter. Wheelchair spaces shall be 30 inches (760 mm) minimum by 48 inches (1220 mm) minimum. Wheelchair spaces shall be positioned for a forward approach to the table and provide knee and toe clearance complying with 306 under the table	Table does not provide wheelchair space or circulation in seating area	Replace table with one with knee and toe clearance, 19" deep at 27" high and 24" deep at 9" high, with a 36" AR around the table at shelter	2015 ABAAS Section: 1011.4.2

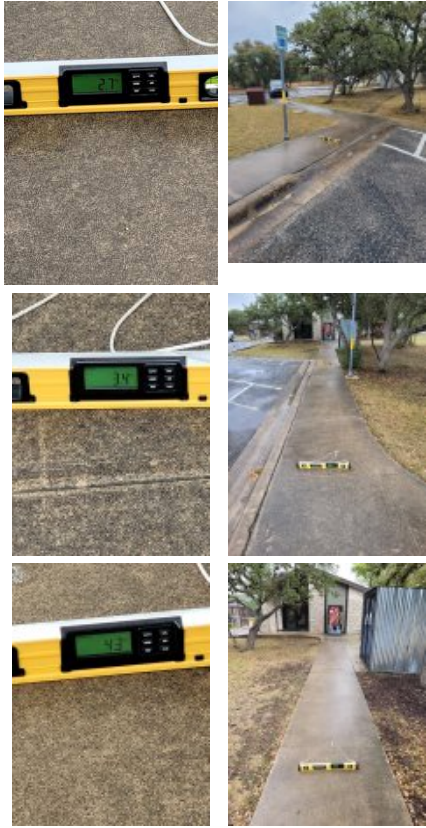
Finding Number	Area Description	Lat/Long	Finding	As Built	Recommendation	Citation	Photos	Figure
9	Headquarters Area: HQ Exterior Accessible Route	[29.85351, -98.50436]	The accessible route of travel contains cross slopes greater than 2%. Cross slopes shall not exceed one unit vertical in 48 units horizontal (2-percent slope).	From west parking at headquarters - 2.7%, 3.4%, 4.3%,	Correct or repair cross slope along AR to max 2.08%.	2015 ABAAS Section: 403.3 2012 TAS Section: 403.3 2010 ADAS Section: 403.3

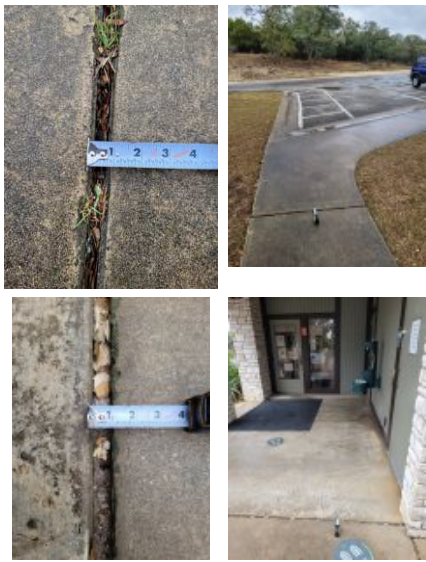
Finding Number	Area Description	Lat/Long	Finding	As Built	Recommendation	Citation	Photos	Figure
11	Headquarters Area: HQ Exterior Accessible Route	[29.8533157, -98.5043479]	There is a gap spaced greater than a 1/2 inch. Openings in floor or ground surfaces shall not allow passage of a sphere more than 1/2 inch diameter. Elongated openings shall be placed so that the long dimension is perpendicular to the dominant direction of travel.	Near west lot - 1", 1" at HQ	Correct or fill gaps to be max .5"	2015 ABAAS Section: 302.3 2012 TAS Section: 302.3 2010 ADAS Section: 302.3

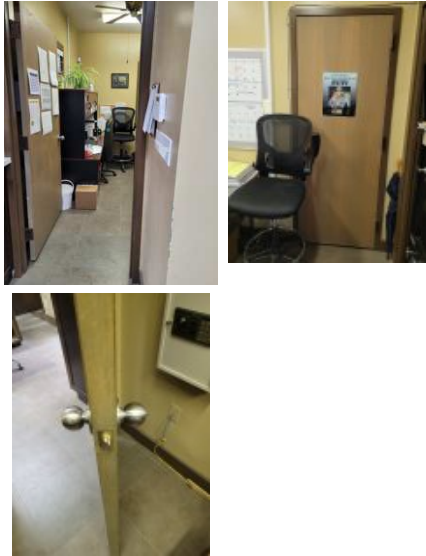
Finding Number	Area Description	Lat/Long	Finding	As Built	Recommendation	Citation	Photos	Figure
13	Headquarters Area: HQ Employee Spaces	[29.85312, -98.50446]	Minimum maneuvering clearances at doors and gates shall comply with 404.2.4. Maneuvering clearances shall extend the full width of the doorway and the required latch side or hinge side clearance. Hand-activated door opening hardware, handles, pulls, latches, locks, and other operating devices on accessible doors shall have a shape that is easy to grasp with one hand and does not require tight grasping, tight pinching or twisting of the wrist to operate. Hardware shall be 34 inches minimum and 48 inches maximum above the finish floor or ground.	Office at gate entry - Lacks maneuvering clearance due to wall on push; interior closet - lacks maneuvering clearance on pull due to table and chair, 2 of 2 knobs	For all doors along the public circulation route, provide required maneuvering clearance on push and pull side of doors. For all doors along the public circulation route, replace hardware with lever hardware or hardware operable without a tight pinch or grasp.	2010 ADAS Section: 404.2.3, 404.2.7, 404.2.4, 404.2.11, 404.2.11 Exception

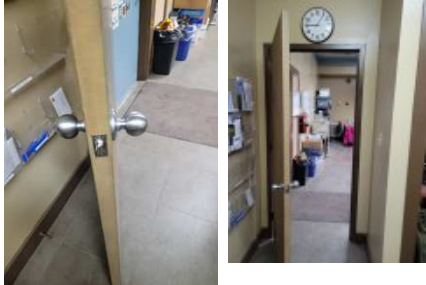
14	Headquarters Area: HQ Employee Spaces	[29.85309, -98.50446]	Minimum maneuvering clearances at doors and gates shall comply with 404.2.4. Maneuvering clearances shall extend the full width of the doorway and the required latch side or hinge side clearance. Maneuvering clearances shall have a max slope of 2.08%. Hand-activated door opening hardware, handles, pulls, latches, locks, and other operating devices on accessible doors shall have a shape that is easy to grasp with one hand and does not require tight grasping, tight pinching or twisting of the wrist to operate. Hardware shall be 34 inches minimum and 48 inches maximum above the finish floor or ground.	Back office - knob, lacks maneuvering clearance on pull	For all doors along the public circulation route, provide required maneuvering clearance on push and pull side of doors. For all doors along the public circulation route, replace hardware with lever hardware or hardware operable without a tight pinch or grasp.	2010 ADAS Section: 404.2.3, 404.2.7, 404.2.4, 404.2.11, 404.2.11 Exception

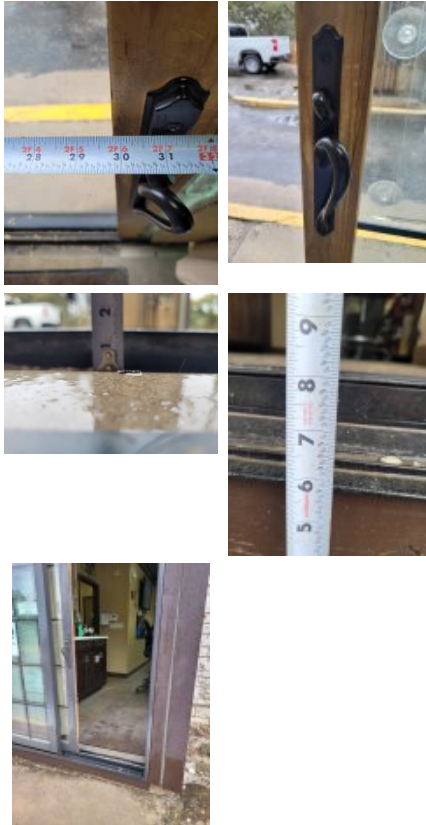
Finding Number	Area Description	Lat/Long	Finding	As Built	Recommendation	Citation	Photos	Figure
17	Headquarters Area: HQ Employee Spaces	[29.8531423 , -98.504416 1]	Door openings shall provide a clear width of 32 inches (815 mm) minimum. Clear openings of doorways with swinging doors shall be measured between the face of the door and the stop, with the door open 90 degrees. Openings more than 24 inches (610 mm) deep shall provide a clear opening of 36 inches (915 mm) minimum. There shall be no projections into the required clear opening width lower than 34 inches (865 mm) above the finish floor or ground. Projections into the clear opening width between 34 inches (865 mm) and 80 inches (2030 mm) above the finish floor or ground shall not exceed 4 inches (100 mm). The threshold has a vertical change greater than 1/4 inch high. Hand-activated door opening hardware, handles, pulls, latches, locks, and other operating devices on accessible doors shall have a shape that is easy to grasp with one hand and does not require tight grasping, tight pinching or twisting of the wrist to operate. Hardware shall be 34 inches minimum and 48 inches maximum above the finish floor or ground.	Sliding door at office - 29.75", hardware latch requires pinch, interior 1.5", exterior 8" changes in level	For all doors along the public circulation route, replace doors with doors having 80" overhead clearance and 32" clear width. For all doors along the public circulation route, repair, bevel, or ramp CILs at door entries to max .25". For all doors along the public circulation route, replace hardware with lever hardware or hardware operable without a tight pinch or grasp.	2010 ADAS Section: 404.2.3, 404.2.7, 404.2.4, 404.2.11, 404.2.11 Exception

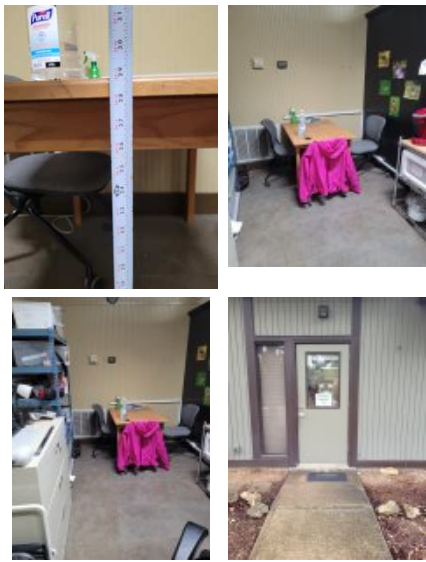
Finding Number	Area Description	Lat/Long	Finding	As Built	Recommendation	Citation	Photos	Figure
18	Headquarters Area: HQ Employee Spaces	[29.85313, -98.50442]	The knee clearance is not compliant. The knee clearance shall be 11 inches deep minimum at 9 inches above the finish floor or ground, and 8 inches deep minimum at 27 inches above the finish floor or ground and 30 inches wide minimum.	break area - table lacks knee clearance 25.75" above finished floor, lacks clear floor space due to furniture and storage	Replace table with one providing a space for knee and toe clearance. Relocated furniture and storage to provide clear floor space.	2015 ABAAS Section: 306.3.3 2012 TAS Section: 306.3.3 2010 ADAS Section: 306.3.3

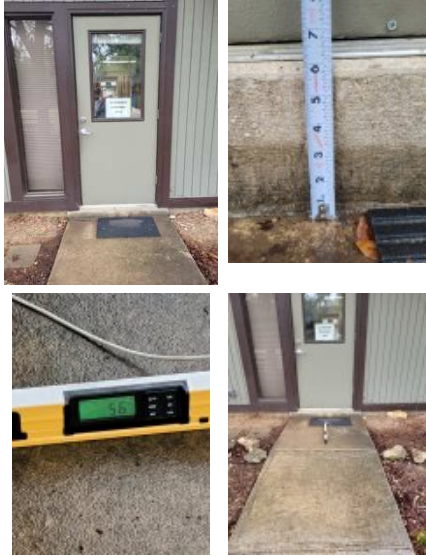
19	Headquarters Area: HQ Employee Spaces	[29.8530947, -98.5044737]	Minimum maneuvering clearances at doors and gates shall comply with 404.2.4. Maneuvering clearances shall extend the full width of the doorway and the required latch side or hinge side clearance. Maneuvering clearances shall have a max slope of 2.08%. The threshold at a doorway shall be no higher than 1/2 inch. Changes in level between 1/4 inch and 1/2 inch must be beveled at 1:2 or less. 1/4 inch is the maximum vertical rise.	Employee back door - lacks maneuvering clearance on pull, 6.75" change in elevation on pull, 5.6% on pull	For all doors along the public circulation route, provide required maneuvering clearance on push and pull side of doors. For all doors along the public circulation route, correct slope in door clearance to max 2.08%. For all doors along the public circulation route, repair, bevel, or ramp CILs at door entries to max .25".	2010 ADAS Section: 404.2.3, 404.2.7, 404.2.4, 404.2.11, 404.2.11 Exception

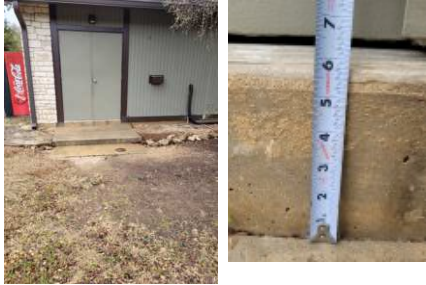
Finding Number	Area Description	Lat/Long	Finding	As Built	Recommendation	Citation	Photos	Figure
20	Headquarters Area: HQ Employee Spaces	[29.85315, -98.50446]	There is no accessible route between the buildings. At least one accessible route shall connect accessible buildings, facilities, elements and spaces that are on the same site. Changes in level between 1/4 inch and 1/2 inch must be beveled at 1:2 or less. 1/4 inch is the maximum vertical rise.	Lacks route to mechanical room, 6.5" change in level	Create AR with crushed and compacted stone or similar outdoor material from building to building within the site For all doors along the public circulation route, repair, bevel, or ramp CILs at door entries to max .25".	2015 ABAAS Section: F206.2.2 2012 TAS Section: 206.2.2 2010 ADAS Section: 206.2.2

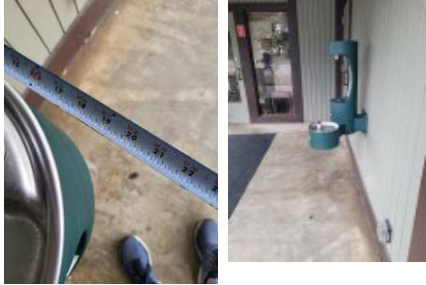
Finding Number	Area Description	Lat/Long	Finding	As Built	Recommendation	Citation	Photos	Figure
23	Headquarters Area: HQ Restrooms	[29.8531673 , -98.504404 1]	An item or items project more than 4 inches into the circulation path. Wall-mounted objects that have leading edges between 27 inches and 80 inches from the floor must not project more than 4 inches into the circulation path. Protruding objects that extend to the floor or within 27 inches of the floor are cane detectable and are therefore not hazardous. Where it is necessary or desirable to have objects protrude from the wall, a manner of cane detection must be provided.	Drinking fountain protrudes 20"	Relocate protruding objects or place cane detectable warning or bollard at foot of item	2015 ABAAS Section: 307.2 2012 TAS Section: 307.2 2010 ADAS Section: 307.2

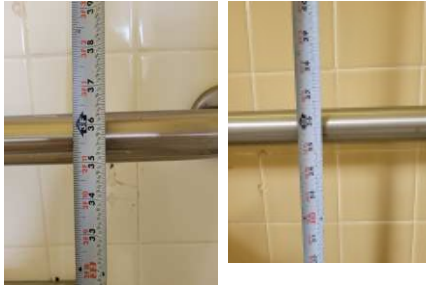
Finding Number	Area Description	Lat/Long	Finding	As Built	Recommendation	Citation	Photos	Figure
27	Headquarters Area: HQ Restrooms	[29.8531418 , -98.504398 7]	The grab bar height and/or spacing fails. Grab bars must be mounted between 33" and 36" to the top of the gripping surface. There must be 1.5" of clearance between the grab bar and the wall. There must be a minimum of 1.5" of clearance below and minimum 12" above the grab bar to any dispenser or other obstruction.	right- side grab bar 36.25", rear grab bar 36.5" above finished floor	Remount grab bars in accessible stall to 33" to 36" above the finished floor (AFF).	2015 ABAAS Section: 609.3, 609.4 2012 TAS Section: 609.4, 609.3 2010 ADAS Section: 609.3, 609.4

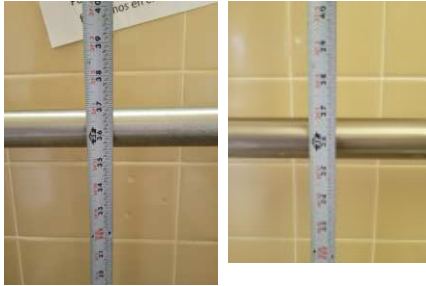
Finding Number	Area Description	Lat/Long	Finding	As Built	Recommendation	Citation	Photos	Figure
33	Headquarters Area: HQ Restrooms	[29.8531511, -98.5043866]	The grab bar height and/or spacing fails. Grab bars must be mounted between 33" and 36" to the top of the gripping surface. There must be 1.5" of clearance between the grab bar and the wall. There must be a minimum of 1.5" of clearance below and minimum 12" above the grab bar to any dispenser or other obstruction.	left- rear grab bar 37" and side grab bar 36.75" above finished floor	Remount grab bars in accessible stall to 33" to 36" above the finished floor (AFF). Remount toilet paper dispenser max 7" to 9" from front of toilet, 15" to 48" above the finished floor (AFF) and min 12" above or 1.5" below grab bar.	2015 ABAAS Section: 609.3, 609.4 2012 TAS Section: 609.4, 609.3 2010 ADAS Section: 609.3, 609.4

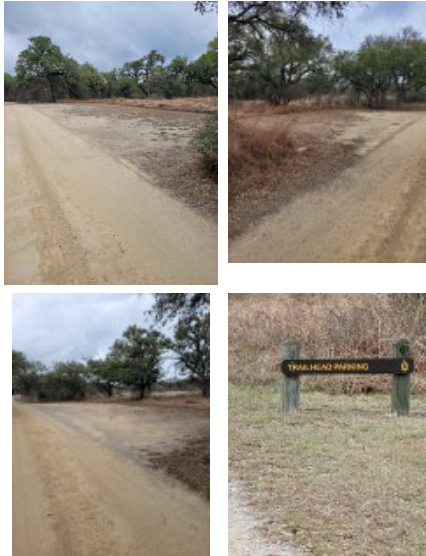
Finding Number	Area Description	Lat/Long	Finding	As Built	Recommendation	Citation	Photos	Figure
35	Equestrian Area: Equestrian Park Site Elements	[29.85264, -98.50316]	The surface of outdoor recreation access routes, passing spaces, and resting intervals shall be firm and stable	trailhead is limestone surface to sign, equestrian trail not required to comply	Repair surface or ORAR to be firm and stable as a smart practice.	2015 ABAAS Section: 1016.2

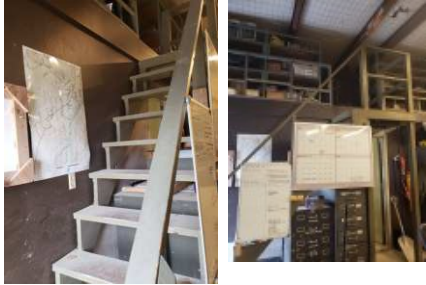
Finding Number	Area Description	Lat/Long	Finding	As Built	Recommendation	Citation	Photos	Figure
39	Employee Areas: Maintenance	[29.8637723 , -98.487798 5]	Employee Work Areas. Common use circulation paths within employee work areas shall comply with 402. EXCEPTIONS: 1. Common use circulation paths located within employee work areas that are less than 1000 square feet (93 m2) and defined by permanently installed partitions, counters, casework, or furnishings shall not be required to comply with 402. 2. Common use circulation paths located within employee work areas that are an integral component of work area equipment shall not be required to comply with 402. 3. Common use circulation paths located within exterior employee work areas that are fully exposed to the weather shall not be required to comply with 402.	Stairs only to loft storage	Leave as is, employee area only; reassign duties if an employee with a disability requires access here	2015 ABAAS Section: F206.2.8, F206.2.8.1, F206.2.8.2 2012 TAS Section: 206.2.8, 206.2.8 Exception 1, 206.2.8 Exception 2, 206.2.8 Exception 3, 206.2.8 Advisory 1, 206.2.8 Advisory 2 2010 ADAS Section: 206.2.8, 206.2.8 Exception 1, 206.2.8 Exception 2, 206.2.8 Exception 3

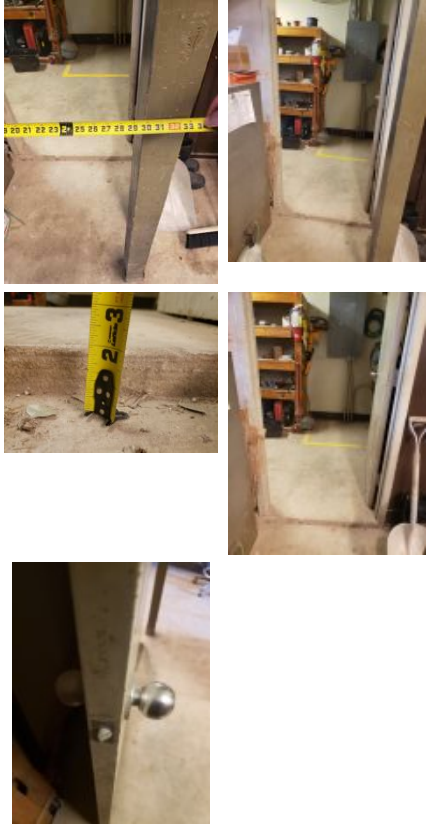
Finding Number	Area Description	Lat/Long	Finding	As Built	Recommendation	Citation	Photos	Figure
40	Employee Areas: Maintenance	[29.8637444 , -98.487970 2]	Spaces and elements within employee work areas shall only be required to comply with 206.2.8, 207.1, and 215.3 and shall be designed and constructed so that individuals with disabilities can approach, enter, and exit the employee work area. Employee work areas, or portions of employee work areas, other than raised courtroom stations, that are less than 300 square feet (28 m2) and elevated 7 inches (180 mm) or more above the finish floor or ground where the elevation is essential to the function of the space shall not be required to comply with these requirements or to be on an accessible route.	Storage - 30" width, 2" change in level, knobs	Replace doors with doors having 80" overhead clearance and 32" clear width. Repair, bevel, or ramp CILs at door entries to max .25". Replace hardware with lever hardware or hardware operable without a tight pinch or grasp.	2015 ABAAS Section: F203.9 2012 TAS Section: 203.9 2010 ADAS Section: 203.9

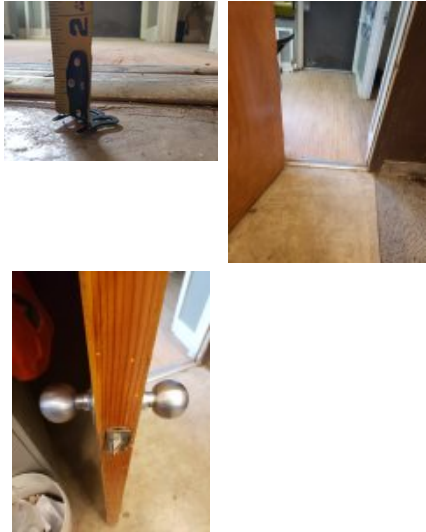
Finding Number	Area Description	Lat/Long	Finding	As Built	Recommendation	Citation	Photos	Figure
41	Employee Areas: Maintenance	[29.8639491, -98.487938]	Spaces and elements within employee work areas shall only be required to comply with 206.2.8, 207.1, and 215.3 and shall be designed and constructed so that individuals with disabilities can approach, enter, and exit the employee work area. Employee work areas, or portions of employee work areas, other than raised courtroom stations, that are less than 300 square feet (28 m2) and elevated 7 inches (180 mm) or more above the finish floor or ground where the elevation is essential to the function of the space shall not be required to comply with these requirements or to be on an accessible route.	Office door - knobs, .5" CIL at threshold	Repair, provide beveled threshold. Replace hardware with lever hardware or hardware operable without a tight pinch or grasp.	2015 ABAAS Section: F203.9 2012 TAS Section: 203.9 2010 ADAS Section: 203.9

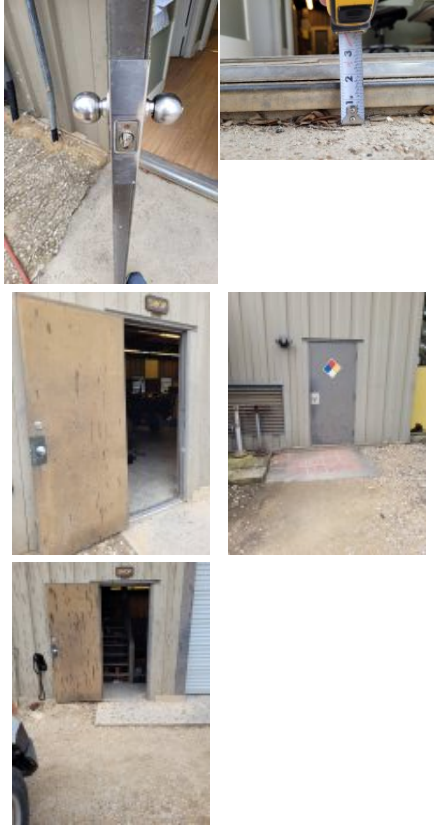
Finding Number	Area Description	Lat/Long	Finding	As Built	Recommendation	Citation	Photos	Figure
42	Employee Areas: Maintenance	[29.86423, -98.48809]	The threshold has a vertical change greater than 1/4 inch high. Hand-activated door opening hardware, handles, pulls, latches, locks, and other operating devices on accessible doors shall have a shape that is easy to grasp with one hand and does not require tight grasping, tight pinching or twisting of the wrist to operate. Hardware shall be 34 inches minimum and 48 inches maximum above the finish floor or ground.	3 of 3 entrances at maintenance building - knobs, 3"+ change in elevation	For all doors along the public circulation route, repair, bevel, or ramp CILs at door entries to max .25". For all doors along the public circulation route, replace hardware with lever hardware or hardware operable without a tight pinch or grasp.	2010 ADAS Section: 404.2.3, 404.2.7, 404.2.4, 404.2.11, 404.2.11 Exception

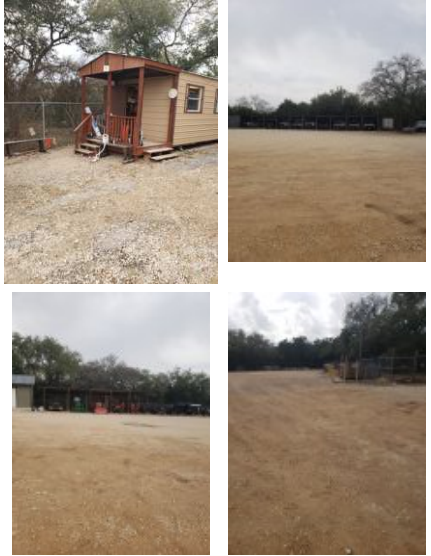
Finding Number	Area Description	Lat/Long	Finding	As Built	Recommendation	Citation	Photos	Figure
43	Employee Areas: Maintenance	[29.8640049 , -98.487876 3]	There is no accessible route to the out buildings. At least one accessible route shall connect accessible buildings, accessible facilities, accessible elements, and accessible spaces that are on the same site.	no accesible route to fuel, carport, and office building	Create an accessible route with crushed stone or other outdoor material from parking or walkway to maintenance facilities	2015 ABAAS Section: F206.2.2 2012 TAS Section: 206.2.2 2010 ADAS Section: 206.2.2

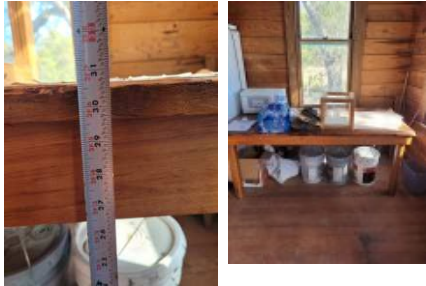
50	Rust House: Rust House	[29.8632839 , -98.4899175]	The top of the work surface is not within a compliant height range. The tops of tables and counters shall be 28 inches to 34 inches from the floor or ground.	break room- work space does not provide knee clearance	Provide tables and work surfaces at 28" to 34" aff with required knee and toe clearances	2015 ABAAS Section: 902.3 2012 TAS Section: 902.3 2010 ADAS Section: 902.3

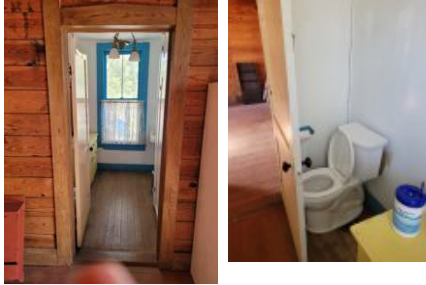
Finding Number	Area Description	Lat/Long	Finding	As Built	Recommendation	Citation	Photos	Figure
51	Rust House: Rust House	[29.8632699 , -98.489896]	The restroom is not compliant. The restroom does not have the required minimum clear floor space or maneuvering clearances for the toilet. The restroom does not have the required minimum clear floor space or maneuvering clearances for the lavatory. The entry door does not contain the required minimum maneuvering spaces on the pull/push sides. The entry door encroach into the required clear floor space for fixtures. Grab bars are missing and/or incorrectly installed. Accessories, such as toilet seat covers, paper towel holders, garbage cans, hand dryers, and mirrors are either too high or without clear floor space or both.	restroom lacks accessible elements	Create a compliant wheelchair accessible restroom and correct all features to be accessible if feasible.	2015 ABAAS Section: 603.1 2012 TAS Section: 603.1 2010 ADAS Section: 603.1

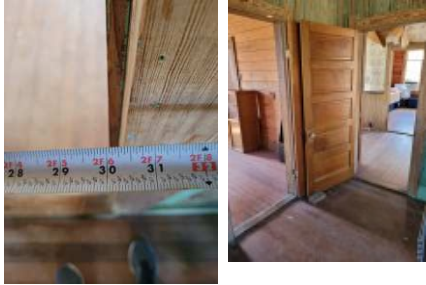
Finding Number	Area Description	Lat/Long	Finding	As Built	Recommendation	Citation	Photos	Figure
54	Rust House: Rust House	[29.86334, -98.48997]	Door openings shall provide a clear width of 32 inches (815 mm) minimum. Clear openings of doorways with swinging doors shall be measured between the face of the door and the stop, with the door open 90 degrees. Openings more than 24 inches (610 mm) deep shall provide a clear opening of 36 inches (915 mm) minimum. There shall be no projections into the required clear opening width lower than 34 inches (865 mm) above the finish floor or ground. Projections into the clear opening width between 34 inches (865 mm) and 80 inches (2030 mm) above the finish floor or ground shall not exceed 4 inches (100 mm). Hand-activated door opening hardware, handles, pulls, latches, locks, and other operating devices on accessible doors shall have a shape that is easy to grasp with one hand and does not require tight grasping, tight pinching or twisting of the wrist to operate. Hardware shall be 34 inches minimum and 48 inches maximum above the finish floor or ground.	Exhibit room - 2 of 2 doors, 30", knobs	For all doors along the public circulation route, provide required maneuvering clearance on push and pull side of doors. For all doors along the public circulation route, replace hardware with lever hardware or hardware operable without a tight pinch or grasp.	2010 ADAS Section: 404.2.3, 404.2.7, 404.2.4, 404.2.11, 404.2.11 Exception

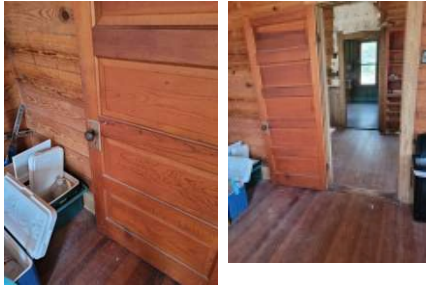
Finding Number	Area Description	Lat/Long	Finding	As Built	Recommendation	Citation	Photos	Figure
58	Rust House: Rust House	[29.86324, -98.4899]	The door operating hardware is not accessible. Hand-activated door opening hardware, handles, pulls, latches, locks, and other operating devices on accessible doors shall have a shape that is easy to grasp with one hand and does not require tight grasping, tight pinching or twisting of the wrist to operate. Hardware shall be 34 inches minimum and 48 inches maximum above the finish floor or ground.	Meeting room - knobs	Replace hardware with lever hardware or hardware operable without a tight pinch or grasp	2015 ABAAS Section: 404.2.7 2012 TAS Section: 404.2.7 2010 ADAS Section: 404.2.7

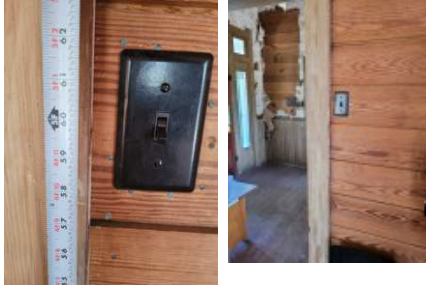
59	Rust House: Rust House	[29.8632746, -98.4899228]	The operable part is positioned too high for either a side or front approach. Where a clear floor or ground space allows a parallel approach to an element and the side reach is unobstructed, the high side reach shall be 48 inches maximum and the low side reach shall be 15 inches minimum above the finish floor or ground. Where a forward reach is unobstructed, the high forward reach shall be 48 inches maximum and the low forward reach shall be 15 inches minimum above the finish floor or ground.	Meeting room - light switch 60" AFF	Remount operable parts to be in reach range of 15" min to 48" max	2015 ABAAS Section: 308.1 2012 TAS Section: 308.1 2010 ADAS Section: 308.1

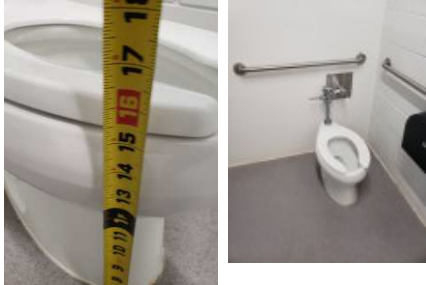
86	Turkey Sink Camping Area: Turkey Sink - Men's Restroom	[29.8679917 , -98.4852665]	The toilet seat is not located within the range allowed off the floor. The height of accessible water closets shall be a minimum of 17 inches and a maximum of 19 inches measured to the top of a maximum 2-inch high toilet seat.	16" seat height	Replace toilet seat, or re-set or replace toilet to 17" to 19" above the finished floor (AFF).	2015 ABAAS Section: 604.4 2012 TAS Section: 604.4 2010 ADAS Section: 604.4

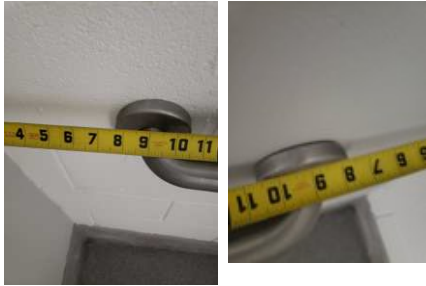
Finding Number	Area Description	Lat/Long	Finding	As Built	Recommendation	Citation	Photos	Figure
90	Turkey Sink Camping Area: Turkey Sink - Shower Rooms	[29.8679963 , -98.485277 2]	In alternate roll-in type shower compartments, grab bars shall be provided on the back wall and the side wall farthest from the compartment entry. Grab bars shall not be provided above the seat. Grab bars shall be installed 6 inches maximum from adjacent walls.	shower rooms A and F- grab bars 9" from adjacent wall	Provide grab bars in the shower mounted in the correct locations for the shower type	2015 ABAAS Section: 608.3.3 2012 TAS Section: 608.3.3 2010 ADAS Section: 608.3.3

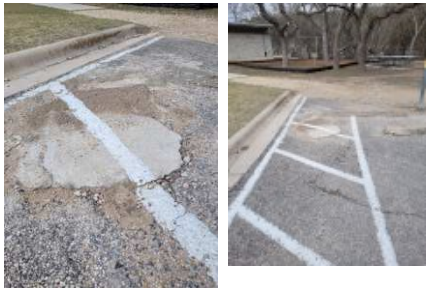
110	Day Use Area: Day Use - Parking	[29.873932, -98.484660 3]	The parking stall contains abrupt edges and surface irregularities over a 1/4 inch vertical. Parking spaces and access aisles serving them shall be stable, firm, and slip resistant. Access aisles shall be at the same level as the parking spaces they serve. Changes in level are not permitted and shall not be sloped steeper than 2% in any direction.	south of bath house- repaired area in access aisle has gaps and changes in level	Resurface stalls and access aisles to eliminate gaps and cracks	2015 ABAAS Section: 502.4 2012 TAS Section: 502.4 2010 ADAS Section: 502.4

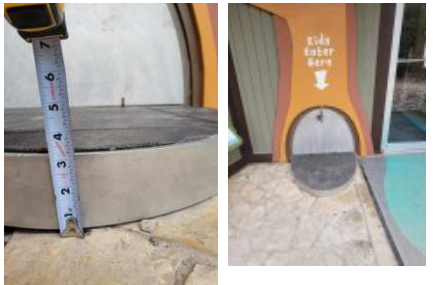
119	Day Use Area: Day Use - Discovery Center	[29.87378, -98.48617]	The entry point or seat is not within the compliant range above the ground. The height of entry points and seats shall be 11 inches minimum and 24 inches maximum measured to the top of the surface from the ground or floor surface.	4" change in level to play component entrance	Adjust entry point to play component to 11" to 24" aff	2012 TAS Section: 1008.4.4 2010 ADAS Section: 1008.4.4

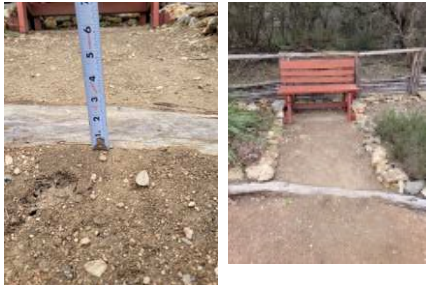
120	Day Use Area: Day Use - Discovery Center	[29.87398, -98.48576]	The walkway contains abrupt vertical edges and/or variations over a 1/4 inch. 1/4 inch is the maximum vertical rise. Changes in level between 1/4 inch and 1/2 inch must be beveled at 1:2 or less. Changes in level greater than 1/2 inch must be by way of a ramp.	2.5" change in level to bench	Repair, bevel or ramp CIL along AR.	2012 TAS Section: 303.2, 303.3 2010 ADAS Section: 303.2, 303.3

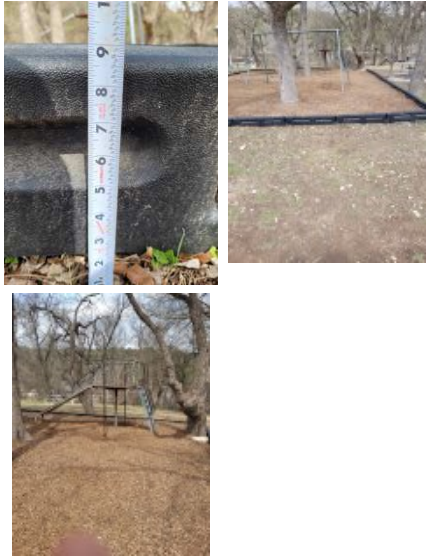
129	Day Use Area: Day Use - Playground	[29.8741433 , -98.484454 7]	There is no accessible route to the play area. Accessible routes serving play areas shall comply with Chapter 4 and 1008.2 and shall be permitted to use the exceptions in 1008.2.1 through 1008.2.3. Where accessible routes serve ground level play components, the vertical clearance shall be 80 inches high (2030 mm) minimum.	lacks route, border 9" change in level	Designate an entry as a smart practice, 60" wide and free of CIL and gaps and with a max slope of 6.25% and create an AR to the play area within the site	2015 ABAAS Section: F206.2.2 2012 TAS Section: 1008.2 2010 ADAS Section: 206.2.2

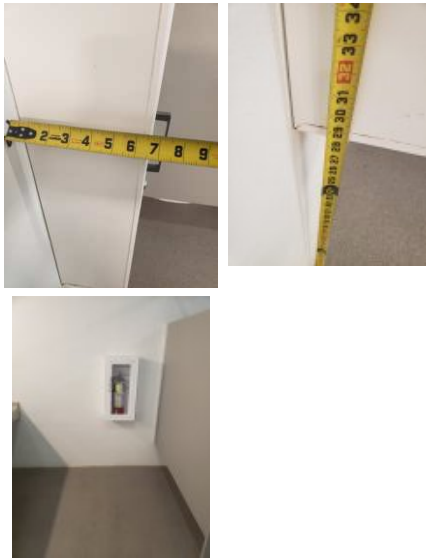
144	Day Use Area: Day Use - Women's Restroom	[29.8741925 , -98.484773]	An item or items project more than 4 inches into the circulation path. Wall-mounted objects that have leading edges between 27 inches and 80 inches from the floor must not project more than 4 inches into the circulation path. Protruding objects that extend to the floor or within 27 inches of the floor are cane detectable and are therefore not hazardous. Where it is necessary or desirable to have objects protrude from the wall, a manner of cane detection must be provided.	Fire extinguisher 6.5"	Relocate protruding objects or place cane detectable warning or bollard at foot of item	2015 ABAAS Section: 307.2 2012 TAS Section: 307.2 2010 ADAS Section: 307.2
