# Access Audit Site Report

**Hill Country State Natural Area**  
**10600 Bandera Creek Rd**  
**Bandera, TX 78003**  
**Accessibility Evaluation**  
**Inspection Date: 03/23/2022**  
**Inspectors: Tanya Scheibe**

Prepared By  
**WT Group**

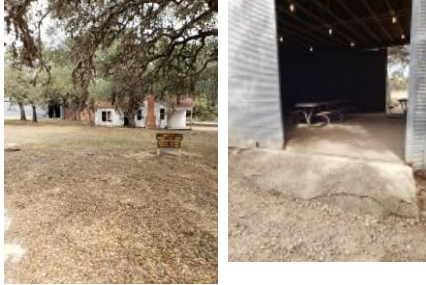
Finding Number	Area Description	Lat/Long	Finding	As Built	Recommendation	Citation	Photos	Figure
1	Chapa's Group Camp Area: Chapa - Camping	[29.6182847 , -99.170249 9]	There is no accessible route to the group house and barn. At least one accessible route shall connect accessible buildings, accessible facilities, accessible elements, and accessible spaces that are on the same site.	Lacks accessible route to group area house and barn	Create an accessible route with crushed stone or other outdoor material from parking or walkway to the group house and barn.	2015 ABAAS Section: F206.2.2  2012 TAS Section: 206.2.2  2010 ADAS Section: 206.2.2

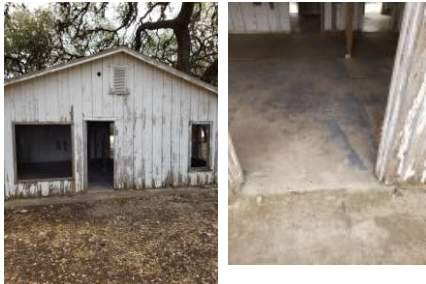
3	Chapa's Group Camp Area: Chapa - House	[29.6180143 , -99.170409 5]	There is no accessible route to the old house. At least one accessible route shall connect accessible buildings, accessible facilities, accessible elements, and accessible spaces that are on the same site.	old house; no doors, windows, ceilings, tables, chairs, or electricity - may not be used	If site feature is used or will be used in the future, create an accessible route with crushed stone or other outdoor material from parking or walkway to old house	2015 ABAAS Section: F206.2.2  2012 TAS Section: 206.2.2  2010 ADAS Section: 206.2.2

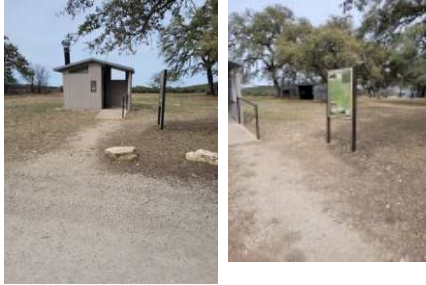
Finding Number	Area Description	Lat/Long	Finding	As Built	Recommendation	Citation	Photos	Figure
10	Comanche Bluff Camp Area: Comanche Bluff - Campsite	[29.6183719 , -99.171161 9]	The building entrance is not located on an accessible route. When a building, or portion of a building, is required to be accessible, an accessible route of travel shall be provided to all portions of the building, to accessible building entrances and between the building and the public way. All walks, halls, corridors, aisles, skywalks, tunnels, and other spaces that are part of an accessible route must comply. An accessible route of travel must not pass through kitchens, storage rooms, restrooms, closets or other spaces used for similar purposes. At least one accessible route within the boundary of the site must be provided from public transportation stops, accessible parking and accessible passenger loading zones and public streets or sidewalks to the accessible building entrance they serve. The accessible route shall, to the maximum extent feasible, coincide with the route for the general public. At least one accessible route shall connect accessible buildings, facilities, elements and spaces that are on the same site. At least one accessible route shall connect accessible building or facility entrances with all accessible spaces and elements.	Lacks accessible route to restroom or sign	Create AR with crushed and compacted stone or similar outdoor material from parking or sidewalk to building entrance	2015 ABAAS Section: F206.2.1  2012 TAS Section: 206.2.1  2010 ADAS Section: 206.2.1

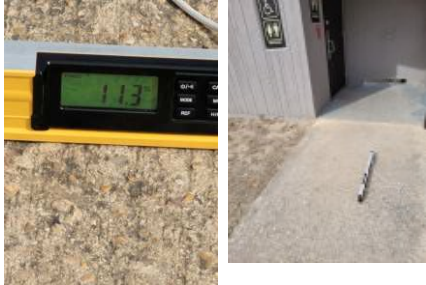
11	Comanche Bluff Camp Area: Comanche Bluff - Campsite	[29.6183423 , -99.171161 3]	The running slope of walking surfaces shall not be steeper than 1:20.	11.3% at restroom	Correct running slope along the AR to max 5%	2015 ABAAS Section: 403.3  2012 TAS Section: 403.3  2010 ADAS Section: 403.3

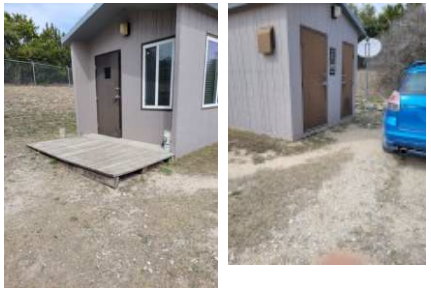
Finding Number	Area Description	Lat/Long	Finding	As Built	Recommendation	Citation	Photos	Figure
22	Employee Areas: Maintenance	[29.6255, -99.1743]	Exterior doors exceed 8.5 lbs of force to open; fire doors shall have a minimum opening force allowable by the appropriate administrative authority	Hilltop - office door at restroom building 15# push	Inspect, adjust, and maintain 8.5 lbf to open exterior doors as a smart practice.	2010 ADAS Section: 404.2.9		
23	Employee Areas: Maintenance	[29.62549, -99.17427]	The building entrance is not located on an accessible route. When a building, or portion of a building, is required to be accessible, an accessible route of travel shall be provided to all portions of the building, to accessible building entrances and between the building and the public way. All walks, halls, corridors, aisles, skywalks, tunnels, and other spaces that are part of an accessible route must comply. An accessible route of travel must not pass through kitchens, storage rooms, restrooms, closets or other spaces used for similar purposes. At least one accessible route within the boundary of the site must be provided from public transportation stops, accessible parking and accessible passenger loading zones and public streets or sidewalks to the accessible building entrance they serve. The accessible route shall, to the maximum extent feasible, coincide with the route for the general public. At least one accessible route shall connect accessible buildings, facilities, elements and spaces that are on the same site. At least one accessible route shall connect accessible building or facility entrances with all accessible spaces and elements.	Hilltop - lacks AR to office/restroom building	Create AR with crushed and compacted stone or similar outdoor material from parking or sidewalk to building entrance	2015 ABAAS Section: F206.2.1  2012 TAS Section: 206.2.1  2010 ADAS Section: 206.2.1

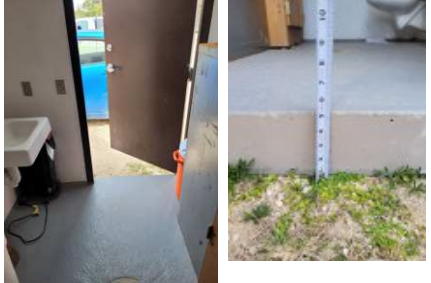
24	Employee Areas: Maintenance	[29.6254688, -99.1742663]	Minimum maneuvering clearances at doors and gates shall comply with 404.2.4. Maneuvering clearances shall extend the full width of the doorway and the required latch side or hinge side clearance. Maneuvering clearances shall have a max slope of 2.08%. The threshold has a vertical change greater than 1/4 inch high.	Hilltop restroom - maneuvering clearance reduced by sink and storage, 5" change in level	For all doors along the public circulation route, provide required maneuvering clearance on push and pull side of doors. For all doors along the public circulation route, repair, bevel, or ramp CILs at door entries to max .25".	2010 ADAS Section: 404.2.3, 404.2.7, 404.2.4, 404.2.11, 404.2.11 Exception

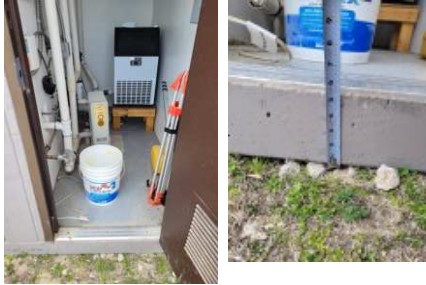
Finding Number	Area Description	Lat/Long	Finding	As Built	Recommendation	Citation	Photos	Figure
31	Employee Areas: Maintenance	[29.6254651, -99.1742759]	Minimum maneuvering clearances at doors and gates shall comply with 404.2.4. Maneuvering clearances shall extend the full width of the doorway and the required latch side or hinge side clearance. The threshold has a vertical change greater than 1/4 inch high.	Hilltop - maintenance closet next to restroom- cannot enter or exit - 6" change in level, lacks maneuvering clearance on push	For all doors along the public circulation route, provide required maneuvering clearance on push and pull side of doors. For all doors along the public circulation route, repair, bevel, or ramp CILs at door entries to max .25".	2010 ADAS Section: 404.2.3, 404.2.7, 404.2.4, 404.2.11, 404.2.11 Exception

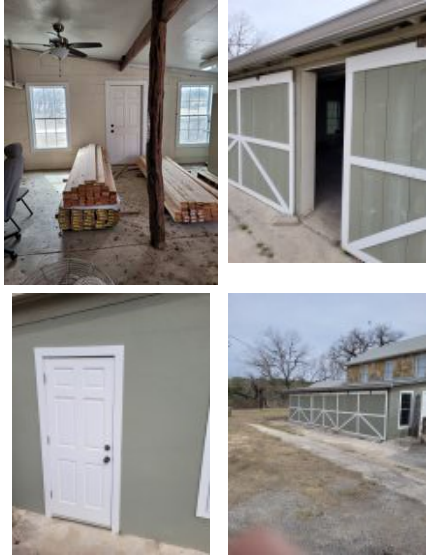
32	Employee Areas: Maintenance	[29.6272581, -99.1775281]	Minimum maneuvering clearances at doors and gates shall comply with 404.2.4. Maneuvering clearances shall extend the full width of the doorway and the required latch side or hinge side clearance. Hand-activated door opening hardware, handles, pulls, latches, locks, and other operating devices on accessible doors shall have a shape that is easy to grasp with one hand and does not require tight grasping, tight pinching or twisting of the wrist to operate. Hardware shall be 34 inches minimum and 48 inches maximum above the finish floor or ground.	Creekside - lacks maneuvering clearance on push side due to storage, knobs, staff use sliding barn doors	For all doors along the public circulation route, provide required maneuvering clearance on push and pull side of doors. For all doors along the public circulation route, replace hardware with lever hardware or hardware operable without a tight pinch or grasp.	2010 ADAS Section: 404.2.3, 404.2.7, 404.2.4, 404.2.11, 404.2.11 Exception

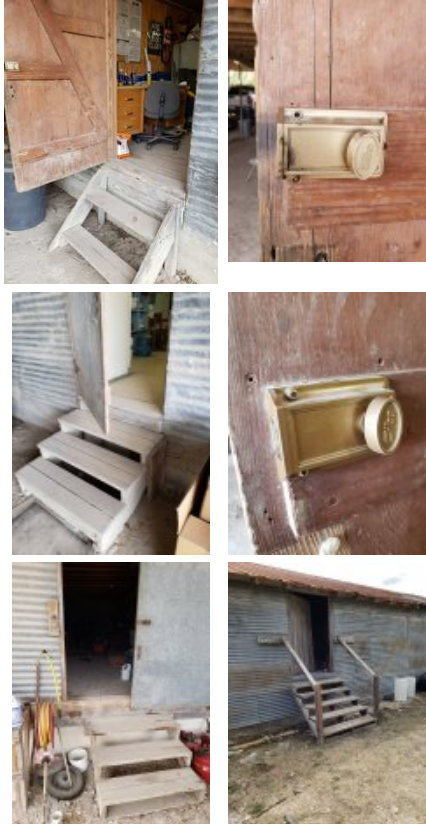
Finding Number	Area Description	Lat/Long	Finding	As Built	Recommendation	Citation	Photos	Figure
38	Employee Areas: Maintenance	[29.6254359 , -99.174434 2]	Spaces and elements within employee work areas shall only be required to comply with 206.2.8, 207.1, and 215.3 and shall be designed and constructed so that individuals with disabilities can approach, enter, and exit the employee work area. Employee work areas, or portions of employee work areas, other than raised courtroom stations, that are less than 300 square feet (28 m2) and elevated 7 inches (180 mm) or more above the finish floor or ground where the elevation is essential to the function of the space shall not be required to comply with these requirements or to be on an accessible route.	Hilltop maintenance area: office door - steps only, knob on push side; Break room door - steps only, knob on push side; storage door - steps only; barn loft door - steps only	For employee spaces, relocate storage, furniture, and other obstacles at doorways to provide approach, enter and exit at the employee space. Provide required maneuvering clearance on push and pull side of doors. Replace hardware with lever hardware or hardware operable without a tight pinch or grasp.	2015 ABAAS Section: F203.9 2012 TAS Section: 203.9 2010 ADAS Section: 203.9

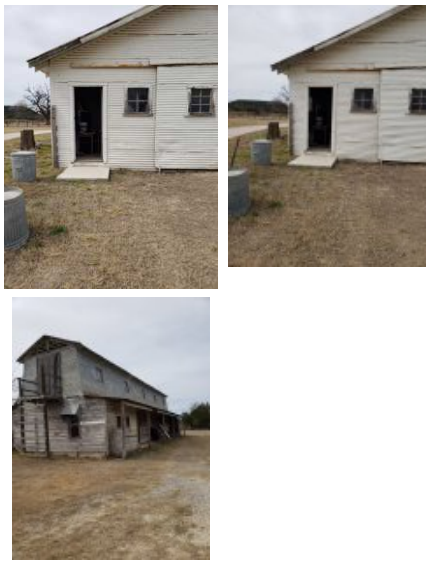
Finding Number	Area Description	Lat/Long	Finding	As Built	Recommendation	Citation	Photos	Figure
41	Employee Areas: Maintenance	[29.6278468 , -99.177913]	There is no accessible route to the barn. At least one accessible route shall connect accessible buildings, accessible facilities, accessible elements, and accessible spaces that are on the same site.	Creekside maintenance area - no accessible route to maintenance barns	Create an accessible route with crushed stone or other outdoor material from parking or walkway to barn.	2015 ABAAS Section: F206.2.2  2012 TAS Section: 206.2.2  2010 ADAS Section: 206.2.2

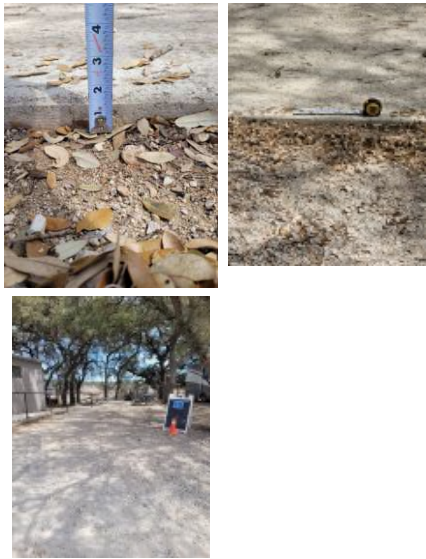
48	Headquarters Area: HQ - Public Spaces	[29.6279097 , -99.1808782]	The walkway contains abrupt vertical edges and/or variations over a 1/4 inch. 1/4 inch is the maximum vertical rise. Changes in level between 1/4 inch and 1/2 inch must be beveled at 1:2 or less. Changes in level greater than 1/2 inch must be by way of a ramp.	Accessible camp/day use site - CIL from parking surface to picnic table area	Repair, bevel or ramp change in level along accessible route.	2012 TAS Section: 303.2, 303.3  2010 ADAS Section: 303.2, 303.3

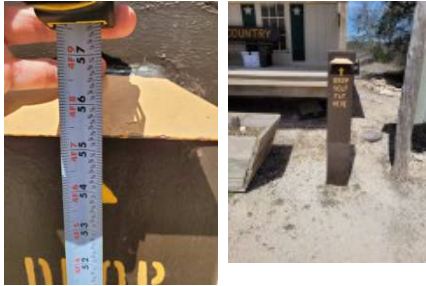
Finding Number	Area Description	Lat/Long	Finding	As Built	Recommendation	Citation	Photos	Figure
50	Headquarters Area: HQ - Public Spaces	[29.6280275 , -99.1810324]	The operable part is positioned too high for either a side or front approach. Where a clear floor or ground space allows a parallel approach to an element and the side reach is unobstructed, the high side reach shall be 48 inches maximum and the low side reach shall be 15 inches minimum above the finish floor or ground. Where a forward reach is unobstructed, the high forward reach shall be 48 inches maximum and the low forward reach shall be 15 inches minimum above the finish floor or ground.	Payment box 54.25" above ground level	Remount operable parts to be in reach range of 15" min to 48" max	2015 ABAAS Section: 308.1  2012 TAS Section: 308.1  2010 ADAS Section: 308.1

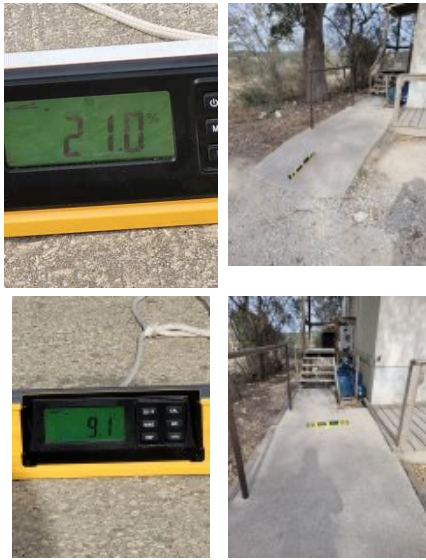
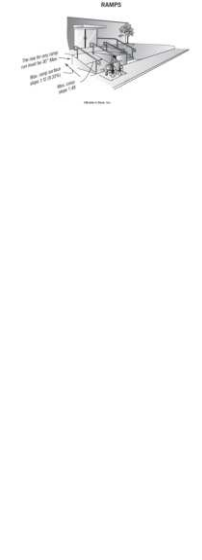
51	Headquarters Area: HQ - Public Spaces	[29.6280578 , -99.1812]	The ramp slope exceeds the maximum running slope (direction of travel) allowable of 8.33%. Ramps should have the least possible slope but in no case more than 8.3% (1:12).	Ramp slopes - 21%, 9.1%	Correct slope of ramp to max 8.33%	2015 ABAAS Section: 405.2  2012 TAS Section: 405.2  2010 ADAS Section: 405.2

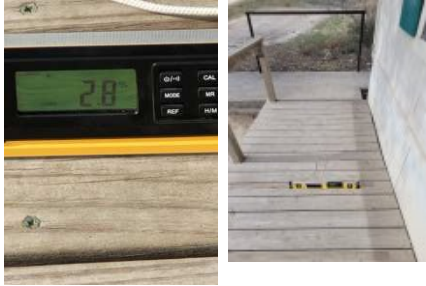
52	Headquarters Area: HQ - Public Spaces	[29.6280496 , -99.1811974]	The ramp on the accessible route contains cross slopes greater than 2%. Surface cross slopes shall not exceed one unit vertical in 48 units horizontal (2-percent slope).	2.8% cross slope	Correct ramp cross slope to max 2.08%	2015 ABAAS Section: 405.3  2012 TAS Section: 405.3  2010 ADAS Section: 405.3

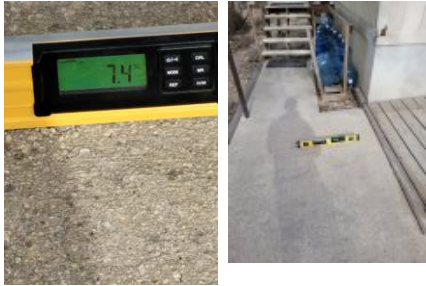
Finding Number	Area Description	Lat/Long	Finding	As Built	Recommendation	Citation	Photos	Figure
53	Headquarters Area: HQ - Public Spaces	[29.6280706 , -99.181213 5]	The landing at the bottom of the ramp has a slope greater than 2%. Bottom landings shall have a dimension in the direction of ramp run of not less than 60 inches and have a slope of less than 2% in any direction.	Bottom landing 7.4%	Correct ramp landing slope to max 2.08%	2015 ABAAS Section: 405.7.1, 405.7.1 EXCEPTION  2012 TAS Section: 405.7.1, 405.7.1 Exception  2010 ADAS Section: 405.7.1, 405.7.1 Exception

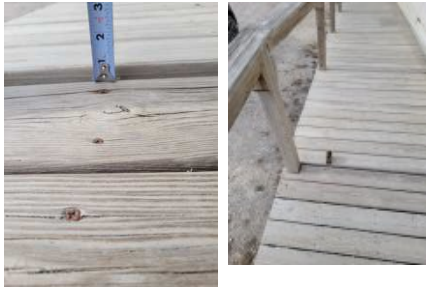
54	Headquarters Area: HQ - Public Spaces	[29.6279983 , -99.181179 9]	There is a change in level greater than 1/4 inch. 1/4 inch is the maximum vertical rise. Changes in level between 1/4 inch and 1/2 inch must be beveled at 1:2 or less. Changes in level greater than 1/2 inch must be by way of a ramp.	.75" change in level at top of ramp	Repair, bevel or ramp CIL along accessible route (AR) to max .25".	2015 ABAAS Section: 303.3  2012 TAS Section: 303.3  2010 ADAS Section: 303.3

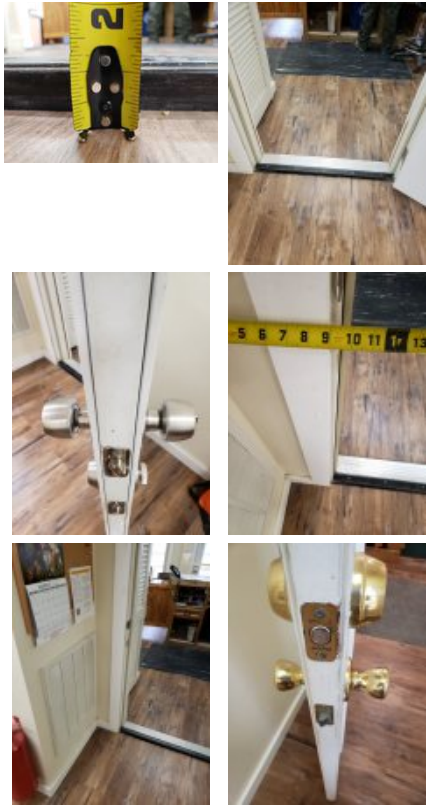
69	Headquarters Area: HQ - Employee Spaces	[29.6280566 , -99.181116 9]	Spaces and elements within employee work areas shall only be required to comply with 206.2.8, 207.1, and 215.3 and shall be designed and constructed so that individuals with disabilities can approach, enter, and exit the employee work area. Employee work areas, or portions of employee work areas, other than raised courtroom stations, that are less than 300 square feet (28 m2) and elevated 7 inches (180 mm) or more above the finish floor or ground where the elevation is essential to the function of the space shall not be required to comply with these requirements or to be on an accessible route.	Loose mat at counter, 0.5" change in level to back office, knobs, 9.5" pull side maneuvering clearance; rear office door - knobs, 7" pull side maneuvering clearance; center office door - desk and chair in pull side maneuvering clearance, knobs	For employee spaces, relocate storage, furniture, and other obstacles at doorways to provide approach, enter and exit at the employee space. Provide required maneuvering clearance on push and pull side of doors. Secure rug at door to prevent trip hazard. Repair, bevel, or ramp CILs at door entries to max .25". Replace hardware with lever hardware or hardware operable without a tight pinch or grasp.	2015 ABAAS Section: F203.9  2012 TAS Section: 203.9  2010 ADAS Section: 203.9

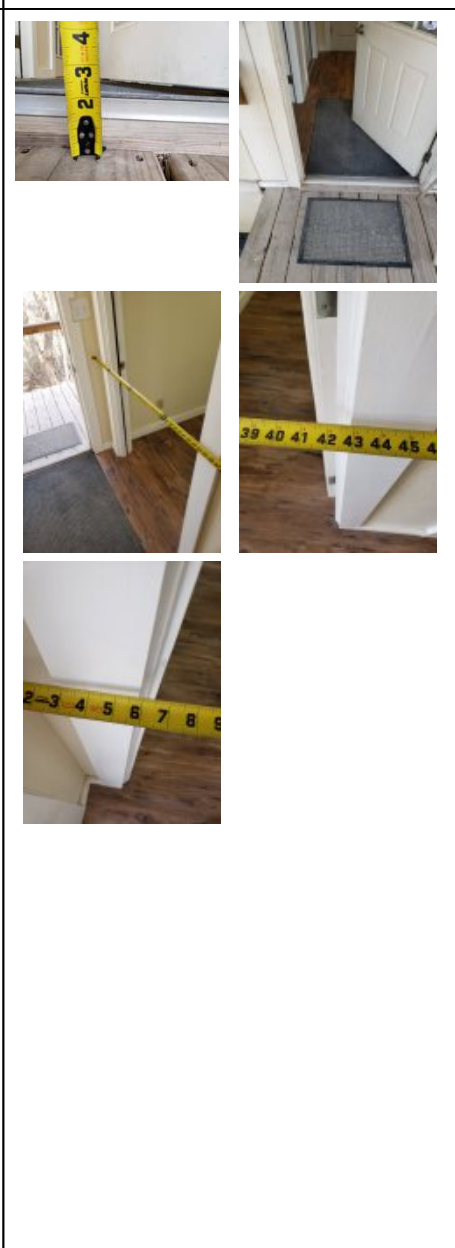
Finding Number	Area Description	Lat/Long	Finding	As Built	Recommendation	Citation	Photos	Figure
70	Headquarters Area: HQ - Employee Spaces	[29.6280449 , -99.181118 2]	Minimum maneuvering clearances at doors and gates shall comply with 404.2.4. Maneuvering clearances shall extend the full width of the doorway and the required latch side or hinge side clearance. The threshold has a vertical change greater than 1/4 inch high. Secure mat/carpet at door.	Rear door exterior- 2" change in level, loose mats on both sides, lacks maneuvering clearance on pull side	For all doors along the public circulation route, provide required maneuvering clearance on push and pull side of doors. For all doors along the public circulation route, repair, bevel, or ramp CILs at door entries to max .25". Secure mat/carpet at door.	2010 ADAS Section: 404.2.3, 404.2.7, 404.2.4, 404.2.11, 404.2.11 Exception

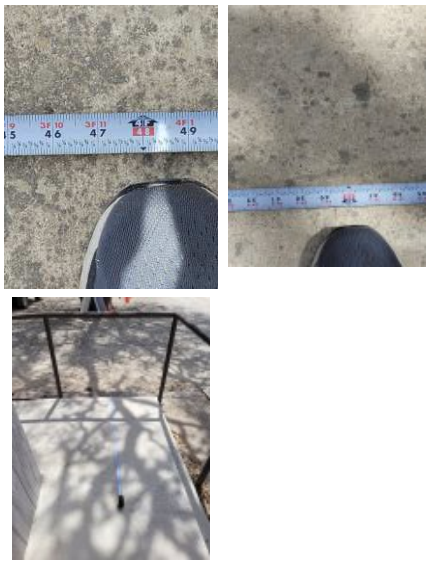
75	Headquarters Area: HQ - Restrooms	[29.627933, -99.1809439]	The landing at the change of direction is not the correct size. Landings at a change of direction shall have a dimension in the direction of ramp run of not less than 60 inches by 60 inches.	48" x 48"	Enlarge landing on ramp where directions change to 60" by 60"	2015 ABAAS Section: 405.7.4 2012 TAS Section: 405.7.4 2010 ADAS Section: 405.7.4

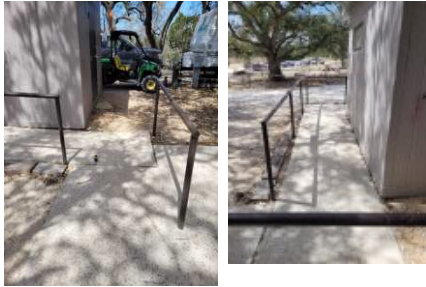
77	Headquarters Area: HQ - Restrooms	[29.6279214 , -99.180910 4]	The ramp does not have compliant handrails. Handrails are required on both sides of all surfaces that are sloped greater than 5 percent (1:20). Handrails must be between 34 inches and 38 inches above the ramp surface, must extend beyond the top and bottom of the ramp 12 inches and be parallel to the floor or ground surface. The diameter of the handrails must be between 1 inches and 2 inches in cross-sectional nominal dimension for circular handrails and handrail gripping surfaces with a non-circular cross section shall have a perimeter dimension of 4 inches minimum and 6 inches maximum, and a cross-section dimension of 2 inches maximum. The clear space between handrails and walls must 1-1/2 inches minimum.	handrail on one side only	Install handrails that are rounded and/or extend to the ground, with handrail extensions and mounted 34" to 38" aff	2015 ABAAS Section: 505.1  2012 TAS Section: 505.1  2010 ADAS Section: 505.1

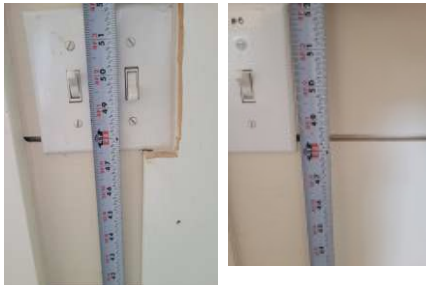
94	Group Lodge: Group Lodge - Public Spaces	[29.6485556 , -99.200116 3]	The operable part is positioned too high for either a side or front approach. Where a clear floor or ground space allows a parallel approach to an element and the side reach is unobstructed, the high side reach shall be 48 inches maximum and the low side reach shall be 15 inches minimum above the finish floor or ground. Where a forward reach is unobstructed, the high forward reach shall be 48 inches maximum and the low forward reach shall be 15 inches minimum above the finish floor or ground.	main room- light switches 49.5" and 50" AFF	Remount operable parts to be in reach range of 15" min to 48" max	2015 ABAAS Section: 308.1  2012 TAS Section: 308.1  2010 ADAS Section: 308.1

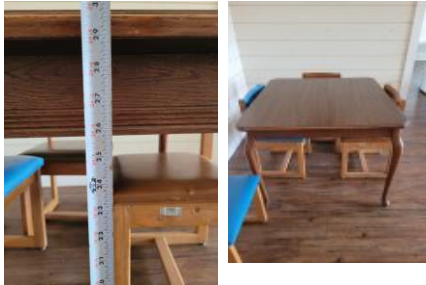
95	Group Lodge: Group Lodge - Public Spaces	[29.6485672 , -99.200115]	The top of the work surface is not within a compliant height range. The tops of tables and counters shall be 28 inches to 34 inches from the floor or ground.	main room- 25.75" knee clearance	Provide tables and work surfaces at 28" to 34" aff with required knee and toe clearances	2015 ABAAS Section: 902.3  2012 TAS Section: 902.3  2010 ADAS Section: 902.3

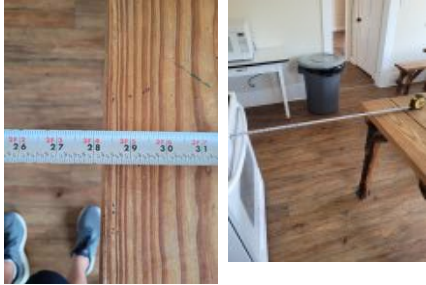
Finding Number	Area Description	Lat/Long	Finding	As Built	Recommendation	Citation	Photos	Figure
96	Group Lodge: Group Lodge - Public Spaces	[29.6485894 , -99.200121 7]	The U-shaped kitchen is not wide enough. In U-shaped kitchens enclosed on three contiguous sides, clearance between all opposing base cabinets, counter tops, appliances, or walls within kitchen work areas shall be 60 inches.	kitchen- 28.25" between stove and table	Renovate U shaped kitchen to provide required 60" clearance between cabinets, counter tops and appliances	2015 ABAAS Section: 804.2.2  2012 TAS Section: 804.2.2  2010 ADAS Section: 804.2.2

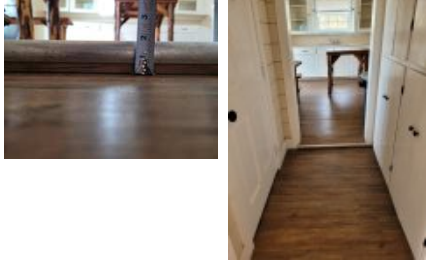
100	Group Lodge: Group Lodge - Public Spaces	[29.6485789 , -99.200121 7]	There is a change in level greater than 1/4 inch. 1/4 inch is the maximum vertical rise. Changes in level between 1/4 inch and 1/2 inch must be beveled at 1:2 or less. Changes in level greater than 1/2 inch must be by way of a ramp.	kitchen- 1.5" entering kitchen	Repair, bevel or ramp CIL along accessible route (AR) to max .25".	2015 ABAAS Section: 303.3  2012 TAS Section: 303.3  2010 ADAS Section: 303.3

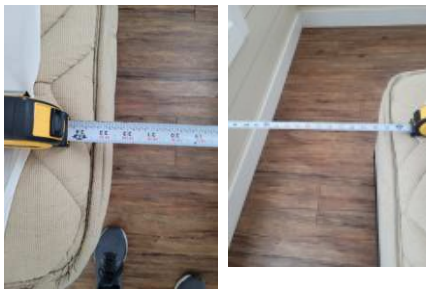
106	Group Lodge: Group Lodge - Public Spaces	[29.6485672 , -99.200076 1]	The route of travel at this location does not provide a minimum width of 36 inches. The clear width shall be permitted to be reduced to 32 inches minimum for a length of 24 inches maximum provided that reduced width segments are separated by segments that are 48 inches long minimum and 36 inches wide minimum.	Front right bedroom- reduces to 23" at bed by window	Widen AR to compliant 36" clear width	2015 ABAAS Section: 403.5.1  2012 TAS Section: 403.5.1  2010 ADAS Section: 403.5.1

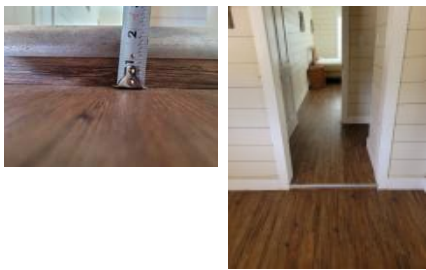
107	Group Lodge: Group Lodge - Public Spaces	[29.6485812 , -99.200121 7]	There is a change in level greater than 1/4 inch. 1/4 inch is the maximum vertical rise. Changes in level between 1/4 inch and 1/2 inch must be beveled at 1:2 or less. Changes in level greater than 1/2 inch must be by way of a ramp.	front right bedroom- 2" approaching entry to right front bedroom	Repair, bevel or ramp CIL along accessible route (AR) to max .25".	2015 ABAAS Section: 303.3  2012 TAS Section: 303.3  2010 ADAS Section: 303.3

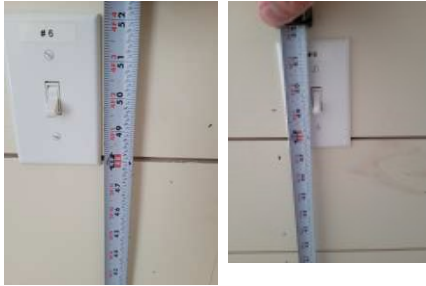
Finding Number	Area Description	Lat/Long	Finding	As Built	Recommendation	Citation	Photos	Figure
108	Group Lodge: Group Lodge - Public Spaces	[29.6485998 , -99.200117 7]	The operable part is positioned too high for either a side or front approach. Where a clear floor or ground space allows a parallel approach to an element and the side reach is unobstructed, the high side reach shall be 48 inches maximum and the low side reach shall be 15 inches minimum above the finish floor or ground. Where a forward reach is unobstructed, the high forward reach shall be 48 inches maximum and the low forward reach shall be 15 inches minimum above the finish floor or ground.	Front right bedroom - light switches 50" and 49.5" AFF	Remount operable parts to be in reach range of 15" min to 48" max	2015 ABAAS Section: 308.1  2012 TAS Section: 308.1  2010 ADAS Section: 308.1

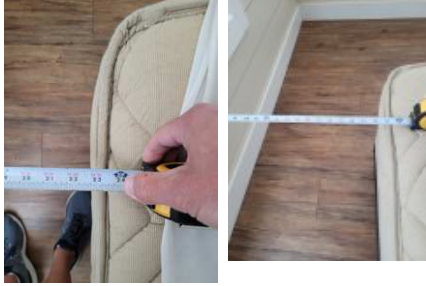
109	Group Lodge: Group Lodge - Public Spaces	[29.6485991 , -99.200115 1]	The required clear space on both sides of the bed has not been provided. Accessible sleeping rooms shall have a 30 inch minimum by 48 inch minimum clear width space located along both sides of a bed.	front bedroom 2 - 23" on one side of bed	Provide 30" x 48" CFS on both sides of bed	2015 ABAAS Section: 806.2.3  2012 TAS Section: 806.2.3  2010 ADAS Section: 806.2.3

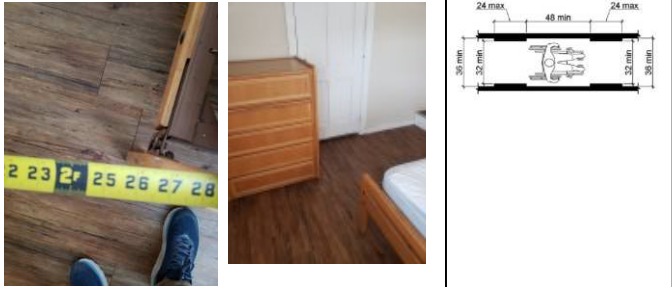
112	Group Lodge: Group Lodge - Public Spaces	[29.6485824, -99.200129 7]	The route of travel at this location does not provide a minimum width of 36 inches. The clear width shall be permitted to be reduced to 32 inches minimum for a length of 24 inches maximum provided that reduced width segments are separated by segments that are 48 inches long minimum and 36 inches wide minimum.	rear bedroom- 26" between dresser and bed	Widen AR to compliant 36" clear width	2015 ABAAS Section: 403.5.1  2012 TAS Section: 403.5.1  2010 ADAS Section: 403.5.1

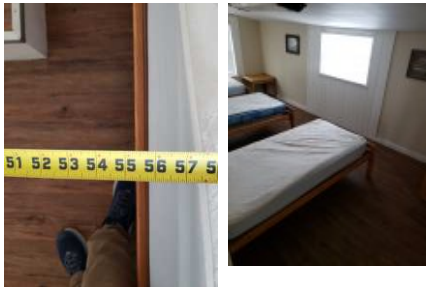
114	Group Lodge: Group Lodge - Public Spaces	[29.6485824 , -99.200132 4]	There is insufficient turning space within this room or space. The space required for a wheelchair to make a 180-degree turn is a clear space of 60 inches in diameter or a T-shaped space.	rear bedroom- lacks turning space	Relocate obstacles to create turning space in back bedroom.	2015 ABAAS Section: 304.3.1, 304.3.2  2012 TAS Section: 304.3.1, 304.3.2  2010 ADAS Section: 304.3.1, 304.3.2

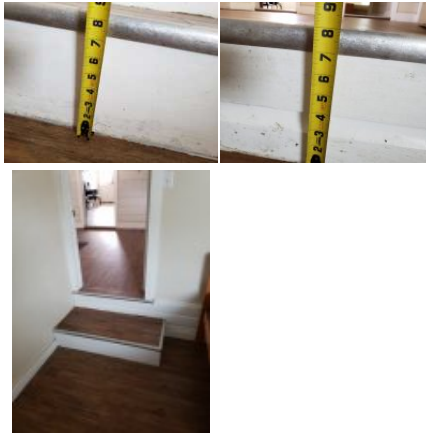
115	Group Lodge: Group Lodge - Public Spaces	[29.64858, -99.200129 7]	There is a change in level greater than 1/4 inch. 1/4 inch is the maximum vertical rise. Changes in level between 1/4 inch and 1/2 inch must be beveled at 1:2 or less. Changes in level greater than 1/2 inch must be by way of a ramp.	rear bedroom - 8" step to door	Repair, bevel or ramp CIL along accessible route (AR) to max .25".	2015 ABAAS Section: 303.3  2012 TAS Section: 303.3  2010 ADAS Section: 303.3

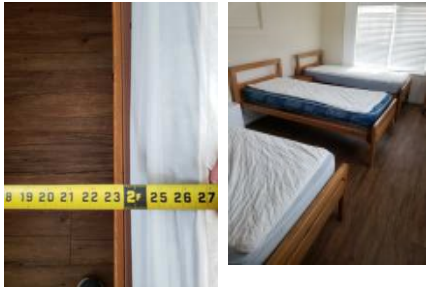
119	Group Lodge: Group Lodge - Public Spaces	[29.6485614 , -99.200115]	The required clear space between the beds has not been provided. Accessible sleeping rooms shall have a 30 inch minimum by 48 inch minimum clear space located between the beds to provide a parallel approach.	Rear bedroom - 24" between beds	Provide 30" x 48" CFS between both beds	2015 ABAAS Section: 806.2.3, 806.2.3 EXCEPTION  2012 TAS Section: 806.2.3, 806.2.3 Exception  2010 ADAS Section: 806.2.3 Exception

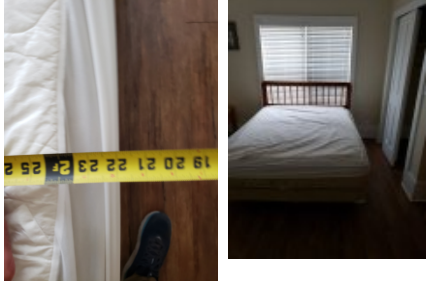
120	Group Lodge: Group Lodge - Public Spaces	[29.6485987 , -99.200115]	The required clear space on both sides of the bed has not been provided. Accessible sleeping rooms shall have a 30 inch minimum by 48 inch minimum clear width space located along both sides of a bed.	Front bedroom 1 - 22" between bed and closet	Provide 30" x 48" CFS on both sides of bed	2015 ABAAS Section: 806.2.3  2012 TAS Section: 806.2.3  2010 ADAS Section: 806.2.3

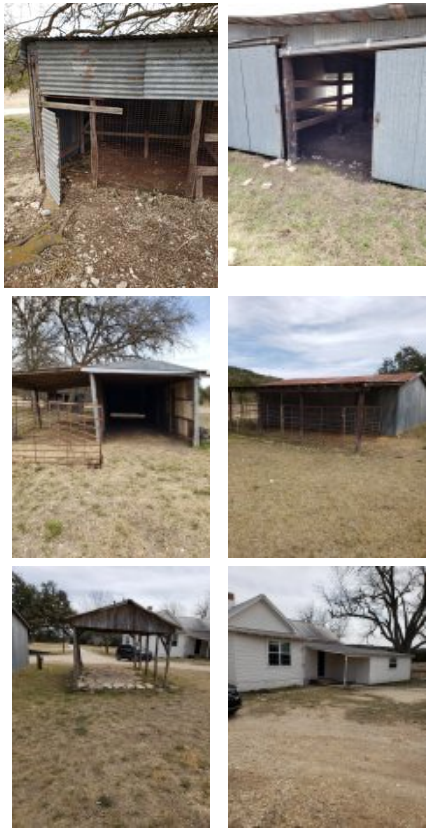
122	Group Lodge: Group Lodge - Public Spaces	[29.6484763 , -99.200204 8]	There is no accessible route to site elements. At least one accessible route shall connect accessible buildings, accessible facilities, accessible elements, and accessible spaces that are on the same site.	group lodge area - no accessible route to chicken coop, horse barn, 2 stock pens, carport, group lodge, picnic area (16 tables, 0 accessible), barrel race bleachers, and cook shack	Create an accessible route with crushed stone or other outdoor material from parking or walkway to amenities. Replace 20% of picnic tables with ones of accessible design as a smart practice	2015 ABAAS Section: F206.2.2  2012 TAS Section: 206.2.2  2010 ADAS Section: 206.2.2

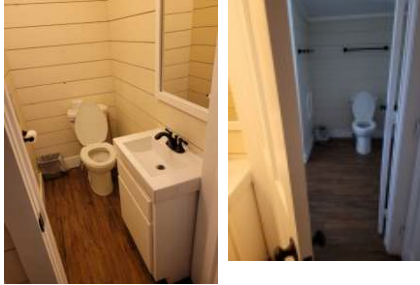
123	Group Lodge: Group Lodge - Restrooms	[29.6485789 , -99.200117 7]	50% of the single accommodation restrooms provided in this grouping are not nearly compliant. The restrooms do not have the required minimum clear floor space or maneuvering clearances for the toilet, The restrooms do not have the required minimum clear floor space or maneuvering clearances for the lavatory, The entry doors do not contain the required minimum maneuvering spaces on the pull/push sides, The entry doors encroach into the required clear floor space for fixtures, Grab bars are missing and/or incorrectly installed, Accessories, such as toilet seat covers, paper towel holders, garbage cans, hand dryers, and mirrors are either too high or without clear floor space or both, The restrooms contain floor level changes greater than a 1/2 inch, the showers are too small and missing numerous accessible elements.	small restrooms not accessible	Create compliant wheelchair accessible restrooms and correct all features to be accessible if feasible to meet 50% compliant restrooms in this location.	2015 ABAAS Section: 603.1  2012 TAS Section: 603.1  2010 ADAS Section: 603.1

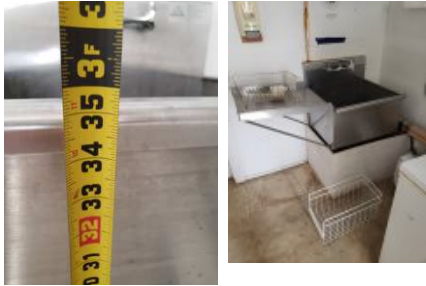
Finding Number	Area Description	Lat/Long	Finding	As Built	Recommendation	Citation	Photos	Figure
128	Group Lodge: Group Lodge - Cook Shack	[29.6485194 , -99.200302 7]	The sink is not accessible. A clear floor space at least 30 inches by 48 shall be provided in front of a sink to allow forward approach. -The clear floor space shall be on an accessible route and shall extend a maximum of 19 inches underneath the sink. -Sinks shall be mounted with the counter or rim no higher than 34 inches above the finish floor. -Knee clearance at least 27 inches high, 30 inches wide and 19 inches deep shall be provided. -Hot water and drain pipes exposed under sinks shall be insulated or otherwise configured so as to protect against contact. There shall be no sharp or abrasive surfaces under sinks. -Faucet controls not require tight grasping, pinching or twisting of the wrist. -The force required to activate controls shall be not greater than 5 lb. Lever-operated, push-type and electronically controlled mechanisms are examples of acceptable designs. -Self-closing valves are allowed if the faucet remains open for at least 10 seconds.	Sink is not accessible, 35.25" aff, lacks knee clearance, pipes not insulated	Replace sink providing 27" knee clearance, mounted max 34" aff to front of rim Insulate exposed pipes under one sink	2015 ABAAS Section: 606.2, 606.2 EXCEPTION S: 1, 606.2 E XCEPTIONS: 4, 606.2 EXC EPTIONS: 5, 606.2 EXCEP TIONS: 6, 606.2 EXCEP TIONS: 7, 606.3, 606.4, 606.5  2012 TAS Section: 606.2, 606.2 Exception 1, 606.2 Exception 4, 606.2 Exception 5, 606.2 Exception 6, 606.2 Exception 7, 606.3, 606.4, 606.5  2010 ADAS Section: 606.2, 606.2 Exception 1, 606.2 Exception 4, 606.2 Exception 5, 606.2 Exception 6, 606.2 Exception 7, 606.3, 606.4, 606.5
