Access Audit Site Report

Hueco Tanks State Park and Historic Site

Accessibility Evaluation

Inspection Date: 10/19/2022

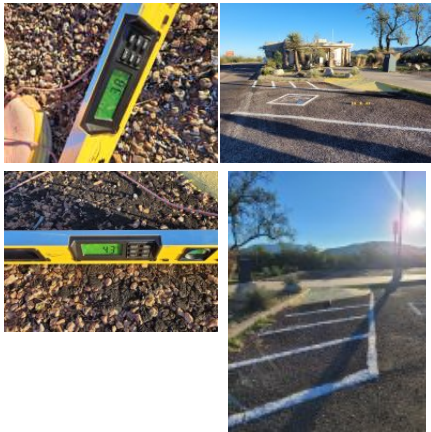
Finding Number	Area Description	Lat/Long	Finding	As Built	Recommendation	Citation	Photos	Figure
1	Headquarters Area: HQ - Parking	[31.92632, -106.0424]	Element meets all standards and requirements	HQ parking meets scoping requirements - 8 standard, 1 accessible	None	2010 ADAS Section: N/A		
2	Headquarters Area: HQ - Parking	[31.92632, -106.0424]	The cross slopes (narrow dimension) and/or running slopes (long dimension) of the access aisle exceeds 2%. The running slope and the cross slope in an accessible parking stall and the access aisle must not exceed 2%.	3.8% slope in stall, 4.3% slope in access aisle, curb ramp is also in access aisle	Repair or correct slope of parking space and access aisle to max 2.08% in any direction. Remove curb ramp from access aisle and resurface access aisles to eliminate slopes.	2015 ABAAS Section: 502.4 2012 TAS Section: 502.4 2010 ADAS Section: 502.4

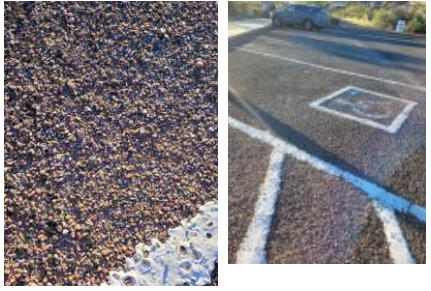
3	Headquarters Area: HQ - Parking	[31.92632, -106.0424]	The parking stall contains abrupt edges and surface irregularities over a 1/4 inch vertical. Parking spaces and access aisles serving them shall be stable, firm, and slip resistant. Access aisles shall be at the same level as the parking spaces they serve. Changes in level are not permitted and shall not be sloped steeper than 2% in any direction.	Heavy loose rock in both stall and access aisle	Resurface accessible stalls and access aisles with a firm, stable, and slip resistant material. Cost included in previous finding.	2015 ABAAS Section: 502.4 2012 TAS Section: 502.4 2010 ADAS Section: 502.4

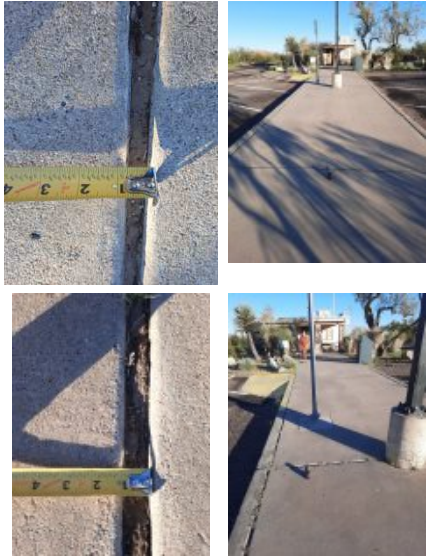
Finding Number	Area Description	Lat/Long	Finding	As Built	Recommendation	Citation	Photos	Figure
4	Headquarters Area: HQ - Exterior Accessible Route	[31.9262191, -106.0422852]	There is a gap spaced greater than a 1/2 inch. Openings in floor or ground surfaces shall not allow passage of a sphere more than 1/2 inch diameter. Elongated openings shall be placed so that the long dimension is perpendicular to the dominant direction of travel.	.75" and 1" gaps on route to HQ	Correct or fill gaps to be max .5".	2015 ABAAS Section: 302.3 2012 TAS Section: 302.3 2010 ADAS Section: 302.3

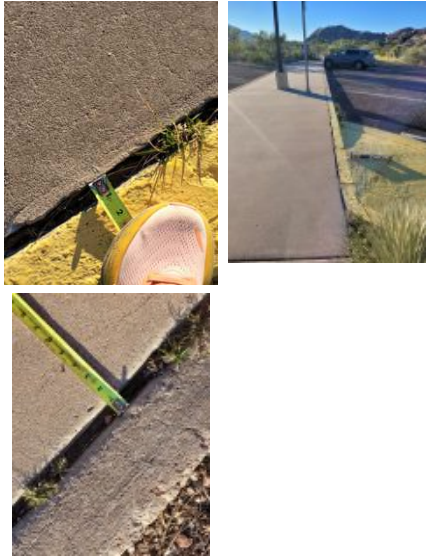
Finding Number	Area Description	Lat/Long	Finding	As Built	Recommendation	Citation	Photos	Figure
8	Headquarters Area: HQ - Exterior Accessible Route	[31.9262898, -106.0423477]	There is a gap spaced greater than a 1/2 inch. Openings in floor or ground surfaces shall not allow passage of a sphere more than 1/2 inch diameter. Elongated openings shall be placed so that the long dimension is perpendicular to the dominant direction of travel.	Two 1" gaps along parking stalls (vertical gaps on route to trail)	Correct or fill gaps to be max .5".	2015 ABAAS Section: 302.3 2012 TAS Section: 302.3 2010 ADAS Section: 302.3

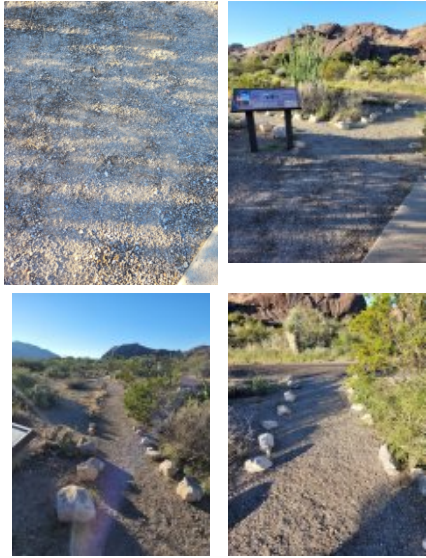
Finding Number	Area Description	Lat/Long	Finding	As Built	Recommendation	Citation	Photos	Figure
14	Headquarters Area: HQ - Public Spaces	[31.9260451, -106.0421879]	The surface of trails, passing spaces, and resting intervals shall be firm and stable.	"Hidden oasis" walking path at end of HQ accessible route is loose and not accessible surface	Establish protocols for regular and frequent inspection and maintenance of accessible trail surface as a smart practice.	2015 ABAAS Section: 1017.2

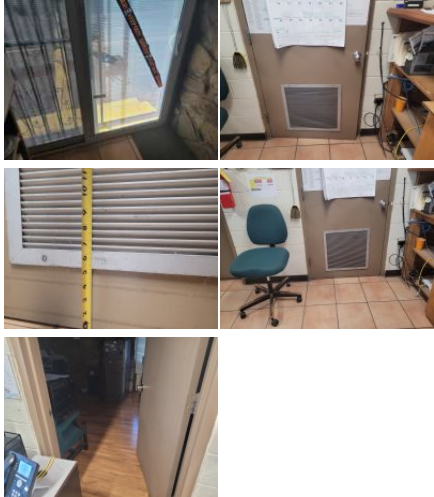
Finding Number	Area Description	Lat/Long	Finding	As Built	Recommendation	Citation	Photos	Figure
20	Headquarters Area: HQ - Employee Spaces	[31.92644, -106.042453 6]	Spaces and elements within employee work areas shall only be required to comply with 206.2.8, 207.1, and 215.3 and shall be designed and constructed so that individuals with disabilities can approach, enter, and exit the employee work area. Employee work areas, or portions of employee work areas, other than raised courtroom stations, that are less than 300 square feet (28 m2) and elevated 7 inches (180 mm) or more above the finish floor or ground where the elevation is essential to the function of the space shall not be required to comply with these requirements or to be on an accessible route.	Sliding door - stairs on exterior side, storage in interior side clearance; safe room door - knob, counter in pull side clearance, vent 6"; Superintendent office door - knob, desk in push side clearance, chairs in pull side	For employee spaces, relocate storage, furniture, and other obstacles at doorways to provide approach, enter and exit at the employee space. Provide required maneuvering clearance on push and pull side of doors. Provide ramp for access. Replace hardware with lever hardware or hardware operable without a tight pinch or grasp. Provide kick plate on push side of door from floor to 10" AFF.	2015 ABAAS Section: F203.9 2012 TAS Section: 203.9 2010 ADAS Section: 203.9

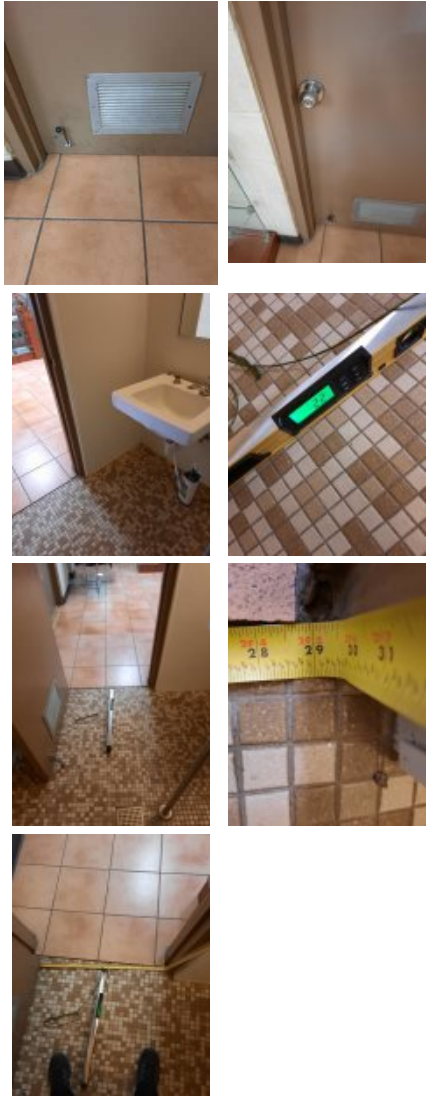
Finding Number	Area Description	Lat/Long	Finding	As Built	Recommendation	Citation	Photos	Figure
22	Headquarters Area: HQ - Men's Restroom	[31.926461, -106.04244 98]	Minimum maneuvering clearances at doors and gates shall comply with 404.2.4. Maneuvering clearances shall extend the full width of the doorway and the required latch side or hinge side clearance. Maneuvering clearances shall have a max slope of 2.08%. Door openings shall provide a clear width of 32 inches (815 mm) minimum. Clear openings of doorways with swinging doors shall be measured between the face of the door and the stop, with the door open 90 degrees. Openings more than 24 inches (610 mm) deep shall provide a clear opening of 36 inches (915 mm) minimum. There shall be no projections into the required clear opening width lower than 34 inches (865 mm) above the finish floor or ground. Projections into the clear opening width between 34 inches (865 mm) and 80 inches (2030 mm) above the finish floor or ground shall not exceed 4 inches (100 mm). Hand-activated door opening hardware, handles, pulls, latches, locks, and other operating devices on accessible doors shall have a shape that is easy to grasp with one hand and does not require tight grasping, tight pinching or twisting of the wrist to operate. Hardware shall be 34 inches minimum and 48 inches maximum above the finish floor or ground. The bottom 10 inches on the push side must be smooth and free of obstructions (hold open devices). Opening hardware must be mounted between 30 and 44 inches above the floor or ground.	HQ Men's Restroom door - grate and hold open device on push side, knobs, sink in pull side clearance, slope of 2.2% in pull side clearance, 29.5" wide	For all doors along the public circulation route, provide required maneuvering clearance on push and pull side of doors. For all doors along the public circulation route, correct slope in door clearance to max 2.08%, in the alternative, leave as is citing construction tolerance. For all doors along the public circulation route, replace doors with doors having 80" overhead clearance and 32" clear width. For all doors along the public circulation route, replace hardware with lever hardware or hardware operable without a tight pinch or grasp. For all doors along the public circulation route, replace hardware with lever hardware or hardware operable without a tight pinch or grasp and having a max profile of 4". For all doors along the public circulation route, provide kick plate on push side of door from floor to 10" AFF. For all doors along the public circulation route, remove door holder to provide a smooth surface on the push side of door from floor to 10" AFF.	2010 ADAS Section: 404.2.3, 404.2.7, 404.2.4, 404.2.11, 404.2.11 Exception

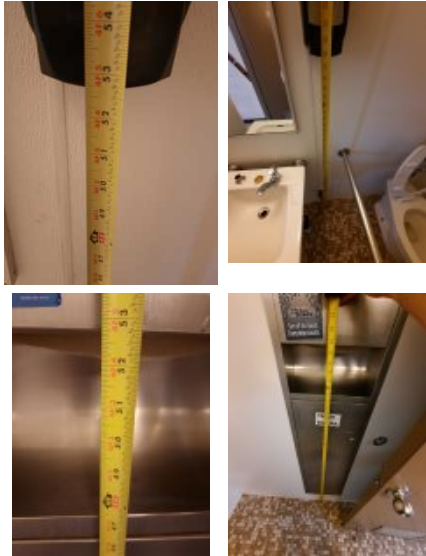
Finding Number	Area Description	Lat/Long	Finding	As Built	Recommendation	Citation	Photos	Figure
26	Headquarters Area: HQ - Men's Restroom	[31.9264388, -106.0424349]	Where a high forward reach is over an obstruction, the clear floor space shall extend beneath the element for a distance not less than the required reach depth over the obstruction. The high forward reach shall be 48 inches (1220 mm) maximum where the reach depth is 20 inches (510 mm) maximum. Where the reach depth exceeds 20 inches (510 mm), the high forward reach shall be 44 inches (1120 mm) maximum and the reach depth shall be 25 inches (635 mm) maximum. Where a clear floor or ground space allows a parallel approach to an element and the high side reach is over an obstruction, the height of the obstruction shall be 34 inches (865 mm) maximum and the depth of the obstruction shall be 24 inches (610 mm) maximum. The high side reach shall be 48 inches (1220 mm) maximum for a reach depth of 10 inches (255 mm) maximum. Where the reach depth exceeds 10 inches (255 mm), the high side reach shall be 46 inches (1170 mm) maximum for a reach depth of 24 inches (610 mm) maximum.	Soap dispenser at 52.75", paper towel dispenser at 52.75"	Leave as is paper towel dispenser citing safe harbor.	2015 ABAAS Section: 308.2.1, 308.3.2 2012 TAS Section: 308.2.1, 308.3.2 2010 ADAS Section: 308.2.1, 308.3.2

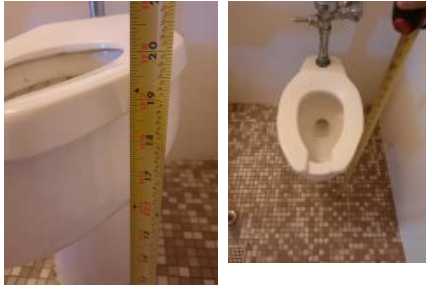
Finding Number	Area Description	Lat/Long	Finding	As Built	Recommendation	Citation	Photos	Figure
28	Headquarters Area: HQ - Men's Restroom	[31.9264297, -106.0424563]	The toilet seat is not located within the range allowed off the floor. The height of accessible water closets shall be a minimum of 17 inches and a maximum of 19 inches measured to the top of a maximum 2-inch high toilet seat.	Toilet seat at 19.5"	Replace toilet seat, or re-set or replace toilet to 17" to 19" above the finished floor (AFF).	2015 ABAAS Section: 604.4 2012 TAS Section: 604.4 2010 ADAS Section: 604.4

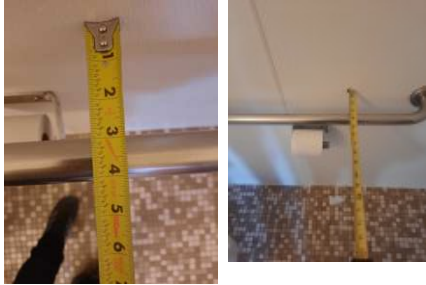
Finding Number	Area Description	Lat/Long	Finding	As Built	Recommendation	Citation	Photos	Figure
31	Headquarters Area: HQ - Men's Restroom	[31.9264274, -106.0424376]	The grab bar height and/or spacing fails. Grab bars must be mounted between 33" and 36" to the top of the gripping surface. There must be 1.5" of clearance between the grab bar and the wall. There must be a minimum of 1.5" of clearance below and minimum 12" above the grab bar to any dispenser or other obstruction.	3" space between wall and grab bar	Replace side grab bar with one providing 1.5" of clearance between the grab bar and the wall, 33" to 36" above the finished floor (AFF). Cost included in previous finding.	2015 ABAAS Section: 609.3, 609.4 2012 TAS Section: 609.4, 609.3 2010 ADAS Section: 609.3, 609.4

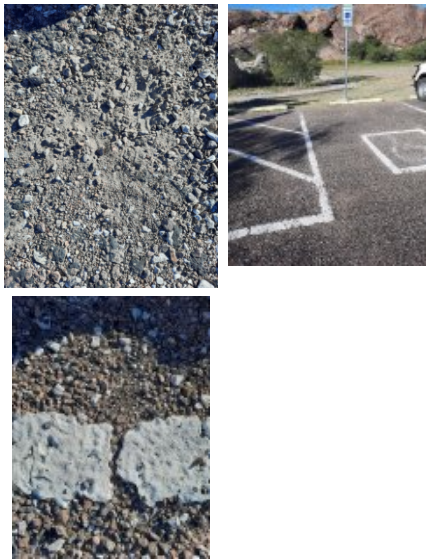
59	Interpretive Center: Interpretive - Parking	[31.9250611, -106.0417785]	The parking stall contains abrupt edges and surface irregularities over a 1/4 inch vertical. Parking spaces and access aisles serving them shall be stable, firm, and slip resistant. Access aisles shall be at the same level as the parking spaces they serve. Changes in level are not permitted and shall not be sloped steeper than 2% in any direction.	Rough stone and binding agent surface, with dirt and loose rock on it	Resurface accessible stalls and access aisles with a firm, stable, and slip resistant material.	2015 ABAAS Section: 502.4 2012 TAS Section: 502.4 2010 ADAS Section: 502.4

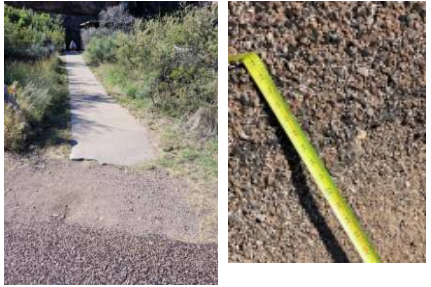
89	Interpretive Center: Interpretive - Picnic Areas	[31.92599, -106.0434]	There is a gap spaced greater than a 1/2 inch. Openings in floor or ground surfaces shall not allow passage of a sphere more than 1/2 inch diameter. Elongated openings shall be placed so that the long dimension is perpendicular to the dominant direction of travel.	Site 2 - 38" gap in compliant surface to picnic table	Connect route to shelter with firm and stable material as a smart practice.	2015 ABAAS Section: 302.3 2012 TAS Section: 302.3 2010 ADAS Section: 302.3

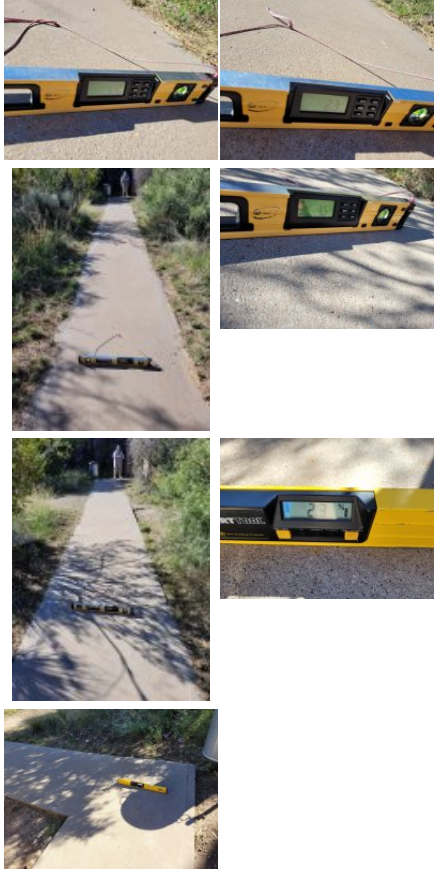
Finding Number	Area Description	Lat/Long	Finding	As Built	Recommendation	Citation	Photos	Figure
90	Interpretive Center: Interpretive - Picnic Areas	[31.92601, -106.0434]	The cross slope shall not be steeper than 1:48. EXCEPTION: Where the surface is other than concrete, asphalt, or boards, cross slopes not steeper than 1:20 shall be permitted when necessary for drainage.	Path to picnic area 2 - 4.4% slope by road, 2.3% middle of path, 7.5%, 2.3% cross slope at turn.	Correct or repair ORAR cross slope to max 2.08% as a smart practice.	2015 ABAAS Section: 1016.7.2, 1016.7.2 EXCEPTION

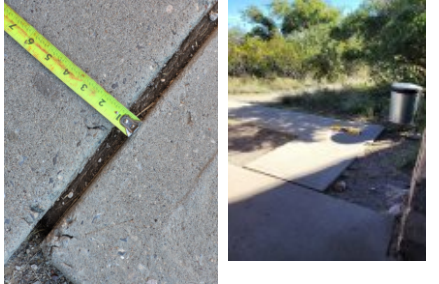
91	Interpretive Center: Interpretive - Picnic Areas	[31.9257662, -106.0433771]	The outdoor recreation access route has obstacles openings that are greater than 1/2 inch wide. Openings in the surface of outdoor recreation access routes shall not allow the passage of a sphere more than 1/2 inch in diameter.	1" gap at picnic site 2	Correct or fill gaps to max .5" as a smart practice.	2015 ABAAS Section: 1016.6

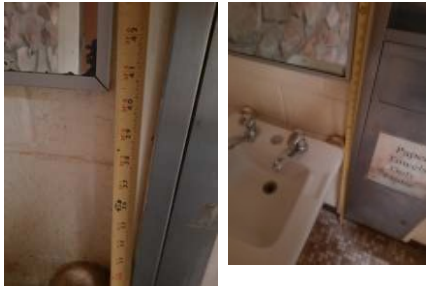
103	Campground: Campground - Men's Restroom	[31.9196038, -106.0364356]	The mirror is mounted too high. Mirrors must have the bottom edge of the reflecting surface a maximum of 40 inches above the floor if above a sink or counter. Mirrors not located above lavatories or countertops shall be installed with the bottom edge of the reflecting surface 35 inches maximum above the finish floor or ground.	Bottom of mirror at 41"	Lower mirror so bottom reflective surface is max 40" AFF and 74" at the top.	2015 ABAAS Section: 603.3 2012 TAS Section: 603.3 2010 ADAS Section: 603.3

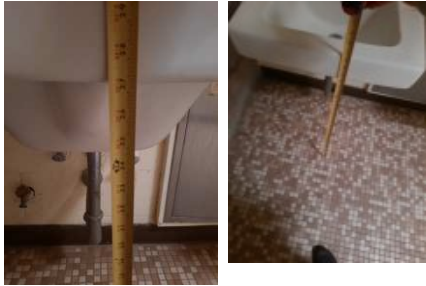
Finding Number	Area Description	Lat/Long	Finding	As Built	Recommendation	Citation	Photos	Figure
104	Campground: Campground - Men's Restroom	[31.9196038 , -106.0364 303]	Knee clearance at 27 inches off the floor is not 8 inches minimum deep. The knee clearance, measured from the bottom of the apron or the outside bottom edge of the lavatory, must be 27 inches at a point located 8 inches back from the front edge and continuing to 11 inches minimum in depth at 9 inches above the floor. The top of the lavatory rim may be no higher than 34 inches.	Sinks lack knee clearance	Replace sink with one providing 27" knee clearance that is a min 8" deep.	2015 ABAAS Section: 306.3.1, 306.3.2, 306.3.3, 306.3.4 , 306.3.5 2012 TAS Section: 306.3.2, 306.3.3, 306.3.4, 306.3.5, 306.3.1 2010 ADAS Section: 306.3.3, 306.3.2, 306.3.4, 306.3.5, 306.3.1

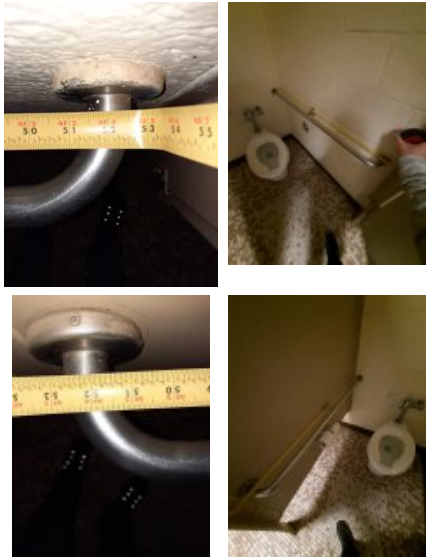
111	Campground: Campground - Men's Restroom	[31.9195959 , -106.0364 437]	The side grab bars are not in the correct location. Grab bars on the side wall must be installed so that the end closest to the rear wall is maximum 12" from the rear wall. The end furthest from the rear wall must be mounted minimum 54" from the rear wall.	Both bars end 52" from rear wall	Remount side grab bars to max 12" from the rear wall at the close end and min 54" on the far end, and 33" to 36" AFF. In the alternative, use existing stall to create required wheelchair accessible stall.	2015 ABAAS Section: 604.5.1 2012 TAS Section: 604.5.1 2010 ADAS Section: 604.5.1

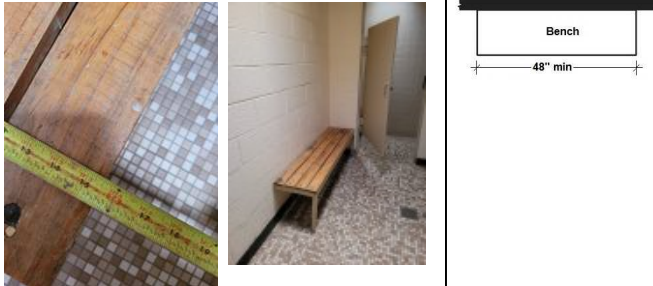
120	Campground: Campground - Women's Restroom	[31.9196052, -106.0364356]	The bench is not deep enough or long enough or is missing. Benches shall be provided having seats that are 42 inches long minimum and 20 inches deep minimum and 24 inches deep maximum. The bench shall provide for back support or shall be affixed to a wall. Back support shall be 42 inches (1065 mm) long minimum and shall extend from a point 2 inches (51 mm) maximum above the seat surface to a point 18 inches (455 mm) minimum above the seat surface. Back support shall be 2½ inches (64 mm) maximum from the rear edge of the seat measured horizontally. The top of the bench seat surface shall be 17 inches (430 mm) minimum and 19 inches (485 mm) maximum above the finish floor or ground. Clear floor or ground space complying with 305 shall be provided and shall be positioned at the end of the bench seat and parallel to the short axis of the bench	Bench is 15.5" deep	Replace bench in dressing area with one having a seat depth of 20" to 24" deep, 42" long, affixed to the wall or having a back and mounted 17" to 19" AFF and provide required clear floor space on the short axis of the bench.	2012 TAS Section: 903.4, 903.2, 903.3, 903.5 2010 ADAS Section: 903.4, 903.2, 903.3, 903.5

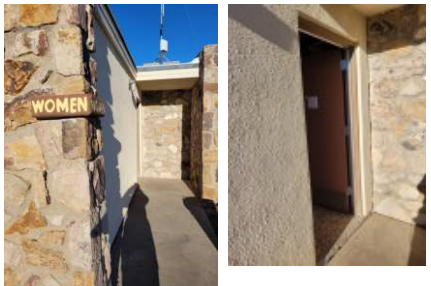
123	Campground: Campground - Women's Restroom	[31.9196113 , -106.03644 9]	The restroom sign does not comply with one or more applicable requirements for the location, height, and properties of the sign.	Lacks accessible signage at restroom, lacks ISA	Replace sign with one of contrasting colors that includes Braille, raised characters, and the symbol of accessibility and mount on the wall, latch side of the door, 48" to the baseline of the lowest character and 60" to the baseline of the highest character.	2015 ABAAS Section: F216.2, 703.1, 703.2, 703.5, 703.6 2012 TAS Section: 216.2, 703.1, 703.2, 703.5, 703.6 2010 ADAS Section: 216.2, 703.1, 703.2, 703.5, 703.6

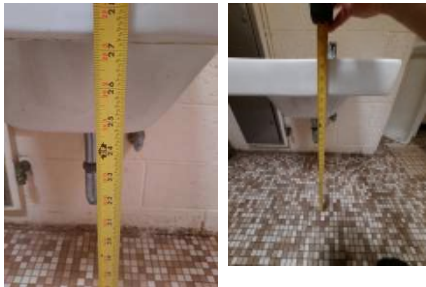
153	Restrooms at Gate: Gate - Men's Restroom	[31.926609, -106.0452732]	Knee clearance at 27 inches off the floor is not 8 inches minimum deep. The knee clearance, measured from the bottom of the apron or the outside bottom edge of the lavatory, must be 27 inches at a point located 8 inches back from the front edge and continuing to 11 inches minimum in depth at 9 inches above the floor. The top of the lavatory rim may be no higher than 34 inches.	Sink lacks knee clearance	Replace sink with one providing 27" knee clearance that is a min 8" deep.	2015 ABAAS Section: 306.3.1, 306.3.2, 306.3.3, 306.3.4, 306.3.5 2012 TAS Section: 306.3.2, 306.3.3, 306.3.4, 306.3.5, 306.3.1 2010 ADAS Section: 306.3.3, 306.3.2, 306.3.4, 306.3.5, 306.3.1

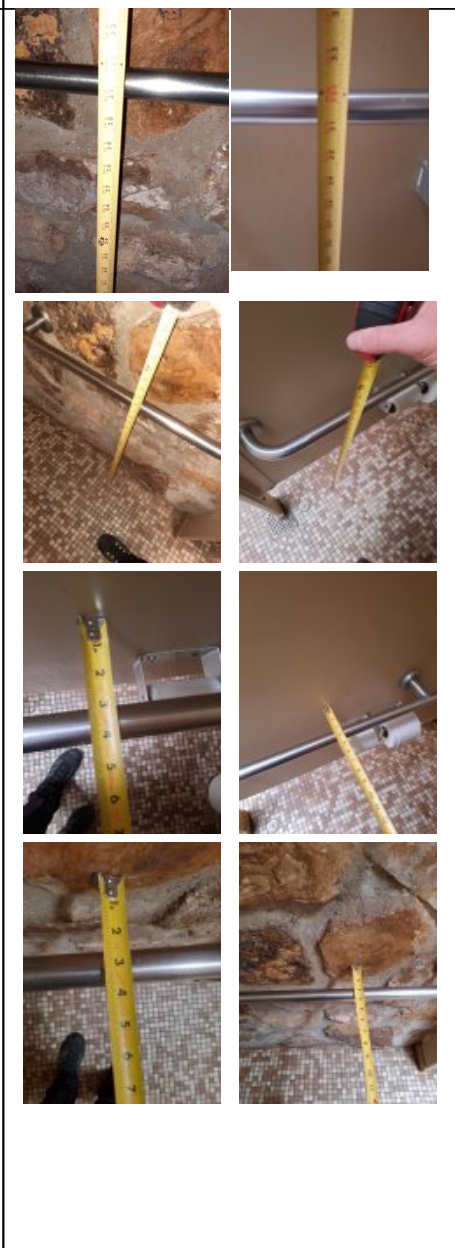
161	Restrooms at Gate: Gate - Men's Restroom	[31.92665, -106.0453]	The grab bar height and/or spacing fails. Grab bars must be mounted between 33" and 36" to the top of the gripping surface. There must be 1.5" of clearance between the grab bar and the wall. There must be a minimum of 1.5" of clearance below and	Both bars 32" AFF and 2.5-3" from partition/wall	Replace grab bars in accessible stall to have 1.5" of clearance between the grab bar and the wall, 33" to 36" above the finished floor (AFF). Add rear grab bar.	2015 ABAAS Section: 609.3, 609.4 2012 TAS Section:

Finding Number	Area Description	Lat/Long	Finding	As Built	Recommendation	Citation	Photos	Figure
			minimum 12" above the grab bar to any dispenser or other obstruction.			609.4, 609.3 2010 ADAS Section: 609.3, 609.4

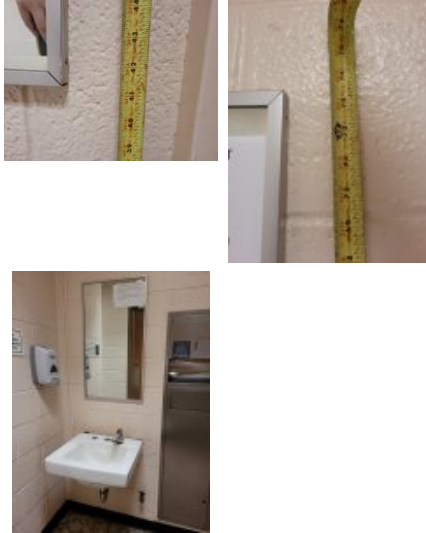
168	Restrooms at Gate: Gate - Women's Restroom	[31.92661, -106.0453]	The mirror is mounted too high. Mirrors must have the bottom edge of the reflecting surface a maximum of 40 inches above the floor if above a sink or counter. Mirrors not located above lavatories or countertops shall be installed with the bottom edge of the reflecting surface 35 inches maximum above the finish floor or ground.	Bottom edge of mirror at 41.5" above the finished floor (AFF), 73" AFF to top edge	Replace mirror mount to max 40" AFF to the bottom reflective surface and 74" to the top.	2015 ABAAS Section: 603.3 2012 TAS Section: 603.3 2010 ADAS Section: 603.3

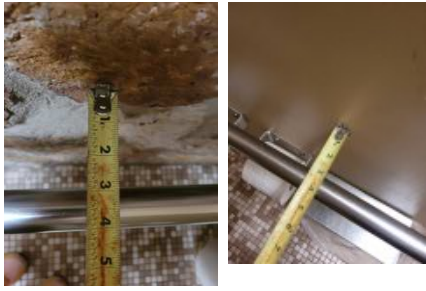
177	Restrooms at Gate: Gate - Women's Restroom	[31.9265963, -106.0452866]	The grab bar height and/or spacing fails. Grab bars must be mounted between 33" and 36" to the top of the gripping surface. There must be 1.5" of clearance between the grab bar and the wall. There must be a minimum of 1.5" of clearance below and minimum 12" above the grab bar to any dispenser or other obstruction.	Both bars have 3" clearance between them and wall	Replace grab bars in new accessible stall to have 1.5" of clearance between the grab bar and the wall, 33" to 36" above the finished floor (AFF). Add rear grab bar.	2015 ABAAS Section: 609.3, 609.4 2012 TAS Section: 609.4, 609.3 2010 ADAS Section: 609.3, 609.4

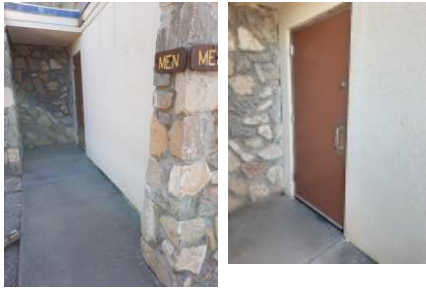
187	West Restrooms: West RR - Men's Restroom	[31.9216437 , -106.0489 257]	The restroom sign does not comply with one or more applicable requirements for the location, height, and properties of the sign.	Lacks signage near door, existing signage lacks Braille, raised characters, ISA	Replace sign with one of contrasting colors that includes Braille, raised characters, and the symbol of accessibility and mount on the wall, latch side of the door, 48" to the baseline of the lowest character and 60" to the baseline of the highest character.	2015 ABAAS Section: F216.2, 703.1, 703.2, 703.5, 703.6 2012 TAS Section: 216.2, 703.1, 703.2, 703.5, 703.6 2010 ADAS Section: 216.2, 703.1, 703.2, 703.5, 703.6

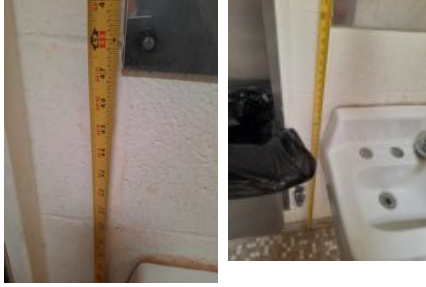
188	West Restrooms: West RR - Men's Restroom	[31.9216277 , -106.04892 7]	The mirror is mounted too high. Mirrors must have the bottom edge of the reflecting surface a maximum of 40 inches above the floor if above a sink or counter. Mirrors not located above lavatories or countertops shall be installed with the bottom edge of the reflecting surface 35 inches maximum above the finish floor or ground.	Bottom of mirror at 47.25"	Replace mirror mount to max 40" AFF to the bottom reflective surface and 74" to the top.	2015 ABAAS Section: 603.3 2012 TAS Section: 603.3 2010 ADAS Section: 603.3

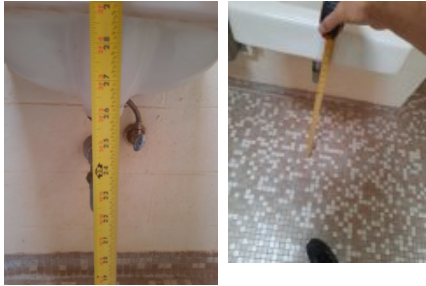
Finding Number	Area Description	Lat/Long	Finding	As Built	Recommendation	Citation	Photos	Figure
189	West Restrooms: West RR - Men's Restroom	[31.9216414, -106.0489404]	Knee clearance at 27 inches off the floor is not 8 inches minimum deep. The knee clearance, measured from the bottom of the apron or the outside bottom edge of the lavatory, must be 27 inches at a point located 8 inches back from the front edge and continuing to 11 inches minimum in depth at 9 inches above the floor. The top of the lavatory rim may be no higher than 34 inches.	Sink lacks knee clearance	Replace sink with one providing 27" knee clearance that is a min 8" deep	2015 ABAAS Section: 306.3.1, 306.3.2, 306.3.3, 306.3.4, 306.3.5 2012 TAS Section: 306.3.2, 306.3.3, 306.3.4, 306.3.5, 306.3.1 2010 ADAS Section: 306.3.3, 306.3.2, 306.3.4, 306.3.5, 306.3.1

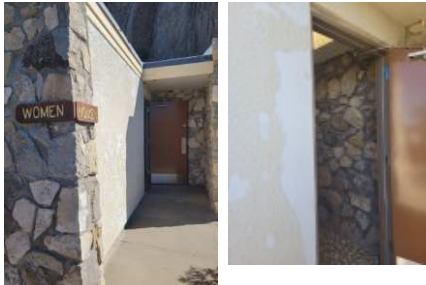
201	West Restrooms: West RR - Women's Restroom	[31.9216464, -106.0489303]	The restroom sign does not comply with one or more applicable requirements for the location, height, and properties of the sign.	Lacks signage at door, lacks Braille, ISA, raised characters	Replace sign with one of contrasting colors that includes Braille, raised characters, and the symbol of accessibility and mount on the wall, latch side of the door, 48" to the baseline of the lowest character and 60" to the baseline of the highest character.	2015 ABAAS Section: F216.2, 703.1, 703.2, 703.5, 703.6 2012 TAS Section: 216.2, 703.1, 703.2, 703.5, 703.6 2010 ADAS Section: 216.2, 703.1, 703.2, 703.5, 703.6
