Access Audit Site Report

Huntsville State Park

Accessibility Evaluation

Inspection Date: 06/14/2021

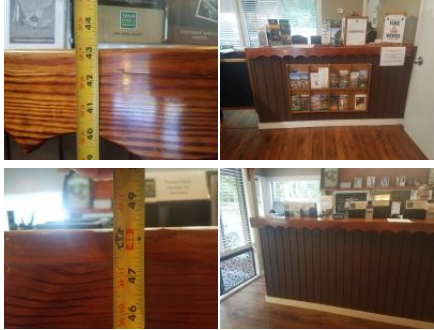
| Finding Number | Area Description | Lat/Long | Finding | As Built | Recommendation | Citation | Photos | Figure |
|---|---|---|---|--|---|--|---|---|
| 12 | Headquarters Area: Headquarters | [30.6284096 , -95.525943 6] | The transaction counter is too high. A portion of the counter surface that is 36 inches long minimum and 36 inches high maximum above the finish floor shall be provided. Knee and toe space must be provided for a forward approach. A 30 inch by 48 inch clear floor space on an accessible route must be provided for either a forward or parallel approach. | Both transaction counters exceed 36" height maximum (43.25" aff) | Lower 36" wide segment of service counter to max 36" aff, in the alternative, train staff to come out from around the counter to provide customer service | 2015 ABAAS Section: 904.4.2, 904.4.1 2012 TAS Section: 904.4.1, 904.4.2 2010 ADAS Section: 904.4.2, 904.4.1 | | |

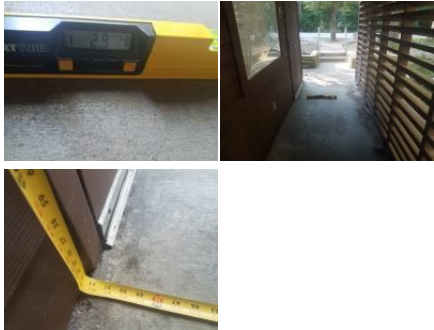
| Finding Number | Area Description | Lat/Long | Finding | As Built | Recommendation | Citation | Photos | Figure |
|---|---|---|--|--|---|--|---|---|
| 18 | Headquarters Area: Headquarters | [30.6284069 , -95.525963 2] | Minimum maneuvering clearances at doors and gates shall comply with 404.2.4. Maneuvering clearances shall extend the full width of the doorway and the required latch side or hinge side clearance. Floor or ground surface within required maneuvering clearances shall comply with 302. Changes in level are not permitted. EXCEPTIONS: 1. Slopes not steeper than 1:48 shall be permitted. The sweep period for doors with closers shall be adjusted so that from an open position of 70 degrees, the door will take at least 3 seconds to move to a point 3 inches from the latch, measured to the leading edge of the door. Exterior doors are recommended to be maintained at 8.5 lbf as a smart practice. Force is to be measured at the operating hardware or 30 inches from the hinges, whichever is greater. | Men's restroom door - Lacks maneuvering clearance on pull side (52" to wall - structural), slope of 2.9% on pull side landing, lacks compliant closing speed, and exceeds 8.5 lbs of force to open (12 lbf required) | For all doors along the public circulation route, provide required maneuvering clearance on push and pull side of doors For all doors along the public circulation route, correct or repair slope at doorway landing to max 2.08% in any direction for level CFS For all doors along the public circulation route, inspect, adjust, and maintain closing speed on door closers For all doors along the public circulation route, inspect, adjust, and maintain 8.5 lbf to open exterior doors as a smart practice | 2010 ADAS Section: 404.2.3, 404.2.7, 404.2.4, 404.2.11, 404.2.11 Exception | | |

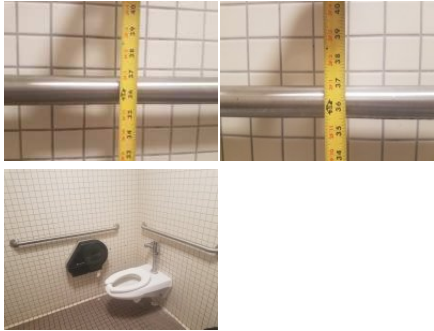
| Finding Number | Area Description | Lat/Long | Finding | As Built | Recommendation | Citation | Photos | Figure |
|---|---|---|--|---|---|---|--|---|
| 23 | Headquarters Area: Headquarters | [30.6284267 , -95.525951 5] | The grab bar height and/or spacing fails. Grab bars must be mounted between 33" and 36" to the top of the gripping surface. There must be 1.5" of clearance between the grab bar and the wall. There must be a minimum of 1.5" of clearance below and minimum 12" above the grab bar to any dispenser or other obstruction. | Gripping surfaces of the side and rear grab bars are 37" aff | Remount grab bars in accessible stall to 33" to 36" aff | 2015 ABAAS Section: 609.3, 609.4 2012 TAS Section: 609.4, 609.3 2010 ADAS Section: 609.3, 609.4 | | |

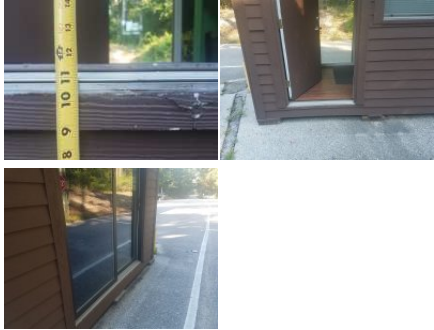
| Finding Number | Area Description | Lat/Long | Finding | As Built | Recommendation | Citation | Photos | Figure |
|---|---|---|--|---|---|---|--|---|
| 25 | Headquarters Area: Headquarters | [30.6285017 , -95.526014 5] | Changes in level of 1/4 inch (6.4 mm) high maximum shall be permitted to be vertical. Changes in level between 1/4 inch (6.4 mm) high minimum and 1/2 inch (13 mm) high maximum shall be beveled with a slope not steeper than 1:2. Changes in level greater than 1/2 inch (13 mm) high shall be ramped, and shall comply with 405 or 406. | Two CILs greater than .5" at gate house doors (standard and sliding) | Repair, bevel or ramp CIL at doorway | 2015 ABAAS Section: 303.3, 404.2.5, 303.2, 303.4 2012 TAS Section: 303.3, 404.2.5, 303.2, 303.4 2010 ADAS Section: 303.3, 404.2.5, 303.2, 303.4 | | |

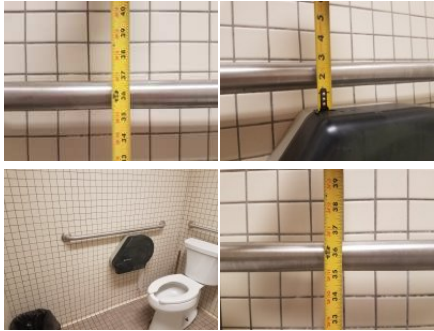
| Finding Number | Area Description | Lat/Long | Finding | As Built | Recommendation | Citation | Photos | Figure |
|---|---|---|--|---|---|---|--|--|
| 39 | Headquarters Area: Nature Center | [30.6263703, -95.5278813] | The grab bar height and/or spacing fails. Grab bars must be mounted between 33" and 36" to the top of the gripping surface. There must be 1.5" of clearance between the grab bar and the wall. There must be a minimum of 1.5" of clearance below and minimum 12" above the grab bar to any dispenser or other obstruction. | Gripping surface of grab bar is 36.75" aff, and lacks 1.5" clearance below the bar due to toilet paper dispenser location Gripping surface of the rear grab bar is 36.5" aff | Remount grab bars in accessible stall to 33" to 36" aff Remount toilet paper dispenser max 7" to 9" from front of toilet, 15" to 48" aff and min 12" above or 1.5" below grab bar | 2015 ABAAS Section: 609.3, 609.4 2012 TAS Section: 609.4, 609.3 2010 ADAS Section: 609.3, 609.4 | | |

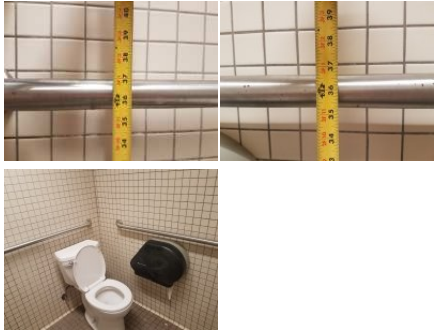
| Finding Number | Area Description | Lat/Long | Finding | As Built | Recommendation | Citation | Photos | Figure |
|---|---|---|--|--|---|---|--|--|
| 42 | Headquarters Area: Nature Center | [30.6263726, -95.5278961] | The grab bar height and/or spacing fails. Grab bars must be mounted between 33" and 36" to the top of the gripping surface. There must be 1.5" of clearance between the grab bar and the wall. There must be a minimum of 1.5" of clearance below and minimum 12" above the grab bar to any dispenser or other obstruction. | rear 37", side 36.75" Gripping surface of the side grab bar is 36.75" aff, and the gripping surface of the rear grab bar is 37" aff | Remount grab bars in accessible stall to 33" to 36" aff | 2015 ABAAS Section: 609.3, 609.4 2012 TAS Section: 609.4, 609.3 2010 ADAS Section: 609.3, 609.4 | | |

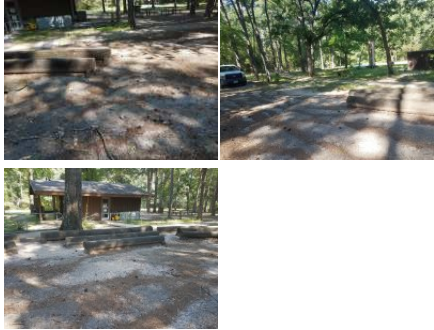
| Finding Number | Area Description | Lat/Long | Finding | As Built | Recommendation | Citation | Photos | Figure |
|---|---|---|--|--|---|--|--|---|
| 48 | Headquarters Area: Nature Center | [30.6264095, -95.5280007] | The floor surface at the wheelchair seating spaces contain abrupt edges and/or variation over a 1/2", In addition the floor area is sloped greater than 2% and is not slip resistant. Floor and ground surfaces shall not be sloped steeper than 1:48 (2%) and shall be stable, firm, and slip resistant Changes in level are not permitted. | Amphitheater lacks firm, stable, and slip resistant surface (natural debris) | Establish protocols for regular and frequent inspection and maintenance of amphitheater surface | 2015 ABAAS Section: 802.1.1, 802.1.1 EXCEPTION 2012 TAS Section: 802.1.1, 802.1.1 Exception 2010 ADAS Section: 802.1.1 Exception | | |

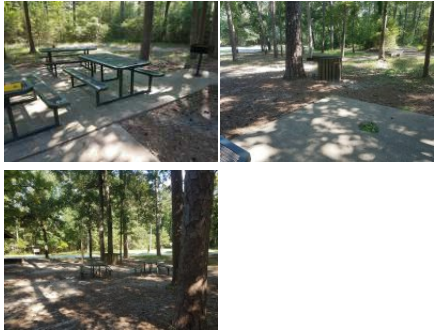
| Finding Number | Area Description | Lat/Long | Finding | As Built | Recommendation | Citation | Photos | Figure |
|---|---|---|--|---|---|---|---|---|
| 52 | Headquarters Area: Nature Center | [30.626316, -95.5279712] | Where picnic facilities contain two or fewer picnic units, each picnic unit shall provide mobility features complying with F245.2. | tables block entry, block grill access, no AR to garbage cans | Relocate tables to provide accessible route to picnic area features as a smart practice. | 2015 ABAAS Section: F245.2.1 | | |

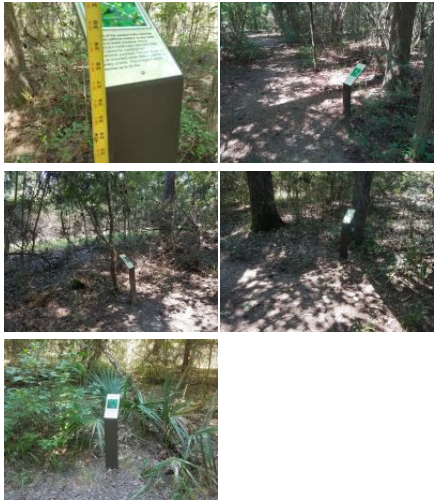
| Finding Number | Area Description | Lat/Long | Finding | As Built | Recommendation | Citation | Photos | Figure |
|---|---|---|--|--|---|---|--|---|
| 65 | Headquarters Area: Nature Center | [30.62696, -95.5284] | Visual characters shall be 40 inches (1015 mm) minimum above the finish floor or ground. EXCEPTION: Visual characters indicating elevator car controls shall not be required to comply with 703.5.6. | Loblolly Trail interpretive sign visual characters lack 40" minimum above the finish floor or ground (28") | Remount signage to min 40" aff. | 2015 ABAAS Section: 703.5.6, 703.5.6 EXCEPTION 2012 TAS Section: 703.5.6, 703.5.6 Exception 2010 ADAS Section: 703.5.6, 703.5.6 Exception | | |

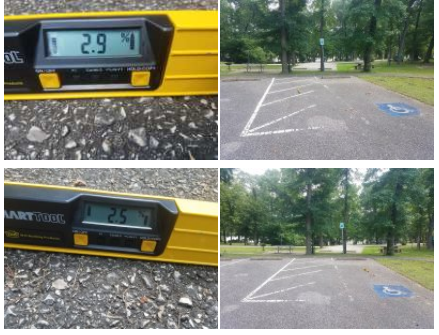
| Finding Number | Area Description | Lat/Long | Finding | As Built | Recommendation | Citation | Photos | Figure |
|---|--|---|--|--|---|--|--|--|
| 68 | Employee Spaces: Parking - Office Building | [30.6149816 , -95.529663 7] | The cross slopes (narrow dimension) and/or running slopes (long dimension) of the access aisle exceeds 2%. The running slope and the cross slope in an accessible parking stall and the access aisle must not exceed 2%. | Slope of 2.9% in single stall access aisle, and 2.5% in single stall | Repair or correct slope of parking space and access aisle to max 2.08% in any direction | 2015 ABAAS Section: 502.4 2012 TAS Section: 502.4 2010 ADAS Section: 502.4 | | |

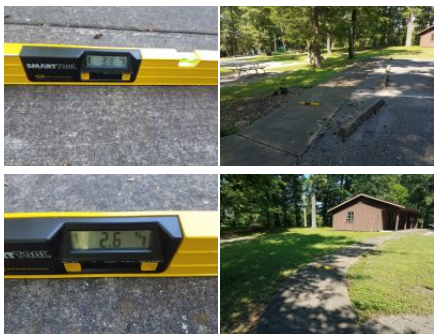
| Finding Number | Area Description | Lat/Long | Finding | As Built | Recommendation | Citation | Photos | Figure |
|---|--|---|--|--|---|--|--|--|
| 70 | Employee Spaces: Law Enforcement Office (Under Construction) | [30.6149831 , -95.529507 3] | The accessible route of travel on the accessible route contains cross slopes greater than 2%. Cross slopes shall not exceed one unit vertical in 48 units horizontal (2-percent slope). | Cross slopes of 3.1% and 2.6% | Correct or repair cross slope along AR to max 2.08% | 2015 ABAAS Section: 403.3 2012 TAS Section: 403.3 2010 ADAS Section: 403.3 | | |

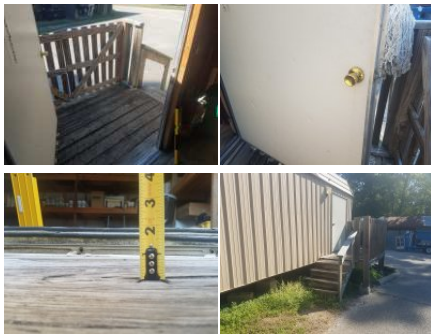
| Finding Number | Area Description | Lat/Long | Finding | As Built | Recommendation | Citation | Photos | Figure |
|---|---|---|---|--|--|---|--|---|
| 85 | Employee Spaces: Maintenance | [30.6224003 , -95.532638 2] | Spaces and elements within employee work areas shall only be required to comply with 206.2.8, 207.1, and 215.3 and shall be designed and constructed so that individuals with disabilities can approach, enter, and exit the employee work area. Employee work areas, or portions of employee work areas, other than raised courtroom stations, that are less than 300 square feet (28 m2) and elevated 7 inches (180 mm) or more above the finish floor or ground where the elevation is essential to the function of the space shall not be required to comply with these requirements or to be on an accessible route. | cleaning supplies- stairs, threshold, knob | For employee spaces, relocate storage, furniture, and other obstacles at doorways to provide approach, enter and exit at the employee space. | 2015 ABAAS Section: F203.9 2012 TAS Section: 203.9 2010 ADAS Section: 203.9 | | |

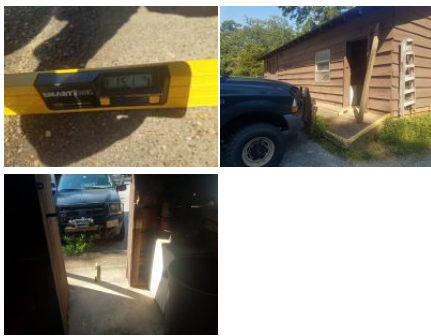
| Finding Number | Area Description | Lat/Long | Finding | As Built | Recommendation | Citation | Photos | Figure |
|---|---|---|---|--|--|---|--|---|
| 86 | Employee Spaces: Maintenance | [30.6224973 , -95.532599 3] | Minimum maneuvering clearances at doors and gates shall comply with 404.2.4. Maneuvering clearances shall extend the full width of the doorway and the required latch side or hinge side clearance. Floor or ground surface within required maneuvering clearances shall comply with 302. Changes in level are not permitted. EXCEPTIONS: 1. Slopes not steeper than 1:48 shall be permitted. The threshold has a vertical change greater than 1/4 inch high. | Storage shed door - Lacks maneuvering clearance on push side (slope of 15.1%) and pull side (cabinet), and large CIL/step at push side landing | For all doors along the public circulation route, provide required maneuvering clearance on push and pull side of doors Correct or repair slope at doorway landing to max 2.08% in any direction for level For all doors along the public circulation route, repair, bevel, or ramp CILs at door entries to max .25" | 2010 ADAS Section: 404.2.3, 404.2.7, 404.2.4, 404.2.11, 404.2.11 Exception | | |

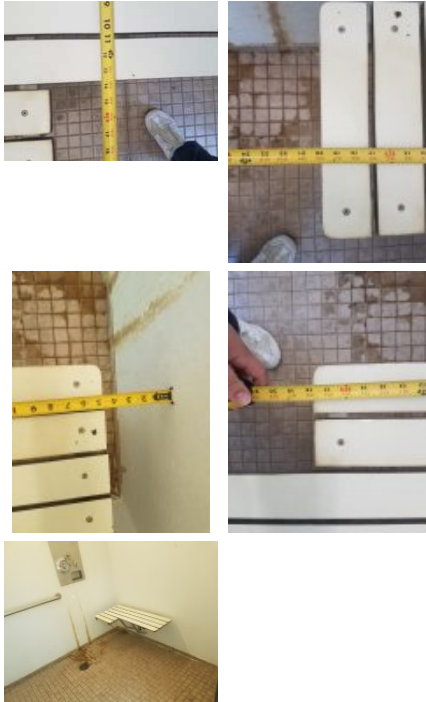
| Finding Number | Area Description | Lat/Long | Finding | As Built | Recommendation | Citation | Photos | Figure |
|---|--|---|--|---|--|--|--|---|
| 108 | Raven Hill Camping Area: Raven Hill Camping Restrooms | [30.6180886 , -95.52891] | The shower seat does not have a compliant space between it and the wall. The folding seat must be mounted 17-19 inches above the floor, and have a maximum space of 1-1/2 inches between the edge of the seat and the side wall and 2-1/2 inches maximum to the seat wall. | The shower seat lacks required dimensions and spacing between it and the wall | Remount shower seat to the correct location and height in the shower | 2015 ABAAS Section: 610.3.2 2012 TAS Section: 610.3.2 2010 ADAS Section: 610.3.2 | | |

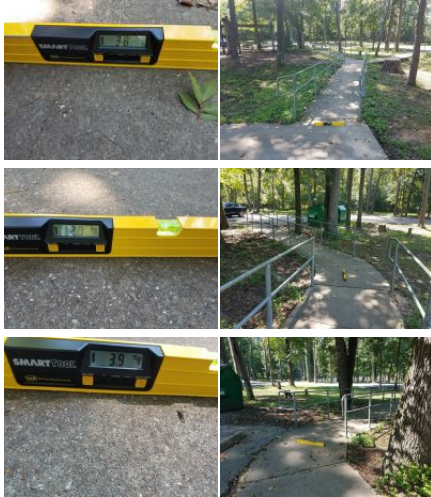
| Finding Number | Area Description | Lat/Long | Finding | As Built | Recommendation | Citation | Photos | Figure |
|---|--|---|--|--|--|---|---|---|
| 117 | Raven Hill Camping Area: Raven Hill Camping Restrooms | [30.6178497 , -95.5288724], [30.6178912 , -95.5290843] | The landing at the bottom of the ramp has a slope greater than 2%. Bottom landings shall have a dimension in the direction of ramp run of not less than 60 inches and have a slope of less than 2% in any direction. | Slopes of 3.8% (bottom landing), 2.8% (upper middle landing), and 3.9% (top landing) | Correct ramp landing slope to max 2.08% | 2015 ABAAS Section: 405.7.1, 405.7.1 EXCEPTION 2012 TAS Section: 405.7.1, 405.7.1 Exception 2010 ADAS Section: 405.7.1, 405.7.1 Exception | | |

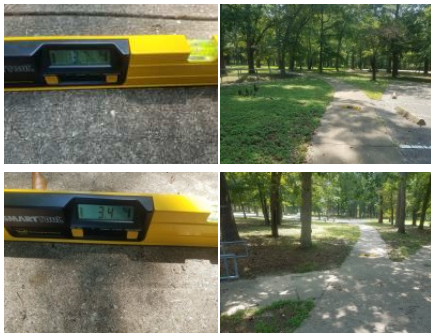
| Finding Number | Area Description | Lat/Long | Finding | As Built | Recommendation | Citation | Photos | Figure |
|---|---|--|---|--|--|--|---|---|
| 160 | Coloneh Camping Area: Coloneh Trailhead Area Restrooms | [30.6168894 , -95.52492 02], [30.6168871 , -95.525016 7] | The accessible path of travel between the building entrance and the accessible parking contains cross slopes greater than 2%. Surface cross slopes shall not exceed one unit vertical in 48 units horizontal (2-percent slope). When the slope in the direction of travel of any walk exceeds 1 unit vertical in 20 units horizontal (5-percent slope), it must be constructed as ramp. | Cross slope of 3.7% along parking and 3.4% from ramp to campsite | Correct or repair sidewalk cross slope along AR to max 2.08% | 2015 ABAAS Section: 403.3 2012 TAS Section: 403.3 2010 ADAS Section: 403.3 | | |

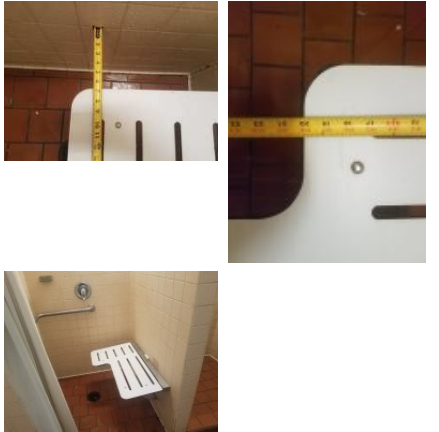
| Finding Number | Area Description | Lat/Long | Finding | As Built | Recommendation | Citation | Photos | Figure |
|---|--|---|--|--|---|--|--|---|
| 167 | Coloneh Camping Area: Coloneh Trailhead Area Restrooms | [30.617036, -95.5255143] | The shower seat does not have a compliant space between it and the wall. The folding seat must be mounted 17-19 inches above the floor, and have a maximum space of 1-1/2 inches between the edge of the seat and the side wall and 2-1/2 inches maximum to the seat wall. | Men's showers - The shower seat lacks required dimensions and spacing between it and the wall (7" from back wall and L portion 20" from back wall) | Remount shower seat to the correct location and height in the shower | 2015 ABAAS Section: 610.3.2 2012 TAS Section: 610.3.2 2010 ADAS Section: 610.3.2 | | |

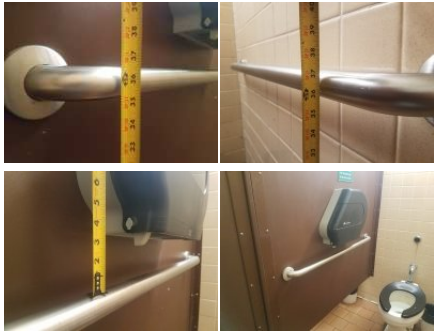
| Finding Number | Area Description | Lat/Long | Finding | As Built | Recommendation | Citation | Photos | Figure |
|---|--|---|---|--|---|--|---|---|
| 183 | Coloneh Camping Area: Coloneh Trailhead Area Restrooms | [30.6170337 , -95.5255196] | The grab bar height and/or spacing fails. Grab bars must be mounted between 33" and 36" to the top of the gripping surface. There must be 1.5" of clearance between the grab bar and the wall. There must be a minimum of 1.5" of clearance below and minimum 12" above the grab bar to any dispenser or other obstruction. | Women's restroom - Gripping surfaces of grab bars are 36.5" aff and 37.25" aff, and lacks 12" clearance above the bar due to toilet paper dispenser location | Remount grab bars in accessible stall to 33" to 36" aff Remount toilet paper dispenser max 7" to 9" from front of toilet, 15" to 48" aff and min 12" above or 1.5" below grab bar | 2015 ABAAS Section: 609.3, 609.4 2012 TAS Section: 609.4, 609.3 2010 ADAS Section: 609.3, 609.4 | | |

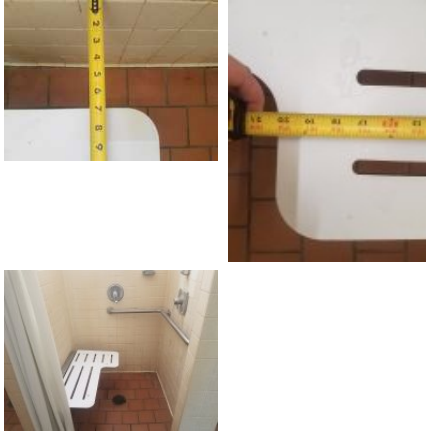
| Finding Number | Area Description | Lat/Long | Finding | As Built | Recommendation | Citation | Photos | Figure |
|---|--|---|--|--|--|--|--|--|
| 190 | Coloneh Camping Area: Coloneh Trailhead Area Restrooms | [30.617036, -95.5255089] | The shower seat does not have a compliant space between it and the wall. The folding seat must be mounted 17-19 inches above the floor, and have a maximum space of 1-1/2 inches between the edge of the seat and the side wall and 2-1/2 inches maximum to the seat wall. | Women's showers - shower seat lacks required dimensions and spacing between it and the wall (6.75" from rear wall and L portion 20.25" from back wall) | Remount shower seat to the correct location and height in the shower | 2015 ABAAS Section: 610.3.2 2012 TAS Section: 610.3.2 2010 ADAS Section: 610.3.2 | | <p>(a) size</p> <p>(b) distance from wall</p> |

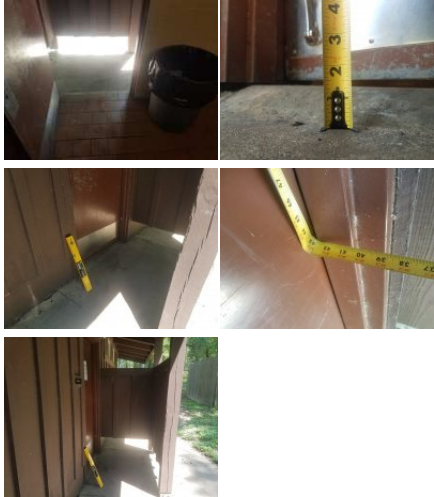
| Finding Number | Area Description | Lat/Long | Finding | As Built | Recommendation | Citation | Photos | Figure |
|---|--|---|---|--|--|--|--|---|
| 191 | Coloneh Camping Area: Coloneh Trailhead Area Restrooms | [30.6170377 , -95.525504 5] | Minimum maneuvering clearances at doors and gates shall comply with 404.2.4. Maneuvering clearances shall extend the full width of the doorway and the required latch side or hinge side clearance. The threshold has a vertical change greater than 1/4 inch high. | Men's restroom door - Lacks maneuvering clearance on push side (43" back - structural) and pull side (garbage can), and CIL of 1.25" | For all doors along the public circulation route, provide required maneuvering clearance on push and pull side of doors For all doors along the public circulation route, repair, bevel, or ramp CILs at door entries to max .25" | 2010 ADAS Section: 404.2.3, 404.2.7, 404.2.4, 404.2.11, 404.2.11 Exception | | |

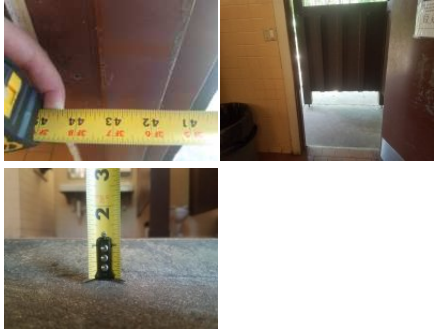
| Finding Number | Area Description | Lat/Long | Finding | As Built | Recommendation | Citation | Photos | Figure |
|---|--|---|---|--|--|--|--|---|
| 192 | Coloneh Camping Area: Coloneh Trailhead Area Restrooms | [30.6170439 , -95.525513 2] | Minimum maneuvering clearances at doors and gates shall comply with 404.2.4. Maneuvering clearances shall extend the full width of the doorway and the required latch side or hinge side clearance. The threshold has a vertical change greater than 1/4 inch high. | Women's restroom door - Lacks maneuvering clearance on push side (43.25" back - structural) and pull side (garbage can), and CIL of 1" | For all doors along the public circulation route, provide required maneuvering clearance on push and pull side of doors For all doors along the public circulation route, repair, bevel, or ramp CILs at door entries to max .25" | 2010 ADAS Section: 404.2.3, 404.2.7, 404.2.4, 404.2.11, 404.2.11 Exception | | |

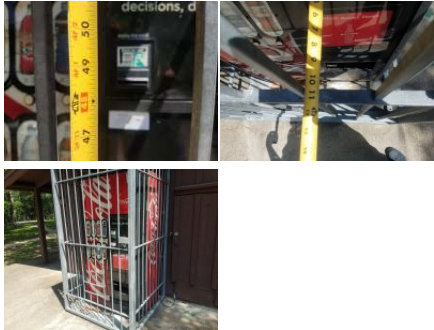
| Finding Number | Area Description | Lat/Long | Finding | As Built | Recommendation | Citation | Photos | Figure |
|---|--|---|--|--|--|---|---|---|
| 193 | Coloneh Camping Area: Coloneh Trailhead Area Restrooms | [30.61701, -95.52555] | Where a high forward reach is over an obstruction, the clear floor space shall extend beneath the element for a distance not less than the required reach depth over the obstruction. The high forward reach shall be 48 inches (1220 mm) maximum where the reach depth is 20 inches (510 mm) maximum. Where the reach depth exceeds 20 inches (510 mm), the high forward reach shall be 44 inches (1120 mm) maximum and the reach depth shall be 25 inches (635 mm) maximum. Where a clear floor or ground space allows a parallel approach to an element and the high side reach is over an obstruction, the height of the obstruction shall be 34 inches (865 mm) maximum and the depth of the obstruction shall be 24 inches (610 mm) maximum. The high side reach shall be 48 inches (1220 mm) maximum for a reach depth of 10 inches (255 mm) maximum. Where the reach depth exceeds 10 inches (255 mm), the high side reach shall be 46 inches (1170 mm) maximum for a reach depth of 24 inches (610 mm) maximum. | Vending machine money intake (48.5" agl) exceeds reach range (and is 11" from outside of cage to money intake) | Work with vendor to replace machine with one that has operable parts within reach range and relocate to reduce obstruction through cage. | 2015 ABAAS Section: 308.2.1, 308.3.2 2012 TAS Section: 308.2.1, 308.3.2 2010 ADAS Section: 308.2.1, 308.3.2 | | |

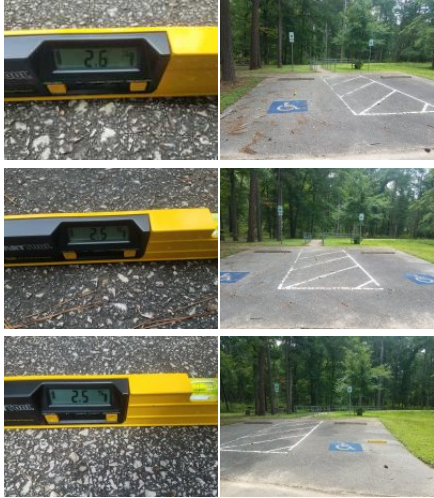
| Finding Number | Area Description | Lat/Long | Finding | As Built | Recommendation | Citation | Photos | Figure |
|---|--|---|---|--|--|--|---|---|
| 196 | Coloneh Camping Area: Parking - Trailhead At Coloneh Camping | [30.6170337 , -95.524371 7] | The cross slopes (narrow dimension) and/or running slopes (long dimension) of the access aisle exceeds 2%. The running slope and the cross slope in an accessible parking stall and the access aisle must not exceed 2%. | Slopes of 2.6% in left stall, 2.5% in shared access aisle, and 2.5% in right stall | Resurface stalls and access aisles to eliminate slopes | 2015 ABAAS Section: 502.4 2012 TAS Section: 502.4 2010 ADAS Section: 502.4 | | |

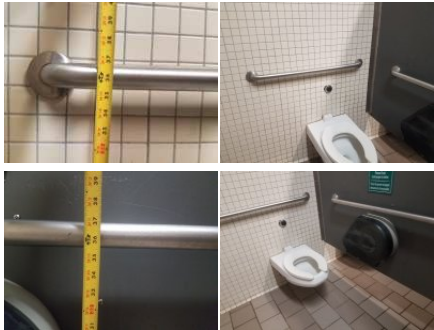
| Finding Number | Area Description | Lat/Long | Finding | As Built | Recommendation | Citation | Photos | Figure |
|---|---|---|---|--|--|--|--|---|
| 205 | Coloneh Camping Area: Coloneh Camping Restrooms | [30.6154664 , -95.529422 3] | The grab bar height and/or spacing fails. Grab bars must be mounted between 33" and 36" to the top of the gripping surface. There must be 1.5" of clearance between the grab bar and the wall. There must be a minimum of 1.5" of clearance below and minimum 12" above the grab bar to any dispenser or other obstruction. | Men's restroom - side grab bar is 37" aff, rear grab bar is 36.75" aff | Remount grab bars in accessible stall to 33" to 36" aff | 2015 ABAAS Section: 609.3, 609.4 2012 TAS Section: 609.4, 609.3 2010 ADAS Section: 609.3, 609.4 | | |

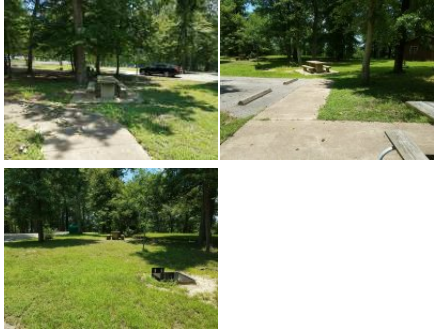
| Finding Number | Area Description | Lat/Long | Finding | As Built | Recommendation | Citation | Photos | Figure |
|---|---|---|--|---|--|---|--|---|
| 239 | Coloneh Camping Area: Coloneh Campsites | [30.6148397 , -95.529648 9] | There are not enough outdoor constructed features with mobility features located in the common uses and public use areas. Where provided in common use and public use areas that serve picnic units with mobility features, at least 20 percent, but not less than one, of each type of outdoor constructed feature must be provided at each location. | Site 74 - 3 of 3 stone picnic tables lack an accessible route and are not of an accessible design | Replace 20% of picnic tables with ones with knee and toe clearance, 19" deep at 27" high and 24" deep at 9" high, with a 36" AR around table | 2015 ABAAS Section: F245.3 | | |

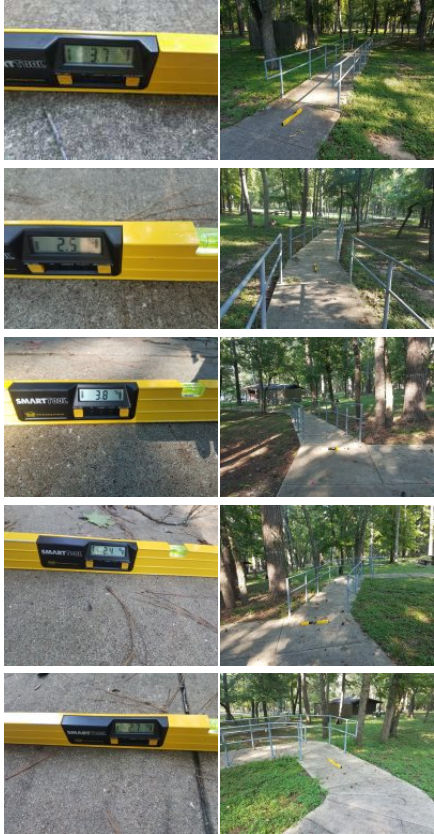
| Finding Number | Area Description | Lat/Long | Finding | As Built | Recommendation | Citation | Photos | Figure |
|---|---|---|--|---|--|---|---|---|
| 246 | Coloneh Camping Area: Coloneh Campsites | [30.6170464 , -95.525348] , [30.617253, -95.525357 4] | The landing of the ramp has a slope greater than 2%. Landings shall have a dimension in the direction of ramp run of not less than 60 inches and have a slope of 2% maximum in any direction. | Slopes of 3.7% (bottom landing), 2.5% (2nd landing), 3.8% (near picnic table), 2.4% (near picnic table), and 2.7% (top landing) | Correct ramp landing slope to max 2.08% | 2015 ABAAS Section: 405.7.1, 405.7.1 EXCEPTION 2012 TAS Section: 405.7.1, 405.7.1 Exception 2010 ADAS Section: 405.7.1, 405.7.1 Exception | | |

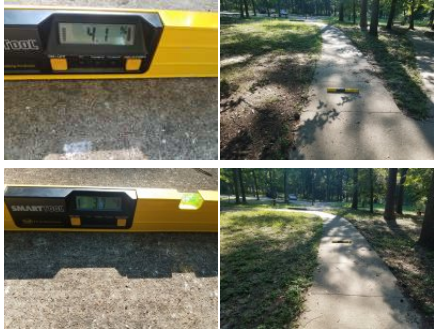
| Finding Number | Area Description | Lat/Long | Finding | As Built | Recommendation | Citation | Photos | Figure |
|---|---|---|---|---|---|--|--|--|
| 255 | Coloneh Camping Area: Coloneh Campsites | [30.6169192 , -95.524809 3] | The accessible route of travel on the accessible route contains cross slopes greater than 2%. Cross slopes shall not exceed one unit vertical in 48 units horizontal (2-percent slope). | Cross slopes of 4.1% and 3% on walkway to campsite | Correct or repair cross slope along AR to max 2.08% | 2015 ABAAS Section: 403.3 2012 TAS Section: 403.3 2010 ADAS Section: 403.3 | | |

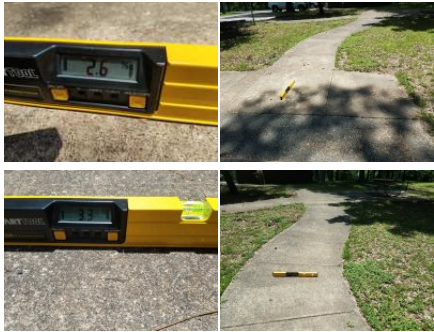
| Finding Number | Area Description | Lat/Long | Finding | As Built | Recommendation | Citation | Photos | Figure |
|---|---|---|---|--|--|--|--|---|
| 272 | Coloneh Camping Area: Coloneh Campsites | [30.6170268, -95.524765 9] | The cross slope shall not be steeper than 1:48. EXCEPTION: Where the surface is other than concrete, asphalt, or boards, cross slopes not steeper than 1:20 shall be permitted when necessary for drainage. | Site 105 - Cross slopes of 2.6% (near parking) and 3.3% (near table) | Correct or repair ORAR cross slope to max 2.08% or 5% for surfaces other than concrete, asphalt or board as a smart practices | 2015 ABAAS Section: 1016.7.2, 1016.7.2 EXCEPTION | | |

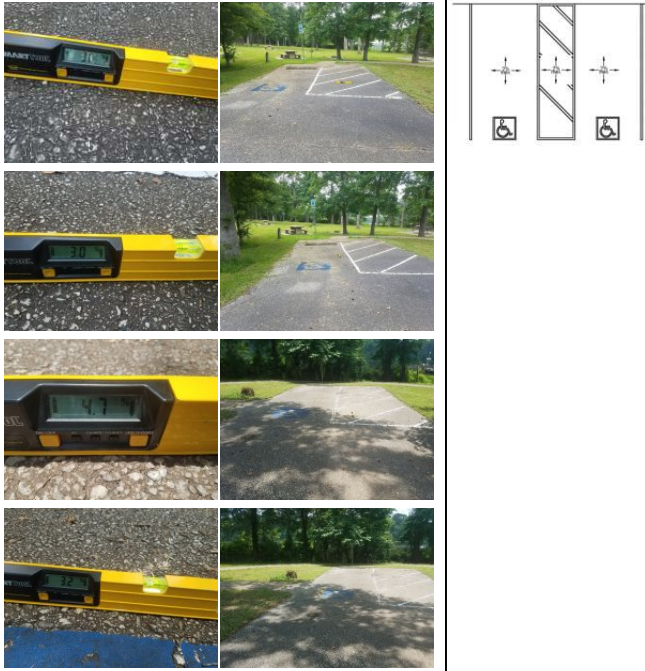
| Finding Number | Area Description | Lat/Long | Finding | As Built | Recommendation | Citation | Photos | Figure |
|---|---|--|---|--|--|--|--|---|
| 274 | Coloneh Camping Area: Parking - Lake Raven Fishing/Coloneh Campground | [30.6152021 , -95.5281402], [30.6153983 , -95.5281187] | The cross slopes (narrow dimension) and/or running slopes (long dimension) of the access aisle exceeds 2%. The running slope and the cross slope in an accessible parking stall and the access aisle must not exceed 2%. | Slopes of 3% in left access aisle, 3% in left stall, 4.7% in right access aisle, and 3.2% in right stall | Resurface stalls and access aisles to eliminate slopes | 2015 ABAAS Section: 502.4 2012 TAS Section: 502.4 2010 ADAS Section: 502.4 | | |

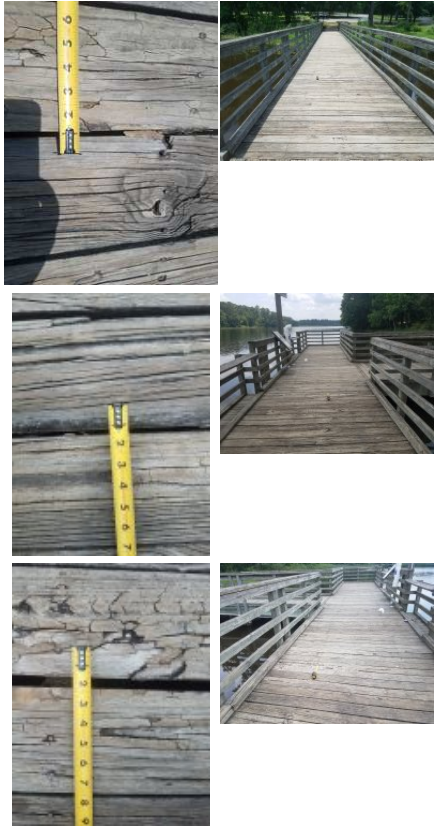
| Finding Number | Area Description | Lat/Long | Finding | As Built | Recommendation | Citation | Photos | Figure |
|---|--|---|--|--|--|--|---|---|
| 278 | Coloneh Camping Area: Lake Raven Fishing At Coloneh Campground | [30.6148523 , -95.5281589] | There is a gap spaced greater than a 1/2 inch. Openings in floor or ground surfaces shall not allow passage of a sphere more than 1/2 inch diameter. Elongated openings shall be placed so that the long dimension is perpendicular to the dominant direction of travel. | Multiple gaps exceed .5" on pier due to damaged boards | Correct or fill gaps to be max .5" | 2015 ABAAS Section: 302.3 2012 TAS Section: 302.3 2010 ADAS Section: 302.3 | | |

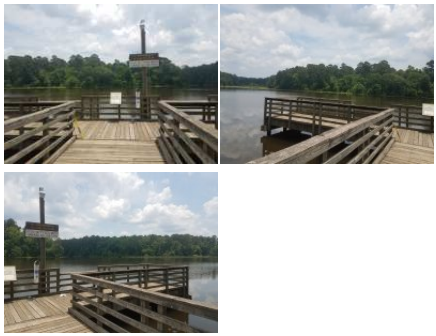
| Finding Number | Area Description | Lat/Long | Finding | As Built | Recommendation | Citation | Photos | Figure |
|---|--|---|--|--|--|--|---|---|
| 279 | Coloneh Camping Area: Lake Raven Fishing At Coloneh Campground | [30.6148212 , -95.5281267] | Not enough of the railings, guards, or handrails are at the allowable height. At least 25 percent of the railings, guards, or handrails shall be 34 inches maximum above the ground or deck surface. | Pier lacks 25% of railings with 34" maximum height above the deck surface (approximately 25% comply, but only on the longest and most open side of the pier) | Lower 25% of the railing; dispersed through pier, to max 34" | 2015 ABAAS Section: 1005.2.1 2010 ADAS Section: 1005.2.1 | | |

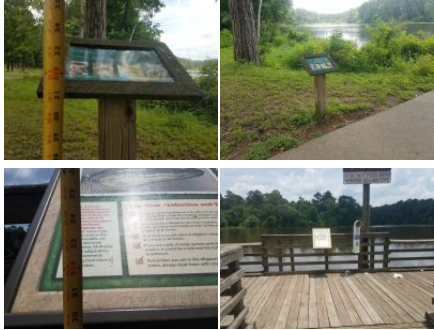
| Finding Number | Area Description | Lat/Long | Finding | As Built | Recommendation | Citation | Photos | Figure |
|---|--|---|--|---|---|---|---|---|
| 284 | Coloneh Camping Area: Lake Raven Fishing At Coloneh Campground | [30.6149981 , -95.5282618] | Visual characters shall be 40 inches (1015 mm) minimum above the finish floor or ground. EXCEPTION: Visual characters indicating elevator car controls shall not be required to comply with 703.5.6. | Visual characters of alligator informational sign lack 40" minimum above the finish floor or ground | Remount signage to min 40" aff. | 2015 ABAAS Section: 703.5.6, 703.5.6 EXCEPTION 2012 TAS Section: 703.5.6, 703.5.6 Exception 2010 ADAS Section: 703.5.6, 703.5.6 Exception | | |

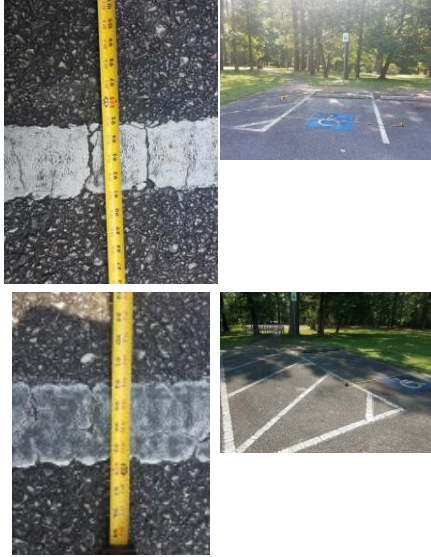
| Finding Number | Area Description | Lat/Long | Finding | As Built | Recommendation | Citation | Photos | Figure |
|---|---|---|---|---|--|--|--|---|
| 293 | Day Use Area: Parking - Group Shelter | [30.6182305 , -95.532651 6] | The accessible parking stall is not wide enough. Each parking space must be at least 8' feet wide and shall be marked to define the width. The measurements of parking spaces and access aisles shall be made from the centerline of the markings. Where the parking space is not adjacent to another parking space or access aisle, the measurement shall be permitted to include the full width of the line defining the parking space. | Lacks width requirement for accessible parking stall (93" picnic stall and 94" right stall) | Repaint stalls to be 8' wide each | 2015 ABAAS Section: 502.2 2012 TAS Section: 502.2 2010 ADAS Section: 502.2 | | |

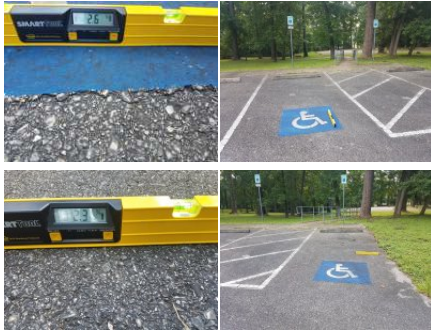
| Finding Number | Area Description | Lat/Long | Finding | As Built | Recommendation | Citation | Photos | Figure |
|---|---|---|---|---|--|--|--|---|
| 294 | Day Use Area: Parking - Group Shelter | [30.6182121 , -95.532659 7] | The cross slopes (narrow dimension) and/or running slopes (long dimension) of the access aisle exceeds 2%. The running slope and the cross slope in an accessible parking stall and the access aisle must not exceed 2%. | Slope of 2.6% (left stall) and 2.3% (right stall) | Resurface stalls and access aisles to eliminate slopes | 2015 ABAAS Section: 502.4 2012 TAS Section: 502.4 2010 ADAS Section: 502.4 | | |

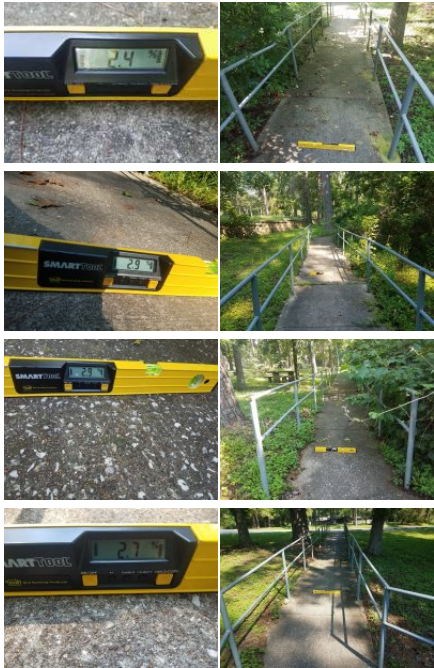
| Finding Number | Area Description | Lat/Long | Finding | As Built | Recommendation | Citation | Photos | Figure |
|---|---|--|--|--|---|--|--|---|
| 304 | Day Use Area: Group Shelter | [30.6176281, -95.53197 17], [30.6180897, -95.532304 3] | The ramp on the accessible route contains cross slopes greater than 2%. Surface cross slopes shall not exceed one unit vertical in 48 units horizontal (2-percent slope). | Cross slopes of 2.4% (lowest ramp run), 2.9% (2nd run), 2.9% (4th run), and 2.7% (bottom run at parking) | Correct ramp cross slope to max 2.08% | 2015 ABAAS Section: 405.3 2012 TAS Section: 405.3 2010 ADAS Section: 405.3 | | |

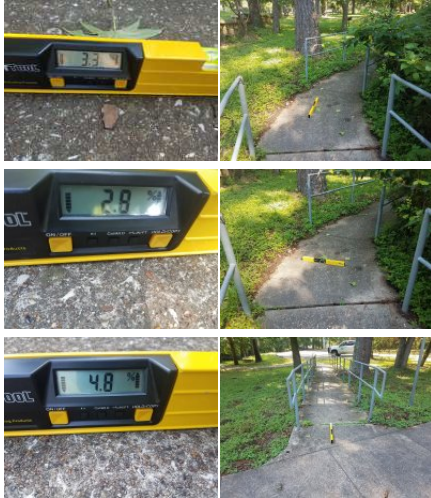
| Finding Number | Area Description | Lat/Long | Finding | As Built | Recommendation | Citation | Photos | Figure |
|---|---|---|--|--|---|---|---|---|
| 306 | Day Use Area: Group Shelter | [30.618039, -95.532425] | The landing at the bottom of the ramp has a slope greater than 2%. Bottom landings shall have a dimension in the direction of ramp run of not less than 60 inches and have a slope of less than 2% in any direction. | Slopes of 3.3% and 2.8% (3rd landing), and 4.8% (top landing at parking) | Correct ramp landing slope to max 2.08% | 2015 ABAAS Section: 405.7.1, 405.7.1 EXCEPTION 2012 TAS Section: 405.7.1, 405.7.1 Exception 2010 ADAS Section: 405.7.1, 405.7.1 Exception | | |

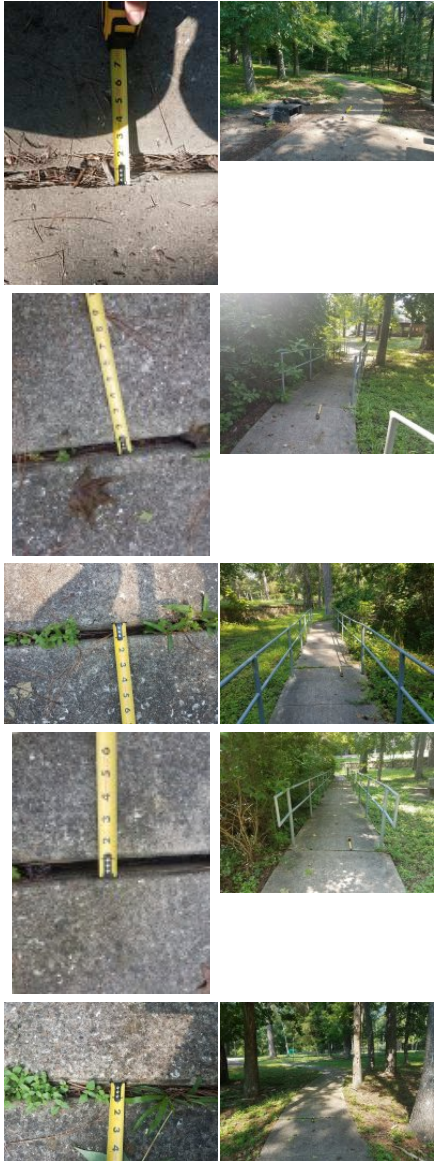
| Finding Number | Area Description | Lat/Long | Finding | As Built | Recommendation | Citation | Photos | Figure |
|---|---|---|--|--|---|--|--|---|
| 311 | Day Use Area: Group Shelter | [30.6176223 , -95.531951 6] | There is a gap spaced greater than a 1/2 inch. Openings in floor or ground surfaces shall not allow passage of a sphere more than 1/2 inch diameter. Elongated openings shall be placed so that the long dimension is perpendicular to the dominant direction of travel. | Multiple gaps of 2" (near shelter), four gaps of 1" (on ramp), 1" (between ramps), 1.5" (near upper ramp), and 1.25" (on upper ramp) | Correct or fill gaps to be max .5" | 2015 ABAAS Section: 302.3 2012 TAS Section: 302.3 2010 ADAS Section: 302.3 | | |

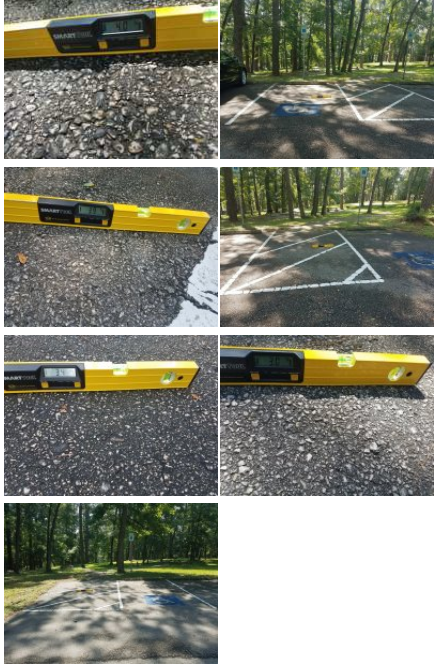
| Finding Number | Area Description | Lat/Long | Finding | As Built | Recommendation | Citation | Photos | Figure |
|---|---|---|--|---|--|--|--|---|
| 315 | Day Use Area: Parking - Picnic Area | [30.6208088 , -95.530653 4] | The cross slopes (narrow dimension) and/or running slopes (long dimension) of the access aisle exceeds 2%. The running slope and the cross slope in an accessible parking stall and the access aisle must not exceed 2%. | Slopes of 4% (in left stall), 3.9% (in shared access aisle), 3.4% (in middle stall), and 3% (in right stall access aisle) | Resurface stalls and access aisles to eliminate slopes | 2015 ABAAS Section: 502.4 2012 TAS Section: 502.4 2010 ADAS Section: 502.4 | | |

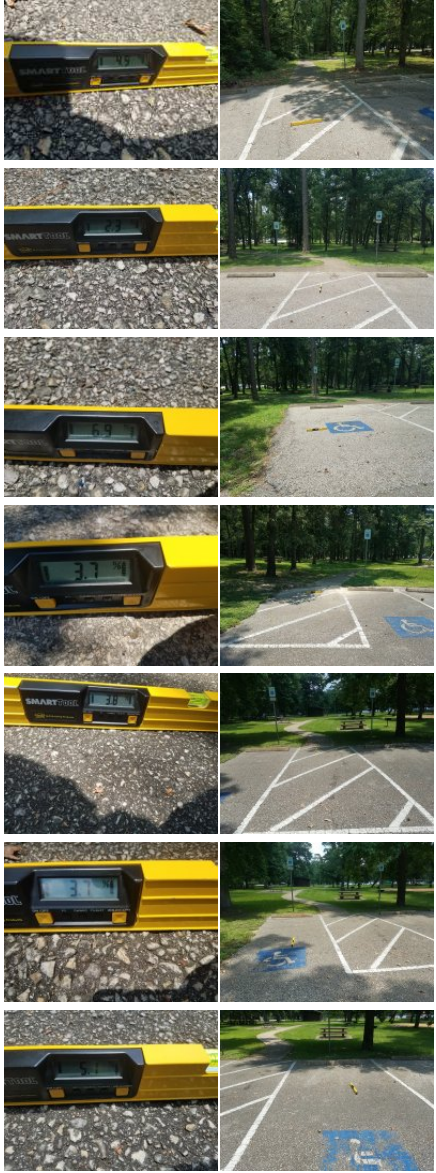
| Finding Number | Area Description | Lat/Long | Finding | As Built | Recommendation | Citation | Photos | Figure |
|---|---|---|--|---|--|--|--|---|
| 317 | Day Use Area: Parking - Picnic Area | [30.6208227 , -95.5306534] | The cross slopes (narrow dimension) and/or running slopes (long dimension) of the access aisle exceeds 2%. The running slope and the cross slope in an accessible parking stall and the access aisle must not exceed 2%. | Slopes of 4.5% (roadway access aisle), 2.3% (loop access aisle), 6.7% (loop left stall), 3.7% (middle roadway stall access aisle), 3.8% (south access aisle), 3.7% (south left stall), and 5.1% (south right stall) | Resurface stalls and access aisles to eliminate slopes | 2015 ABAAS Section: 502.4 2012 TAS Section: 502.4 2010 ADAS Section: 502.4 | | |

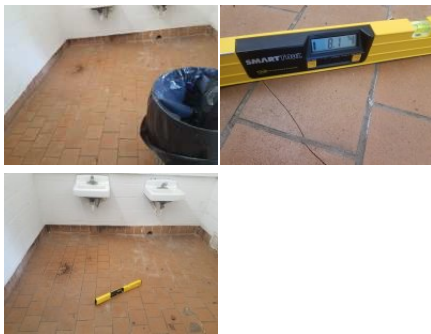
| Finding Number | Area Description | Lat/Long | Finding | As Built | Recommendation | Citation | Photos | Figure |
|---|---|---|---|--|---|--|--|---|
| 341 | Day Use Area: Day Use Picnic Restrooms | [30.6153509 , -95.533268 5] | The accessible route contains running slopes greater than 5 percent and cross slopes greater than 2 percent across the width of the walk and has not been constructed as a ramp (i.e. handrails, wheel guides, etc.). When the slope in the direction of travel of any walk exceeds 1 unit vertical in 20 units horizontal (5-percent slope), it must be constructed as ramp. Surface cross slopes must not exceed one unit vertical in 48 units. Horizontal (2-percent slope). | Men's restroom - Slope of 8.1% in front of sinks (damaged floor with slope where floor buckled) | Correct or repair slope to max 5% running and 2.08% cross | 2015 ABAAS Section: 403.3 2012 TAS Section: 403.3 2010 ADAS Section: 403.3 | | |

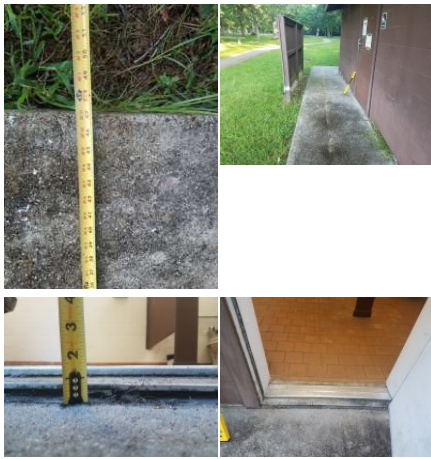
| Finding Number | Area Description | Lat/Long | Finding | As Built | Recommendation | Citation | Photos | Figure |
|---|---|---|---|--|---|--|--|---|
| 343 | Day Use Area: Day Use Picnic Restrooms | [30.6153477 , -95.533256 1] | Minimum maneuvering clearances at doors and gates shall comply with 404.2.4. Maneuvering clearances shall extend the full width of the doorway and the required latch side or hinge side clearance. The threshold at a doorway shall be no higher than 1/2 inch. Changes in level between 1/4 inch and 1/2 inch must be beveled at 1:2 or less. 1/4 inch is the maximum vertical rise. The sweep period for doors with closers shall be adjusted so that from an open position of 70 degrees, the door will take at least 3 seconds to move to a point 3 inches from the latch, measured to the leading edge of the door. | Women's restroom door - Lacks maneuvering clearance on pull side (47" deep landing), CIL of 1.5" at threshold, and lacks compliant closing speed | For all doors along the public circulation route, provide required maneuvering clearance on push and pull side of doors For all doors along the public circulation route, repair, provide beveled threshold For all doors along the public circulation route, inspect, adjust, and maintain closing speed on door closers | 2010 ADAS Section: 404.2.3, 404.2.7, 404.2.4, 404.2.11, 404.2.11 Exception | | |

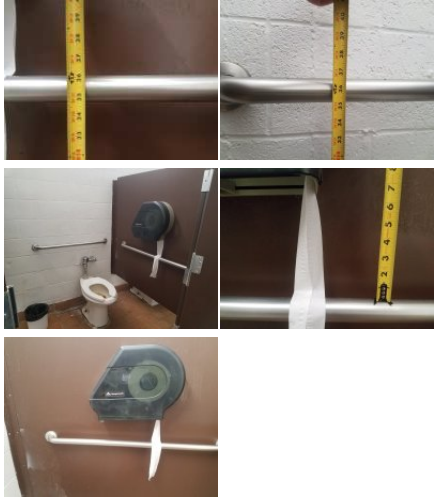
| Finding Number | Area Description | Lat/Long | Finding | As Built | Recommendation | Citation | Photos | Figure |
|---|---|---|---|---|---|--|---|---|
| 352 | Day Use Area: Day Use Picnic Restrooms | [30.6153429 , -95.533259 2] | The grab bar height and/or spacing fails. Grab bars must be mounted between 33" and 36" to the top of the gripping surface. There must be 1.5" of clearance between the grab bar and the wall. There must be a minimum of 1.5" of clearance below and minimum 12" above the grab bar to any dispenser or other obstruction. | Women's restroom - side grab bar is 36.25" aff, and lacks 12" clearance above the bar due to toilet paper dispenser location, rear grab bar is 36.75" aff | Remount grab bars in accessible stall to 33" to 36" aff Remount toilet paper dispenser max 7" to 9" from front of toilet, 15" to 48" aff and min 12" above or 1.5" below grab bar | 2015 ABAAS Section: 609.3, 609.4 2012 TAS Section: 609.4, 609.3 2010 ADAS Section: 609.3, 609.4 | | |

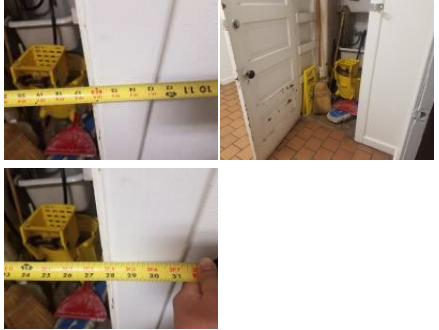
| Finding Number | Area Description | Lat/Long | Finding | As Built | Recommendation | Citation | Photos | Figure |
|---|---|---|--|--|---|--|---|---|
| 367 | Day Use Area: Lodge | [30.6132777 , -95.533759 2] | Minimum maneuvering clearances at doors and gates shall comply with 404.2.4. Maneuvering clearances shall extend the full width of the doorway and the required latch side or hinge side clearance. Door openings shall provide a clear width of 32 inches (815 mm) minimum. Clear openings of doorways with swinging doors shall be measured between the face of the door and the stop, with the door open 90 degrees. Openings more than 24 inches (610 mm) deep shall provide a clear opening of 36 inches (915 mm) minimum. There shall be no projections into the required clear opening width lower than 34 inches (865 mm) above the finish floor or ground. Projections into the clear opening width between 34 inches (865 mm) and 80 inches (2030 mm) above the finish floor or ground shall not exceed 4 inches (100 mm). Hand-activated door opening hardware, handles, pulls, latches, locks, and other operating devices on accessible doors shall have a shape that is easy to grasp with one hand and does not require tight grasping, tight pinching or twisting of the wrist to operate. Hardware shall be 34 inches minimum and 48 inches maximum above the finish floor or ground. | Janitor closet door - Lacks maneuvering clearance on pull side (16" to wall - structural) and push side (storage), lacks 32" clear width (29"), and lacks compliant hardware (knobs) | For all doors along the public circulation route, provide required maneuvering clearance on push and pull side of doors For all doors along the public circulation route, replace doors with doors having 80" overhead clearance and 32" clear width For all doors along the public circulation route, replace hardware with lever hardware or hardware operable without a tight pinch or grasp | 2010 ADAS Section: 404.2.3, 404.2.7, 404.2.4, 404.2.11, 404.2.11 Exception | | |

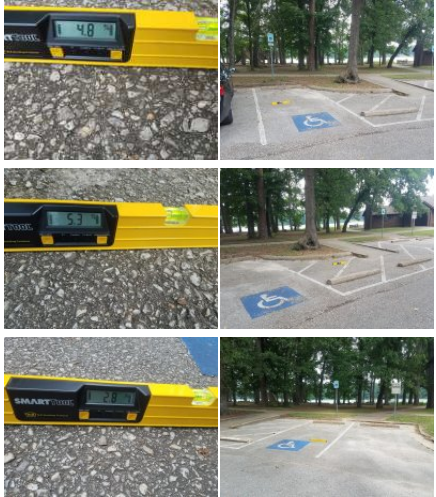
| Finding Number | Area Description | Lat/Long | Finding | As Built | Recommendation | Citation | Photos | Figure |
|---|---|---|---|---|---|--|---|---|
| 402 | Day Use Area: Lodge | [30.6135297 , -95.5336534] | The cross slopes (narrow dimension) and/or running slopes (long dimension) of the access aisle exceeds 2%. The running slope and the cross slope in an accessible parking stall and the access aisle must not exceed 2%. | Slopes of 4.8% (in van stall), 5.3% in van side access aisle), and 2.8% (in right side stall) | Repair or correct slope of parking space and access aisle to max 2.08% in any direction | 2015 ABAAS Section: 502.4 2012 TAS Section: 502.4 2010 ADAS Section: 502.4 | | |

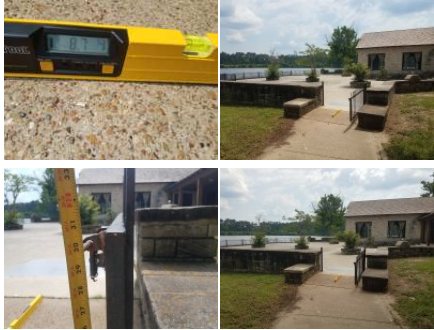
| Finding Number | Area Description | Lat/Long | Finding | As Built | Recommendation | Citation | Photos | Figure |
|---|---|---|--|--|---|--|---|---|
| 404 | Day Use Area: Lodge | [30.6132439 , -95.533555 4] | Minimum maneuvering clearances at doors and gates shall comply with 404.2.4. Maneuvering clearances shall extend the full width of the doorway and the required latch side or hinge side clearance. Floor or ground surface within required maneuvering clearances shall comply with 302. Changes in level are not permitted. EXCEPTIONS: 1. Slopes not steeper than 1:48 shall be permitted. The door operating hardware is not located within the compliant range. Hand-activated door opening hardware, handles, pulls, latches, locks, and other operating devices on accessible doors shall have a shape that is easy to grasp with one hand and does not require tight grasping, tight pinching or twisting of the wrist to operate. Hardware shall be 34 inches minimum and 48 inches maximum above the finish floor or ground. | Gated entry - Lacks maneuvering clearance on pull side (slope of 8.7% and wall - structural); and lacks compliant hardware (30" agl) | For all doors along the public circulation route, provide required maneuvering clearance on push and pull side of doors For all doors along the public circulation route, correct or repair slope at doorway landing to max 2.08% in any direction for level CFS For all doors along the public circulation route, replace hardware with lever hardware where indicated, mounted 34" to 48" aff | 2010 ADAS Section: 404.2.3, 404.2.7, 404.2.4, 404.2.11, 404.2.11 Exception | | |

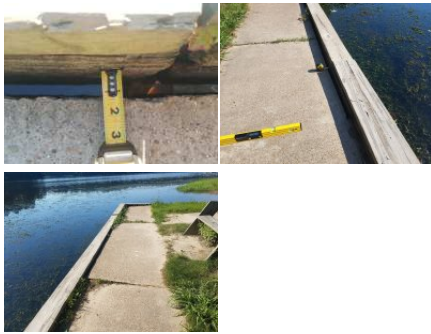
| Finding Number | Area Description | Lat/Long | Finding | As Built | Recommendation | Citation | Photos | Figure |
|---|---|---|--|--|---|---|--|---|
| 439 | Day Use Area: Day Use Area Park Amenities | [30.6154515 , -95.532311] | There is a gap spaced greater than a 1/2 inch. Openings in floor or ground surfaces shall not allow passage of a sphere more than 1/2 inch diameter. Elongated openings shall be placed so that the long dimension is perpendicular to the dominant direction of travel. | Multiple gaps along edge of accessible route due to shifting walkway border | Correct or fill gaps to be max .5" | 2015 ABAAS Section: 302.3 2012 TAS Section: 302.3 2010 ADAS Section: 302.3 | | |

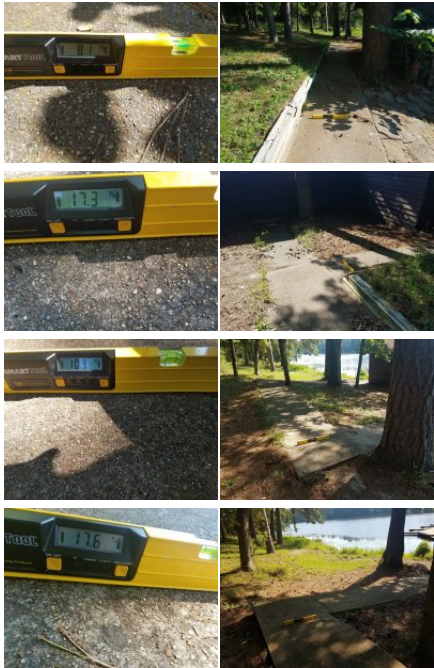
| Finding Number | Area Description | Lat/Long | Finding | As Built | Recommendation | Citation | Photos | Figure |
|---|---|---|---|--|---|--|--|---|
| 467 | Day Use Area: Boat Rental | [30.6157693 , -95.532385 5] | The accessible route of travel on the accessible route contains cross slopes greater than 2%. Cross slopes shall not exceed one unit vertical in 48 units horizontal (2-percent slope). | Cross slopes of 8.1% (behind boathouse), 17.3% (at turn), 10.9% (at turn), and 17.6% (at turn to dock) | Correct or repair cross slope along AR to max 2.08% | 2015 ABAAS Section: 403.3 2012 TAS Section: 403.3 2010 ADAS Section: 403.3 | | |

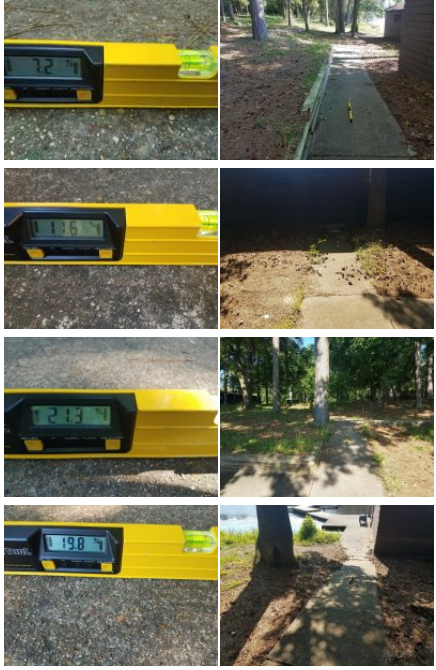
| Finding Number | Area Description | Lat/Long | Finding | As Built | Recommendation | Citation | Photos | Figure |
|---|---|--|---|--|--|--|--|---|
| 474 | Day Use Area: Boat Rental | [30.6157523 , -95.53238 83], [30.6158562 , -95.532298 5] | The running slope of walking surfaces shall not be steeper than 1:20. | Running slopes of 7.2%, 11.7%, 21.4% (behind boathouse), and 19.8% (to dock) | Correct running slope along the AR to max 5% | 2015 ABAAS Section: 403.3 2012 TAS Section: 403.3 2010 ADAS Section: 403.3 | | |
