Access Audit Site Report

Huntsville State Park

Accessibility Evaluation

Inspection Date: 06/14/2021

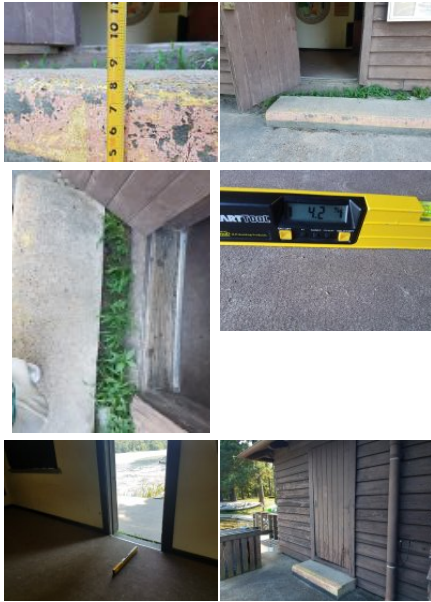
| Finding Number | Area Description | Lat/Long | Finding | As Built | Recommendation | Citation | Photos | Figure |
|---|---|---|---|--|---|--|--|---|
| 478 | Day Use Area: Boat Rental | [30.6156854 , -95.532314 7] | Minimum maneuvering clearances at doors and gates shall comply with 404.2.4. Maneuvering clearances shall extend the full width of the doorway and the required latch side or hinge side clearance. Floor or ground surface within required maneuvering clearances shall comply with 302. Changes in level are not permitted. Openings in floor or ground surfaces shall not allow passage of a sphere more than 1/2 inch (13 mm) diameter except as allowed in 407.4.3, 409.4.3, 410.4, 810.5.3 and 810.10. Elongated openings shall be placed so that the long dimension is perpendicular to the dominant direction of travel. EXCEPTIONS: 1. Slopes not steeper than 1:48 shall be permitted. The threshold has a vertical change greater than 1/4 inch high. | Entries - Lacks maneuvering clearance on pull side (CIL/step of 8" and large gap due to step separating) and push side (slope of 4.2%), and CIL in doorway | For all doors along the public circulation route, provide required maneuvering clearance on push and pull side of doors For all doors along the public circulation route, fill and maintain gaps at doorways to max .5" For all doors along the public circulation route, repair, bevel, or ramp CILs at door entries to max .25" Correct or repair slope at doorway landing to max 2.08% in any direction for level | 2010 ADAS Section: 404.2.3, 404.2.7, 404.2.4, 404.2.11, 404.2.11 Exception | | |

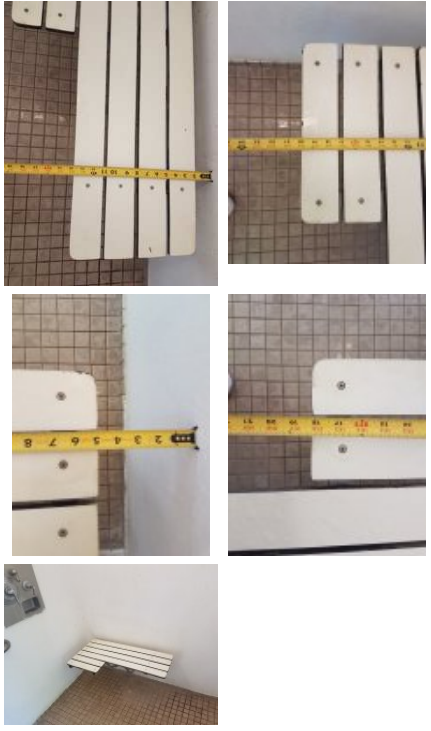
| Finding Number | Area Description | Lat/Long | Finding | As Built | Recommendation | Citation | Photos | Figure |
|---|---|---|--|---|---|---|--|---|
| 511 | Shelter Sites: Shelter Sites Restroom | [30.6168698 , -95.536092 9] | The shower seat does not have a compliant space between it and the wall. The folding seat must be mounted 17-19 inches above the floor, and have a maximum space of 1-1/2 inches between the edge of the seat and the side wall and 2-1/2 inches maximum to the seat wall. | Accessible shower - shower seat dimensions and spacing fails | Remount shower seat to the correct location and height in the shower | 2015 ABAAS Section: 610.3.2 2012 TAS Section: 610.3.2 2010 ADAS Section: 610.3.2 | | |

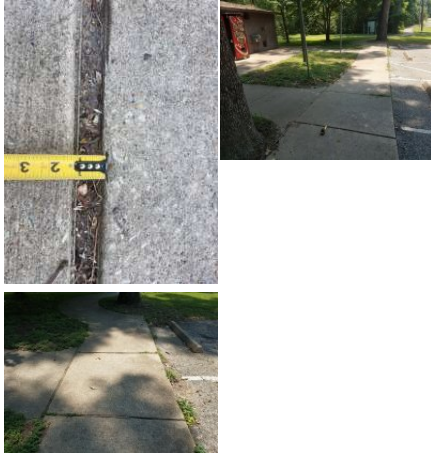
| Finding Number | Area Description | Lat/Long | Finding | As Built | Recommendation | Citation | Photos | Figure |
|---|---|---|---|--|--|--|---|---|
| 512 | Shelter Sites: Shelter Sites Restroom | [30.6168019 , -95.536043 4] | There is a gap spaced greater than a 1/2 inch. Openings in floor or ground surfaces shall not allow passage of a sphere more than 1/2 inch diameter. Elongated openings shall be placed so that the long dimension is perpendicular to the dominant direction of travel. | Multiple gaps (3) of 1" near parking | Correct or fill gaps to be max .5" | 2015 ABAAS Section: 302.3 2012 TAS Section: 302.3 2010 ADAS Section: 302.3 | | |

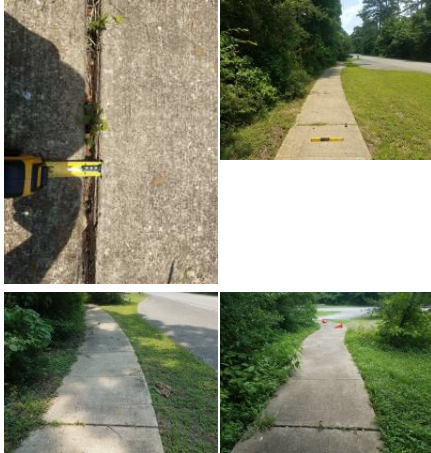
| Finding Number | Area Description | Lat/Long | Finding | As Built | Recommendation | Citation | Photos | Figure |
|---|---|--|---|--|---|--|---|---|
| 515 | Shelter Sites: Shelter Sites Restroom | [30.6168892 , -95.53575 03], [30.6169712 , -95.535492 8] | There is a gap spaced greater than a 1/2 inch. Openings in floor or ground surfaces shall not allow passage of a sphere more than 1/2 inch diameter. Elongated openings shall be placed so that the long dimension is perpendicular to the dominant direction of travel. | Multiple gaps (3) of 1" on walkway to park host | Correct or fill gaps to be max .5" | 2015 ABAAS Section: 302.3 2012 TAS Section: 302.3 2010 ADAS Section: 302.3 | | |

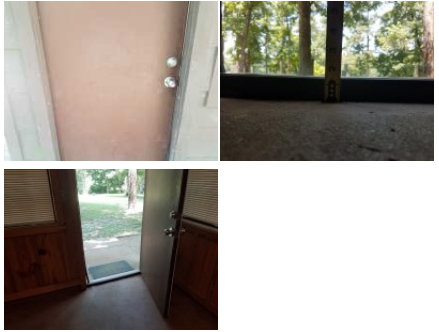
| Finding Number | Area Description | Lat/Long | Finding | As Built | Recommendation | Citation | Photos | Figure |
|---|--|---|--|--|--|--|---|---|
| 553 | Shelter Sites: Shelter Campsites | [30.6174646 , -95.536734] | The threshold at a doorway shall be no higher than 1/2 inch. Changes in level between 1/4 inch and 1/2 inch must be beveled at 1:2 or less. 1/4 inch is the maximum vertical rise. Hand-activated door opening hardware, handles, pulls, latches, locks, and other operating devices on accessible doors shall have a shape that is easy to grasp with one hand and does not require tight grasping, tight pinching or twisting of the wrist to operate. Hardware shall be 34 inches minimum and 48 inches maximum above the finish floor or ground. | Site 21 door - CIL of 1.25" at threshold, and lacks compliant hardware (knobs) | For all doors along the public circulation route, repair, provide beveled threshold For all doors along the public circulation route, replace hardware with lever hardware or hardware operable without a tight pinch or grasp | 2010 ADAS Section: 404.2.3, 404.2.7, 404.2.4, 404.2.11, 404.2.11 Exception | | |

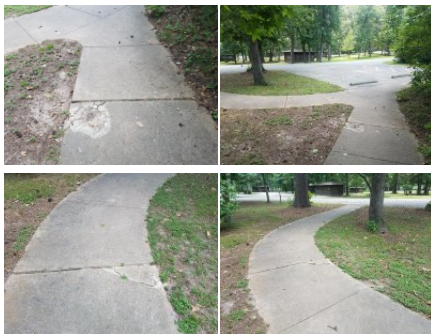
| Finding Number | Area Description | Lat/Long | Finding | As Built | Recommendation | Citation | Photos | Figure |
|---|--|---|--|---|---|--|--|--|
| 556 | Shelter Sites: Shelter Campsites | [30.6174666 , -95.536056 2] | There is a gap spaced greater than a 1/2 inch. Openings in floor or ground surfaces shall not allow passage of a sphere more than 1/2 inch diameter. Elongated openings shall be placed so that the long dimension is perpendicular to the dominant direction of travel. | Multiple large gaps where walkway is damaged near parking at Shelter 23 | Correct or fill gaps to be max .5" | 2015 ABAAS Section: 302.3 2012 TAS Section: 302.3 2010 ADAS Section: 302.3 | | |

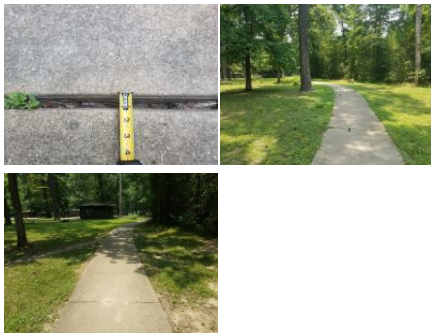
| Finding Number | Area Description | Lat/Long | Finding | As Built | Recommendation | Citation | Photos | Figure |
|---|--|---|--|---|---|--|--|--|
| 558 | Shelter Sites: Shelter Campsites | [30.61689, -95.53591] | There is a gap spaced greater than a 1/2 inch. Openings in floor or ground surfaces shall not allow passage of a sphere more than 1/2 inch diameter. Elongated openings shall be placed so that the long dimension is perpendicular to the dominant direction of travel. | Two gaps of 1" along walkway to shelter parking | Correct or fill gaps to be max .5" | 2015 ABAAS Section: 302.3 2012 TAS Section: 302.3 2010 ADAS Section: 302.3 | | |

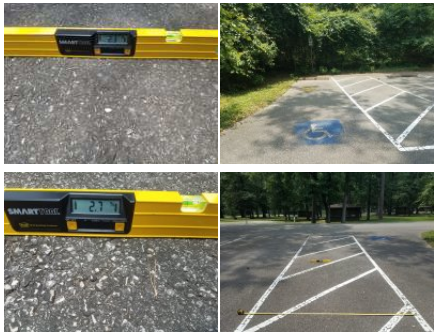
| Finding Number | Area Description | Lat/Long | Finding | As Built | Recommendation | Citation | Photos | Figure |
|---|--|---|--|--|--|--|--|---|
| 566 | Shelter Sites: Shelter Campsites | [30.6175946 , -95.536031 2] | The cross slopes (narrow dimension) and/or running slopes (long dimension) of the access aisle exceeds 2%. The running slope and the cross slope in an accessible parking stall and the access aisle must not exceed 2%. | Site 23 - Slopes of 2.3% in stall and 2.6% in access aisle | Resurface stalls and access aisles to eliminate slopes | 2015 ABAAS Section: 502.4 2012 TAS Section: 502.4 2010 ADAS Section: 502.4 | | |

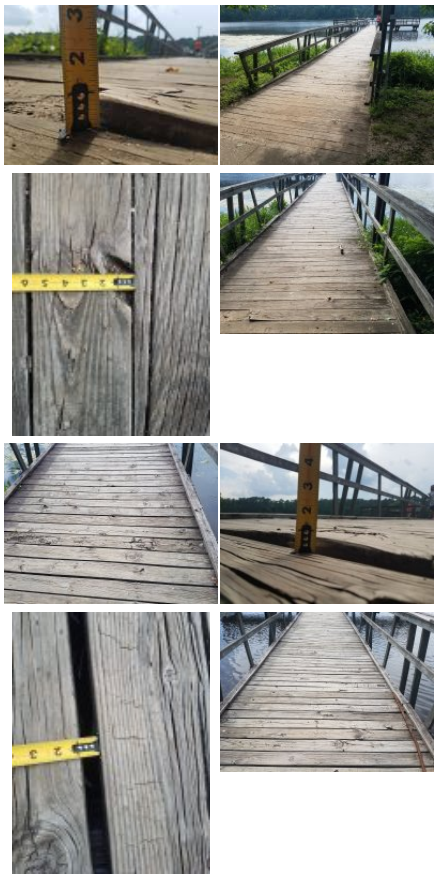
| Finding Number | Area Description | Lat/Long | Finding | As Built | Recommendation | Citation | Photos | Figure |
|---|---|---|--|--|---|---|---|---|
| 612 | Prairie Branch Camping Area: Prairie Branch Loop Fishing | [30.6192104 , -95.536550 2] | The walkway contains abrupt vertical edges and/or variations over a 1/4 inch. 1/4 inch is the maximum vertical rise. Changes in level between 1/4 inch and 1/2 inch must be beveled at 1:2 or less. Changes in level greater than 1/2 inch must be by way of a ramp. | Multiple CILs between .5" and 1.25" due to upheaval of damaged and warped boards along pier | Repair, bevel or ramp CIL along AR | 2012 TAS Section: 303.2, 303.3 2010 ADAS Section: 303.2, 303.3 | | |

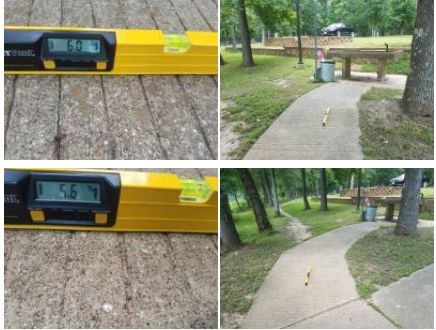
| Finding Number | Area Description | Lat/Long | Finding | As Built | Recommendation | Citation | Photos | Figure |
|---|--|--|--|--|---|--|--|--|
| 617 | Prairie Branch Camping Area: Prairie Branch Loop Fishing | [30.6191781 , -95.536311] | The running slope of walking surfaces shall not be steeper than 1:20. | Running slopes of 6% and 5.6% near fish cleaning station | Correct running slope along the AR to max 5% | 2015 ABAAS Section: 403.3 2012 TAS Section: 403.3 2010 ADAS Section: 403.3 | | |

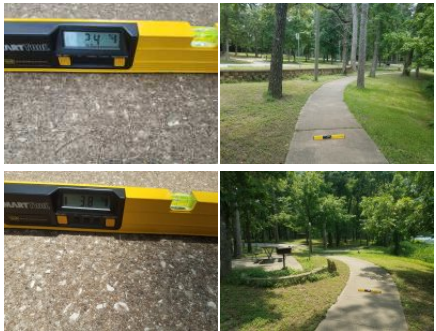
| Finding Number | Area Description | Lat/Long | Finding | As Built | Recommendation | Citation | Photos | Figure |
|---|--|--|--|--|---|--|--|--|
| 619 | Prairie Branch Camping Area: Prairie Branch Loop Fishing | [30.6188747 , -95.5363954], [30.6190893 , -95.5363364] | The accessible route of travel on the accessible route contains cross slopes greater than 2%. Cross slopes shall not exceed one unit vertical in 48 units horizontal (2-percent slope). | Cross slopes of 2.5% (near pier) and 3.8% (near table) | Correct or repair cross slope along AR to max 2.08% | 2015 ABAAS Section: 403.3 2012 TAS Section: 403.3 2010 ADAS Section: 403.3 | | |

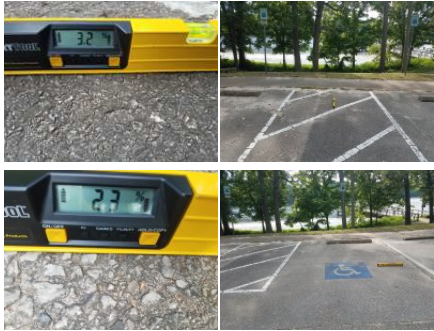
| Finding Number | Area Description | Lat/Long | Finding | As Built | Recommendation | Citation | Photos | Figure |
|---|---|---|--|--|---|--|--|--|
| 622 | Prairie Branch Camping Area: Parking - Fishing At Prairie Branch Loop | [30.6189703 , -95.536272 6] | The cross slopes (narrow dimension) and/or running slopes (long dimension) of the access aisle exceeds 2%. The running slope and the cross slope in an accessible parking stall and the access aisle must not exceed 2%. | Slopes of 3.2% in access aisle and 2.3% in right stall | Repair or correct slope of parking space and access aisle to max 2.08% in any direction | 2015 ABAAS Section: 502.4 2012 TAS Section: 502.4 2010 ADAS Section: 502.4 | | |

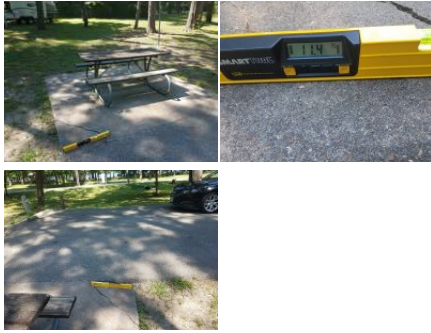
| Finding Number | Area Description | Lat/Long | Finding | As Built | Recommendation | Citation | Photos | Figure |
|---|--|---|--|--|--|--|---|---|
| 628 | Prairie Branch Camping Area: Prairie Branch Camping | [30.6192923 , -95.5351501] | 36 inches (915 mm) on all usable sides of the table measured from the back edge of the benches | Site 127 - Lacks 36" clear ground space around picnic table, and has a slope (11.4%) and CIL exceeding .5" due to crack at the corner of the table pad | Provide required 36" clear ground space around all usable portions of the table as a smart practice | 2015 ABAAS Section: 1011.2.1 | | |

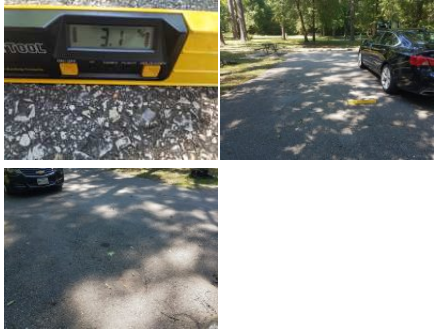
| Finding Number | Area Description | Lat/Long | Finding | As Built | Recommendation | Citation | Photos | Figure |
|---|--|---|--|--|---|--|--|--|
| 632 | Prairie Branch Camping Area: Prairie Branch Camping | [30.6192958 , -95.5351327] | The surface of parking spaces and pull-up spaces shall be firm and stable. The slope of the surface of parking spaces and pull-up spaces shall not be steeper than 1:48 in any direction. EXCEPTION: Where the surface is other than asphalt, concrete, or boards, slopes not steeper than 1:20 shall be permitted when necessary for drainage. | Site 127 - Slope of 3.1% and depressions near the head of the stall | Correct surface of parking spaces to be firm and stable with slopes max of 2.08% or 5% for surfaces other than concrete, asphalt or boards as a smart practice. | 2015 ABAAS Section: 1012.4, 1012.5, 1012.5 EXCEPTION | | |

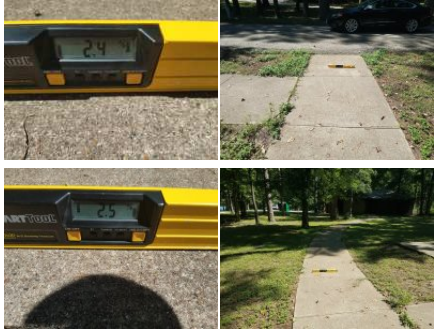
| Finding Number | Area Description | Lat/Long | Finding | As Built | Recommendation | Citation | Photos | Figure |
|---|--|---|---|---|--|--|--|---|
| 635 | Prairie Branch Camping Area: Prairie Branch Camping | [30.6194458 , -95.5346378] | The cross slope shall not be steeper than 1:48. EXCEPTION: Where the surface is other than concrete, asphalt, or boards, cross slopes not steeper than 1:20 shall be permitted when necessary for drainage. | Site 129 - Cross slopes of 2.4% and 2.5% | Correct or repair ORAR cross slope to max 2.08% or 5% for surfaces other than concrete, asphalt or board as a smart practices | 2015 ABAAS Section: 1016.7.2, 1016.7.2 EXCEPTION | | |

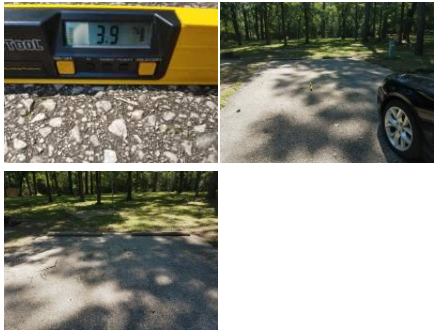
| Finding Number | Area Description | Lat/Long | Finding | As Built | Recommendation | Citation | Photos | Figure |
|---|--|---|---|---|--|--|--|---|
| 638 | Prairie Branch Camping Area: Prairie Branch Camping | [30.6194447 , -95.5346459] | The surface of parking spaces and pull-up spaces shall be firm and stable. The slope of the surface of parking spaces and pull-up spaces shall not be steeper than 1:48 in any direction. EXCEPTION: Where the surface is other than asphalt, concrete, or boards, slopes not steeper than 1:20 shall be permitted when necessary for drainage. | Site 129 - Slope of 3.9% and deterioration near head of stall | Resurface stalls and access aisles to eliminate slopes and CILs as a smart practice. | 2015 ABAAS Section: 1012.4, 1012.5, 1012.5 EXCEPTION | | |

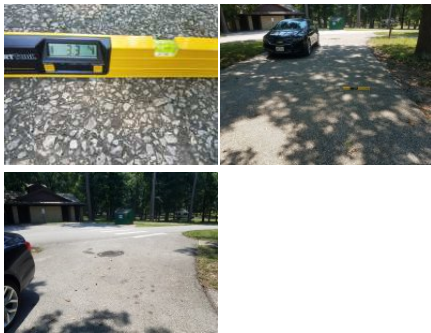
| Finding Number | Area Description | Lat/Long | Finding | As Built | Recommendation | Citation | Photos | Figure |
|---|--|---|--|---|--|--|---|---|
| 653 | Prairie Branch Camping Area: Prairie Branch Camping | [30.6201198 , -95.535061 6] | The surface of parking spaces and pull-up spaces shall be firm and stable. The slope of the surface of parking spaces and pull-up spaces shall not be steeper than 1:48 in any direction. EXCEPTION: Where the surface is other than asphalt, concrete, or boards, slopes not steeper than 1:20 shall be permitted when necessary for drainage. | Site 138 - Slope of 3.3% and large depression at foot of stall | Resurface stalls and access aisles to eliminate slopes and CILs | 2015 ABAAS Section: 1012.4, 1012.5, 1012.5 EXCEPTION | | |

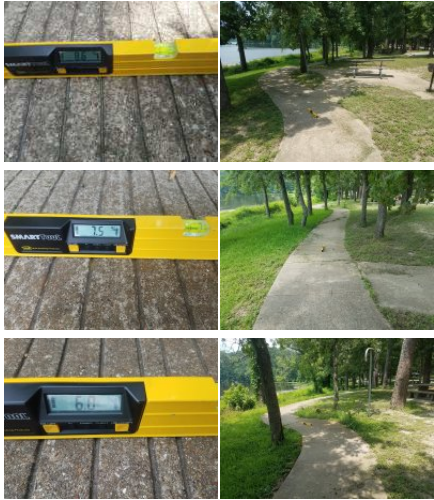
| Finding Number | Area Description | Lat/Long | Finding | As Built | Recommendation | Citation | Photos | Figure |
|---|--|---|--|--|---|--|---|---|
| 659 | Prairie Branch Camping Area: Prairie Branch Camping | [30.6192962 , -95.5362523] | The running slope of walking surfaces shall not be steeper than 1:20. | Running slopes of 8.6% and 7.5% (near campsite next to parking), and 6.8% (at curve) | Correct running slope along the AR to max 5% | 2015 ABAAS Section: 403.3 2012 TAS Section: 403.3 2010 ADAS Section: 403.3 | | |

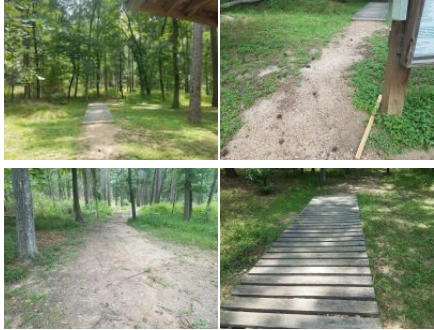
| Finding Number | Area Description | Lat/Long | Finding | As Built | Recommendation | Citation | Photos | Figure |
|---|---|---|---|--|---|--|---|---|
| 674 | Trails: Trails | [30.6171969 , -95.523956 2] | The surface of trails, passing spaces, and resting intervals shall be firm and stable Openings in the surface of outdoor recreation access routes shall not allow the passage of a sphere more than 1/2 inch (13 mm) in diameter. Advisory: Spaces between the boards in a boardwalk and drainage grates are examples of openings. Where possible, drainage grates should be located outside the minimum clear width of the outdoor recreation access route. Elongated openings should be placed so that the long dimension is perpendicular, or as close to perpendicular as possible, to the dominant direction of travel. Obstacles on outdoor recreation access routes, passing spaces, and resting intervals shall not exceed 1/2 inch (13 mm) in height measured vertically to the highest point. EXCEPTION: Where the surface is other than asphalt, concrete, or boards, obstacles shall be permitted to not exceed 1 inch (25 mm) in height measured vertically to the highest point. | Chinquapin Trail - Lacks firm and stable surface (mixed surface - mostly natural dirt) on Chinquapin Trail CIL at bridge and large gaps between boards on bridge surface | Consider resurfacing trail with a surface that is firm, stable, and maneuverable Correct or fill gaps along the ORAR to max .5" as a smart practice. Repair, bevel or ramp CIL along the ORAR to max .5" or 1" for surfaces other than concrete, asphalt or boards as a smart practice. | 2015 ABAAS Section: 1017.2 | | |

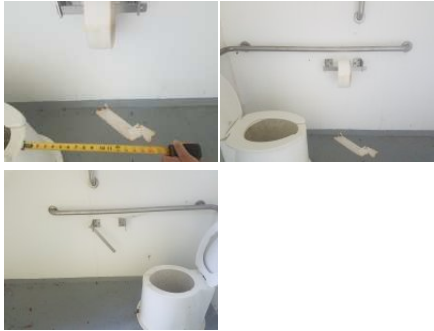
| Finding Number | Area Description | Lat/Long | Finding | As Built | Recommendation | Citation | Photos | Figure |
|---|---|---|--|--|---|--|---|---|
| 696 | Equestrian Area (Closed): Equestrian Area (Closed) | [30.6253628, -95.526386] | The toilet paper is not installed within the compliant range in front of the toilet. Toilet paper dispensers shall be 7 inches minimum and 9 inches maximum in front of the water closet measured to the centerline of the dispenser. The outlet of the dispenser shall be 15 inches minimum and 48 inches maximum above the finish floor and shall not be located behind grab bars. Dispensers shall not be of a type that controls delivery or that does not allow continuous paper flow. There shall be a clearance of 1 1/2 inches minimum below the grab bar. | TP 11" from front of toilet | Remount toilet paper dispenser max 7" to 9" from front of toilet, 15" to 48" aff and min 12" above or 1.5" below grab bar | 2015 ABAAS Section: 604.7 2012 TAS Section: 604.7 2010 ADAS Section: 604.7 | | |
