# Access Audit Site Report

**Lake Bob Sandlin State Park**

**Accessibility Evaluation**

**Inspection Date: 04/06/2022**

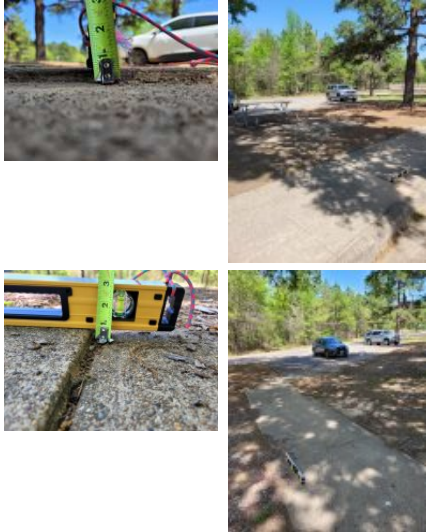
| Finding Number | Area Description | Lat/Long | Finding | As Built | Recommendation | Citation | Photos | Figure |
|---|---|---|--|--|--|---|--|---|
| 16 | Headquarters Area: HQ Public Spaces | [33.0540367 , -95.0989677] | The walkway contains abrupt vertical edges and/or variations over a 1/4 inch. 1/4 inch is the maximum vertical rise. Changes in level between 1/4 inch and 1/2 inch must be beveled at 1:2 or less. Changes in level greater than 1/2 inch must be by way of a ramp. | .5" CIL parallel to picnic table, .5" CIL in middle of path to exit side parking | Repair, bevel or ramp CIL along AR. | 2012 TAS Section: 303.2, 303.3<br><br>2010 ADAS Section: 303.2, 303.3 | | |

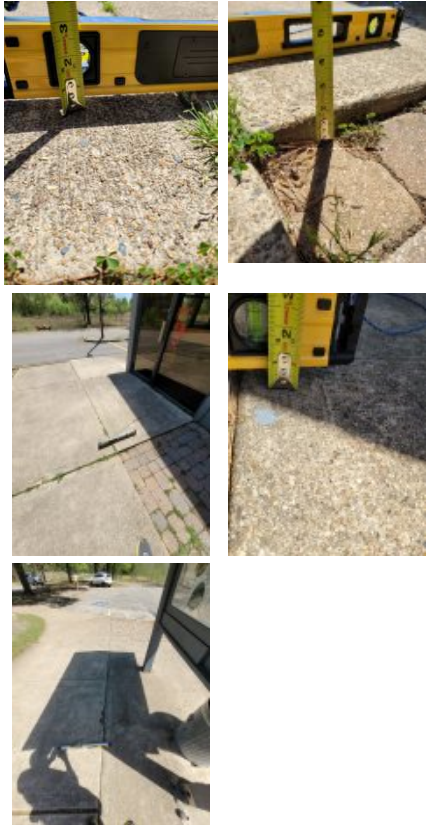
| Finding Number | Area Description | Lat/Long | Finding | As Built | Recommendation | Citation | Photos | Figure |
|---|---|---|--|--|---|--|---|---|
| 21 | Headquarters Area: HQ Public Spaces | [33.0539542, -95.0991294] | The walkway contains abrupt vertical edges and/or variations over a 1/4 inch. 1/4 inch is the maximum vertical rise. Changes in level between 1/4 inch and 1/2 inch must be beveled at 1:2 or less. Changes in level greater than 1/2 inch must be by way of a ramp. | .75" CIL at sign, .5" CIL at walk, 1.5" CIL at edge of walk/pavers (4 locations) | Repair, bevel or ramp CIL along AR. | 2012 TAS Section: 303.2, 303.3<br><br>2010 ADAS Section: 303.2, 303.3 | | |

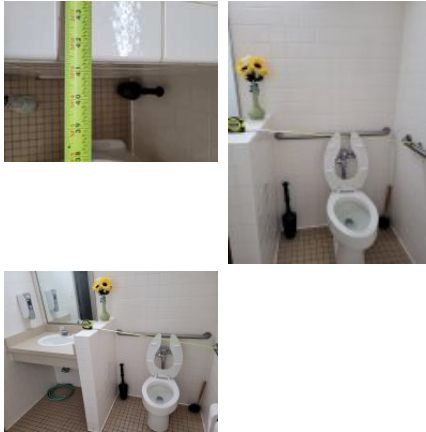
| Finding Number | Area Description | Lat/Long | Finding | As Built | Recommendation | Citation | Photos | Figure |
|---|---|---|---|--|--|---|--|---|
| 29 | Headquarters Area: HQ Men's Restroom | [33.0539816 , -95.0992078] | The required 56 inches by 60 inches clear floor space for the water closet has been obstructed. The clear floor space around the water closet shall be 60 inches minimum measured perpendicular from the side wall and 56 inches minimum measured perpendicular from the rear wall. | 41.25" clearance at toilet due to wall | Renovate restroom to provide 60" by 56" clearance around the toilet. | 2015 ABAAS Section: 604.3.<br><br>2012 TAS Section: 604.3.1<br><br>2010 ADAS Section: 604.3.1 | | |

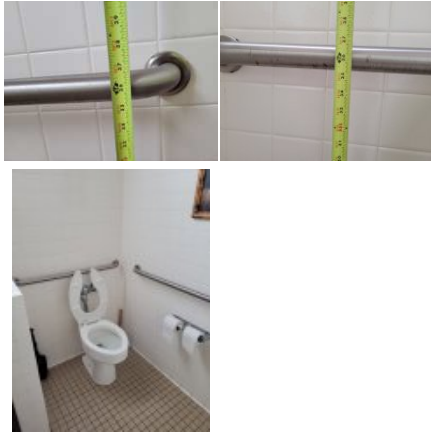
| Finding Number | Area Description | Lat/Long | Finding | As Built | Recommendation | Citation | Photos | Figure |
|---|---|---|---|---|---|---|--|---|
| 31 | Headquarters Area: HQ Men's Restroom | [33.053976, -95.0992238] | The grab bar height and/or spacing fails. Grab bars must be mounted between 33" and 36" to the top of the gripping surface. There must be 1.5" of clearance between the grab bar and the wall. There must be a minimum of 1.5" of clearance below and minimum 12" above the grab bar to any dispenser or other obstruction. | Grab bars at 36.75" AFF | Remount grab bars in accessible stall to 33" to 36" above the finished floor (AFF). | 2015 ABAAS Section: 609.3, 609.4<br><br>2012 TAS Section: 609.4, 609.3<br><br>2010 ADAS Section: 609.3, 609.4 | | |

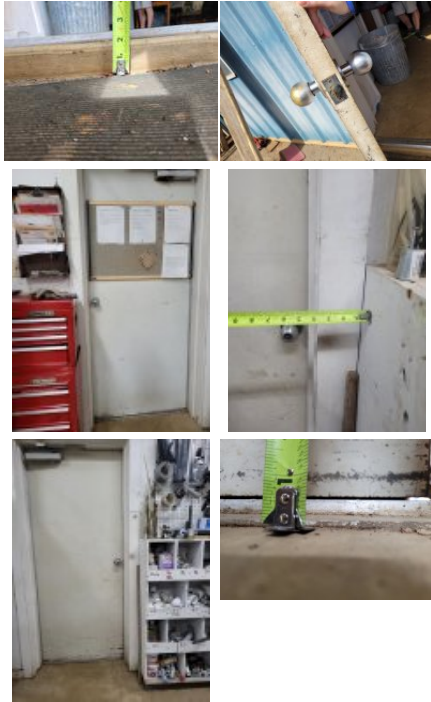
| Finding Number | Area Description | Lat/Long | Finding | As Built | Recommendation | Citation | Photos | Figure |
|---|---|---|---|---|---|---|--|--|
| 45 | Employee Areas: Maintenance | [33.0599456 , -95.087580 4] | Spaces and elements within employee work areas shall only be required to comply with 206.2.8, 207.1, and 215.3 and shall be designed and constructed so that individuals with disabilities can approach, enter, and exit the employee work area. Employee work areas, or portions of employee work areas, other than raised courtroom stations, that are less than 300 square feet (28 m2) and elevated 7 inches (180 mm) or more above the finish floor or ground where the elevation is essential to the function of the space shall not be required to comply with these requirements or to be on an accessible route. | Entry to main maintenance space - knob, 2.5" CIL, clearance on push reduced by tool box<br>Door to carport from inside - knob, 4.5" clearance on push due to shelf, .5" threshold | For employee spaces, relocate storage, furniture, and other obstacles at doorways to provide approach, enter and exit at the employee space. Provide required maneuvering clearance on push and pull side of doors. Repair, bevel, or ramp CILs at door entries to max .25". Repair, provide beveled threshold. Replace hardware with lever hardware or hardware operable without a tight pinch or grasp. | 2015 ABAAS Section: F203.9<br><br>2012 TAS Section: 203.9<br><br>2010 ADAS Section: 203.9 | | |

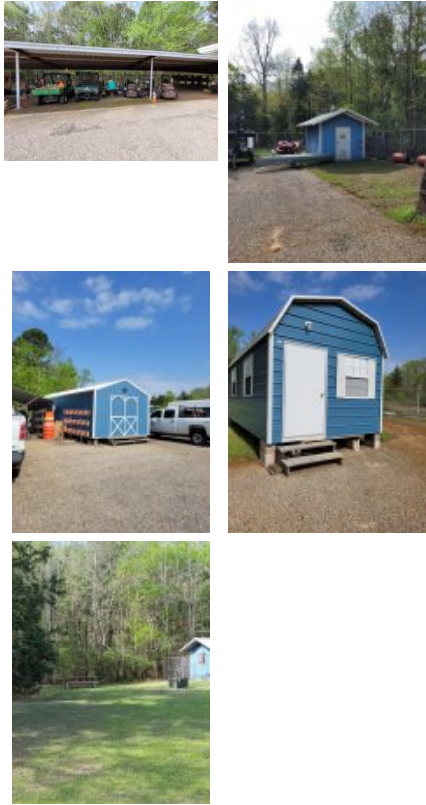
| Finding Number | Area Description | Lat/Long | Finding | As Built | Recommendation | Citation | Photos | Figure |
|---|---|---|---|--|--|---|---|---|
| 47 | Employee Areas: Maintenance | [33.0600715 , -95.087679 6] | Spaces and elements within employee work areas shall only be required to comply with 206.2.8, 207.1, and 215.3 and shall be designed and constructed so that individuals with disabilities can approach, enter, and exit the employee work area. Employee work areas, or portions of employee work areas, other than raised courtroom stations, that are less than 300 square feet (28 m2) and elevated 7 inches (180 mm) or more above the finish floor or ground where the elevation is essential to the function of the space shall not be required to comply with these requirements or to be on an accessible route. | Lacks AR to picnic table, side carport<br>Lacks AR to flammable materials shed Middle shed - 2 steps up Edge shed - knob, 2 steps up | For employee spaces, relocate storage, furniture, and other obstacles at doorways to provide approach, enter and exit at the employee space. Create an accessible route with crushed stone or other outdoor material from parking or walkway to picnic table, side carport, and flammable materials shed. Repair, bevel, or ramp CILs at door entries to max .25". Replace hardware with lever hardware or hardware operable without a tight pinch or grasp. | 2015 ABAAS Section: F203.9<br>2012 TAS Section: 203.9<br>2010 ADAS Section: 203.9 | | |

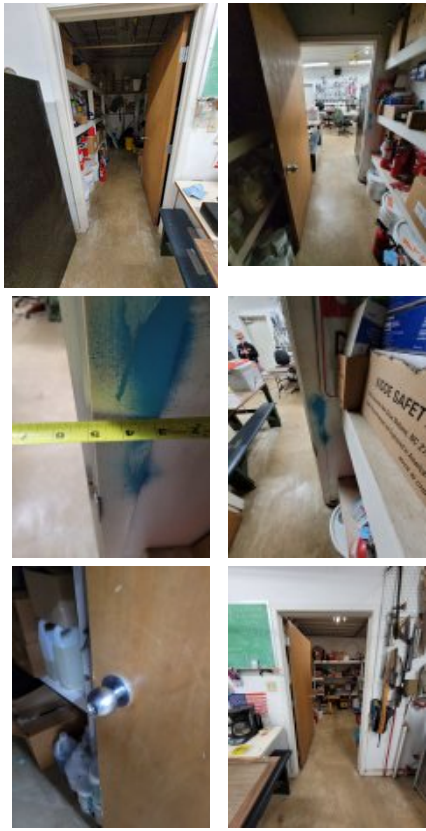
| Finding Number | Area Description | Lat/Long | Finding | As Built | Recommendation | Citation | Photos | Figure |
|---|---|---|---|--|---|--|--|---|
| 50 | Employee Areas: Maintenance | [33.0599456 , -95.0875911] | Spaces and elements within employee work areas shall only be required to comply with 206.2.8, 207.1, and 215.3 and shall be designed and constructed so that individuals with disabilities can approach, enter, and exit the employee work area. Employee work areas, or portions of employee work areas, other than raised courtroom stations, that are less than 300 square feet (28 m2) and elevated 7 inches (180 mm) or more above the finish floor or ground where the elevation is essential to the function of the space shall not be required to comply with these requirements or to be on an accessible route. | Room 1 - lacks pull side clearance, knob hardware; Room 2 - lacks pull side clearance, knob hardware | For employee spaces, relocate storage, furniture, and other obstacles at doorways to provide approach, enter and exit at the employee space. Provide required maneuvering clearance on push and pull side of doors. Replace hardware with lever hardware or hardware operable without a tight pinch or grasp. | 2015 ABAAS Section: F203.9<br><br>2012 TAS Section: 203.9<br><br>2010 ADAS Section: 203.9 | | |

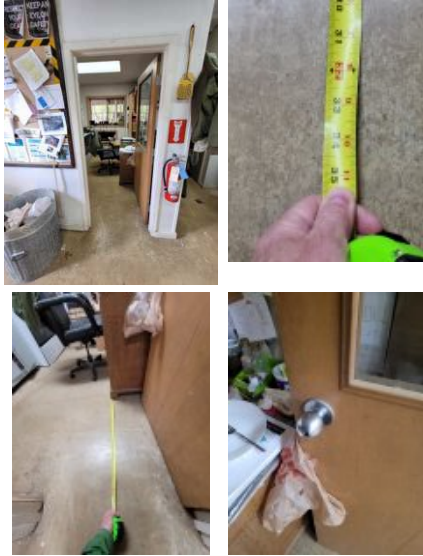
| Finding Number | Area Description | Lat/Long | Finding | As Built | Recommendation | Citation | Photos | Figure |
|---|---|---|---|--|---|---|--|---|
| 51 | Employee Areas: Maintenance | [33.0599411<br>,<br>-95.087591<br>1] | Spaces and elements within employee work areas shall only be required to comply with 206.2.8, 207.1, and 215.3 and shall be designed and constructed so that individuals with disabilities can approach, enter, and exit the employee work area. Employee work areas, or portions of employee work areas, other than raised courtroom stations, that are less than 300 square feet (28 m2) and elevated 7 inches (180 mm) or more above the finish floor or ground where the elevation is essential to the function of the space shall not be required to comply with these requirements or to be on an accessible route. | Office with range and microwave - 35" pull side clearance, obstructed by desk, knob hardware | For employee spaces, relocate storage, furniture, and other obstacles at doorways to provide approach, enter and exit at the employee space. Provide required maneuvering clearance on push and pull side of doors. Replace hardware with lever hardware or hardware operable without a tight pinch or grasp. | 2015 ABAAS<br>Section:<br>F203.9<br><br>2012 TAS<br>Section:<br>203.9<br><br>2010 ADAS<br>Section:<br>203.9 | | |

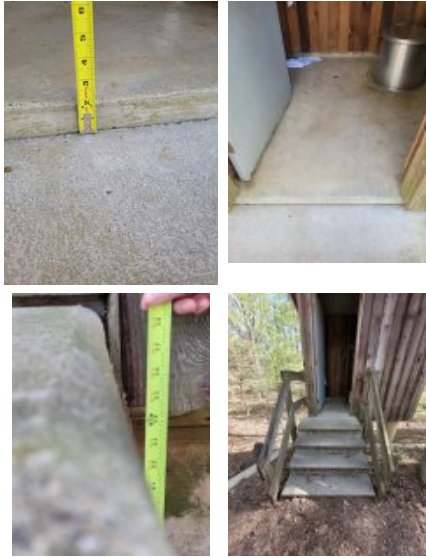
| Finding Number | Area Description | Lat/Long | Finding | As Built | Recommendation | Citation | Photos | Figure |
|---|---|---|---|---|--|--|--|---|
| 70 | Trailhead: Trail Restrooms | [33.061146, -95.091786 1] | Minimum maneuvering clearances at doors and gates shall comply with 404.2.4. Maneuvering clearances shall extend the full width of the doorway and the required latch side or hinge side clearance. Maneuvering clearances shall have a max slope of 2.08%. The threshold has a vertical change greater than 1/4 inch high. The threshold at a doorway shall be no higher than 1/2 inch. Changes in level between 1/4 inch and 1/2 inch must be beveled at 1:2 or less. 1/4 inch is the maximum vertical rise. | 2" CIL at threshold, 4 risers for 29" AFF | For all doors along the public circulation route, provide required maneuvering clearance on push and pull side of doors. For all doors along the public circulation route, repair, bevel, or ramp CILs at door entries to max .25". For all doors along the public circulation route, provide beveled threshold. For all doors along the public circulation route, provide ramp or other accessible route instead of or in addition to stairs. | 2010 ADAS Section: 404.2.3, 404.2.7, 404.2.4, 404.2.11, 404.2.11 Exception | | |

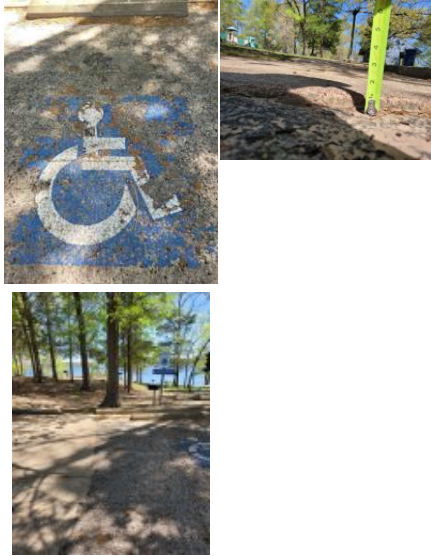
| Finding Number | Area Description | Lat/Long | Finding | As Built | Recommendation | Citation | Photos | Figure |
|---|---|---|---|---|--|--|--|--|
| 78 | Day Use Area:<br>Day Use -<br>Parking | [33.0483746<br>,<br>-95.094146<br>4] | The parking stall contains abrupt edges and surface irregularities over a 1/4 inch vertical. Parking spaces and access aisles serving them shall be stable, firm, and slip resistant. Access aisles shall be at the same level as the parking spaces they serve. Changes in level are not permitted and shall not be sloped steeper than 2% in any direction. | On boat ramp side, closest to playground<br>- Multiple cracks and 1" CIL where space meets sidewalk | Resurface stalls and access aisles to eliminate gaps, cracks, and CILs. | 2015 ABAAS<br>Section:<br>502.4<br><br>2012 TAS<br>Section:<br>502.4<br><br>2010 ADAS<br>Section:<br>502.4 | | |

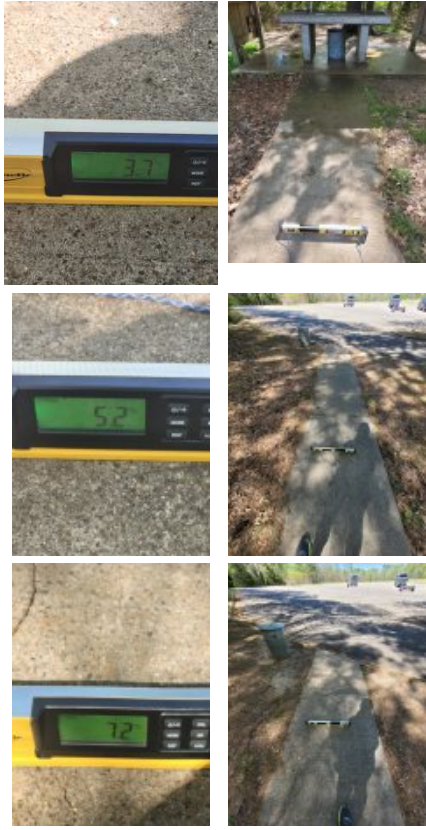
| Finding Number | Area Description | Lat/Long | Finding | As Built | Recommendation | Citation | Photos | Figure |
|---|--|---|---|---|--|--|---|---|
| 86 | Day Use Area:<br>Day Use - Fish Cleaning | [33.0485, -95.09515] | The accessible route of travel contains cross slopes greater than 2%. Cross slopes shall not exceed one unit vertical in 48 units horizontal (2-percent slope). | 3.7% slope end of, 5.2% slope middle of, 7.2% slope beginning of route - approximately 40' of slope | Correct or repair cross slope along AR to max 2.08%. | 2015 ABAAS Section: 403.3<br><br>2012 TAS Section: 403.3<br><br>2010 ADAS Section: 403.3 | | |

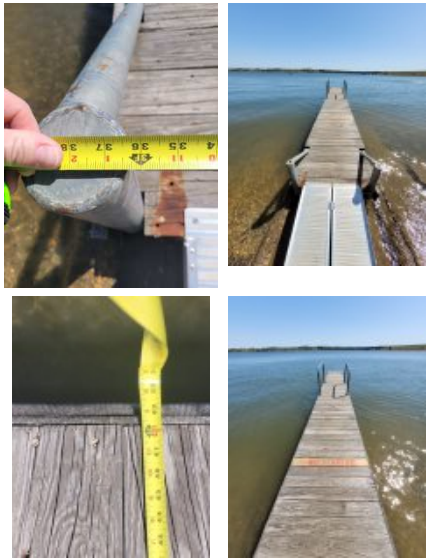
| Finding Number | Area Description | Lat/Long | Finding | As Built | Recommendation | Citation | Photos | Figure |
|---|---|---|--|---|--|---|---|---|
| 89 | Day Use Area:<br>Day Use - Boat Ramp | [33.0479115<br>,<br>-95.094755<br>3] | The boat slip/pier is not wide enough. Boat slips and boarding piers shall provide clear pier space 60 inches wide minimum and at least as long as the boat slips/boarding pier. Each 10 feet maximum of linear pier edge serving boat slips and boarding piers shall contain at least one continuous clear opening 60 inches wide minimum. The clear width shall be permitted to be reduced to 36 inches minimum for a length of 24 inches maximum provided that reduced width segments are separated by segments that are 60 inches long minimum and 60 inches wide minimum. | 36" wide opening, 49" wide pier | Provide 60" wide clearance at accessible slips and a 60" wide opening every 10'. | 2015 ABAAS<br>Section:<br>1003.3.1<br><br>2012 TAS<br>Section:<br>1003.3.1<br><br>2010 ADAS<br>Section:<br>1003.3.1 | | |

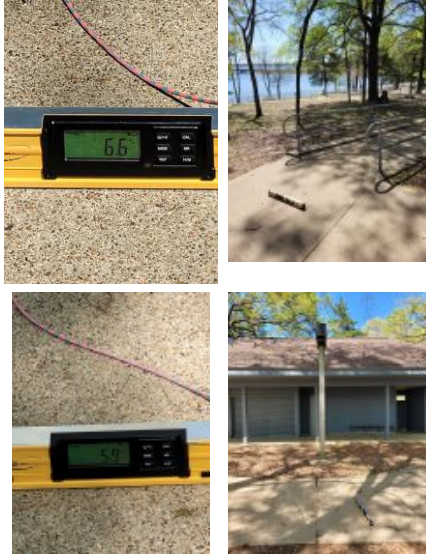
| Finding Number | Area Description | Lat/Long | Finding | As Built | Recommendation | Citation | Photos | Figure |
|---|---|---|---|--|---|---|---|---|
| 92 | Day Use Area:<br>Day Use - Fishing | [33.0481621<br>,<br>-95.0938889] | The accessible route of travel contains cross slopes greater than 2%. Cross slopes shall not exceed one unit vertical in 48 units horizontal (2-percent slope). | 6.6% near top of ramp to fishing pier, 5.9% parallel to light by bathroom | Correct or repair cross slope along AR to max 2.08%. | 2015 ABAAS<br>Section:<br>403.3<br><br>2012 TAS<br>Section:<br>403.3<br><br>2010 ADAS<br>Section:<br>403.3 | | |

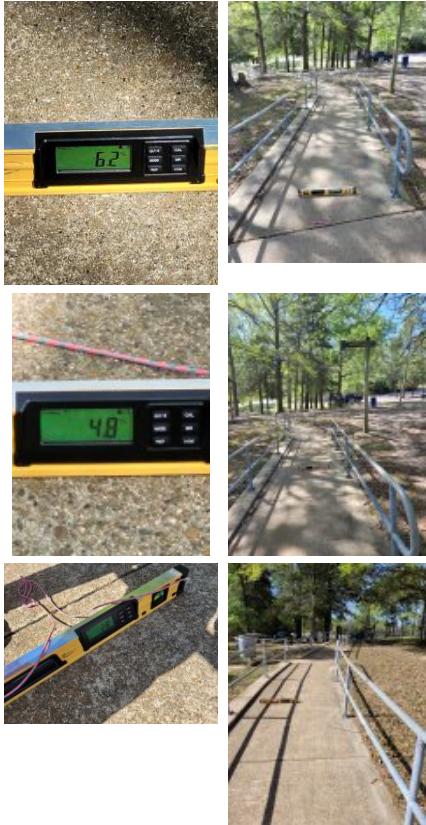
| Finding Number | Area Description | Lat/Long | Finding | As Built | Recommendation | Citation | Photos | Figure |
|---|---|---|---|--|--|--|--|---|
| 94 | Day Use Area:<br>Day Use - Fishing | [33.0481644<br>,<br>-95.093934<br>5] | The ramp on the accessible route contains cross slopes greater than 2%. Surface cross slopes shall not exceed one unit vertical in 48 units horizontal (2-percent slope). | long ramp from restroom to pier-<br>From top to bottom -<br>Set 1 - 6.2% at top<br>and 4.8% at middle,<br>Set 4 - 2.8% in middle | Correct ramp cross slope to max 2.08%. | 2015 ABAAS<br>Section:<br>405.3<br><br>2012 TAS<br>Section:<br>405.3<br><br>2010 ADAS<br>Section:<br>405.3 | | |

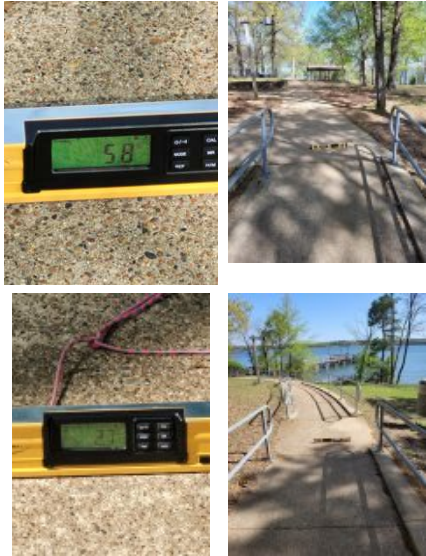
| Finding Number | Area Description | Lat/Long | Finding | As Built | Recommendation | Citation | Photos | Figure |
|---|---|---|--|---|--|---|--|---|
| 95 | Day Use Area:<br>Day Use - Fishing | [33.0481689<br>,<br>-95.093938<br>6] | The landing at the bottom of the ramp has a slope greater than 2%. Bottom landings shall have a dimension in the direction of ramp run of not less than 60 inches and have a slope of less than 2% in any direction. | long ramp from restroom to pier- Set 1 - 5.8% at top landing, Set 3 - 2.7% at bottom landing | Correct ramp landing slope to max 2.08%. | 2015 ABAAS<br>Section:<br>405.7.1,<br>405.7.1<br>EXCEPTION<br><br>2012 TAS<br>Section:<br>405.7.1,<br>405.7.1<br>Exception<br><br>2010 ADAS<br>Section:<br>405.7.1,<br>405.7.1<br>Exception | | |

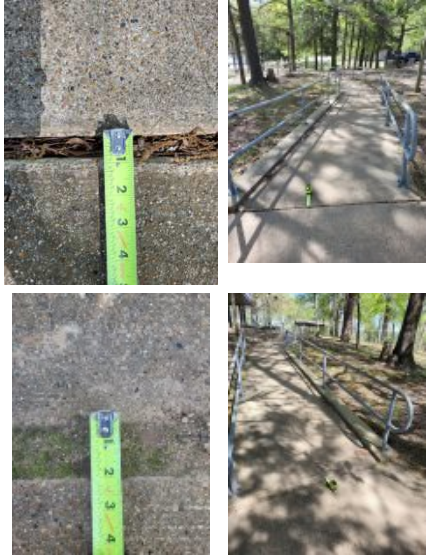
| Finding Number | Area Description | Lat/Long | Finding | As Built | Recommendation | Citation | Photos | Figure |
|---|---|---|--|---|--|---|--|---|
| 96 | Day Use Area:<br>Day Use - Fishing | [33.04817,<br>-95.093926<br>5] | Openings in floor or ground surfaces shall not allow passage of a sphere more than 1/2 inch (13 mm) diameter except as allowed in 407.4.3, 409.4.3, 410.4, 810.5.3 and 810.10. Elongated openings shall be placed so that the long dimension is perpendicular to the dominant direction of travel. | long ramp from restroom to pier- Set 1 - 1" gap at top, Set 2 - 2" at bottom and 1.5" at top, Set 3 - 1.25" at top and 1" at bottom, Set 4 - 1" gap at top, Set 5 - 2.5" gap at top and 1.5" at bottom, Set 6 - 1" at top and 1.25" at bottom | Fill and maintain gaps to max .5". | 2015 ABAAS<br>Section:<br>302.3<br><br>2012 TAS<br>Section:<br>302.3<br><br>2010 ADAS<br>Section:<br>302.3 | | |

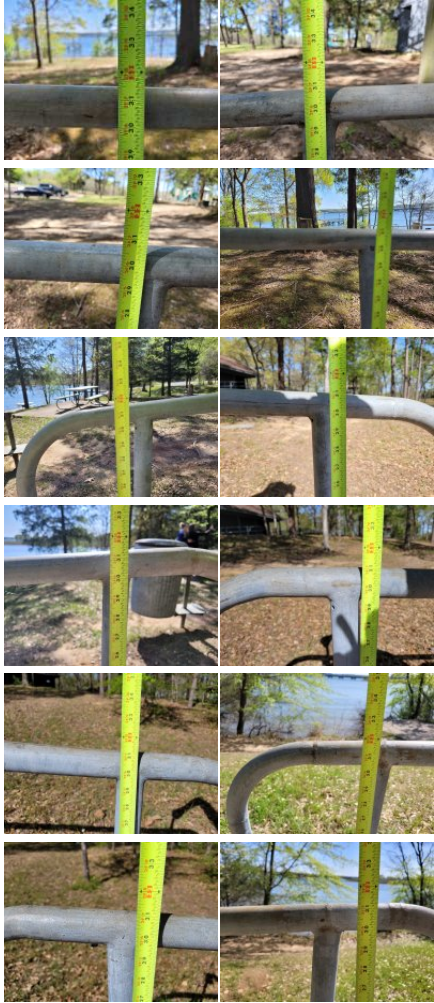
| Finding Number | Area Description | Lat/Long | Finding | As Built | Recommendation | Citation | Photos | Figure |
|---|---|---|--|---|---|--|--|---|
| 97 | Day Use Area:<br>Day Use - Fishing | [33.0481678<br>,<br>-95.093935<br>9] | The handrail is mounted incorrectly. Handrails are measured at the top and must be between 34 inches and 38 inches above the ramp surface. Handrails must extend horizontally beyond the top and bottom of the ramp 12 inches minimum. | long ramp from restroom to pier- Handrail heights fail at - Set 1 water side at 31.5" AGL and park side at 31" AGL, Set 2 - 31" AGL for both, Set 3 at 31" AGL for both handrails, Set 4 at 31" AGL for both, Set 5 restroom side at 31.5" AGL and water side at 32" AGL, Set 6 restroom side at 31" AGL and water side at 31.25" AGL | Remount handrails to 34" to 38" AFF. | 2015 ABAAS Section: 505.4<br><br>2012 TAS Section: 505.4<br><br>2010 ADAS Section: 505.4 | | |

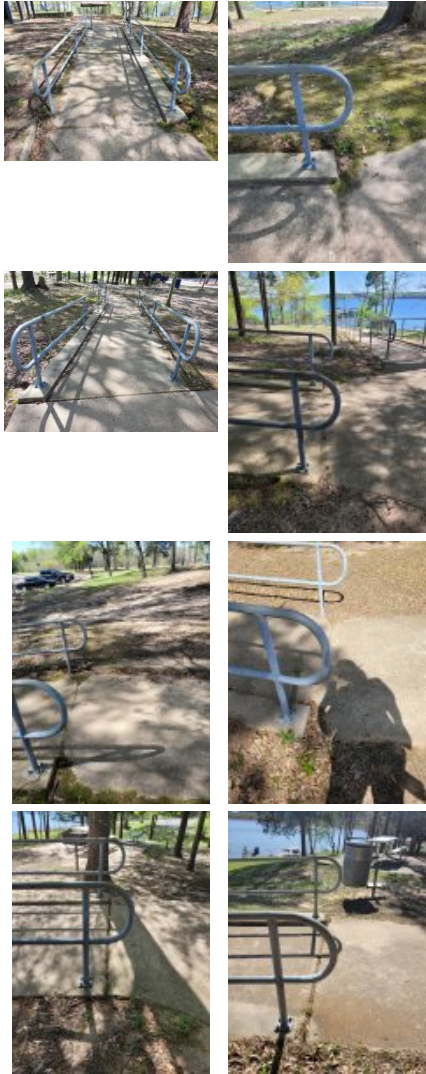
| Finding Number | Area Description | Lat/Long | Finding | As Built | Recommendation | Citation | Photos | Figure |
|---|---|---|--|--|---|---|--|---|
| 98 | Day Use Area:<br>Day Use - Fishing | [33.04817,<br>-95.093939<br>9] | The handrail is not continuous the entire length of the ramp. The handrail must be continuous. Handrails shall be placed on each side of each ramp, shall be continuous the full length of the ramp. The inside handrail on switch back or dogleg ramps shall always be continuous. Handrail shall have top and bottom extensions. | long ramp from restroom to pier- 0 of 6 sets extend at top or bottom | Replace handrail with one that is continuous along the full length of the ramp and having required top and bottom extensions. | 2015 ABAAS<br>Section:<br>505.3,<br>505.10.1<br><br>2012 TAS<br>Section:<br>505.3,<br>505.10.1<br><br>2010 ADAS<br>Section:<br>505.3,<br>505.10.1 | | |

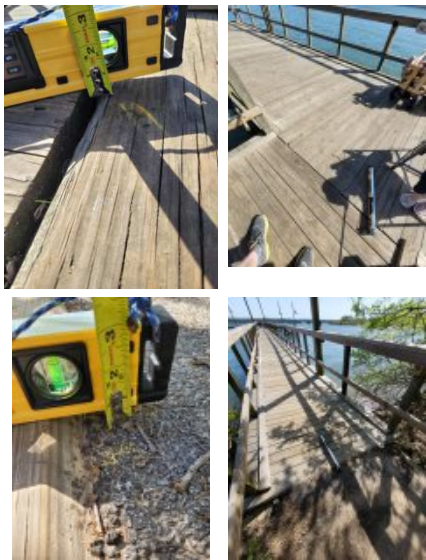
| Finding Number | Area Description | Lat/Long | Finding | As Built | Recommendation | Citation | Photos | Figure |
|---|---|---|--|--|---|---|---|---|
| 105 | Day Use Area:<br>Day Use - Fishing | [33.047408,<br>-95.093998<br>3] | The walkway contains abrupt vertical edges and/or variations over a 1/4 inch. 1/4 inch is the maximum vertical rise. Changes in level between 1/4 inch and 1/2 inch must be beveled at 1:2 or less. Changes in level greater than 1/2 inch must be by way of a ramp. | Fishing pier - .5" CIL at pier T intersection, .5" CIL at pier entry | Repair, bevel or ramp CIL along AR. | 2012 TAS<br>Section:<br>303.2, 303.3<br><br>2010 ADAS<br>Section:<br>303.2, 303.3 | | |

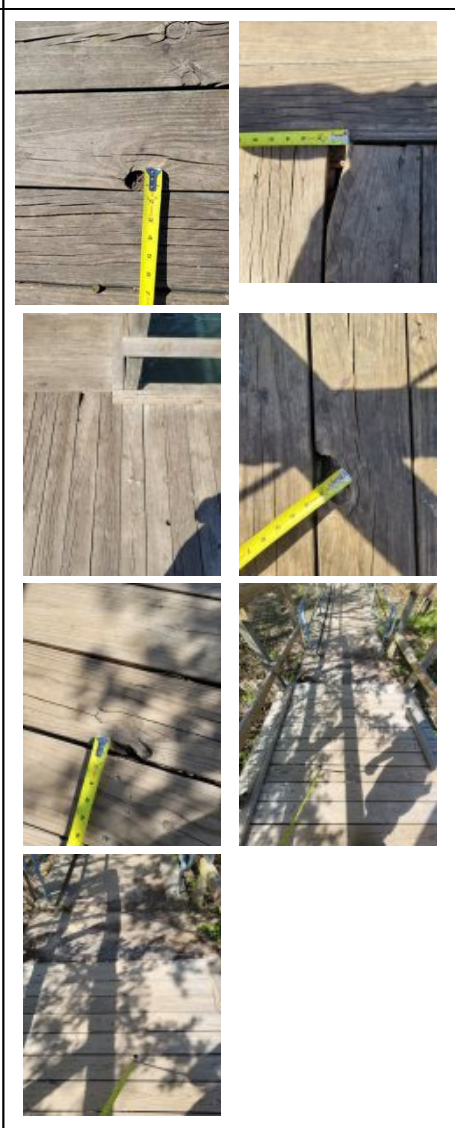
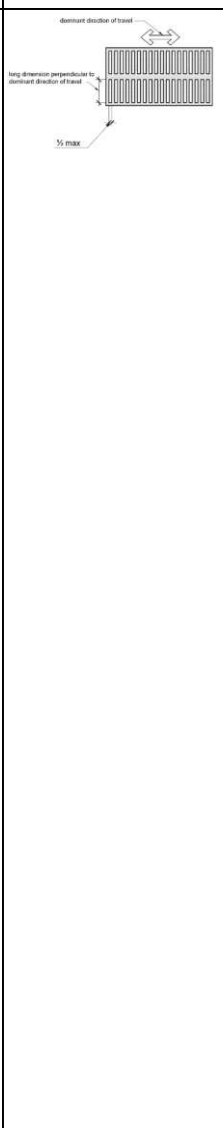
| Finding Number | Area Description | Lat/Long | Finding | As Built | Recommendation | Citation | Photos | Figure |
|---|---|---|--|--|---|--|--|--|
| 106 | Day Use Area:<br>Day Use - Fishing | [33.0474136<br>,<br>-95.094001] | There is a gap spaced greater than a 1/2 inch. Openings in floor or ground surfaces shall not allow passage of a sphere more than 1/2 inch diameter. Elongated openings shall be placed so that the long dimension is perpendicular to the dominant direction of travel. | Fishing pier - 1" and 1.5" gaps near T intersection, 1" gap at trash can, two 1" gaps near entry | Correct or fill gaps to be max .5". | 2015 ABAAS<br>Section:<br>302.3<br><br>2012 TAS<br>Section:<br>302.3<br><br>2010 ADAS<br>Section:<br>302.3 | | |

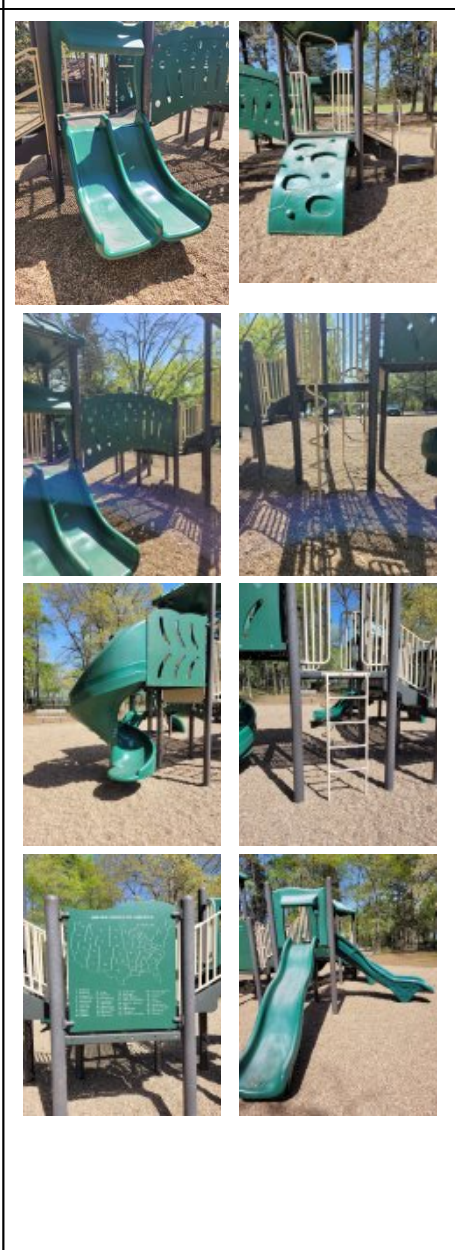
| Finding Number | Area Description | Lat/Long | Finding | As Built | Recommendation | Citation | Photos | Figure |
|---|--|---|--|--|---|---|--|---|
| 111 | Day Use Area:<br>Day Use -<br>Playground | [33.0484747<br>,<br>-95.093903<br>7] | Element meets all standards and requirements | 6 of 7 EPCs comply-<br>on AR- double slide,<br>rounded peg climber,<br>swirl ladder, map, 2<br>medium slides; swirl<br>slide not on AR due<br>to 11.75" step | None | 2010 ADAS<br>Section: N/A | | |

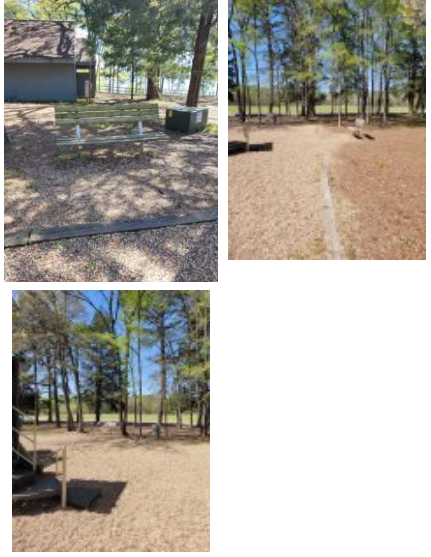
| Finding Number | Area Description | Lat/Long | Finding | As Built | Recommendation | Citation | Photos | Figure |
|---|--|---|--|---|--|--|---|---|
| 114 | Day Use Area:<br>Day Use -<br>Playground | [33.0484938<br>,<br>-95.093910<br>4] | At least one accessible route shall connect accessible buildings, accessible facilities, accessible elements, and accessible spaces that are on the same site. | Lacks AR to 3 of 3 benches and 1 of 1 garbage cans | Provide an accessible route to each element within the site. | 2010 ADAS<br>Section:<br>206.2.2,<br>206.2 | | |

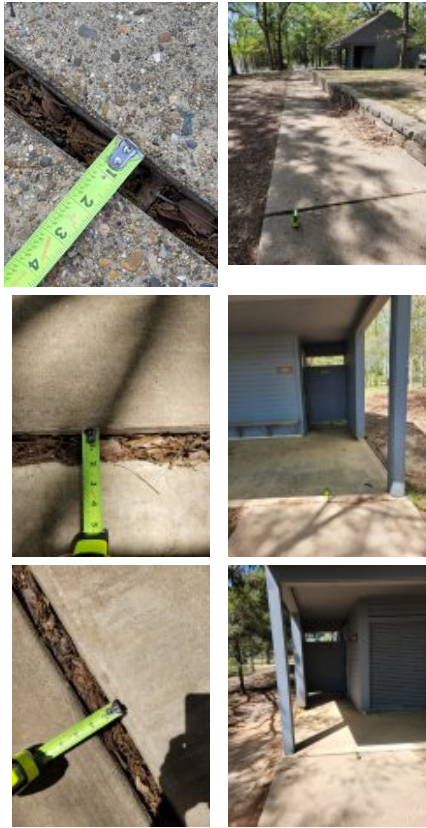
| Finding Number | Area Description | Lat/Long | Finding | As Built | Recommendation | Citation | Photos | Figure |
|---|---|---|---|---|---|--|--|---|
| 129 | Day Use Area:<br>Day Use - Women's Restroom | [33.0482206 ,<br>-95.093854 1] | There is a gap spaced greater than a 1/2 inch. Openings in floor or ground surfaces shall not allow passage of a sphere more than 1/2 inch diameter. Elongated openings shall be placed so that the long dimension is perpendicular to the dominant direction of travel. | 1" gap to restroom from pavilion where brick wall starts, 2" gap at entry to men's restroom, 2" gap at entry to women's | Correct or fill gaps to be max .5". | 2015 ABAAS Section: 302.3<br><br>2012 TAS Section: 302.3<br><br>2010 ADAS Section: 302.3 | | |

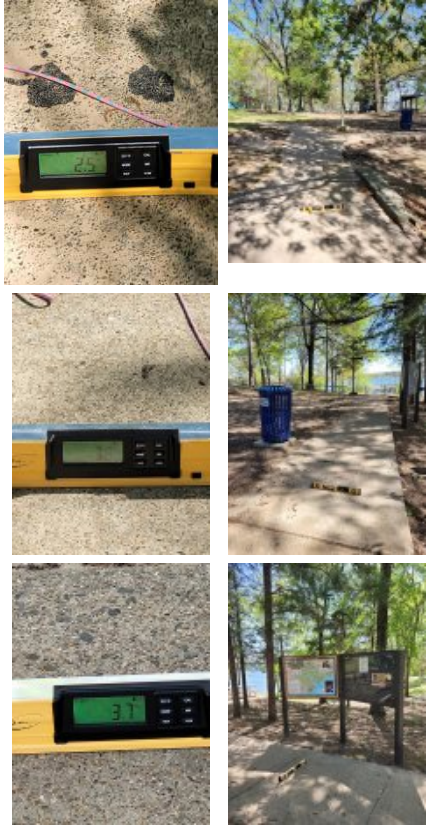
| Finding Number | Area Description | Lat/Long | Finding | As Built | Recommendation | Citation | Photos | Figure |
|---|---|---|--|---|--|--|--|---|
| 145 | Day Use Area:<br>Day Use -<br>Women's<br>Restroom | [33.0482386<br>,<br>-95.094040<br>5] | The accessible route of travel contains cross slopes greater than 2%. Cross slopes shall not exceed one unit vertical in 48 units horizontal (2-percent slope). | 2.5% cross slope at beginning path to play area and restroom from accessible stall, 3.6% by recycling, 3.7% by sign | Correct or repair cross slope along AR to max 2.08%. | 2015 ABAAS<br>Section:<br>403.3<br><br>2012 TAS<br>Section:<br>403.3<br><br>2010 ADAS<br>Section:<br>403.3 | | |

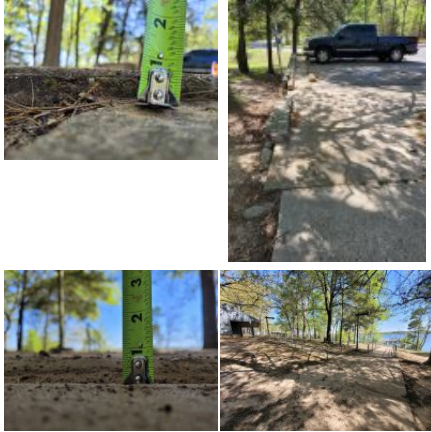
| Finding Number | Area Description | Lat/Long | Finding | As Built | Recommendation | Citation | Photos | Figure |
|---|---|---|--|--|---|---|---|---|
| 146 | Day Use Area:<br>Day Use -<br>Women's<br>Restroom | [33.0482127<br>,<br>-95.094090<br>1] | The walkway contains abrupt vertical edges and/or variations over a 1/4 inch. 1/4 inch is the maximum vertical rise. Changes in level between 1/4 inch and 1/2 inch must be beveled at 1:2 or less. Changes in level greater than 1/2 inch must be by way of a ramp. | .75" CIL at beginning path to play area and restroom from accessible stall, .75" CIL at turn to restroom | Repair, bevel or ramp CIL along AR. | 2012 TAS<br>Section:<br>303.2, 303.3<br><br>2010 ADAS<br>Section:<br>303.2, 303.3 | | |

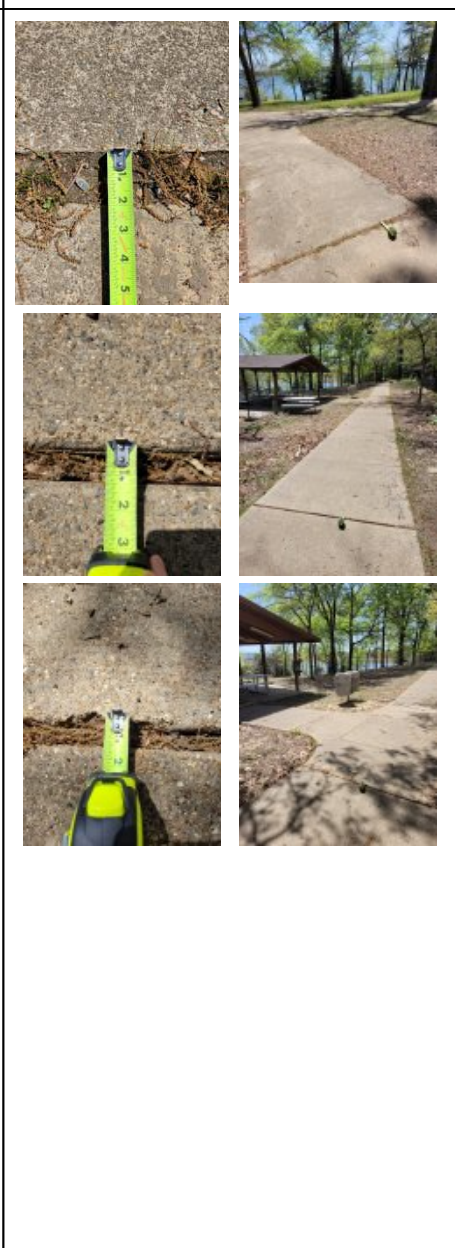
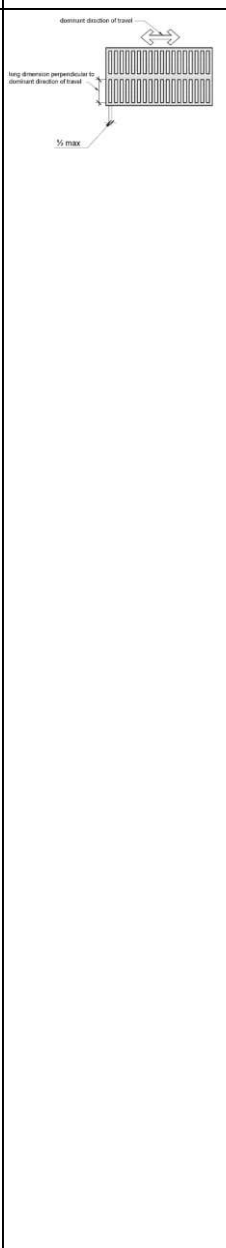
| Finding Number | Area Description | Lat/Long | Finding | As Built | Recommendation | Citation | Photos | Figure |
|---|---|---|--|--|---|--|--|--|
| 147 | Day Use Area:<br>Day Use - Group Pavilion | [33.0481678<br>,<br>-95.093344<br>4] | There is a gap spaced greater than a 1/2 inch. Openings in floor or ground surfaces shall not allow passage of a sphere more than 1/2 inch diameter. Elongated openings shall be placed so that the long dimension is perpendicular to the dominant direction of travel. | EAR to pavilion - 2" gap by sign, 1.5" at pathway, 1.25" right before turn | Correct or fill gaps to be max .5". | 2015 ABAAS<br>Section:<br>302.3<br><br>2012 TAS<br>Section:<br>302.3<br><br>2010 ADAS<br>Section:<br>302.3 | | |

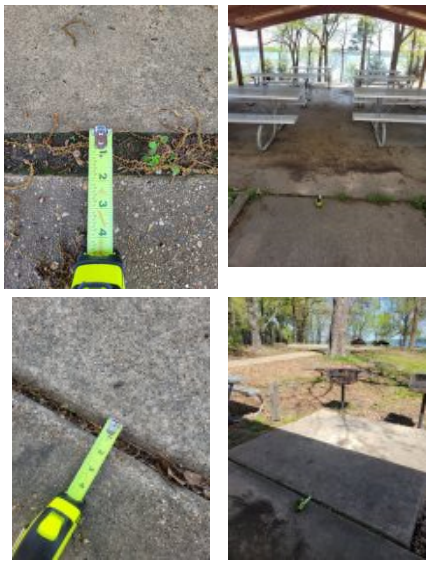
| Finding Number | Area Description | Lat/Long | Finding | As Built | Recommendation | Citation | Photos | Figure |
|---|---|---|--|---|--|--|---|---|
| 148 | Day Use Area:<br>Day Use - Group Pavilion | [33.0481127 ,<br>-95.093391 4] | There is a gap spaced greater than a 1/2 inch. Openings in floor or ground surfaces shall not allow passage of a sphere more than 1/2 inch diameter. Elongated openings shall be placed so that the long dimension is perpendicular to the dominant direction of travel. | 1.75" gap at entry,<br>1.5" gap at grills | Correct or fill gaps to be max .5". | 2015 ABAAS<br>Section:<br>302.3<br><br>2012 TAS<br>Section:<br>302.3<br><br>2010 ADAS<br>Section:<br>302.3 | | |

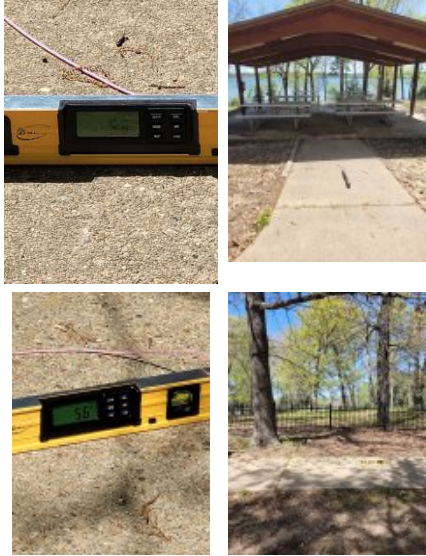
| Finding Number | Area Description | Lat/Long | Finding | As Built | Recommendation | Citation | Photos | Figure |
|---|---|---|---|--|---|--|---|---|
| 151 | Day Use Area:<br>Day Use - Group Pavilion | [33.0481273<br>,<br>-95.093383<br>3] | The running slope of walking surfaces shall not be steeper than 1:20. | 5.3% slope at entry to group pavilion, 5.6% by tree going towards restroom beyond pavilion | Correct running slope along the AR to max 5%. | 2015 ABAAS<br>Section:<br>403.3<br><br>2012 TAS<br>Section:<br>403.3<br><br>2010 ADAS<br>Section:<br>403.3 | | |

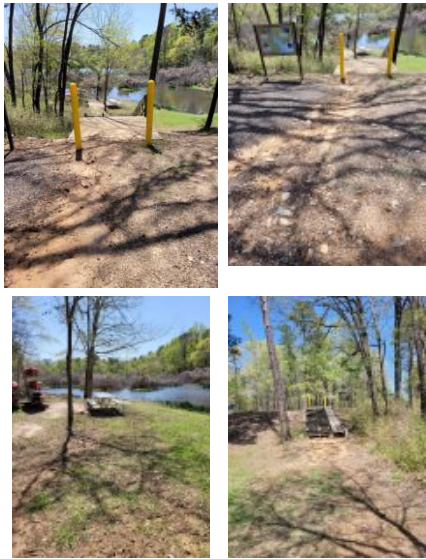
| Finding Number | Area Description | Lat/Long | Finding | As Built | Recommendation | Citation | Photos | Figure |
|---|---|---|--|--|---|---|---|---|
| 155 | Canoe Launch:<br>Canoe Launch | [33.0556924<br>,<br>-95.093434<br>3] | There is no accessible route to the water and canoe rental/storage. At least one accessible route shall connect accessible buildings, accessible facilities, accessible elements, and accessible spaces that are on the same site. | Lacks AR to water due to surface, and lacks AR to picnic table or canoe rental/storage | Create an accessible route with crushed stone or other outdoor material from parking or walkway to the water and canoe rental/storage. | 2015 ABAAS<br>Section:<br>F206.2.2<br><br>2012 TAS<br>Section:<br>206.2.2<br><br>2010 ADAS<br>Section:<br>206.2.2 | | |

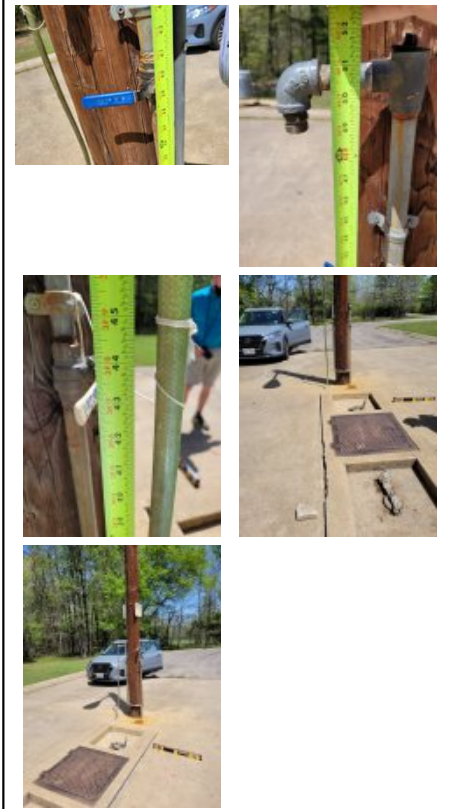
| Finding Number | Area Description | Lat/Long | Finding | As Built | Recommendation | Citation | Photos | Figure |
|---|---|---|---|---|--|---|--|---|
| 157 | Canoe Launch:<br>RV Dump Station | [33.0580517<br>,<br>-95.091875<br>9] | Water spouts at water hydrants and water utility hook-ups shall be 28 inches (710 mm) minimum and 36 inches (915 mm) maximum above the ground | Blue lever at 39" AGL, water spout at 49" AGL, white lever at 43" AGL | Remount at least one water spout to 28" min or 36" max above the ground as a smart practice. | 2015 ABAAS<br>Section:<br>1011.6 | | |

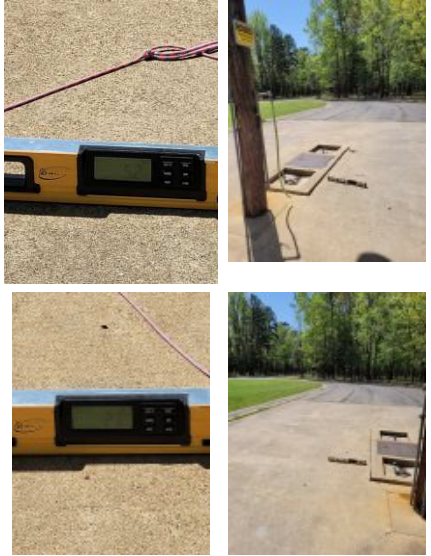
| Finding Number | Area Description | Lat/Long | Finding | As Built | Recommendation | Citation | Photos | Figure |
|---|---|---|--|--|---|--|--|---|
| 158 | Canoe Launch:<br>RV Dump Station | [33.0580573<br>,<br>-95.091871<br>9] | The 30 inches minimum by 48 inches minimum clear floor space required at the operable part is not flat (2% or 1:48 maximum slope) in all directions. Changes in level are not permitted at required clear floor or ground space except that slopes not steeper than 1:48 shall be permitted. | 5.2% slope on backside in CFS, 2.3% slope on road side | Correct or repair slope in CFS to max 2.08%. | 2015 ABAAS<br>Section:<br>305.2<br><br>2012 TAS<br>Section:<br>305.2<br><br>2010 ADAS<br>Section:<br>305.2 | | |

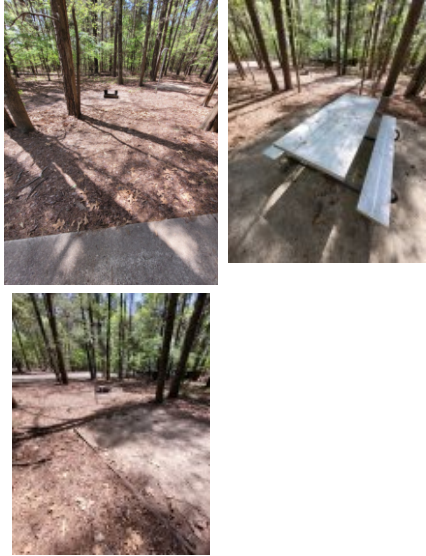
| Finding Number | Area Description | Lat/Long | Finding | As Built | Recommendation | Citation | Photos | Figure |
|---|---|---|---|---|--|---|---|---|
| 169 | Fort Sherman/Cherokee Trace (FS/CT) Camping Areas: FS/CT - Campsite | [33.0541108 , -95.087353 7] | The surface of the outdoor recreation access route, passing spaces, and/or resting intervals are not firm and stable. The surface of outdoor recreation access route, passing spaces, and resting intervals shall be firm and stable, having a width of 36", max gaps of .5" and tread obstacles of .5" or less. | Site 34 - Natural surface only, approximately 75' from parking pad to picnic table (most remote element in camp site), fire pit, tent pad, and hook | Correct surface of ORAR to be firm and stable, a min 36" wide and having gaps and changes in level of max .5". | 2015 ABAAS Section: 1016.2 | | |

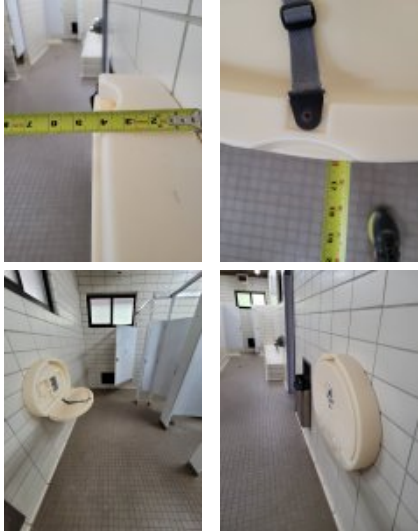
| Finding Number | Area Description | Lat/Long | Finding | As Built | Recommendation | Citation | Photos | Figure |
|---|---|---|--|--|---|--|---|---|
| 183 | Fort Sherman/Cherokee Trace (FS/CT) Camping Areas: FS/CT - Men's Restroom | [33.0542952 , -95.088075 2] | The baby changing table is not compliant. Baby changing tables are work surfaces. If fixed or built-in baby changing tables are provided, at least 5%, but not less than one, must comply with TAS 902 based TAS 226.1. Baby changing tables cannot violate the protruding object requirements in either an open or closed position since either position is a potential hazard for persons with visual impairments. Baby changing tables are not prohibited from being located in wheelchair accessible toilet compartments; however, the minimum space required for the compartment cannot be obstructed by the baby changing table in either an open or closed position. The clear floor space required for a baby changing table may overlap the water closet clearance since baby changing tables are considered convenience "fixtures" based on Advisory 604.8.1.1. The overlap is applicable only to the clear floor space and not to actual table itself. Baby changing tables must be dispersed throughout a space, however, an additional baby changing table is not required in a common use area of a toilet or bathing room when the only baby changing table is located in a toilet compartment. | Baby changing table protrudes 16" when in open position, 4.25" when in closed position | Relocate baby changing table to eliminate protrusion when in both the open and closed position. | 2012 TAS Section: 226.1, 902.3, 604.3.2, 204.1, 226.1 Advisory, 226.2, 307.1, 604.8.1.1 Advisory, 902.1, 902.1 Advisory, 902.2 | | |

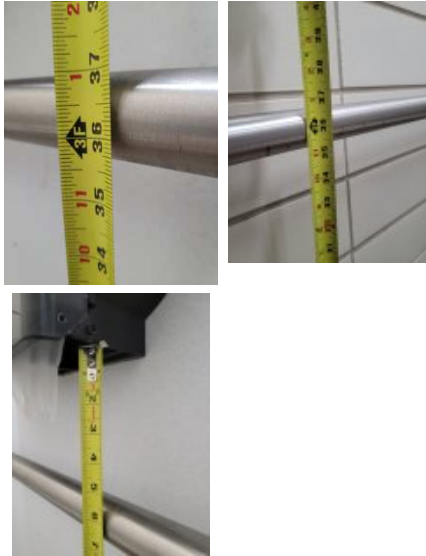
| Finding Number | Area Description | Lat/Long | Finding | As Built | Recommendation | Citation | Photos | Figure |
|---|---|---|--|--|---|---|--|---|
| 188 | Fort Sherman/Cherokee Trace (FS/CT) Camping Areas: FS/CT - Men's Restroom | [33.0542963, -95.0880766] | The grab bar height and/or spacing fails. Grab bars must be mounted between 33" and 36" to the top of the gripping surface. There must be 1.5" of clearance between the grab bar and the wall. There must be a minimum of 1.5" of clearance below and minimum 12" above the grab bar to any dispenser or other obstruction. | 1 bar at 36.5" AFF, 1 bar at 36.75" AFF, 5" between TP and bar | Remount grab bars in accessible stall to 33" to 36" above the finished floor (AFF). Remount toilet paper dispenser max 7" to 9" from front of toilet, 15" to 48" above the finished floor (AFF) and min 12" above or 1.5" below grab bar. | 2015 ABAAS Section: 609.3, 609.4<br><br>2012 TAS Section: 609.4, 609.3<br><br>2010 ADAS Section: 609.3, 609.4 | | |

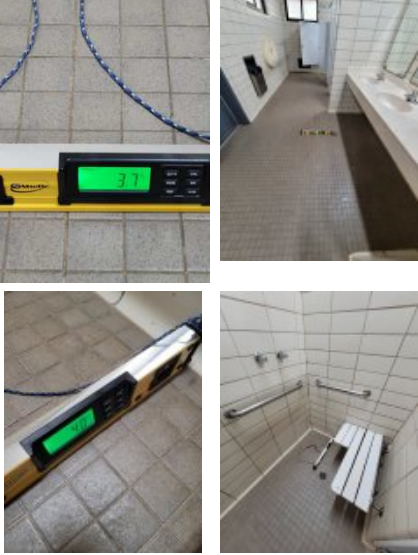
| Finding Number | Area Description | Lat/Long | Finding | As Built | Recommendation | Citation | Photos | Figure |
|---|---|---|---|--|--|--|--|---|
| 191 | Fort Sherman/Cherokee Trace (FS/CT) Camping Areas: FS/CT - Men's Restroom | [33.0542941 , -95.0880793] | The accessible route contains running slopes greater than 5 percent and cross slopes greater than 2 percent across the width of the walk and has not been constructed as a ramp (i.e. handrails, wheel guides, etc.). When the slope in the direction of travel of any walk exceeds 1 unit vertical in 20 units horizontal (5-percent slope), it must be constructed as ramp. Surface cross slopes must not exceed one unit vertical in 48 units. Horizontal (2-percent slope). | 3.7% at sink floor drain, 4% slope at shower drain | Correct or repair slope to max 2.08% in restroom. | 2015 ABAAS Section: 403.3<br>2012 TAS Section: 403.3<br>2010 ADAS Section: 403.3 | | |

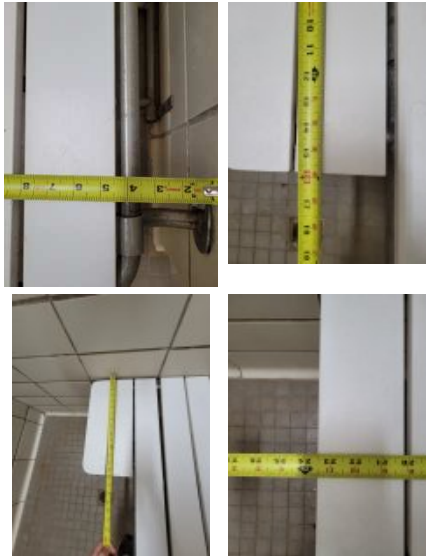
| Finding Number | Area Description | Lat/Long | Finding | As Built | Recommendation | Citation | Photos | Figure |
|---|---|---|--|---|---|--|--|---|
| 199 | Fort Sherman/Cherokee Trace (FS/CT) Camping Areas: FS/CT - Men's Restroom | [33.0542918 , -95.088079 3] | The shower seat does not have a compliant space between it and the wall. The folding seat must be mounted 17-19 inches above the floor, and have a maximum space of 1-1/2 inches between the edge of the seat and the side wall and 2-1/2 inches maximum to the seat wall. | 5.5" to back edge, 16" to back L from wall, 23.5" to end of L from wall | Remount shower seat to the correct location and height in the shower. | 2015 ABAAS Section: 610.3.2<br><br>2012 TAS Section: 610.3.2<br><br>2010 ADAS Section: 610.3.2 | | |

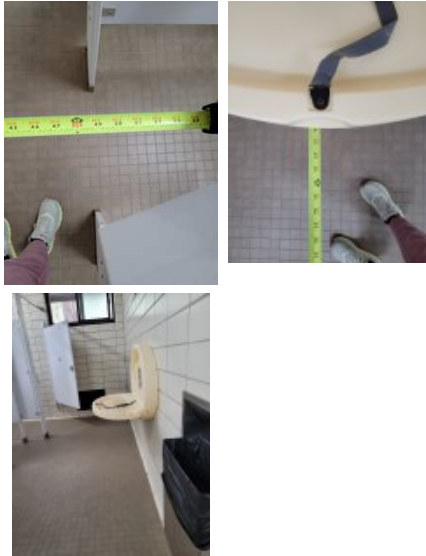
| Finding Number | Area Description | Lat/Long | Finding | As Built | Recommendation | Citation | Photos | Figure |
|---|---|---|--|--|---|--|---|---|
| 209 | Fort Sherman/Cherokee Trace (FS/CT) Camping Areas: FS/CT - Women's Restroom | [33.0542952 , -95.088075 2] | The baby changing table is not compliant. Baby changing tables are work surfaces. If fixed or built-in baby changing tables are provided, at least 5%, but not less than one, must comply with TAS 902 based TAS 226.1. Baby changing tables cannot violate the protruding object requirements in either an open or closed position since either position is a potential hazard for persons with visual impairments. Baby changing tables are not prohibited from being located in wheelchair accessible toilet compartments; however, the minimum space required for the compartment cannot be obstructed by the baby changing table in either an open or closed position. The clear floor space required for a baby changing table may overlap the water closet clearance since baby changing tables are considered convenience "fixtures" based on Advisory 604.8.1.1. The overlap is applicable only to the clear floor space and not to actual table itself. Baby changing tables must be dispersed throughout a space, however, an additional baby changing table is not required in a common use area of a toilet or bathing room when the only baby changing table is located in a toilet compartment. | Baby changing table projects 20" when in open position | Relocate baby changing table to eliminate protrusion when in the open position. | 2012 TAS Section: 226.1, 902.3, 604.3.2, 204.1, 226.1 Advisory, 226.2, 307.1, 604.8.1.1 Advisory, 902.1, 902.1 Advisory, 902.2 | | |

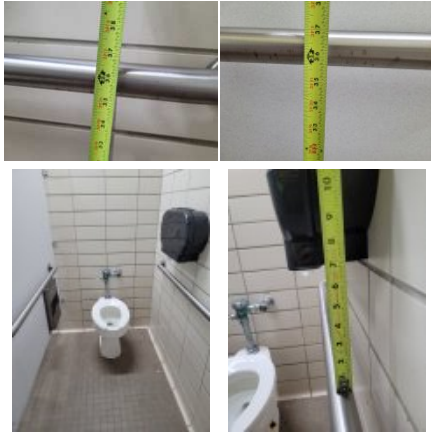
| Finding Number | Area Description | Lat/Long | Finding | As Built | Recommendation | Citation | Photos | Figure |
|---|---|---|--|---|---|---|---|---|
| 214 | Fort Sherman/Cherokee Trace (FS/CT) Camping Areas: FS/CT - Women's Restroom | [33.0542941, -95.0880739] | The grab bar height and/or spacing fails. Grab bars must be mounted between 33" and 36" to the top of the gripping surface. There must be 1.5" of clearance between the grab bar and the wall. There must be a minimum of 1.5" of clearance below and minimum 12" above the grab bar to any dispenser or other obstruction. | 36.75" tile side, 37" partition side, toilet paper 7" above bar | Remount grab bars in accessible stall to 33" to 36" above the finished floor (AFF). Remount toilet paper dispenser max 7" to 9" from front of toilet, 15" to 48" above the finished floor (AFF) and min 12" above or 1.5" below grab bar. | 2015 ABAAS Section: 609.3, 609.4<br><br>2012 TAS Section: 609.4, 609.3<br><br>2010 ADAS Section: 609.3, 609.4 | | |

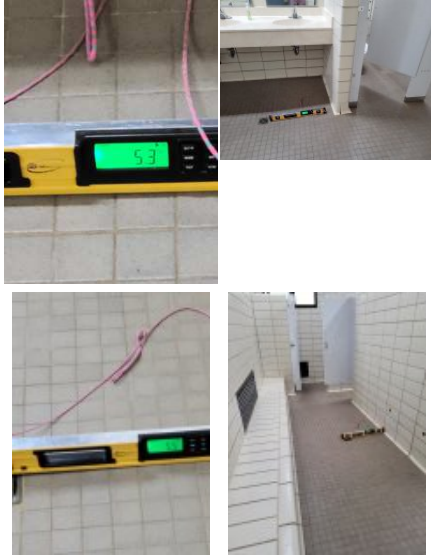
| Finding Number | Area Description | Lat/Long | Finding | As Built | Recommendation | Citation | Photos | Figure |
|---|---|---|---|--|--|--|--|---|
| 217 | Fort Sherman/Cherokee Trace (FS/CT) Camping Areas: FS/CT - Women's Restroom | [33.0542929 , -95.088073 9] | The accessible route contains running slopes greater than 5 percent and cross slopes greater than 2 percent across the width of the walk and has not been constructed as a ramp (i.e. handrails, wheel guides, etc.). When the slope in the direction of travel of any walk exceeds 1 unit vertical in 20 units horizontal (5-percent slope), it must be constructed as ramp. Surface cross slopes must not exceed one unit vertical in 48 units. Horizontal (2-percent slope). | 5.3% cross slope in front of sink closest to stalls, 5.5% cross slope by drain in hallway near accessible shower entry | Correct or repair slope to max 2.08% in restroom. | 2015 ABAAS Section: 403.3<br><br>2012 TAS Section: 403.3<br><br>2010 ADAS Section: 403.3 | | |

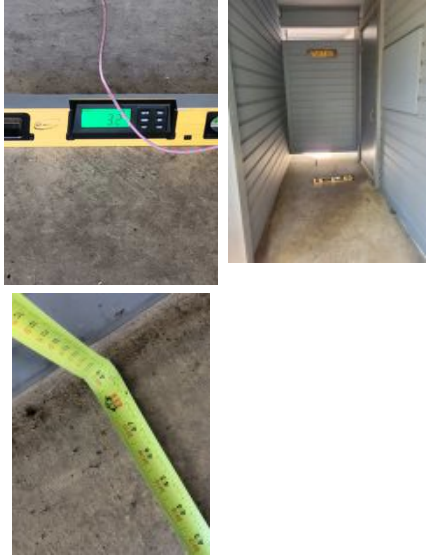
| Finding Number | Area Description | Lat/Long | Finding | As Built | Recommendation | Citation | Photos | Figure |
|---|---|---|---|--|--|--|--|---|
| 218 | Fort Sherman/Cherokee Trace (FS/CT) Camping Areas: FS/CT - Women's Restroom | [33.0542941 , -95.088076 6] | Minimum maneuvering clearances at doors and gates shall comply with 404.2.4. Maneuvering clearances shall extend the full width of the doorway and the required latch side or hinge side clearance. Maneuvering clearances shall have a max slope of 2.08%. | women's- 3.2% slope, latch approach back on pull side is 49" | For all doors along the public circulation route, provide required maneuvering clearance on push and pull side of doors. For all doors along the public circulation route, correct slope in door clearance to max 2.08%. | 2010 ADAS Section: 404.2.3, 404.2.7, 404.2.4, 404.2.11, 404.2.11 Exception | | |
