# Access Audit Site Report

**Lake Bob Sandlin State Park**

**Accessibility Evaluation**

**Inspection Date: 04/06/2022**

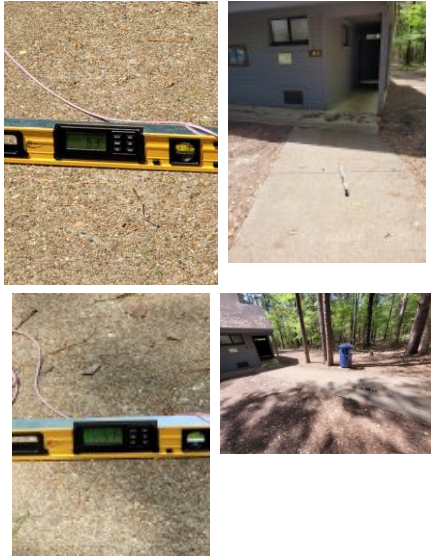
| Finding Number | Area Description | Lat/Long | Finding | As Built | Recommendation | Citation | Photos | Figure |
|---|---|---|--|--|---|--|--|---|
| 221 | Fort Sherman/Cherokee Trace (FS/CT) Camping Areas: FS/CT - Women's Restroom | [33.0542727 , -95.0880592] | The running slope of walking surfaces shall not be steeper than 1:20. | 6.3% slope at bottom of path to restroom, 5.7% at top | Correct running slope along the AR to max 5%. | 2015 ABAAS Section: 403.3<br>2012 TAS Section: 403.3<br>2010 ADAS Section: 403.3 | | |

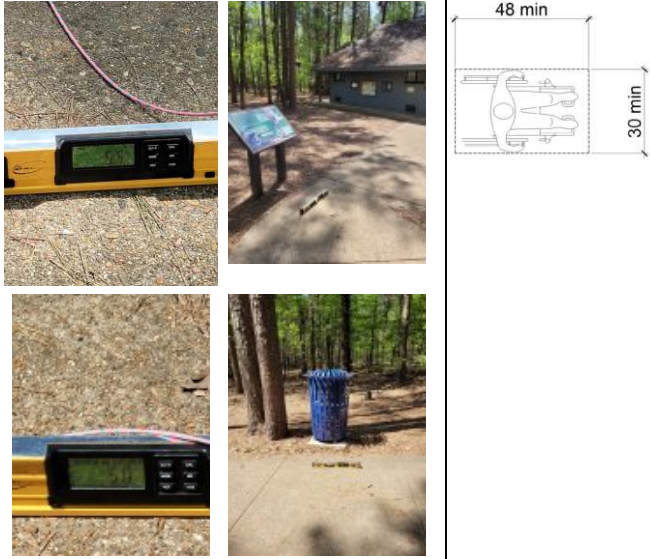
| Finding Number | Area Description | Lat/Long | Finding | As Built | Recommendation | Citation | Photos | Figure |
|---|---|---|--|--|---|--|--|---|
| 222 | Fort Sherman/Cherokee Trace (FS/CT) Camping Areas: FS/CT - Women's Restroom | [33.0542896 , -95.0880377] | The 30 inches minimum by 48 inches minimum clear floor space required at the operable part is not flat (2% or 1:48 maximum slope) in all directions. Changes in level are not permitted at required clear floor or ground space except that slopes not steeper than 1:48 shall be permitted. | 5.5% slope in CFS for racoon sign, 5% slope in CFS for recycling | Correct or repair slope in CFS to max 2.08%. | 2015 ABAAS Section: 305.2<br>2012 TAS Section: 305.2<br>2010 ADAS Section: 305.2 | | |

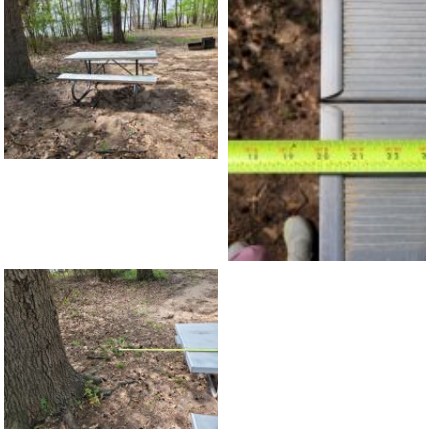
| Finding Number | Area Description | Lat/Long | Finding | As Built | Recommendation | Citation | Photos | Figure |
|---|---|---|--|--|--|---|---|---|
| 229 | Moccasin Track/Broken Bow (MT/BB) Camping Areas: MT/BB - Shelter Campsite | [33.0569322 , -95.0802097] | 36 inches (915 mm) on all usable sides of the table measured from the back edge of the benches. | Site 80 - Lacks 36" around picnic table - natural surface doesn't comply, table 20" to tree root | Provide required 36" clear ground space around all usable portions of the table as a smart practice. | 2015 ABAAS Section: 1011.2.1 | | |

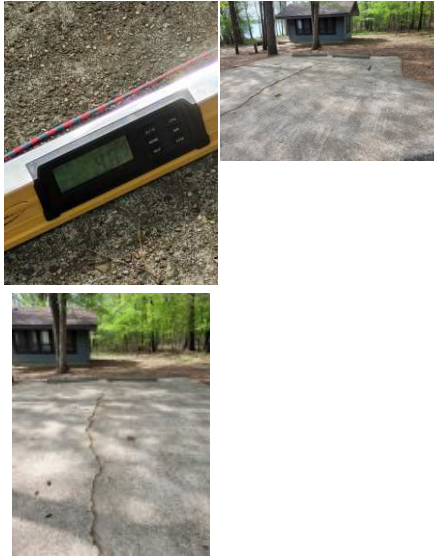
| Finding Number | Area Description | Lat/Long | Finding | As Built | Recommendation | Citation | Photos | Figure |
|---|---|---|---|--|---|---|--|---|
| 233 | Moccasin Track/Broken Bow (MT/BB) Camping Areas: MT/BB - Shelter Campsite | [33.0569423 , -95.0802056] | The surface of parking spaces and pull-up spaces shall be firm and stable. The slope of the surface of parking spaces and pull-up spaces shall not be steeper than 1:48 in any direction. EXCEPTION: Where the surface is other than asphalt, concrete, or boards, slopes not steeper than 1:20 shall be permitted when necessary for drainage. | Site 80 - Right space - 4%, large crack within | Correct surface of parking spaces to be firm and stable with slopes max of 2.08% or 5% for surfaces other than concrete, asphalt or boards as a smart practice. | 2015 ABAAS Section: 1012.4, 1012.5, 1012.5 EXCEPTION | | |

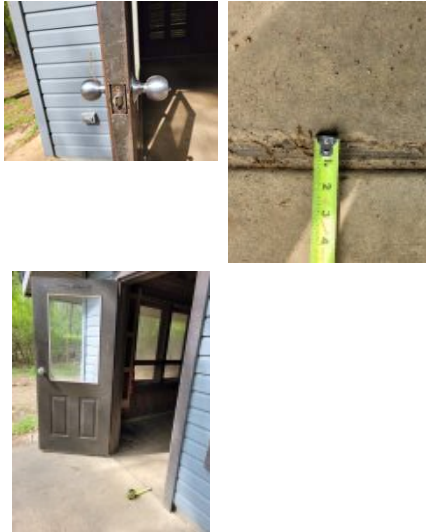
| Finding Number | Area Description | Lat/Long | Finding | As Built | Recommendation | Citation | Photos | Figure |
|---|---|---|---|--|--|--|--|---|
| 235 | Moccasin Track/Broken Bow (MT/BB) Camping Areas: MT/BB - Shelter Campsite | [33.0569356 , -95.080211] | The threshold has a gap greater than 1/2 inch wide. Hand-activated door opening hardware, handles, pulls, latches, locks, and other operating devices on accessible doors shall have a shape that is easy to grasp with one hand and does not require tight grasping, tight pinching or twisting of the wrist to operate. Hardware shall be 34 inches minimum and 48 inches maximum above the finish floor or ground. | Shelter 80 door - knob, 1.25" gap | For all doors along the public circulation fill gaps at door entries to max .5". For all doors along the public circulation route, replace hardware with lever hardware or hardware operable without a tight pinch or grasp. | 2010 ADAS Section: 404.2.3, 404.2.7, 404.2.4, 404.2.11, 404.2.11 Exception | | |

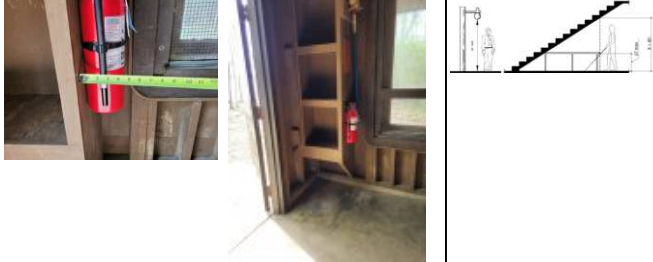
| Finding Number | Area Description | Lat/Long | Finding | As Built | Recommendation | Citation | Photos | Figure |
|---|---|---|---|--|--|--|--|---|
| 236 | Moccasin Track/Broken Bow (MT/BB) Camping Areas: MT/BB - Shelter Campsite | [33.0569378 , -95.0802056] | An item or items project more than 4 inches into the circulation path. Wall-mounted objects that have leading edges between 27 inches and 80 inches from the floor must not project more than 4 inches into the circulation path. Protruding objects that extend to the floor or within 27 inches of the floor are cane detectable and are therefore not hazardous. Where it is necessary or desirable to have objects protrude from the wall, a manner of cane detection must be provided. | Site 80 - Fire extinguisher protrudes 4.5" | Relocate protruding objects or place cane detectable warning or bollard at foot of item. | 2015 ABAAS Section: 307.2<br><br>2012 TAS Section: 307.2<br><br>2010 ADAS Section: 307.2 | | |

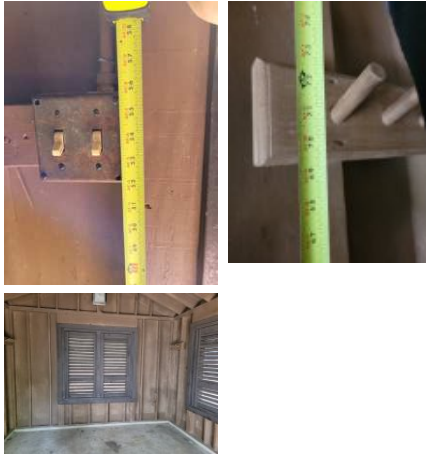
| Finding Number | Area Description | Lat/Long | Finding | As Built | Recommendation | Citation | Photos | Figure |
|---|---|---|---|---|--|---|--|---|
| 237 | Moccasin Track/Broken Bow (MT/BB) Camping Areas: MT/BB - Shelter Campsite | [33.0569412 , -95.080223 1] | The operable part is positioned too high for either a side or front approach. Where a clear floor or ground space allows a parallel approach to an element and the side reach is unobstructed, the high side reach shall be 48 inches maximum and the low side reach shall be 15 inches minimum above the finish floor or ground. Where a forward reach is unobstructed, the high forward reach shall be 48 inches maximum and the low forward reach shall be 15 inches minimum above the finish floor or ground. | Site 80 - Light switches at 53" AFF, hooks at 72" AFF | Remount operable parts to be in reach range of 15" min to 48" max. | 2015 ABAAS Section: 308.1<br><br>2012 TAS Section: 308.1<br><br>2010 ADAS Section: 308.1 | | |

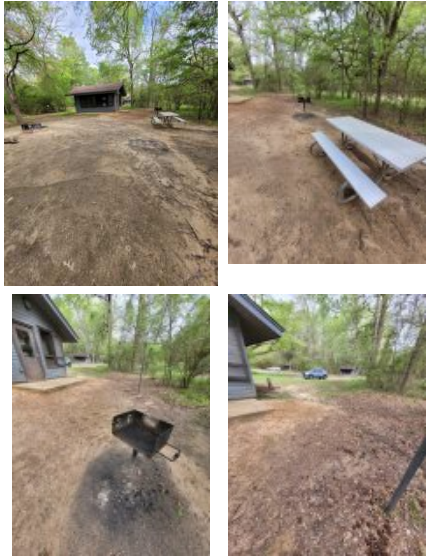
| Finding Number | Area Description | Lat/Long | Finding | As Built | Recommendation | Citation | Photos | Figure |
|---|---|---|---|--|--|--|--|---|
| 240 | Moccasin Track/Broken Bow (MT/BB) Camping Areas: MT/BB - Campsite | [33.0561153, -95.081539 7] | An accessible access route is not provided between elements, spaces and the facilities provided within the accessible camping unit. At least one outdoor recreation access route shall connect accessible elements, spaces and facilities provided within camping units with mobility features. Picnic tables shall provide at least one wheelchair space for each 24 linear feet (7320 mm) of usable table surface perimeter. Wheelchair spaces shall be 30 inches (760 mm) minimum by 48 inches (1220 mm) minimum. Wheelchair spaces shall be positioned for a forward approach to the table and provide knee and toe clearance complying with 306 under the table. | Cottage 66 - lacks AR to water spout, to entry porch, to camp hook, to 1 of 2 grills, to 1 of 1 non-compliant picnic table | Create AR with crushed and compacted stone or similar outdoor material to camp sites and one of each type of amenity. Replace picnic table with one of an accessible design as a smart practice. | 2015 ABAAS Section: F244.5.1 | | |

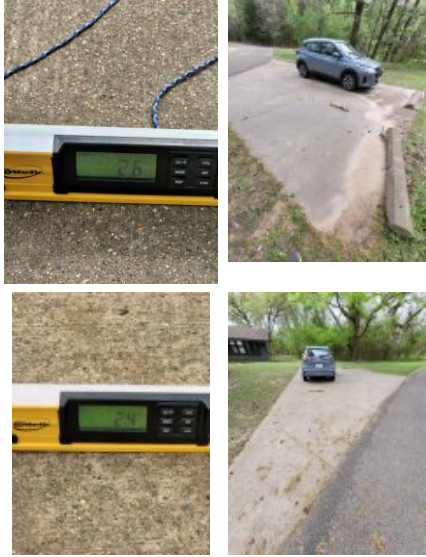
| Finding Number | Area Description | Lat/Long | Finding | As Built | Recommendation | Citation | Photos | Figure |
|---|---|---|---|--|---|--|---|---|
| 241 | Moccasin Track/Broken Bow (MT/BB) Camping Areas: MT/BB - Campsite | [33.0562154 , -95.081573 3] | The surface of parking spaces and pull-up spaces shall be firm and stable. The slope of the surface of parking spaces and pull-up spaces shall not be steeper than 1:48 in any direction. EXCEPTION: Where the surface is other than asphalt, concrete, or boards, slopes not steeper than 1:20 shall be permitted when necessary for drainage. | Cottage 66 - lacks accessible parking, right space 2.6% slope, left space 2.4% slope | Correct surface of parking spaces to be firm and stable with slopes max of 2.08% or 5% for surfaces other than concrete, asphalt or boards as a smart practice. | 2015 ABAAS Section: 1012.4, 1012.5, 1012.5 EXCEPTION | | |

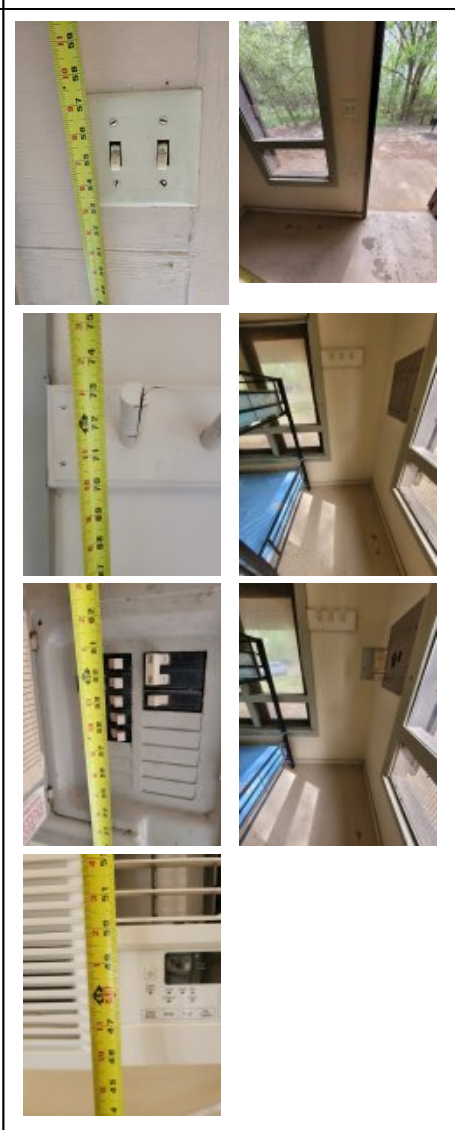
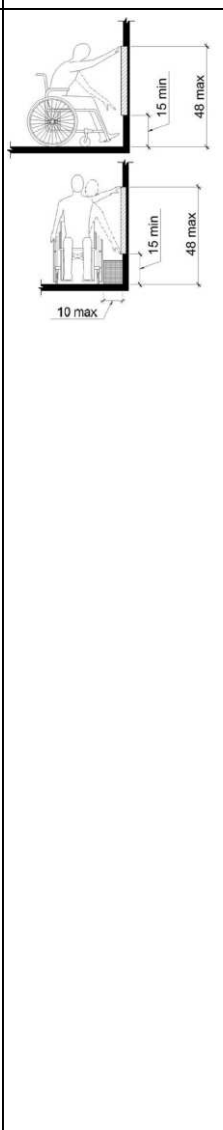
| Finding Number | Area Description | Lat/Long | Finding | As Built | Recommendation | Citation | Photos | Figure |
|---|---|---|---|--|--|--|--|--|
| 244 | Moccasin Track/Broken Bow (MT/BB) Camping Areas: MT/BB - Campsite | [33.0560925 , -95.081523 9] | The operable part is positioned too high for either a side or front approach. Where a clear floor or ground space allows a parallel approach to an element and the side reach is unobstructed, the high side reach shall be 48 inches maximum and the low side reach shall be 15 inches minimum above the finish floor or ground. Where a forward reach is unobstructed, the high forward reach shall be 48 inches maximum and the low forward reach shall be 15 inches minimum above the finish floor or ground. | Cottage 66 - Light switches at 55" AFF and hook at 73" AFF, AC controls at 48.5" AFF | Remount operable parts to be in reach range of 15" min to 48" max. | 2015 ABAAS Section: 308.1<br>2012 TAS Section: 308.1<br>2010 ADAS Section: 308.1 | | |

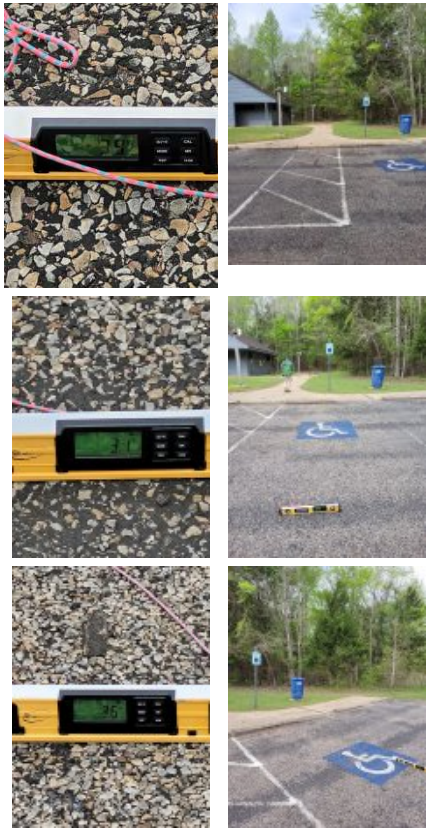
| Finding Number | Area Description | Lat/Long | Finding | As Built | Recommendation | Citation | Photos | Figure |
|---|--|---|--|---|--|--|--|---|
| 246 | Moccasin Track/Broken Bow (MT/BB) Camping Areas: MT/BB - Parking | [33.0567782, -95.081326 8] | The cross slopes (narrow dimension) and/or running slopes (long dimension) of the access aisle exceeds 2%. The running slope and the cross slope in an accessible parking stall and the access aisle must not exceed 2%. | Access aisle - 3.9% slope, stall - 3.1% slope, 3.6% | Repair or correct slope of parking space and access aisle to max 2.08% in any direction. | 2015 ABAAS Section: 502.4<br>2012 TAS Section: 502.4<br>2010 ADAS Section: 502.4 | | |

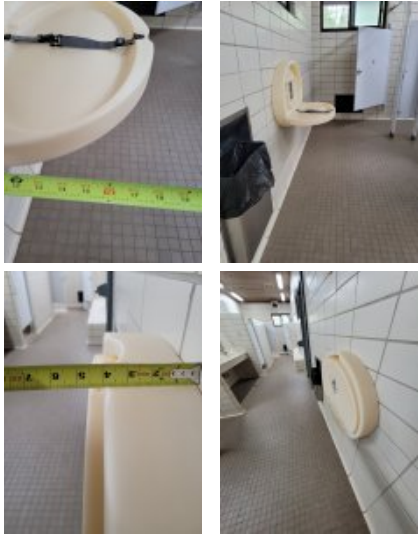
| Finding Number | Area Description | Lat/Long | Finding | As Built | Recommendation | Citation | Photos | Figure |
|---|---|---|--|--|---|--|--|---|
| 248 | Moccasin Track/Broken Bow (MT/BB) Camping Areas: MT/BB - Men's Restroom | [33.0566883 , -95.081549 4] | The baby changing table is not compliant. Baby changing tables are work surfaces. If fixed or built-in baby changing tables are provided, at least 5%, but not less than one, must comply with TAS 902 based TAS 226.1. Baby changing tables cannot violate the protruding object requirements in either an open or closed position since either position is a potential hazard for persons with visual impairments. Baby changing tables are not prohibited from being located in wheelchair accessible toilet compartments; however, the minimum space required for the compartment cannot be obstructed by the baby changing table in either an open or closed position. The clear floor space required for a baby changing table may overlap the water closet clearance since baby changing tables are considered convenience "fixtures" based on Advisory 604.8.1.1. The overlap is applicable only to the clear floor space and not to actual table itself. Baby changing tables must be dispersed throughout a space, however, an additional baby changing table is not required in a common use area of a toilet or bathing room when the only baby changing table is located in a toilet compartment. | Baby changing table projects 17" when in open position, 4.5" when in the closed position | Relocate baby changing table to eliminate protrusion when in the open position. | 2012 TAS Section: 226.1, 902.3, 604.3.2, 204.1, 226.1 Advisory, 226.2, 307.1, 604.8.1.1 Advisory, 902.1, 902.1 Advisory, 902.2 | | |

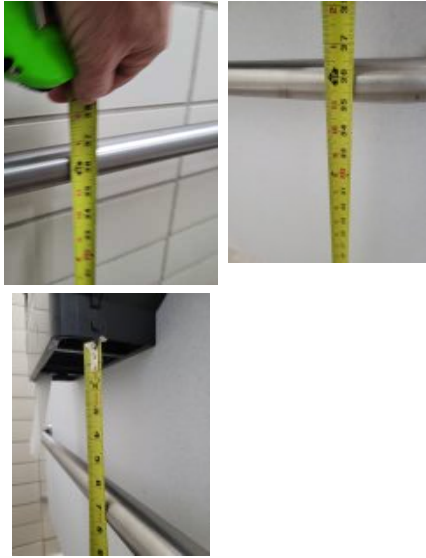
| Finding Number | Area Description | Lat/Long | Finding | As Built | Recommendation | Citation | Photos | Figure |
|---|---|---|--|---|---|---|--|---|
| 260 | Moccasin Track/Broken Bow (MT/BB) Camping Areas: MT/BB - Men's Restroom | [33.0566928, -95.0815615] | The grab bar height and/or spacing fails. Grab bars must be mounted between 33" and 36" to the top of the gripping surface. There must be 1.5" of clearance between the grab bar and the wall. There must be a minimum of 1.5" of clearance below and minimum 12" above the grab bar to any dispenser or other obstruction. | Both bars at 36.5" AFF, 6" between TP dispenser and bar | Remount grab bars in accessible stall to 33" to 36" above the finished floor (AFF). Remount toilet paper dispenser max 7" to 9" from front of toilet, 15" to 48" above the finished floor (AFF) and min 12" above or 1.5" below grab bar. | 2015 ABAAS Section: 609.3, 609.4<br><br>2012 TAS Section: 609.4, 609.3<br><br>2010 ADAS Section: 609.3, 609.4 | | |

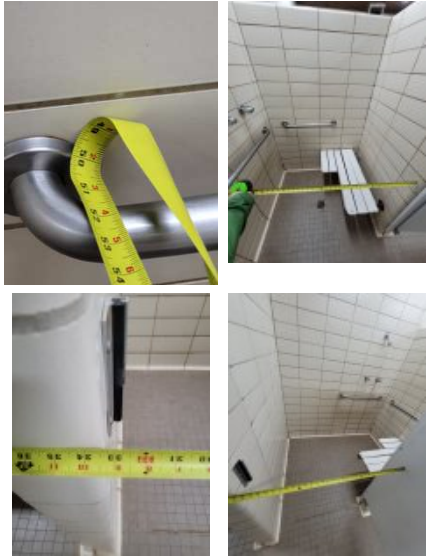
| Finding Number | Area Description | Lat/Long | Finding | As Built | Recommendation | Citation | Photos | Figure |
|---|---|---|--|---|---|--|--|---|
| 264 | Moccasin Track/Broken Bow (MT/BB) Camping Areas: MT/BB - Men's Restroom | [33.0566804 , -95.0815602] | Alternate roll-in type shower compartments shall be 36 inches (915 mm) wide and 60 inches (1525 mm) deep minimum clear inside dimensions measured at center points of opposing sides. A 36 inch (915 mm) wide minimum entry shall be provided at one end of the long side of the compartment. | 49" deep, 33.5" opening | Renovate shower stall, if feasible, to compliant dimensions for an alternate roll in shower of 36" deep by 60" wide with a 36" opening on the long dimension. | 2015 ABAAS Section: 608.2.3<br>2012 TAS Section: 608.2.3<br>2010 ADAS Section: 608.2.3 | | |

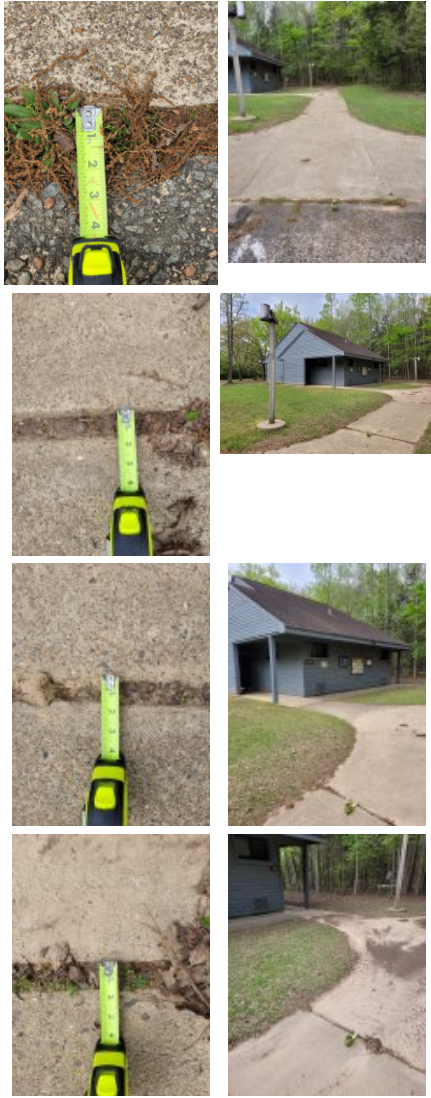
| Finding Number | Area Description | Lat/Long | Finding | As Built | Recommendation | Citation | Photos | Figure |
|---|---|---|--|---|---|--|--|---|
| 271 | Moccasin Track/Broken Bow (MT/BB) Camping Areas: MT/BB - Women's Restroom | [33.0567703 , -95.081525 3] | There is a gap spaced greater than a 1/2 inch. Openings in floor or ground surfaces shall not allow passage of a sphere more than 1/2 inch diameter. Elongated openings shall be placed so that the long dimension is perpendicular to the dominant direction of travel. | 2.5" gap at AR to restroom building from lot, 1.5" gap by light post, 1.5" at turn to women's restroom, 1.5" gap at turn to men's restroom, 1.25" gap at entry to men's restroom, 1.5" gap at entry to women's restroom | Correct or fill gaps to be max .5". | 2015 ABAAS Section: 302.3<br><br>2012 TAS Section: 302.3<br><br>2010 ADAS Section: 302.3 | | |

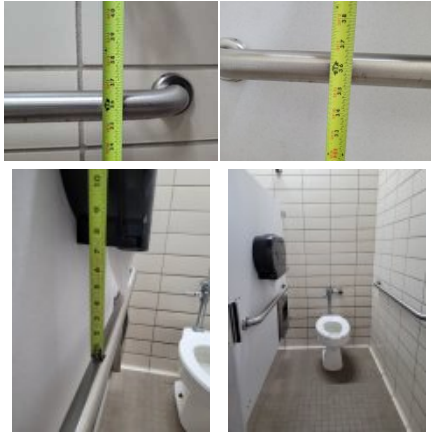
| Finding Number | Area Description | Lat/Long | Finding | As Built | Recommendation | Citation | Photos | Figure |
|---|---|---|---|--|---|---|---|---|
| 279 | Moccasin Track/Broken Bow (MT/BB) Camping Areas: MT/BB - Women's Restroom | [33.0566905, -95.0815561] | The grab bar height and/or spacing fails. Grab bars must be mounted between 33" and 36" to the top of the gripping surface. There must be 1.5" of clearance between the grab bar and the wall. There must be a minimum of 1.5" of clearance below and minimum 12" above the grab bar to any dispenser or other obstruction. | Grab bars at 36.5" AFF, TP over grab bar 7.25" | Remount grab bars in accessible stall to 33" to 36" above the finished floor (AFF). Remount toilet paper dispenser max 7" to 9" from front of toilet, 15" to 48" above the finished floor (AFF) and min 12" above or 1.5" below grab bar. | 2015 ABAAS Section: 609.3, 609.4<br><br>2012 TAS Section: 609.4, 609.3<br><br>2010 ADAS Section: 609.3, 609.4 | | |

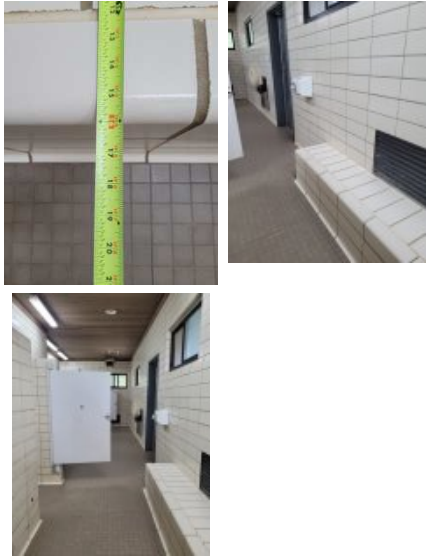
| Finding Number | Area Description | Lat/Long | Finding | As Built | Recommendation | Citation | Photos | Figure |
|---|---|---|--|--|--|---|--|--|
| 282 | Moccasin Track/Broken Bow (MT/BB) Camping Areas: MT/BB - Women's Restroom | [33.0566928 , -95.081564 2] | The bench is not deep enough or long enough or is missing. Benches shall be provided having seats that are 42 inches long minimum and 20 inches deep minimum and 24 inches deep maximum. The bench shall provide for back support or shall be affixed to a wall. Back support shall be 42 inches (1065 mm) long minimum and shall extend from a point 2 inches (51 mm) maximum above the seat surface to a point 18 inches (455 mm) minimum above the seat surface. Back support shall be 2½ inches (64 mm) maximum from the rear edge of the seat measured horizontally. The top of the bench seat surface shall be 17 inches (430 mm) minimum and 19 inches (485 mm) maximum above the finish floor or ground. Clear floor or ground space complying with 305 shall be provided and shall be positioned at the end of the bench seat and parallel to the short axis of the bench | 16" depth, clearance reduced by hand dryer and shower stall door | Replace bench in dressing area with one having a seat depth of 20" to 24" deep, 42" long, affixed to the wall or having a back and mounted 17" to 19" AFF and provide required clear floor space on the short axis of the bench. | 2012 TAS Section: 903.4, 903.2, 903.3, 903.5<br><br>2010 ADAS Section: 903.4, 903.2, 903.3, 903.5 | | |

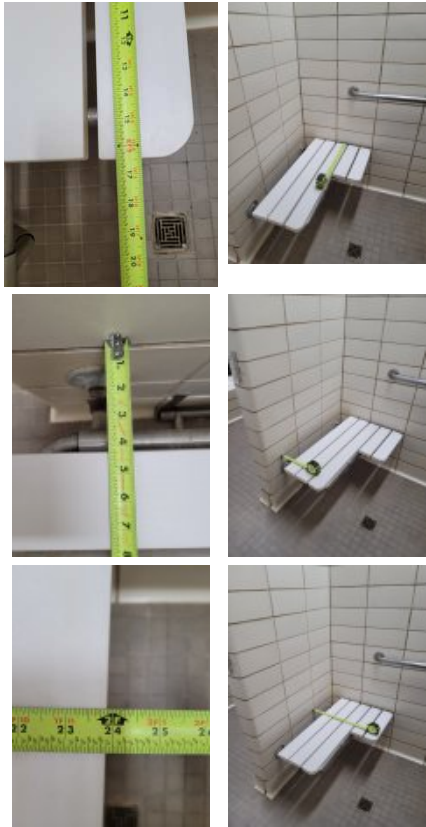
| Finding Number | Area Description | Lat/Long | Finding | As Built | Recommendation | Citation | Photos | Figure |
|---|---|---|--|--|---|--|--|---|
| 287 | Moccasin Track/Broken Bow (MT/BB) Camping Areas: MT/BB - Women's Restroom | [33.0566883, -95.081553 5] | The shower seat does not have a compliant space between it and the wall. The folding seat must be mounted 17-19 inches above the floor, and have a maximum space of 1-1/2 inches between the edge of the seat and the side wall and 2-1/2 inches maximum to the seat wall. | 16.5" from adjacent wall to wide part of L, 4.25" gap on backside, wide part of L is 24.75" from back wall | Remount shower seat to the correct location and height in the shower. | 2015 ABAAS Section: 610.3.2<br>2012 TAS Section: 610.3.2<br>2010 ADAS Section: 610.3.2 | | |
