Access Audit Site Report

Lake Brownwood State Park
200 State Hwy Park Rd 15
Brownwood, TX 76801
Accessibility Evaluation
Inspection Date: 02/28/2022
Inspectors: Tanya Scheibe

Prepared By
WT Group

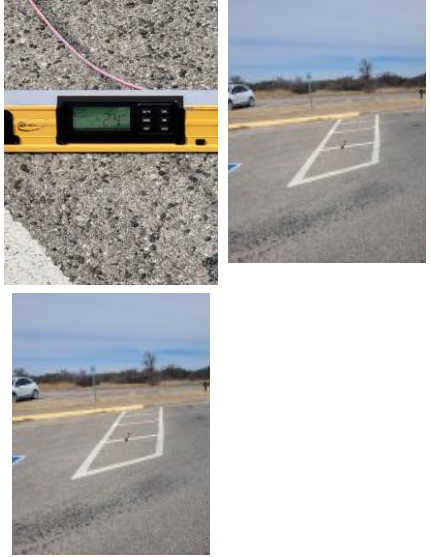
4	Headquarters (HQ) : HQ - Parking	[31.8569385 , -99.028369 8]	The cross slopes (narrow dimension) and/or running slopes (long dimension) of the access aisle exceeds 2%. The running slope and the cross slope in an accessible parking stall and the access aisle must not exceed 2%.	HQ parking - access aisle - 2.4% slope	Repair or correct slope of parking space and access aisle to max 2.08% in any direction.	2015 ABAAS Section: 502.4 2012 TAS Section: 502.4 2010 ADAS Section: 502.4

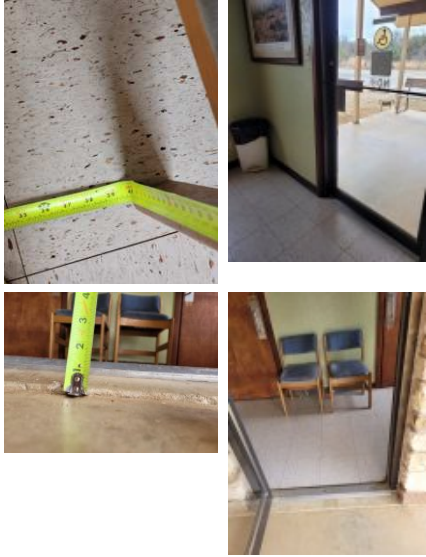
Finding Number	Area Description	Lat/Long	Finding	As Built	Recommendation	Citation	Photos	Figure
8	Headquarters (HQ) : HQ - Public Spaces	[31.8570034 , -99.028607 1]	Minimum maneuvering clearances at doors and gates shall comply with 404.2.4. Maneuvering clearances shall extend the full width of the doorway and the required latch side or hinge side clearance. Maneuvering clearances shall have a max slope of 2.08%. The threshold has a vertical change greater than 1/4 inch high. All interior doors must be maintained so that the operating pressure does not exceed 5 lb. force to open.	restroom double door exterior entry - 40" back MC on push side due to chairs, 10# push, 1.5" CIL	For all doors along the public circulation route, provide required maneuvering clearance on push and pull side of doors. For all doors along the public circulation route, repair, bevel, or ramp CILs at door entries to max .25". For all doors along the public circulation route, inspect, adjust, and maintain 5 lbf to open interior doors.	2010 ADAS Section: 404.2.3, 404.2.7, 404.2.4, 404.2.11, 404.2.11 Exception

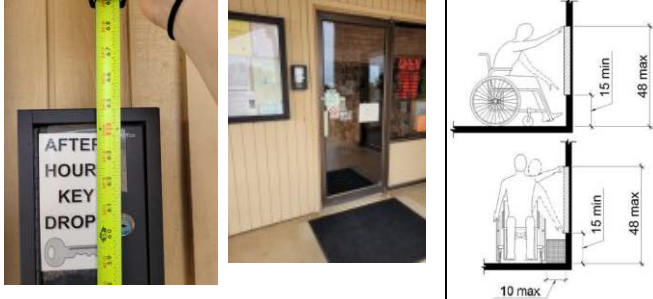
9	Headquarters (HQ) : HQ - Public Spaces	[31.8570011 , -99.028585 7]	The operable part is positioned too high for either a side or front approach. Where a clear floor or ground space allows a parallel approach to an element and the side reach is unobstructed, the high side reach shall be 48 inches maximum and the low side reach shall be 15 inches minimum above the finish floor or ground. Where a forward reach is unobstructed, the high forward reach shall be 48 inches maximum and the low forward reach shall be 15 inches minimum above the finish floor or ground.	key drop 65" AFF	Remount operable parts to be in reach range of 15" min to 48" max	2015 ABAAS Section: 308.1 2012 TAS Section: 308.1 2010 ADAS Section: 308.1

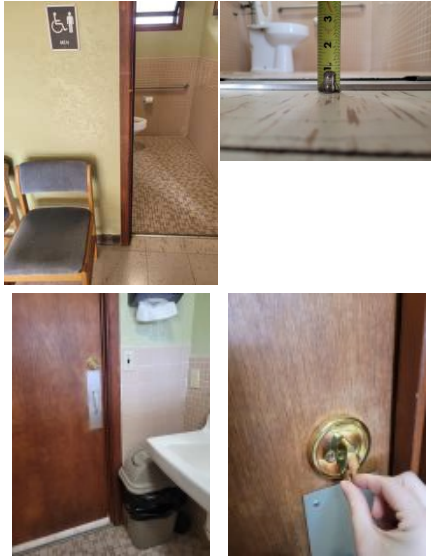
Finding Number	Area Description	Lat/Long	Finding	As Built	Recommendation	Citation	Photos	Figure
13	Headquarters (HQ) : HQ - Men's Restroom	[31.8569989 , -99.028607 1]	Minimum maneuvering clearances at doors and gates shall comply with 404.2.4. Maneuvering clearances shall extend the full width of the doorway and the required latch side or hinge side clearance. Maneuvering clearances shall have a max slope of 2.08%. The threshold has a vertical change greater than 1/4 inch high. All interior doors must be maintained so that the operating pressure does not exceed 5 lb. force to open. Hand-activated door opening hardware, handles, pulls, latches, locks, and other operating devices on accessible doors shall have a shape that is easy to grasp with one hand and does not require tight grasping, tight pinching or twisting of the wrist to operate. Hardware shall be 34 inches minimum and 48 inches maximum above the finish floor or ground.	men's door - .5 CIL, lock requires pinch, maneuvering clearance on pull reduced by chairs, maneuvering clearance on push reduced by sink and trash	For all doors along the public circulation route, provide required maneuvering clearance on push and pull side of doors. For all doors along the public circulation route, repair, bevel, or ramp CILs at door entries to max .25". For all doors along the public circulation route, inspect, adjust, and maintain 5 lbf to open interior doors. For all doors along the public circulation route, replace hardware with lever hardware or hardware operable without a tight pinch or grasp.	2010 ADAS Section: 404.2.3, 404.2.7, 404.2.4, 404.2.11, 404.2.11 Exception

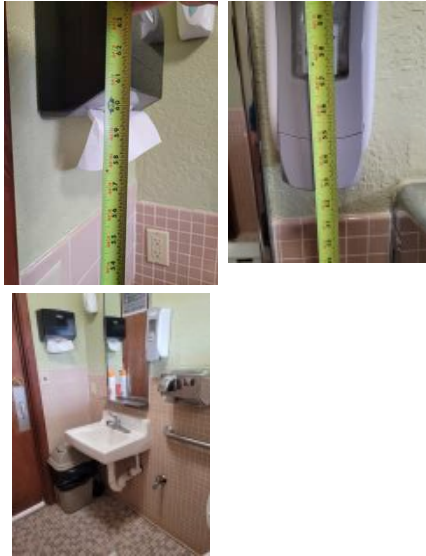
Finding Number	Area Description	Lat/Long	Finding	As Built	Recommendation	Citation	Photos	Figure
15	Headquarters (HQ) : HQ - Men's Restroom	[31.8570171 , -99.0285884]	Where a high forward reach is over an obstruction, the clear floor space shall extend beneath the element for a distance not less than the required reach depth over the obstruction. The high forward reach shall be 48 inches (1220 mm) maximum where the reach depth is 20 inches (510 mm) maximum. Where the reach depth exceeds 20 inches (510 mm), the high forward reach shall be 44 inches (1120 mm) maximum and the reach depth shall be 25 inches (635 mm) maximum. Where a clear floor or ground space allows a parallel approach to an element and the high side reach is over an obstruction, the height of the obstruction shall be 34 inches (865 mm) maximum and the depth of the obstruction shall be 24 inches (610 mm) maximum. The high side reach shall be 48 inches (1220 mm) maximum for a reach depth of 10 inches (255 mm) maximum. Where the reach depth exceeds 10 inches (255 mm), the high side reach shall be 46 inches (1170 mm) maximum for a reach depth of 24 inches (610 mm) maximum.	paper towels 58" AFF, soap 54" AFF	Lower operating mechanisms to max 48" above the finished floor (AFF) to highest operable part. Lower soap dispenser to max 44" above the finished floor (AFF) for a forward reach over counter.	2015 ABAAS Section: 308.2.1, 308.3.2 2012 TAS Section: 308.2.1, 308.3.2 2010 ADAS Section: 308.2.1, 308.3.2

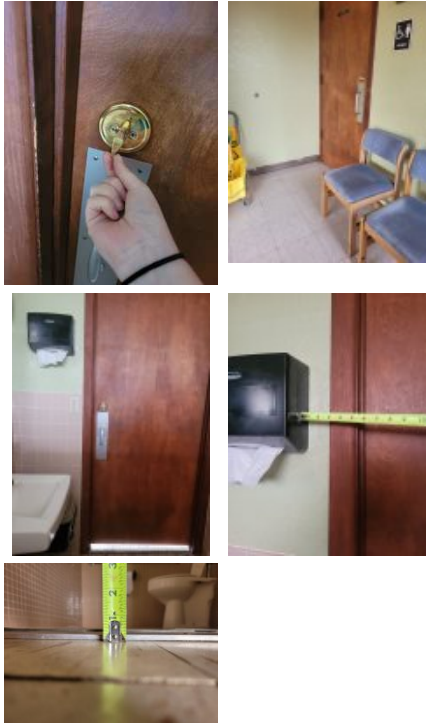
Finding Number	Area Description	Lat/Long	Finding	As Built	Recommendation	Citation	Photos	Figure
27	Headquarters (HQ) : HQ - Women's Restroom	[31.8569966 , -99.028604 5]	Minimum maneuvering clearances at doors and gates shall comply with 404.2.4. Maneuvering clearances shall extend the full width of the doorway and the required latch side or hinge side clearance. Maneuvering clearances shall have a max slope of 2.08%. The threshold has a vertical change greater than 1/4 inch high. Hand-activated door opening hardware, handles, pulls, latches, locks, and other operating devices on accessible doors shall have a shape that is easy to grasp with one hand and does not require tight grasping, tight pinching or twisting of the wrist to operate. Hardware shall be 34 inches minimum and 48 inches maximum above the finish floor or ground.	women's door - .5" CIL, lock requires pinch, maneuvering clearance on pull reduced by chairs, maneuvering clearance on push reduced to 5" by sink and paper towels	For all doors along the public circulation route, provide required maneuvering clearance on push and pull side of doors. For all doors along the public circulation route, repair, bevel, or ramp CILs at door entries to max .25". For all doors along the public circulation route, replace hardware with lever hardware or hardware operable without a tight pinch or grasp.	2010 ADAS Section: 404.2.3, 404.2.7, 404.2.4, 404.2.11, 404.2.11 Exception

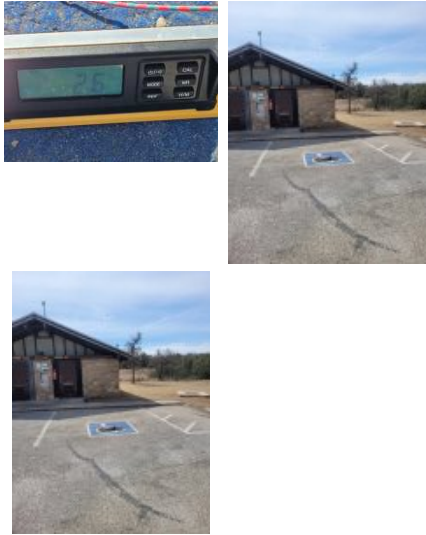
67	Council Bluff (CB) Area: CB - Parking	[31.8587211, -99.0292294]	The parking stall contains abrupt edges and surface irregularities over a 1/4 inch vertical. Parking spaces and access aisles serving them shall be stable, firm, and slip resistant. Access aisles shall be at the same level as the parking spaces they serve. Changes in level are not permitted and shall not be sloped steeper than 2% in any direction.	CB restroom building - access aisle has sand within and needs repainted	Maintain stalls and access aisles to be free of debris. Repaint stalls and access aisles where faded.	2015 ABAAS Section: 502.4 2012 TAS Section: 502.4 2010 ADAS Section: 502.4

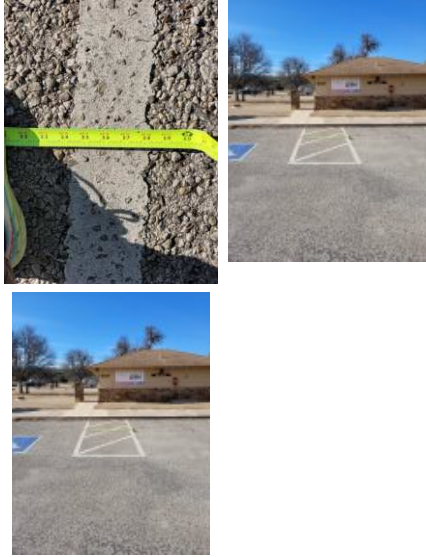
117	Willow Point (WP) Area: WP - Parking	[31.8629909 , -99.024369 3]	There are no van accessible parking stalls. 1 in every 6, minimum of one, required accessible stalls must be a van accessible stall. There are a total of 17 parking stalls in the parking lot that could be reasonably associated with this facility. There should be a minimum of 1 accessible stalls with a minimum of 1 being designed as van accessible.	WP restroom building by site 20 - 11' stall, 4' 8" access aisle	Add van parking sign to one accessible stall and repaint stall and access aisle to 11' and 5' or 8' and 8'.	2015 ABAAS Section: F208.2, F208.2.4 2012 TAS Section: 208.2, 208.2.4 2010 ADAS Section: 208.2, 208.2.4

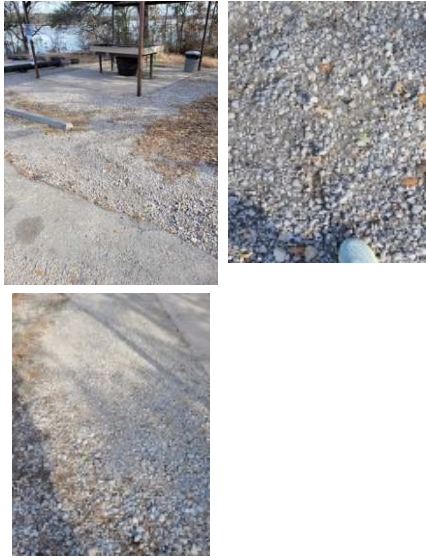
180	Willow Point (WP) Area: WP - Fishing Pier	[31.8623297 , -99.026716 2]	There is a gap spaced greater than a 1/2 inch. Openings in floor or ground surfaces shall not allow passage of a sphere more than 1/2 inch diameter. Elongated openings shall be placed so that the long dimension is perpendicular to the dominant direction of travel.	9" gap at walkway to pier by fish cleaning	Correct or fill gaps to be max .5"	2015 ABAAS Section: 302.3 2012 TAS Section: 302.3 2010 ADAS Section: 302.3

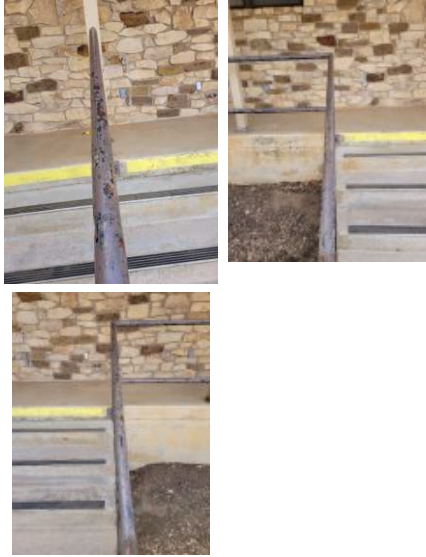
200	Day Use Restroom Buildings : Day Use - Exterior Accessible Route	[31.8628023 , -99.022538 6]	The handrails as well as the handrail extensions are not at the correct height. The tops of handrails and their extensions must be between 34 inches and 38 inches above the stair nosing or ground.	Stairs behind Day Use restroom - 3 of 3 are 30.5" AFF	Replace or remount handrails to 34" to 38" aff	2015 ABAAS Section: 505.4 2012 TAS Section: 505.4 2010 ADAS Section: 505.4

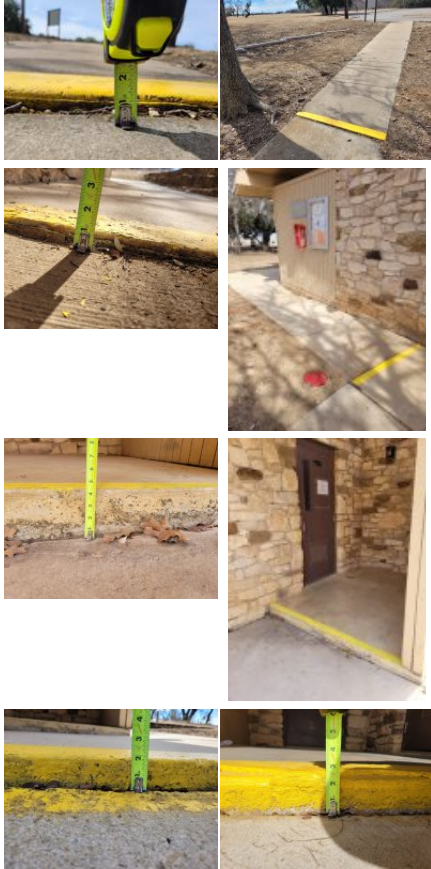
Finding Number	Area Description	Lat/Long	Finding	As Built	Recommendation	Citation	Photos	Figure
205	Day Use Restroom Buildings : Day Use - Exterior Accessible Route	[31.862615, -99.022727 1]	The running slope of walking surfaces shall not be steeper than 1:20.	11.5% slope at entry to day use restroom building, 7.4% at top of path to restroom, 7.7% in middle, 7.3% at bottom	Correct running slope along the AR to max 5%	2015 ABAAS Section: 403.3 2012 TAS Section: 403.3 2010 ADAS Section: 403.3

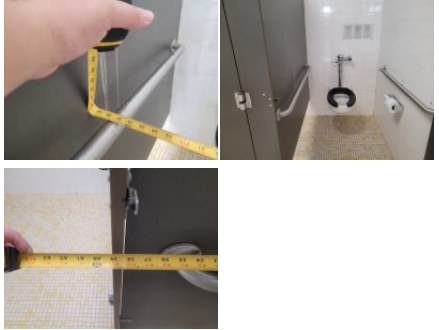
224	Day Use Restroom Buildings : Day Use - Men's Restroom (by dining hall)	[31.8627898 , -99.0225266]	The toilet is not located within the range to the side wall or partition. The centerline of the toilet shall be 17 inches minimum and 19 inches maximum side wall or partition in the ambulatory accessible toilet compartment.	toilet centerline 21" from wall side	Remount toilet to 17" to 19" from the side wall to center line in ambulatory stalls.	2015 ABAAS Section: 604.9.1 2012 TAS Section: 604.9.1 2010 ADAS Section: 604.9.1

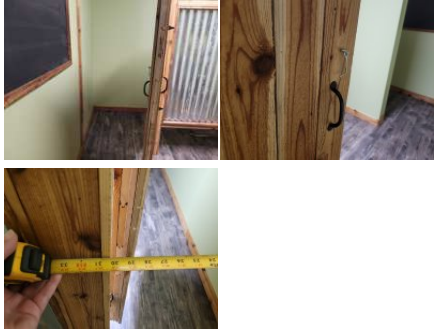
258	Day Use Restroom Buildings : Day Use - Men's Restroom (by beach lodge)	[31.8609378 , -99.019611]	Grab bars shall comply with 609. A side-wall grab bar complying with 604.5.1 shall be provided on both sides of the compartment. The space between the wall and the grab bar shall be 1½ inches (38 mm). The space between the grab bar and projecting objects below and at the ends shall be 1½ inches (38 mm) minimum. The space between the grab bar and projecting objects above shall be 12 inches (305 mm) minimum. Grab bars shall be installed in a horizontal position, 33 inches (840 mm) minimum and 36 inches (915 mm) maximum above the finish floor measured to the top of the gripping surface, except that at water closets for children's use complying with 604.9, grab bars shall be installed in a horizontal position 18 inches (455 mm) minimum and 27 inches (685 mm) max	30" square bars	Replace or add side grab bars with a 42" long grab bar, mounted max 12" from the rear wall at the close end and min 54" on the far end and 33" to 36" aff	2015 ABAAS Section: 604.8.2.3, 609.3, 609.4 2012 TAS Section: 609.4, 609.3, 604.8.2.3 2010 ADAS Section: 609.3, 609.4, 604.8.2.3

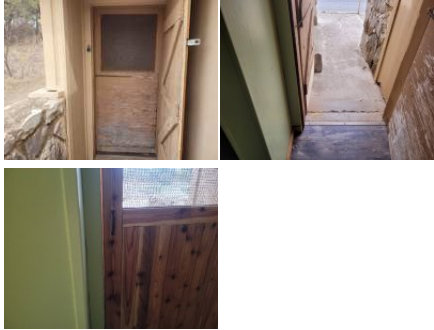
266	Day Use Restroom Buildings : Day Use - Women's Restroom (by beach lodge)	[31.8609446 , -99.019597 6]	The restroom sign does not comply with one or more applicable requirements for the location, height, and properties of the sign.	lacks Braille and raised characters, not located adjacent to latch side of door	Replace sign with one of contrasting colors that includes Braille, raised characters, and the symbol of accessibility and mount on the wall, latch side of the door, 48" to the baseline of the lowest character and 60" to the baseline of the highest character	2015 ABAAS Section: F216.2, 703.1, 703.2, 703.5, 703.6 2012 TAS Section: 216.2, 703.1, 703.2, 703.5, 703.6 2010 ADAS Section: 216.2, 703.1, 703.2, 703.5, 703.6

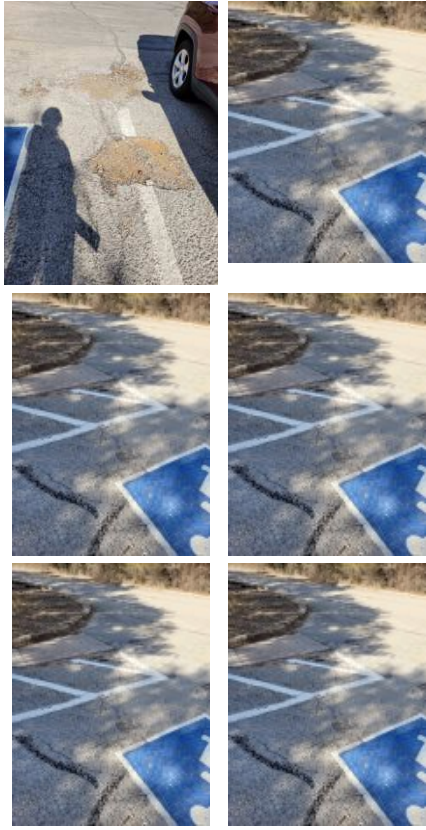
285	Comanche Trails (CT) Area: CT - Parking	[31.852177, -99.017695 9]	The accessible parking stall signage is incorrect and/or missing from each accessible parking space. Parking space identification signs shall include the International Symbol of Accessibility. Signs identifying van parking spaces shall contain the designation "van accessible." Signs shall be 60 inches minimum above the finish floor or ground surface measured to the bottom of the sign.	CT restroom parking - no signage	Acquire and mount at appropriate heights and locations accessible parking signs where missing	2015 ABAAS Section: 502.6 2012 TAS Section: 502.6

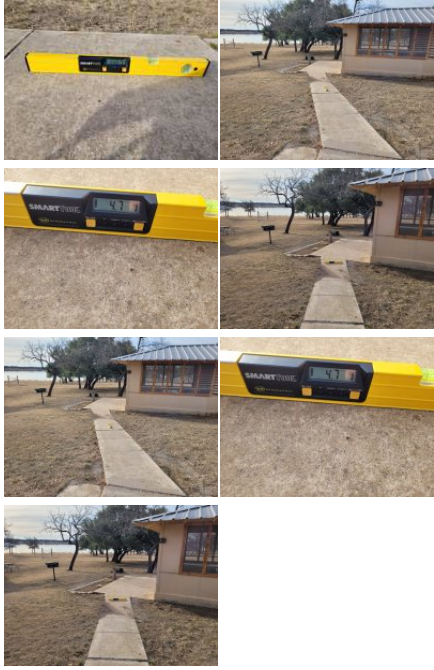
329	Comanche Trails (CT) Area: CT - Sample Shelter Campsite	[31.851827, -99.017191 3]	Picnic tables shall provide at least one wheelchair space for each 24 linear feet (7320 mm) of usable table surface perimeter. Wheelchair spaces shall be 30 inches (760 mm) minimum by 48 inches (1220 mm) minimum. Wheelchair spaces shall be positioned for a forward approach to the table and provide knee and toe clearance complying with 306 under the table	shelter 1 - lacks accessible table both outdoor and indoor	Replace picnic tables with ones of an accessible design as a smart practice	2015 ABAAS Section: 1011.4.2

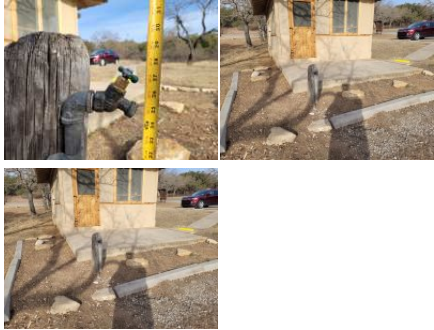
336	Comanche Trails (CT) Area: CT - Sample Shelter Campsite	[31.8518065 , -99.017251 7]	Camping facilities shall provide camping units with mobility features complying with F244.2 in accordance with Table F244.2. Where a camping facility provides different types of camping units, Table F244.2 shall apply to each type of camping unit provided. Total Number of Camping Units Provided in Camping Facility Minimum Number of Camping Units with Mobility Features Required 1 1 2 to 25 2 26 to 50 3 51 to 75 4 76 to 100 5 101 to 150 7 151 to 200 8 201 and over 8, plus 2 percent of the number over 200	0 of 10 shelters accessible at time of audit	Create the required number of accessible camp sites per table F244.2 as a smart practice	2015 ABAAS Section: F244.2

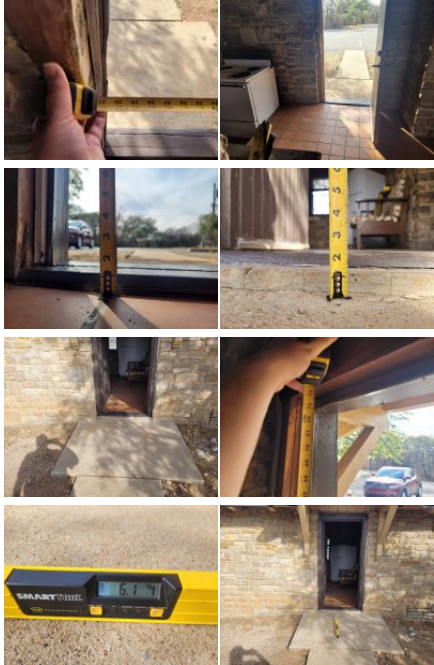
Finding Number	Area Description	Lat/Long	Finding	As Built	Recommendation	Citation	Photos	Figure
340	Cabin Area: Sample Cabin Campsite	[31.85324, -99.01469]	<p>Minimum maneuvering clearances at doors and gates shall comply with 404.2.4. Maneuvering clearances shall extend the full width of the doorway and the required latch side or hinge side clearance. Maneuvering clearances shall have a max slope of 2.08%. Door openings shall provide a clear width of 32 inches (815 mm) minimum. Clear openings of doorways with swinging doors shall be measured between the face of the door and the stop, with the door open 90 degrees. Openings more than 24 inches (610 mm) deep shall provide a clear opening of 36 inches (915 mm) minimum. There shall be no projections into the required clear opening width lower than 34 inches (865 mm) above the finish floor or ground. Projections into the clear opening width between 34 inches (865 mm) and 80 inches (2030 mm) above the finish floor or ground shall not exceed 4 inches (100 mm). The threshold has a vertical change greater than 1/4 inch high. The threshold at a doorway shall be no higher than 1/2 inch. Changes in level between 1/4 inch and 1/2 inch must be beveled at 1:2 or less. 1/4 inch is the maximum vertical rise.</p>	cabin 7 patio door - 3.2% slope, bed pull side, knob, 2" threshold, step down push side, 70" overhead	For all doors along the public circulation route, provide required maneuvering clearance on push and pull side of doors. For all doors along the public circulation route, correct slope in door clearance to max 2.08%. For all doors along the public circulation route, replace doors with doors having 80" overhead clearance and 32" clear width. For all doors along the public circulation route, repair, bevel, or ramp CILs at door entries to max .25". For all doors along the public circulation route, repair, provide beveled threshold.	2010 ADAS Section: 404.2.3, 404.2.7, 404.2.4, 404.2.11, 404.2.11 Exception

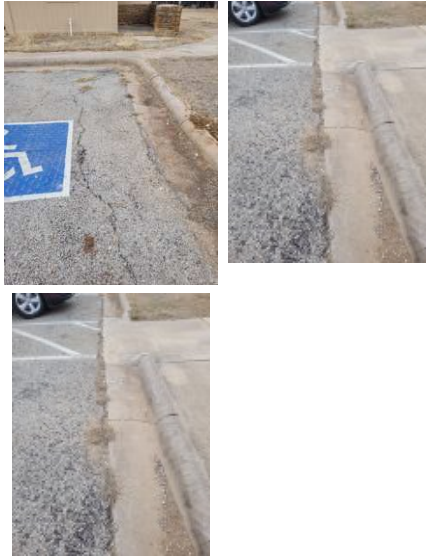
376	Group Dining Hall : Dining Hall - Parking	[31.8617169 , -99.0220921]	The accessible parking stall signage is incorrect and/or missing from each accessible parking space. Parking space identification signs shall include the International Symbol of Accessibility. Signs identifying van parking spaces shall contain the designation "van accessible." Signs shall be 60 inches minimum above the finish floor or ground surface measured to the bottom of the sign.	Group Dining Hall - lacks signage	Acquire and mount at appropriate heights and locations accessible parking signs where missing.	2015 ABAAS Section: 502.6 2012 TAS Section: 502.6

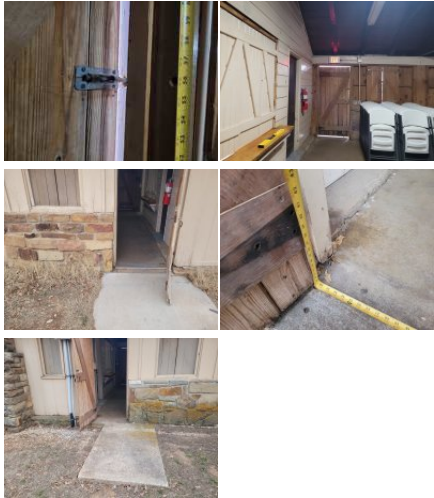
Finding Number	Area Description	Lat/Long	Finding	As Built	Recommendation	Citation	Photos	Figure
390	Group Dining Hall : Dining Hall - Public Spaces	[31.8617647 , -99.022151 1]	<p>Minimum maneuvering clearances at doors and gates shall comply with 404.2.4. Maneuvering clearances shall extend the full width of the doorway and the required latch side or hinge side clearance. Maneuvering clearances shall have a max slope of 2.08%. Door openings shall provide a clear width of 32 inches (815 mm) minimum. Clear openings of doorways with swinging doors shall be measured between the face of the door and the stop, with the door open 90 degrees. Openings more than 24 inches (610 mm) deep shall provide a clear opening of 36 inches (915 mm) minimum. There shall be no projections into the required clear opening width lower than 34 inches (865 mm) above the finish floor or ground. Projections into the clear opening width between 34 inches (865 mm) and 80 inches (2030 mm) above the finish floor or ground shall not exceed 4 inches (100 mm). Hand-activated door opening hardware, handles, pulls, latches, locks, and other operating devices on accessible doors shall have a shape that is easy to grasp with one hand and does not require tight grasping, tight pinching or twisting of the wrist to operate. Hardware shall be 34 inches minimum and 48 inches maximum above the finish floor or ground.</p>	<p>door from kitchen to main space - knob, 7.7% slope, 29.5" width, 7.5" clearance on pull due to outlet</p>	<p>For all doors along the public circulation route, provide required maneuvering clearance on push and pull side of doors. For all doors along the public circulation route, correct slope in door clearance to max 2.08%. For all doors along the public circulation route, replace doors with doors having 80" overhead clearance and 32" clear width. For all doors along the public circulation route, replace hardware with lever hardware or hardware operable without a tight pinch or grasp.</p>	<p>2010 ADAS Section: 404.2.3, 404.2.7, 404.2.4, 404.2.11, 404.2.11 Exception</p>

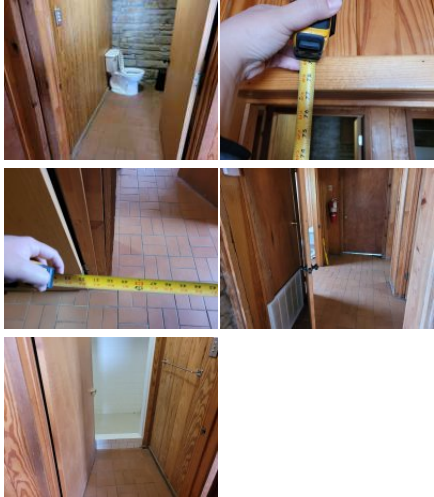
Finding Number	Area Description	Lat/Long	Finding	As Built	Recommendation	Citation	Photos	Figure
469	Beach Lodge : Beach Lodge - Public Space	[31.8604999 , -99.019053 2]	Minimum maneuvering clearances at doors and gates shall comply with 404.2.4. Maneuvering clearances shall extend the full width of the doorway and the required latch side or hinge side clearance. Maneuvering clearances shall have a max slope of 2.08%. Door openings shall provide a clear width of 32 inches (815 mm) minimum. Clear openings of doorways with swinging doors shall be measured between the face of the door and the stop, with the door open 90 degrees. Openings more than 24 inches (610 mm) deep shall provide a clear opening of 36 inches (915 mm) minimum. There shall be no projections into the required clear opening width lower than 34 inches (865 mm) above the finish floor or ground. Projections into the clear opening width between 34 inches (865 mm) and 80 inches (2030 mm) above the finish floor or ground shall not exceed 4 inches (100 mm).	kitchen - oven in pull side clearance, 29.5" wide	For all doors along the public circulation route, provide required maneuvering clearance on push and pull side of doors. For all doors along the public circulation route, replace doors with doors having 80" overhead clearance and 32" clear width.	2010 ADAS Section: 404.2.3, 404.2.7, 404.2.4, 404.2.11, 404.2.11 Exception

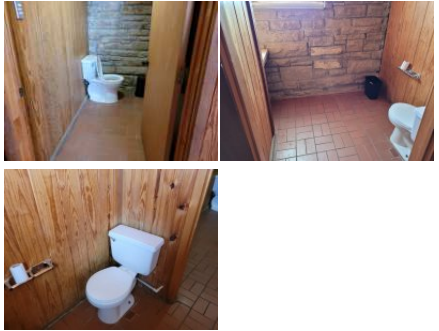
482	Beach Lodge : Beach Lodge - Restroom	[31.8604844 , -99.019039 7]	This restroom is not accessible. Where existing toilet rooms or bathing rooms do not comply, directional signs indicating the location of the nearest accessible toilet room or bathing room within the facility shall be provided. Signs shall include the International Symbol of Accessibility. Where existing toilet rooms or bathing rooms do comply), the accessible toilet rooms or bathing rooms shall be identified by the International Symbol of Where clustered single user toilet rooms or bathing facilities are permitted, accessible toilet rooms or bathing facilities shall be identified by the International Symbol of Accessibility unless all toilet rooms and bathing facilities are accessible.	toilet rooms lack signs, other restroom in lodge not accessible, no directional signage to nearest accessible restroom	Restroom not accessible, acquire and mount signage directing patrons to accessible restroom until an accessible restroom is provide in beach lodge	2015 ABAAS Section: F216.8 2012 TAS Section: 216.8 2010 ADAS Section: 216.8

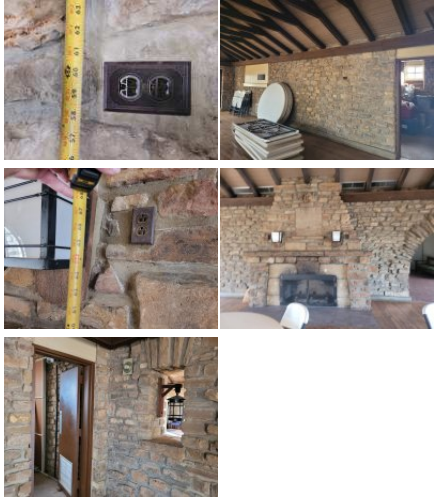
Finding Number	Area Description	Lat/Long	Finding	As Built	Recommendation	Citation	Photos	Figure
507	Group Rec Bldg: Rec Bldg- Main Room	[31.85936, -99.01778]	Door openings shall provide a clear width of 32 inches (815 mm) minimum. Clear openings of doorways with swinging doors shall be measured between the face of the door and the stop, with the door open 90 degrees. Openings more than 24 inches (610 mm) deep shall provide a clear opening of 36 inches (915 mm) minimum. There shall be no projections into the required clear opening width lower than 34 inches (865 mm) above the finish floor or ground. Projections into the clear opening width between 34 inches (865 mm) and 80 inches (2030 mm) above the finish floor or ground shall not exceed 4 inches (100 mm). The threshold has a vertical change greater than 1/4 inch high. The sweep period for doors with closers shall be adjusted so that from an open position of 70 degrees, the door will take at least 3 seconds to move to a point 3 inches from the latch, measured to the leading edge of the door. Exterior doors are recommended to be maintained at 8.5 lbf as a smart practice. Force is to be measured at the operating hardware or 30 inches from the hinges, whichever is greater.	entry double- 7.5" CIL, 13lbf, closes fast, bar protrudes 5.5"	For all doors along the public circulation route, replace doors with doors having 80" overhead clearance and 32" clear width, and projections maximum 4". For all doors along the public circulation route, repair, bevel, or ramp CILs at door entries to max .25". For all doors along the public circulation route, inspect, adjust, and maintain closing speed on door closers. For all doors along the public circulation route, inspect, adjust, and maintain 8.5 lbf to open exterior doors as a smart practice.	2010 ADAS Section: 404.2.3, 404.2.7, 404.2.4, 404.2.11, 404.2.11 Exception

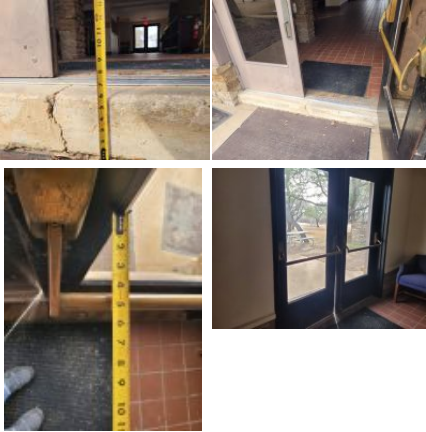
Finding Number	Area Description	Lat/Long	Finding	As Built	Recommendation	Citation	Photos	Figure
508	Group Rec Bldg: Rec Bldg- Main Room	[31.8593176 , -99.017773 6]	Minimum maneuvering clearances at doors and gates shall comply with 404.2.4. Maneuvering clearances shall extend the full width of the doorway and the required latch side or hinge side clearance. Maneuvering clearances shall have a max slope of 2.08%. Door openings shall provide a clear width of 32 inches (815 mm) minimum. Clear openings of doorways with swinging doors shall be measured between the face of the door and the stop, with the door open 90 degrees. Openings more than 24 inches (610 mm) deep shall provide a clear opening of 36 inches (915 mm) minimum. There shall be no projections into the required clear opening width lower than 34 inches (865 mm) above the finish floor or ground. Projections into the clear opening width between 34 inches (865 mm) and 80 inches (2030 mm) above the finish floor or ground shall not exceed 4 inches (100 mm). The threshold has a vertical change greater than 1/4 inch high. The sweep period for doors with closers shall be adjusted so that from an open position of 70 degrees, the door will take at least 3 seconds to move to a point 3 inches from the latch, measured to the leading edge of the door. Exterior doors are recommended to be maintained at 8.5 lbf as a smart practice. Force is to be measured at the operating hardware or 30 inches from the hinges, whichever is greater.	side exit with push bar - bar protrudes 5.5", 26" wide, 4" CIL, 6.1% slope, 14#, closes fast, deterioration on interior	For all doors along the public circulation route, provide required maneuvering clearance on push and pull side of doors. For all doors along the public circulation route, correct slope in door clearance to max 2.08%. For all doors along the public circulation route, replace doors with doors having 80" overhead clearance and 32" clear width, with maximum 4" projections. For all doors along the public circulation route, repair, bevel, or ramp CILs at door entries to max .25". For all doors along the public circulation route, inspect, adjust, and maintain closing speed on door closers. For all doors along the public circulation route, inspect, adjust, and maintain 8.5 lbf to open exterior doors as a smart practice.	2010 ADAS Section: 404.2.3, 404.2.7, 404.2.4, 404.2.11, 404.2.11 Exception

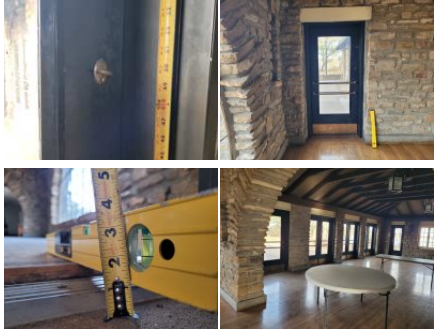
Finding Number	Area Description	Lat/Long	Finding	As Built	Recommendation	Citation	Photos	Figure
510	Group Rec Bldg: Rec Bldg- Main Room	[31.8593491 , -99.017762 2]	Door openings shall provide a clear width of 32 inches (815 mm) minimum. Clear openings of doorways with swinging doors shall be measured between the face of the door and the stop, with the door open 90 degrees. Openings more than 24 inches (610 mm) deep shall provide a clear opening of 36 inches (915 mm) minimum. There shall be no projections into the required clear opening width lower than 34 inches (865 mm) above the finish floor or ground. Projections into the clear opening width between 34 inches (865 mm) and 80 inches (2030 mm) above the finish floor or ground shall not exceed 4 inches (100 mm). The threshold has a vertical change greater than 1/4 inch high. The sweep period for doors with closers shall be adjusted so that from an open position of 70 degrees, the door will take at least 3 seconds to move to a point 3 inches from the latch, measured to the leading edge of the door. Exterior doors are recommended to be maintained at 8.5 lbf as a smart practice. Force is to be measured at the operating hardware or 30 inches from the hinges, whichever is greater.	rear double- 6.5" CIL, bar protrudes 5.25", 13#, closes fast	For all doors along the public circulation route, replace doors with doors having 80" overhead clearance, 32" clear width, and maximum 4" projections. For all doors along the public circulation route, repair, bevel, or ramp CILs at door entries to max .25". For all doors along the public circulation route, inspect, adjust, and maintain closing speed on door closers. For all doors along the public circulation route, inspect, adjust, and maintain 8.5 lbf to open exterior doors as a smart practice.	2010 ADAS Section: 404.2.3, 404.2.7, 404.2.4, 404.2.11, 404.2.11 Exception

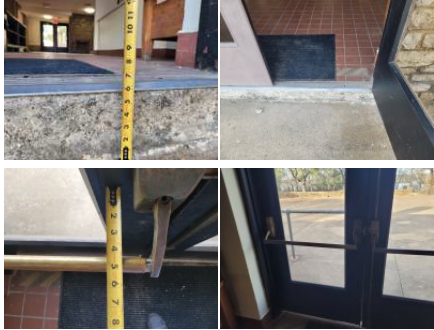
511	Group Rec Bldg: Rec Bldg- Main Room	[31.8593818 , -99.017737 9]	Minimum maneuvering clearances at doors and gates shall comply with 404.2.4. Maneuvering clearances shall extend the full width of the doorway and the required latch side or hinge side clearance. Maneuvering clearances shall have a max slope of 2.08%. The sweep period for doors with closers shall be adjusted so that from an open position of 70 degrees, the door will take at least 3 seconds to move to a point 3 inches from the latch, measured to the leading edge of the door. Exterior doors are recommended to be maintained at 8.5 lbf as a smart practice. Force is to be measured at the operating hardware or 30 inches from the hinges, whichever is greater.	door to restrooms- 15# closes fast, wall push side	For all doors along the public circulation route, provide required maneuvering clearance on push and pull side of doors. For all doors along the public circulation route, inspect, adjust, and maintain closing speed on door closers. For all doors along the public circulation route, inspect, adjust, and maintain 8.5 lbf to open exterior doors as a smart practice.	2010 ADAS Section: 404.2.3, 404.2.7, 404.2.4, 404.2.11, 404.2.11 Exception
