Access Audit Site Report

Lake Colorado City State Park

Accessibility Evaluation

Inspection Date: 12/13/2021

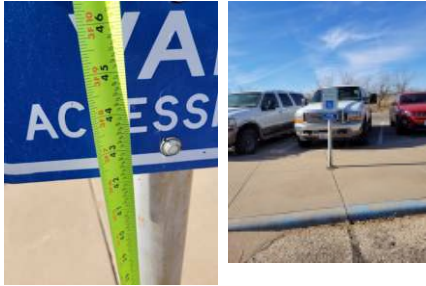
Finding Number	Area Description	Lat/Long	Finding	As Built	Recommendation	Citation	Photos	Figure
1	Headquarters : HQ Parking	[32.3183302 , -100.9364 415]	The parking sign is mounted too low. Parking space identification signs shall include the International Symbol of Accessibility complying with. Signs identifying van parking spaces shall contain the designation "van accessible." Signs shall be 60 inches minimum above the finish floor or ground surface measured to the bottom of the sign.	HQ parking - 42.5" agl	Raise existing accessible parking signs so lowest end of bottom sign is min 60" aff.	2015 ABAAS Section: 502.6 2012 TAS Section: 502.6 2010 ADAS Section: 502.6

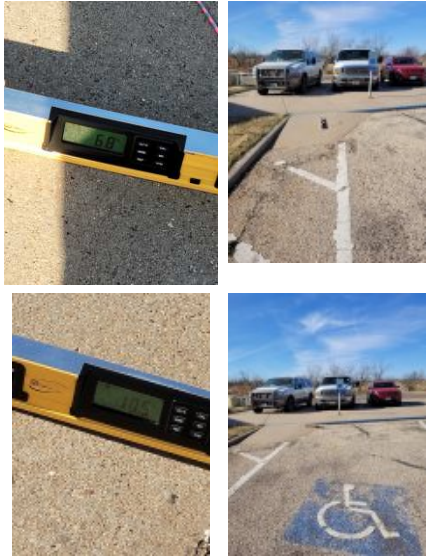
Finding Number	Area Description	Lat/Long	Finding	As Built	Recommendation	Citation	Photos	Figure																						
3	Headquarters : HQ Parking	[32.3183302 , -100.9364 321]	The accessible parking stall's access aisle contains a built up curb ramp which results in significant slopes greater than 2 percent. Surface slopes of accessible parking spaces and access aisles shall be the minimum possible and shall not exceed one unit vertical in 50 units' horizontal (2-percent slope) in any direction.	HQ - curb ramp in access aisle and stall; access aisle- 6.9%, stall - 10.5%	Remove built up curb ramp in access aisle and stall and create a curb ramp to be max running slope 8.33%, max cross slope 2.08%, having a top landing as wide as the ramp and 36" deep and side flares with a max slope 10%	2015 ABAAS Section: 502.4 2012 TAS Section: 502.4 2010 ADAS Section: 502.4

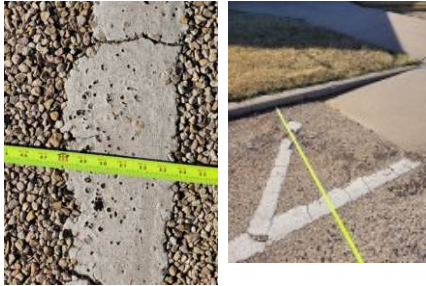
Finding Number	Area Description	Lat/Long	Finding	As Built	Recommendation	Citation	Photos	Figure
5	Headquarters : HQ Parking	[32.3183188 , -100.93641 6]	The access aisle is not a minimum 5 feet wide. A car accessible parking stall's access aisle must be a minimum of 5 feet wide measured from centerline to centerline. Where the access aisle is not adjacent to another parking space or access aisle, measurements shall be permitted to include the full width of the line defining the access aisle.	HQ parking - access aisle is 4' 3"	Repaint access aisles to be 5' each.	2015 ABAAS Section: 502.3.1 2012 TAS Section: 502.3.1 2010 ADAS Section: 502.3.1

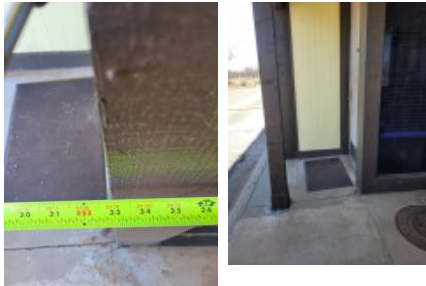
6	Headquarters : Exterior Accessible Route	[32.3182814 , -100.9364 858]	The route of travel at this location does not provide the required minimum width. The minimum clear width for sidewalks and walks is 36 inches.	33" width at turn to entry due to post	Widen EAR to min 36" clear width if feasible.	2015 ABAAS Section: 403.5.1 2012 TAS Section: 403.5.1 2010 ADAS Section: 403.5.1

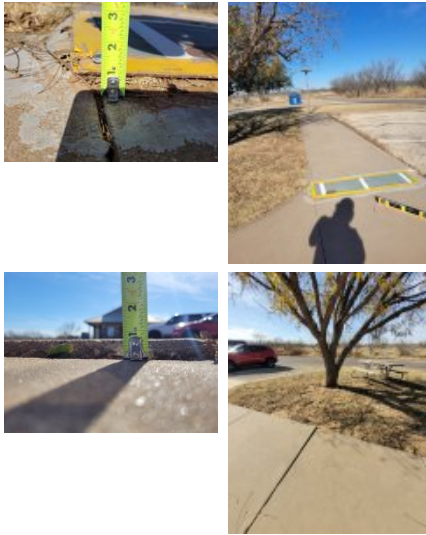
7	Headquarters : Exterior Accessible Route	[32.3184605 , -100.9364 469]	The walkway contains abrupt vertical edges and/or variations over a 1/4 inch. 1/4 inch is the maximum vertical rise. Changes in level between 1/4 inch and 1/2 inch must be beveled at 1:2 or less. Changes in level greater than 1/2 inch must be by way of a ramp.	1" change in level (CIL) at narrow part of path at HQ parking, Parallel to picnic - .75 CIL	Repair, bevel or ramp CIL along AR.	2012 TAS Section: 303.2, 303.3 2010 ADAS Section: 303.2, 303.3

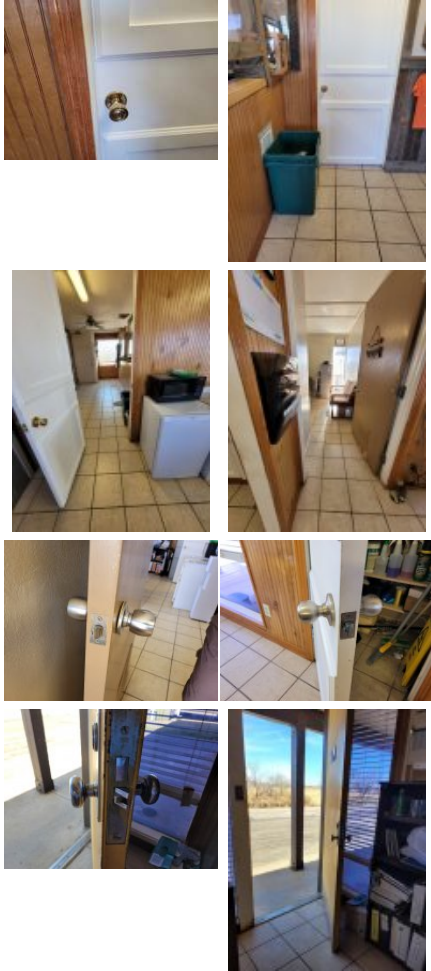
Finding Number	Area Description	Lat/Long	Finding	As Built	Recommendation	Citation	Photos	Figure
9	Headquarters : Employee Spaces	[32.31572, -100.9417]	Spaces and elements within employee work areas shall only be required to comply with 206.2.8, 207.1, and 215.3 and shall be designed and constructed so that individuals with disabilities can approach, enter, and exit the employee work area. Employee work areas, or portions of employee work areas, other than raised courtroom stations, that are less than 300 square feet (28 m2) and elevated 7 inches (180 mm) or more above the finish floor or ground where the elevation is essential to the function of the space shall not be required to comply with these requirements or to be on an accessible route.	HQ - knob, recycling in push side maneuvering clearance (MC), MC on pull side reduced by fridge, no MC on push or pull for Leslie's office, knob on closet, exterior employee entry - knob, doesn't open 90 degrees, 25# push	For employee spaces, relocate storage, furniture, and other obstacles at doorways to provide approach, enter and exit at the employee space. Provide required maneuvering clearance on push and pull side of doors. Inspect, adjust, and maintain 5 lbf to open interior doors. Replace hardware with lever hardware or hardware operable without a tight pinch or grasp.	2015 ABAAS Section: F203.9 2012 TAS Section: 203.9 2010 ADAS Section: 203.9

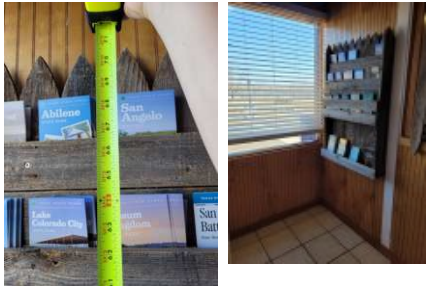
11	Headquarters : Public Spaces	[32.31572, -100.9417]	The brochures are positioned too high for either a side or front approach. Where a forward reach is unobstructed, the high forward reach shall be 48 inches maximum and the low forward reach shall be 15 inches minimum above the finish floor or ground.	67" aff to brochures	Remount operable parts to be in reach range of 15" min to 48" max.	2015 ABAAS Section: 308.1 2012 TAS Section: 308.1 2010 ADAS Section: 308.1

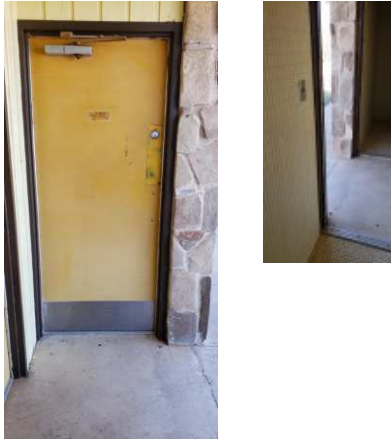
Finding Number	Area Description	Lat/Long	Finding	As Built	Recommendation	Citation	Photos	Figure
14	Headquarters : HQ Women's Restroom	[32.31572, -100.9417]	Minimum maneuvering clearances at doors and gates shall comply with 404.2.4. Maneuvering clearances shall extend the full width of the doorway and the required latch side or hinge side clearance. The sweep period for doors with closers shall be adjusted so that from an open position of 70 degrees, the door will take at least 3 seconds to move to a point 3 inches from the latch, measured to the leading edge of the door. Exterior doors are recommended to be maintained at 8.5 lbf as a smart practice. Force is to be measured at the operating hardware or 30 inches from the hinges, whichever is greater.	Womens Restroom Door - wall in push side clearance, 20# push, fast close	For all doors along the public circulation route, provide required maneuvering clearance on push and pull side of doors For all doors along the public circulation route, inspect, adjust, and maintain closing speed on door closers For all doors along the public circulation route, inspect, adjust, and maintain 8.5 lbf to open exterior doors as a smart practice	2010 ADAS Section: 404.2.3, 404.2.7, 404.2.4, 404.2.11, 404.2.11 Exception

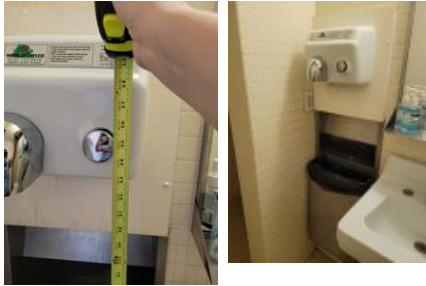
Finding Number	Area Description	Lat/Long	Finding	As Built	Recommendation	Citation	Photos	Figure
17	Headquarters : HQ Women's Restroom	[32.31572, -100.9417]	Where a high forward reach is over an obstruction, the clear floor space shall extend beneath the element for a distance not less than the required reach depth over the obstruction. The high forward reach shall be 48 inches (1220 mm) maximum where the reach depth is 20 inches (510 mm) maximum. Where the reach depth exceeds 20 inches (510 mm), the high forward reach shall be 44 inches (1120 mm) maximum and the reach depth shall be 25 inches (635 mm) maximum.	Women's Restroom - hand dryer button is 55" aff	Lower operating mechanisms in Women's Restroom to max 48" aff to highest operable part.	2015 ABAAS Section: 308.2.1, 308.3.2 2012 TAS Section: 308.2.1, 308.3.2 2010 ADAS Section: 308.2.1, 308.3.2

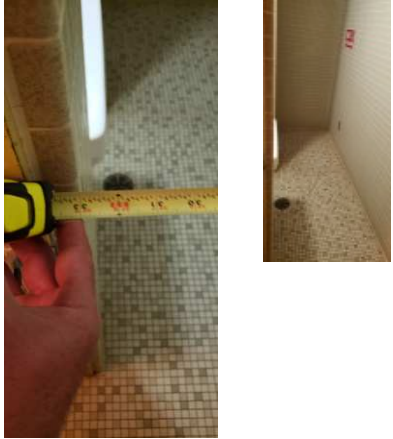
Finding Number	Area Description	Lat/Long	Finding	As Built	Recommendation	Citation	Photos	Figure
26	Headquarters : HQ Men's Restroom	[32.31572, -100.9417]	The route of travel at this location does not provide a minimum width of 36 inches. The clear width shall be permitted to be reduced to 32 inches minimum for a length of 24 inches maximum provided that reduced width segments are separated by segments that are 48 inches long minimum and 36 inches wide minimum.	Men's Restroom - 33" wide to access stall	Widen AR to compliant 36" clear width.	2015 ABAAS Section: 403.5.1 2012 TAS Section: 403.5.1 2010 ADAS Section: 403.5.1

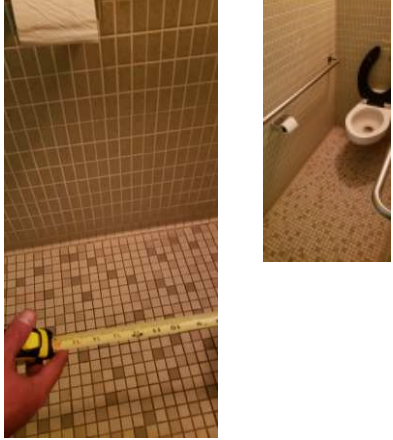
27	Headquarters : HQ Men's Restroom	[32.31572, -100.9417]	The toilet paper is not installed within the compliant range in front of the toilet. Toilet paper dispensers shall be 7 inches minimum and 9 inches maximum in front of the water closet measured to the centerline of the dispenser. The outlet of the dispenser shall be 15 inches minimum and 48 inches maximum above the finish floor and shall not be located behind grab bars. Dispensers shall not be of a type that controls delivery or that does not allow continuous paper flow. There shall be a clearance of 1 1/2 inches minimum below the grab bar.	Men's Restroom - toilet paper 14" from toilet	Remount toilet paper dispenser max 7" to 9" from front of toilet, 15" to 48" aff and min 12" above or 1.5" below grab bar.	2015 ABAAS Section: 604.7 2012 TAS Section: 604.7 2010 ADAS Section: 604.7

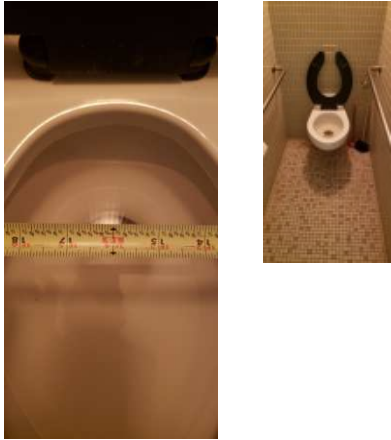
Finding Number	Area Description	Lat/Long	Finding	As Built	Recommendation	Citation	Photos	Figure
30	Headquarters : HQ Men's Restroom	[32.31572, -100.9417]	The toilet is not located within the range to the side wall or partition. The centerline of the toilet shall be 17 inches minimum and 19 inches maximum side wall or partition in the ambulatory accessible toilet compartment.	Men's Restroom - 16" right, 17" left	Remount toilet to 17" to 19" from the side wall to center line in ambulatory stalls, o 16" to 18" in new wheelchair stall.	2015 ABAAS Section: 604.9.1 2012 TAS Section: 604.9.1 2010 ADAS Section: 604.9.1

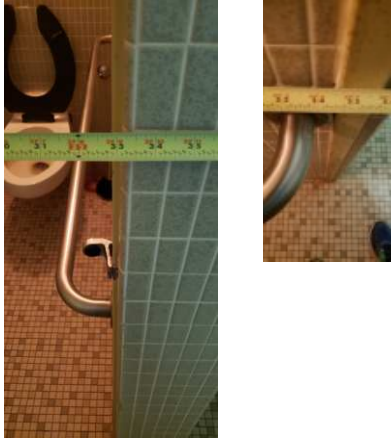
31	Headquarters : HQ Men's Restroom	[32.31572, -100.9417]	The ambulatory stall is not between 35" to 37" wide and 60" deep.	Men's Restroom - ambulatory stall 40" wide, 54.5" deep	Correct ambulatory stall to be 35" to 37" wide and minimum 60" deep. In the alternative, use existing stall to create required wheelchair stall.	2015 ABAAS Section: 604.8.2.1 2012 TAS Section: 604.8.2.1 2010 ADAS Section: 604.8.2.1

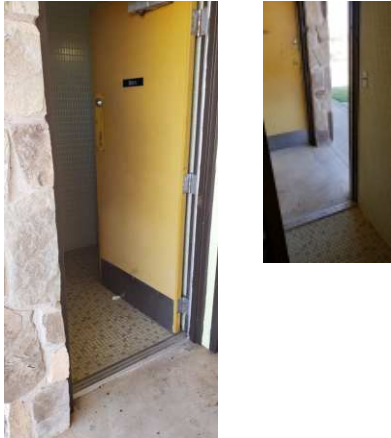
Finding Number	Area Description	Lat/Long	Finding	As Built	Recommendation	Citation	Photos	Figure
38	Headquarters : HQ Men's Restroom	[32.31572, -100.9417]	Minimum maneuvering clearances at doors and gates shall comply with 404.2.4. Maneuvering clearances shall extend the full width of the doorway and the required latch side or hinge side clearance. The sweep period for doors with closers shall be adjusted so that from an open position of 70 degrees, the door will take at least 3 seconds to move to a point 3 inches from the latch, measured to the leading edge of the door. Exterior doors are recommended to be maintained at 8.5 lbf as a smart practice. Force is to be measured at the operating hardware or 30 inches from the hinges, whichever is greater.	Mens Restroom Door - wall in pull side latch clearance, 20# push, fast close	For all doors along the public circulation route, provide required maneuvering clearance on push and pull side of doors For all doors along the public circulation route, inspect, adjust, and maintain closing speed on door closers For all doors along the public circulation route, inspect, adjust, and maintain 8.5 lbf to open exterior doors as a smart practice	2010 ADAS Section: 404.2.3, 404.2.7, 404.2.4, 404.2.11, 404.2.11 Exception

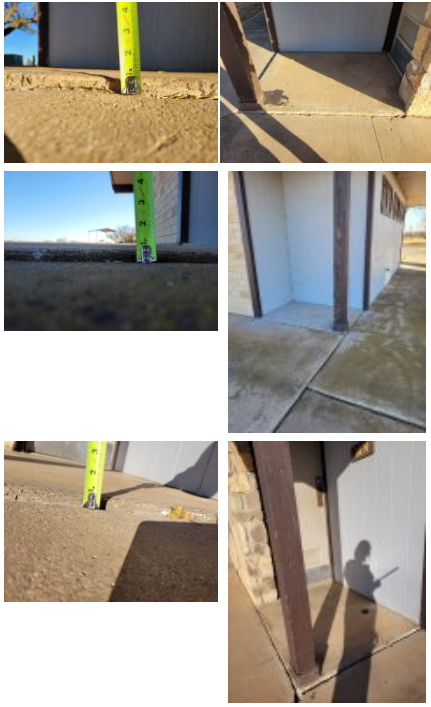
53	Park Site: Restroom 5 Parking	[32.3385481, -100.9289327]	The walkway contains abrupt vertical edges and/or variations over a 1/4 inch. 1/4 inch is the maximum vertical rise. Changes in level between 1/4 inch and 1/2 inch must be beveled at 1:2 or less. Changes in level greater than 1/2 inch must be by way of a ramp.	Boat Ramp Restroom/ Restroom 5 - 1" CIL at entry to women's restroom, back corner on lake side has a .75 CIL, 1" CIL entry to men's restroom	Repair, bevel or ramp CIL along AR	2012 TAS Section: 303.2, 303.3 2010 ADAS Section: 303.2, 303.3

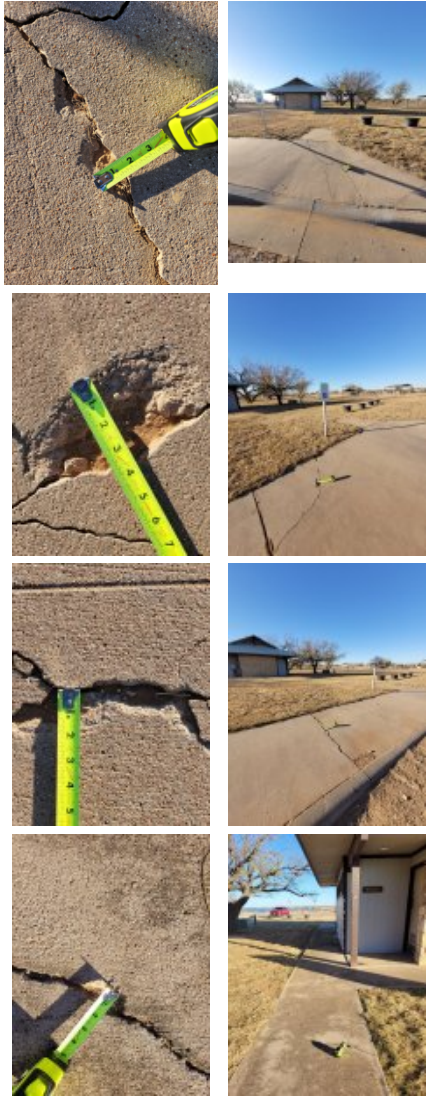
Finding Number	Area Description	Lat/Long	Finding	As Built	Recommendation	Citation	Photos	Figure
54	Park Site: Restroom 5 Parking	[32.338658, -100.92888 17]	There is a gap spaced greater than a 1/2 inch. Openings in floor or ground surfaces shall not allow passage of a sphere more than 1/2 inch diameter. Elongated openings shall be placed so that the long dimension is perpendicular to the dominant direction of travel.	Boat Ramp Restroom/ Restroom 5 - 1.5" gap, 4" gap, 2" gap at entry to bathroom building by boat ramp on water side parking entry, on other side towards womens restroom from parking - 1.5" gap at path to women's, 1" gap on corner on waterside of restroom building, 3" gap by meter, 1" gap on path to men's parallel to playground, 2" crack by men's restroom	Correct or fill gaps to be max .5".	2015 ABAAS Section: 302.3 2012 TAS Section: 302.3 2010 ADAS Section: 302.3

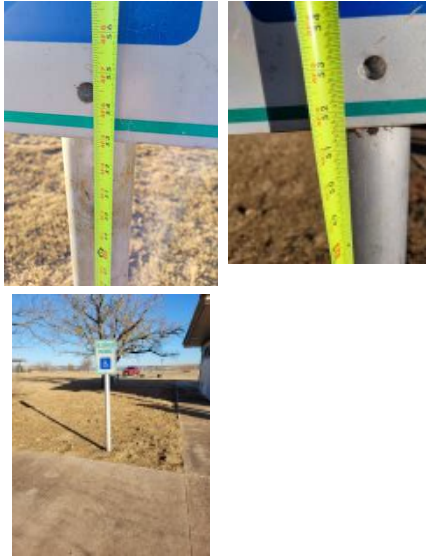
59	Park Site: Restroom 5 Parking	[32.3387158, -100.9289702]	The parking sign is mounted too low. Parking space identification signs shall include the International Symbol of Accessibility complying with. Signs identifying van parking spaces shall contain the designation "van accessible." Signs shall be 60 inches minimum above the finish floor or ground surface measured to the bottom of the sign.	Boat ramp restroom/ restroom 5 - water side - 53" above ground level (agl) not water side - 51.5" agl	Raise existing accessible parking signs so lowest end of bottom sign is min 60" aff	2015 ABAAS Section: 502.6 2012 TAS Section: 502.6 2010 ADAS Section: 502.6

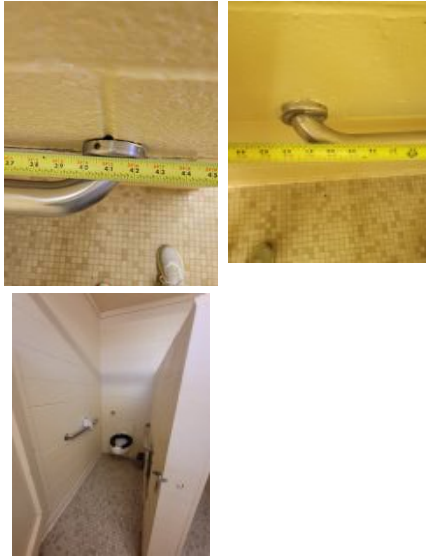
67	Park Site: Restroom Building 5 Boat Ramp - Women's	[32.31572, -100.9417]	The side grab bars are not in the correct location. Grab bars on the side wall must be installed so that the end closest to the rear wall is maximum 12" from the rear wall. The end furthest from the rear wall must be mounted minimum 54" from the rear wall.	Women's Restroom - both grab bars are 41" from rear wall to end	Remount side grab bar to max 12" from the rear wall at the close end and min 54" on the far end, and 33" to 36" aff. Cost included in previous finding.	2015 ABAAS Section: 604.5.1 2012 TAS Section: 604.5.1 2010 ADAS Section: 604.5.1

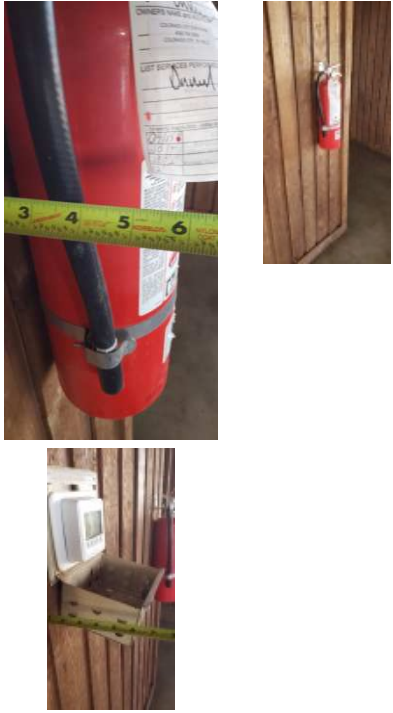
132	Buildings: Recreation Hall	[32.31572, -100.9417]	The fire extinguisher and thermostat project more than 4 inches into the circulation path. Wall-mounted objects that have leading edges between 27 inches and 80 inches from the floor must not project more than 4 inches into the circulation path. Protruding objects that extend to the floor or within 27 inches of the floor are cane detectable and are therefore not hazardous. Where it is necessary or desirable to have objects protrude from the wall, a manner of cane detection must be provided.	fire extinguisher and thermostat protrude 6"	Relocate protruding objects or place cane detectable warning or bollard at foot of items	2015 ABAAS Section: 307.2 2012 TAS Section: 307.2 2010 ADAS Section: 307.2

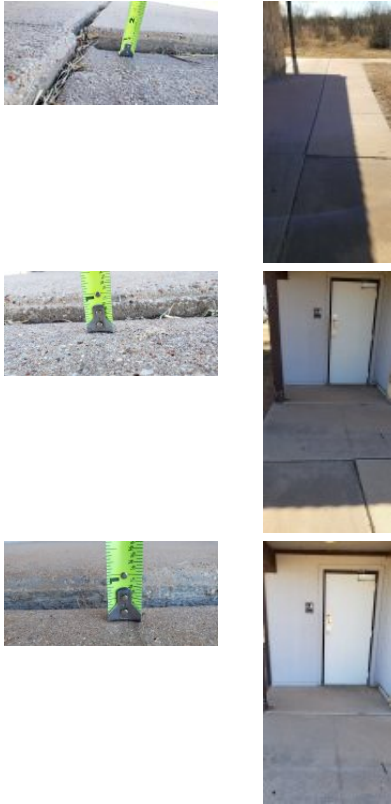
Finding Number	Area Description	Lat/Long	Finding	As Built	Recommendation	Citation	Photos	Figure
154	Cabins: Exterior Accessible Route	[32.3308064, -100.9309162]	The walkway contains abrupt vertical edges and/or variations over a 1/4 inch. 1/4 inch is the maximum vertical rise. Changes in level between 1/4 inch and 1/2 inch must be beveled at 1:2 or less. Changes in level greater than 1/2 inch must be by way of a ramp.	Restroom 4/ cabin restroom, changes in level (CIL) - 1.5", 1", 1"	Repair, bevel or ramp CIL along AR	2012 TAS Section: 303.2, 303.3 2010 ADAS Section: 303.2, 303.3

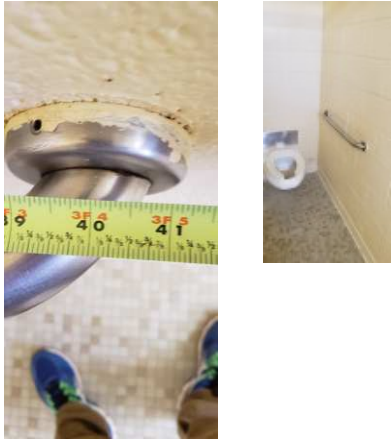
Finding Number	Area Description	Lat/Long	Finding	As Built	Recommendation	Citation	Photos	Figure
171	Cabins: Restroom Building 4 Cabin Restroom - Men's	[32.31572, -100.9417]	The side grab bars are not in the correct location. Grab bars on the side wall must be installed so that the end closest to the rear wall is maximum 12" from the rear wall. The end furthest from the rear wall must be mounted minimum 54" from the rear wall.	Men's Restroom - grab bars are 40" from the rear wall	Remount side grab bar to max 12" from the rear wall at the close end and min 54" on the far end, and 33" to 36" AFF.	2015 ABAAS Section: 604.5.1 2012 TAS Section: 604.5.1 2010 ADAS Section: 604.5.1

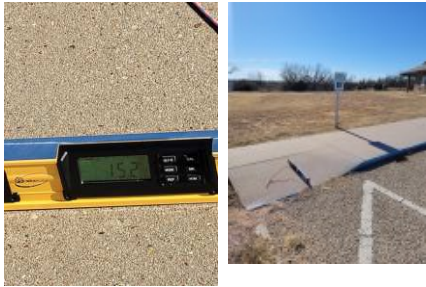
193	Campsites: Exterior Accessible Route	[32.3221268 , -100.9308 934]	The curb ramp slope exceeds the maximum running slope (Parallel to the direction of travel) allowable of 8.33%. Curb ramps should have the least possible slope but in no case more than 8.3% (1:12).	15.2% slope up at parking lot for restroom building 2/ Mesquite Loop	Correct curb ramp running slope to max 8.33%	2015 ABAAS Section: 406.1 2012 TAS Section: 406.1 2010 ADAS Section: 406.1
