# Access Audit Site Report

Prepared By  
**WT Group**

**Lake Livingston State Park**  
**300 State Park Rd 65**  
**Livingston, TX 77351**  
**Accessibility Evaluation**  
**Inspection Date: 11/08/2021**  
**Inspectors: Tanya Scheibe**

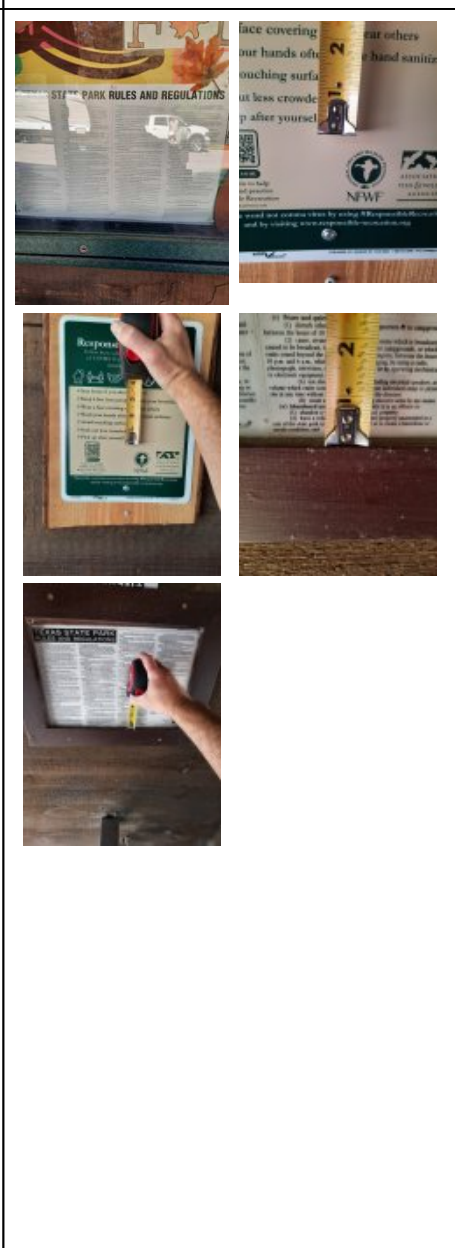
Finding Number	Area Description	Lat/Long	Finding	As Built	Recommendation	Citation	Photos	Figure																														
9	Headquarters: Headquarters Exterior Accessible Route	[30.65691, -95.00105]	Minimum character height shall comply with Table 703.5.5. Viewing distance shall be measured as the horizontal distance between the character and an obstruction preventing further approach towards the sign. Character height shall be based on the uppercase letter "I".	3 of 4 informational signs lacks character height	Replace signage with compliant signage having larger font based on the viewing distance.	2015 ABAAS Section: 703.5.5  2012 TAS Section: 703.5.5  2010 ADAS Section: 703.5.5

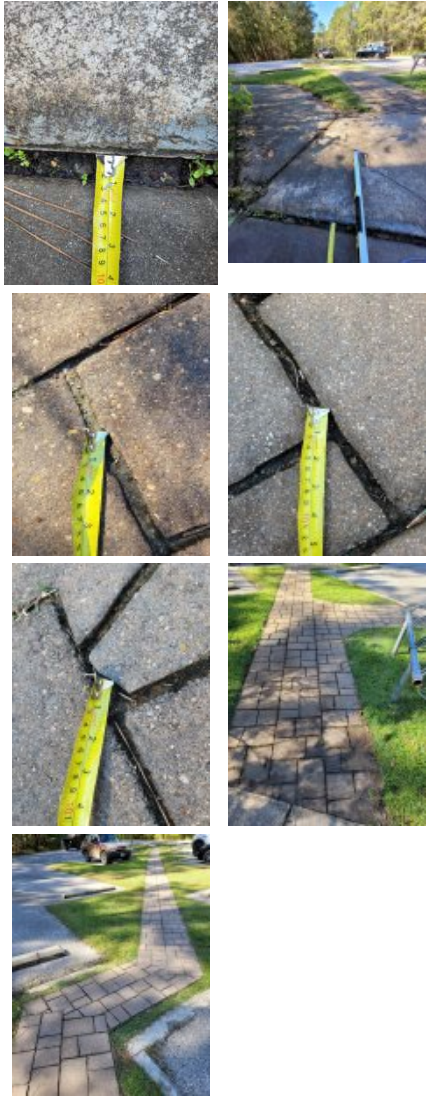
Finding Number	Area Description	Lat/Long	Finding	As Built	Recommendation	Citation	Photos	Figure
10	Headquarters: Headquarters Exterior Accessible Route	[30.65699, -95.0012]	There is a gap spaced greater than a 1/2 inch. Openings in floor or ground surfaces shall not allow passage of a sphere more than 1/2 inch diameter. Elongated openings shall be placed so that the long dimension is perpendicular to the dominant direction of travel.	Gap of 1" at sidewalk and multiple 1" gaps on walkway of pavers	Correct or fill gaps to be max .5".	2015 ABAAS Section: 302.3  2012 TAS Section: 302.3  2010 ADAS Section: 302.3

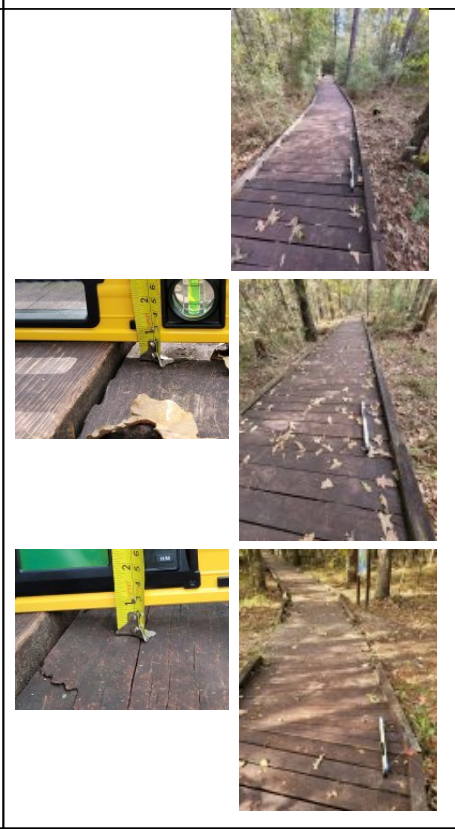
57	Trails and Trailheads: Pineywoods Boardwalk Trail	[30.66454, -95.00497]	The cross slope shall not be steeper than 1:48. EXCEPTION: Where the surface is other than concrete, asphalt, or boards, cross slopes not steeper than 1:20 shall be permitted when necessary for drainage.	Multiple cross slopes of 5.2% near boardwalk entry, 4.7%, 6.6%, 7.2% near platform, and 2.4% near Bakba Trail crossing	Correct or repair pathway cross slope to max 2.08% or 5% depending on surface as a smart practice.	2015 ABAAS Section: 1017.2

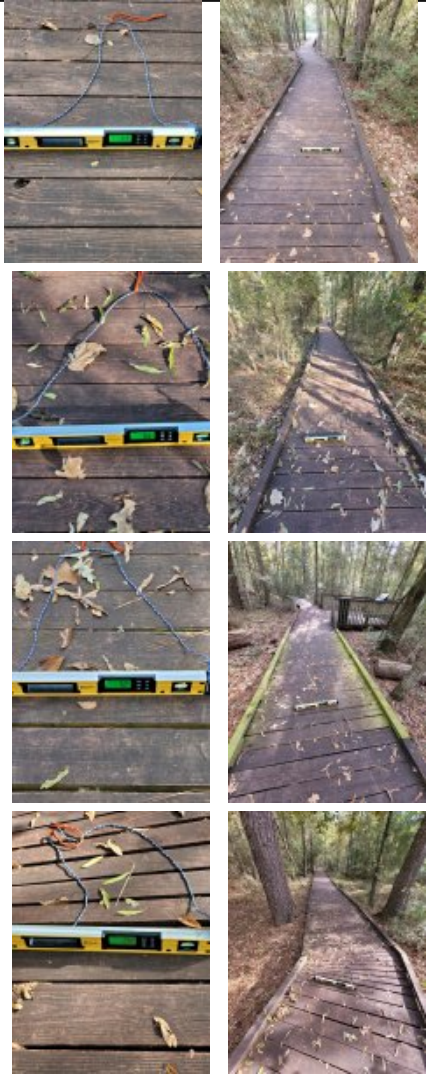
Finding Number	Area Description	Lat/Long	Finding	As Built	Recommendation	Citation	Photos	Figure
58	Trails and Trailheads: Pineywoods Boardwalk Trail	[30.6643855 , -95.004912 4]	Tread obstacles on trails, passing spaces, and resting intervals shall not exceed 1/2 inch (13 mm) in height measured vertically to the highest point. EXCEPTION: Where the surface is other than asphalt, concrete, or boards, tread obstacles shall be permitted to not exceed 2 inches (50 mm) in height measured vertically to the highest point.	Multiple CILs of .75", 1", 1.25", .75", and 1.25"	Repair, bevel or ramp tread obstacle along pathway to max .5" as a smart practice.	2015 ABAAS Section: 1017.5

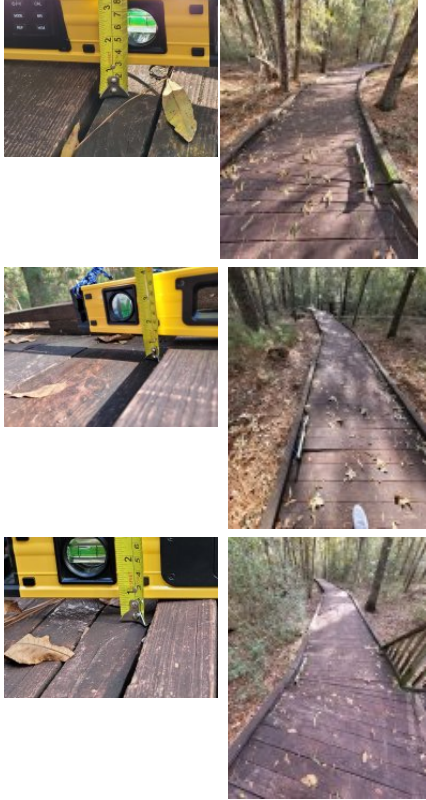
Finding Number	Area Description	Lat/Long	Finding	As Built	Recommendation	Citation	Photos	Figure
59	Trails and Trailheads: Pineywoods Boardwalk Trail	[30.66574, -95.00495]	Openings in the surface of outdoor recreation access routes shall not allow the passage of a sphere more than 1/2 inch (13 mm) in diameter. Advisory: Spaces between the boards in a boardwalk and drainage grates are examples of openings. Where possible, drainage grates should be located outside the minimum clear width of the outdoor recreation access route. Elongated openings should be placed so that the long dimension is perpendicular, or as close to perpendicular as possible, to the dominant direction of travel	Multiple gaps (8) exceeding .5"	Correct or fill gaps along the ORAR to max .5" as a smart practice.	2015 ABAAS Section: 1016.6, Advisory 1016.6

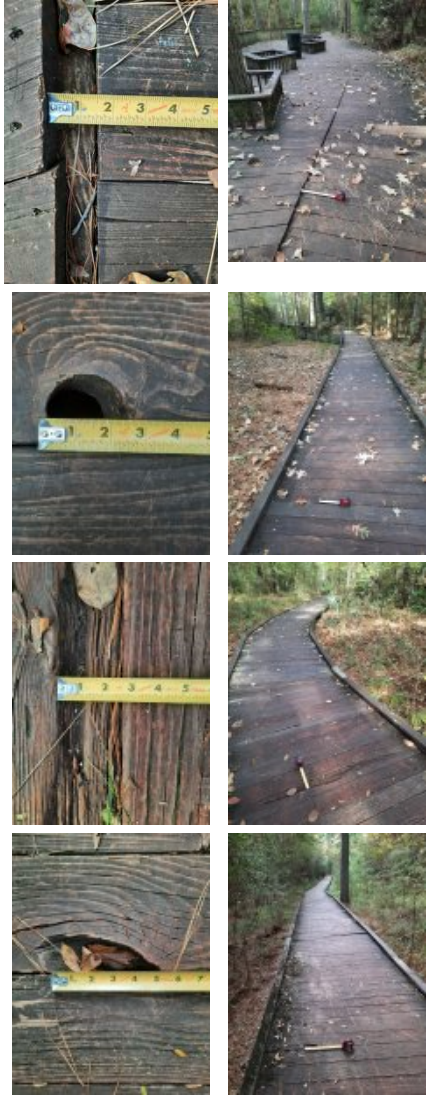
Finding Number	Area Description	Lat/Long	Finding	As Built	Recommendation	Citation	Photos	Figure
74	Trails and Trailheads: Pineywoods Boardwalk Trail	[30.66541, -95.00185]	The surface of trails, passing spaces, and resting intervals shall be firm and stable.	Break in accessible boardwalk surface, lacks firm and stable surface	Extend boardwalk trail surface as a smart practice to connect portions.	2015 ABAAS Section: 1017.2

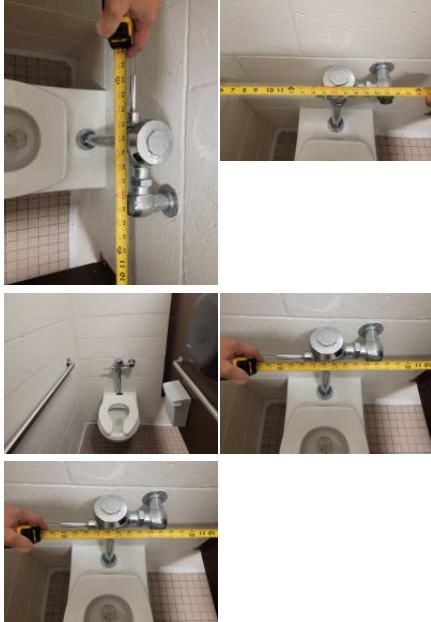
Finding Number	Area Description	Lat/Long	Finding	As Built	Recommendation	Citation	Photos	Figure
113	Hercules Club Loop: Hercules Club Loop Women's Restroom	[30.6517099 , -95.003451 7]	Grab bars shall comply with 609. A side-wall grab bar complying with 604.5.1 shall be provided on both sides of the compartment. The space between the wall and the grab bar shall be 1½ inches (38 mm). The space between the grab bar and projecting objects below and at the ends shall be 1½ inches (38 mm) minimum. The space between the grab bar and projecting objects above shall be 12 inches (305 mm) minimum. Grab bars shall be installed in a horizontal position, 33 inches (840 mm) minimum and 36 inches (915 mm) maximum above the finish floor measured to the top of the gripping surface, except that at water closets for children's use complying with 604.9, grab bars shall be installed in a horizontal position 18 inches (455 mm) minimum and 27 inches (685 mm) max	Side grab bar 36" long	Replace or add side grab bars with a 42" long grab bar, mounted max 12" from the rear wall at the close end and min 54" on the far end and 33" to 36" aff	2015 ABAAS Section: 604.8.2.3, 609.3, 609.4  2012 TAS Section: 609.4, 609.3, 604.8.2.3  2010 ADAS Section: 609.3, 609.4, 604.8.2.3

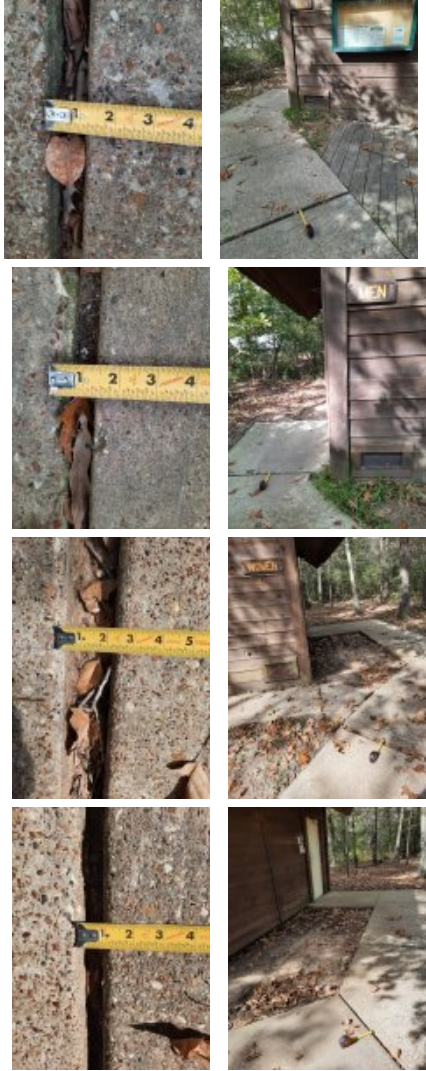
127	Piney Shores: Piney Shores Restroom Exterior Route	[30.652969, -95.006686 7]	The walkway contains abrupt vertical edges and/or variations over a 1/4 inch. 1/4 inch is the maximum vertical rise. Changes in level between 1/4 inch and 1/2 inch must be beveled at 1:2 or less. Changes in level	changes in level of .75", .5", .75", and 1"	Repair, bevel or ramp CIL along AR	2012 TAS Section: 303.2, 303.3  2010 ADAS

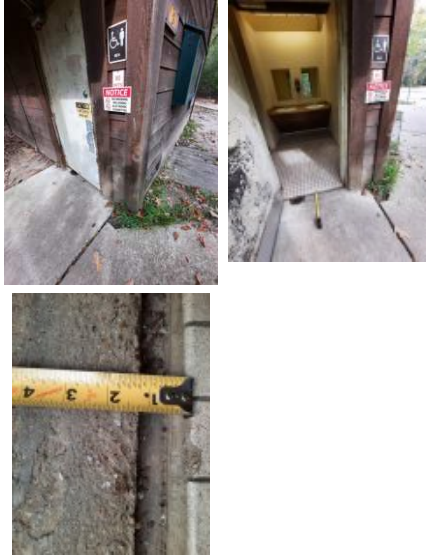
Finding Number	Area Description	Lat/Long	Finding	As Built	Recommendation	Citation	Photos	Figure
131	Piney Shores: Piney Shores Men's Restroom	[30.6530105 , -95.00668]	The mirror is mounted too high. Mirrors must have the bottom edge of the reflecting surface a maximum of 40 inches above the floor if above a sink or counter. Mirrors not located above lavatories or countertops shall be installed with the bottom edge of the reflecting surface 35 inches maximum above the finish floor or ground.	Bottom edge of reflecting surface of mirror is 43.75" aff and top edge of reflecting surface is 73" aff	Replace mirror mount to max 40" AFF to the bottom reflective surface and 74" to the top.	2015 ABAAS Section: 603.3  2012 TAS Section: 603.3  2010 ADAS Section: 603.3		
132	Piney Shores: Piney Shores Men's Restroom	[30.6529875 , -95.006681 3]	Knee clearance at 27 inches off the floor is not 8 inches minimum deep. The knee clearance, measured from the bottom of the apron or the outside bottom edge of the lavatory, must be 27 inches at a point located 8 inches back from the front edge and continuing to 11 inches minimum in depth at 9 inches above the floor. The top of the lavatory rim may be no higher than 34 inches.	Sink lacks 8" deep knee clearance, only 5.5"	Remove face board to provide 8" deep knee clearance.	2015 ABAAS Section: 306.3.1, 306.3.2, 306.3.3, 306.3.4 , 306.3.5  2012 TAS Section: 306.3.2, 306.3.3, 306.3.4, 306.3.5, 306.3.1  2010 ADAS Section: 306.3.3, 306.3.2, 306.3.4, 306.3.5, 306.3.1

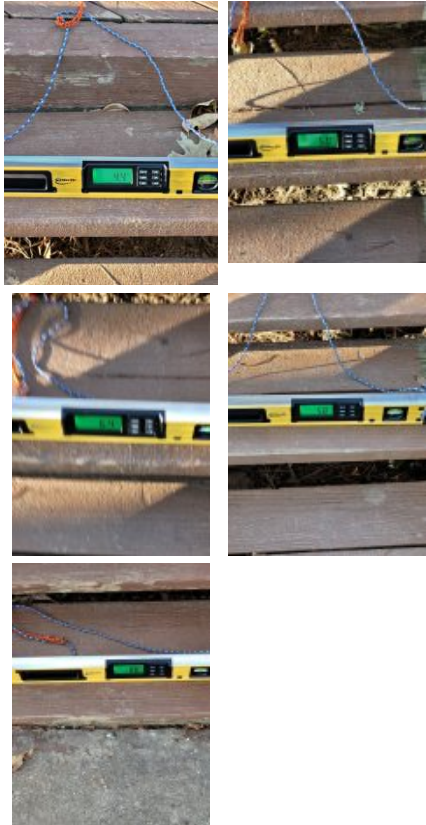
183	Piney Shores: Piney Shores Screened Shelter - 2	[30.6525375 , -95.007227 1]	The stripe on the stair tread does not contrast adequately with the stair tread. Exterior and interior stairs are recommended to have the upper approach and lower treads marked by a stripe providing clear visual contrast.	Lacks contrasting stripe along front 2" of each tread	SMART PRACTICE Install contrasting stripe along front 2" of each tread The stripe shall be a minimum of 2 inches wide to a maximum of 4 inches wide placed parallel to, and not more than 1 inch from, the nose of the step or upper approach. The stripe shall extend the full width of the step or upper approach and shall be of material that is at least as slip resistant as the other treads of the stair. A painted stripe shall be acceptable. Grooves shall not be used to satisfy this requirement.	2015 ABAAS Section: Advisory 504.4  2012 TAS Section: 504.4 Advisory  2010 ADAS Section: 504.4

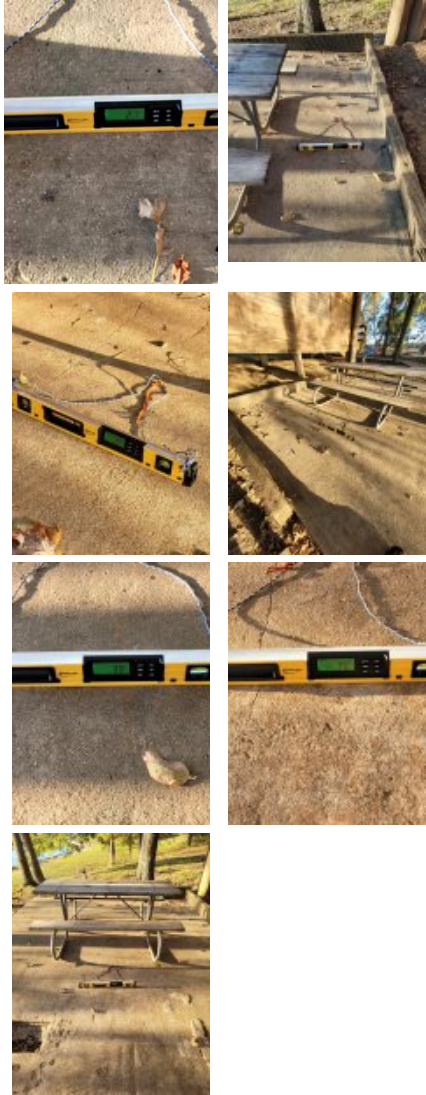
Finding Number	Area Description	Lat/Long	Finding	As Built	Recommendation	Citation	Photos	Figure
189	Piney Shores: Piney Shores Screened Shelter - 2	[30.6525514 , -95.007224 4]	Picnic tables are required to have clear ground space 36 inches (915 mm) on all usable sides of the table measured from the back edge of the benches.	Lacks 36" clear width around picnic table (32")	Provide required 36" clear ground space around all usable portions of the table as a smart practice.	2015 ABAAS Section: 1011.2.1

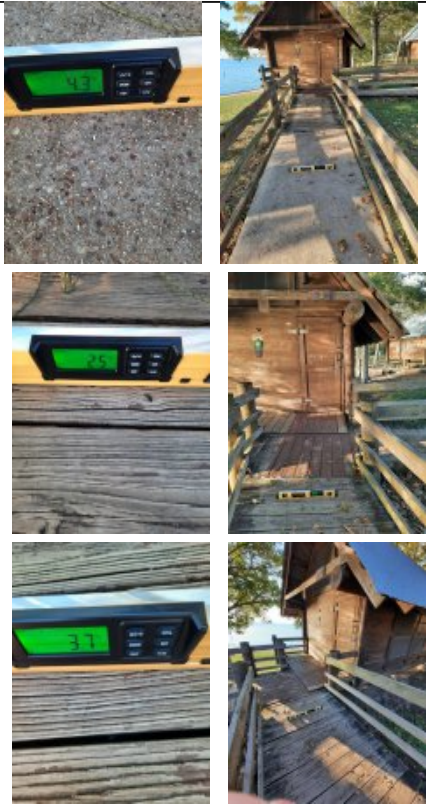
198	Piney Shores: Piney Shores Screened Shelter - 3	[30.6523968 , -95.007299 5]	There are openings in the surface of the trails, passing spaces, and resting intervals that allow the passage of a sphere more than 1/2 inch in diameter. Openings in the surface of trails, passing spaces, and resting intervals shall not allow the passage of a sphere more than 1/2 inch (13 mm) in diameter.	Gaps of .75", 1", .75", and 1" on board walk	Correct for fill gaps to max .5" as a smart practice.	2015 ABAAS Section: 1017.6

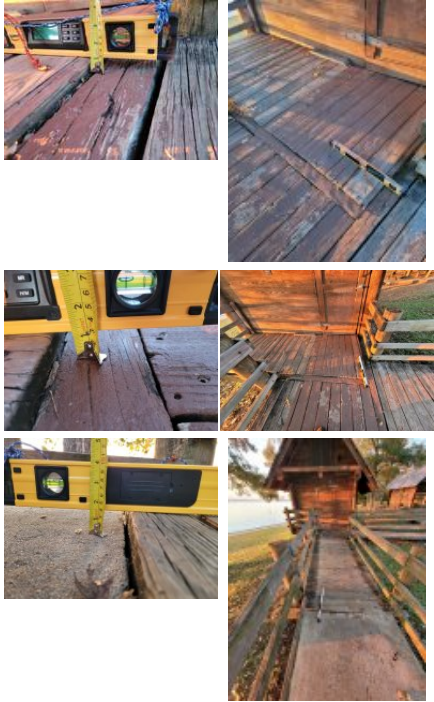
Finding Number	Area Description	Lat/Long	Finding	As Built	Recommendation	Citation	Photos	Figure
208	Piney Shores: Piney Shores Screened Shelter - 4	[30.6519491 , -95.007282 1]	Minimum maneuvering clearances at doors and gates shall comply with 404.2.4. Maneuvering clearances shall extend the full width of the doorway and the required latch side or hinge side clearance.	4" to railing on the pull side of the door	Provide required maneuvering clearance around pull side of door.	2015 ABAAS Section: 404.2.4.1 , 404.2.4.4  2012 TAS Section: 404.2.4.4, 404.2.4.1  2010 ADAS Section: 404.2.4.4, 404.2.4.1

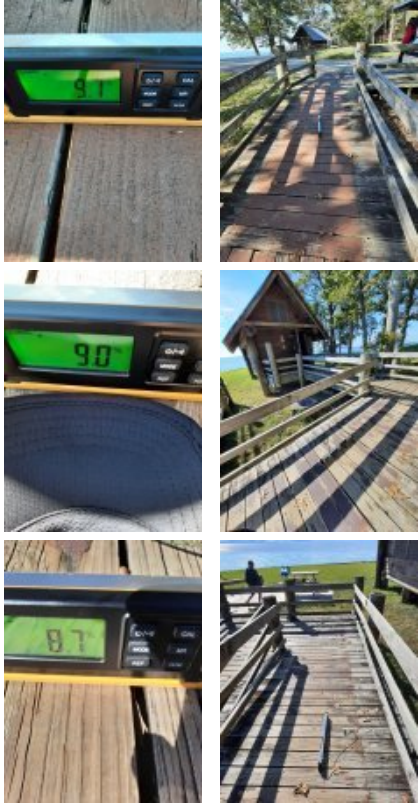
Finding Number	Area Description	Lat/Long	Finding	As Built	Recommendation	Citation	Photos	Figure
212	Piney Shores: Piney Shores Screened Shelter - 4	[30.6519306 , -95.007304 9]	The ramp on the accessible route contains cross slopes greater than 2%. Surface cross slopes shall not exceed one unit vertical in 48 units horizontal (2-percent slope).	Cross slopes of 4.6% and 3.4%	Correct ramp cross slope to max 2.08%. Cost included in previous finding.	2015 ABAAS Section: 405.3  2012 TAS Section: 405.3  2010 ADAS Section: 405.3

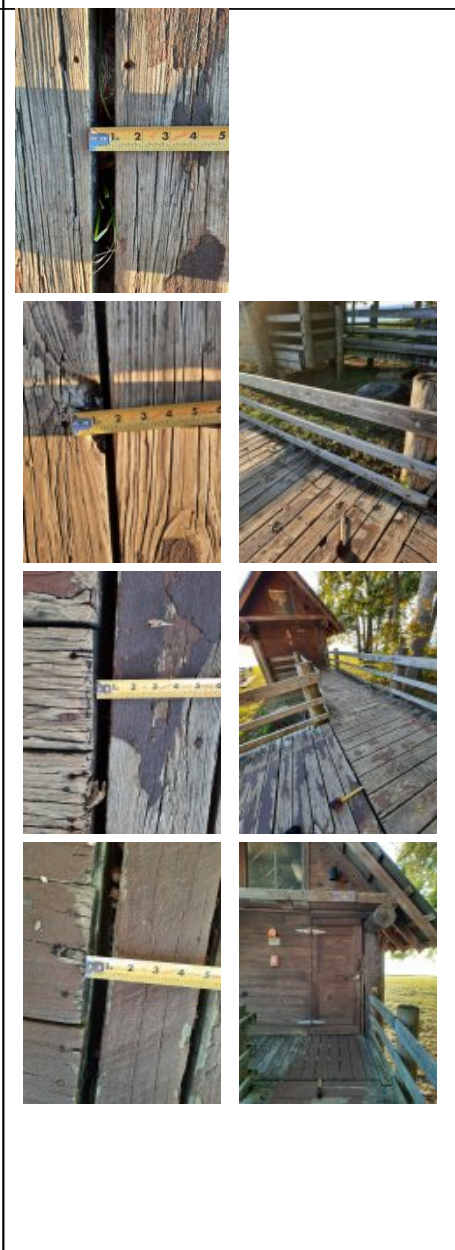
Finding Number	Area Description	Lat/Long	Finding	As Built	Recommendation	Citation	Photos	Figure
219	Piney Shores: Piney Shores Screened Shelter - 4	[30.6519514 , -95.007272 7]	The surface of the outdoor recreation access route, passing spaces, and/or resting intervals are not firm and stable. The surface of outdoor recreation access route, passing spaces, and resting intervals shall be firm and stable, having a width of 36", max gaps of .5" and tread obstacles of .5" or less.	Gaps of 30", 2" at table and 55" near bench	Correct surface of ORAR to be firm and stable, a min 36" wide and having gaps and changes in level of max .5"	2015 ABAAS Section: 1016.2

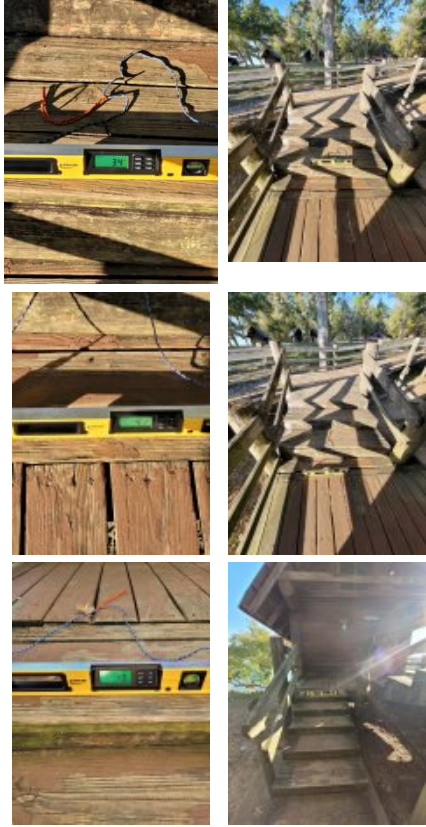
<p>(a) stairs</p>
240	Piney Shores: Piney Shores Screened Shelter - 5	[30.6519514 , -95.007135 9]	The stripe on the stair tread does not contrast adequately with the stair tread. Exterior and interior stairs are recommended to have the upper approach and lower treads marked by a stripe providing clear visual contrast.	Lacks contrasting stripe along front 2" of each tread	Install contrasting strip along front 2" of each tread. The stripe shall be a minimum of 2 inches wide to a maximum of 4 inches wide placed parallel to, and not more than 1 inch from, the nose of the step or upper approach. The stripe shall extend the full width of the step or upper approach and shall be of material that is at least as slip resistant as the other treads of the stair. A painted stripe shall be acceptable. Grooves shall not be used to satisfy this requirement.	2015 ABAAS Section: Advisory 504.4  2012 TAS Section: 504.4 Advisory  2010 ADAS Section: 504.4

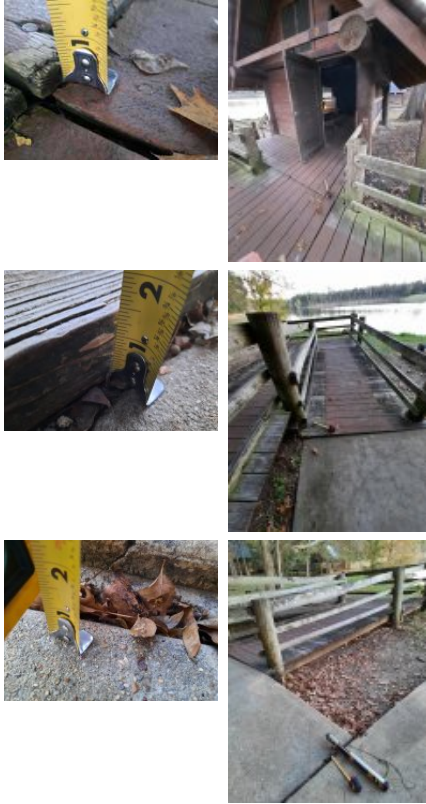
252	Piney Shores: Piney Shores Screened Shelter - 6	[30.6520553 , -95.006910 6]	The stair risers are not uniform in height. Stair riser heights shall be 7 inches maximum and 4 inches minimum. On any given flight of stairs, all steps shall have uniform riser height and uniform tread widths.	Lacks uniform height of stair risers (vary between 3.5" and 6.5")	Correct riser heights on stairs to consistent height between 4" to 7", leave as is if technically infeasible	2015 ABAAS Section: 504.2  2012 TAS Section: 504.2  2010 ADAS Section: 504.2

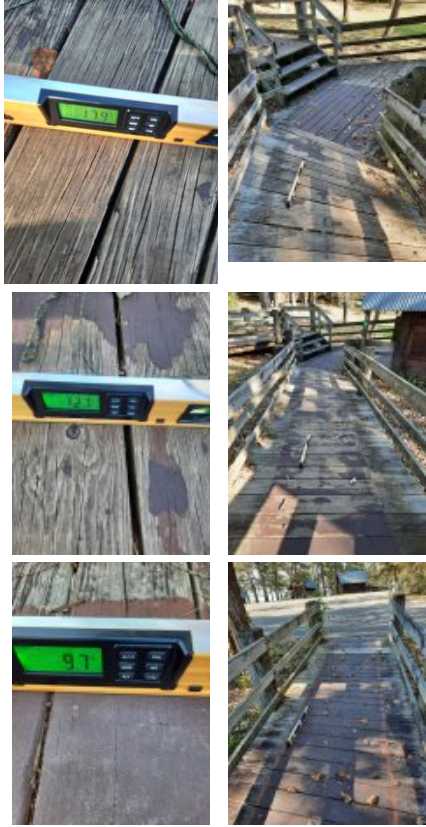
270	Piney Shores: Piney Shores Screened Shelter - 7	[30.6521452 , -95.006785 9]	The ramp on the accessible route contains cross slopes greater than 2%. Surface cross slopes shall not exceed one unit vertical in 48 units horizontal (2-percent slope).	Entry ramp - cross slopes of 2.2%, 3.2%, 9.2%, 5.9%, and 2.2%	Correct ramp cross slope to max 2.08%. Cost included in previous finding.	2015 ABAAS Section: 405.3  2012 TAS Section: 405.3  2010 ADAS Section: 405.3

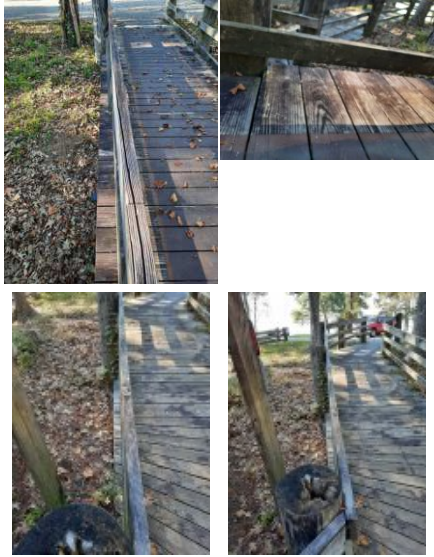
Finding Number	Area Description	Lat/Long	Finding	As Built	Recommendation	Citation	Photos	Figure
274	Piney Shores: Piney Shores Screened Shelter - 7	[30.6521246 , -95.006780 5]	There is a gap spaced greater than a 1/2 inch. Openings in floor or ground surfaces shall not allow passage of a sphere more than 1/2 inch diameter. Elongated openings shall be placed so that the long dimension is perpendicular to the dominant direction of travel.	Gaps of 1.25" and 1.25"	Correct or fill gaps to be max .5"	2015 ABAAS Section: 302.3  2012 TAS Section: 302.3  2010 ADAS Section: 302.3

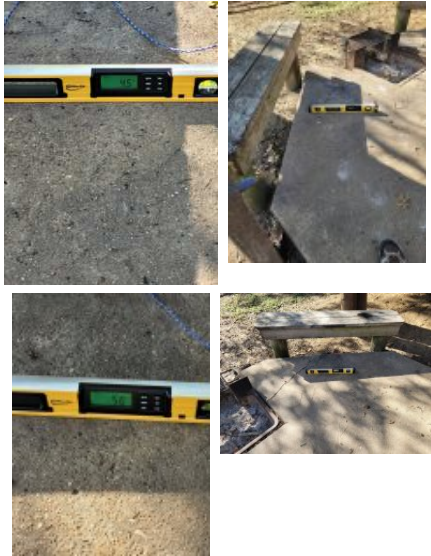
281	Piney Shores: Piney Shores Screened Shelter - 7	[30.6521406 , -95.006771 2]	Clear ground space 48 inches (1220 mm) by 48 inches (1220 mm) should be provided on all usable sides of the fire ring, grill, fireplace, and woodstove. Center the space on each usable side of the grill, fireplace, and woodstove.	Lacks 48" by 48" clear floor space on all usable sides of the fire ring	Provide required 48" clear ground space centered along usable side of fire ring, grill, fireplace, or woodstove as a smart practice.	2015 ABAAS Section: 1011.2

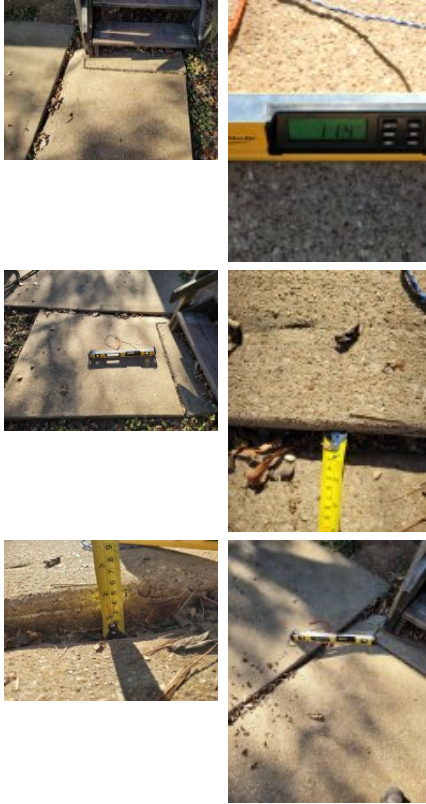
Finding Number	Area Description	Lat/Long	Finding	As Built	Recommendation	Citation	Photos	Figure
291	Piney Shores: Piney Shores Screened Shelter - 7	[30.6521291 , -95.006784 6]	The stairway treads are sloped greater than 2.08% in any direction.	Stairs to picnic area - Cross slopes range from 3% to 4.8% on treads	Correct or repair slope of tread to max 2.08% in any direction.	2015 ABAAS Section: 504.4  2012 TAS Section: 504.4  2010 ADAS Section: 403.3, 504.4

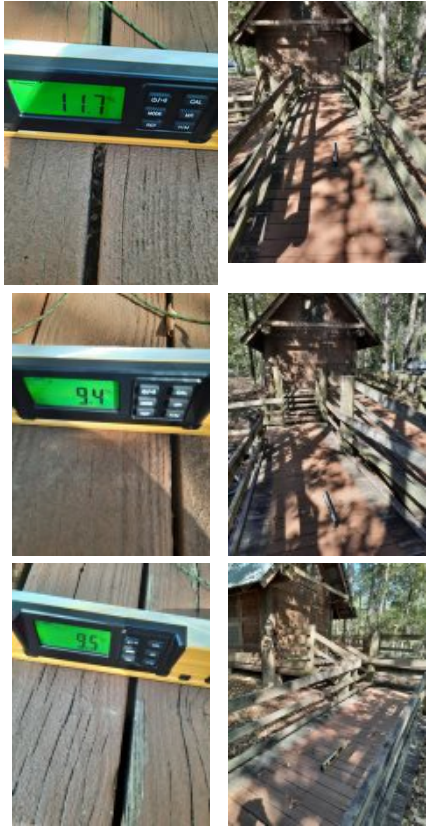
299	Piney Shores: Piney Shores Screened Shelter - 8	[30.6522906 , -95.006580 7]	The ramp on the accessible route contains cross slopes greater than 2%. Surface cross slopes shall not exceed one unit vertical in 48 units horizontal (2-percent slope).	Entry Ramp - Cross slope of 2.6%	Correct ramp cross slope to max 2.08%. Cost included in previous finding.	2015 ABAAS Section: 405.3  2012 TAS Section: 405.3  2010 ADAS Section: 405.3

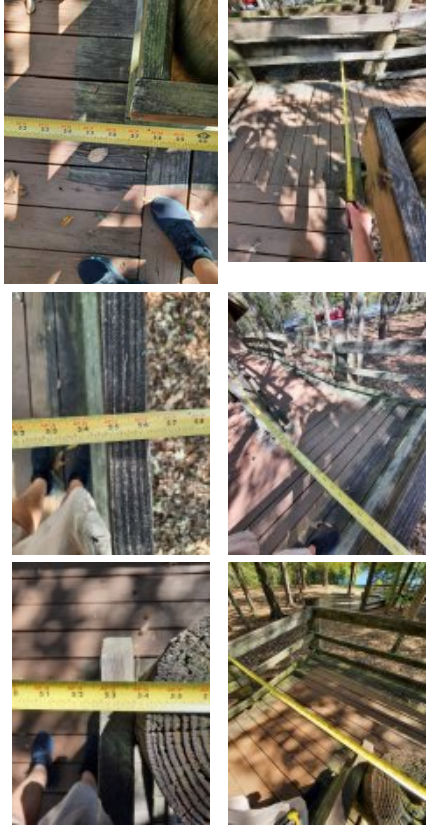
Finding Number	Area Description	Lat/Long	Finding	As Built	Recommendation	Citation	Photos	Figure
301	Piney Shores: Piney Shores Screened Shelter - 8	[30.6522756 , -95.006583 4]	The ramp does not have compliant handrails. Handrails are required on both sides of all surfaces that are sloped greater than 5 percent (1:20). Handrails must be between 34 inches and 38 inches above the ramp surface, must extend beyond the top and bottom of the ramp 12 inches and be parallel to the floor or ground surface. The diameter of the handrails must be between 1 inches and 2 inches in cross-sectional nominal dimension for circular handrails and handrail gripping surfaces with a non-circular cross section shall have a perimeter dimension of 4 inches minimum and 6 inches maximum, and a cross-section dimension of 2 inches maximum. The clear space between handrails and walls must 1-1/2 inches minimum.	Entry Ramp - lacks compliant handrails	Install handrails that are rounded and/or extend to the ground, with handrail extensions and mounted 34" to 38" aff.	2015 ABAAS Section: 505.1  2012 TAS Section: 505.1  2010 ADAS Section: 505.1

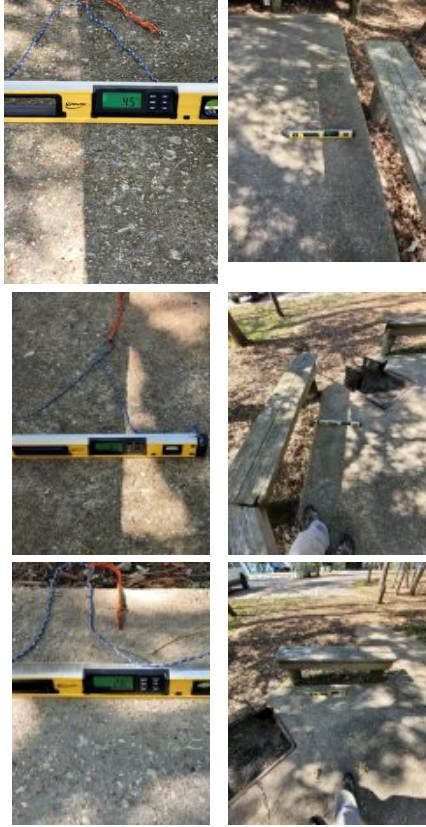
315	Piney Shores: Piney Shores Screened Shelter - 8	[30.6522871 , -95.006598 1]	Where provided, cooking surfaces shall be 15 inches (380 mm) minimum and 34 inches (865 mm) maximum above the ground.	Cooking surface of grill 8" at highest setting	Raise or lower cooking surface to be 15" min to 34" max above the ground; in the alternative, replace with a compliant surface as a smart practice.	2015 ABAAS Section: 1011.5.2

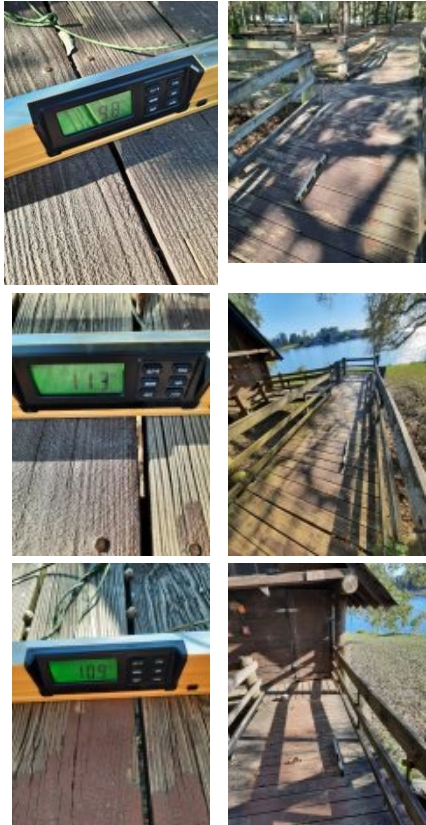
Finding Number	Area Description	Lat/Long	Finding	As Built	Recommendation	Citation	Photos	Figure
321	Piney Shores: Piney Shores Screened Shelter - 9	[30.6521672 , -95.006405]	The ramp on the accessible route contains cross slopes greater than 2%. Surface cross slopes shall not exceed one unit vertical in 48 units horizontal (2-percent slope).	Entry Ramp - cross slopes of 2.8%, 4.2%, 2.3%, 3.4%, 9.0%, and 4.9%	Correct ramp cross slope to max 2.08%. Cost included in previous finding.	2015 ABAAS Section: 405.3  2012 TAS Section: 405.3  2010 ADAS Section: 405.3

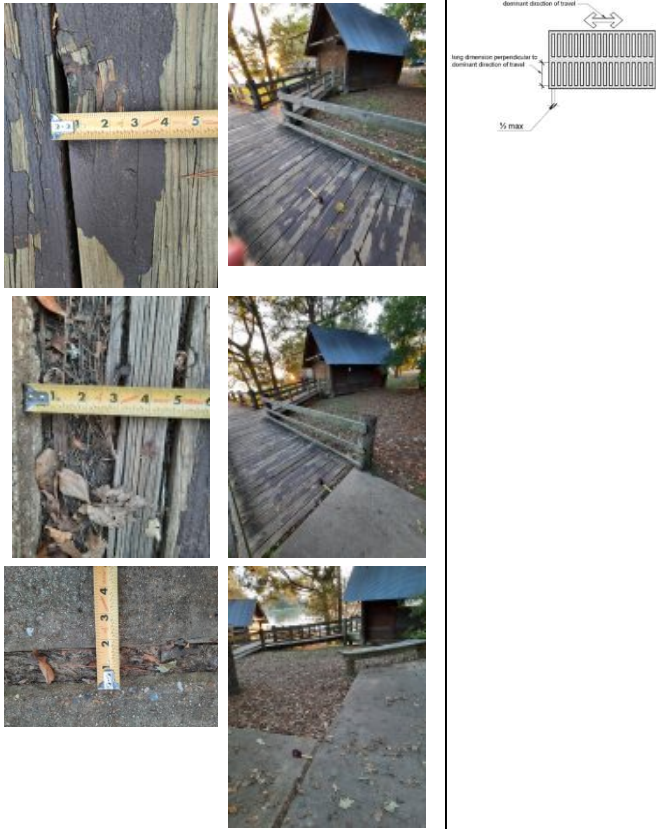
Finding Number	Area Description	Lat/Long	Finding	As Built	Recommendation	Citation	Photos	Figure
328	Piney Shores: Piney Shores Screened Shelter - 9	[30.6521602 , -95.006402 3]	The walkway contains abrupt vertical edges and/or variations over a 1/4 inch. 1/4 inch is the maximum vertical rise. Changes in level between 1/4 inch and 1/2 inch must be beveled at 1:2 or less. Changes in level greater than 1/2 inch must be by way of a ramp.	CILs of .5", .75", 2", and 1.75"	Repair, bevel or ramp CIL along AR	2012 TAS Section: 303.2, 303.3  2010 ADAS Section: 303.2, 303.3

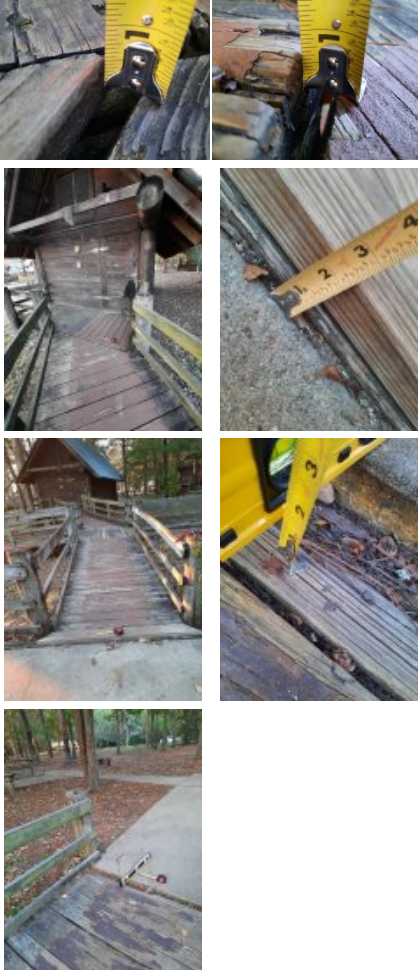
Finding Number	Area Description	Lat/Long	Finding	As Built	Recommendation	Citation	Photos	Figure
329	Piney Shores: Piney Shores Screened Shelter - 10	[30.6520183 , -95.006456]	Minimum maneuvering clearances at doors and gates shall comply with 404.2.4. Maneuvering clearances shall extend the full width of the doorway and the required latch side or hinge side clearance.	3" to railing on pull side of door	Provide required maneuvering clearance around pull side of door	2015 ABAAS Section: 404.2.4.1 , 404.2.4.4  2012 TAS Section: 404.2.4.4, 404.2.4.1  2010 ADAS Section: 404.2.4.4, 404.2.4.1

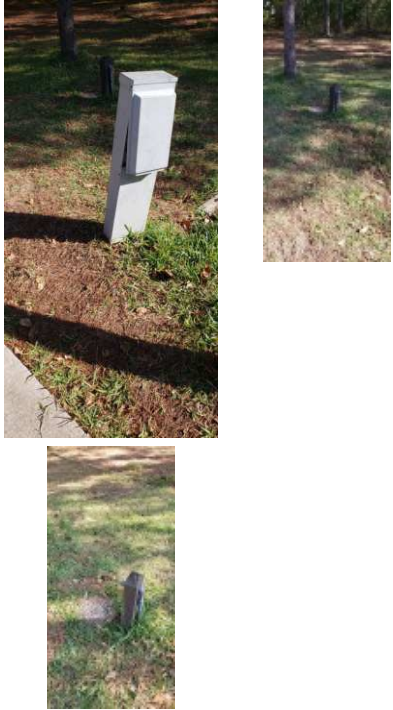
338	Piney Shores: Site 55	[30.6548888, -95.006586 1]	Water spouts at water hydrants and water utility hook-ups shall be 28 inches (710 mm) minimum and 36 inches (915 mm) maximum above the ground	Water spout is 15" above ground level	Remount water spouts to 28" min or 36" max above the ground as a smart practice	2015 ABAAS Section: 1011.6

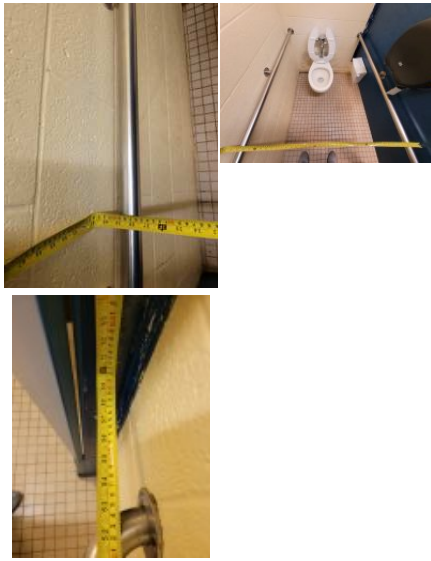
Finding Number	Area Description	Lat/Long	Finding	As Built	Recommendation	Citation	Photos	Figure
464	Picnic Area/Day Use - South: Picnic Area/Day Use - South Women's Restroom	[30.6575653 , -95.007916 5]	The toilet is not located within the range to the side wall or partition. The centerline of the toilet shall be 17 inches minimum and 19 inches maximum side wall or partition in the ambulatory accessible toilet compartment.	Centerline of the toilet is 22.5" from the side wall	Remount toilet to 17" to 19" from the side wall to center line in ambulatory stalls or 16" to 18" in new wheelchair stall.	2015 ABAAS Section: 604.9.1  2012 TAS Section: 604.9.1  2010 ADAS Section: 604.9.1

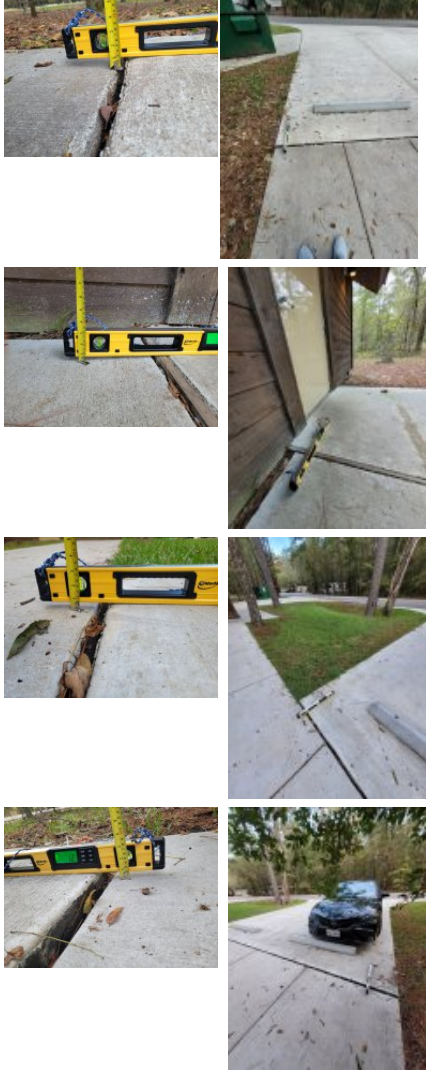
Finding Number	Area Description	Lat/Long	Finding	As Built	Recommendation	Citation	Photos	Figure
502	Pin Oak Loop: Pin Oak Loop Restroom Parking and Exterior Accessible Route	[30.6697339 , -95.008935 4]	There is a gap spaced greater than a 1/2 inch. Openings in floor or ground surfaces shall not allow passage of a sphere more than 1/2 inch diameter. Elongated openings shall be placed so that the long dimension is perpendicular to the dominant direction of travel.	Gaps of .75", 1.25", and long gap of 1"	Correct or fill gaps to be max .5".	2015 ABAAS Section: 302.3  2012 TAS Section: 302.3  2010 ADAS Section: 302.3

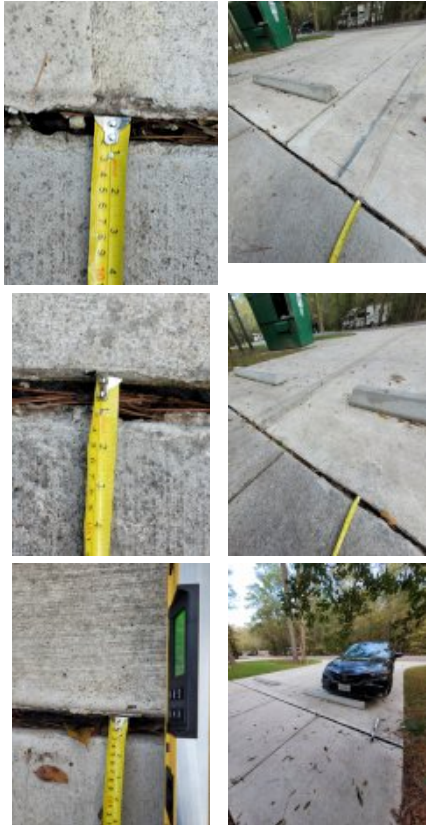
Finding Number	Area Description	Lat/Long	Finding	As Built	Recommendation	Citation	Photos	Figure
503	Pin Oak Loop: Pin Oak Loop Men's Restroom	[30.6697356 , -95.008900 8]	Minimum maneuvering clearances at doors and gates shall comply with 404.2.4. Maneuvering clearances shall extend the full width of the doorway and the required latch side or hinge side clearance. Maneuvering clearances shall have a max slope of 2.08%. The threshold has a vertical change greater than 1/4 inch high. Exterior doors are recommended to be maintained at 8.5 lbf as a smart practice. Force is to be measured at the operating hardware or 30 inches from the hinges, whichever is greater.	Door - slope of 2.3% on pull side landing, 1" at threshold, 12# push	For all doors along the public circulation route, provide required maneuvering clearance on push and pull side of doors. For all doors along the public circulation route, correct slope in door clearance to max 2.08%. For all doors along the public circulation route, repair, bevel, or ramp CILs at door entries to max .25". For all doors along the public circulation route, inspect, adjust, and maintain 8.5 lbf to open exterior doors as a smart practice.	2010 ADAS Section: 404.2.3, 404.2.7, 404.2.4, 404.2.11, 404.2.11 Exception
