Access Audit Site Report

Lake Mineral Wells State Park and Trailway

Accessibility Evaluation

Inspection Date: 07/12/2021

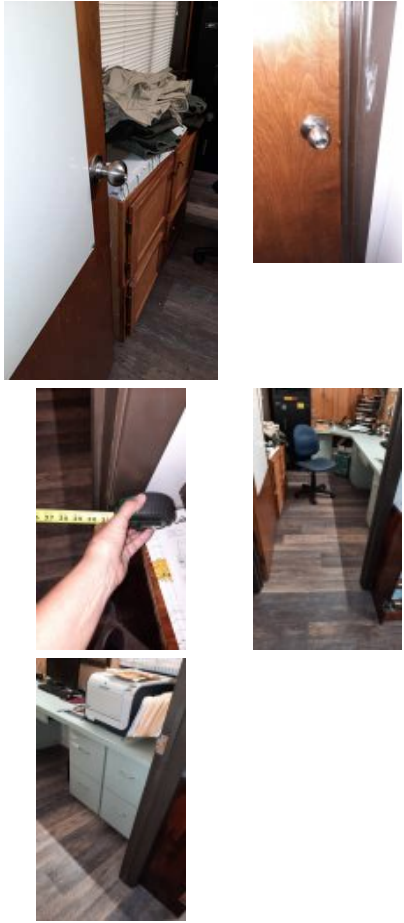
Finding Number	Area Description	Lat/Long	Finding	As Built	Recommendation	Citation	Photos	Figure
3	Headquarters : Headquarters	[32.8126, -98.04362]	Spaces and elements within employee work areas shall only be required to comply with 206.2.8, 207.1, and 215.3 and shall be designed and constructed so that individuals with disabilities can approach, enter, and exit the employee work area. Employee work areas, or portions of employee work areas, other than raised courtroom stations, that are less than 300 square feet (28 m2) and elevated 7 inches (180 mm) or more above the finish floor or ground where the elevation is essential to the function of the space shall not be required to comply with these requirements or to be on an accessible route.	2 offices- Both have knobs, door width 30", counter on pull side	Provide required maneuvering clearance on push and pull side of doors. Replace doors with doors having 80" overhead clearance and 32" clear width. Replace hardware with lever hardware or hardware operable without a tight pinch or grasp.	2015 ABAAS Section: F203.9 2012 TAS Section: 203.9 2010 ADAS Section: 203.9

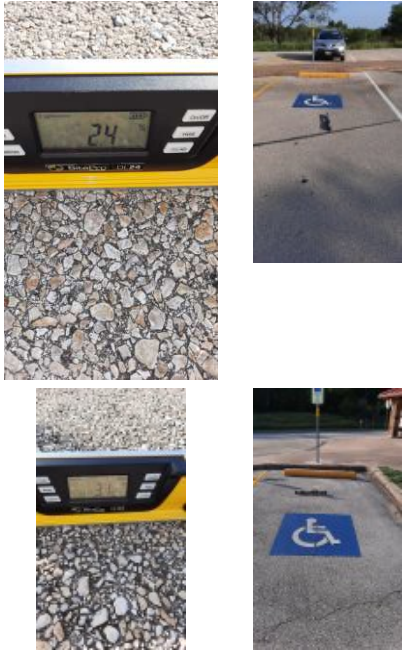
Finding Number	Area Description	Lat/Long	Finding	As Built	Recommendation	Citation	Photos	Figure
5	Headquarters : Headquarters	[32.8126, -98.04362]	The cross slopes (narrow dimension) and/or running slopes (long dimension) of the access aisle exceeds 2%. The running slope and the cross slope in an accessible parking stall and the access aisle must not exceed 2%.	Inbound side: stall - 2.4%, outbound side: stall 3.1%	Repair or correct slope of parking space and access aisle to max 2.08% in any direction	2015 ABAAS Section: 502.4 2012 TAS Section: 502.4 2010 ADAS Section: 502.4

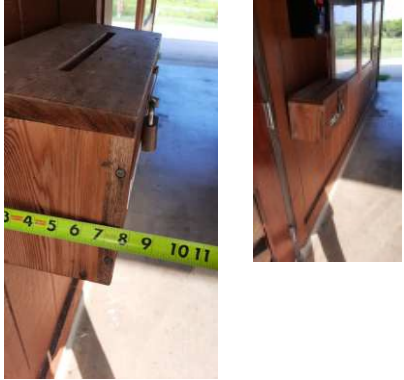
Finding Number	Area Description	Lat/Long	Finding	As Built	Recommendation	Citation	Photos	Figure
15	Headquarters : Headquarters	[32.8126, -98.04362]	The key box projects more than 4 inches into the circulation path. Wall-mounted objects that have leading edges between 27 inches and 80 inches from the floor must not project more than 4 inches into the circulation path. Protruding objects that extend to the floor or within 27 inches of the floor are cane detectable and are therefore not hazardous. Where it is necessary or desirable to have objects protrude from the wall, a manner of cane detection must be provided.	shelter key box - protrudes 8"	Relocate protruding objects or place cane detectable warning or bollard at foot of item	2015 ABAAS Section: 307.2 2012 TAS Section: 307.2 2010 ADAS Section: 307.2

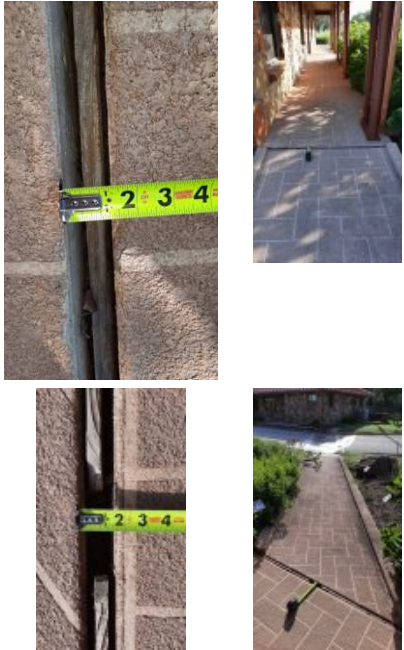
Finding Number	Area Description	Lat/Long	Finding	As Built	Recommendation	Citation	Photos	Figure
34	Administration Training Center: Administration Training Center	[32.8126, -98.04362]	There is a gap spaced greater than a 1/2 inch. Openings in floor or ground surfaces shall not allow passage of a sphere more than 1/2 inch diameter. Elongated openings shall be placed so that the long dimension is perpendicular to the dominant direction of travel.	1.25" gap from parking, 1.5" from registration building	Correct or fill gaps to be max .5"	2015 ABAAS Section: 302.3 2012 TAS Section: 302.3 2010 ADAS Section: 302.3

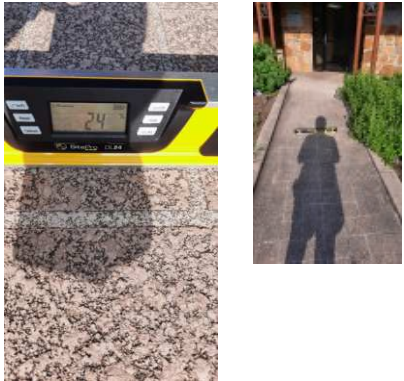
35	Administration Training Center: Administration Training Center	[32.8126, -98.04362]	The accessible route of travel on the accessible route contains cross slopes greater than 2%. Cross slopes shall not exceed one unit vertical in 48 units horizontal (2-percent slope).	2.4% from registration building	Correct or repair cross slope along AR to max 2.08%	2015 ABAAS Section: 403.3 2012 TAS Section: 403.3 2010 ADAS Section: 403.3

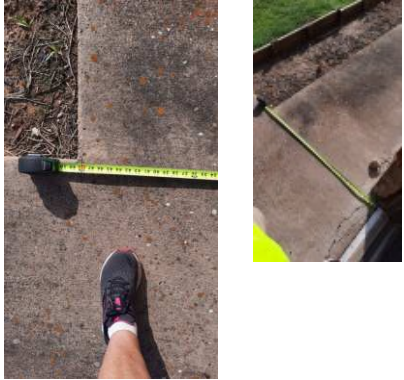
38	Administration Training Center: Administration Training Center	[32.8126, -98.04362]	Minimum maneuvering clearances at doors and gates shall comply with 404.2.4. Maneuvering clearances shall extend the full width of the doorway and the required latch side or hinge side clearance. Exterior doors are recommended to be maintained at 8.5 lbf as a smart practice. Force is to be measured at the operating hardware or 30 inches from the hinges, whichever is greater.	Break room exit - 10# push, 48" deep MC on pull	For all doors along the public circulation route, provide required maneuvering clearance on push and pull side of doors For all doors along the public circulation route, inspect, adjust, and maintain 8.5 lbf to open exterior doors as a smart practice	2010 ADAS Section: 404.2.3, 404.2.7, 404.2.4, 404.2.11, 404.2.11 Exception

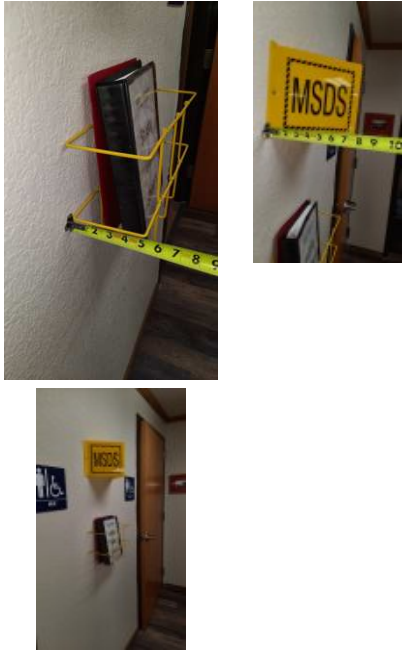
Finding Number	Area Description	Lat/Long	Finding	As Built	Recommendation	Citation	Photos	Figure
39	Administration Training Center: Administration Training Center	[32.8126, -98.04362]	The MSDS holder and sign project more than 4 inches into the circulation path. Wall-mounted objects that have leading edges between 27 inches and 80 inches from the floor must not project more than 4 inches into the circulation path. Protruding objects that extend to the floor or within 27 inches of the floor are cane detectable and are therefore not hazardous. Where it is necessary or desirable to have objects protrude from the wall, a manner of cane detection must be provided.	MSDS cage and sign protrude	Relocate protruding objects or place cane detectable warning or bollard at foot of item	2015 ABAAS Section: 307.2 2012 TAS Section: 307.2 2010 ADAS Section: 307.2

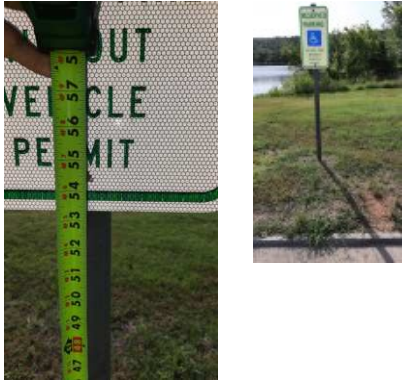
Finding Number	Area Description	Lat/Long	Finding	As Built	Recommendation	Citation	Photos	Figure
55	Day Use Area: Swimming/Boat Ramp/Concession Area	[32.8142501, -98.0388028]	The parking sign is mounted too low. Parking space identification signs shall include the International Symbol of Accessibility complying with. Signs identifying van parking spaces shall contain the designation "van accessible." Signs shall be 60 inches minimum above the finish floor or ground surface measured to the bottom of the sign.	53.25" AFF at restroom	Raise existing accessible parking signs so lowest end of bottom sign is min 60" aff	2015 ABAAS Section: 502.6 2012 TAS Section: 502.6 2010 ADAS Section: 502.6

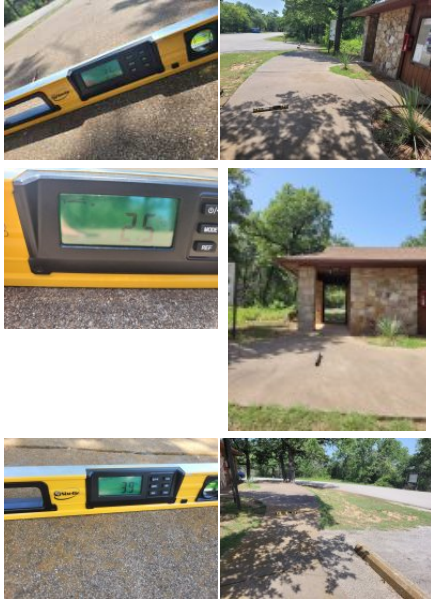
Finding Number	Area Description	Lat/Long	Finding	As Built	Recommendation	Citation	Photos	Figure
86	Day Use Area: Day Use	[32.8153221 , -98.032728]	The accessible path of travel between the building entrance and the accessible parking contains cross slopes greater than 2%. Surface cross slopes shall not exceed one unit vertical in 48 units horizontal (2-percent slope). When the slope in the direction of travel of any walk exceeds 1 unit vertical in 20 units horizontal (5-percent slope), it must be constructed as ramp.	3.5% in center of building, 2.7% by mens, 3.9% by accessible parking	Correct or repair sidewalk cross slope along AR to max 2.08%	2015 ABAAS Section: 403.3 2012 TAS Section: 403.3 2010 ADAS Section: 403.3

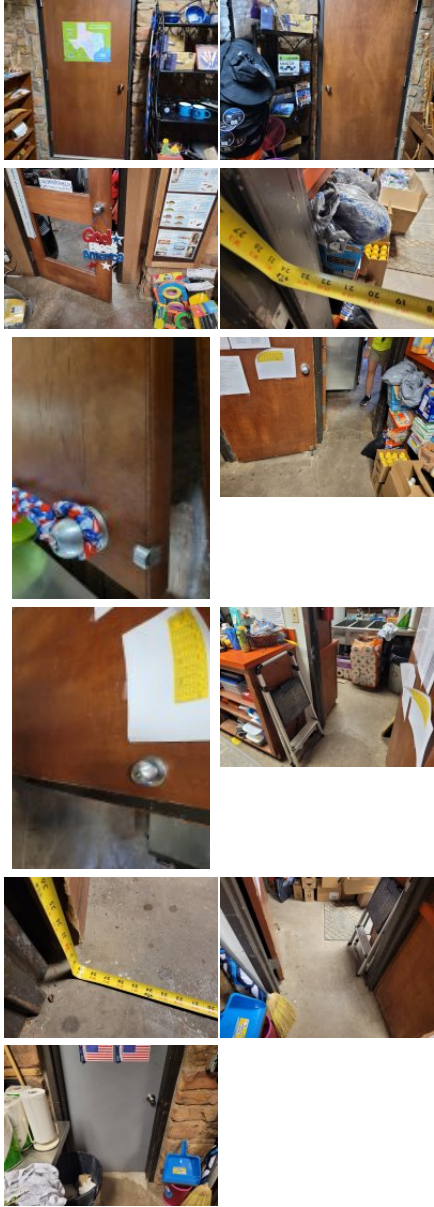
Finding Number	Area Description	Lat/Long	Finding	As Built	Recommendation	Citation	Photos	Figure
100	Day Use Area: Park Store	[32.8147235 , -98.038631 1]	Spaces and elements within employee work areas shall only be required to comply with 206.2.8, 207.1, and 215.3 and shall be designed and constructed so that individuals with disabilities can approach, enter, and exit the employee work area. Employee work areas, or portions of employee work areas, other than raised courtroom stations, that are less than 300 square feet (28 m2) and elevated 7 inches (180 mm) or more above the finish floor or ground where the elevation is essential to the function of the space shall not be required to comply with these requirements or to be on an accessible route.	storage rooms- knobs, shelves pull side; rental supplies- knob, storage pull side; concession- 24" wide, knob, fridge pull side; concession interior- knob, counter pull side, 29" wide; concession exit- knob, sink in pull side clearance	For employee spaces, relocate storage, furniture, and other obstacles at doorways to provide approach, enter and exit at the employee space. Provide required maneuvering clearance on push and pull side of doors. Replace doors with doors having 80" overhead clearance and 32" clear width. Replace hardware with lever hardware or hardware operable without a tight pinch or grasp.	2015 ABAAS Section: F203.9 2012 TAS Section: 203.9 2010 ADAS Section: 203.9

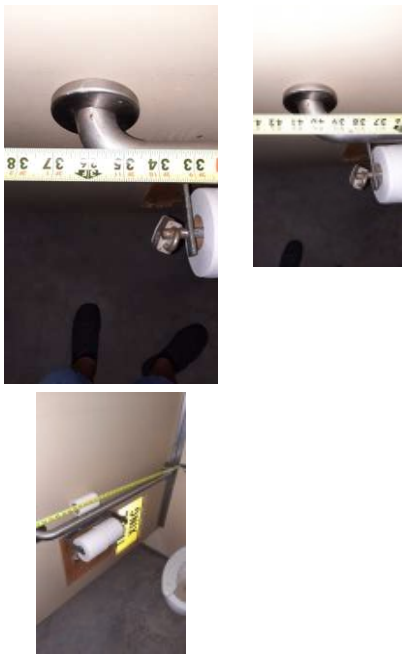
Finding Number	Area Description	Lat/Long	Finding	As Built	Recommendation	Citation	Photos	Figure
194	Trails: Mineral Wells Trailhead	[32.8062202 , -98.113974 3]	The side grab bars are not in the correct location. Grab bars on the side wall must be installed so that the end closest to the rear wall is maximum 12" from the rear wall. The end furthest from the rear wall must be mounted minimum 54" from the rear wall.	women's- side bar 36", bar extends to 41.5"	Replace side grab bar with min 42" bar, mounted to max 12" from the rear wall at the close end and min 54" on the far end, and 33" to 36" aff	2015 ABAAS Section: 604.5.1 2012 TAS Section: 604.5.1 2010 ADAS Section: 604.5.1

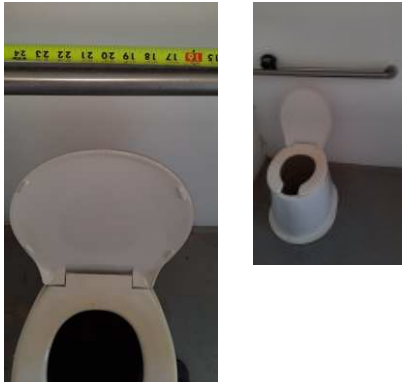
215	Trails: Amphitheater Trailhead	[32.8135952 , -98.031487]	The rear grab bar is not 36" long or is not mounted in the correct location. The rear grab bar must be a minimum of 36" long and extend from the toilet centerline a minimum 12" towards the wall side and a minimum 24" towards the open side of the toilet. Grab bars shall be installed in a horizontal position, 33 inches minimum and 36 inches maximum above the finish floor measured to the top of the gripping surface and the space between the grab bar and the top of the tank shall be 1-1/2 inches minimum.	women's- 20.5" to open side	Remount rear grab bar to behind the toilet, 12" to one side of center and 24" to the other and 33" to 36" aff	2015 ABAAS Section: 604.5.2 2012 TAS Section: 604.5.2 2010 ADAS Section: 604.5.2

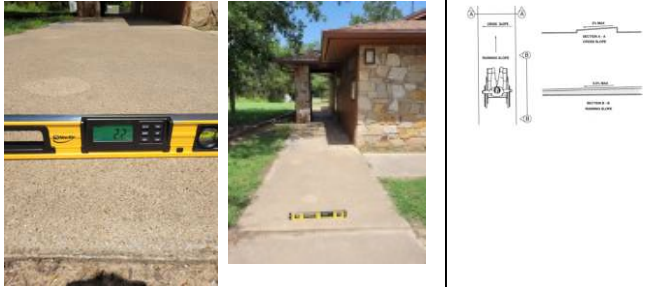
355	Camping: Live Oak Camping Area	[32.8204061, -98.0351912]	The accessible path of travel between the building entrance and the accessible parking contains cross slopes greater than 2%. Surface cross slopes shall not exceed one unit vertical in 48 units horizontal (2-percent slope). When the slope in the direction of travel of any walk exceeds 1 unit vertical in 20 units horizontal (5-percent slope), it must be constructed as ramp.	big oak restroom- 2.2% by women's restroom	Correct or repair sidewalk cross slope along AR to max 2.08%	2015 ABAAS Section: 403.3 2012 TAS Section: 403.3 2010 ADAS Section: 403.3
