# Access Audit Site Report

## Lake Somerville State Park & Trailway

Accessibility Evaluation

Inspection Date: 08/24/2021

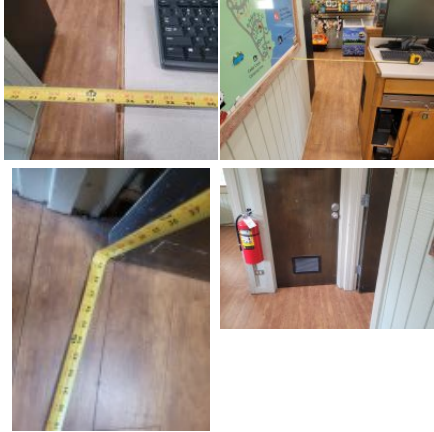
Finding Number	Area Description	Lat/Long	Finding	As Built	Recommendation	Citation	Photos	Figure
1	Nails Creek - Headquarters: (NC)Headquarters - Employee Spaces	[30.2906883 , -96.667227 2]	Spaces and elements within employee work areas shall only be required to comply with 206.2.8, 207.1, and 215.3 and shall be designed and constructed so that individuals with disabilities can approach, enter, and exit the employee work area. Employee work areas, or portions of employee work areas, other than raised courtroom stations, that are less than 300 square feet (28 m2) and elevated 7 inches (180 mm) or more above the finish floor or ground where the elevation is essential to the function of the space shall not be required to comply with these requirements or to be on an accessible route.	Approach to enter (25.25" wide), office door - 29.5" wide), knobs	For employee spaces, relocate storage, furniture, and other obstacles at doorways to provide approach, enter and exit at the employee space. Widen AR to compliant 36" clear width For deficit, leave as is, employee work area pursuant to 2010 Standards 106.5 Defined Terms, until an employee with a disability works here For all doors along the public circulation route, replace doors with doors having 80" overhead clearance and 32" clear width For all doors along the public circulation route, replace hardware with lever hardware or hardware operable without a tight pinch or grasp	2015 ABAAS Section: F203.9 2012 TAS Section: 203.9 2010 ADAS Section: 203.9

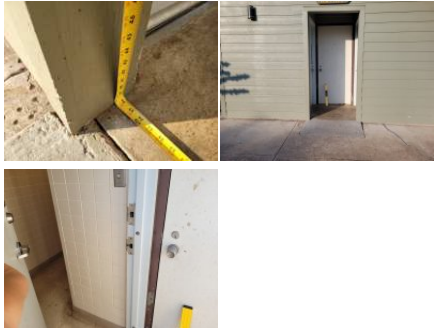
8	Nails Creek - Headquarters: (N C)Headquarters- Men's Restroom	[30.2907162 , -96.6672231]	Minimum maneuvering clearances at doors and gates shall comply with 404.2.4. Maneuvering clearances shall extend the full width of the doorway and the required latch side or hinge side clearance. The sweep period for doors with closers shall be adjusted so that from an open position of 70 degrees, the door will take at least 3 seconds to move to a point 3 inches from the latch, measured to the leading edge of the door. Exterior doors are recommended to be maintained at 8.5 lbf as a smart practice. Force is to be measured at the operating hardware or 30 inches from the hinges, whichever is greater.	Men's restroom- door push side, wall pull side, 38.5" back from door on push side, 10#, closes fast	For all doors along the public circulation route, provide required maneuvering clearance on push and pull side of doors For all doors along the public circulation route, inspect, adjust, and maintain closing speed on door closers For all doors along the public circulation route, inspect, adjust, and maintain 8.5 lbf to open exterior doors as a smart practice	2010 ADAS Section: 404.2.3, 404.2.7, 404.2.4, 404.2.11, 404.2.11 Exception

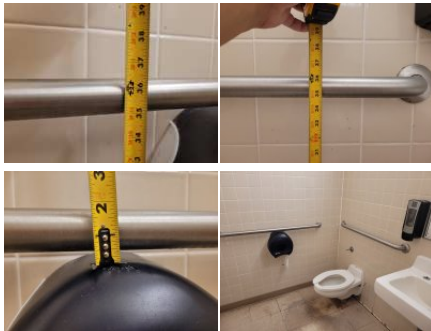
16	Nails Creek - Headquarters: (N C)Headquarters-Men's Restroom	[30.2907277 , -96.667203 1]	The grab bar height and/or spacing fails. Grab bars must be mounted between 33" and 36" to the top of the gripping surface. There must be 1.5" of clearance between the grab bar and the wall. There must be a minimum of 1.5" of clearance below and minimum 12" above the grab bar to any dispenser or other obstruction.	Gripping surface of both grab bars is 36.25" aff, and lacks 1.5" clearance below the bar due to toilet paper dispenser location	Remount grab bars in accessible stall to 33" to 36" aff Remount toilet paper dispenser max 7" to 9" from front of toilet, 15" to 48" aff and min 12" above or 1.5" below grab bar	2015 ABAAS Section: 609.3, 609.4  2012 TAS Section: 609.4, 609.3  2010 ADAS Section: 609.3, 609.4

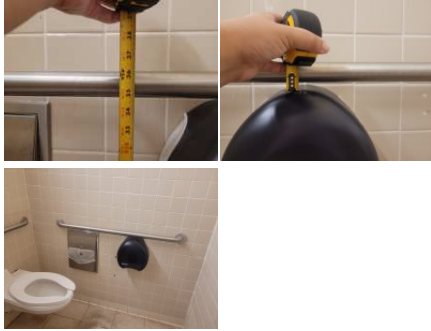
25	Nails Creek - Headquarters: (NC)Headquarters - Women's Restroom	[30.2906999 , -96.6672245]	The grab bar height and/or spacing fails. Grab bars must be mounted between 33" and 36" to the top of the gripping surface. There must be 1.5" of clearance between the grab bar and the wall. There must be a minimum of 1.5" of clearance below and minimum 12" above the grab bar to any dispenser or other obstruction.	Gripping surface of side grab bar is 36.25" aff, and lacks 1.5" clearance below the bar due to toilet paper dispenser location	Remount grab bars in accessible stall to 33" to 36" aff Remount toilet paper dispenser max 7" to 9" from front of toilet, 15" to 48" aff and min 12" above or 1.5" below grab bar	2015 ABAAS Section: 609.3, 609.4 2012 TAS Section: 609.4, 609.3 2010 ADAS Section: 609.3, 609.4

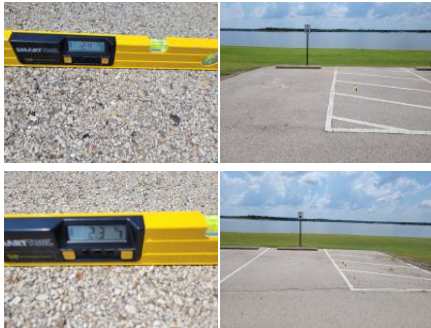
39	Nails Creek - Rocky Point: (NC) Rocky Point Parking	[30.2936748 , -96.65811 17], [30.2939504 , -96.657602 1]	The cross slopes (narrow dimension) and/or running slopes (long dimension) of the access aisle exceeds 2%. The running slope and the cross slope in an accessible parking stall and the access aisle must not exceed 2%.	Slopes of 2.4% in right access aisle and 2.3% in left access aisle	Repair or correct slope of parking space and access aisle to max 2.08% in any direction	2015 ABAAS Section: 502.4  2012 TAS Section: 502.4  2010 ADAS Section: 502.4

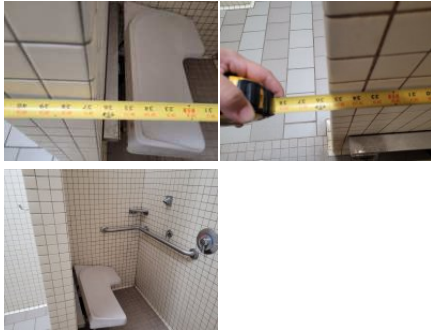
123	Nails Creek - Amenities: (NC) Boat Ramp-Men's Restroom	[30.2940234 , -96.664692 5]	Shower controls are in the incorrect location In transfer type shower compartments, the controls, faucets, and shower spray unit shall be installed on the side wall opposite the seat 38 inches (965 mm) minimum and 48 inches (1220 mm) maximum above the shower floor and shall be located on the control wall 15 inches (380 mm) maximum from the centerline of the seat toward the shower opening.	controls located at entry to shower	Remount shower controls to the correct location in the transfer shower	2015 ABAAS Section: 608.5.1  2012 TAS Section: 608.5.1  2010 ADAS Section: 608.5.1

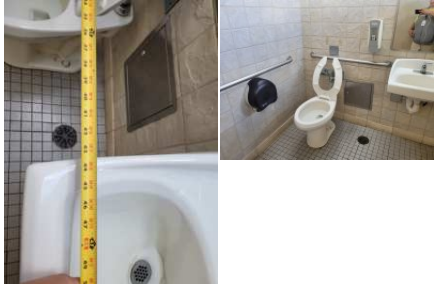
195	Birch Creek - Headquarters: (BC) Headquarters-Restrooms	[30.3086058 , -96.6349777]	The toilet paper is not installed within the compliant range in front of the toilet. Toilet paper dispensers shall be 7 inches minimum and 9 inches maximum in front of the water closet measured to the centerline of the dispenser. The outlet of the dispenser shall be 15 inches minimum and 48 inches maximum above the finish floor and shall not be located behind grab bars. Dispensers shall not be of a type that controls delivery or that does not allow continuous paper flow. There shall be a clearance of 1 1/2 inches minimum below the grab bar.	men's- TP too close to toilet	Remount toilet paper dispenser max 7" to 9" from front of toilet, 15" to 48" aff and min 12" above or 1.5" below grab bar	2015 ABAAS Section: 604.7  2012 TAS Section: 604.7  2010 ADAS Section: 604.7

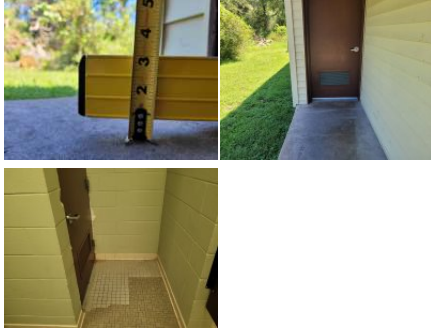
Finding Number	Area Description	Lat/Long	Finding	As Built	Recommendation	Citation	Photos	Figure
344	Birch Creek - Post Oak Camping Area: (BC) Post Oak-Women's Restroom	[30.3109225, -96.6256195]	The restroom sign does not comply with one or more applicable requirements for the location, height, and properties of the sign.	Lacks compliant signage	Acquire and mount signage, including Braille and access symbol mounted on wall, latch side of door, 48" to baseline of lowest character and 60" to baseline of highest character	2015 ABAAS Section: F216.2, 703.1, 703.2, 703.5, 703.6  2012 TAS Section: 216.2, 703.1, 703.2, 703.5, 703.6  2010 ADAS Section: 216.2, 703.1, 703.2, 703.5, 703.6

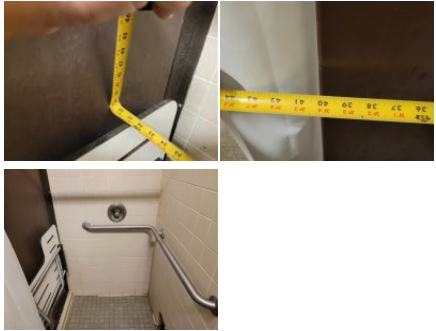
Finding Number	Area Description	Lat/Long	Finding	As Built	Recommendation	Citation	Photos	Figure
412	Birch Creek - Yaupon Camping Area: (BC) Yaupon-Men's Restroom	[30.3182267, -96.6145406]	Shower controls are in the incorrect location In transfer type shower compartments, the controls, faucets, and shower spray unit shall be installed on the side wall opposite the seat 38 inches (965 mm) minimum and 48 inches (1220 mm) maximum above the shower floor and shall be located on the control wall 15 inches (380 mm) maximum from the centerline of the seat toward the shower opening.	shower controls on back wall	Remount shower controls to the correct location in the transfer shower	2015 ABAAS Section: 608.5.1  2012 TAS Section: 608.5.1  2010 ADAS Section: 608.5.1
