Access Audit Site Report

Lake Whitney State Park

Accessibility Evaluation

Inspection Date: 01/20/2022

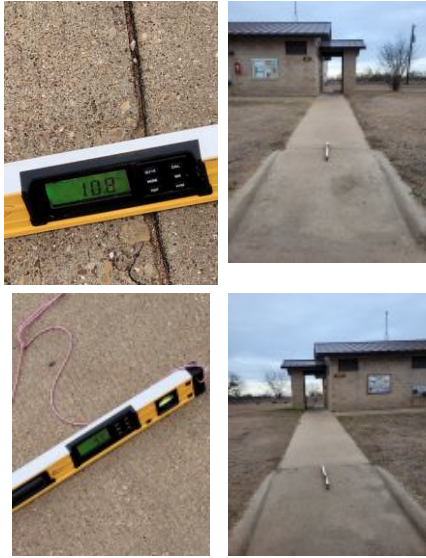
Finding Number	Area Description	Lat/Long	Finding	As Built	Recommendation	Citation	Photos	Figure
14	Exterior: Exterior Accessible Route	[31.9219213 , -97.3649367]	The curb ramp slope exceeds the maximum running slope (Parallel to the direction of travel) allowable of 8.33%. Curb ramps should have the least possible slope but in no case more than 8.3% (1:12).	Post Oak restroom - men's side - 10.8%; Blue Bird restroom - women's side - 9.7%	Correct curb ramp running slope to max 8.33%.	2015 ABAAS Section: 406.1 2012 TAS Section: 406.1 2010 ADAS Section: 406.1

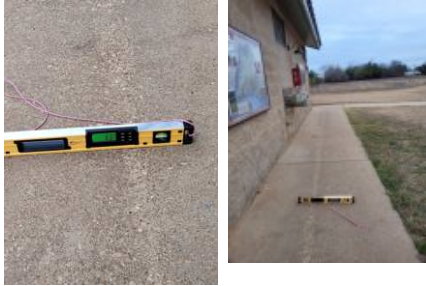
15	Exterior: Exterior Accessible Route	[31.921952, -97.3648535]	The accessible route of travel on the accessible route contains cross slopes greater than 2%. Cross slopes shall not exceed one unit vertical in 48 units horizontal (2-percent slope).	Post Oak restroom - 3.3% on path with water fountain	Correct or repair cross slope along AR to max 2.08%	2015 ABAAS Section: 403.3 2012 TAS Section: 403.3 2010 ADAS Section: 403.3

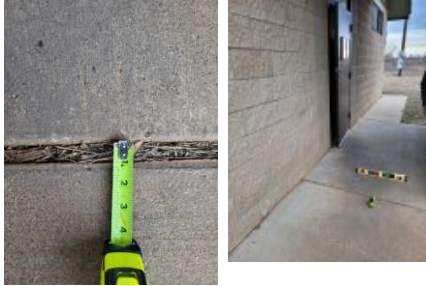
16	Exterior: Exterior Accessible Route	[31.9219759 , -97.3648991]	There is a gap spaced greater than a 1/2 inch. Openings in floor or ground surfaces shall not allow passage of a sphere more than 1/2 inch diameter. Elongated openings shall be placed so that the long dimension is perpendicular to the dominant direction of travel.	Post Oak - 1" at men's restroom	Correct or fill gaps to be max .5"	2015 ABAAS Section: 302.3 2012 TAS Section: 302.3 2010 ADAS Section: 302.3

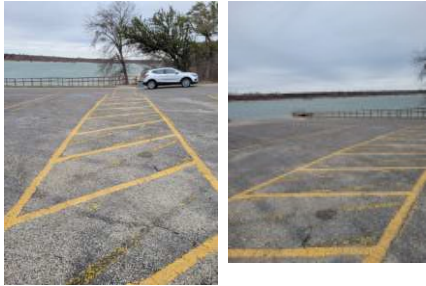
Finding Number	Area Description	Lat/Long	Finding	As Built	Recommendation	Citation	Photos	Figure
17	Exterior: Parking	[31.9232781 , -97.372709 7]	The accessible parking is not located on the shortest accessible route to the building. Accessible parking spaces serving a particular building or facility entrance shall be located on the shortest accessible route of travel from the parking to an accessible entrance.	Boat ramp - parking is located opposite side of ramp to pier	Consider relocating stalls to be on the shortest AR to the building entry or park features	2015 ABAAS Section: F208.3.1 2012 TAS Section: 208.3.1 2010 ADAS Section: 208.3.1

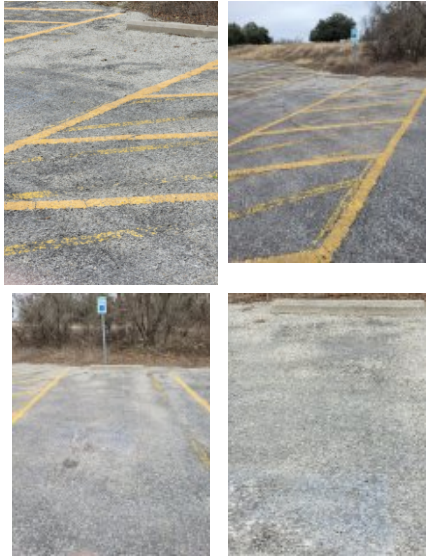
Finding Number	Area Description	Lat/Long	Finding	As Built	Recommendation	Citation	Photos	Figure
19	Exterior: Parking	[31.923269, -97.372729 8]	The accessible parking space and/or access aisle contains loose gravel and/or surface materials that do not provide for a stable, firm slip resistant surface. Parking spaces and access aisles serving them shall comply with floor or ground surface requirements. The ground surface shall be stable, firm, and slip resistant. Access aisles shall be at the same level as the parking spaces they serve. Changes in level, slopes exceeding 1:48, and detectable warnings shall not be permitted.	Parking at boat ramp - loose, uneven surface	Resurface accessible parking stalls to be free of loose material, CILs, and gaps.	2015 ABAAS Section: 502.4 2012 TAS Section: 502.4 2010 ADAS Section: 502.4

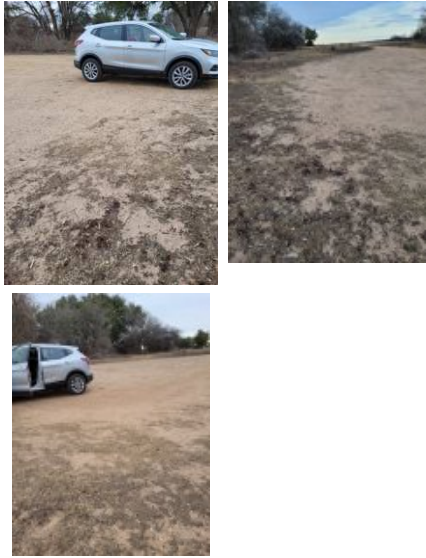
Finding Number	Area Description	Lat/Long	Finding	As Built	Recommendation	Citation	Photos	Figure
23	Exterior: Parking	[31.92024, -97.36067]	There are no accessible parking stalls. Each lot where parking is provided for the public as clients, guests or employees, shall provide accessible parking and shall be located on the shortest accessible route of travel from adjacent parking to an accessible entrance. There are a total of (12-15) parking stalls in the parking lot that could be reasonably associated with this facility. There should be a minimum of (1) accessible stalls with a minimum of (1) being designed as van accessible.	Washita day use area parking - approximately 12-15 unmarked parking spaces, no accessible parking stalls	Create one or more 8' accessible parking stalls, with one 5' adjacent access aisle, with proper signage and striping based on the total number of stalls	2015 ABAAS Section: F208.2 2012 TAS Section: 208.2 2010 ADAS Section: 208.2

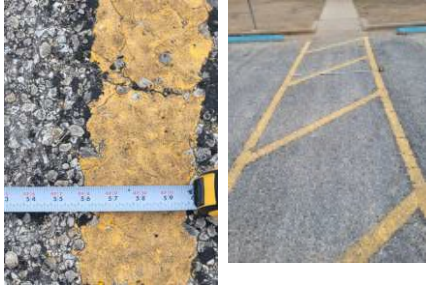
24	Exterior: Parking	[31.9218632, -97.3649072]	The access aisle is not a minimum 5 feet wide. A car accessible parking stall's access aisle must be a minimum of 5 feet wide measured from centerline to centerline. Where the access aisle is not adjacent to another parking space or access aisle, measurements shall be permitted to include the full width of the line defining the access aisle.	Parking at restroom near Road Runner, Blue Bird and Star View - 58" width	Repaint access aisles to be 5' each.	2015 ABAAS Section: 502.3.1 2012 TAS Section: 502.3.1 2010 ADAS Section: 502.3.1

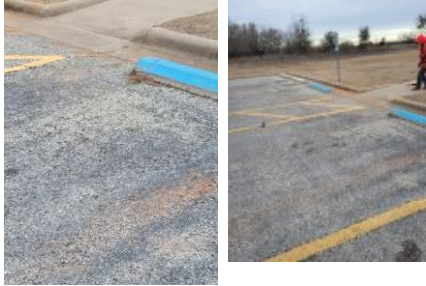
25	Exterior: Parking	[31.9218791, -97.3648924]	The accessible parking space and/or access aisle contains loose gravel and/or surface materials that do not provide for a stable, firm slip resistant surface. Parking spaces and access aisles serving them shall comply with floor or ground surface requirements. The ground surface shall be stable, firm, and slip resistant. Access aisles shall be at the same level as the parking spaces they serve. Changes in level, slopes exceeding 1:48, and detectable warnings shall not be permitted.	Parking at restroom near Road Runner, Blue Bird and Star View - loose gravel in 2 of 2 accessible stalls and access aisle	Resurface stalls and access aisles to be free of loose material, CILs, and gaps.	2015 ABAAS Section: 502.4 2012 TAS Section: 502.4 2010 ADAS Section: 502.4

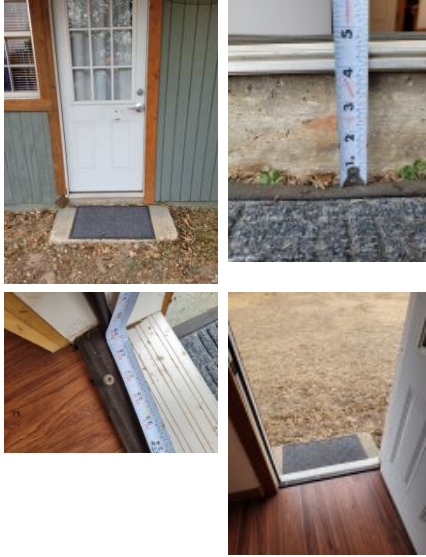
Finding Number	Area Description	Lat/Long	Finding	As Built	Recommendation	Citation	Photos	Figure
40	Headquarters Building: HQ - Employee Spaces	[31.9312832 , -97.356908 8]	Minimum maneuvering clearances at doors and gates shall comply with 404.2.4. Maneuvering clearances shall extend the full width of the doorway and the required latch side or hinge side clearance. Maneuvering clearances shall have a max slope of 2.08%. Door openings shall provide a clear width of 32 inches (815 mm) minimum. Clear openings of doorways with swinging doors shall be measured between the face of the door and the stop, with the door open 90 degrees. Openings more than 24 inches (610 mm) deep shall provide a clear opening of 36 inches (915 mm) minimum. There shall be no projections into the required clear opening width lower than 34 inches (865 mm) above the finish floor or ground. Projections into the clear opening width between 34 inches (865 mm) and 80 inches (2030 mm) above the finish floor or ground shall not exceed 4 inches (100 mm). The threshold has a vertical change greater than 1/4 inch high. Carpet or carpet tile shall be securely attached	employee exterior - 29" width, lacks maneuvering clearance on push side, 4.75" change in elevation, mat not secure	For all doors along the public circulation route, provide required maneuvering clearance on push and pull side of doors. For all doors along the public circulation route, replace doors with doors having 80" overhead clearance and 32" clear width. For all doors along the public circulation route, repair, bevel, or ramp CILs at door entries to max .25". Carpet or carpet tile shall be securely attached	2010 ADAS Section: 404.2.3, 404.2.7, 404.2.4, 404.2.11, 404.2.11 Exception

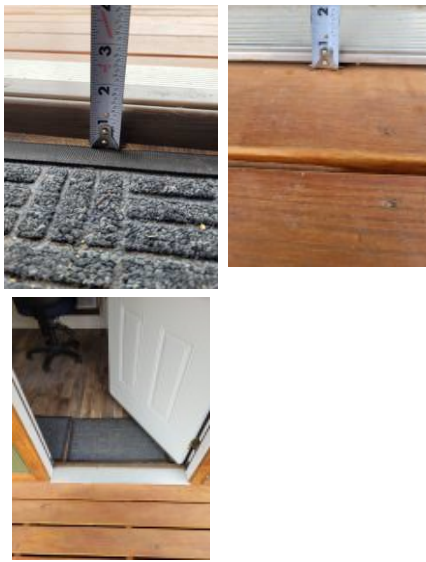
Finding Number	Area Description	Lat/Long	Finding	As Built	Recommendation	Citation	Photos	Figure
43	Headquarters Building: HQ - Employee Spaces	[31.9312661 , -97.356902 1]	The threshold is greater than 1/2 inch high. The threshold at a doorway shall be no higher than 1/2 inch. Changes in level between 1/4 inch and 1/2 inch must be beveled at 1:2 or less. 1/4 inch is the maximum vertical rise.	Ranger hut at park entry - 1.75" change in elevation at threshold; 0.75" push side	For all doors along the public circulation route, replace thresholds at exterior doors with ADA thresholds	2015 ABAAS Section: 404.2.5 2012 TAS Section: 404.2.5 2010 ADAS Section: 404.2.5

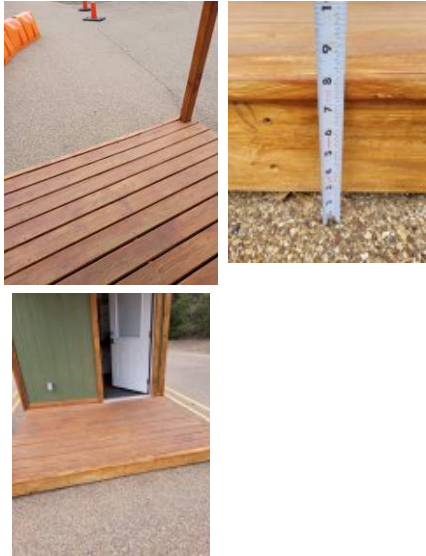
Finding Number	Area Description	Lat/Long	Finding	As Built	Recommendation	Citation	Photos	Figure
45	Headquarters Building: HQ - Employee Spaces	[31.9312923 , -97.3569196]	The walkway contains abrupt vertical edges and/or variations over a 1/2 inch. 1/4 inch is the maximum vertical rise. Changes in level between 1/4 inch and 1/2 inch must be beveled at 1:2 or less. Changes in level greater than 1/2 inch must be by way of a ramp.	8" change in elevation to Ranger hut entry	Provide a ramp for access to the ranger hut entry	2015 ABAAS Section: 303.2, 303.3 2012 TAS Section: 303.3, 303.2 2010 ADAS Section: 303.3, 303.2

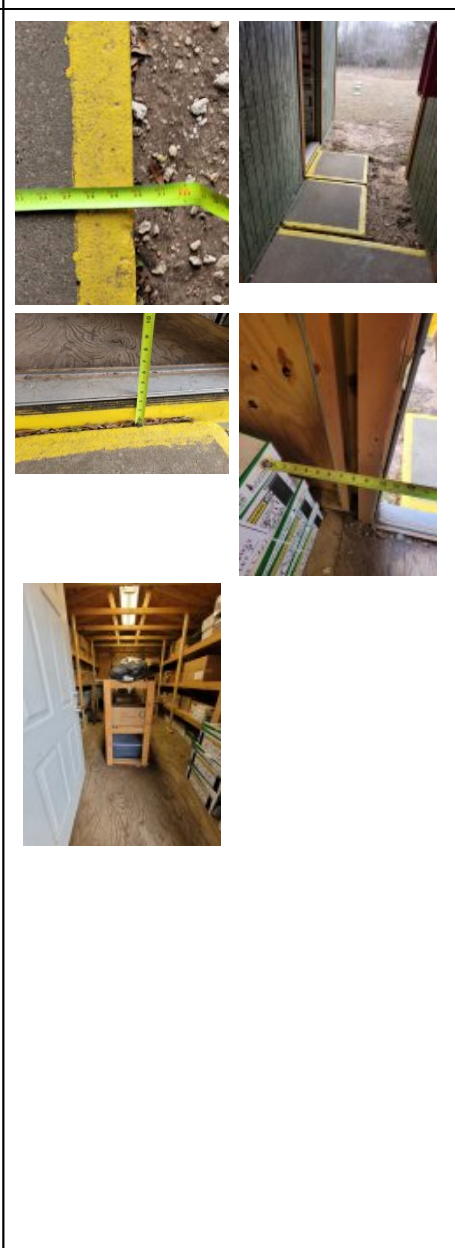
Finding Number	Area Description	Lat/Long	Finding	As Built	Recommendation	Citation	Photos	Figure
46	Headquarters Building: HQ - Employee Spaces	[31.9312923 , -97.356908 8]	Spaces and elements within employee work areas shall only be required to comply with 206.2.8, 207.1, and 215.3 and shall be designed and constructed so that individuals with disabilities can approach, enter, and exit the employee work area. Employee work areas, or portions of employee work areas, other than raised courtroom stations, that are less than 300 square feet (28 m2) and elevated 7 inches (180 mm) or more above the finish floor or ground where the elevation is essential to the function of the space shall not be required to comply with these requirements or to be on an accessible route.	Storage - 30" width, 4" step up, maneuvering clearance on pull side reduced by storage and shelf, maneuvering clearance on push side reduced by lack of landing or clear floor space	For employee spaces, relocate storage, furniture, and other obstacles at doorways to provide approach, enter and exit at the employee space. Provide required maneuvering clearance on push and pull side of doors. Replace doors with doors having 80" overhead clearance and 32" clear width. Repair, bevel, or ramp CILs at door entries to max .25".	2015 ABAAS Section: F203.9 2012 TAS Section: 203.9 2010 ADAS Section: 203.9

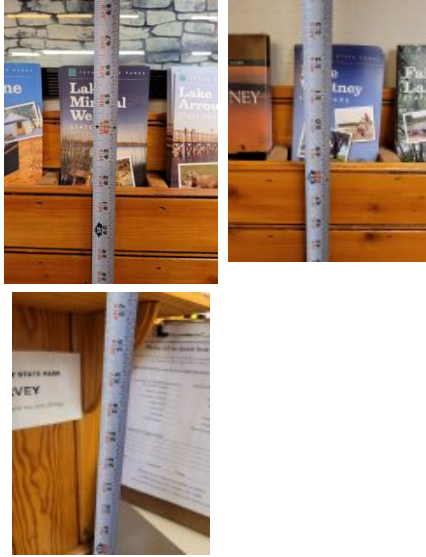
Finding Number	Area Description	Lat/Long	Finding	As Built	Recommendation	Citation	Photos	Figure
49	Headquarters Building: HQ - Public Spaces	[31.9312923 , -97.3569303]	The operable part is positioned too high for either a side or front approach. Where a clear floor or ground space allows a parallel approach to an element and the side reach is unobstructed, the high side reach shall be 48 inches maximum and the low side reach shall be 15 inches minimum above the finish floor or ground. Where a forward reach is unobstructed, the high forward reach shall be 48 inches maximum and the low forward reach shall be 15 inches minimum above the finish floor or ground.	section of brochures and park survey above reach range	Remount operable parts to be in reach range of 15" min to 48" max	2015 ABAAS Section: 308.1 2012 TAS Section: 308.1 2010 ADAS Section: 308.1

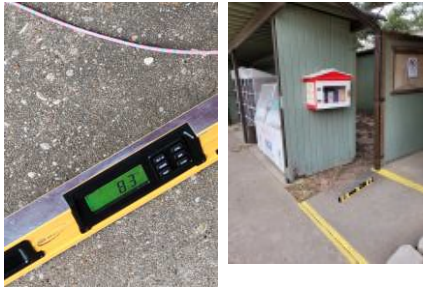
53	Headquarters Building: HQ - Public Spaces	[31.9313329, -97.3568813]	The 30 inches minimum by 48 inches minimum clear floor space required at the operable part is not flat (2% or 1:48 maximum slope) in all directions. Changes in level are not permitted at required clear floor or ground space except that slopes not steeper than 1:48 shall be permitted.	8.3% at clear floor space for park library exchange	Correct or repair slope in CFS to max 2.08%	2015 ABAAS Section: 305.2 2012 TAS Section: 305.2 2010 ADAS Section: 305.2

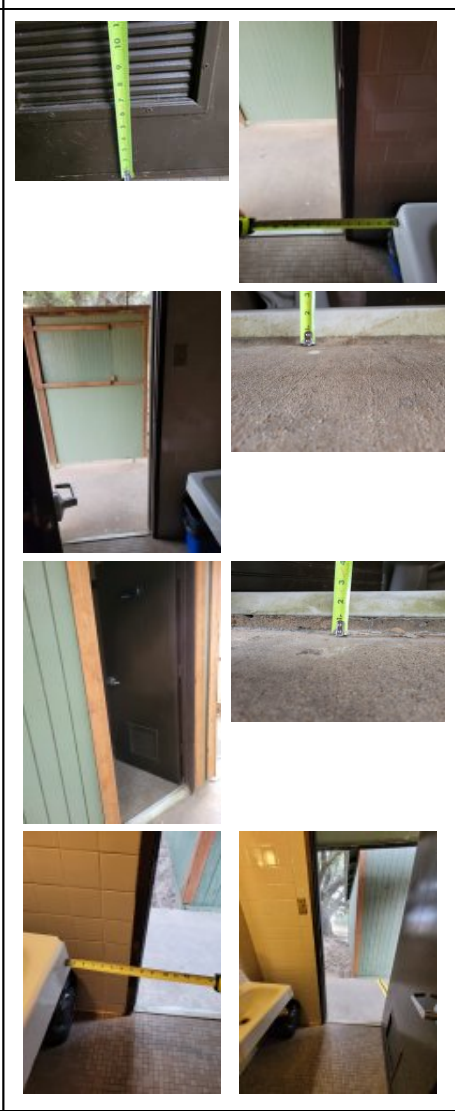
Finding Number	Area Description	Lat/Long	Finding	As Built	Recommendation	Citation	Photos	Figure
58	Headquarters Building: HQ - Restroom	[31.9312923 , -97.3569356]	Minimum maneuvering clearances at doors and gates shall comply with 404.2.4. Maneuvering clearances shall extend the full width of the doorway and the required latch side or hinge side clearance. Maneuvering clearances shall have a max slope of 2.08%. The threshold has a vertical change greater than 1/4 inch high. The threshold at a doorway shall be no higher than 1/2 inch. Changes in level between 1/4 inch and 1/2 inch must be beveled at 1:2 or less. 1/4 inch is the maximum vertical rise. The bottom 10 inches on the push side must be smooth and free of obstructions (hold open devices). Opening hardware must be mounted between 30 and 44 inches above the floor or ground.	Women's restroom - 5.5" maneuvering clearance on pull side due to sink, 2" change in elevation, 6.5" above finished floor door grate at bottom of door; Men's restroom - 2.5" change in elevation, 8" maneuvering clearance due to sink on pull side	For all doors along the public circulation route, provide required maneuvering clearance on push and pull side of doors. For all doors along the public circulation route, repair, bevel, or ramp CILs at door entries to max .25". For all doors along the public circulation route, provide kick plate on push side of door from floor to 10" aff.	2010 ADAS Section: 404.2.3, 404.2.7, 404.2.4, 404.2.11, 404.2.11 Exception

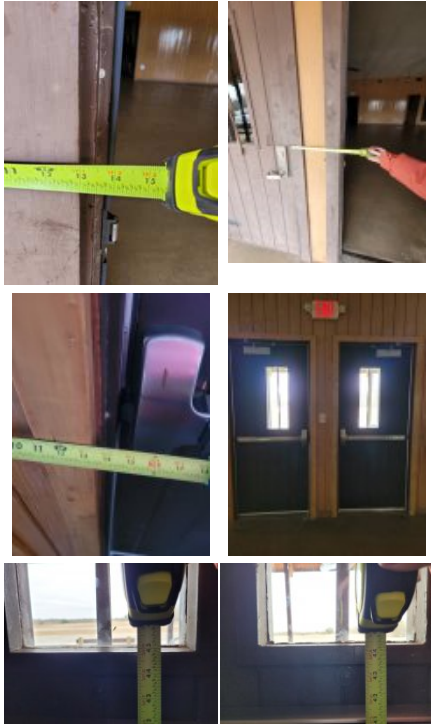
Finding Number	Area Description	Lat/Long	Finding	As Built	Recommendation	Citation	Photos	Figure
71	Dining Hall: Dining Hall	[31.924405, -97.370073 1]	Minimum maneuvering clearances at doors and gates shall comply with 404.2.4. Maneuvering clearances shall extend the full width of the doorway and the required latch side or hinge side clearance. Doors, gates, and side lights adjacent to doors or gates, containing one or more glazing panels that permit viewing through the panels shall have the bottom of at least one glazed panel located 43 inches (1090 mm) maximum above the finish floor. EXCEPTION: Vision lights with the lowest part more than 66 inches (1675 mm) from the finish floor or ground shall not be required to comply with 404.2.11.	Front entry double doors - when facing from the inside - 14" maneuvering clearance on push and pull sides for both doors, both have windows 44.5" above finished floor	For all doors along the public circulation route, provide required maneuvering clearance on push and pull side of doors For all doors along the public circulation route, replace doors with ones having sidelight viewing windows max 43" aff	2010 ADAS Section: 404.2.3, 404.2.7, 404.2.4, 404.2.11, 404.2.11 Exception

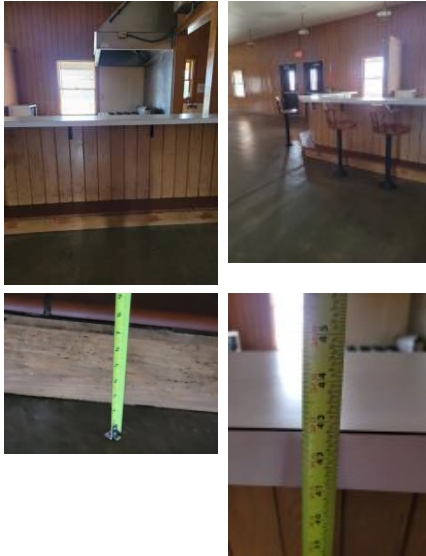
Finding Number	Area Description	Lat/Long	Finding	As Built	Recommendation	Citation	Photos	Figure
81	Dining Hall: Dining Hall - Kitchen	[31.9243902 , -97.370164 3]	The top of the work surface is not within a compliant height range. The tops of tables and counters shall be 28 inches to 34 inches from the floor or ground.	Bar top counter installed 43" AFF	Provide tables and work surfaces at 28" to 34" aff with required knee and toe clearances	2015 ABAAS Section: 902.3 2012 TAS Section: 902.3 2010 ADAS Section: 902.3

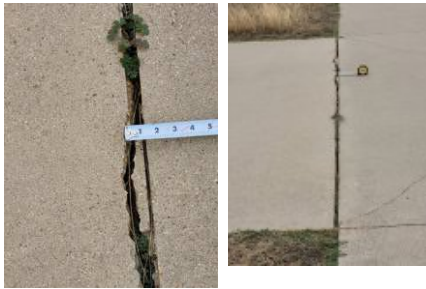
94	Park Site: Air Strip	[31.9270714 , -97.36071]	There is a gap spaced greater than a 1/2 inch. Openings in floor or ground surfaces shall not allow passage of a sphere more than 1/2 inch diameter. Elongated openings shall be placed so that the long dimension is perpendicular to the dominant direction of travel.	1.25" gap on walkway to air field	Correct or fill gaps to be max .5"	2015 ABAAS Section: 302.3 2012 TAS Section: 302.3 2010 ADAS Section: 302.3

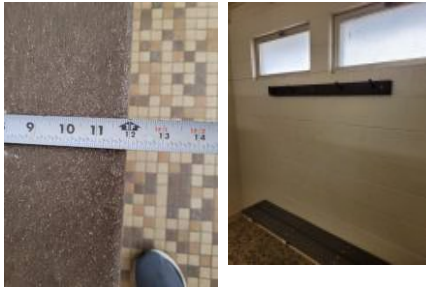
101	Horseshoe Camping Loop: Horseshoe - Men's Restroom	[31.9285037, -97.3652854]	The bench is not deep enough or long enough or is missing. Benches shall be provided having seats that are 42 inches long minimum and 20 inches deep minimum and 24 inches deep maximum. The bench shall provide for back support or shall be affixed to a wall. Back support shall be 42 inches (1065 mm) long minimum and shall extend from a point 2 inches (51 mm) maximum above the seat surface to a point 18 inches (455 mm) minimum above the seat surface. Back support shall be 2½ inches (64 mm) maximum from the rear edge of the seat measured horizontally. The top of the bench seat surface shall be 17 inches (430 mm) minimum and 19 inches (485 mm) maximum above the finish floor or ground.	Bench 12" seat depth	Replace bench in dressing area with one having a seat depth of 20" to 24" deep, 42" long, affixed to the wall or having a back and mounted 17" to 19" aff	2012 TAS Section: 903.4, 903.2, 903.3, 903.5 2010 ADAS Section: 903.4, 903.2, 903.3, 903.5

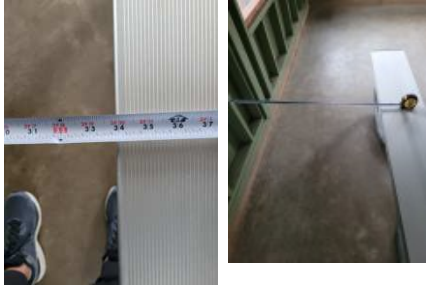
117	Towash Shelter Loop: Towash - Screened Shelters	[31.9202104 , -97.373881 8]	The route of travel at this location does not provide a minimum width of 36 inches. The clear width shall be permitted to be reduced to 32 inches minimum for a length of 24 inches maximum provided that reduced width segments are separated by segments that are 48 inches long minimum and 36 inches wide minimum.	Shelter 3 - reduced to 34" width at picnic table	Relocate picnic table to provide minimum 36" width route through shelter	2015 ABAAS Section: 403.5.1 2012 TAS Section: 403.5.1 2010 ADAS Section: 403.5.1

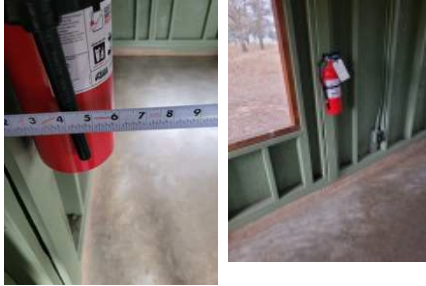
118	Towash Shelter Loop: Towash - Screened Shelters	[31.9202218 , -97.373884 5]	An item or items project more than 4 inches into the circulation path. Wall-mounted objects that have leading edges between 27 inches and 80 inches from the floor must not project more than 4 inches into the circulation path. Protruding objects that extend to the floor or within 27 inches of the floor are cane detectable and are therefore not hazardous. Where it is necessary or desirable to have objects protrude from the wall, a manner of cane detection must be provided.	Shelter 3 - fire extinguisher projects 6" into circulation path	Relocate protruding objects or place cane detectable warning or bollard at foot of item	2015 ABAAS Section: 307.2 2012 TAS Section: 307.2 2010 ADAS Section: 307.2

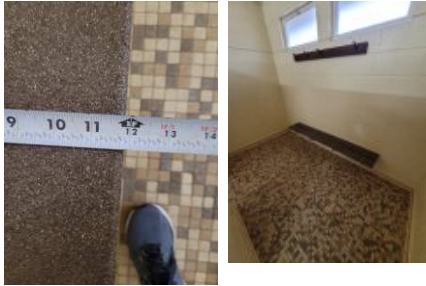
Finding Number	Area Description	Lat/Long	Finding	As Built	Recommendation	Citation	Photos	Figure
127	Towash Shelter Loop: Towash - Men's Restroom	[31.920133, -97.372763 4]	The bench is not deep enough or long enough or is missing. Benches shall be provided having seats that are 42 inches long minimum and 20 inches deep minimum and 24 inches deep maximum. The bench shall provide for back support or shall be affixed to a wall. Back support shall be 42 inches (1065 mm) long minimum and shall extend from a point 2 inches (51 mm) maximum above the seat surface to a point 18 inches (455 mm) minimum above the seat surface. Back support shall be 2½ inches (64 mm) maximum from the rear edge of the seat measured horizontally. The top of the bench seat surface shall be 17 inches (430 mm) minimum and 19 inches (485 mm) maximum above the finish floor or ground.	Bench 12" seat depth	Replace bench in dressing area with one having a seat depth of 20" to 24" deep, 42" long, affixed to the wall or having a back and mounted 17" to 19" aff	2012 TAS Section: 903.4, 903.2, 903.3, 903.5 2010 ADAS Section: 903.4, 903.2, 903.3, 903.5

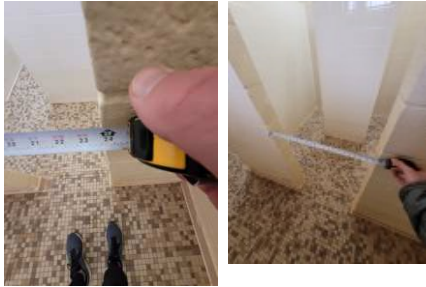
128	Towash Shelter Loop: Towash - Men's Restroom	[31.9201353, -97.372779 5]	There are no accessible bathing or shower facilities. Where facilities for bathing are provided for the public, clients or employees, including showers or bathtubs, at least one shower or bathtub and support facilities such as lockers, and not less than 1 percent of all facilities, shall be accessible.	24" width into shower area, lacks accessible showers	Create an accessible shower in locker/bathing room	2015 ABAAS Section: F213.3.6 2012 TAS Section: 213.3.6 2010 ADAS Section: 213.3.6

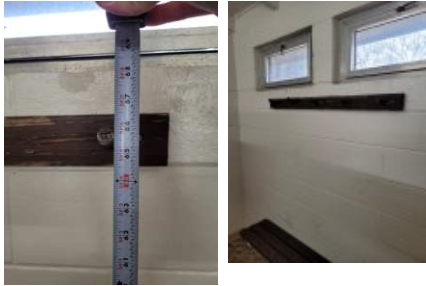
Finding Number	Area Description	Lat/Long	Finding	As Built	Recommendation	Citation	Photos	Figure
142	White Tail Camping Loop: White Tail - Men's Restroom	[31.9201728 , -97.368906 3]	Coat hooks provided within the room shall be located within one of the reach ranges specified in 308. Shelves shall be 40 inches (1015 mm) minimum and 48 inches (1220 mm) maximum above the finish floor or ground. Where coat hooks or shelves are provided in dressing, fitting or locker rooms without individual compartments, at least one of each type shall comply with 803.5. Where coat hooks or shelves are provided in individual compartments at least one of each type complying with 803.5 shall be provided in individual compartments in dressing, fitting, or locker rooms required to comply with 222.1.	Hooks installed 66" above finished floor	Remount at least one hook to max 48" aff and shelves to 40" - 48" AFF.	2015 ABAAS Section: 308.2.1, 308.1, F222.2, 803.5 2012 TAS Section: 308.2.1, 308.1, 222.2, 803.5 2010 ADAS Section: 308.2.1, 308.1, 222.2, 803.5
