Access Audit Site Report

Longhorn Cavern State Park

Accessibility Evaluation

Inspection Date: 08/24/2021

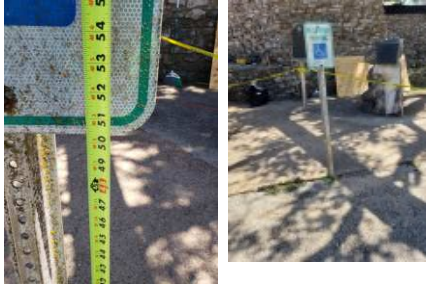
Finding Number	Area Description	Lat/Long	Finding	As Built	Recommendation	Citation	Photos	Figure
4	Visitor Center: Visitor Center Parking	[30.68459, -98.351077 6]	The parking sign is mounted too low. Parking space identification signs shall include the International Symbol of Accessibility complying with. Signs identifying van parking spaces shall contain the designation "van accessible." Signs shall be 60 inches minimum above the finish floor or ground surface measured to the bottom of the sign.	parking sign 50.5"	Raise existing accessible parking signs so lowest end of bottom sign is min 60" aff	2015 ABAAS Section: 502.6 2012 TAS Section: 502.6 2010 ADAS Section: 502.6

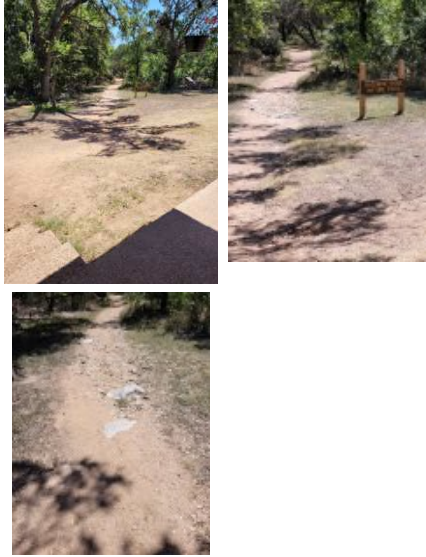
Finding Number	Area Description	Lat/Long	Finding	As Built	Recommendation	Citation	Photos	Figure
6	Visitor Center: Visitor Center Exterior Accessible Route	[30.6841956 , -98.350846 9]	There is no accessible route to the Backbone Ridge Nature Trail trailhead. At least one accessible route shall connect accessible buildings, accessible facilities, accessible elements, and accessible spaces that are on the same site.	Lacks accessible route to the Backbone Ridge Nature Trail trailhead	Create an accessible route with crushed stone or other outdoor material from parking or walkway to the Backbone Ridge Nature Trail trailhead	2015 ABAAS Section: F206.2.2 2012 TAS Section: 206.2.2 2010 ADAS Section: 206.2.2

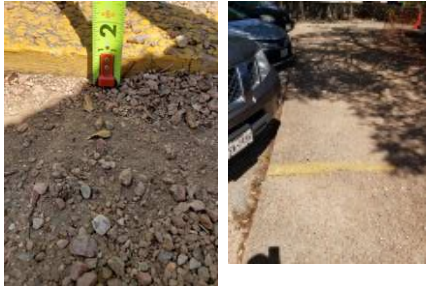
7	Visitor Center: Visitor Center Exterior Accessible Route	[30.6846615 , -98.350753]	The walkway contains abrupt vertical edges and/or variations over a 1/4 inch. 1/4 inch is the maximum vertical rise. Changes in level between 1/4 inch and 1/2 inch must be beveled at 1:2 or less. Changes in level greater than 1/2 inch must be by way of a ramp.	CIL of 1"	Repair, bevel or ramp CIL along AR	2012 TAS Section: 303.2, 303.3 2010 ADAS Section: 303.2, 303.3

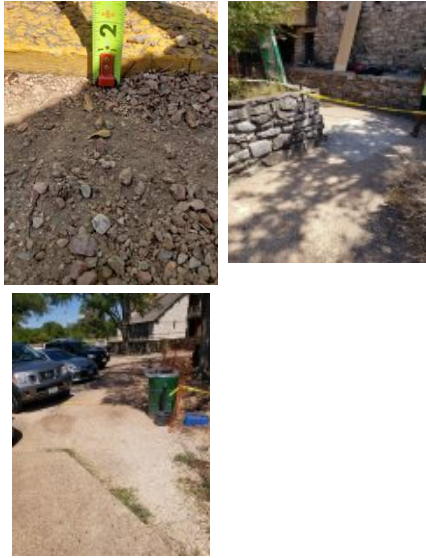
Finding Number	Area Description	Lat/Long	Finding	As Built	Recommendation	Citation	Photos	Figure
8	Visitor Center: Visitor Center Exterior Accessible Route	[30.6846731 , -98.350723 5]	The accessible route contains loose gravel and/or surface materials that do not provide for a stable, firm slip resistant surface. Floor and ground surfaces shall be stable, firm, and slip resistant.	Accessible route from accessible parking to building lacks a firm and stable surface (loose gravel)	Create AR with crushed and compacted stone or similar outdoor material from parking or sidewalk to the building	2015 ABAAS Section: 302.1 2012 TAS Section: 302.1 2010 ADAS Section: 302.1

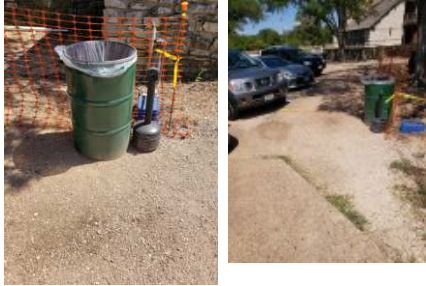
9	Visitor Center: Visitor Center Exterior Accessible Route	[30.6846281 , -98.350804]	The accessible route contains loose gravel and/or surface materials that do not provide for a stable, firm slip resistant surface. Floor and ground surfaces shall be stable, firm, and slip resistant.	Lacks accessible route to and clear ground space at garbage can (loose gravel)	Relocate 20% of garbage cans to be along AR	2015 ABAAS Section: 302.1 2012 TAS Section: 302.1 2010 ADAS Section: 302.1

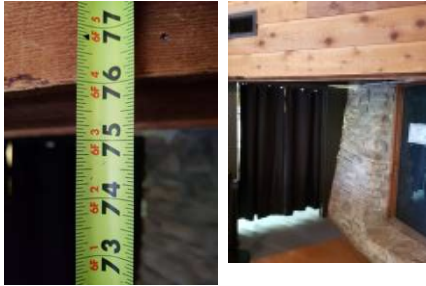
Finding Number	Area Description	Lat/Long	Finding	As Built	Recommendation	Citation	Photos	Figure
12	Visitor Center: Visitor Center Public Spaces	[30.68462, -98.35115]	The kitchen entry extends down too close to the route of travel. Any obstruction that overhangs a route of travel must be a minimum of 80 inches above the walking surface as measured from the bottom of the obstruction.	76" overhead at kitchen entry	Raise the kitchen area entry to min 80", or pad object to prevent hazard in overhead clearance along AR	2015 ABAAS Section: 307.4 2012 TAS Section: 307.4 2010 ADAS Section: 307.4

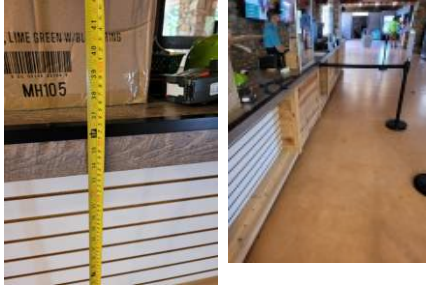
17	Visitor Center: Visitor Center Public Spaces	[30.68462, -98.35115]	The transaction counter provides for a parallel approach and is not within the required height range. Transaction counters shall be 36 inches high maximum and a minimum of 36 inches wide and should extend the same depth as the sales or service counter tops.	Transaction counter 37" aff	Lower 36" wide segment of service counter to max 36" aff, in the alternative, train staff to come out from around the counter to provide customer service	2015 ABAAS Section: 904.4.1 2012 TAS Section: 904.4.1 2010 ADAS Section: 904.4.1

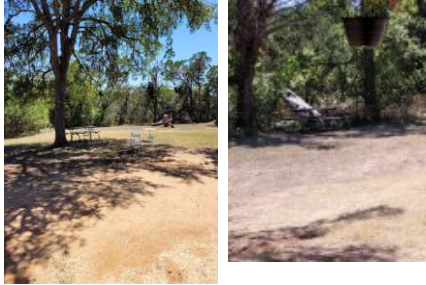
20	Visitor Center: Visitor Center Public Spaces	[30.6842371 , -98.350932 7]	There is no accessible route to the 2 picnic tables, white chairs, and small table. At least one accessible route shall connect accessible buildings, accessible facilities, accessible elements, and accessible spaces that are on the same site.	Lacks accessible route to 2 picnic tables (not accessible design), white chairs, and small table	Create an accessible route with crushed stone or other outdoor material from parking or walkway to the 2 picnic tables, white chairs, and small table Replace one picnic table with one that is of an accessible design as a smart practice	2015 ABAAS Section: F206.2.2 2012 TAS Section: 206.2.2 2010 ADAS Section: 206.2.2

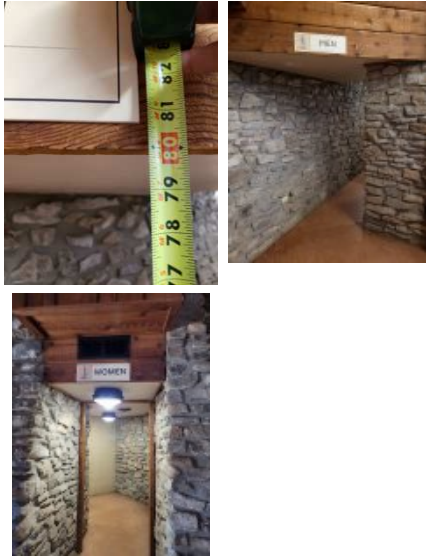
Finding Number	Area Description	Lat/Long	Finding	As Built	Recommendation	Citation	Photos	Figure
21	Visitor Center: Visitor Center Restrooms	[30.68462, -98.35115]	The restroom sign does not comply with one or more applicable requirements for the location, height, and properties of the sign.	both restrooms lack compliant signage	Acquire and mount signage, including Braille and access symbol mounted on wall, latch side of door, 48" to baseline of lowest character and 60" to baseline of highest character	2015 ABAAS Section: F216.2, 703.1, 703.2, 703.5, 703.6 2012 TAS Section: 216.2, 703.1, 703.2, 703.5, 703.6 2010 ADAS Section: 216.2, 703.1, 703.2, 703.5, 703.6

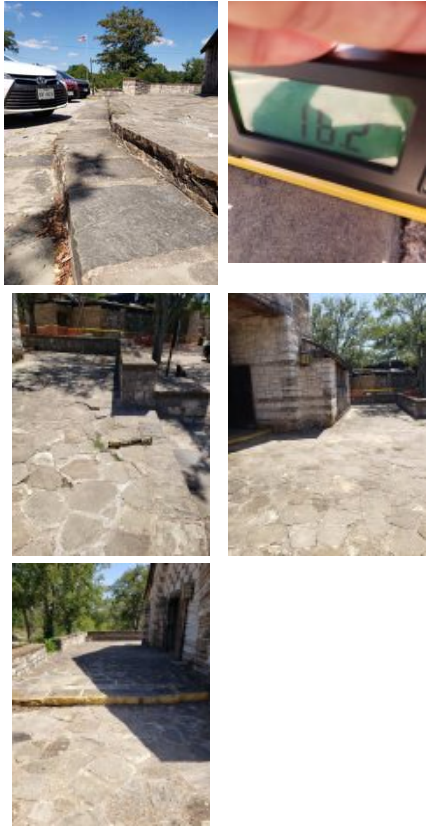
Finding Number	Area Description	Lat/Long	Finding	As Built	Recommendation	Citation	Photos	Figure
23	CCC Administration Building: CCC Administration Building Exterior Accessible Route	[30.6845877 , -98.3509327]	The path of contains multiple issues and is not accessible. The path of travel exceeds the maximum allowable cross and running slope requirements. It also contains changes in level and/or gaps that exceed the allowable maximum requirements. The path of travel does not meet the minimum width requirements for clearances, turning spaces, and/or passing spaces. The floor or ground surface is not firm, stable, and slip resistant.	steps are only means of access to building, slope of 16.2%, and natural stone pavers on route of travel around building creating many CILs	Create AR with crushed and compacted stone or similar outdoor material from parking or sidewalk to the building. In the alternative, provide a ramp for access.	2015 ABAAS Section: 403.1 2010 ADAS Section: 403.1

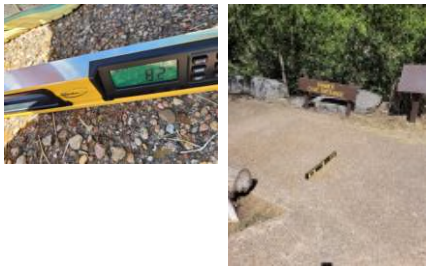
24	CCC Administration Building: CCC Administration Building Exterior Accessible Route	[30.6844828 , -98.350639]	The accessible route of travel on the accessible route contains cross slopes greater than 2%. Cross slopes shall not exceed one unit vertical in 48 units horizontal (2-percent slope).	Cross slope of 8.2% behind the Visitor's Center near the danger sign	Correct or repair cross slope along AR to max 2.08%	2015 ABAAS Section: 403.3 2012 TAS Section: 403.3 2010 ADAS Section: 403.3

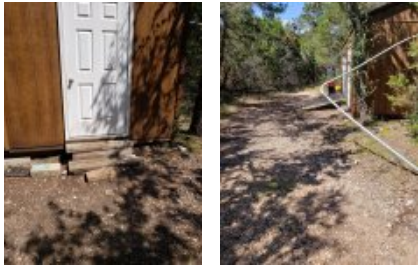
30	Concessionaire Maintenance Building (near water well): Concessionaire Maintenance Building (near water well)	[30.68462, -98.35115]	The building entrance is not located on an accessible route. When a building, or portion of a building, is required to be accessible, an accessible route of travel shall be provided to all portions of the building, to accessible building entrances and between the building and the public way. All walks, halls, corridors, aisles, skywalks, tunnels, and other spaces that are part of an accessible route must comply. An accessible route of travel must not pass through kitchens, storage rooms, restrooms, closets or other spaces used for similar purposes. At least one accessible route within the boundary of the site must be provided from public transportation stops, accessible parking and accessible passenger loading zones and public streets or sidewalks to the accessible building entrance they serve. The accessible route shall, to the maximum extent feasible, coincide with the route for the general public. At least one accessible route shall connect accessible buildings, facilities, elements and spaces that are on the same site. At least one accessible route shall connect accessible building or facility entrances with all accessible spaces and elements.	Lacks accessible route to storage building/shed	Create AR with crushed and compacted stone or similar outdoor material from parking or sidewalk to building entrance	2015 ABAAS Section: F206.2.1 2012 TAS Section: 206.2.1 2010 ADAS Section: 206.2.1

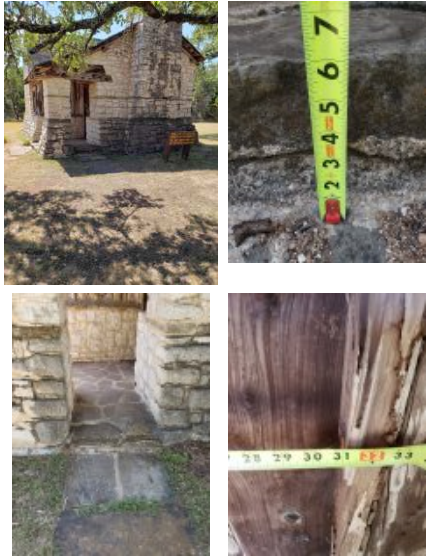
Finding Number	Area Description	Lat/Long	Finding	As Built	Recommendation	Citation	Photos	Figure
31	CCC Cabin: CCC Cabin Employee Spaces	[30.68462, -98.35115]	Door openings shall provide a clear width of 32 inches (815 mm) minimum. Clear openings of doorways with swinging doors shall be measured between the face of the door and the stop, with the door open 90 degrees. Openings more than 24 inches (610 mm) deep shall provide a clear opening of 36 inches (915 mm) minimum. There shall be no projections into the required clear opening width lower than 34 inches (865 mm) above the finish floor or ground. Projections into the clear opening width between 34 inches (865 mm) and 80 inches (2030 mm) above the finish floor or ground shall not exceed 4 inches (100 mm). The threshold has a vertical change greater than 1/4 inch high.	CCC Cabin storage door - 31" wide, and CIL/steps of 6"	For all doors along the public circulation route, replace doors with doors having 80" overhead clearance and 32" clear width For all doors along the public circulation route, repair, bevel, or ramp CILs at door entries to max .25"	2010 ADAS Section: 404.2.3, 404.2.7, 404.2.4, 404.2.11, 404.2.11 Exception

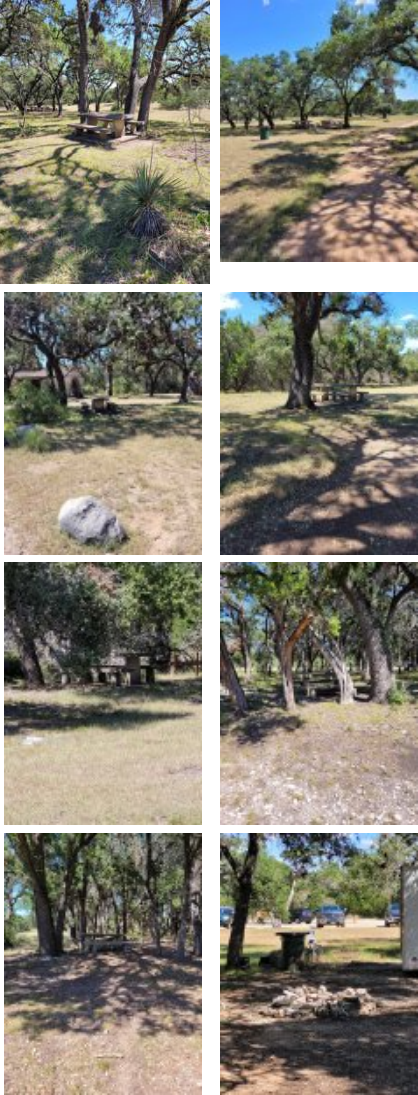
Finding Number	Area Description	Lat/Long	Finding	As Built	Recommendation	Citation	Photos	Figure
33	CCC Observation Tower: CCC Observation Tower	[30.6839303 , -98.352448 2]	There is no accessible route to 14 picnic tables, 3 garbage cans, and 1 fire ring. At least one accessible route shall connect accessible buildings, accessible facilities, accessible elements, and accessible spaces that are on the same site.	Lacks accessible route to 14 picnic tables, 3 garbage cans, and 1 fire ring	Create an accessible route with crushed stone or other outdoor material from parking or walkway to 3 picnic tables, 1 garbage can, and 1 fire ring	2015 ABAAS Section: F206.2.2 2012 TAS Section: 206.2.2 2010 ADAS Section: 206.2.2

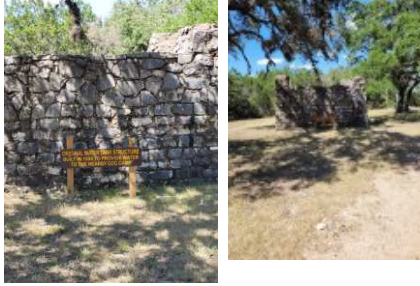
34	CCC Observation Tower: CCC Observation Tower	[30.6852382 , -98.352323 5]	There is no accessible route to the Original Water Tank Structure . At least one accessible route shall connect accessible buildings, accessible facilities, accessible elements, and accessible spaces that are on the same site.	Lacks accessible route to the Original Water Tank Structure	Create an accessible route with crushed stone or other outdoor material from parking or walkway to the Original Water Tank Structure	2015 ABAAS Section: F206.2.2 2012 TAS Section: 206.2.2 2010 ADAS Section: 206.2.2

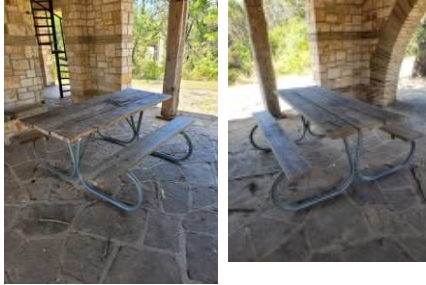
Finding Number	Area Description	Lat/Long	Finding	As Built	Recommendation	Citation	Photos	Figure
36	CCC Observation Tower: CCC Observation Tower	[30.6846062 , -98.352748 6]	Picnic tables shall provide at least one wheelchair space for each 24 linear feet (7320 mm) of usable table surface perimeter. Wheelchair spaces shall be 30 inches (760 mm) minimum by 48 inches (1220 mm) minimum. Wheelchair spaces shall be positioned for a forward approach to the table and provide knee and toe clearance complying with 306 under the table	2 of 2 picnic tables are not of an accessible design	Replace both picnic tables with ones of an accessible design as a smart practice	2015 ABAAS Section: 1011.4.2

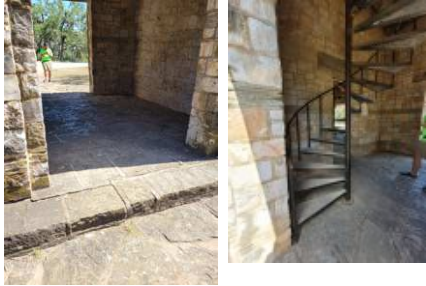
37	CCC Observation Tower: CCC Observation Tower	[30.6845739 , -98.352818 3]	At least one accessible route (i.e. elevator, ramp or platform lift) shall connect each story and mezzanine in multistory buildings and facilities. The elevator exemption note below does not apply to Title II government facilities and entities. Title II facilities must make their programs accessible. If vertical access cannot be achieved, then the program must be relocated, removed or made accessible. The mezzanine area is approximately 165 sq. ft. and currently contains a means of observation for patrons. It may possible to covert this area to an employee work/storage area and relocate the items to the lower level, or prohibit ALL public access and require staff to access this area on behalf of the public, or provide vertical access via an elevator, lift or ramp. The following buildings and facilities do not require vertical access: In private buildings or facilities that are less than three stories or that have less than 3000 square feet per story, an accessible route shall not be required to connect stories provided that the building or facility is not a shopping center, a shopping mall, the professional office of a health care provider, a terminal, depot or other station used for specified public transportation, an airport passenger terminal, or another type of facility as determined by the Attorney General.	Lacks accessible route to the top of the CCC Observation Tower (stairs are the only means of access)	Provide vertical access to upper levels if feasible; in the alternative, leave as is and provide a similar accessible experience	2015 ABAAS Section: F206.2.3 2012 TAS Section: 206.2.3 2010 ADAS Section: 206.2.3

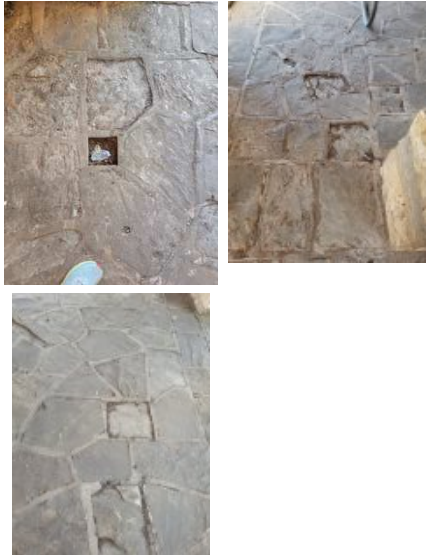
Finding Number	Area Description	Lat/Long	Finding	As Built	Recommendation	Citation	Photos	Figure
38	CCC Observation Tower: CCC Observation Tower	[30.6845877 , -98.352780 8]	The accessible route contains loose gravel and/or surfaces that do not provide for a stable, firm slip resistant surface.	Lacks firm and stable surface on accessible route of CCC Observation Tower due to natural rock surface	Resurface AR where deterioration occurs	2015 ABAAS Section: 302.1 2012 TAS Section: 302.1 2010 ADAS Section: 302.1

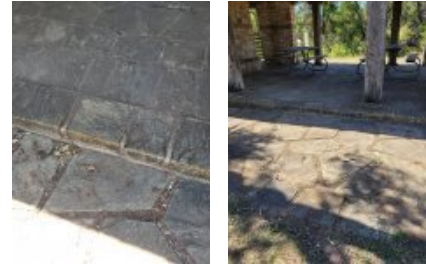
39	CCC Observation Tower: CCC Observation Tower	[30.6845854 , -98.352735 2]	The walkway contains abrupt vertical edges and/or variations over a 1/4 inch. 1/4 inch is the maximum vertical rise. Changes in level between 1/4 inch and 1/2 inch must be beveled at 1:2 or less. Changes in level greater than 1/2 inch must be by way of a ramp.	CIL (step) at entry to CCC Observation Tower picnic shelter area	Repair, bevel or ramp CIL along AR	2012 TAS Section: 303.2, 303.3 2010 ADAS Section: 303.2, 303.3

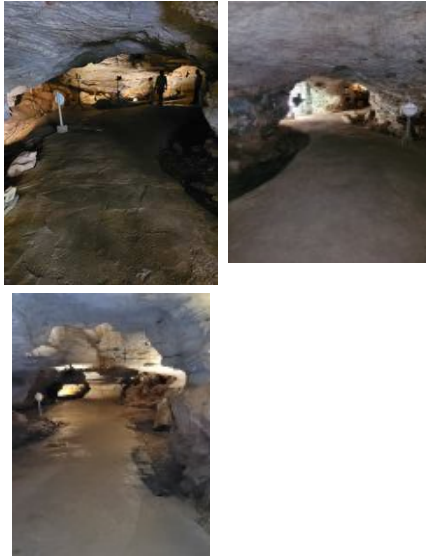
Finding Number	Area Description	Lat/Long	Finding	As Built	Recommendation	Citation	Photos	Figure
40	Cave Area: Exterior Accessible Route	[30.6844539 , -98.350342 7]	The cave ceiling extends down too close to the route of travel. Any obstruction that overhangs a route of travel must be a minimum of 80 inches above the walking surface as measured from the bottom of the obstruction.	cave - overhead clearance reduces throughout	Add padding or rails if possible to reduce injury in cave	2015 ABAAS Section: 307.3 2012 TAS Section: 307.3 2010 ADAS Section: 307.3

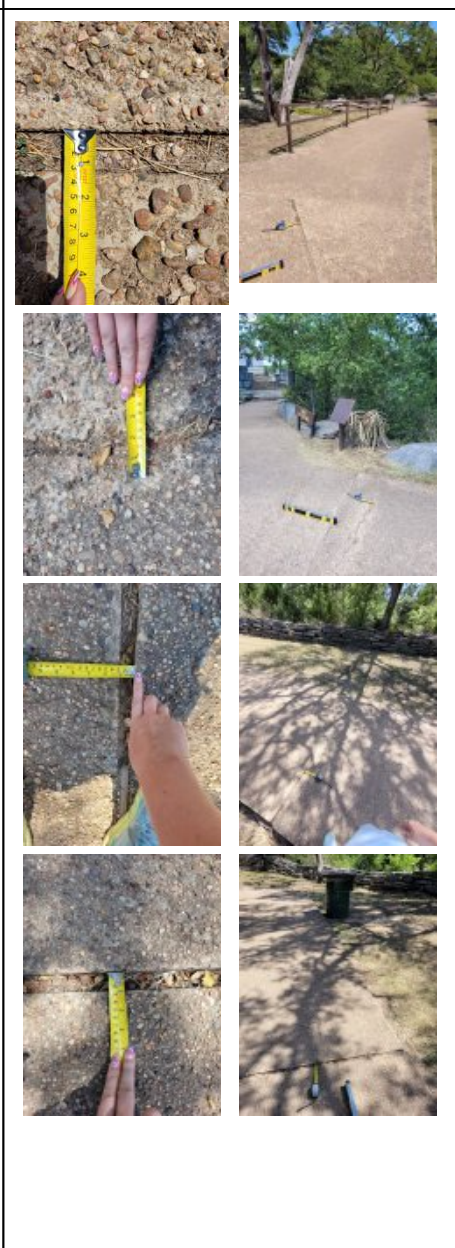
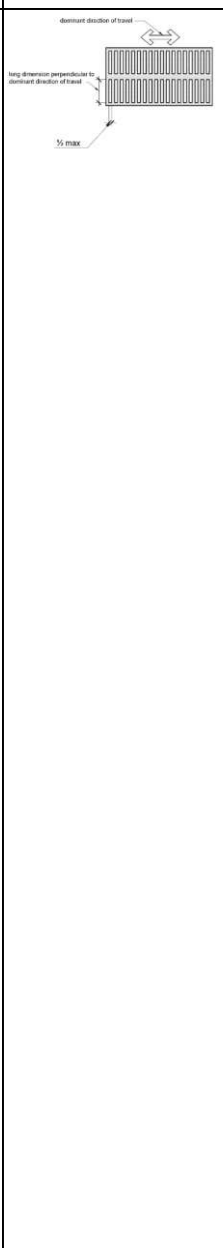
Finding Number	Area Description	Lat/Long	Finding	As Built	Recommendation	Citation	Photos	Figure
42	Cave Area: Exterior Accessible Route	[30.6843559 , -98.350399]	There is a gap spaced greater than a 1/2 inch. Openings in floor or ground surfaces shall not allow passage of a sphere more than 1/2 inch diameter. Elongated openings shall be placed so that the long dimension is perpendicular to the dominant direction of travel.	1" gap near railing, 3" near danger cave entrance sign, 1" near communications box, and 1" near garbage can	Correct or fill gaps to be max .5"	2015 ABAAS Section: 302.3 2012 TAS Section: 302.3 2010 ADAS Section: 302.3

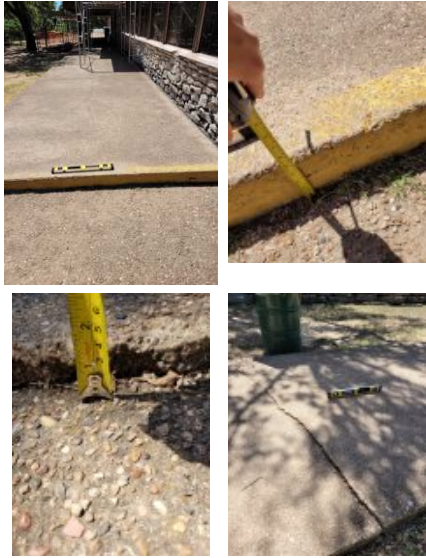
Finding Number	Area Description	Lat/Long	Finding	As Built	Recommendation	Citation	Photos	Figure
43	Cave Area: Exterior Accessible Route	[30.6844851 , -98.350655 1]	The walkway contains abrupt vertical edges and/or variations over a 1/4 inch. 1/4 inch is the maximum vertical rise. Changes in level between 1/4 inch and 1/2 inch must be beveled at 1:2 or less. Changes in level greater than 1/2 inch must be by way of a ramp.	CIL/step of 5" near building corner, and CIL of 1" near garbage can	Repair, bevel or ramp CIL along AR	2012 TAS Section: 303.2, 303.3 2010 ADAS Section: 303.2, 303.3

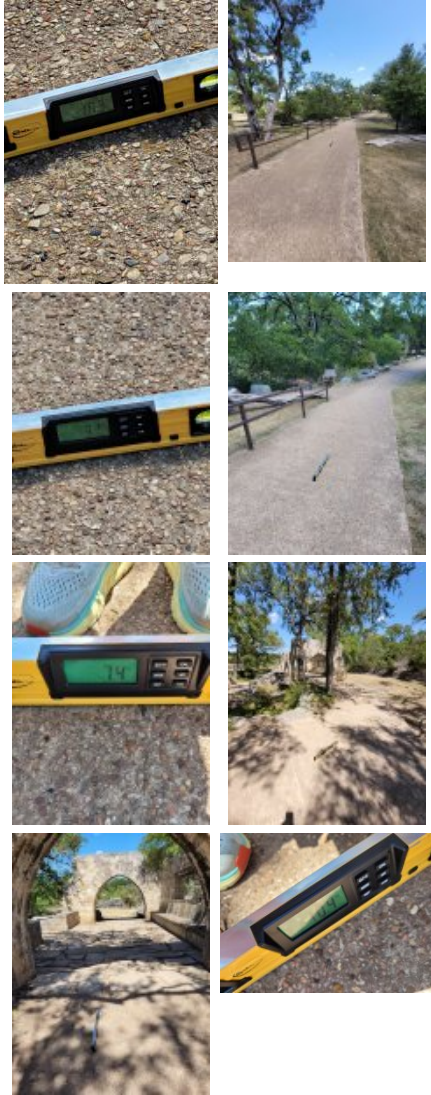
Finding Number	Area Description	Lat/Long	Finding	As Built	Recommendation	Citation	Photos	Figure
45	Cave Area: Exterior Accessible Route	[30.6844435 , -98.350537 1]	The running slope of walking surfaces shall not be steeper than 1:20.	Running slopes of 10.3% middle of railing, 9.7% towards bottom of railing, 7.4% at turn for slope entry, and 10.4% up to cave underpass entry	Correct running slope along the AR to max 5%	2015 ABAAS Section: 403.3 2012 TAS Section: 403.3 2010 ADAS Section: 403.3
