Access Audit Site Report

Lyndon B Johnson State Park and Historic Site

**199 Park Road 52
Stonewall, TX 78671**

**Inspection Date: 09/27/2022
Inspectors: Tanya Scheibe**

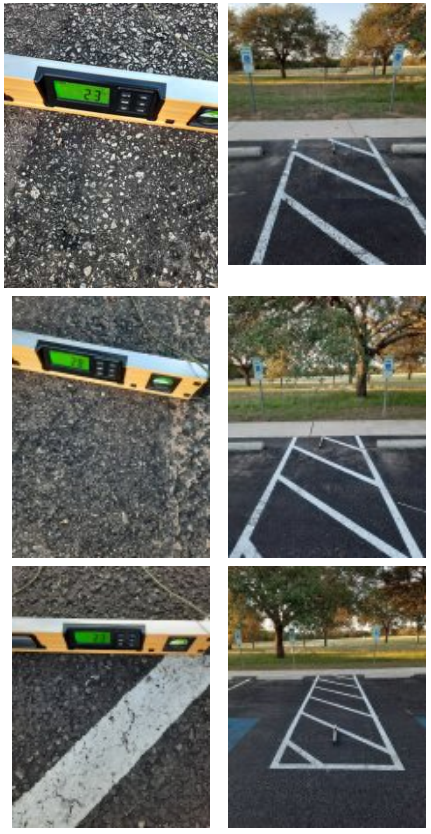
2	Visitor Center Complex: Visitor Center - Parking	[30.2375365 , -98.6268478]	The cross slopes (narrow dimension) and/or running slopes (long dimension) of the access aisle exceeds 2%. The running slope and the cross slope in an accessible parking stall and the access aisle must not exceed 2%.	From left to right/east to west when facing south: Access aisle (AA) 2 - 2.3%, AA 3 - 2.8%, AA 4 - 2.3%, AA 5 - 2.5%	Repair or correct slope of parking space and access aisle to max 2.08% in any direction.	2015 ABAAS Section: 502.4 2012 TAS Section: 502.4 2010 ADAS Section: 502.4

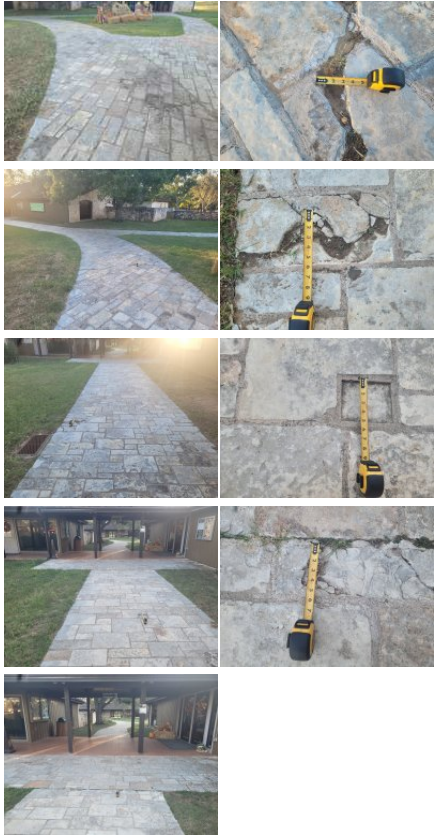
Finding Number	Area Description	Lat/Long	Finding	As Built	Recommendation	Citation	Photos	Figure
10	Visitor Center Complex: Visitor Center - Exterior Accessible Route	[30.2375474 , -98.626436 6]	There is a gap spaced greater than a 1/2 inch. Openings in floor or ground surfaces shall not allow passage of a sphere more than 1/2 inch diameter. Elongated openings shall be placed so that the long dimension is perpendicular to the dominant direction of travel.	Sunken paver where path turns, 3" gap at crack, 5.5" gap at damaged paver, 5" gap at sunken paver, 5" gap at joint by Visitor Center entry	Correct or fill gaps to be max .5".	2015 ABAAS Section: 302.3 2012 TAS Section: 302.3 2010 ADAS Section: 302.3

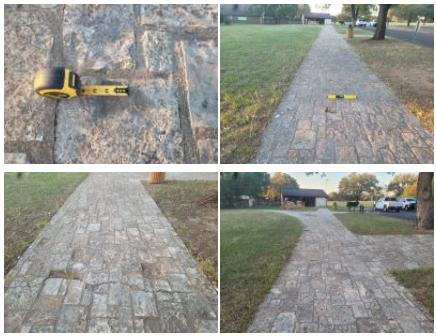
11	Visitor Center Complex: Visitor Center - Exterior Accessible Route	[30.237623, -98.626627 6], [30.2380922 , -98.626642 4]	There is a gap spaced greater than a 1/2 inch. Openings in floor or ground surfaces shall not allow passage of a sphere more than 1/2 inch diameter. Elongated openings shall be placed so that the long dimension is perpendicular to the dominant direction of travel.	3" gap in stone paver, surface of pavers varied, crack and 5 pavers sunken along parking, 4 gaps closer to park map	Correct or fill gaps to be max .5".	2015 ABAAS Section: 302.3 2012 TAS Section: 302.3 2010 ADAS Section: 302.3

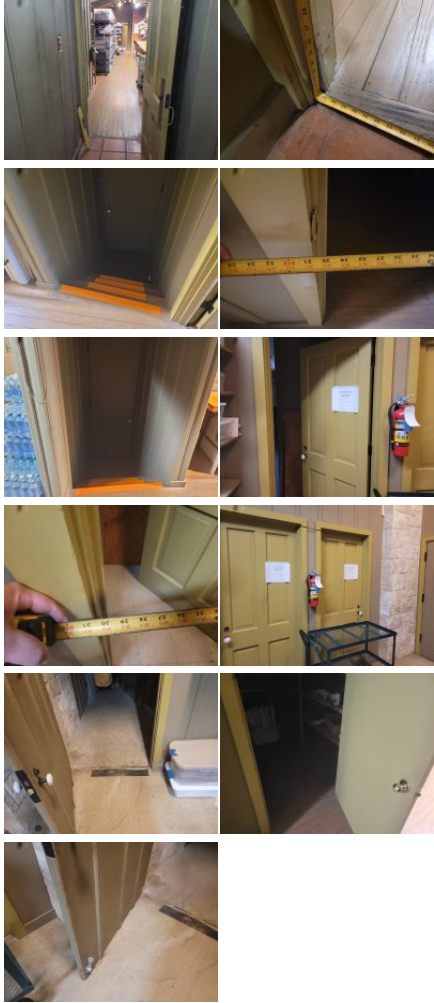
Finding Number	Area Description	Lat/Long	Finding	As Built	Recommendation	Citation	Photos	Figure
48	Visitor Center Complex: Visitor Center - Employee Spaces	[30.237407, -98.626242 2]	Spaces and elements within employee work areas shall only be required to comply with 206.2.8, 207.1, and 215.3 and shall be designed and constructed so that individuals with disabilities can approach, enter, and exit the employee work area. Employee work areas, or portions of employee work areas, other than raised courtroom stations, that are less than 300 square feet (28 m2) and elevated 7 inches (180 mm) or more above the finish floor or ground where the elevation is essential to the function of the space shall not be required to comply with these requirements or to be on an accessible route.	Hall entry - wall in pull side clearance, door 29", door stop on push side, 11#; doors from theater (2) - stairs, knob, wall in pull side clearance; storage closet - knob, 30" wide; two storage closets - knob, wall back in pull side clearance, 30" wide; uniform closet - storage in pull side clearance, knob, door sticks	For employee spaces, relocate storage, furniture, and other obstacles at doorways to provide approach, enter and exit at the employee space. Provide required maneuvering clearance on push and pull side of doors. Replace doors with doors having 80" overhead clearance and 32" clear width. Repair, bevel, or ramp CILs at door entries to max .25". Inspect, adjust, and maintain 5 lbf to open interior doors. Replace hardware with lever hardware or hardware operable without a tight pinch or grasp. Remove door holder to provide a smooth surface on the push side of door from floor to 10" AFF.	2015 ABAAS Section: F203.9 2012 TAS Section: 203.9 2010 ADAS Section: 203.9

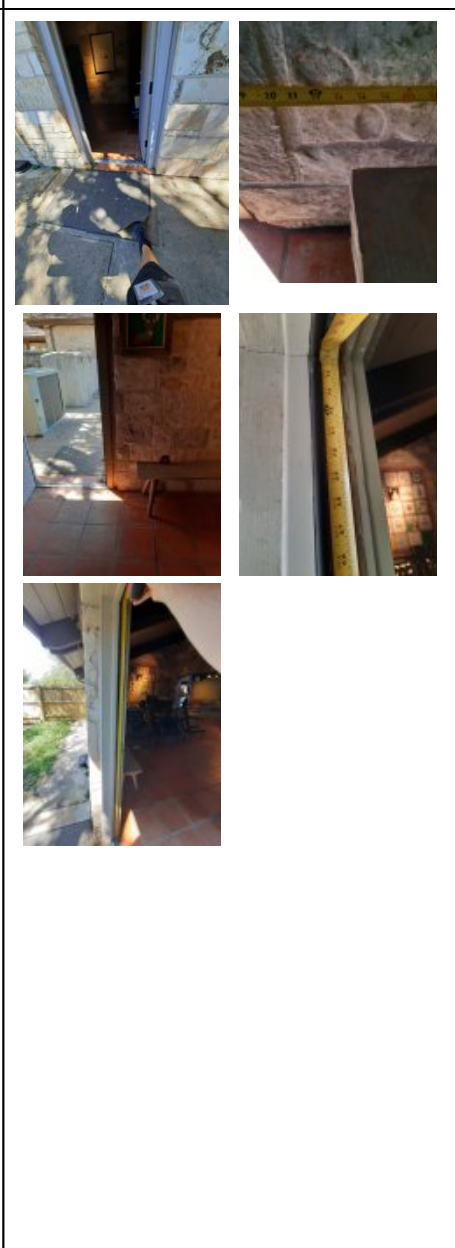
Finding Number	Area Description	Lat/Long	Finding	As Built	Recommendation	Citation	Photos	Figure
97	Visitor Center Complex: Visitor Center - Exhibit Hall	[30.23776, -98.62609]	<p>Minimum maneuvering clearances at doors and gates shall comply with 404.2.4. Maneuvering clearances shall extend the full width of the doorway and the required latch side or hinge side clearance. Door openings shall provide a clear width of 32 inches (815 mm) minimum. Clear openings of doorways with swinging doors shall be measured between the face of the door and the stop, with the door open 90 degrees. Openings more than 24 inches (610 mm) deep shall provide a clear opening of 36 inches (915 mm) minimum. There shall be no projections into the required clear opening width lower than 34 inches (865 mm) above the finish floor or ground. Projections into the clear opening width between 34 inches (865 mm) and 80 inches (2030 mm) above the finish floor or ground shall not exceed 4 inches (100 mm).</p>	Emergency exit door on west side of exhibit hall leading to office building - loose floor mat on push side, bench in pull side clearance, 75" high door	For all doors along the public circulation route, provide required maneuvering clearance on push and pull side of doors. For all doors along the public circulation route, secure rug in door clearance to prevent trip hazard. For all doors along the public circulation route, replace doors with doors having 80" overhead clearance and 32" clear width.	2010 ADAS Section: 404.2.3, 404.2.7, 404.2.4, 404.2.11, 404.2.11 Exception

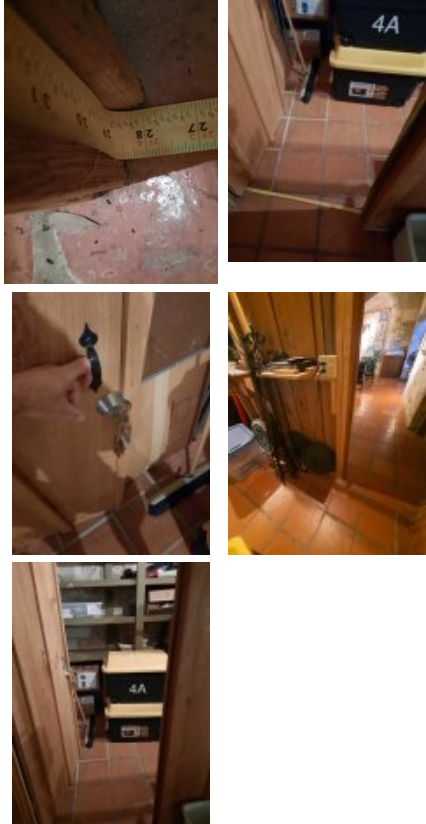
Finding Number	Area Description	Lat/Long	Finding	As Built	Recommendation	Citation	Photos	Figure
98	Visitor Center Complex: Visitor Center - Exhibit Hall	[30.2377723 , -98.626054 4]	Spaces and elements within employee work areas shall only be required to comply with 206.2.8, 207.1, and 215.3 and shall be designed and constructed so that individuals with disabilities can approach, enter, and exit the employee work area. Employee work areas, or portions of employee work areas, other than raised courtroom stations, that are less than 300 square feet (28 m2) and elevated 7 inches (180 mm) or more above the finish floor or ground where the elevation is essential to the function of the space shall not be required to comply with these requirements or to be on an accessible route.	Storage closet in Exhibit Hall - 28.5" wide door, small hardware, storage in pull side clearance	For employee spaces, relocate storage, furniture, and other obstacles at doorways to provide approach, enter and exit at the employee space. Replace doors with doors having 80" overhead clearance and 32" clear width. Replace hardware with lever hardware or hardware operable without a tight pinch or grasp.	2015 ABAAS Section: F203.9 2012 TAS Section: 203.9 2010 ADAS Section: 203.9

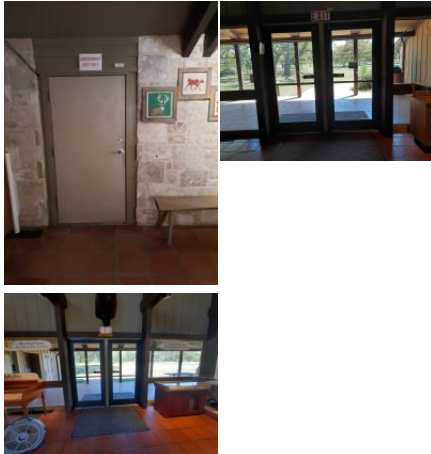
Finding Number	Area Description	Lat/Long	Finding	As Built	Recommendation	Citation	Photos	Figure
99	Visitor Center Complex: Visitor Center - Exhibit Hall	[30.2377687, -98.6260581]	The tactile EXIT sign is missing at the door. Wall signs identifying exits shall have characters raised 1/32 inch minimum and shall be uppercase characters a minimum of 5/8 inch and a maximum of 2 inches high. Braille shall be placed directly below the tactile characters; flush left or centered. Signs shall be located a minimum of 48 inches above the floor, measured from the baseline of the lowest tactile characters and 60 inches maximum above the finish floor or ground surface, measured from the baseline of the highest tactile characters. Where a tactile sign is provided at a door, the sign shall be located on the latch side. Where a tactile sign is provided at double doors the sign shall be located to the right of the right-hand door. Where there is no wall space at the latch side of a single door or at the right side of double doors, signs shall be located on the nearest adjacent wall.	Exhibit Hall - 3 of 3 egress doors/exits lack tactile exit signs	Mount compliant signage at all doors along the egress route.	2015 ABAAS Section: F216.4.1 2012 TAS Section: 216.4.1 2010 ADAS Section: 216.4.1

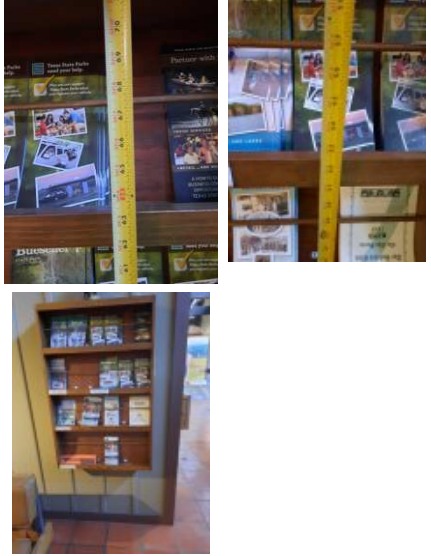
100	Visitor Center Complex: Visitor Center - Exhibit Hall	[30.2377672, -98.6260773]	The operable part is positioned too high for either a side or front approach. Where a clear floor or ground space allows a parallel approach to an element and the side reach is unobstructed, the high side reach shall be 48 inches maximum and the low side reach shall be 15 inches minimum above the finish floor or ground. Where a forward reach is unobstructed, the high forward reach shall be 48 inches maximum and the low forward reach shall be 15 inches minimum above the finish floor or ground.	Top two shelves of brochure rack exceed reach range	Remount brochure rack to be in reach range of 15" min to 48" max.	2015 ABAAS Section: 308.1 2012 TAS Section: 308.1 2010 ADAS Section: 308.1

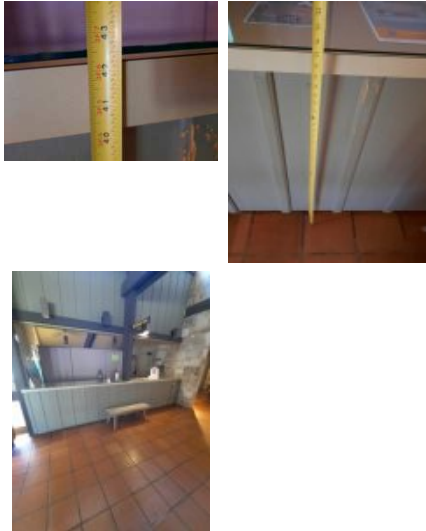
Finding Number	Area Description	Lat/Long	Finding	As Built	Recommendation	Citation	Photos	Figure
101	Visitor Center Complex: Visitor Center - Exhibit Hall	[30.2377745 , -98.626050 2]	The transaction counter is too high. A portion of the counter surface that is 36 inches long minimum and 36 inches high maximum above the finish floor shall be provided. Knee and toe space must be provided for a forward approach. A 30 inch by 48 inch clear floor space on an accessible route must be provided for either a forward or parallel approach.	Service counter at information desk in Exhibit Hall at 42.5" aff	Lower 36" wide segment of service counter to max 36" AFF.	2015 ABAAS Section: 904.4.2, 904.4.1 2012 TAS Section: 904.4.1, 904.4.2 2010 ADAS Section: 904.4.2, 904.4.1

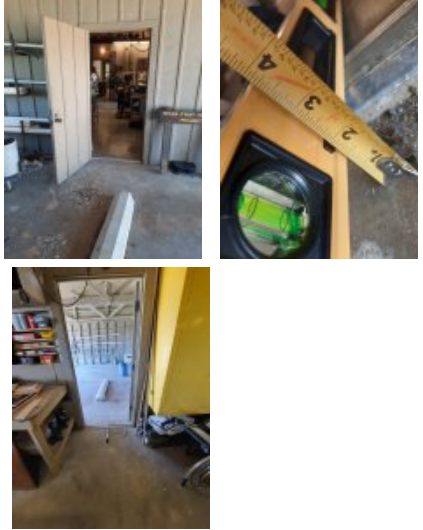
133	Employee Areas: Maintenance	[30.2368744, -98.6423786]	The tactile EXIT sign is missing at the door. Wall signs identifying exits shall have characters raised 1/32 inch minimum and shall be uppercase characters a minimum of 5/8 inch and a maximum of 2 inches high. Braille shall be placed directly below the tactile characters; flush left or centered. Signs shall be located a minimum of 48 inches above the floor, measured from the baseline of the lowest tactile characters and 60 inches maximum above the finish floor or ground surface, measured from the baseline of the highest tactile characters. Where a tactile sign is provided at a door, the sign shall be located on the latch side. Where a tactile sign is provided at double doors the sign shall be located to the right of the right-hand door. Where there is no wall space at the latch side of a single door or at the right side of double doors, signs shall be located on the nearest adjacent wall.	3 of 3 egress doors lack tactile exit signs	Mount compliant signage at all doors along the egress route	2015 ABAAS Section: F216.4.1 2012 TAS Section: 216.4.1 2010 ADAS Section: 216.4.1

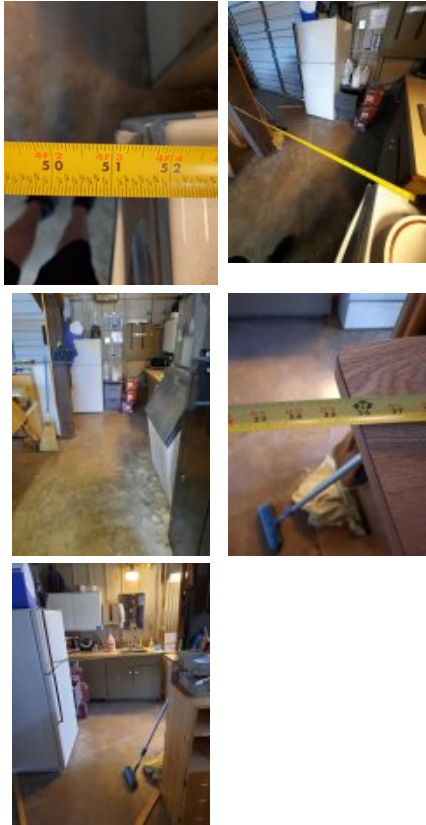
Finding Number	Area Description	Lat/Long	Finding	As Built	Recommendation	Citation	Photos	Figure
134	Employee Areas: Maintenance	[30.2368776 , -98.642370 3]	The U-shaped kitchen is not wide enough. In U-shaped kitchens enclosed on three contiguous sides, clearance between all opposing base cabinets, counter tops, appliances, or walls within kitchen work areas shall be 60 inches.	Lacks 60" between support column and kitchen elements	Renovate U shaped kitchen to provide required 60" clearance between cabinets, counter tops and appliances.	2015 ABAAS Section: 804.2.2 2012 TAS Section: 804.2.2 2010 ADAS Section: 804.2.2

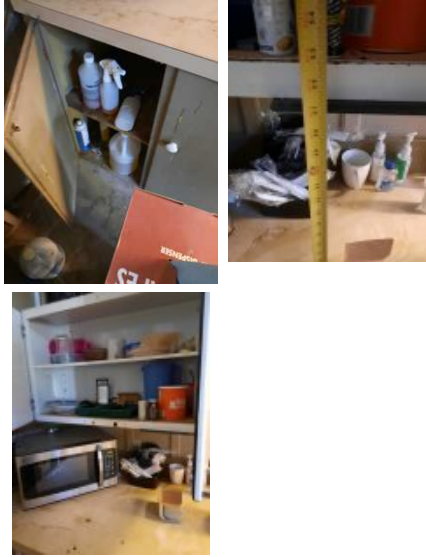
Finding Number	Area Description	Lat/Long	Finding	As Built	Recommendation	Citation	Photos	Figure
135	Employee Areas: Maintenance	[30.2368868, -98.6423864]	The storage space is not within reach range. At least 50% of the storage space must be a minimum of 15 inches and a maximum of 48 inches off the floor with an unobstructed approach. For side approach, the maximum reach range is 46 inches high over an obstruction that is a maximum of 34 inches tall and 24 inches deep.	Lacks 50% of storage space within reach range	Lower 50% of shelving, or relocate supplies to within reach range, max 48" AFF	2015 ABAAS Section: 804.5 2012 TAS Section: 804.5 2010 ADAS Section: 804.5

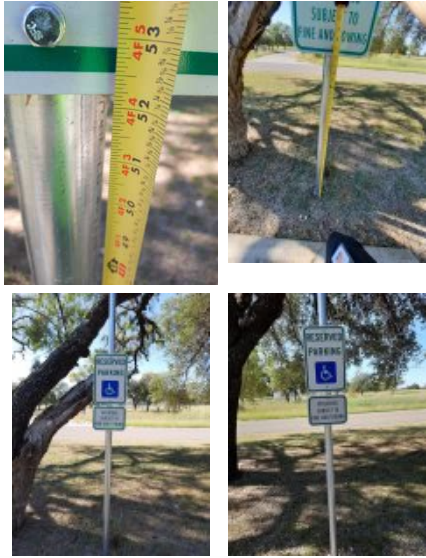
Finding Number	Area Description	Lat/Long	Finding	As Built	Recommendation	Citation	Photos	Figure
173	Group Dining Hall: Group Dining - Parking	[30.2373424 , -98.6387313]	The parking sign is mounted too low. Parking space identification signs shall include the International Symbol of Accessibility complying with. Signs identifying van parking spaces shall contain the designation "van accessible." Signs shall be 60 inches minimum above the finish floor or ground surface measured to the bottom of the sign.	R7-8 signs comply, but lower "Violators Subject To Fine And Towing" signs at both stalls at 52.25"	Raise existing accessible parking related signs so lowest end of bottom sign is min 60" above ground level (AGL) measured from the surface of the stall.	2015 ABAAS Section: 502.6 2012 TAS Section: 502.6 2010 ADAS Section: 502.6

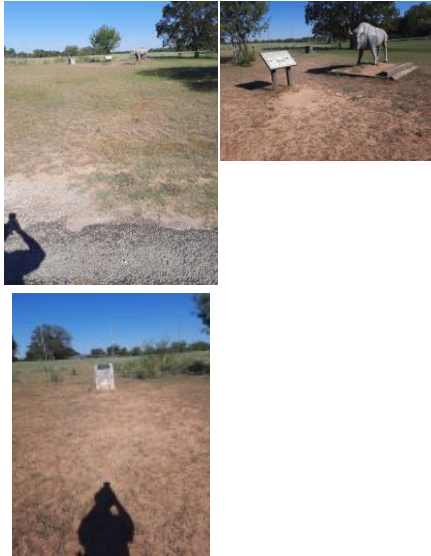
Finding Number	Area Description	Lat/Long	Finding	As Built	Recommendation	Citation	Photos	Figure
363	Park Elements: Bison Herd	[30.23576, -98.62056]	There is no accessible route to the bison statue and 2 info signs. At least one accessible route shall connect accessible buildings, accessible facilities, accessible elements, and accessible spaces that are on the same site.	Lacks route to bison statue and 2 of 2 info signs	Create an accessible route with crushed stone or other outdoor material from parking or walkway to the bison statue and 2 info signs.	2015 ABAAS Section: F206.2.2 2012 TAS Section: 206.2.2 2010 ADAS Section: 206.2.2

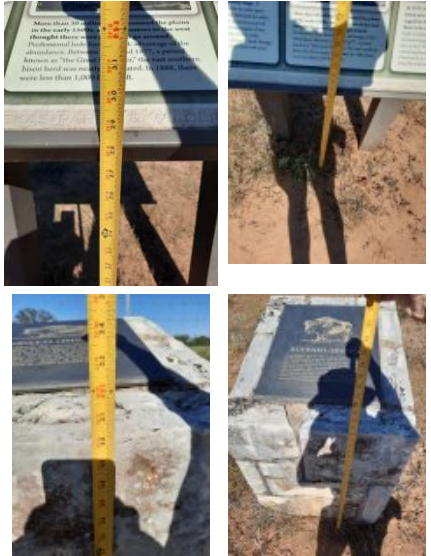
364	Park Elements: Bison Herd	[30.23575, -98.62057]	Visual characters shall be 40 inches (1015 mm) minimum above the finish floor or ground. EXCEPTION: Visual characters indicating elevator car controls shall not be required to comply with 703.5.6.	2 of 2 bison info signs are low: "An American icon" sign - text starts at 30.5" AGL, "Buffaloa (Bison)" sign at 33"	Remount signage to min 40" AFF.	2015 ABAAS Section: 703.5.6, 703.5.6 EXCEPTION 2012 TAS Section: 703.5.6, 703.5.6 Exception 2010 ADAS Section: 703.5.6, 703.5.6 Exception
