Access Audit Site Report

Prepared By
WT Group

Martin Dies Jr. State Park
634 Park Road 48 South
Jasper, TX 75951
Accessibility Evaluation
Inspection Date: 11/10/2021
Inspectors: Tanya Scheibe

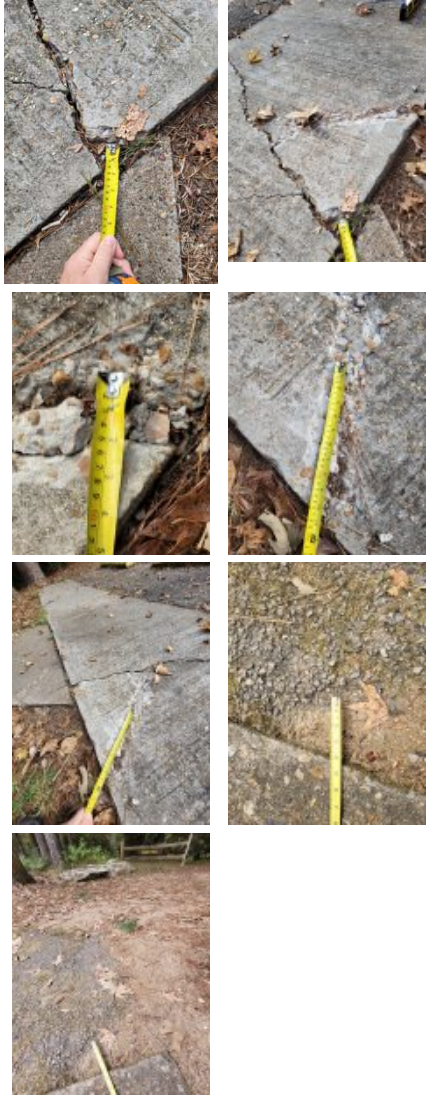
Finding Number	Area Description	Lat/Long	Finding	As Built	Recommendation	Citation	Photos	Figure
8	Headquarters: Headquarters Exterior Accessible Route	[30.8464869 , -94.165822 2]	There is a gap spaced greater than a 1/2 inch. Openings in floor or ground surfaces shall not allow passage of a sphere more than 1/2 inch diameter. Elongated openings shall be placed so that the long dimension is perpendicular to the dominant direction of travel.	Multiple gaps - 2" to 4"	Correct or fill gaps to be max .5"	2015 ABAAS Section: 302.3 2012 TAS Section: 302.3 2010 ADAS Section: 302.3

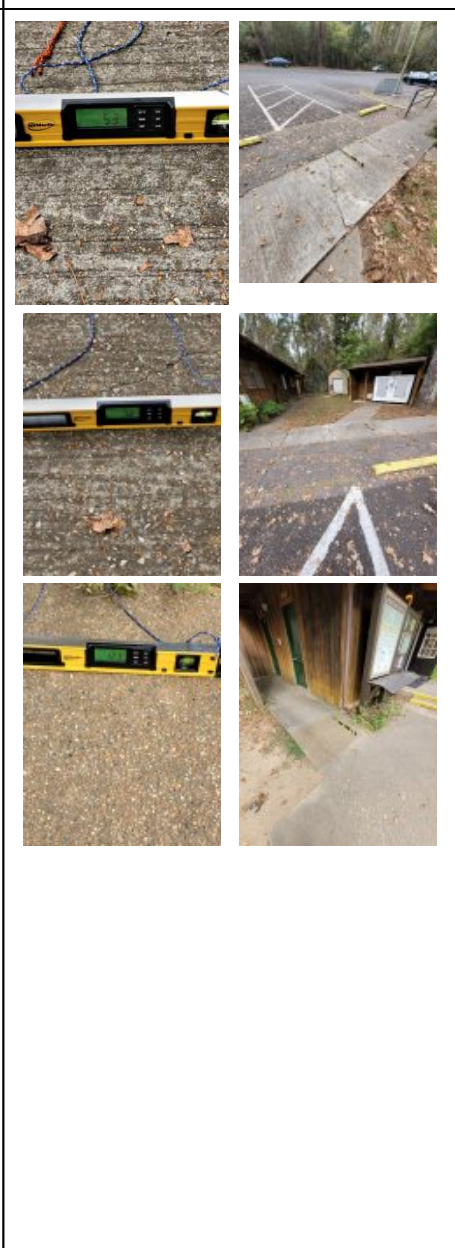
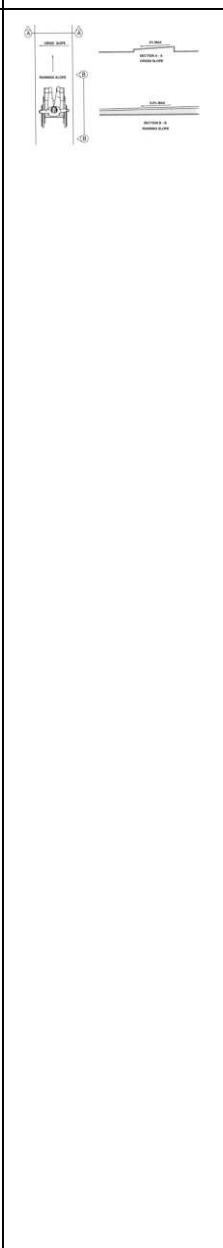
Finding Number	Area Description	Lat/Long	Finding	As Built	Recommendation	Citation	Photos	Figure
9	Headquarters: Headquarters Exterior Accessible Route	[30.8464685 , -94.165824 9]	The accessible route has running slopes greater than 5% and has not been constructed as a ramp (i.e. handrails, edge protection, etc.). Cross slopes are greater than 2% across the width of the walk. When the slope in the direction of travel of any walk exceeds 1 unit vertical in 20 units horizontal (5-percent slope), it must be constructed as a ramp. Surface cross slopes must not exceed 1 unit vertical in 48 units horizontal (2-percent slope).	Cross slope of 5.3% and running slope of 9.8% to ice machine, running slope of 12.3% near restrooms	Correct or repair cross slope along AR to max 2.08% Correct running slope along the AR to max 5%	2015 ABAAS Section: 403.3 2012 TAS Section: 403.3 2010 ADAS Section: 403.3

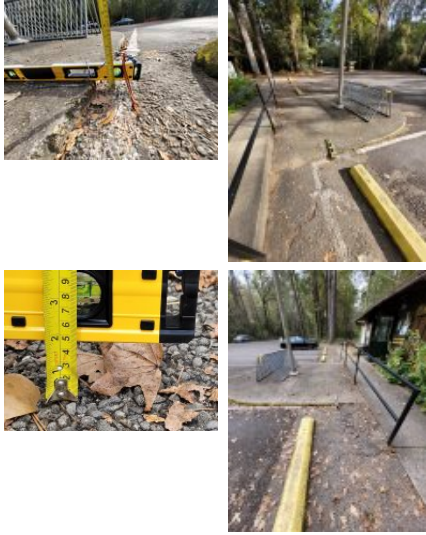
Finding Number	Area Description	Lat/Long	Finding	As Built	Recommendation	Citation	Photos	Figure
10	Headquarters: Headquarters Exterior Accessible Route	[30.84663, -94.1659]	At least one accessible route shall connect accessible buildings, accessible facilities, accessible elements, and accessible spaces that are on the same site. For areas of sport activity, an accessible route is required to connect to the boundary of each area of sport activity. The size of an area of sport activity includes only the space needed to play. Where multiple sports fields or courts are provided, an accessible route is required to each field or area of sport activity.	Lacks accessible route to bike rack and CILs of 1.5" and 2"	Provide an accessible route to each element within the site.	2010 ADAS Section: 206.2.2, 206.2

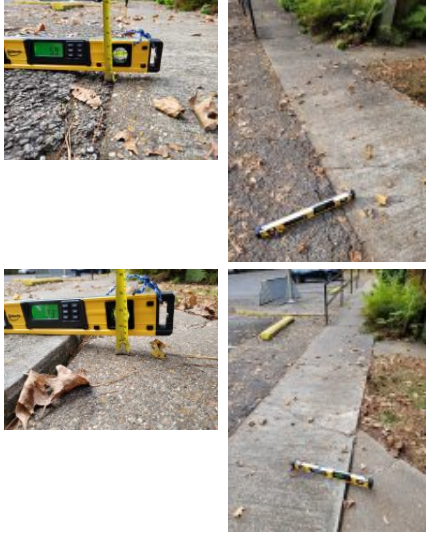
11	Headquarters: Headquarters Exterior Accessible Route	[30.8464915 , -94.165795 4]	The walkway contains abrupt vertical edges and/or variations over a 1/4 inch. 1/4 inch is the maximum vertical rise. Changes in level between 1/4 inch and 1/2 inch must be beveled at 1:2 or less. Changes in level greater than 1/2 inch must be by way of a ramp.	Changes in level (CIL) of .75", 1", and 1.5"	Repair, bevel or ramp CIL along AR	2012 TAS Section: 303.2, 303.3 2010 ADAS Section: 303.2, 303.3

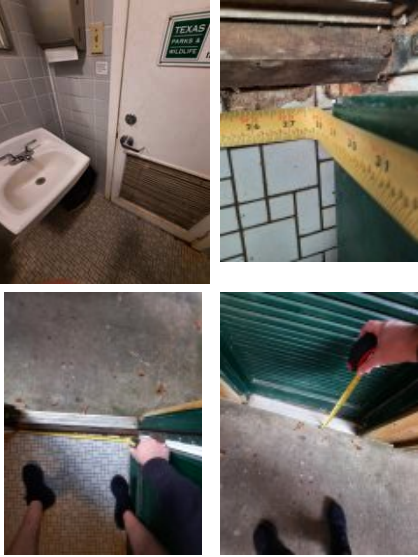
Finding Number	Area Description	Lat/Long	Finding	As Built	Recommendation	Citation	Photos	Figure
16	Headquarters: Headquarters Men's Restroom	[30.8464991 , -94.165794 1]	Minimum maneuvering clearances at doors and gates shall comply with 404.2.4. Maneuvering clearances shall extend the full width of the doorway and the required latch side or hinge side clearance. Maneuvering clearances shall have a max slope of 2.08%. Door openings shall provide a clear width of 32 inches (815 mm) minimum. Clear openings of doorways with swinging doors shall be measured between the face of the door and the stop, with the door open 90 degrees. Openings more than 24 inches (610 mm) deep shall provide a clear opening of 36 inches (915 mm) minimum. There shall be no projections into the required clear opening width lower than 34 inches (865 mm) above the finish floor or ground. Projections into the clear opening width between 34 inches (865 mm) and 80 inches (2030 mm) above the finish floor or ground shall not exceed 4 inches (100 mm). The threshold has a vertical change greater than 1/4 inch high. The sweep period for doors with closers shall be adjusted so that from an open position of 70 degrees, the door will take at least 3 seconds to move to a point 3 inches from the latch, measured to the leading edge of the door. Exterior doors are recommended to be maintained at 8.5 lbf as a smart practice. Force is to be measured at the operating hardware or 30 inches from the hinges, whichever is greater.	Door - sink in pull side clearance, width 28", 2" change in level at , 15# push, fast close	For all doors along the public circulation route, provide required maneuvering clearance on push and pull side of doors. For all doors along the public circulation route, replace doors with doors having 80" overhead clearance and 32" clear width. For all doors along the public circulation route, repair, bevel, or ramp CILs at door entries to max .25". For all doors along the public circulation route, inspect, adjust, and maintain closing speed on door closers. For all doors along the public circulation route, inspect, adjust, and maintain 8.5 lbf to open exterior doors as a smart practice.	2010 ADAS Section: 404.2.3, 404.2.7, 404.2.4, 404.2.11, 404.2.11 Exception

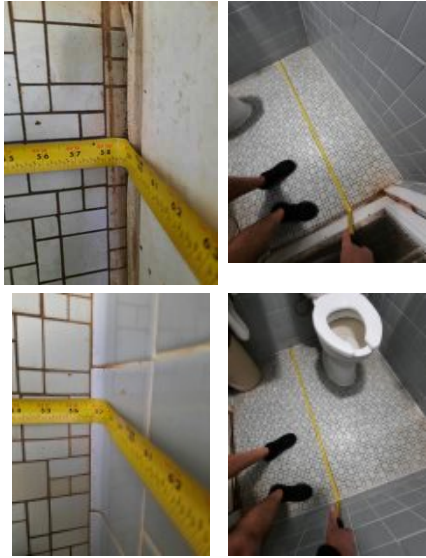
Finding Number	Area Description	Lat/Long	Finding	As Built	Recommendation	Citation	Photos	Figure
19	Headquarters: Headquarters Women's Restroom	[30.846491, -94.165808 9]	This restroom is not accessible. Where existing toilet rooms or bathing rooms do not comply, directional signs indicating the location of the nearest accessible toilet room or bathing room within the facility shall be provided. Signs shall include the International Symbol of Accessibility. Where existing toilet rooms or bathing rooms do comply), the accessible toilet rooms or bathing rooms shall be identified by the International Symbol of Accessibility. Where clustered single user toilet rooms or bathing facilities are permitted, accessible toilet rooms or bathing facilities shall be identified by the International Symbol of Accessibility unless all toilet rooms and bathing facilities are accessible.	Restroom is not accessible and lacks signage directing patrons to an accessible restroom	Restroom not accessible, acquire and mount signage directing patrons to accessible restroom	2015 ABAAS Section: F216.8 2012 TAS Section: 216.8 2010 ADAS Section: 216.8

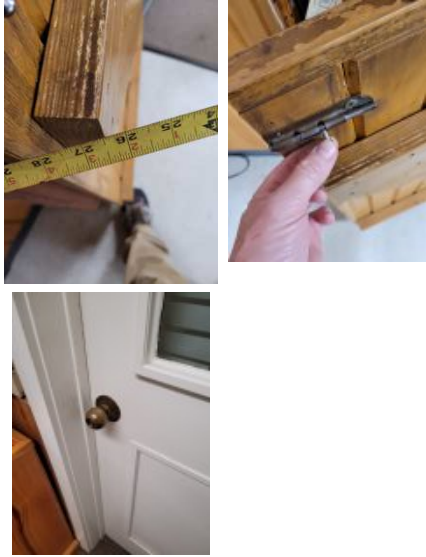
Finding Number	Area Description	Lat/Long	Finding	As Built	Recommendation	Citation	Photos	Figure
32	Headquarters: Headquarters Building	[30.8464961, -94.1657927]	Door openings shall provide a clear width of 32 inches (815 mm) minimum. Clear openings of doorways with swinging doors shall be measured between the face of the door and the stop, with the door open 90 degrees. Openings more than 24 inches (610 mm) deep shall provide a clear opening of 36 inches (915 mm) minimum. There shall be no projections into the required clear opening width lower than 34 inches (865 mm) above the finish floor or ground. Projections into the clear opening width between 34 inches (865 mm) and 80 inches (2030 mm) above the finish floor or ground shall not exceed 4 inches (100 mm). Hand-activated door opening hardware, handles, pulls, latches, locks, and other operating devices on accessible doors shall have a shape that is easy to grasp with one hand and does not require tight grasping, tight pinching or twisting of the wrist to operate. Hardware shall be 34 inches minimum and 48 inches maximum above the finish floor or ground.	Counter gate - 26.5" clear width and locking bolt requires tight pinch Door near counter gate - knob hardware	For all doors along the public circulation route, replace doors with doors having 80" overhead clearance and 32" clear width For all doors along the public circulation route, replace hardware with lever hardware or hardware operable without a tight pinch or grasp	2010 ADAS Section: 404.2.3, 404.2.7, 404.2.4, 404.2.11, 404.2.11 Exception

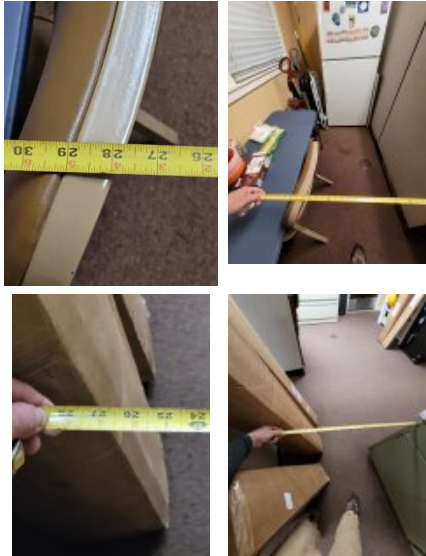
33	Headquarters: Headquarters Building	[30.8464961, -94.1658061]	The route of travel at this location does not provide a minimum width of 36 inches. The clear width shall be permitted to be reduced to 32 inches minimum for a length of 24 inches maximum provided that reduced width segments are separated by segments that are 48 inches long minimum and 36 inches wide minimum.	Break room - Lacks 36" clear width accessible route due to location of table and boxes	Relocate obstacles such as tables and chairs to create AR throughout building	2015 ABAAS Section: 403.5.1 2012 TAS Section: 403.5.1 2010 ADAS Section: 403.5.1

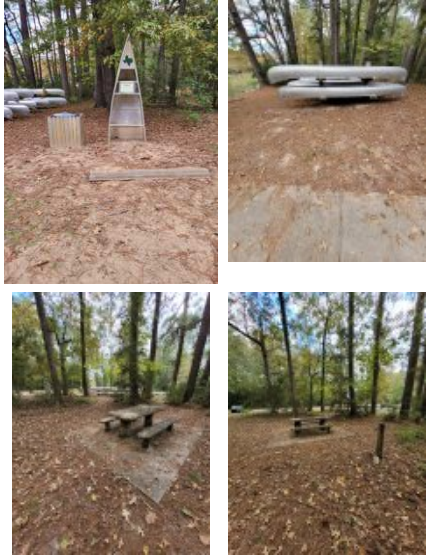
Finding Number	Area Description	Lat/Long	Finding	As Built	Recommendation	Citation	Photos	Figure																		
121	Hen House Ridge Unit (Sites 300-327): Hen House Ridge Unit (Sites 300-327) Canoe/Kayak Launch	[30.8436625 , -94.166759 6]	At least one accessible route shall connect accessible buildings, accessible facilities, accessible elements, and accessible spaces that are on the same site. For areas of sport activity, an accessible route is required to connect to the boundary of each area of sport activity. The size of an area of sport activity includes only the space needed to play. Where multiple sports fields or courts are provided, an accessible route is required to each field or area of sport activity.	Lacks accessible route to canoe rack, trash can, picnic table, water spout, and Canoe/Kayak rental info	Provide an accessible route to each element within the site.	2010 ADAS Section: 206.2.2, 206.2

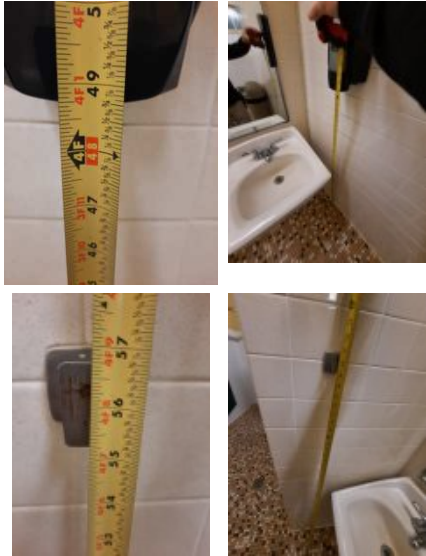
191	Hen House Ridge Unit (Shelter Sites 400-420) : Hen House Ridge Unit (Shelter Sites 400-420) Men's Restroom Bldg 4	[30.8473096 , -94.170990 9]	There are not enough accessible toilet compartments. The room contains 2 toilet compartments. A minimum of 1 must be wheelchair accessible .	Lacks wheelchair accessible stall - ambulatory only	Create a wheelchair accessible stall with grab bars and fixtures mounted in correct locations and at correct heights.	2015 ABAAS Section: F213.3.1 2012 TAS Section: 213.3.1 2010 ADAS Section: 213.3.1

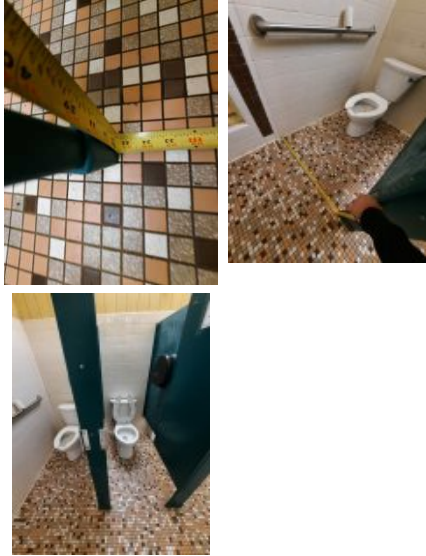
Finding Number	Area Description	Lat/Long	Finding	As Built	Recommendation	Citation	Photos	Figure
192	Hen House Ridge Unit (Shelter Sites 400-420) : Hen House Ridge Unit (Shelter Sites 400-420) Men's Restroom Bldg 4	[30.847305, -94.1710017]	The stall door fails to comply with all of the door requirements. The stall door must be a minimum of 32" wide and have compliant hardware on both sides. The stall door must be self-closing.	Stall lacks self-closing door and lacks compliant hardware	Adjust stall door to be self-closing Replace stall hardware with hardware operable without a tight pinch or grasp on both sides of the stall door	2015 ABAAS Section: 404.2.3, 404.2.7, 604.8.2.2 2012 TAS Section: 404.2.3, 404.2.7, 604.8.2.2 2010 ADAS Section: 404.2.3, 404.2.7, 604.8.2.2

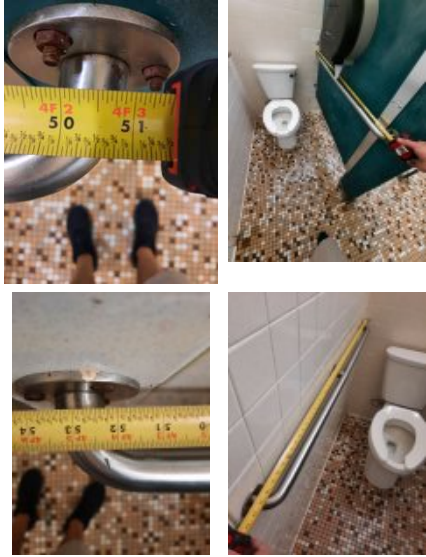
260	Hen House Ridge Unit Day Use Area: Hen House Ridge Unit Day Use Area Men's Restroom (near site 128)	[30.8432336 , -94.173311]	The grab bar height and/or spacing fails. Grab bars must be mounted between 33" and 36" to the top of the gripping surface. There must be 1.5" of clearance between the grab bar and the wall. There must be a minimum of 1.5" of clearance below and minimum 12" above the grab bar to any dispenser or other obstruction.	TP is 3.5" above grab bar and too close to toilet	Remount toilet paper dispenser max 7" to 9" from front of toilet, 15" to 48" aff and min 12" above or 1.5" below grab bar.	2015 ABAAS Section: 609.3, 609.4 2012 TAS Section: 609.4, 609.3 2010 ADAS Section: 609.3, 609.4

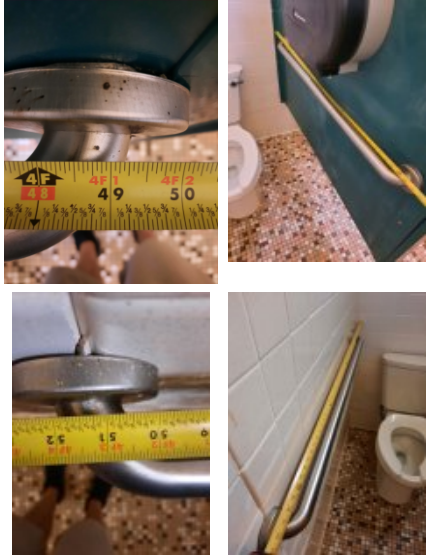
Finding Number	Area Description	Lat/Long	Finding	As Built	Recommendation	Citation	Photos	Figure
306	Walnut Ridge Unit (Sites 549-574): Walnut Ridge Unit (Sites 549-574) Men's Restroom Bldg 5B	[30.8600616 , -94.1759074]	The grab bar height and/or spacing fails. Grab bars must be mounted between 33" and 36" to the top of the gripping surface. There must be 1.5" of clearance between the grab bar and the wall. There must be a minimum of 1.5" of clearance below and minimum 12" above the grab bar to any dispenser or other obstruction.	Gripping surface of grab bars are 36.25" aff and 36.5" aff, and TP 4.5" above bar and too close to toilet	Remount grab bars in accessible stall to 33" to 36" aff. Remount toilet paper dispenser max 7" to 9" from front of toilet, 15" to 48" aff and min 12" above or 1.5" below grab bar	2015 ABAAS Section: 609.3, 609.4 2012 TAS Section: 609.4, 609.3 2010 ADAS Section: 609.3, 609.4

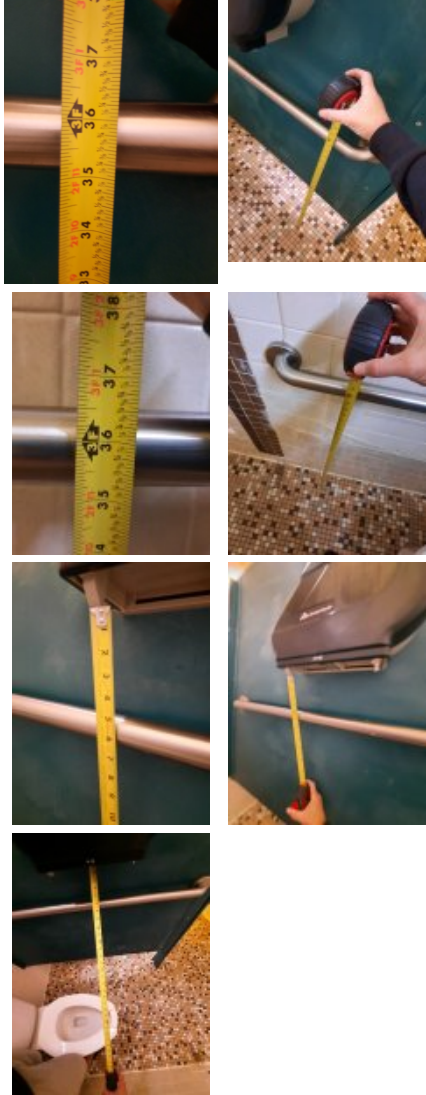
Finding Number	Area Description	Lat/Long	Finding	As Built	Recommendation	Citation	Photos	Figure
307	Walnut Ridge Unit (Sites 549-574): Walnut Ridge Unit (Sites 549-574) Men's Restroom Bldg 5B	[30.8600662, -94.1759235]	The route of travel at this location does not provide a minimum width of 36 inches. The clear width shall be permitted to be reduced to 32 inches minimum for a length of 24 inches maximum provided that reduced width segments are separated by segments that are 48 inches long minimum and 36 inches wide minimum.	Lacks 36" wide route of travel due to 32.5" between garbage can and wall	Relocate obstacles such as garbage cans to create AR through indicated rooms	2015 ABAAS Section: 403.5.1 2012 TAS Section: 403.5.1 2010 ADAS Section: 403.5.1		
308	Walnut Ridge Unit (Sites 549-574): Walnut Ridge Unit (Sites 549-574) Men's Restroom Bldg 5B	[30.8600754, -94.1759262]	The bathroom stall support bar extends down too close to the route of travel. Any obstruction that overhangs a route of travel must be a minimum of 80 inches above the walking surface as measured from the bottom of the obstruction.	Lacks 80" overhead clearance due to the bathroom stall support bar height at 79" aff	Raise the bathroom stall support bar to min 80".	2015 ABAAS Section: 307.4 2012 TAS Section: 307.4 2010 ADAS Section: 307.4

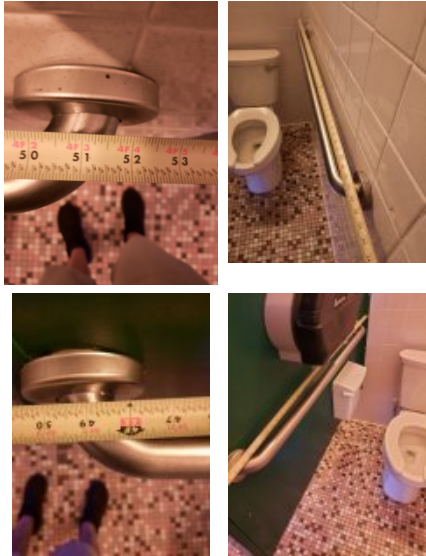
Finding Number	Area Description	Lat/Long	Finding	As Built	Recommendation	Citation	Photos	Figure
323	Walnut Ridge Unit (Sites 549-574): Walnut Ridge Unit (Sites 549-574) Women's Restroom Bldg 5B	[30.8600731 , -94.175915 5]	The grab bar height and/or spacing fails. Grab bars must be mounted between 33" and 36" to the top of the gripping surface. There must be 1.5" of clearance between the grab bar and the wall. There must be a minimum of 1.5" of clearance below and minimum 12" above the grab bar to any dispenser or other obstruction.	Gripping surface of grab bars are 36.5" aff, and TP 4.5" above bar and too close to toilet	Remount grab bars in accessible stall to 33" to 36" aff Remount toilet paper dispenser max 7" to 9" from front of toilet, 15" to 48" aff and min 12" above or 1.5" below grab bar	2015 ABAAS Section: 609.3, 609.4 2012 TAS Section: 609.4, 609.3 2010 ADAS Section: 609.3, 609.4
