# Access Audit Site Report

**McKinney Falls State Park**  
**5808 McKinney Falls Pkwy**  
**Austin, TX 78744**  
**Accessibility Evaluation**  
**Inspection Date: 11/11/2021**  
**Inspectors: Tanya Scheibe**

Prepared By  
**WT Group**

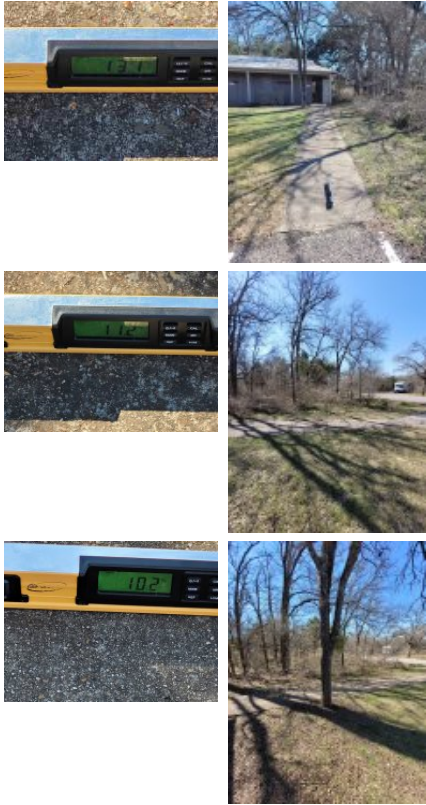
Finding Number	Area Description	Lat/Long	Finding	As Built	Recommendation	Citation	Photos	Figure
4	Exterior: Exterior Accessible Route	[30.1801164 , -97.72468 56], [30.1801959 , -97.724792 2]	The running slope of walking surfaces shall not be steeper than 1:20.	13.1% slope at bottom of path to Big Oak Restroom (RR) building (no showers), 11.2% slope half way up, 10.2% slope at top	Correct running slope along the AR to max 5%	2015 ABAAS Section: 403.3  2012 TAS Section: 403.3  2010 ADAS Section: 403.3

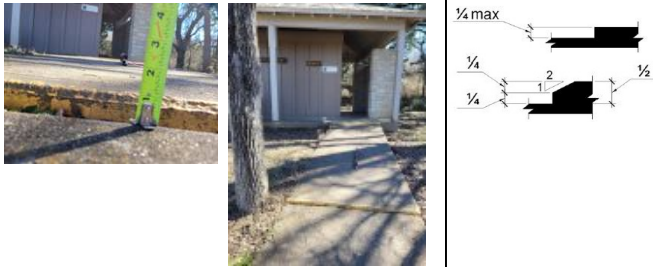
5	Exterior: Exterior Accessible Route	[30.1801437 , -97.724718 4]	The walkway contains abrupt vertical edges and/or variations over a 1/4 inch. 1/4 inch is the maximum vertical rise. Changes in level between 1/4 inch and 1/2 inch must be beveled at 1:2 or less. Changes in level greater than 1/2 inch must be by way of a ramp.	Big Oak RR Building (non shower) - 1" CIL at tree	Repair, bevel or ramp CIL along AR	2012 TAS Section: 303.2, 303.3  2010 ADAS Section: 303.2, 303.3

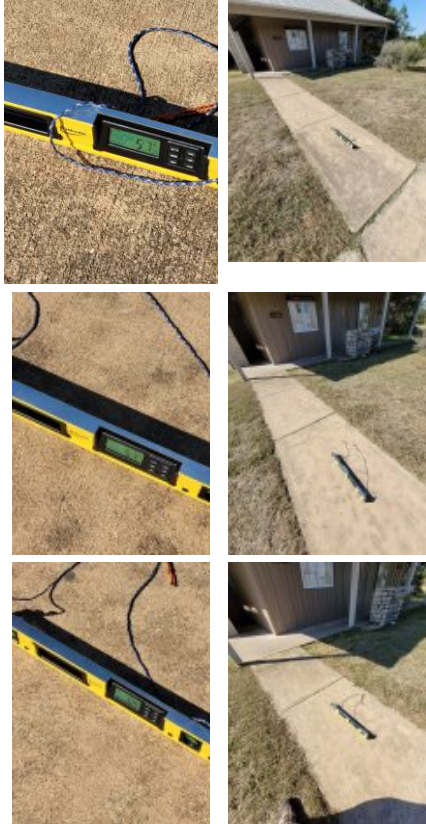
Finding Number	Area Description	Lat/Long	Finding	As Built	Recommendation	Citation	Photos	Figure
18	Exterior: Cabin Area Restroom Parking	[30.178333, -97.728913 7], [30.178378, -97.728875 5]	The running slope of walking surfaces shall not be steeper than 1:20.	5.7% slope and 5.8% slope along route near RR	Correct running slope along the AR to max 5%	2015 ABAAS Section: 403.3  2012 TAS Section: 403.3  2010 ADAS Section: 403.3

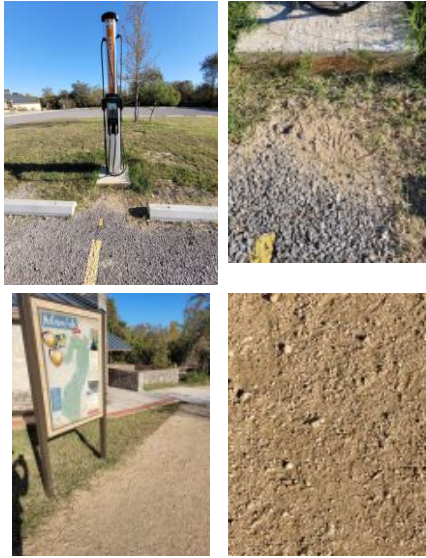
58	Exterior: Smith Visitor Center Parking	[30.1832762 , -97.724812 6]	At least one accessible route shall connect accessible buildings, accessible facilities, accessible elements, and accessible spaces that are on the same site. For areas of sport activity, an accessible route is required to connect to the boundary of each area of sport activity. The size of an area of sport activity includes only the space needed to play. Where multiple sports fields or courts are provided, an accessible route is required to each field or area of sport activity.	Lacks accessible route to Chimney Swift Tower	Provide an accessible route to each element within the site.	2010 ADAS Section: 206.2.2, 206.2

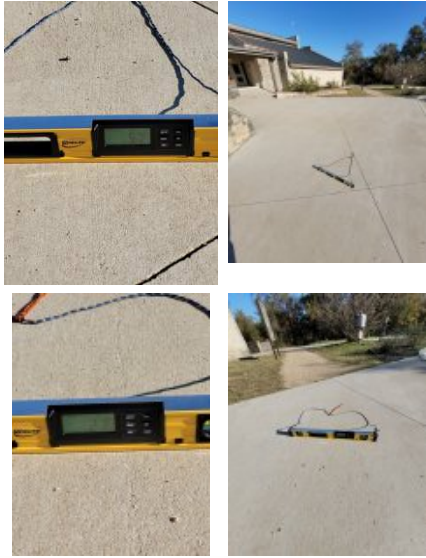
60	Exterior: Smith Visitor Center Parking	[30.183923, -97.7248427]	There is a gap spaced greater than a 1/2 inch. Openings in floor or ground surfaces shall not allow passage of a sphere more than 1/2 inch diameter. Elongated openings shall be placed so that the long dimension is perpendicular to the dominant direction of travel.	1 inch gap along route	Correct or fill gaps to be max .5"	2015 ABAAS Section: 302.3 2012 TAS Section: 302.3 2010 ADAS Section: 302.3

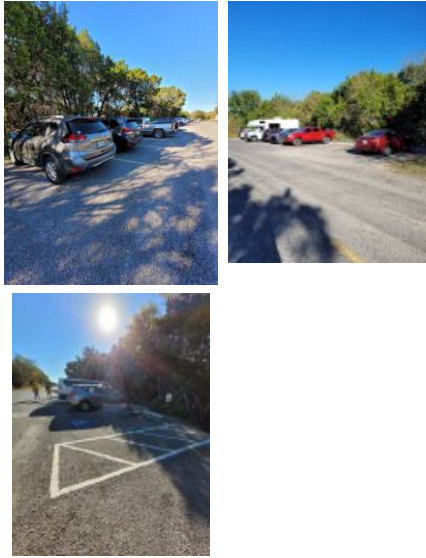
73	Exterior: Homestead Trail Trailhead Parking	[30.1859627 , -97.721558 8]	The vehicle route to the accessible parking contains vertical clearances less than 98 inches. A minimum vertical clearance of 98 inches must be provided at accessible parking spaces and along at least one vehicle access route to such spaces from site entrances and exits.	Branches at 70 inches at parking space	Raise obstructions over van stalls to provide 98" vertical clearance	2015 ABAAS Section: 502.5  2012 TAS Section: 502.5  2010 ADAS Section: 502.5

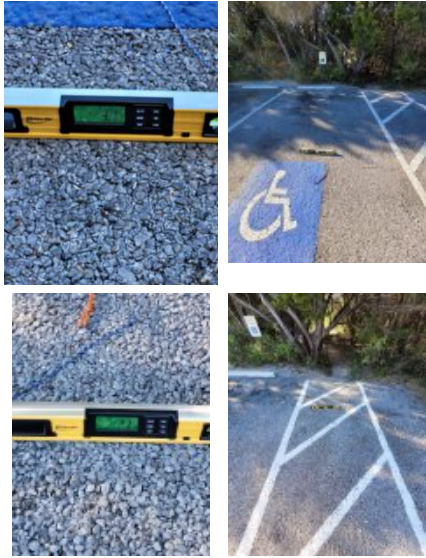
75	Exterior: Homestead Trail Trailhead Parking	[30.1859671 , -97.721567 5]	The parking sign is mounted too low. Parking space identification signs shall include the International Symbol of Accessibility complying with. Signs identifying van parking spaces shall contain the designation "van accessible." Signs shall be 60 inches minimum above the finish floor or ground surface measured to the bottom of the sign.	36 inches to bottom of sign	Raise existing accessible parking signs so lowest end of bottom sign is min 60" AGL	2015 ABAAS Section: 502.6  2012 TAS Section: 502.6  2010 ADAS Section: 502.6

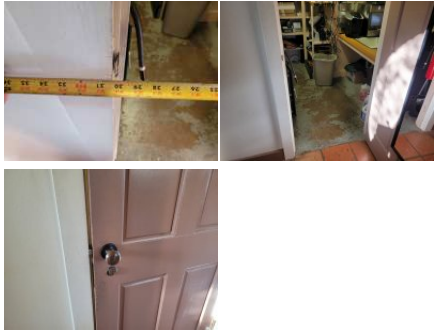
102	Headquarters: Headquarters Building	[30.1807944, -97.7220134]	Spaces and elements within employee work areas shall only be required to comply with 206.2.8, 207.1, and 215.3 and shall be designed and constructed so that individuals with disabilities can approach, enter, and exit the employee work area. Employee work areas, or portions of employee work areas, other than raised courtroom stations, that are less than 300 square feet (28 m2) and elevated 7 inches (180 mm) or more above the finish floor or ground where the elevation is essential to the function of the space shall not be required to comply with these requirements or to be on an accessible route.	Mechanical- 28" wide, 5.7% slope, equipment push side; pipe chase- 22" wide, storage push side	For employee spaces, relocate storage, furniture, and other obstacles at doorways to provide approach, enter and exit at the employee space. Correct or repair floor slope at door CFS to max 2.08% For all doors along the public circulation route, replace doors with doors having 80" overhead clearance and 32" clear width For all doors along the public circulation route, replace hardware with lever hardware where indicated	2015 ABAAS Section: F203.9 2012 TAS Section: 203.9 2010 ADAS Section: 203.9

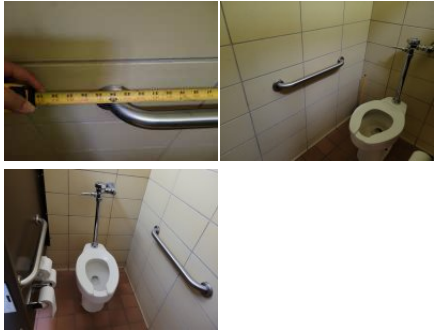
128	Headquarters: Headquarters Staff Restrooms	[30.18076, -97.722]	The toilet paper is not installed within the compliant range in front of the toilet. Toilet paper dispensers shall be 7 inches minimum and 9 inches maximum in front of the water closet measured to the centerline of the dispenser. The outlet of the dispenser shall be 15 inches minimum and 48 inches maximum above the finish floor and shall not be located behind grab bars. Dispensers shall not be of a type that controls delivery or that does not allow continuous paper flow. There shall be a clearance of 1 1/2 inches minimum below the grab bar.	Toilet paper too close	Remount toilet paper dispenser max 7" to 9" from front of toilet, 15" to 48" AFF and min 12" above or 1.5" below grab bar	2015 ABAAS Section: 604.7  2012 TAS Section: 604.7  2010 ADAS Section: 604.7

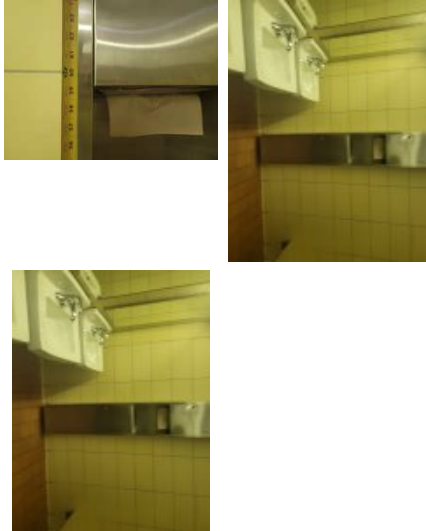
158	Cabin Area: Cabin Area Women's Restroom	[30.1783534 , -97.72898]	There are not enough accessible toilet compartments. The room contains toilet compartments. A minimum of 1 must be wheelchair accessible .	Ambulatory stall only	Create a wheelchair accessible stall with grab bars and fixtures mounted in correct locations and at correct heights.	2015 ABAAS Section: F213.3.1  2012 TAS Section: 213.3.1  2010 ADAS Section: 213.3.1

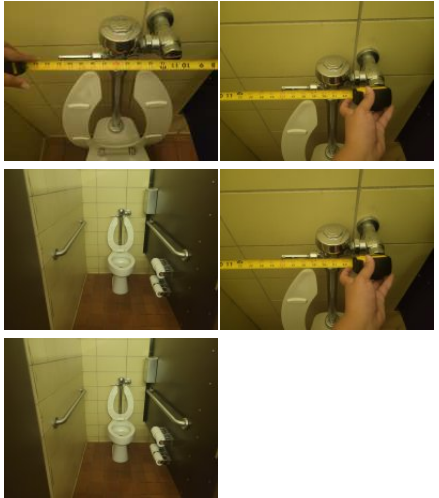
160	Cabin Area: Cabin Area Women's Restroom	[30.1783534 , -97.728972]	The side grab bars are not in the correct location. Grab bars on the side wall must be installed so that the end closest to the rear wall is maximum 12" from the rear wall. The end furthest from the rear wall must be mounted minimum 54" from the rear wall.	Grab bars extend 49.5"	Remount side grab bar to max 12" from the rear wall at the close end and min 54" on the far end, and 33" to 36" AFF	2015 ABAAS Section: 604.5.1  2012 TAS Section: 604.5.1  2010 ADAS Section: 604.5.1

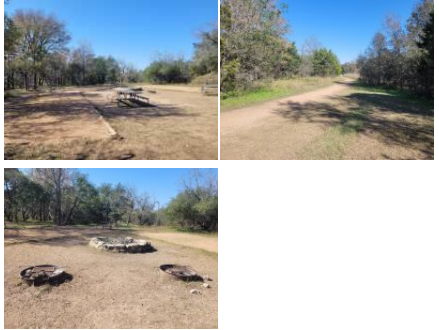
181	Youth Group Camping Area: Youth Camping	[30.1774908 , -97.729195 7]	There are no accessible parking stalls. Each lot where parking is provided for the public as clients, guests or employees, shall provide accessible parking and shall be located on the shortest accessible route of travel from adjacent parking to an accessible entrance. There are a total of (12) parking stalls in the parking lot that could be reasonably associated with this facility. There should be a minimum of (1) accessible stalls with a minimum of (1) being designed as van accessible.	Gravel lot, no accessible stalls	Create one or more 8' accessible parking stalls, with one 5' adjacent access aisle, with proper signage and striping based on the total number of stalls	2015 ABAAS Section: F208.2  2012 TAS Section: 208.2  2010 ADAS Section: 208.2

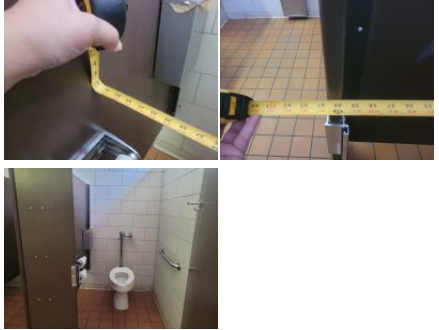
231	Grapevine Loop Camping Area: Grapevine Loop Camping Women's Restroom	[30.1770611 , -97.726231 2]	The toilet is not located within the range to the side wall or partition. The centerline of the toilet shall be 17 inches minimum and 19 inches maximum side wall or partition in the ambulatory accessible toilet compartment.	Toilet reach range is too far both sides	Remount toilet to 17" to 19" from the side wall to center line in ambulatory stalls	2015 ABAAS Section: 604.9.1  2012 TAS Section: 604.9.1  2010 ADAS Section: 604.9.1

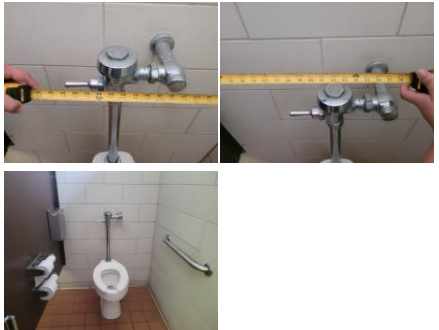
232	Grapevine Loop Camping Area: Grapevine Loop Camping Women's Restroom	[30.177066 , -97.726232 5]	The stall door fails to comply with some of the door requirements. The stall door must be a minimum of 32" wide and must be self-closing.	Stall door 31", not self-closing	Widen stall doors to 32" when opened to 90 degrees Adjust stall door to be self-closing	2015 ABAAS Section: 404.2.3, 404.2.7, 604.8.2.2  2012 TAS Section: 404.2.3, 404.2.7, 604.8.2.2  2010 ADAS Section: 404.2.3, 404.2.7, 604.8.2.2

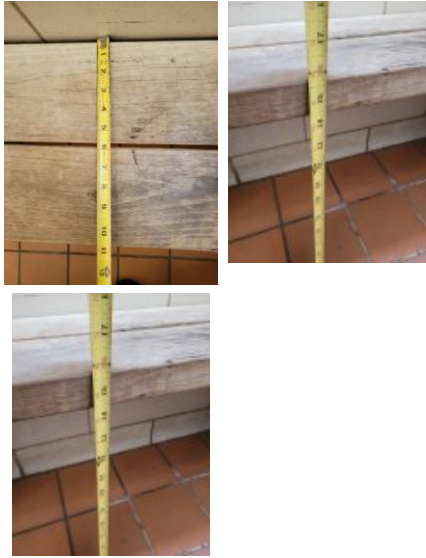
239	Grapevine Loop Camping Area: Grapevine Loop Camping Area Men's Shower	[30.1770784 , -97.7262218]	There are no accessible bathing or shower facilities. Where facilities for bathing are provided for the public, clients or employees, including showers or bathtubs, at least one shower or bathtub and support facilities such as lockers, and not less than 1 percent of all facilities, shall be accessible.	Shower lacks accessible features	Create an accessible shower in locker/bathing room	2015 ABAAS Section: F213.3.6  2012 TAS Section: 213.3.6  2010 ADAS Section: 213.3.6

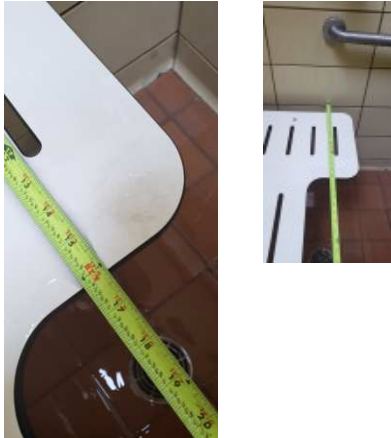
244	Little Oak Camping Area: Little Oak Camping Area Men's Restroom	[30.1787794 , -97.723971 4]	Where a seat is provided in a standard roll-in shower compartment, it shall be a folding type, shall be installed on the side wall adjacent to the controls, and shall extend from the back wall to a point within 3 inches (75 mm) of the compartment entry. Where a seat is provided in an alternate roll-in type shower compartment, it shall be a folding type, shall be installed on the front wall opposite the back wall, and shall extend from the adjacent side wall to a point within 3 inches (75 mm) of the compartment entry. In transfer-type showers, the seat shall extend from the back wall to a point within 3 inches (75 mm) of the compartment entry. The top of the seat shall be 17 inches (430 mm) minimum and 19 inches (485 mm) maximum above the bathroom finish floor. Seats shall comply with 610.3.1 or 610.3.2.	Seat 11" from edge	Provide the correct seat based on shower type.	2015 ABAAS Section: 610.3  2012 TAS Section: 610.3  2010 ADAS Section: 610.3

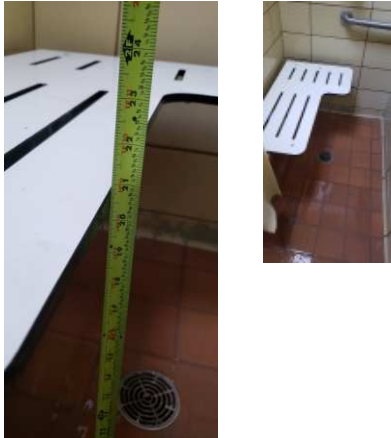
246	Little Oak Camping Area: Little Oak Camping Area Men's Restroom	[30.1787917 , -97.723973 4]	The operable part is not accessible because it requires tight grasping, pinching or twisting of the wrist.	Knob on one shower, other shower less than 5# push	Replace operable part with one usable without a tight pinch or grasp	2015 ABAAS Section: 309.4  2012 TAS Section: 309.4  2010 ADAS Section: 309.4

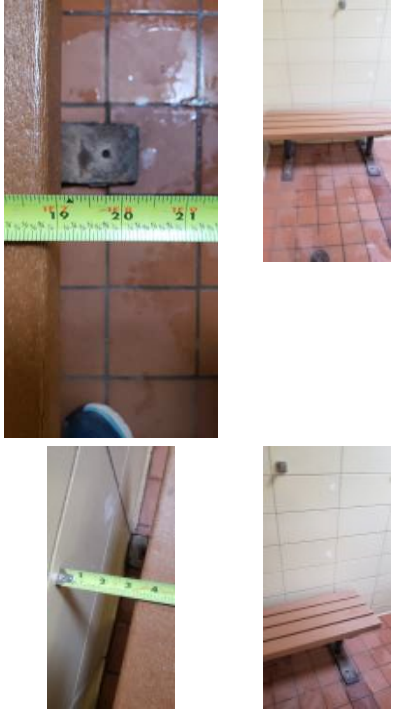
250	Little Oak Camping Area: Little Oak Camping Area Men's Restroom	[30.1787663 , -97.723952 6]	Minimum maneuvering clearances at doors and gates shall comply with 404.2.4. Maneuvering clearances shall extend the full width of the doorway and the required latch side or hinge side clearance.	Lacks clearance due to wall	Provide required maneuvering clearance around pull side of door	2015 ABAAS Section: 404.2.4.1 , 404.2.4.4  2012 TAS Section: 404.2.4.4, 404.2.4.1  2010 ADAS Section: 404.2.4.4, 404.2.4.1

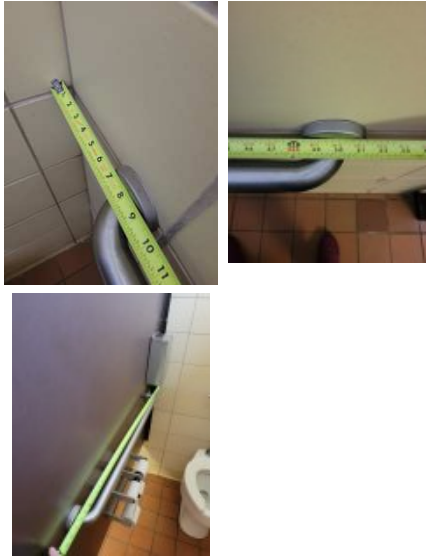
261	Little Oak Camping Area: Little Oak Camping Area Women's Restroom	[30.1787749 , -97.723966 1]	The grab bar height and/or spacing fails. Grab bars must be mounted between 33" and 36" to the top of the gripping surface. There must be 1.5" of clearance between the grab bar and the wall. There must be a minimum of 1.5" of clearance below and minimum 12" above the grab bar to any dispenser or other obstruction.	4.5" overhead spacing to grab bar on partition wall	Remount napkin disposal, 15" to 48" above the finished floor (AFF) and min 12" above or 1.5" below grab bar.	2015 ABAAS Section: 609.3, 609.4  2012 TAS Section: 609.4, 609.3  2010 ADAS Section: 609.3, 609.4

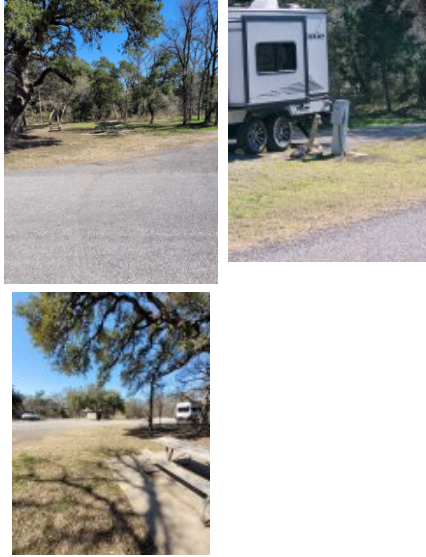
267	Little Oak Camping Area: Little Oak Campsites	[30.1784646 , -97.723679 1]	Picnic tables shall provide at least one wheelchair space for each 24 linear feet (7320 mm) of usable table surface perimeter. Wheelchair spaces shall be 30 inches (760 mm) minimum by 48 inches (1220 mm) minimum. Wheelchair spaces shall be positioned for a forward approach to the table and provide knee and toe clearance complying with 306 under the table	Picnic table lacks toe clearance	Replace picnic table with one of an accessible design as a smart practice	2015 ABAAS Section: 1011.4.2

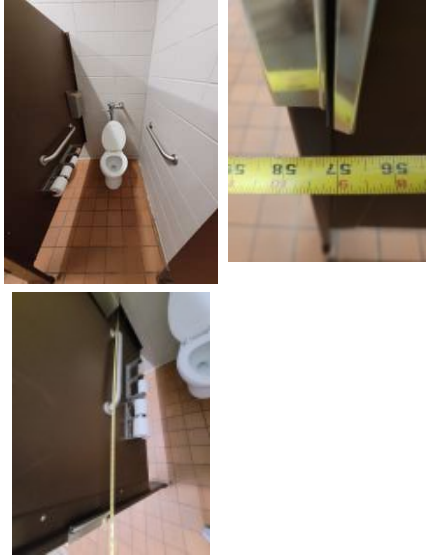
411	Picnic Area: Picnic Area Women's Restroom	[30.1829625 , -97.723367 9]	The stall door fails to comply with some of the door requirements. The stall door must be self-closing.	Lacks self-closing door	Adjust stall door to be self-closing	2015 ABAAS Section: 404.2.3, 404.2.7, 604.8.2.2  2012 TAS Section: 404.2.3, 404.2.7, 604.8.2.2  2010 ADAS Section: 404.2.3, 404.2.7, 604.8.2.2
