Access Audit Site Report

Meridian State Park

Accessibility Evaluation

Inspection Date: 01/19/2022

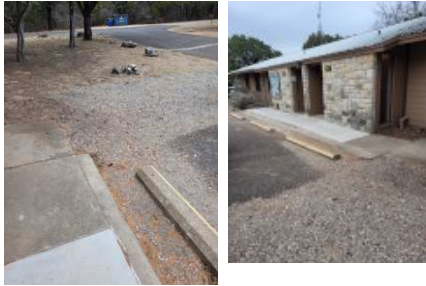
Finding Number	Area Description	Lat/Long	Finding	As Built	Recommendation	Citation	Photos	Figure
4	Exterior: Exterior Accessible Route	[31.8912766 , -97.701503 4]	There is no accessible route to the restroom or dining hall. At least one accessible route shall connect accessible buildings, accessible facilities, accessible elements, and accessible spaces that are on the same site.	Lacks accessible route to restroom or dining hall due to non accessible surface at curb ramp	Create an accessible route with crushed stone or other outdoor material from parking or walkway to restroom or dining hall.	2015 ABAAS Section: F206.2.2 2012 TAS Section: 206.2.2 2010 ADAS Section: 206.2.2

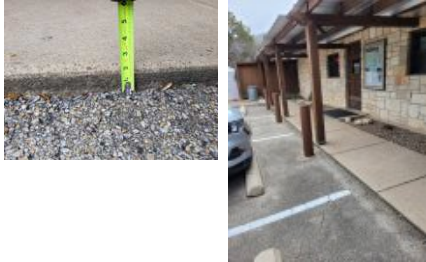
6	Exterior: Exterior Accessible Route	[31.8908166 , -97.697576 7]	The walkway contains abrupt vertical edges and/or variations over a 1/4 inch. 1/4 inch is the maximum vertical rise. Changes in level between 1/4 inch and 1/2 inch must be beveled at 1:2 or less. Changes in level greater than 1/2 inch must be by way of a ramp.	2" change in elevation on accessible route to Headquarters	Repair, bevel or ramp CIL along AR	2012 TAS Section: 303.2, 303.3 2010 ADAS Section: 303.2, 303.3

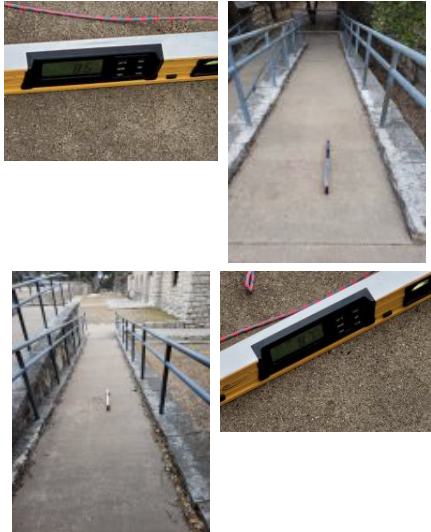
Finding Number	Area Description	Lat/Long	Finding	As Built	Recommendation	Citation	Photos	Figure
7	Exterior: Exterior Accessible Route	[31.8889036 , -97.699765 4]	The ramps slope exceeds the maximum running slope (direction of travel) allowable of 8.33%. Ramps should have the least possible slope but in no case more than 8.3% (1:12).	Ramp - 8.6% at top and second run middle 8.7%	Correct slope of ramp to max 8.33%	2015 ABAAS Section: 405.2 2012 TAS Section: 405.2 2010 ADAS Section: 405.2

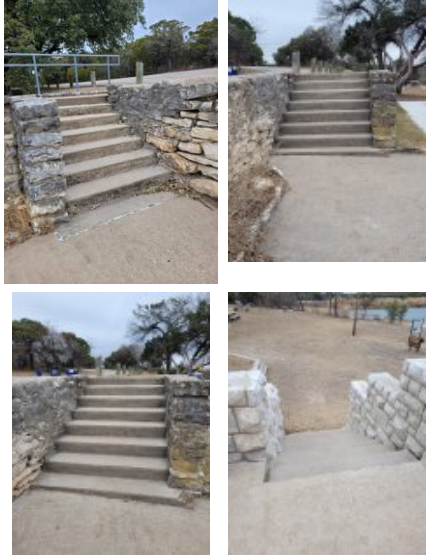
Finding Number	Area Description	Lat/Long	Finding	As Built	Recommendation	Citation	Photos	Figure
9	Exterior: Exterior Accessible Route	[31.8888694 , -97.6998297]	Stairways must have handrails on both sides. Handrails and their extensions must be between 34 inches and 38 inches above the stair nosing or ground. The top handrails shall extend a minimum of 12 inches beyond the top nosing and shall be parallel with the floor or ground surface. At the bottom of a stair flight, handrails shall extend at the slope of the stair flight for a horizontal distance at least equal to one tread depth beyond the last riser nosing. Extension shall return to a wall, guard, or the landing surface, or shall be continuous to the handrail of an adjacent stair flight. The orientation of at least one handrail, including the extension, shall be in the direction of the run of the stair and perpendicular to the direction of the stair nosing. Handrail gripping surfaces with a circular cross section shall have an outside diameter of 1-1/4 inches minimum and 2 inches maximum. Handrail gripping surfaces with a non-circular cross section shall have a perimeter dimension of 4 inches minimum and 6 1/4 inches maximum, and a cross-section dimension of 2-1/4 inches maximum. The hand grip portion of handrails shall have a smooth surface with no sharp corners. Gripping surfaces (top or sides) shall be uninterrupted by newel posts, other construction elements or obstructions. Any wall or other surface adjacent to the handrail shall be free of sharp or abrasive elements. Handrails projecting from a wall shall have a space of 1-1/2 inches minimum between the wall and the handrail.	stairs at lakeside day use by ramp and building, lack handrails. 3 sets of stairs total, around building lack handrails	Install handrails on both sides of stairway, mounted 34" to 38" aff with top and bottom extensions and having a 1.25" – 2" in diameter, or a non-circular grip that has a perimeter dimension of 4"- 6.25" max with a min gap of 1.5" between handrail and wall	2015 ABAAS Section: 505.2 2012 TAS Section: 505.2 2010 ADAS Section: 505.2

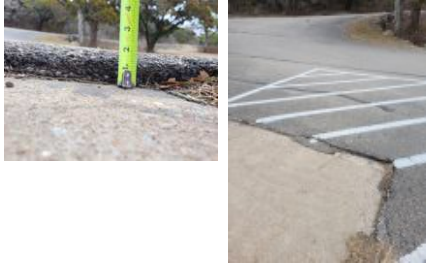
11	Exterior: Exterior Accessible Route	[31.8887578 , -97.6997949]	The walkway contains abrupt vertical edges and/or variations over a 1/4 inch. 1/4 inch is the maximum vertical rise. Changes in level between 1/4 inch and 1/2 inch must be beveled at 1:2 or less. Changes in level greater than 1/2 inch must be by way of a ramp.	2" change in elevation at access aisle to steps at lakeside building	Repair, bevel or ramp CIL along AR	2012 TAS Section: 303.2, 303.3 2010 ADAS Section: 303.2, 303.3

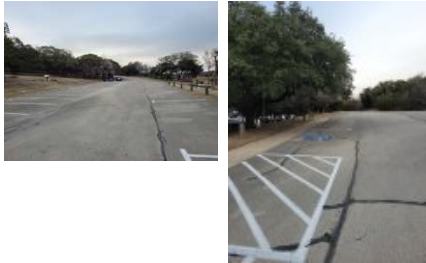
Finding Number	Area Description	Lat/Long	Finding	As Built	Recommendation	Citation	Photos	Figure
16	Exterior: Parking	[31.8888307 , -97.6994864]	There are no or not enough accessible parking stalls. Each lot where parking is provided for the public as clients, guests or employees, shall provide accessible parking and shall be located on the shortest accessible route of travel from adjacent parking to an accessible entrance. There are a total of (XX) parking stalls in the parking lot that could be reasonably associated with this facility. There should be a minimum of (XX) accessible stalls with a minimum of (XX) being designed as van accessible.	28 standard parking spaces, 1 accessible parking space	Create one or more 8' accessible parking stalls, with one 5' adjacent access aisle, with proper signage and striping based on the total number of stalls.	2015 ABAAS Section: F208.2 2012 TAS Section: 208.2 2010 ADAS Section: 208.2

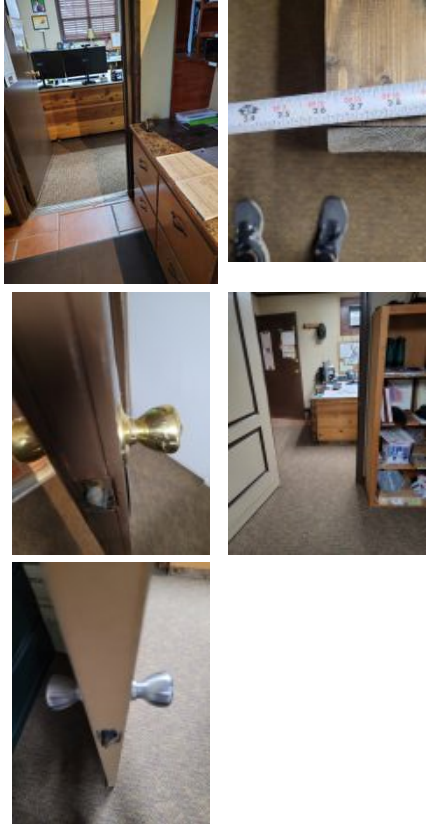
Finding Number	Area Description	Lat/Long	Finding	As Built	Recommendation	Citation	Photos	Figure
23	Headquarters Building: HQ - Employee Spaces	[31.8907673, -97.6975476]	Minimum maneuvering clearances at doors and gates shall comply with 404.2.4. Maneuvering clearances shall extend the full width of the doorway and the required latch side or hinge side clearance. Hand-activated door opening hardware, handles, pulls, latches, locks, and other operating devices on accessible doors shall have a shape that is easy to grasp with one hand and does not require tight grasping, tight pinching or twisting of the wrist to operate. Hardware shall be 34 inches minimum and 48 inches maximum above the finish floor or ground.	1st door into office - push side maneuvering clearance reduced by work counter, circulation path reduced to 26" by furniture, knob hardware 2 of 2 doors. Superintendent office pull side maneuvering clearance reduced by book shelf	For all doors along the public circulation route, provide required maneuvering clearance on push and pull side of doors For all doors along the public circulation route, replace hardware with lever hardware or hardware operable without a tight pinch or grasp	2010 ADAS Section: 404.2.3, 404.2.7, 404.2.4, 404.2.11, 404.2.11 Exception

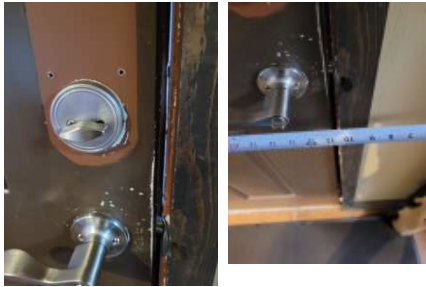
24	Headquarters Building: HQ - Employee Spaces	[31.89083, -97.69749]	Minimum maneuvering clearances at doors and gates shall comply with 404.2.4. Maneuvering clearances shall extend the full width of the doorway and the required latch side or hinge side clearance. Maneuvering clearances shall have a max slope of 2.08%. The threshold at a doorway shall be no higher than 1/2 inch. Changes in level between 1/4 inch and 1/2 inch must be beveled at 1:2 or less. 1/4 inch is the maximum vertical rise. Hand-activated door opening hardware, handles, pulls, latches, locks, and other operating devices on accessible doors shall have a shape that is	Rear employee entrance - push side maneuvering clearance reduced by rock, 1" change in elevation at threshold, 0.75" at push side entry, pinch required for lock hardware, 12.2% slope on push side landing, decorative column in maneuvering clearance on pull side	For all doors along the public circulation route, provide required maneuvering clearance on push and pull side of doors. For all doors along the public circulation route, correct slope in door clearance to max 2.08%. For all doors along the public circulation route, provide beveled threshold. For all doors along the public circulation route, replace hardware with lever hardware or hardware operable without a tight pinch or grasp.	2010 ADAS Section: 404.2.3, 404.2.7, 404.2.4, 404.2.11, 404.2.11 Exception

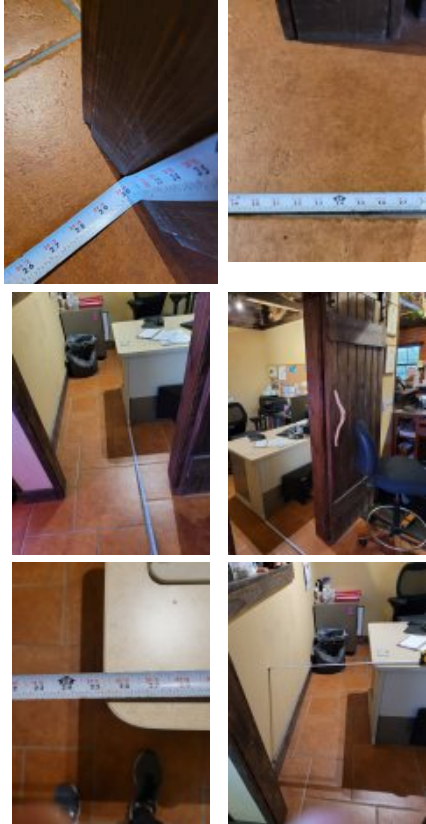
Finding Number	Area Description	Lat/Long	Finding	As Built	Recommendation	Citation	Photos	Figure
25	Headquarters Building: HQ - Employee Spaces	[31.8907958 , -97.697546 9]	Minimum maneuvering clearances at doors and gates shall comply with 404.2.4. Maneuvering clearances shall extend the full width of the doorway and the required latch side or hinge side clearance. Door openings shall provide a clear width of 32 inches (815 mm) minimum. Clear openings of doorways with swinging doors shall be measured between the face of the door and the stop, with the door open 90 degrees. Openings more than 24 inches (610 mm) deep shall provide a clear opening of 36 inches (915 mm) minimum. There shall be no projections into the required clear opening width lower than 34 inches (865 mm) above the finish floor or ground. Projections into the clear opening width between 34 inches (865 mm) and 80 inches (2030 mm) above the finish floor or ground shall not exceed 4 inches (100 mm).	First office at reception - 24" depth to desk, door width 30" sliding barn door, circulation path reduced by desk to 25.25"	For all doors along the public circulation route, provide required maneuvering clearance on push and pull side of doors For all doors along the public circulation route, replace doors with doors having 80" overhead clearance and 32" clear width	2010 ADAS Section: 404.2.3, 404.2.7, 404.2.4, 404.2.11, 404.2.11 Exception

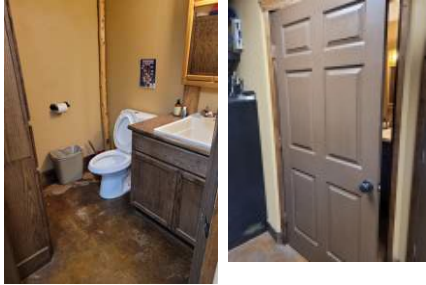
Finding Number	Area Description	Lat/Long	Finding	As Built	Recommendation	Citation	Photos	Figure
26	Headquarters Building: HQ - Employee Spaces	[31.8907892 , -97.6975606]	The restroom is not compliant. The restroom does not have the required minimum clear floor space or maneuvering clearances for the toilet. The restroom does not have the required minimum clear floor space or maneuvering clearances for the lavatory. The entry door does not contain the required minimum maneuvering spaces on the pull/push sides. The entry door encroach into the required clear floor space for fixtures. Grab bars are missing and/or incorrectly installed. Accessories, such as toilet seat covers, paper towel holders, garbage cans, hand dryers, and mirrors are either too high or without clear floor space or both.	restroom lacks accessible features	Create a compliant wheelchair accessible restroom and correct all features to be accessible if feasible.	2015 ABAAS Section: 603.1 2012 TAS Section: 603.1 2010 ADAS Section: 603.1

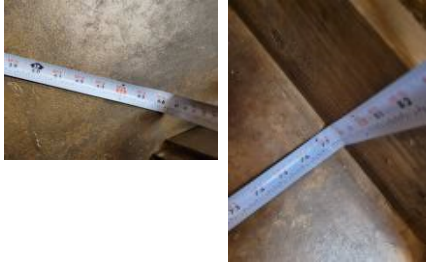
27	Headquarters Building: HQ - Employee Spaces	[31.8907665 , -97.6975445]	This restroom is not accessible. Where existing toilet rooms or bathing rooms do not comply, directional signs indicating the location of the nearest accessible toilet room or bathing room within the facility shall be provided. Signs shall include the International Symbol of Accessibility. Where existing toilet rooms or bathing rooms do comply), the accessible toilet rooms or bathing rooms shall be identified by the International Symbol of Where clustered single user toilet rooms or bathing facilities are permitted, accessible toilet rooms or bathing facilities shall be identified by the International Symbol of Accessibility unless all toilet rooms and bathing facilities are accessible.	lacks directional signage, toilet compartment - 66" d x 77" w	Restroom not accessible, acquire and mount signage directing patrons to accessible restroom	2015 ABAAS Section: F216.8 2012 TAS Section: 216.8 2010 ADAS Section: 216.8

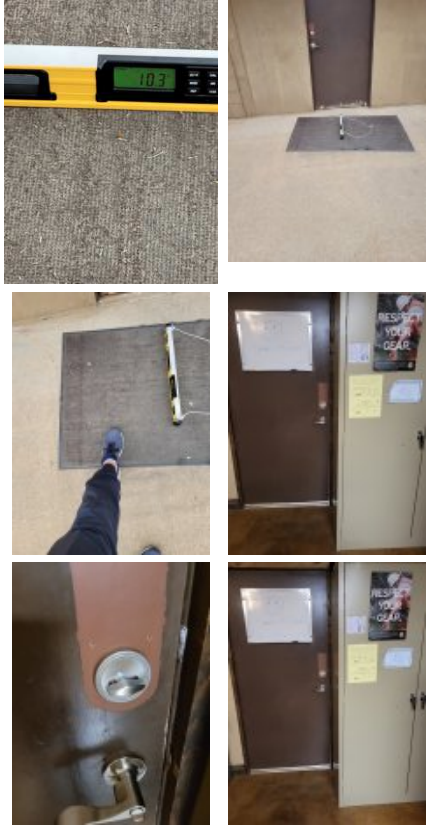
Finding Number	Area Description	Lat/Long	Finding	As Built	Recommendation	Citation	Photos	Figure
29	Headquarters Building: HQ - Employee Spaces	[31.8907915, -97.6975204]	Minimum maneuvering clearances at doors and gates shall comply with 404.2.4. Maneuvering clearances shall extend the full width of the doorway and the required latch side or hinge side clearance. Maneuvering clearances shall have a max slope of 2.08%. Hand-activated door opening hardware, handles, pulls, latches, locks, and other operating devices on accessible doors shall have a shape that is easy to grasp with one hand and does not require tight grasping, tight pinching or twisting of the wrist to operate. Hardware shall be 34 inches minimum and 48 inches maximum above the finish floor or ground.\	Exit door from break room - 10.3% slope push side approach, carpet not secured on push side, pull side lock hardware requires pinch, pull side maneuvering clearance reduced by storage	For all doors along the public circulation route, provide required maneuvering clearance on push and pull side of doors. For all doors along the public circulation route, secure rug in door clearance to prevent trip hazard. For all doors along the public circulation route, correct slope in door clearance to max 2.08%. For all doors along the public circulation route, replace hardware with lever hardware or hardware operable without a tight pinch or grasp.	2010 ADAS Section: 404.2.3, 404.2.7, 404.2.4, 404.2.11, 404.2.11 Exception

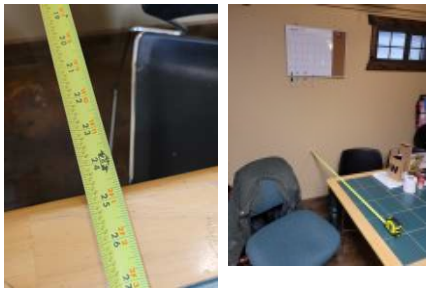
30	Headquarters Building: HQ - Employee Spaces	[31.890771, -97.6975552]	The route of travel at this location does not provide a minimum width of 36 inches. The clear width shall be permitted to be reduced to 32 inches minimum for a length of 24 inches maximum provided that reduced width segments are separated by segments that are 48 inches long minimum and 36 inches wide minimum.	Break room - minimum width reduced to 25" behind table	Widen AR to compliant 36" clear width	2015 ABAAS Section: 403.5.1 2012 TAS Section: 403.5.1 2010 ADAS Section: 403.5.1

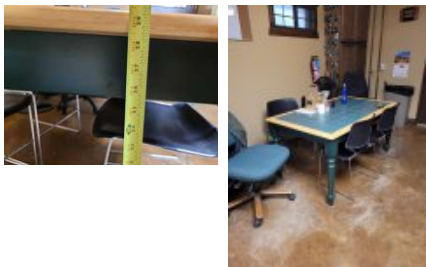
Finding Number	Area Description	Lat/Long	Finding	As Built	Recommendation	Citation	Photos	Figure
31	Headquarters Building: HQ - Employee Spaces	[31.8907847 , -97.697549 9]	The top of the work surface is not within a compliant height range. The tops of tables and counters shall be 28 inches to 34 inches from the floor or ground.	Table does not provide knee clearance - bottom 25.5" above finished floor	Provide tables and work surfaces at 28" to 34" aff with required knee and toe clearances	2015 ABAAS Section: 902.3 2012 TAS Section: 902.3 2010 ADAS Section: 902.3

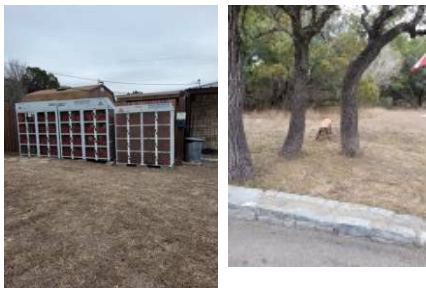
32	Headquarters Building: HQ - Public Spaces	[31.8907414 , -97.697682 6]	There is no accessible route to the wood bundles or dog waste bags. At least one accessible route shall connect accessible buildings, accessible facilities, accessible elements, and accessible spaces that are on the same site.	Lacks accessible route to wood bundles, no accessible route to dog waste bags	Create an accessible route with crushed stone or other outdoor material from parking or walkway to the wood bundles or dog waste bags.	2015 ABAAS Section: F206.2.2 2012 TAS Section: 206.2.2 2010 ADAS Section: 206.2.2

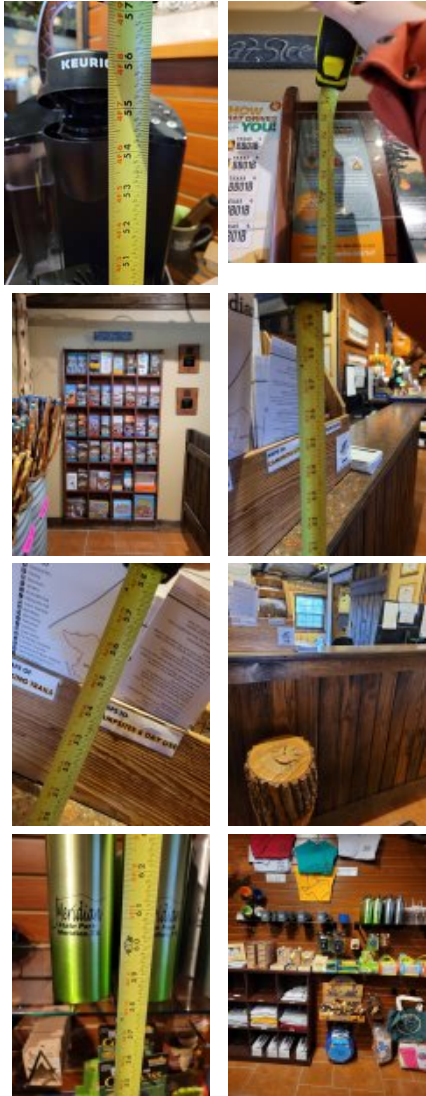
Finding Number	Area Description	Lat/Long	Finding	As Built	Recommendation	Citation	Photos	Figure
34	Headquarters Building: HQ - Public Spaces	[31.890771, -97.697571 3]	The operable part is positioned too high for either a side or front approach. Where a clear floor or ground space allows a parallel approach to an element and the side reach is unobstructed, the high side reach shall be 48 inches maximum and the low side reach shall be 15 inches minimum above the finish floor or ground. Where a forward reach is unobstructed, the high forward reach shall be 48 inches maximum and the low forward reach shall be 15 inches minimum above the finish floor or ground.	Elements out of reach range - measurements above finished floor - 55" to the keurig, 77" to park brochures, 55" to park and trail maps, 57" to merchandise	Remount operable parts to be in reach range of 15" min to 48" max	2015 ABAAS Section: 308.1 2012 TAS Section: 308.1 2010 ADAS Section: 308.1

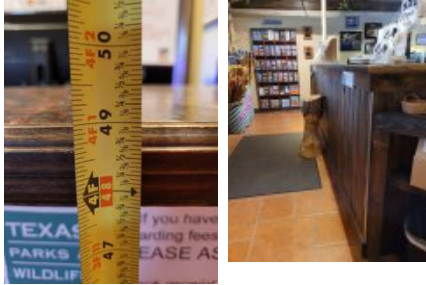
Finding Number	Area Description	Lat/Long	Finding	As Built	Recommendation	Citation	Photos	Figure
35	Headquarters Building: HQ - Public Spaces	[31.8907824 , -97.697555 2]	The transaction counter is too high. A portion of the counter surface that is 36 inches long minimum and 36 inches high maximum above the finish floor shall be provided. Knee and toe space must be provided for a forward approach. A 30 inch by 48 inch clear floor space on an accessible route must be provided for either a forward or parallel approach.	Service counter 49" above finished floor	Lower 36" wide segment of service counter to max 36" aff	2015 ABAAS Section: 904.4.2, 904.4.1 2012 TAS Section: 904.4.1, 904.4.2 2010 ADAS Section: 904.4.2, 904.4.1

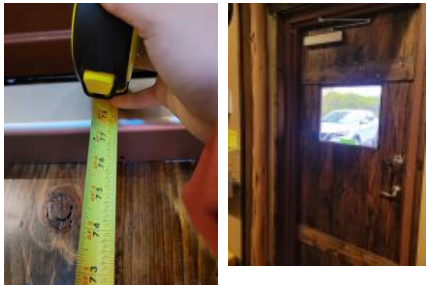
36	Headquarters Building: HQ - Public Spaces	[31.8907756 , -97.697566]	Vertical clearance shall be 80 inches (2030 mm) high minimum. Guardrails or other barriers shall be provided where the vertical clearance is less than 80 inches (2030 mm) high. The leading edge of such guardrail or barrier shall be located 27 inches (685 mm) maximum above the finish floor or ground. EXCEPTION: Door closers and door stops shall be permitted to be 78 inches (1980 mm) minimum above the finish floor or ground.	closer 77.5" above finished floor	Replace closer with one mounted min of 78" aff	2015 ABAAS Section: 307.4, 307.4 EXCEPTION 2012 TAS Section: 307.4, 307.4 Exception 2010 ADAS Section: 307.4, 307.4 Exception

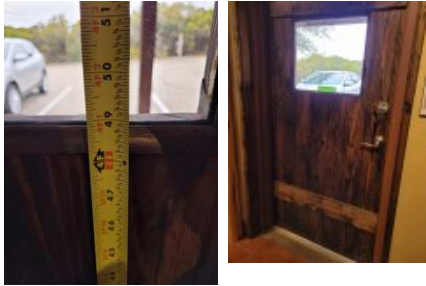
Finding Number	Area Description	Lat/Long	Finding	As Built	Recommendation	Citation	Photos	Figure
38	Headquarters Building: HQ - Public Spaces	[31.8907938 , -97.697549 9]	The vision light panels (glazing/window) are mounted too high. Doors, gates, and side lights adjacent to doors or gates, containing one or more glazing panels that permit viewing through the panels shall have the bottom of at least one glazed panel located 43 inches maximum above the finish floor.	Entry - door window 49" above finished floor	Replace doors with ones having sidelight viewing windows max 43" aff	2015 ABAAS Section: 404.2.11 2012 TAS Section: 404.2.11 2010 ADAS Section: 404.2.11

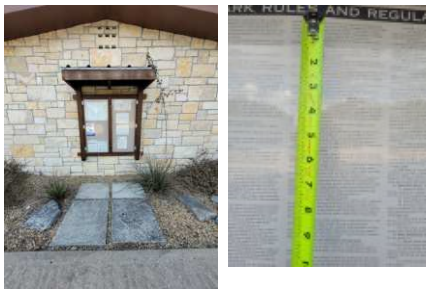
Finding Number	Area Description	Lat/Long	Finding	As Built	Recommendation	Citation	Photos	Figure
39	Park Site: Park Elements	[31.8900559 , -97.698577 1]	The operable part is not accessible because there is not adequate clear floor space for either a forward or side approach. The clear floor or ground space shall be 30 inches minimum by 48 inches minimum.	Cross timber restroom building - no CFS for display board	Provide required 30" by 48" CFS at sign board	2015 ABAAS Section: 305.3 2012 TAS Section: 305.3 2010 ADAS Section: 305.3

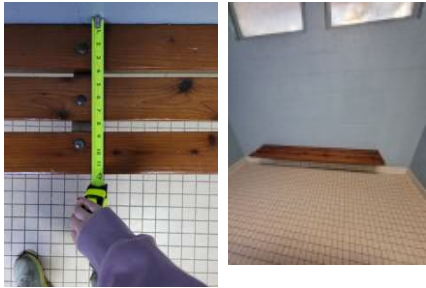
87	Crosstimbers Campground: Crosstimbers - Women's Restroom	[31.8900764 , -97.698530 2]	The bench is not deep enough or long enough or is missing. Benches shall be provided having seats that are 42 inches long minimum and 20 inches deep minimum and 24 inches deep maximum. The bench shall provide for back support or shall be affixed to a wall. Back support shall be 42 inches (1065 mm) long minimum and shall extend from a point 2 inches (51 mm) maximum above the seat surface to a point 18 inches (455 mm) minimum above the seat surface. Back support shall be 2½ inches (64 mm) maximum from the rear edge of the seat measured horizontally. The top of the bench seat surface shall be 17 inches (430 mm) minimum and 19 inches (485 mm) maximum above the finish floor or ground.	Women's restroom -12" seat depth	Replace bench in dressing area with one having a seat depth of 20" to 24" deep, 42" long, affixed to the wall or having a back and mounted 17" to 19" aff	2012 TAS Section: 903.4, 903.2, 903.3, 903.5 2010 ADAS Section: 903.4, 903.2, 903.3, 903.5

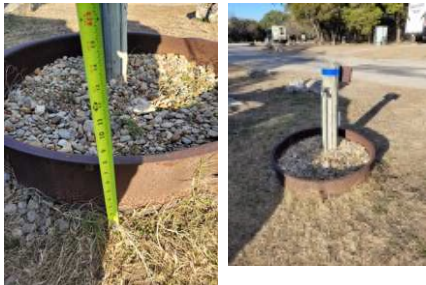
92	Crosstimbers Campground: Crosstimbers - Dump Station	[31.8898305 , -97.698641 5]	30 inches (760 mm) by 60 inches (1525 mm) with the long side of the space adjoining or overlapping an accessible parking space or pull-up space for recreational vehicles. Locate the space so that the hook-ups are at the rear center of the space. Bollards or other barriers shall not obstruct the clear ground space in front of the hook-ups	lacks clear ground space at utility hookup	Provide required 30" by 60" clear ground space with hook ups at the rear of the space as a smart practice	2015 ABAAS Section: 1011.2

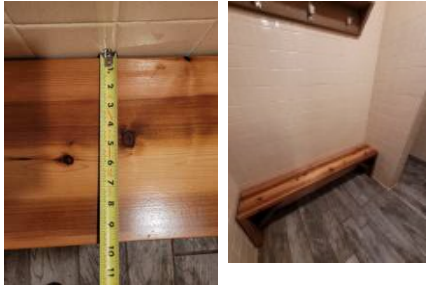
Finding Number	Area Description	Lat/Long	Finding	As Built	Recommendation	Citation	Photos	Figure
103	Juniper Ridge Campground: Juniper Ridge - Men's Restroom	[31.8912356 , -97.701541]	The bench is not deep enough or long enough or is missing. Benches shall be provided having seats that are 42 inches long minimum and 20 inches deep minimum and 24 inches deep maximum. The bench shall provide for back support or shall be affixed to a wall. Back support shall be 42 inches (1065 mm) long minimum and shall extend from a point 2 inches (51 mm) maximum above the seat surface to a point 18 inches (455 mm) minimum above the seat surface. Back support shall be 2½ inches (64 mm) maximum from the rear edge of the seat measured horizontally. The top of the bench seat surface shall be 17 inches (430 mm) minimum and 19 inches (485 mm) maximum above the finish floor or ground.	Men's restroom - bench 9.5" depth	Replace bench in dressing area with one having a seat depth of 20" to 24" deep, 42" long, affixed to the wall or having a back and mounted 17" to 19" aff	2012 TAS Section: 903.4, 903.2, 903.3, 903.5 2010 ADAS Section: 903.4, 903.2, 903.3, 903.5

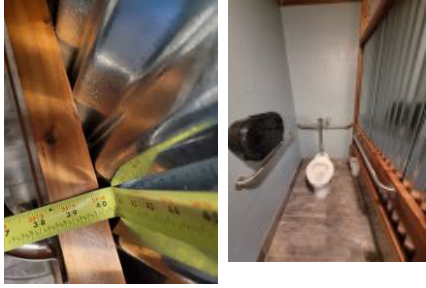
109	Juniper Ridge Campground: Juniper Ridge - Men's Restroom	[31.891231, -97.701530 3]	There are not enough accessible toilet compartments. The room contains toilet compartments. A minimum of 1 must be wheelchair accessible .	Men's restroom - lacks accessible toilet compartment. 1 ambulatory stall and 1 urinal	Create a wheelchair accessible stall with grab bars and fixtures mounted in correct locations and at correct heights.	2015 ABAAS Section: F213.3.1 2012 TAS Section: 213.3.1 2010 ADAS Section: 213.3.1

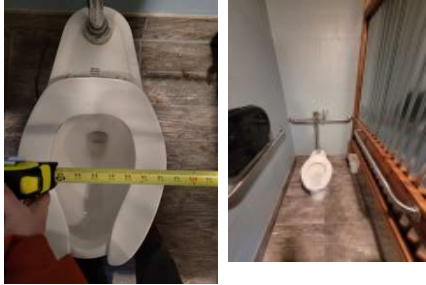
Finding Number	Area Description	Lat/Long	Finding	As Built	Recommendation	Citation	Photos	Figure
111	Juniper Ridge Campground: Juniper Ridge - Men's Restroom	[31.891247, -97.701530 3]	The toilet is not located within the range to the side wall or partition. The centerline of the toilet shall be 17 inches minimum and 19 inches maximum side wall or partition in the ambulatory accessible toilet compartment.	Men's restroom - toilet centerline 22" from partition side	Remount toilet to 17" to 19" from the side wall to center line in ambulatory stalls	2015 ABAAS Section: 604.9.1 2012 TAS Section: 604.9.1 2010 ADAS Section: 604.9.1

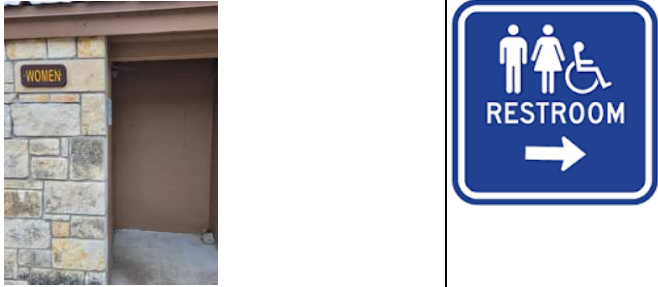
116	Juniper Ridge Campground: Juniper Ridge - Women's Restroom	[31.8912356, -97.701546 4]	This restroom is not accessible. Where existing toilet rooms or bathing rooms do not comply, directional signs indicating the location of the nearest accessible toilet room or bathing room within the facility shall be provided. Signs shall include the International Symbol of Accessibility. Where existing toilet rooms or bathing rooms do comply), the accessible toilet rooms or bathing rooms shall be identified by the International Symbol of Where clustered single user toilet rooms or bathing facilities are permitted, accessible toilet rooms or bathing facilities shall be identified by the International Symbol of Accessibility unless all toilet rooms and bathing facilities are accessible.	Women's restroom - not accessible, lacks directional signage	Restroom not accessible, acquire and mount signage directing patrons to accessible restroom	2015 ABAAS Section: F216.8 2012 TAS Section: 216.8 2010 ADAS Section: 216.8

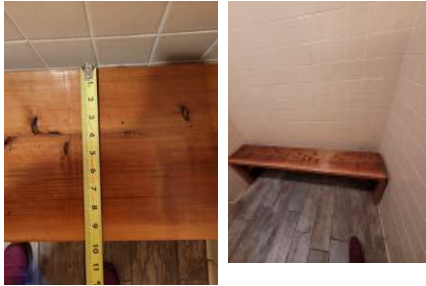
Finding Number	Area Description	Lat/Long	Finding	As Built	Recommendation	Citation	Photos	Figure
119	Juniper Ridge Campground: Juniper Ridge - Women's Restroom	[31.8912675 , -97.701578 5]	The bench is not deep enough or long enough or is missing. Benches shall be provided having seats that are 42 inches long minimum and 20 inches deep minimum and 24 inches deep maximum. The bench shall provide for back support or shall be affixed to a wall. Back support shall be 42 inches (1065 mm) long minimum and shall extend from a point 2 inches (51 mm) maximum above the seat surface to a point 18 inches (455 mm) minimum above the seat surface. Back support shall be 2½ inches (64 mm) maximum from the rear edge of the seat measured horizontally. The top of the bench seat surface shall be 17 inches (430 mm) minimum and 19 inches (485 mm) maximum above the finish floor or ground.	Women's restroom - bench 9.5" depth	Replace bench in dressing area with one having a seat depth of 20" to 24" deep, 42" long, affixed to the wall or having a back and mounted 17" to 19" aff	2012 TAS Section: 903.4, 903.2, 903.3, 903.5 2010 ADAS Section: 903.4, 903.2, 903.3, 903.5

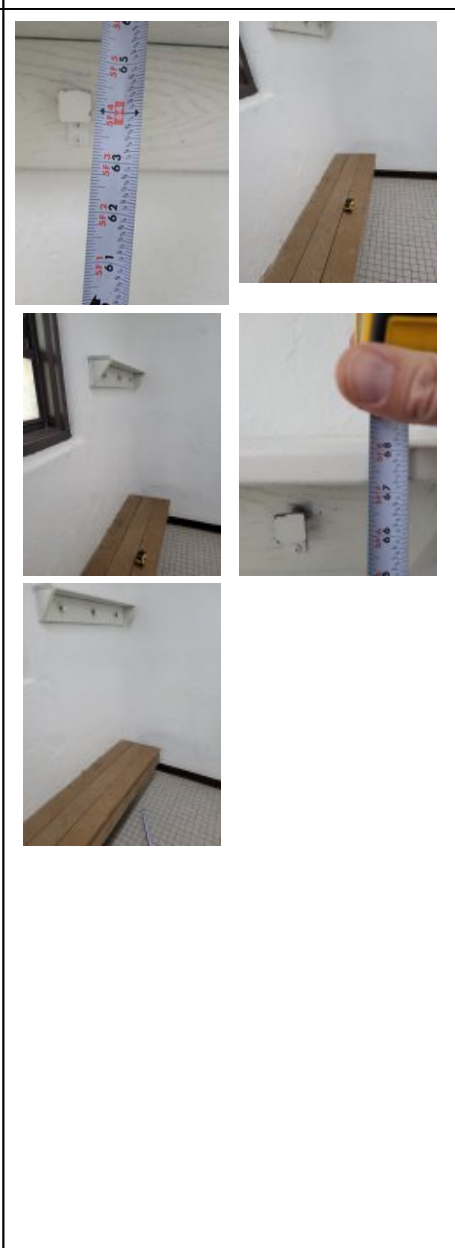
Finding Number	Area Description	Lat/Long	Finding	As Built	Recommendation	Citation	Photos	Figure
143	Lakeside Campground: Lakeside - Men's Restroom	[31.8888216 , -97.699773 4]	Coat hooks provided within the room shall be located within one of the reach ranges specified in 308. Shelves shall be 40 inches (1015 mm) minimum and 48 inches (1220 mm) maximum above the finish floor or ground. Where coat hooks or shelves are provided in dressing, fitting or locker rooms without individual compartments, at least one of each type shall comply with 803.5. Where coat hooks or shelves are provided in individual compartments at least one of each type complying with 803.5 shall be provided in individual compartments in dressing, fitting, or locker rooms required to comply with 222.1.	Men's restroom - hook installed 64.5", shelf 68" AFF	Remount at least one hook to max 48" aff and shelves to 40" - 48" AFF.	2015 ABAAS Section: 308.2.1, 308.1, F222.2, 803.5 2012 TAS Section: 308.2.1, 308.1, 222.2, 803.5 2010 ADAS Section: 308.2.1, 308.1, 222.2, 803.5

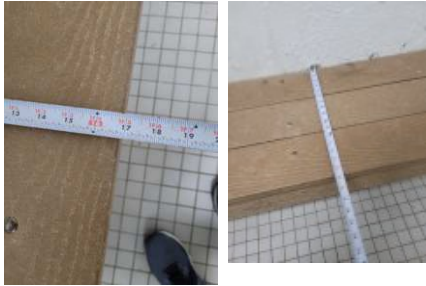
Finding Number	Area Description	Lat/Long	Finding	As Built	Recommendation	Citation	Photos	Figure
144	Lakeside Campground: Lakeside - Men's Restroom	[31.8888284 , -97.6997815]	The bench is not deep enough or long enough or is missing. Benches shall be provided having seats that are 42 inches long minimum and 20 inches deep minimum and 24 inches deep maximum. The bench shall provide for back support or shall be affixed to a wall. Back support shall be 42 inches (1065 mm) long minimum and shall extend from a point 2 inches (51 mm) maximum above the seat surface to a point 18 inches (455 mm) minimum above the seat surface. Back support shall be 2½ inches (64 mm) maximum from the rear edge of the seat measured horizontally. The top of the bench seat surface shall be 17 inches (430 mm) minimum and 19 inches (485 mm) maximum above the finish floor or ground.	Men's restroom - bench seat depth 17"	Replace bench in dressing area with one having a seat depth of 20" to 24" deep, 42" long, affixed to the wall or having a back and mounted 17" to 19" aff	2012 TAS Section: 903.4, 903.2, 903.3, 903.5 2010 ADAS Section: 903.4, 903.2, 903.3, 903.5

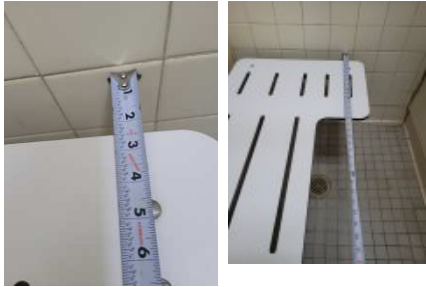
145	Lakeside Campground: Lakeside - Men's Restroom	[31.8888148 , -97.699768]	The shower seat does not have a compliant space between it and the wall. The folding seat must be mounted 17-19 inches above the floor, and have a maximum space of 1-1/2 inches between the edge of the seat and the side wall and 2-1/2 inches maximum to the seat wall.	Men's restroom - shower seat installed 2.5" from side wall	Remount shower seat to the correct location and height in the shower	2015 ABAAS Section: 610.3.2 2012 TAS Section: 610.3.2 2010 ADAS Section: 610.3.2
