# Access Audit Site Report

**Mission Tejas State Park**

**Accessibility Evaluation**

**Inspection Date: 09/14/2022**

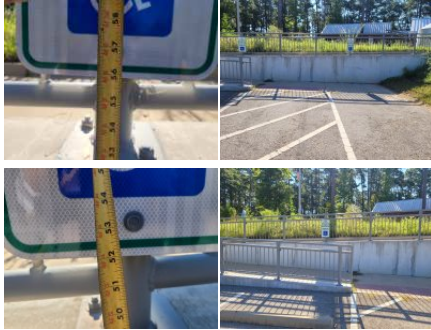
Finding Number	Area Description	Lat/Long	Finding	As Built	Recommendation	Citation	Photos	Figure																						
4	Headquarters Area: HQ - Parking	[31.54236, -95.23393]	The parking sign is mounted too low. Parking space identification signs shall include the International Symbol of Accessibility complying with. Signs identifying van parking spaces shall contain the designation "van accessible." Signs shall be 60 inches minimum above the finish floor or ground surface measured to the bottom of the sign.	Right stall 56", left stall 52"	Raise existing accessible parking signs so lowest end of bottom sign is min 60" above ground level (AGL) measured from the surface of the stall.	2015 ABAAS Section: 502.6 2012 TAS Section: 502.6 2010 ADAS Section: 502.6

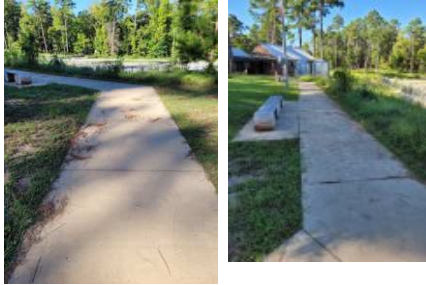
Finding Number	Area Description	Lat/Long	Finding	As Built	Recommendation	Citation	Photos	Figure
19	Headquarters Area: HQ - Exterior Accessible Route	[31.5424031, -95.2337939]	The accessible route contains loose gravel and/or surfaces that do not provide for a stable, firm slip resistant surface.	Debris on route from parking to headquarters building	Maintain surface and remove debris along accessible route as required.	2015 ABAAS Section: 302.1 2012 TAS Section: 302.1 2010 ADAS Section: 302.1

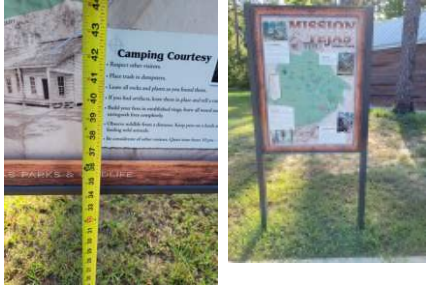
20	Headquarters Area: HQ - Exterior Accessible Route	[31.54241, -95.23376]	Visual characters shall be 40 inches (1015 mm) minimum above the finish floor or ground. EXCEPTION: Visual characters indicating elevator car controls shall not be required to comply with 703.5.6.	Sign mounted low	Remount signage to min 40" AFF.	2015 ABAAS Section: 703.5.6, 703.5.6 EXCEPTION 2012 TAS Section: 703.5.6, 703.5.6 Exception 2010 ADAS Section: 703.5.6, 703.5.6 Exception

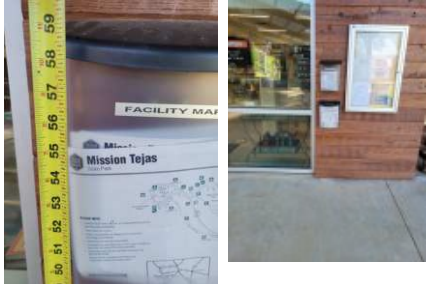
21	Headquarters Area: HQ - Exterior Accessible Route	[31.5420397, -95.2337037]	The operable part is positioned too high for either a side or front approach. Where a clear floor or ground space allows a parallel approach to an element and the side reach is unobstructed, the high side reach shall be 48 inches maximum and the low side reach shall be 15 inches minimum above the finish floor or ground. Where a forward reach is unobstructed, the high forward reach shall be 48 inches maximum and the low forward reach shall be 15 inches minimum above the finish floor or ground.	Facility maps 58" AFF at headquarters	Remount operable parts to be in reach range of 15" min to 48" max.	2015 ABAAS Section: 308.1 2012 TAS Section: 308.1 2010 ADAS Section: 308.1

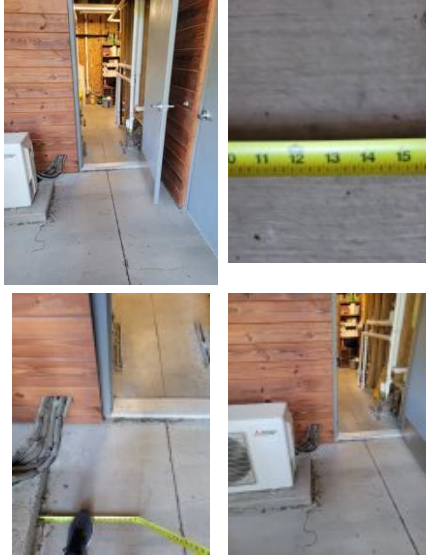
35	Headquarters Area: HQ - Employee Spaces	[31.5419989, -95.2336908]	Spaces and elements within employee work areas shall only be required to comply with 206.2.8, 207.1, and 215.3 and shall be designed and constructed so that individuals with disabilities can approach, enter, and exit the employee work area. Employee work areas, or portions of employee work areas, other than raised courtroom stations, that are less than 300 square feet (28 m2) and elevated 7 inches (180 mm) or more above the finish floor or ground where the elevation is essential to the function of the space shall not be required to comply with these requirements or to be on an accessible route.	Restroom supply storage - CIL at door, 14" clearance on pull due to ac pad, piping reduces width	For employee spaces, relocate storage, furniture, and other obstacles at doorways to provide approach, enter and exit at the employee space. Provide required maneuvering clearance on push and pull side of doors. Replace doors with doors having 80" overhead clearance and 32" clear width. Repair, bevel, or ramp CILs at door entries to max .25".	2015 ABAAS Section: F203.9  2012 TAS Section: 203.9  2010 ADAS Section: 203.9

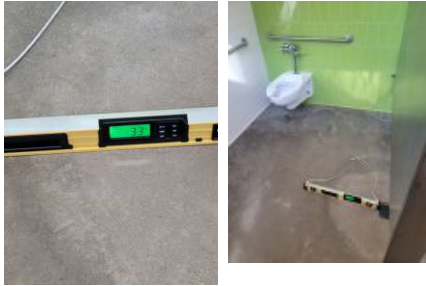
Finding Number	Area Description	Lat/Long	Finding	As Built	Recommendation	Citation	Photos	Figure
39	Headquarters Area: HQ - Men's Restroom	[31.5419863 , -95.2336874]	The accessible route contains running slopes greater than 5 percent and cross slopes greater than 2 percent across the width of the walk and has not been constructed as a ramp (i.e. handrails, wheel guides, etc.). When the slope in the direction of travel of any walk exceeds 1 unit vertical in 20 units horizontal (5-percent slope), it must be constructed as ramp. Surface cross slopes must not exceed one unit vertical in 48 units. Horizontal (2-percent slope).	3.3% in accessible stall, near drain	Correct or repair slope to max 2.08% in restroom.	2015 ABAAS Section: 403.3 2012 TAS Section: 403.3 2010 ADAS Section: 403.3

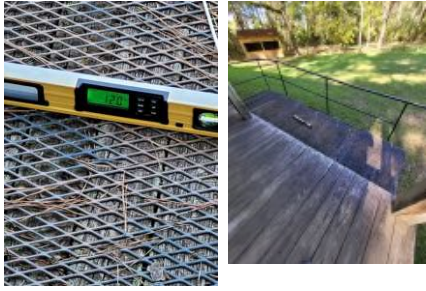
114	Day Use Area: Rice Family Log Home	[31.5429106 , -95.23299]	The landing is not the correct length. Landings shall have a dimension in the direction of ramp run of not less than 60 inches.	Entry Ramp - Lacks landing and route	Enlarge landing to be 60" deep and as wide as the ramp and connect to an accessible route.	2015 ABAAS Section: 405.7.3  2012 TAS Section: 405.7.3  2010 ADAS Section: 405.7.3

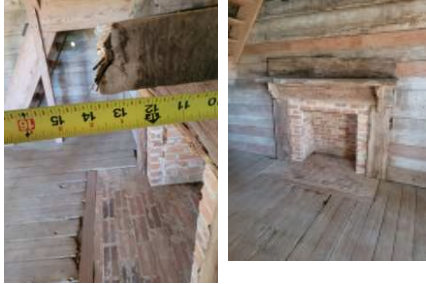
126	Day Use Area: Rice Family Log Home	[31.5428374 , -95.232966 4]	Openings in floor or ground surfaces shall not allow passage of a sphere more than 1/2 inch (13 mm) diameter except as allowed in 407.4.3, 409.4.3, 410.4, 810.5.3 and 810.10. Elongated openings shall be placed so that the long dimension is perpendicular to the dominant direction of travel.	Middle room - gap of 1.5" at fireplace	Fill and maintain gaps to max .5".	2015 ABAAS Section: 302.3  2012 TAS Section: 302.3  2010 ADAS Section: 302.3

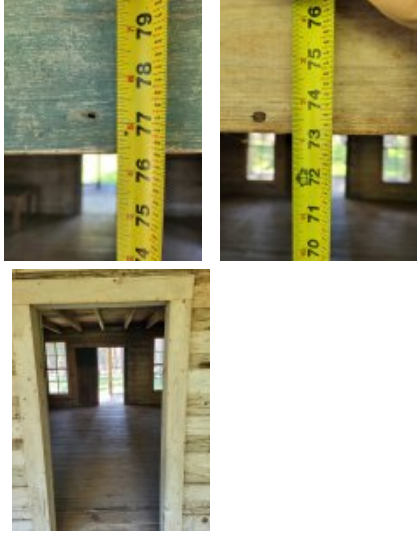
132	Day Use Area: Rice Family Log Home	[31.5427949 , -95.232971 5]	Door openings shall provide a clear width of 32 inches (815 mm) minimum. Clear openings of doorways with swinging doors shall be measured between the face of the door and the stop, with the door open 90 degrees. Openings more than 24 inches (610 mm) deep shall provide a clear opening of 36 inches (915 mm) minimum. There shall be no projections into the required clear opening width lower than 34 inches (865 mm) above the finish floor or ground. Projections into the clear opening width between 34 inches (865 mm) and 80 inches (2030 mm) above the finish floor or ground shall not exceed 4 inches (100 mm). The threshold has a gap greater than 1/2 inch wide. The threshold at a doorway shall be no higher than 1/2 inch. Changes in level between 1/4 inch and 1/2 inch must be beveled at 1:2 or less. 1/4 inch is the maximum vertical rise.	Back room - ramp side - 30.5" width, 62" overhead, 1" CIL at threshold; middle door - 29.75" width, 69.85" overhead, 1.25" CIL at threshold; other side - 71.5" overhead, 1.25" CIL and .75" gap at threshold	For all doors along the public circulation route, replace doors with doors having 80" overhead clearance and 32" clear width. For all doors along the public circulation route, fill gaps at door entries to max .5". For all doors along the public circulation route, provide beveled threshold.	2010 ADAS Section: 404.2.3, 404.2.7, 404.2.4, 404.2.11, 404.2.11 Exception

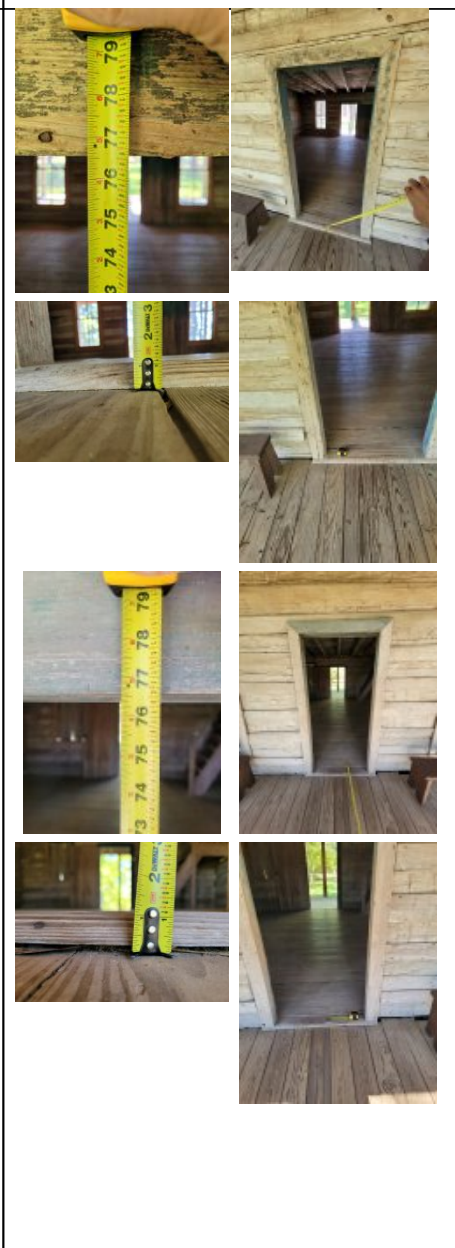
Finding Number	Area Description	Lat/Long	Finding	As Built	Recommendation	Citation	Photos	Figure
134	Day Use Area: Rice Family Log Home	[31.5428114 , -95.232956 6]	The walkway contains abrupt vertical edges and/or variations over a 1/4 inch. 1/4 inch is the maximum vertical rise. Changes in level between 1/4 inch and 1/2 inch must be beveled at 1:2 or less. Changes in level greater than 1/2 inch must be by way of a ramp.	1.25" and 1.5" CIL in breezeway between middle and back rooms	Repair, bevel or ramp CIL along AR.	2012 TAS Section: 303.2, 303.3  2010 ADAS Section: 303.2, 303.3

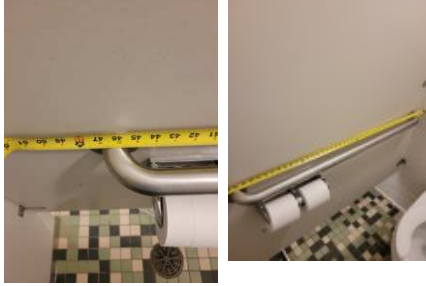
147	Day Use Area: Day Use - Men's Restroom	[31.5484023, -95.2375444]	The rear grab bar is not 36" long or is not mounted in the correct location. The rear grab bar must be a minimum of 36" long and extend from the toilet centerline a minimum 12" towards the wall side and a minimum 24" towards the open side of the toilet. Grab bars shall be installed in a horizontal position, 33 inches minimum and 36 inches maximum above the finish floor measured to the top of the gripping surface and the space between the grab bar and the top of the tank shall be 1-1/2 inches minimum.	rear grab bar 22.75" to open side	Remount rear grab bar to behind the toilet, 12" to the wall side of center and 24" to the open side and 33" to 36" AFF.	2015 ABAAS Section: 604.5.2  2012 TAS Section: 604.5.2  2010 ADAS Section: 604.5.2

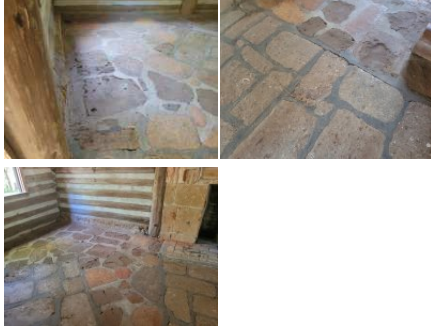
Finding Number	Area Description	Lat/Long	Finding	As Built	Recommendation	Citation	Photos	Figure																														
177	Main Camping Loop (Campsites 1-15): Commemorative Mission	[31.548214, -95.239954]	At least one accessible route shall connect accessible buildings, accessible facilities, accessible elements, and accessible spaces that are on the same site.	Lacks route to signage - natural surface, uneven stone surface and 5.5" CIL to access mission	Provide an accessible route (AR) to each element within the site. Ramp entry to mission for access.	2010 ADAS Section: 206.2.2, 206.2

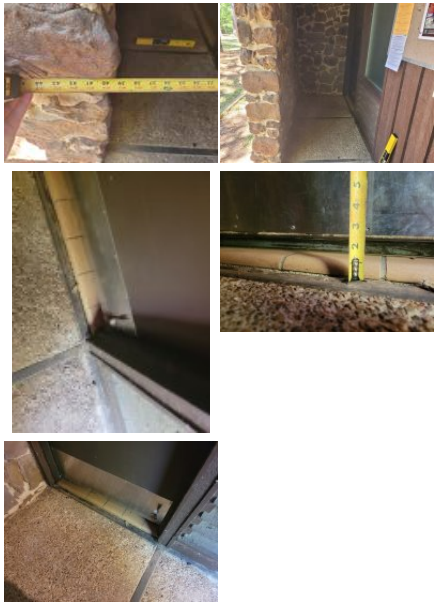
Finding Number	Area Description	Lat/Long	Finding	As Built	Recommendation	Citation	Photos	Figure
186	Main Camping Loop (Campsites 1-15): Main - Women's Restroom	[31.54778, -95.23962]	This restroom is not accessible. Where existing toilet rooms or bathing rooms do not comply, directional signs indicating the location of the nearest accessible toilet room or bathing room within the facility shall be provided. Signs shall include the International Symbol of Accessibility. Where existing toilet rooms or bathing rooms do comply), the accessible toilet rooms or bathing rooms shall be identified by the International Symbol of Where clustered single user toilet rooms or bathing facilities are permitted, accessible toilet rooms or bathing facilities shall be identified by the International Symbol of Accessibility unless all toilet rooms and bathing facilities are accessible.	Lacks directional signage, accessible restrooms are in day use area and at HQ	Restroom not accessible, acquire and mount signage directing patrons to accessible restroom.	2015 ABAAS Section: F216.8 2012 TAS Section: 216.8 2010 ADAS Section: 216.8

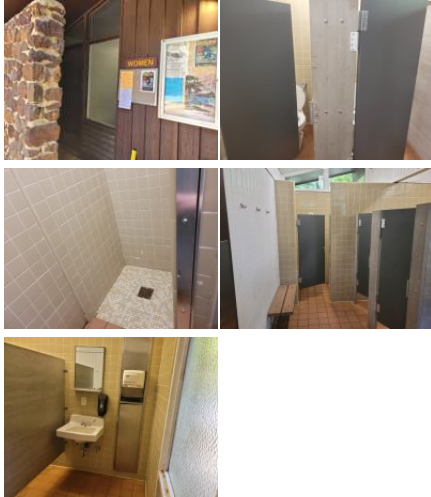
187	Main Camping Loop (Campsites 1-15): Main - Women's Restroom	[31.54782, -95.23963]	There are no accessible bathing or shower facilities. Where facilities for bathing are provided for the public, clients or employees, including showers or bathtubs, at least one shower or bathtub and support facilities such as lockers, and not less than 1 percent of all facilities, shall be accessible.	Showers at campsite inaccessible, no other showers at this park	Create an accessible shower in locker/bathing room.	2015 ABAAS Section: F213.3.6 2012 TAS Section: 213.3.6 2010 ADAS Section: 213.3.6

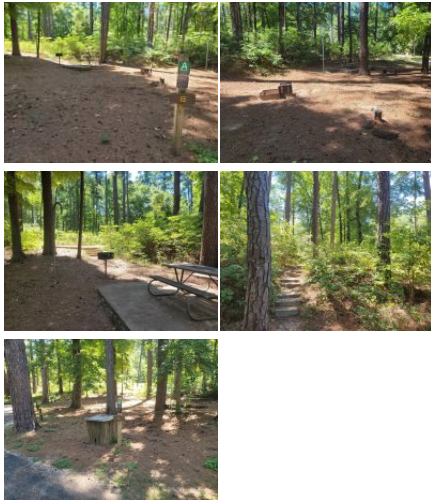
192	Small Camping Area (A &B): Sample Campsite	[31.5489969 , -95.236275 3]	An accessible access route is not provided between elements, spaces and the facilities provided within the accessible camping unit. At least one outdoor recreation access route shall connect accessible elements, spaces and facilities provided within camping units with mobility features.	Lacks route from parking to all amenities	Create AR with crushed and compacted stone or similar outdoor material to camp sites and one of each type of amenity as a smart practice.	2015 ABAAS Section: F244.5.1
