Access Audit Site Report

Mother Neff State Park
1921 Park Road 14
Moody, TX 76557
Accessibility Evaluation
Inspection Date: 09/29/2022
Inspectors: Tanya Scheibe

Prepared By
WT Group

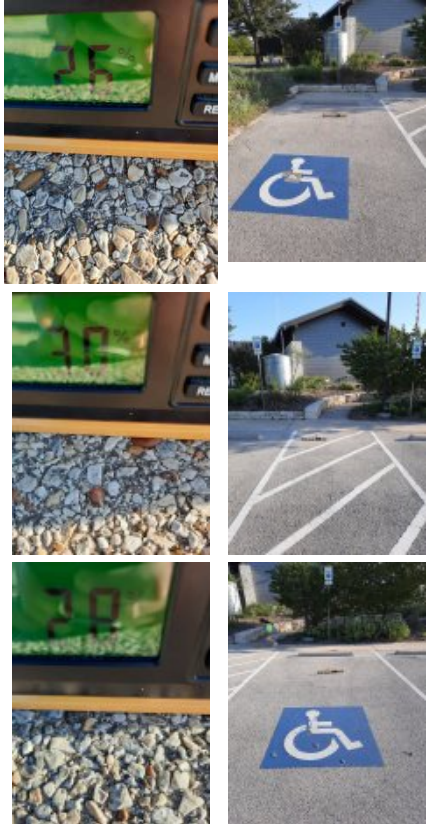
Finding Number	Area Description	Lat/Long	Finding	As Built	Recommendation	Citation	Photos	Figure
4	Headquarters Area: HQ - Parking	[31.3339555 , -97.467963 6]	The cross slopes (narrow dimension) and/or running slopes (long dimension) of the access aisle exceeds 2%. The running slope and the cross slope in an accessible parking stall and the access aisle must not exceed 2%.	HQ main parking: Left stall - 2.6%, shared access aisle (AA) - 3%, right stall - 2.8%	Repair or correct slope of parking space and access aisle to max 2.08% in any direction.	2015 ABAAS Section: 502.4 2012 TAS Section: 502.4 2010 ADAS Section: 502.4

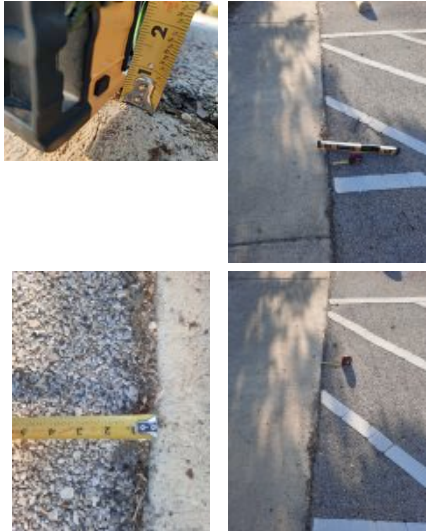
Finding Number	Area Description	Lat/Long	Finding	As Built	Recommendation	Citation	Photos	Figure
5	Headquarters Area: HQ - Parking	[31.3339601 , -97.467958 3]	The parking stall contains abrupt edges and surface irregularities over a 1/4 inch vertical. Parking spaces and access aisles serving them shall be stable, firm, and slip resistant. Access aisles shall be at the same level as the parking spaces they serve. Changes in level are not permitted and shall not be sloped steeper than 2% in any direction.	HQ main parking - .5" change in elevation (CIL) and gap of 1" at head of access aisle (AA)	Repair, bevel and ramp CIL in stalls and access aisles. Correct or fill gaps in parking surfaces.	2015 ABAAS Section: 502.4 2012 TAS Section: 502.4 2010 ADAS Section: 502.4

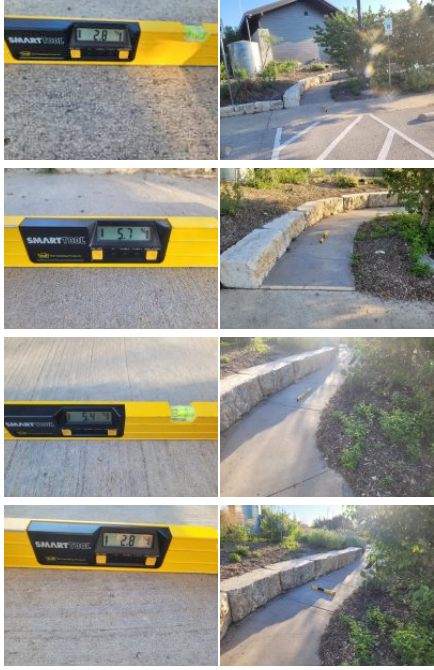
Finding Number	Area Description	Lat/Long	Finding	As Built	Recommendation	Citation	Photos	Figure
6	Headquarters Area: HQ - Exterior Accessible Route	[31.3340227, -97.4679072]	The running slope of walking surfaces shall not be steeper than 1:20. The cross slope of walking surfaces shall not be steeper than 1:48.	2.8% at parking, 5.7% running, 5.4% running, 2.8% cross	Correct running slopes to max 5% and cross to max 2.08%.	2012 TAS Section: 403.3 2010 ADAS Section: 403.3

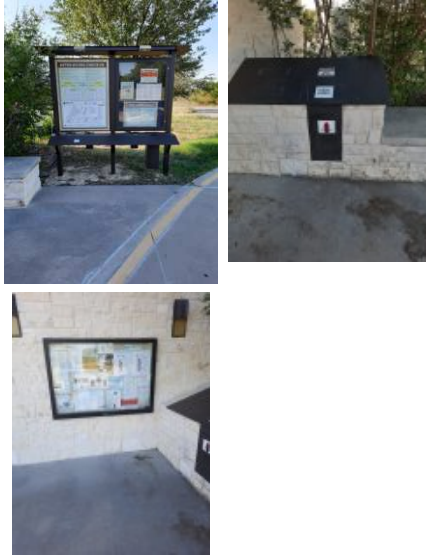
Finding Number	Area Description	Lat/Long	Finding	As Built	Recommendation	Citation	Photos	Figure
15	Headquarters Area: HQ - Public Spaces	[31.3340994 , -97.467940 5]	Element meets all standards and requirements	After hours check-in station and info kiosk, self-pay depository station and envelope slot, display box at HQ comply	None	2010 ADAS Section: N/A

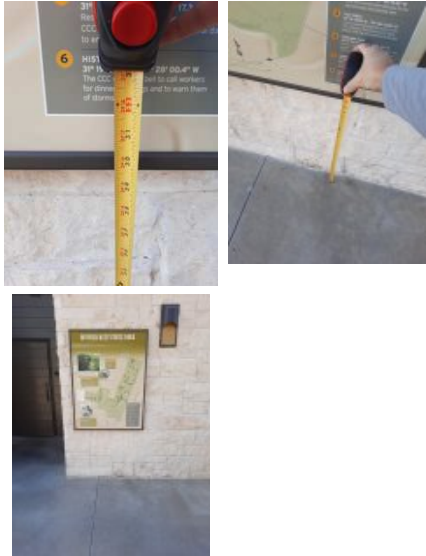
16	Headquarters Area: HQ - Public Spaces	[31.3341601 , -97.467881 6]	Visual characters shall be 40 inches (1015 mm) minimum above the finish floor or ground. EXCEPTION: Visual characters indicating elevator car controls shall not be required to comply with 703.5.6.	Park map and info sign at HQ is mounted low - text at 32.25" above ground level (AGL)	Remount signage to min 40" AFF.	2015 ABAAS Section: 703.5.6, 703.5.6 EXCEPTION 2012 TAS Section: 703.5.6, 703.5.6 Exception 2010 ADAS Section: 703.5.6, 703.5.6 Exception

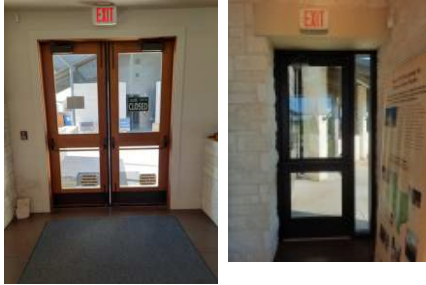
Finding Number	Area Description	Lat/Long	Finding	As Built	Recommendation	Citation	Photos	Figure
17	Headquarters Area: HQ - Public Spaces	[31.3342349 , -97.467863 6]	The tactile EXIT sign is missing at the door. Wall signs identifying exits shall have characters raised 1/32 inch minimum and shall be uppercase characters a minimum of 5/8 inch and a maximum of 2 inches high. Braille shall be placed directly below the tactile characters; flush left or centered. Signs shall be located a minimum of 48 inches above the floor, measured from the baseline of the lowest tactile characters and 60 inches maximum above the finish floor or ground surface, measured from the baseline of the highest tactile characters. Where a tactile sign is provided at a door, the sign shall be located on the latch side. Where a tactile sign is provided at double doors the sign shall be located to the right of the right-hand door. Where there is no wall space at the latch side of a single door or at the right side of double doors, signs shall be located on the nearest adjacent wall.	2 of 2 public entrances/exits lack tactile exit signs	Mount compliant signage at all doors along the egress route.	2015 ABAAS Section: F216.4.1 2012 TAS Section: 216.4.1 2010 ADAS Section: 216.4.1

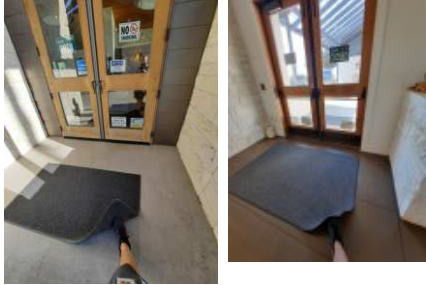
18	Headquarters Area: HQ - Public Spaces	[31.3342573 , -97.467846 5]	Exterior doors exceed 8.5 lbs of force to open; fire doors shall have a minimum opening force allowable by the appropriate administrative authority	Single door public entrance at HQ - 18# push	Inspect, adjust, and maintain 8.5 lbf to open exterior doors as a smart practice.	2010 ADAS Section: 404.2.9		
19	Headquarters Area: HQ - Public Spaces	[31.3342463 , -97.467869 7]	Minimum maneuvering clearances at doors and gates shall comply with 404.2.4. Maneuvering clearances shall extend the full width of the doorway and the required latch side or hinge side clearance. Maneuvering clearances shall have a max slope of 2.08%. Exterior doors are recommended to be maintained at 8.5 lbf as a smart practice. Force is to be measured at the operating hardware or 30 inches from the hinges, whichever is greater.	Main entry double doors: left leaf - 15# push, right leaf - 10# push; loose floor mats on push and pull sides	For all doors along the public circulation route, provide required maneuvering clearance on push and pull side of doors. For all doors along the public circulation route, secure rug in door clearance to prevent trip hazard. For all doors along the public circulation route, inspect, adjust, and maintain 8.5 lbf to open exterior doors as a smart practice.	2010 ADAS Section: 404.2.3, 404.2.7, 404.2.4, 404.2.11, 404.2.11 Exception

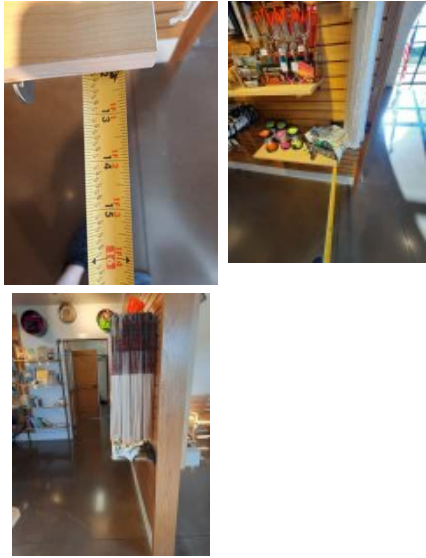
Finding Number	Area Description	Lat/Long	Finding	As Built	Recommendation	Citation	Photos	Figure
20	Headquarters Area: HQ - Public Spaces	[31.3342465 , -97.467860 4]	An item or items project more than 4 inches into the circulation path. Wall-mounted objects that have leading edges between 27 inches and 80 inches from the floor must not project more than 4 inches into the circulation path. Protruding objects that extend to the floor or within 27 inches of the floor are cane detectable and are therefore not hazardous. Where it is necessary or desirable to have objects protrude from the wall, a manner of cane detection must be provided.	HQ Main Public Room - merchandise shelf protrudes 12"	Relocate protruding objects or place cane detectable warning or bollard at foot of item.	2015 ABAAS Section: 307.2 2012 TAS Section: 307.2 2010 ADAS Section: 307.2

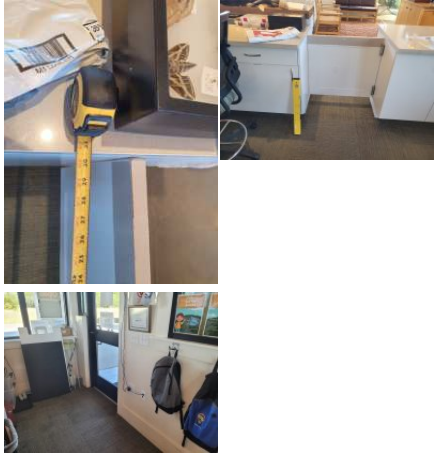
Finding Number	Area Description	Lat/Long	Finding	As Built	Recommendation	Citation	Photos	Figure
24	Headquarters Area: HQ - Employee Spaces	[31.3342733 , -97.467866 1]	Spaces and elements within employee work areas shall only be required to comply with 206.2.8, 207.1, and 215.3 and shall be designed and constructed so that individuals with disabilities can approach, enter, and exit the employee work area. Employee work areas, or portions of employee work areas, other than raised courtroom stations, that are less than 300 square feet (28 m2) and elevated 7 inches (180 mm) or more above the finish floor or ground where the elevation is essential to the function of the space shall not be required to comply with these requirements or to be on an accessible route.	Employee space behind front desk of HQ - 30" entry, storage at delivery door	For employee spaces, relocate storage, furniture, and other obstacles at doorways to provide approach, enter and exit at the employee space. Provide required maneuvering clearance on push and pull side of doors. Replace doors with doors having 80" overhead clearance and 32" clear width.	2015 ABAAS Section: F203.9 2012 TAS Section: 203.9 2010 ADAS Section: 203.9

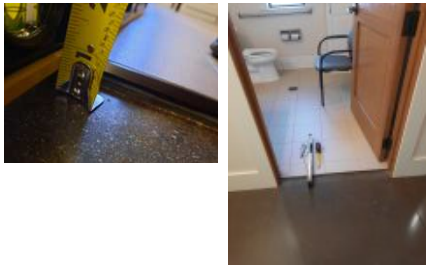
30	Headquarters Area: HQ - Employee Spaces	[31.3343477 , -97.467840 2]	The threshold has a vertical change greater than 1/4 inch high.	Employee restroom in HQ Office Area door - .5" change in elevation (CIL) at threshold	For all doors along the public circulation route, repair, bevel, or ramp CILs at door entries to max .25".	2010 ADAS Section: 404.2.3, 404.2.7, 404.2.4, 404.2.11, 404.2.11 Exception

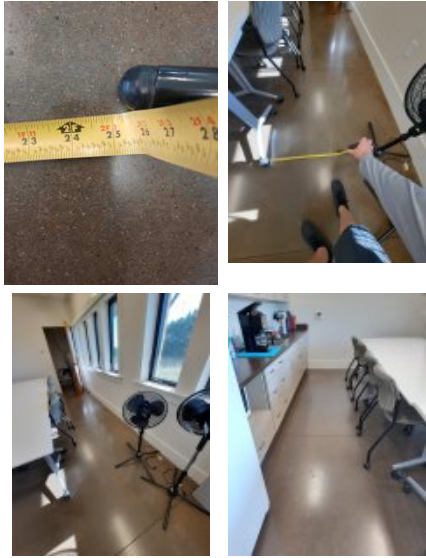
Finding Number	Area Description	Lat/Long	Finding	As Built	Recommendation	Citation	Photos	Figure
31	Headquarters Area: HQ - Employee Spaces	[31.3343279 , -97.467760 8]	The route of travel at this location does not provide a minimum width of 36 inches. The clear width shall be permitted to be reduced to 32 inches minimum for a length of 24 inches maximum provided that reduced width segments are separated by segments that are 48 inches long minimum and 36 inches wide minimum.	HQ employee break room - Route reduces to 26" between table and fans on window side of table, wheels of chairs on cabinet side of table reduce route to 35" - space to move tables and chairs towards window to provide 36" clear width around table	Reposition tables and chairs to widen AR to compliant 36" clear width.	2015 ABAAS Section: 403.5.1 2012 TAS Section: 403.5.1 2010 ADAS Section: 403.5.1

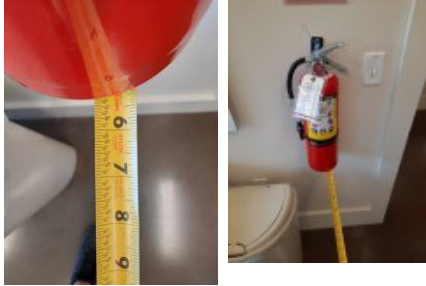
32	Headquarters Area: HQ - Employee Spaces	[31.3343428 , -97.467775 5]	An item or items project more than 4 inches into the circulation path. Wall-mounted objects that have leading edges between 27 inches and 80 inches from the floor must not project more than 4 inches into the circulation path. Protruding objects that extend to the floor or within 27 inches of the floor are cane detectable and are therefore not hazardous. Where it is necessary or desirable to have objects protrude from the wall, a manner of cane detection must be provided.	HQ employee break room - Fire extinguisher protrudes 5.25"	Relocate protruding objects or place cane detectable warning or bollard at foot of item.	2015 ABAAS Section: 307.2 2012 TAS Section: 307.2 2010 ADAS Section: 307.2

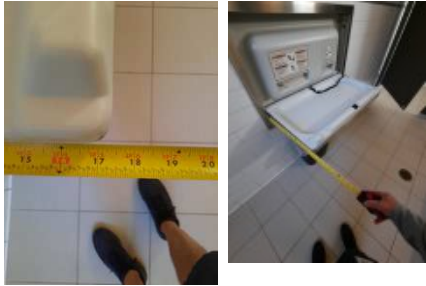
Finding Number	Area Description	Lat/Long	Finding	As Built	Recommendation	Citation	Photos	Figure
43	Headquarters Area: HQ - Men's Restroom	[31.3340963 , -97.467866 4]	The baby changing table is not compliant. Baby changing tables are work surfaces. If fixed or built-in baby changing tables are provided, at least 5%, but not less than one, must comply with TAS 902 based TAS 226.1. Baby changing tables cannot violate the protruding object requirements in either an open or closed position since either position is a potential hazard for persons with visual impairments. Baby changing tables are not prohibited from being located in wheelchair accessible toilet compartments; however, the minimum space required for the compartment cannot be obstructed by the baby changing table in either an open or closed position. The clear floor space required for a baby changing table may overlap the water closet clearance since baby changing tables are considered convenience "fixtures" based on Advisory 604.8.1.1. The overlap is applicable only to the clear floor space and not to actual table itself. Baby changing tables must be dispersed throughout a space, however, an additional baby changing table is not required in a common use area of a toilet or bathing room when the only baby changing table is located in a toilet compartment.	Baby changing table protrudes 17.5" in open position	Relocate baby changing table to eliminate protrusion when in the open position.	2012 TAS Section: 226.1, 902.3, 604.3.2, 204.1, 226.1 Advisory, 226.2, 307.1, 604.8.1.1 Advisory, 902.1, 902.1 Advisory, 902.2

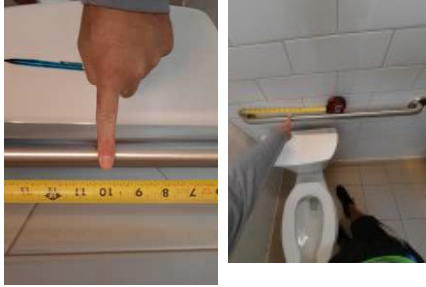
44	Headquarters Area: HQ - Men's Restroom	[31.3340917 , -97.467861]	The rear grab bar is not 36" long or is not mounted in the correct location. The rear grab bar must be a minimum of 36" long and extend from the toilet centerline a minimum 12" towards the wall side and a minimum 24" towards the open side of the toilet. Grab bars shall be installed in a horizontal position, 33 inches minimum and 36 inches maximum above the finish floor measured to the top of the gripping surface and the space between the grab bar and the top of the tank shall be 1-1/2 inches minimum.	rear grab bar mounted 10" towards wall	Remount rear grab bar to behind the toilet, 12" to the wall side of center and 24" to the open side and 33" to 36" AFF.	2015 ABAAS Section: 604.5.2 2012 TAS Section: 604.5.2 2010 ADAS Section: 604.5.2

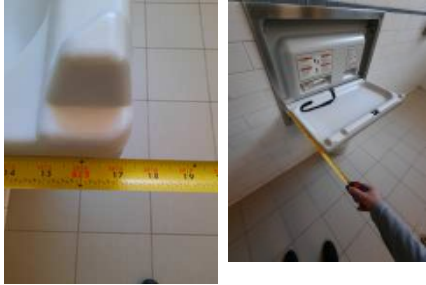
Finding Number	Area Description	Lat/Long	Finding	As Built	Recommendation	Citation	Photos	Figure
49	Headquarters Area: HQ - Women's Restrom	[31.3340985, -97.4678658]	The baby changing table is not compliant. Baby changing tables are work surfaces. If fixed or built-in baby changing tables are provided, at least 5%, but not less than one, must comply with TAS 902 based TAS 226.1. Baby changing tables cannot violate the protruding object requirements in either an open or closed position since either position is a potential hazard for persons with visual impairments. Baby changing tables are not prohibited from being located in wheelchair accessible toilet compartments; however, the minimum space required for the compartment cannot be obstructed by the baby changing table in either an open or closed position. The clear floor space required for a baby changing table may overlap the water closet clearance since baby changing tables are considered convenience "fixtures" based on Advisory 604.8.1.1. The overlap is applicable only to the clear floor space and not to actual table itself. Baby changing tables must be dispersed throughout a space, however, an additional baby changing table is not required in a common use area of a toilet or bathing room when the only baby changing table is located in a toilet compartment.	Baby changing table protrudes 17.5" when in open position	Relocate baby changing table to eliminate protrusion when in the open position.	2012 TAS Section: 226.1, 902.3, 604.3.2, 204.1, 226.1 Advisory, 226.2, 307.1, 604.8.1.1 Advisory, 902.1, 902.1 Advisory, 902.2

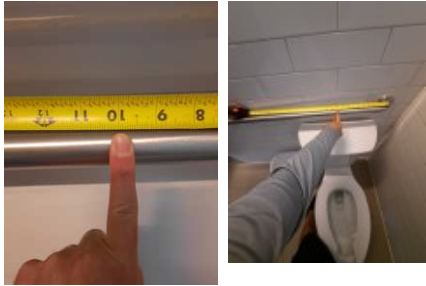
Finding Number	Area Description	Lat/Long	Finding	As Built	Recommendation	Citation	Photos	Figure
51	Headquarters Area: HQ - Women's Restrom	[31.3340927 , -97.467868 5]	The rear grab bar is not 36" long or is not mounted in the correct location. The rear grab bar must be a minimum of 36" long and extend from the toilet centerline a minimum 12" towards the wall side and a minimum 24" towards the open side of the toilet. Grab bars shall be installed in a horizontal position, 33 inches minimum and 36 inches maximum above the finish floor measured to the top of the gripping surface and the space between the grab bar and the top of the tank shall be 1-1/2 inches minimum.	rear grab bar mounted 10" towards wall	Remount rear grab bar to behind the toilet, 12" to the wall side of center and 24" to the open side and 33" to 36" AFF.	2015 ABAAS Section: 604.5.2 2012 TAS Section: 604.5.2 2010 ADAS Section: 604.5.2

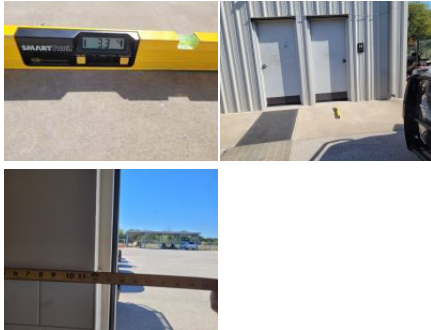
Finding Number	Area Description	Lat/Long	Finding	As Built	Recommendation	Citation	Photos	Figure
53	Employee Areas: Maintenance	[31.3337556, -97.4644503]	Minimum maneuvering clearances at doors and gates shall comply with 404.2.4. Maneuvering clearances shall extend the full width of the doorway and the required latch side or hinge side clearance. Maneuvering clearances shall have a max slope of 2.08%. Exterior doors are recommended to be maintained at 8.5 lbf as a smart practice. Force is to be measured at the operating hardware or 30 inches from the hinges, whichever is greater.	Maintenance restroom door - 3.3% slope in push side clearance, 13" to cabinet in pull side clearance, 11# push	For all doors along the public circulation route, provide required maneuvering clearance on push and pull side of doors. For all doors along the public circulation route, correct slope in door clearance to max 2.08%. For all doors along the public circulation route, inspect, adjust, and maintain 8.5 lbf to open exterior doors as a smart practice.	2010 ADAS Section: 404.2.3, 404.2.7, 404.2.4, 404.2.11, 404.2.11 Exception

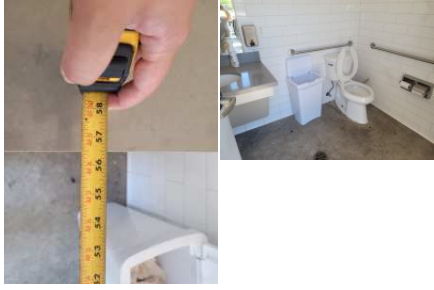
Finding Number	Area Description	Lat/Long	Finding	As Built	Recommendation	Citation	Photos	Figure
55	Employee Areas: Maintenance	[31.3337512 , -97.4644445]	The required 56 inches by 60 inches clear floor space for the water closet has been obstructed. The clear floor space around the water closet shall be 60 inches minimum measured perpendicular from the side wall and 56 inches minimum measured perpendicular from the rear wall.	Maintenance employee restroom - 56.5" to sink, garbage can in clearance	Relocate garbage can to provide required 60" clearance around toilet.	2015 ABAAS Section: 604.3. 2012 TAS Section: 604.3.1 2010 ADAS Section: 604.3.1

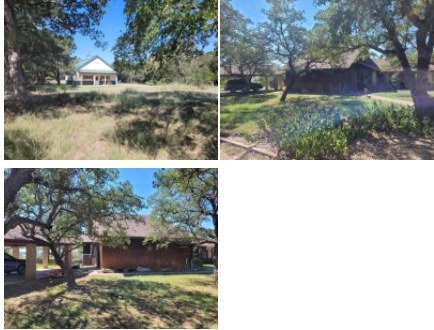
Finding Number	Area Description	Lat/Long	Finding	As Built	Recommendation	Citation	Photos	Figure
69	Employee Areas: Residence 1	[31.3214667 , -97.473804 1]	The accessible route of travel contains cross slopes greater than 2%. Cross slopes shall not exceed one unit vertical in 48 units horizontal (2-percent slope).	8.7% cross slope to entry	Correct or repair cross slope along accessible route to max 2.08%.	2015 ABAAS Section: 403.3 2012 TAS Section: 403.3 2010 ADAS Section: 403.3

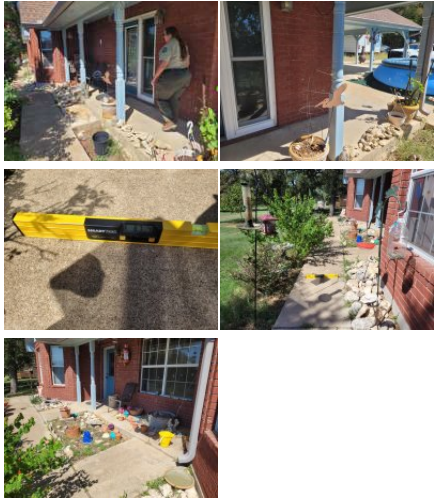
Finding Number	Area Description	Lat/Long	Finding	As Built	Recommendation	Citation	Photos	Figure
70	Employee Areas: Intern Residence	[31.3214978 , -97.474379 3]	The building entrance is not located on an accessible route. When a building, or portion of a building, is required to be accessible, an accessible route of travel shall be provided to all portions of the building, to accessible building entrances and between the building and the public way. All walks, halls, corridors, aisles, skywalks, tunnels, and other spaces that are part of an accessible route must comply. An accessible route of travel must not pass through kitchens, storage rooms, restrooms, closets or other spaces used for similar purposes. At least one accessible route within the boundary of the site must be provided from public transportation stops, accessible parking and accessible passenger loading zones and public streets or sidewalks to the accessible building entrance they serve. The accessible route shall, to the maximum extent feasible, coincide with the route for the general public. At least one accessible route shall connect accessible buildings, facilities, elements and spaces that are on the same site. At least one accessible route shall connect accessible building or facility entrances with all accessible spaces and elements.	intern cabin is primarily for staff, sometimes volunteers utilize restroom space, no AR	Create AR with crushed and compacted stone or similar outdoor material from parking or sidewalk to building entrance	2015 ABAAS Section: F206.2.1 2012 TAS Section: 206.2.1 2010 ADAS Section: 206.2.1

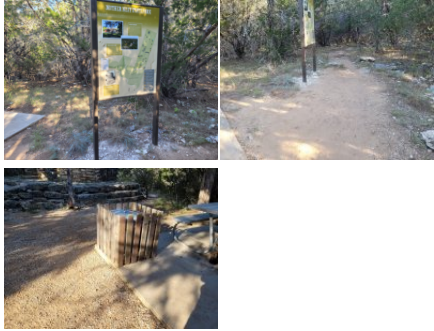
115	Park Elements: Cave Viewing Area	[31.32286, -97.47206]	Visual characters shall be 40 inches (1015 mm) minimum above the finish floor or ground. EXCEPTION: Visual characters indicating elevator car controls shall not be required to comply with 703.5.6. There is no accessible route to the interpretive sign.. At least one accessible route shall connect accessible buildings, accessible facilities, accessible elements, and accessible spaces that are on the same site.	Interpretive signs low, steep slopes, narrow path	Remount signage to min 40" AFF as a smart practice. Create an accessible route with crushed stone or other outdoor material from parking or walkway to interpretive sign.	2015 ABAAS Section: 703.5.6, 703.5.6 EXCEPTION 2012 TAS Section: 703.5.6, 703.5.6 Exception 2010 ADAS Section: 703.5.6, 703.5.6 Exception

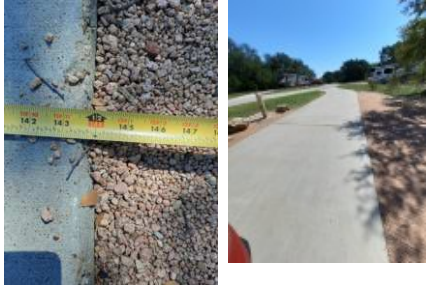
151	Full Hook-Up Campsites: Full Hook-Up - Campsite 18	[31.3274455, -97.468559]	30 inches (760 mm) by 60 inches (1525 mm) with the long side of the space adjoining or overlapping an accessible parking space or pull-up space for recreational vehicles. Locate the space so that the hook-ups are at the rear center of the space. Bollards or other barriers shall not obstruct the clear ground space in front of the hook-ups	Lacks clear round space (CGS) due to non-compliant surface	Provide required 30" by 60" clear ground space with hook ups at the rear of the space as a smart practice	2015 ABAAS Section: 1011.2

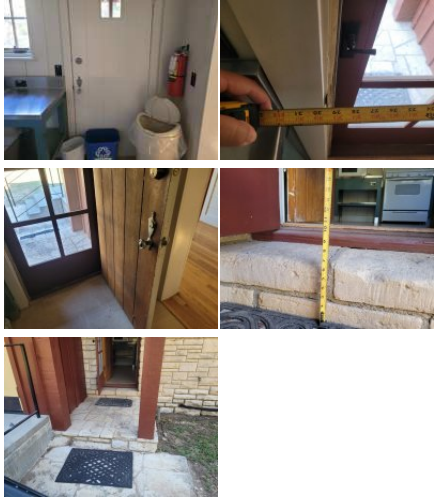
Finding Number	Area Description	Lat/Long	Finding	As Built	Recommendation	Citation	Photos	Figure
180	CCC Cabin: CCC Cabin - Cabin	[31.3212612 , -97.4691967]	Minimum maneuvering clearances at doors and gates shall comply with 404.2.4. Maneuvering clearances shall extend the full width of the doorway and the required latch side or hinge side clearance. Door openings shall provide a clear width of 32 inches (815 mm) minimum. Clear openings of doorways with swinging doors shall be measured between the face of the door and the stop, with the door open 90 degrees. Openings more than 24 inches (610 mm) deep shall provide a clear opening of 36 inches (915 mm) minimum. There shall be no projections into the required clear opening width lower than 34 inches (865 mm) above the finish floor or ground. Projections into the clear opening width between 34 inches (865 mm) and 80 inches (2030 mm) above the finish floor or ground shall not exceed 4 inches (100 mm). Hand-activated door opening hardware, handles, pulls, latches, locks, and other operating devices on accessible doors shall have a shape that is easy to grasp with one hand and does not require tight grasping, tight pinching or twisting of the wrist to operate. Hardware shall be 34 inches minimum and 48 inches maximum above the finish floor or ground.	Dining room between rooms door - 29.5" wide, knob, wall in pull side clearance	For all doors along the public circulation route, provide required maneuvering clearance on push and pull side of doors. For all doors along the public circulation route, replace doors with doors having 80" overhead clearance and 32" clear width. For all doors along the public circulation route, replace hardware with lever hardware or hardware operable without a tight pinch or grasp.	2010 ADAS Section: 404.2.3, 404.2.7, 404.2.4, 404.2.11, 404.2.11 Exception

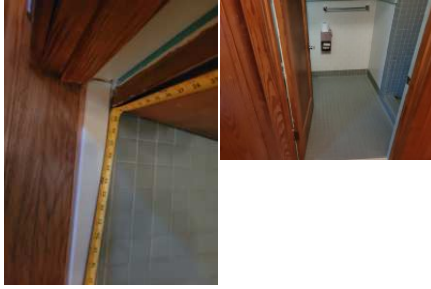
Finding Number	Area Description	Lat/Long	Finding	As Built	Recommendation	Citation	Photos	Figure
198	CCC Cabin: CCC Cabin - Cabin	[31.3212092 , -97.4691787]	This restroom is not accessible. Where existing toilet rooms or bathing rooms do not comply, directional signs indicating the location of the nearest accessible toilet room or bathing room within the facility shall be provided. Signs shall include the International Symbol of Accessibility. Where existing toilet rooms or bathing rooms do comply), the accessible toilet rooms or bathing rooms shall be identified by the International Symbol of Where clustered single user toilet rooms or bathing facilities are permitted, accessible toilet rooms or bathing facilities shall be identified by the International Symbol of Accessibility unless all toilet rooms and bathing facilities are accessible.	Hall bathroom not accessible, lacks directional signage	Restroom not accessible, acquire and mount signage directing patrons to accessible restroom.	2015 ABAAS Section: F216.8 2012 TAS Section: 216.8 2010 ADAS Section: 216.8
