Access Audit Site Report

Mustang Island State Park
9394 TX-361
Corpus Christi, TX 78418
Accessibility Evaluation
Inspection Date: 06/13/2022
Inspectors: Tanya Scheibe

Prepared By
WT Group

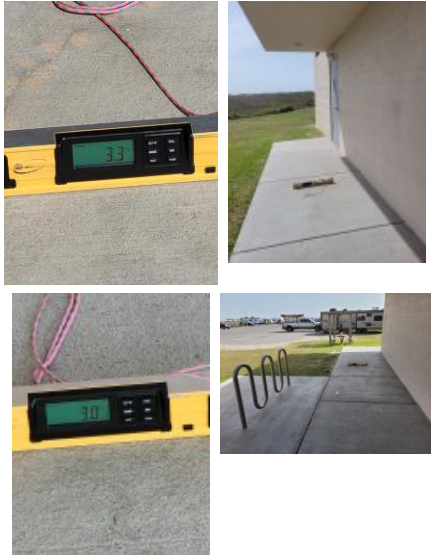
Finding Number	Area Description	Lat/Long	Finding	As Built	Recommendation	Citation	Photos	Figure
9	Exterior: Exterior Accessible Route	[27.6730412 , -97.17323]	The accessible route of travel contains cross slopes greater than 2%. Cross slopes shall not exceed one unit vertical in 48 units horizontal (2-percent slope).	3.3% slope by men's chase, 3% at turn to men's chase by bike rack	Correct or repair cross slope along AR to max 2.08%.	2015 ABAAS Section: 403.3 2012 TAS Section: 403.3 2010 ADAS Section: 403.3

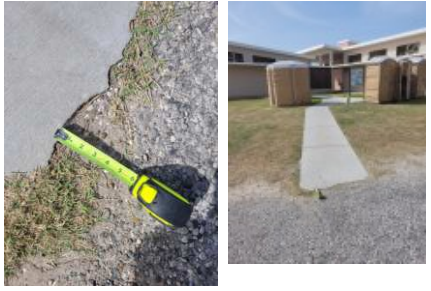
10	Exterior: Exterior Accessible Route	[27.6731469 , -97.173368 2]	There is a gap spaced greater than a 1/2 inch. Openings in floor or ground surfaces shall not allow passage of a sphere more than 1/2 inch diameter. Elongated openings shall be placed so that the long dimension is perpendicular to the dominant direction of travel.	5" gap on path to restrooms from electric sites	Correct or fill gaps to be max .5".	2015 ABAAS Section: 302.3 2012 TAS Section: 302.3 2010 ADAS Section: 302.3

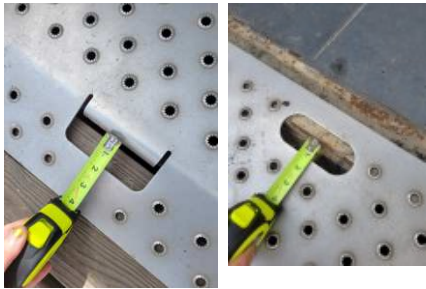
13	Headquarters (HQ) : HQ - Parking and Exterior Accessible Route	[27.6723512 , -97.1750405]	The walkway contains abrupt vertical edges and/or variations over a 1/4 inch. 1/4 inch is the maximum vertical rise. Changes in level between 1/4 inch and 1/2 inch must be beveled at 1:2 or less. Changes in level greater than 1/2 inch must be by way of a ramp.	1" change in level at mat to temporary HQ 1.5" change in level at wood planks	Repair, bevel or ramp CIL along AR.	2012 TAS Section: 303.2, 303.3 2010 ADAS Section: 303.2, 303.3

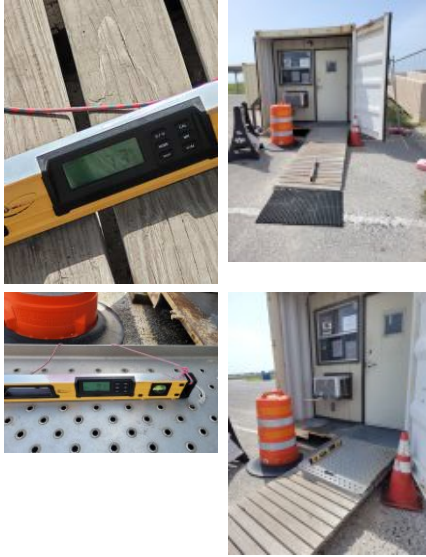
Finding Number	Area Description	Lat/Long	Finding	As Built	Recommendation	Citation	Photos	Figure
14	Headquarters (HQ) : HQ - Parking and Exterior Accessible Route	[27.6723524 , -97.175036 5]	The running slope of walking surfaces shall not be steeper than 1:20.	7.3% slope at HQ (temporary) entry on planks, 9.1% at metal grate	Correct running slope along the AR to max 5%	2015 ABAAS Section: 403.3 2012 TAS Section: 403.3 2010 ADAS Section: 403.3

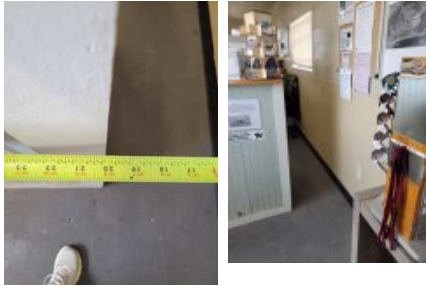
15	Headquarters (HQ) : HQ - Employee Spaces	[27.6722989 , -97.174993 6]	Spaces and elements within employee work areas shall only be required to comply with 206.2.8, 207.1, and 215.3 and shall be designed and constructed so that individuals with disabilities can approach, enter, and exit the employee work area. Employee work areas, or portions of employee work areas, other than raised courtroom stations, that are less than 300 square feet (28 m2) and elevated 7 inches (180 mm) or more above the finish floor or ground where the elevation is essential to the function of the space shall not be required to comply with these requirements or to be on an accessible route.	HQ - 20" width to employee space	Replace or relocate counter to provide 32" clear width.	2015 ABAAS Section: F203.9 2012 TAS Section: 203.9 2010 ADAS Section: 203.9

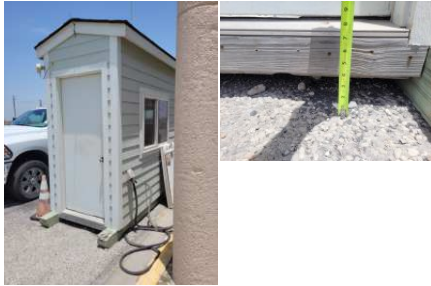
Finding Number	Area Description	Lat/Long	Finding	As Built	Recommendation	Citation	Photos	Figure
17	Headquarters (HQ) : HQ - Employee Spaces	[27.6733773 , -97.174945 3]	Spaces and elements within employee work areas shall only be required to comply with 206.2.8, 207.1, and 215.3 and shall be designed and constructed so that individuals with disabilities can approach, enter, and exit the employee work area. Employee work areas, or portions of employee work areas, other than raised courtroom stations, that are less than 300 square feet (28 m2) and elevated 7 inches (180 mm) or more above the finish floor or ground where the elevation is essential to the function of the space shall not be required to comply with these requirements or to be on an accessible route.	maintenance says this booth is temporary and that they plan to build new one - knob, 7.5" change in level	Repair, bevel, or ramp CILs at door entries to max .25". Replace hardware with lever hardware or hardware operable without a tight pinch or grasp. In the alternative, leave as is until replaced.	2015 ABAAS Section: F203.9 2012 TAS Section: 203.9 2010 ADAS Section: 203.9

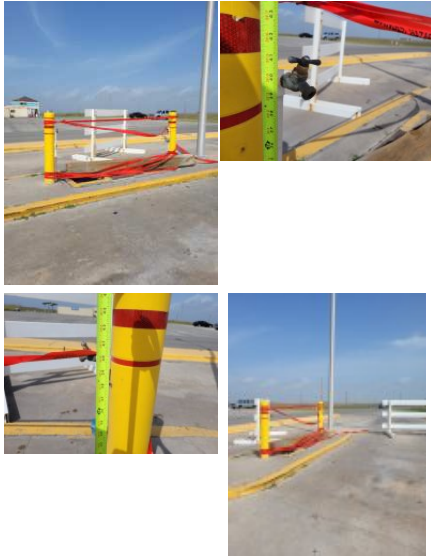
Finding Number	Area Description	Lat/Long	Finding	As Built	Recommendation	Citation	Photos	Figure
25	Park Site: Dump Station	[27.6726481 , -97.174465 2]	Water spouts at water hydrants and water utility hook-ups shall be 28 inches (710 mm) minimum and 36 inches (915 mm) maximum above the ground.	dump station is closed - spigots we're 42" above finished floor, curb around station	Remount water spouts to 28" min or 36" max above the ground as a smart practice.	2015 ABAAS Section: 1011.6

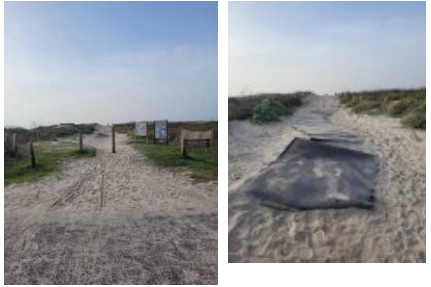
26	Park Site: Fishing/ Beach/ Swimming	[27.6710542 , -97.171753 5]	Beach access routes shall connect an entry point to the beach to the: 1. High tide level at tidal beaches; 2. Mean high water level at river beaches; or 3. Normal recreation water level at lake, pond, and reservoir beaches	no accessible route to beach, route had a poorly maintained mat that piled up in areas greater than 1/4 of an inch	Create a beach access route to normal recreational water level of a firm and stable material as a smart practice. Maintain walking surface so that it securely fastened.	2015 ABAAS Section: 1018.2

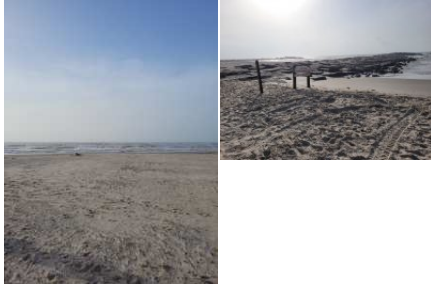
Finding Number	Area Description	Lat/Long	Finding	As Built	Recommendation	Citation	Photos	Figure
28	Park Site: Fishing/ Beach/ Swimming	[27.6591478 , -97.17780 45], [27.6762515 , -97.166260 3]	The surface of beach access routes and resting intervals shall be firm and stable	no AR to swimming area, no AR to fishing pier (note -- both sides of beach allow driving but no accessible spots)	Create a beach access route of a firm and stable material as a smart practice.	2015 ABAAS Section: 1018.3

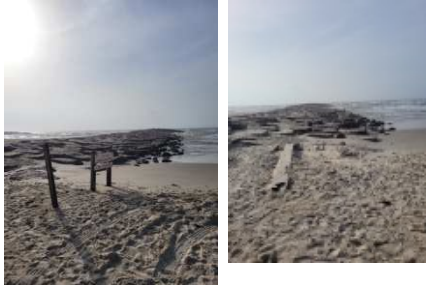
29	Park Site: Fishing/ Beach/ Swimming	[27.6760805 , -97.165423 5]	The fishing pier or platform does not have the required turning space. At least one turning space shall be provided on fishing piers and platforms. The turning space shall be a space of 60 inches diameter minimum. The space shall be permitted to include knee and toe clearance. The turning space can also be a T-shaped space within a 60 inch square minimum with arms and base 36 inches wide minimum. Each arm of the T shall be clear of obstructions 12 inches minimum in each direction and the base shall be clear of obstructions 24 inches minimum. The space shall be permitted to include knee and toe clearance only at the end of either the base or one arm.	fishing area is natural rock, not accessible	Provide at least one 60" by 60" turning space on pier. Resurface route to the fishing pier and make corrections for a compliant route.	2015 ABAAS Section: 1005.5 2010 ADAS Section: 1005.5

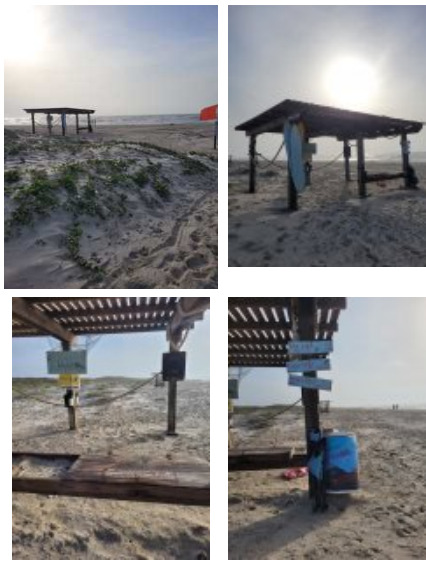
Finding Number	Area Description	Lat/Long	Finding	As Built	Recommendation	Citation	Photos	Figure
30	Park Site: Park Elements	[27.6707976 , -97.171088 3]	There is no accessible route to the outdoor classroom. At least one accessible route shall connect accessible buildings, accessible facilities, accessible elements, and accessible spaces that are on the same site.	no AR to outdoor classroom - within classroom - demonstration table, trash bags, trash	Create an accessible route with crushed stone or other outdoor material from parking or walkway to outdoor classroom.	2015 ABAAS Section: F206.2.2 2012 TAS Section: 206.2.2 2010 ADAS Section: 206.2.2

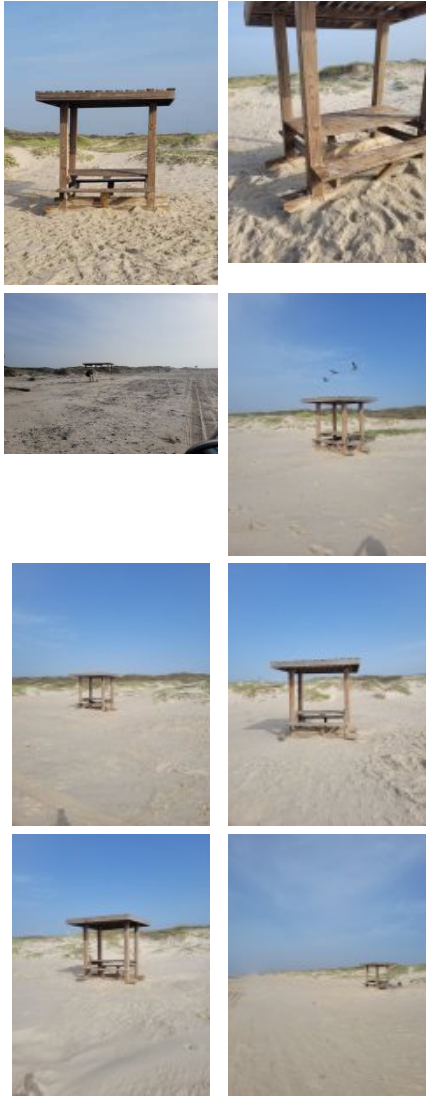
Finding Number	Area Description	Lat/Long	Finding	As Built	Recommendation	Citation	Photos	Figure
34	Park Site: Park Elements	[27.6758762 , -97.1670328]	Picnic tables shall provide at least one wheelchair space for each 24 linear feet (7320 mm) of usable table surface perimeter. Wheelchair spaces shall be 30 inches (760 mm) minimum by 48 inches (1220 mm) minimum. Wheelchair spaces shall be positioned for a forward approach to the table and provide knee and toe clearance complying with 306 under the table	at beach - 0 of 16 picnic tables of accessible design due to lack of toe clearance	Replace 4 picnic tables with ones of an accessible design as a smart practice. Provide an outdoor accessible route to the 4 new tables.	2015 ABAAS Section: 1011.4.2

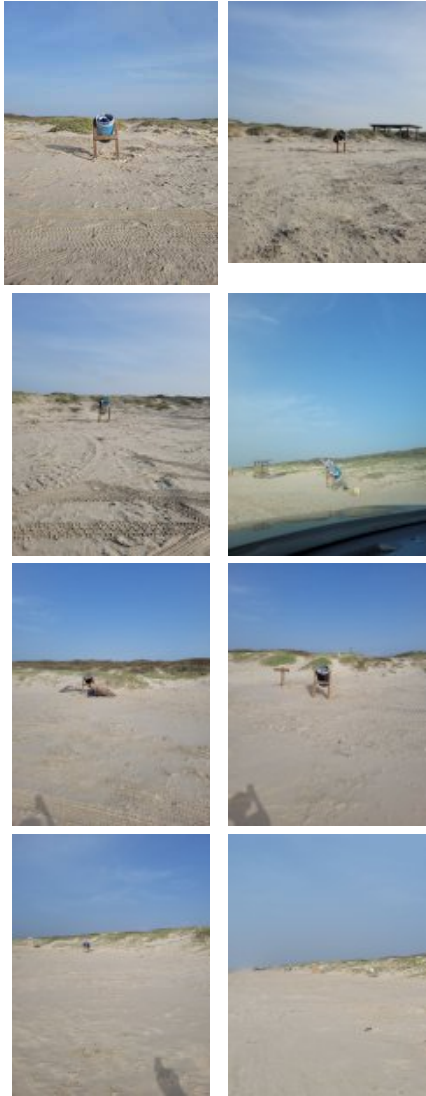
Finding Number	Area Description	Lat/Long	Finding	As Built	Recommendation	Citation	Photos	Figure
35	Park Site: Park Elements	[27.6671798 , -97.1732206]	There is no accessible route to the trash cans. At least one accessible route shall connect accessible buildings, accessible facilities, accessible elements, and accessible spaces that are on the same site.	no route to trash on beach - 9 of 9	Create an accessible route with crushed stone or other outdoor material from parking or walkway to trash bins, or relocate them to be along the new beach access route.	2015 ABAAS Section: F206.2.2 2012 TAS Section: 206.2.2 2010 ADAS Section: 206.2.2

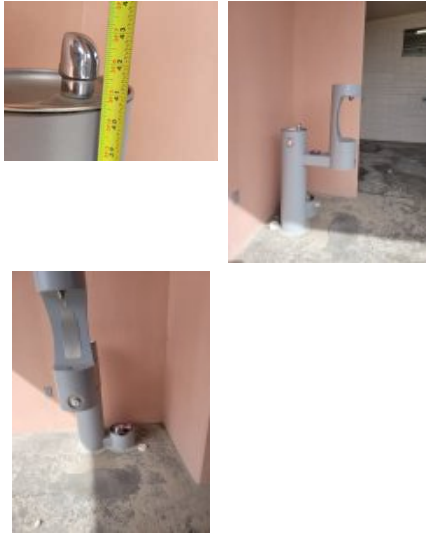
Finding Number	Area Description	Lat/Long	Finding	As Built	Recommendation	Citation	Photos	Figure
37	Park Site: Park Elements	[27.672983, -97.173319 9]	The there is no lower drinking fountain meeting the requirements for persons using wheelchairs. Spout outlets of the lower bowl drinking fountains shall be 36 inches maximum above the finish floor or ground. Lower bowl drinking fountains shall provide knee and toe clearance centered on the unit.	at restroom - high bowl, bottle filler, dog bowl	Add second low bowl fountain for persons using wheelchairs.	2015 ABAAS Section: 602.4 2012 TAS Section: 602.4 2010 ADAS Section: 211.2

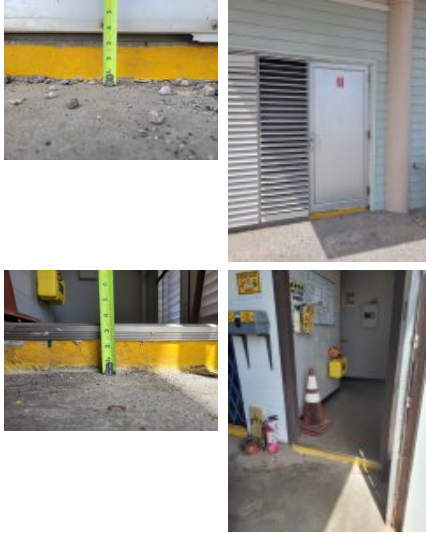
Finding Number	Area Description	Lat/Long	Finding	As Built	Recommendation	Citation	Photos	Figure
48	Park Site: Maintenance	[27.6708309 , -97.1745859]	Spaces and elements within employee work areas shall only be required to comply with 206.2.8, 207.1, and 215.3 and shall be designed and constructed so that individuals with disabilities can approach, enter, and exit the employee work area. Employee work areas, or portions of employee work areas, other than raised courtroom stations, that are less than 300 square feet (28 m2) and elevated 7 inches (180 mm) or more above the finish floor or ground where the elevation is essential to the function of the space shall not be required to comply with these requirements or to be on an accessible route.	main maintenance - 5" change in level, excessive force required due to sticking, 3.5" change in level at garage stall	Repair, bevel, or ramp CILs at door entries to max .25". Inspect, adjust, and maintain 8.5 lbf to open exterior doors as a smart practice.	2015 ABAAS Section: F203.9 2012 TAS Section: 203.9 2010 ADAS Section: 203.9

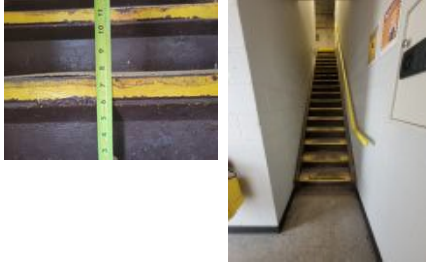
49	Park Site: Maintenance	[27.6708214 , -97.1745698]	The stair risers are not uniform in height. Stair riser heights shall be 7 inches maximum and 4 inches minimum. On any given flight of stairs, all steps shall have uniform riser height and uniform tread widths.	Interior Stairs - 7.75" above finished floor	Correct riser heights on stairs to consistent height between 4" to 7", leave as is if technically infeasible.	2015 ABAAS Section: 504.2 2012 TAS Section: 504.2 2010 ADAS Section: 504.2

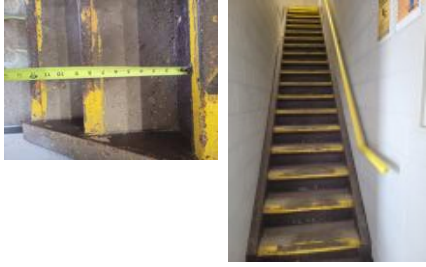
50	Park Site: Maintenance	[27.6708261 , -97.1745752]	Treads shall be 11 inches (280 mm) deep minimum and uniform	Interior Stairs - 8.5" depth	Correct tread depth on stairs to 11" minimum and consistent, leave as is if technically infeasible.	2015 ABAAS Section: 504.2 2012 TAS Section: 504.2 2010 ADAS Section: 504.2

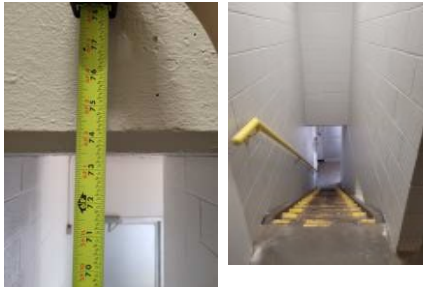
53	Park Site: Maintenance	[27.6708356 , -97.174607 4]	The stairway projects more than 4 inches into the circulation path. Wall-mounted objects that have leading edges between 27 inches and 80 inches from the floor must not project more than 4 inches into the circulation path. Protruding objects that extend to the floor or within 27 inches of the floor are cane detectable and are therefore not hazardous. Where it is necessary or desirable to have objects protrude from the wall, a manner of cane detection must be provided.	Interior Stairs - overhead is reduced by 73.5" cement beam halfway up	Relocate or recess obstruction in stairway; if not feasible, provide a bollard or detectable warning of protrusion.	2015 ABAAS Section: 307.2 2010 ADAS Section: 307.2

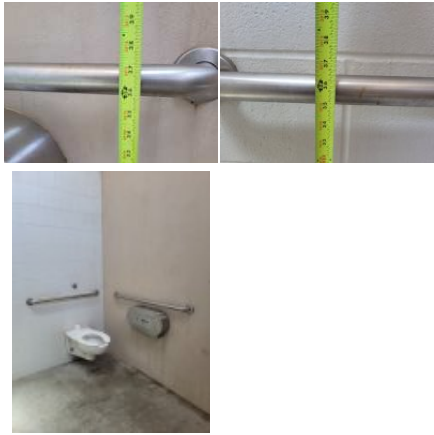
Finding Number	Area Description	Lat/Long	Finding	As Built	Recommendation	Citation	Photos	Figure
63	Restrooms: Men's Restroom	[27.672926, -97.173277]	The grab bar height and/or spacing fails. Grab bars must be mounted between 33" and 36" to the top of the gripping surface. There must be 1.5" of clearance between the grab bar and the wall. There must be a minimum of 1.5" of clearance below and minimum 12" above the grab bar to any dispenser or other obstruction.	ambulatory stall - both 37.5" above finished floor	Remount grab bars in accessible stall to 33" to 36" above the finished floor (AFF).	2015 ABAAS Section: 609.3, 609.4 2012 TAS Section: 609.4, 609.3 2010 ADAS Section: 609.3, 609.4

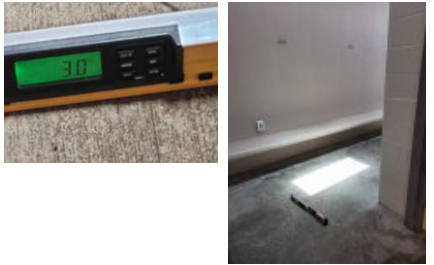
65	Restrooms: Men's Restroom	[27.672964, -97.1733709]	The accessible route contains running slopes greater than 5 percent and cross slopes greater than 2 percent across the width of the walk and has not been constructed as a ramp (i.e. handrails, wheel guides, etc.). When the slope in the direction of travel of any walk exceeds 1 unit vertical in 20 units horizontal (5-percent slope), it must be constructed as ramp. Surface cross slopes must not exceed one unit vertical in 48 units. Horizontal (2-percent slope).	3% along shower side	Correct or repair slope to max 5% running and 2.08% cross.	2015 ABAAS Section: 403.3 2012 TAS Section: 403.3 2010 ADAS Section: 403.3

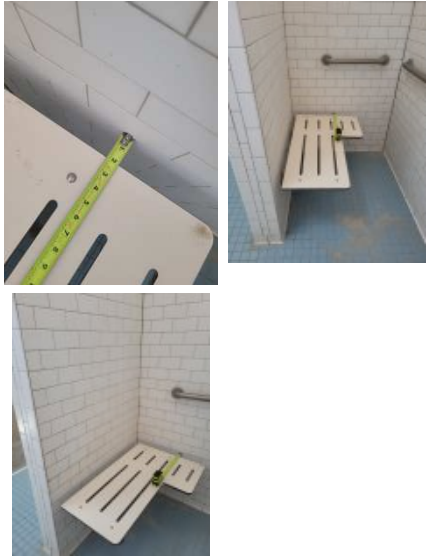
Finding Number	Area Description	Lat/Long	Finding	As Built	Recommendation	Citation	Photos	Figure
68	Restrooms: Men's Restroom	[27.672926, -97.173277]	The shower seat does not have a compliant space between it and the wall. The folding seat must be mounted 17-19 inches above the floor, and have a maximum space of 1-1/2 inches between the edge of the seat and the side wall and 2-1/2 inches maximum to the seat wall.	mounted 2" from side wall	Remount shower seat to the correct location and height in the shower.	2015 ABAAS Section: 610.3.2 2012 TAS Section: 610.3.2 2010 ADAS Section: 610.3.2

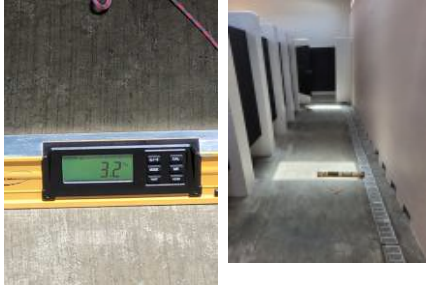
76	Restrooms: Women's Restroom	[27.672964, -97.173234 1]	The accessible route contains running slopes greater than 5 percent and cross slopes greater than 2 percent across the width of the walk and has not been constructed as a ramp (i.e. handrails, wheel guides, etc.). When the slope in the direction of travel of any walk exceeds 1 unit vertical in 20 units horizontal (5-percent slope), it must be constructed as ramp. Surface cross slopes must not exceed one unit vertical in 48 units. Horizontal (2-percent slope).	3.2% along front of toilet compartments	Correct or repair slope to max 5% running and 2.08% cross.	2015 ABAAS Section: 403.3 2012 TAS Section: 403.3 2010 ADAS Section: 403.3

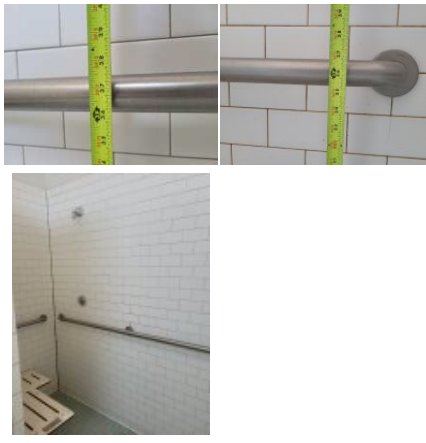
79	Restrooms: Women's Restroom	[27.6729403, -97.173255 5]	Grab bars shall be installed in a horizontal position, 33 inches (840 mm) minimum and 36 inches (915 mm) maximum above the finish floor measured to the top of the gripping surface	both 37" above finished floor	Remount shower grab bar to 33" min. and 36" max. AFF.	2015 ABAAS Section: 609.3 Exception, 609.4 2012 TAS Section: 609.4, 609.3 Exception 2010 ADAS Section: 609.4, 609.3 Exception

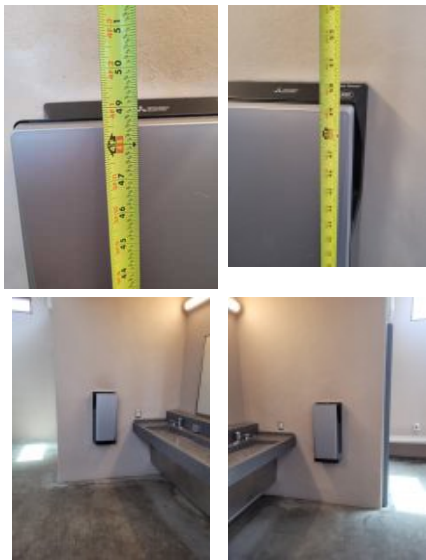
Finding Number	Area Description	Lat/Long	Finding	As Built	Recommendation	Citation	Photos	Figure
80	Restrooms: Women's Restroom	[27.6729165 , -97.173244 8]	Where a high forward reach is over an obstruction, the clear floor space shall extend beneath the element for a distance not less than the required reach depth over the obstruction. The high forward reach shall be 48 inches (1220 mm) maximum where the reach depth is 20 inches (510 mm) maximum. Where the reach depth exceeds 20 inches (510 mm), the high forward reach shall be 44 inches (1120 mm) maximum and the reach depth shall be 25 inches (635 mm) maximum. Where a clear floor or ground space allows a parallel approach to an element and the high side reach is over an obstruction, the height of the obstruction shall be 34 inches (865 mm) maximum and the depth of the obstruction shall be 24 inches (610 mm) maximum. The high side reach shall be 48 inches (1220 mm) maximum for a reach depth of 10 inches (255 mm) maximum. Where the reach depth exceeds 10 inches (255 mm), the high side reach shall be 46 inches (1170 mm) maximum for a reach depth of 24 inches (610 mm) maximum.	2 of 2 hand dryers 49" above finished floor	Lower one hand dryer to max 48" above the finished floor (AFF) to highest operable part.	2015 ABAAS Section: 308.2.1, 308.3.2 2012 TAS Section: 308.2.1, 308.3.2 2010 ADAS Section: 308.2.1, 308.3.2

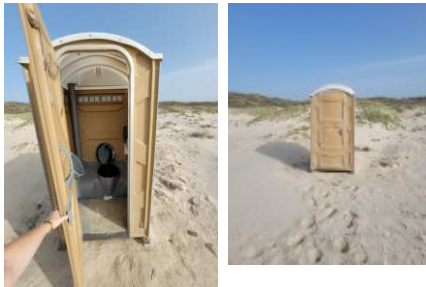
81	Restrooms: Chemical Toilets Along Beach	[27.6674126 , -97.173062 4]	The portable public restroom is not compliant. 5% of portable toilets must be accessible, minimum of 1. If sanitary facilities are provided, they must be made accessible to persons with disabilities. If public restrooms are desired, It is recommended that the portable unit be replaced with a permanent built in compliant restroom. The utilization of an accessible portable unit may be a temporary solution and is not recommended as a permanent solution.	0 of 5 toilets on beach of accessible design	Replace 5% of portable toilets with compliant models and place along AR	2015 ABAAS Section: F213.1 2012 TAS Section: 213.1 2010 ADAS Section: 213.1, 213.2 Exception 3

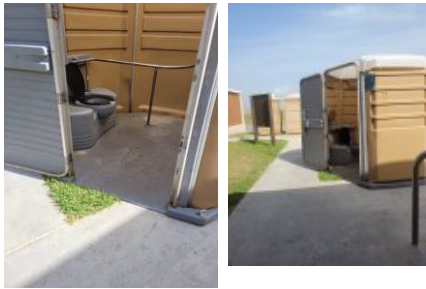
87	Restrooms: H1A - Accessible Restroom	[27.67304, -97.173277]	The portable toilet is not located along an accessible route.	large gap at entry to restroom	Relocate portable toilet to be along the accessible route.	2015 ABAAS Section: 401.1, 402.1 2012 TAS Section: 401.1, 402.1 2010 ADAS Section: 401.1, 402.1

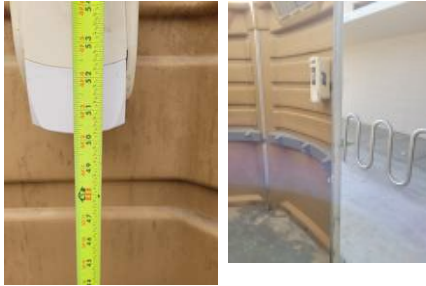
Finding Number	Area Description	Lat/Long	Finding	As Built	Recommendation	Citation	Photos	Figure
88	Restrooms: H1A - Accessible Restroom	[27.6730495 , -97.1732877]	Where a high forward reach is over an obstruction, the clear floor space shall extend beneath the element for a distance not less than the required reach depth over the obstruction. The high forward reach shall be 48 inches (1220 mm) maximum where the reach depth is 20 inches (510 mm) maximum. Where the reach depth exceeds 20 inches (510 mm), the high forward reach shall be 44 inches (1120 mm) maximum and the reach depth shall be 25 inches (635 mm) maximum. Where a clear floor or ground space allows a parallel approach to an element and the high side reach is over an obstruction, the height of the obstruction shall be 34 inches (865 mm) maximum and the depth of the obstruction shall be 24 inches (610 mm) maximum. The high side reach shall be 48 inches (1220 mm) maximum for a reach depth of 10 inches (255 mm) maximum. Where the reach depth exceeds 10 inches (255 mm), the high side reach shall be 46 inches (1170 mm) maximum for a reach depth of 24 inches (610 mm) maximum.	hand sanitizer mounted 50.25" above finished floor	Lower operating mechanisms to max 48" above the finished floor (AFF) to highest operable part.	2015 ABAAS Section: 308.2.1, 308.3.2 2012 TAS Section: 308.2.1, 308.3.2 2010 ADAS Section: 308.2.1, 308.3.2

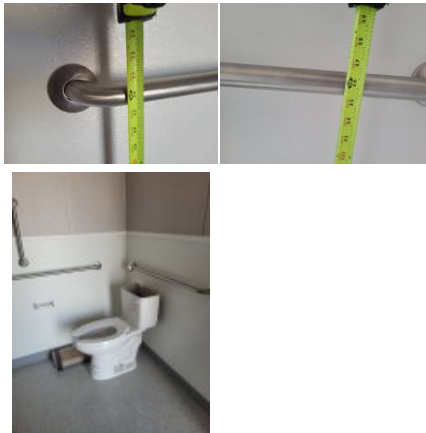
94	Restrooms: Restroom Administration Building (New)	[27.6705696 , -97.174543]	The grab bar height and/or spacing fails. Grab bars must be mounted between 33" and 36" to the top of the gripping surface. There must be 1.5" of clearance between the grab bar and the wall. There must be a minimum of 1.5" of clearance below and minimum 12" above the grab bar to any dispenser or other obstruction.	both 36.75" AFF	Remount grab bars in accessible stall to 33" to 36" above the finished floor (AFF).	2015 ABAAS Section: 609.3, 609.4 2012 TAS Section: 609.4, 609.3 2010 ADAS Section: 609.3, 609.4

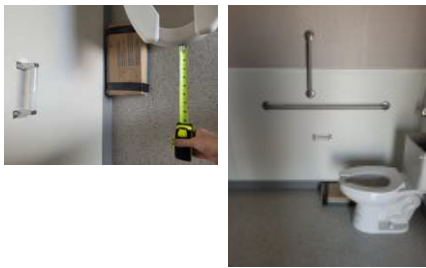
95	Restrooms: Restroom Administration Building (New)	[27.6705981 , -97.174521 5]	The toilet paper is not installed within the compliant range in front of the toilet. Toilet paper dispensers shall be 7 inches minimum and 9 inches maximum in front of the water closet measured to the centerline of the dispenser. The outlet of the dispenser shall be 15 inches minimum and 48 inches maximum above the finish floor and shall not be located behind grab bars. Dispensers shall not be of a type that controls delivery or that does not allow continuous paper flow. There shall be a clearance of 1 1/2 inches minimum below the grab bar.	mounted too close to front of toilet	Remount toilet paper dispenser max 7" to 9" from front of toilet, 15" to 48" aff and min 12" above or 1.5" below grab bar.	2015 ABAAS Section: 604.7 2012 TAS Section: 604.7 2010 ADAS Section: 604.7
