Access Audit Site Report

Palo Duro Canyon State Park
11450 State Hwy Park Rd 5
Canyon, TX 79015
Accessibility Evaluation
Inspection Date: 08/10/2021
Inspectors: Tanya Scheibe

Prepared By
WT Group

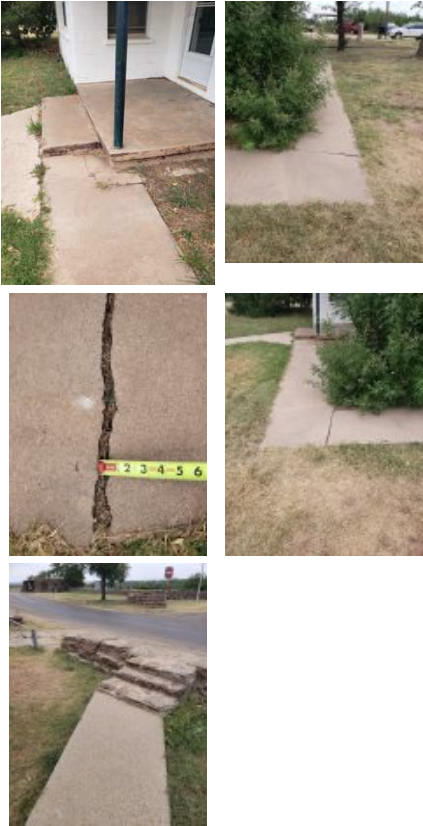
Finding Number	Area Description	Lat/Long	Finding	As Built	Recommendation	Citation	Photos	Figure
6	Headquarters: Headquarters EAR	[34.9854965 , -101.7018 605], [34.985347, -101.70196 24]	The building entrance is not located on an accessible route. When a building, or portion of a building, is required to be accessible, an accessible route of travel shall be provided to all portions of the building, to accessible building entrances and between the building and the public way. All walks, halls, corridors, aisles, skywalks, tunnels, and other spaces that are part of an accessible route must comply. An accessible route of travel must not pass through kitchens, storage rooms, restrooms, closets or other spaces used for similar purposes. At least one accessible route within the boundary of the site must be provided from public transportation stops, accessible parking and accessible passenger loading zones and public streets or sidewalks to the accessible building entrance they serve. The accessible route shall, to the maximum extent feasible, coincide with the route for the general public. At least one accessible route shall connect accessible buildings, facilities, elements and spaces that are on the same site. At least one accessible route shall connect accessible building or facility entrances with all accessible spaces and elements.	admin building: steps only to entrance, plants blocking path, cracks in sidewalk	Resurface route from parking to entry and ramp steps for access.	2015 ABAAS Section: F206.2.1 2012 TAS Section: 206.2.1 2010 ADAS Section: 206.2.1

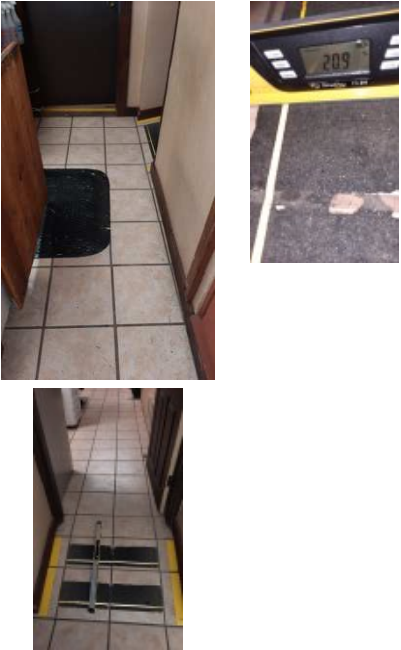
Finding Number	Area Description	Lat/Long	Finding	As Built	Recommendation	Citation	Photos	Figure
9	Headquarters: Headquarters Employee Spaces	[34.9847196 , -101.7018 471]	Employee Work Areas. Common use circulation paths within employee work areas shall comply with 402. EXCEPTIONS: 1. Common use circulation paths located within employee work areas that are less than 1000 square feet (93 m2) and defined by permanently installed partitions, counters, casework, or furnishings shall not be required to comply with 402. 2. Common use circulation paths located within employee work areas that are an integral component of work area equipment shall not be required to comply with 402. 3. Common use circulation paths located within exterior employee work areas that are fully exposed to the weather shall not be required to comply with 402.	check-in - 27.5" from front to employee area, 20.9% slope	Make corrections for compliant circulation path. Widen entry and correct slope to max 12.5%	2015 ABAAS Section: F206.2.8, F206.2.8.1, F206.2.8.2 2012 TAS Section: 206.2.8, 206.2.8 Exception 1, 206.2.8 Exception 2, 206.2.8 Exception 3, 206.2.8 Advisory 1, 206.2.8 Advisory 2 2010 ADAS Section: 206.2.8, 206.2.8 Exception 1, 206.2.8 Exception 2, 206.2.8 Exception 3

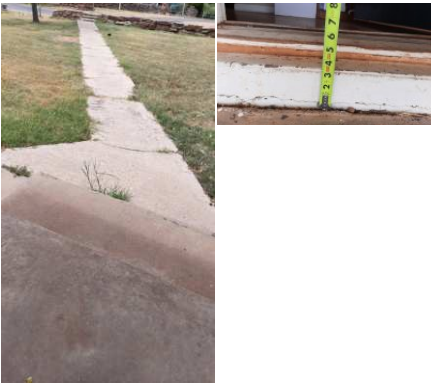
10	Headquarters: Headquarters Employee Spaces	[34.9855052 , -101.7019 034]	Spaces and elements within employee work areas shall only be required to comply with 206.2.8, 207.1, and 215.3 and shall be designed and constructed so that individuals with disabilities can approach, enter, and exit the employee work area. Employee work areas, or portions of employee work areas, other than raised courtroom stations, that are less than 300 square feet (28 m2) and elevated 7 inches (180 mm) or more above the finish floor or ground where the elevation is essential to the function of the space shall not be required to comply with these requirements or to be on an accessible route.	admin - stairs to enter front, 6" change in elevation at entry door, offices have knobs, too narrow at 29" (5), change in elevation at back exit, knob, 5" change in elevation at side entry	For employee spaces, relocate storage, furniture, and other obstacles at doorways to provide approach, enter and exit at the employee space. Widen doors to min 32" clear width and replace door knobs with lever hardware.	2015 ABAAS Section: F203.9 2012 TAS Section: 203.9 2010 ADAS Section: 203.9

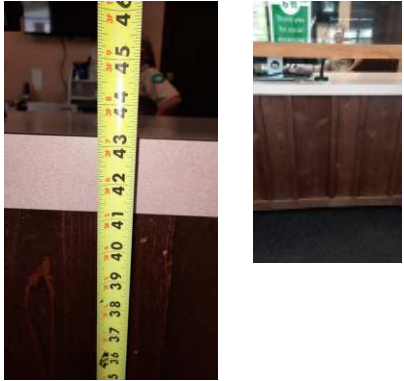
Finding Number	Area Description	Lat/Long	Finding	As Built	Recommendation	Citation	Photos	Figure
16	Headquarters: Headquarters Public Spaces	[34.9847163 , -101.7018 404]	The transaction counter is too high. A portion of the counter surface that is 36 inches long minimum and 36 inches high maximum above the finish floor shall be provided. Knee and toe space must be provided for a forward approach. A 30 inch by 48 inch clear floor space on an accessible route must be provided for either a forward or parallel approach.	service counter at check-in - 43.25" above finished floor	Lower 36" wide segment of service counter to max 36" aff.	2015 ABAAS Section: 904.4.2, 904.4.1 2012 TAS Section: 904.4.1, 904.4.2 2010 ADAS Section: 904.4.2, 904.4.1

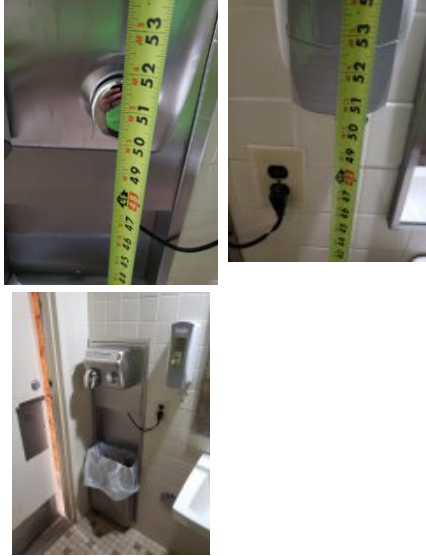
17	Headquarters: Headquarters Restrooms	[34.9848592 , -101.7015 843]	Where a high forward reach is over an obstruction, the clear floor space shall extend beneath the element for a distance not less than the required reach depth over the obstruction. The high forward reach shall be 48 inches (1220 mm) maximum where the reach depth is 20 inches (510 mm) maximum. Where the reach depth exceeds 20 inches (510 mm), the high forward reach shall be 44 inches (1120 mm) maximum and the reach depth shall be 25 inches (635 mm) maximum. Where a clear floor or ground space allows a parallel approach to an element and the high side reach is over an obstruction, the height of the obstruction shall be 34 inches (865 mm) maximum and the depth of the obstruction shall be 24 inches (610 mm) maximum. The high side reach shall be 48 inches (1220 mm) maximum for a reach depth of 10 inches (255 mm) maximum. Where the reach depth exceeds 10 inches (255 mm), the high side reach shall be 46 inches (1170 mm) maximum for a reach depth of 24 inches (610 mm) maximum.	Men's RR - hand dryer and soap dispenser mounted 51" above finished floor	Lower operating mechanisms to max 48" aff to highest operable part.	2015 ABAAS Section: 308.2.1, 308.3.2 2012 TAS Section: 308.2.1, 308.3.2 2010 ADAS Section: 308.2.1, 308.3.2

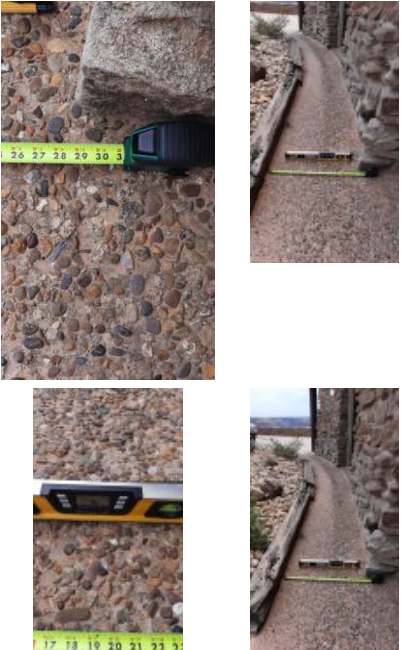
Finding Number	Area Description	Lat/Long	Finding	As Built	Recommendation	Citation	Photos	Figure
34	Visitor Center: Visitor Center EAR	[34.979253, -101.6914106]	The route of travel at this location does not provide the required minimum width. The minimum clear width for sidewalks and walks is 36 inches.	route along building 29" wide, 4% cross slope, not accessible; mount signage	Mount signage along this route directing patrons with disabilities to an accessible route.	2015 ABAAS Section: 403.5.1 2012 TAS Section: 403.5.1 2010 ADAS Section: 403.5.1

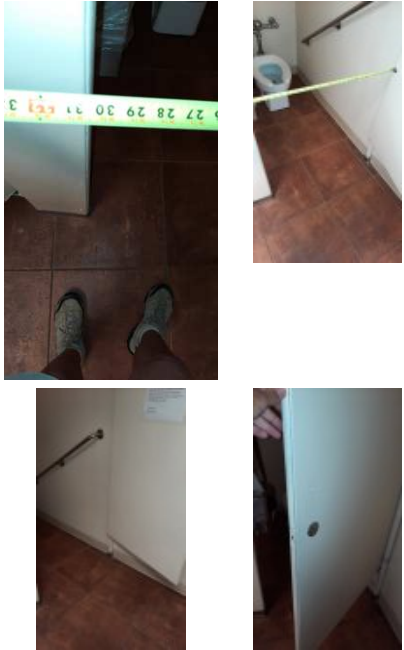
67	Visitor Center: Visitor Center Restrooms	[34.9791717 , -101.69146 7]	The stall door fails to comply with all of the door requirements. The stall door must be a minimum of 32" wide and have compliant hardware on both sides. The stall door must be self-closing.	Women's restroom - stall door 30.5" wide, not self closing and lacks hardware	Widen stall doors to 32" when opened to 90 degrees Adjust stall door to be self-closing Replace stall hardware with hardware operable without a tight pinch or grasp on both sides of the stall door	2015 ABAAS Section: 404.2.3, 404.2.7, 604.8.2.2 2012 TAS Section: 404.2.3, 404.2.7, 604.8.2.2 2010 ADAS Section: 404.2.3, 404.2.7, 604.8.2.2

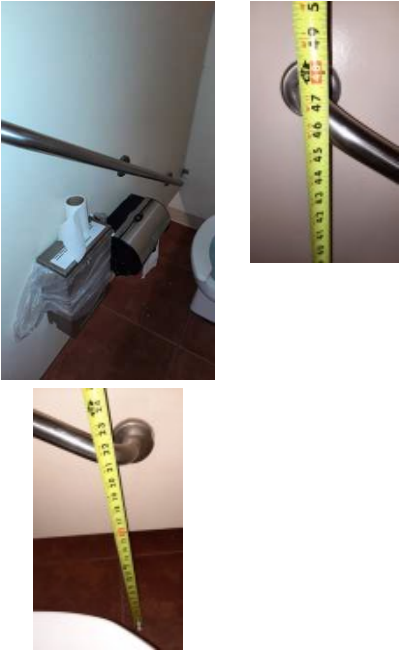
Finding Number	Area Description	Lat/Long	Finding	As Built	Recommendation	Citation	Photos	Figure
68	Visitor Center: Visitor Center Restrooms	[34.9791937 , -101.6915 018]	The grab bar height and/or spacing fails. Grab bars must be mounted between 33" and 36" to the top of the gripping surface. There must be 1.5" of clearance between the grab bar and the wall. There must be a minimum of 1.5" of clearance below and minimum 12" above the grab bar to any dispenser or other obstruction.	Women's restroom - grab bar height on a diagonal, range above finished floor - 22" to 47"	Remount grab bars in accessible stall to 33" to 36" aff, in the alternative, use existing ambulatory stall to create required wheelchair stall.	2015 ABAAS Section: 609.3, 609.4 2012 TAS Section: 609.4, 609.3 2010 ADAS Section: 609.3, 609.4

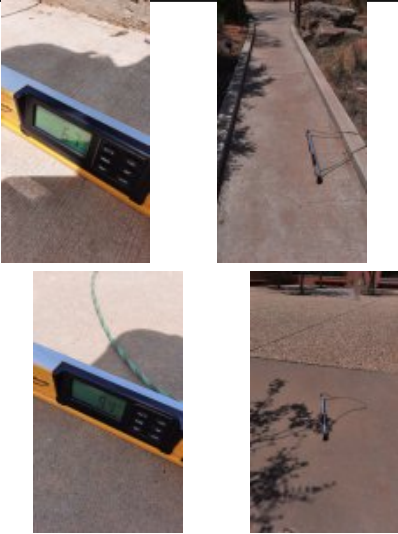
121	Pioneer Amphitheater: Pioneer Amphitheater EAR	[34.9760949 , -101.67973 1]	The route of travel at this location does not provide the required minimum width. The minimum clear width for sidewalks and walks is 36 inches.	pathway near ticket booth reduces to 30" at bench	Widen EAR to min 36" clear width.	2015 ABAAS Section: 403.5.1 2012 TAS Section: 403.5.1 2010 ADAS Section: 403.5.1

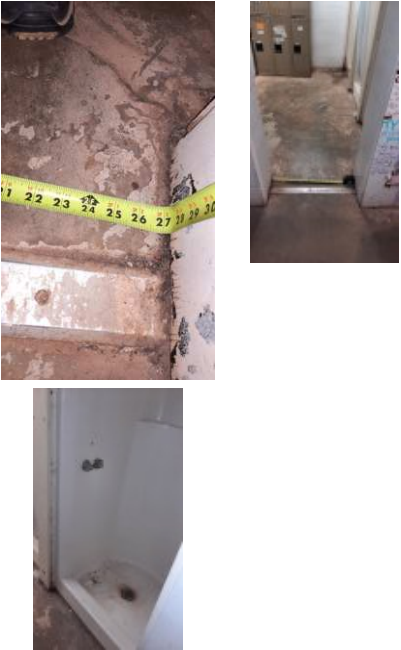
Finding Number	Area Description	Lat/Long	Finding	As Built	Recommendation	Citation	Photos	Figure
187	Pioneer Amphitheater: Pioneer Amphitheater Employee Spaces	[34.9753323 , -101.6792 334]	Employee Work Areas. Common use circulation paths within employee work areas shall comply with 402. EXCEPTIONS: 1. Common use circulation paths located within employee work areas that are less than 1000 square feet (93 m2) and defined by permanently installed partitions, counters, casework, or furnishings shall not be required to comply with 402. 2. Common use circulation paths located within employee work areas that are an integral component of work area equipment shall not be required to comply with 402. 3. Common use circulation paths located within exterior employee work areas that are fully exposed to the weather shall not be required to comply with 402.	Shop - reduces to 27" at inaccessible showers	Make corrections for compliant circulation path. Widen passageway if feasible.	2015 ABAAS Section: F206.2.8, F206.2.8.1, F206.2.8.2 2012 TAS Section: 206.2.8, 206.2.8 Exception 1, 206.2.8 Exception 2, 206.2.8 Exception 3, 206.2.8 Advisory 1, 206.2.8 Advisory 2 2010 ADAS Section: 206.2.8, 206.2.8 Exception 1, 206.2.8 Exception 2, 206.2.8 Exception 3

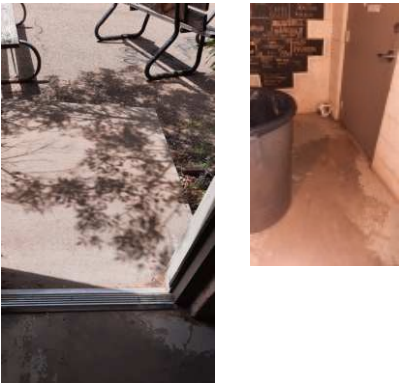
188	Pioneer Amphitheater: Pioneer Amphitheater Employee Spaces	[34.9752839 , -101.6790 671]	Minimum maneuvering clearances at doors and gates shall comply with 404.2.4. Maneuvering clearances shall extend the full width of the doorway and the required latch side or hinge side clearance.	Men's dressing room exit - tables in pull side clearance and narrow pad.	Provide required maneuvering clearance around pull side of door Relocate storage, furniture and other obstacles to create 60" maneuvering clearance around door	2015 ABAAS Section: 404.2.4.1 , 404.2.4.4 2012 TAS Section: 404.2.4.4, 404.2.4.1 2010 ADAS Section: 404.2.4.4, 404.2.4.1

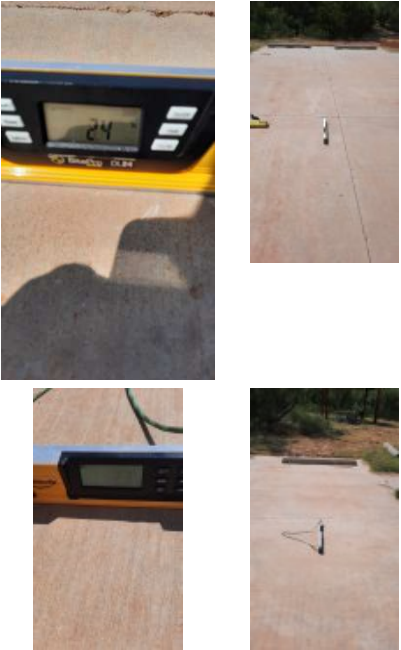
Finding Number	Area Description	Lat/Long	Finding	As Built	Recommendation	Citation	Photos	Figure
221	Sagebrush Camp Area: Sagebrush Camp Area Campsites	[34.9768531, -101.6765834]	The surface of parking spaces and pull-up spaces shall be firm and stable. The slope of the surface of parking spaces and pull-up spaces shall not be steeper than 1:48 in any direction. EXCEPTION: Where the surface is other than asphalt, concrete, or boards, slopes not steeper than 1:20 shall be permitted when necessary for drainage.	2.4% slope at bottom of 144, 2.3% slope at top of 146	Correct surface of parking spaces to be firm and stable with slopes max of 2.08% as a smart practice.	2015 ABAAS Section: 1012.4, 1012.5, 1012.5 EXCEPTION

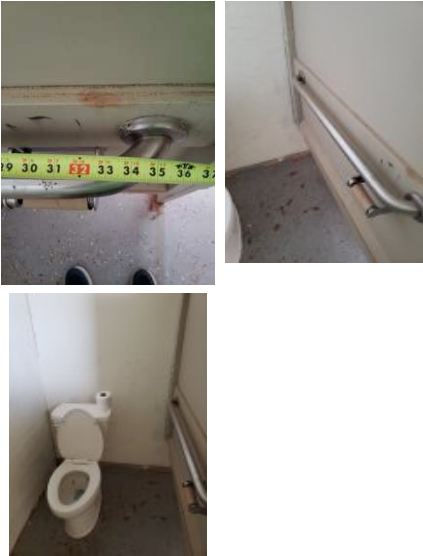
Finding Number	Area Description	Lat/Long	Finding	As Built	Recommendation	Citation	Photos	Figure
267	Old West Stables: Old West Stables Restrooms	[34.9716311 , -101.67859 5]	Grab bars shall comply with 609. A side-wall grab bar complying with 604.5.1 shall be provided on both sides of the compartment. The space between the wall and the grab bar shall be 1½ inches (38 mm). The space between the grab bar and projecting objects below and at the ends shall be 1½ inches (38 mm) minimum. The space between the grab bar and projecting objects above shall be 12 inches (305 mm) minimum. Grab bars shall be installed in a horizontal position, 33 inches (840 mm) minimum and 36 inches (915 mm) maximum above the finish floor measured to the top of the gripping surface, except that at water closets for children's use complying with 604.9, grab bars shall be installed in a horizontal position 18 inches (455 mm) minimum and 27 inches (685 mm) max	Unisex Restroom - one grab bar 35"	Replace or add side grab bars with a 42" long grab bar, mounted max 12" from the rear wall at the close end and min 54" on the far end and 33" to 36" aff, in the alternative, use existing ambulatory stall to create required wheelchair stall.	2015 ABAAS Section: 604.8.2.3, 609.3, 609.4 2012 TAS Section: 609.4, 609.3, 604.8.2.3 2010 ADAS Section: 609.3, 609.4, 604.8.2.3

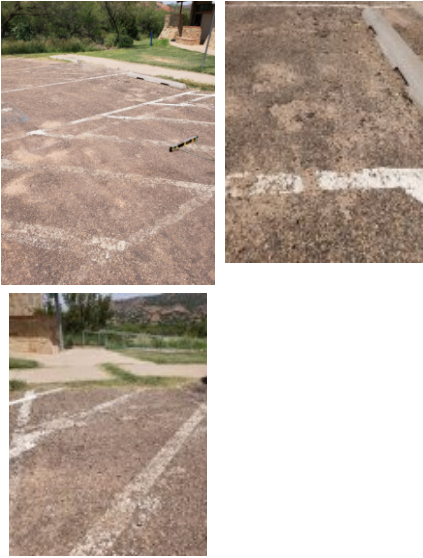
Finding Number	Area Description	Lat/Long	Finding	As Built	Recommendation	Citation	Photos	Figure
356	Juniper Camp Area: Juniper Camp Area Parking	[34.9363428 , -101.6499 598]	The parking stall contains abrupt edges and surface irregularities over a 1/4 inch vertical. Parking spaces and access aisles serving them shall be stable, firm, and slip resistant. Access aisles shall be at the same level as the parking spaces they serve. Changes in level are not permitted and shall not be sloped steeper than 2% in any direction.	loose asphalt not stable, transition to EAR has tall grass	Resurface accessible stalls and access aisles with a firm, stable, and slip resistant material.	2015 ABAAS Section: 502.4 2012 TAS Section: 502.4 2010 ADAS Section: 502.4

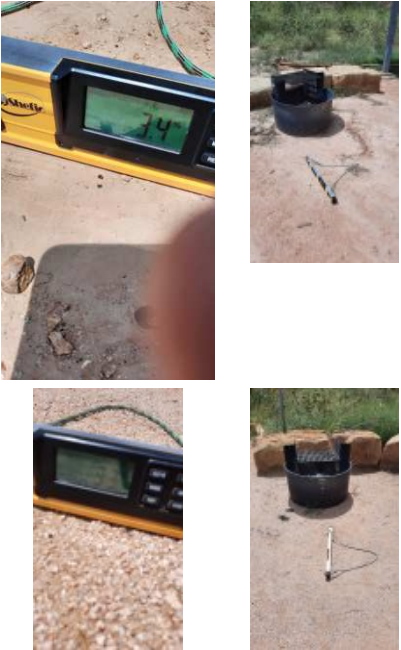
Finding Number	Area Description	Lat/Long	Finding	As Built	Recommendation	Citation	Photos	Figure
363	Juniper Camp Area: Juniper Camp Area Campsites	[34.9365451, -101.6493187]	48 inches (1220 mm) by 48 inches (1220 mm) on all usable sides of the fire ring, grill, fireplace, and woodstove Center the space on each usable side of the grill, fireplace, and woodstove	111 - 3.4% slope in clearance, 115 - 3.3%	Provide level (2.085) required 48" clear ground space centered along usable side of fire ring, grill, fireplace, or woodstove as a smart practice	2015 ABAAS Section: 1011.2

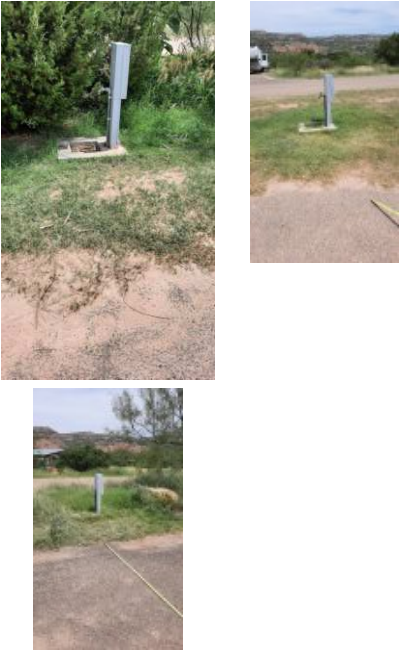
Finding Number	Area Description	Lat/Long	Finding	As Built	Recommendation	Citation	Photos	Figure
367	Juniper Camp Area: Juniper Camp Area Campsites	[34.9366639 , -101.6497881]	30 inches (760 mm) by 60 inches (1525 mm) with the long side of the space adjoining or overlapping an accessible parking space or pull-up space for recreational vehicles Locate the space so that the hook-ups are at the rear center of the space. Bollards or other barriers shall not obstruct the clear ground space in front of the hook-ups	111, 113, 115 - no route to utility hook up	Provide required 30" by 60" clear ground space with hook ups at the rear of the space as a smart practice	2015 ABAAS Section: 1011.2

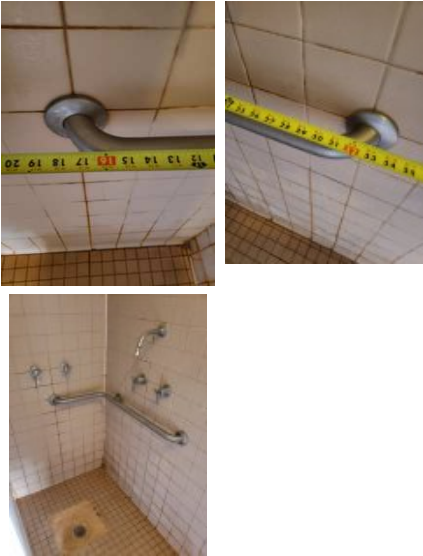
424	Mesquite Camp Area: Mesquite Camp Area Restrooms	[34.9358063 , -101.6371 603]	In transfer type compartments, grab bars shall be provided across the control wall and back wall to a point 18 inches (455 mm) from the control wall.	Men's Restroom - grab bars do not meet requirements	Remount grab bars to the correct location in the transfer shower.	2015 ABAAS Section: 608.3.1 2012 TAS Section: 608.3.1 2010 ADAS Section: 608.3.1
