Access Audit Site Report

Pedernales Falls State Park
2585 Park Rd 6026
Johnson City, TX 78636
Accessibility Evaluation
Inspection Date: 02/08/2022
Inspectors: Tanya Scheibe

Prepared By
WT Group

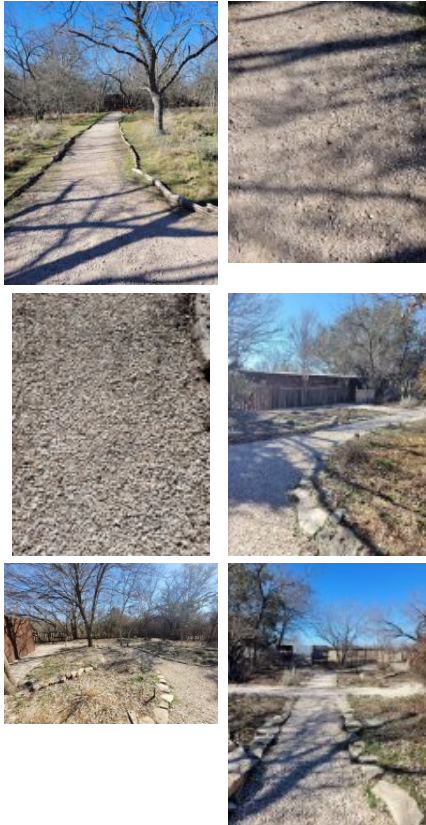
Finding Number	Area Description	Lat/Long	Finding	As Built	Recommendation	Citation	Photos	Figure
3	Exterior : Exterior Accessible Route	[30.3251471 , -98.255794 4]	There is no accessible route to the bird blind. At least one accessible route shall connect accessible buildings, accessible facilities, accessible elements, and accessible spaces that are on the same site.	no AR to bird blind due to gravel path, no AR within bird blind area due to surface	Create an accessible route with crushed stone or other outdoor material from parking or walkway to bird blind.	2015 ABAAS Section: F206.2.2 2012 TAS Section: 206.2.2 2010 ADAS Section: 206.2.2

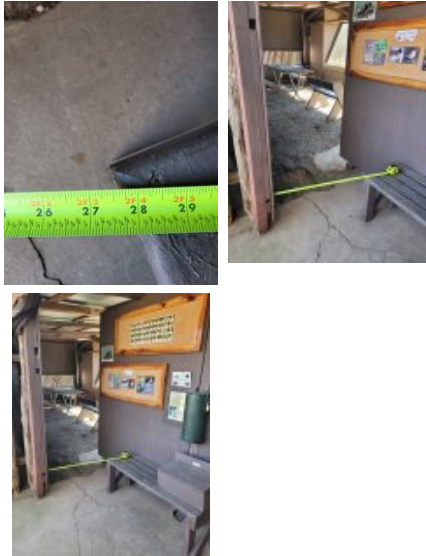
Finding Number	Area Description	Lat/Long	Finding	As Built	Recommendation	Citation	Photos	Figure
4	Exterior : Exterior Accessible Route	[30.3251286 , -98.255832]	The route of travel at this location does not provide the required minimum width. The minimum clear width for sidewalks and walks is 36 inches.	27.5" width into bird blind closer to stables	Widen EAR to min 36" clear width	2015 ABAAS Section: 403.5.1 2012 TAS Section: 403.5.1 2010 ADAS Section: 403.5.1

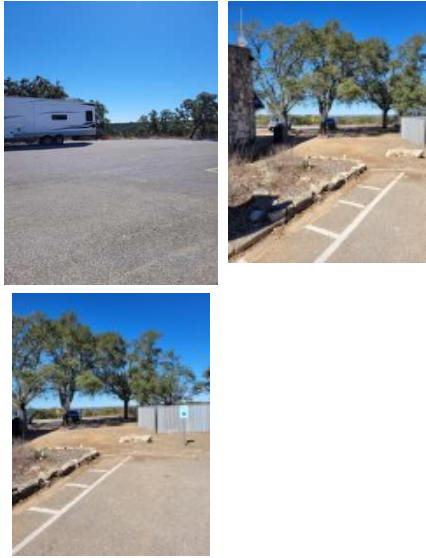
Finding Number	Area Description	Lat/Long	Finding	As Built	Recommendation	Citation	Photos	Figure
5	Headquarters (HQ) : HQ - Parking and Exterior Accessible Route	[30.30802, -98.25768]	Element meets all standards and requirements	HQ - 4 employee spaces, 6 standard, 1 accessible	None	2010 ADAS Section: N/A

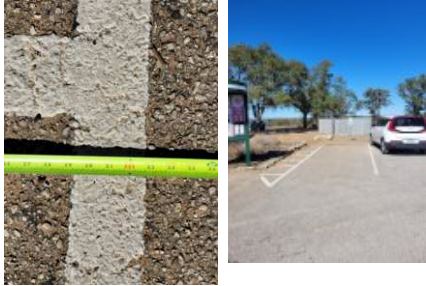
6	Headquarters (HQ) : HQ - Parking and Exterior Accessible Route	[30.30802, -98.25768]	The access aisle is not a minimum 5 feet wide. A car accessible parking stall's access aisle must be a minimum of 5 feet wide measured from centerline to centerline. Where the access aisle is not adjacent to another parking space or access aisle, measurements shall be permitted to include the full width of the line defining the access aisle.	HQ - 31" access aisle	Repaint access aisles to be 5' each	2015 ABAAS Section: 502.3.1 2012 TAS Section: 502.3.1 2010 ADAS Section: 502.3.1

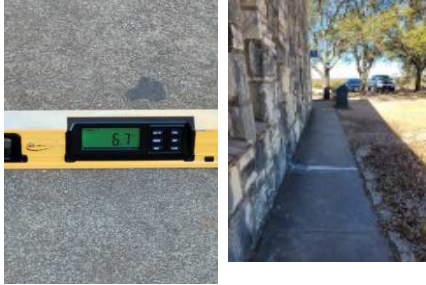
Finding Number	Area Description	Lat/Long	Finding	As Built	Recommendation	Citation	Photos	Figure
10	Headquarters (HQ) : HQ - Parking and Exterior Accessible Route	[30.3080351, -98.2576693]	The accessible route of travel contains cross slopes greater than 2%. Cross slopes shall not exceed one unit vertical in 48 units horizontal (2-percent slope).	6.7% slope on path to restrooms at HQ	Correct or repair cross slope along AR to max 2.08%	2015 ABAAS Section: 403.3 2012 TAS Section: 403.3 2010 ADAS Section: 403.3

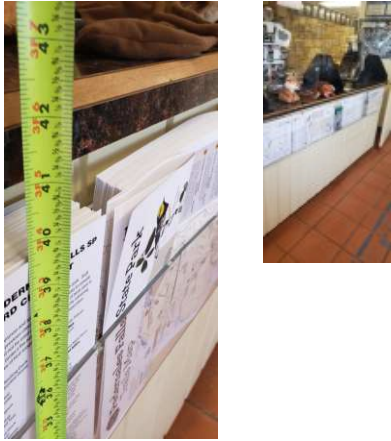
Finding Number	Area Description	Lat/Long	Finding	As Built	Recommendation	Citation	Photos	Figure
14	Headquarters (HQ) : HQ - Public Spaces	[30.30802, -98.25768]	The transaction counter provides for a parallel approach and is not within the required height range. Transaction counters shall be 36 inches high maximum and a minimum of 36 inches wide and should extend the same depth as the sales or service counter tops.	sales counter 42.5" aff	Lower 36" wide segment of service counter to max 36" aff, in the alternative.	2015 ABAAS Section: 904.4.1 2012 TAS Section: 904.4.1 2010 ADAS Section: 904.4.1

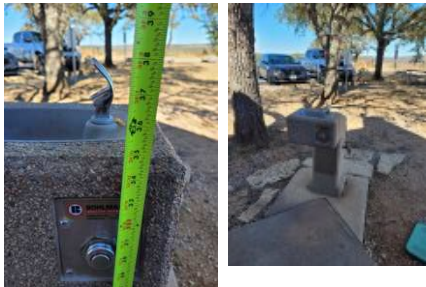
15	Headquarters (HQ) : HQ - Public Spaces	[30.30802, -98.25768]	There is no drinking fountain for standing persons. Spout outlets of drinking fountains for standing persons shall be 38 inches minimum and 43 inches maximum above the finish floor or ground.	single bowl fountain lacks high bowl for standing persons	Add second high bowl fountain for standing persons.	2015 ABAAS Section: 602.7 2012 TAS Section: 602.7 2010 ADAS Section: 602.7, 211.2

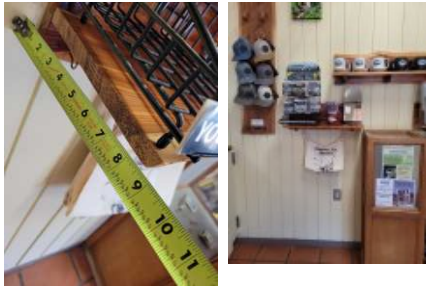
16	Headquarters (HQ) : HQ - Public Spaces	[30.30802, -98.25768]	An item or items project more than 4 inches into the circulation path. Wall-mounted objects that have leading edges between 27 inches and 80 inches from the floor must not project more than 4 inches into the circulation path. Protruding objects that extend to the floor or within 27 inches of the floor are cane detectable and are therefore not hazardous. Where it is necessary or desirable to have objects protrude from the wall, a manner of cane detection must be provided.	merchandise projects 9"	Relocate protruding objects or place cane detectable warning or bollard at foot of item.	2015 ABAAS Section: 307.2 2012 TAS Section: 307.2 2010 ADAS Section: 307.2

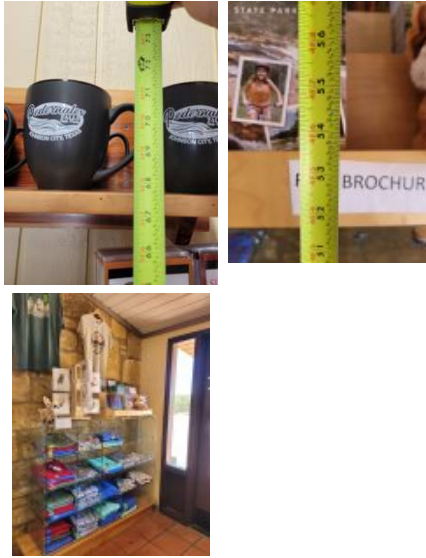
Finding Number	Area Description	Lat/Long	Finding	As Built	Recommendation	Citation	Photos	Figure
17	Headquarters (HQ) : HQ - Public Spaces	[30.30802, -98.25768]	The operable part is positioned too high for either a side or front approach. Where a clear floor or ground space allows a parallel approach to an element and the side reach is unobstructed, the high side reach shall be 48 inches maximum and the low side reach shall be 15 inches minimum above the finish floor or ground. Where a forward reach is unobstructed, the high forward reach shall be 48 inches maximum and the low forward reach shall be 15 inches minimum above the finish floor or ground.	mugs 67.5" aff, brochures 54" aff	Remount operable parts to be in reach range of 15" min to 48" max.	2015 ABAAS Section: 308.1 2012 TAS Section: 308.1 2010 ADAS Section: 308.1

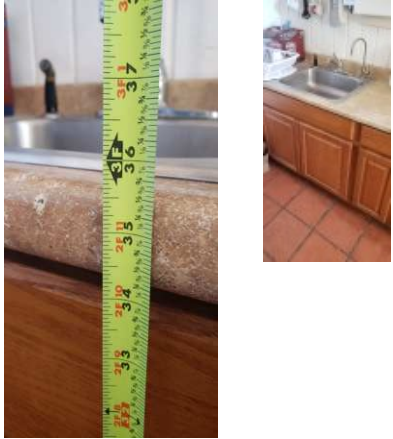
Finding Number	Area Description	Lat/Long	Finding	As Built	Recommendation	Citation	Photos	Figure
21	Headquarters (HQ) : HQ - Employee Spaces	[30.30802, -98.25768]	The top rim of the sink is too high. All lavatories/sinks that are designated to be accessible shall be a minimum 17 inches in horizontal depth and mounted with the rim or counter edge no higher than 34 inches above the finished floor.	Break Room - sink 36" aff	Lower sinks to max 34" above the finished floor (AFF) to front of rim.	2015 ABAAS Section: 606.3 2012 TAS Section: 606.3 2010 ADAS Section: 606.3

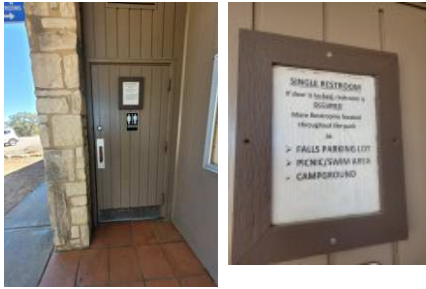
22	Headquarters (HQ) : HQ - Unisex Restroom	[30.30802, -98.25768]	There are not enough accessible toilet compartments. The room contains toilet compartments. A minimum of 1 must be wheelchair accessible .	non accessible restroom at HQ, no accessible restrooms in the area	Create a wheelchair accessible stall with grab bars and fixtures mounted in correct locations and at correct heights.	2015 ABAAS Section: F213.3.1 2012 TAS Section: 213.3.1 2010 ADAS Section: 213.3.1

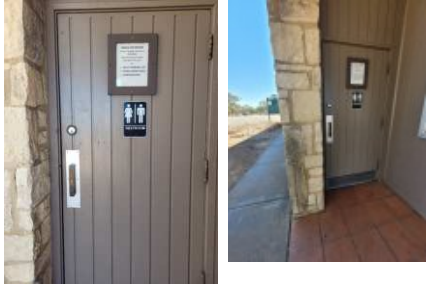
Finding Number	Area Description	Lat/Long	Finding	As Built	Recommendation	Citation	Photos	Figure
23	Headquarters (HQ) : HQ - Unisex Restroom	[30.30802, -98.25768]	The restroom sign does not comply with one or more applicable requirements for the location, height, and properties of the sign.	sign in non compliant location	Remount signage on wall, latch side of the door, 48" to baseline of lowest character and 60" to baseline of highest character.	<p>2015 ABAAS Section: F216.2, 703.1, 703.2, 703.5, 703.6</p> <p>2012 TAS Section: 216.2, 703.1, 703.2, 703.5, 703.6</p> <p>2010 ADAS Section: 216.2, 703.1, 703.2, 703.5, 703.6</p>

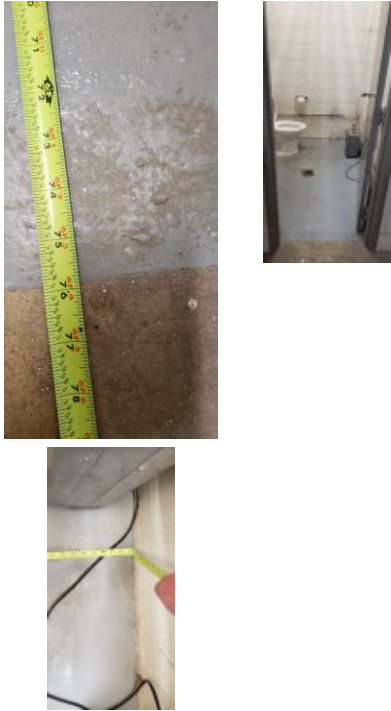
Finding Number	Area Description	Lat/Long	Finding	As Built	Recommendation	Citation	Photos	Figure
34	Park Site: Maintenance	[30.31875, -98.255515 5]	This restroom is not accessible. Where existing toilet rooms or bathing rooms do not comply, directional signs indicating the location of the nearest accessible toilet room or bathing room within the facility shall be provided. Signs shall include the International Symbol of Accessibility. Where existing toilet rooms or bathing rooms do comply), the accessible toilet rooms or bathing rooms shall be identified by the International Symbol of Where clustered single user toilet rooms or bathing facilities are permitted, accessible toilet rooms or bathing facilities shall be identified by the International Symbol of Accessibility unless all toilet rooms and bathing facilities are accessible.	63" by 76" restroom lacks signage to nearest accessible restroom	Restroom not accessible, acquire and mount signage directing patrons to accessible restroom until renovations occur.	2015 ABAAS Section: F216.8 2012 TAS Section: 216.8 2010 ADAS Section: 216.8

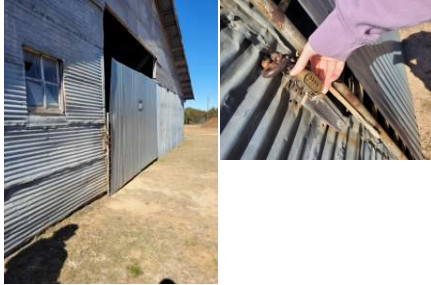
Finding Number	Area Description	Lat/Long	Finding	As Built	Recommendation	Citation	Photos	Figure
37	Park Site: Maintenance	[30.318398, -98.2552124]	Spaces and elements within employee work areas shall only be required to comply with 206.2.8, 207.1, and 215.3 and shall be designed and constructed so that individuals with disabilities can approach, enter, and exit the employee work area. Employee work areas, or portions of employee work areas, other than raised courtroom stations, that are less than 300 square feet (28 m2) and elevated 7 inches (180 mm) or more above the finish floor or ground where the elevation is essential to the function of the space shall not be required to comply with these requirements or to be on an accessible route.	no route to barn, barn door requires pinch on lock	Provide a route for access to barn.	2015 ABAAS Section: F203.9 2012 TAS Section: 203.9 2010 ADAS Section: 203.9

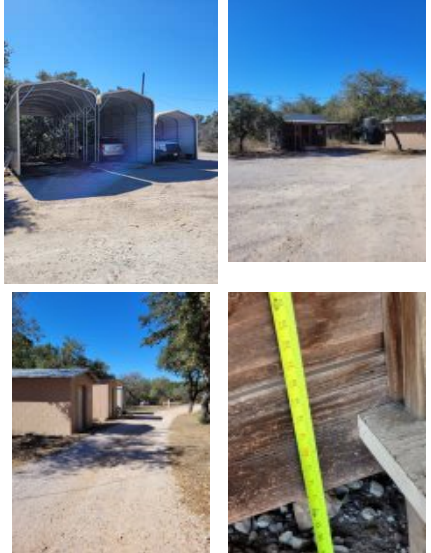
38	Park Site: Maintenance	[30.3189422, -98.2555128]	Spaces and elements within employee work areas shall only be required to comply with 206.2.8, 207.1, and 215.3 and shall be designed and constructed so that individuals with disabilities can approach, enter, and exit the employee work area. Employee work areas, or portions of employee work areas, other than raised courtroom stations, that are less than 300 square feet (28 m2) and elevated 7 inches (180 mm) or more above the finish floor or ground where the elevation is essential to the function of the space shall not be required to comply with these requirements or to be on an accessible route.	no route to car ports, law enforcement shed has 18" step entry, interpretive center has no route, 13" step up, knob no AR to picnic area by interpretive center	For employee spaces, relocate storage, furniture, and other obstacles at doorways to provide approach, enter and exit at the employee space. Provide an accessible route for access to employee buildings. Ramp steps at two door entries to max .25". Replace hardware with lever hardware or hardware operable without a tight pinch or grasp.	2015 ABAAS Section: F203.9 2012 TAS Section: 203.9 2010 ADAS Section: 203.9

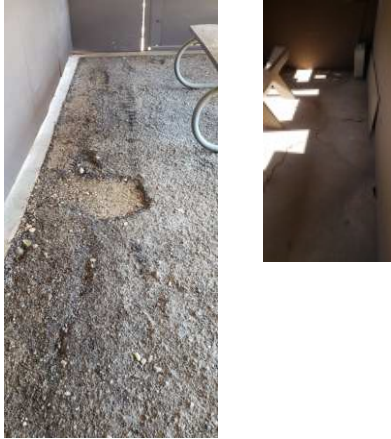
Finding Number	Area Description	Lat/Long	Finding	As Built	Recommendation	Citation	Photos	Figure
44	Park Site: Bird Blinds	[30.3251749 , -98.255797 1]	The floor surface does not appear to be firm, stable and slip resistant. Floor and ground surfaces shall be stable, firm, and slip resistant	deteriorated asphalt and concrete on the interior	Resurface or repair floors to be firm, stable and slip resistant.	2015 ABAAS Section: 302.1 2012 TAS Section: 302.1 2010 ADAS Section: 302.1, 302

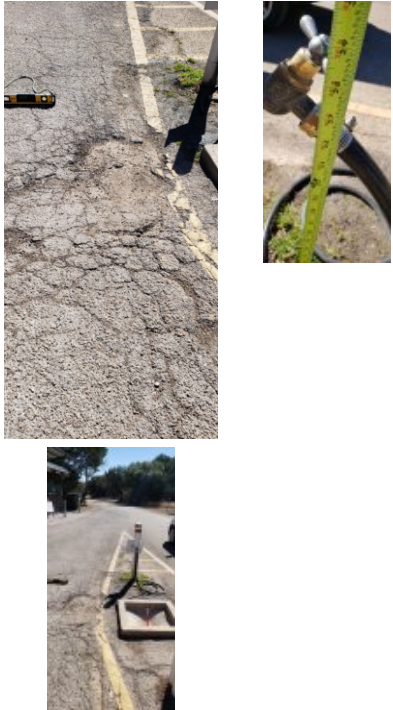
Finding Number	Area Description	Lat/Long	Finding	As Built	Recommendation	Citation	Photos	Figure
49	Park Site: Dump Station	[30.3128456 , -98.249582 4]	The surface of the clear ground space shall be firm and stable The slope of the clear ground space surface shall not be steeper than 1:48 in any direction. EXCEPTION: Where the surface is other than asphalt, concrete, or boards, slopes not steeper than 1:20 shall be permitted when necessary for drainage	deteriorated asphalt at dump station	Correct surface at the dump station to firm, stable and having max slope of 2.08% as a smart practice	2015 ABAAS Section: 1011.2.2, 1011.2.3, 1011.2 EXCEPTION

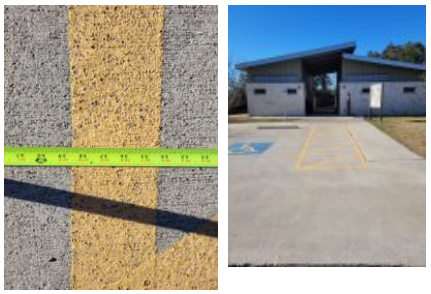
52	Camping Area - Site 63: Camping - Parking by Site 63 and Exterior Accessible Route	[30.31141, -98.2475734]	The access aisle is not a minimum 5 feet wide. A car accessible parking stall's access aisle must be a minimum of 5 feet wide measured from centerline to centerline. Where the access aisle is not adjacent to another parking space or access aisle, measurements shall be permitted to include the full width of the line defining the access aisle.	restroom building by site 63 - 57" width	Repaint access aisles to be 5' each	2015 ABAAS Section: 502.3.1 2012 TAS Section: 502.3.1 2010 ADAS Section: 502.3.1

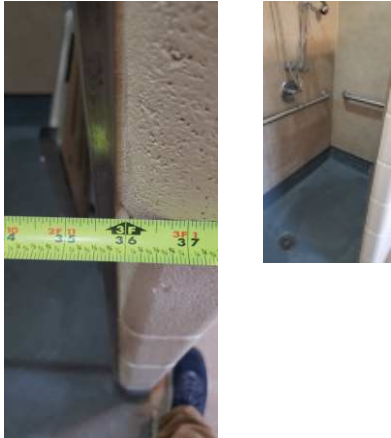
61	Camping Area - Site 63: Camping Area - Men's Restroom By 63	[30.30802, -98.25768]	Where a seat is provided in a standard roll-in shower compartment, it shall be a folding type, shall be installed on the side wall adjacent to the controls, and shall extend from the back wall to a point within 3 inches (75 mm) of the compartment entry. Where a seat is provided in an alternate roll-in type shower compartment, it shall be a folding type, shall be installed on the front wall opposite the back wall, and shall extend from the adjacent side wall to a point within 3 inches (75 mm) of the compartment entry. In transfer-type showers, the seat shall extend from the back wall to a point within 3 inches (75 mm) of the compartment entry. The top of the seat shall be 17 inches (430 mm) minimum and 19 inches (485 mm) maximum above the bathroom finish floor. Seats shall comply with 610.3.1 or 610.3.2.	seat mounted 11" from front of compartment	Provide the correct seat based on shower type and mount to within 3" of the front of the compartment.	2015 ABAAS Section: 610.3 2012 TAS Section: 610.3 2010 ADAS Section: 610.3

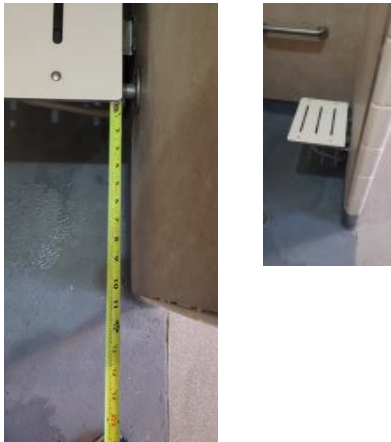
Finding Number	Area Description	Lat/Long	Finding	As Built	Recommendation	Citation	Photos	Figure
62	Camping Area - Site 63: Camping Area - Men's Restroom By 63	[30.30802, -98.25768]	The shower seat does not have a compliant space between it and the seat wall. The folding seat must be mounted 17-19 inches above the floor, and have a maximum space of 2-1/2 inches between the edge of the seat and the seat wall and 1-1/2 inches maximum to the side wall.	seat mounted 11" from wall	Remount shower seat to the correct location and height in the shower. See previous finding.	2015 ABAAS Section: 610.3.1 2012 TAS Section: 610.3.1 2010 ADAS Section: 610.3.1

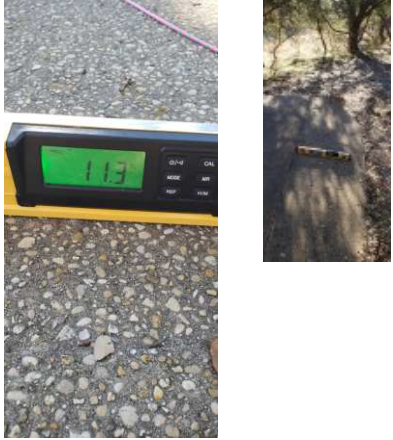
82	Camping Area - Site 63: Campsite Area - Site 67	[30.3118268 , -98.246237 7]	The cross slope shall not be steeper than 1:48. EXCEPTION: Where the surface is other than concrete, asphalt, or boards, cross slopes not steeper than 1:20 shall be permitted when necessary for drainage.	site 67 - 11.3% cross slope	Correct or repair ORAR cross slope to max 2.08% as a smart practice.	2015 ABAAS Section: 1016.7.2, 1016.7.2 EXCEPTION

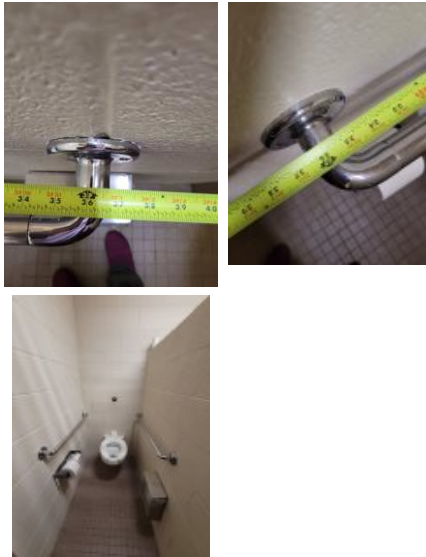
Finding Number	Area Description	Lat/Long	Finding	As Built	Recommendation	Citation	Photos	Figure
145	Trails: Pedernales Falls Trailhead - Women's Restroom	[30.3340696 , -98.252389 3]	The side grab bars are not in the correct location. Grab bars on the side wall must be installed so that the end closest to the rear wall is maximum 12" from the rear wall. The end furthest from the rear wall must be mounted minimum 54" from the rear wall.	both mounted 40" to grab bar end from rear wall	Replace side grab bar with a 42" long bar mounted to max 12" from the rear wall at the close end and min 54" on the far end, and 33" to 36" aff.	2015 ABAAS Section: 604.5.1 2012 TAS Section: 604.5.1 2010 ADAS Section: 604.5.1

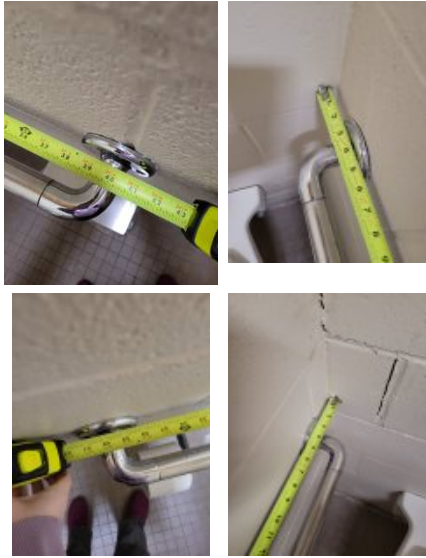
146	Trails: Pedernales Falls Trailhead - Women's Restroom	[30.3340811 , -98.252390 7]	The grab bar height and/or spacing fails. Grab bars must be mounted between 33" and 36" to the top of the gripping surface. There must be 1.5" of clearance between the grab bar and the wall. There must be a minimum of 1.5" of clearance below and minimum 12" above the grab bar to any dispenser or other obstruction.	2.25" clearance between wall and grab bar.	Replace grab bars with ones that provide 1.5" of clearance between the grab bar and the wall. See previous findings for cost.	2015 ABAAS Section: 609.3, 609.4 2012 TAS Section: 609.4, 609.3 2010 ADAS Section: 609.3, 609.4

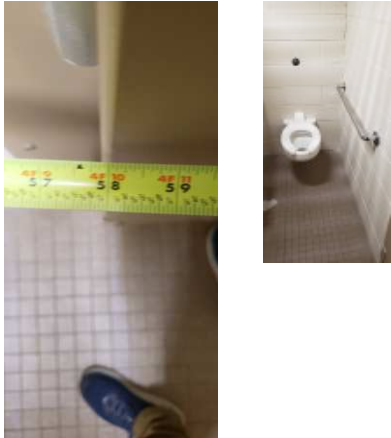
155	Trails: Pedernales Falls Trailhead - Men's Restroom	[30.3340742 , -98.2523907]	The stall door fails to comply with all of the door requirements. The stall door must be a minimum of 32" wide and have compliant hardware on both sides. The stall door must be self-closing.	29" width, not self closing	Widen stall doors to 32" when opened to 90 degrees Adjust stall door to be self-closing	2015 ABAAS Section: 404.2.3, 404.2.7, 604.8.2.2 2012 TAS Section: 404.2.3, 404.2.7, 604.8.2.2 2010 ADAS Section: 404.2.3, 404.2.7, 604.8.2.2
