Access Audit Site Report

Ray Roberts Lake State Park - Greenbelt Unit

Accessibility Evaluation

Inspection Date: 10/20/2021

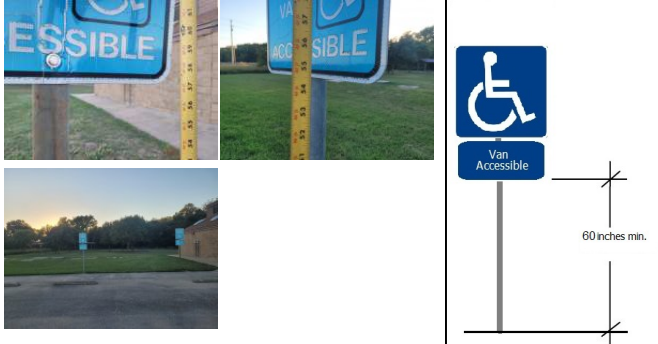
3	FM 428 Access Point: FM 428 - Parking	[33.307607, -97.040826 3]	The parking sign is mounted too low. Parking space identification signs shall include the International Symbol of Accessibility complying with. Signs identifying van parking spaces shall contain the designation "van accessible." Signs shall be 60 inches minimum above the finish floor or ground surface measured to the bottom of the sign.	Van accessible signs are low at 57"	Raise existing accessible parking signs so lowest end of bottom sign is min 60" AFF.	2015 ABAAS Section: 502.6 2012 TAS Section: 502.6 2010 ADAS Section: 502.6

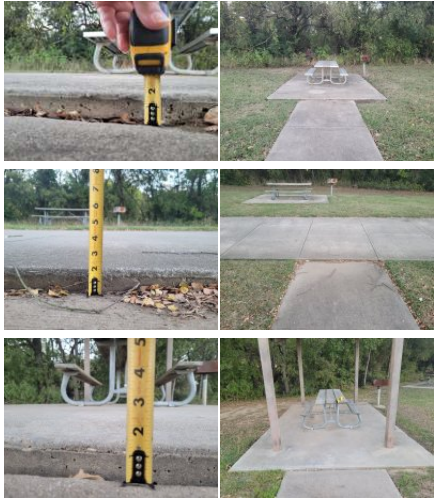
5	FM 428 Access Point: FM 428 - Picnic Area	[33.3076126 , -97.041401 7]	The walkway contains abrupt vertical edges and/or variations over a 1/4 inch. 1/4 inch is the maximum vertical rise. Changes in level between 1/4 inch and 1/2 inch must be beveled at 1:2 or less. Changes in level greater than 1/2 inch must be by way of a ramp.	1.5" change in level (CIL) at picnic area by woods, 2" at picnic area nearest to restrooms, 1.25" at shelter closest to restrooms	Repair, bevel or ramp CIL along AR.	2012 TAS Section: 303.2, 303.3 2010 ADAS Section: 303.2, 303.3

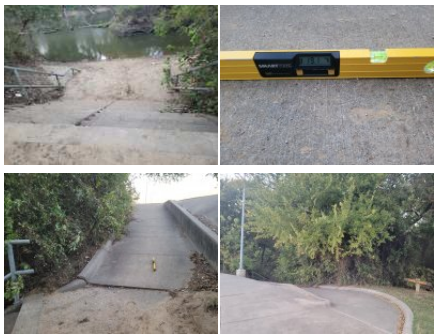
10	FM 428 Access Point: FM 428 - Canoe Launch	[33.30822, -97.04071]	At least one accessible route shall connect accessible buildings, accessible facilities, accessible elements, and accessible spaces that are on the same site. For areas of sport activity, an accessible route is required to connect to the boundary of each area of sport activity. The size of an area of sport activity includes only the space needed to play. Where multiple sports fields or courts are provided, an accessible route is required to each field or area of sport activity.	Canoe launch lacks route, sand/mud has built up onto stairs, stairs steep, ramped area before stairs has 19.1% slope	Provide a compliant ramp having max slopes of 8.33% for access to canoe launch.	2010 ADAS Section: 206.2.2, 206.2

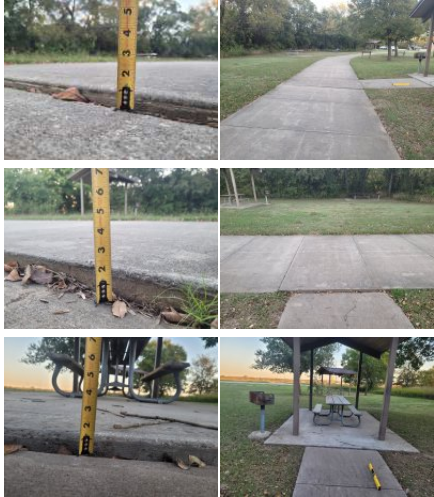
Finding Number	Area Description	Lat/Long	Finding	As Built	Recommendation	Citation	Photos	Figure
11	FM 428 Access Point: FM 428 - Trailhead	[33.3074609 , -97.041437]	Obstacles on outdoor recreation access routes, passing spaces, and resting intervals shall not exceed 1/2 inch (13 mm) in height measured vertically to the highest point. EXCEPTION: Where the surface is other than asphalt, concrete, or boards, obstacles shall be permitted to not exceed 1 inch (25 mm) in height measured vertically to the highest point.	1" change in level (CIL) near accessible picnic area, 2" and 1.25" at picnic area closest to road	Repair, bevel or ramp CIL along the ORAR to max .5" or 1" for surfaces other than concrete, asphalt or boards as a smart practice.	2015 ABAAS Section: 1016.5, 1016.5 EXCEPTION

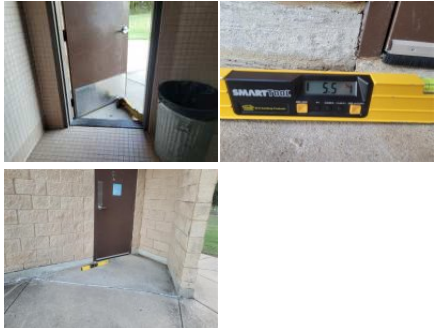
18	FM 428 Access Point: FM 428 - Men's Restroom	[33.3076483, -97.0408969]	Minimum maneuvering clearances at doors and gates shall comply with 404.2.4. Maneuvering clearances shall extend the full width of the doorway and the required latch side or hinge side clearance. Maneuvering clearances shall have a max slope of 2.08%.	men's restroom - garbage can push side, 5.5% slope	For all doors along the public circulation route, provide required maneuvering clearance on push and pull side of doors. For all doors along the public circulation route, correct slope in door clearance to max 2.08%.	2010 ADAS Section: 404.2.3, 404.2.7, 404.2.4, 404.2.11, 404.2.11 Exception

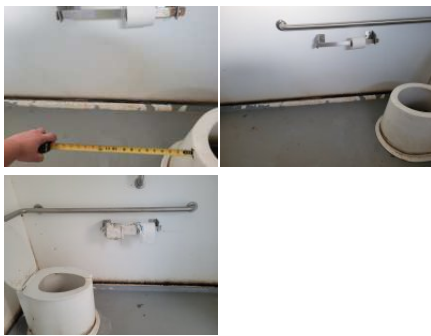
45	US 380 Access Point: US 380 - Restroom	[33.2405122 , -97.041613 6]	The toilet paper is not installed within the compliant range in front of the toilet. Toilet paper dispensers shall be 7 inches minimum and 9 inches maximum in front of the water closet measured to the centerline of the dispenser. The outlet of the dispenser shall be 15 inches minimum and 48 inches maximum above the finish floor and shall not be located behind grab bars. Dispensers shall not be of a type that controls delivery or that does not allow continuous paper flow. There shall be a clearance of 1 1/2 inches minimum below the grab bar.	TP too far from front of toilet in both restrooms	Remount toilet paper dispenser max 7" to 9" from front of toilet, 15" to 48" AFF and min 12" above or 1.5" below grab bar.	2015 ABAAS Section: 604.7 2012 TAS Section: 604.7 2010 ADAS Section: 604.7
