Access Audit Site Report

Ray Roberts Lake State Park/Complex

Accessibility Evaluation

Inspection Date: 10/18/2021

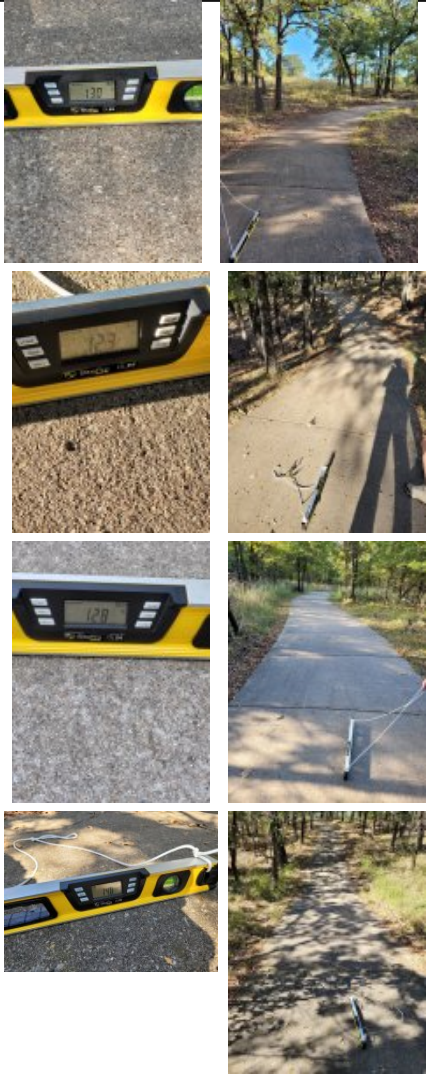
Finding Number	Area Description	Lat/Long	Finding	As Built	Recommendation	Citation	Photos	Figure
56	Isle Du Bois Unit: IDB - Trails	[33.3760468 , -97.018739 4]	There are openings in the surface of the trails, passing spaces, and resting intervals that allow the passage of a sphere more than 1/2 inch in diameter. Openings in the surface of trails, passing spaces, and resting intervals shall not allow the passage of a sphere more than 1/2 inch (13 mm) in diameter.	Randy Bell Trail - 4" near bollard at Hawthorn kiosk, 5" near path to Hawthorn camping area, 6" opening, 1" gap near bollard, 2" gap at bollard, 6" gap nearing main road, 1" gap along side of water tower; spur trail: 1.25" at ravine	Correct for fill gaps to max .5" as a smart practice.	2015 ABAAS Section: 1017.6

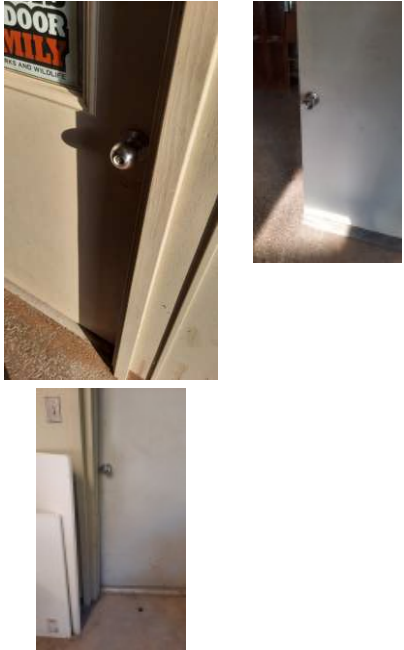
89	Isle Du Bois Unit: IDB - Maintenance	[33.3769719, -97.0076779]	The restroom is not compliant. The restroom does not have the required minimum clear floor space or maneuvering clearances for the toilet. The restroom does not have the required minimum clear floor space or maneuvering clearances for the lavatory. The entry door does not contain the required minimum maneuvering spaces on the pull/push sides. The entry door encroach into the required clear floor space for fixtures. Grab bars are missing and/or incorrectly installed. Accessories, such as toilet seat covers, paper towel holders, garbage cans, hand dryers, and mirrors are either too high or without clear floor space or both.	Law Enforcement Restroom - lacks compliant features - 35" wide by 65" deep	Create a compliant wheelchair accessible restroom and correct all features to be accessible if feasible.	2015 ABAAS Section: 603.1 2012 TAS Section: 603.1 2010 ADAS Section: 603.1

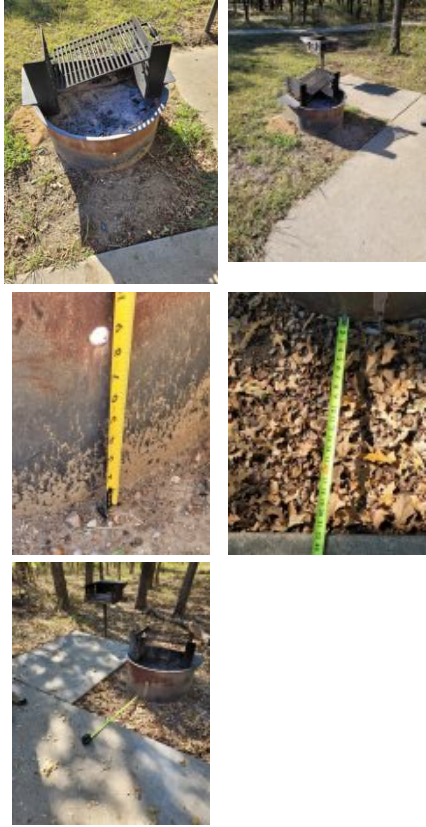
172	Isle Du Bois Unit: IDB - Deer Ridge Campsites	[33.3764164 , -97.024541]	Camping facilities shall provide camping units with mobility features complying with F244.2 in accordance with Table F244.2. Where a camping facility provides different types of camping units, Table F244.2 shall apply to each type of camping unit provided. Total Number of Camping Units Provided in Camping Facility Minimum Number of Camping Units with Mobility Features Required 1 1 2 to 25 2 26 to 50 3 51 to 75 4 76 to 100 5 101 to 150 7 151 to 200 8 201 and over 8, plus 2 percent of the number over 200	76 sites, 4 accessible site	Create the required number of accessible camp sites per table F244.2 as a smart practice.	2015 ABAAS Section: F244.2

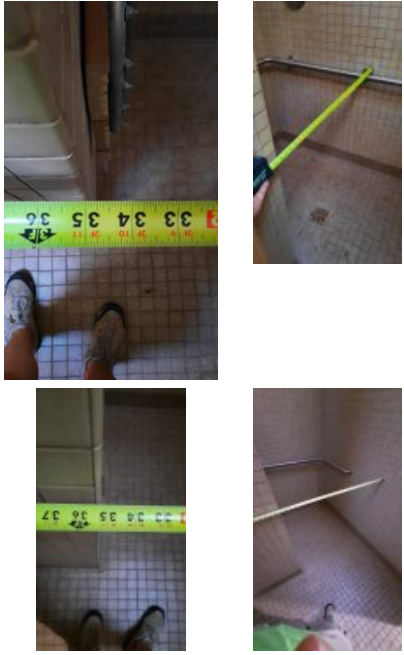
Finding Number	Area Description	Lat/Long	Finding	As Built	Recommendation	Citation	Photos	Figure
209	Isle Du Bois Unit: IDB - Deer Ridge East Women's Restroom	[33.42978, -97.05647]	The operable parts of controls are incorrectly installed. In alternate roll-in type shower compartments, the controls, faucets, and shower spray unit shall be located above the grab bar, but no higher than 48 inches (1220 mm) above the shower floor. Where a seat is provided, the controls, faucets, and shower spray unit shall be located on the side wall adjacent to the seat 27 inches (685 mm) maximum from the side wall behind the seat or shall be located on the back wall opposite the seat 15 inches (380 mm) maximum, left or right, of the centerline of the seat. Where a seat is not provided, the controls, faucets, and shower spray unit shall be installed on the side wall farthest from the compartment entry.	Shower control at 49"	Remount shower controls to the correct location in the alternate shower with compliant lever hardware.	2015 ABAAS Section: 608.5.3 2012 TAS Section: 608.5.3 2010 ADAS Section: 608.5.3

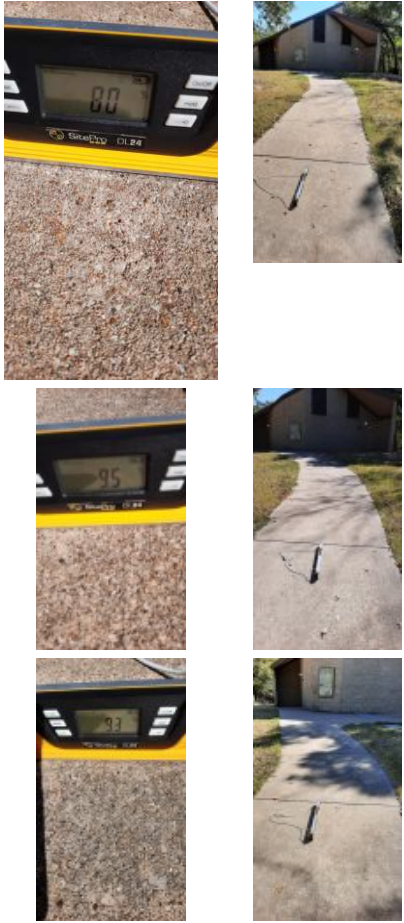
Finding Number	Area Description	Lat/Long	Finding	As Built	Recommendation	Citation	Photos	Figure
228	Isle Du Bois Unit: IDB - Deer Ridge West Men's Restroom	[33.37521, -97.02203]	The accessible route of travel contains cross slopes greater than 2%. Cross slopes shall not exceed one unit vertical in 48 units horizontal (2-percent slope).	Slopes: 3.8% and 2.4% from parking to RR	Correct or repair cross slope along AR to max 2.08%.	2015 ABAAS Section: 403.3 2012 TAS Section: 403.3 2010 ADAS Section: 403.3

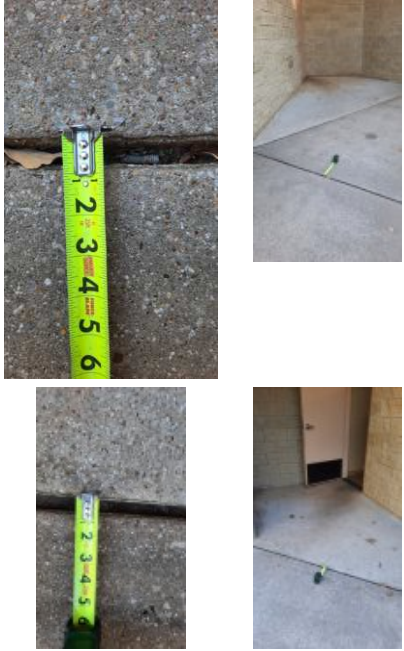
Finding Number	Area Description	Lat/Long	Finding	As Built	Recommendation	Citation	Photos	Figure
308	Isle Du Bois Unit: IDB - Quail Run Men's Restroom	[33.42978, -97.05647]	The running slope of walking surfaces shall not be steeper than 1:20.	12.5%, 15.3%, 14.2% on path along as area to back sites	Correct running slope along the AR to max 5%.	2015 ABAAS Section: 403.3 2012 TAS Section: 403.3 2010 ADAS Section: 403.3		
309	Isle Du Bois Unit: IDB - Quail Run Men's Restroom	[33.42978, -97.05647]	The accessible route of travel on the accessible route contains cross slopes greater than 2%. Cross slopes shall not exceed one unit vertical in 48 units horizontal (2-percent slope).	3%, 2.6% from parking to Men's, 3.3% along parking, 5.1% on path along playground to back sites	Correct or repair cross slope along AR to max 2.08%	2015 ABAAS Section: 403.3 2012 TAS Section: 403.3 2010 ADAS Section:

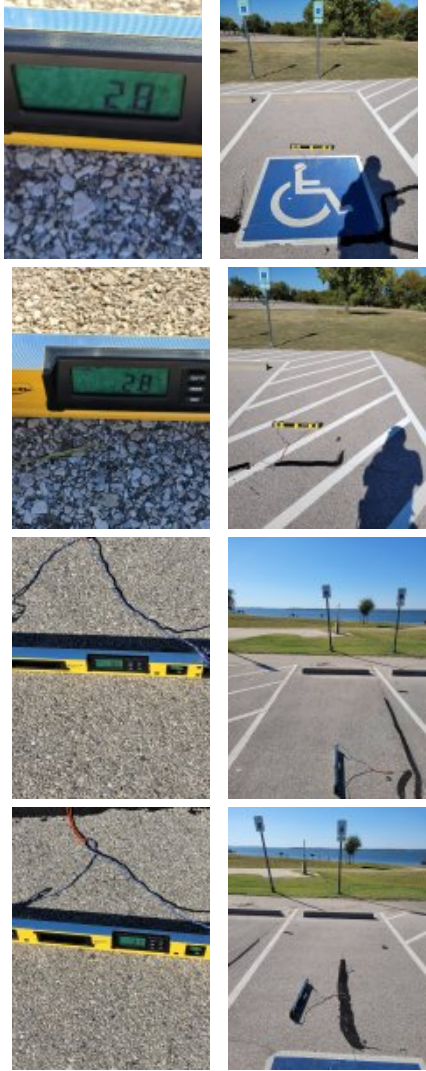
Finding Number	Area Description	Lat/Long	Finding	As Built	Recommendation	Citation	Photos	Figure
342	Isle Du Bois Unit: IDB - Day Use Parking	[33.3789911, -97.0318594]	The cross slopes (narrow dimension) and/or running slopes (long dimension) of the access aisle exceeds 2%. The running slope and the cross slope in an accessible parking stall and the access aisle must not exceed 2%.	Trailer area 2 spaces, Pier area 2 spaces Left (L) or Right (R): L space 3.0%, R space 2.3%. 3 (2 van) shelter area 1: 3rd space 2.7%. 2 (2 van) shelter area 2. (2 van) shelter area 3. 2 (1 van) volleyball area: L space 2.6%, aisle 2.9%, R space 2.9%	Repair or correct slope of parking space and access aisle to max 2.08% in any direction	2015 ABAAS Section: 502.4 2012 TAS Section: 502.4 2010 ADAS Section: 502.4

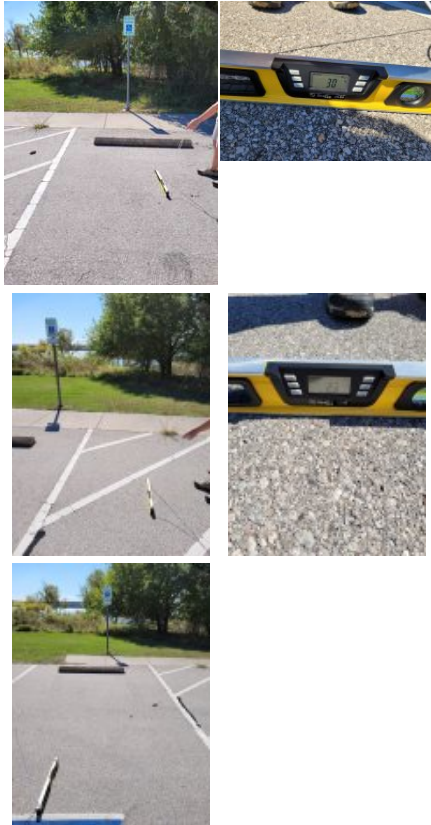
470	Isle Du Bois Unit: IDB - Deer Ridge Parking - West Restroom	[33.3759864 , -97.025823 1]	The cross slopes (narrow dimension) and/or running slopes (long dimension) of the access aisle exceeds 2%. The running slope and the cross slope in an accessible parking stall and the access aisle must not exceed 2%.	Slopes: left (L) stall 3.5%, 2.3% access aisle, 4.7% right (R) stall	Repair or correct slope of parking space and access aisle to max 2.08% in any direction	2015 ABAAS Section: 502.4 2012 TAS Section: 502.4 2010 ADAS Section: 502.4

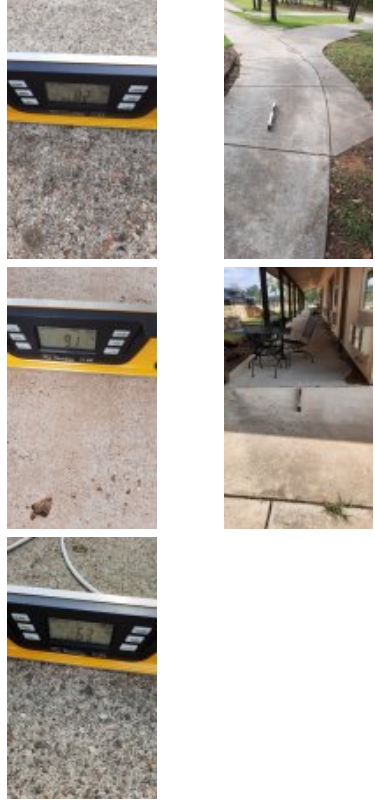
495	Jordan Park: Jordan - Lone Star Lodge Exterior Accessible Route	[33.4055631 , -97.000342 1]	The surface of outdoor recreation access routes, passing spaces, and resting intervals shall be firm and stable	Lacks route to picnic area near blg 2	Extend a firm and stable ORAR to to picnic area as a smart practice.	2015 ABAAS Section: 1016.2

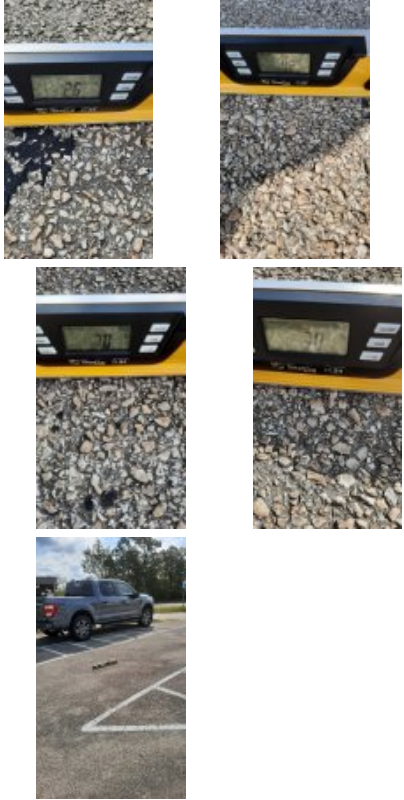
578	Jordan Park: Jordan - Boat Ramp Parking	[33.4010938 , -97.005261 3]	The access aisle is on the driver's side of the stall. Access aisles must be located on the passenger side of the stall for angled van accessible stalls.	Van stall aisle on driver side	Relocate access aisle to the passenger side of the stall.	2015 ABAAS Section: 502.3.4 2012 TAS Section: 502.3.4 2010 ADAS Section: 502.3.4

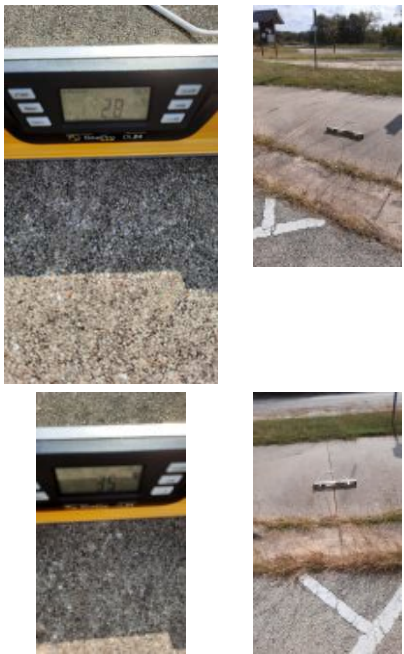
583	Jordan Park: Jordan - Boat Ramp	[33.4010781 , -97.005269 3]	The curb ramp side flares are too steep. The sides of curb ramps (curb ramp flares) where provided, shall not be steeper than 1:10.	Slopes: ramp 1 - left flare 12.6%, right 12.8%; ramp 2 - left 15.7%, right 16.4%; 3rd ramp - left 11.6%, right 18.7%; 4th ramp - left 14.6%, right 18.7%	Correct slope of curb ramp side flares to max 10%.	2015 ABAAS Section: 406.3 2012 TAS Section: 406.1, 406.3 2010 ADAS Section: 406.1, 406.3

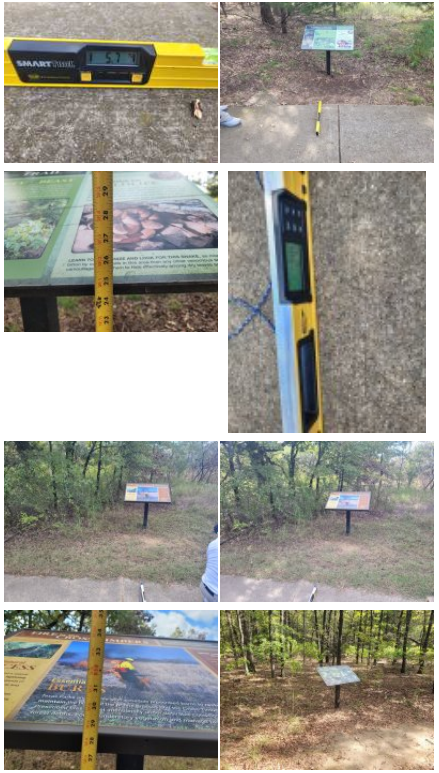
Finding Number	Area Description	Lat/Long	Finding	As Built	Recommendation	Citation	Photos	Figure
709	Johnson Branch Unit: Johnson - Trails	[33.4241031, -97.053423]	There are openings in the surface of the trails, passing spaces, and resting intervals that allow the passage of a sphere more than 1/2 inch in diameter. Openings in the surface of trails, passing spaces, and resting intervals shall not allow the passage of a sphere more than 1/2 inch (13 mm) in diameter.	Paved Loop Trail - 7" gap near Dogwood crossing, 2" gap across main crossing near Dogwood, 4.5" gap past dogwood, 1.25" gap, 3" gap, (multiple gaps in 1-2").	Correct for fill gaps to max .5" as a smart practice.	2015 ABAAS Section: 1017.6

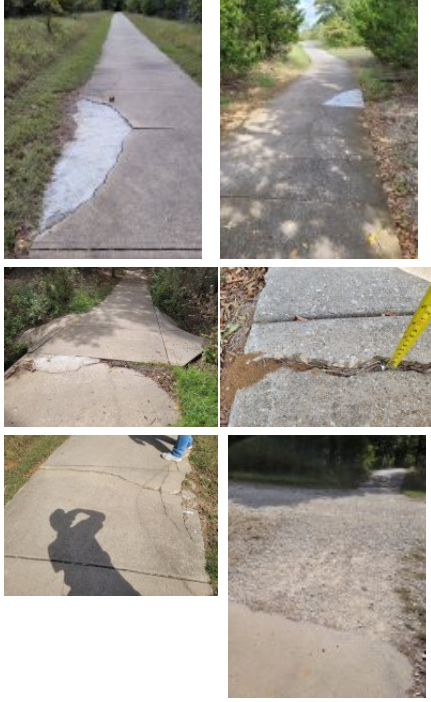
710	Johnson Branch Unit: Johnson - Trails	[33.4238882 , -97.053423]	Tread obstacles on trails, passing spaces, and resting intervals shall not exceed 1/2 inch (13 mm) in height measured vertically to the highest point. EXCEPTION: Where the surface is other than asphalt, concrete, or boards, tread obstacles shall be permitted to not exceed 2 inches (50 mm) in height measured vertically to the highest point.	Paved Loop Trail - 1" rise at main road crossing to Dogwood & 3/4" rise at crack, 1" rise at cross timbers sign (multiple areas with 1"-2" rise), 1.5" broken/repared section (multiple patches), 2" rise at playground	Repair, bevel or ramp tread obstacle along pathway to max .5" as a smart practice.	2015 ABAAS Section: 1017.5

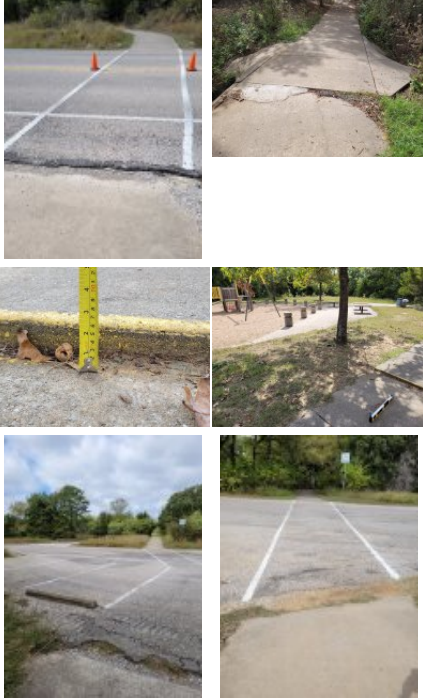
711	Johnson Branch Unit: Johnson - Trails	[33.4221599 , -97.054839 2]	The cross slope shall not be steeper than 1:48. EXCEPTION: Where the surface is other than concrete, asphalt, or boards, cross slopes not steeper than 1:20 shall be permitted when necessary for drainage.	Paved Loop Trail - 3.5% at dogwood trailhead, multiple cross slopes not to exceed 13.5%	Correct or repair pathway cross slope to max 2.08% as a smart practice.	2015 ABAAS Section: 1017.2

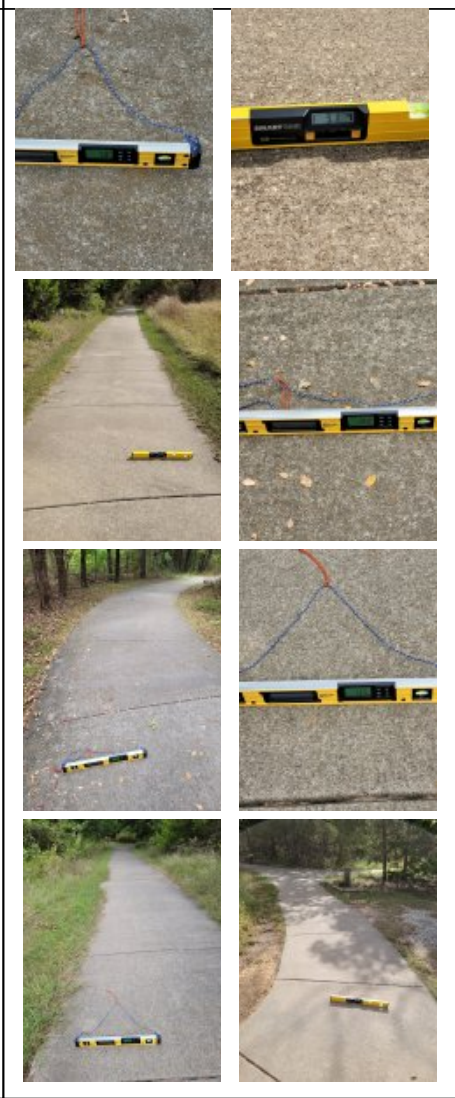
712	Johnson Branch Unit: Johnson - Trails	[33.4239777, -97.0534981]	Not more than 30 percent of the total length of a trail shall have a running slope steeper than 1:12 (8.33%). The running slope of any segment of a trail shall not be steeper than 1:8 (12%). Where the running slope of a	Paved Loop Trail - 12.2% slope near Dogwood Main Rd Crossing & 14.2% across the road,	Frequently maintain trail running slope to assure it does not exceed 8.33% slope for 200' max, 10% for 30' max or 12.5% for 10' with resting spaces on the trail as a smart practice.	2015 ABAAS Section: 1017.7.1

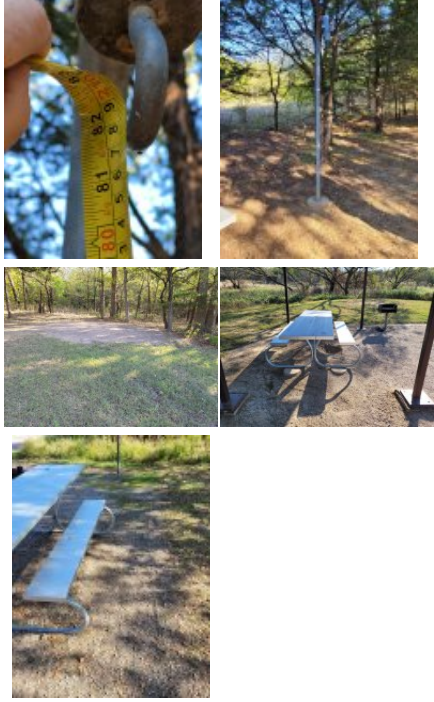
719	Johnson Branch Unit: Johnson - Dogwood Canyon Campsites	[33.4215465 , -97.054689]	Fire building surfaces shall be 9 inches (230 mm) minimum above the ground	Site 135: fire building surface not raised	Correct fire building surface to be 9" min above the ground as a smart practice. In the alternative, acquire an ADA model as a smart practice.	2015 ABAAS Section: 1011.5.1

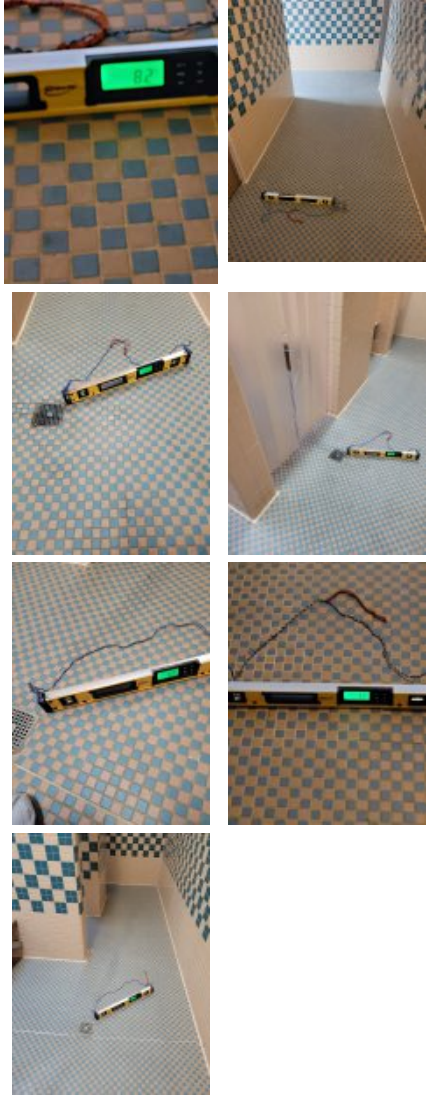
Finding Number	Area Description	Lat/Long	Finding	As Built	Recommendation	Citation	Photos	Figure
838	Johnson Branch Unit: Johnson - Juniper Cove Men's Restroom	[33.418569, -97.053423]	Floor or ground surface within required maneuvering clearances shall comply with 302. Changes in level are not permitted. EXCEPTIONS: 1. Slopes not steeper than 1:48 shall be permitted. 2. Changes in level at thresholds complying with 404.2.5 shall be permitted.	Shower side door - 4.1% slope on pull side	Correct or repair slope at doorway landing to max 2.08% in any direction for level landing.	<p>2015 ABAAS Section: 404.2.4.4, 404.2.4.4 EX CEPTIONS: 1, 404.2.4.4 E XCEPTIONS: 2</p> <p>2012 TAS Section: 404.2.4.4, 404.2.4.4 Exception 1, 404.2.4.4 Exception 2</p> <p>2010 ADAS Section: 404.2.4.4, 404.2.4.4 Exception 1, 404.2.4.4 Exception 2</p>

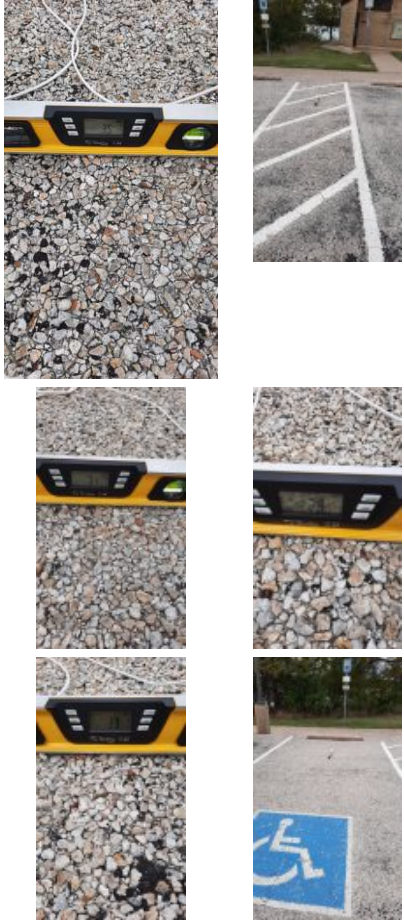
Finding Number	Area Description	Lat/Long	Finding	As Built	Recommendation	Citation	Photos	Figure
982	Johnson Branch Unit: Johnson - Boat Ramp Parking	[33.4091366, -97.04992]	The parking stall contains abrupt edges and surface irregularities over a 1/4 inch vertical. Parking spaces and access aisles serving them shall be stable, firm, and slip resistant. Access aisles shall be at the same level as the parking spaces they serve. Changes in level are not permitted and shall not be sloped steeper than 2% in any direction.	RR - surface very degraded with loose gravel	Resurface accessible stalls and access aisles with a firm, stable, and slip resistant material, cost included in slope correction.	2015 ABAAS Section: 502.4 2012 TAS Section: 502.4 2010 ADAS Section: 502.4
