Access Audit Site Report

Resaca de la Palma State Park
1000 New Carmen Ave
Brownsville, TX 78520
Accessibility Evaluation
Inspection Date: 07/12/2022
Inspectors: Tanya Scheibe

Prepared By
WT Group

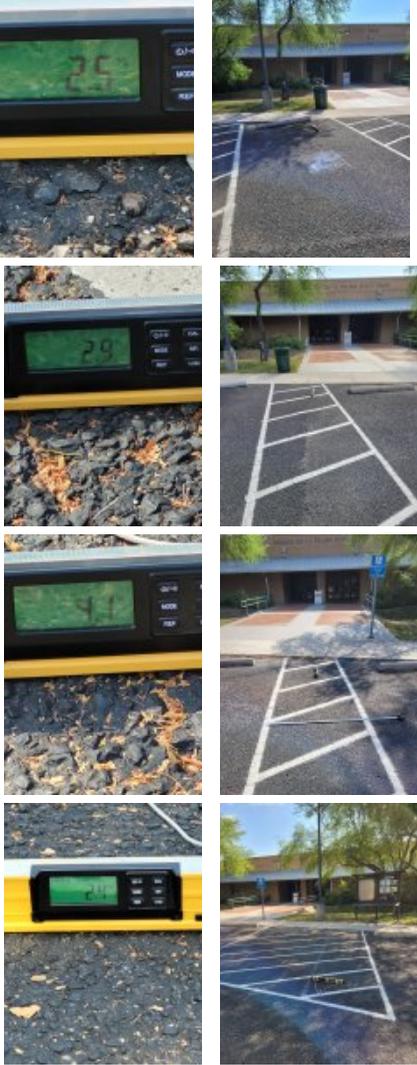
3	Exterior: Parking	[25.9966813, -97.569041 9]	The cross slopes (narrow dimension) and/or running slopes (long dimension) of the access aisle exceeds 2%. The running slope and the cross slope in an accessible parking stall and the access aisle must not exceed 2%.	HQ main building- 4.9% left aisle; 2.5% left stall; 2.9% left center aisle; 4.1% right center aisle; 2.4% right aisle	Repair or correct slope of parking space and access aisle to max 2.08% in any direction.	2015 ABAAS Section: 502.4 2012 TAS Section: 502.4 2010 ADAS Section: 502.4

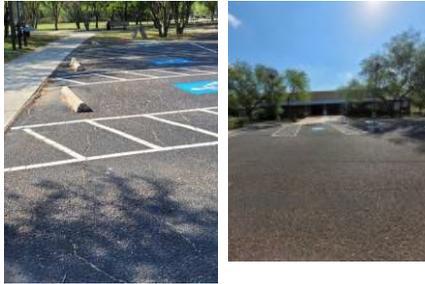
Finding Number	Area Description	Lat/Long	Finding	As Built	Recommendation	Citation	Photos	Figure
4	Exterior: Parking	[25.9967042 , -97.569027 2]	The parking stall contains abrupt edges and surface irregularities over a 1/4 inch vertical. Parking spaces and access aisles serving them shall be stable, firm, and slip resistant. Access aisles shall be at the same level as the parking spaces they serve. Changes in level are not permitted and shall not be sloped steeper than 2% in any direction.	HQ Main building - Gaps beginning to form at the head of the stalls, areas at .5"	Resurface stalls and access aisles to eliminate gaps and cracks.	2015 ABAAS Section: 502.4 2012 TAS Section: 502.4 2010 ADAS Section: 502.4

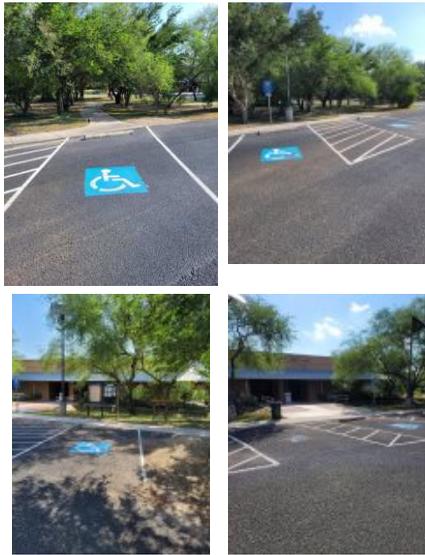
5	Exterior: Parking	[25.9966765 , -97.569036 6]	The accessible parking stall signage is incorrect and/or missing from each accessible parking space. Parking space identification signs shall include the International Symbol of Accessibility. Signs identifying van parking spaces shall contain the designation "van accessible." Signs shall be 60 inches minimum above the finish floor or ground surface measured to the bottom of the sign.	left stall in main lot, lacks signage; HQ building - 3 of 4 stalls lack signage	Acquire and mount at appropriate heights and locations accessible parking signs where missing.	2015 ABAAS Section: 502.6 2012 TAS Section: 502.6

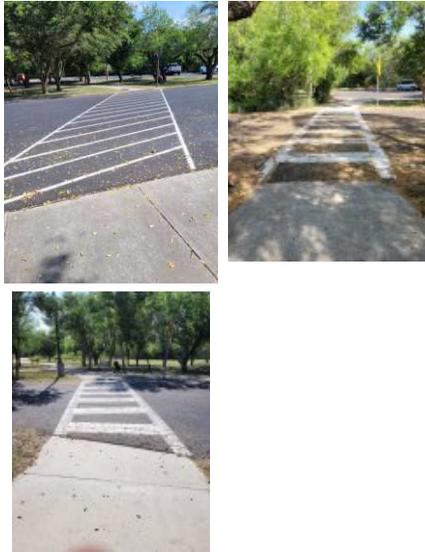
Finding Number	Area Description	Lat/Long	Finding	As Built	Recommendation	Citation	Photos	Figure
6	Exterior: Parking	[25.9966133 , -97.569741 7]	The accessible route of travel that crosses or adjoins the vehicular way and the walking surface is not separated by curbs, railings, or other elements between the pedestrian areas and vehicular areas.	Lacks detectable warning connecting to East parking, bus lot and parking area to visitor center	Install detectable warning where accessible route crosses the vehicular way as a smart practice.	2012 TAS Section: 705.1 2010 ADAS Section: 705

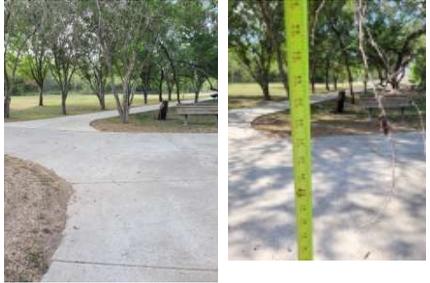
Finding Number	Area Description	Lat/Long	Finding	As Built	Recommendation	Citation	Photos	Figure
9	Exterior: Exterior Accessible Route	[25.9969947 , -97.5690205]	The tree branch extends down too close to the route of travel. Any obstruction that overhangs a route of travel must be a minimum of 80 inches above the walking surface as measured from the bottom of the obstruction.	Overhead clearance reduced to 46" at fork to ebony trail due to tree	Raise tree branches to min 80" and maintain overhead clearance.	2015 ABAAS Section: 307.3 2012 TAS Section: 307.3 2010 ADAS Section: 307.3

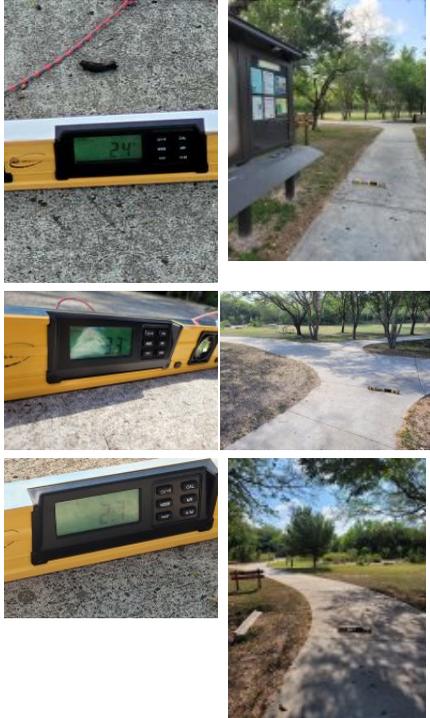
10	Exterior: Exterior Accessible Route	[25.9968452 , -97.5690446]	The accessible route of travel contains cross slopes greater than 2%. Cross slopes shall not exceed one unit vertical in 48 units horizontal (2-percent slope).	2.4% cross on top of ADA stalls on route to ebony ADA trail, 3.3% at fork to ebony, 2.7% over gutter system	Correct or repair cross slope along AR to max 2.08%.	2015 ABAAS Section: 403.3 2012 TAS Section: 403.3 2010 ADAS Section: 403.3

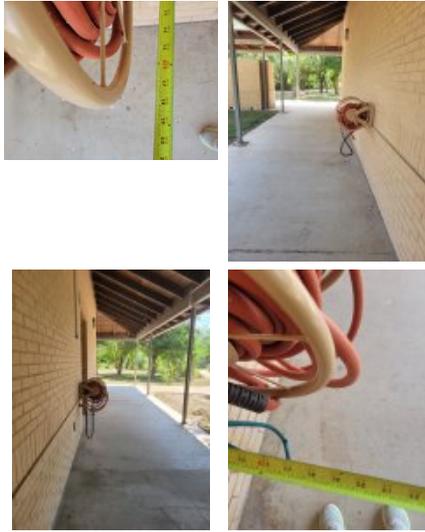
Finding Number	Area Description	Lat/Long	Finding	As Built	Recommendation	Citation	Photos	Figure
13	Exterior: Exterior Accessible Route	[25.9967343 , -97.5688113]	An item or items project more than 4 inches into the circulation path. Wall-mounted objects that have leading edges between 27 inches and 80 inches from the floor must not project more than 4 inches into the circulation path. Protruding objects that extend to the floor or within 27 inches of the floor are cane detectable and are therefore not hazardous. Where it is necessary or desirable to have objects protrude from the wall, a manner of cane detection must be provided.	HQ - Hose reel projects 19" along route on two sides of building	Relocate protruding objects or place cane detectable warning or bollard at foot of item.	2015 ABAAS Section: 307.2 2012 TAS Section: 307.2 2010 ADAS Section: 307.2

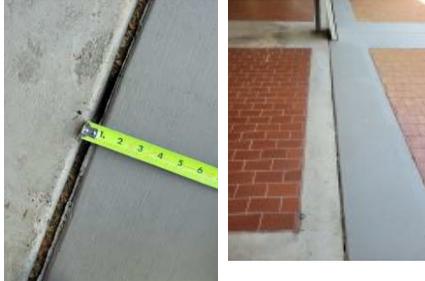
14	Exterior: Exterior Accessible Route	[25.9967235 , -97.5688569]	There is a gap spaced greater than a 1/2 inch. Openings in floor or ground surfaces shall not allow passage of a sphere more than 1/2 inch diameter. Elongated openings shall be placed so that the long dimension is perpendicular to the dominant direction of travel.	.75" gap along entry to HQ	Correct or fill gaps to be max .5"	2015 ABAAS Section: 302.3 2012 TAS Section: 302.3 2010 ADAS Section: 302.3

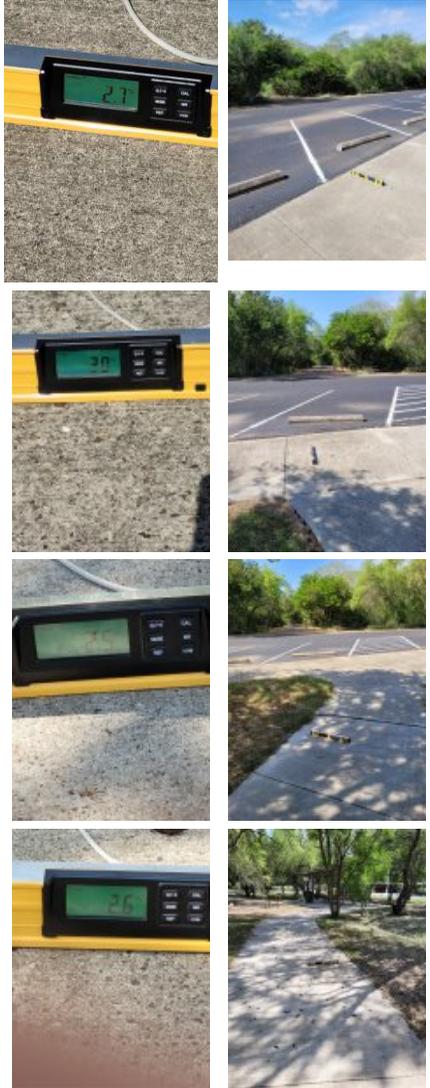
Finding Number	Area Description	Lat/Long	Finding	As Built	Recommendation	Citation	Photos	Figure
15	Exterior: Exterior Accessible Route	[25.9961818 , -97.5688885]	The accessible route of travel contains cross slopes greater than 2%. Cross slopes shall not exceed one unit vertical in 48 units horizontal (2-percent slope).	near end of main trail at parking/ picnic area - 2.7%, 3%, 2.5%; near shelter - 2.6%; from bus lot to east side of parking - 2.8%, 3.1%, continuing on the route 2.4%	Correct or repair cross slope along AR to max 2.08%.	2015 ABAAS Section: 403.3 2012 TAS Section: 403.3 2010 ADAS Section: 403.3

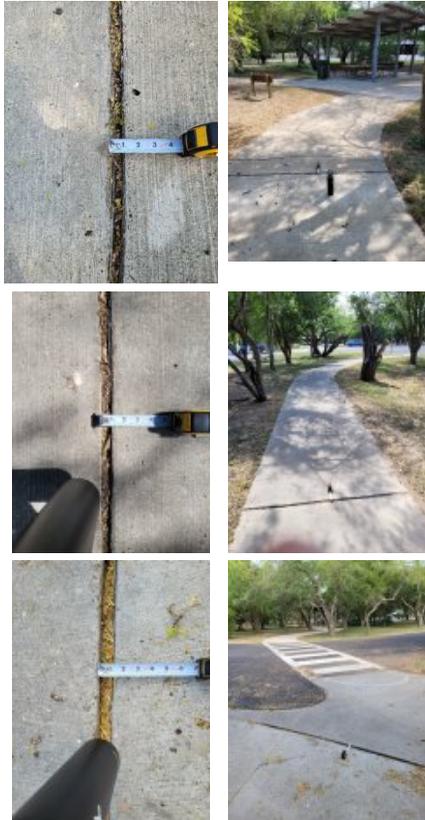
Finding Number	Area Description	Lat/Long	Finding	As Built	Recommendation	Citation	Photos	Figure
16	Exterior: Exterior Accessible Route	[25.9960422 , -97.568934 5]	There is a gap spaced greater than a 1/2 inch. Openings in floor or ground surfaces shall not allow passage of a sphere more than 1/2 inch diameter. Elongated openings shall be placed so that the long dimension is perpendicular to the dominant direction of travel.	1" near shelter; 1" from bus lot to HQ; 1.25" from parking area	Correct or fill gaps to be max .5"	2015 ABAAS Section: 302.3 2012 TAS Section: 302.3 2010 ADAS Section: 302.3

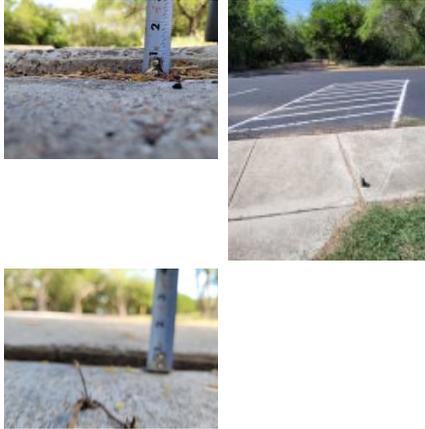
Finding Number	Area Description	Lat/Long	Finding	As Built	Recommendation	Citation	Photos	Figure
17	Exterior: Exterior Accessible Route	[25.9960134 , -97.569591]	The walkway contains abrupt vertical edges and/or variations over a 1/4 inch.	Near end of tram tour near parking/picnic area 1.25" CIL; near parking 1"	Repair, bevel or ramp CIL along AR.	2012 TAS Section: 303.2, 303.3 2010 ADAS Section: 303.2, 303.3

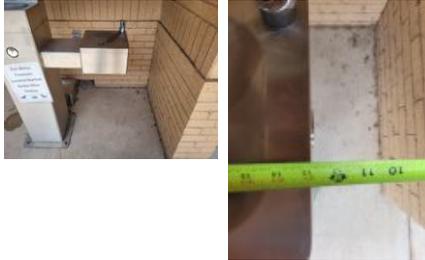
Finding Number	Area Description	Lat/Long	Finding	As Built	Recommendation	Citation	Photos	Figure
21	Headquarters (HQ) : HQ - Public Spaces	[25.9967392 , -97.5688113]	The clear floor space required at accessible drinking fountains is not positioned for a forward approach. Units shall have a clear floor or ground space positioned for a forward approach and centered on the unit.	13" clear floor space on forward approach due to wall, side approach only	Remount or relocate drinking fountain to provide a forward approach 30" X 48" CFS to the fountain.	2015 ABAAS Section: 602.2 2012 TAS Section: 602.2 2010 ADAS Section: 602.2

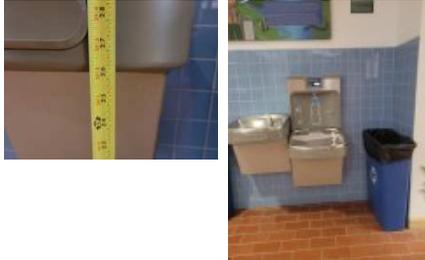
22	Headquarters (HQ) : HQ - Public Spaces	[25.9967488 , -97.5688059]	There is not enough knee clearance under the drinking fountain. The drinking fountain must have a clear knee space between the bottom of the apron and the floor not less than 27 inches in height, 30 inches in width, and 8 inches in depth.	26" knee clearance	Raise drinking fountain to provide required 27" knee clearance.	2015 ABAAS Section: 602.2 2012 TAS Section: 602.2 2010 ADAS Section: 602.2

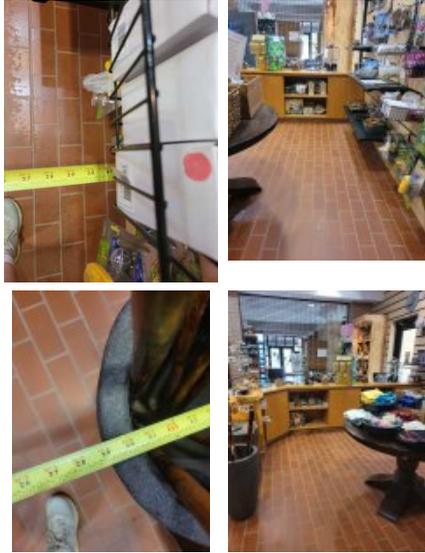
Finding Number	Area Description	Lat/Long	Finding	As Built	Recommendation	Citation	Photos	Figure
24	Headquarters (HQ) : HQ - Public Spaces	[25.996756, -97.5687603]	The route of travel at this location does not provide a minimum width of 36 inches. The clear width shall be permitted to be reduced to 32 inches minimum for a length of 24 inches maximum provided that reduced width segments are separated by segments that are 48 inches long minimum and 36 inches wide minimum.	31" between table and wall, 29" between table and walking sticks	Widen AR to compliant 36" clear width. Relocate furniture and storage.	2015 ABAAS Section: 403.5.1 2012 TAS Section: 403.5.1 2010 ADAS Section: 403.5.1

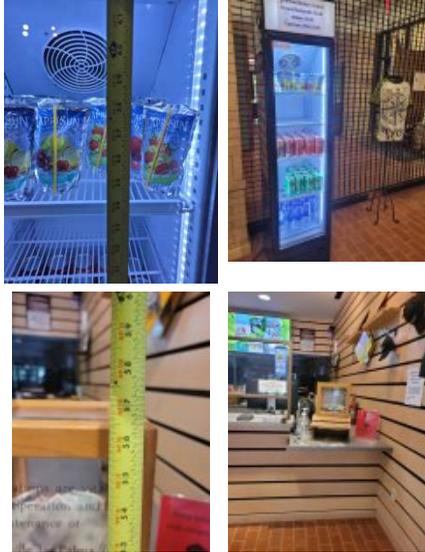
25	Headquarters (HQ) : HQ - Public Spaces	[25.9967392, -97.5687844]	The operable part is positioned too high for either a side or front approach. Where a clear floor or ground space allows a parallel approach to an element and the side reach is unobstructed, the high side reach shall be 48 inches maximum and the low side reach shall be 15 inches minimum above the finish floor or ground. Where a forward reach is unobstructed, the high forward reach shall be 48 inches maximum and the low forward reach shall be 15 inches minimum above the finish floor or ground.	Juice 54" AFF, donate box 56.5" AFF	Remount operable parts to be in reach range of 15" min to 48" max	2015 ABAAS Section: 308.1 2012 TAS Section: 308.1 2010 ADAS Section: 308.1

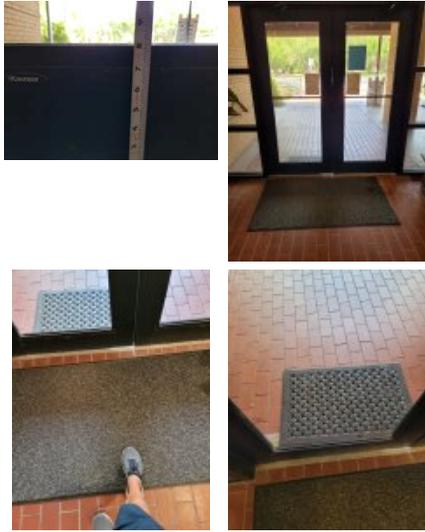
Finding Number	Area Description	Lat/Long	Finding	As Built	Recommendation	Citation	Photos	Figure
31	Headquarters (HQ) : HQ - Public Spaces	[25.9966201 , -97.568738 3]	Minimum maneuvering clearances at doors and gates shall comply with 404.2.4. Maneuvering clearances shall extend the full width of the doorway and the required latch side or hinge side clearance. The bottom 10 inches on the push side must be smooth and free of obstructions (hold open devices). Opening hardware must be mounted between 30 and 44 inches above the floor or ground.	Left exit doors to parking - window starts at 8", rug not secure, outdoor rug loose also	For all doors along the public circulation route, provide required maneuvering clearance on push and pull side of doors. For all doors along the public circulation route, secure rug in door clearance to prevent trip hazard. For all doors along the public circulation route, provide kick plate on push side of door from floor to 10" AFF.	2010 ADAS Section: 404.2.3, 404.2.7, 404.2.4, 404.2.11, 404.2.11 Exception

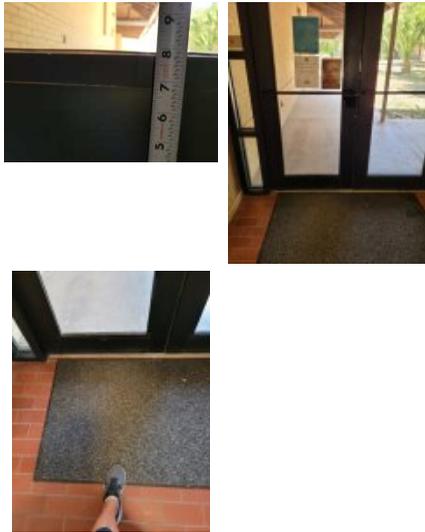
32	Headquarters (HQ) : HQ - Public Spaces	[25.9968564 , -97.568880 4]	Minimum maneuvering clearances at doors and gates shall comply with 404.2.4. Maneuvering clearances shall extend the full width of the doorway and the required latch side or hinge side clearance. Exterior doors are recommended to be maintained at 8.5 lbf as a smart practice. Force is to be measured at the operating hardware or 30 inches from the hinges, whichever is greater. The bottom 10 inches on the push side must be smooth and free of obstructions (hold open devices). Opening hardware must be mounted between 30 and 44 inches above the floor or ground.	North exit doors to tram - window starts at 8", rug not secure, left door 10 lbf	For all doors along the public circulation route, provide required maneuvering clearance on push and pull side of doors. For all doors along the public circulation route, secure rug in door clearance to prevent trip hazard. For all doors along the public circulation route, inspect, adjust, and maintain 8.5 lbf to open exterior doors as a smart practice. For all doors along the public circulation route, provide kick plate on push side of door from floor to 10" AFF.	2010 ADAS Section: 404.2.3, 404.2.7, 404.2.4, 404.2.11, 404.2.11 Exception

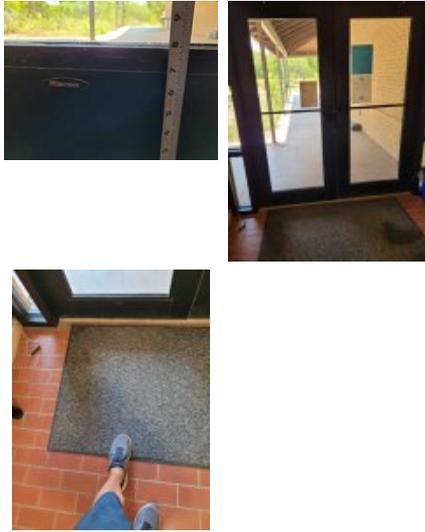
Finding Number	Area Description	Lat/Long	Finding	As Built	Recommendation	Citation	Photos	Figure
33	Headquarters (HQ) : HQ - Public Spaces	[25.9968299 , -97.5688027]	Minimum maneuvering clearances at doors and gates shall comply with 404.2.4. Maneuvering clearances shall extend the full width of the doorway and the required latch side or hinge side clearance. Exterior doors are recommended to be maintained at 8.5 lbf as a smart practice. Force is to be measured at the operating hardware or 30 inches from the hinges, whichever is greater. The bottom 10 inches on the push side must be smooth and free of obstructions (hold open devices). Opening hardware must be mounted between 30 and 44 inches above the floor or ground.	Exit doors to butterfly garden - window starts at 8", rug not secure, left door 13 lbf	For all doors along the public circulation route, provide required maneuvering clearance on push and pull side of doors. For all doors along the public circulation route, secure rug in door clearance to prevent trip hazard. For all doors along the public circulation route, inspect, adjust, and maintain 8.5 lbf to open exterior doors as a smart practice. For all doors along the public circulation route, provide kick plate on push side of door from floor to 10" AFF.	2010 ADAS Section: 404.2.3, 404.2.7, 404.2.4, 404.2.11, 404.2.11 Exception

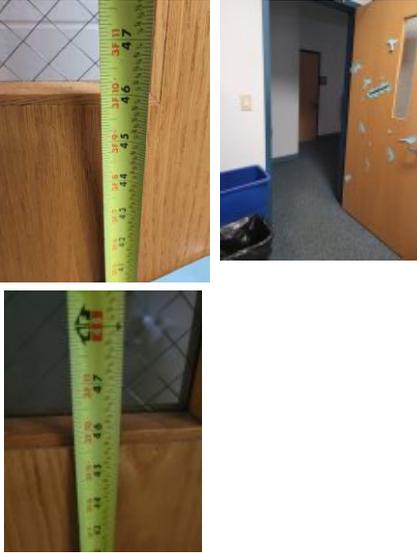
Finding Number	Area Description	Lat/Long	Finding	As Built	Recommendation	Citation	Photos	Figure
35	Headquarters (HQ) : HQ - Employee Spaces	[25.9968693 , -97.5686208]	Spaces and elements within employee work areas shall only be required to comply with 206.2.8, 207.1, and 215.3 and shall be designed and constructed so that individuals with disabilities can approach, enter, and exit the employee work area. Employee work areas, or portions of employee work areas, other than raised courtroom stations, that are less than 300 square feet (28 m2) and elevated 7 inches (180 mm) or more above the finish floor or ground where the elevation is essential to the function of the space shall not be required to comply with these requirements or to be on an accessible route.	Office 118 - window 46" AFF, clearance on pull reduced by trash; office 117 - 46" window	For employee spaces, relocate storage, furniture, and other obstacles at doorways to provide approach, enter and exit at the employee space. Provide required maneuvering clearance on push and pull side of doors. Replace doors with ones having sidelight viewing windows max 43" AFF.	2015 ABAAS Section: F203.9 2012 TAS Section: 203.9 2010 ADAS Section: 203.9

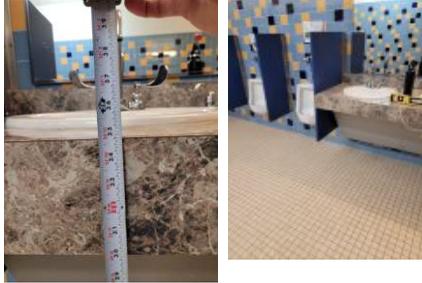
38	Headquarters (HQ) : HQ - Men's Restroom	[25.9967392 , -97.568789 8]	The top rim of the sink is too high. All lavatories/sinks that are designated to be accessible shall be a minimum 17 inches in horizontal depth and mounted with the rim or counter edge no higher than 34 inches above the finished floor.	Sink 35.5" AFF	Lower sinks to max 34" above the finished floor (AFF) to front of rim.	2015 ABAAS Section: 606.3 2012 TAS Section: 606.3 2010 ADAS Section: 606.3

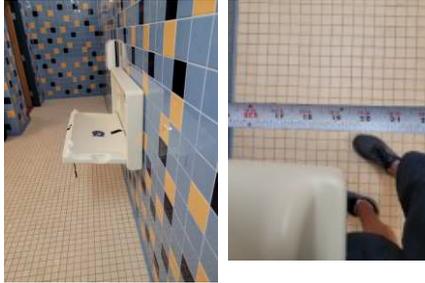
Finding Number	Area Description	Lat/Long	Finding	As Built	Recommendation	Citation	Photos	Figure
39	Headquarters (HQ) : HQ - Men's Restroom	[25.9967343 , -97.568795 2]	The baby changing table is not compliant. Baby changing tables are work surfaces. If fixed or built-in baby changing tables are provided, at least 5%, but not less than one, must comply with TAS 902 based TAS 226.1. Baby changing tables cannot violate the protruding object requirements in either an open or closed position since either position is a potential hazard for persons with visual impairments. Baby changing tables are not prohibited from being located in wheelchair accessible toilet compartments; however, the minimum space required for the compartment cannot be obstructed by the baby changing table in either an open or closed position. The clear floor space required for a baby changing table may overlap the water closet clearance since baby changing tables are considered convenience "fixtures" based on Advisory 604.8.1.1. The overlap is applicable only to the clear floor space and not to actual table itself. Baby changing tables must be dispersed throughout a space, however, an additional baby changing table is not required in a common use area of a toilet or bathing room when the only baby changing table is located in a toilet compartment.	Changing table protrudes 19.5"	Relocate baby changing table to eliminate protrusion when in the open position or place cane detectable warning on sides of baby changing table.	2012 TAS Section: 226.1, 902.3, 604.3.2, 204.1, 226.1 Advisory, 226.2, 307.1, 604.8.1.1 Advisory, 902.1, 902.1 Advisory, 902.2

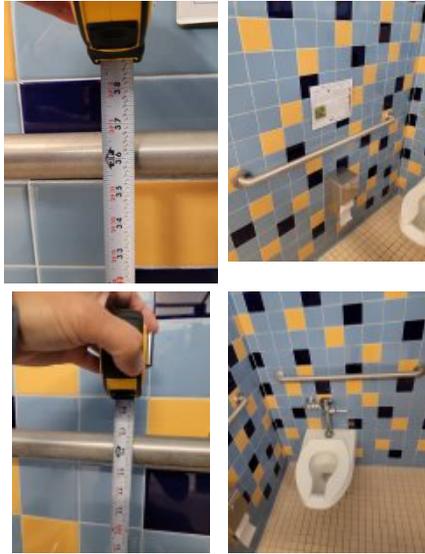
Finding Number	Area Description	Lat/Long	Finding	As Built	Recommendation	Citation	Photos	Figure
40	Headquarters (HQ) : HQ - Men's Restroom	[25.996744, -97.568795 2]	The grab bar height and/or spacing fails. Grab bars must be mounted between 33" and 36" to the top of the gripping surface. There must be 1.5" of clearance between the grab bar and the wall. There must be a minimum of 1.5" of clearance below and minimum 12" above the grab bar to any dispenser or other obstruction.	Both grab bars installed 36.75" AFF	Remount grab bars in accessible stall to 33" to 36" above the finished floor (AFF).	2015 ABAAS Section: 609.3, 609.4 2012 TAS Section: 609.4, 609.3 2010 ADAS Section: 609.3, 609.4

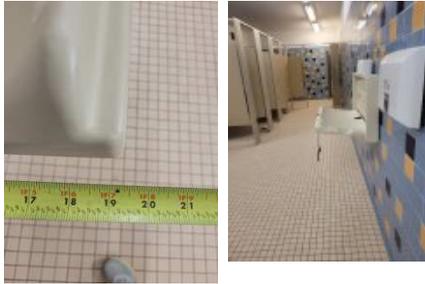
Finding Number	Area Description	Lat/Long	Finding	As Built	Recommendation	Citation	Photos	Figure
45	Headquarters (HQ) : HQ - Women's Restroom	[25.9967609 , -97.568784 4]	The baby changing table is not compliant. Baby changing tables are work surfaces. If fixed or built-in baby changing tables are provided, at least 5%, but not less than one, must comply with TAS 902 based TAS 226.1. Baby changing tables cannot violate the protruding object requirements in either an open or closed position since either position is a potential hazard for persons with visual impairments. Baby changing tables are not prohibited from being located in wheelchair accessible toilet compartments; however, the minimum space required for the compartment cannot be obstructed by the baby changing table in either an open or closed position. The clear floor space required for a baby changing table may overlap the water closet clearance since baby changing tables are considered convenience "fixtures" based on Advisory 604.8.1.1. The overlap is applicable only to the clear floor space and not to actual table itself. Baby changing tables must be dispersed throughout a space, however, an additional baby changing table is not required in a common use area of a toilet or bathing room when the only baby changing table is located in a toilet compartment.	Changing table projects 19.5" when open	Relocate baby changing table to eliminate protrusion when in the open position or place cane detectable warning on sides of baby changing table.	2012 TAS Section: 226.1, 902.3, 604.3.2, 204.1, 226.1 Advisory, 226.2, 307.1, 604.8.1.1 Advisory, 902.1, 902.1 Advisory, 902.2

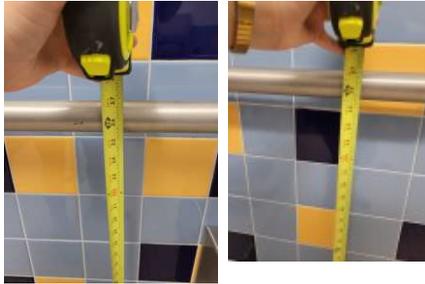
Finding Number	Area Description	Lat/Long	Finding	As Built	Recommendation	Citation	Photos	Figure
49	Headquarters (HQ) : HQ Single Use Restrooms In Employee Area - Mens	[25.9968549 , -97.568639 6]	The grab bar height and/or spacing fails. Grab bars must be mounted between 33" and 36" to the top of the gripping surface. There must be 1.5" of clearance between the grab bar and the wall. There must be a minimum of 1.5" of clearance below and minimum 12" above the grab bar to any dispenser or other obstruction.	Both grab bars installed 37" AFF	Remount grab bars in accessible stall to 33" to 36" above the finished floor (AFF).	2015 ABAAS Section: 609.3, 609.4 2012 TAS Section: 609.4, 609.3 2010 ADAS Section: 609.3, 609.4

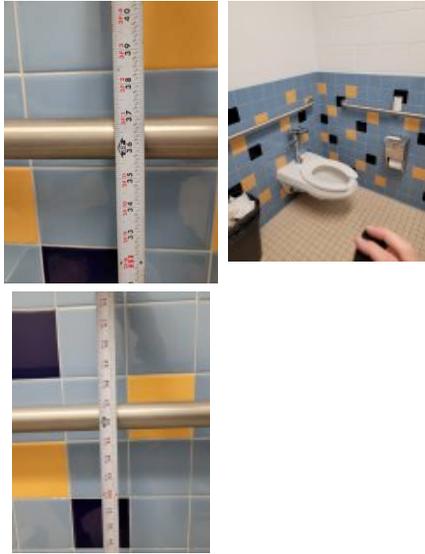
Finding Number	Area Description	Lat/Long	Finding	As Built	Recommendation	Citation	Photos	Figure
52	Headquarters (HQ) : HQ Single Use Restrooms In Employee Space - Womens	[25.9968428 , -97.568655 7]	The grab bar height and/or spacing fails. Grab bars must be mounted between 33" and 36" to the top of the gripping surface. There must be 1.5" of clearance between the grab bar and the wall. There must be a minimum of 1.5" of clearance below and minimum 12" above the grab bar to any dispenser or other obstruction.	Both grab bars mounted 37" AFF	Remount grab bars in accessible stall to 33" to 36" above the finished floor (AFF).	2015 ABAAS Section: 609.3, 609.4 2012 TAS Section: 609.4, 609.3 2010 ADAS Section: 609.3, 609.4

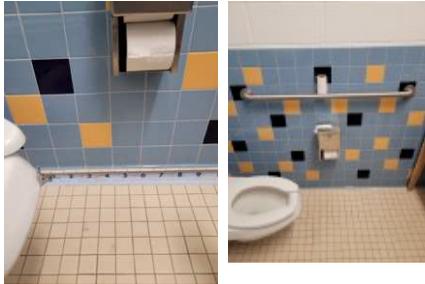
53	Headquarters (HQ) : HQ Single Use Restrooms In Employee Space - Womens	[25.9968018 , -97.568693 2]	The toilet paper is not installed within the compliant range in front of the toilet. Toilet paper dispensers shall be 7 inches minimum and 9 inches maximum in front of the water closet measured to the centerline of the dispenser. The outlet of the dispenser shall be 15 inches minimum and 48 inches maximum above the finish floor and shall not be located behind grab bars. Dispensers shall not be of a type that controls delivery or that does not allow continuous paper flow. There shall be a clearance of 1 1/2 inches minimum below the grab bar.	Toilet paper dispenser 6" from toilet	Remount toilet paper dispenser max 7" to 9" from front of toilet, 15" to 48" aff and min 12" above or 1.5" below grab bar.	2015 ABAAS Section: 604.7 2012 TAS Section: 604.7 2010 ADAS Section: 604.7

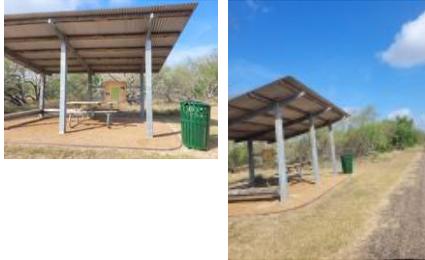
Finding Number	Area Description	Lat/Long	Finding	As Built	Recommendation	Citation	Photos	Figure
57	Tram System: Tram Stops	[25.9823409 , -97.567470 1]	There is no accessible route to the tram stop shelter, garbage or sign. At least one accessible route shall connect accessible buildings, accessible facilities, accessible elements, and accessible spaces that are on the same site.	Lacks accessible route to tram stop by coyote trail; lacks route to trash or sign	Create an accessible route with crushed stone or other outdoor material from parking or walkway to the tram stop shelter, garbage or sign.	2015 ABAAS Section: F206.2.2 2012 TAS Section: 206.2.2 2010 ADAS Section: 206.2.2

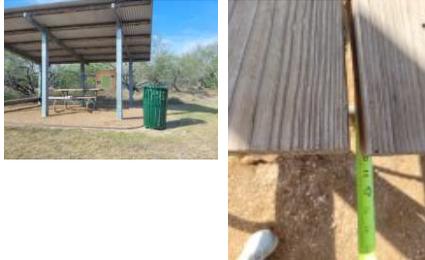
58	Tram System: Tram Stops	[25.9823409 , -97.567475 5]	Picnic tables shall provide at least one wheelchair space for each 24 linear feet (7320 mm) of usable table surface perimeter. Wheelchair spaces shall be 30 inches (760 mm) minimum by 48 inches (1220 mm) minimum. Wheelchair spaces shall be positioned for a forward approach to the table and provide knee and toe clearance complying with 306 under the table	Picnic table at tram stop by Coyote trail does not provide wheelchair space	Replace picnic table with one of an accessible design as a smart practice.	2015 ABAAS Section: 1011.4.2

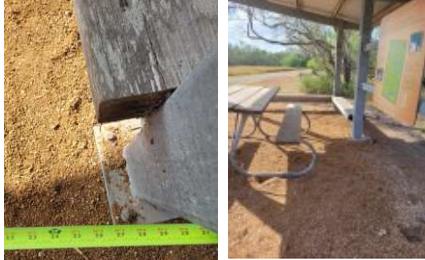
59	Tram System: Tram Stops	[25.9823264 , -97.567480 9]	Picnic tables are required to have clear ground space 36 inches (915 mm) on all usable sides of the table measured from the back edge of the benches.	26" width around table	Provide required 36" clear ground space around all usable portions of the table as a smart practice.	2015 ABAAS Section: 1011.2.1

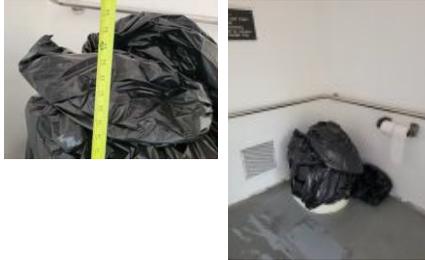
Finding Number	Area Description	Lat/Long	Finding	As Built	Recommendation	Citation	Photos	Figure
64	Restrooms: Mexican Olive Trail - Women's Restroom	[25.9886337 , -97.5641281]	The toilet seat is not located within the range allowed off the floor. The height of accessible water closets shall be a minimum of 17 inches and a maximum of 19 inches measured to the top of a maximum 2-inch high toilet seat.	seems to be 21"	Assure toilet seat is 17" to 19" above the finished floor (AFF).	2015 ABAAS Section: 604.4 2012 TAS Section: 604.4 2010 ADAS Section: 604.4

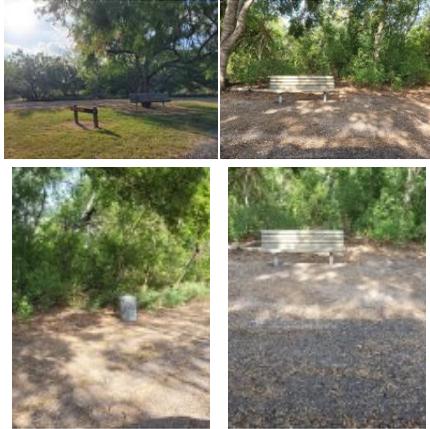
Finding Number	Area Description	Lat/Long	Finding	As Built	Recommendation	Citation	Photos	Figure
66	Park Site: Park Elements	[25.9886723 , -97.5600994]	There is no accessible route to the benches or garbage. At least one accessible route shall connect accessible buildings, accessible facilities, accessible elements, and accessible spaces that are on the same site.	Lacks accessible route to bench under tree by mesquite trailhead; no accessible route to bench and garbage on tram road due to surface	Create an accessible route with crushed stone or other outdoor material from parking or walkway to the benches and garbage.	2015 ABAAS Section: F206.2.2 2012 TAS Section: 206.2.2 2010 ADAS Section: 206.2.2

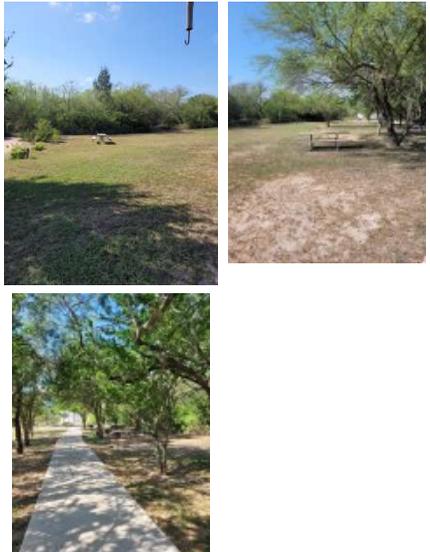
67	Park Site: Park Elements	[25.9961111 , -97.5687978]	There is no accessible route to the tables and grills. At least one accessible route shall connect accessible buildings, accessible facilities, accessible elements, and accessible spaces that are on the same site.	no AR to 5 of 5 picnic tables at HQ, 4 of 4 grills, all tables not of ACC design	Create an outdoor recreation access route to at least 2 tables and grills. Replace two tables with ones of an accessible design.	2015 ABAAS Section: F206.2.2 2012 TAS Section: 206.2.2 2010 ADAS Section: 206.2.2

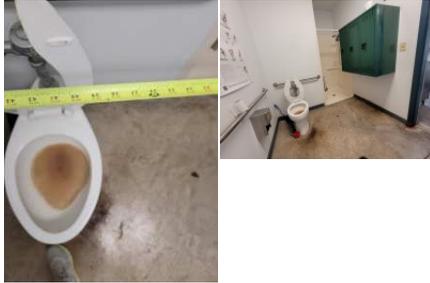
Finding Number	Area Description	Lat/Long	Finding	As Built	Recommendation	Citation	Photos	Figure
79	Employee Areas: Maintenance	[25.997636, -97.570683 4]	The required 56 inches by 60 inches clear floor space for the water closet has been obstructed. The clear floor space around the water closet shall be 60 inches minimum measured perpendicular from the side wall and 56 inches minimum measured perpendicular from the rear wall.	Restroom - 39" between toilet and locker	Relocate lockers to provide required 60" clearance around toilet.	2015 ABAAS Section: 604.3. 2012 TAS Section: 604.3.1 2010 ADAS Section: 604.3.1

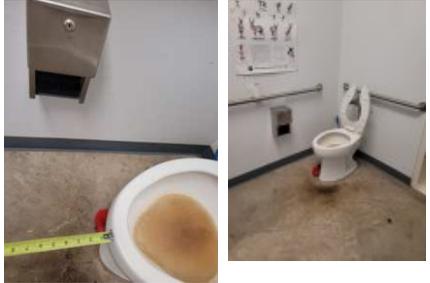
80	Employee Areas: Maintenance	[25.9976215, -97.570694 2]	The toilet paper is not installed within the compliant range in front of the toilet. Toilet paper dispensers shall be 7 inches minimum and 9 inches maximum in front of the water closet measured to the centerline of the dispenser. The outlet of the dispenser shall be 15 inches minimum and 48 inches maximum above the finish floor and shall not be located behind grab bars. Dispensers shall not be of a type that controls delivery or that does not allow continuous paper flow. There shall be a clearance of 1 1/2 inches minimum below the grab bar.	Restroom - Toilet paper dispenser too close to toilet	Remount toilet paper dispenser max 7" to 9" from front of toilet, 15" to 48" aff and min 12" above or 1.5" below grab bar. Do not store supplies on grab bars.	2015 ABAAS Section: 604.7 2012 TAS Section: 604.7 2010 ADAS Section: 604.7

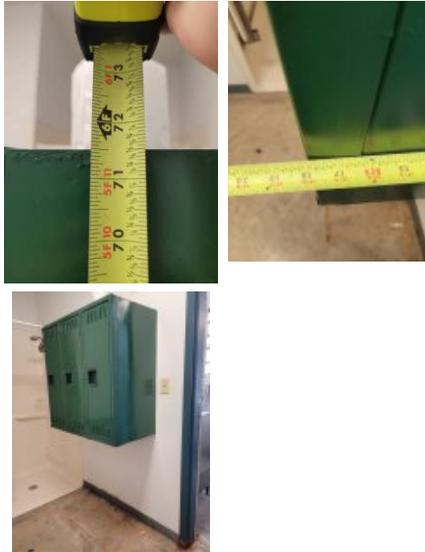
Finding Number	Area Description	Lat/Long	Finding	As Built	Recommendation	Citation	Photos	Figure
81	Employee Areas: Maintenance	[25.997636, -97.570672 7]	An item or items project more than 4 inches into the circulation path. Wall-mounted objects that have leading edges between 27 inches and 80 inches from the floor must not project more than 4 inches into the circulation path. Protruding objects that extend to the floor or within 27 inches of the floor are cane detectable and are therefore not hazardous. Where it is necessary or desirable to have objects protrude from the wall, a manner of cane detection must be provided.	Restroom - Lockers project 18" into circulation path	Relocate protruding objects or place cane detectable warning or bollard at foot of item.	2015 ABAAS Section: 307.2 2012 TAS Section: 307.2 2010 ADAS Section: 307.2

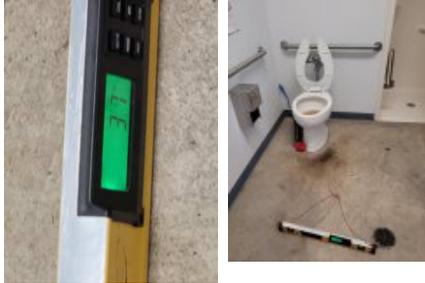
82	Employee Areas: Maintenance	[25.9976408, -97.570694 2]	The accessible path of travel contains cross slopes greater than 2%. Surface cross slopes shall not exceed one unit vertical in 48 units horizontal (2-percent slope). When the slope in the direction of travel of any walk exceeds 1 unit vertical in 20 units horizontal (5-percent slope), it must be constructed as ramp.	Restroom - 3.7% near toilet	Correct or repair cross slope of AR to max 2.08%	2015 ABAAS Section: F206.2.4, 403.3 2012 TAS Section: 206.2.4, 403.3 2010 ADAS Section: 206.2.4, 403.3

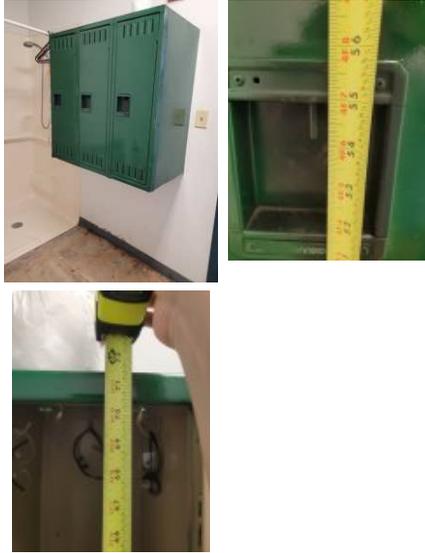
Finding Number	Area Description	Lat/Long	Finding	As Built	Recommendation	Citation	Photos	Figure
83	Employee Areas: Maintenance	[25.9976408 , -97.570694 2]	Accessible lockers are not provided. 5% but not less than one of each type of locker must be accessible. Lockers of different size are considered different types. Although not specifically required, it is considered "best practices" that accessible elements be identified to prevent confusion for those needing accessible elements and to indicate to those that do not need accessible elements that they should only be used if others are unavailable.	Restroom - 0 of 3 symbol of accessibility, Latch 54" AFF; hooks 69.5" AFF	Designate 5% or no less than 1 locker as accessible with accessible hardware. Mount signage with the access symbol as a (smart practice). Mount hooks and operating mechanisms max 48" AFF.	2015 ABAAS Section: F225.2.1 2012 TAS Section: 225.2.1 2010 ADAS Section: 225.2.1

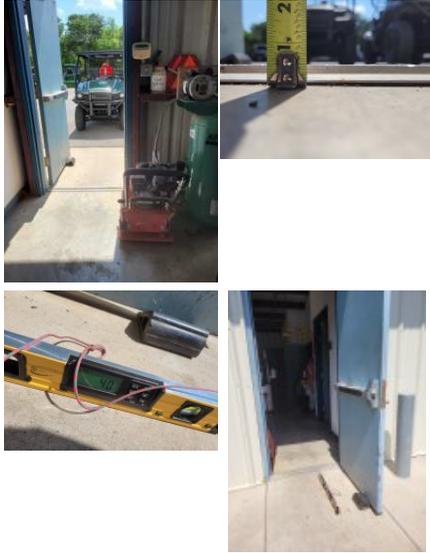
Finding Number	Area Description	Lat/Long	Finding	As Built	Recommendation	Citation	Photos	Figure
89	Employee Areas: Maintenance	[25.9976408 , -97.570688 8]	Spaces and elements within employee work areas shall only be required to comply with 206.2.8, 207.1, and 215.3 and shall be designed and constructed so that individuals with disabilities can approach, enter, and exit the employee work area. Employee work areas, or portions of employee work areas, other than raised courtroom stations, that are less than 300 square feet (28 m2) and elevated 7 inches (180 mm) or more above the finish floor or ground where the elevation is essential to the function of the space shall not be required to comply with these requirements or to be on an accessible route.	Office door - window 46.25" AFF, 7" clearance on push due to surge counter (projects 4.5"), clearance on pull reduced by desk, lipped threshold, 15 lbf	For employee spaces, relocate storage, furniture, and other obstacles at doorways to provide approach, enter and exit at the employee space. Provide required maneuvering clearance on push and pull side of doors. Repair, bevel, or ramp CILs at door entries to max .25". Fill gaps at door entries to max .5". Repair, provide beveled threshold. Inspect, adjust, and maintain 5 lbf to open interior doors. Replace doors with ones having sidelight viewing windows max 43" AFF.	2015 ABAAS Section: F203.9 2012 TAS Section: 203.9 2010 ADAS Section: 203.9

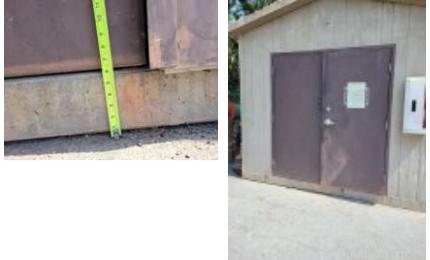
91	Employee Areas: Maintenance	[25.9976408 , -97.5706888]	Spaces and elements within employee work areas shall only be required to comply with 206.2.8, 207.1, and 215.3 and shall be designed and constructed so that individuals with disabilities can approach, enter, and exit the employee work area. Employee work areas, or portions of employee work areas, other than raised courtroom stations, that are less than 300 square feet (28 m2) and elevated 7 inches (180 mm) or more above the finish floor or ground where the elevation is essential to the function of the space shall not be required to comply with these requirements or to be on an accessible route.	6" change in level at entry to storage shed	Ramp step at door entries to max .25".	2015 ABAAS Section: F203.9 2012 TAS Section: 203.9 2010 ADAS Section: 203.9

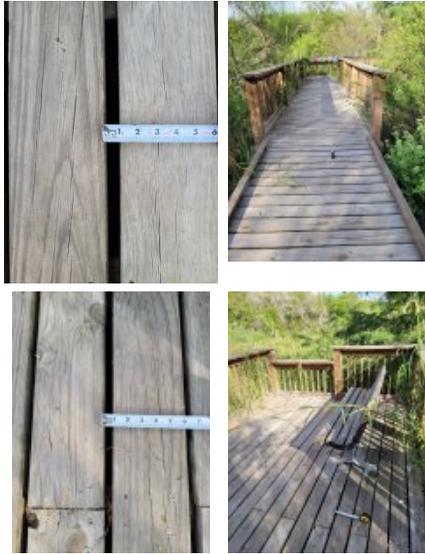
Finding Number	Area Description	Lat/Long	Finding	As Built	Recommendation	Citation	Photos	Figure
96	Trails: ADA Accessible Trails	[25.9880714 , -97.564769]	There is a gap spaced greater than a 1/2 inch. Openings in floor or ground surfaces shall not allow passage of a sphere more than 1/2 inch diameter. Elongated openings shall be placed so that the long dimension is perpendicular to the dominant direction of travel.	Kiskadee trail - multiple gaps throughout decking on viewing area exceeding .75"	Correct or fill gaps to be max .5"	2015 ABAAS Section: 302.3 2012 TAS Section: 302.3 2010 ADAS Section: 302.3

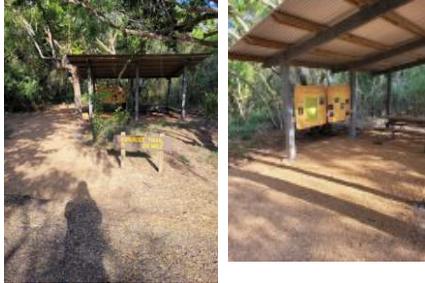
97	Trails: ADA Accessible Trails	[25.9885479 , -97.564268 5]	The surface of the trails, passing spaces, and/or resting intervals is not firm and stable. The surface of trails, passing spaces, and resting intervals shall be firm and stable	Kiskadee trail - trail surface loose, not accessible	Leave as inaccessible trail and designate other trails in the park as accessible.	2015 ABAAS Section: 1017.2

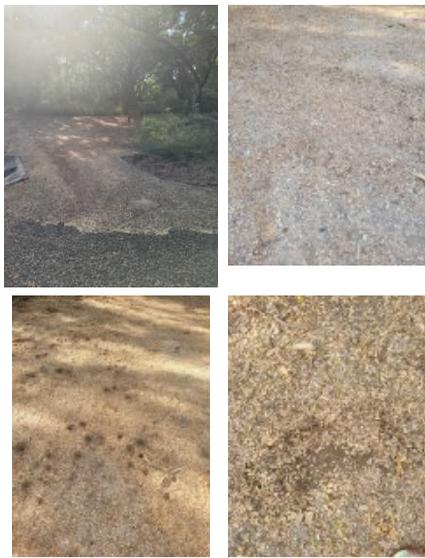
Finding Number	Area Description	Lat/Long	Finding	As Built	Recommendation	Citation	Photos	Figure
98	Trails: ADA Accessible Trails	[25.9883781, -97.56364]	The surface of trails, passing spaces, and resting intervals shall be firm and stable	Mexican olive trail - surface is low, needs fill and maintenance	Frequently maintain trail surface in identified washout areas to assure CIL's remain 2" or less and gaps are filled as a smart practice.	2015 ABAAS Section: 1017.2

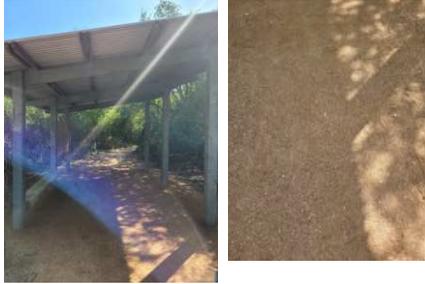
104	Trails: ADA Accessible Trails	[25.9966885, -97.567821 5]	The surface of trails, passing spaces, and resting intervals shall be firm and stable.	Natural/dirt surface within first covered area on ebony trail, must pass through to continue on trail	Establish protocols for regular and frequent inspection and maintenance of accessible trail surface as a smart practice. Replace surface of trail with one that is firm and stable as a smart practice.	2015 ABAAS Section: 1017.2

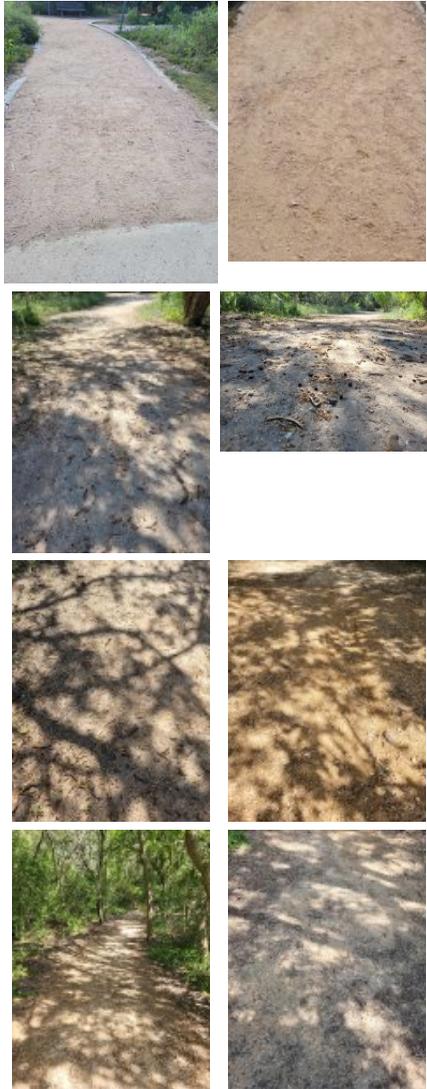
Finding Number	Area Description	Lat/Long	Finding	As Built	Recommendation	Citation	Photos	Figure
105	Trails: ADA Accessible Trails	[25.9966138 , -97.567902]	The surface of trails, passing spaces, and resting intervals shall be firm and stable	Ebony trail - crusher fine fill is low, more debris and mud/ dirt than crusher fines.	Establish protocols for regular and frequent inspection and maintenance of accessible trail surface as a smart practice. Replace surface of trail with one that is firm and stable as a smart practice.	2015 ABAAS Section: 1017.2
