Access Audit Site Report

Prepared By
WT Group

San Angelo State Park
362 FM 2288
San Angelo, TX 76901
Accessibility Evaluation
Inspection Date: 10/05/2021
Inspectors: Tanya Scheibe

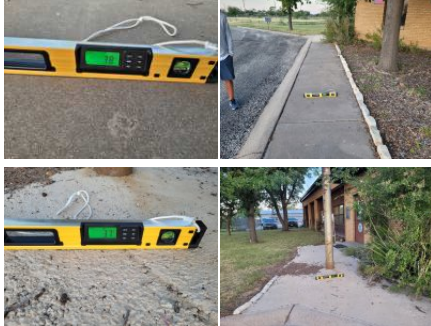
| Finding Number | Area Description | Lat/Long | Finding | As Built | Recommendation | Citation | Photos | Figure |
|---|---|--|--|---|---|--|--|--|
| 2 | Headquarters Area: Headquarters Building | [31.4544369, -100.4927465], [31.4544552, -100.492662] | The accessible route of travel on the accessible route contains cross slopes greater than 2%. Cross slopes shall not exceed one unit vertical in 48 units horizontal (2-percent slope). | 3.8% near flagpole | Correct or repair cross slope along AR to max 2.08% | 2015 ABAAS Section: 403.3 2012 TAS Section: 403.3 2010 ADAS Section: 403.3 | | |

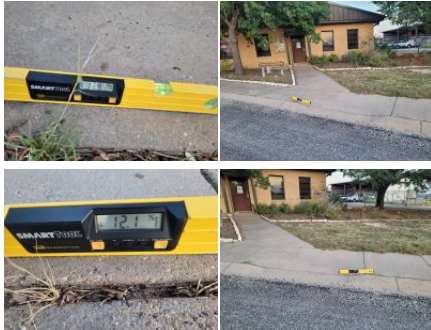
| Finding Number | Area Description | Lat/Long | Finding | As Built | Recommendation | Citation | Photos | Figure |
|---|---|---|---|--|--|---|---|--|
| 6 | Headquarters Area: Headquarters Building | [31.4544784 , -100.4926 075] | The curb ramp does not have a compliant top landing and the side flares are too steep. In alterations, where there is no landing at the top of Curb Ramps, Curb Ramp flares shall be provided and shall not be steeper than 1:12. | curb ramp - left 13.9%, right 12.1% | Correct slope of side flares to max 8.33% | 2015 ABAAS Section: 406.4 EXCEPTION 2012 TAS Section: 406.4 Exception 2010 ADAS Section: 406.4 Exception | | <p>at least 36 inches wide at least 1:12 slope at least 1:12 slope Exception: In alterations, where there is no landing at the top of Curb Ramps, Curb Ramp flares shall be provided and shall not be steeper than 1:12.</p> |

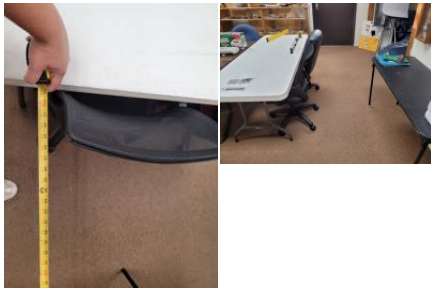
| Finding Number | Area Description | Lat/Long | Finding | As Built | Recommendation | Citation | Photos | Figure |
|---|---|---|---|--|--|---|---|--|
| 7 | Headquarters Area: Headquarters Building | [31.4545011 , -100.49281 2] | Employee Work Areas. Common use circulation paths within employee work areas shall comply with 402. EXCEPTIONS: 1. Common use circulation paths located within employee work areas that are less than 1000 square feet (93 m2) and defined by permanently installed partitions, counters, casework, or furnishings shall not be required to comply with 402. 2. Common use circulation paths located within employee work areas that are an integral component of work area equipment shall not be required to comply with 402. 3. Common use circulation paths located within exterior employee work areas that are fully exposed to the weather shall not be required to comply with 402. | Meeting space - reduces to about 27" to get around table | Make corrections for compliant circulation path. | 2015 ABAAS Section: F206.2.8, F206.2.8.1, F206.2.8.2 2012 TAS Section: 206.2.8, 206.2.8 Exception 1, 206.2.8 Exception 2, 206.2.8 Exception 3, 206.2.8 Advisory 1, 206.2.8 Advisory 2 2010 ADAS Section: 206.2.8, 206.2.8 Exception 1, 206.2.8 Exception 2, 206.2.8 Exception 3 | | |

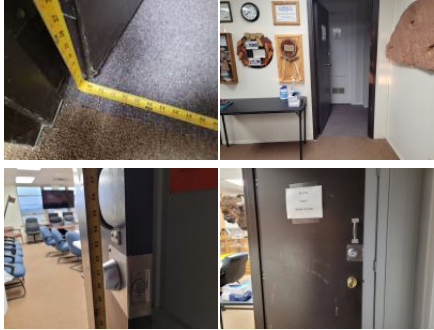
| Finding Number | Area Description | Lat/Long | Finding | As Built | Recommendation | Citation | Photos | Figure |
|---|---|---|--|--|--|---|---|---|
| 8 | Headquarters Area: Headquarters Building | [31.4545071, -100.4927999] | Spaces and elements within employee work areas shall only be required to comply with 206.2.8, 207.1, and 215.3 and shall be designed and constructed so that individuals with disabilities can approach, enter, and exit the employee work area. Employee work areas, or portions of employee work areas, other than raised courtroom stations, that are less than 300 square feet (28 m2) and elevated 7 inches (180 mm) or more above the finish floor or ground where the elevation is essential to the function of the space shall not be required to comply with these requirements or to be on an accessible route. | hall door- 29", knob, lock and handle high | For employee spaces, relocate storage, furniture, and other obstacles at doorways to provide approach, enter and exit at the employee space. Widen door to 32" and replace hardware. | 2015 ABAAS Section: F203.9 2012 TAS Section: 203.9 2010 ADAS Section: 203.9 | | |

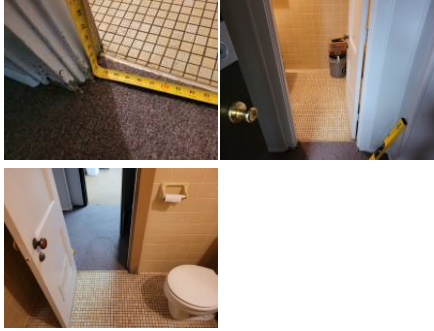
| Finding Number | Area Description | Lat/Long | Finding | As Built | Recommendation | Citation | Photos | Figure |
|---|---|---|--|--|--|---|---|---|
| 9 | Headquarters Area: Headquarters Building | [31.4545824, -100.4928142] | Minimum maneuvering clearances at doors and gates shall comply with 404.2.4. Maneuvering clearances shall extend the full width of the doorway and the required latch side or hinge side clearance. Door openings shall provide a clear width of 32 inches (815 mm) minimum. Clear openings of doorways with swinging doors shall be measured between the face of the door and the stop, with the door open 90 degrees. Openings more than 24 inches (610 mm) deep shall provide a clear opening of 36 inches (915 mm) minimum. There shall be no projections into the required clear opening width lower than 34 inches (865 mm) above the finish floor or ground. Projections into the clear opening width between 34 inches (865 mm) and 80 inches (2030 mm) above the finish floor or ground shall not exceed 4 inches (100 mm). Hand-activated door opening hardware, handles, pulls, latches, locks, and other operating devices on accessible doors shall have a shape that is easy to grasp with one hand and does not require tight grasping, tight pinching or twisting of the wrist to operate. Hardware shall be 34 inches minimum and 48 inches maximum above the finish floor or ground. | women's restroom door - 22" wide, knob, toilet pull side reduces maneuvering clearance | For all doors along the public circulation route, provide required maneuvering clearance on push and pull side of doors. Replace hardware and widen door to min 32". For all doors along the public circulation route, replace doors with doors having 80" overhead clearance and 32" clear width For all doors along the public circulation route, replace hardware with lever hardware or hardware operable without a tight pinch or grasp | 2010 ADAS Section: 404.2.3, 404.2.7, 404.2.4, 404.2.11, 404.2.11 Exception | | |

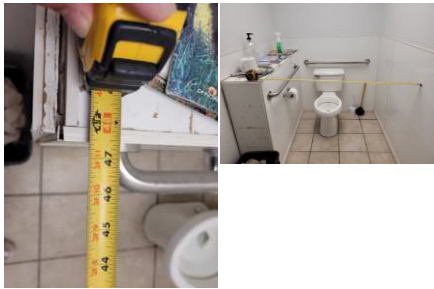
| Finding Number | Area Description | Lat/Long | Finding | As Built | Recommendation | Citation | Photos | Figure |
|---|---|---|---|---|--|---|--|--|
| 16 | Headquarters Area: Headquarters Building | [31.4545057 , -100.4927972] | The width of the toilet room is too narrow. Where a water closet is installed within an accessible water closet room, clear floor space around the water closet shall be 60 inches minimum measured perpendicular from the side wall and 56 inches minimum measured perpendicular from the rear wall. | men's- 47.5" wide | Widen accessible stalls to min. 60" clear width, 59" depth | 2015 ABAAS Section: 604.3. 2012 TAS Section: 604.3.1 2010 ADAS Section: 604.3.1 | | |

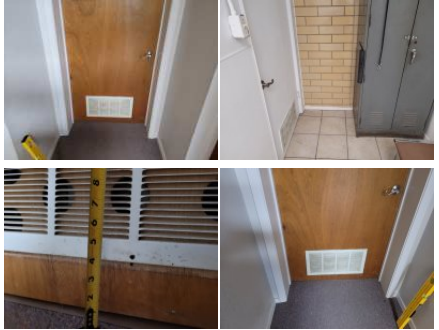
| Finding Number | Area Description | Lat/Long | Finding | As Built | Recommendation | Citation | Photos | Figure |
|---|---|---|---|--|---|---|--|---|
| 22 | Headquarters Area: Headquarters Building | [31.45446, -100.4928] | Minimum maneuvering clearances at doors and gates shall comply with 404.2.4. Maneuvering clearances shall extend the full width of the doorway and the required latch side or hinge side clearance. Door openings shall provide a clear width of 32 inches (815 mm) minimum. Clear openings of doorways with swinging doors shall be measured between the face of the door and the stop, with the door open 90 degrees. Openings more than 24 inches (610 mm) deep shall provide a clear opening of 36 inches (915 mm) minimum. There shall be no projections into the required clear opening width lower than 34 inches (865 mm) above the finish floor or ground. Projections into the clear opening width between 34 inches (865 mm) and 80 inches (2030 mm) above the finish floor or ground shall not exceed 4 inches (100 mm). The sweep period for doors with closers shall be adjusted so that from an open position of 70 degrees, the door will take at least 3 seconds to move to a point 3 inches from the latch, measured to the leading edge of the door. | men's restroom door - recessed push side, does not open full due to cabinet, closes fast, grates start at 5" | For all doors along the public circulation route, provide required maneuvering clearance on push and pull side of doors For all doors along the public circulation route, replace doors with doors having 80" overhead clearance and 36" clear width when recessed greater than 24" For all doors along the public circulation route, inspect, adjust, and maintain closing speed on door closers | 2010 ADAS Section: 404.2.3, 404.2.7, 404.2.4, 404.2.11, 404.2.11 Exception | | |

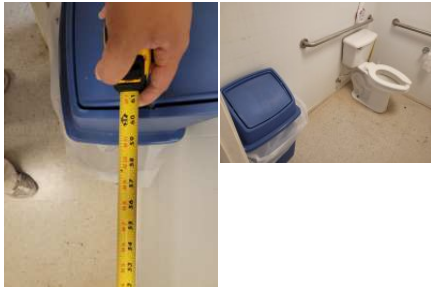
| Finding Number | Area Description | Lat/Long | Finding | As Built | Recommendation | Citation | Photos | Figure |
|---|--|---|--|--|---|--|---|---|
| 35 | Headquarters Area: Headquarters Building | [31.4545285, -100.4927972] | The required 56 inches by 60 inches clear floor space for the water closet has been obstructed. The clear floor space around the water closet shall be 60 inches minimum measured perpendicular from the side wall and 56 inches minimum measured perpendicular from the rear wall. | unisex restroom-garbage can reduces clearance space required | Relocate garbage can to provide required 60" clearance around toilet | 2015 ABAAS Section: 604.3. 2012 TAS Section: 604.3.1 2010 ADAS Section: 604.3.1 | | |

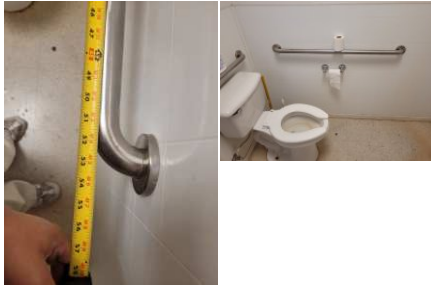
| Finding Number | Area Description | Lat/Long | Finding | As Built | Recommendation | Citation | Photos | Figure |
|---|--|---|--|--|---|--|---|---|
| 36 | Headquarters Area: Headquarters Building | [31.454524, -100.4928402] | The side grab bars are not in the correct location. Grab bars on the side wall must be installed so that the end closest to the rear wall is maximum 12" from the rear wall. The end furthest from the rear wall must be mounted minimum 54" from the rear wall. | unisex restroom- side bar extends 53" | Remount side grab bar to max 12" from the rear wall at the close end and min 54" on the far end, and 33" to 36" aff | 2015 ABAAS Section: 604.5.1 2012 TAS Section: 604.5.1 2010 ADAS Section: 604.5.1 | | |

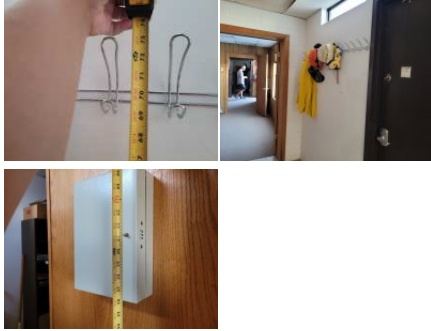
| Finding Number | Area Description | Lat/Long | Finding | As Built | Recommendation | Citation | Photos | Figure |
|---|---|---|---|--|---|---|---|---|
| 39 | Headquarters Area: Headquarters Building | [31.4545148, -100.4928509] | The hooks and key box are positioned too high for either a side or front approach. Where a clear floor or ground space allows a parallel approach to an element and the side reach is unobstructed, the high side reach shall be 48 inches maximum and the low side reach shall be 15 inches minimum above the finish floor or ground. Where a forward reach is unobstructed, the high forward reach shall be 48 inches maximum and the low forward reach shall be 15 inches minimum above the finish floor or ground. | kitchenette- hooks 69.5" and key box 61.25" or positioned out of reach range | Remount operable parts to be in reach range of 15" min to 48" max For deficit, leave as is, employee work area pursuant to 2010 Standards 106.5 Defined Terms, until an employee with a disability works here | 2015 ABAAS Section: 308.1 2012 TAS Section: 308.1 2010 ADAS Section: 308.1 | | |

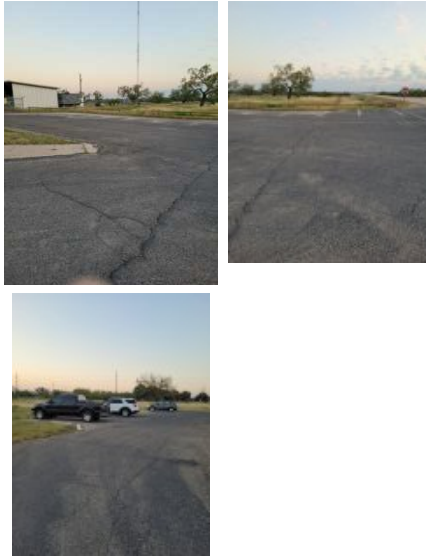
| Finding Number | Area Description | Lat/Long | Finding | As Built | Recommendation | Citation | Photos | Figure |
|---|---|---|---|---|---|--|--|---|
| 46 | Headquarters Area: Headquarters Building | [31.4545904 , -100.492356] | There are no accessible parking stalls. Each lot where parking is provided for the public as clients, guests or employees, shall provide accessible parking and shall be located on the shortest accessible route of travel from adjacent parking to an accessible entrance. There are a total of 18 parking stalls in the parking lot that could be reasonably associated with this facility. There should be a minimum of 1 accessible stalls with a minimum of 1 being designed as van accessible. | 18 stalls, 0 accessible stalls | Create one or more 8' accessible parking stalls, with one 5' adjacent access aisle, with proper signage and striping based on the total number of stalls | 2015 ABAAS Section: F208.2 2012 TAS Section: 208.2 2010 ADAS Section: 208.2 | | |

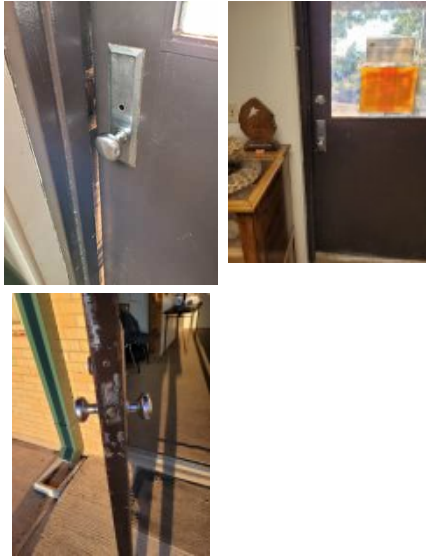
| Finding Number | Area Description | Lat/Long | Finding | As Built | Recommendation | Citation | Photos | Figure |
|---|---|---|---|---|--|---|--|---|
| 48 | Headquarters Area: Headquarters Building | [31.4545766, -100.4927838] | The door operating hardware is not accessible. Hand-activated door opening hardware, handles, pulls, latches, locks, and other operating devices on accessible doors shall have a shape that is easy to grasp with one hand and does not require tight grasping, tight pinching or twisting of the wrist to operate. Hardware shall be 34 inches minimum and 48 inches maximum above the finish floor or ground. | entry- knob hardware and lock at 51" above ground | Replace hardware with lever hardware or hardware operable without a tight pinch or grasp | 2015 ABAAS Section: 404.2.7 2012 TAS Section: 404.2.7 2010 ADAS Section: 404.2.7 | | |

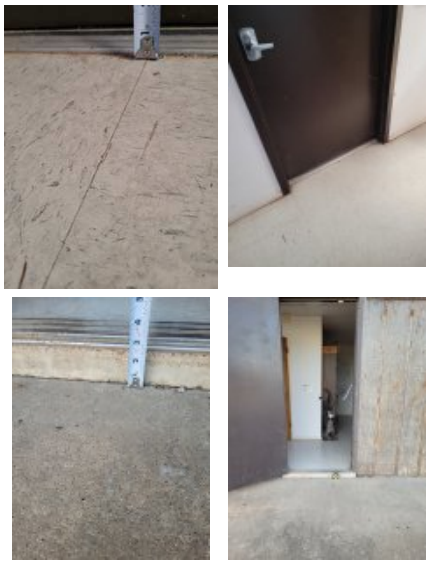
| Finding Number | Area Description | Lat/Long | Finding | As Built | Recommendation | Citation | Photos | Figure |
|---|---|---|---|---|---|---|--|---|
| 56 | Headquarters Area: Headquarters Building | [31.4545468, -100.4928723] | Thresholds, if provided at doorways, shall be 1/2 inch (13 mm) high maximum. Raised thresholds and changes in level at doorways shall comply with 302 and 303. Changes in level of 1/4 inch (6.4 mm) high maximum shall be permitted to be vertical. Changes in level between 1/4 inch (6.4 mm) high minimum and 1/2 inch (13 mm) high maximum shall be beveled with a slope not steeper than 1:2. Changes in level greater than 1/2 inch (13 mm) high shall be ramped, and shall comply with 405 or 406. | threshold change in level 3" on pull side | Repair, bevel or ramp CIL at doorway | 2015 ABAAS Section: 303.3, 404.2.5, 303.2, 303.4 2012 TAS Section: 303.3, 404.2.5, 303.2, 303.4 2010 ADAS Section: 303.3, 404.2.5, 303.2, 303.4 | | |

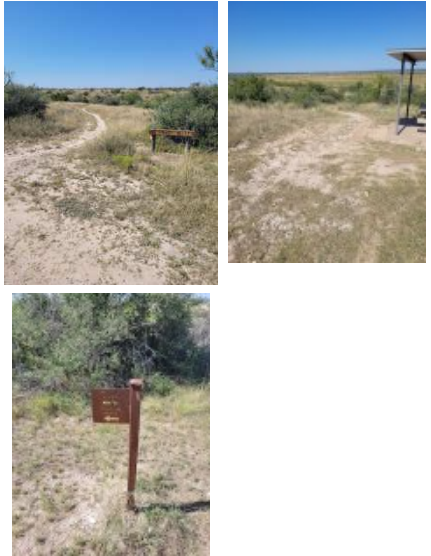
| Finding Number | Area Description | Lat/Long | Finding | As Built | Recommendation | Citation | Photos | Figure |
|---|---|---|---|---|---|---|--|---|
| 83 | Lakeview Day Use Area: Lakeview Shelter | [31.47936, -100.5069] | The surface of trails, passing spaces, and resting intervals shall be firm and stable | Isabel Harte trail, lacks accessible route | Establish protocols for regular and frequent inspection and maintenance of accessible trail surface as a smart practice Frequently maintain trail surface in identified washout areas to assure CIL's remain 2" or less and gaps are filled as a smart practice | 2015 ABAAS Section: 1017.2 | | |

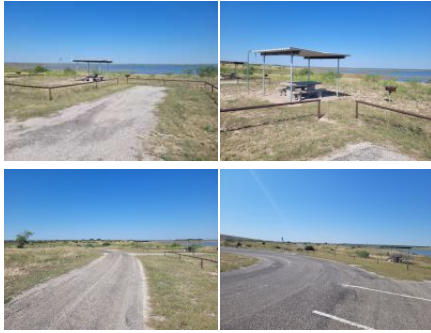
| Finding Number | Area Description | Lat/Long | Finding | As Built | Recommendation | Citation | Photos | Figure |
|---|---|---|---|---|---|---|--|---|
| 84 | Lakeview Day Use Area: Lakeview Day Use Picnic Areas | [31.47434, -100.4897] | Where picnic facilities contain two or fewer picnic units, each picnic unit shall provide mobility features complying with 245.2. Where picnic facilities contain more than two picnic units, at least 20 percent, but not less than two, of the picnic units shall provide mobility features complying with 245.2. | 0 of 25 picnic areas comply, each include shelter with table, grill, nearby parking areas | Provide an AR and accessible tables to shelter/picnic area to achieve the required number accessible | 2015 ABAAS Section: F245.1 | | |

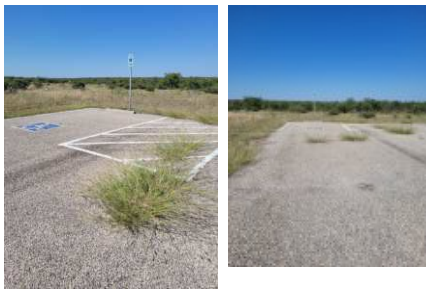
| Finding Number | Area Description | Lat/Long | Finding | As Built | Recommendation | Citation | Photos | Figure |
|---|--|---|--|---|---|---|---|---|
| 85 | Lakeview Day Use Area: Overflow Parking Along Reservoir Dam | [31.4639, -100.508] | The accessible parking is not located on the shortest accessible route to the building. Accessible parking spaces serving a particular building or facility entrance shall be located on the shortest accessible route of travel from the parking to an accessible entrance. | lacks ar, only access to parking lot | Relocate stalls to be on the shortest AR to the building entry or park features | 2015 ABAAS Section: F208.3.1 2012 TAS Section: 208.3.1 2010 ADAS Section: 208.3.1 | | |

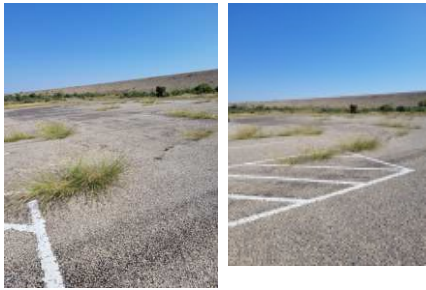
| Finding Number | Area Description | Lat/Long | Finding | As Built | Recommendation | Citation | Photos | Figure |
|---|--|---|--|---|---|---|---|---|
| 86 | Lakeview Day Use Area: Overflow Parking Along Reservoir Dam | [31.4639, -100.508] | There is no accessible route from the overflow lot to any site elements. At least one accessible route shall connect accessible buildings, accessible facilities, accessible elements, and accessible spaces that are on the same site. | lacks accessible route from parking due to loose gravel in areas, overgrown grass patches | Create an accessible route with crushed stone or other outdoor material from parking or walkway to site elements. | 2015 ABAAS Section: F206.2.2 2012 TAS Section: 206.2.2 2010 ADAS Section: 206.2.2 | | |

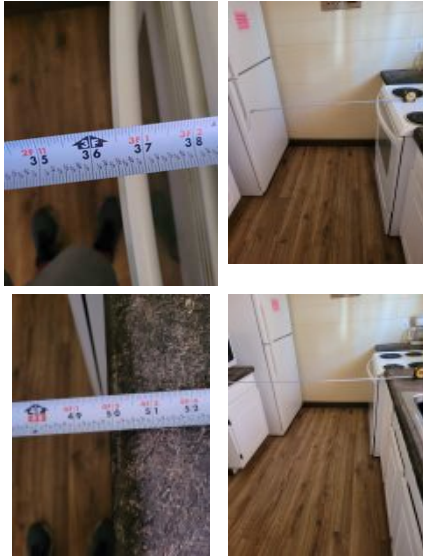
| Finding Number | Area Description | Lat/Long | Finding | As Built | Recommendation | Citation | Photos | Figure |
|---|--|---|--|---|---|--|--|---|
| 89 | Red Arroyo Camping Area: Red Arroyo Group Bunkhouse | [31.4677984, -100.5037621] | The U-shaped kitchen is not wide enough. In U-shaped kitchens enclosed on three contiguous sides, clearance between all opposing base cabinets, counter tops, appliances, or walls within kitchen work areas shall be 60 inches. | kitchen- 36.5" between fridge and stove. between cabinets 50" | Renovate U shaped kitchen to provide required 60" clearance between cabinets, counter tops and appliances | 2015 ABAAS Section: 804.2.2 2012 TAS Section: 804.2.2 2010 ADAS Section: 804.2.2 | | |

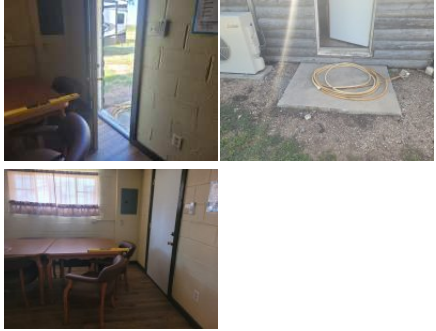
| Finding Number | Area Description | Lat/Long | Finding | As Built | Recommendation | Citation | Photos | Figure |
|---|--|---|---|---|--|--|---|---|
| 97 | Red Arroyo Camping Area: Red Arroyo Group Bunkhouse | [31.4678293, -100.5037376] | Minimum maneuvering clearances at doors and gates shall comply with 404.2.4. Maneuvering clearances shall extend the full width of the doorway and the required latch side or hinge side clearance. Door openings shall provide a clear width of 32 inches (815 mm) minimum. Clear openings of doorways with swinging doors shall be measured between the face of the door and the stop, with the door open 90 degrees. Openings more than 24 inches (610 mm) deep shall provide a clear opening of 36 inches (915 mm) minimum. There shall be no projections into the required clear opening width lower than 34 inches (865 mm) above the finish floor or ground. Projections into the clear opening width between 34 inches (865 mm) and 80 inches (2030 mm) above the finish floor or ground shall not exceed 4 inches (100 mm). The threshold has a vertical change greater than 1/4 inch high. The threshold at a doorway shall be no higher than 1/2 inch. Changes in level between 1/4 inch and 1/2 inch must be beveled at 1:2 or less. 1/4 inch is the maximum vertical rise. All interior doors must be maintained so that the operating pressure does not exceed 5 lb. force to open. The sweep period for doors with closers shall be adjusted so that from an | side door - table pull side, knob hardware, change in level | For all doors along the public circulation route, provide required maneuvering clearance on push and pull side of doors For all doors along the public circulation route, repair, bevel, or ramp CILs at door entries to max .25" For all doors along the public circulation route, repair, provide beveled threshold For all doors along the public circulation route, replace hardware with lever hardware or hardware operable without a tight pinch or grasp | 2010 ADAS Section: 404.2.3, 404.2.7, 404.2.4, 404.2.11, 404.2.11 Exception | | |

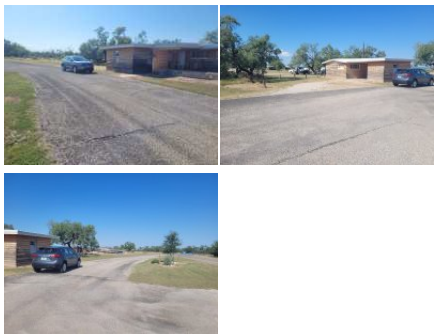
| Finding Number | Area Description | Lat/Long | Finding | As Built | Recommendation | Citation | Photos | Figure |
|---|---|---|--|--|---|---|--|---|
| 103 | Red Arroyo Camping Area: Red Arroyo Group Bunkhouse | [31.4677069 , -100.5036992] | There are no accessible parking stalls. Each lot where parking is provided for the public as clients, guests or employees, shall provide accessible parking and shall be located on the shortest accessible route of travel from adjacent parking to an accessible entrance. | Lacks accessible parking stall near bunkhouse - 5 standard, 0 accessible | Create one or more 8' accessible parking stalls, with one 5' adjacent access aisle, with proper signage and striping based on the total number of stalls | 2015 ABAAS Section: F208.2 2012 TAS Section: 208.2 2010 ADAS Section: 208.2 | | |

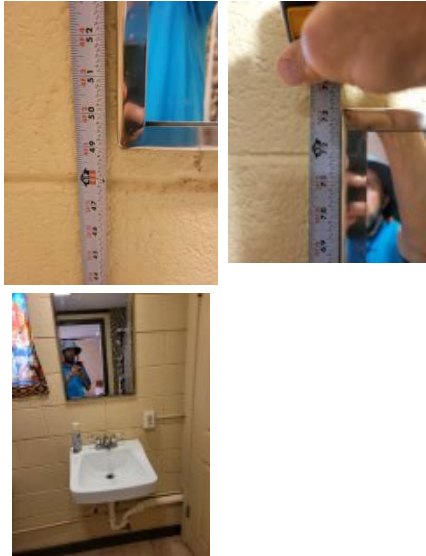
| Finding Number | Area Description | Lat/Long | Finding | As Built | Recommendation | Citation | Photos | Figure |
|---|---|---|--|--|---|--|---|---|
| 106 | Red Arroyo Camping Area: Red Arroyo Bunkhouse Restroom | [31.4677984, -100.5037836] | The mirror is mounted too high. Mirrors must have the bottom edge of the reflecting surface a maximum of 40 inches above the floor if above a sink or counter. Mirrors not located above lavatories or countertops shall be installed with the bottom edge of the reflecting surface 35 inches maximum above the finish floor or ground. | restroom- 49" bottom of mirror, 73" at top | Lower mirror so reflective surface is max 40" aff | 2015 ABAAS Section: 603.3 2012 TAS Section: 603.3 2010 ADAS Section: 603.3 | | |

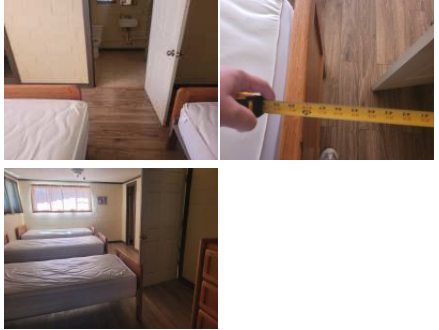
| Finding Number | Area Description | Lat/Long | Finding | As Built | Recommendation | Citation | Photos | Figure |
|---|---|---|---|--|---|---|--|--|
| 112 | Red Arroyo Camping Area: Red Arroyo Bunkhouse Restroom | [31.4678055, -100.5037958] | Minimum maneuvering clearances at doors and gates shall comply with 404.2.4. Maneuvering clearances shall extend the full width of the doorway and the required latch side or hinge side clearance. Hand-activated door opening hardware, handles, pulls, latches, locks, and other operating devices on accessible doors shall have a shape that is easy to grasp with one hand and does not require tight grasping, tight pinching or twisting of the wrist to operate. Hardware shall be 34 inches minimum and 48 inches maximum above the finish floor or ground. | restroom - 48" between wall and beds, knob | For all doors along the public circulation route, provide required maneuvering clearance on push and pull side of doors For all doors along the public circulation route, replace hardware with lever hardware or hardware operable without a tight pinch or grasp | 2010 ADAS Section: 404.2.3, 404.2.7, 404.2.4, 404.2.11, 404.2.11 Exception | | |

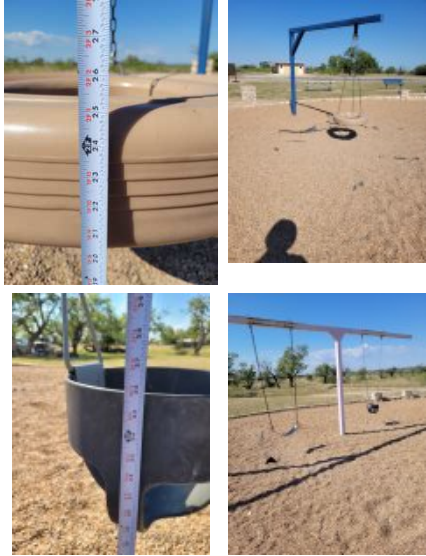
| Finding Number | Area Description | Lat/Long | Finding | As Built | Recommendation | Citation | Photos | Figure |
|---|---|---|--|---|--|---|---|---|
| 120 | Red Arroyo Camping Area: Red Arroyo Playground | [31.4681095 , -100.5034 939] | The entry point or seat is not within the compliant range above the ground. The height of entry points and seats shall be 11 inches minimum and 24 inches maximum measured to the top of the surface from the ground or floor surface. | tire swing 25", 26" bucket swing | Lower or adjust entry point to play component to 11" to 24" aff | 2012 TAS Section: 1008.4.4 2010 ADAS Section: 1008.4.4 | | |

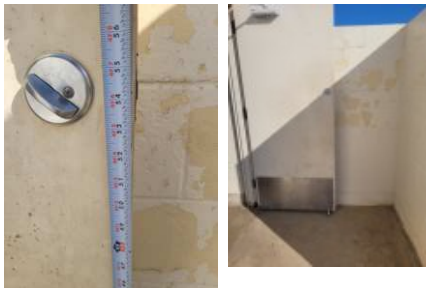
| Finding Number | Area Description | Lat/Long | Finding | As Built | Recommendation | Citation | Photos | Figure |
|---|---|---|--|--|--|--|--|--|
| 135 | Red Arroyo Camping Area: Red Arroyo RV Men's Restroom | [31.4715983, -100.5009994] | The operating hardware is not accessible because it requires tight grasping, pinching or twisting of the wrist to operate. Hand-activated hardware, handles, pulls, latches, locks, and other operating devices on accessible elements shall have a shape that is easy to grasp with one hand and does not require tight grasping, tight pinching or twisting of the wrist to operate. | door lock at 54.5" and requires a pinch or twist | For all doors along the public circulation route, replace hardware with lever hardware where indicated | 2015 ABAAS Section: 309.4 2012 TAS Section: 309.4 2010 ADAS Section: 309.4 | | |

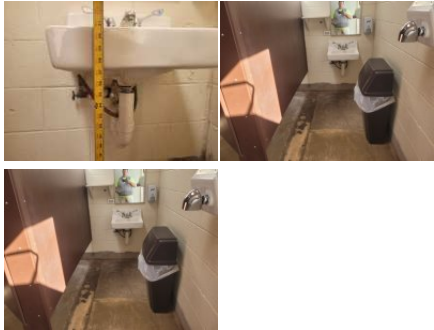
| Finding Number | Area Description | Lat/Long | Finding | As Built | Recommendation | Citation | Photos | Figure |
|---|--|---|---|---|--|--|---|---|
| 146 | Red Arroyo Camping Area: Red Arroyo RV Women's Restroom | [31.4715868, -100.5009887] | Knee clearance at 27 inches off the floor is not 8 inches minimum deep. The knee clearance, measured from the bottom of the apron or the outside bottom edge of the lavatory, must be 27 inches at a point located 8 inches back from the front edge and continuing to 11 inches minimum in depth at 9 inches above the floor. The top of the lavatory rim may be no higher than 34 inches. | sink bowl at 26.5", garbage can in clear floor space | Raise sink to provide knee clearance min 27" aff. Relocate garbage can from sink knee clearance. | 2015 ABAAS Section: 306.3.1, 306.3.2, 306.3.3, 306.3.4, 306.3.5 2012 TAS Section: 306.3.2, 306.3.3, 306.3.4, 306.3.5, 306.3.1 2010 ADAS Section: 306.3.3, 306.3.2, 306.3.4, 306.3.5, 306.3.1 | | |

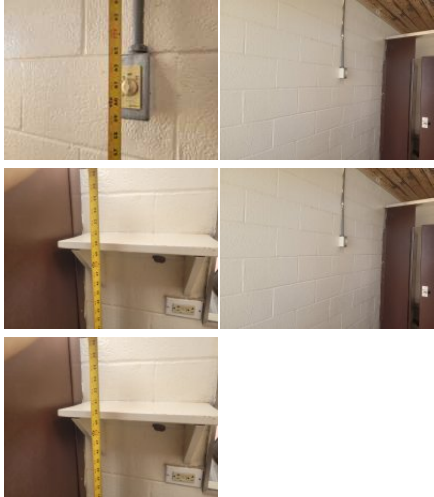
| Finding Number | Area Description | Lat/Long | Finding | As Built | Recommendation | Citation | Photos | Figure |
|---|--|---|--|--|--|---|--|--|
| 147 | Red Arroyo Camping Area: Red Arroyo RV Women's Restroom | [31.4715891, -100.5009941] | Where a high forward reach is over an obstruction, the clear floor space shall extend beneath the element for a distance not less than the required reach depth over the obstruction. The high forward reach shall be 48 inches (1220 mm) maximum where the reach depth is 20 inches (510 mm) maximum. Where the reach depth exceeds 20 inches (510 mm), the high forward reach shall be 44 inches (1120 mm) maximum and the reach depth shall be 25 inches (635 mm) maximum. Where a clear floor or ground space allows a parallel approach to an element and the high side reach is over an obstruction, the height of the obstruction shall be 34 inches (865 mm) maximum and the depth of the obstruction shall be 24 inches (610 mm) maximum. The high side reach shall be 48 inches (1220 mm) maximum for a reach depth of 10 inches (255 mm) maximum. Where the reach depth exceeds 10 inches (255 mm), the high side reach shall be 46 inches (1170 mm) maximum for a reach depth of 24 inches (610 mm) maximum. | heat control knob 61", shelf 51" | Lower operating mechanisms to max 48" above the finished floor (AFF) to highest operable part. | 2015 ABAAS Section: 308.2.1, 308.3.2 2012 TAS Section: 308.2.1, 308.3.2 2010 ADAS Section: 308.2.1, 308.3.2 | | |

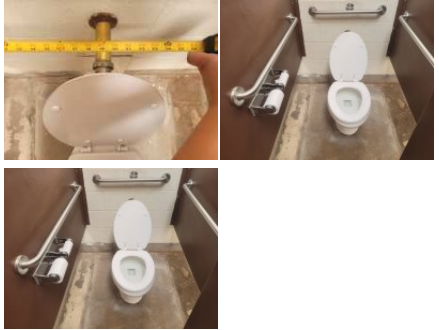
| Finding Number | Area Description | Lat/Long | Finding | As Built | Recommendation | Citation | Photos | Figure |
|---|--|---|---|--|---|--|---|---|
| 149 | Red Arroyo Camping Area: Red Arroyo RV Women's Restroom | [31.471596, -100.5010075] | The toilet is not located within the range to the side wall or partition. The centerline of the toilet shall be 17 inches minimum and 19 inches maximum side wall or partition in the ambulatory accessible toilet compartment. | centerline 19.25" one side | Remount toilet to 17" to 19" from the side wall to center line in ambulatory stalls. | 2015 ABAAS Section: 604.9.1 2012 TAS Section: 604.9.1 2010 ADAS Section: 604.9.1 | | |

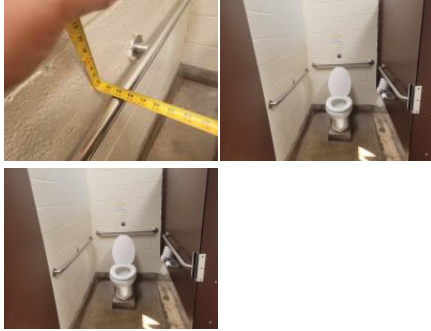
| Finding Number | Area Description | Lat/Long | Finding | As Built | Recommendation | Citation | Photos | Figure |
|---|---|---|--|--|---|--|---|---|
| 154 | Red Arroyo Camping Area: Red Arroyo RV Women's Restroom | [31.4715937, -100.5010035] | The dimensions of the toilet stall do not comply. Wheelchair accessible compartments shall be 60 inches wide and 59 inches deep minimum for floor mounted water closets measured perpendicular to the rear wall. Door shall not swing into the minimum clear floor space required for the toilet. | wheelchair stall stall 45" wide | Widen accessible stalls to min. 60" clear width, 59" depth | 2015 ABAAS Section: 604.8.1.1 2012 TAS Section: 604.3.2 2010 ADAS Section: 604.3.2 | | |

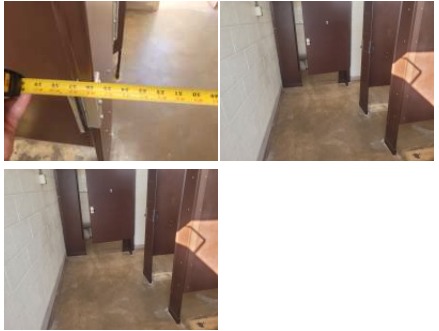
| Finding Number | Area Description | Lat/Long | Finding | As Built | Recommendation | Citation | Photos | Figure |
|---|--|---|---|--|---|---|---|---|
| 160 | Red Arroyo Camping Area: Red Arroyo RV Women's Restroom | [31.4716051, -100.5010102] | There is insufficient turning space within this room or space. The space required for a wheelchair to make a 180-degree turn is a clear space of 60 inches in diameter or a T-shaped space. | lacks turning space, widest area 55.75" | Relocate obstacles to create turning space in restroom. | 2015 ABAAS Section: 304.3.1, 304.3.2 2012 TAS Section: 304.3.1, 304.3.2 2010 ADAS Section: 304.3.1, 304.3.2 | | |

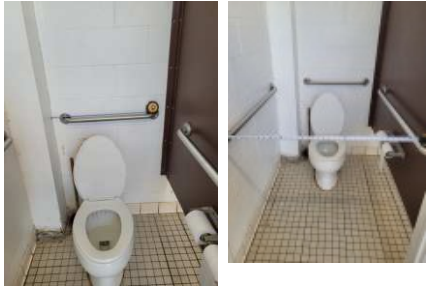
| Finding Number | Area Description | Lat/Long | Finding | As Built | Recommendation | Citation | Photos | Figure |
|---|--|---|---|--|---|---|---|---|
| 162 | Red Arroyo Camping Area: Red Arroyo Tent Men's Restroom | [31.4674072, -100.4960977] | There are not enough accessible toilet compartments. The room contains toilet compartments. A minimum of 1 must be wheelchair accessible . | lacks wheelchair stall, ambulatory only | Create a wheelchair accessible stall with grab bars and fixtures mounted in correct locations and at correct heights. | 2015 ABAAS Section: F213.3.1 2012 TAS Section: 213.3.1 2010 ADAS Section: 213.3.1 | | |

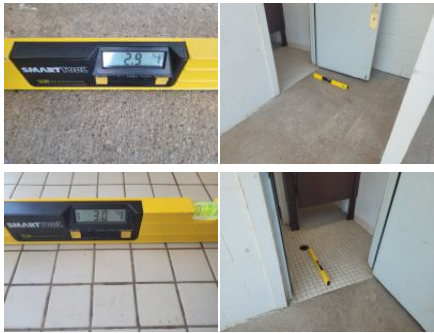
| Finding Number | Area Description | Lat/Long | Finding | As Built | Recommendation | Citation | Photos | Figure |
|---|--|---|--|---|--|---|---|---|
| 177 | Red Arroyo Camping Area: Red Arroyo Tent Women's Restroom | [31.46743, -100.4961] | Minimum maneuvering clearances at doors and gates shall comply with 404.2.4. Maneuvering clearances shall extend the full width of the doorway and the required latch side or hinge side clearance. Door openings shall provide a clear width of 32 inches (815 mm) minimum. Clear openings of doorways with swinging doors shall be measured between the face of the door and the stop, with the door open 90 degrees. Openings more than 24 inches (610 mm) deep shall provide a clear opening of 36 inches (915 mm) minimum. There shall be no projections into the required clear opening width lower than 34 inches (865 mm) above the finish floor or ground. Projections into the clear opening width between 34 inches (865 mm) and 80 inches (2030 mm) above the finish floor or ground shall not exceed 4 inches (100 mm). The threshold has a vertical change greater than 1/4 inch high. The threshold at a doorway shall be no higher than 1/2 inch. Changes in level between 1/4 inch and 1/2 inch must be beveled at 1:2 or less. 1/4 inch is the maximum vertical rise. All interior doors must be maintained so that the operating pressure does not exceed 5 lb. force to open. The sweep period for doors with closers shall be adjusted so that from an open position of 70 degrees, the door will | women's restroom door - 12#, 2.9% slope pull side and 3% slope on push side | For all doors along the public circulation route, inspect, adjust, and maintain 8.5 lbf to open exterior doors as a smart practice Correct or repair slope at doorway landing to max 2.08% in any direction for level clear floor space | 2010 ADAS Section: 404.2.3, 404.2.7, 404.2.4, 404.2.11, 404.2.11 Exception | | |

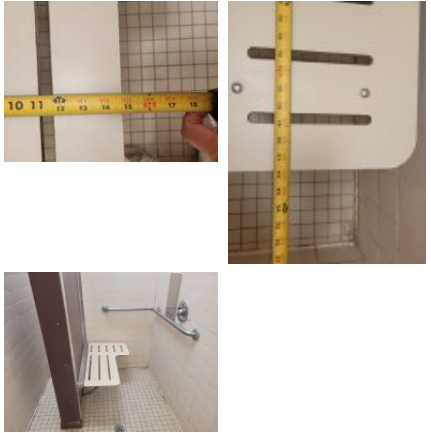
| Finding Number | Area Description | Lat/Long | Finding | As Built | Recommendation | Citation | Photos | Figure |
|---|--|---|--|---|--|--|--|---|
| 181 | Red Arroyo Camping Area: Red Arroyo Tent Women's Restroom | [31.4674095 , -100.4960964] | The shower seat does not have a compliant space between it and the wall. The folding seat must be mounted 17-19 inches above the floor, and have a maximum space of 1-1/2 inches between the edge of the seat and the side wall and 2-1/2 inches maximum to the seat wall. | seat is mounted 14.75" and 21.75" from wall | Remount shower seat to the correct location and height in the shower | 2015 ABAAS Section: 610.3.2 2012 TAS Section: 610.3.2 2010 ADAS Section: 610.3.2 | | <p>(a) size</p> <p>(b) distance from wall</p> |

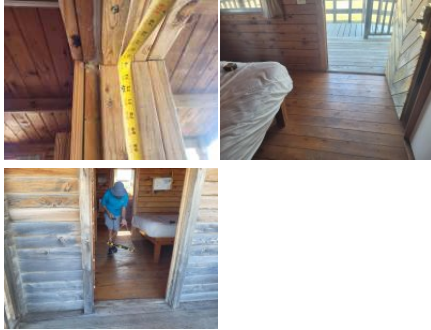
| Finding Number | Area Description | Lat/Long | Finding | As Built | Recommendation | Citation | Photos | Figure |
|---|---|---|--|---|---|--|---|---|
| 186 | Red Arroyo Camping Area: Red Arroyo Cabins - Cabin 1 | [31.4683145, -100.5044134] | Minimum maneuvering clearances at doors and gates shall comply with 404.2.4. Maneuvering clearances shall extend the full width of the doorway and the required latch side or hinge side clearance. Door openings shall provide a clear width of 32 inches (815 mm) minimum. Clear openings of doorways with swinging doors shall be measured between the face of the door and the stop, with the door open 90 degrees. Openings more than 24 inches (610 mm) deep shall provide a clear opening of 36 inches (915 mm) minimum. There shall be no projections into the required clear opening width lower than 34 inches (865 mm) above the finish floor or ground. Projections into the clear opening width between 34 inches (865 mm) and 80 inches (2030 mm) above the finish floor or ground shall not exceed 4 inches (100 mm). | cabin 1- 74" overhead, bed pull side | For all doors along the public circulation route, provide required maneuvering clearance on push and pull side of doors For all doors along the public circulation route, replace doors with doors having 80" overhead clearance and 32" clear width | 2010 ADAS Section: 404.2.3, 404.2.7, 404.2.4, 404.2.11, 404.2.11 Exception | | |

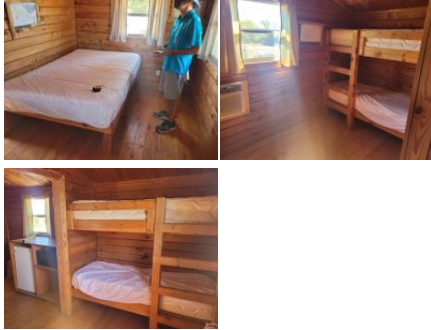
| Finding Number | Area Description | Lat/Long | Finding | As Built | Recommendation | Citation | Photos | Figure |
|---|---|---|--|---|---|--|---|---|
| 187 | Red Arroyo Camping Area: Red Arroyo Cabins - Cabin 1 | [31.4683207, -100.5044092] | The required clear space on both sides of the bed has not been provided. Accessible sleeping rooms shall have a 30 inch minimum by 48 inch minimum clear width space located along both sides of a bed. | cabin 1- 4 bunk beds and full size bed, beds have access on one side only | Provide access to both sides of full size bed in cabin | 2015 ABAAS Section: 806.2.3 2012 TAS Section: 806.2.3 2010 ADAS Section: 806.2.3 | | |

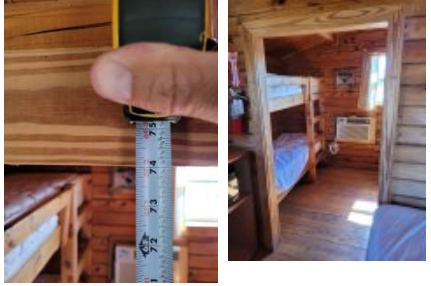
| Finding Number | Area Description | Lat/Long | Finding | As Built | Recommendation | Citation | Photos | Figure |
|---|---|---|--|---|---|--|---|---|
| 188 | Red Arroyo Camping Area: Red Arroyo Cabins - Cabin 1 | [31.4683166, -100.5044099] | The doorway extends down too close to the route of travel. Any obstruction that overhangs a route of travel must be a minimum of 80 inches above the walking surface as measured from the bottom of the obstruction. | 74" at doorway to bedroom area | Raise doorway to min 80", or pad object to prevent hazard in overhead clearance along AR | 2015 ABAAS Section: 307.4 2012 TAS Section: 307.4 2010 ADAS Section: 307.4 | | |

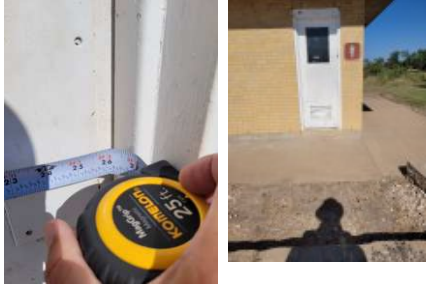
| Finding Number | Area Description | Lat/Long | Finding | As Built | Recommendation | Citation | Photos | Figure |
|---|--|---|---|---|---|---|---|---|
| 201 | Red Arroyo Camping Area: Red Arroyo Playground Men's Restroom | [31.4684756, -100.5031184] | The door opening does not provide at least 32 inches between the face of the door and the opposite stop. Door openings shall provide a clear width of 32 inches minimum. Clear openings of doorways with swinging doors shall be measured between the face of the door and the stop, with the door open 90 degrees. There shall be no projections into the required clear opening width lower than 34 inches above the finish floor or ground. Projections into the clear opening width between 34 inches and 80 inches above the finish floor or ground shall not exceed 4 inches. | door width 26.75" | Replace door with one having 32" clear width | 2015 ABAAS Section: 404.2.3 2012 TAS Section: 404.2.3 2010 ADAS Section: 404.2.3 | | |

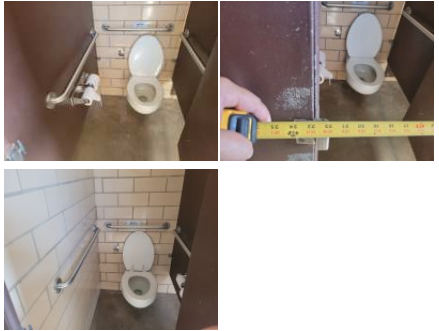
| Finding Number | Area Description | Lat/Long | Finding | As Built | Recommendation | Citation | Photos | Figure |
|---|--|---|---|---|--|---|---|---|
| 207 | Red Arroyo Camping Area: Red Arroyo Playground Women's Restroom | [31.4684824, -100.5031103] | There are not enough accessible toilet compartments. The room contains no accessible toilet compartments. A minimum of 1 must be wheelchair accessible . | 2 very narrow stalls that have had grab bars added on all 3 walls, will not comply with wheelchair or ambulatory requirements | Create a wheelchair accessible stall with grab bars and fixtures mounted in correct locations and at correct heights | 2015 ABAAS Section: F213.3.1 2012 TAS Section: 213.3.1 2010 ADAS Section: 213.3.1 | | |

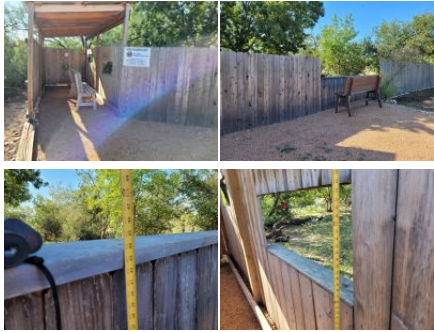
| Finding Number | Area Description | Lat/Long | Finding | As Built | Recommendation | Citation | Photos | Figure |
|---|---|---|--|---|--|--|--|---|
| 226 | Red Arroyo Camping Area: Wildlife Viewing | [31.467, -100.5013] | Each distinct viewing location shall provide a viewing space adjacent to the clear ground space required by 1015.2 through which the point of interest is viewable. The viewing space shall be 32 inches (815 mm) maximum and 51 inches (1295 mm) minimum high above the ground and shall extend the full width of the clear ground space. EXCEPTION: Guards or similar safety barriers shall be permitted to obstruct the viewing space to the extent the obstruction is necessary for the guard or safety barrier to serve its intended purpose. | lower viewing areas are too high, benches located in CFS at lowered areas | Lower a 32" wide portion of railing to max 32" for unobstructed viewing as a smart practice | 2015 ABAAS Section: 1015.3, 1015.3 EXCEPTION | | |

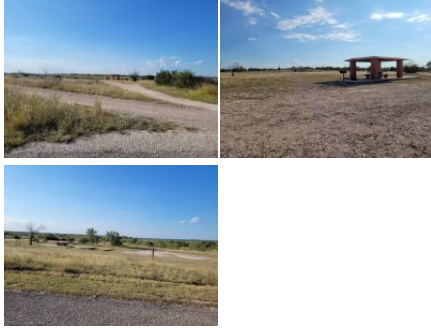
| Finding Number | Area Description | Lat/Long | Finding | As Built | Recommendation | Citation | Photos | Figure |
|---|--|---|---|--|---|---|--|---|
| 240 | Chapparral Camping Area: Chapparral Group Picnic | [31.47107, -100.5059] | Camping facilities shall provide camping units with mobility features complying with F244.2 in accordance with Table F244.2. Where a camping facility provides different types of camping units, Table F244.2 shall apply to each type of camping unit provided. Total Number of Camping Units Provided in Camping Facility Minimum Number of Camping Units with Mobility Features Required 1 1 2 to 25 2 26 to 50 3 51 to 75 4 76 to 100 5 101 to 150 7 151 to 200 8 201 and over 8, plus 2 percent of the number over 200 | 0 of 3 brick shelter campsites comply | Create the required number of accessible camp sites per table F244.2 as a smart practice | 2015 ABAAS Section: F244.2 | | |

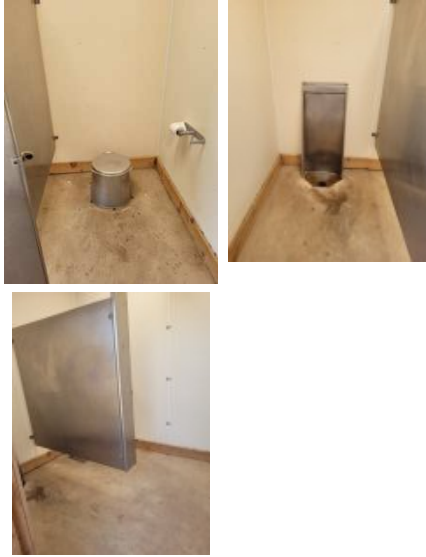
| Finding Number | Area Description | Lat/Long | Finding | As Built | Recommendation | Citation | Photos | Figure |
|---|--|---|---|---|---|---|--|---|
| 250 | Isabel Harte Multi-Use Area: Isabel Harte Men's Restroom | [31.4775025, -100.5044514] | The restroom is not compliant. The restroom does not have the required minimum clear floor space or maneuvering clearances for the toilet. The restroom does not have the required minimum clear floor space or maneuvering clearances for the lavatory. The entry door does not contain the required minimum maneuvering spaces on the pull/push sides. The entry door encroach into the required clear floor space for fixtures. Grab bars are missing and/or incorrectly installed. Accessories, such as toilet seat covers, paper towel holders, garbage cans, hand dryers, and mirrors are either too high or without clear floor space or both. | lacks amenities and accessible features | Create a compliant wheelchair accessible restroom and correct all features to be accessible if feasible. | 2015 ABAAS Section: 603.1 2012 TAS Section: 603.1 2010 ADAS Section: 603.1 | | |

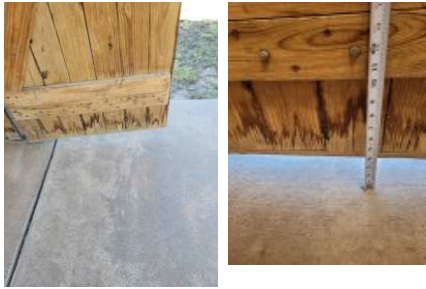
| Finding Number | Area Description | Lat/Long | Finding | As Built | Recommendation | Citation | Photos | Figure |
|---|--|---|---|---|---|---|---|---|
| 253 | Isabel Harte Multi-Use Area: Isabel Harte Men's Restroom | [31.4775002, -100.5044407] | The door must have a smooth surface within 10 inches of the floor on the push side. Swinging door surfaces within 10 inches of the finish floor or ground measured vertically must have a smooth surface on the push side extending the full width of the door. Parts creating horizontal or vertical joints in these surfaces shall be within 1/16 inch of the same plane as the other. All gates, including ticket gates, shall meet all applicable specifications for doors. | additional board on bottom of door at 12" | Provide kick plate on push side of door from floor to 10" aff | 2015 ABAAS Section: 404.2.10 2012 TAS Section: 404.2.10 2010 ADAS Section: 404.2.10 | | |

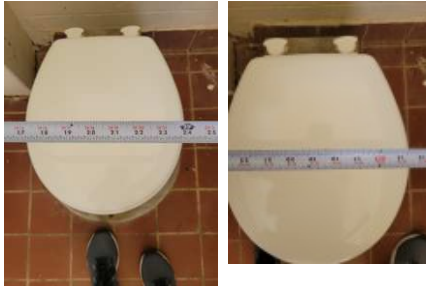
| Finding Number | Area Description | Lat/Long | Finding | As Built | Recommendation | Citation | Photos | Figure |
|---|--|---|--|---|---|--|--|---|
| 267 | Burkett Trailhead and Day Use Area: Burkett Trailhead Men's Restroom | [31.4812025, -100.5243233] | The toilet is not located within the range to the side wall or partition. The centerline of the toilet shall be 17 inches minimum and 19 inches maximum side wall or partition in the ambulatory accessible toilet compartment. | 19.5" from both walls | Remount toilet to 17" to 19" from the side wall to center line in ambulatory stalls | 2015 ABAAS Section: 604.9.1 2012 TAS Section: 604.9.1 2010 ADAS Section: 604.9.1 | | |

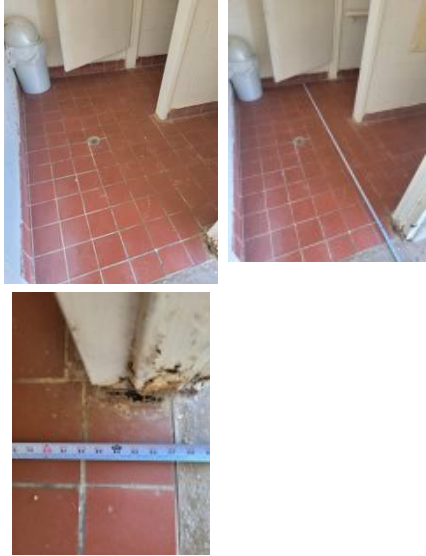
| Finding Number | Area Description | Lat/Long | Finding | As Built | Recommendation | Citation | Photos | Figure |
|---|--|---|---|---|--|---|---|---|
| 269 | Burkett Trailhead and Day Use Area: Burkett Trailhead Men's Restroom | [31.4812059, -100.5243293] | There is insufficient turning space within this room or space. The space required for a wheelchair to make a 180-degree turn is a clear space of 60 inches in diameter or a T-shaped space. | lacks turning space | Relocate obstacles to create turning space in restroom | 2015 ABAAS Section: 304.3.1, 304.3.2 2012 TAS Section: 304.3.1, 304.3.2 2010 ADAS Section: 304.3.1, 304.3.2 | | |

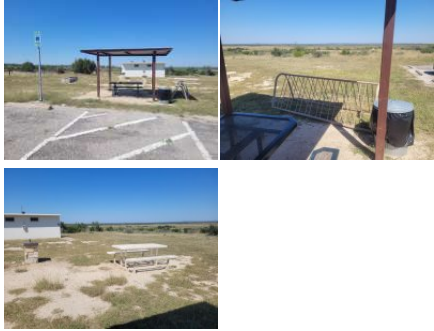
| Finding Number | Area Description | Lat/Long | Finding | As Built | Recommendation | Citation | Photos | Figure |
|---|---|---|--|--|---|---|--|---|
| 280 | Burkett Trailhead and Day Use Area: Burkett Trail | [31.4810893, -100.5241303] | Where picnic facilities contain two or fewer picnic units, each picnic unit shall provide mobility features complying with F245.2. | shelter at restroom building not compliant, rough surface, tables lack wheelchair space, no AR to amenities- garbage can, bike rack, water | Create an ORAR to shelter or picnic area and provide accessible features as a smart practice. | 2015 ABAAS Section: F245.2.1 | | |

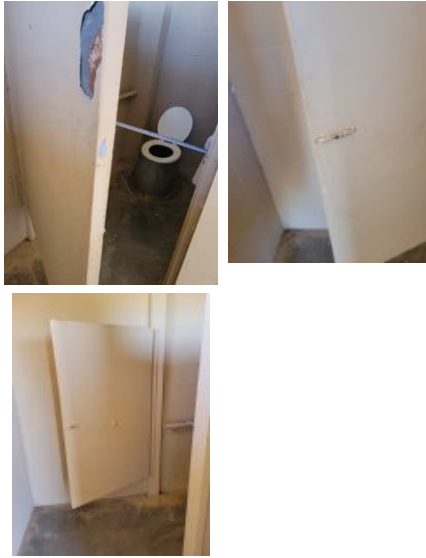
| Finding Number | Area Description | Lat/Long | Finding | As Built | Recommendation | Citation | Photos | Figure |
|---|---|---|---|---|---|---|--|---|
| 297 | River Bend Camping Area: River Bend Men's Restroom | [31.5158562, -100.5518166] | The water closet compartment door is missing a loop handle. Water closet compartments must be equipped with a door that has a loop or U-shaped handle on both sides of the door immediately below the latch. The latch must be flip-over style, sliding or other hardware not requiring the user to grasp or twist. | lacks compliant hardware | Install stall hardware on interior and exterior that is operable without a tight pinch or grasp | 2015 ABAAS Section: 604.8.1.2 2012 TAS Section: 604.8.1.2 2010 ADAS Section: 604.8.1.2 | | |

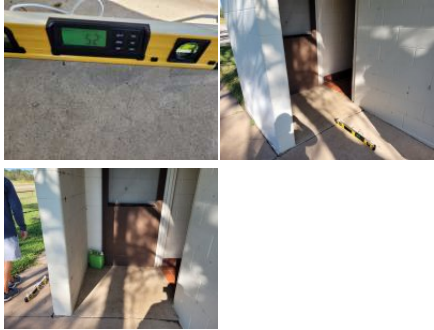
| Finding Number | Area Description | Lat/Long | Finding | As Built | Recommendation | Citation | Photos | Figure |
|---|---|---|---|--|--|--|--|---|
| 317 | North Concho Camping Area: North Concho Men's Restroom | [31.5375177 , -100.5465 429] | Minimum maneuvering clearances at doors and gates shall comply with 404.2.4. Maneuvering clearances shall extend the full width of the doorway and the required latch side or hinge side clearance. The closing speed of doors with spring-hinge closers must not close faster than 1.5 seconds. | men's - spring closer too fast, slope in pull side clearance 5.2%, wall 46.5" back pull side | For all doors along the public circulation route, provide required maneuvering clearance on push and pull side of doors For all doors along the public circulation route, adjust spring-hinge closers to close no faster than 1.5 seconds | 2010 ADAS Section: 404.2.3, 404.2.7, 404.2.4, 404.2.11, 404.2.11 Exception | | |

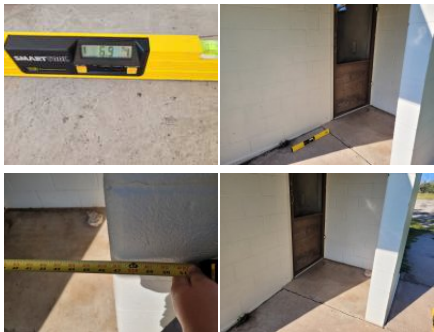
| Finding Number | Area Description | Lat/Long | Finding | As Built | Recommendation | Citation | Photos | Figure |
|---|---|---|---|--|---|---|--|---|
| 340 | North Concho Camping Area: North Concho Women's Restroom | [31.5375143, -100.5465483] | Minimum maneuvering clearances at doors and gates shall comply with 404.2.4. Maneuvering clearances shall extend the full width of the doorway and the required latch side or hinge side clearance. Doors with spring-hinge closers must not close faster than 1.5 seconds. | women's - spring closer too fast, slope on pull side clearance 6.9%, wall 46.5" to back on pull side | For all doors along the public circulation route, provide required maneuvering clearance on push and pull side of doors For all doors along the public circulation route, adjust closing speed on doors with spring-hinge closers to not close faster than 1.5 seconds. For all doors along the public circulation route, correct slope in maneuvering clearance to max 2.08%. | 2010 ADAS Section: 404.2.3, 404.2.7, 404.2.4, 404.2.11, 404.2.11 Exception | | |

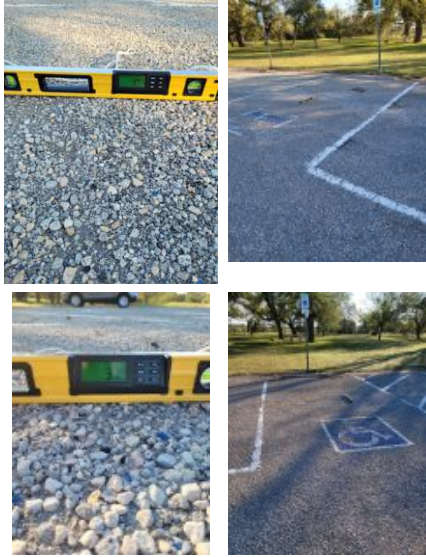
| Finding Number | Area Description | Lat/Long | Finding | As Built | Recommendation | Citation | Photos | Figure |
|---|---|---|---|---|---|---|---|---|
| 346 | North Concho Camping Area: North Concho Campsites | [31.530033, -100.5449139] | The cross slopes (narrow dimension) and/or running slopes (long dimension) of the access aisle exceeds 2%. The running slope and the cross slope in an accessible parking stall and the access aisle must not exceed 2%. | 4.5% slope in right stall and 3.1% slope in left stall | Repair or correct slope of parking space and access aisle to max 2.08% in any direction | 2015 ABAAS Section: 502.4 2012 TAS Section: 502.4 2010 ADAS Section: 502.4 | | |

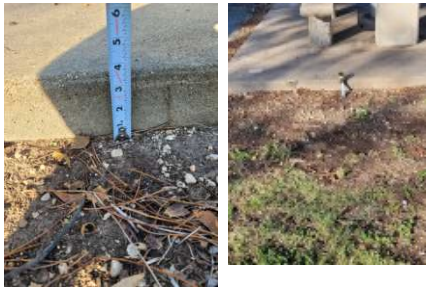
| Finding Number | Area Description | Lat/Long | Finding | As Built | Recommendation | Citation | Photos | Figure |
|---|---|---|--|---|---|--|--|---|
| 355 | North Concho Camping Area: North Concho Group Camping | [31.530672, -100.5450306] | The walkway contains abrupt vertical edges and/or variations over a 1/4 inch. 1/4 inch is the maximum vertical rise. Changes in level between 1/4 inch and 1/2 inch must be beveled at 1:2 or less. Changes in level greater than 1/2 inch must be by way of a ramp. | change in elevation is 4" to picnic table area | Repair, bevel or ramp CIL along AR | 2012 TAS Section: 303.2, 303.3 2010 ADAS Section: 303.2, 303.3 | | |

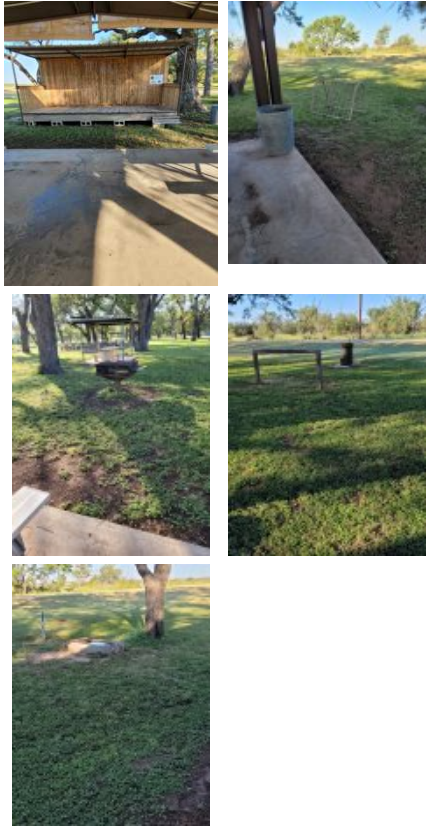
| Finding Number | Area Description | Lat/Long | Finding | As Built | Recommendation | Citation | Photos | Figure |
|---|--|---|--|--|---|---|--|---|
| 361 | North Concho Camping Area: North Concho Group Camping | [31.5309006 , -100.5452 612] | Where picnic facilities contain two or fewer picnic units, each picnic unit shall provide mobility features complying with F245.2. | lacks accessible route to grill, bike rack, stage, tie up, fountain and trough | Create an ORAR to shelter or picnic area and provide accessible features as a smart practice. | 2015 ABAAS Section: F245.2.1 | | |

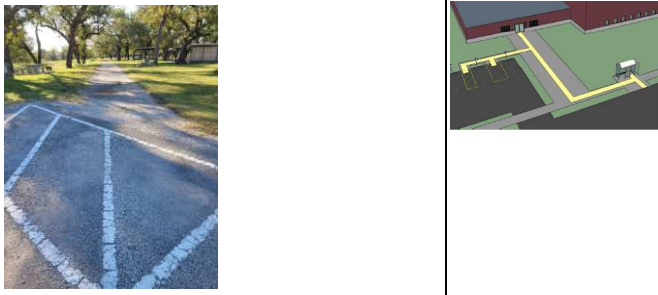
| Finding Number | Area Description | Lat/Long | Finding | As Built | Recommendation | Citation | Photos | Figure |
|---|--|---|---|---|---|---|---|---|
| 365 | North Concho Camping Area: North Concho Group Camping | [31.531303, -100.54537 39] | The access aisle is not located on an accessible route of travel to the accessible building entrance. Accessible parking spaces serving a particular building shall be located on the shortest accessible route of travel from adjacent parking to an accessible entrance. In buildings with multiple accessible entrances with adjacent parking, accessible parking spaces shall be dispersed and located closest to the accessible entrances. | lacks accessible route to amenities | Reconfigure accessible stalls to avoid requiring pedestrians to cross vehicular way, in the alternative, leave as is with striped crosswalk Provide a curb ramp at the head of each access aisle to connect to AR | 2015 ABAAS Section: F208.3.1 2012 TAS Section: 208.3.1 2010 ADAS Section: 208.3.1 | | |
