Access Audit Site Report

Prepared By
WT Group

San Angelo State Park
362 FM 2288
San Angelo, TX 76901
Accessibility Evaluation
Inspection Date: 10/05/2021
Inspectors: Tanya Scheibe

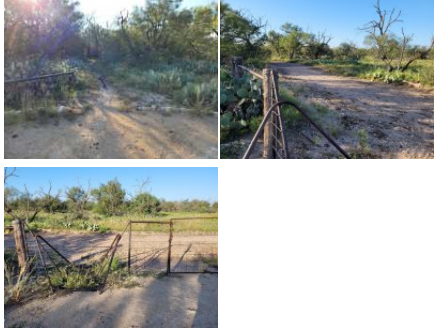
| Finding Number | Area Description | Lat/Long | Finding | As Built | Recommendation | Citation | Photos | Figure |
|---|--|---|--|---|--|---|--|---|
| 371 | North Concho Camping Area: North Concho Group Camping | [31.52896, -100.5449] | The surface of trails, passing spaces, and resting intervals shall be firm and stable | multi use trails are dirt surface. Shady trail narrow, dinosaur trail has cattle guard at entry | Replace surface of trail with one that is firm and stable as a smart practice. | 2015 ABAAS Section: 1017.2 | | |

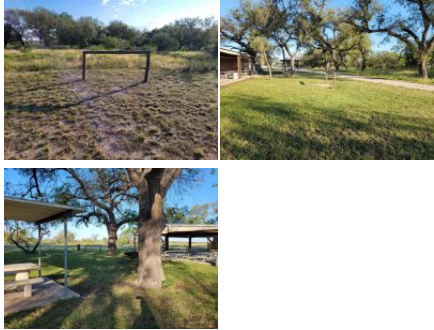
| Finding Number | Area Description | Lat/Long | Finding | As Built | Recommendation | Citation | Photos | Figure |
|---|--|---|---|---|--|---|--|---|
| 372 | North Concho Camping Area: North Concho Group Camping | [31.52907, -100.545] | At least one accessible route shall connect accessible buildings, accessible facilities, accessible elements, and accessible spaces that are on the same site. For areas of sport activity, an accessible route is required to connect to the boundary of each area of sport activity. The size of an area of sport activity includes only the space needed to play. Where multiple sports fields or courts are provided, an accessible route is required to each field or area of sport activity. | horse post lacks AR at trailhead, both at shelter lack AR | Provide an accessible route to each element within the site. | 2010 ADAS Section: 206.2.2, 206.2 | | |

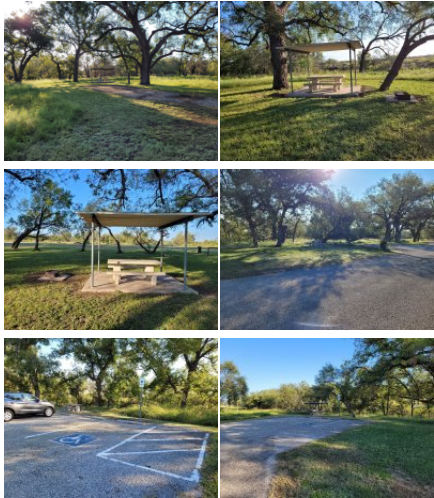
| Finding Number | Area Description | Lat/Long | Finding | As Built | Recommendation | Citation | Photos | Figure |
|---|--|---|---|---|--|---|--|---|
| 374 | North Concho Camping Area: North Concho Group Camping | [31.53015, -100.5445] | Camping facilities shall provide camping units with mobility features complying with F244.2 in accordance with Table F244.2. Where a camping facility provides different types of camping units, Table F244.2 shall apply to each type of camping unit provided. Total Number of Camping Units Provided in Camping Facility Minimum Number of Camping Units with Mobility Features Required 1 1 2 to 25 2 26 to 50 3 51 to 75 4 76 to 100 5 101 to 150 7 151 to 200 8 201 and over 8, plus 2 percent of the number over 200 | 0 of 10 individual sites accessible, most include shelter, all include picnic table, and fire ring/grill, none close to route, all have CIL. accessible parking located near 3 spots, each has slope leading to table pad | Create the required number of accessible camp sites per table F244.2 as a smart practice | 2015 ABAAS Section: F244.2 | | |

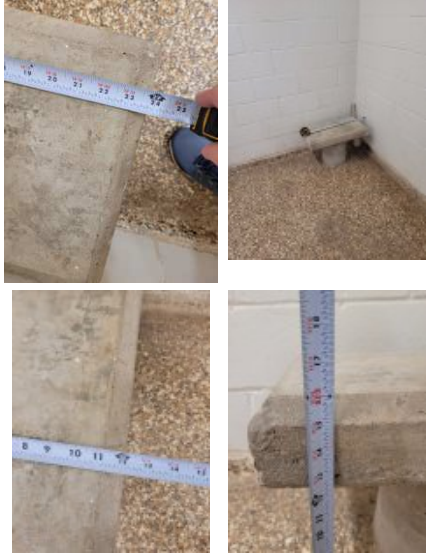
| Finding Number | Area Description | Lat/Long | Finding | As Built | Recommendation | Citation | Photos | Figure |
|---|--|---|---|---|---|---|--|---|
| 384 | Bald Eagle Camping Area: Bald Eagle North Men's Restroom | [31.5415731, -100.5542842] | The bench is not deep enough or long enough or is missing. Benches shall be provided having seats that are 42 inches long minimum and 20 inches deep minimum and 24 inches deep maximum. The bench shall provide for back support or shall be affixed to a wall. Back support shall be 42 inches (1065 mm) long minimum and shall extend from a point 2 inches (51 mm) maximum above the seat surface to a point 18 inches (455 mm) minimum above the seat surface. Back support shall be 2 1/2 inches (64 mm) maximum from the rear edge of the seat measured horizontally. The top of the bench seat surface shall be 17 inches (430 mm) minimum and 19 inches (485 mm) maximum above the finish floor or ground. | bench 24" width, 12" depth, 16" height | Replace bench in dressing area with one having a seat depth of 20" to 24" deep, 42" long, affixed to the wall or having a back and mounted 17" to 19" aff | 2012 TAS Section: 903.4, 903.2, 903.3, 903.5 2010 ADAS Section: 903.4, 903.2, 903.3, 903.5 | | |

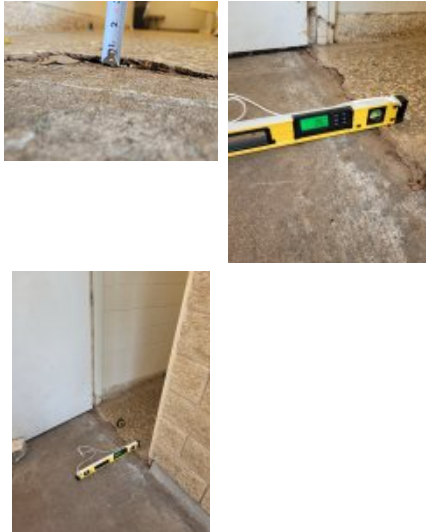
| Finding Number | Area Description | Lat/Long | Finding | As Built | Recommendation | Citation | Photos | Figure |
|---|--|---|--|--|--|--|--|--|
| 398 | Bald Eagle Camping Area: Bald Eagle North Women's Restroom | [31.5415903, -100.5543164] | Floor or ground surface within required maneuvering clearances shall comply with 302. Changes in level are not permitted. EXCEPTIONS: 1. Slopes not steeper than 1:48 shall be permitted. 2. Changes in level at thresholds complying with 404.2.5 shall be permitted. | .75" change in level and 2.5% slope at women's restroom door | Correct or repair slope at doorway landing to max 2.08% in any direction for level landing. Repair or ramp CIL in doorway clearance. | 2015 ABAAS Section: 404.2.4.4, 404.2.4.4 EXCEPTIONS: 1, 404.2.4.4 EXCEPTIONS: 2 2012 TAS Section: 404.2.4.4, 404.2.4.4 Exception 1, 404.2.4.4 Exception 2 2010 ADAS Section: 404.2.4.4, 404.2.4.4 Exception 1, 404.2.4.4 Exception 2 | | |

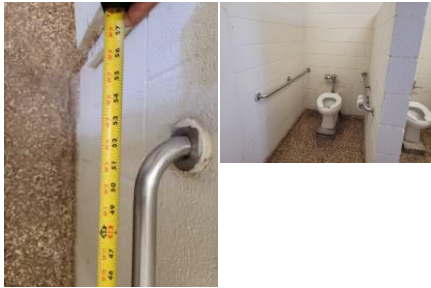
| Finding Number | Area Description | Lat/Long | Finding | As Built | Recommendation | Citation | Photos | Figure |
|---|---|---|--|--|---|--|---|---|
| 410 | Bald Eagle Camping Area: Bald Eagle North Women's Restroom | [31.5415949 , -100.5542 949] | The side grab bars are not in the correct location. Grab bars on the side wall must be installed so that the end closest to the rear wall is maximum 12" from the rear wall. The end furthest from the rear wall must be mounted minimum 54" from the rear wall. | side bars extend 52" from rear wall | Remount side grab bar to max 12" from the rear wall at the close end and min 54" on the far end, and 33" to 36" aff | 2015 ABAAS Section: 604.5.1 2012 TAS Section: 604.5.1 2010 ADAS Section: 604.5.1 | | |

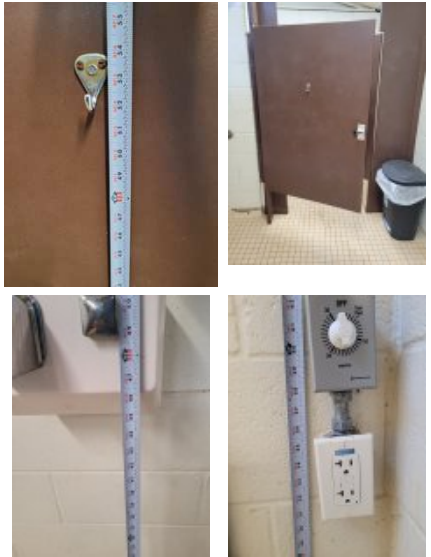
| Finding Number | Area Description | Lat/Long | Finding | As Built | Recommendation | Citation | Photos | Figure |
|---|--|---|--|---|--|---|--|---|
| 428 | Bald Eagle Camping Area: Bald Eagle Camp Men's Restroom | [31.5358981, -100.5442366] | Where a high forward reach is over an obstruction, the clear floor space shall extend beneath the element for a distance not less than the required reach depth over the obstruction. The high forward reach shall be 48 inches (1220 mm) maximum where the reach depth is 20 inches (510 mm) maximum. Where the reach depth exceeds 20 inches (510 mm), the high forward reach shall be 44 inches (1120 mm) maximum and the reach depth shall be 25 inches (635 mm) maximum. Where a clear floor or ground space allows a parallel approach to an element and the high side reach is over an obstruction, the height of the obstruction shall be 34 inches (865 mm) maximum and the depth of the obstruction shall be 24 inches (610 mm) maximum. The high side reach shall be 48 inches (1220 mm) maximum for a reach depth of 10 inches (255 mm) maximum. Where the reach depth exceeds 10 inches (255 mm), the high side reach shall be 46 inches (1170 mm) maximum for a reach depth of 24 inches (610 mm) maximum. | 52" coat hook in stall, hand dryer 49.5", outlet 53", heater control 59.75" | Lower operable parts to max 48" aff to highest operable part | 2015 ABAAS Section: 308.2.1, 308.3.2 2012 TAS Section: 308.2.1, 308.3.2 2010 ADAS Section: 308.2.1, 308.3.2 | | |

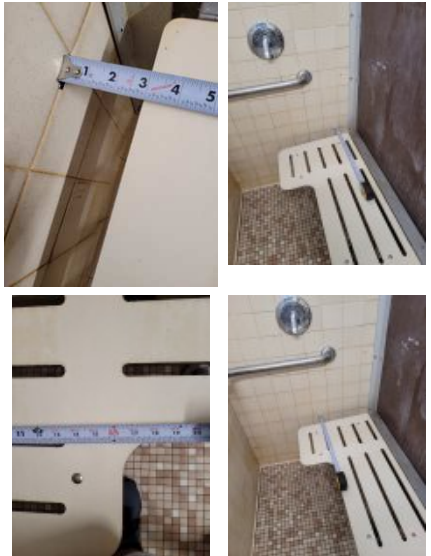
| Finding Number | Area Description | Lat/Long | Finding | As Built | Recommendation | Citation | Photos | Figure |
|---|--|---|--|--|--|--|--|---|
| 440 | Bald Eagle Camping Area: Bald Eagle Camp Men's Restroom | [31.5358913, -100.5442366] | The shower seat does not have a compliant space between it and the wall. The folding seat must be mounted 17-19 inches above the floor, and have a maximum space of 1-1/2 inches between the edge of the seat and the side wall and 2-1/2 inches maximum to the seat wall. | seat 3" from back wall, 17" to the edge of L portion of seat | Remount shower seat to the correct location and height in the shower | 2015 ABAAS Section: 610.3.2 2012 TAS Section: 610.3.2 2010 ADAS Section: 610.3.2 | | |

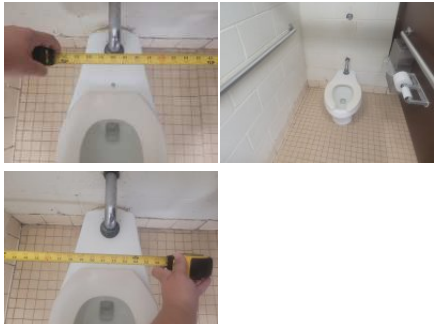
| Finding Number | Area Description | Lat/Long | Finding | As Built | Recommendation | Citation | Photos | Figure |
|---|--|---|---|--|--|--|--|--|
| 451 | Bald Eagle Camping Area: Bald Eagle Camp Women's Restroom | [31.5358981 , -100.5442 366] | The toilet is not located within the range to the side wall or partition. The centerline of the toilet shall be 17 inches minimum and 19 inches maximum side wall or partition in the ambulatory accessible toilet compartment. | 20" from partition and 21.5" from wall | Remount toilet to 17" to 19" from the side wall to center line in ambulatory stalls | 2015 ABAAS Section: 604.9.1 2012 TAS Section: 604.9.1 2010 ADAS Section: 604.9.1 | | |

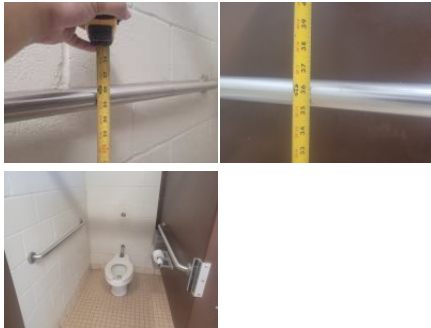
| Finding Number | Area Description | Lat/Long | Finding | As Built | Recommendation | Citation | Photos | Figure |
|---|--|---|---|--|---|--|---|---|
| 454 | Bald Eagle Camping Area: Bald Eagle Camp Women's Restroom | [31.5358935, -100.5442313] | The grab bar height and/or spacing fails. Grab bars must be mounted between 33" and 36" to the top of the gripping surface. There must be 1.5" of clearance between the grab bar and the wall. There must be a minimum of 1.5" of clearance below and minimum 12" above the grab bar to any dispenser or other obstruction. | 36.25" left grab bar and 36.5" right grab bar above finished floor | Remount grab bars in accessible stall to 33" to 36" aff | 2015 ABAAS Section: 609.3, 609.4 2012 TAS Section: 609.4, 609.3 2010 ADAS Section: 609.3, 609.4 | | |

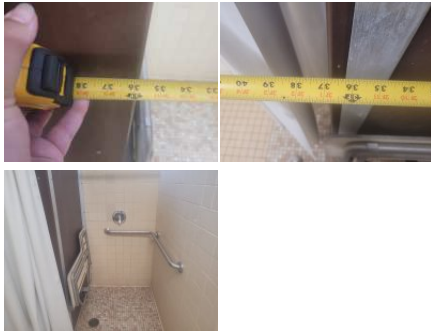
| Finding Number | Area Description | Lat/Long | Finding | As Built | Recommendation | Citation | Photos | Figure |
|---|--|---|--|--|---|---|---|---|
| 460 | Bald Eagle Camping Area: Bald Eagle Camp Women's Restroom | [31.5358958 , -100.54423 4] | Transfer type shower compartments shall be 36 inches (915 mm) by 36 inches (915 mm) clear inside dimensions measured at the center points of opposing sides and shall have a 36 inch (915 mm) wide minimum entry on the face of the shower compartment. Clearance of 36 inches (915 mm) wide minimum by 48 inches (1220 mm) long minimum measured from the control wall shall be provided. | shower stall is 35.75" wide, 37" deep | Correct transfer shower to compliant 36" by 36" clear inside dimension | 2015 ABAAS Section: 608.2.1 2012 TAS Section: 608.2.1 2010 ADAS Section: 608.2.1 | | |

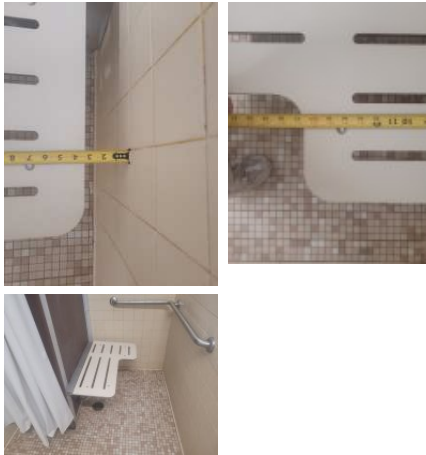
| Finding Number | Area Description | Lat/Long | Finding | As Built | Recommendation | Citation | Photos | Figure |
|---|--|---|--|---|--|--|--|--|
| 463 | Bald Eagle Camping Area: Bald Eagle Camp Women's Restroom | [31.5358958, -100.5442393] | The shower seat does not have a compliant space between it and the wall. The folding seat must be mounted 17-19 inches above the floor, and have a maximum space of 1-1/2 inches between the edge of the seat and the side wall and 2-1/2 inches maximum to the seat wall. | 3.25" gap to wall | Remount shower seat to the correct location and height in the shower | 2015 ABAAS Section: 610.3.2 2012 TAS Section: 610.3.2 2010 ADAS Section: 610.3.2 | | |

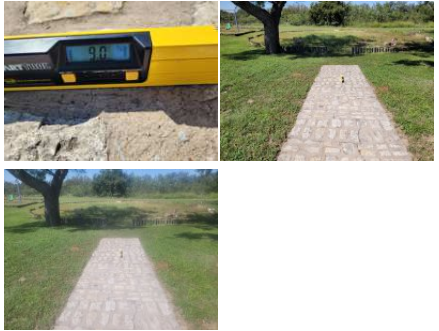
| Finding Number | Area Description | Lat/Long | Finding | As Built | Recommendation | Citation | Photos | Figure |
|---|--|---|---|---|--|---|---|---|
| 471 | Bald Eagle Camping Area: Bald Eagle Playground | [31.53393, -100.5457] | The running slope of walking surfaces shall not be steeper than 1:20. | 9% to playground | Correct running slope along the AR to max 5% | 2015 ABAAS Section: 403.3 2012 TAS Section: 403.3 2010 ADAS Section: 403.3 | | |

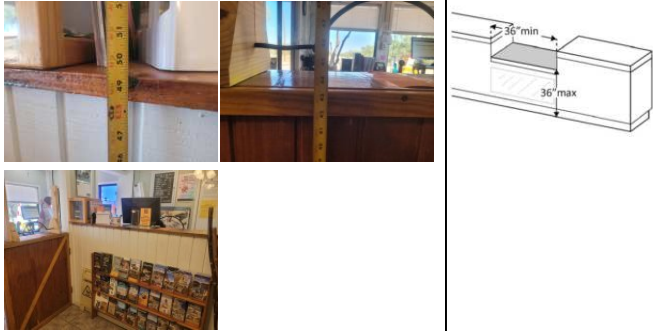
| Finding Number | Area Description | Lat/Long | Finding | As Built | Recommendation | Citation | Photos | Figure |
|---|---|---|---|---|---|---|--|---|
| 489 | South Gate: South Gate Building | [31.4638863, -100.5080443] | The transaction counter is too high. A portion of the counter surface that is 36 inches long minimum and 36 inches high maximum above the finish floor shall be provided. Knee and toe space must be provided for a forward approach. A 30 inch by 48 inch clear floor space on an accessible route must be provided for either a forward or parallel approach. | each counter high, lower counter lacks clearance for parallel due to cabinet | Lower 36" wide segment of service counter to max 36" aff | 2015 ABAAS Section: 904.4.2, 904.4.1 2012 TAS Section: 904.4.1, 904.4.2 2010 ADAS Section: 904.4.2, 904.4.1 | | |

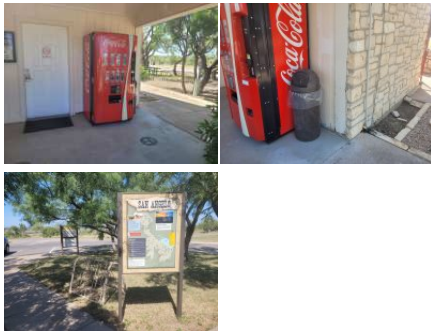
| Finding Number | Area Description | Lat/Long | Finding | As Built | Recommendation | Citation | Photos | Figure |
|---|---|---|---|---|---|--|--|---|
| 495 | South Gate: South Gate Building | [31.4639013, -100.508092] | Element meets all standards and requirements | vending machine complies, 1 of 2 garbage cans comply, bike rack complies, sign complies | None | 2010 ADAS Section: N/A | | |

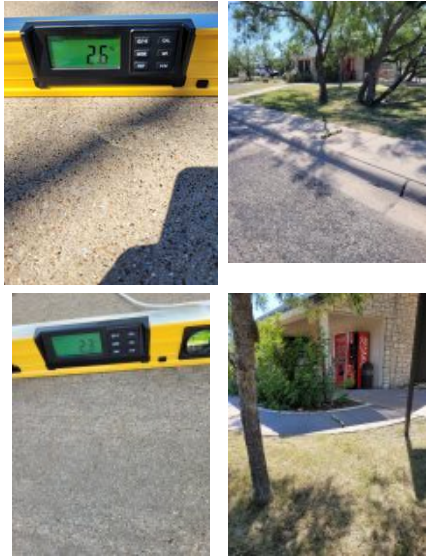
| Finding Number | Area Description | Lat/Long | Finding | As Built | Recommendation | Citation | Photos | Figure |
|---|---|---|--|---|--|---|--|--|
| 500 | South Gate Entry: Parking at South Gate Entry | [31.4640468, -100.5080048] | The accessible route of travel contains cross slopes greater than 2%. Cross slopes shall not exceed one unit vertical in 48 units horizontal (2-percent slope). | 2.6% cross slope, 2.3%, | Correct or repair cross slope along accessible route to max 2.08%. | 2015 ABAAS Section: 403.3 2012 TAS Section: 403.3 2010 ADAS Section: 403.3 | | |

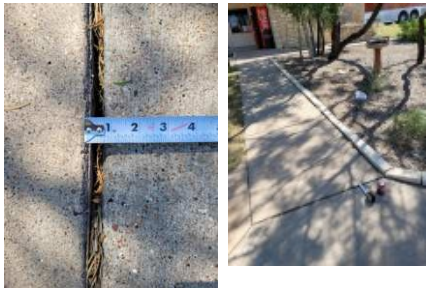
| Finding Number | Area Description | Lat/Long | Finding | As Built | Recommendation | Citation | Photos | Figure |
|---|---|---|--|---|---|--|---|---|
| 502 | South Gate Entry: Parking at South Gate Entry | [31.464, -100.5081] | There is a gap spaced greater than a 1/2 inch. Openings in floor or ground surfaces shall not allow passage of a sphere more than 1/2 inch diameter. Elongated openings shall be placed so that the long dimension is perpendicular to the dominant direction of travel. | 1" gap on approach to building | Correct or fill gaps to be max .5" | 2015 ABAAS Section: 302.3 2012 TAS Section: 302.3 2010 ADAS Section: 302.3 | | |
