# Abilene LE- ADA Evaluation

**LE- Abilene TX, ADA Evaluation**  
**281 N Willis St**  
**Westwood Richland, TX 79603**  
**Accessibility Evaluation**  
**Inspection Date: 05/08/2023**  
**Inspectors: Christopher Meza**

Report Date: 01/12/2024

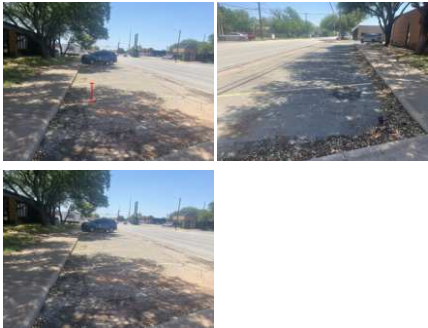
4	Exterior of Property (Public): Parking Lot ( 0 Spaces) - Accessible Van Stall Requirements	The accessible parking space is missing the required markings. Vehicle spaces shall be marked to define the width, and shall have an adjacent access aisle.	Van accessible space requires ISA marking and defined borders with access aisle.	<a href="https://www.access-board.gov/ada/#ada-502_2">https://www.access-board.gov/ada/#ada-502_2</a>	2012 TAS Section: 502.2  2010 ADAS Section: 502.2

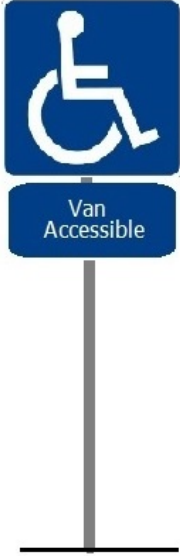
Finding Number	Area Description	Finding	As Built	Recommendation	Citation	Photos	Figure
5	Exterior of Property (Public): Parking Lot ( 0 Spaces) - Accessible Van Stall Requirments	The van stall is missing a sign identifying it as a van accessible stall. Parking space identification signs shall include the International Symbol of Accessibility. Signs identifying van parking spaces shall contain the designation "van accessible."	There are no signs		<a href="https://www.access-board.gov/ada/#ada-502_6">https://www.access-board.gov/ada/#ada-502_6</a>	2012 TAS Section: 502.6 2010 ADAS Section: 502.6

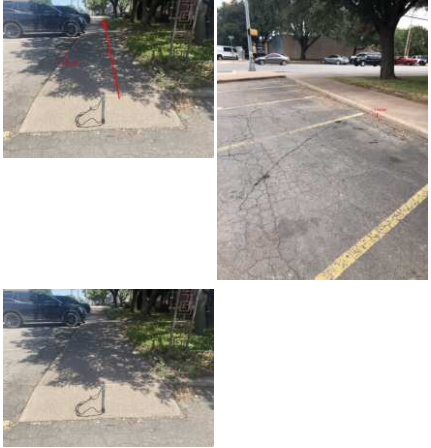
Finding Number	Area Description	Finding	As Built	Recommendation	Citation	Photos	Figure
8	Exterior of Property (Public): Path of Travel to Building	The building entrance is not located on an accessible route. When a building, or portion of a building, is required to be accessible, an accessible route of travel shall be provided to all portions of the building, to accessible building entrances and between the building and the public way. At least one accessible route within the boundary of the site must be provided from public transportation stops, accessible parking and accessible passenger loading zones and public streets or sidewalks to the accessible building entrance they serve. The accessible route shall, to the maximum extent feasible, coincide with the route for the general public. At least one accessible route shall connect accessible buildings, facilities, elements and spaces that are on the same site. At least one accessible route shall connect accessible building or facility entrances with all accessible spaces and elements.	Due to deteriorating condition of pathways, elevated pathway, curb ramp non compliance and distance needed to travel there is no accessible route to building entrance. .	<a href="https://www.access-board.gov/ada/#ada-206_2_1">https://www.access-board.gov/ada/#ada-206_2_1</a>	2012 TAS Section: 206.2.1  2010 ADAS Section: 206.2.1

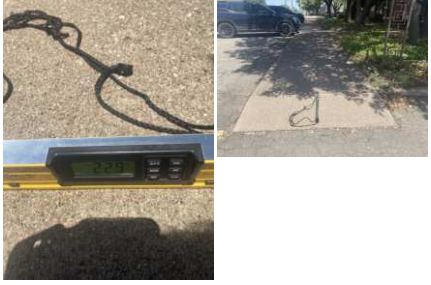
9	Exterior of Property (Public): Path of Travel to Building - Curb Ramp (Main Route)	The curb ramp exceeds the maximum running slope (parallel to the direction of travel) allowable of 8.33%. Curb ramps should have the least possible slope but in no case more than 8.33% (1:12).	Curb ramp running slope is 22.9% Only curb ramp provided is not correctly installed. Curb ramp not in location where accessible parking is.	<a href="https://www.access-board.gov/ada/#ada-405_2">https://www.access-board.gov/ada/#ada-405_2</a>	2012 TAS Section: 406.1  2010 ADAS Section: 406.1

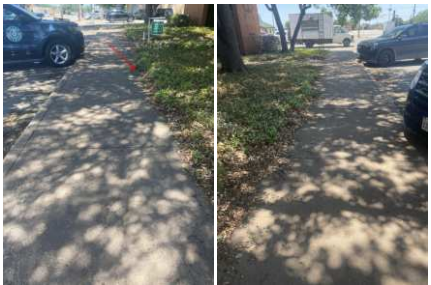
10	Exterior of Property (Public): Path of Travel to Building - Path of Travel (Main Route)	The accessible route contains loose gravel and/or surface materials that do not provide for a stable, firm slip resistant surface. Floor and ground surfaces shall be stable, firm, and slip resistant.	Regular maintenance needed to clear foliage debris from pathway.	<a href="https://www.access-board.gov/ada/#ada-302_1">https://www.access-board.gov/ada/#ada-302_1</a>	2012 TAS Section: 302.1  2010 ADAS Section: 302.1

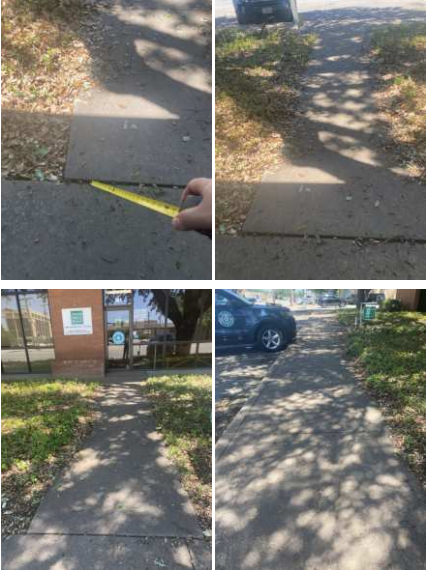
Finding Number	Area Description	Finding	As Built	Recommendation	Citation	Photos	Figure
11	Exterior of Property (Public): Path of Travel to Building - Path of Travel (Main Route)	The route contains openings greater than 1/2 inch. Openings in floor or ground surfaces shall not allow passage of a sphere more than 1/2 inch diameter. Elongated openings shall be placed so that the long dimension is perpendicular to the dominant direction of travel.	There are a few location on pathway with gaps exceeding 1/2" tolerance. See additional photos for location of gap non compliance on accessible pathway to building.	<a href="https://www.access-board.gov/ada/#ada-302_3">https://www.access-board.gov/ada/#ada-302_3</a>	2012 TAS Section: 302.3  2010 ADAS Section: 302.3

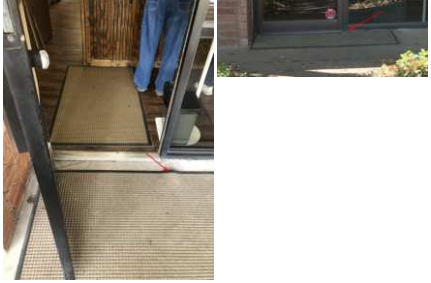
Finding Number	Area Description	Finding	As Built	Recommendation	Citation	Photos	Figure
12	First Floor Main Building LOBBY (Public): Entrance into Lobby - Entrance Doors	The floor mat at the door is not secured in place. If carpet or carpet tile is used on a ground or floor surface, then it shall be securely attached; have a firm cushion, pad or backing or no cushion or pad; and have a level loop, textured loop, level-cut pile or level-cut/uncut pile texture. The maximum pile height shall be 1/2 inch. Exposed edges of carpet shall be fastened to floor surfaces and have trim along the entire length of the exposed edge. Recessed doormats shall be adequately anchored to prevent interference with wheelchair traffic.	Floor Mat (exterior) determined to be non-compliant due to current condition and folding edges.	<a href="https://www.access-board.gov/ada/#ada-302_2">https://www.access-board.gov/ada/#ada-302_2</a>	2012 TAS Section: 302.2 2010 ADAS Section: 302.2

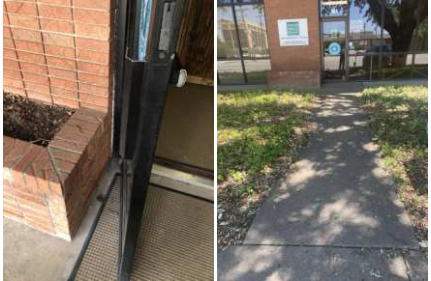
14	First Floor Main Building LOBBY (Public): Entrance into Lobby - Entrance Doors	The door does not open at least 90 degrees. Door openings shall provide a clear width of 32 inches minimum. Clear openings of doorways with swinging doors shall be measured between the face of the door and the stop, with the door open 90 degrees. There shall be no projections into the required clear opening width lower than 34 inches above the finish floor or ground. Projections into the clear opening width between 34 inches and 80 inches above the finish floor or ground shall not exceed 4 inches.	Entrance door does not open 90 degrees	<a href="https://www.access-board.gov/ada/#ada-404_2_3">https://www.access-board.gov/ada/#ada-404_2_3</a>	2012 TAS Section: 404.2.3 2010 ADAS Section: 404.2.3

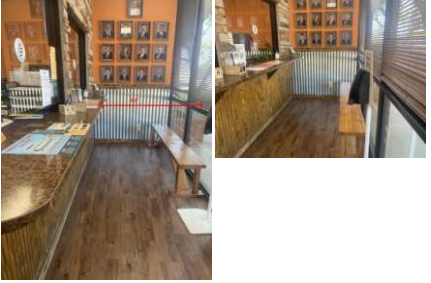
Finding Number	Area Description	Finding	As Built	Recommendation	Citation	Photos	Figure
15	First Floor Main Building LOBBY (Public): Lobby Area	The queuing line is not a minimum 60 inches at the head of each turn with entry widths of 36 inches minimum. Where the accessible route makes a 180 degree turn around an element which is less than 48 inches wide, clear width shall be 42 inches minimum approaching the turn, 48 inches minimum at the turn and 42 inches minimum leaving the turn. Where the clear width at the turn is 60 inches minimum a clear width 36 inches minimum approaching the turn and 36 inches minimum at the turn is acceptable.	There is not enough space provided to perform turn around or have 2 paths of travel simultaneously. Lobby area is tight and does not meet 60" minimum for entirety of lobby. Space from service desk counter to window measures at 49"	<a href="https://www.access-board.gov/ada/#ada-403_5_2">https://www.access-board.gov/ada/#ada-403_5_2</a>	2012 TAS Section: 403.5.2  2010 ADAS Section: 403.5.2

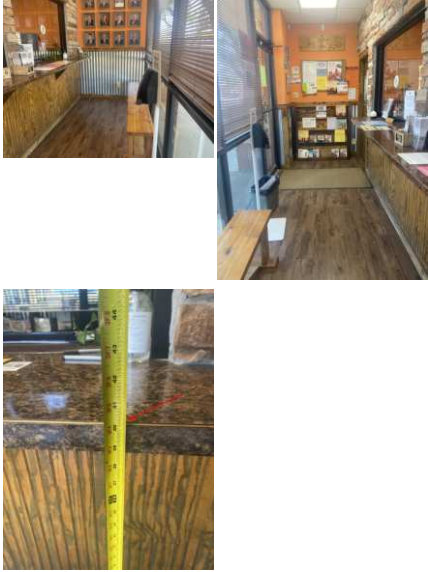
Finding Number	Area Description	Finding	As Built	Recommendation	Citation	Photos	Figure
17	First Floor Main Building LOBBY (Public): Lobby Area - Service Counter	The sales or service counter does not allow for a forward or parallel approach. Accessible counters must provide a compliant forward or parallel approach. Forward approach requirements Space under an element between the finish floor or ground and 9 inches above the finish floor or ground shall be considered toe clearance. Toe clearance shall extend 25 inches maximum and 17 inches minimum under an element. Space extending greater than 6 inches beyond the available knee clearance at 9 inches above the finish floor or ground shall not be considered toe clearance. Toe clearance shall be 30 inches wide minimum. Space under an element between 9 inches and 27 inches above the finish floor or ground shall be considered knee clearance. Knee clearance shall extend 25 inches maximum under an element at 9 inches above the finish floor or ground. Knee clearance shall be 11 inches deep minimum at 9 inches above the finish floor or ground, and 8 inches deep minimum at 27 inches above the finish floor or ground. Knee clearance shall be 30 inches wide minimum. Parallel approach requirements A portion of the counter surface that is 36 inches long minimum and 36 inches high maximum above the finish floor shall be provided.	Service counter height is 40" There are no accessible service desk at this location. Service counter does not provide knee or toe space for front approach and does not meet requirements for parallel approach.	<a href="https://www.access-board.gov/ada/#ada-904_3_2">https://www.access-board.gov/ada/#ada-904_3_2</a>	2012 TAS Section: 904.4  2010 ADAS Section: 904.4

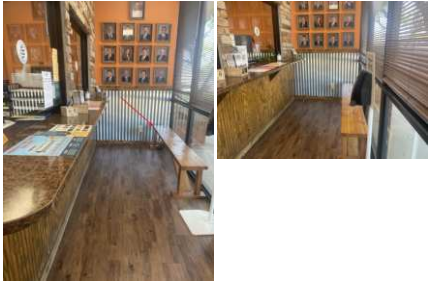
18	First Floor Main Building LOBBY (Public): Lobby Area - Service Counter	The element is not accessible because there is not adequate clear floor space for an approach. The clear floor or ground space shall be 30 inches minimum by 48 inches minimum.	Clear floor space limited by seating bench. Width from window to service desk is 49". Bench limits accessible space to non compliant range.	<a href="https://www.access-board.gov/ada/#ada-305_3">https://www.access-board.gov/ada/#ada-305_3</a>	2012 TAS Section: 305.3  2010 ADAS Section: 305.3

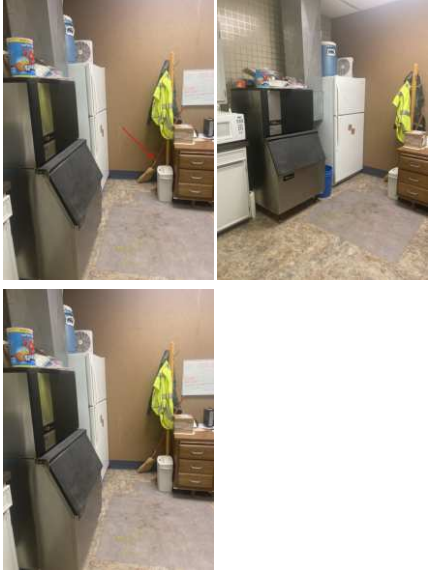
Finding Number	Area Description	Finding	As Built	Recommendation	Citation	Photos	Figure
19	First Floor Main Building (STAFF): Kitchenette	A parallel clear floor space is not provided at the refrigerator/freezer. Combination refrigerators and freezers shall have at least 50 percent of the freezer space 54 inches maximum above the finish floor or ground. The clear floor or ground space shall be positioned for a parallel approach to the space dedicated to a refrigerator/freezer with the centerline of the clear floor or ground space offset 24 inches maximum from the centerline of the dedicated space.	Minimum clear floor space of 30 inches by 48 inches is required in front of a refrigerator to accommodate people using wheelchairs. Trashcan and desk placement prevent parallel approach to Fridge.	<a href="https://www.access-board.gov/ada/#ada-804_6_6">https://www.access-board.gov/ada/#ada-804_6_6</a>	2012 TAS Section: 804.6.6  2010 ADAS Section: 804.6.6

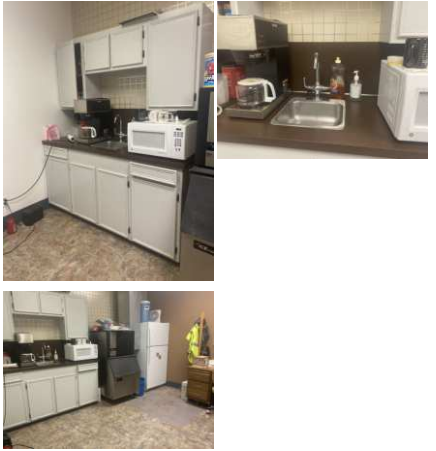
20	First Floor Main Building (STAFF): Kitchenette	The top of the sink is above the allowable height requirement. Sinks shall be installed with the front of the higher of the rim or counter surface 34 inches maximum above the finish floor or ground.	Sink height and counter over 34" Sinks are not accessible via frontal or parallel approach due to rim height. Sinks do not require knee and toe space since there is no stove top oven in vicinity,	<a href="https://www.access-board.gov/ada/#ada-606_3">https://www.access-board.gov/ada/#ada-606_3</a>	2012 TAS Section: 606.3  2010 ADAS Section: 606.3

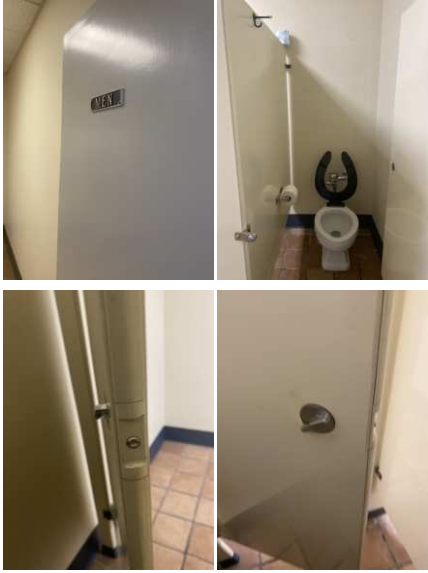
23	First Floor Main Building (STAFF): Restrooms/Water Fountains - Restroom (Men's)	The restroom is not nearly compliant. The restroom does not have the required minimum clear floor space or maneuvering clearances for the toilet. The restroom does not have the required minimum clear floor space or maneuvering clearances for the lavatory. The entry door does not contain the required minimum maneuvering spaces on the pull/push sides. The entry door encroach into the required clear floor space for fixtures. Grab bars are missing and/or incorrectly installed. Accessories, such as toilet seat covers, paper towel holders, garbage cans, hand dryers, and mirrors are either too high or without clear floor space or both. The restroom contain floor level changes greater than a 1/2 inch of the floor drains and is slope (XX) - (XX), the shower is too small and missing numerous accessible elements.	This restroom is for staff only and would need a number of elements installed to gain compliance. - Not enough clear floor space for toilet stall - Stall door encroaches into toilet clear floor space - Stall entrance less than 32" - Stall lock hardware not compliant - Stall door missing handles on both sides - Coat hook height over 48" - ADA stall not compliant dimensions - Side grab bars are not installed - Rear grab bar is not installed - Restroom entrance door over	<a href="https://www.access-board.gov/ada/#ada-213_2">https://www.access-board.gov/ada/#ada-213_2</a> Review restrooms componets to make accessible. <a href="https://www.access-board.gov/ada/#ada-603">https://www.access-board.gov/ada/#ada-603</a>	2012 TAS Section: 213.2 2010 ADAS Section: 213.2

Finding Number	Area Description	Finding	As Built	Recommendation	Citation	Photos	Figure
			5lbs of operating force - Restroom entrance non compliant hardware (door knobs) - Paper towel dispenser height over 48" - Light switch height over 48" - Restroom sign not compliant

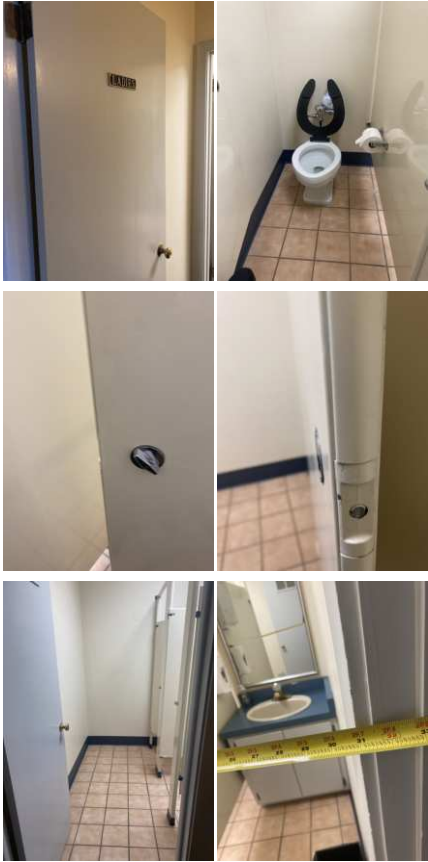
25	First Floor Main Building (STAFF): Restrooms/Water Fountains - Restroom (Women's)	The restroom is not nearly compliant. The restroom does not have the required minimum clear floor space or maneuvering clearances for the toilet. The restroom does not have the required minimum clear floor space or maneuvering clearances for the lavatory. The entry door does not contain the required minimum maneuvering spaces on the pull/push sides. The entry door encroaches into the required clear floor space for fixtures. Grab bars are missing and/or incorrectly installed. Accessories, such as toilet seat covers, paper towel holders, garbage cans, hand dryers, and mirrors are either too high or without clear floor space or both. The restroom contain floor level changes greater than a 1/2 inch of the floor drains and is slope (XX) - (XX), the shower is too small and missing numerous accessible elements.	This restroom is for staff only and would need a number of elements installed to gain compliance. - Not enough clear floor space for toilet stall - Stall door encroaches into toilet clear floor space - Stall entrance less than 32" - Stall lock hardware not compliant - Stall door missing handles on both sides - ADA stall not compliant dimensions - Toilet flusher not on open side - Side grab bars are not installed - Rear grab bar is not installed - Restroom entrance door over 5lbs of operating force - Restroom entrance door less than 32" - Restroom entrance non compliant hardware (door knobs) - Carpet leading to restroom is not accessible - Lavatory is not	<a href="https://www.access-board.gov/ada/#ada-213_2">https://www.access-board.gov/ada/#ada-213_2</a> Review restrooms componets to make accessible. <a href="https://www.access-board.gov/ada/#ada-603">https://www.access-board.gov/ada/#ada-603</a>	2012 TAS Section: 213.2  2010 ADAS Section: 213.2

Finding Number	Area Description	Finding	As Built	Recommendation	Citation	Photos	Figure
			accessible and must provide front approach - Lavatory hardware is not compliant - Clear floor space to lavatory not compliant - Paper towel dispenser height over 48" - Restroom sign not compliant				
26	First Floor Main Building (STAFF): Restrooms/Water Fountains - Restroom (Women's)	Accessible toilets must have grab bars installed. The side grab bar must extend at least 54 inches minimum beyond the rear wall and start a maximum of 12 inches from the rear wall. The rear grab bar must be a minimum of 36 inches long and extend from the centerline of the toilet 12 inches minimum on one side and 24 inches minimum on the other side. Grab bars shall be installed in a horizontal position, 33 inches minimum and 36 inches maximum above the finish floor measured to the top of the gripping surface.	There are no grab bars installed at this time.	<a href="https://www.access-board.gov/ada/#ada-604_5">https://www.access-board.gov/ada/#ada-604_5</a> Review grab bar components to make accessible <a href="https://www.access-board.gov/ada/#ada-609">https://www.access-board.gov/ada/#ada-609</a>	2012 TAS Section: 604.5  2010 ADAS Section: 604.5

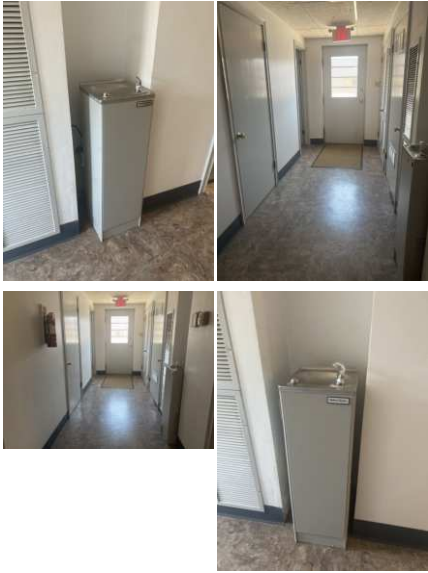
28	First Floor Main Building (STAFF): Restrooms/Water Fountains - Water Fountains	The drinking fountain has multiple violations. Drinking fountains must be on an accessible route that provides a 30 inch by 48 inch clear floor space centered on the low unit, allowing a forward approach. Spout outlets shall be 36 inches maximum above the finish floor or ground. Spout outlets of drinking fountains for standing persons shall be 38 inches minimum and 43 inches maximum above the finish floor or ground. The spout shall be located 15 inches minimum from the vertical support and 5 inches maximum from the front edge of the unit, including bumpers. The spout shall provide a flow of water 4 inches high minimum and shall be located 5 inches maximum from the front of the unit. The angle of the water stream shall be measured horizontally relative to the front face of the unit. Where spouts are located less than 3 inches of the front of the unit, the angle of the water stream shall be 30 degrees maximum. Where spouts are located between 3 inches and 5 inches maximum from the front of the unit, the angle of the water stream shall be 15 degrees maximum. Operable parts shall comply with applicable standards.	This water fountain is not compliant. The Building Code may only require one drinking fountain be provided, but the Accessibility Standards require at least two. One at a lower height and the other at standing height.	Clear floor space <a href="https://www.access-board.gov/ada/#ada-403_5_1">https://www.access-board.gov/ada/#ada-403_5_1</a> Drinking fountain requirements, general <a href="https://www.access-board.gov/ada/#ada-602_1">https://www.access-board.gov/ada/#ada-602_1</a> Minimum number <a href="https://www.access-board.gov/ada/#ada-211_2">https://www.access-board.gov/ada/#ada-211_2</a> Standing person requirements <a href="https://www.access-board.gov/ada/#ada-602_7">https://www.access-board.gov/ada/#ada-602_7</a>	2012 TAS Section: 403.5.1, 602.1  2010 ADAS Section: 403.5.1, 602.1
